MISCELLANEOUS PAPER GL-91-6

# GEOPHYSICAL SURVEYS FOR LOCATION OF A SUSPECTED ABANDONED MINE OPENING: GRAYS LANDING SITE

Dwain K. Butler, Thomas B. Kean II

Geotechnical Laboratory

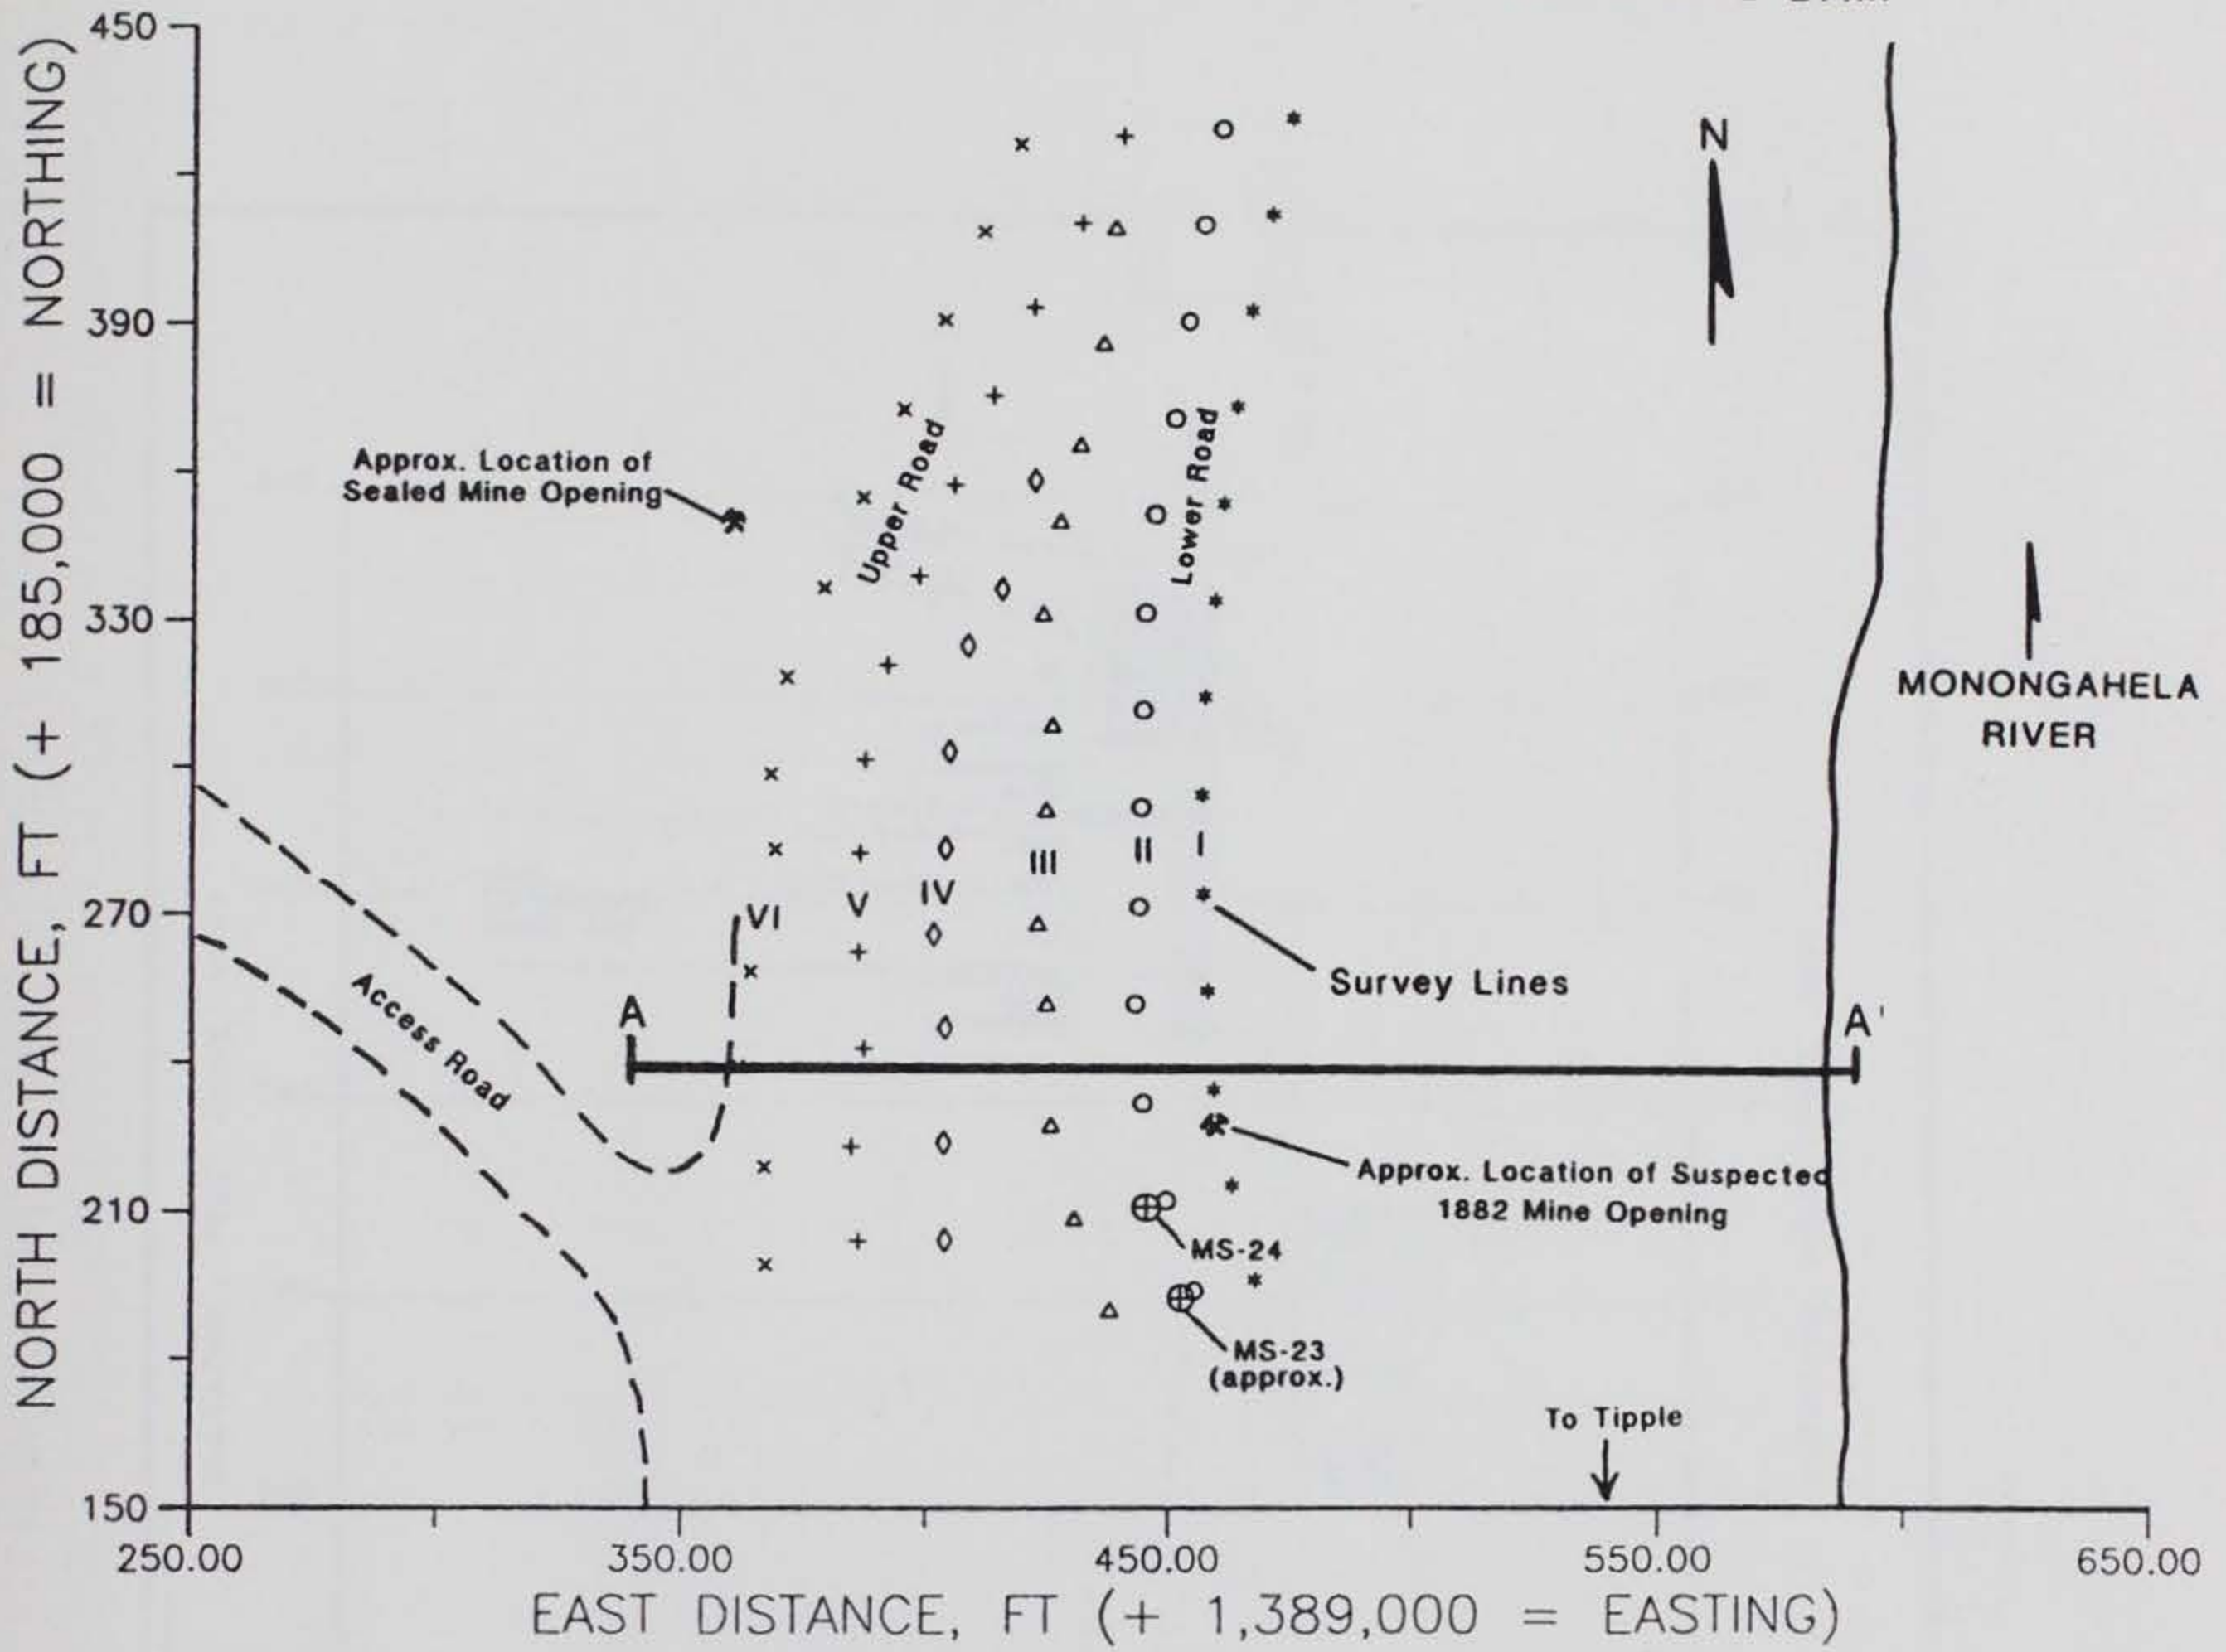
SITE MAP -- LEFT ABUTMENT AREA, GRAYS LANDING LOCK AND DAM

2. Geophysical survey lines established in the left abutment area specified by District personnel are shown in Figure 1a. Various site features are also indicated in Figure 1a, including approximate locations for the sealed mine opening and the suspected 1882 mine opening. MS-23 and MS-24 are existing exploratory borings. The survey line locations were determined

Figure 1a. Geophysical survey site map. Roman Numerals indicate geophysical survey lines. Symbols along survey lines indicate flagged locations.

by a Pittsburgh District survey team, the approximate mine opening locations were obtained from "Evaluation of Left Bank (Abutment Side) Mine Seal and Cut Slope Requirements," Appendix D of Design Memorandum No.4, Feature Design Memorandum, Grays Landing Lock and Dam\*, and other site features were obtained from a Borings Plan/Topographic Map provided by District personnel. Figure 1b is a cross-section from the above reference along cross-section AA' in Figure 1a. The individual survey lines are identified in Figures 1a and 2 by Roman Numerals.

3. The survey lines were located by the geophysical survey team and flagged at 20 ft intervals; flagged locations are indicated in Figures 1 and 2 by different symbols for each line. Geophysical measurements along lines I, II, V, and VI were obtained at 10 ft intervals, where points between flags were located by pacing. Lines I and II and lines V and VI are located along the sides of the Lower Road and the Upper Road, respectively, as indicated in Figure 1a. Measurements along lines III and IV, located on a steep slope, were obtained at 20 ft intervals. The following tabulation summarizes the geophysical surveys conducted at the site and gives approximate or "rule of thumb" depths of investigation:

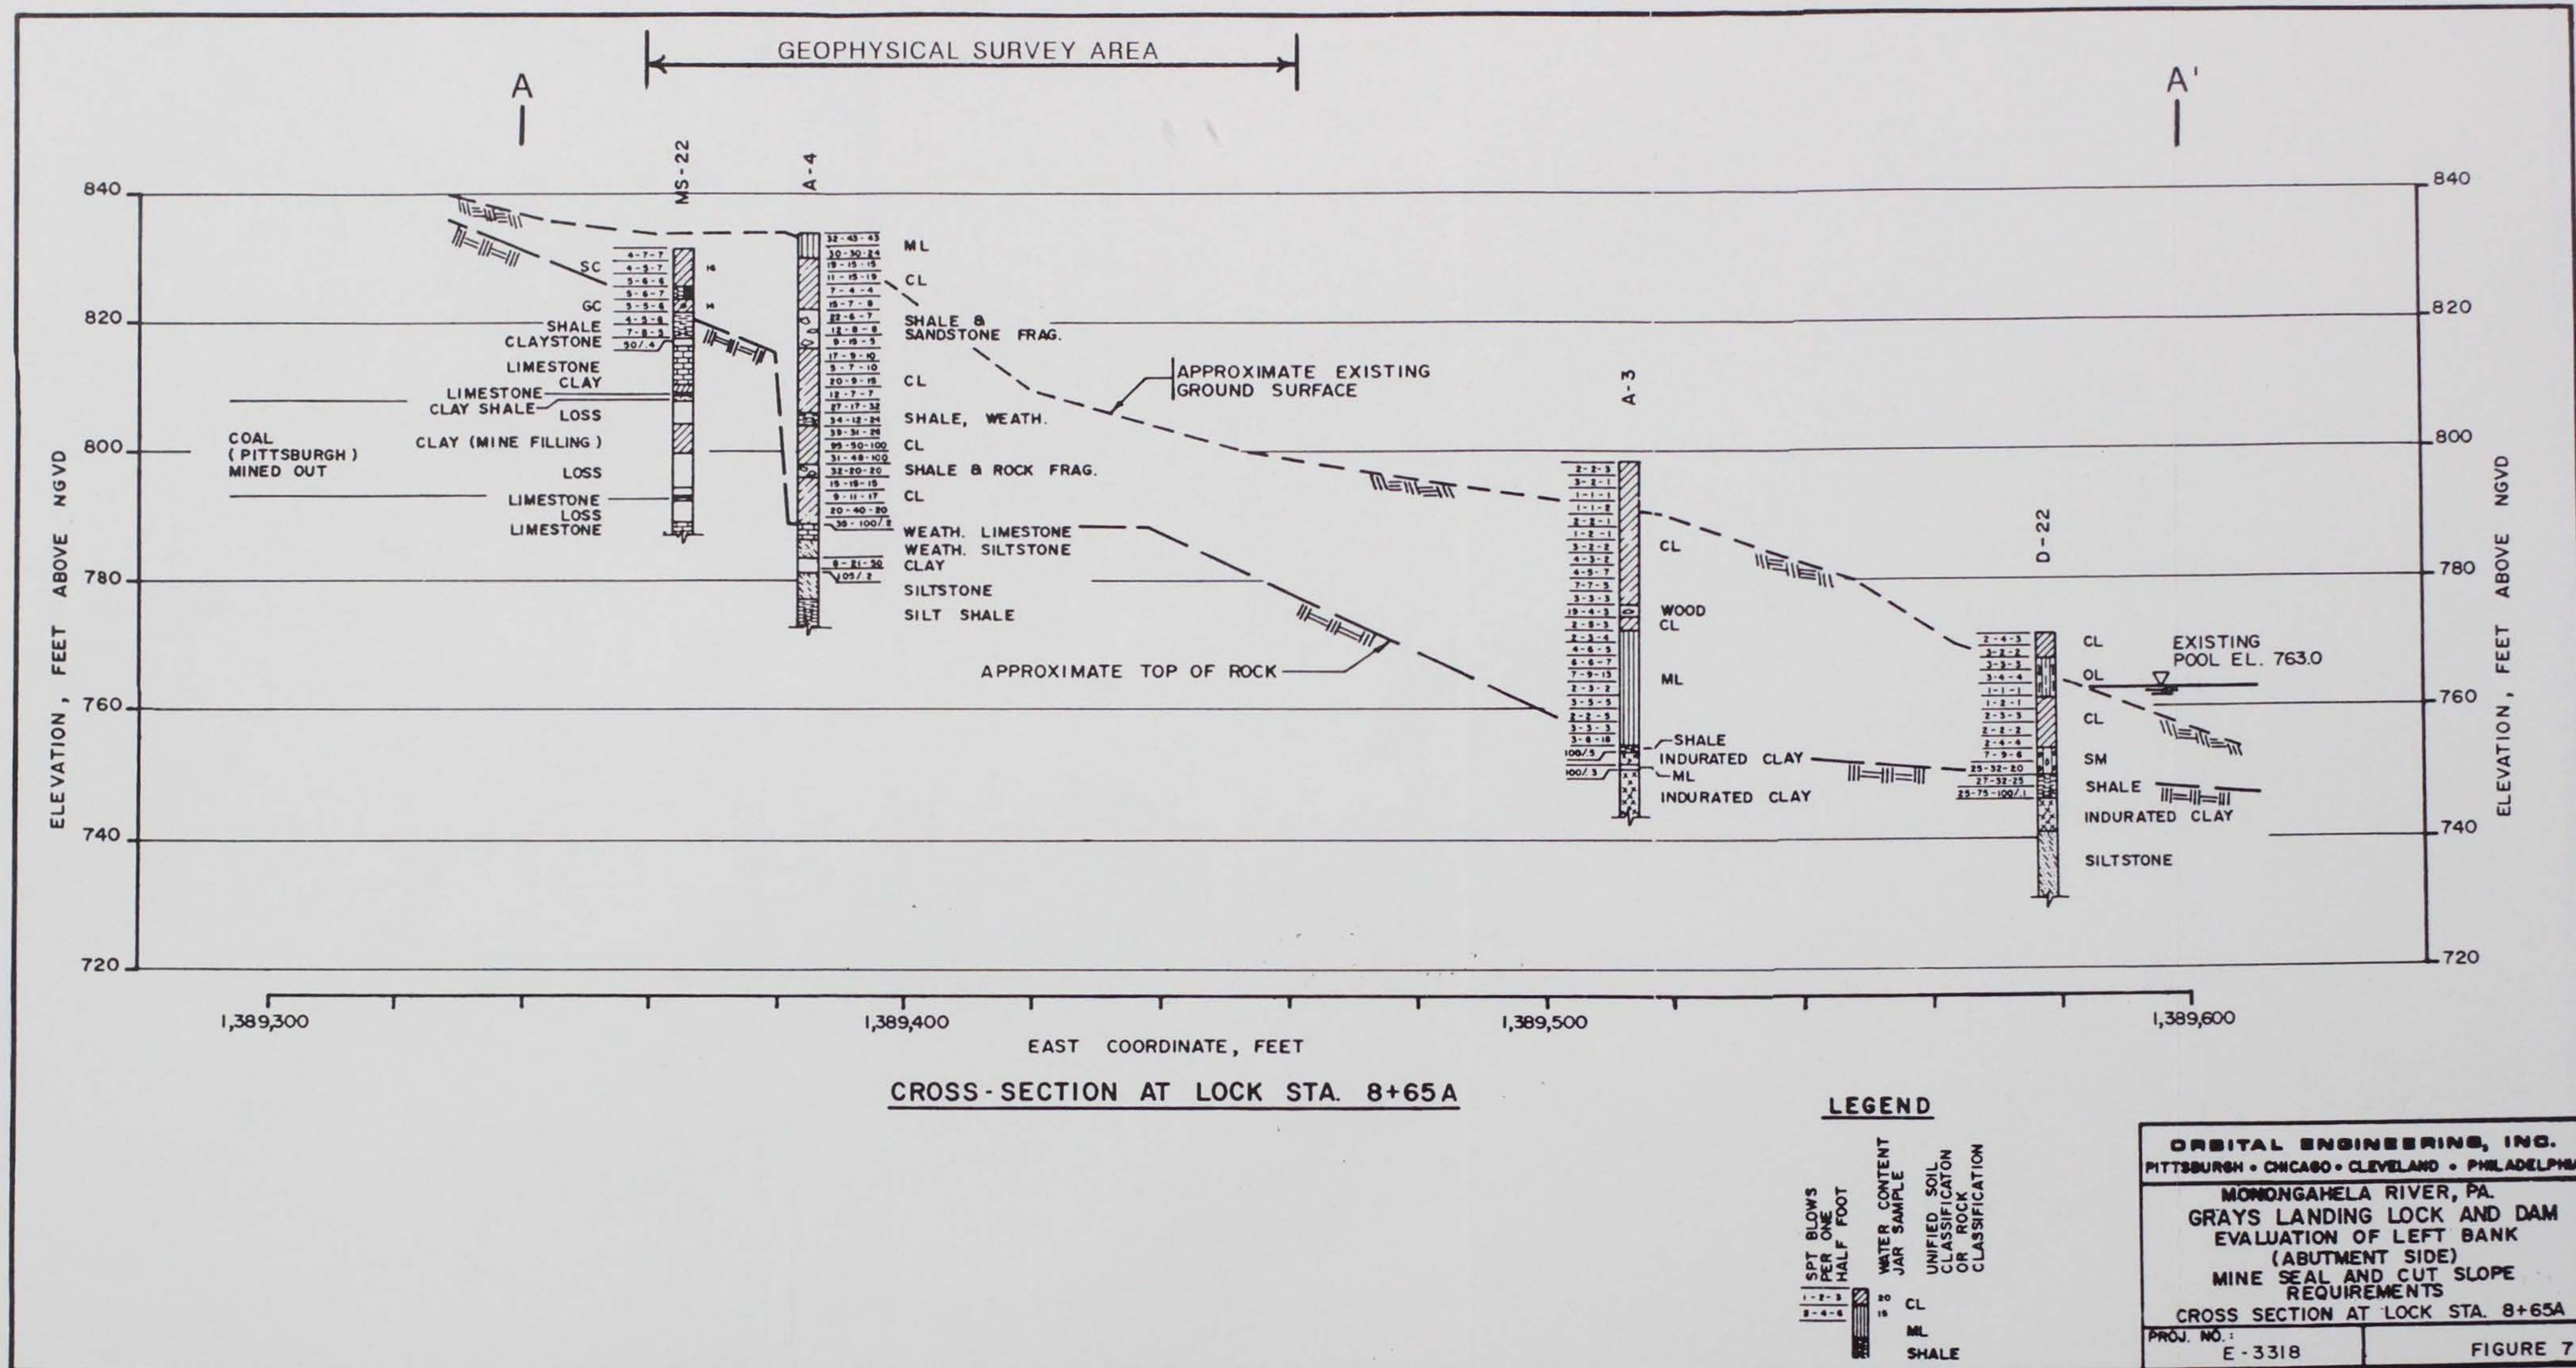
Figure 1b. Cross-section AA'.

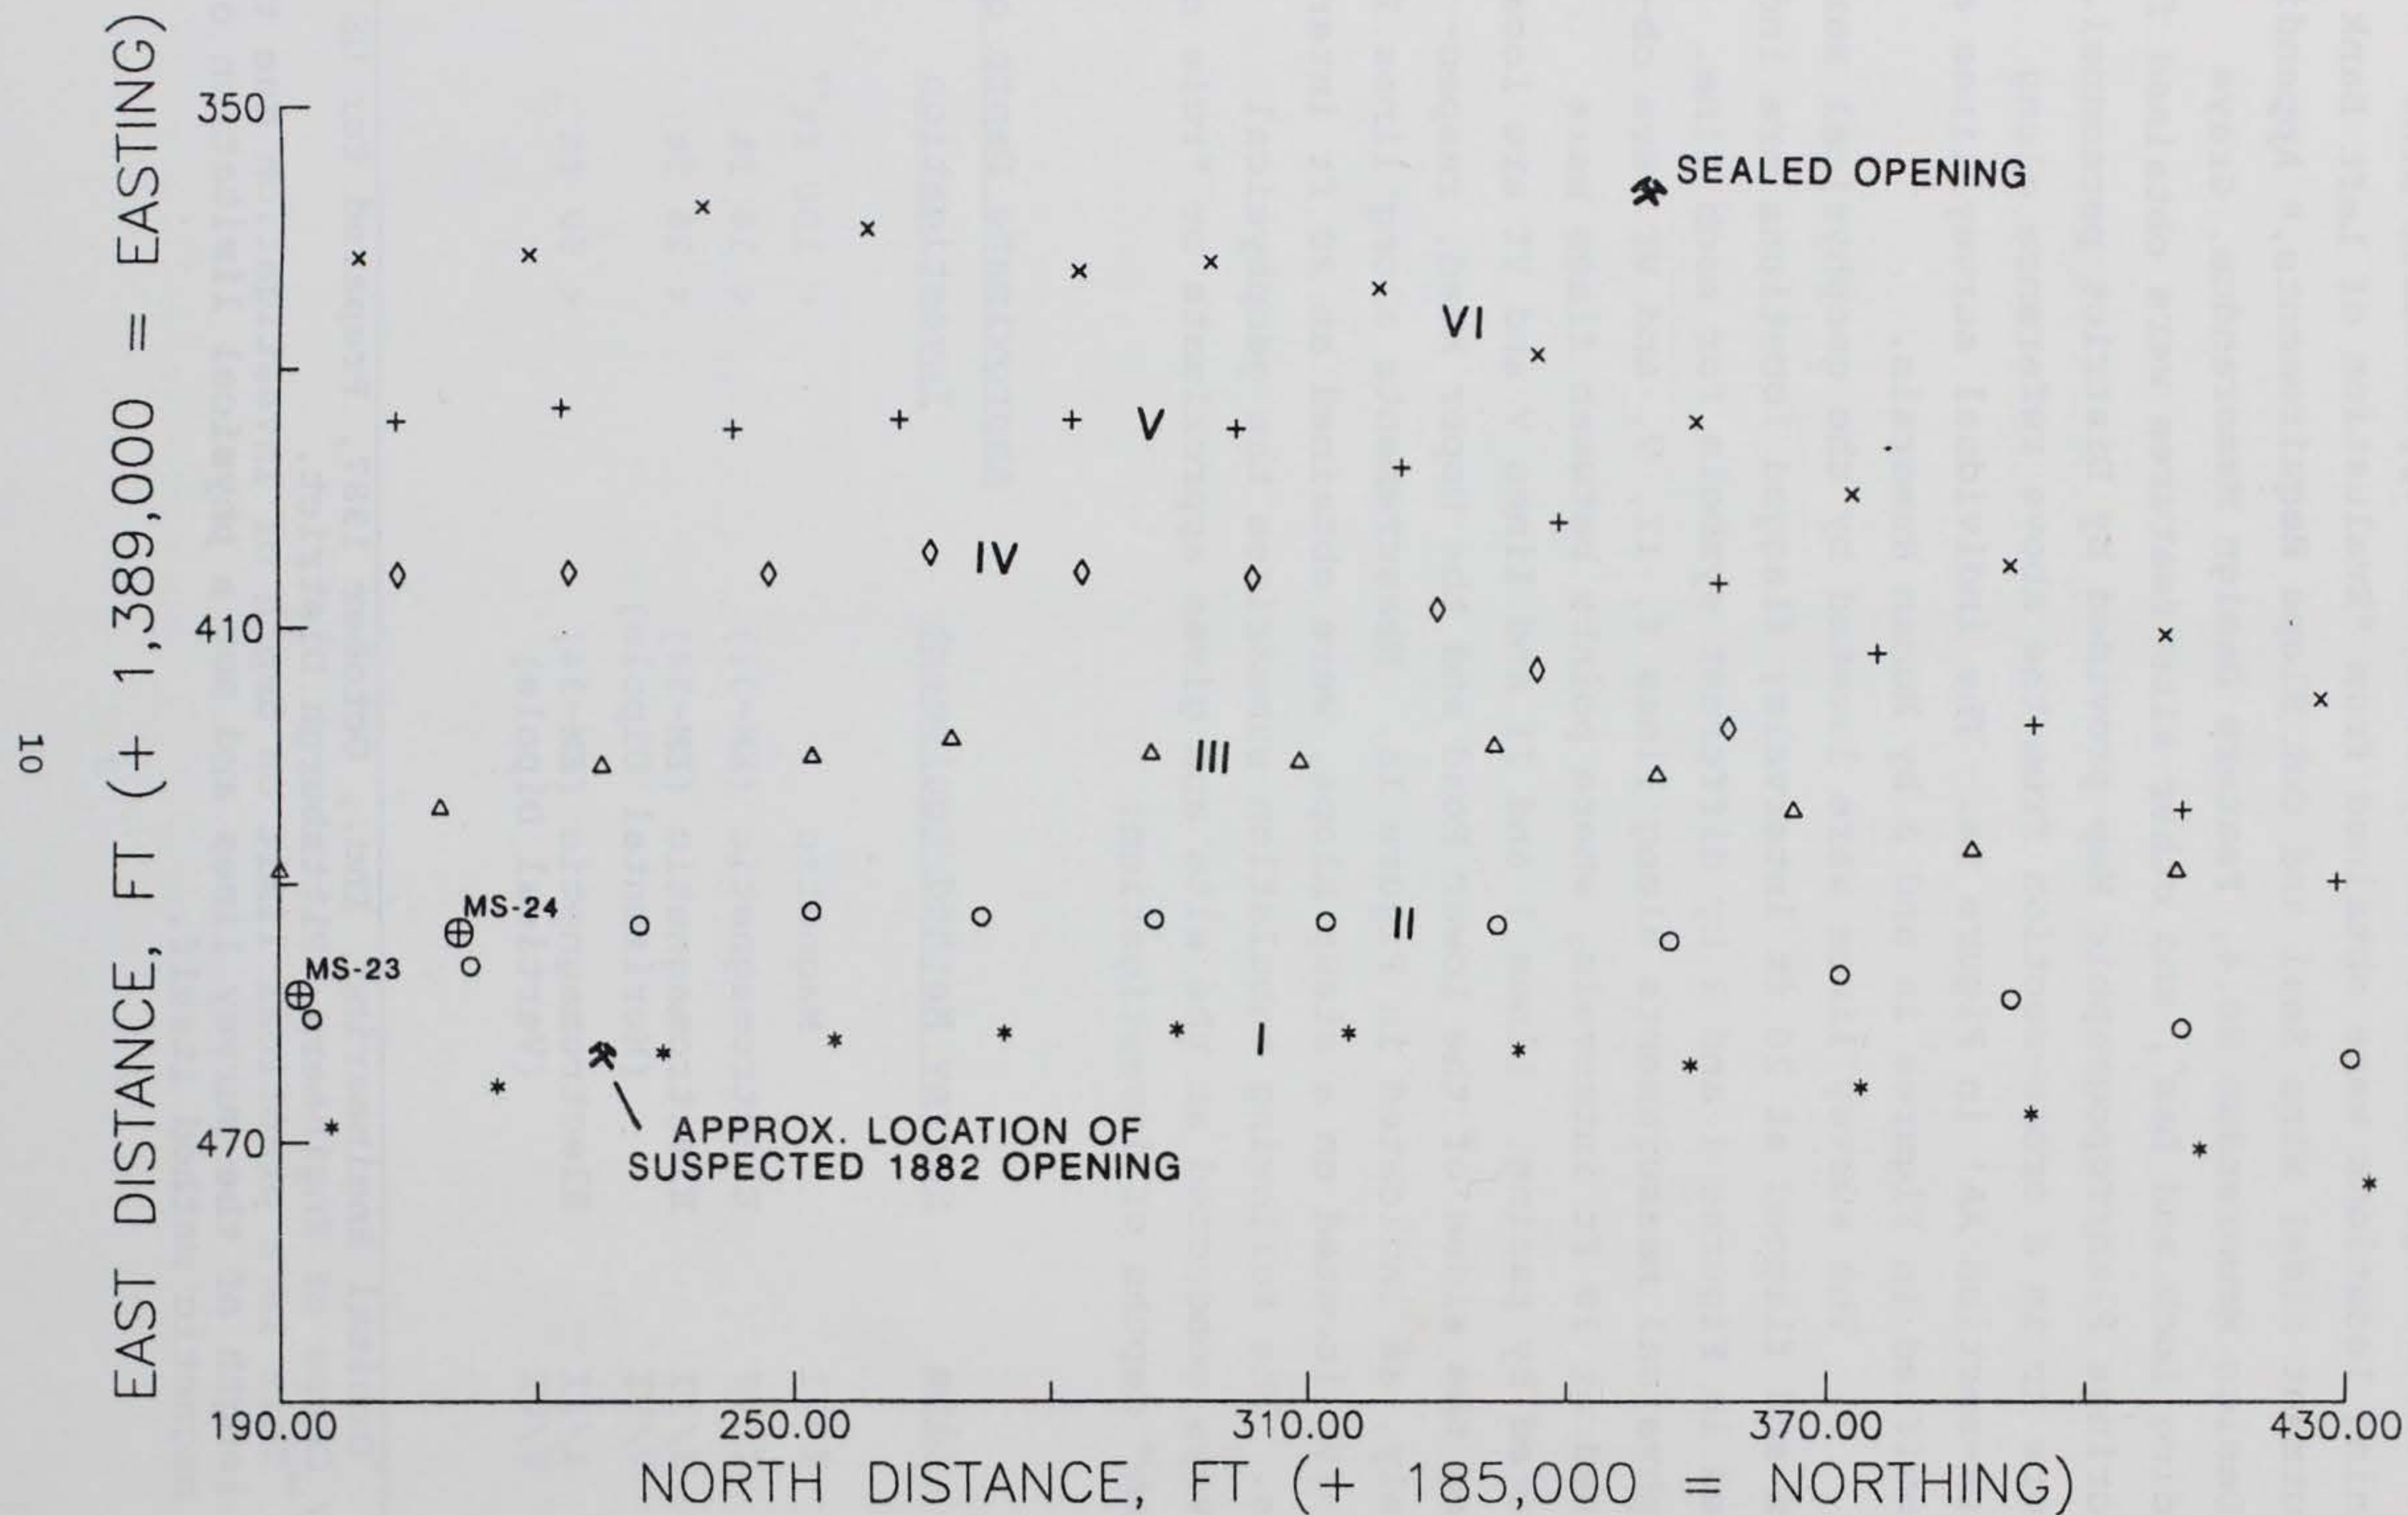
# GRAYS LANDING -- GEOPHYSICAL SURVEY LINES

Figure 2. Geophysical survey lines, designated by Roman Numerals. Different symbols for each survey line designate flagged locations at 20 ft spacing

The designation I/II and V/VI for the EM-34 surveys indicates that the actual measurements were acquired along the Lower Road midway between lines I and II and along the Upper Road midway between lines V and VI, respectively.

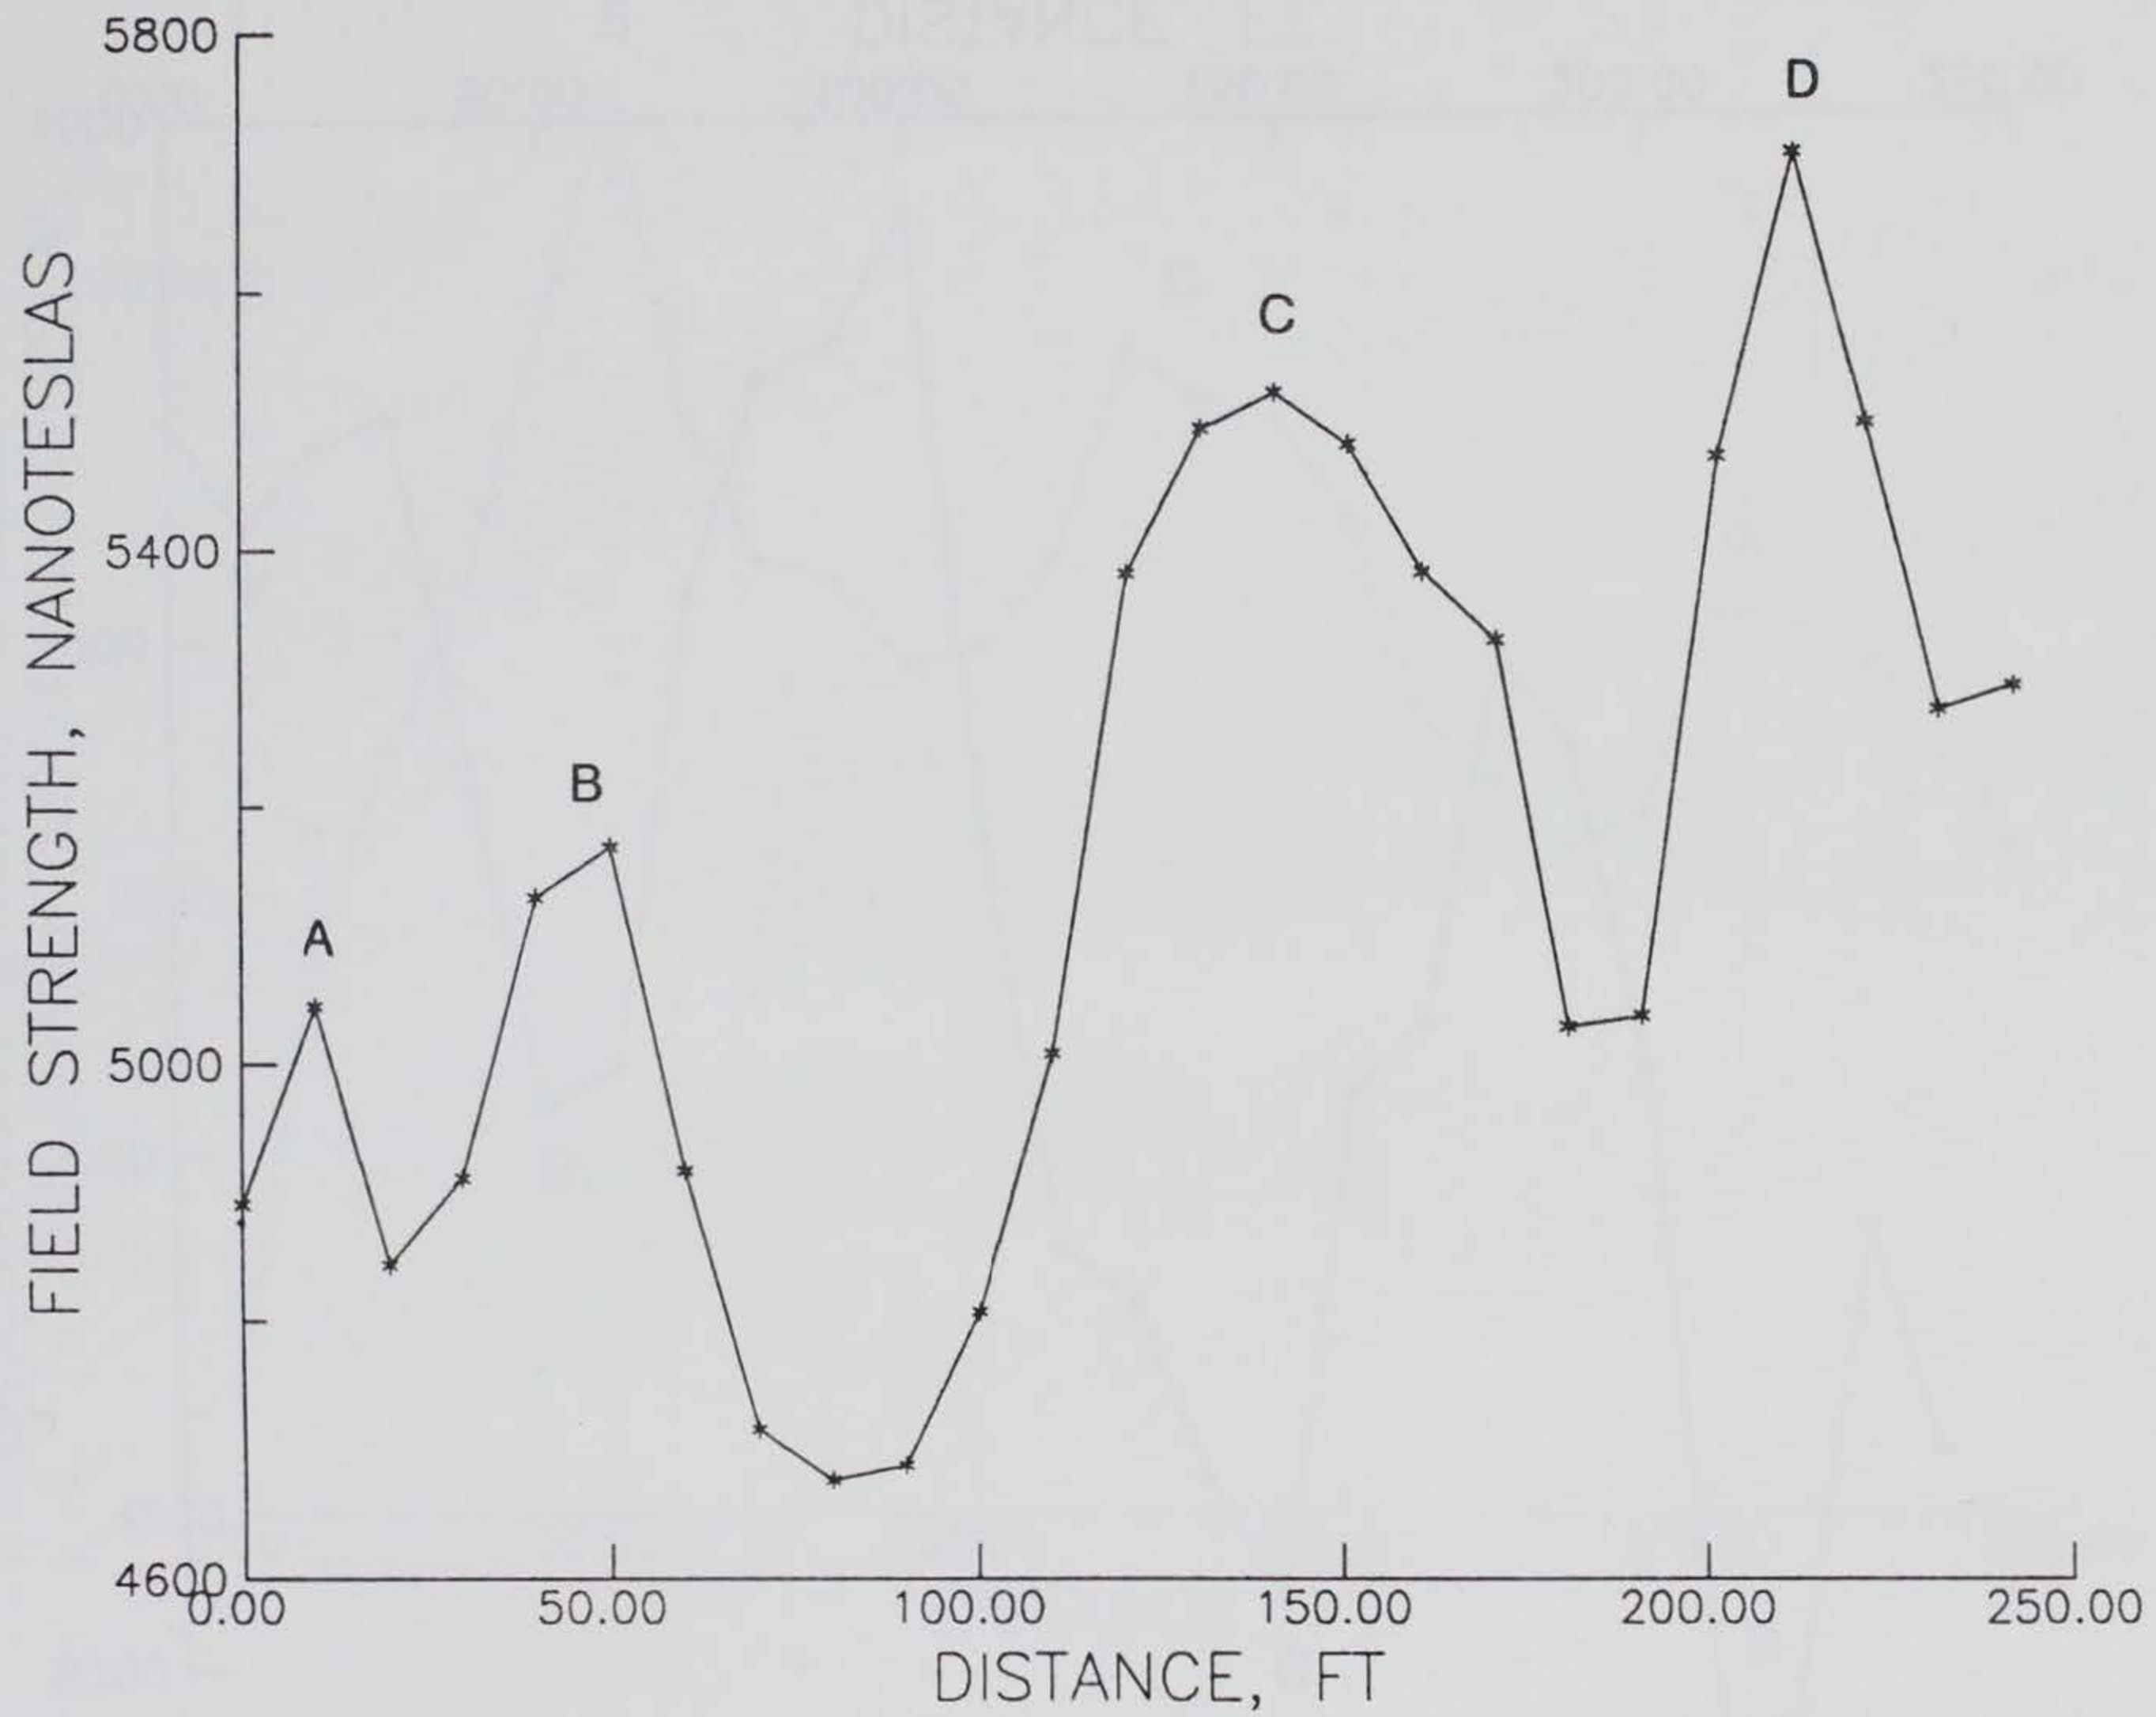
Figure 3. Magnetic survey data, line 1

8. Variation of the magnetic field strength with time, during the survey, was negligible. The field strength values in Figures 3-6 are the measured total magnetic field strengths minus 50,000 nT. Results of the magnetic survey exhibit significant variation along each of the survey lines. Due to their close proximity, lines I and II are qualitatively similar with regard to number and location of maxima and minima. Likewise, lines V and VI are qualitatively similar. There is also some qualitative similarity between the two sets of survey lines; this similarity is indicated in Figures 3-6 by letter labels assigned to the major profile maxima. It appears that the features causing the magnetic anomalies are elongated and pass under the survey lines more or less perpendicular to the lines, consistent with the suspected drift access into the abandoned mine. The qualitative similarity of the anomalies on the four survey lines insures that the anomalies are caused by subsurface metallic features and not scattered surface metallic debris. One qualitative difference between the two sets of magnetic survey data is that overall the magnetic field strength for survey lines I and II increases with increasing distance along the profile line while the data for lines V and VI decrease with increasing distance. This qualitative difference may be due somehow to the fact that the surface elevation increases with distance along I and II but decreases with distance along V and VI.

anomaly maxima to a location under the point of maximum rate of change (slope) (approximately midway) between a maximum and the adjacent minimum located to the north. Closely spaced, sub-surface metallic objects produce magnetic anomalies which overlap, and thus the individual magnetic anomalies cannot be observed completely. Anomaly locations are specified in such a way, i.e., in bands, that this range of possibilities is included; this fact must be remembered when locating boreholes or excavations. Figure 11 is the magnetic anomaly location map, where anomaly bands are indicated and labeled to correspond to anomalies identified in Figures 3-6. Within the bands, locations of the anomaly maxima and points of maximum slope are indicated.

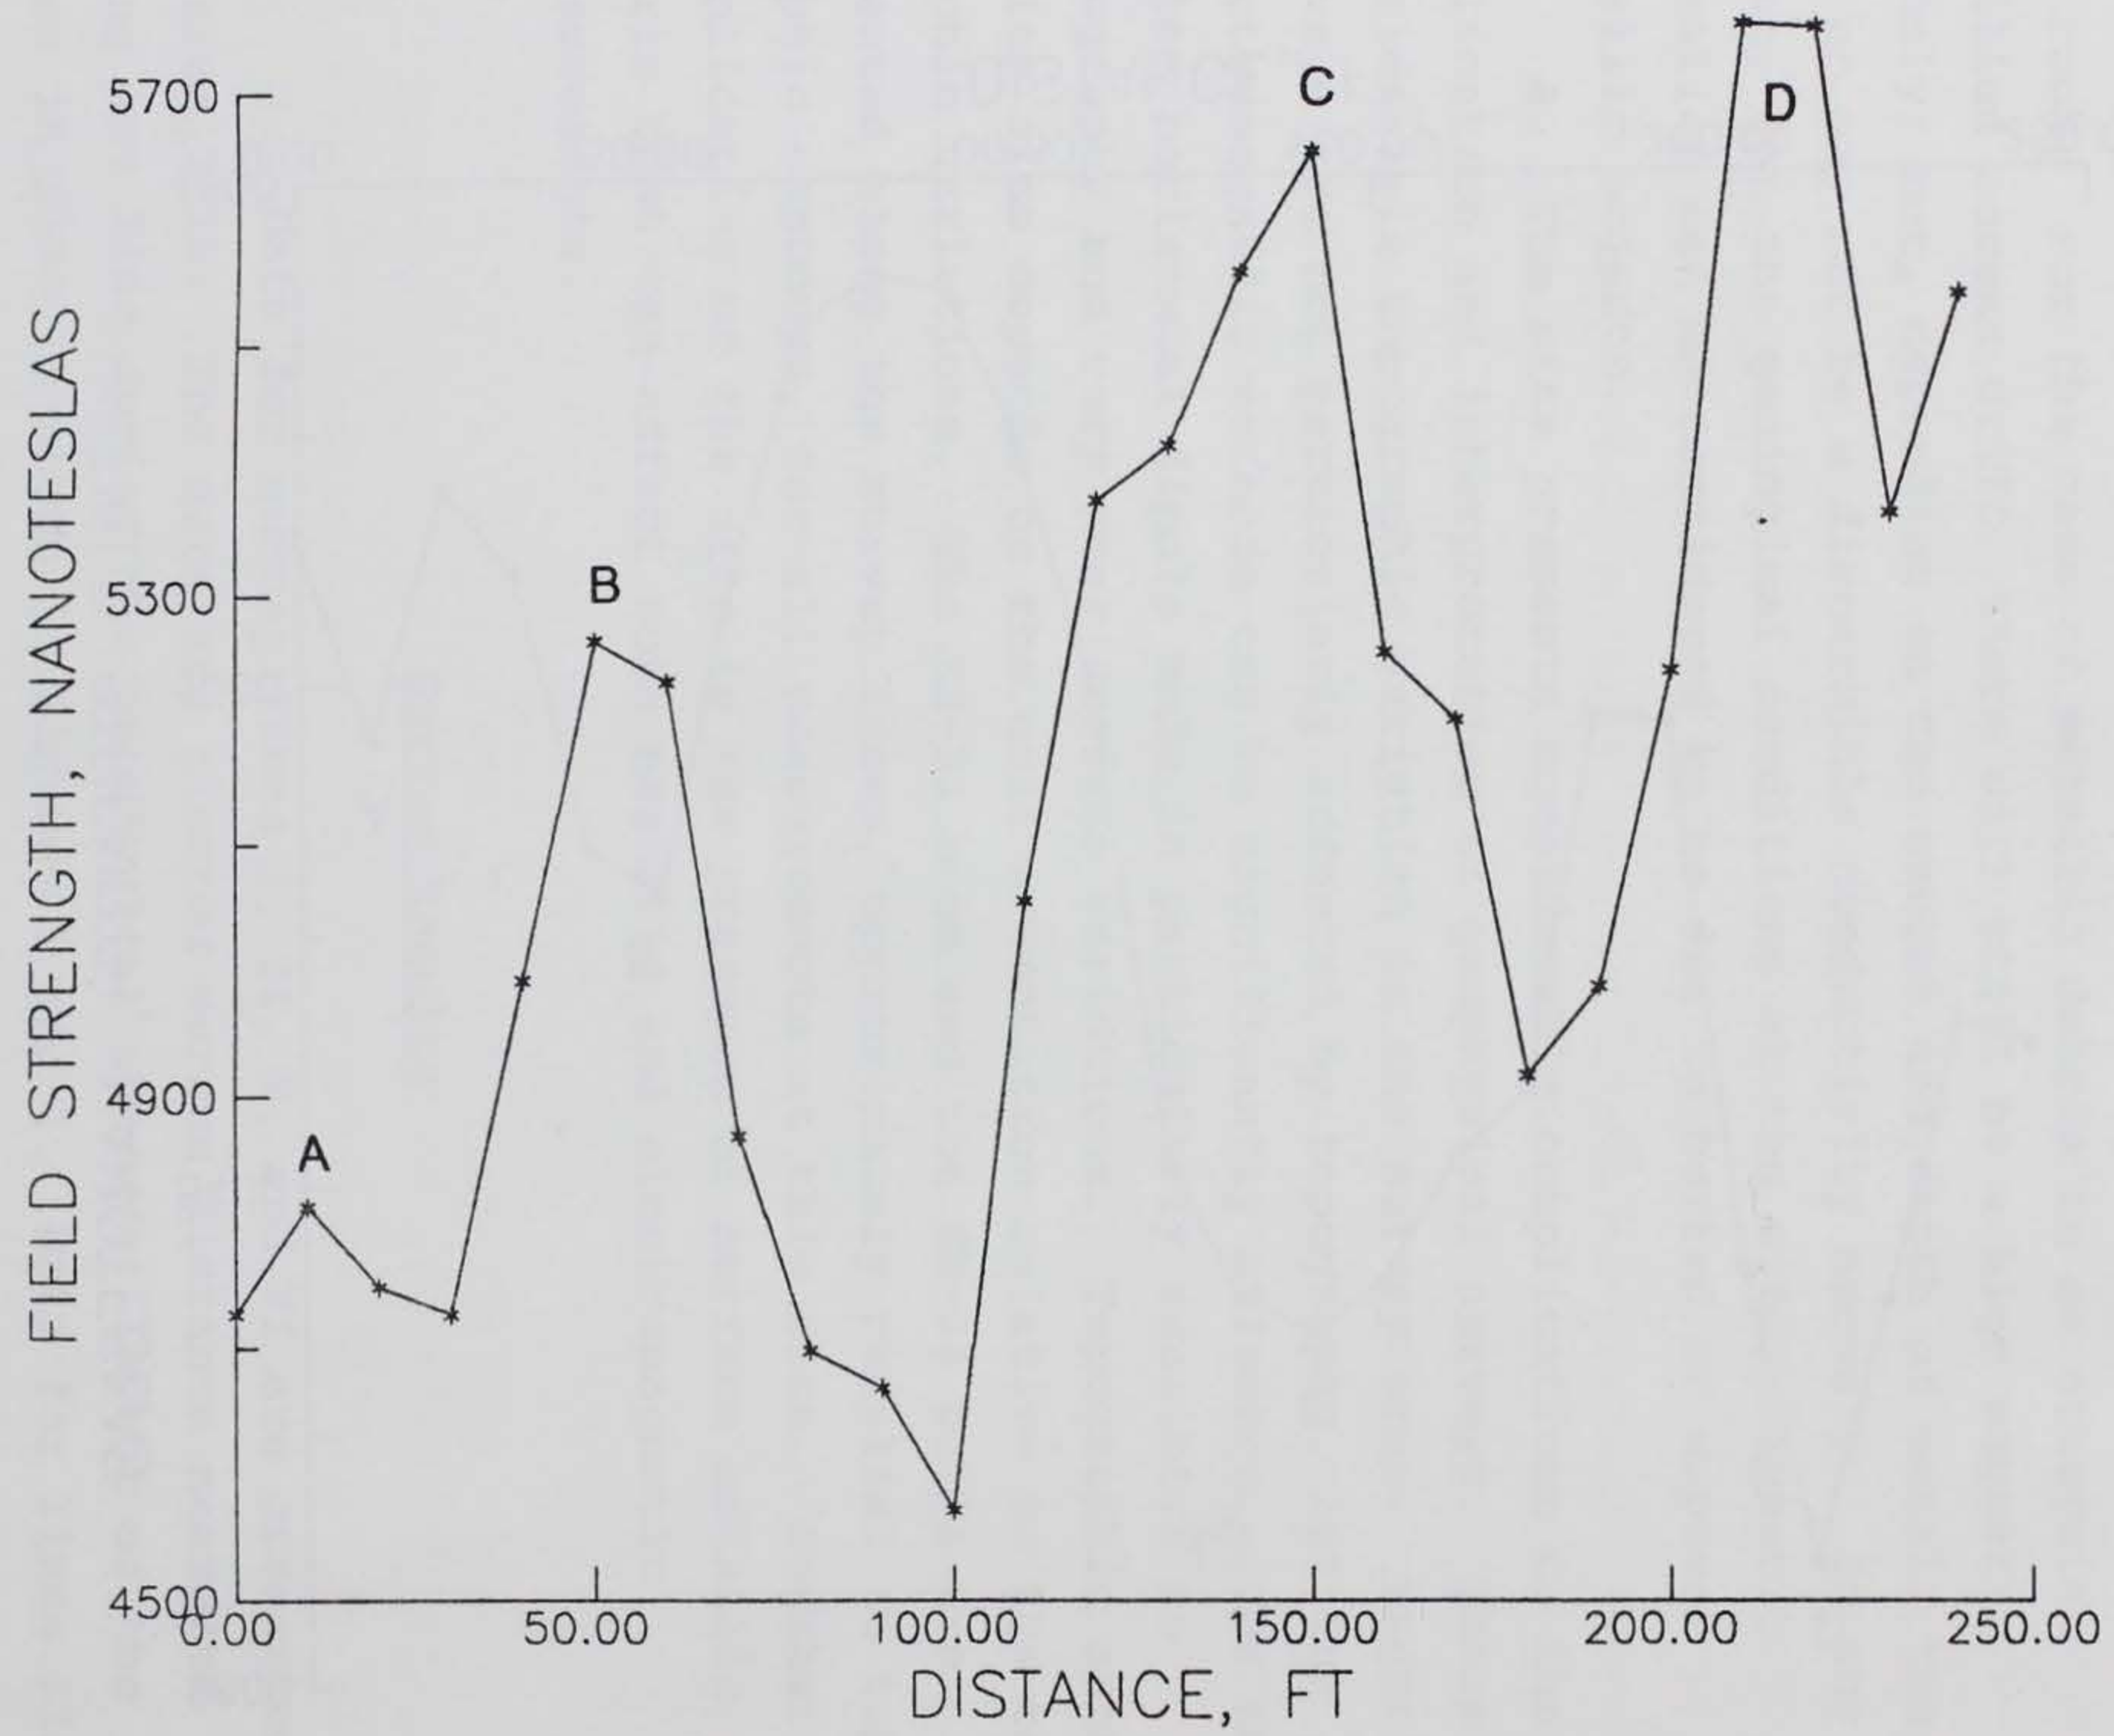
Figure 4. Magnetic survey data, line II
