MISCELLANEOUS PAPER GL-91-6

# GEOPHYSICAL SURVEYS FOR LOCATION OF A SUSPECTED ABANDONED MINE OPENING: GRAYS LANDING SITE

Dwain K. Butler, Thomas B. Kean II

Geotechnical Laboratory

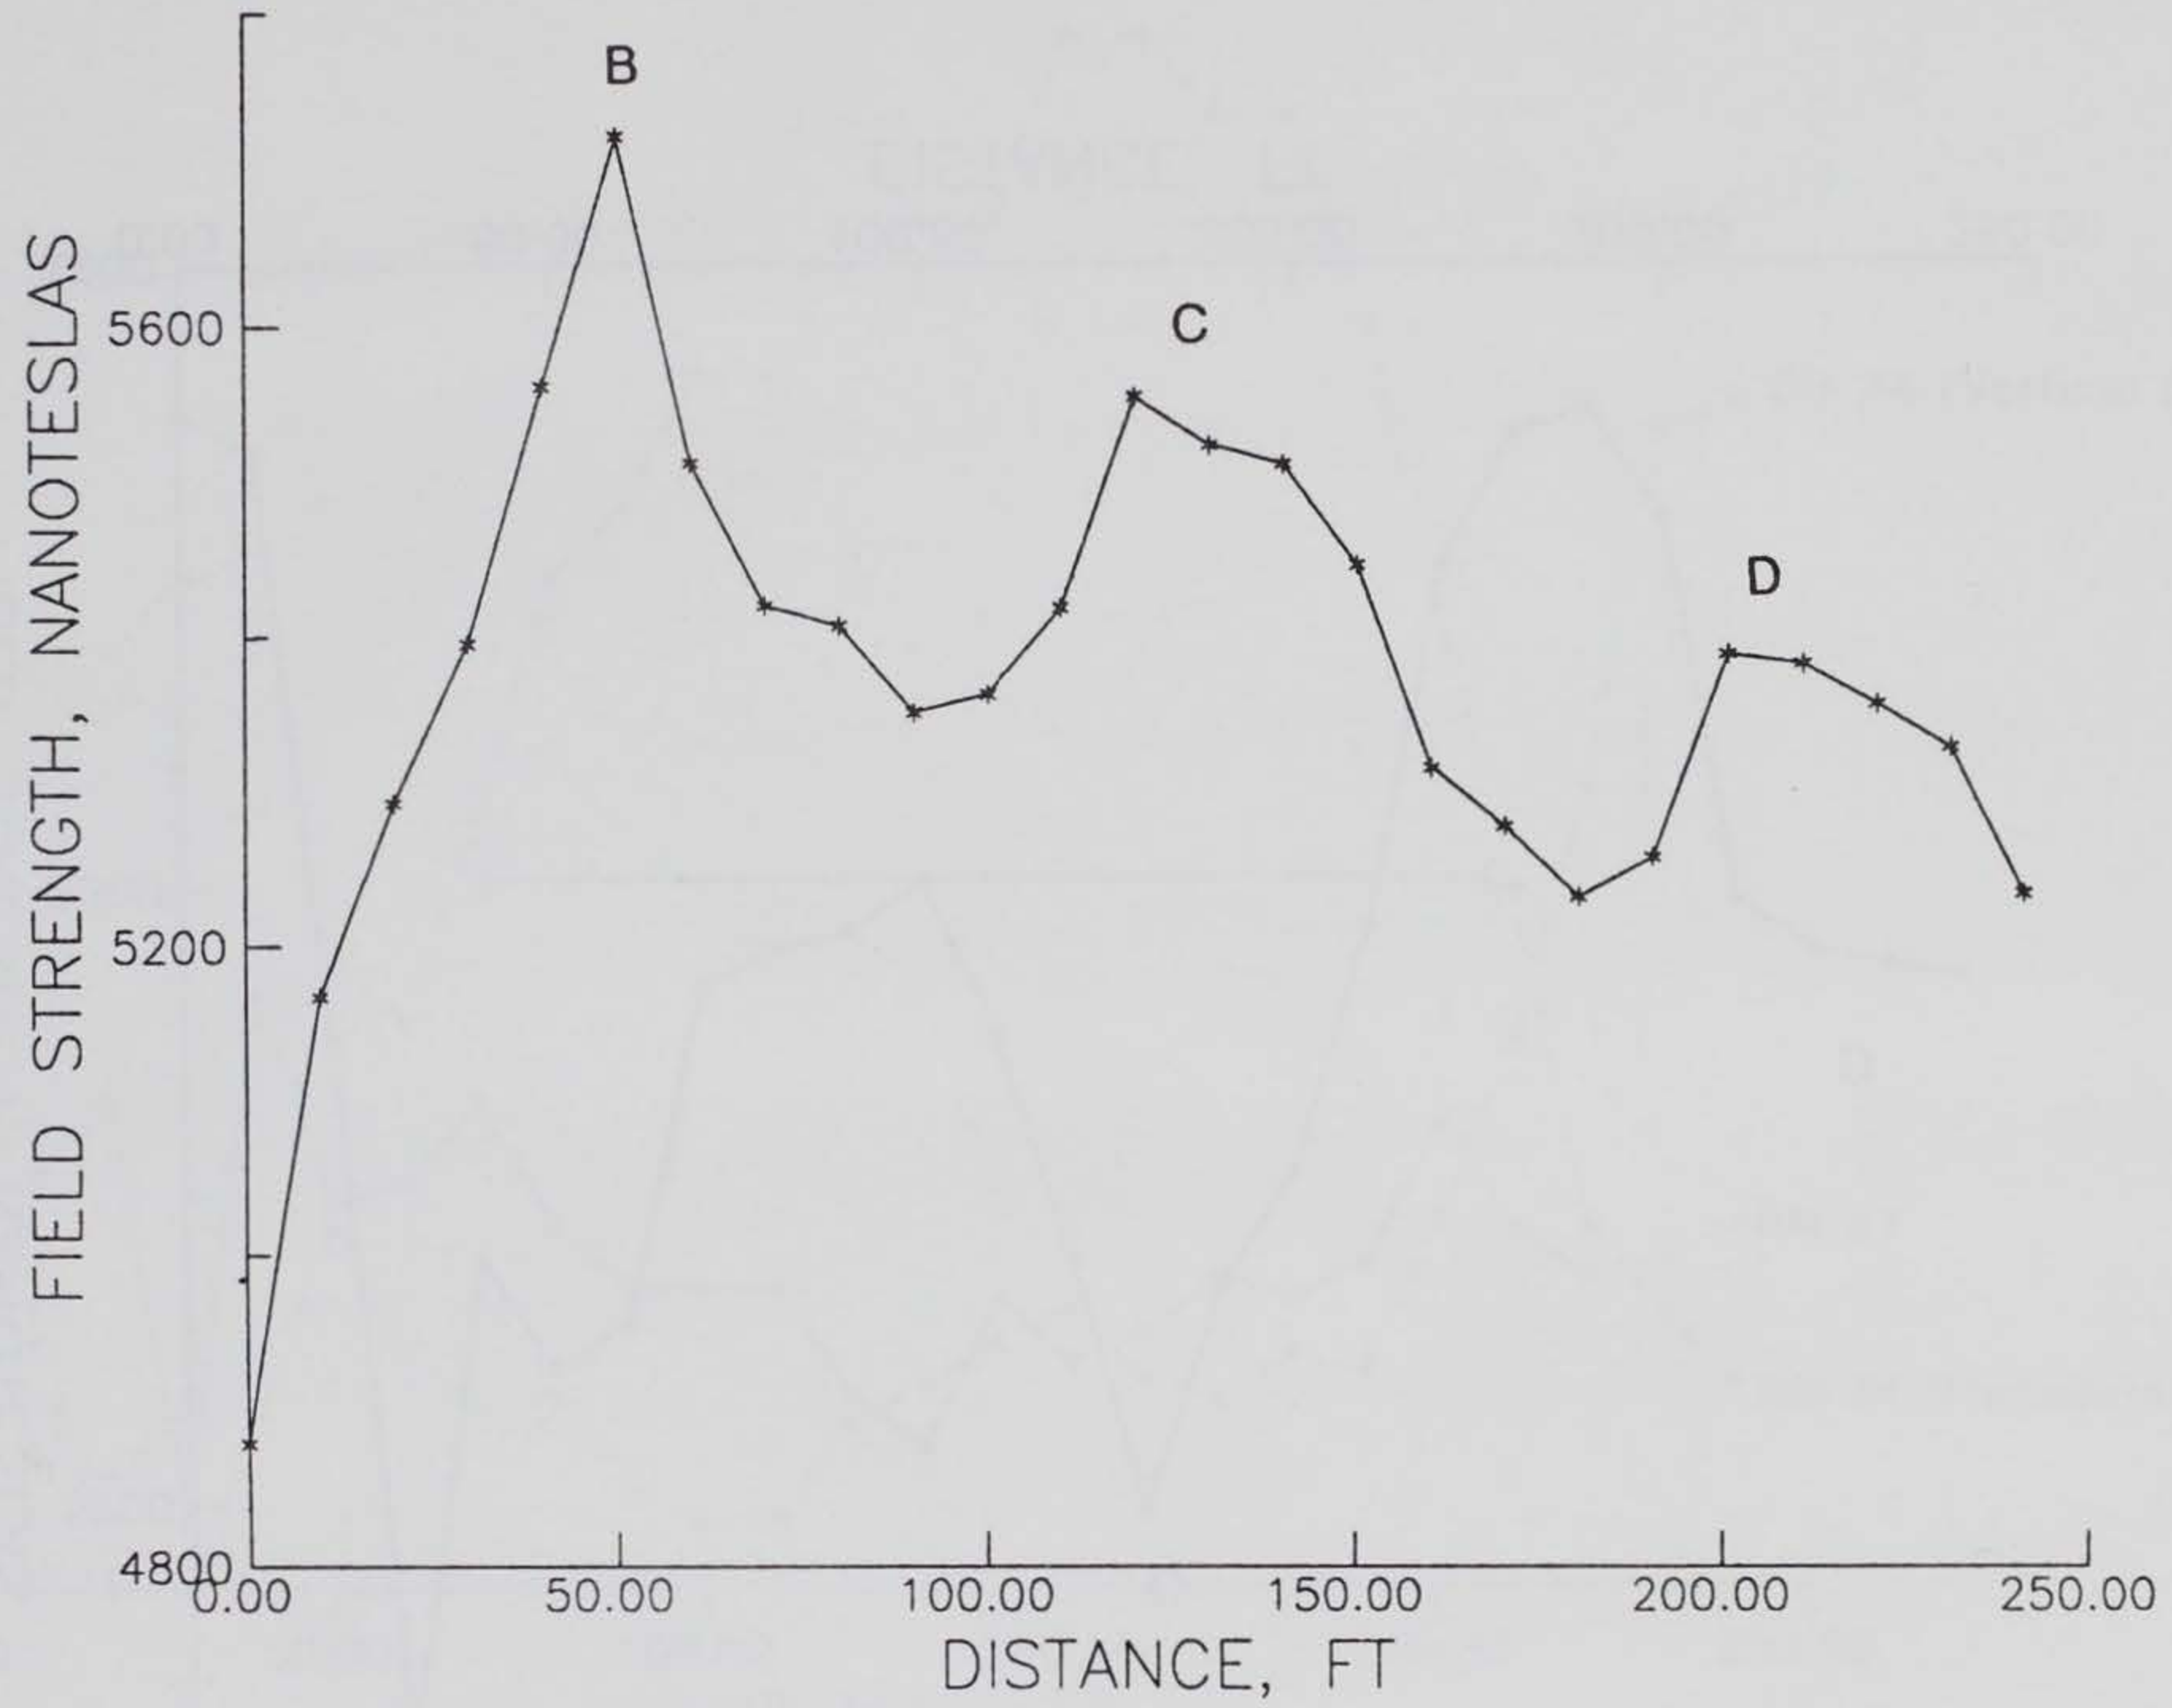
Figure 5. Magnetic survey data, line V

8. Variation of the magnetic field strength with time, during the survey, was negligible. The field strength values in Figures 3-6 are the measured total magnetic field strengths minus 50,000 nT. Results of the magnetic survey exhibit significant variation along each of the survey lines. Due to their close proximity, lines I and II are qualitatively similar with regard to number and location of maxima and minima. Likewise, lines V and VI are qualitatively similar. There is also some qualitative similarity between the two sets of survey lines; this similarity is indicated in Figures 3-6 by letter labels assigned to the major profile maxima. It appears that the features causing the magnetic anomalies are elongated and pass under the survey lines more or less perpendicular to the lines, consistent with the suspected drift access into the abandoned mine. The qualitative similarity of the anomalies on the four survey lines insures that the anomalies are caused by subsurface metallic features and not scattered surface metallic debris. One qualitative difference between the two sets of magnetic survey data is that overall the magnetic field strength for survey lines I and II increases with increasing distance along the profile line while the data for lines V and VI decrease with increasing distance. This qualitative difference may be due somehow to the fact that the surface elevation increases with distance along I and II but decreases with distance along V and VI.

anomaly maxima to a location under the point of maximum rate of change (slope) (approximately midway) between a maximum and the adjacent minimum located to the north. Closely spaced, sub-surface metallic objects produce magnetic anomalies which overlap, and thus the individual magnetic anomalies cannot be observed completely. Anomaly locations are specified in such a way, i.e., in bands, that this range of possibilities is included; this fact must be remembered when locating boreholes or excavations. Figure 11 is the magnetic anomaly location map, where anomaly bands are indicated and labeled to correspond to anomalies identified in Figures 3-6. Within the bands, locations of the anomaly maxima and points of maximum slope are indicated.

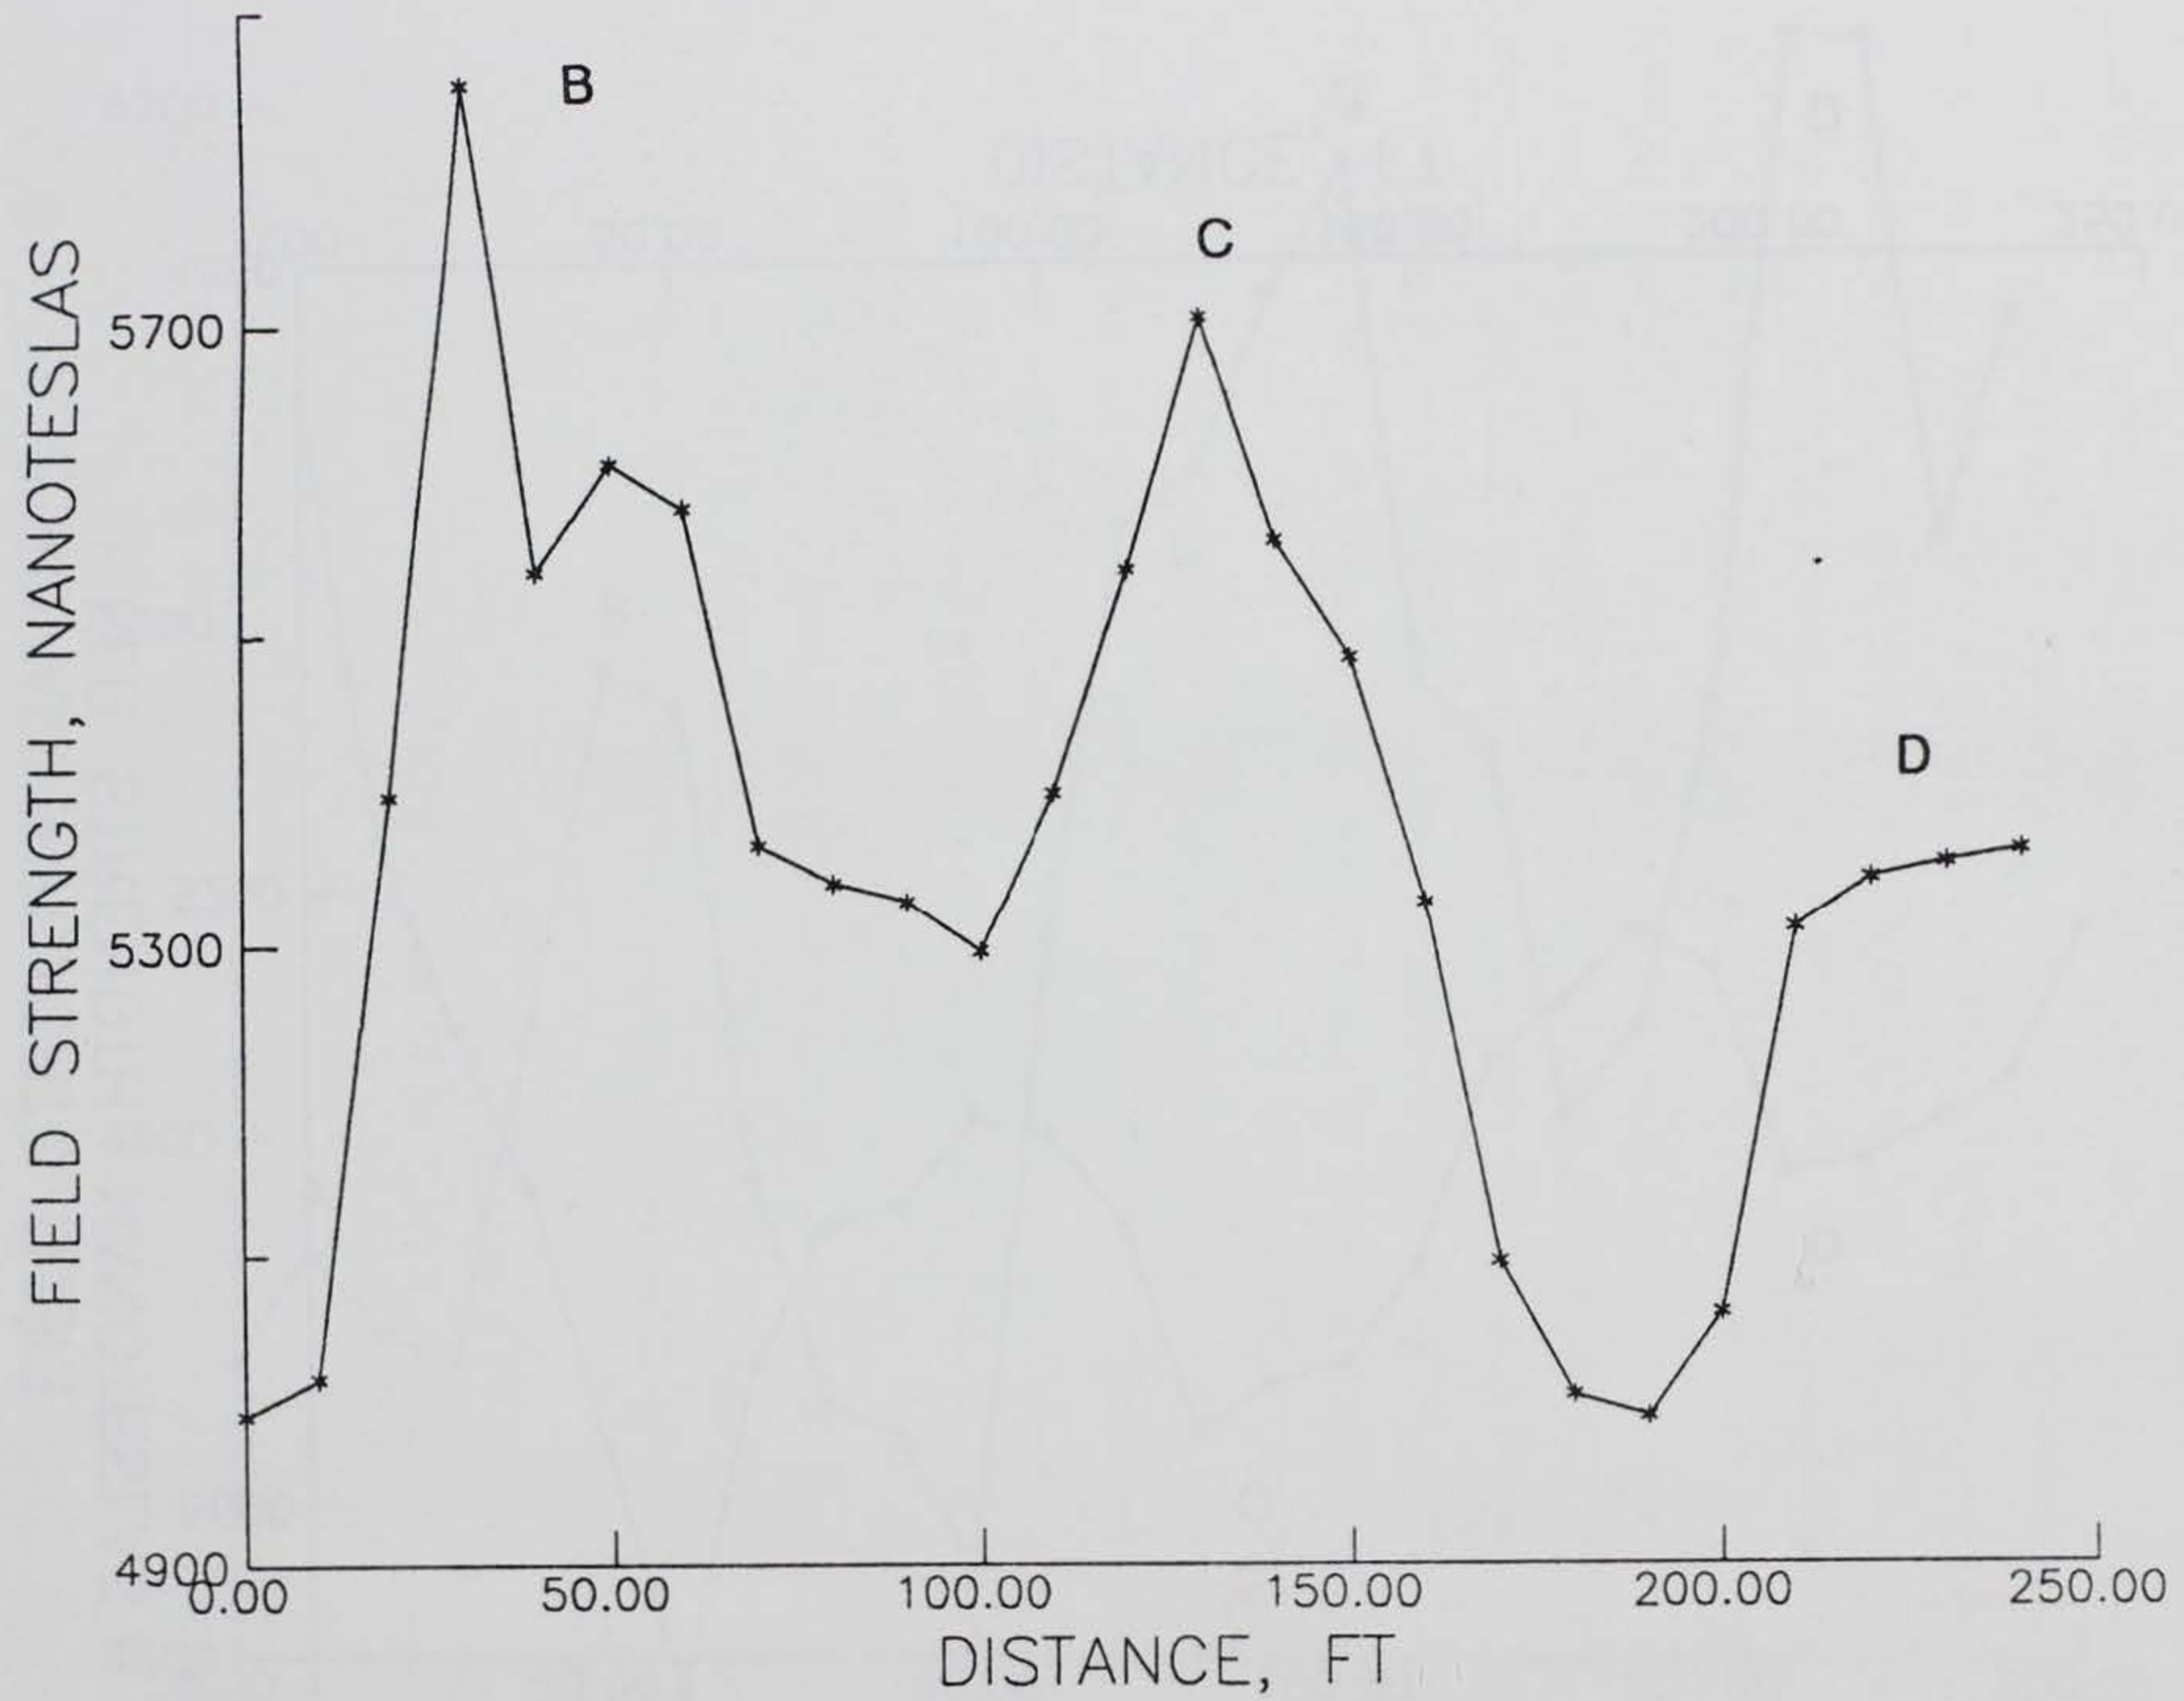
Figure 6. Magnetic survey data, line VI

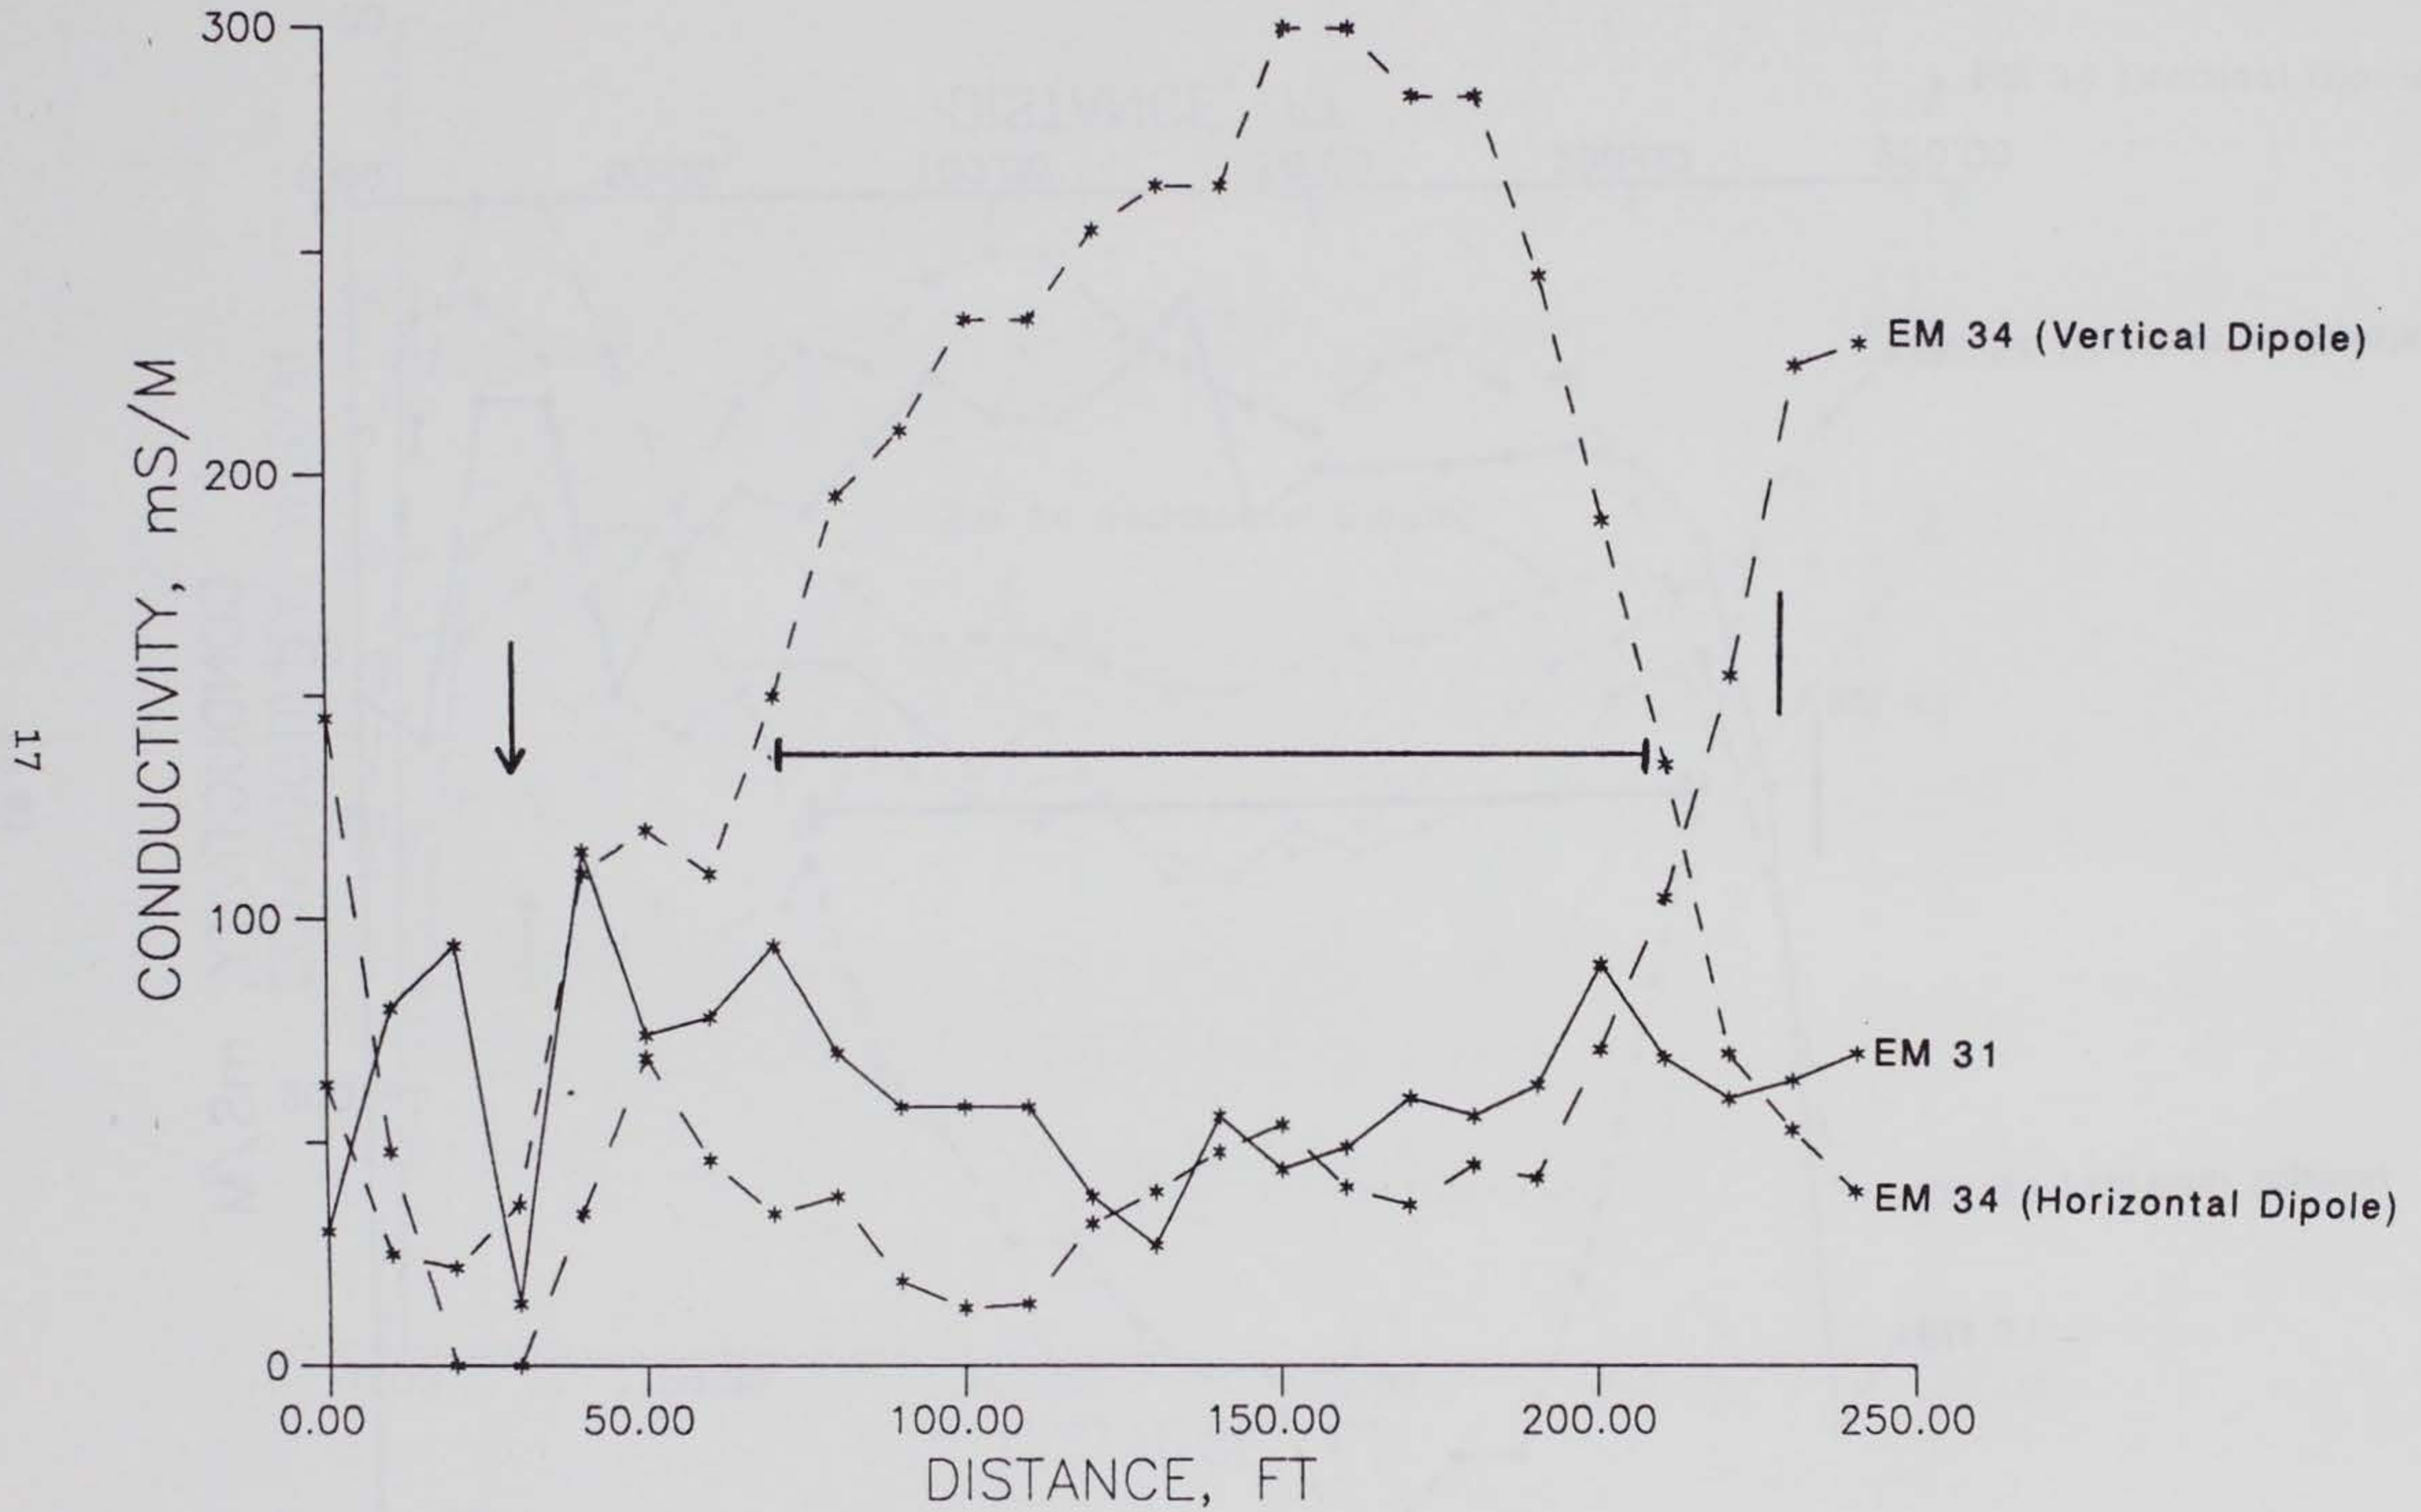
Figure 7. Electromagnetic survey data, line I

10. The electromagnetic survey results, Figures 7-10, do not have the large, nearly periodic sequences of maxima and minima exhibited by the magnetic field data. Figures 7 and 8 show a large, broad response for the horizontal dipole EM 34 response (indicated by the horizontal bar in the figures); this response, which is not as evident (if at all) in Figures 9 and 10, is considered to be due to topographic effects on the data (sharp dropoff on one side and steep slope on the other side of the survey line). There is no evidence to support such a large conductivity value, since both the EM 31 and the vertical dipole EM 34 data consistently show much lower conductivity in this region of the survey line. All of the data in Figures 7 and 8 are consistent in exhibiting the anomaly indicated by the arrow; the anomaly has the classic appearance (maximum, minimum, maximum) produced by crossing a very conductive object, even tending to become negative directly over the object. The object causing this anomaly (at the arrow) is shallow (less than 18 ft, since it produces such a prominent effect on the EM 31 response) and must be large in size and possess a high conductivity (since the effect on the EM 34 is significant and the conductivity measurements tend to go negative). A high conductivity anomaly is present near the 240 ft profile position (indicated by the

vertical line) in Figures 7-10; in Figures 7 and 10, the anomaly is indicated by the vertical dipole EM 34 data but not obviously by the EM 31 data, while in Figures 8 and 9, the anomaly is indicated by both the EM 31 and the vertical dipole EM 34 data. Figure 12 indicates anomalous areas in plan from an analysis of the electromagnetic data.

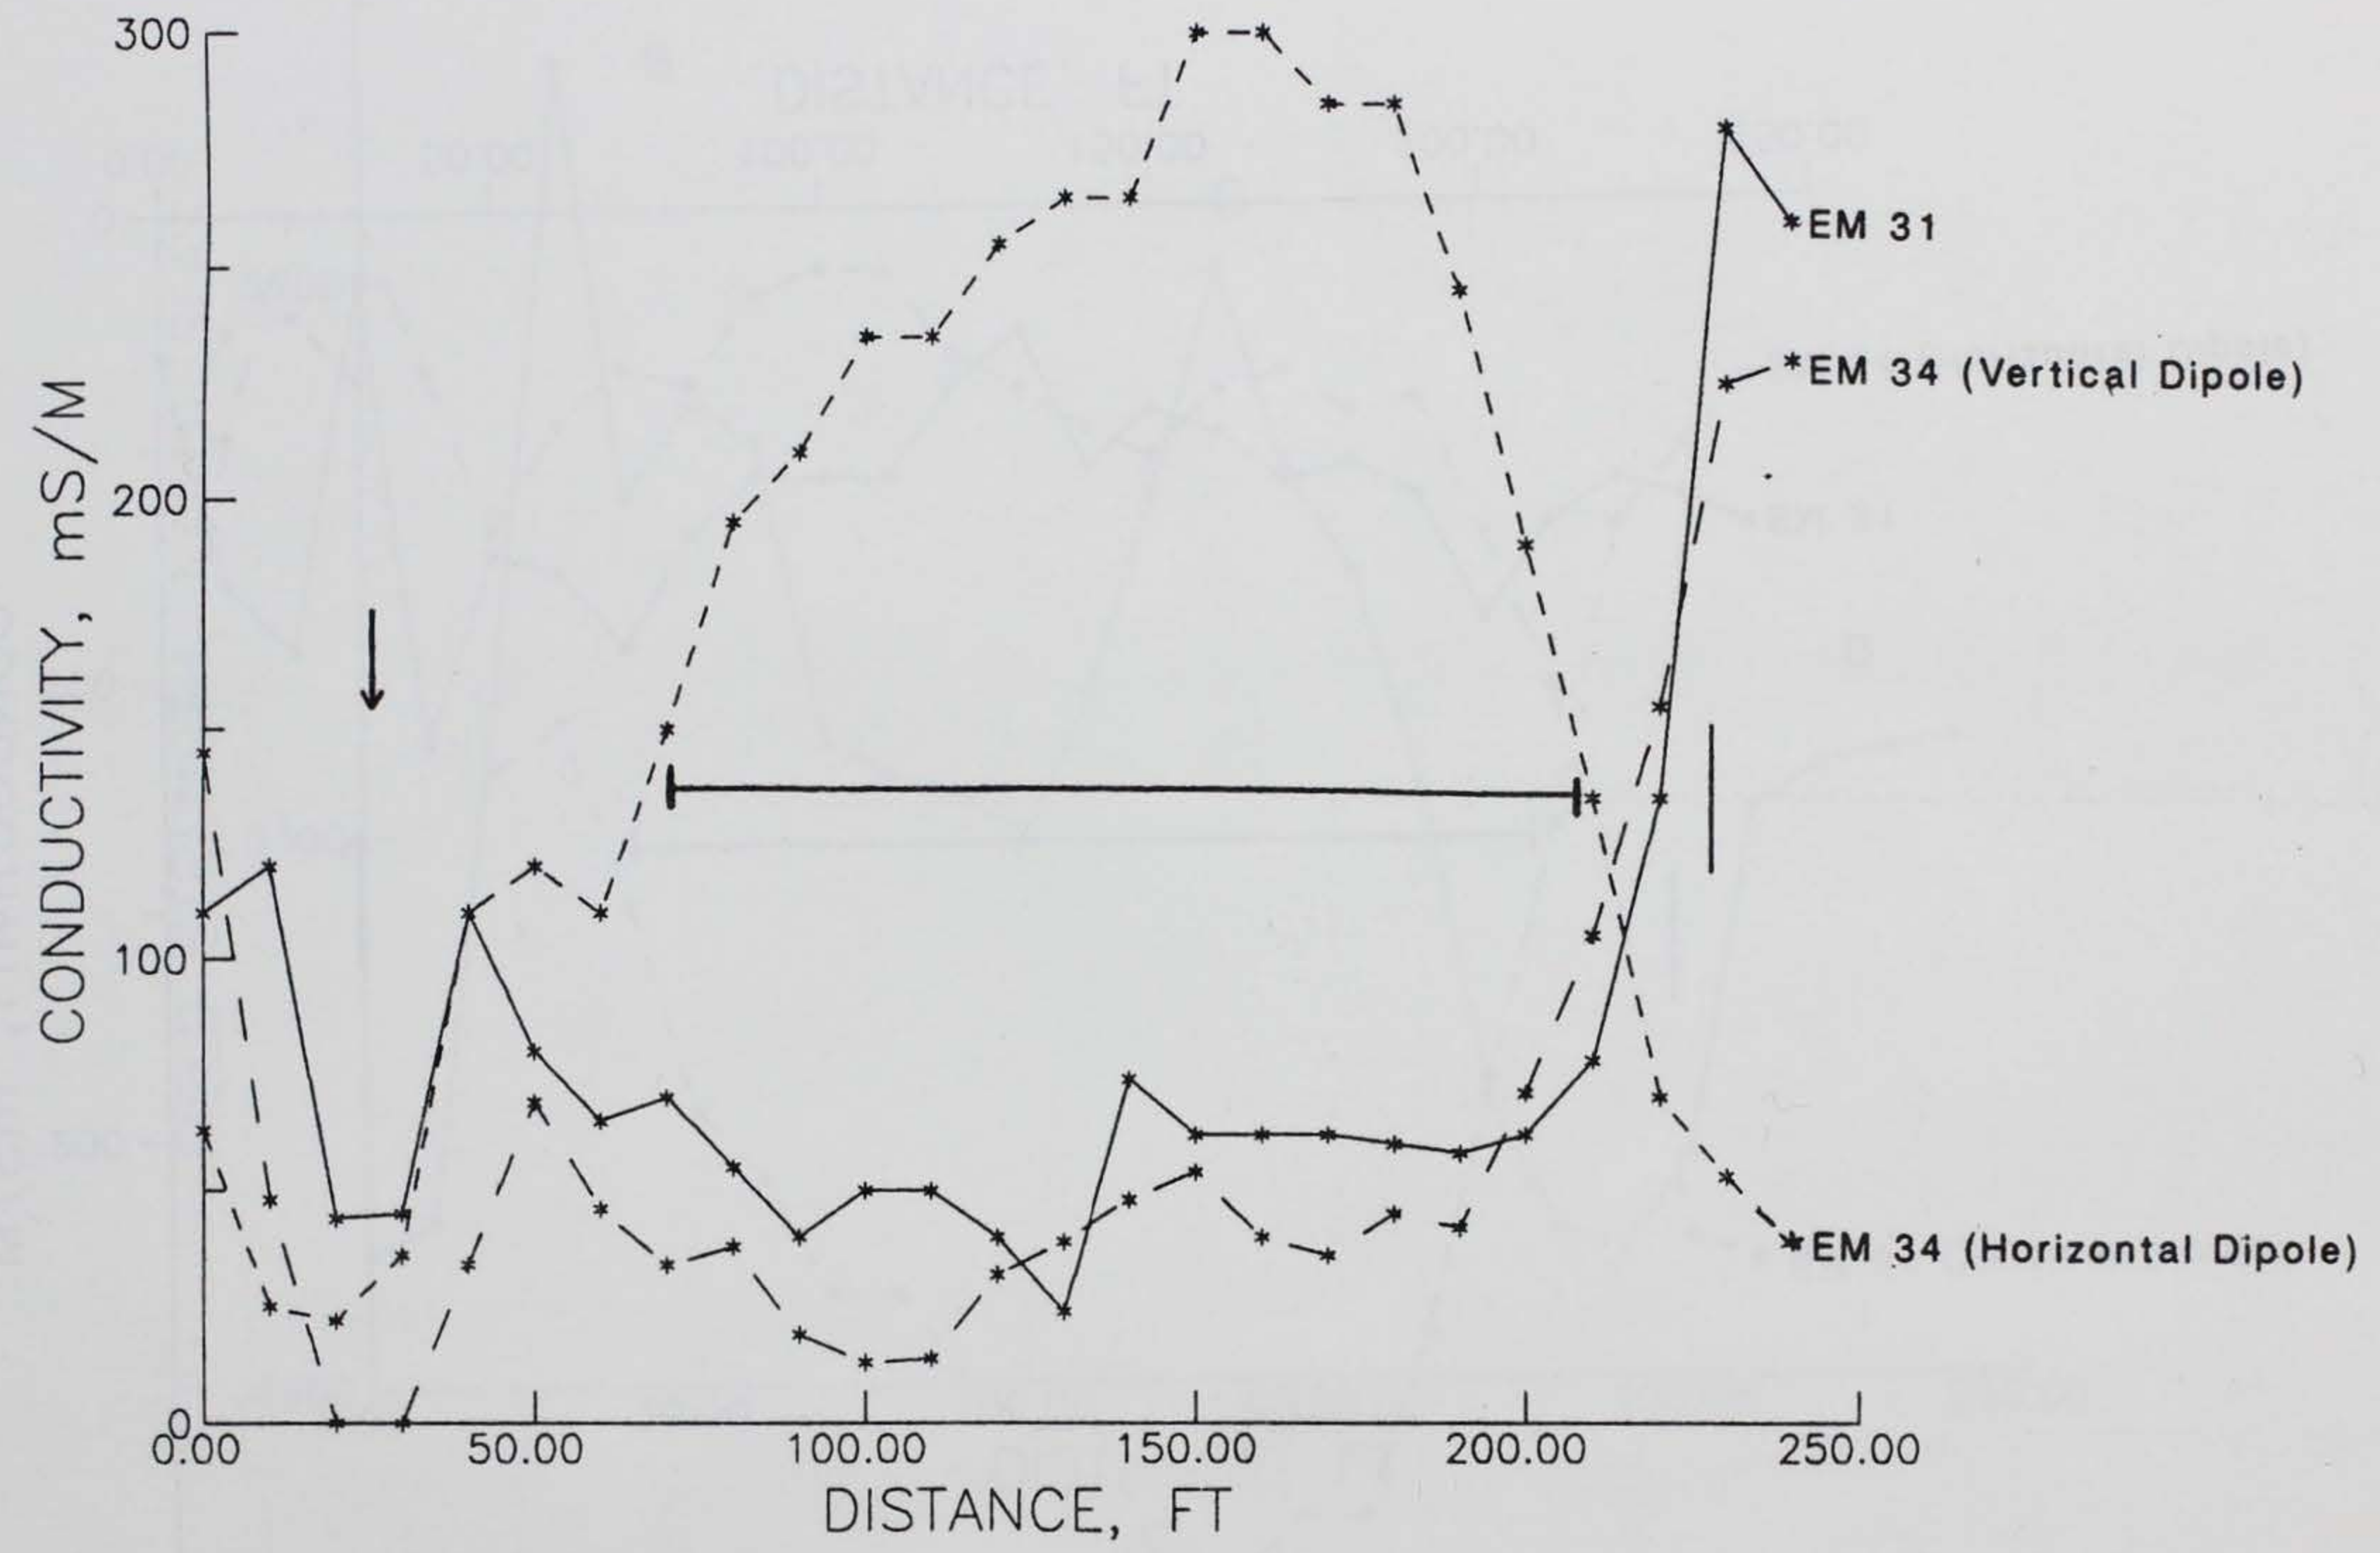
Figure 8. Electromagnetic survey data, line II

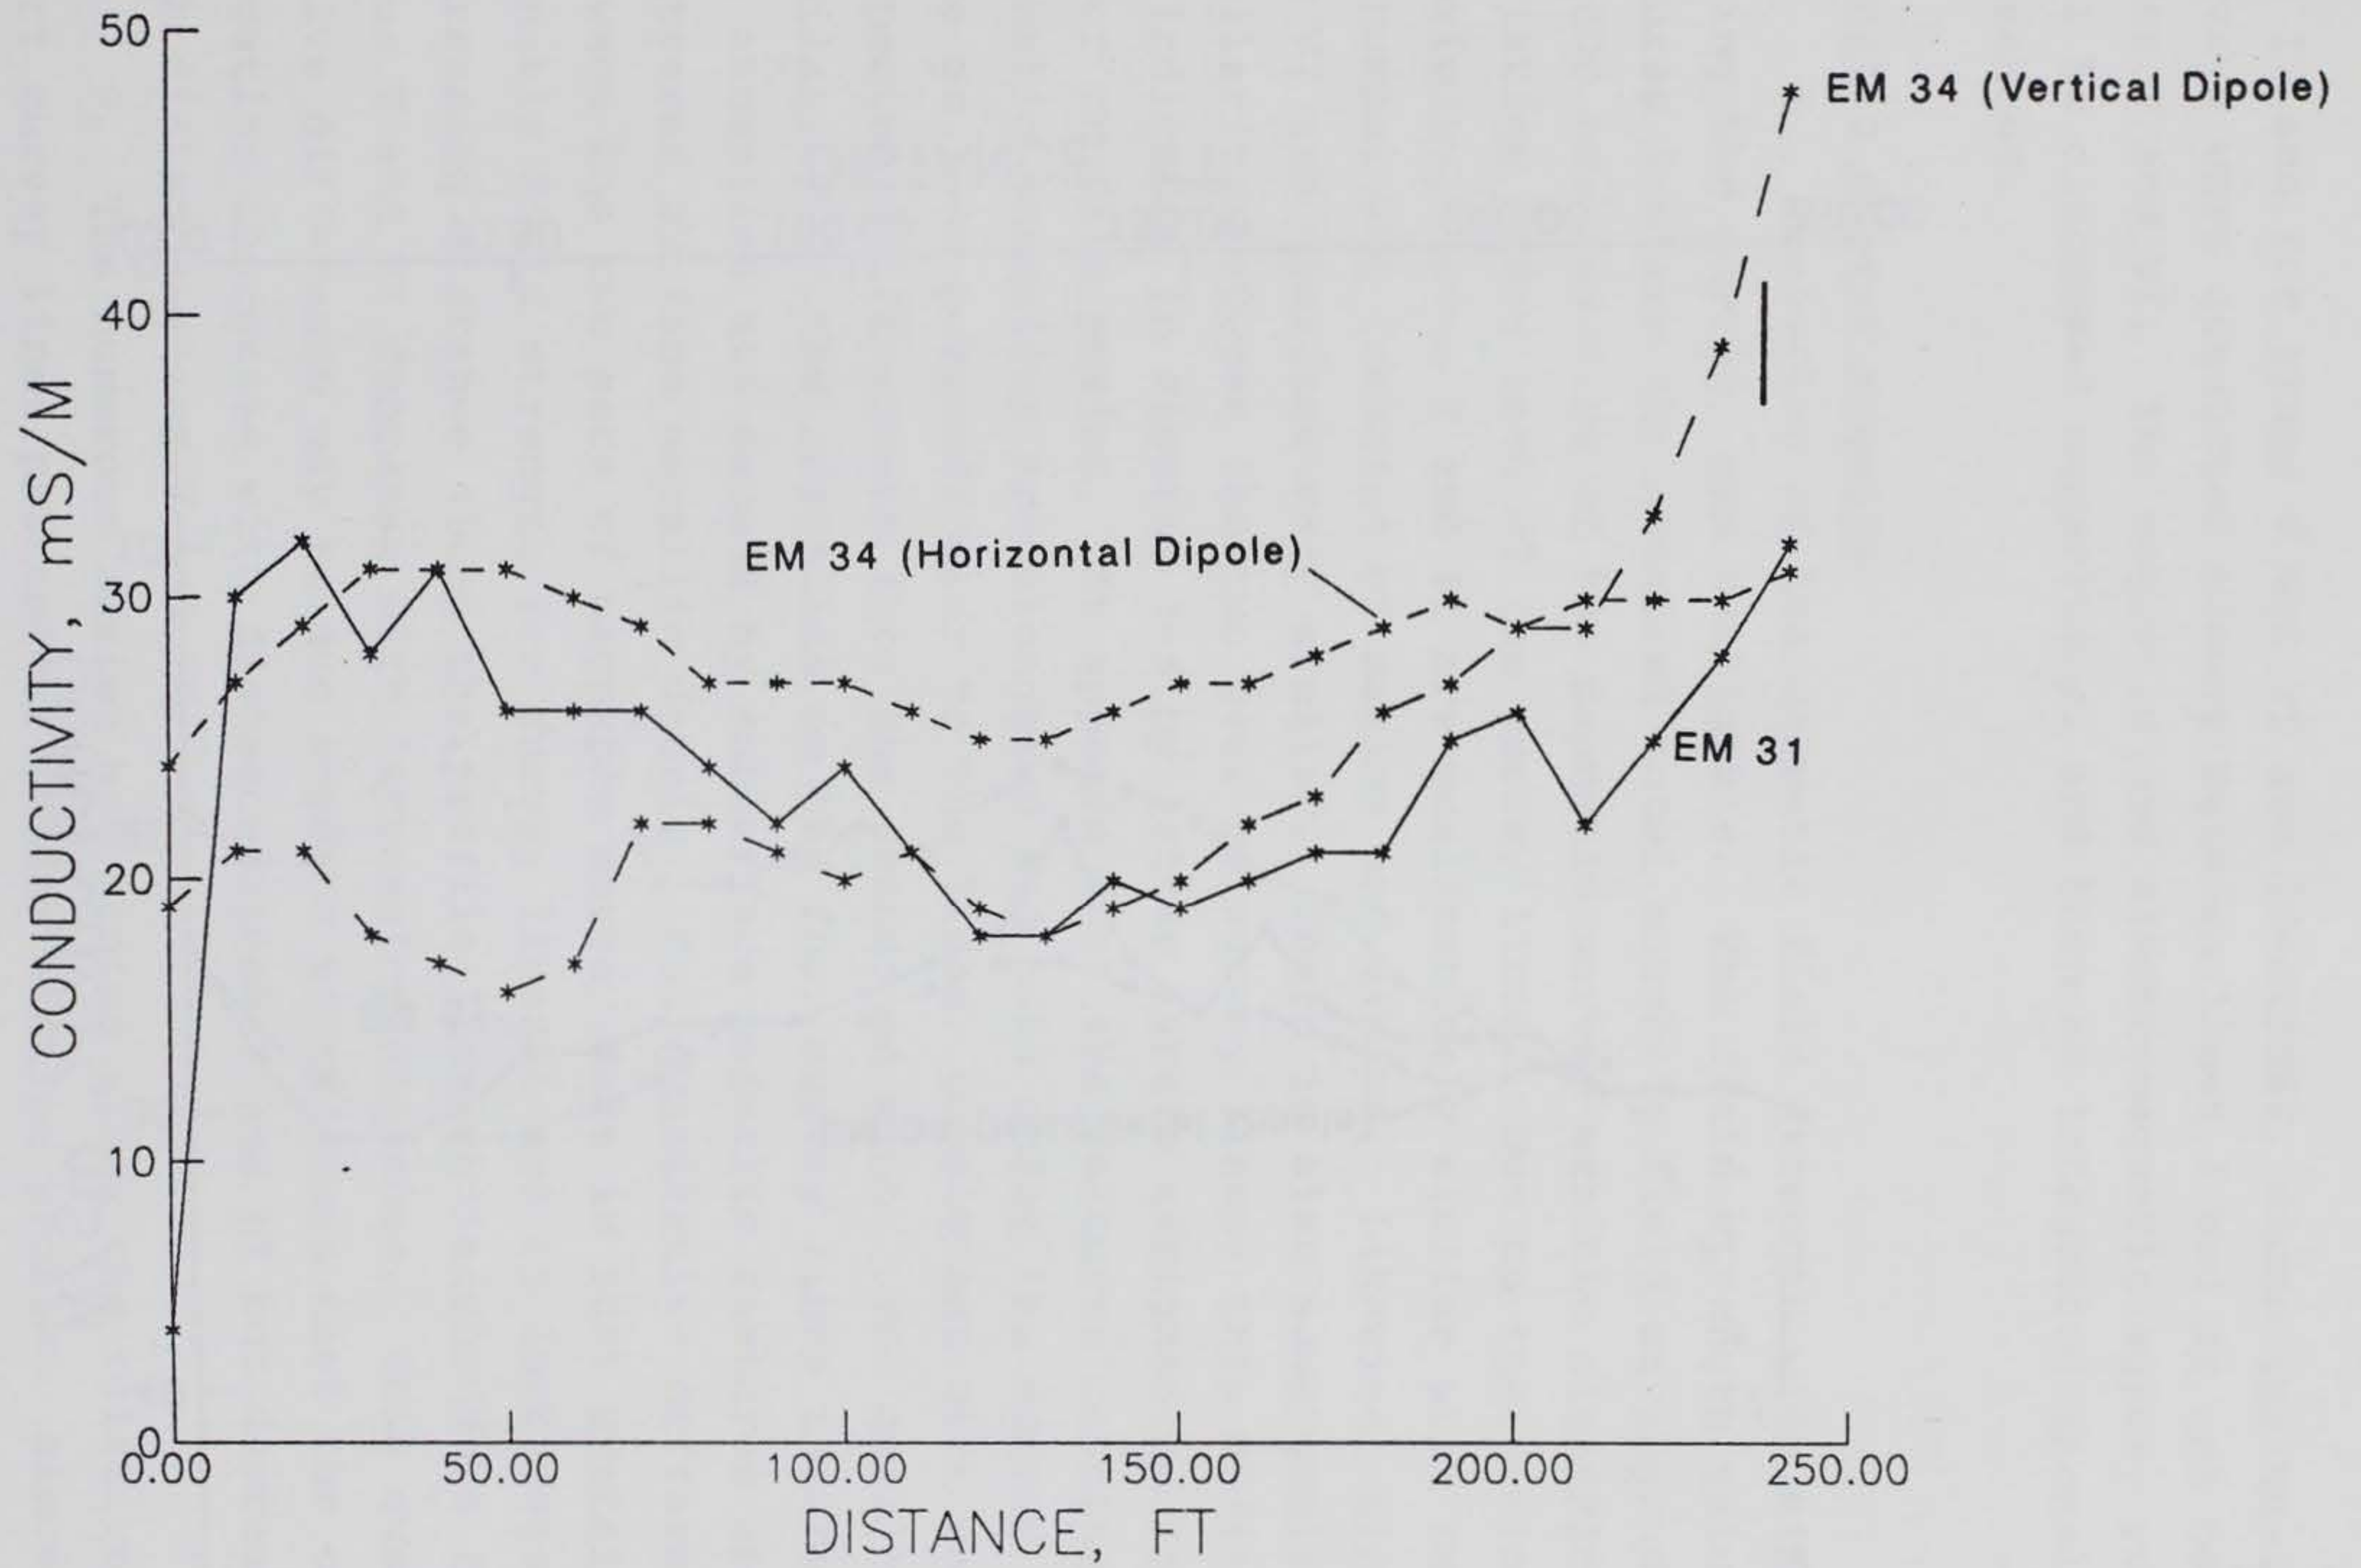
Figure 9. Electromagnetic survey data, line V
