MISCELLANEOUS PAPER GL-91-6

# GEOPHYSICAL SURVEYS FOR LOCATION OF A SUSPECTED ABANDONED MINE OPENING: GRAYS LANDING SITE

Dwain K. Butler, Thomas B. Kean II

Geotechnical Laboratory

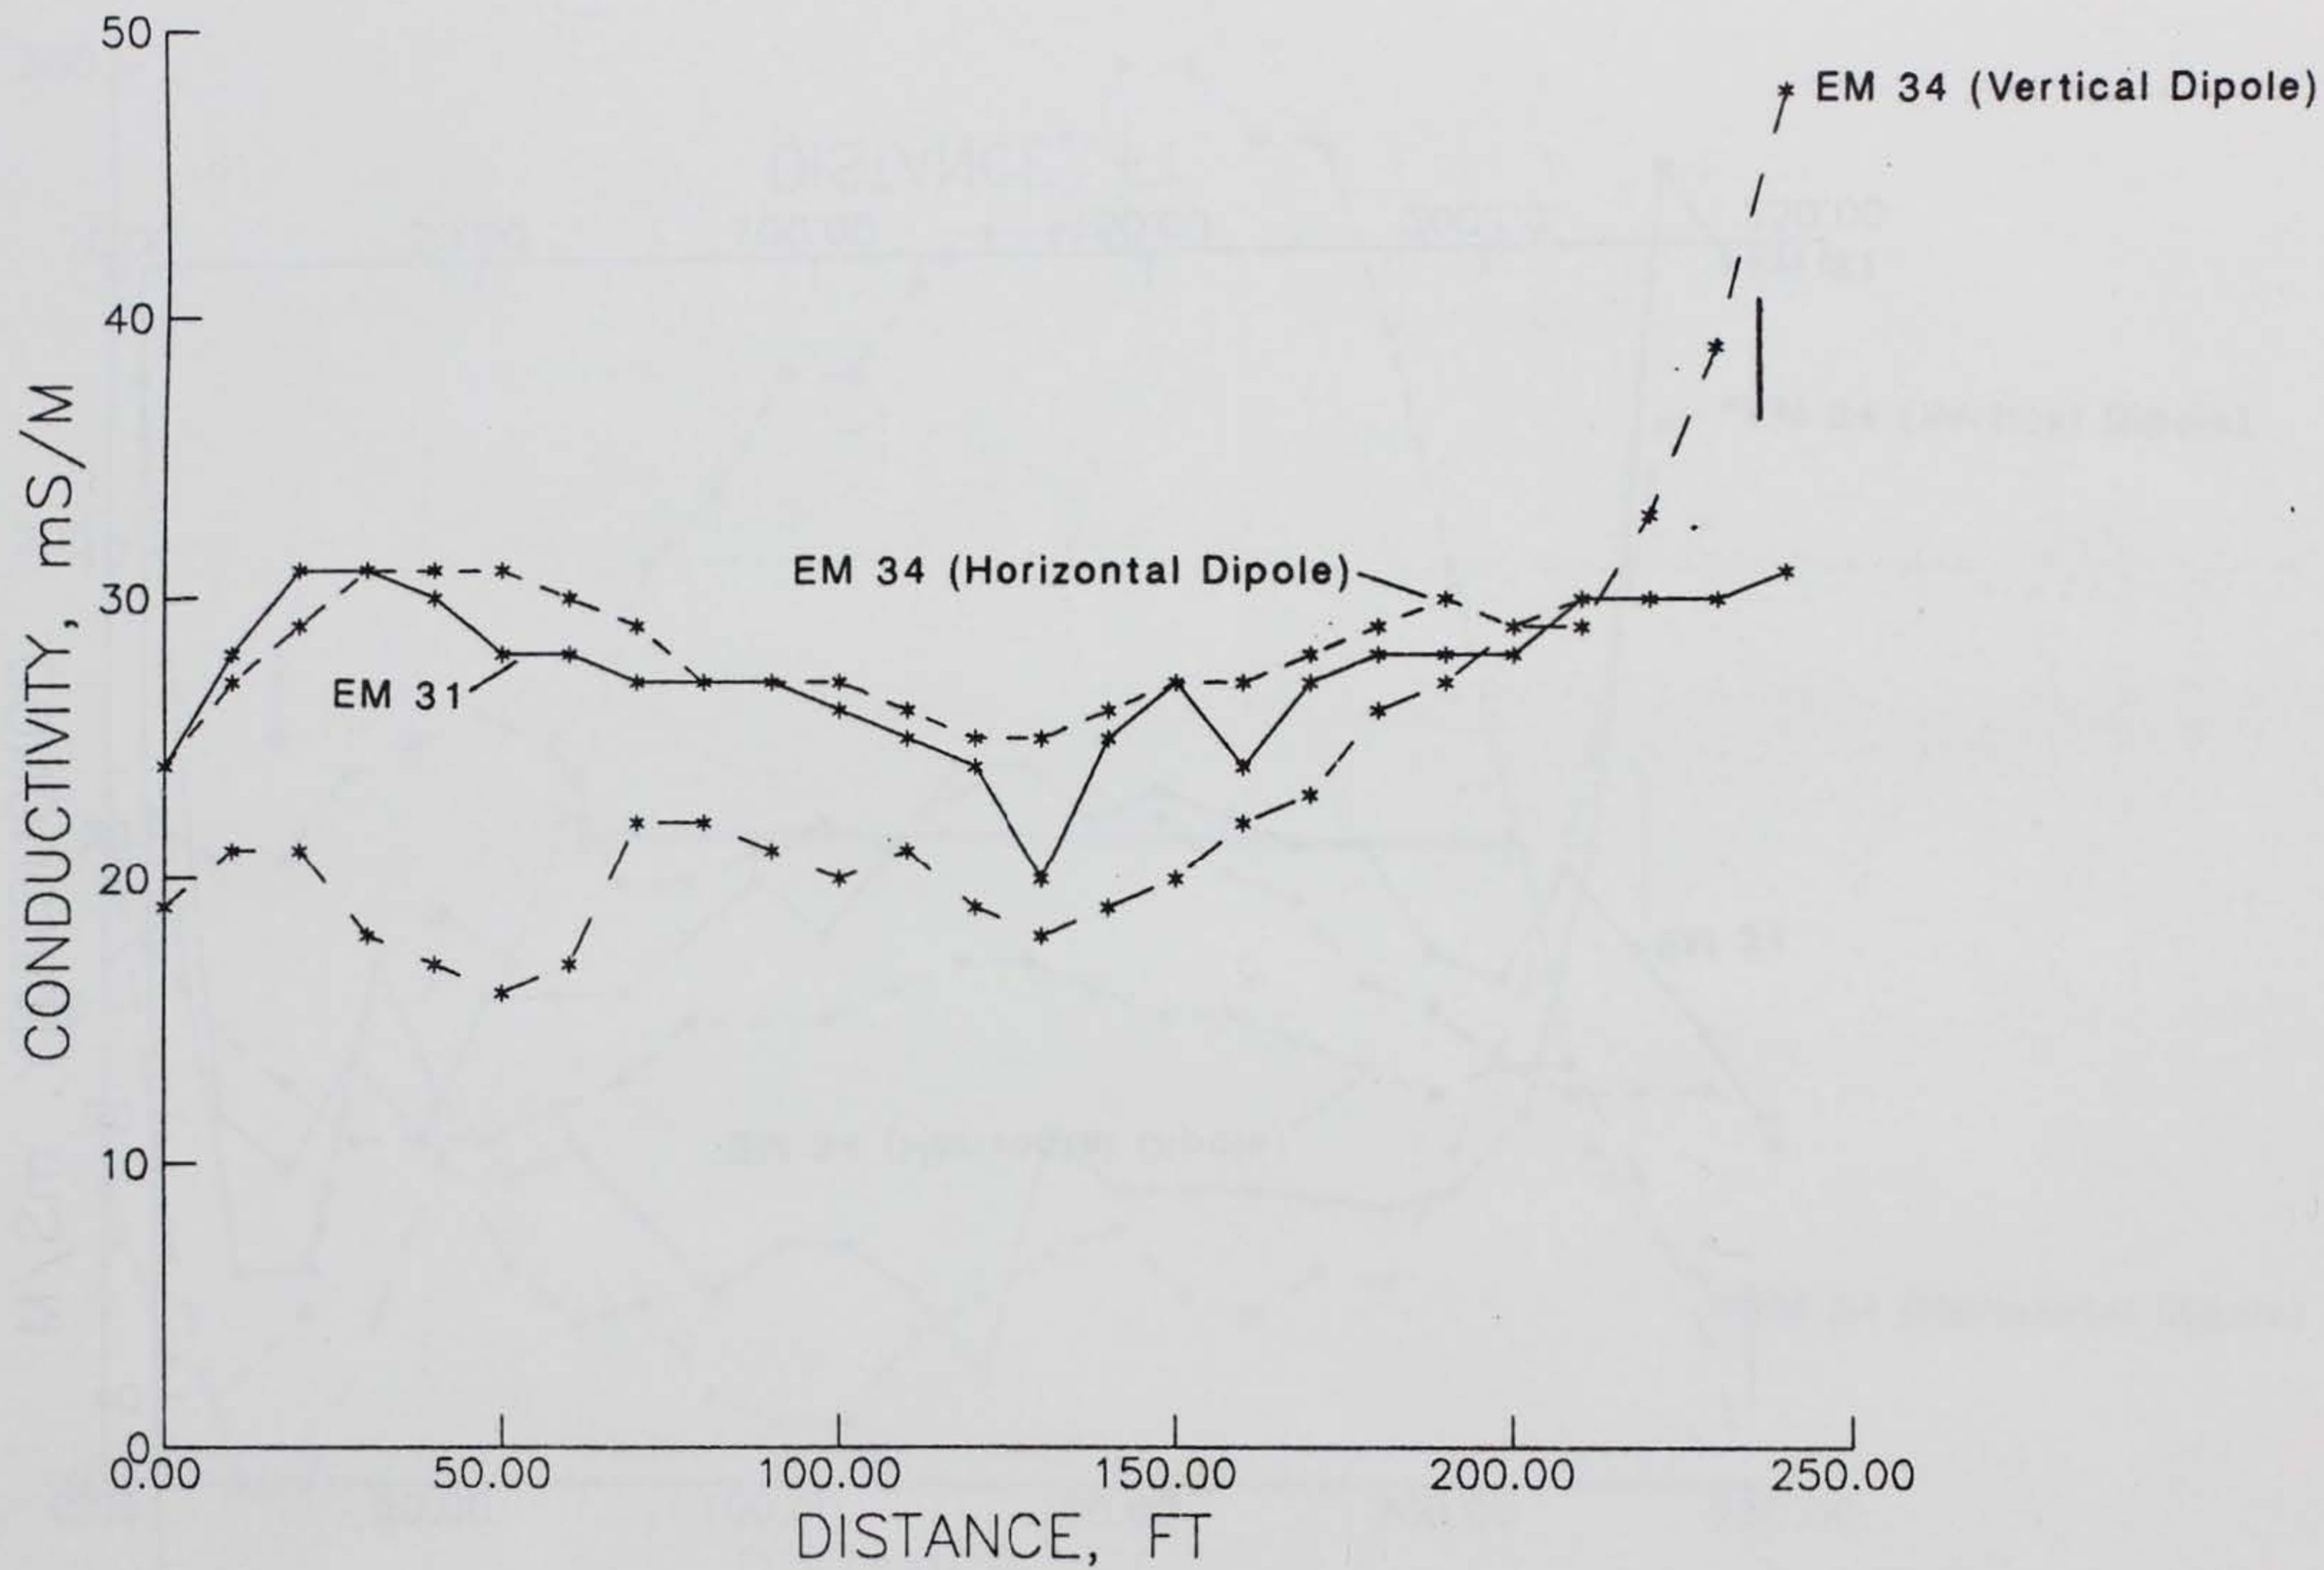
Figure 10. Electromagnetic survey data, line VI

10. The electromagnetic survey results, Figures 7-10, do not have the large, nearly periodic sequences of maxima and minima exhibited by the magnetic field data. Figures 7 and 8 show a large, broad response for the horizontal dipole EM 34 response (indicated by the horizontal bar in the figures); this response, which is not as evident (if at all) in Figures 9 and 10, is considered to be due to topographic effects on the data (sharp dropoff on one side and steep slope on the other side of the survey line). There is no evidence to support such a large conductivity value, since both the EM 31 and the vertical dipole EM 34 data consistently show much lower conductivity in this region of the survey line. All of the data in Figures 7 and 8 are consistent in exhibiting the anomaly indicated by the arrow; the anomaly has the classic appearance (maximum, minimum, maximum) produced by crossing a very conductive object, even tending to become negative directly over the object. The object causing this anomaly (at the arrow) is shallow (less than 18 ft, since it produces such a prominent effect on the EM 31 response) and must be large in size and possess a high conductivity (since the effect on the EM 34 is significant and the conductivity measurements tend to go negative). A high conductivity anomaly is present near the 240 ft profile position (indicated by the

vertical line) in Figures 7-10; in Figures 7 and 10, the anomaly is indicated by the vertical dipole EM 34 data but not obviously by the EM 31 data, while in Figures 8 and 9, the anomaly is indicated by both the EM 31 and the vertical dipole EM 34 data. Figure 12 indicates anomalous areas in plan from an analysis of the electromagnetic data.

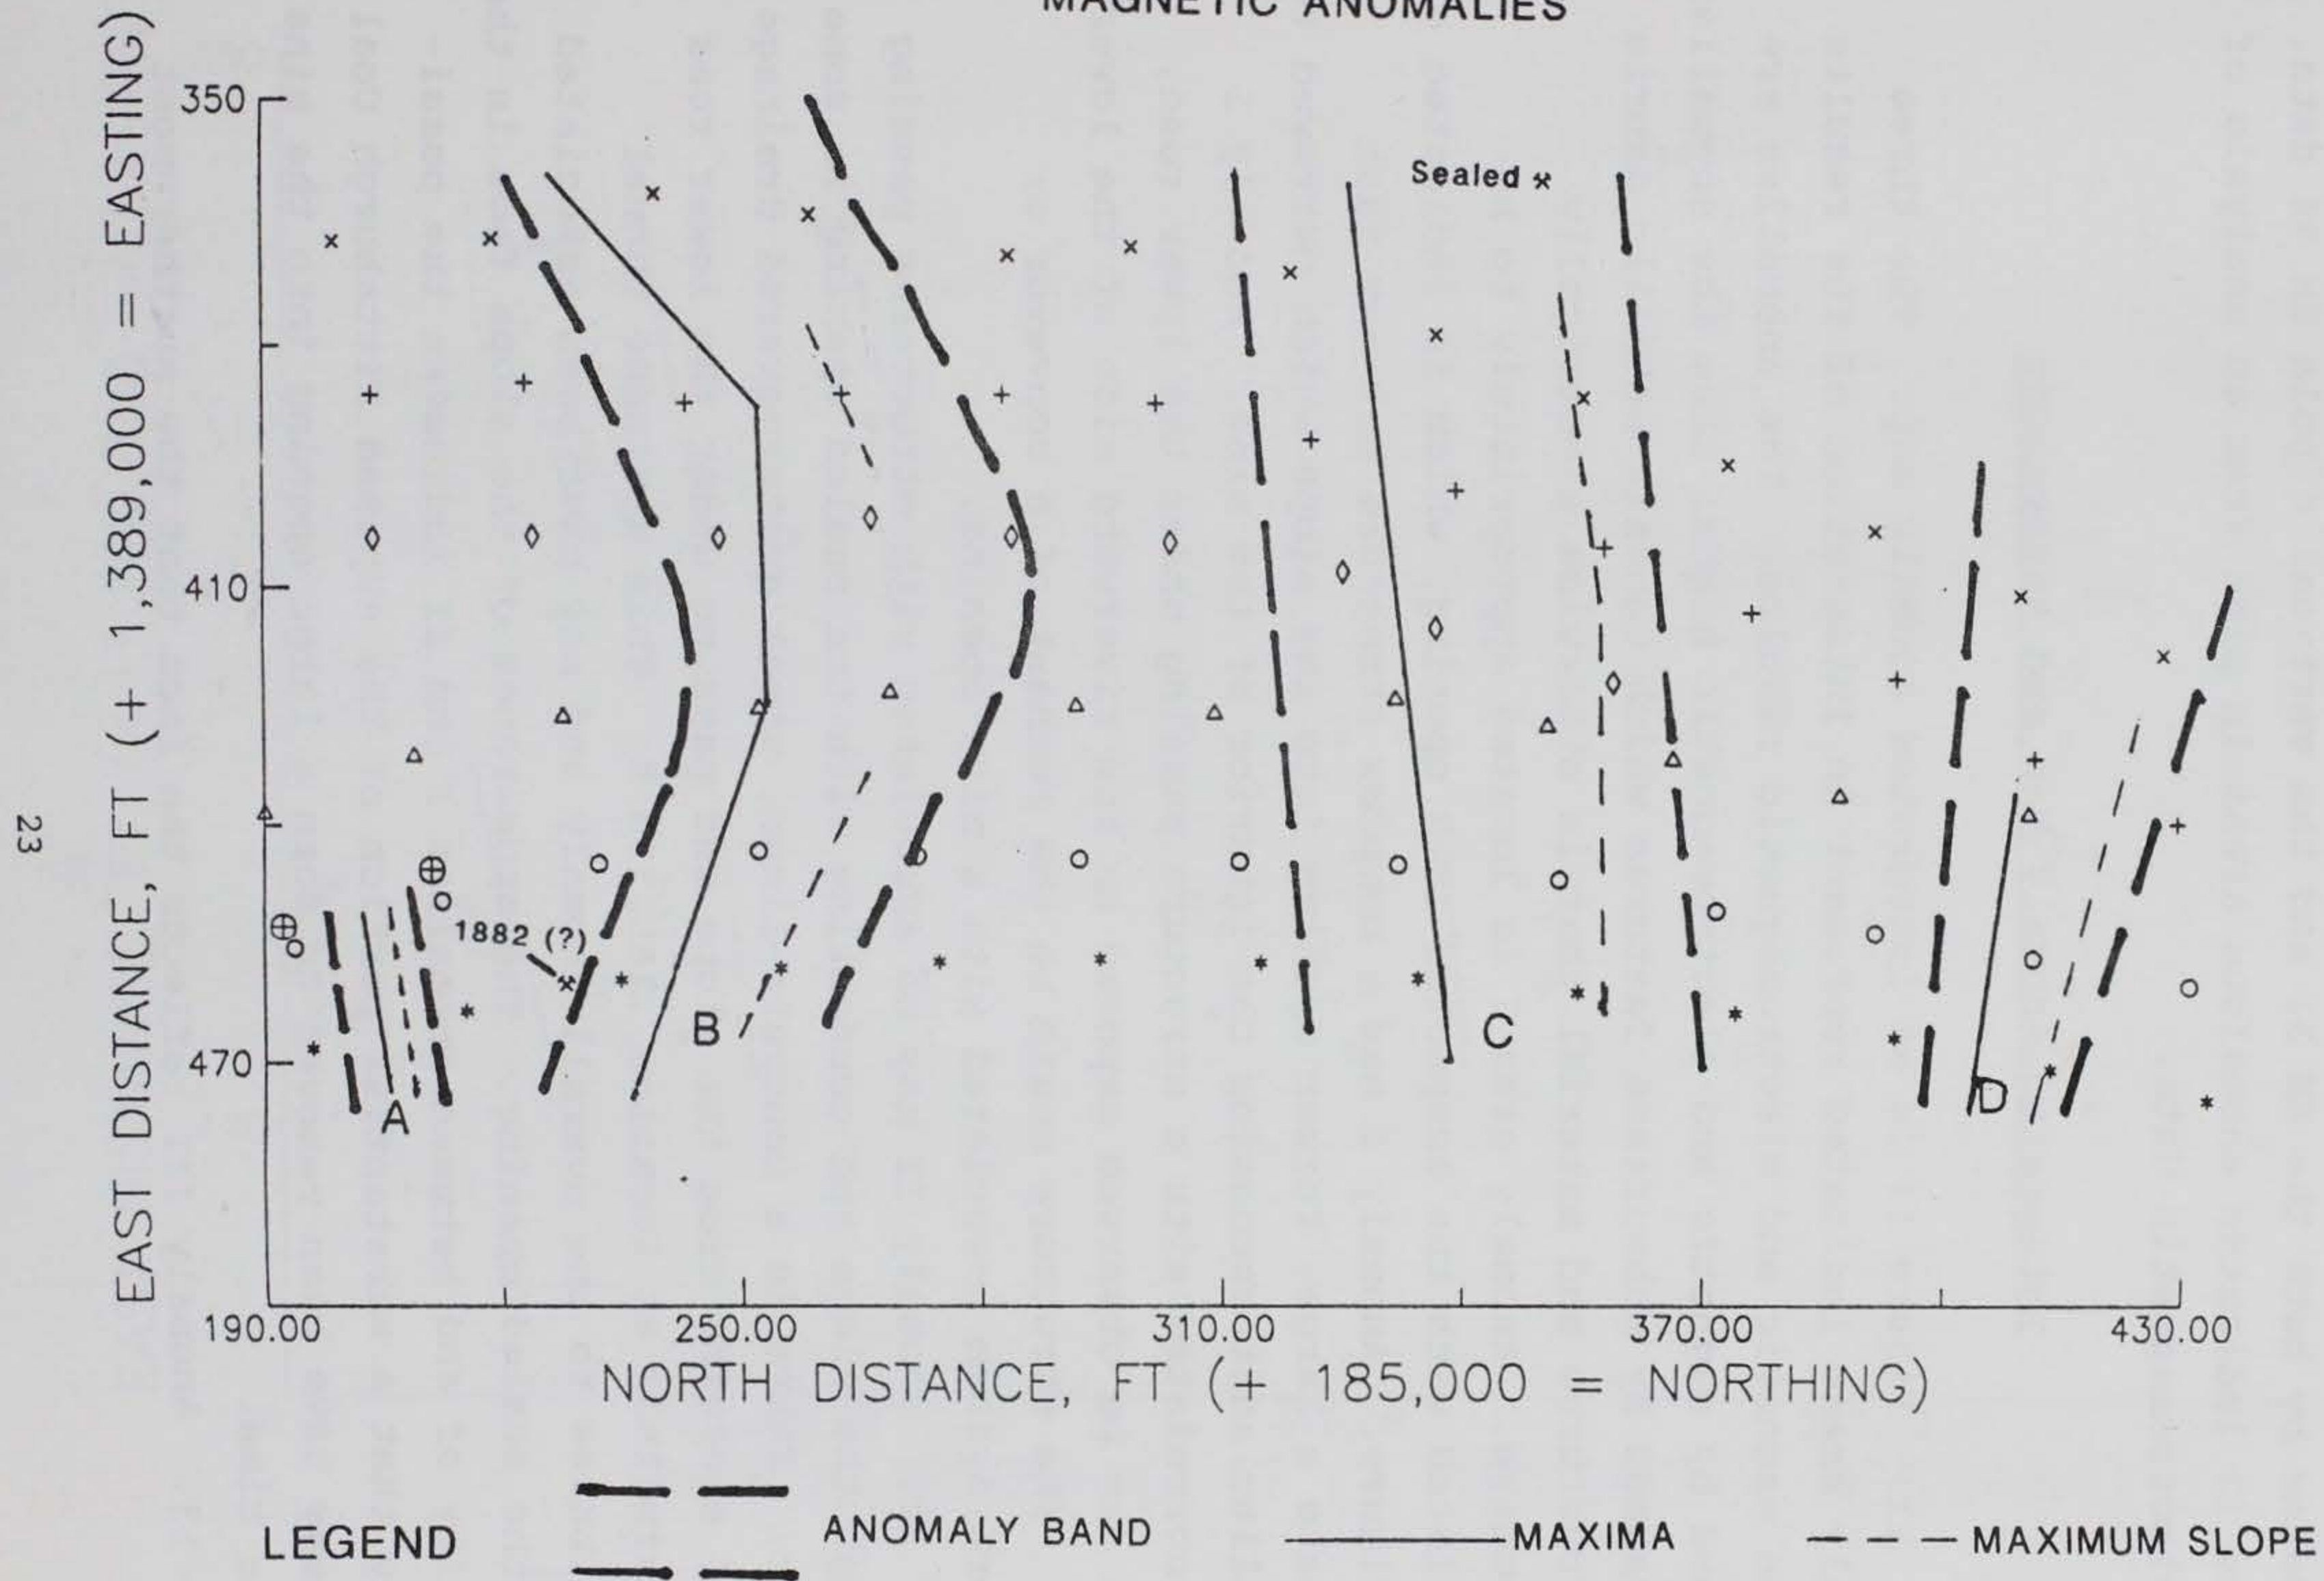
# MAGNETIC ANOMALIES

Figure 11. Magnetic anomaly map

anomaly maxima to a location under the point of maximum rate of change (slope) (approximately midway) between a maximum and the adjacent minimum located to the north. Closely spaced, sub-surface metallic objects produce magnetic anomalies which overlap, and thus the individual magnetic anomalies cannot be observed completely. Anomaly locations are specified in such a way, i.e., in bands, that this range of possibilities is included; this fact must be remembered when locating boreholes or excavations. Figure 11 is the magnetic anomaly location map, where anomaly bands are indicated and labeled to correspond to anomalies identified in Figures 3-6. Within the bands, locations of the anomaly maxima and points of maximum slope are indicated.

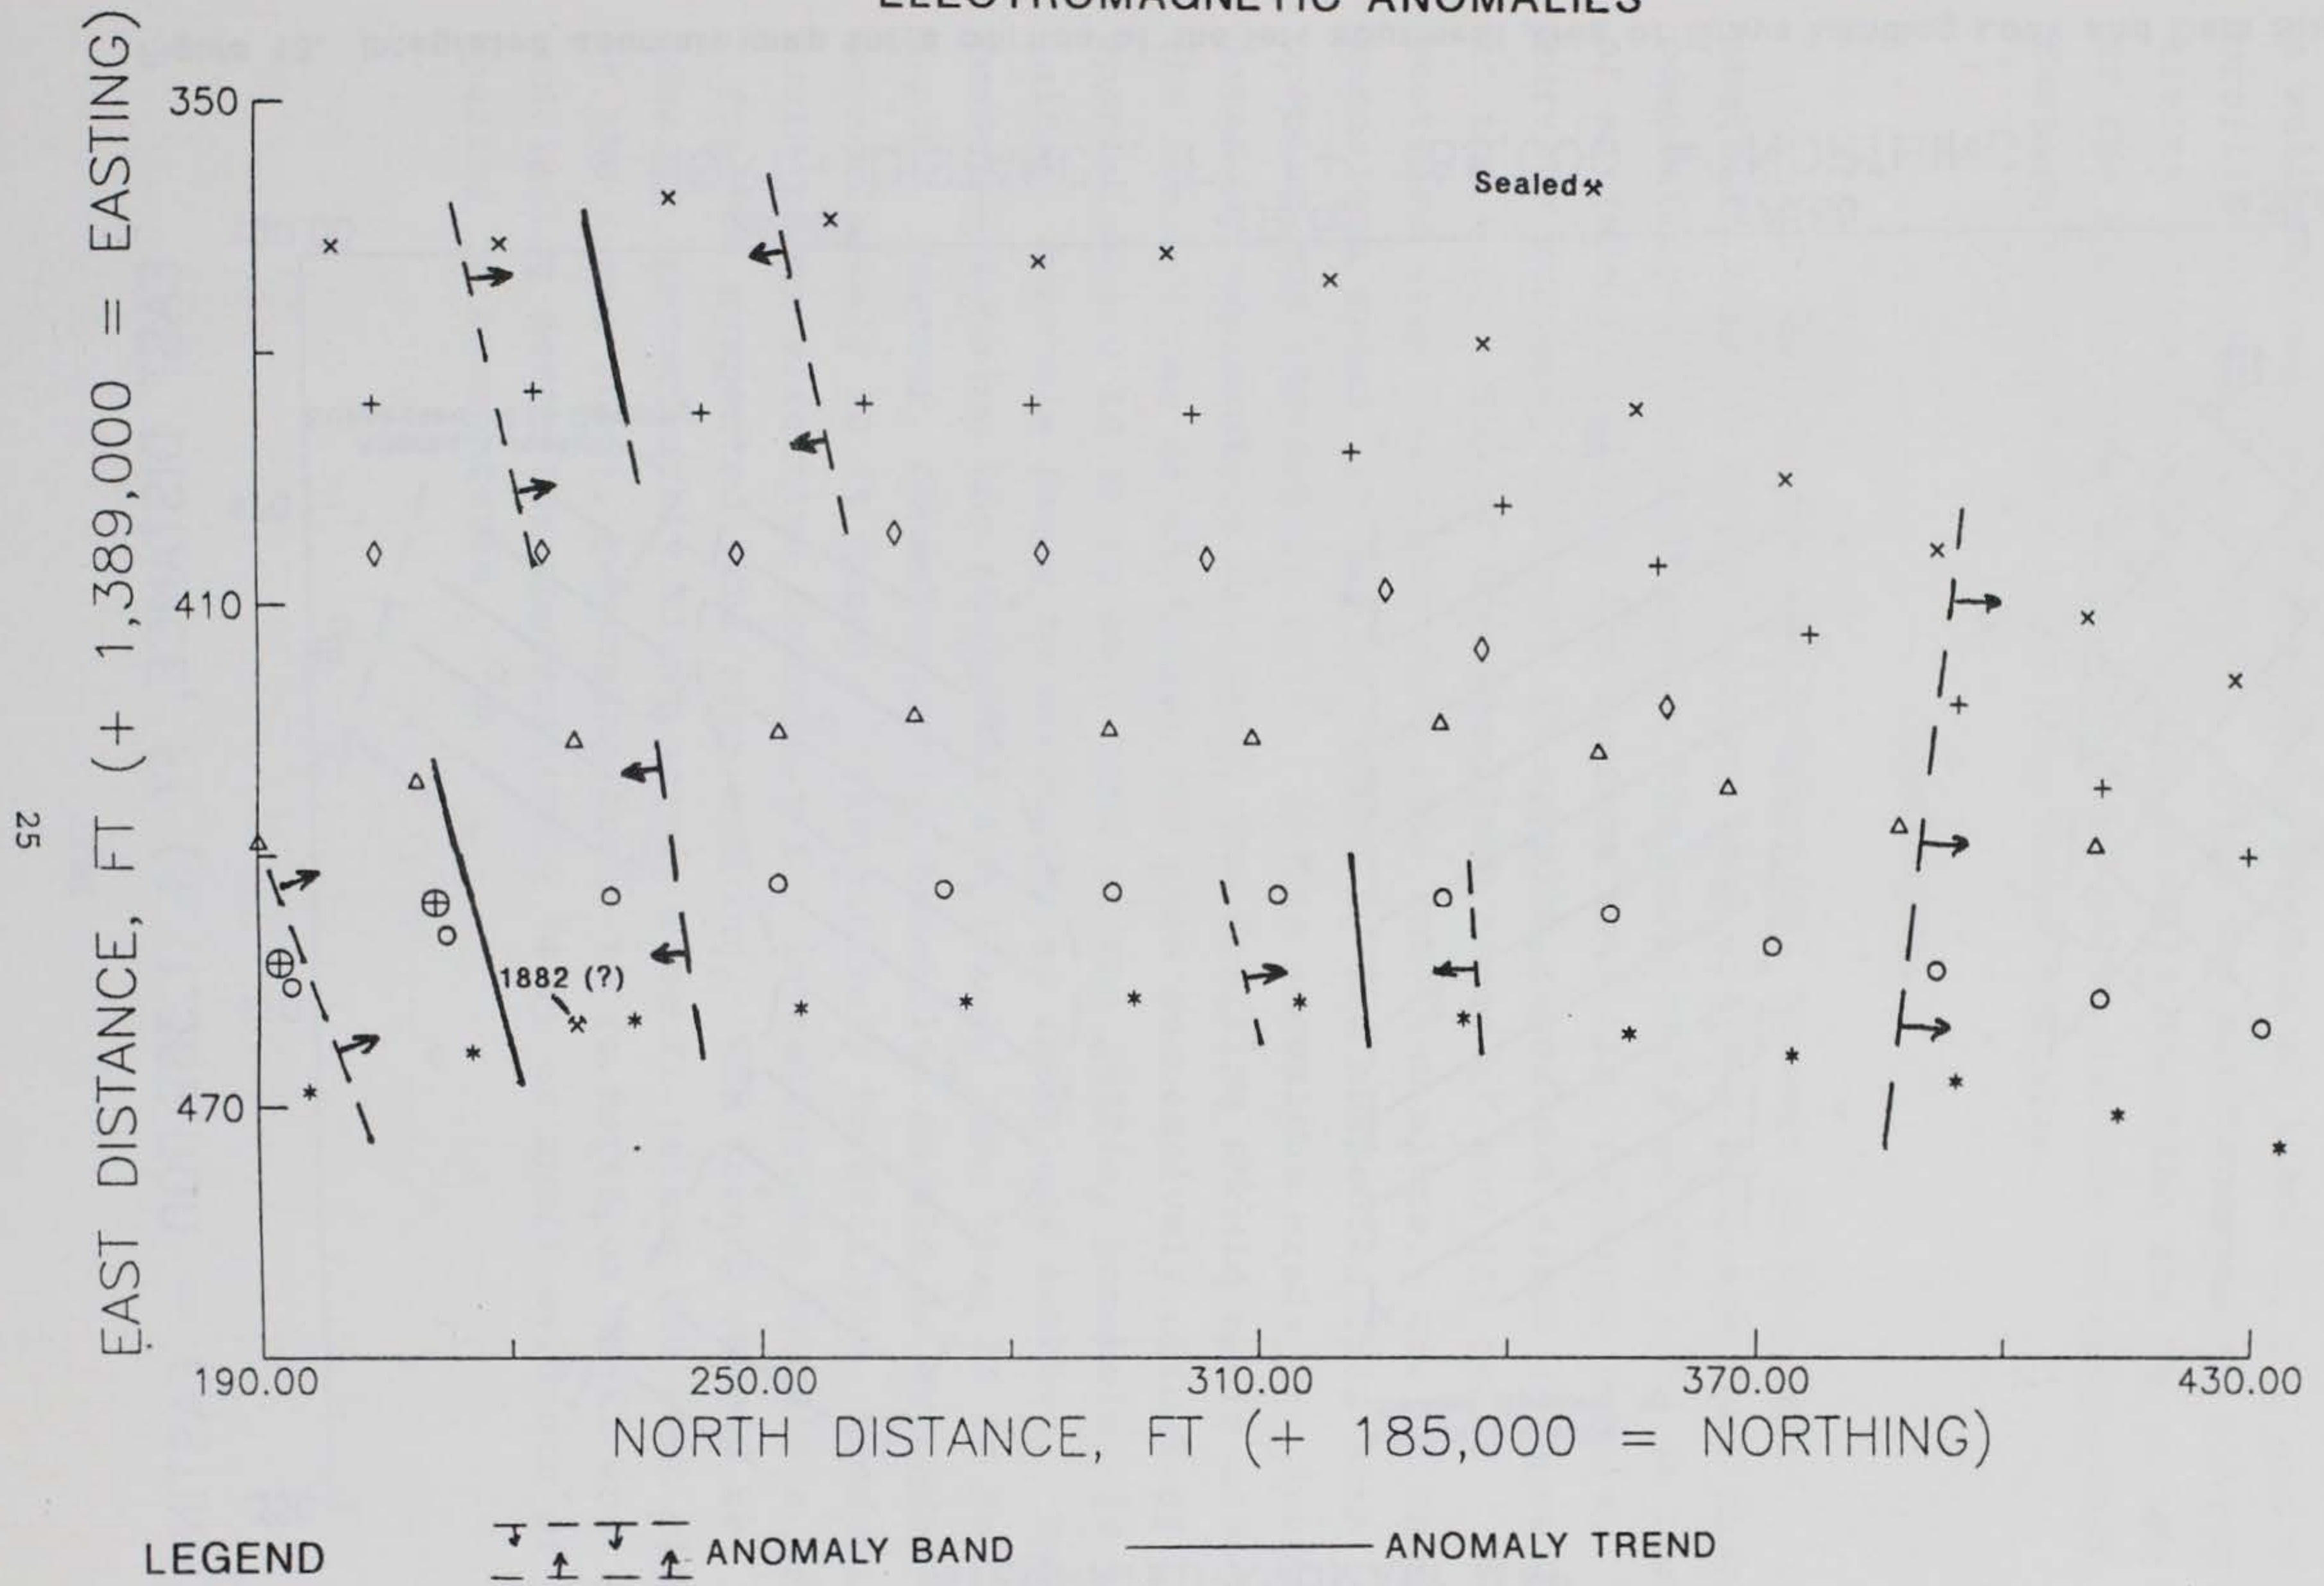
# ELECTROMAGNETIC ANOMALIES

Figure 12. Electromagnetic anomaly map

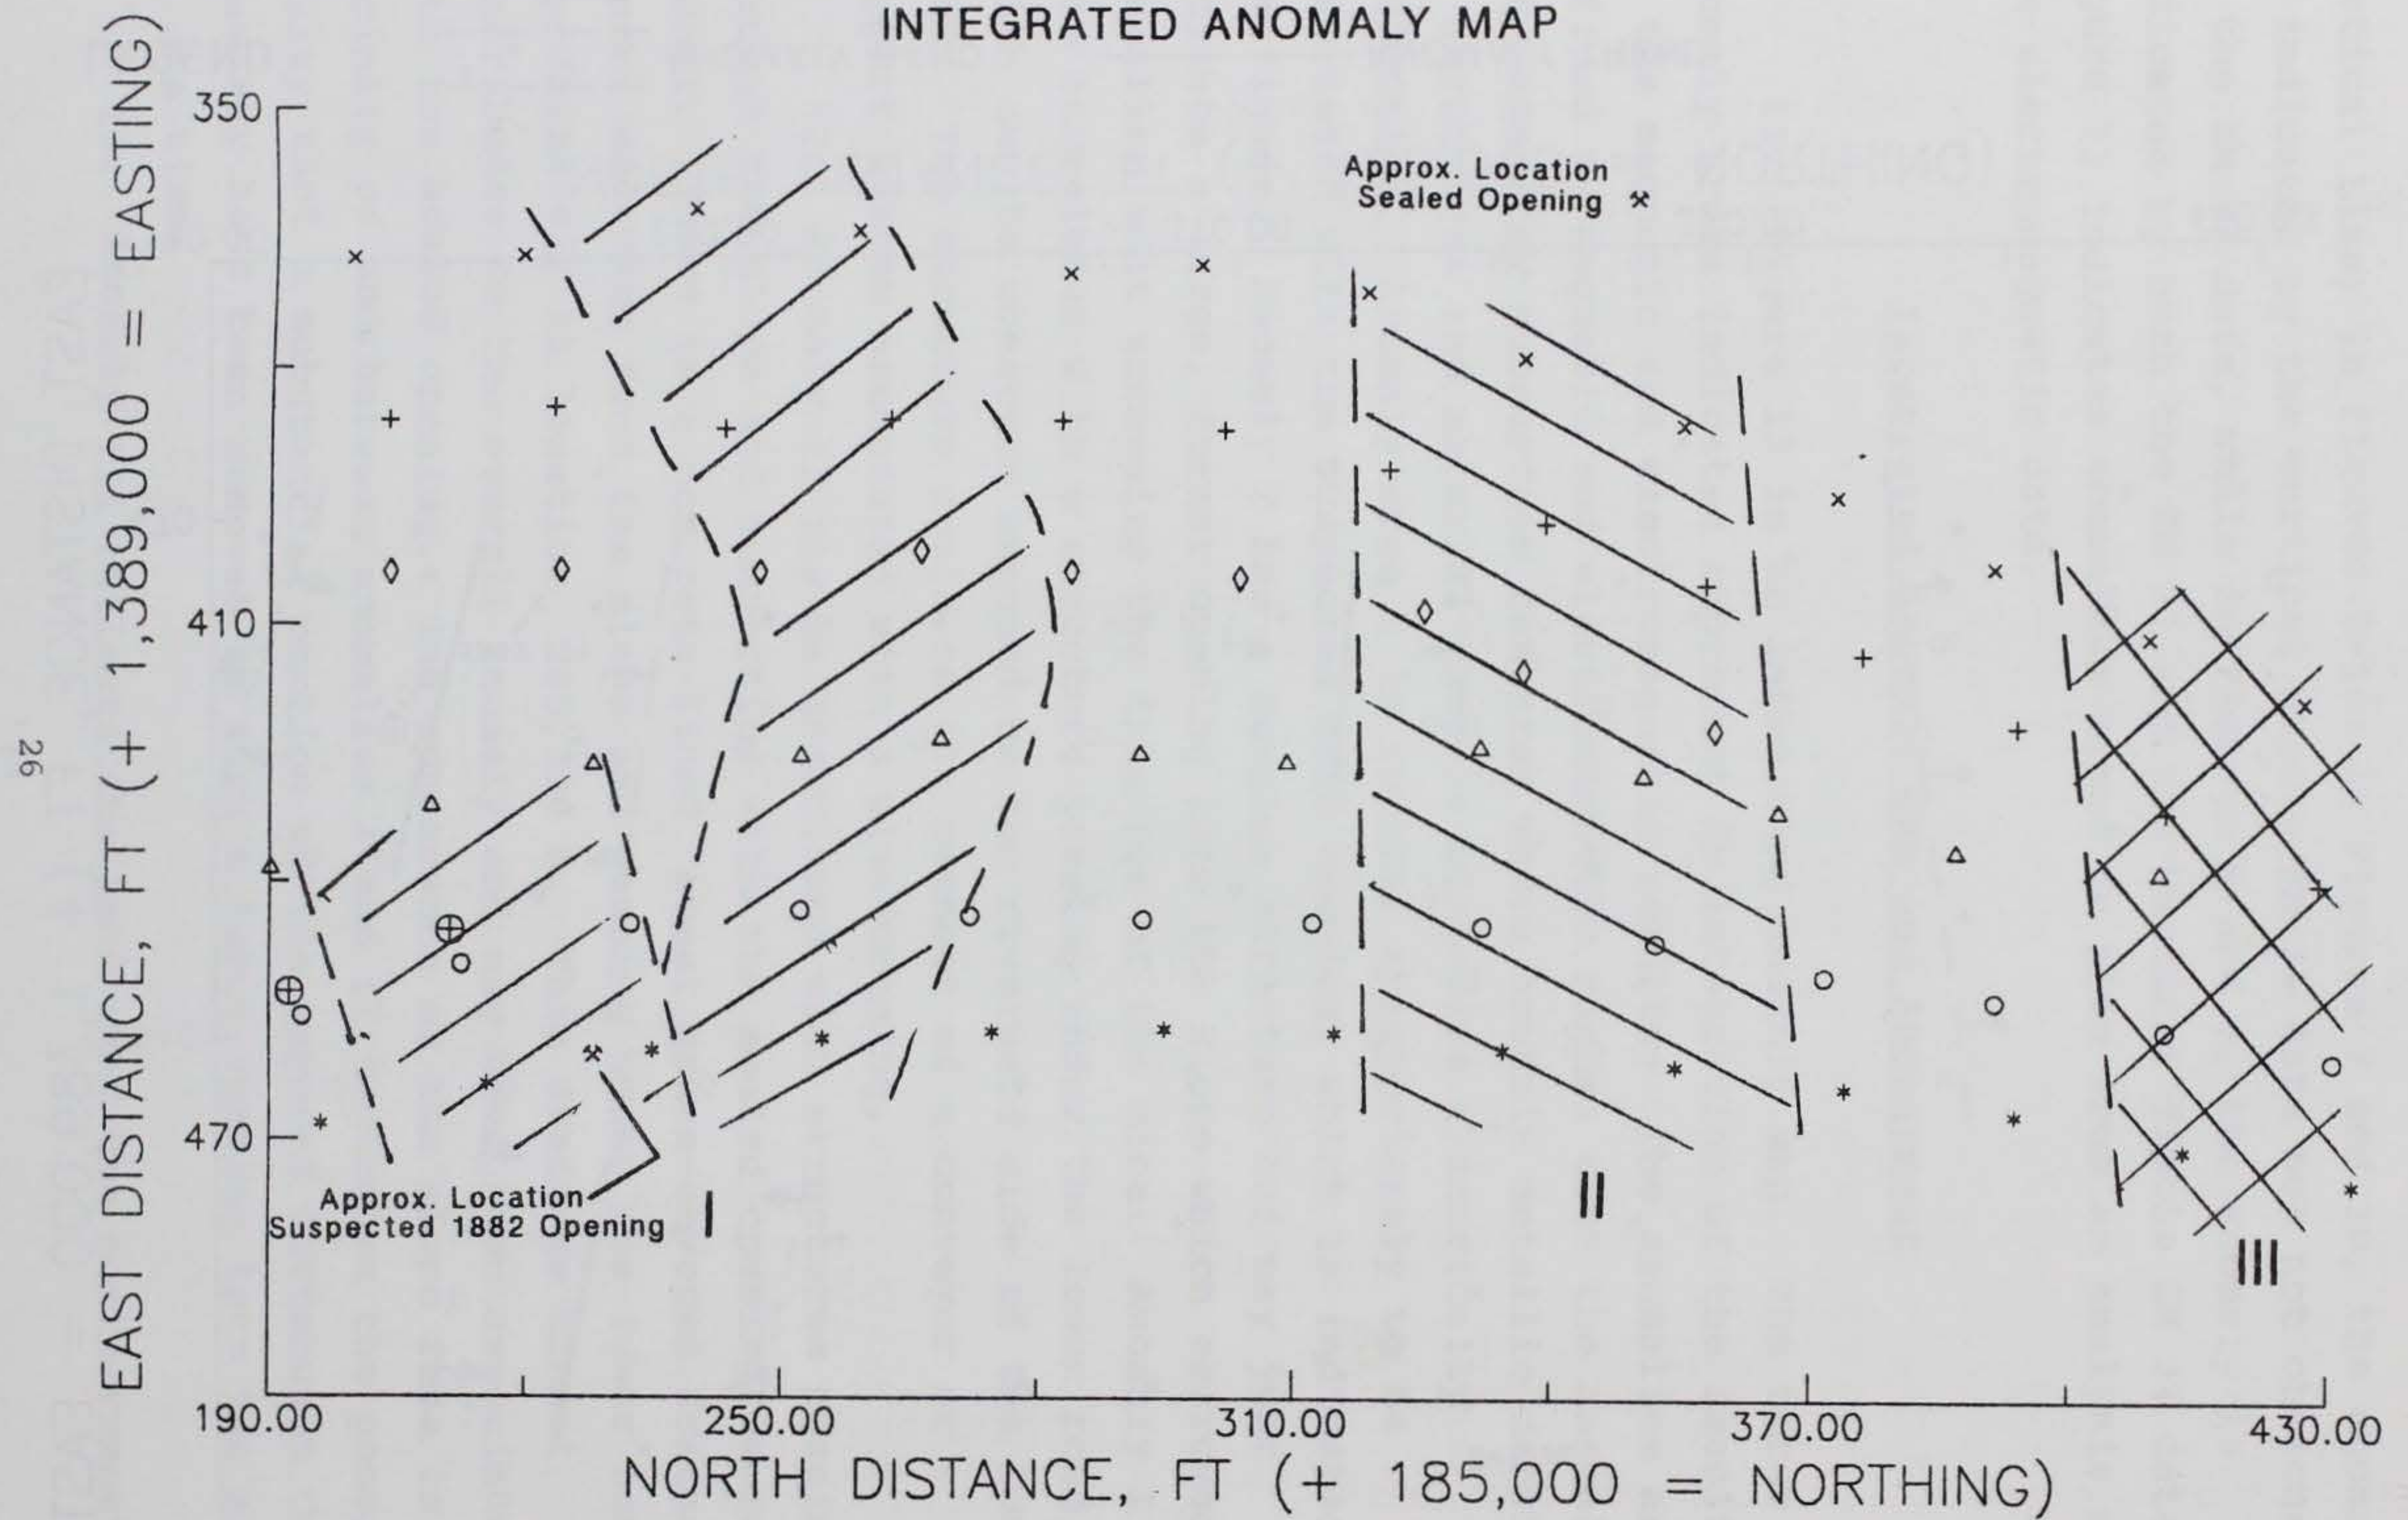
11. Figure 13 is an integrated anomaly map. The three anomaly areas indicated represent an integration of the results of the magnetic and electromagnetic results. The anomalies are defined by magnetic and electromagnetic highs; thus the anomalies are caused by subsurface features which contain metallic debris or structures and material that is otherwise electrically conductive. Anomaly area I is located appropriately to be associated with the suspected 1882 opening, which is indicated on the figure. Anomaly I has a complex structure but may just indicate a large, former opening into the slope which narrowed to a smaller adit accessing the interior of the mine. Anomaly I also correlates with a structure passing under the lower road, which can be observed exposed on the riverward side of the lower road. The structure could be the remnant of a conveyor or support system associated with a mine opening.

Figure 13. Integrated anomaly map for a portion of the left abutment area of Grays Landing Lock and Dam Site

12. Anomaly II may be associated with structures passing through the slope and connecting with the sealed opening in some manner. There is a concrete-lined, steel grate-covered drainage tunnel emerging from the slope and passing under the lower road approximately at location 185,330 N. This drainage tunnel contributes to the overall anomaly and may have been associated with the sealed opening. The appearance of the slope face in the vicinity of and between anomalies I and II indicates the possibility that a substantial portion of the exposed Pittsburgh Coal seam may have been removed to form a large opening into the mine at one time.

end of all the geophysical survey lines was anomalous. There is a well-defined magnetic anomaly maximum on lines I, II, and V at profile location 200-210 ft, while the electromagnetic conductivity increases steadily from profile location 200 ft to the end of the survey lines. There is no known surface or subsurface feature to correlate with this anomalous area.

14. Results of the geophysical surveys in the left abutment area of Grays Landing Lock and Dam Site are less than completely satisfying due to the complexity of the site in terms of surface topography and surface metallic, cultural debris. The surveys succeed, however, in mapping anomalous areas (Figure 13) at the site. Two of the anomalous areas (I and II) trend westward from the lower road area into the slope. One of these anomalous areas (I) may be caused by the suspected 1882 mine opening and its debris fill. If the anomalous areas are investigated by exploratory drilling, the drilling should begin along the centerlines of the areas and then successively offset by approximately 10 ft to each side of the initial borehole, if the initial borehole fails to encounter an anomalous feature. The features causing the anomalies are likely less than 25 ft in depth. However, conservatively, boreholes should be extended to approximately 50 ft depth. Alternatively to drilling, trenching would be an effective technique for investigating anomalous area I for the suspected 1882 mine opening. The trench should be located approximately along survey line II (along the west side of the lower road), beginning about 10 ft north of MS-23 and continuing north for approximately 70 ft or until evidence of an opening is encountered.
