MISCELLANEOUS PAPER GL-91-11

GEOPHYSICAL INVESTIGATION AT AN EXISTING LANDFILL, BADGER ARMY AMMUNITION PLANT, BARABOO, WISCONSIN

Final Report

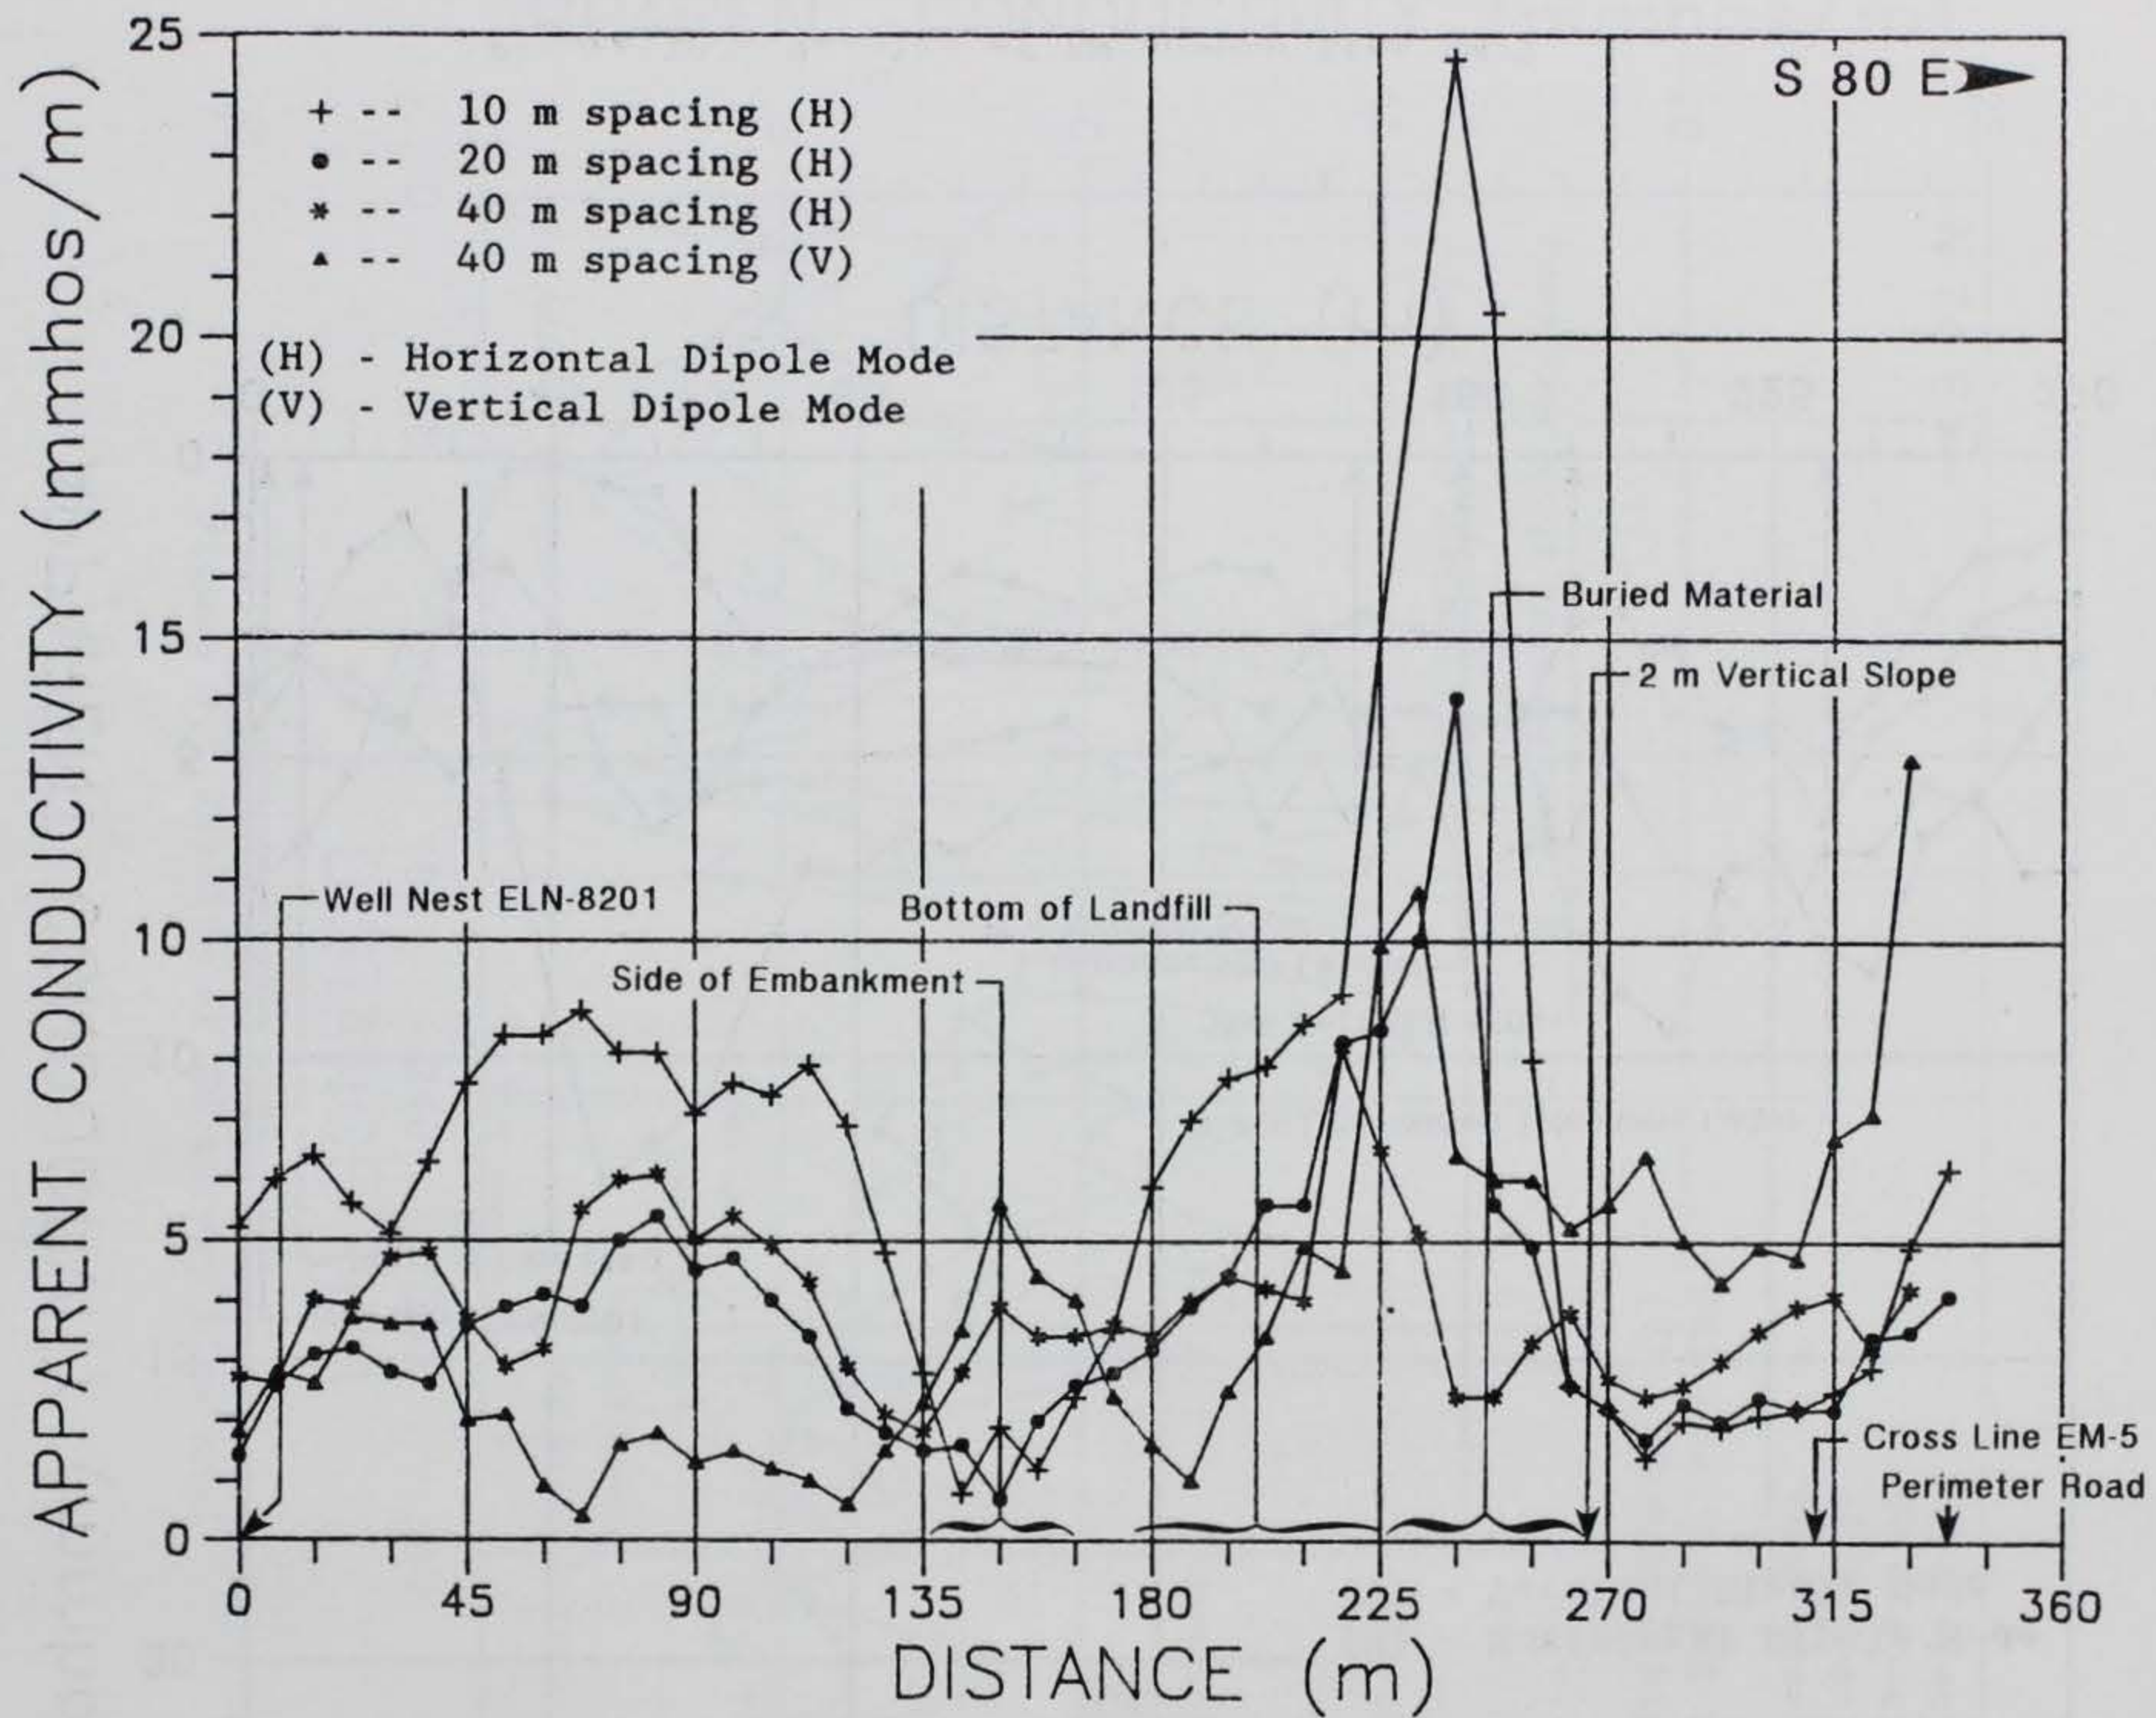
Figure 11. Results of EM survey line EM-3

22. Line EM-3. Line EM-3 is located along the north side of the landfill site, as illustrated in Figure 8. The results are presented in the conductivity versus distance plot shown in Figure 11. Between 50 and 110 m, an area of slightly high conductivity readings were detected with the 10, 20, and 40-m intercoil spacings with the coils orientated vertically. Within this area, partially exposed pieces of sheet metal are scattered along the surface, suggesting that buried material located near the surface is causing the higher readings. Beginning at a distance of 140 m, the survey line descends a steep embankment (elevation difference roughly 6 m) to the unfilled portion of the landfill. A low conductivity anomaly is detected using the 10- and 20-m coil spacings during this descent. Along the bottom of the landfill, between 170 and 225 m, the conductivity increases as the survey progresses. A zone of high conductivity is detected beginning at 225 m and extends for 40 m and is likely caused by recently buried materials. Located nearby were two truck loads of refuse material containing paint cans, wire, creosoted railroad ties, treated lumber, and other construction material. Using the 10-m coil spacing, a region of low conductivity is detected near the surface between 260 and 320 m. Beyond 320 m, there is an overall high conductivity trend in the data.

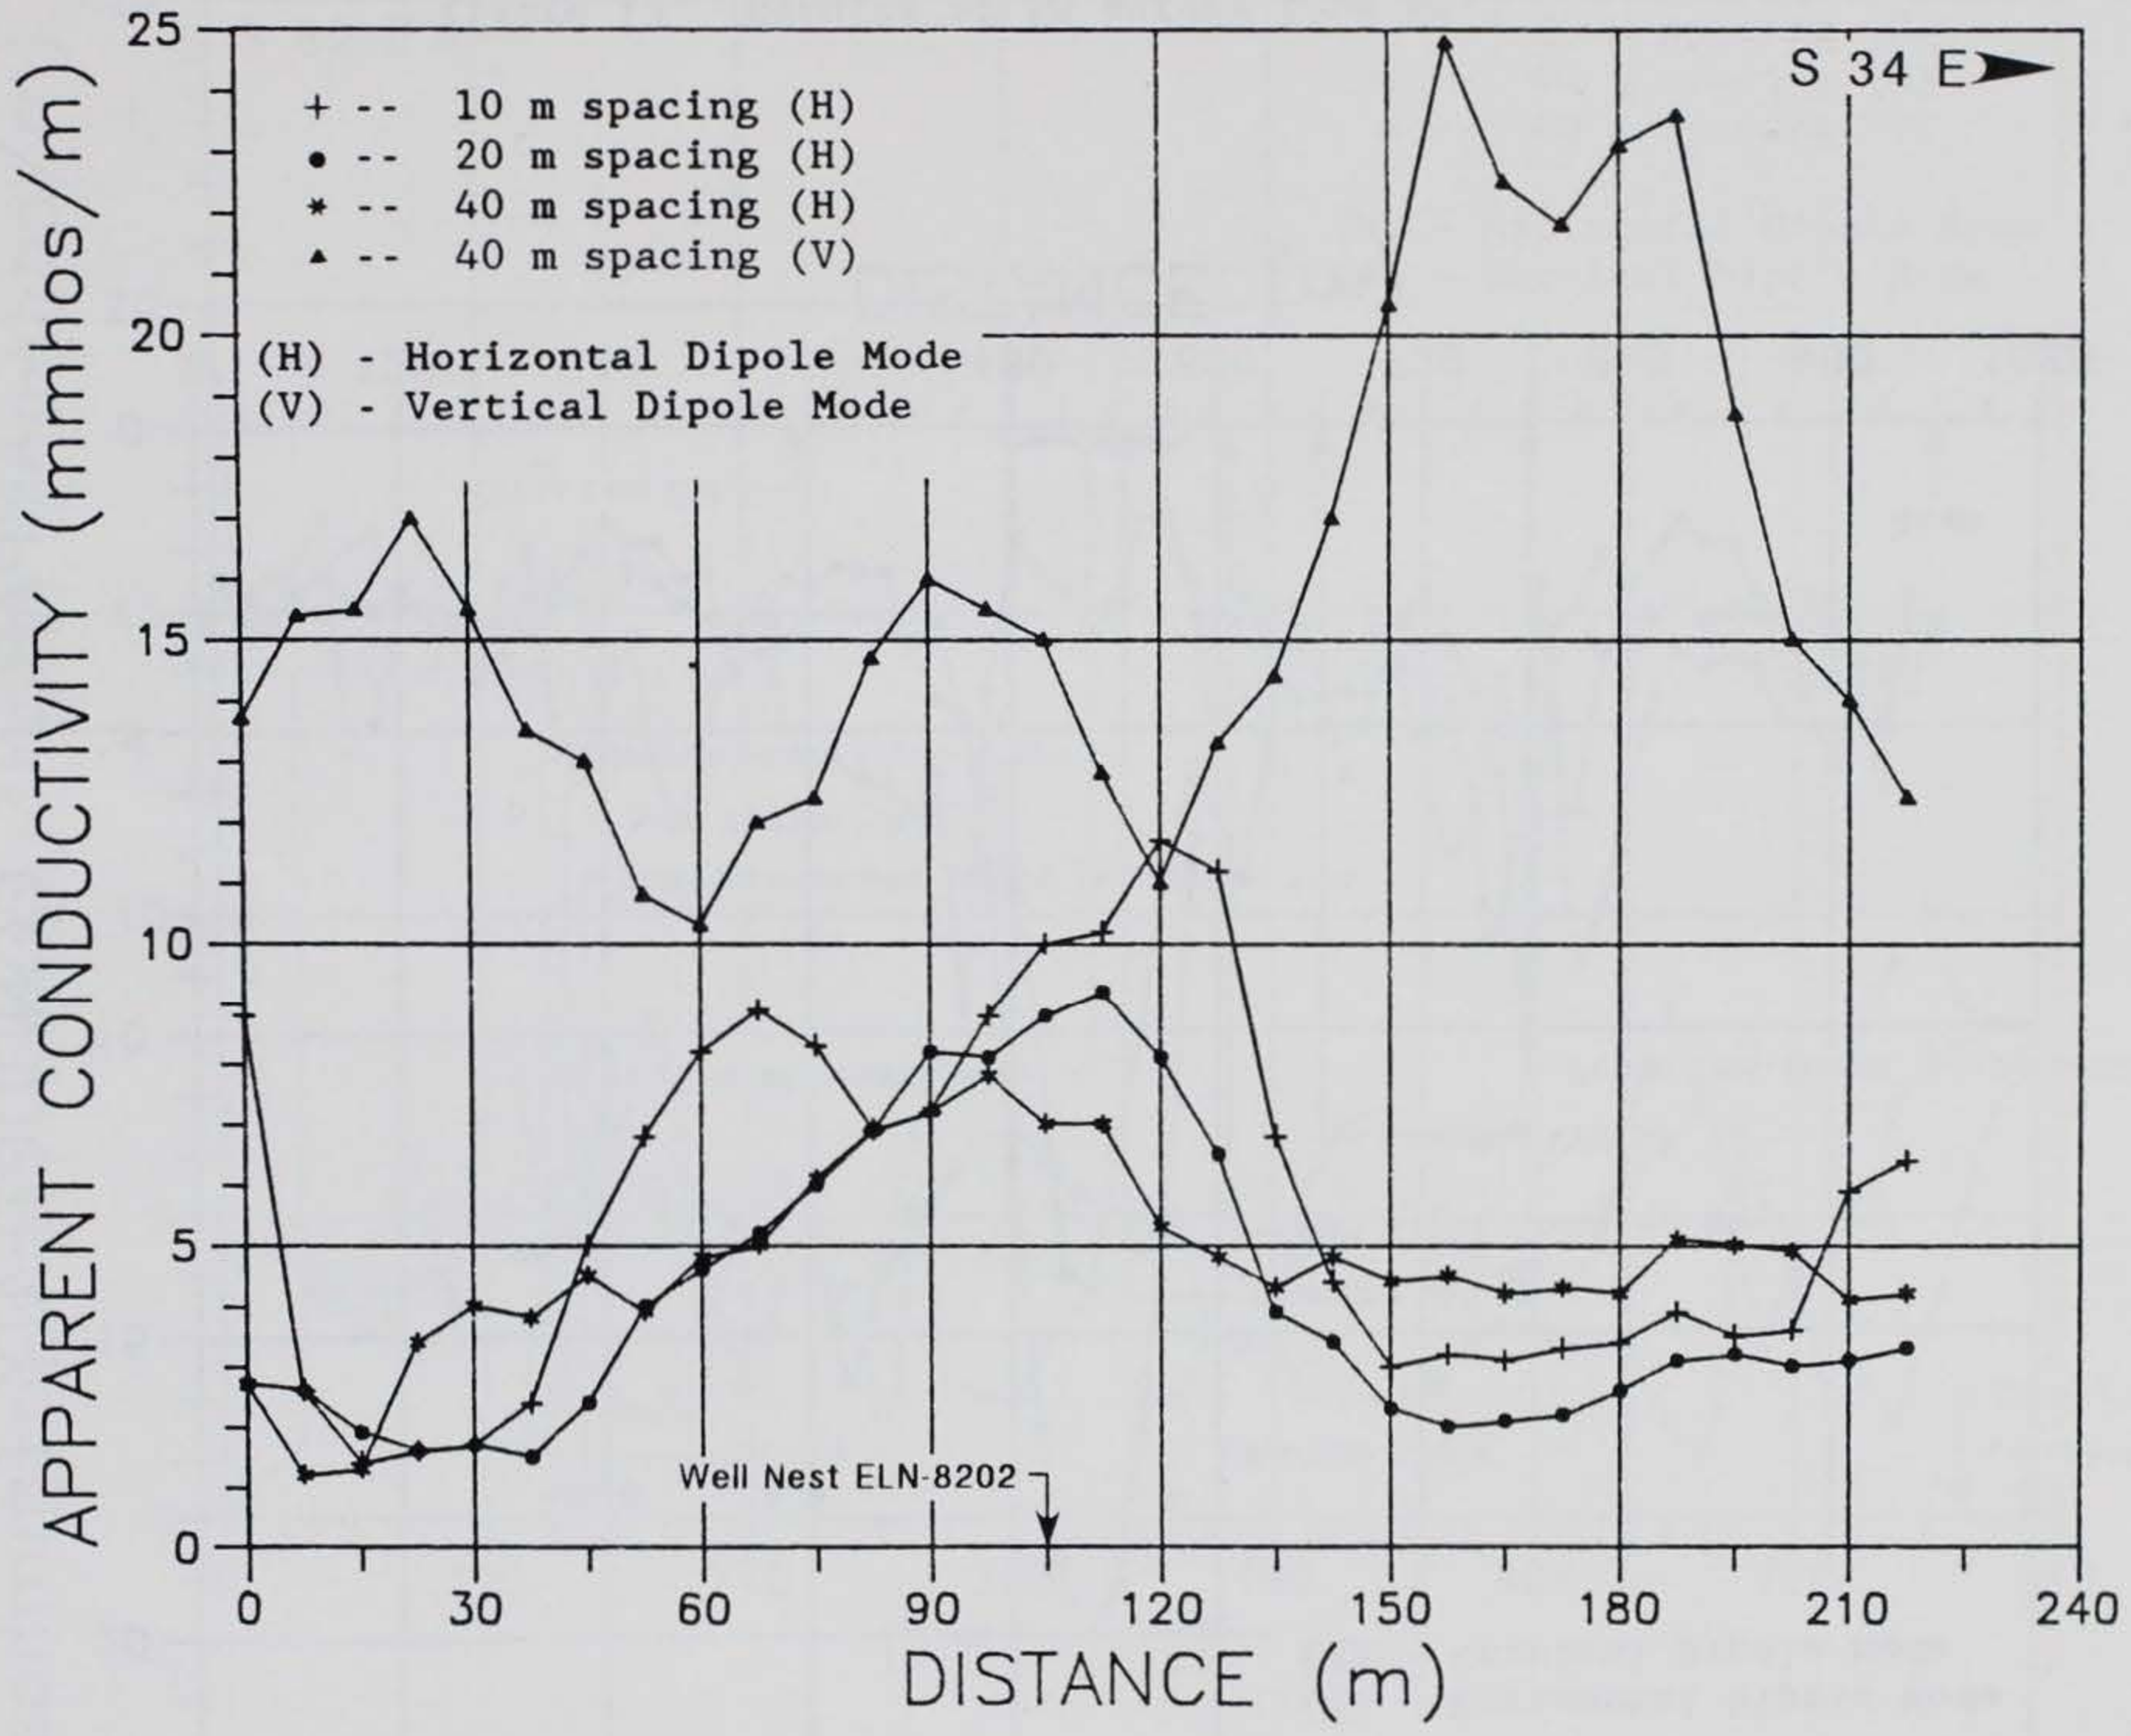
Figure 12. Results of EM survey line EM-4

23. Line EM-4. Figure 12 shows the results of line EM-4 which is situated along the Perimeter Road on the eastern side of the landfill, as illustrated in Figure 8. The conductivity readings acquired using the 40-m intercoil spacing in the vertical dipole mode are much higher than those obtained using the horizontal dipole mode. A chain link fence located 18 m away and parallel to the survey line is believed to create the higher readings but not the recorded fluctuations as shown in the results. These variations are due to conductivity contrasts in the subsurface. A prominent region of high conductivity, detected near the surface as well as at depth, is located between 50 and 135 m near well ELN-8202 and another is detected at depth between 130 and 200 m by the vertical dipole method.

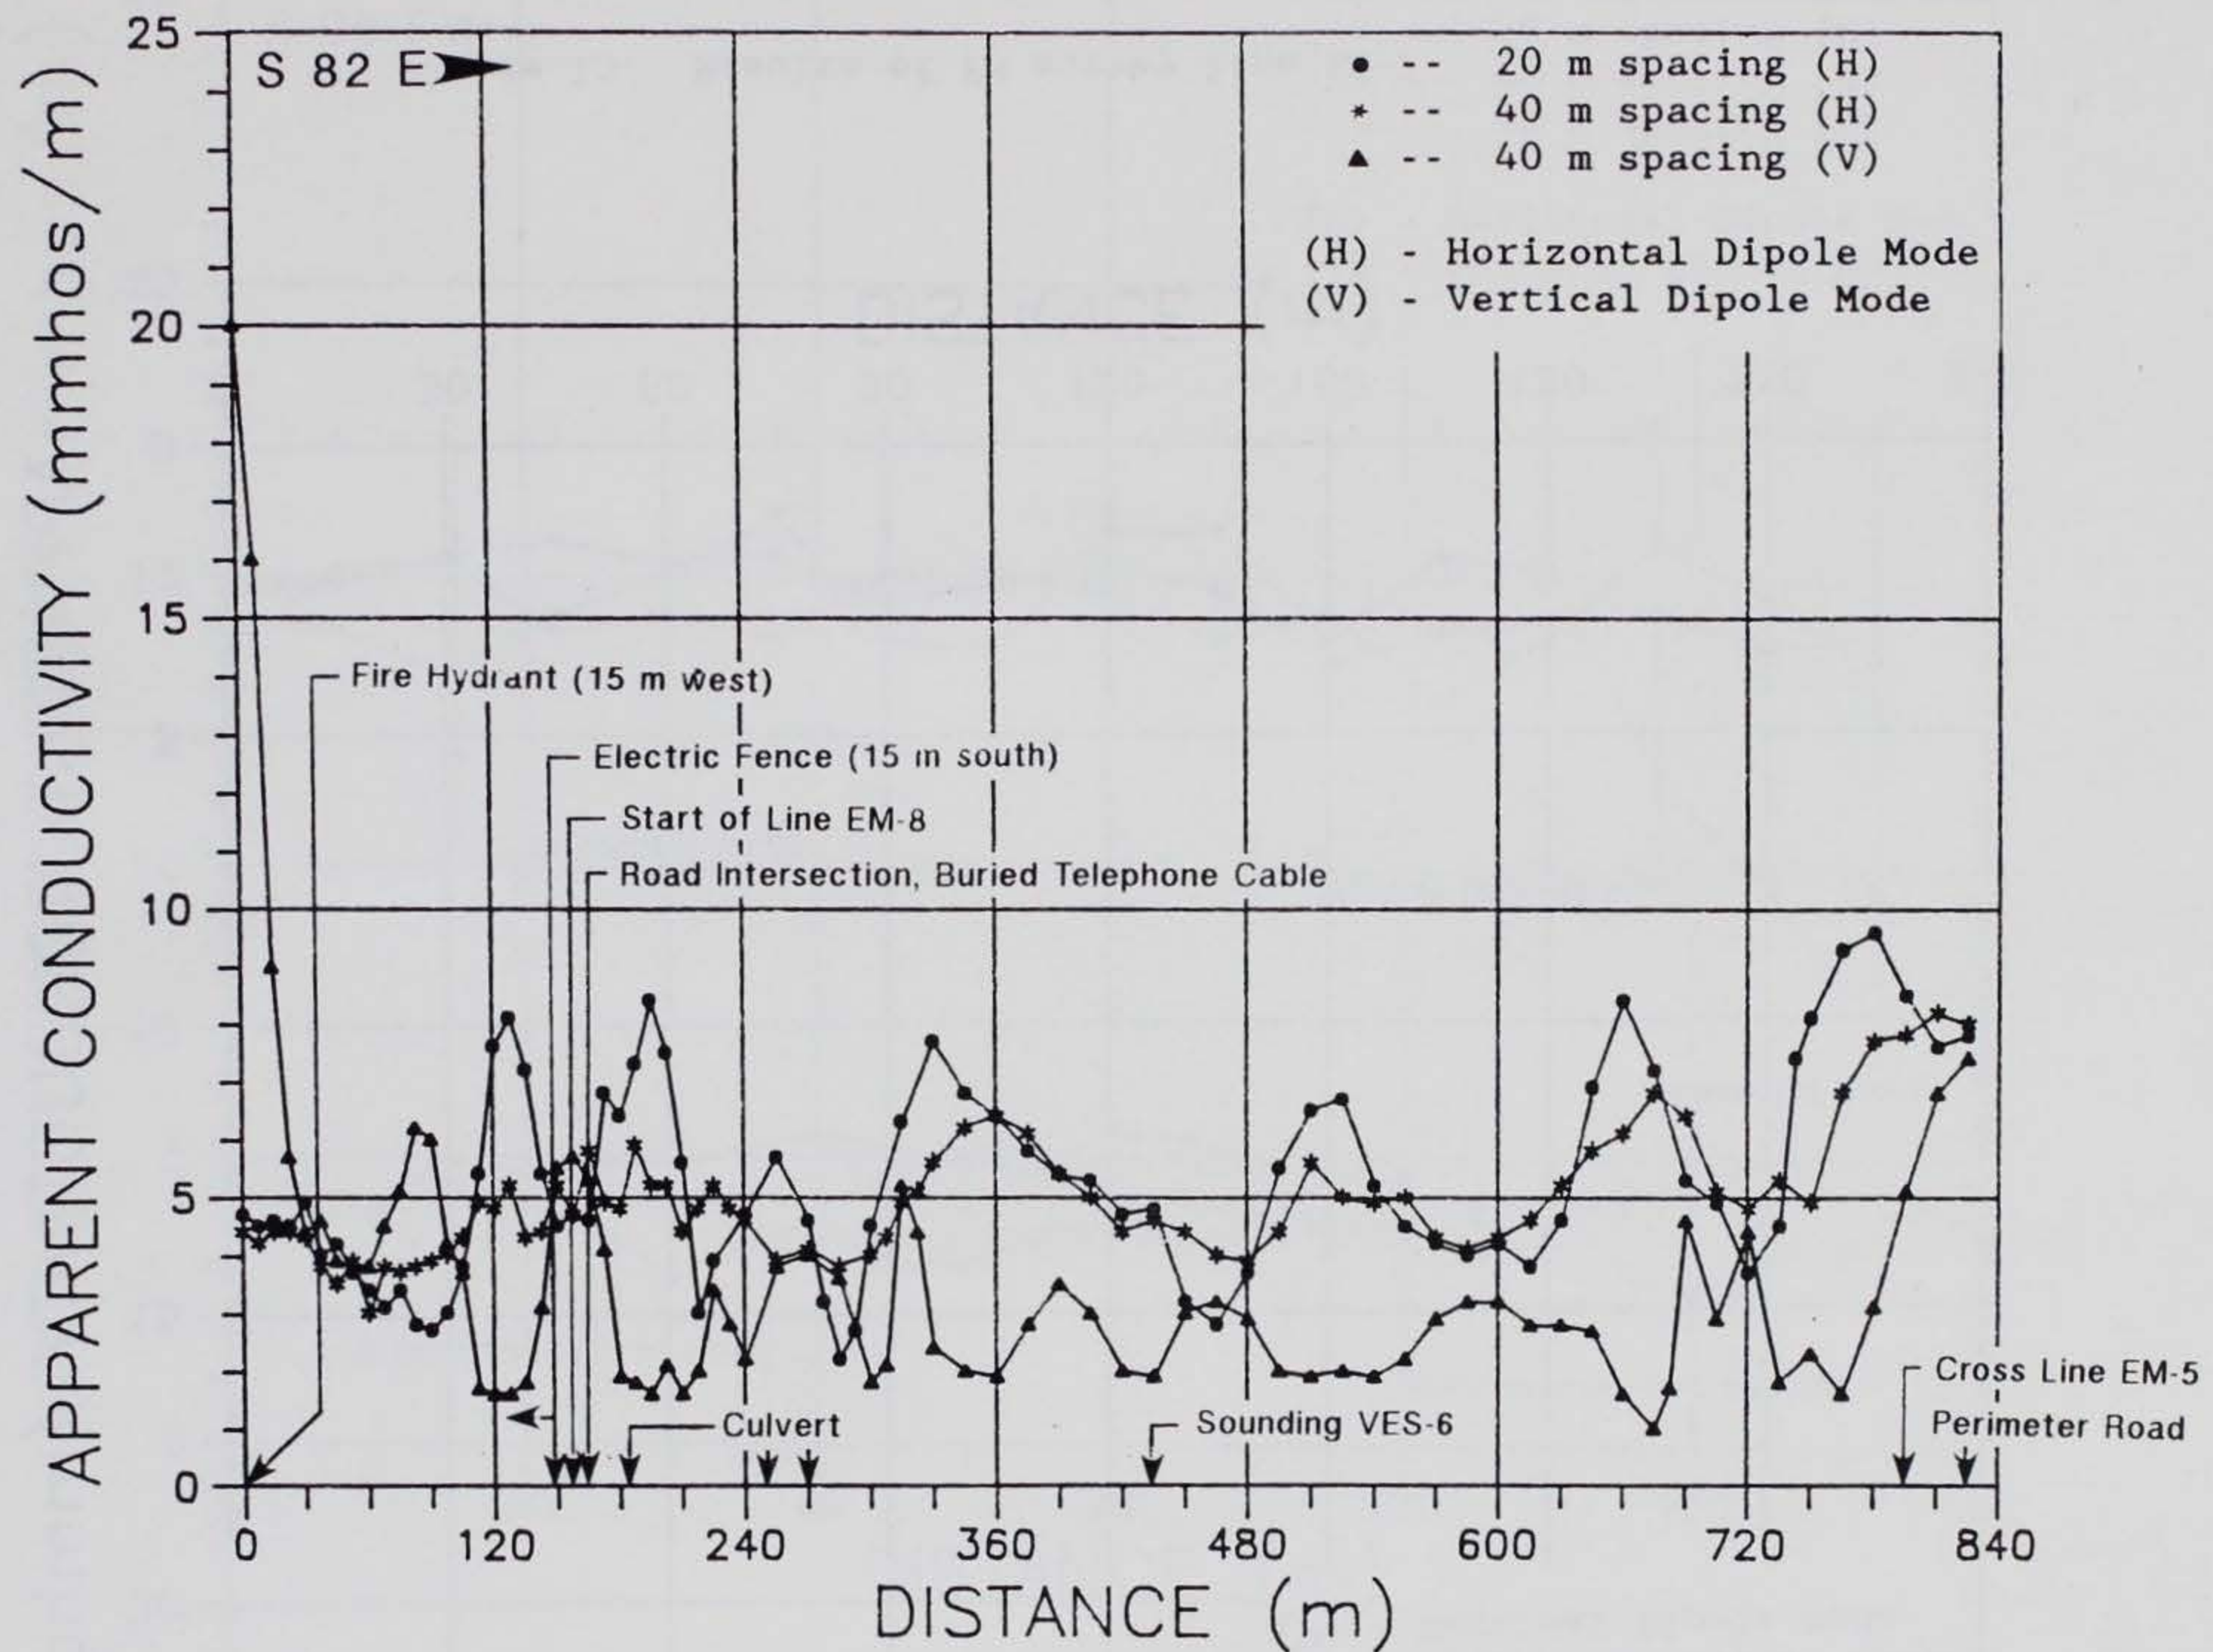
Figure 14. Results of EM survey line EM-6

25. Line EM-6. Line EM-6 was conducted along the east-west road located south of the landfill as indicated in Figure 8. The western portion of the survey line was conducted along the southern boundary of the deterrent burning area. The conductivity versus distance plot for this line is shown in Figure 14. The increasing conductivity trend at the end of the survey line is possibly due to the influence of a nearby power line, located parallel to the Perimeter Road. Numerous anomalies are located along the survey line and of these, only the ones occurring near 165 m may be caused by cultural features. The dramatic conductivity high detected using the 40-m coil spacing in the vertical dipole mode at the end of the survey line is likely due to a nearby fire hydrant and associated water line.

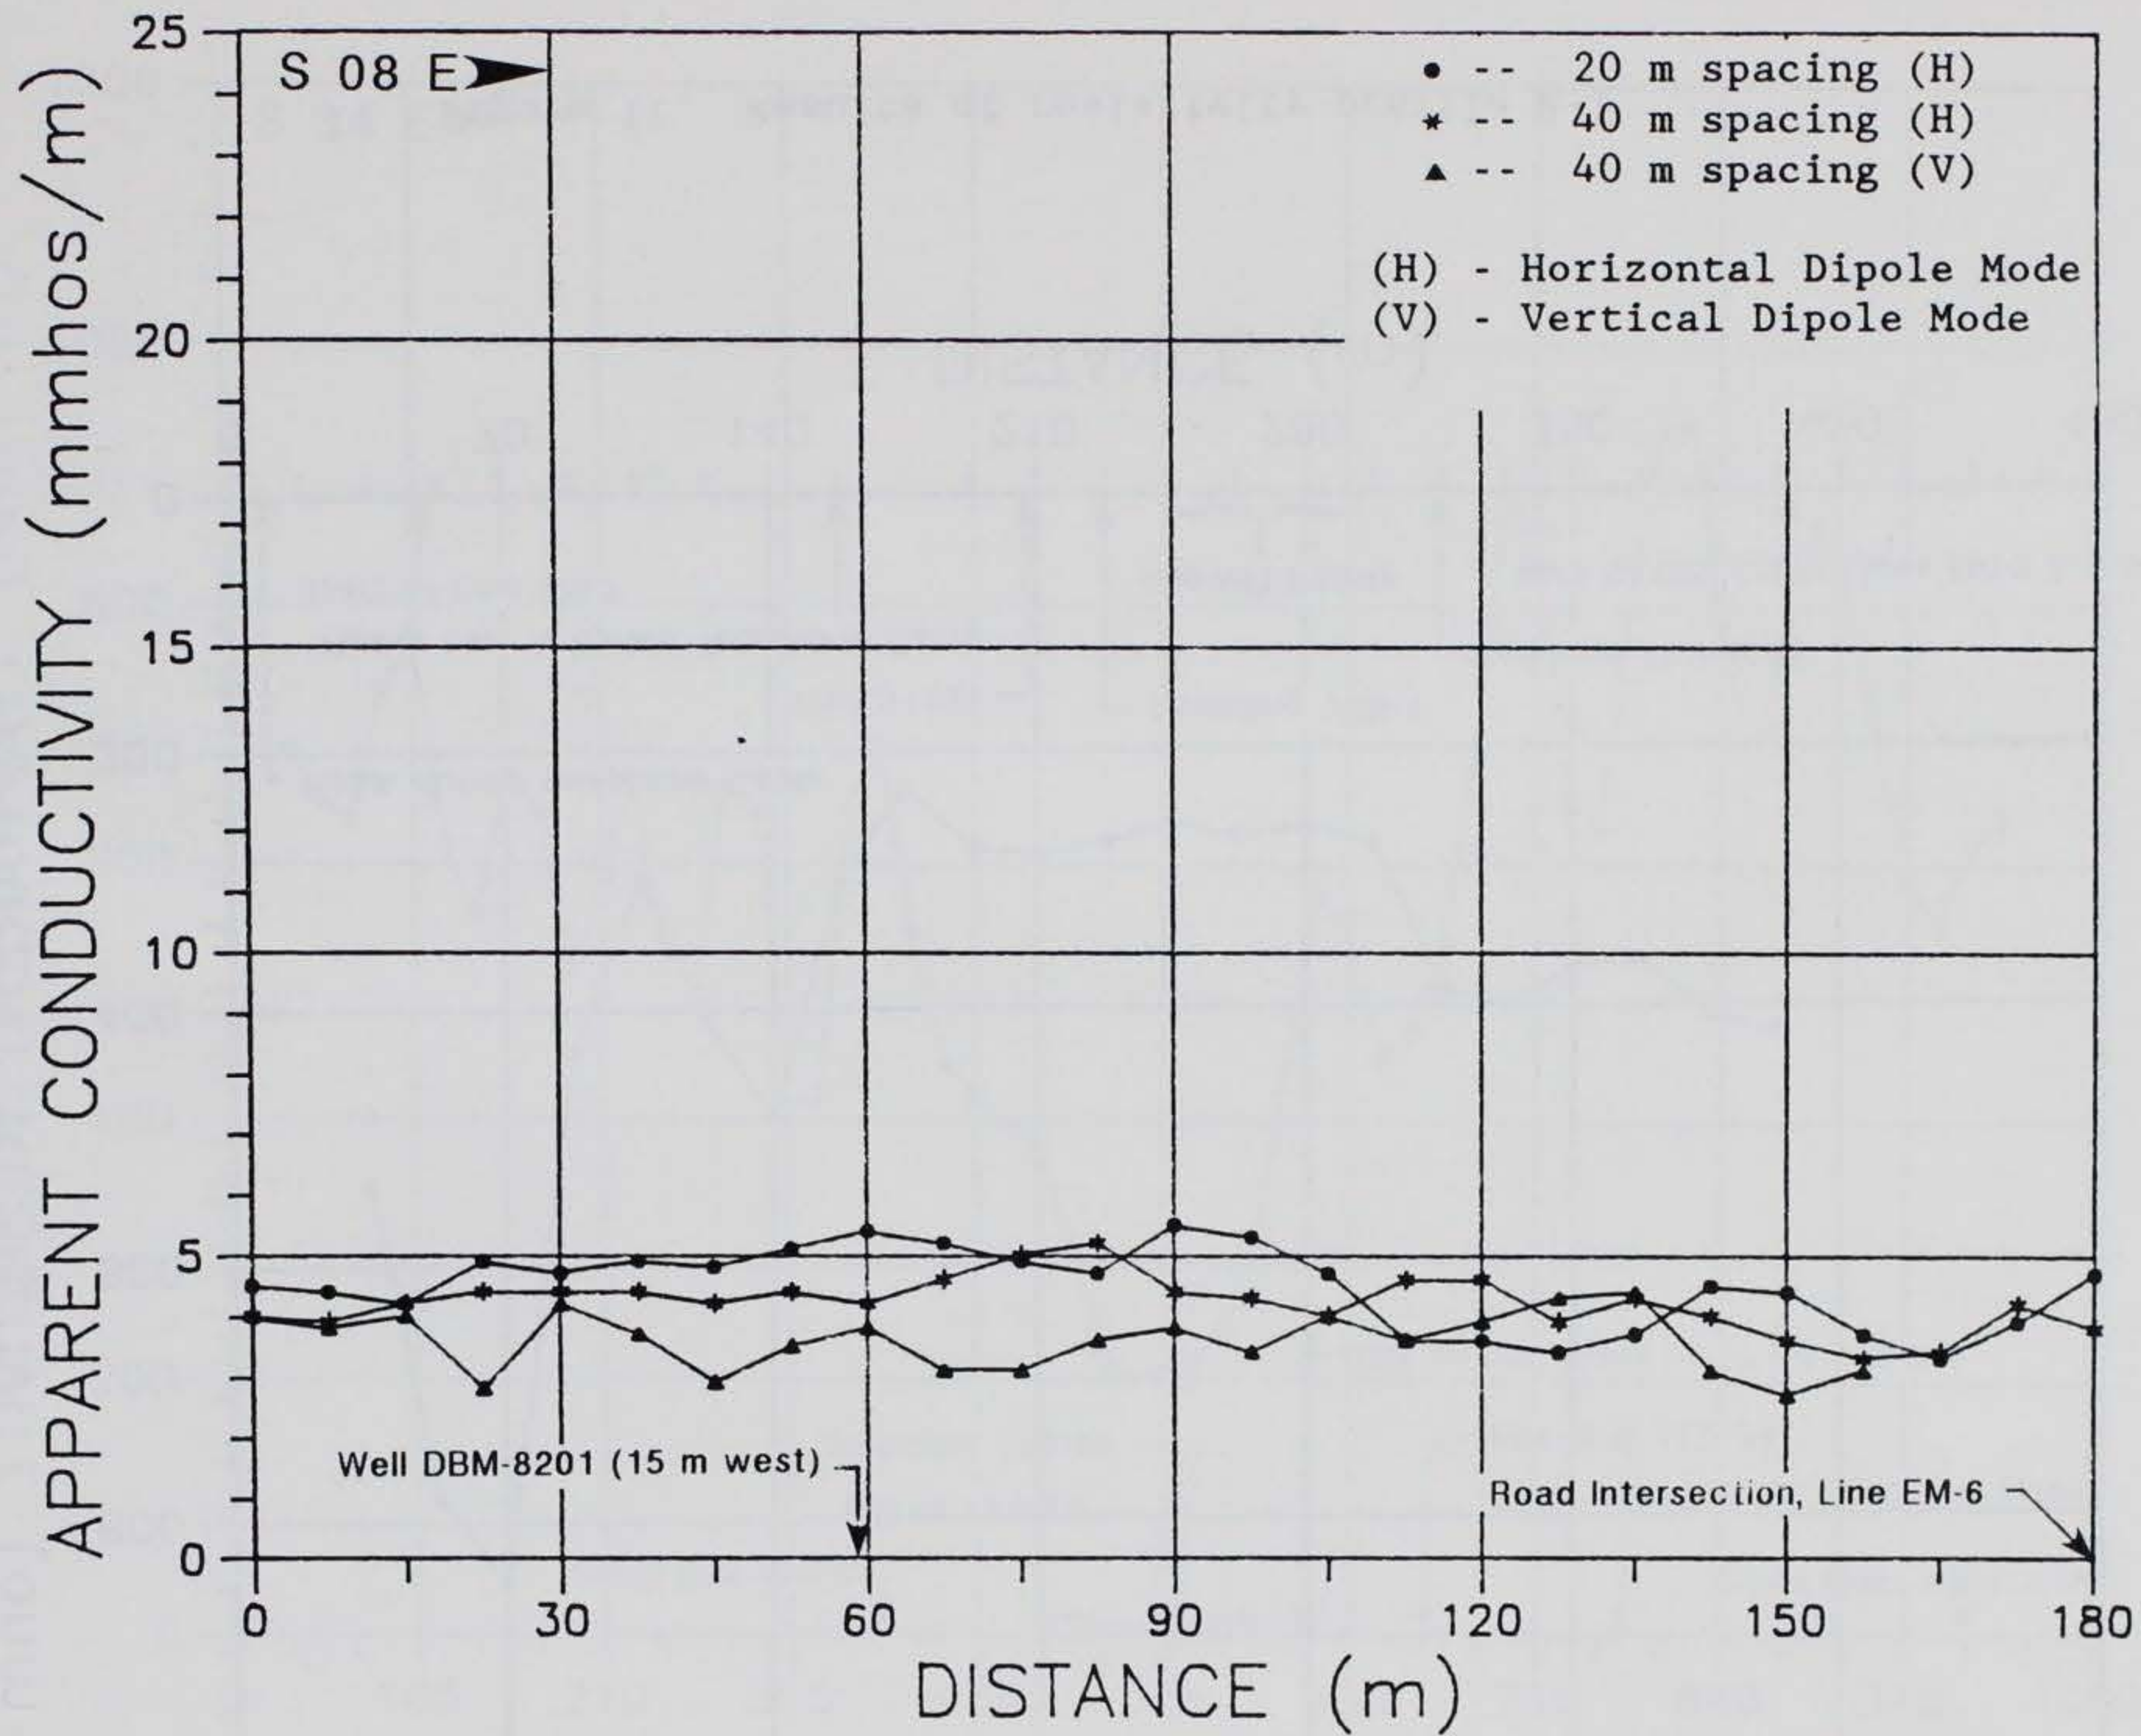
Figure 16. Results of EM survey line EM-8

27. Line EM-8. Figure 16 shows the results of line EM-8 which was conducted along the eastern edge of the Deterrent Burning Area, as shown in Figure 8. No anomalous areas are detected along this survey line.

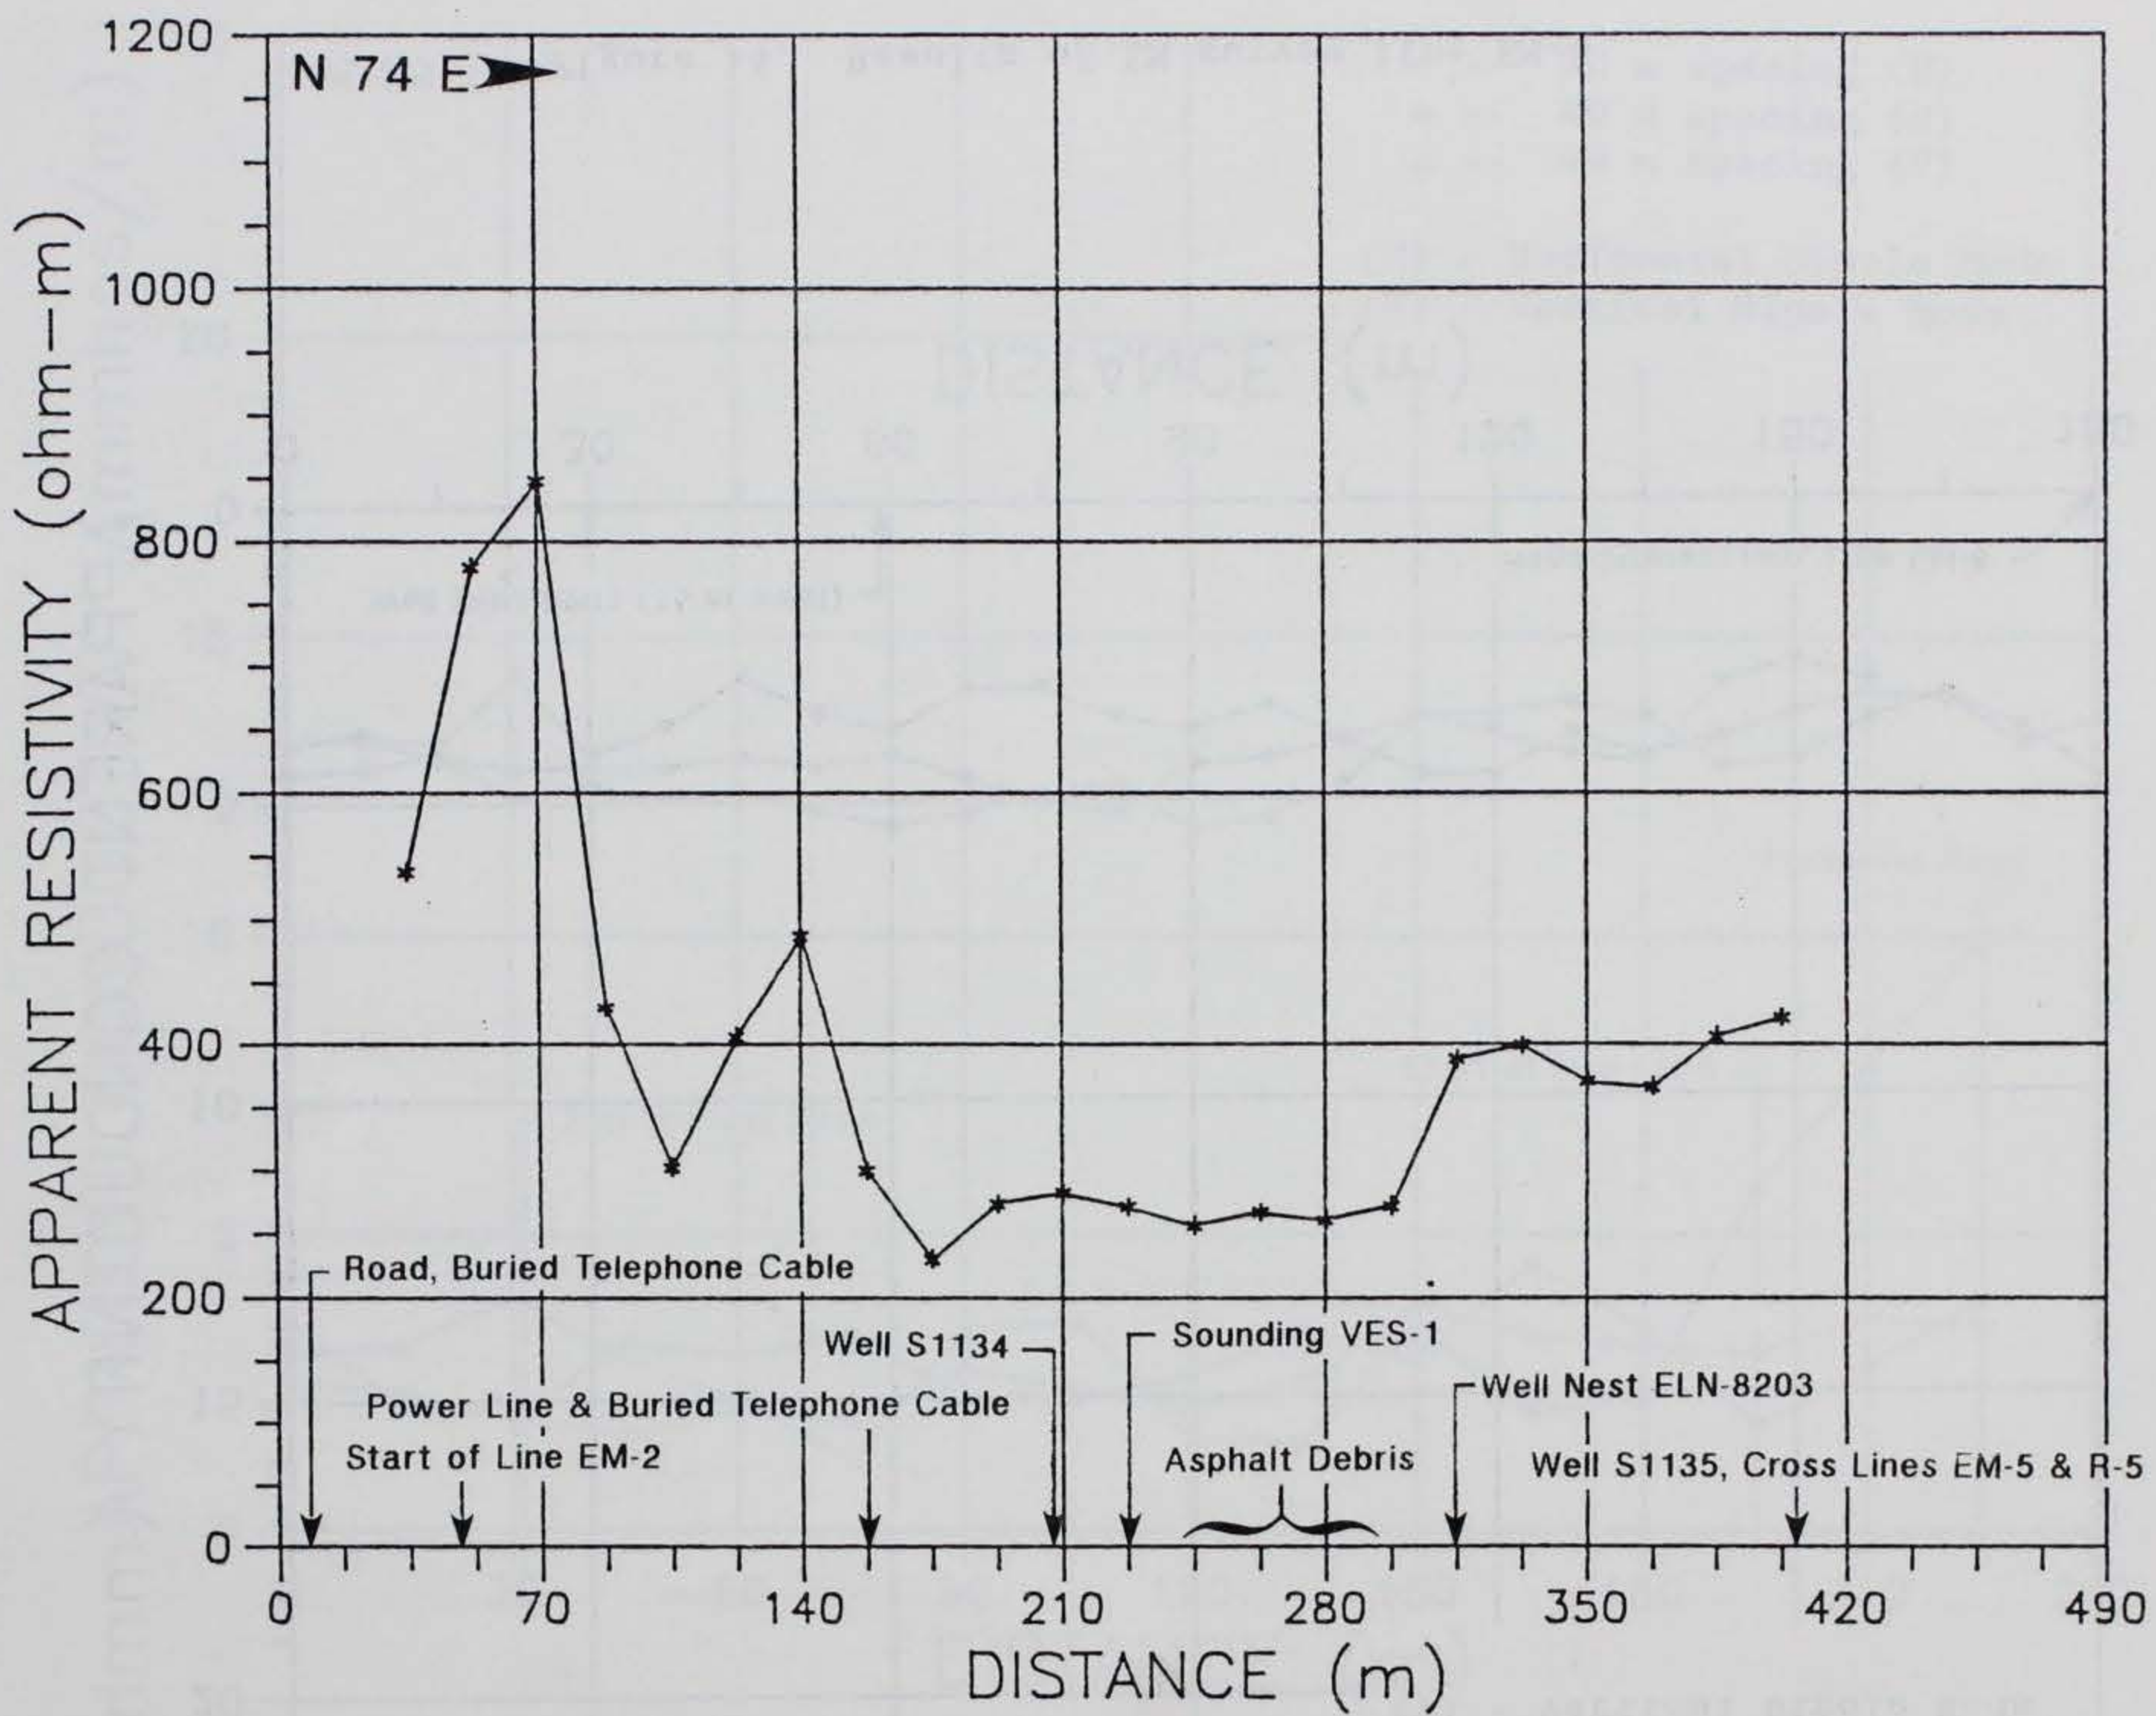
Figure 17. Results of resistivity profile R-1
