MISCELLANEOUS PAPER GL-91-11

GEOPHYSICAL INVESTIGATION AT AN EXISTING LANDFILL, BADGER ARMY AMMUNITION PLANT, BARABOO, WISCONSIN

Final Report

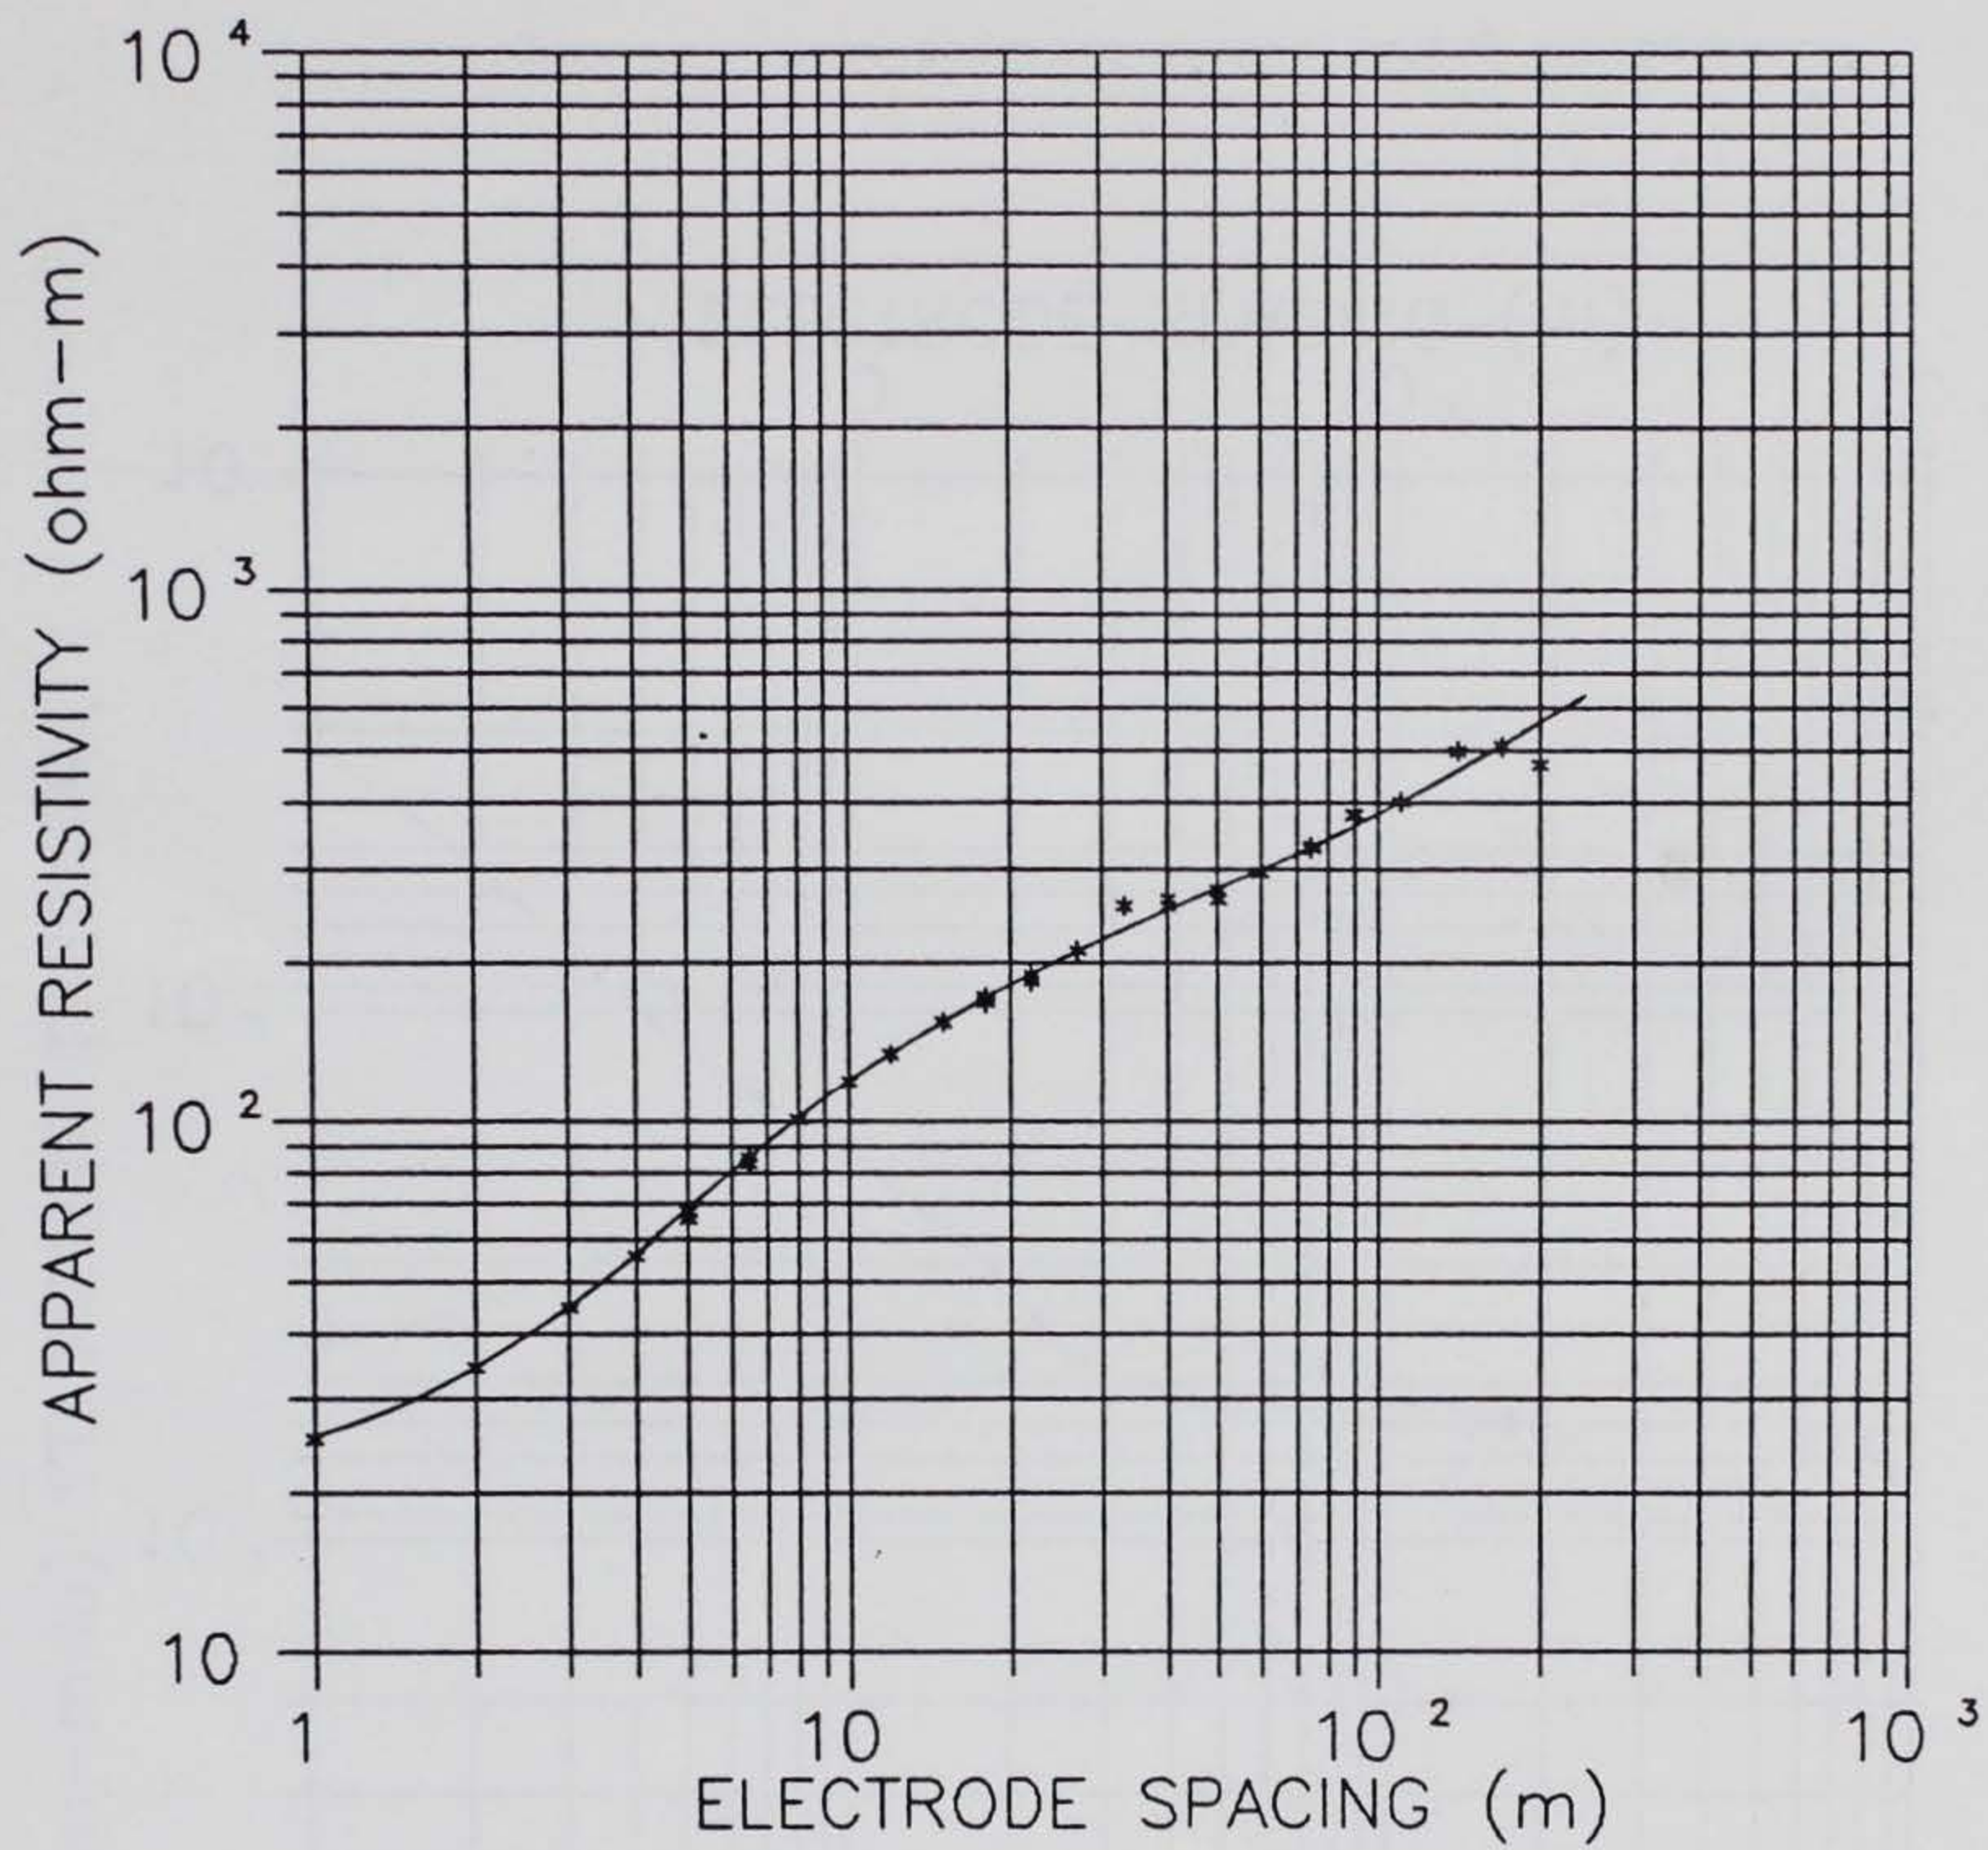
Figure 20. Data acquired from sounding VES-1

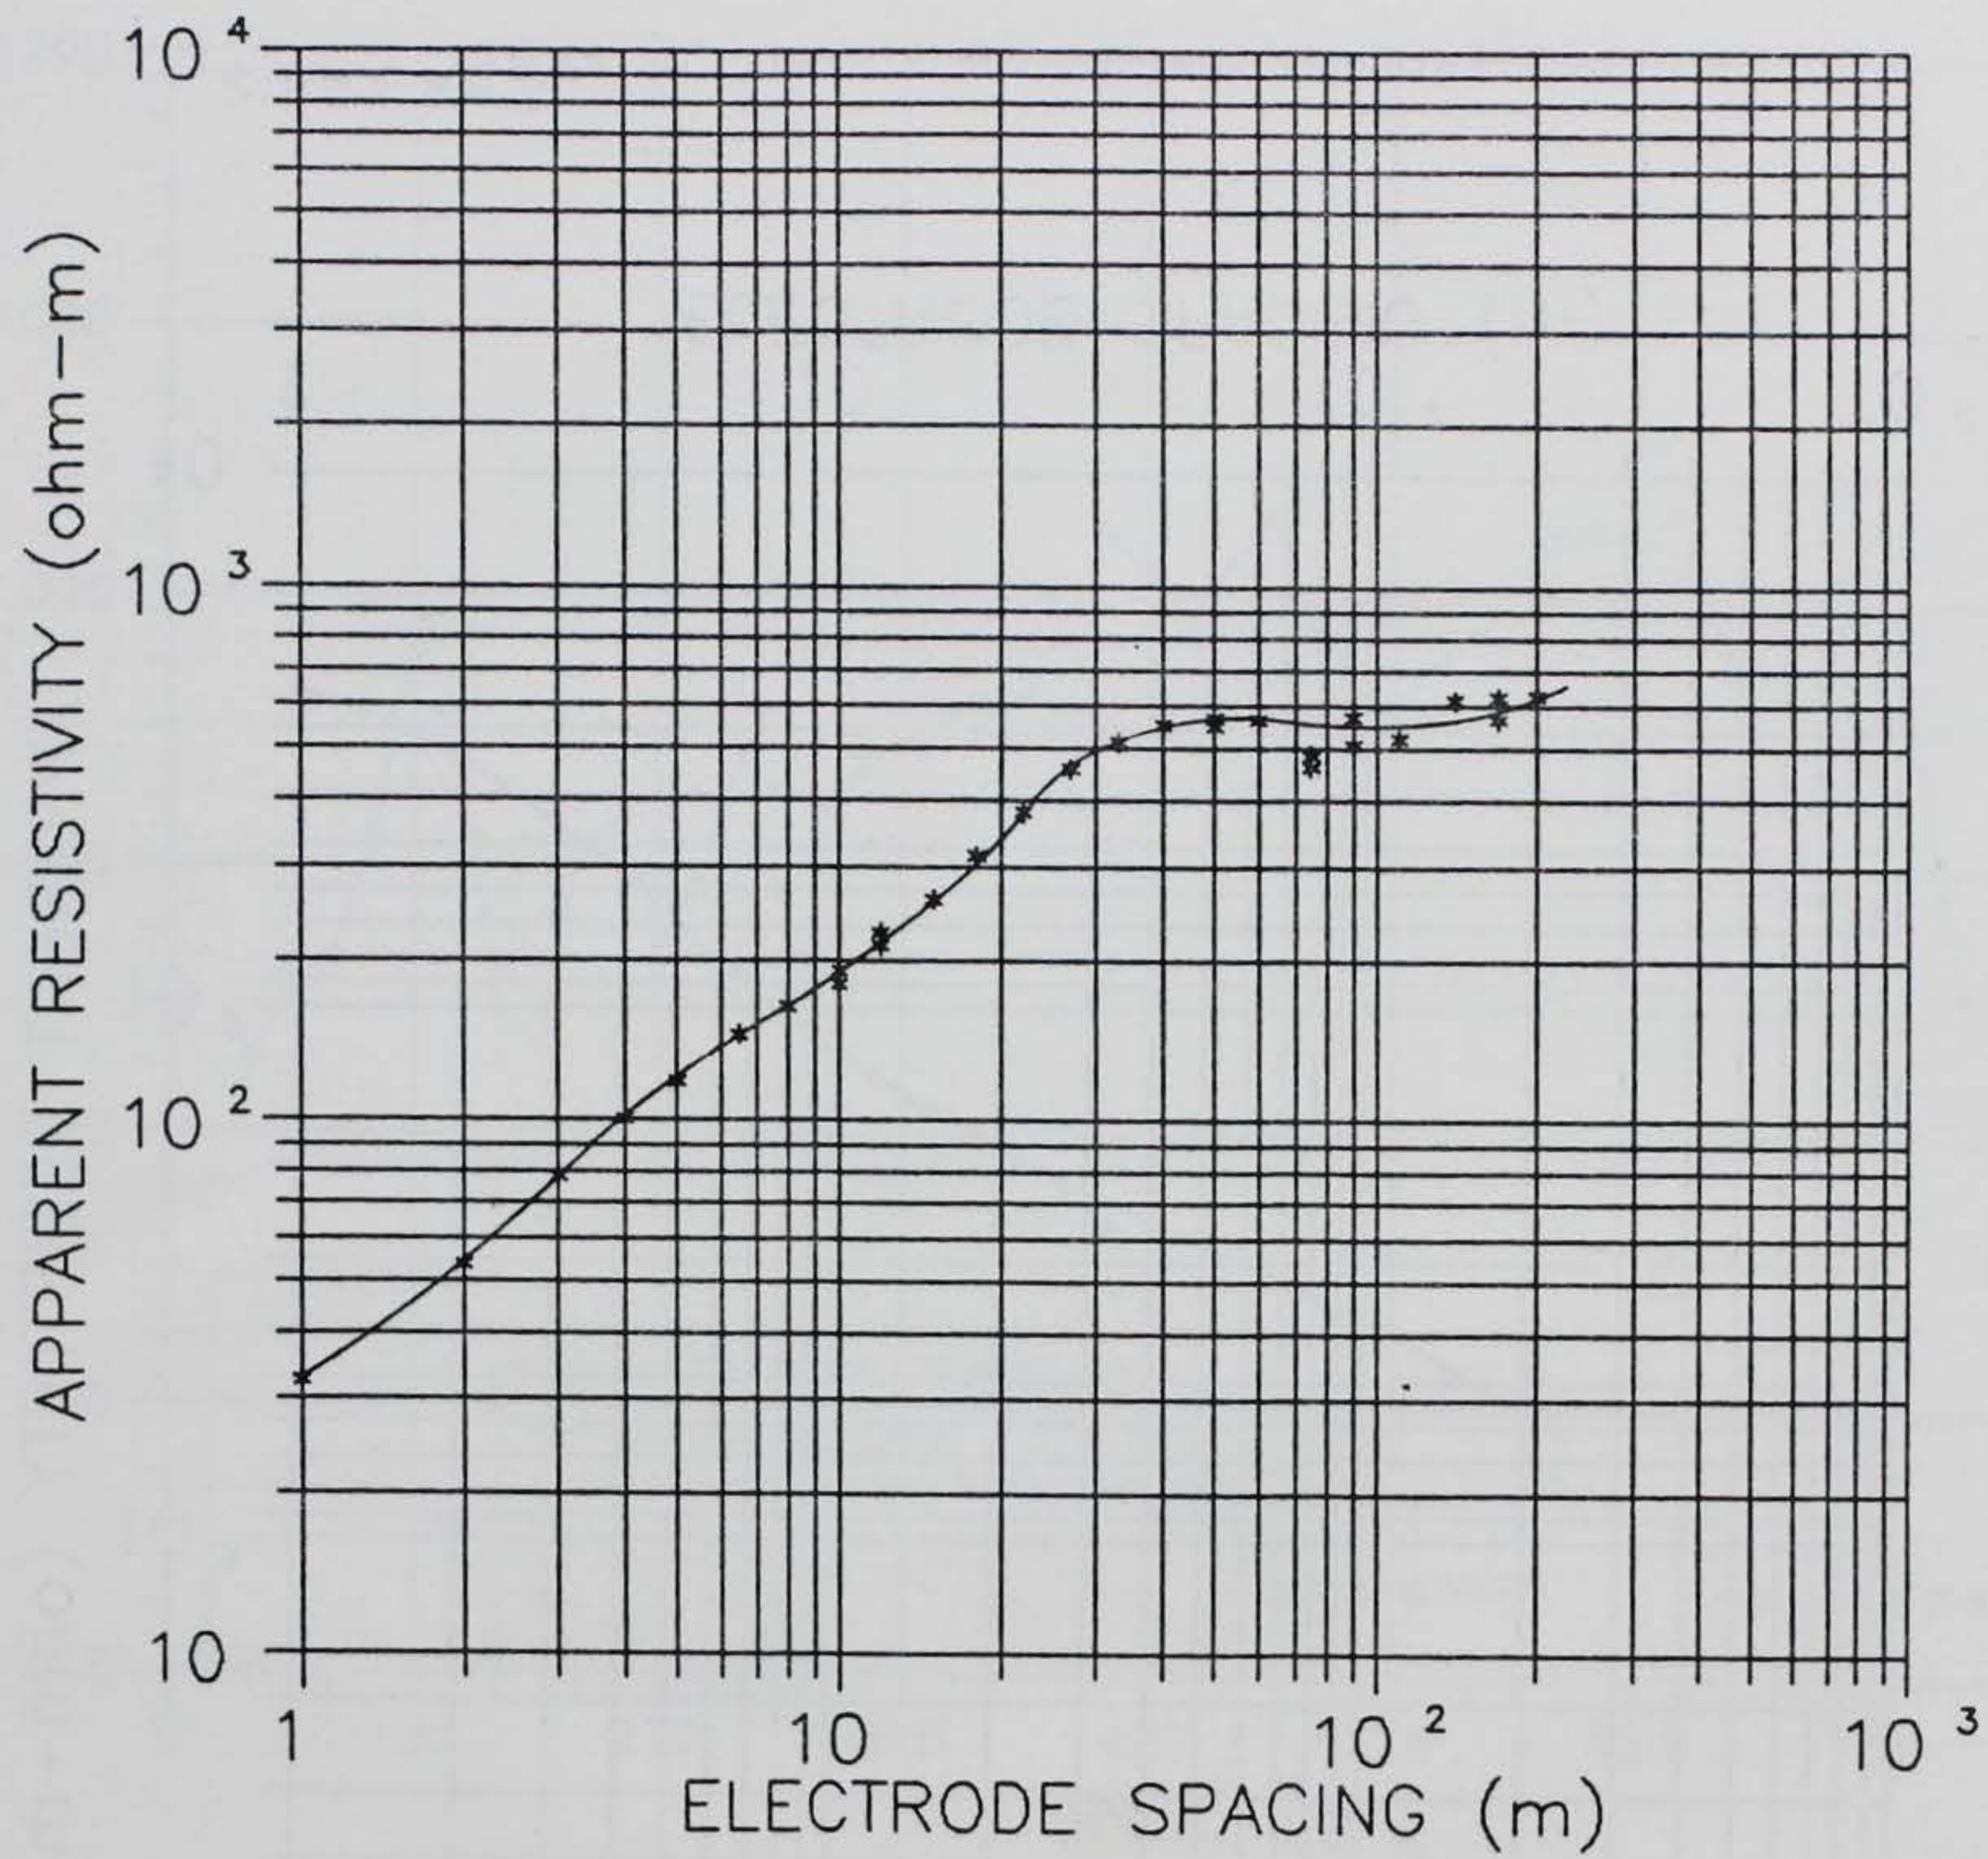
Figure 21. Data acquired from sounding VES-5a

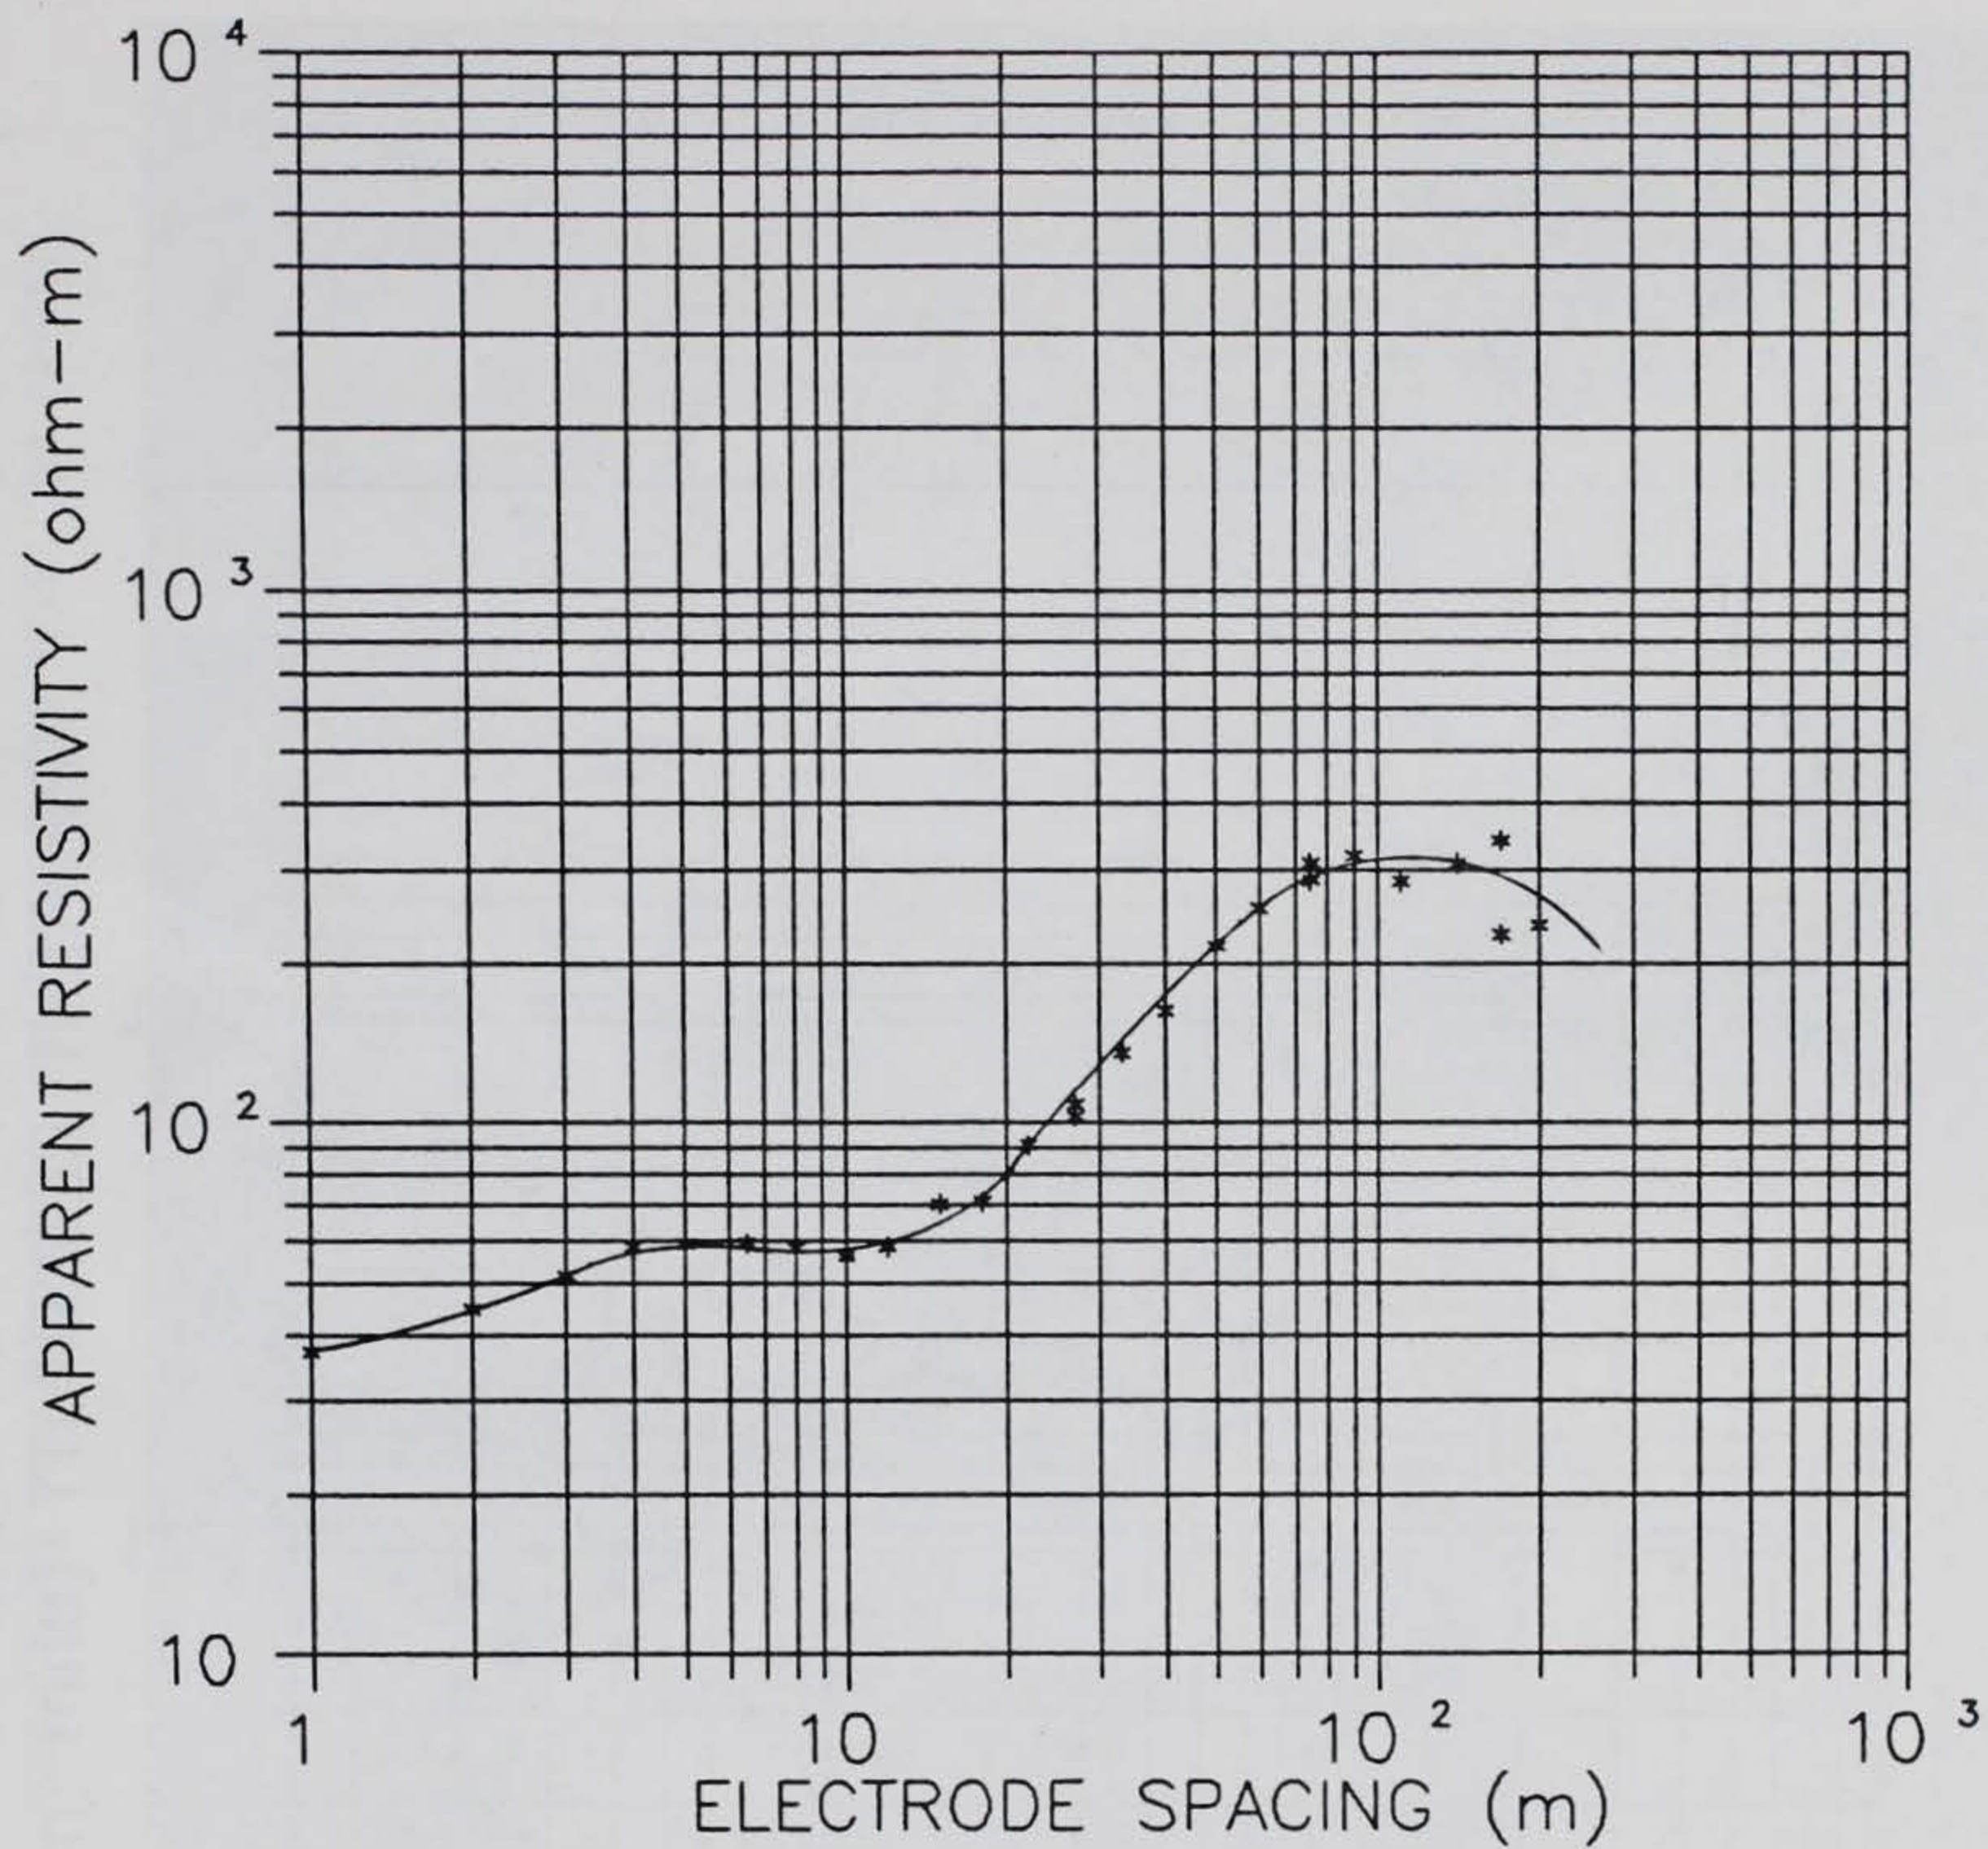
Figure 22. Data acquired from sounding VES-5b.
