## **Evaluation of Airfield Pavement Drainage Layers**

John F. Rushing and Mariely Mejías-Santiago

July 2009

Final report

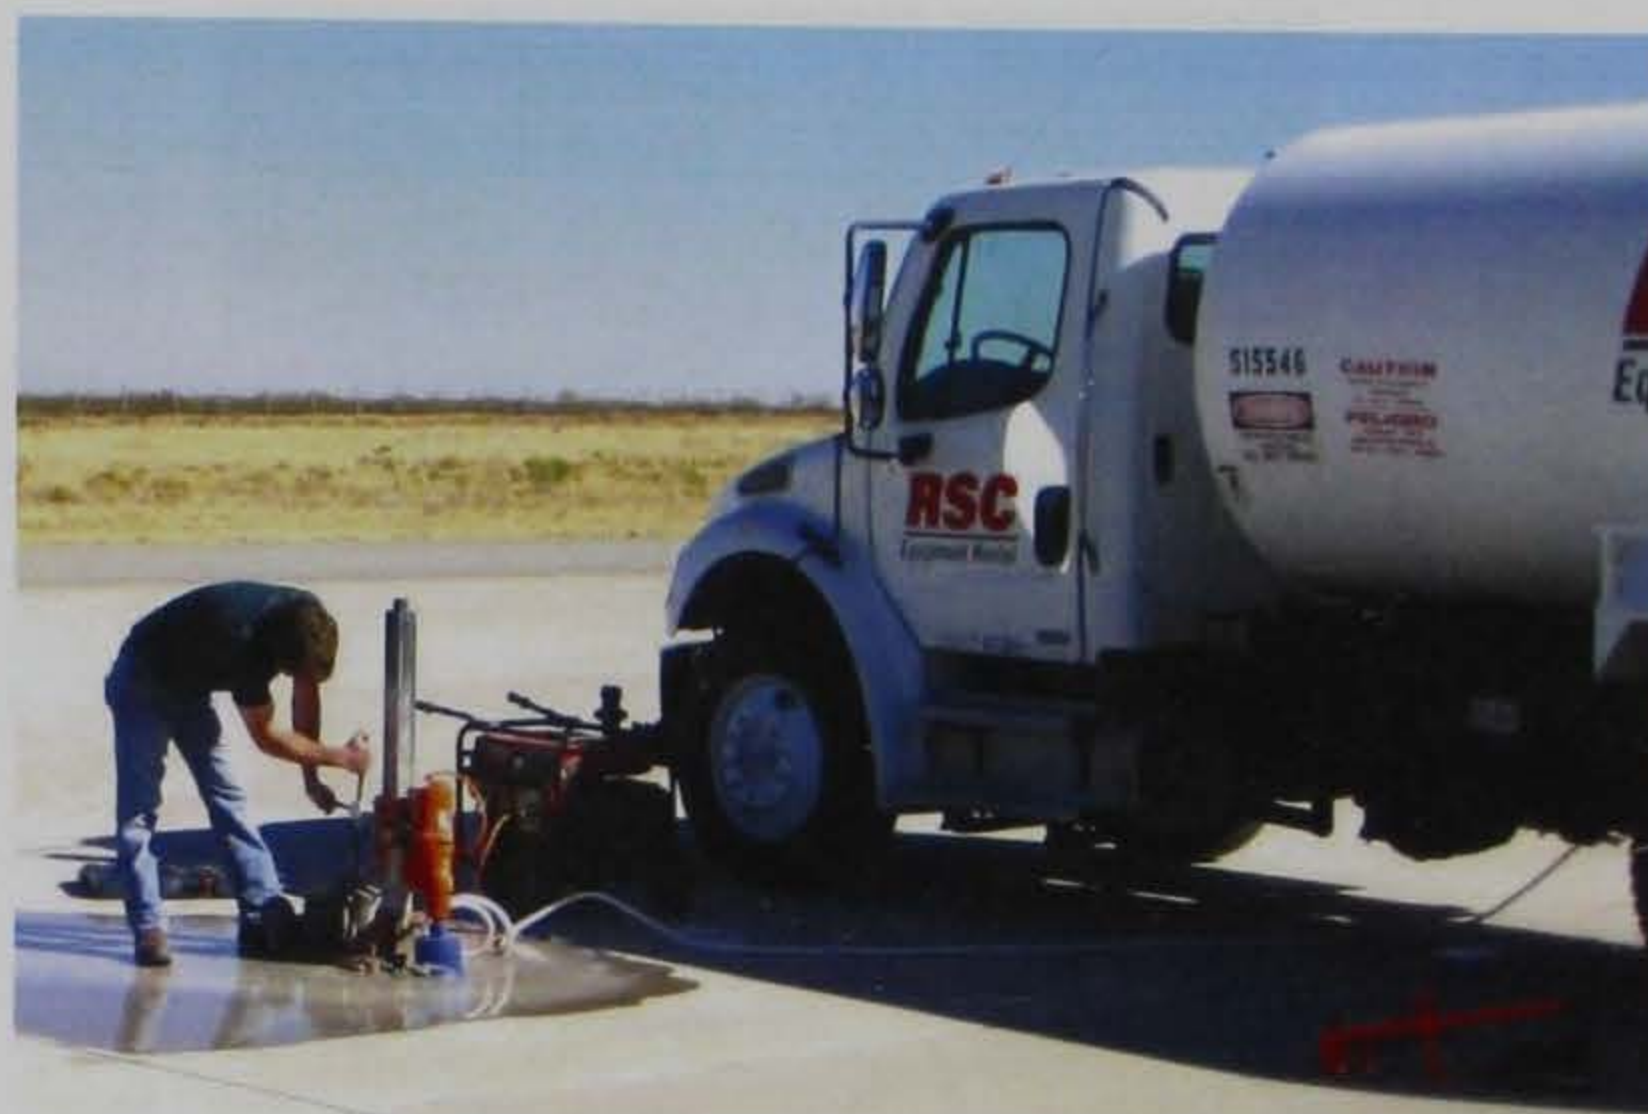
Figure 4. Coring and flow test equipment.

The test equipment is shown in Figures 4 through 8. A core rig with a 6-in.-diam by 15-in.-long core bit was used to drill a hole through the pavement surface down to the top of the drainage layer. Once the hole was drilled, a 4-in.-diam by 5-ft-long PVC pipe was installed in the hole to increase the pressure head. The pipe was sealed to the hole with polyurethane foam, as shown in Figure 5. After the foam set (20 min), a 2-in. hose was placed in the PVC pipe. The hose was connected to a flowmeter that was connected to the water truck (Figures 6 and 7). The initial flowmeter reading was recorded. Water flow was started and allowed to reach the maximum that the drainage layer could accommodate without water spilling out of the top of the PVC pipe. Then the water flow was reduced to a steady-state rate maintaining a water column of about 4 ft inside the PVC pipe. Water volume and time were constantly recorded as water was allowed to flow into the pavement. Once water outflow was observed at the nearest outlet, a tracer dye was added to the inflowing water. The following times were recorded: (1) the time to when outflow was first observed, (2) the time to when tracer dye outflow was observed, (3) the time to when water inflow was stopped, and (4) the time to when water outflow (when observed) ceased.

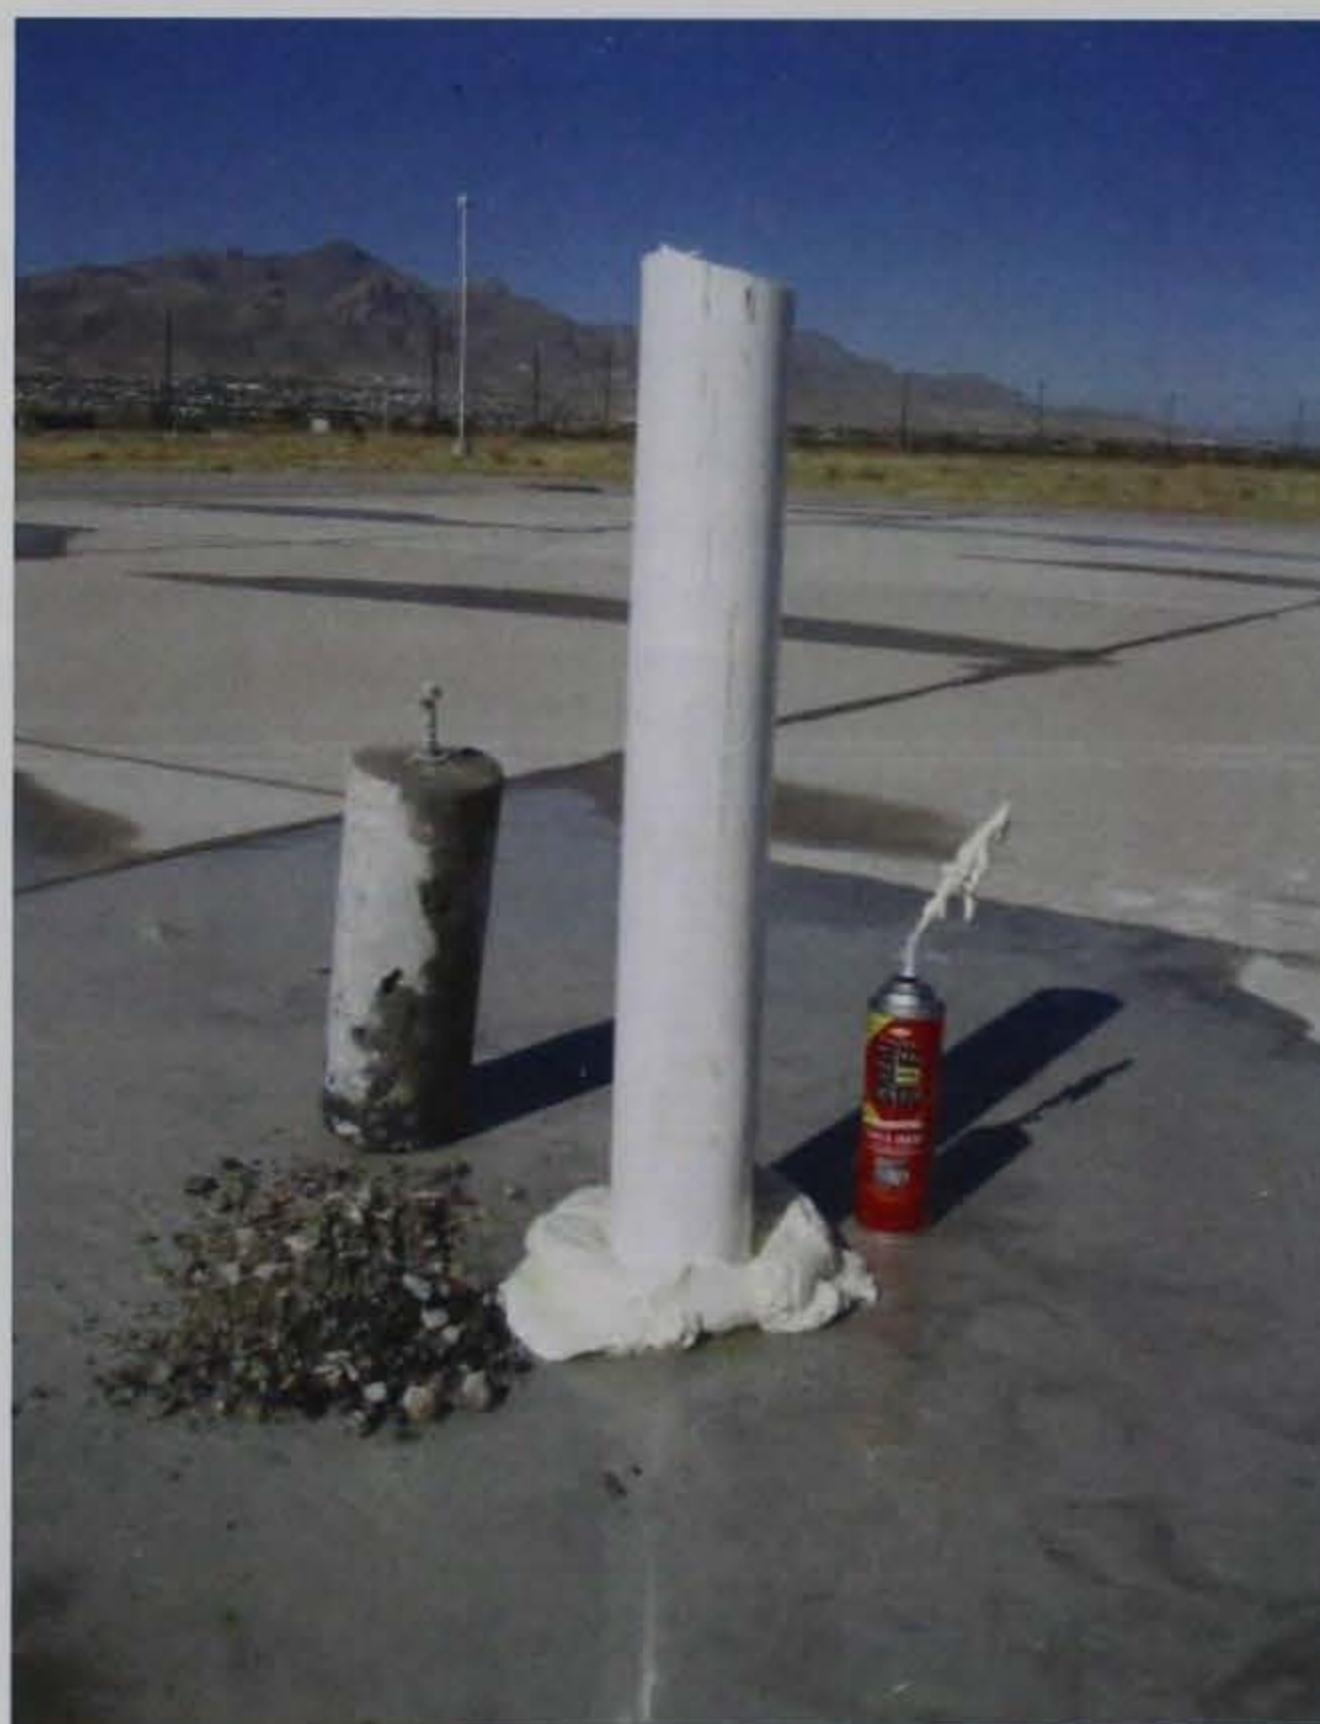
Figure 5. PVC pipe used to increase pressure head.

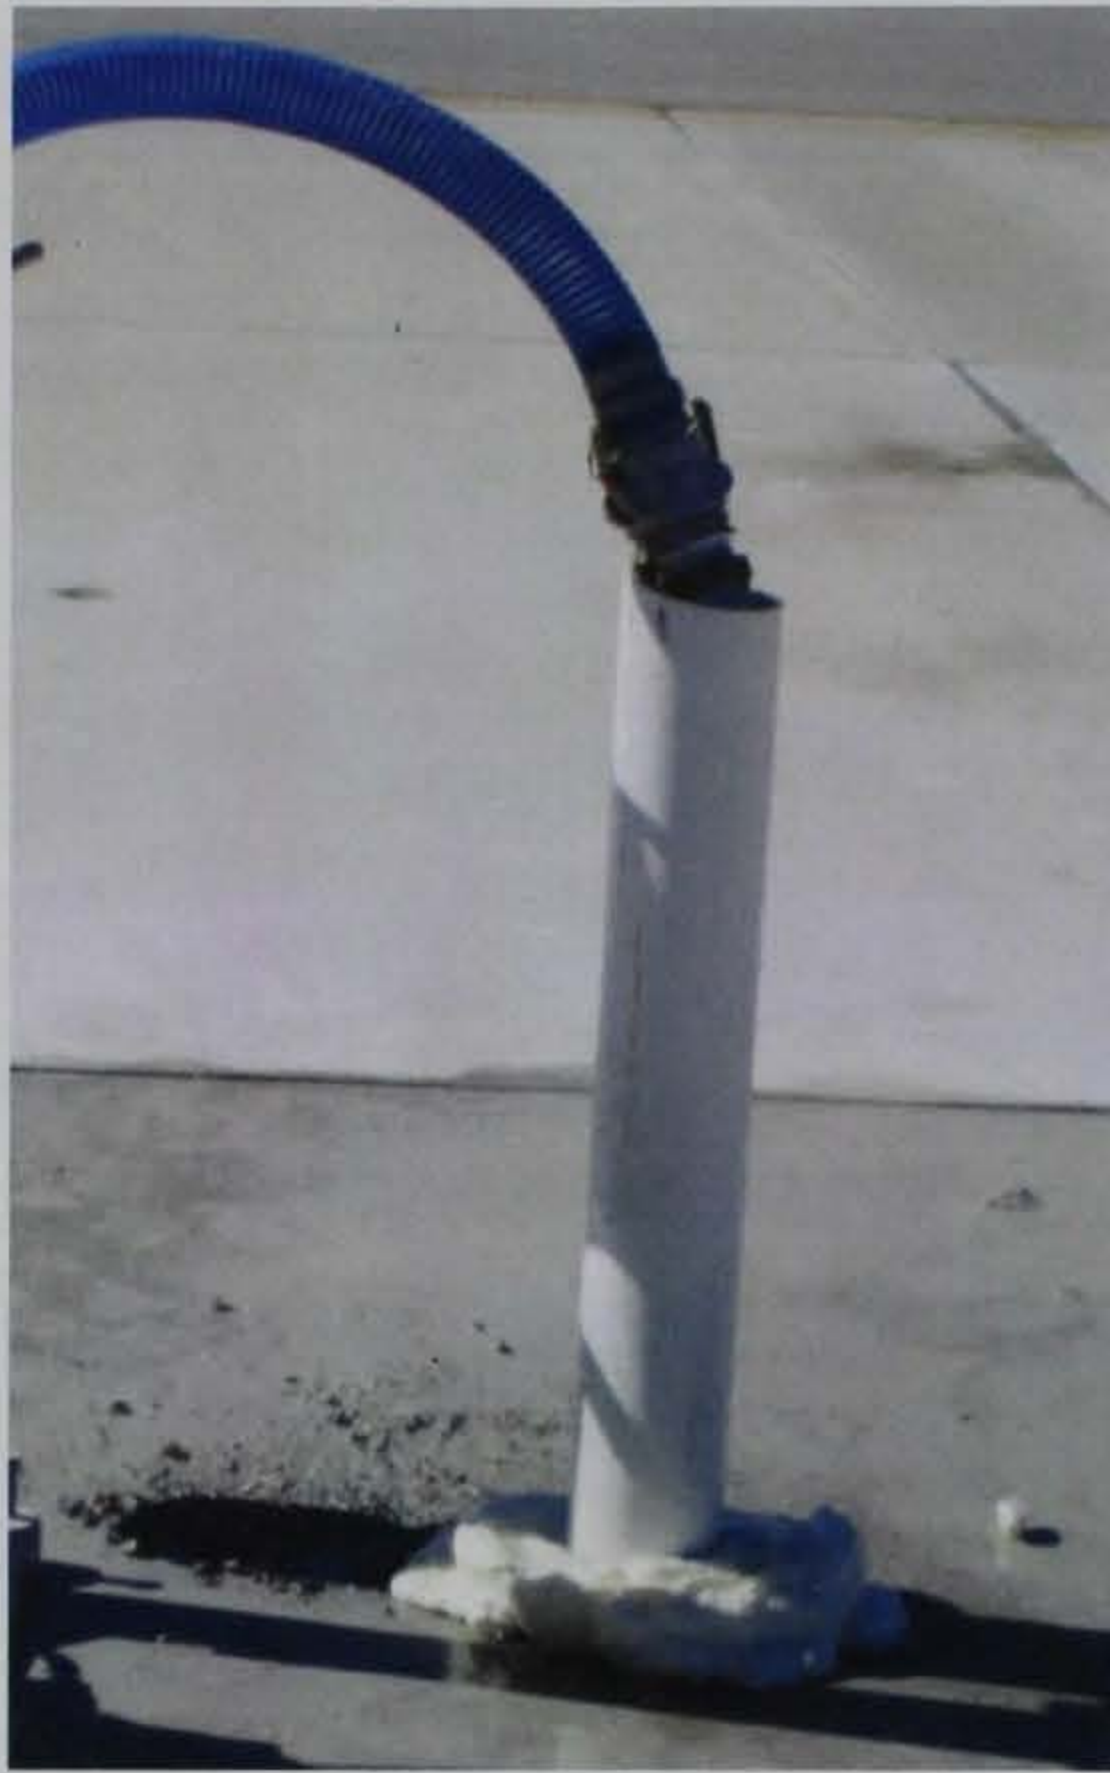
Figure 6. Test setup.

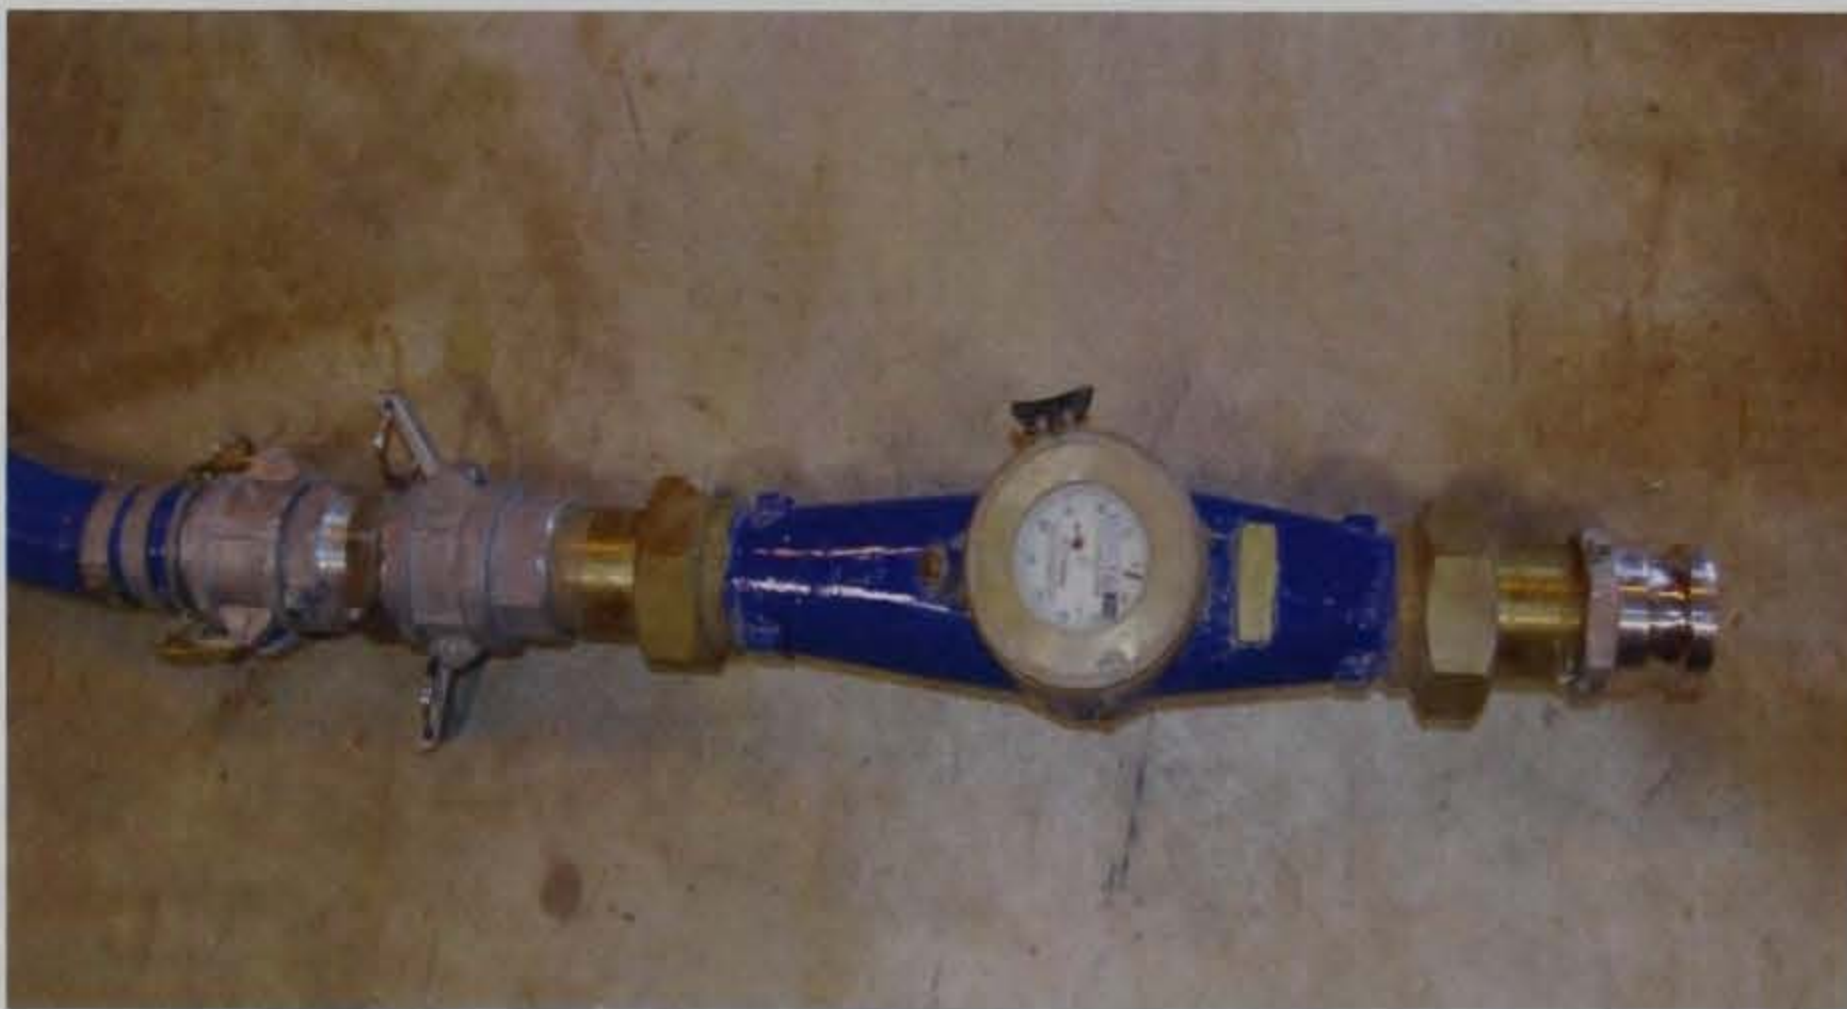
Figure 7. Flowmeter.

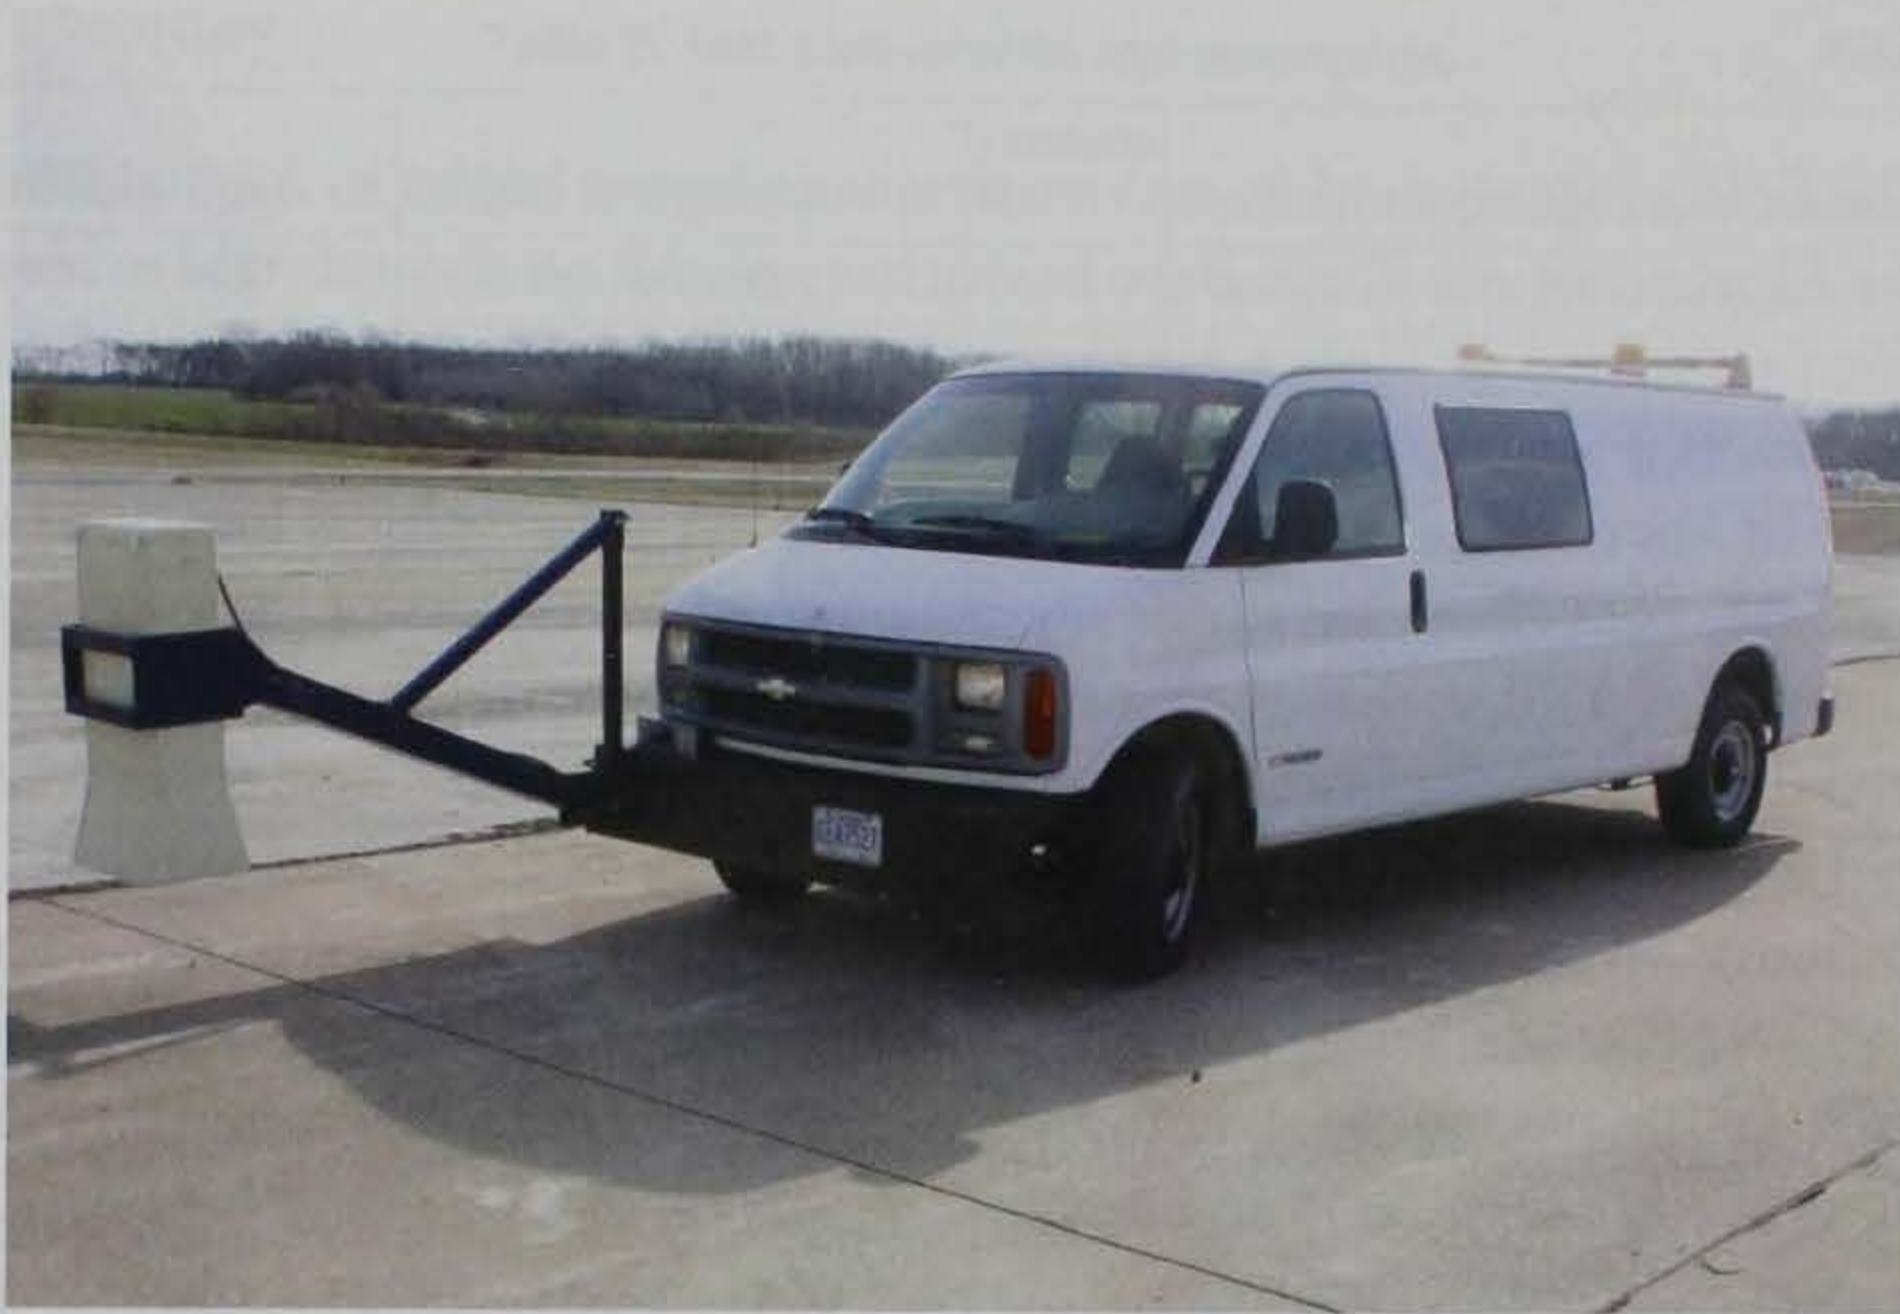
Figure 8. Ground penetrating radar van.

The GPR shown in Figure 8 was used to establish moisture profiles underneath asphalt concrete pavements.

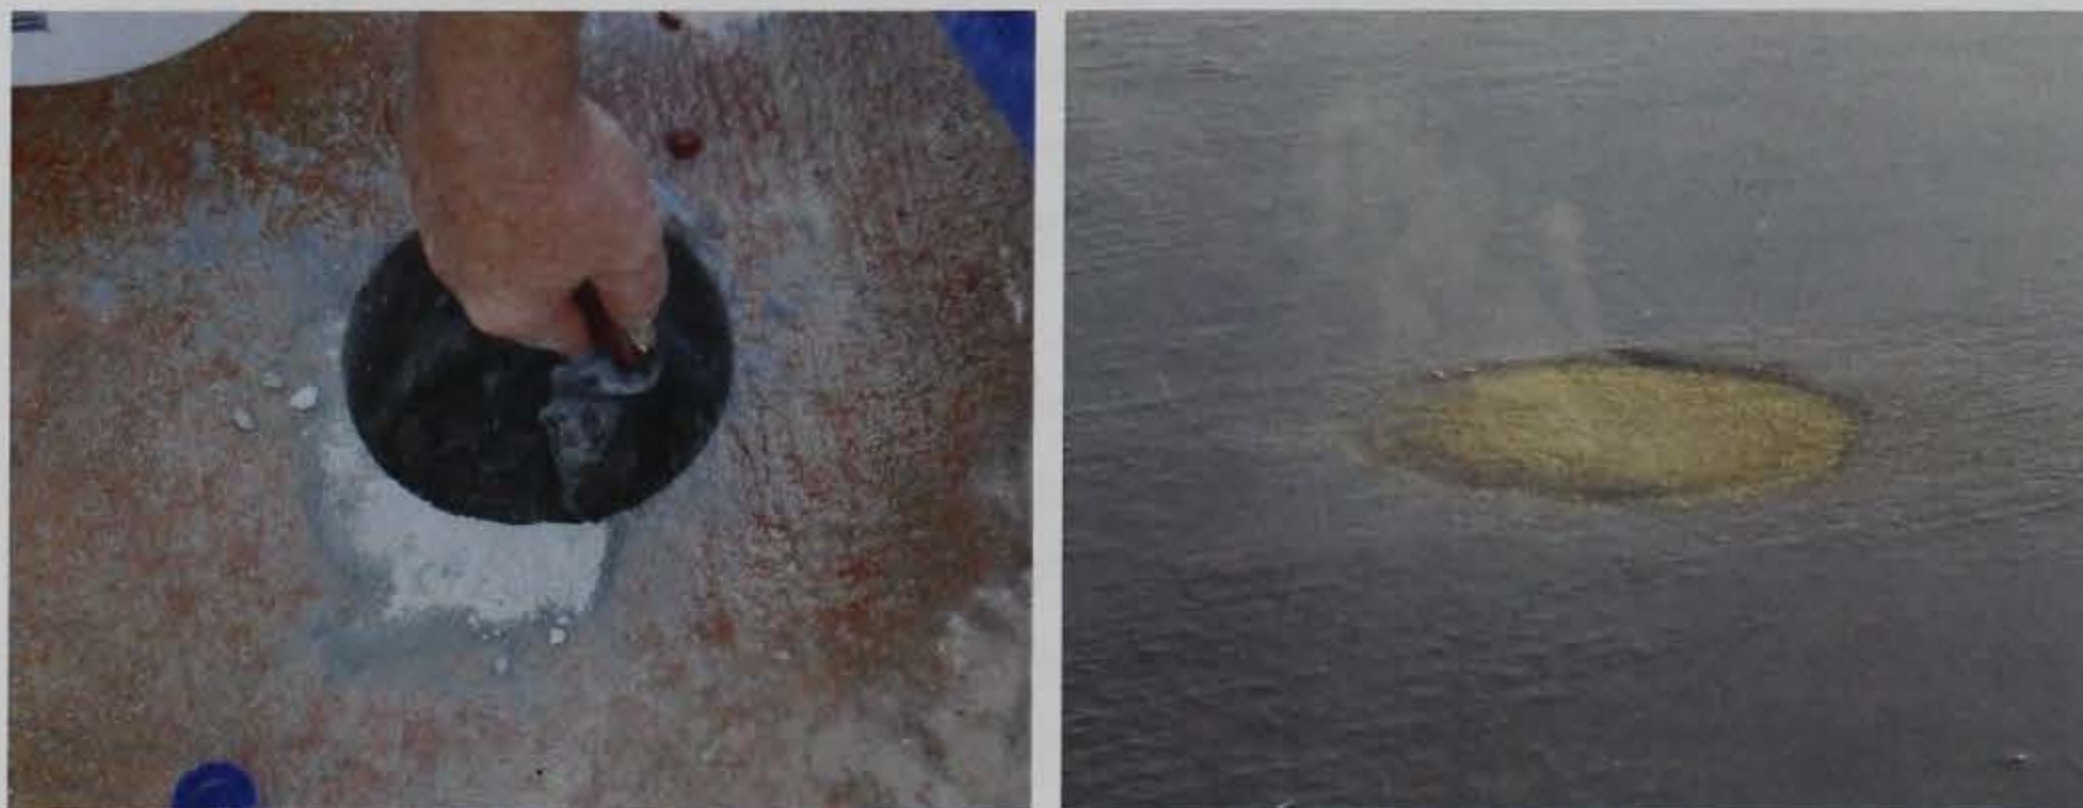
Once the test was finished, the PVC pipe was removed and material from the drainage layer was collected for characterization. Subgrade material was also collected at each airfield for characterization. Core holes were patched with appropriate patch materials, as shown in Figure 9.

Figure 9. Core hole patching.

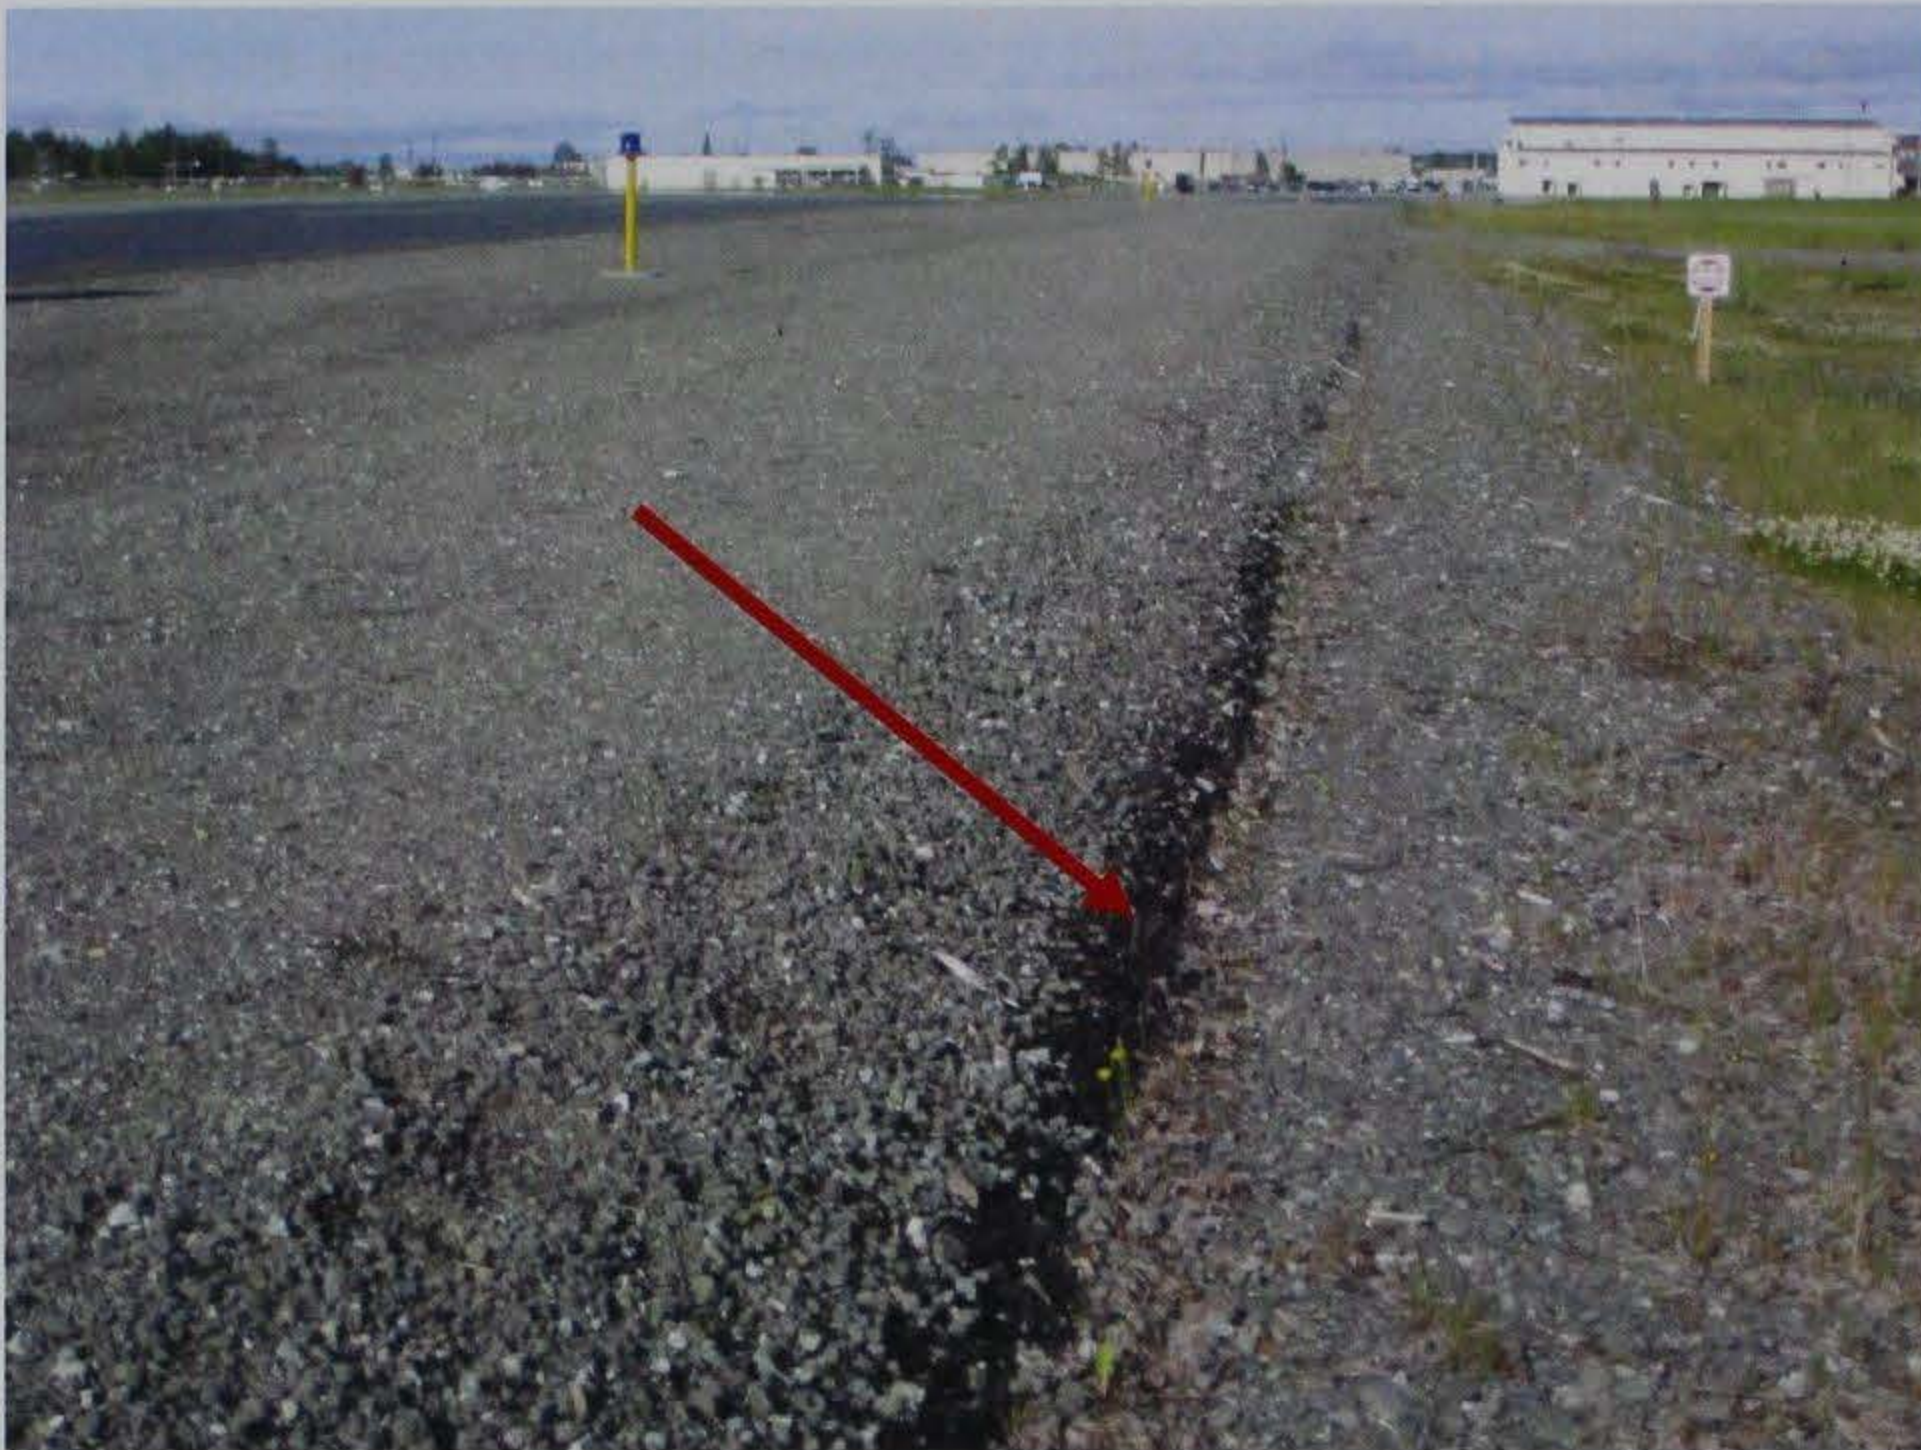
The drainage layer beneath this pavement is “daylighted” to the pavement shoulders (Figure 13). Water is expected to flow transversely to the traffic direction and flow out of the pavement shoulders. This type of drainage design is sometimes used in highway pavements but is not recommended as a drainage system in UFC 3-230-06a.

Figure 13. Photo of daylighted drainage layer on fuel cell taxiway.

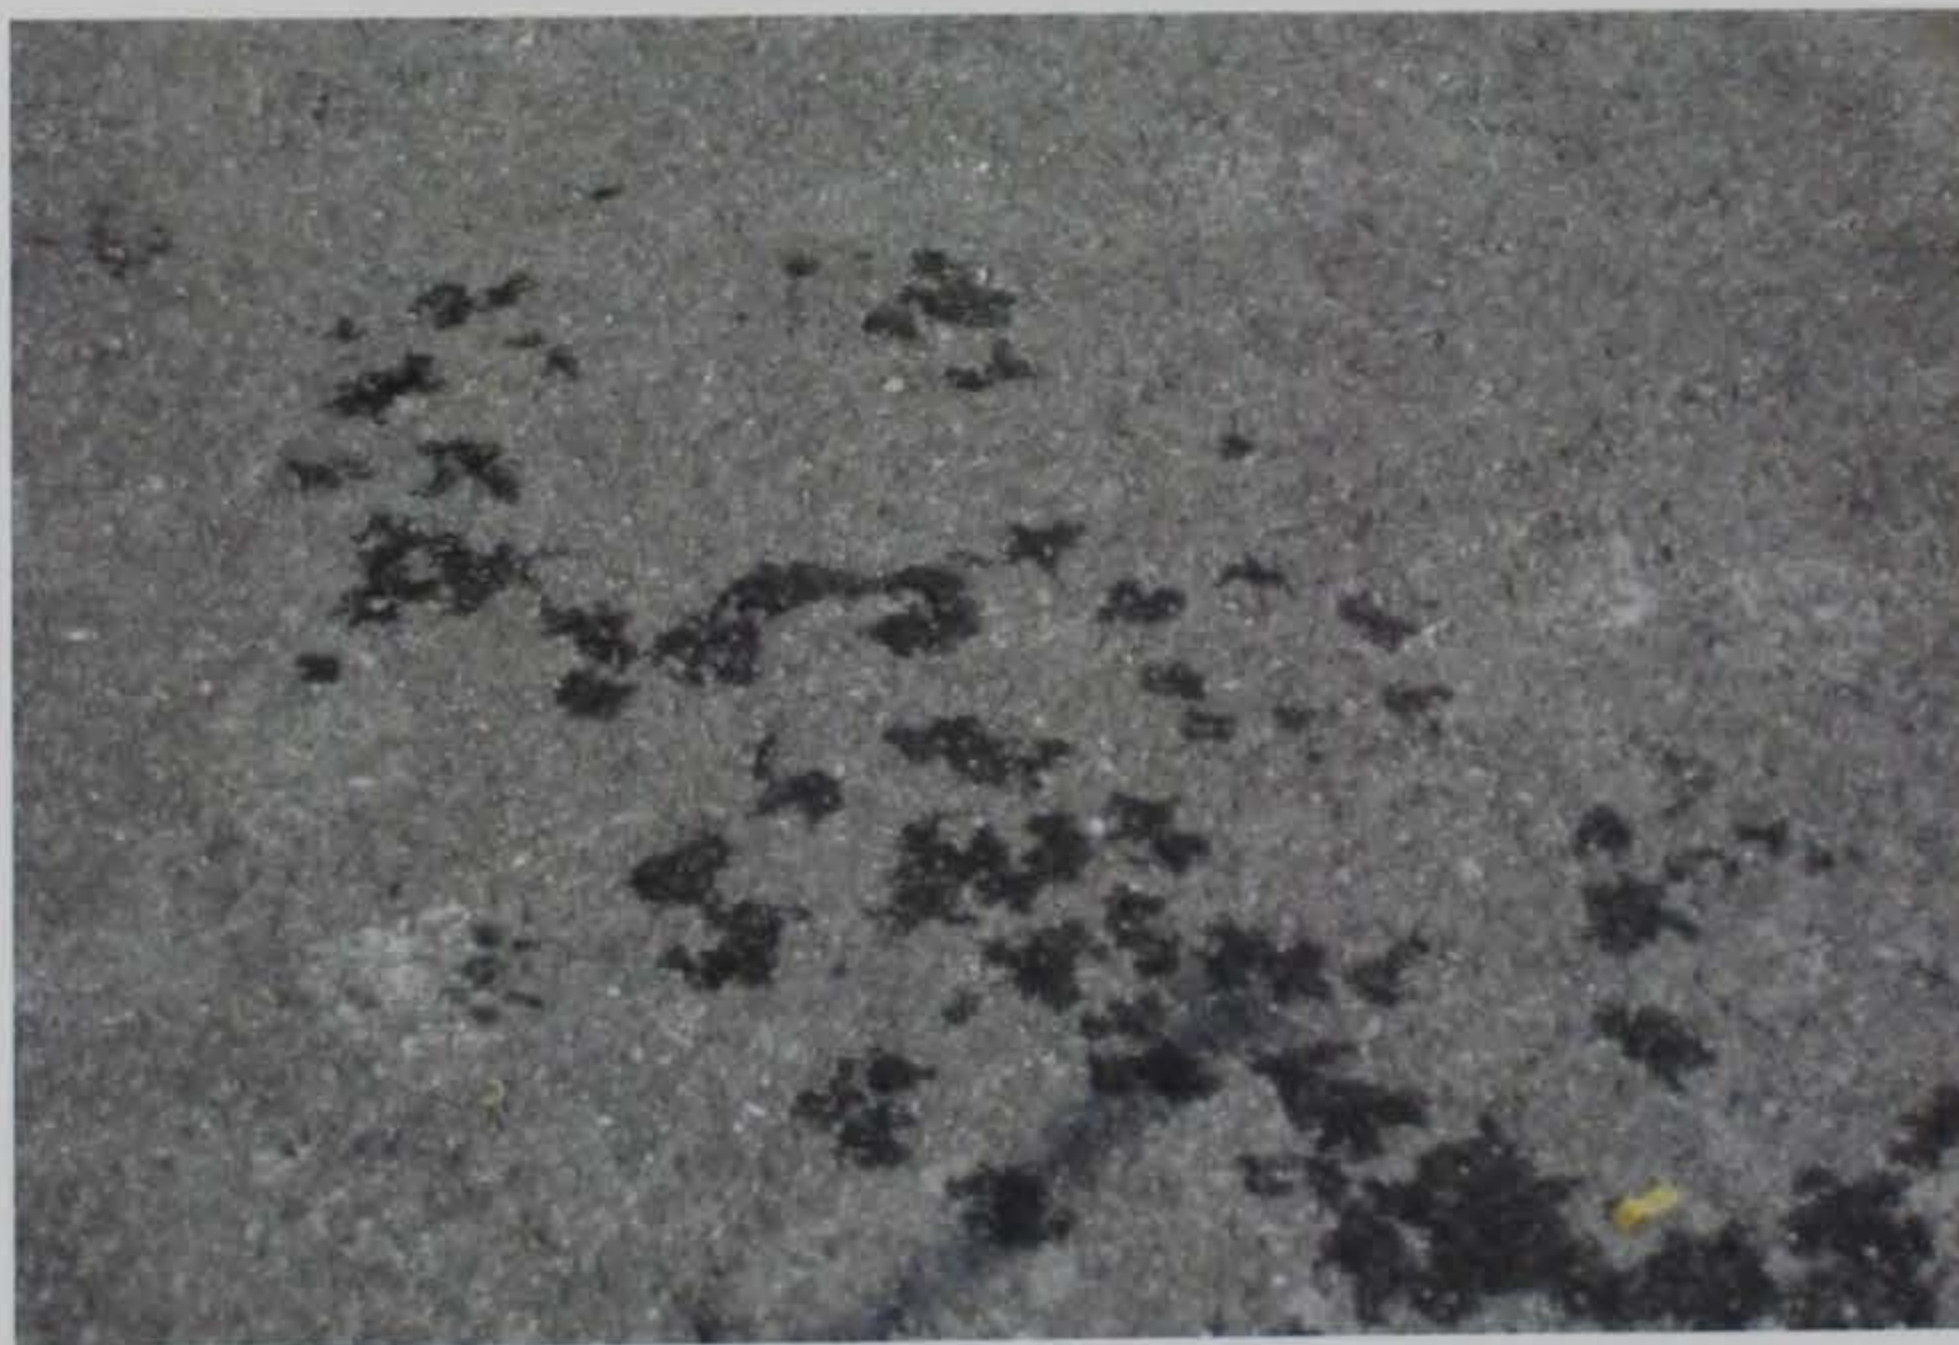
During the process of introducing water into the pavement, moisture was noticed on the surface of the pavement (Figure 17). The water was not evenly dispersed. Only some areas of the pavement experienced this phenomenon.

Figure 17. Water bleeding up through pavement on fuel cell taxiway.

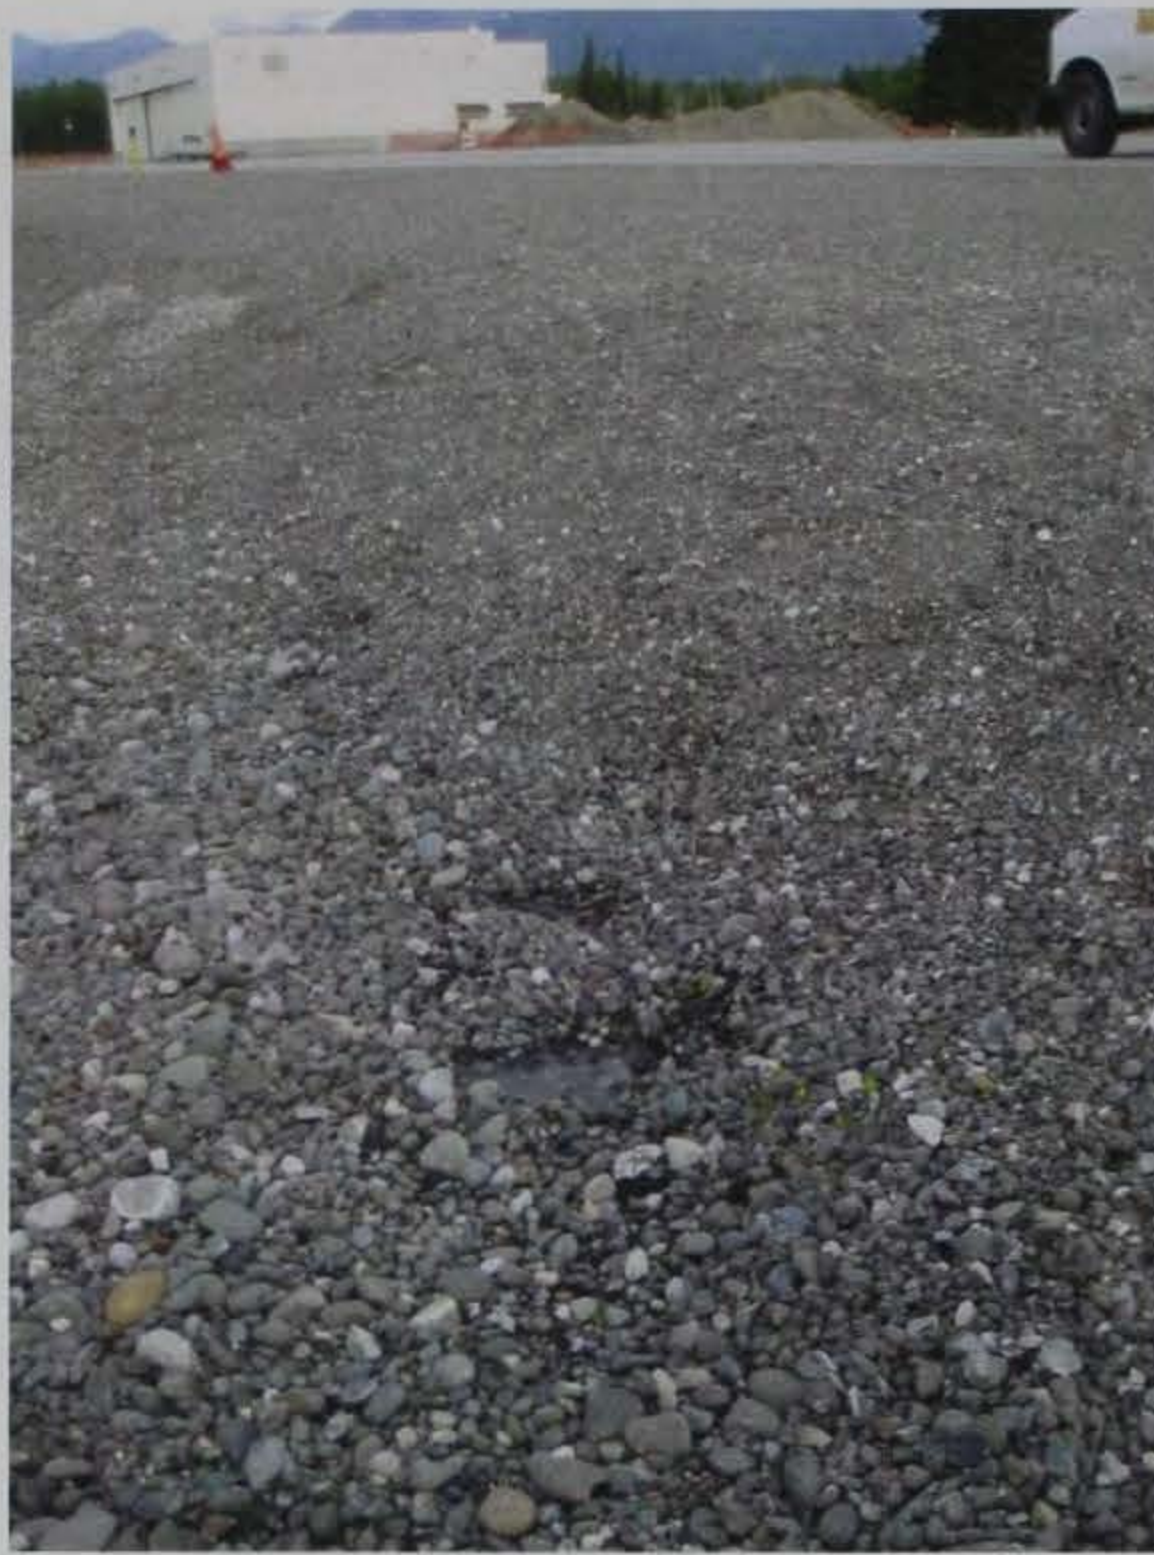
After approximately 2.5 hr and the introduction of 900 gal of water, moisture was noticed emerging from the daylighted edge of the drainage layer (Figure 18). However, GPR data indicate that the water had reached the pavement shoulder after 1.5 hr of flow.

Figure 18. Water emerging from drainage layer on fuel cell taxiway.

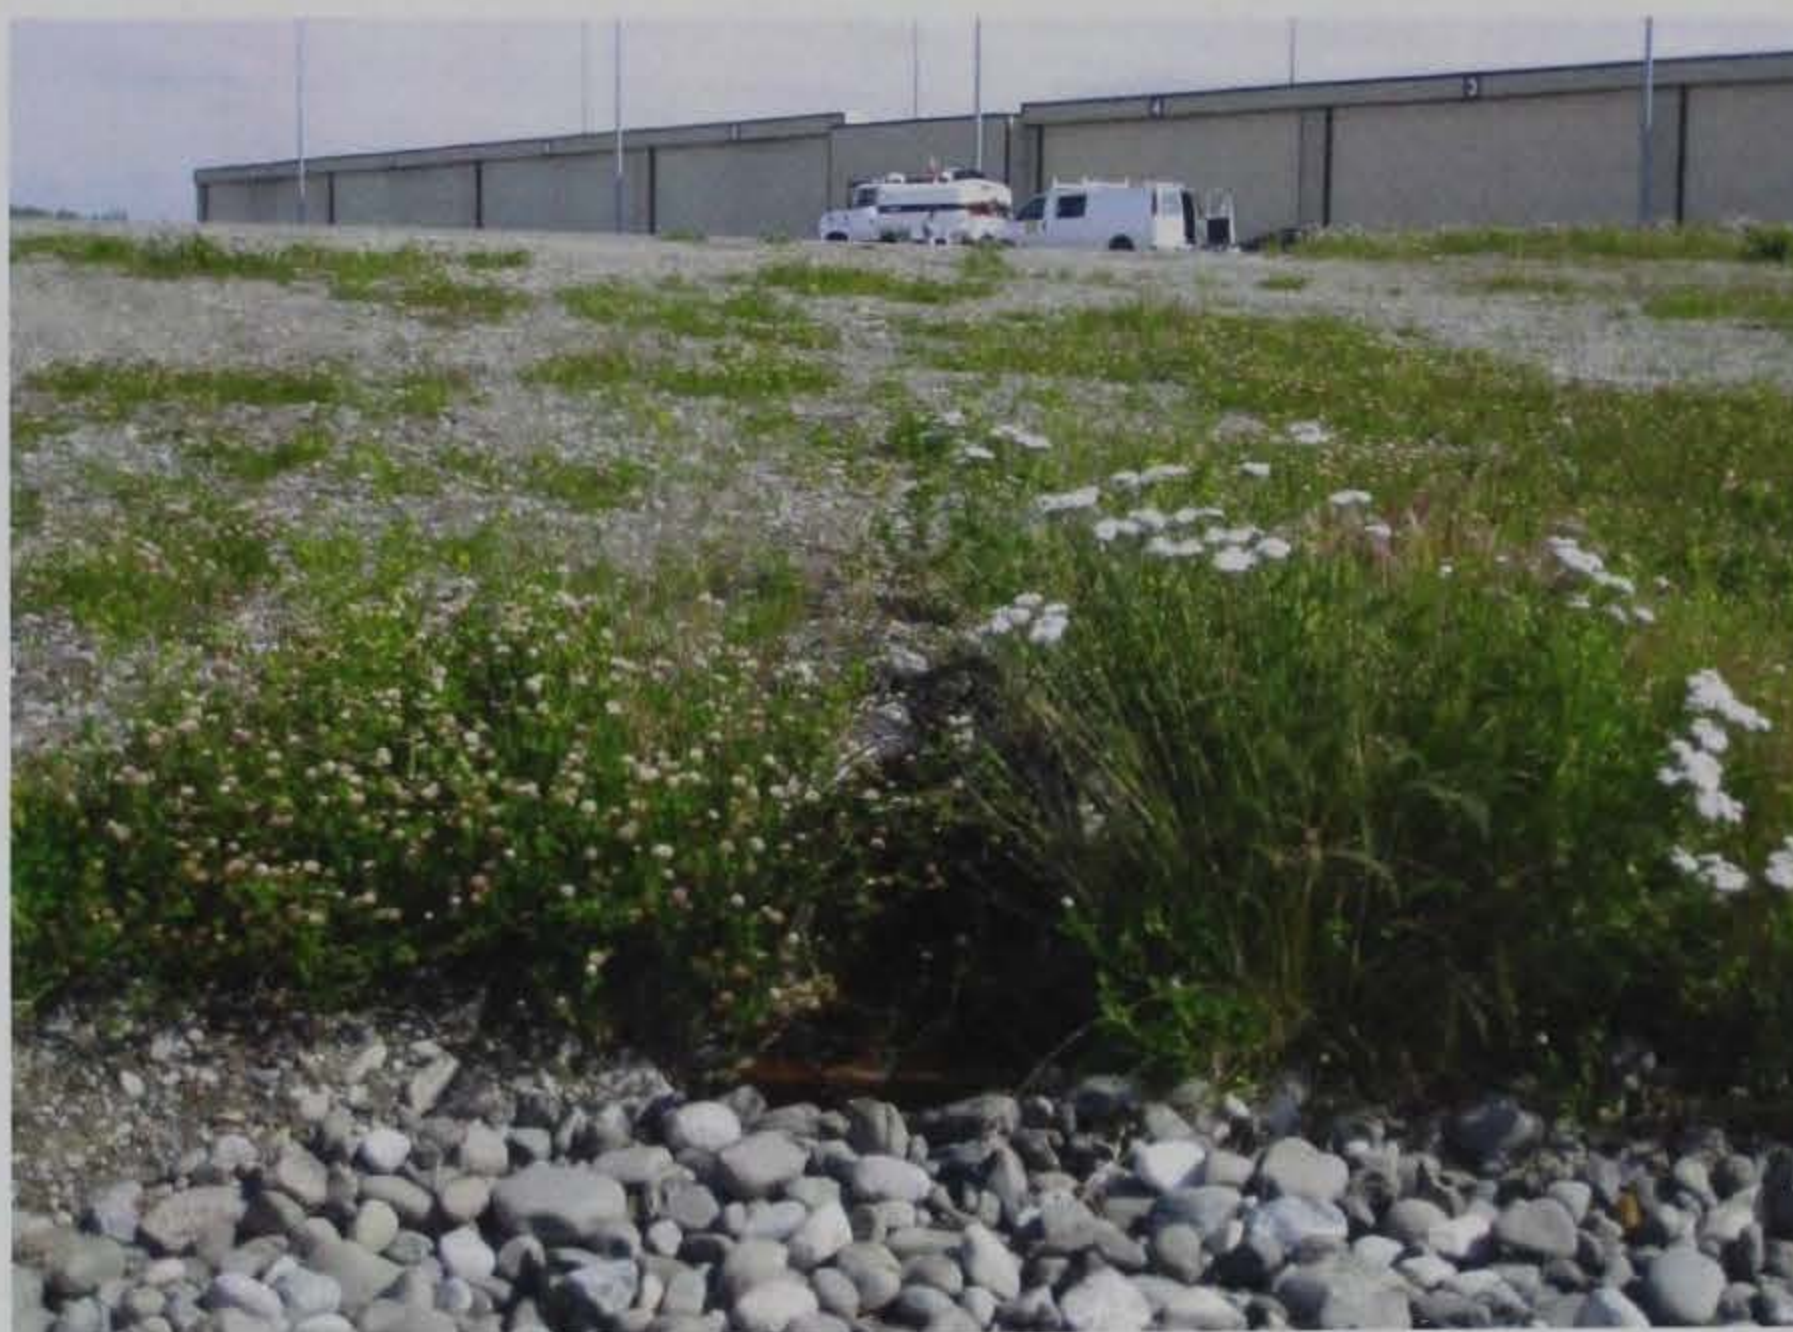
Figure 22. Outlet pipe leading from weather shelter apron.
