## **Evaluation of Airfield Pavement Drainage Layers**

John F. Rushing and Mariely Mejías-Santiago

July 2009

Final report

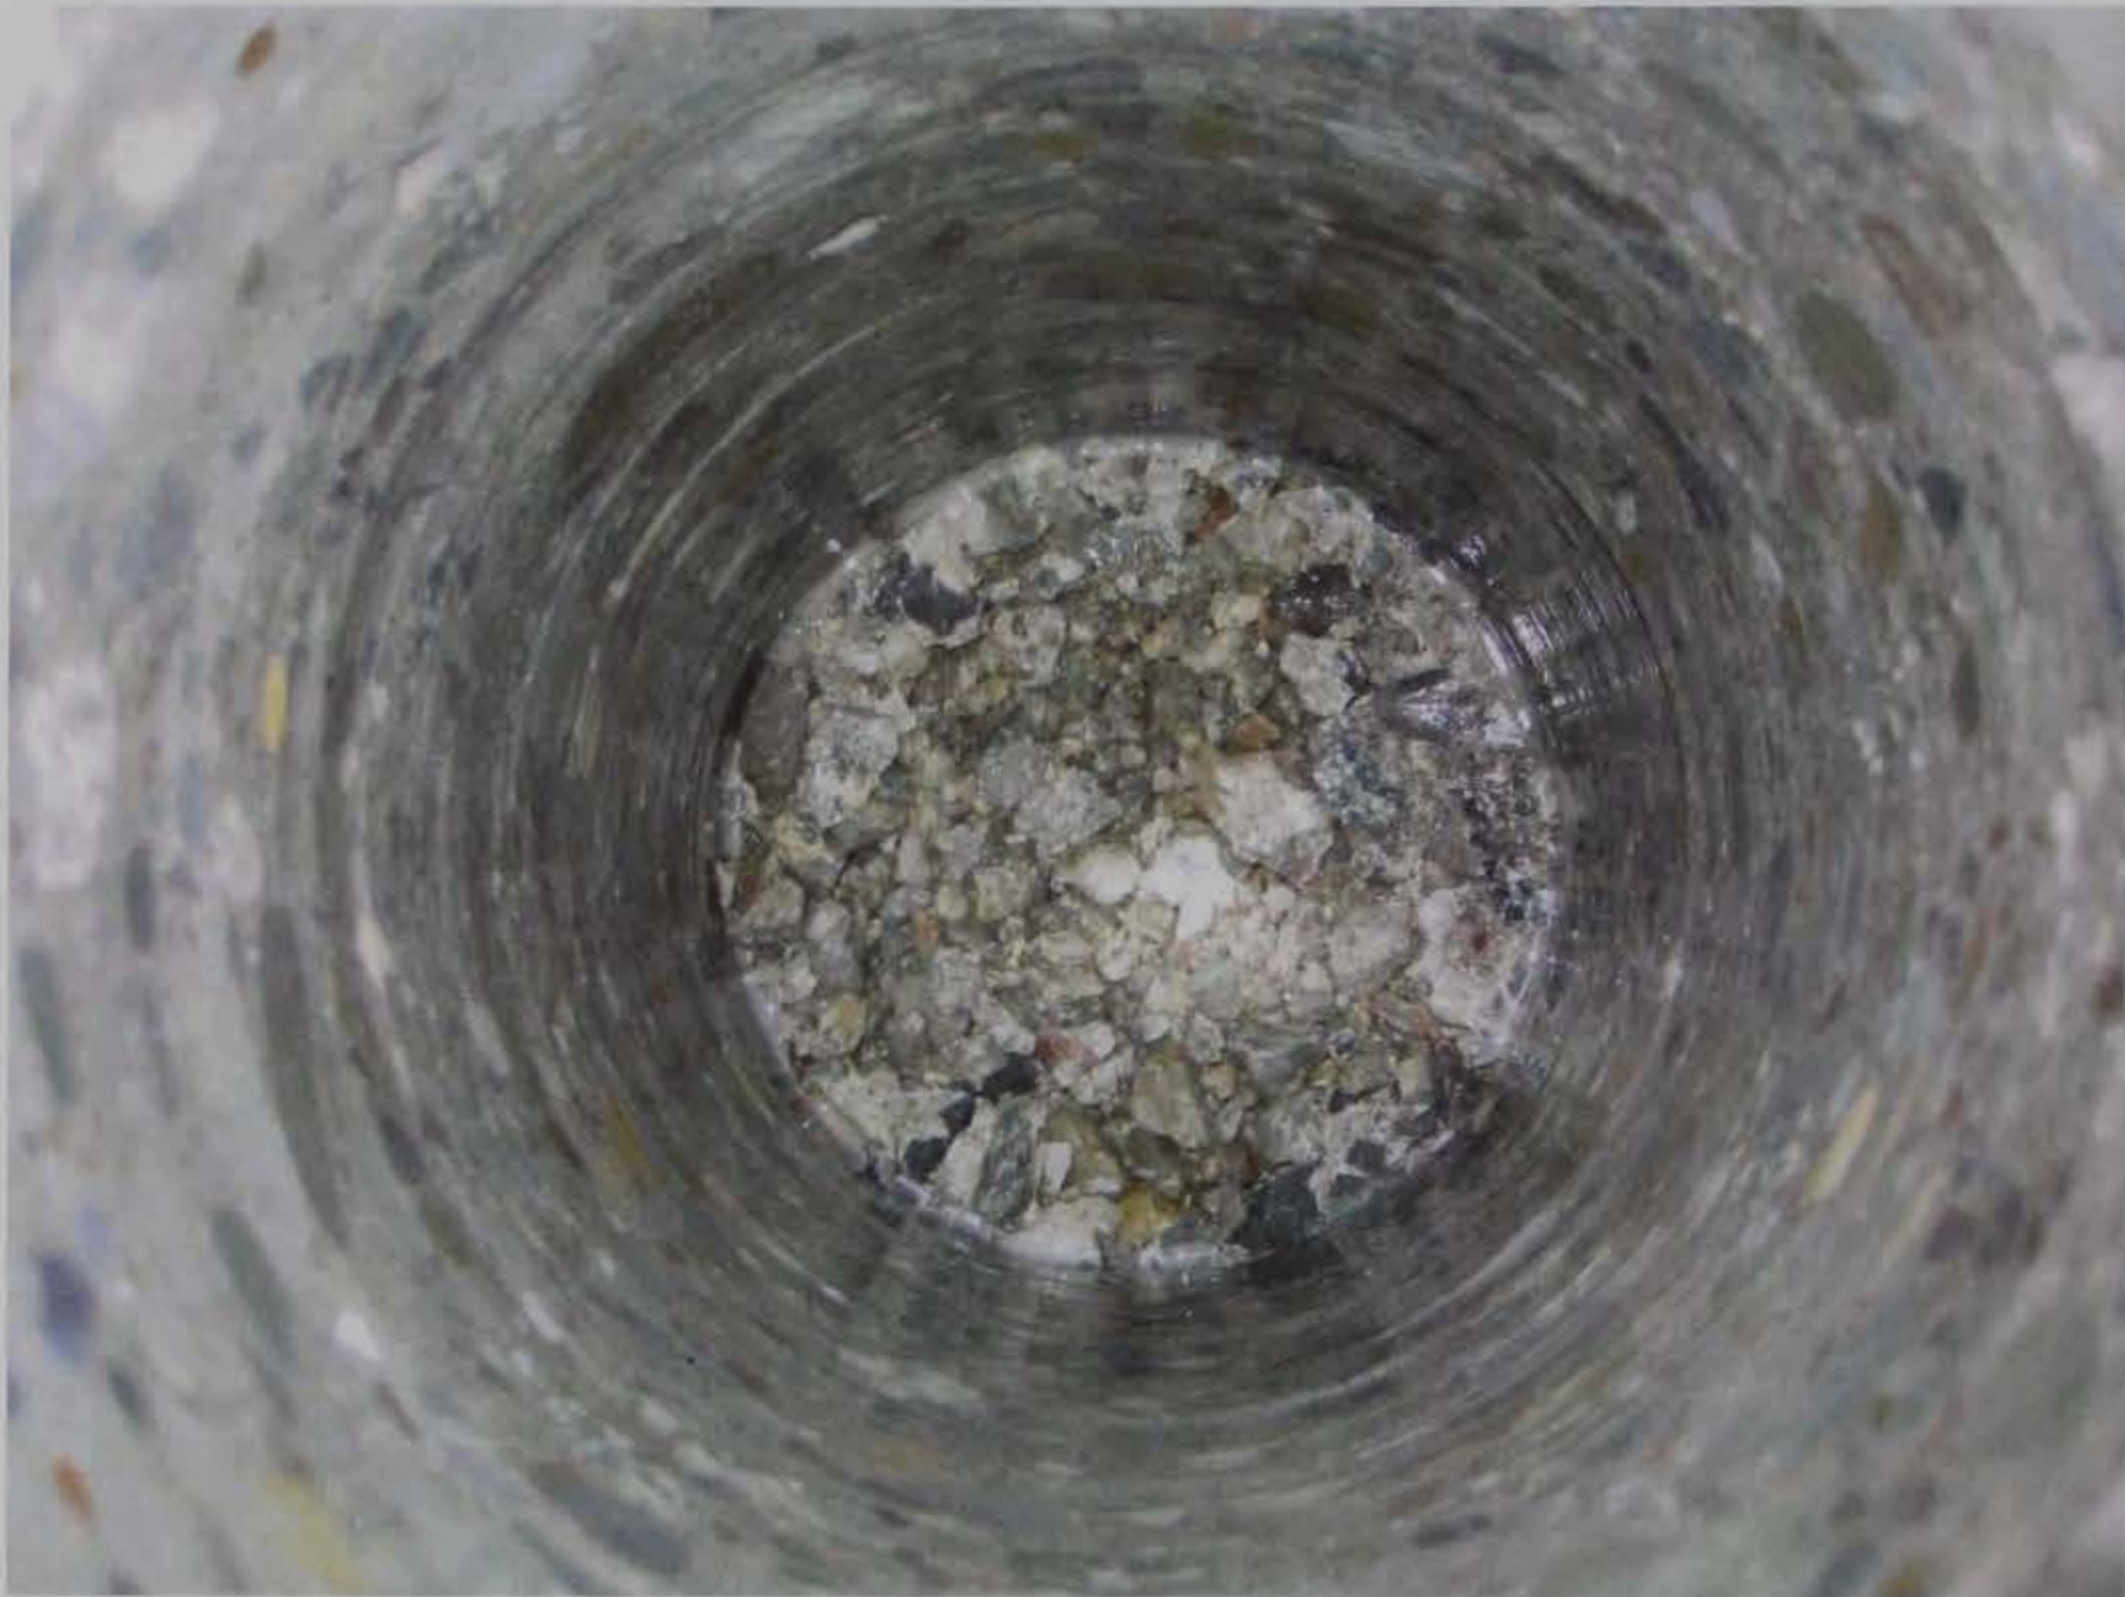
For the evaluation, a 6-in.-diam core hole (Figure 23) was drilled 195 ft from the end of the drainage pipe. The core was taken in this location to promote flow towards the drainage pipe and at a distance that was

Figure 23. Rapid draining material beneath PCC at weather shelter apron.

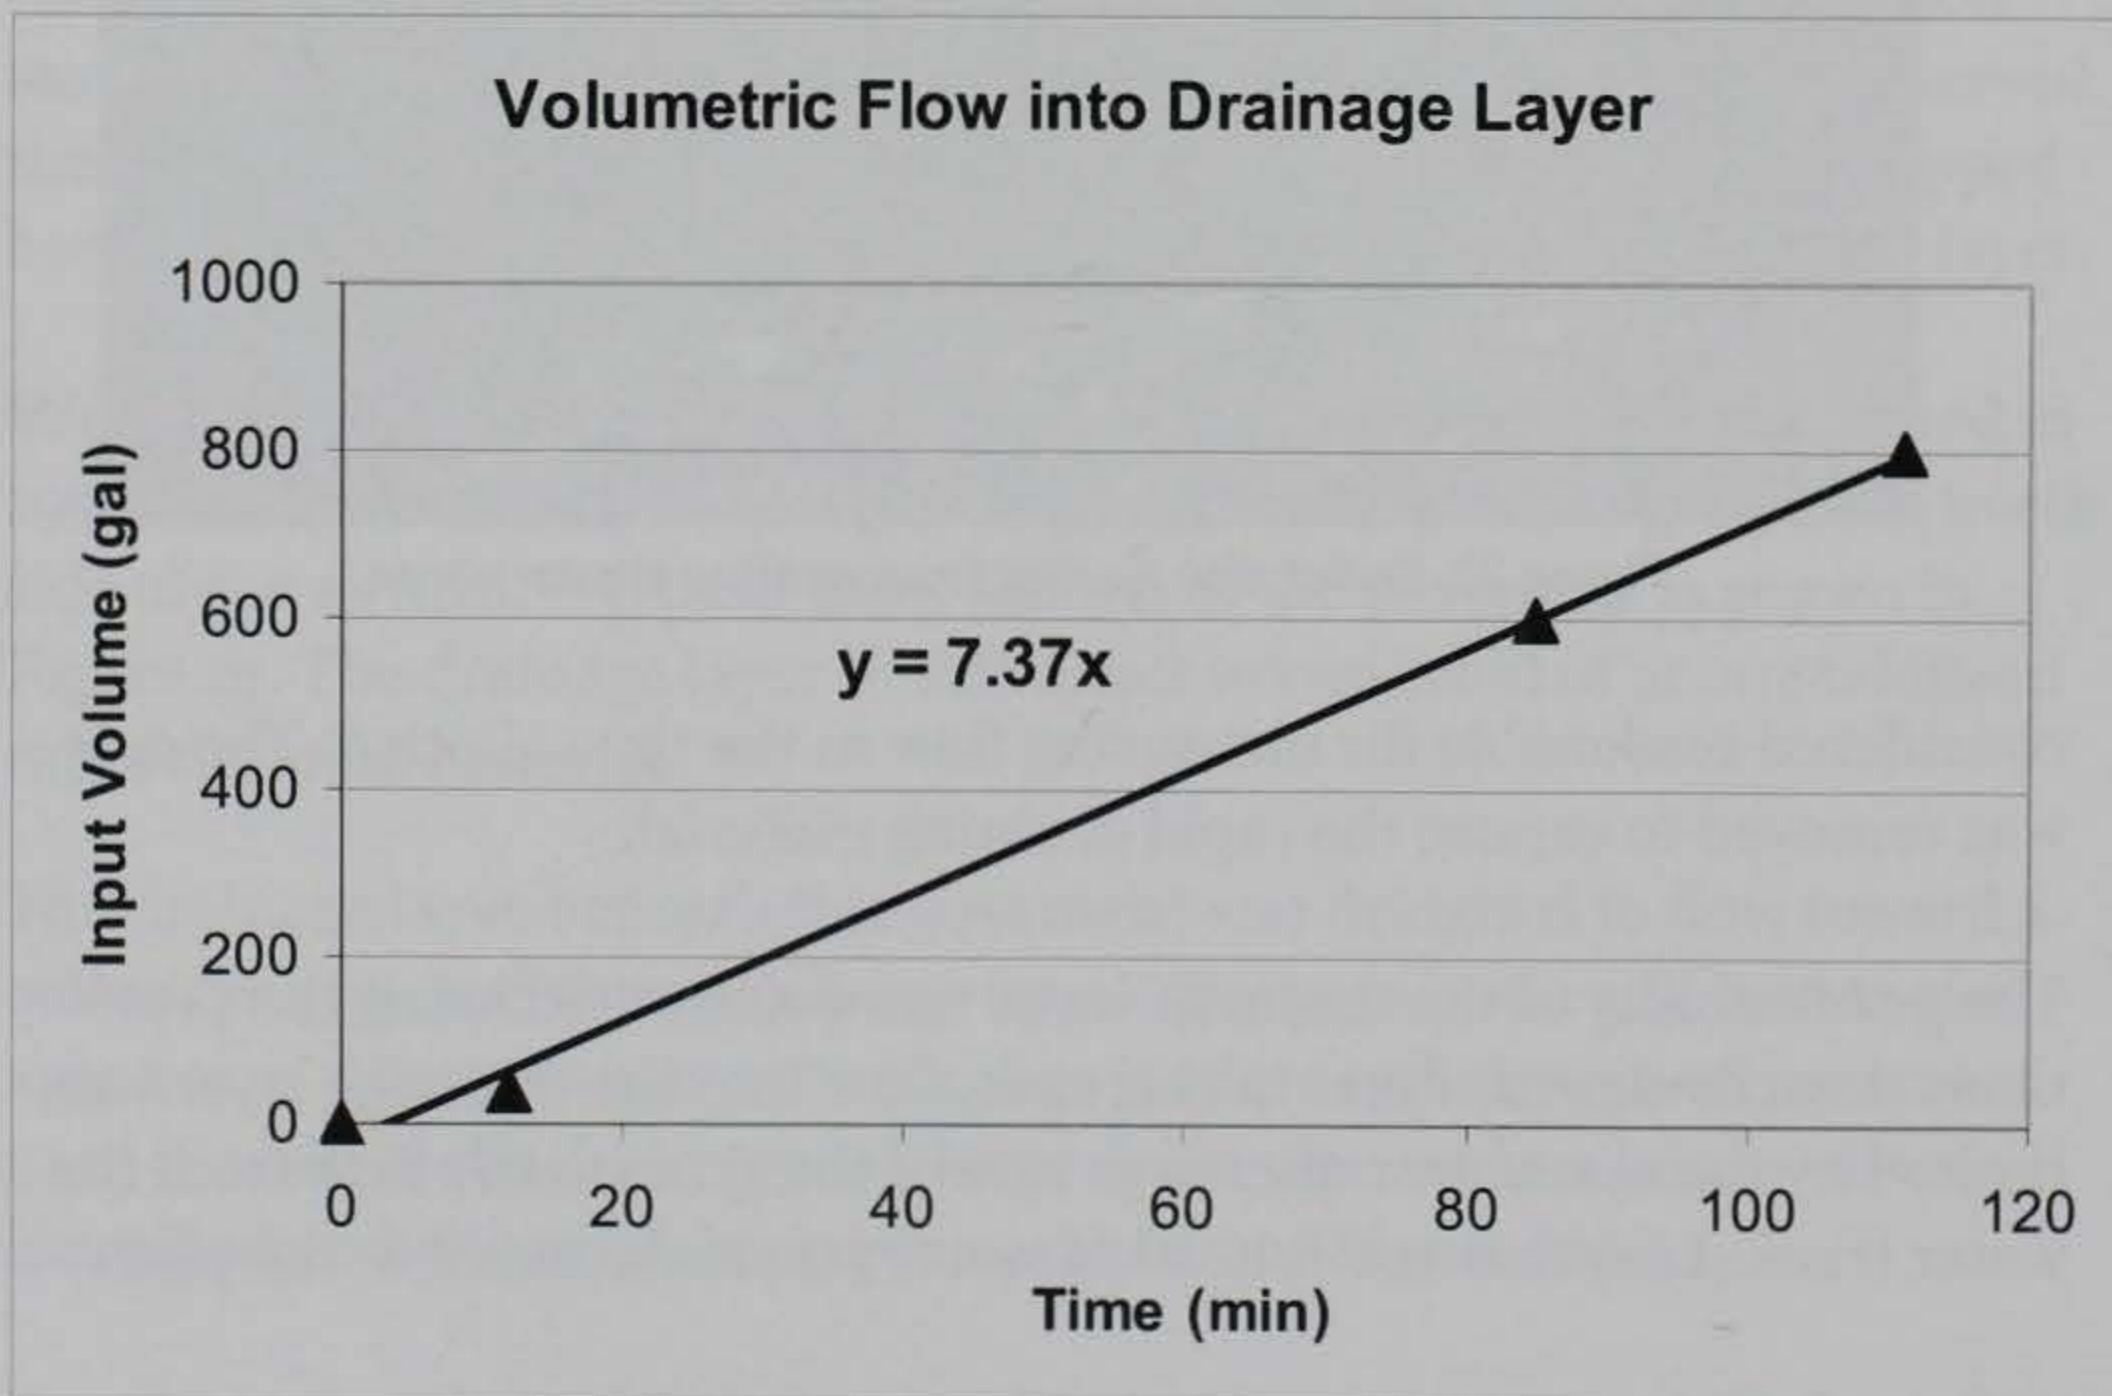
Figure 24 shows the plot of gallons of water placed in the pipe over time. Each data point was determined by reading the output gage on the flow-meter and monitoring the time. The trendline in the graph represents the volumetric flow rate in gallons per minute.

Figure 24. Flow rate of water introduced in drainage layer at weather shelter apron.

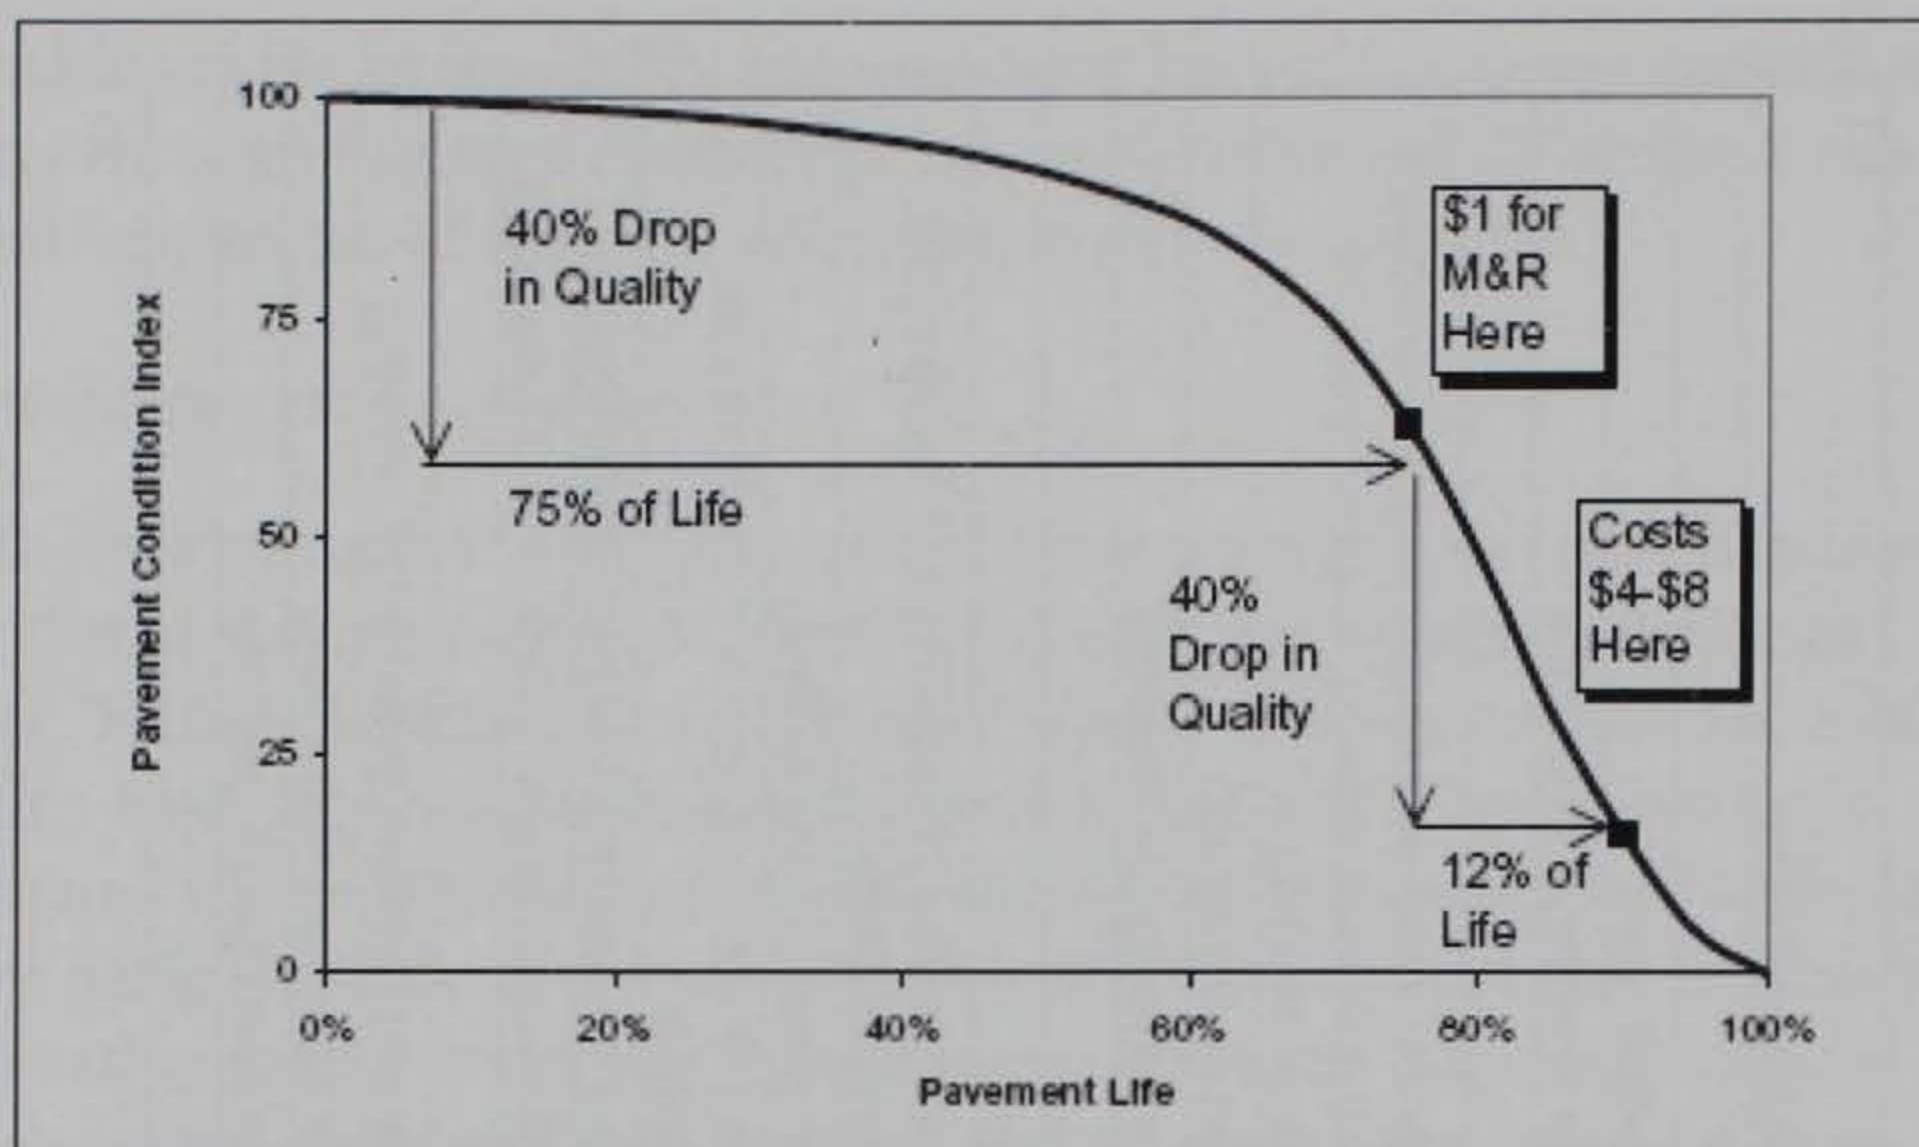
Figure 25. Graph of pavement condition index versus pavement life.

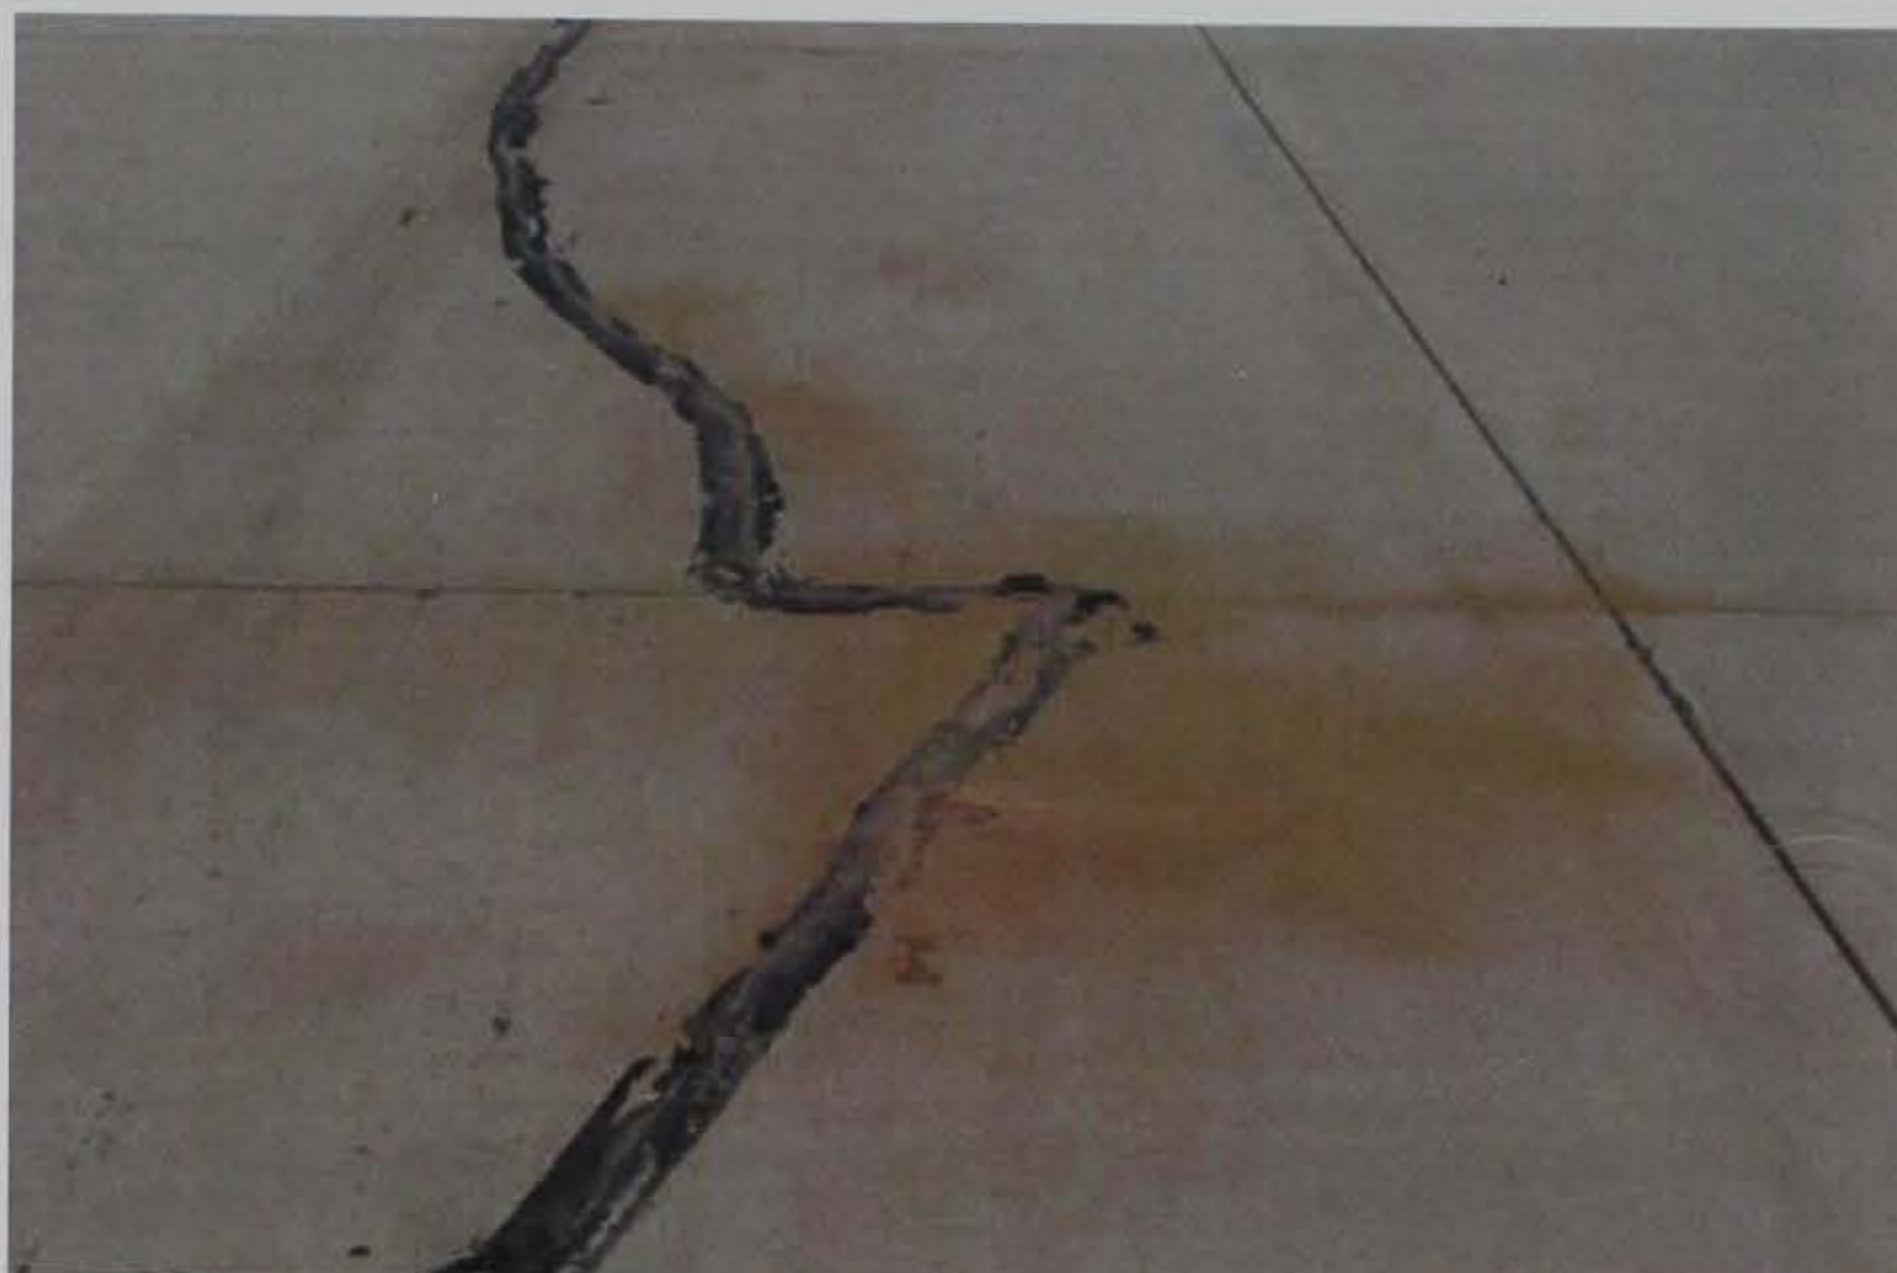
The natural subgrade soils in the Tinker AFB area are not very permeable and do not drain very well. Pumping (Figure 27) and other problems related to poor drainage were a concern in several areas. Another concern was the swell potential of the expansive subgrade soils. Swelling damage occurs on pavements, due to the little resistance to soil expansion that the small surcharge load of an asphalt pavement or a concrete slab can provide. The use of a subbase provides additional surcharge pressure, but it

Figure 27. Staining from pumping due to inadequate base course material.

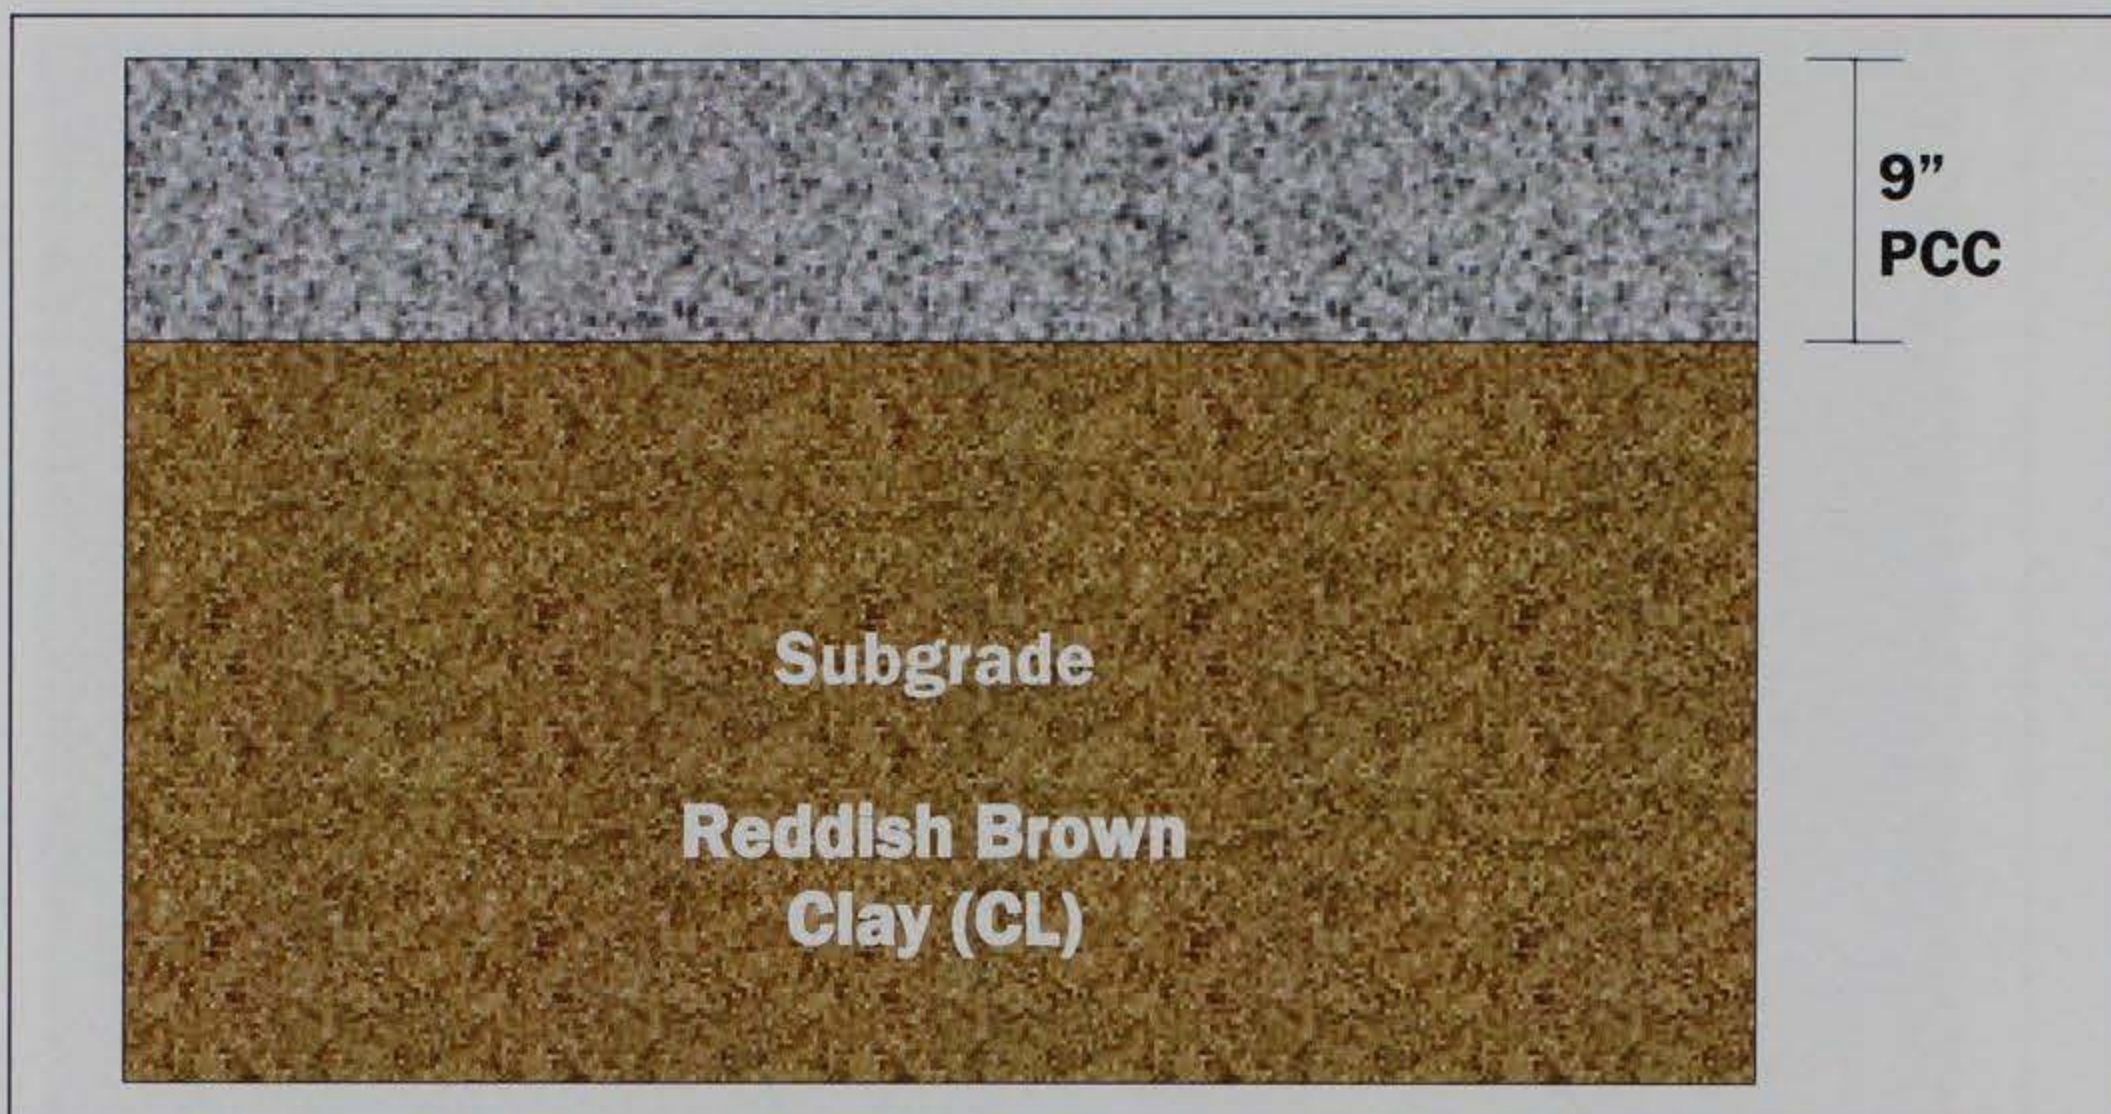
**ALC ramp.** After coring through the concrete, it was observed that there was no base material. The concrete slab was placed directly on top of the subgrade material as shown in Figure 28. By visual characterization of the soil and by simply observing the accumulation of water inside the core hole for a few minutes after coring, it was determined that the subgrade

Figure 28. Pavement structure at the ALC Ramp, Tinker AFB, OK.

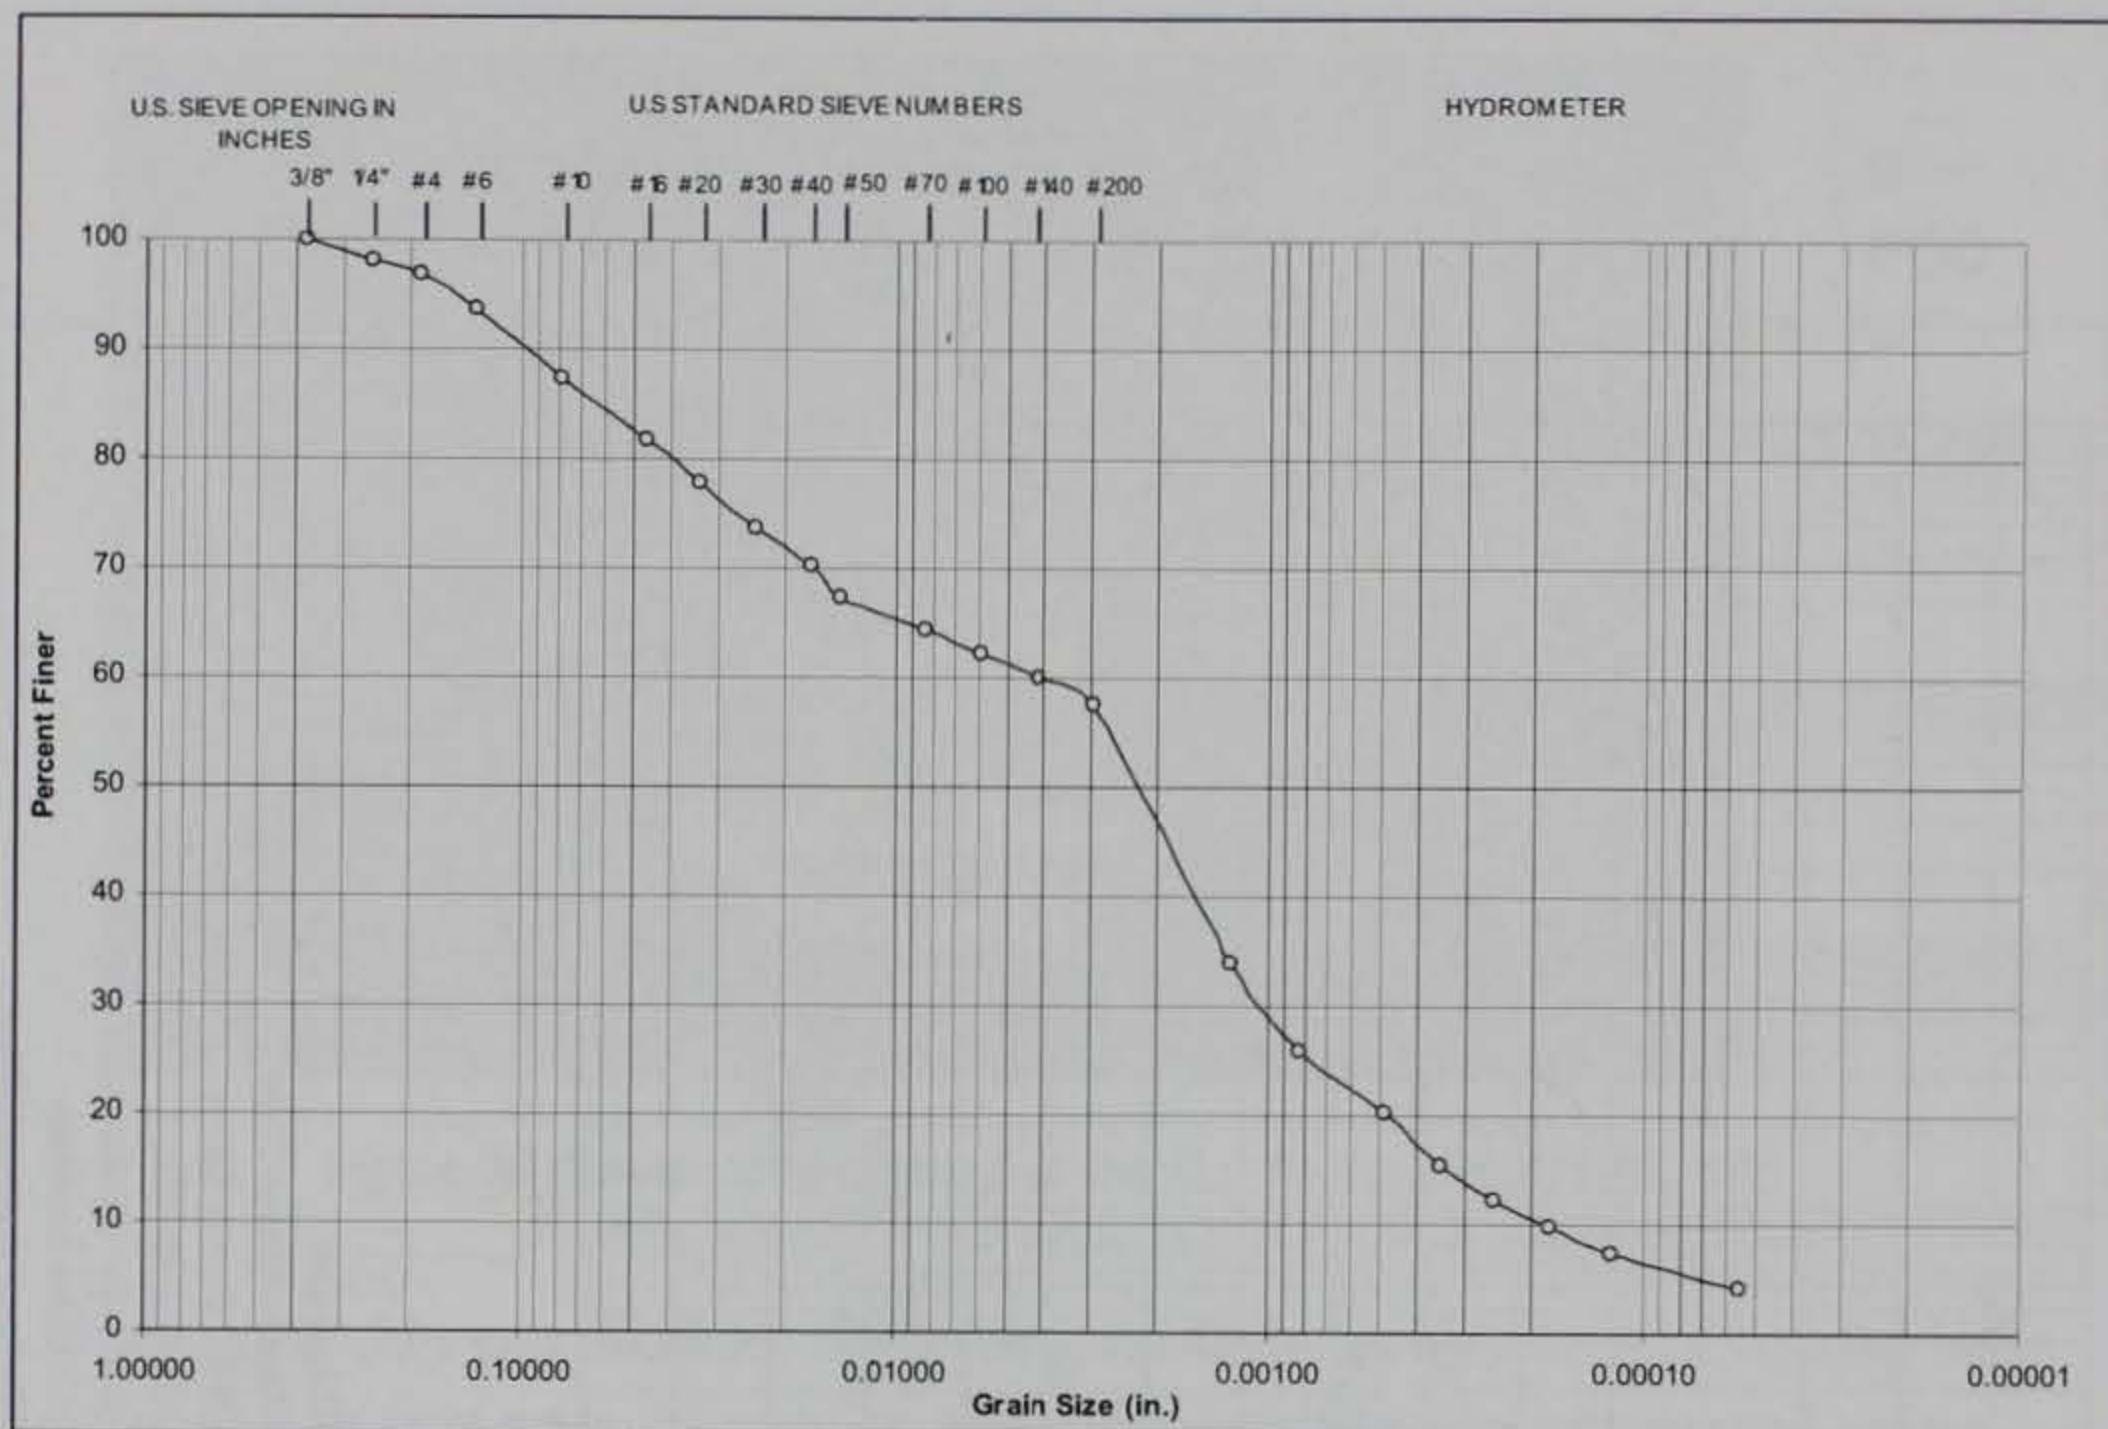
Figure 30. Gradation curve of subgrade material at Tinker AFB, OK.

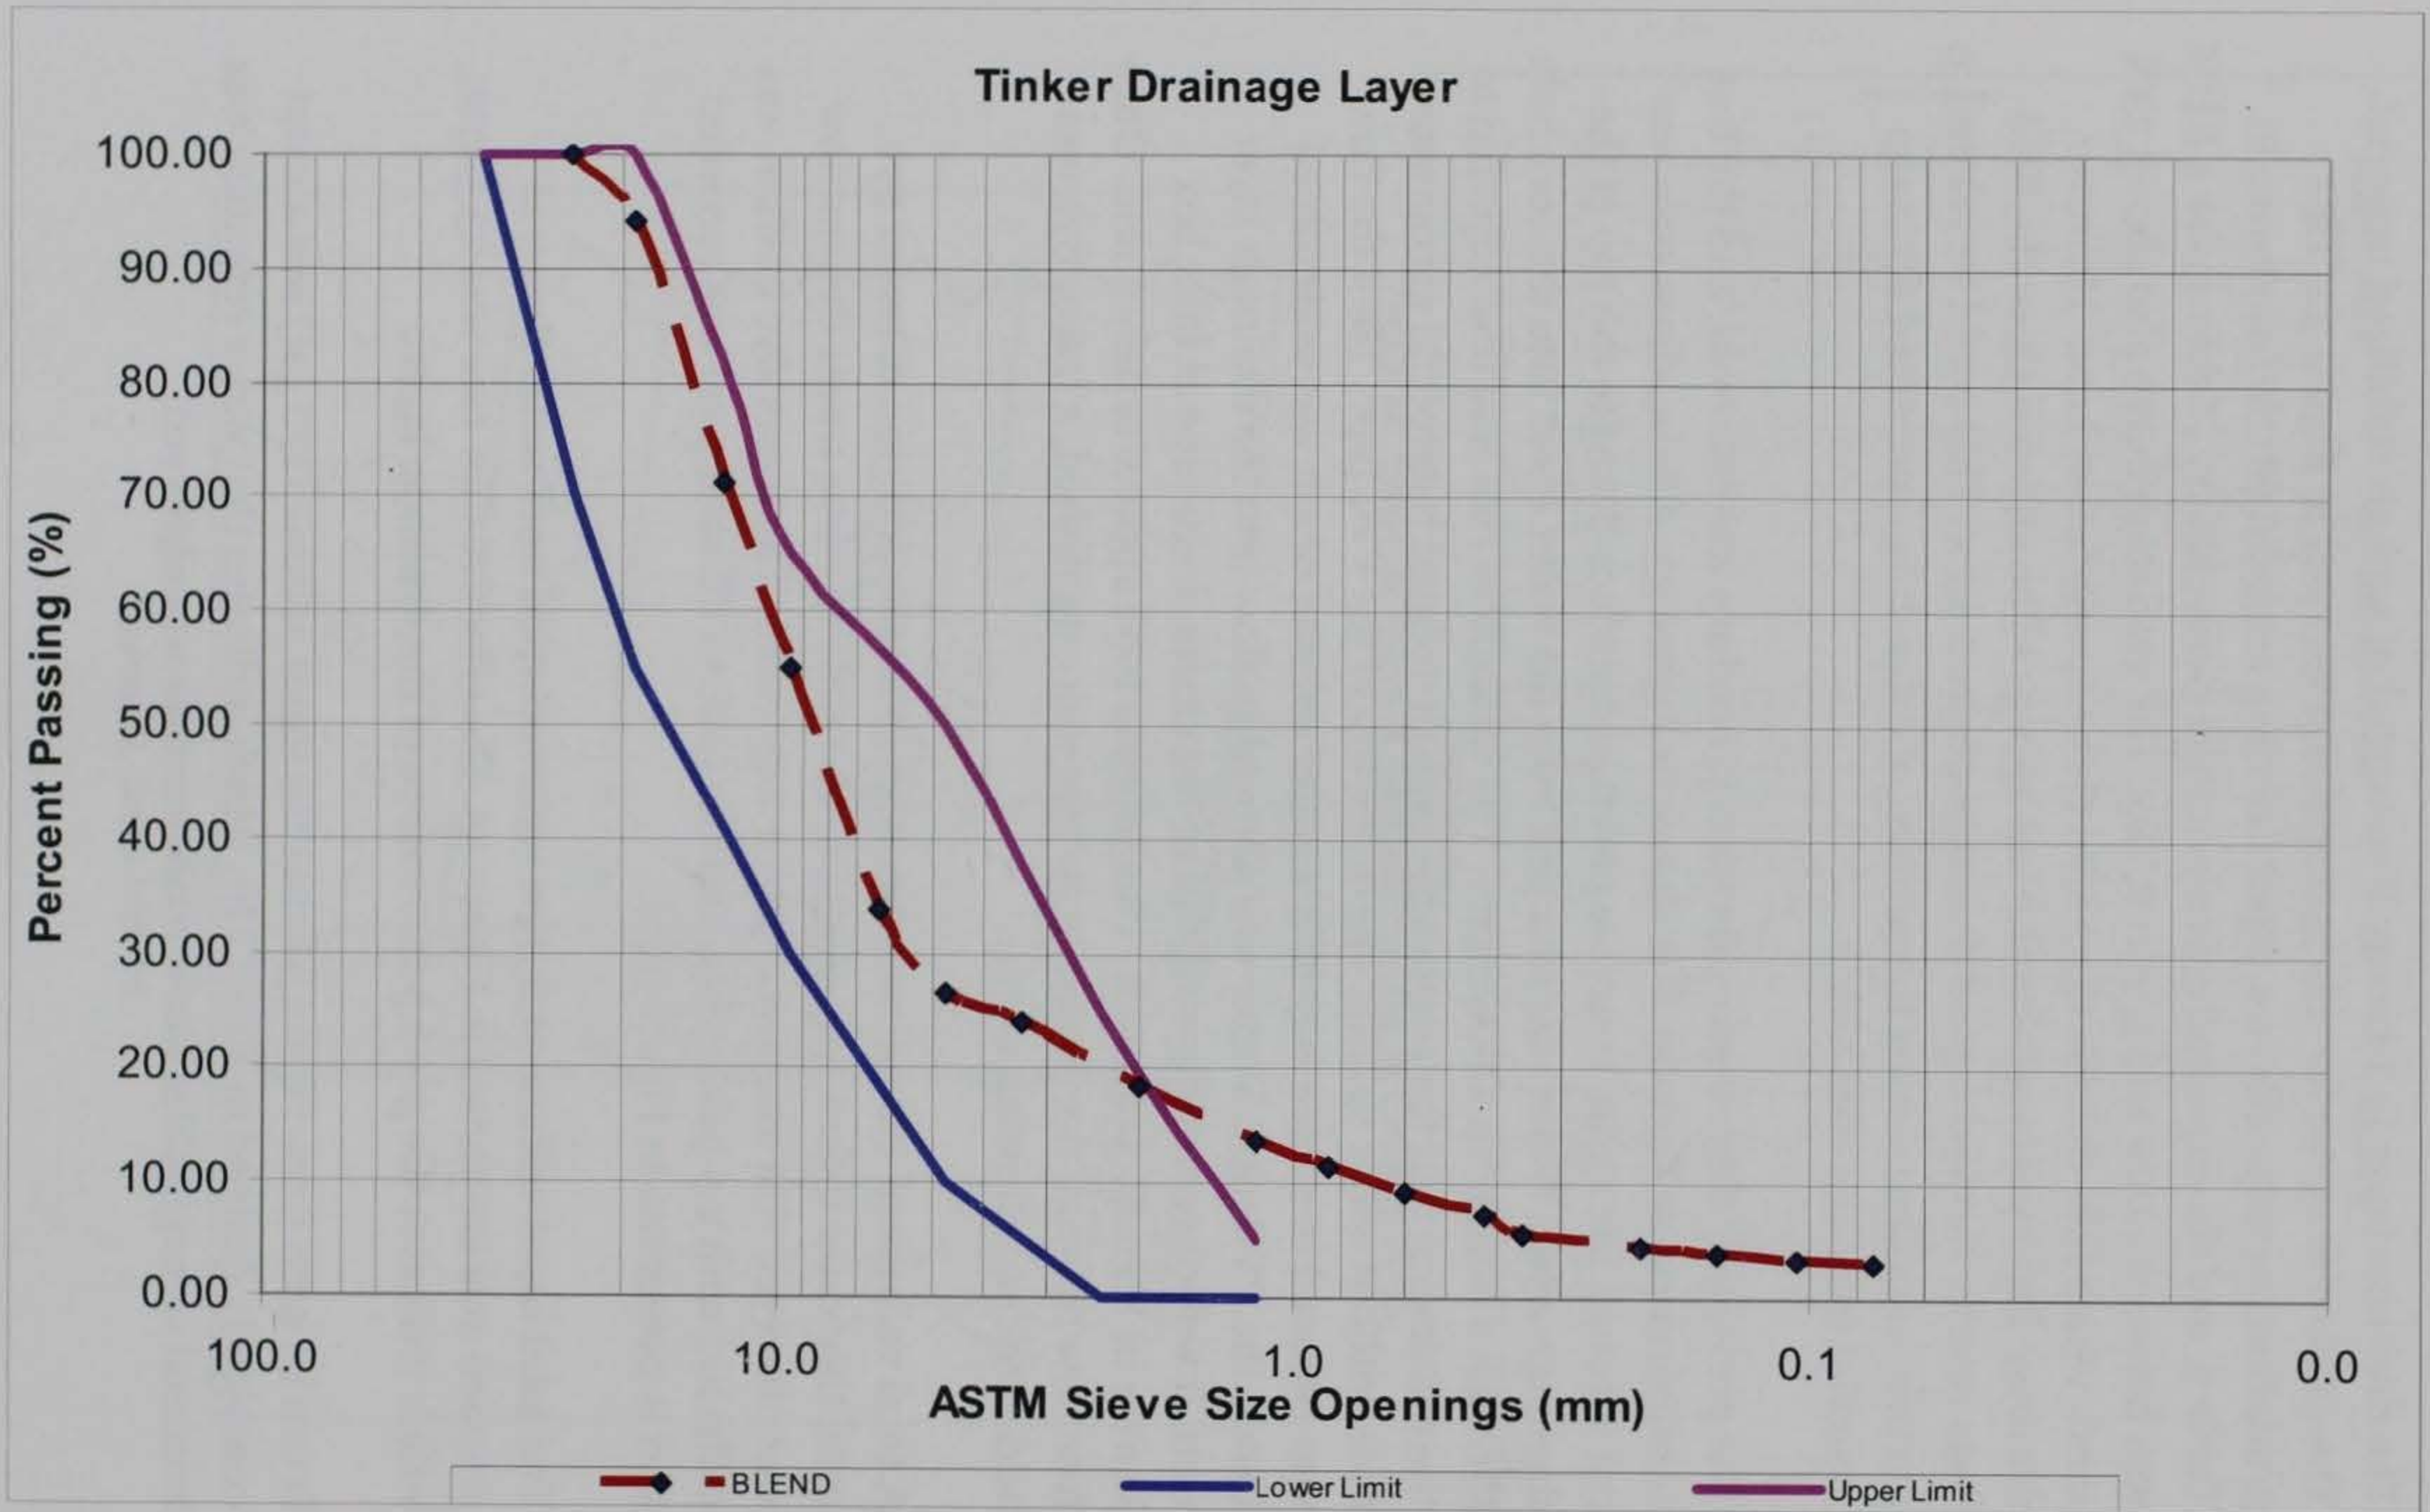
Figure 32. Gradation curve of drainage layer material at Taxiway B, Tinker AFB, OK.
