## **Evaluation of Airfield Pavement Drainage Layers**

John F. Rushing and Mariely Mejías-Santiago

July 2009

Final report

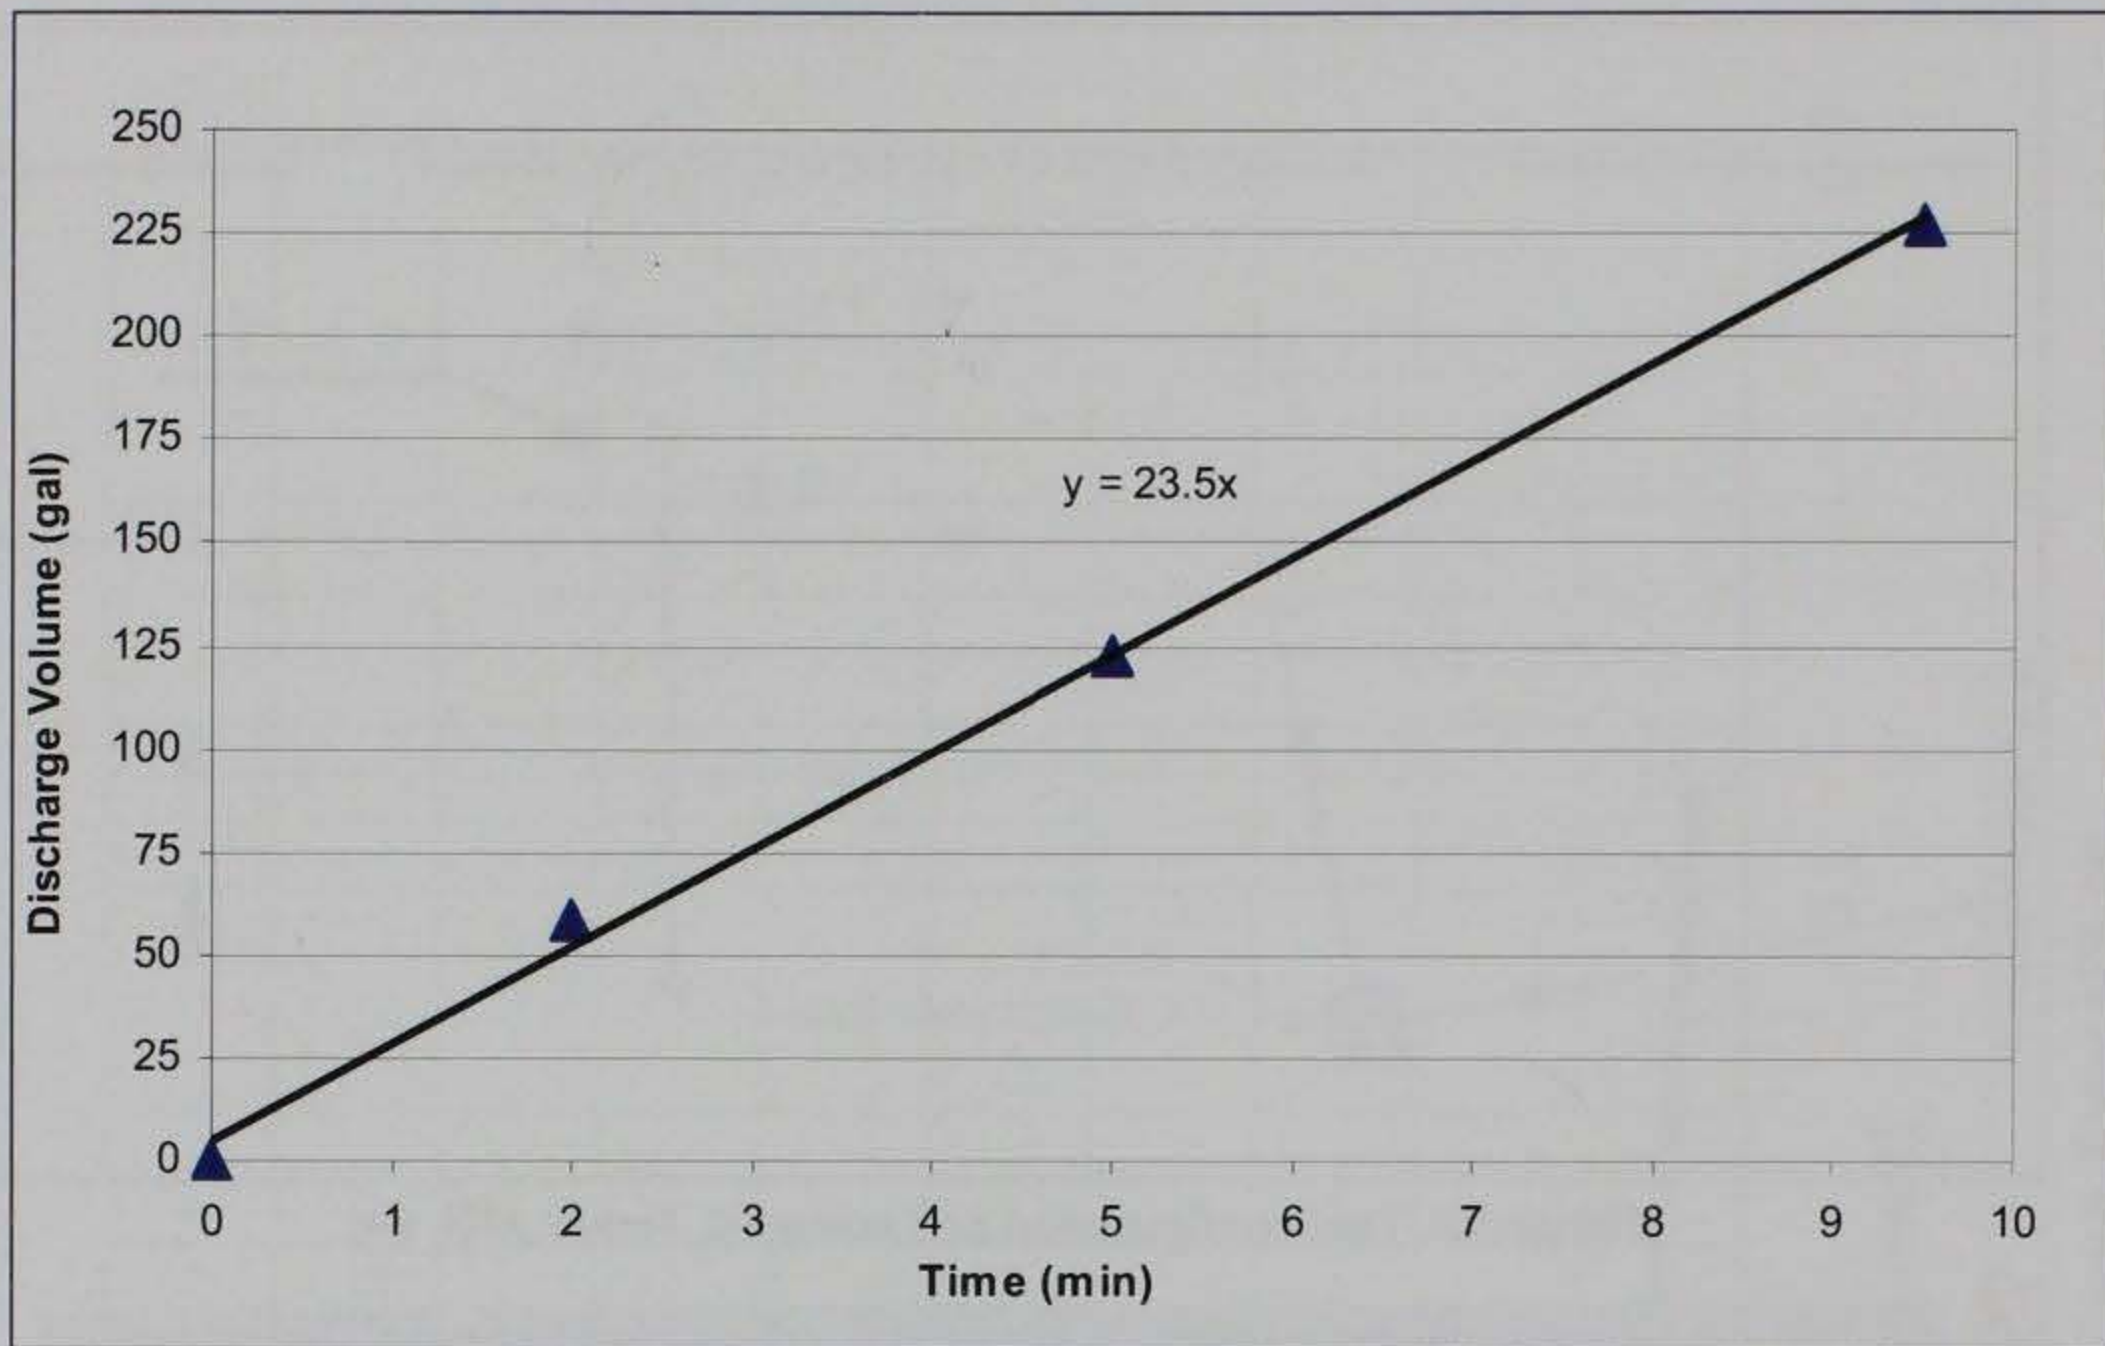
Figure 35. Volumetric flow into drainage layer.

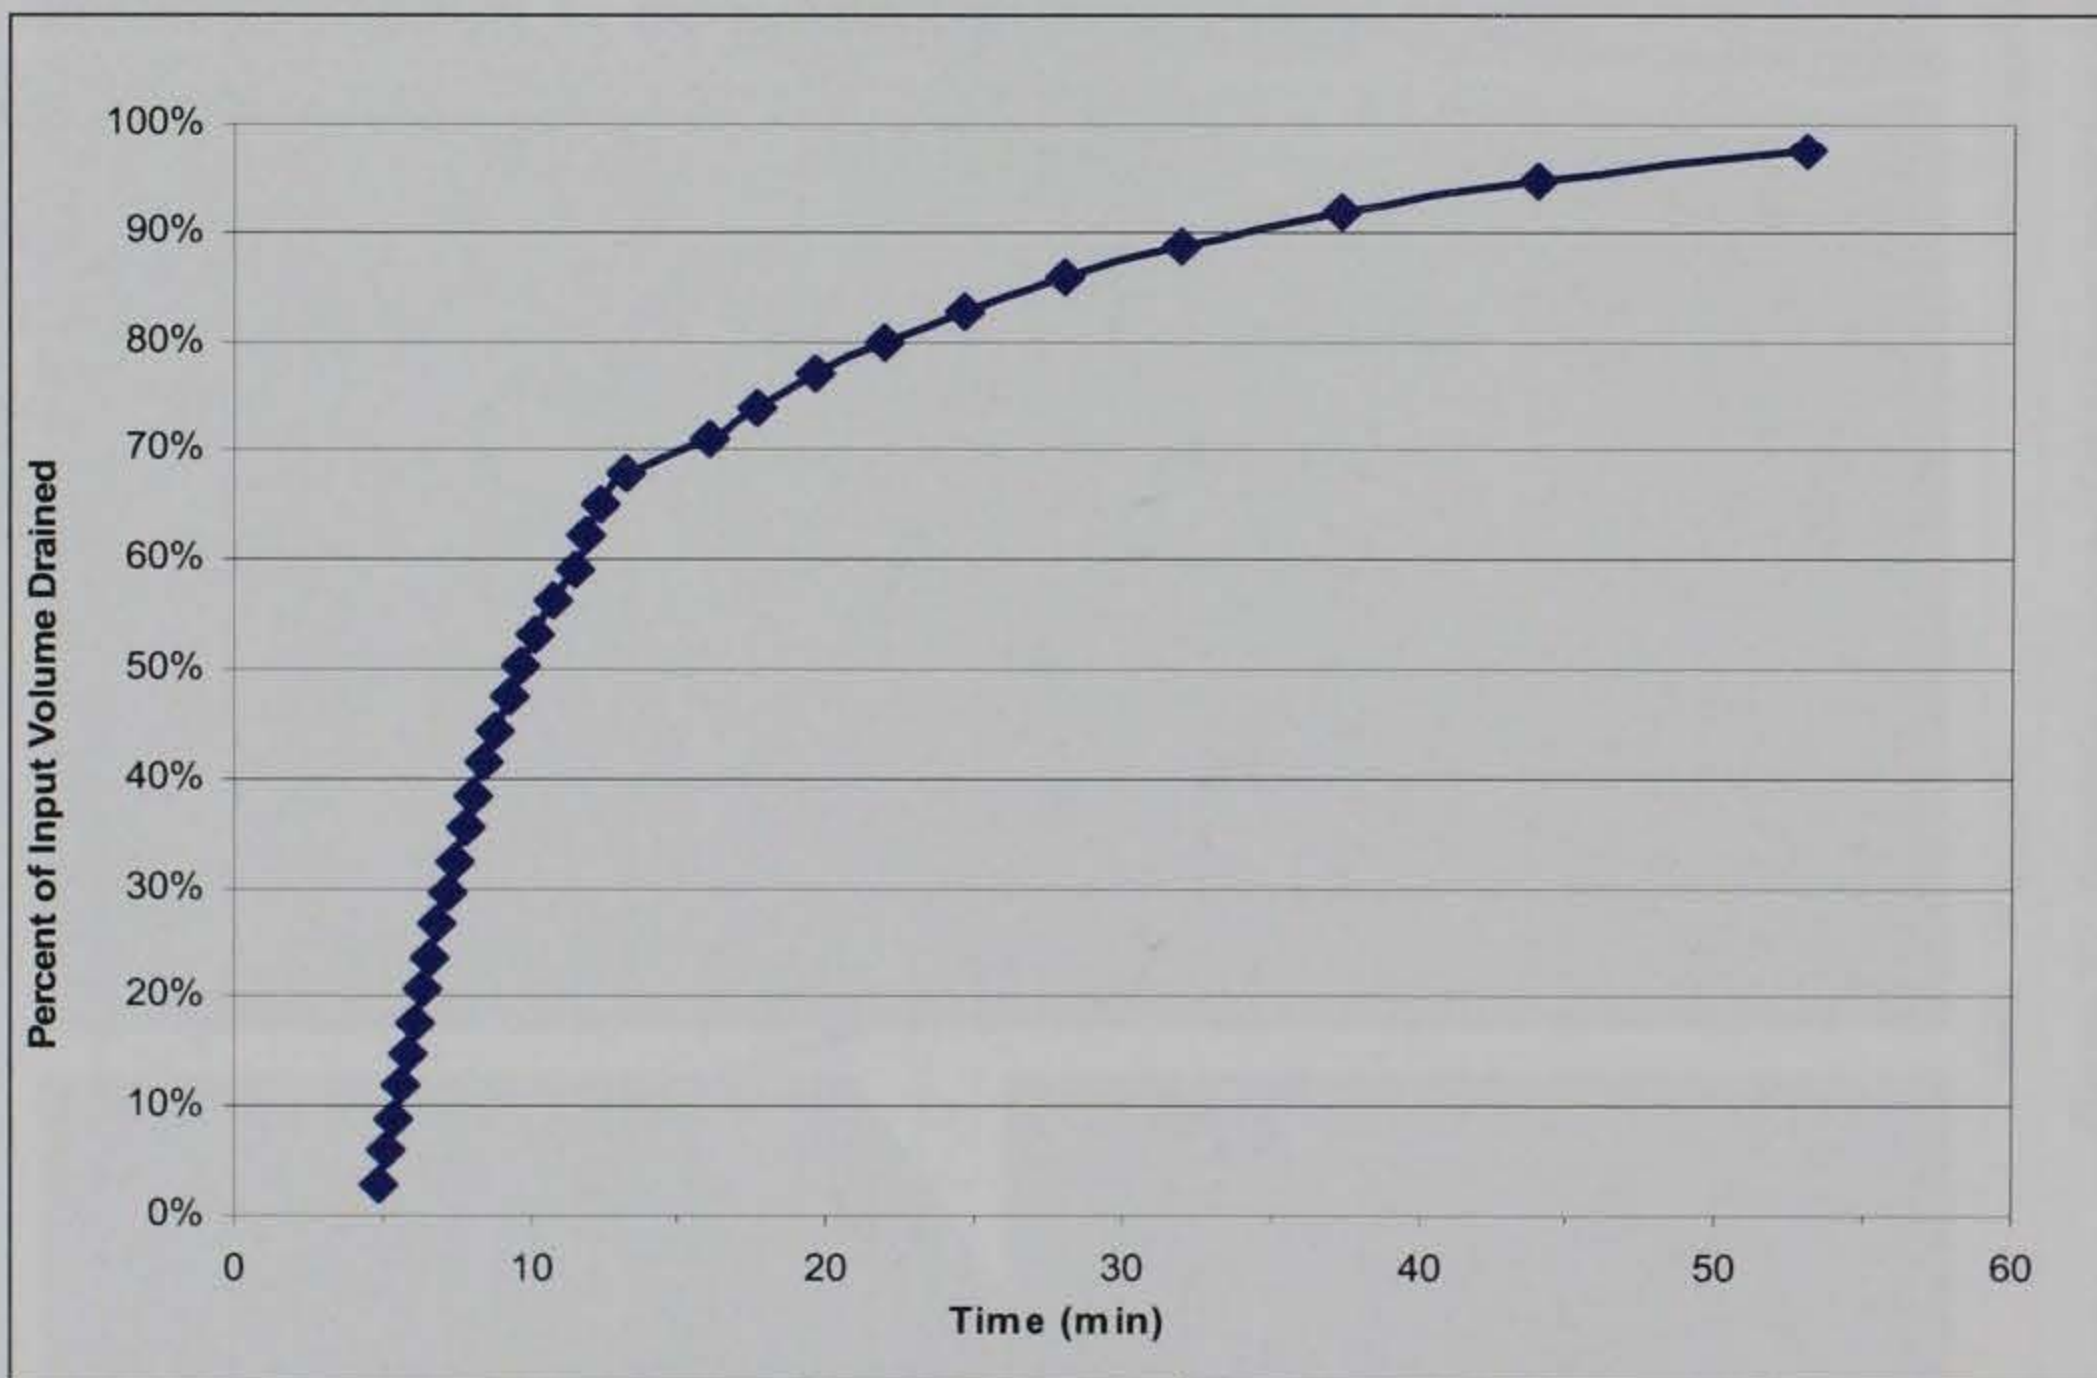
It can be seen from Figure 36 that the input volume (170 gal) was almost completely drained in about 1 hr, which indicates that water retention was minimal or negligible. No flow obstruction was observed.

Figure 36. Percent of total input volume collected at the outlet.

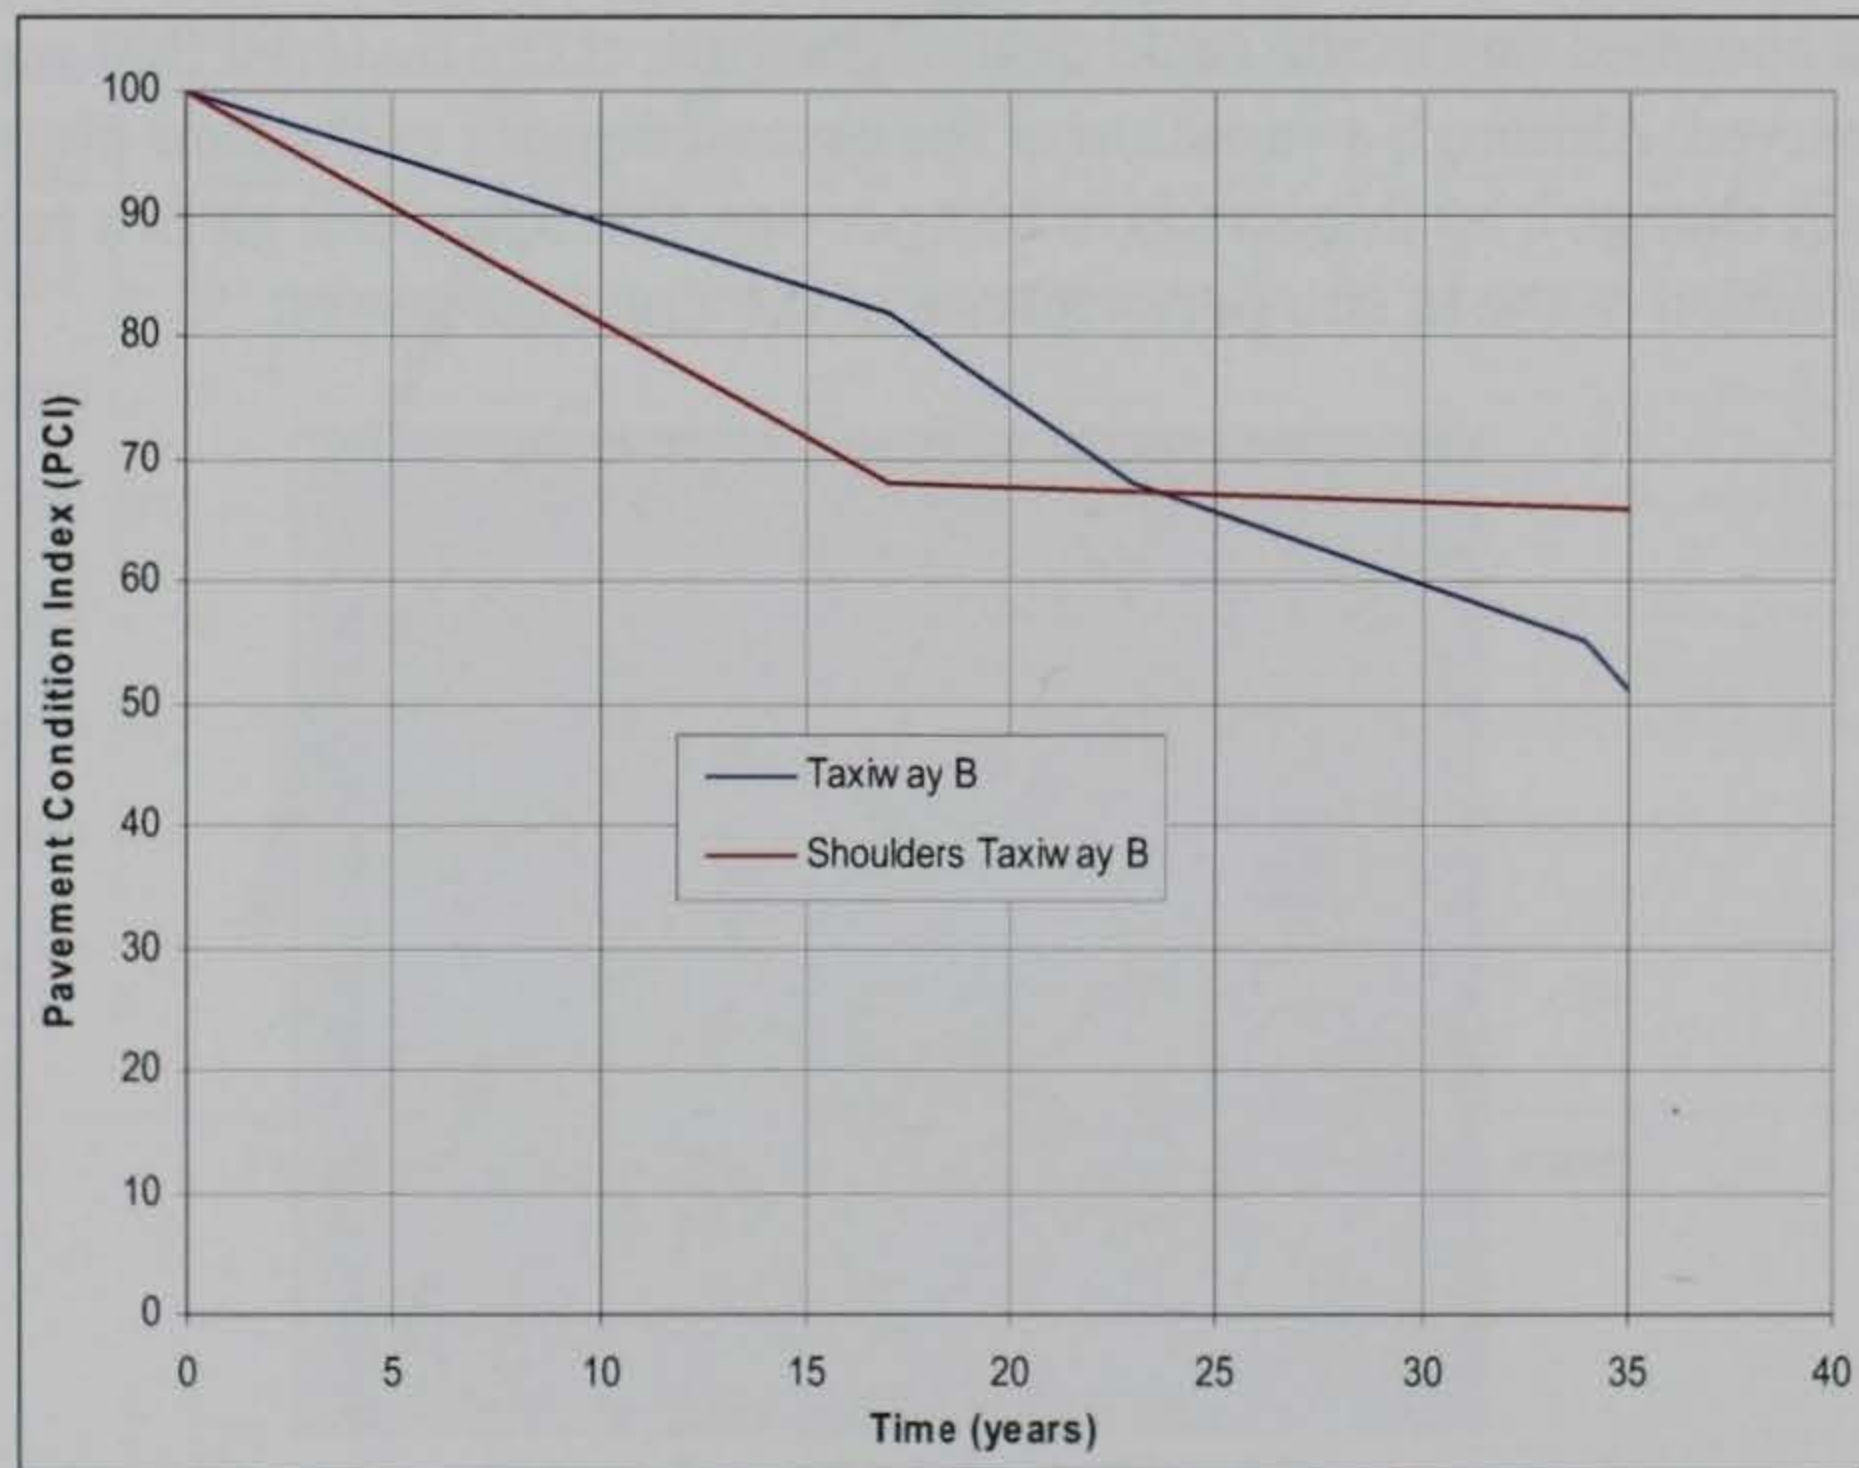
Figure 38. Taxiway B pavement life cycle.

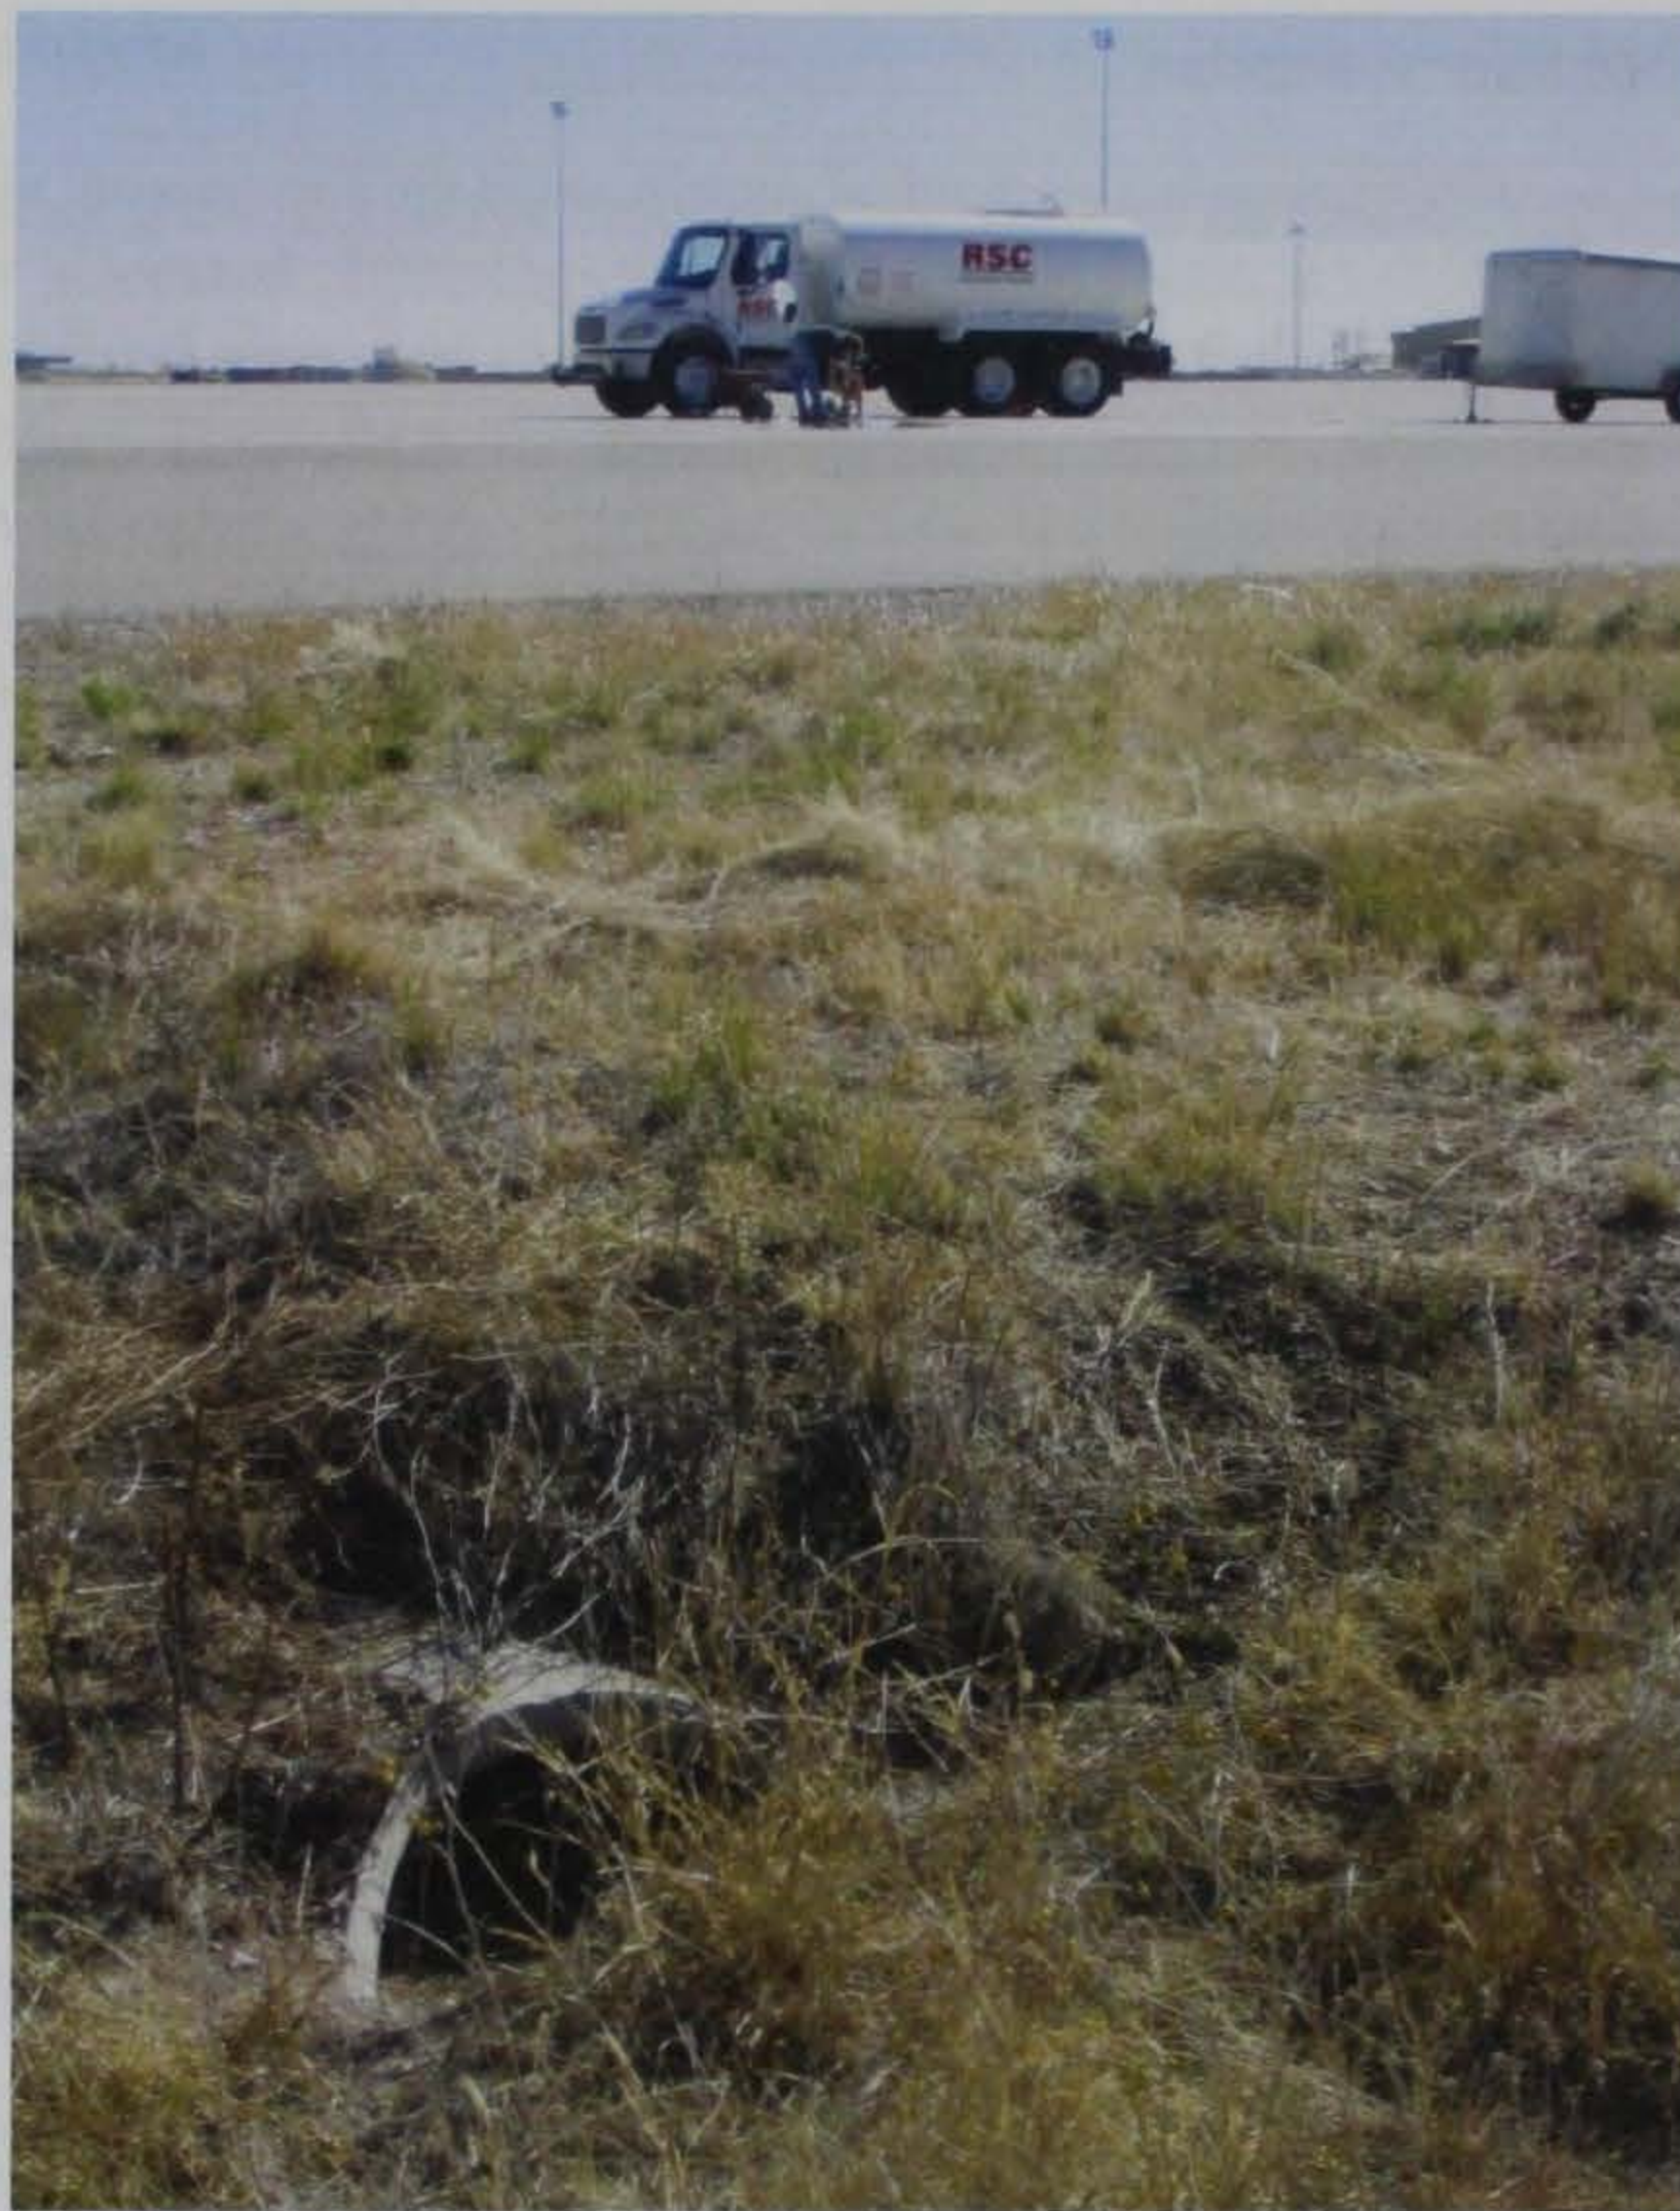
An outflow pipe was located on the northwest corner of the apron (Figure 41). The pipe led from a manhole to a drainage basin. Two pavement drainage pipes were located under the shoulder running parallel to the west and north edges of the apron. These pipes emptied into the manhole (Figure 42).

Figure 41. Poorly maintained outlet pipe leading from DAACG Ramp.

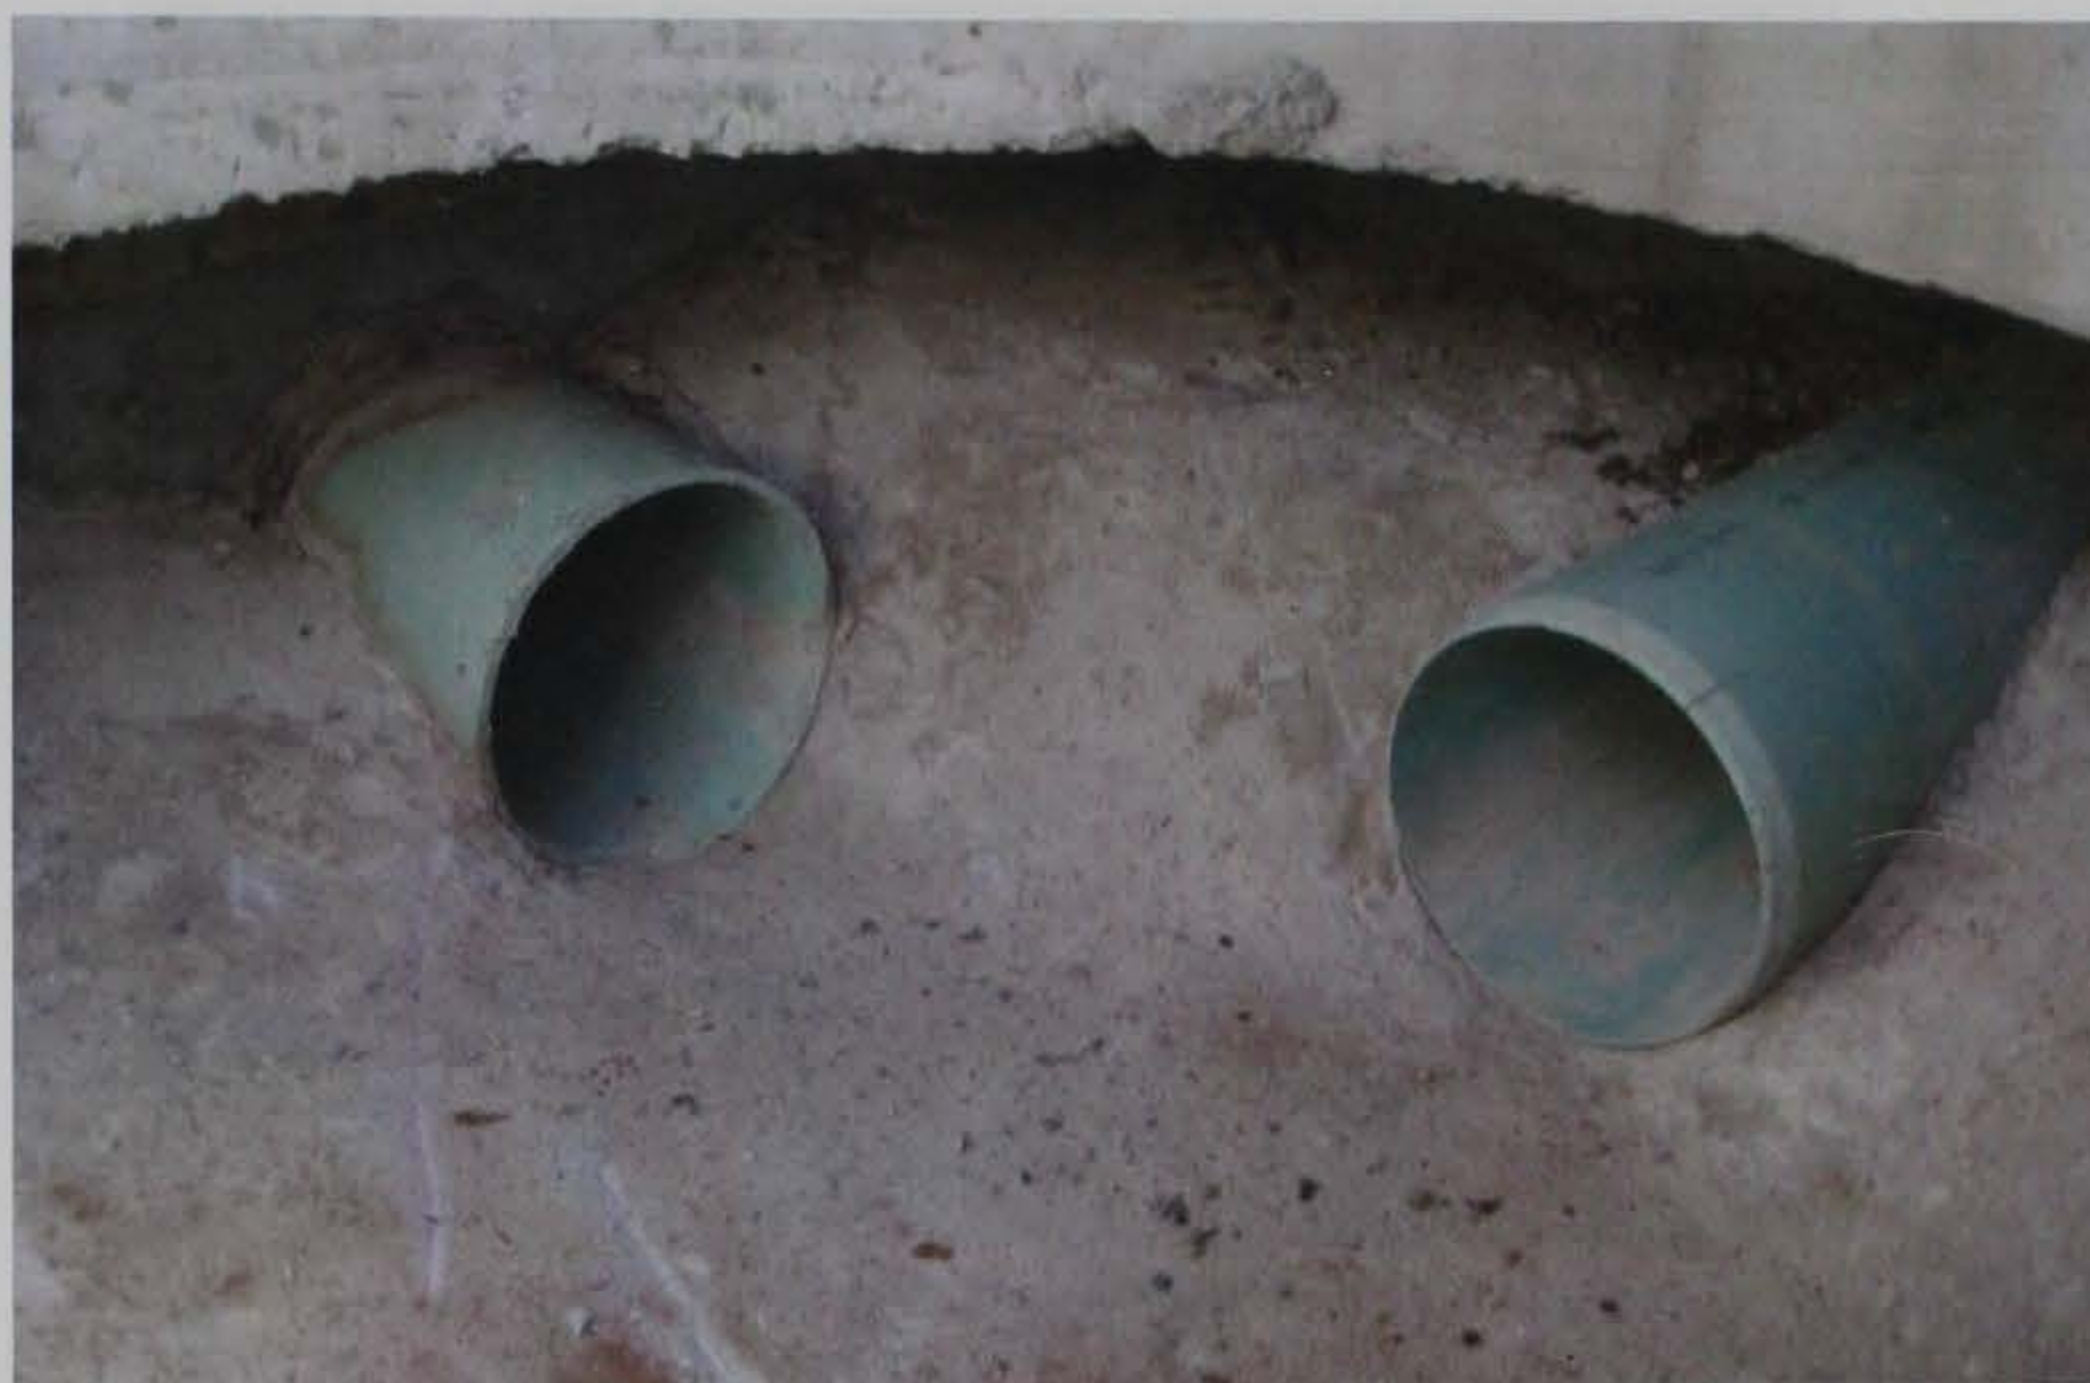
Figure 42. Drainage pipes converging at manhole on DAACG ramp.

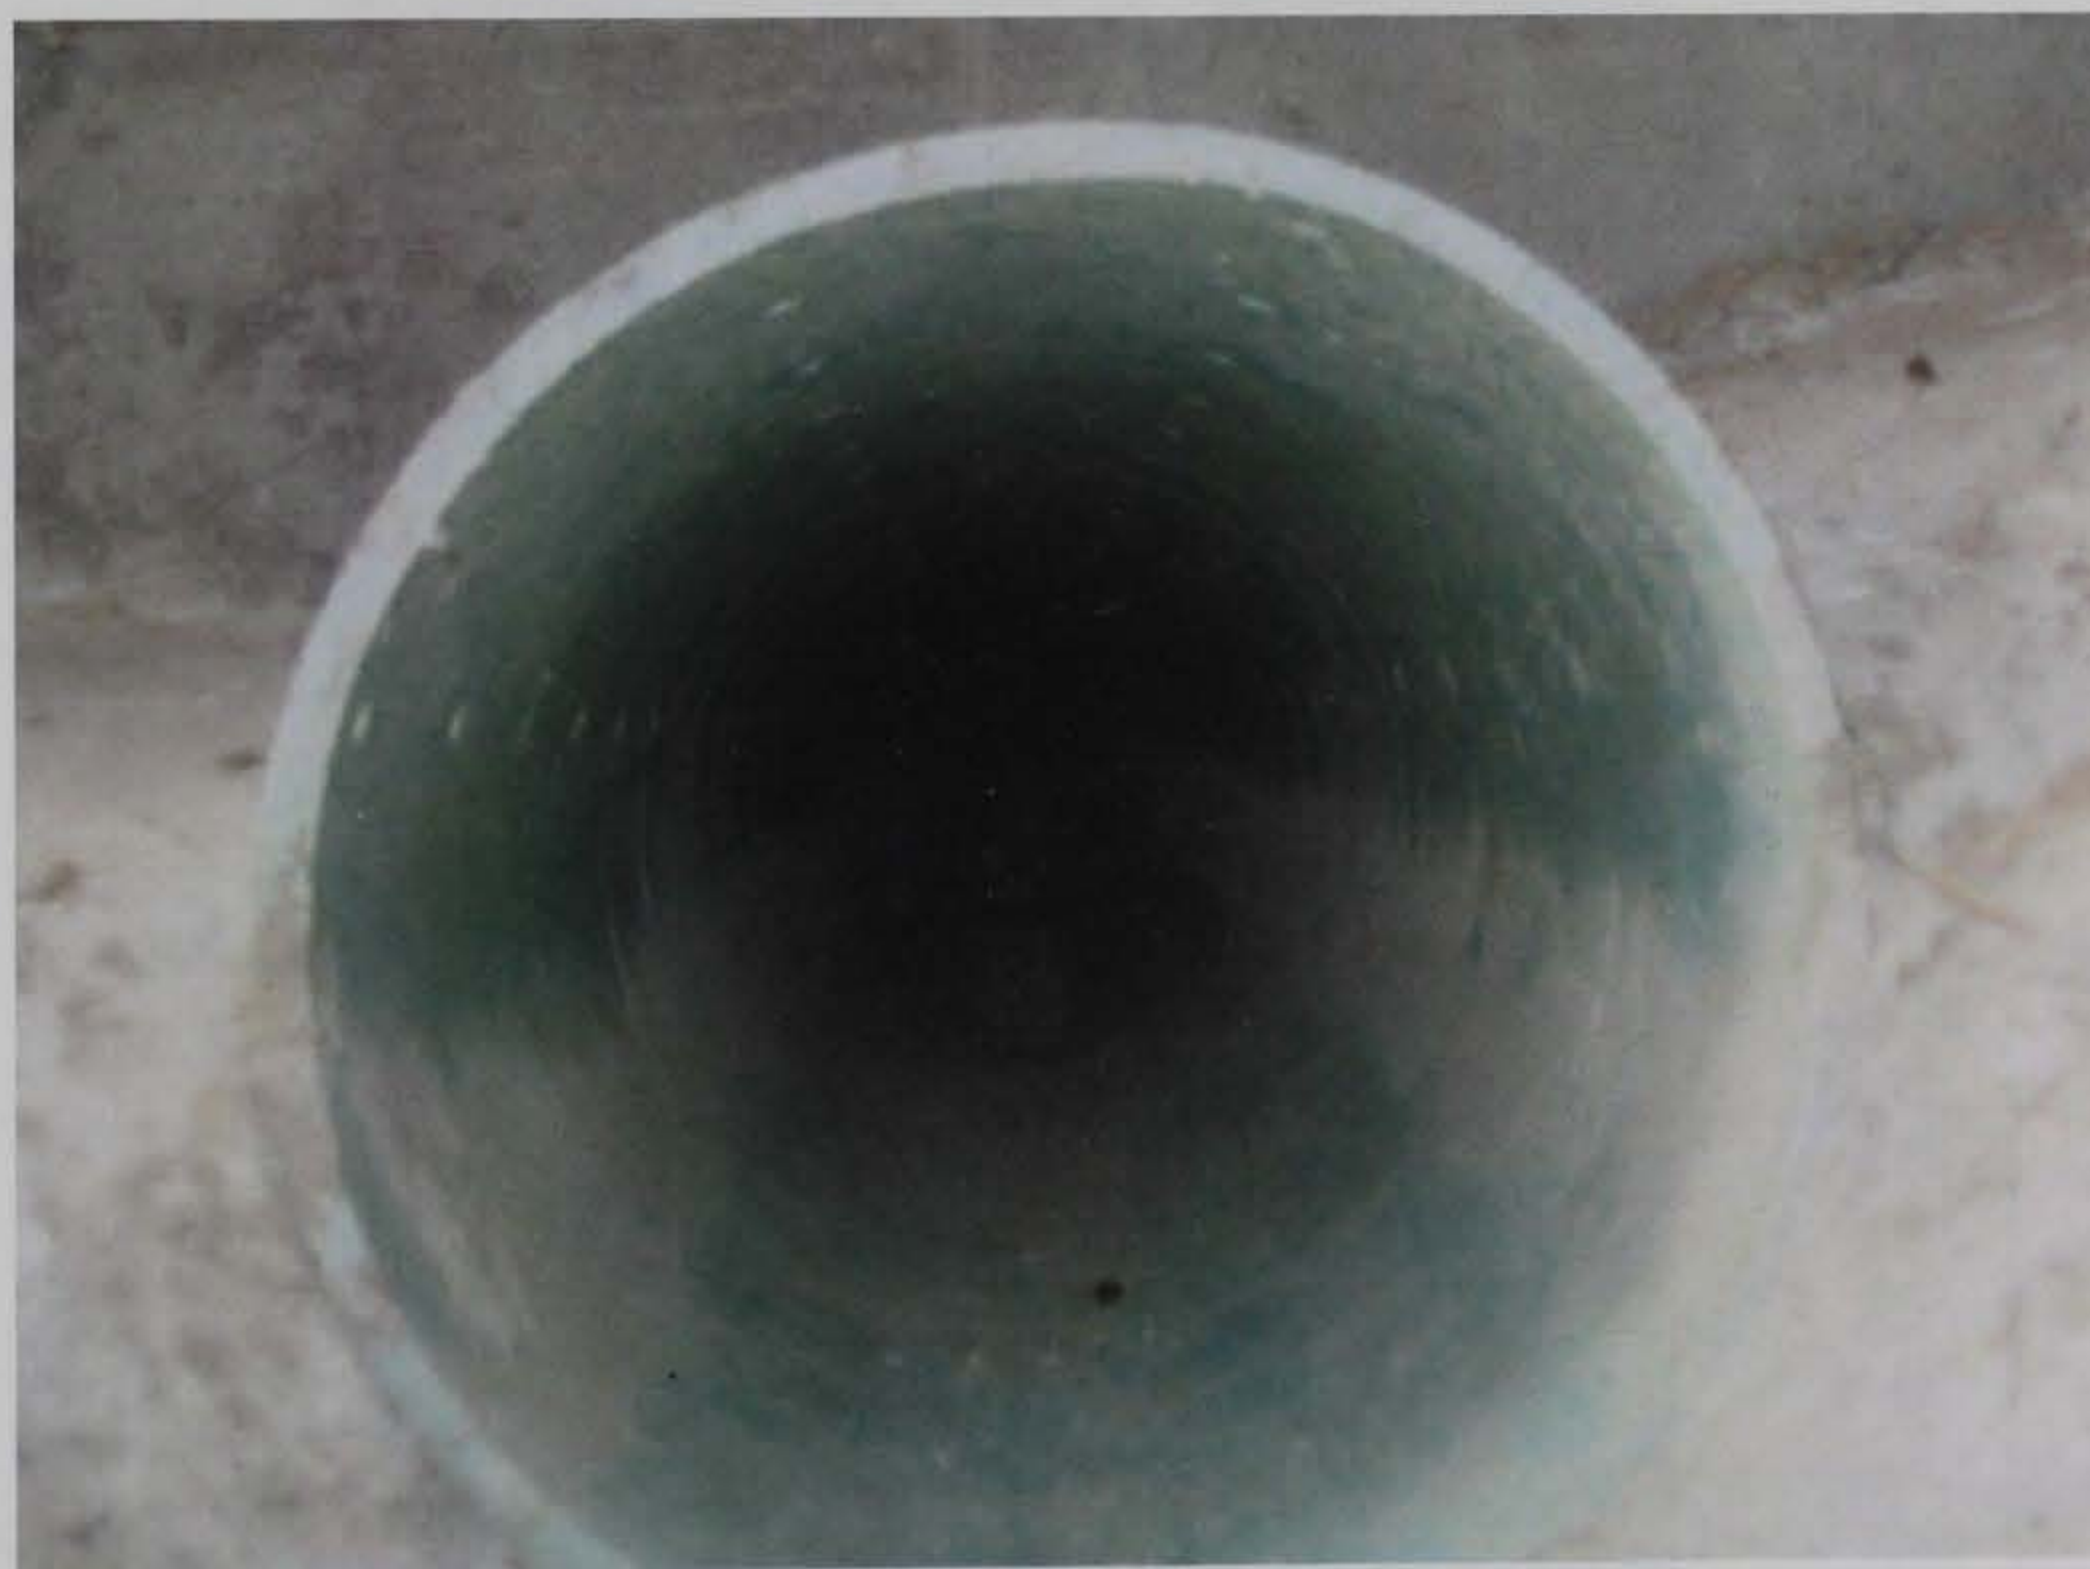
Figure 43. Perforated drainage pipe.

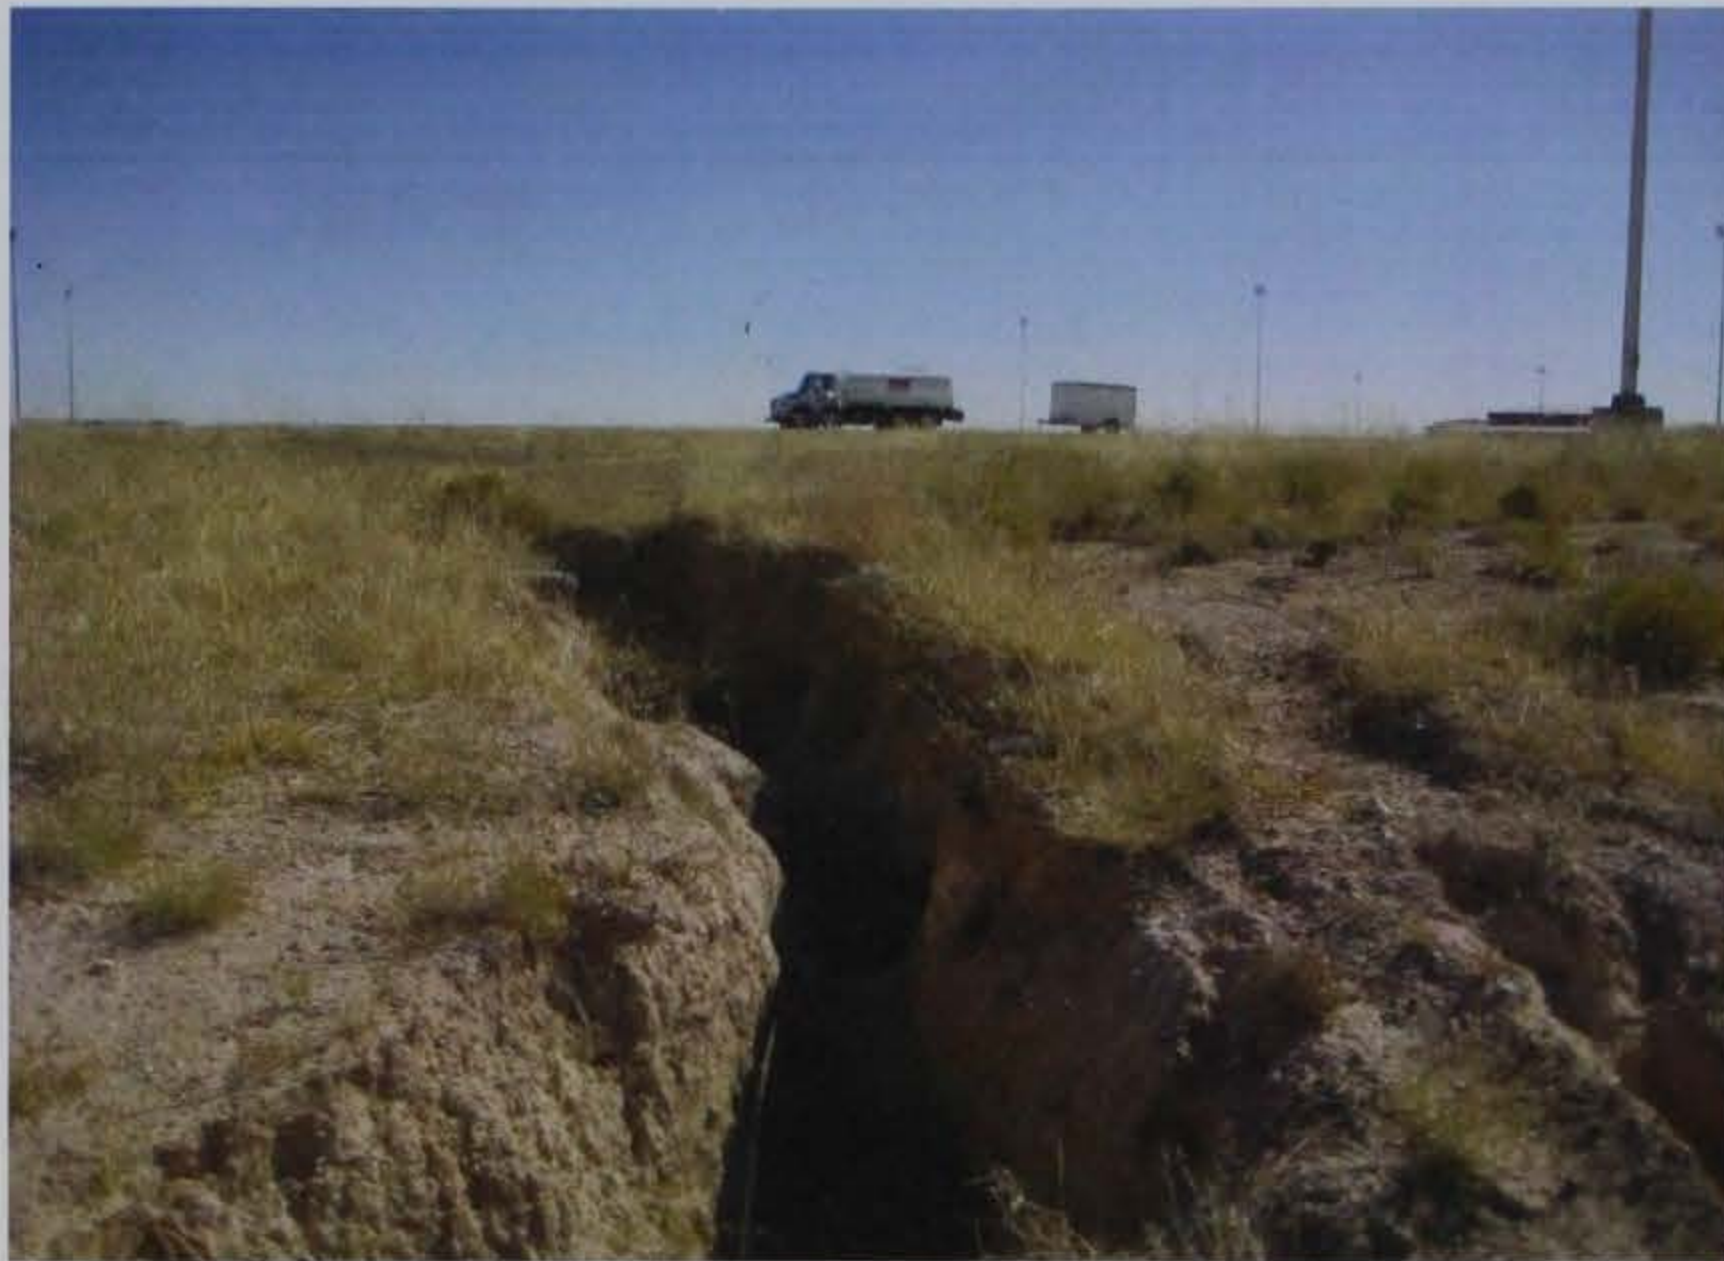
An area of exposed soil downslope from the outflow pipe was experiencing erosion from water flow. (Figure 44). The erosion was thought to originate from water flowing from the drainage system. However, closer inspection revealed soil erosion on top of the outflow pipe and the observation that all surface runoff travels through the location (Figure 45). The erosion could occur even if no water was flowing through the drainage system.

Figure 44. Soil erosion caused by surface water drainage.

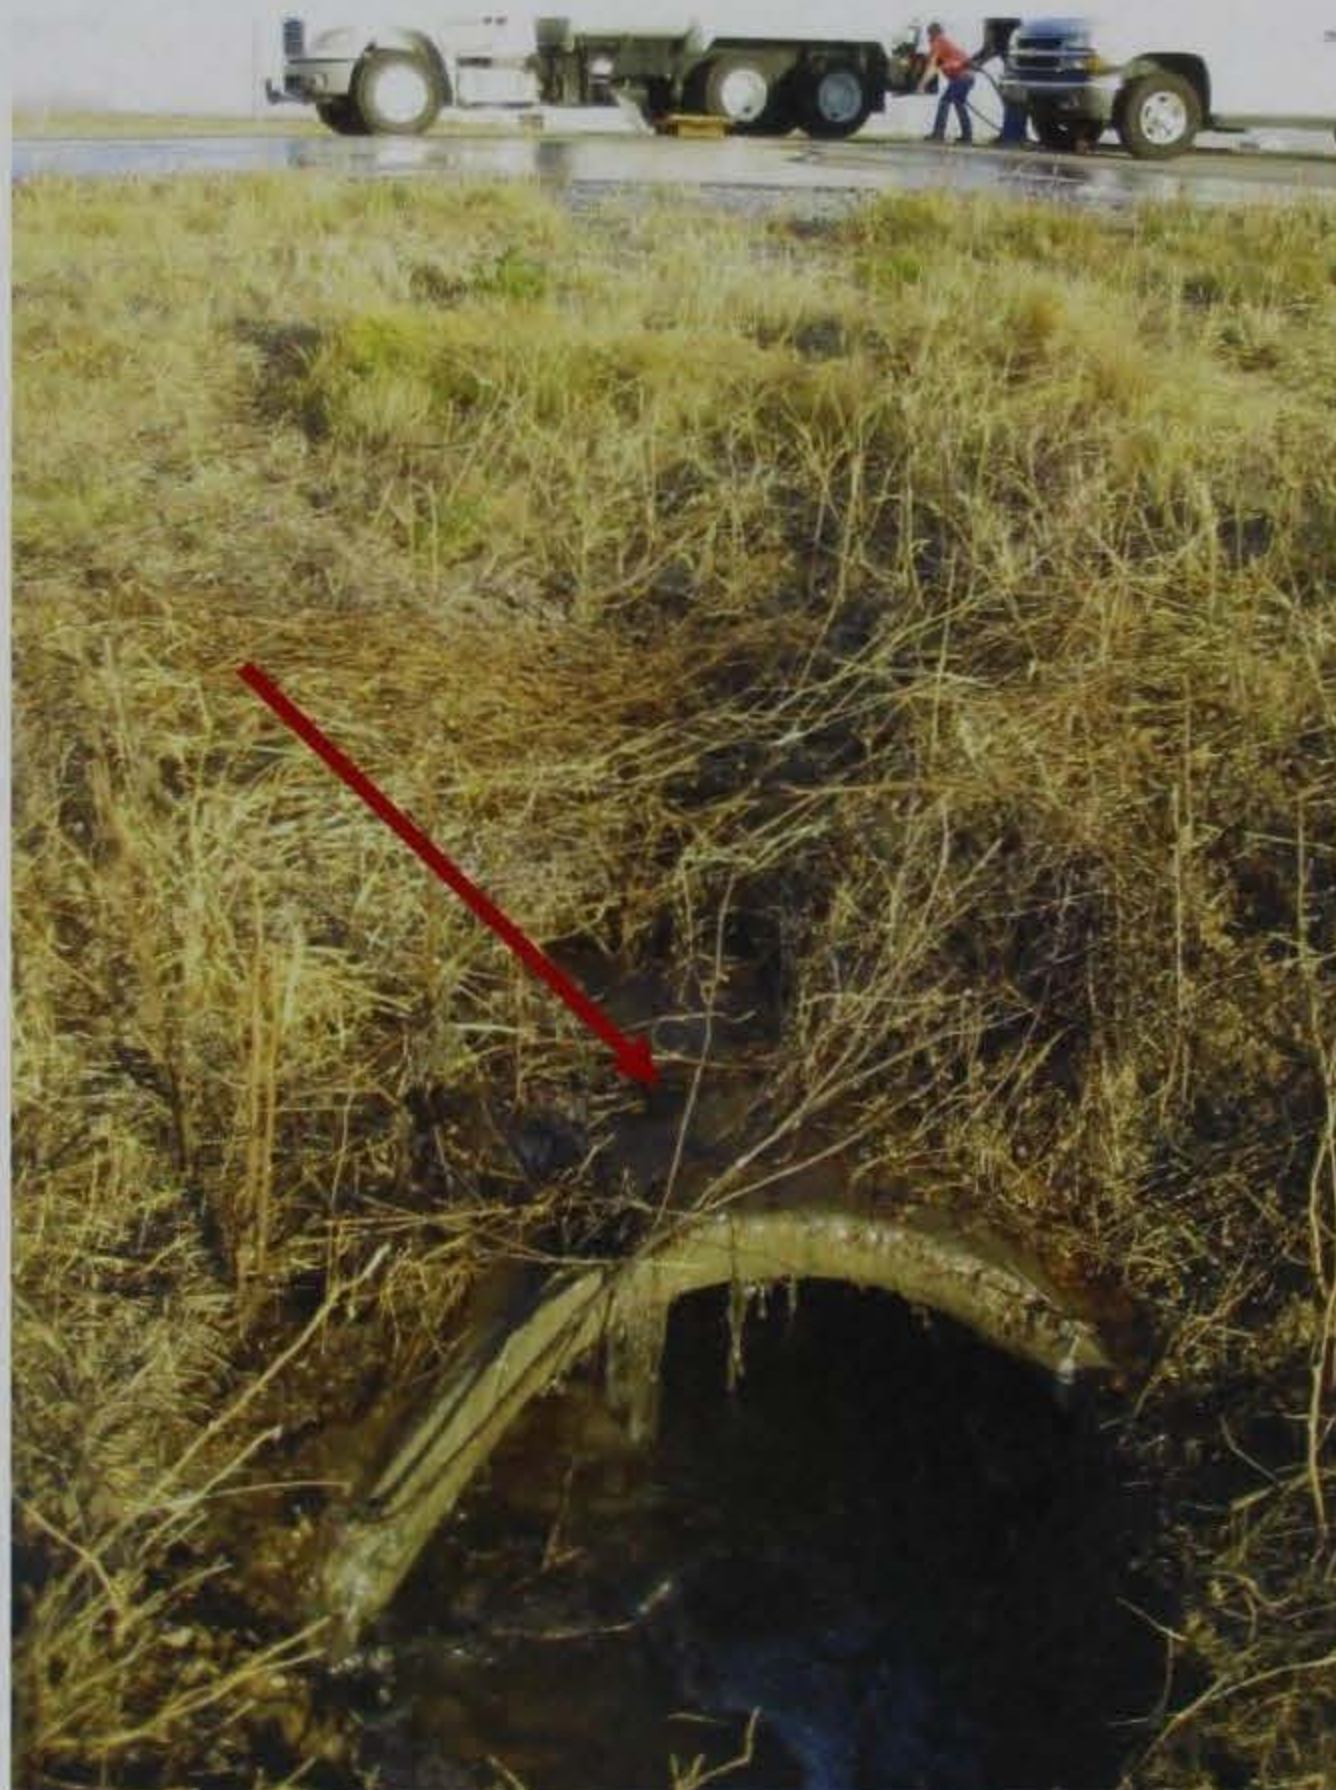
Figure 45. Surface drainage following path of drainage outlet pipe.
