## **Evaluation of Airfield Pavement Drainage Layers**

John F. Rushing and Mariely Mejías-Santiago

July 2009

Final report

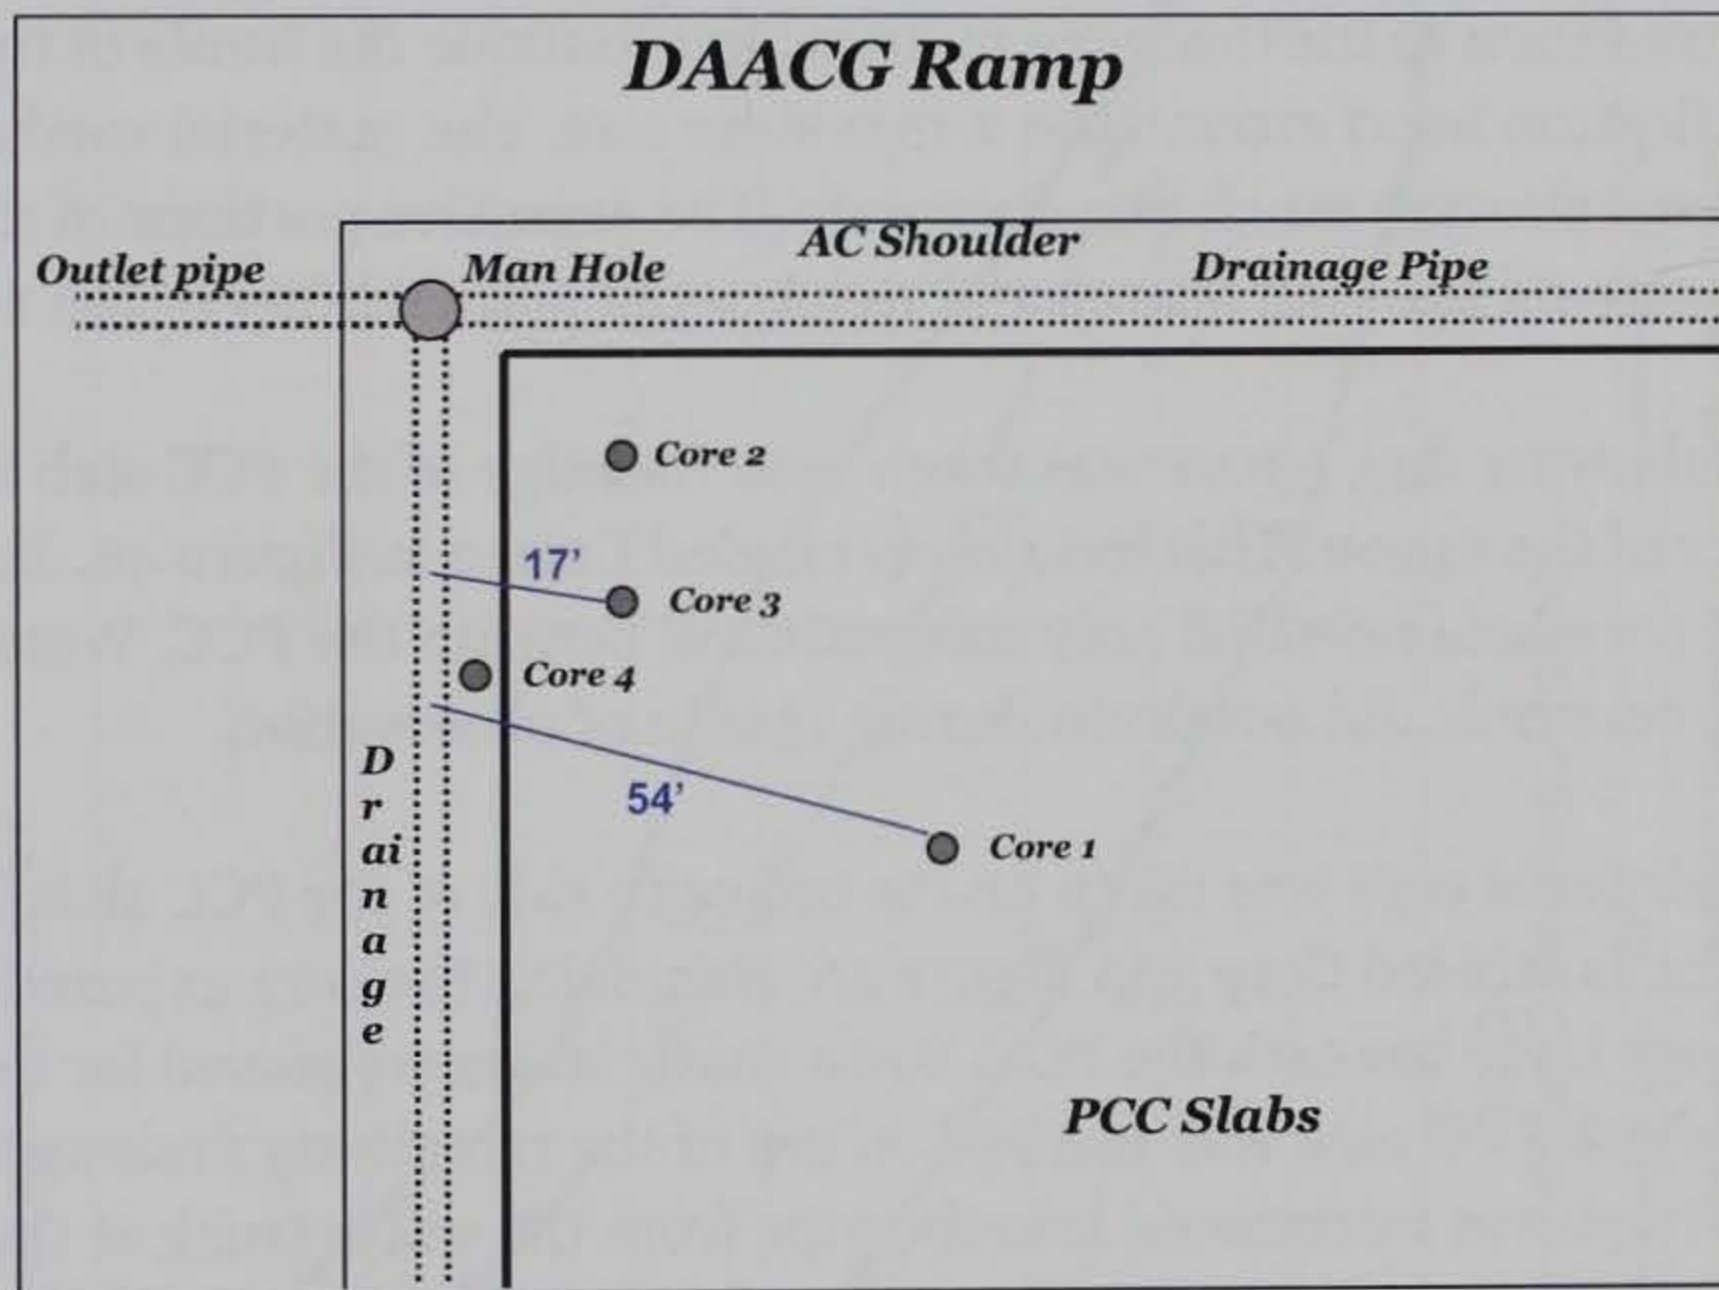
An initial core was taken in the PCC at the location shown in Figure 46 designated as Core 1. The upper portion of the drainage layer was removed for analysis. A 4-in.-diam PVC pipe was secured on top of the remaining drainage material. Water was introduced into the pipe from the water truck at the maximum rate to sustain a constant 4-ft head of water in the pipe. A plot of the input volume versus time is shown in Figure 47.

Figure 46. Layout of testing area on DAACG Ramp.

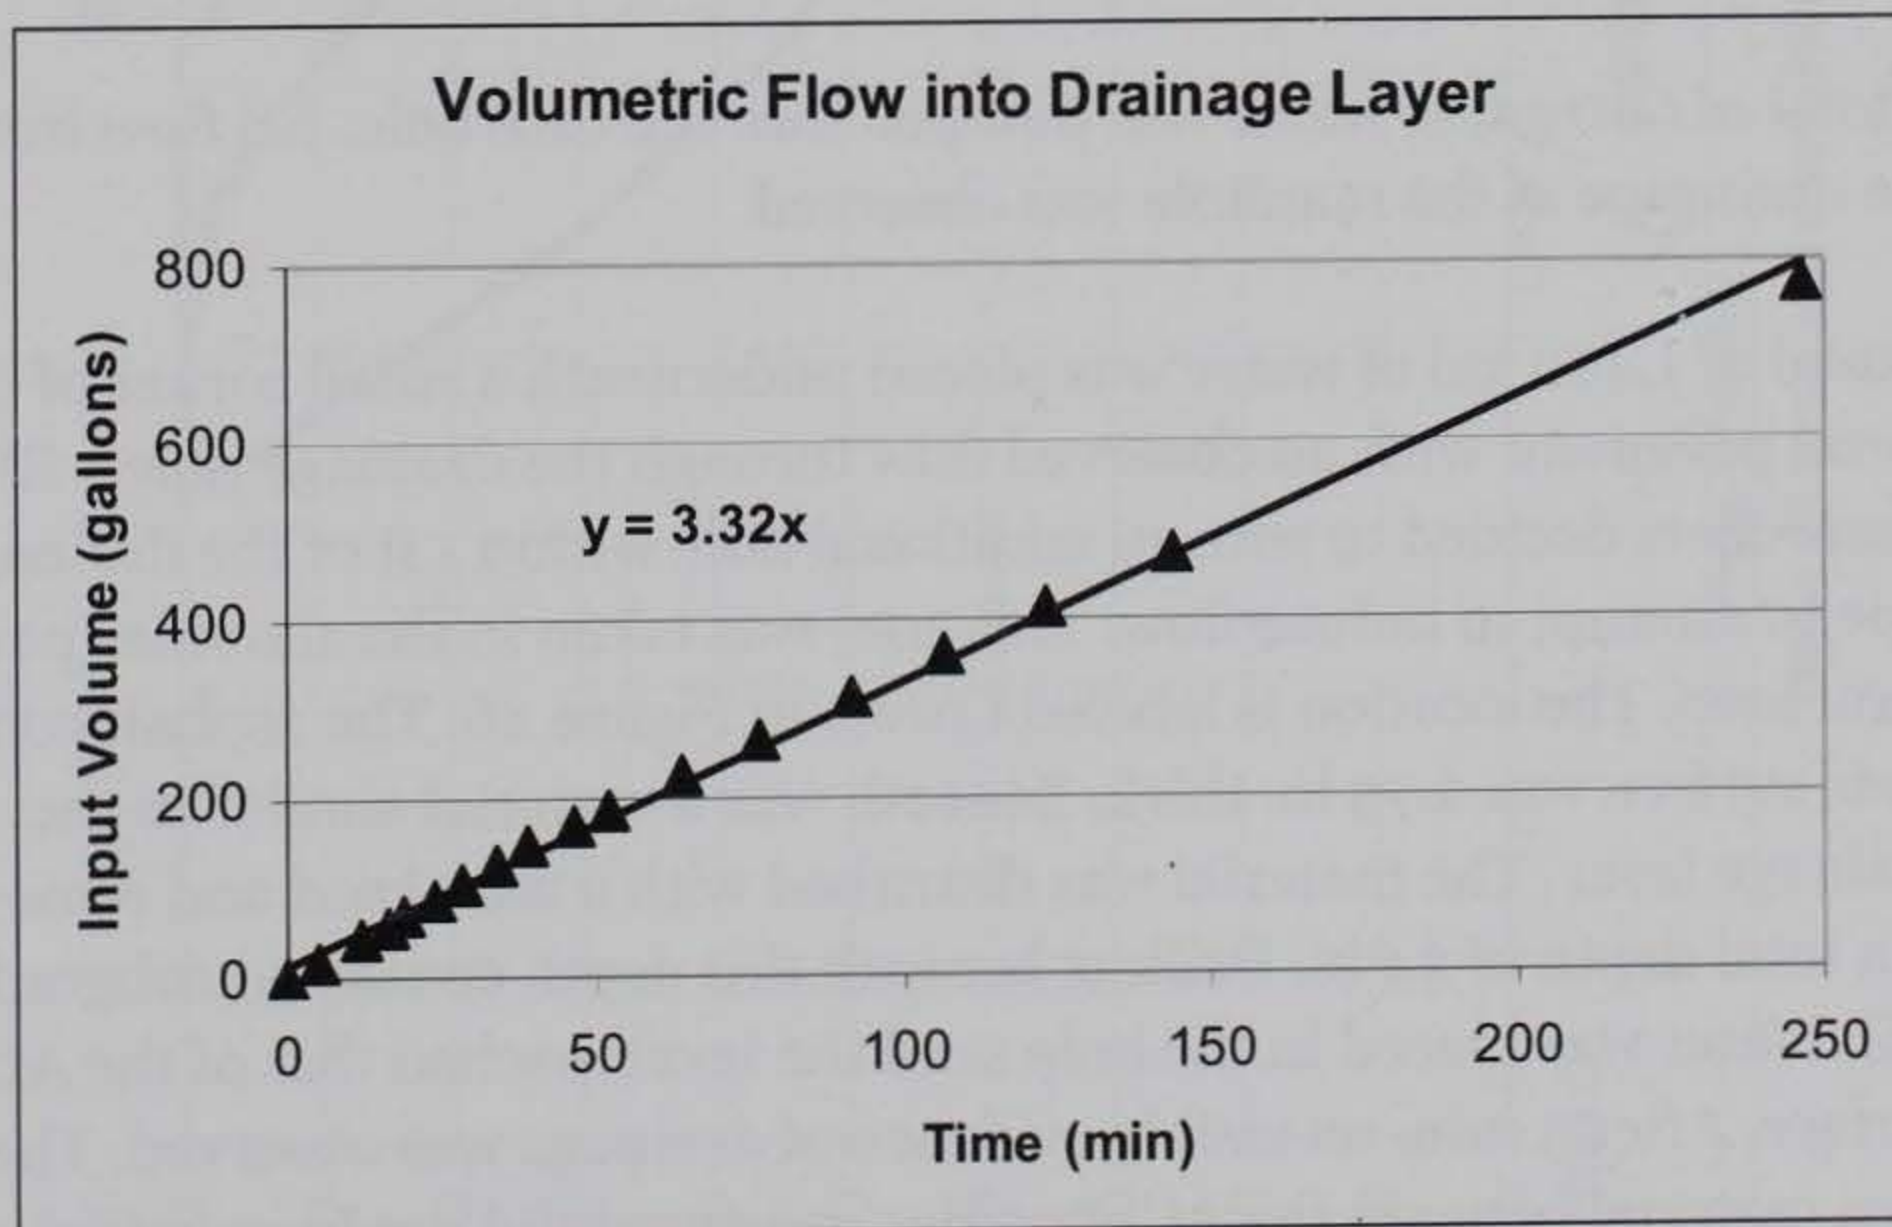
Figure 47. Flow rate of water introduced into drainage layer on DAACG Ramp.

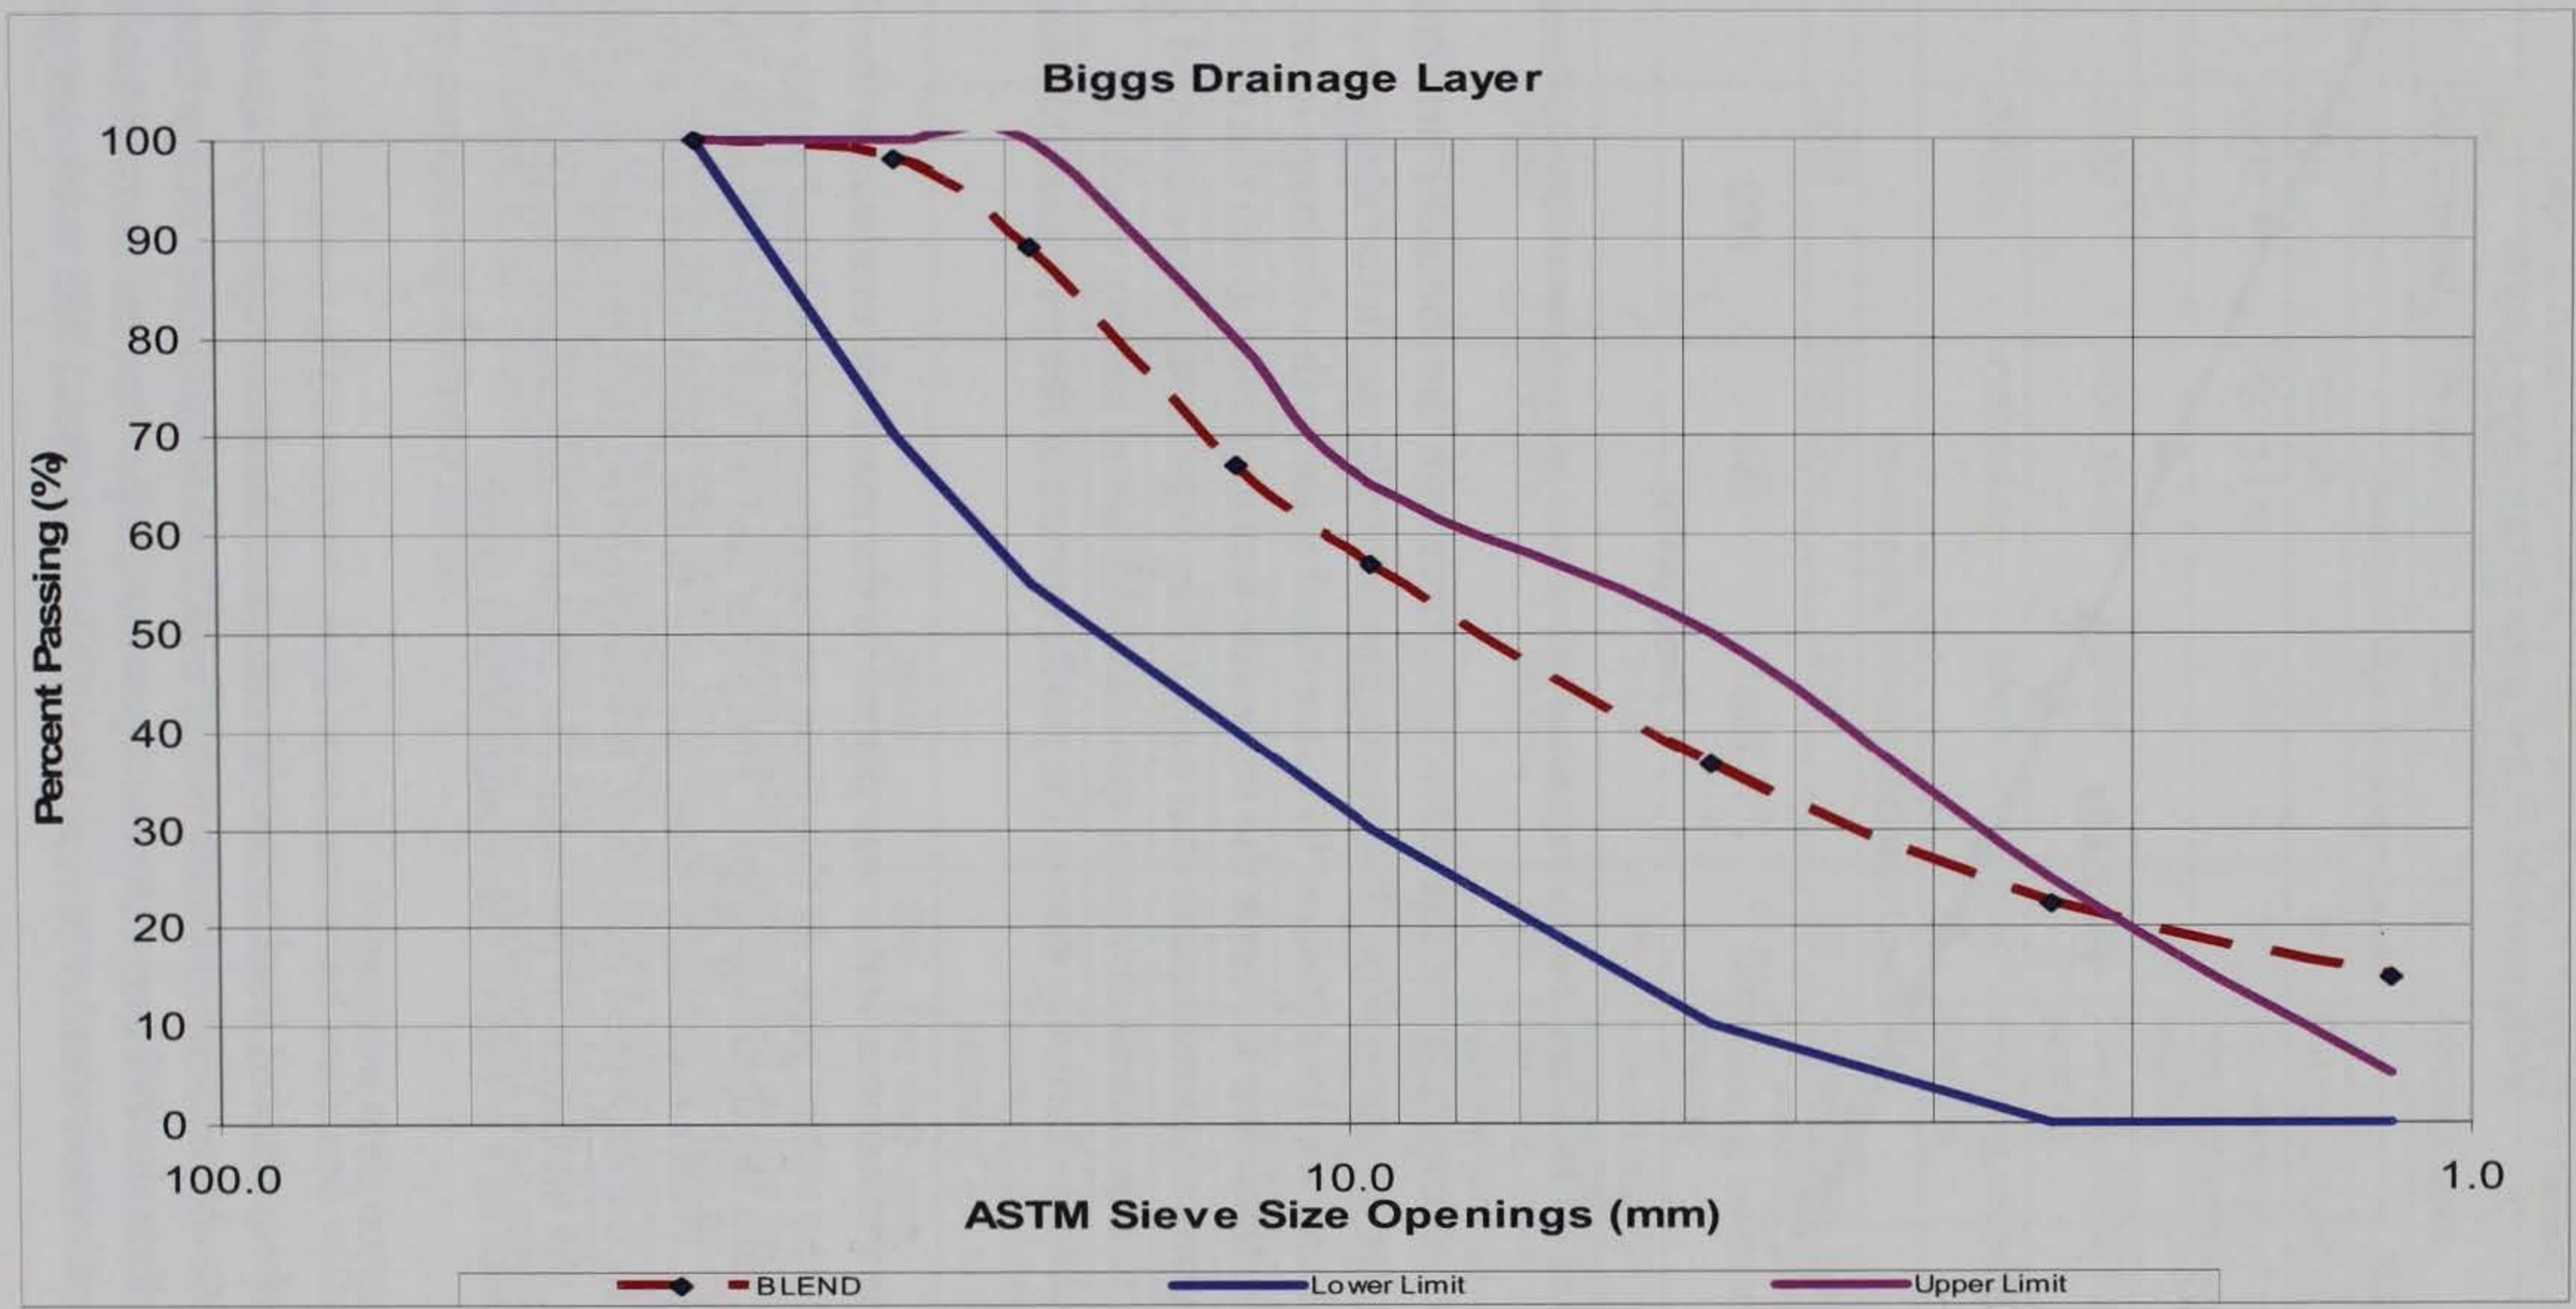
A total of 1,400 gal of water was placed underneath a small corner of the apron pavement with no observed flow through the drainage pipes. ERDC researchers decided to core an additional hole within 1 ft of the drainage pipe to attempt to induce flow. This core was taken in the shoulder pavement area. The location is labeled Core 4 in Figure 46. The asphalt concrete surface was 2.75 in. thick. Beneath was a material similar to the drainage layer. The material was disturbed with a metal rod and removed to a total depth of 24 in. Drilling beneath this depth contacted subgrade soil. Water was placed in the hole until the level reached that of the AC surface. After 5 min, no visible evidence of drainage was observed. The base material beneath the AC shoulder pavement did not have sufficient permeability to promote flow.

Figure 48. Grain size distribution of drainage layer on DAACG Ramp and specification limits.
