Reformulation of the CBR Procedure

Report II: Design, Construction, and Behavior Under Traffic of the Pavement Test Sections

Carlos R. Gonzalez, Walter R. Barker,
and Alessandra Bianchini

December 2013

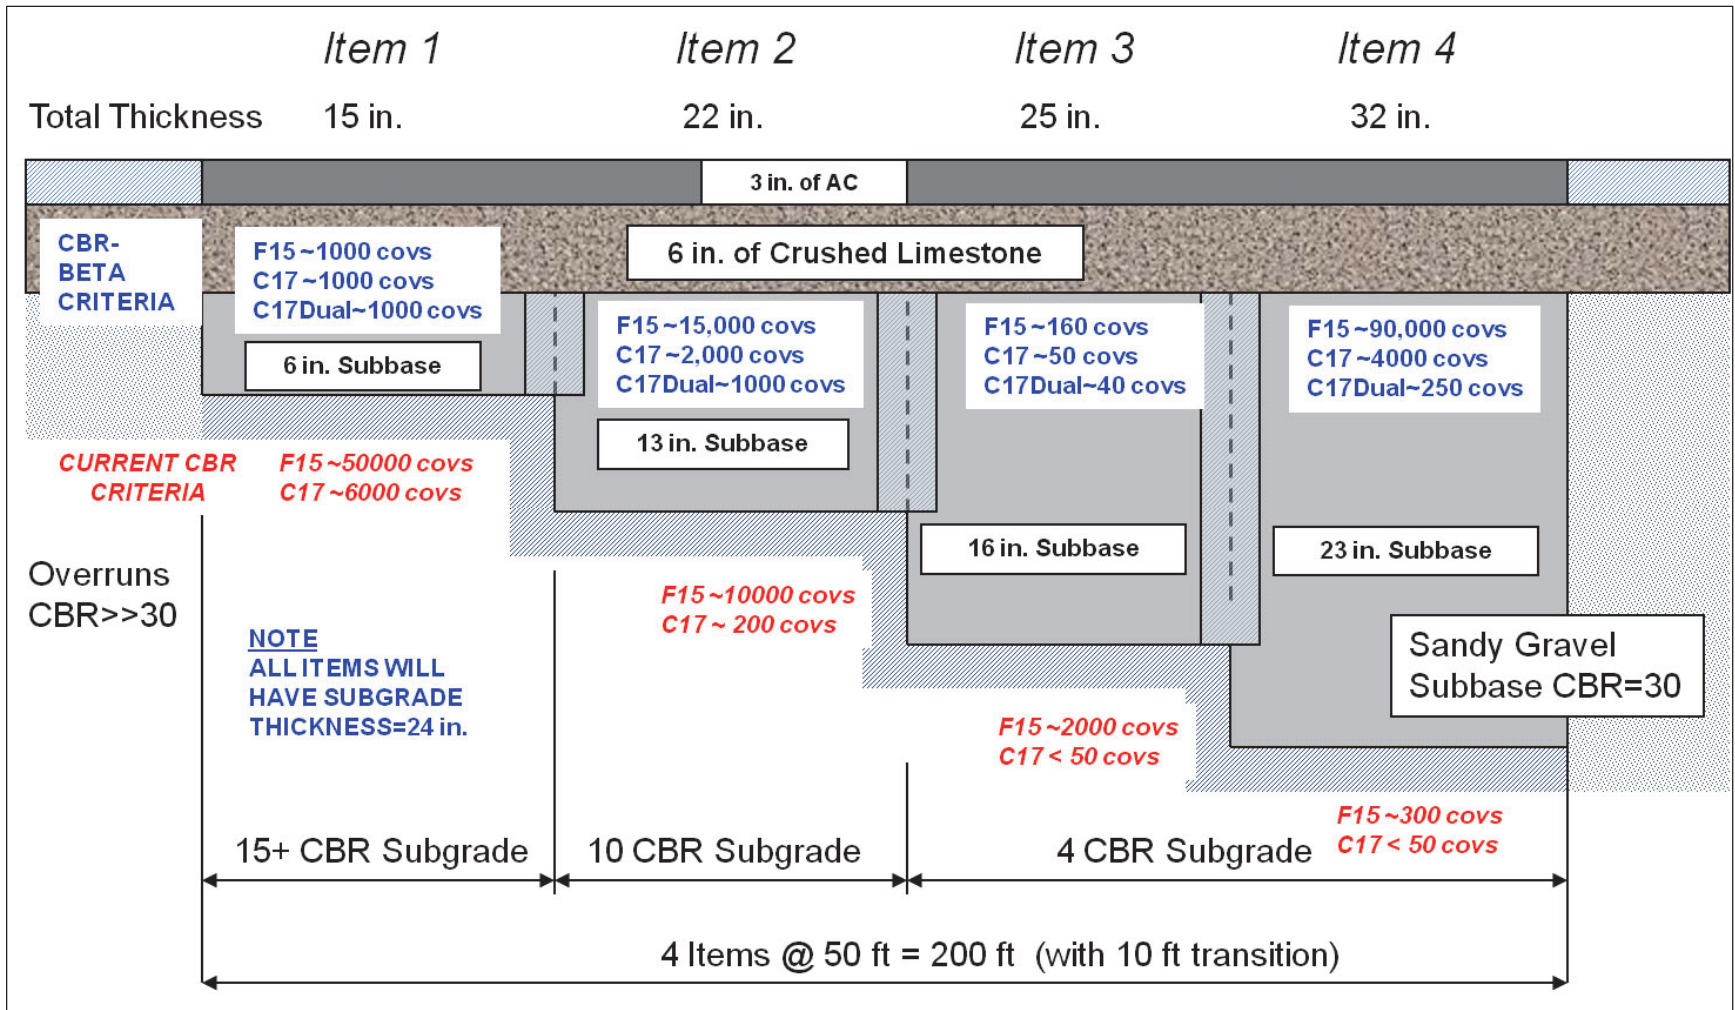
The coverage levels shown in Figure 1, and therefore the section thicknesses, were initially chosen to fill the gaps (represented by blue ovals in Figure 2) in terms of failure points in the Beta-coverages curve (Figure 2). Figure 1 shows the predicted coverages to failure computed with the CBR-Alpha (in red) and CBR-Beta (in blue) procedures, respectively.

Figure 1. Test section design details.

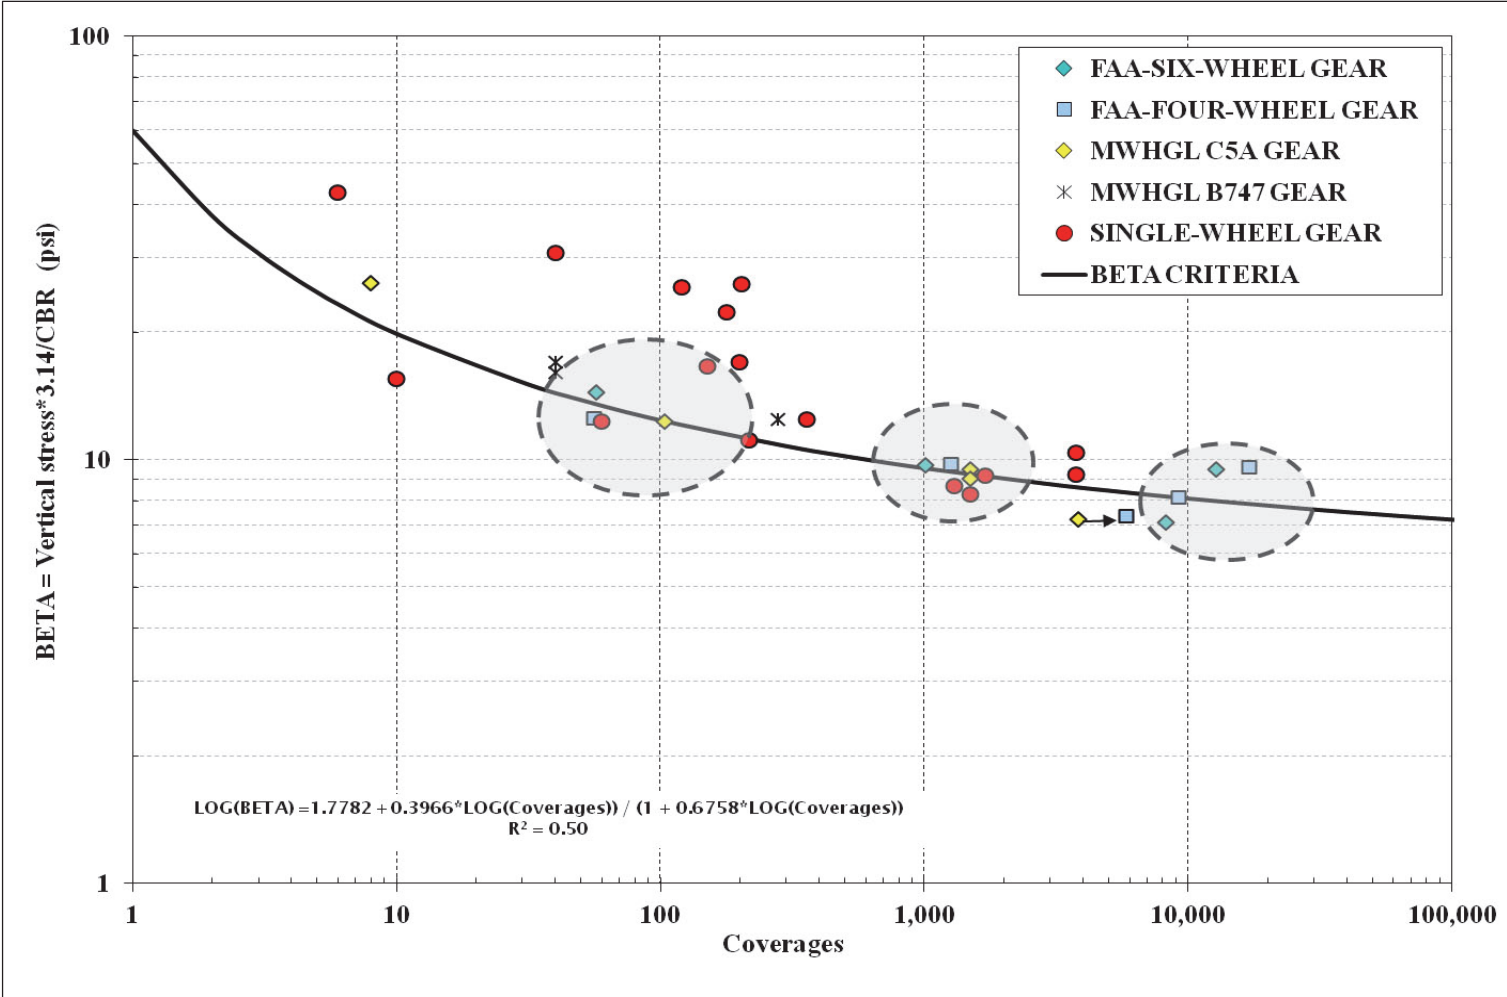
Figure 2. Beta-coverages curve and pavement failure data.

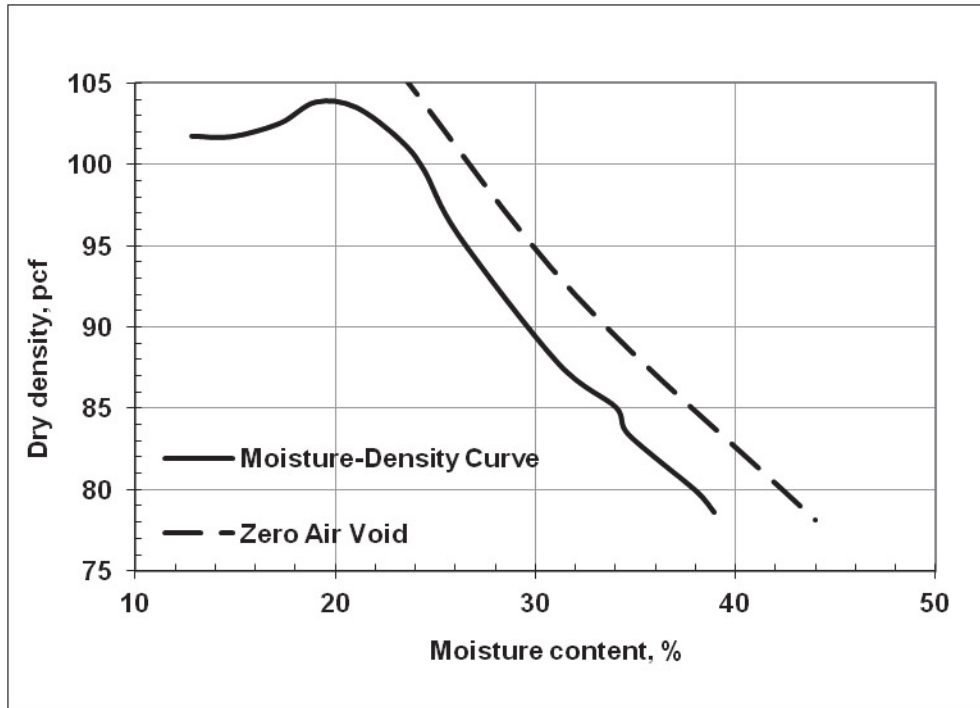
All test items were constructed over a compacted high-plasticity clay (Vicksburg Buckshot Clay) material. The material was extracted from a borrow pit located about 10 miles south of Vicksburg in the floodplain of the Mississippi River. The soil had a Liquid Limit (LL) of 79 and Plasticity Index (PI) of 51, and was classified as high-plasticity clay (CH). The soil’s specific gravity was 2.74. The soil gradation curve is contained in Figure 6. The results from laboratory compaction, according to modified Proctor ASTM D1557, are summarized in Figure 7, which shows the clay moisture-density curve.

Figure 7. Subgrade moisture-density curve.

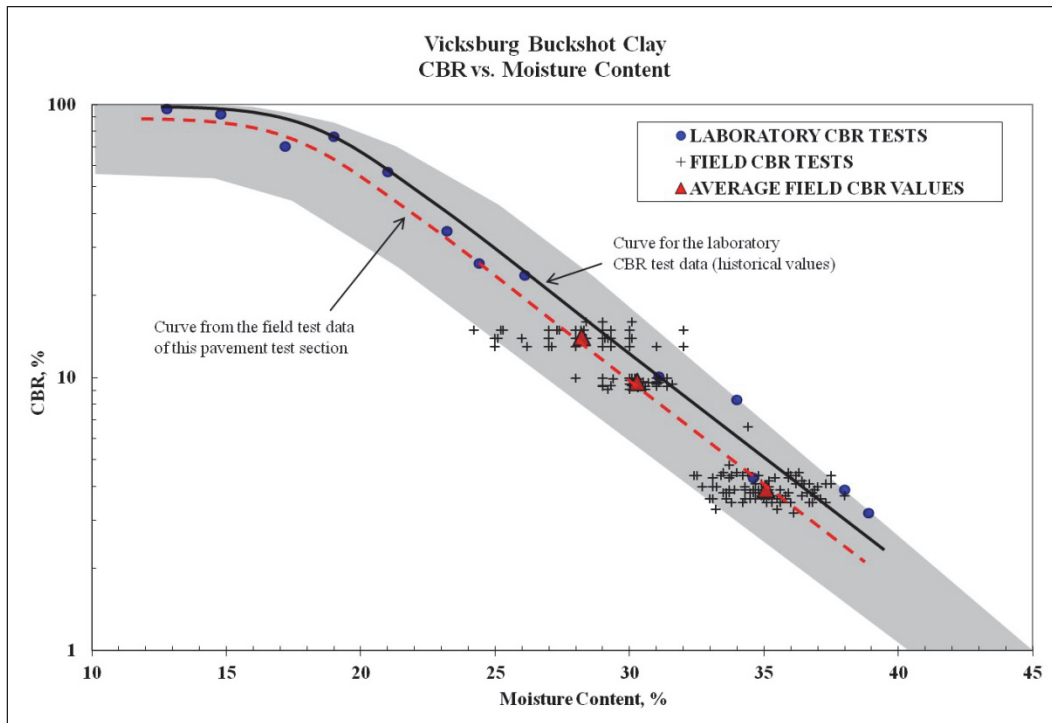
The design subgrade CBR values selected for the test section construction were 4%, 10%, and 15%. The high plasticity clay moisture content required to achieve these CBR values was determined from moisture content versus CBR relationship (Figure 8) developed at ERDC from historical field and laboratory test data. After placement of the subgrade material, undisturbed samples were obtained to conduct laboratory triaxial compression testing.

Figure 8. Subgrade CBR-moisture content curve and CBR field test results.

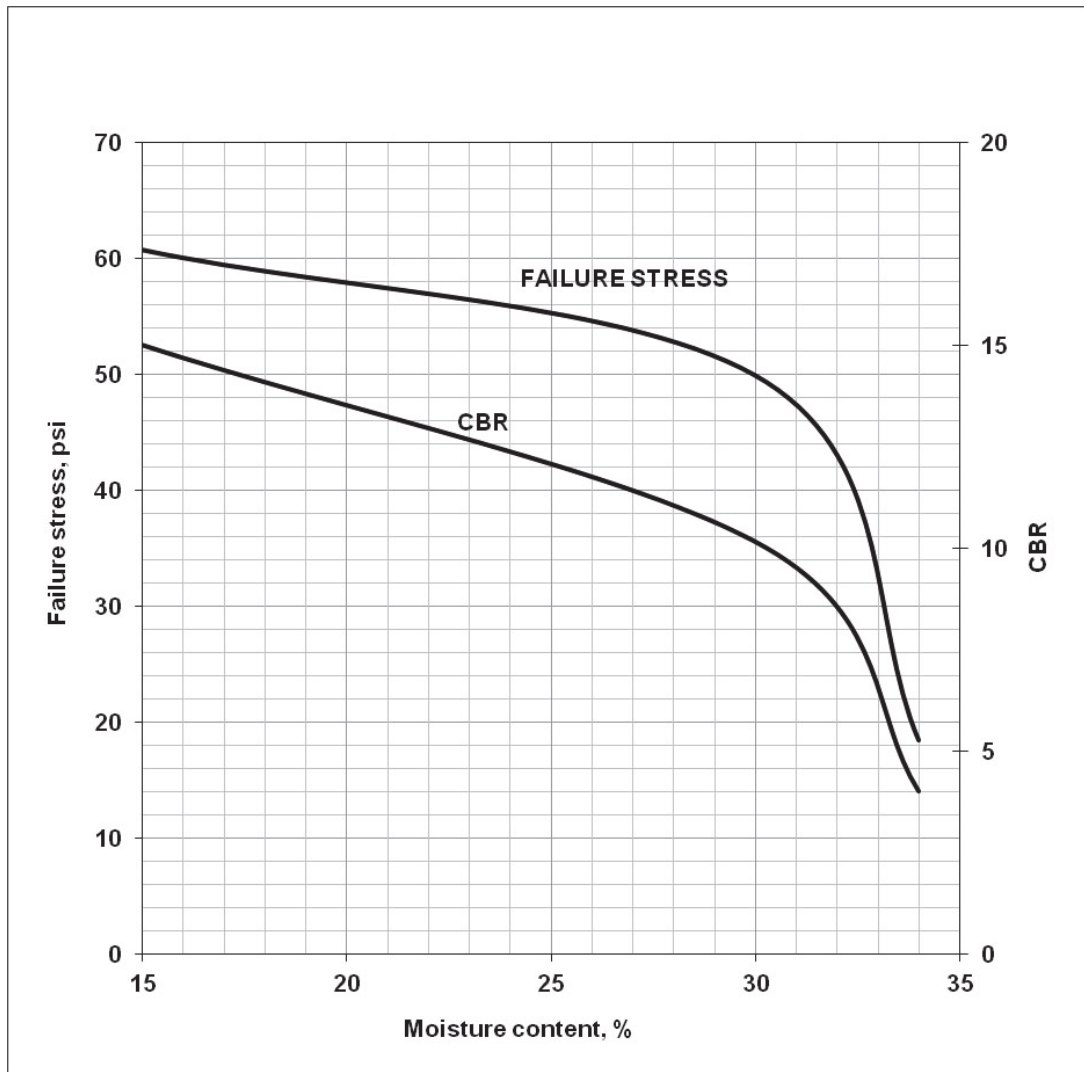
Figure 9. Relationships between subgrade material moisture content, CBR, and failure stress.

The subgrade material was processed at a facility next to Hangar 4 before its placement. Material processing consisted of spreading the clay in a uniform strip to a depth of approximately 12 in. and tilling the soil with a rotary mixer to break all material clumps and ensure uniformity. The subgrade design CBR for each test item was achieved by adding water or drying the CH material to the appropriate moisture content predicted from Figure 9. Figures 19 and 20 show the material processing.

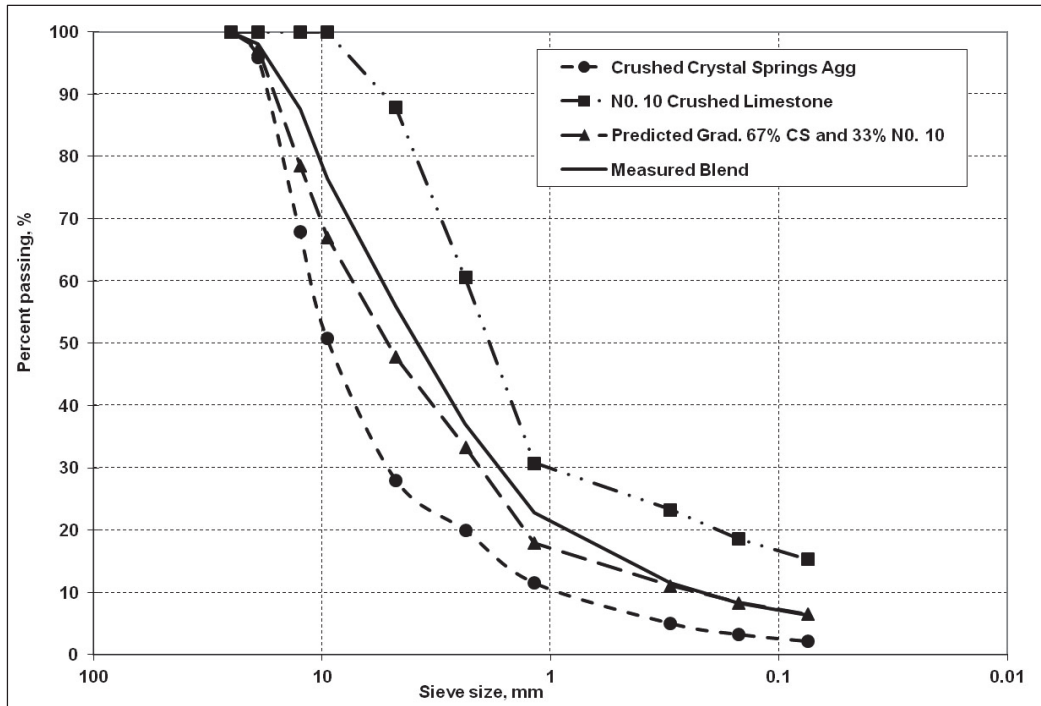
Figure 12. Subbase aggregate blend grain-size distributions.

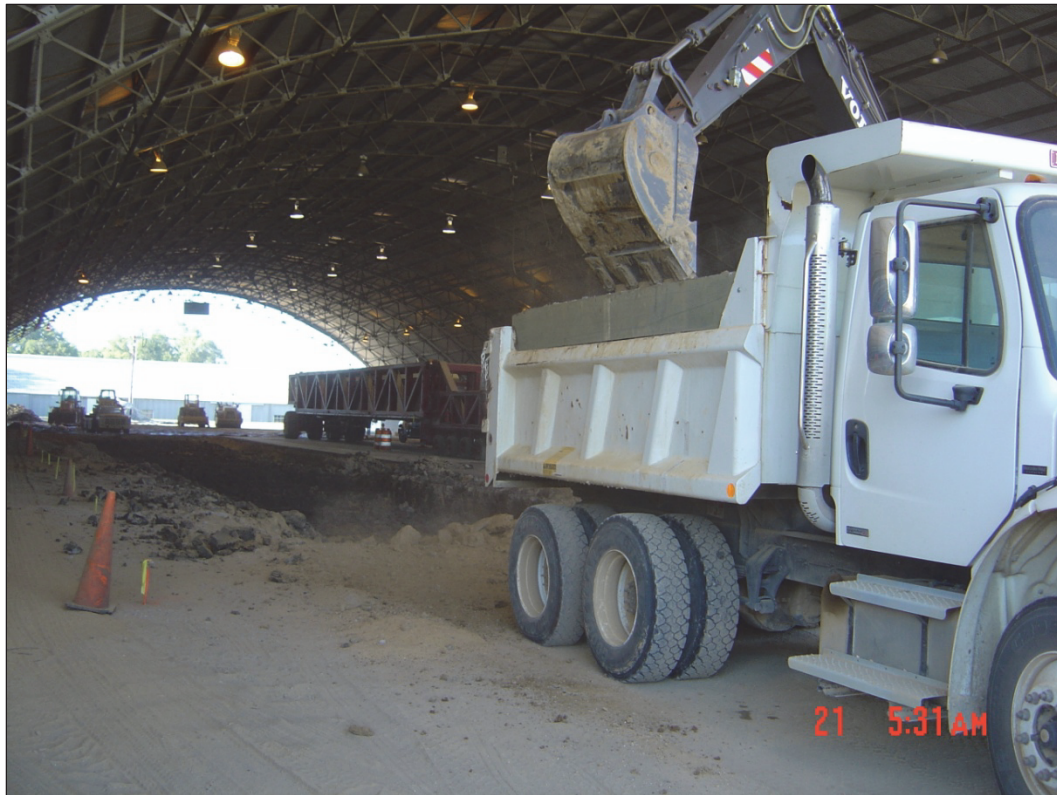
The CH material was placed and compacted in four lifts for the subgrade of Item 1. After placement of the CH material for Item 1, the CL fill was graded to the proper depth to allow placement of the CH subgrade for Item 2. The CH material was again placed and compacted in four lifts over a plastic moisture barrier. For Items 3 and 4, the CL layer was graded to the proper elevation to allow the placement of the CH material layer. A lift of CH material was first placed in Item 4, followed by subsequent lifts for both Items 3 and 4, which were placed at the same time to obtain a total layer thickness of 2 ft of CH material. Figure 17 shows a schematic final profile of the CL and CH layers that were constructed for this test section. Figure 18 shows the test section excavation.

Figure 18. Test section excavation.

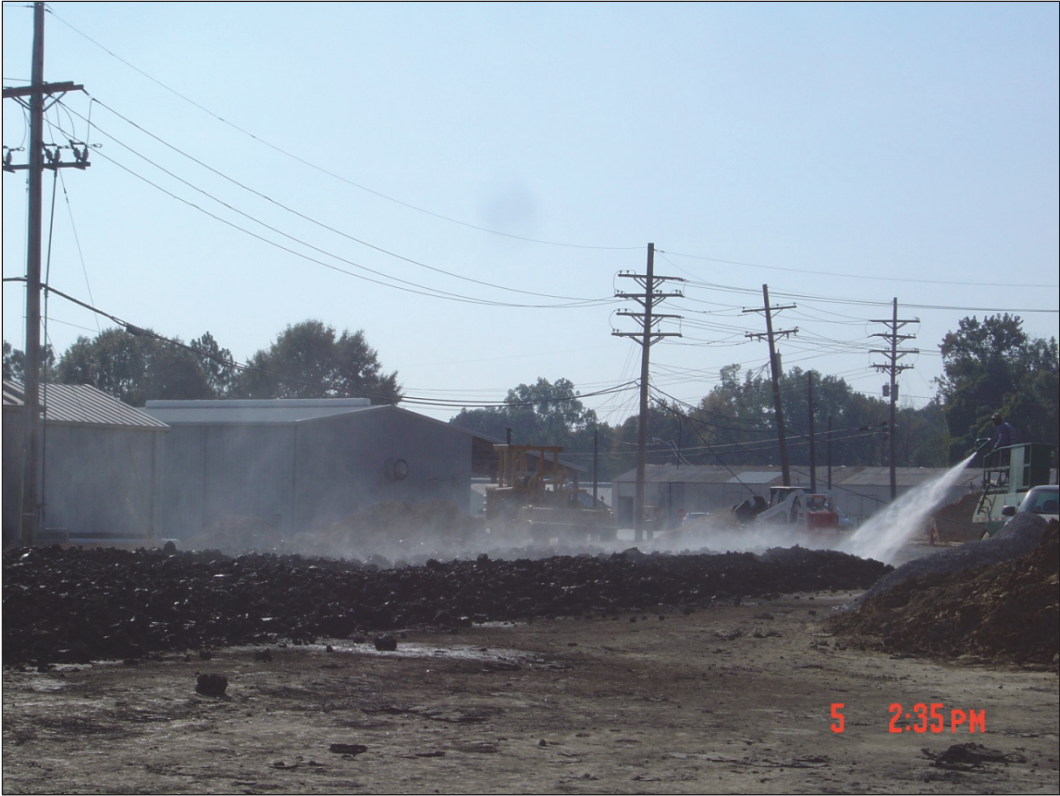
Figure 19. Adding water to the subgrade material.

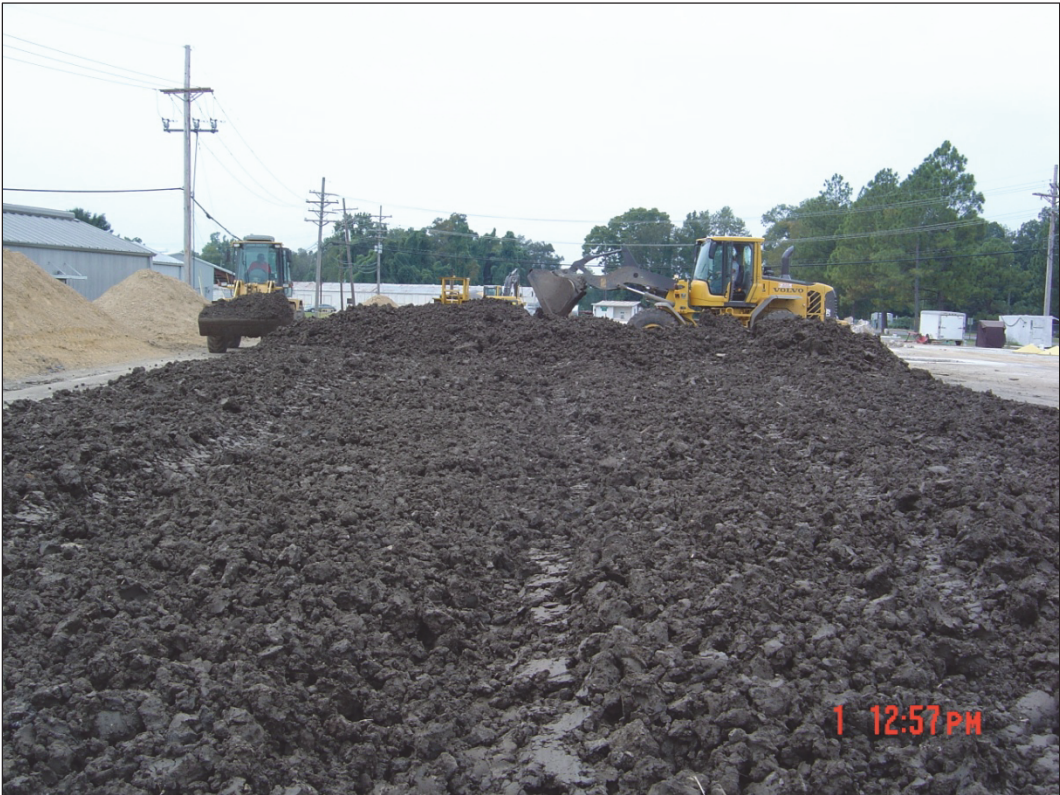
Figure 20. Subgrade material processing.

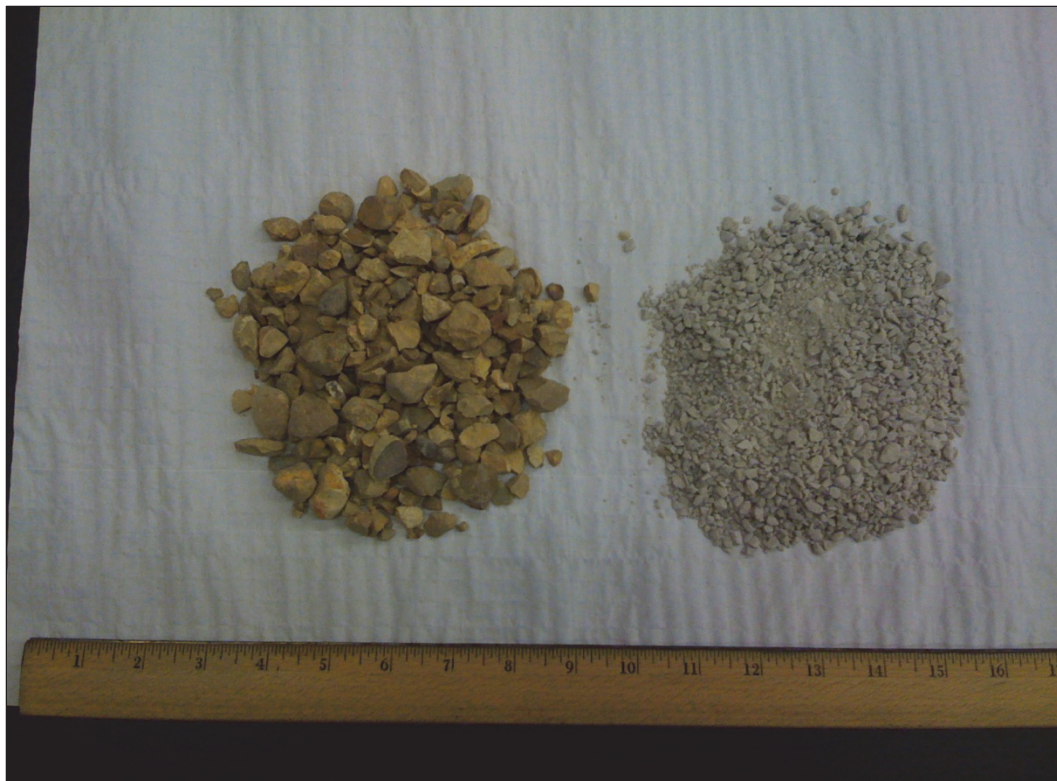
The subbase material, a blended mix of 67% crushed aggregate (Figure 23, left) and 33% No. 10 crushed limestone (Figure 23, right), was placed in lifts to total thicknesses of 7 to 23 in. to achieve the required design thicknesses. The subbase material was delivered by dump trucks and placed in 5- to 7-in.-thick lifts. Each lift was compacted by 22 passes of a vibratory steel-wheel roller. Target moisture content to achieve 100% modified Proctor compaction was 3.5%. During compaction, the subbase material was kept moist by sprinkling each lift with water prior to each pass of the vibratory roller. Figures 24 and 25 show stockpiled subbase material and subbase construction activities, respectively.

Figure 23. Material included in the subbase blended mix: crushed aggregate (left) and crushed limestone (right).

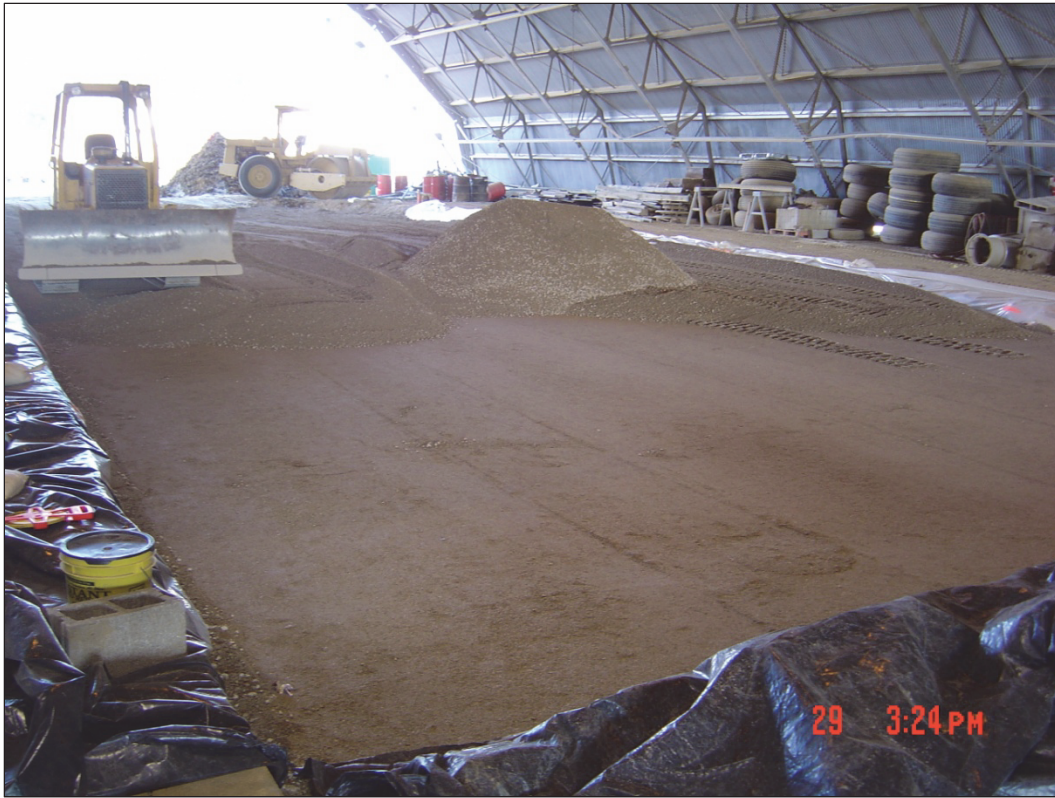
Figure 25. Subbase placement activities.

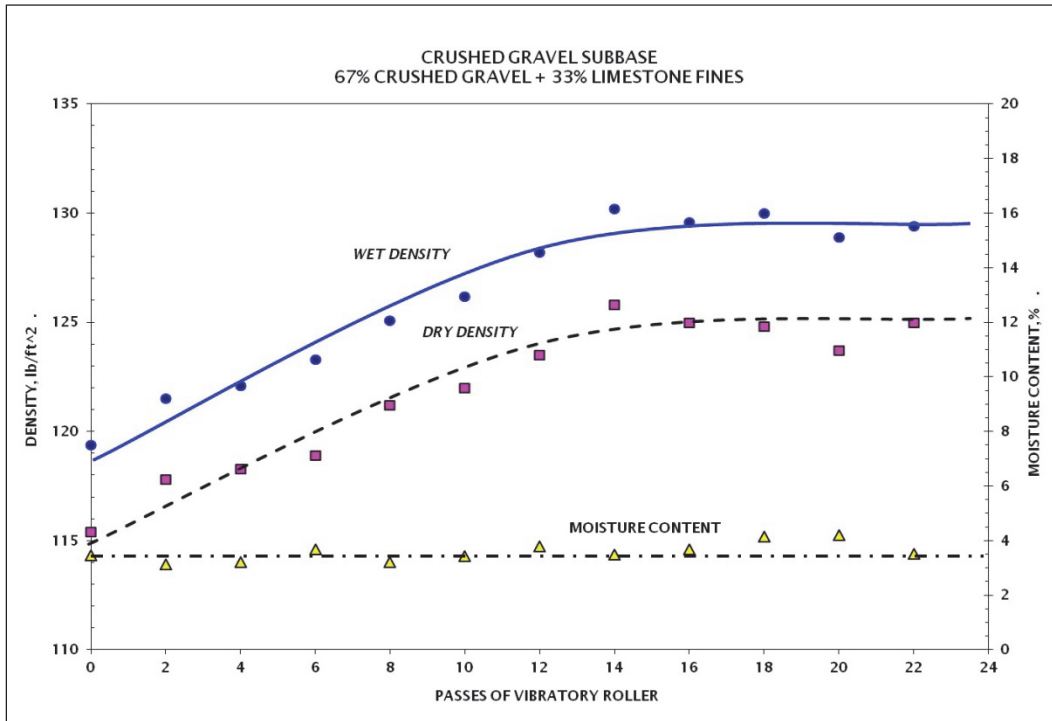
The dry density, wet density, and moisture content of the subbase material were monitored during compaction to determine at what pass level the material would achieve maximum density. A nuclear gauge was used to obtain measurements of density and moisture in accordance to ASTM D-6938-10. Maximum density was achieved after approximately 16 to 18 passes of the self-propelled vibratory steel roller. The moisture content remained constant at about 3.5% during placement. Figure 26 shows dry

Figure 26. Subbase material field characteristics.

density, wet density, and moisture content values as a function of the number of passes of the vibratory roller. Table 5 contains the measured values of density (wet and dry) and moisture content in relation to the number of passes of the vibratory roller. CBR tests were executed after placement and final compaction of the granular material. Table 6 contains the CBR test results for each test item.

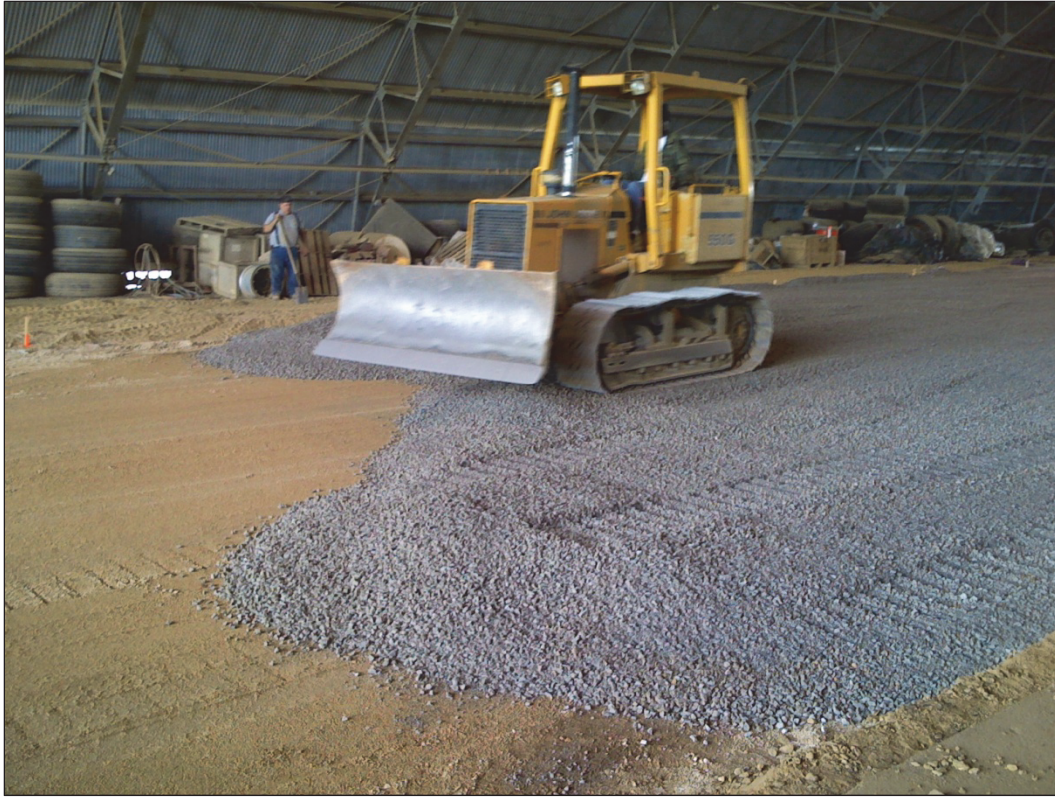
The base course was a 6-in.-thick layer of ASTM 568 crushed limestone. Figure 27 shows the placement process of base course material. The base lift was compacted by 16 passes of a self-propelled vibratory steel roller. Figure 28 shows dry density, wet density, and moisture content values as a function of the number of passes of the vibratory roller following the same procedure used for the subbase material. The base material achieved maximum density in about 10 passes of the vibratory roller. Moisture content remained constant at approximately 3% during placement. Table 7 contains the measured values of density (wet and dry) and moisture content in relation to the number of passes of the vibratory roller. CBR tests were executed after placement and final compaction of the granular material. Table 8 contains the CBR test results for each test item.

Figure 27. Base layer placement.

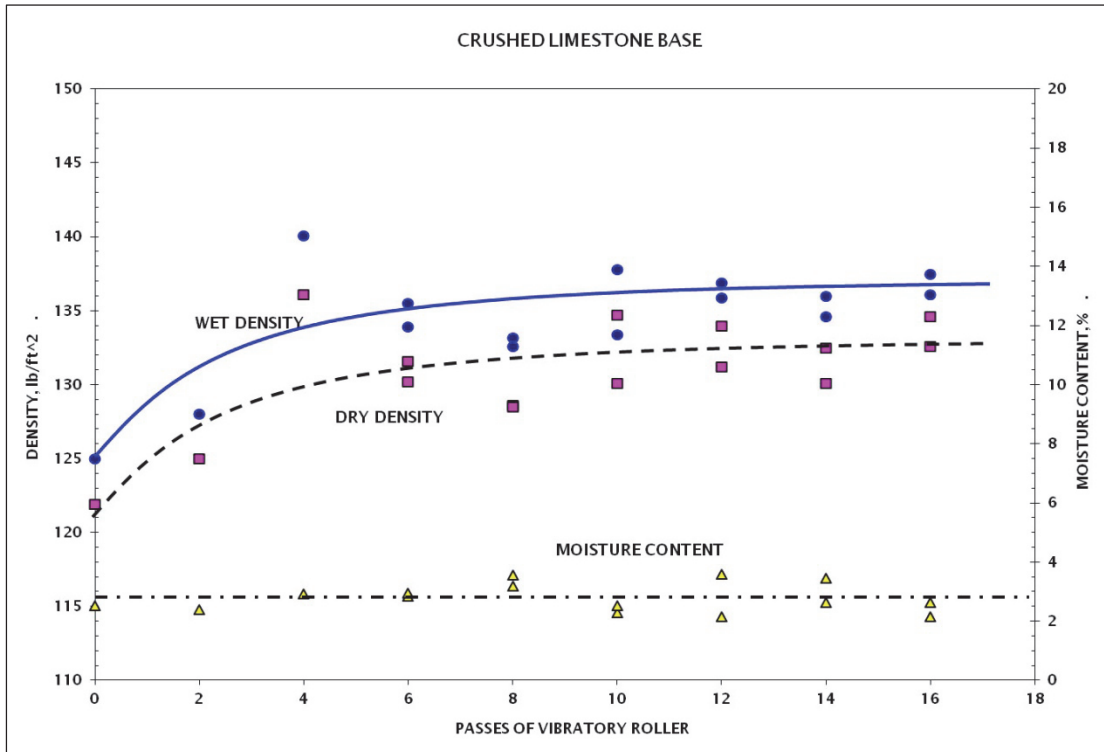
Figure 28. Base material field compaction characteristics.

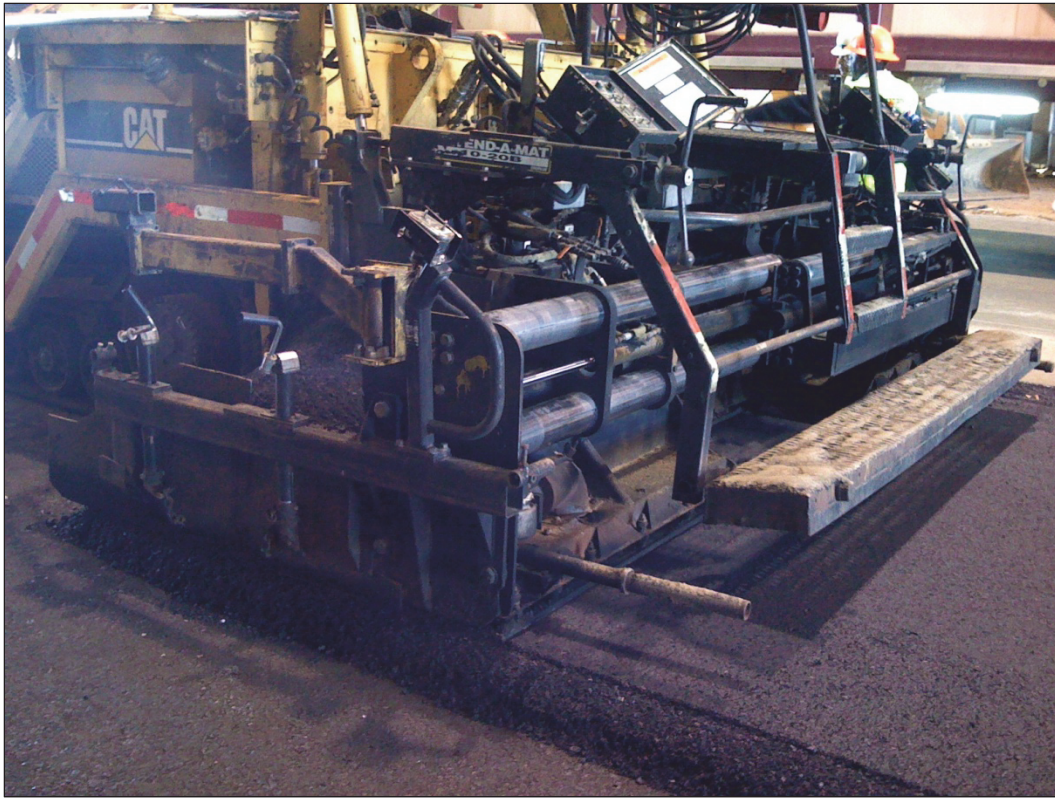
Figure 29. Paving operations, mat placement.

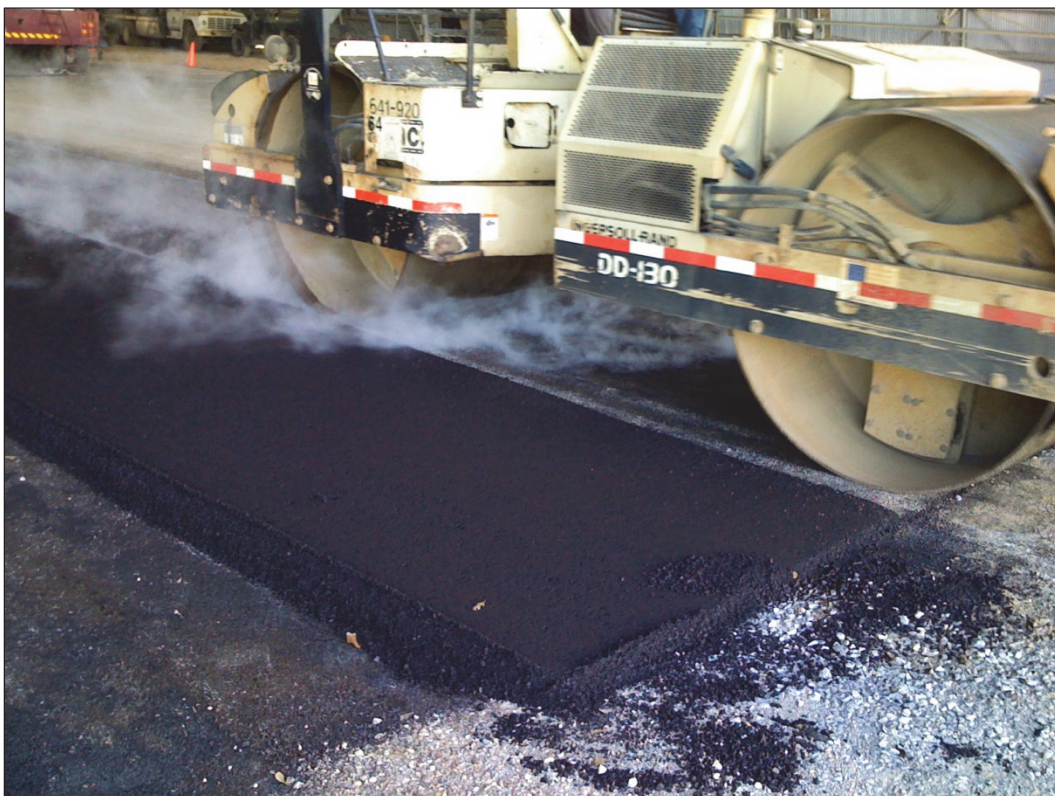
Figure 30. Paving operations, break-down rolling.

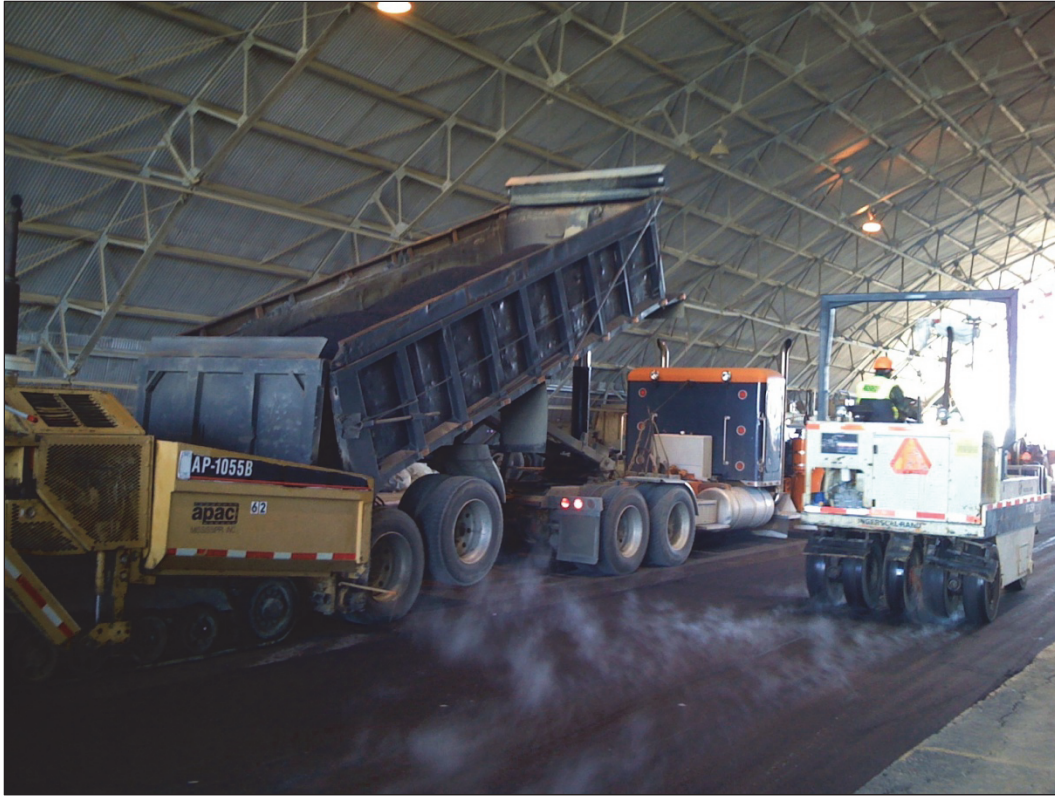
Figure 31. Paving operations, rubber-tire roller compaction.

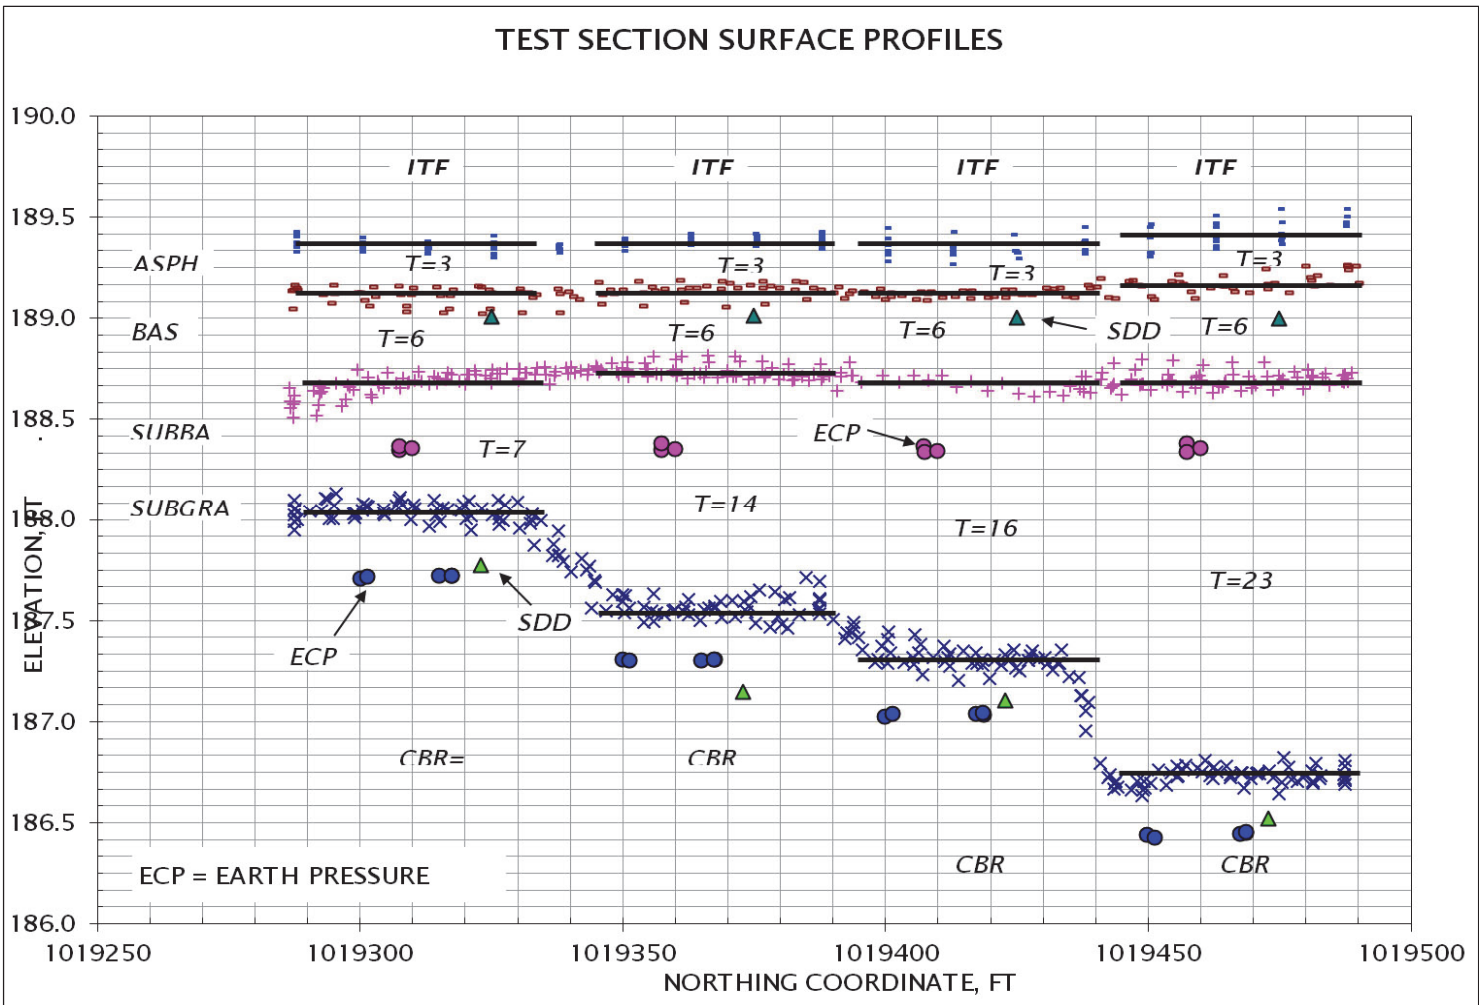
Figure 33. Elevation data for each layer and sensor location.

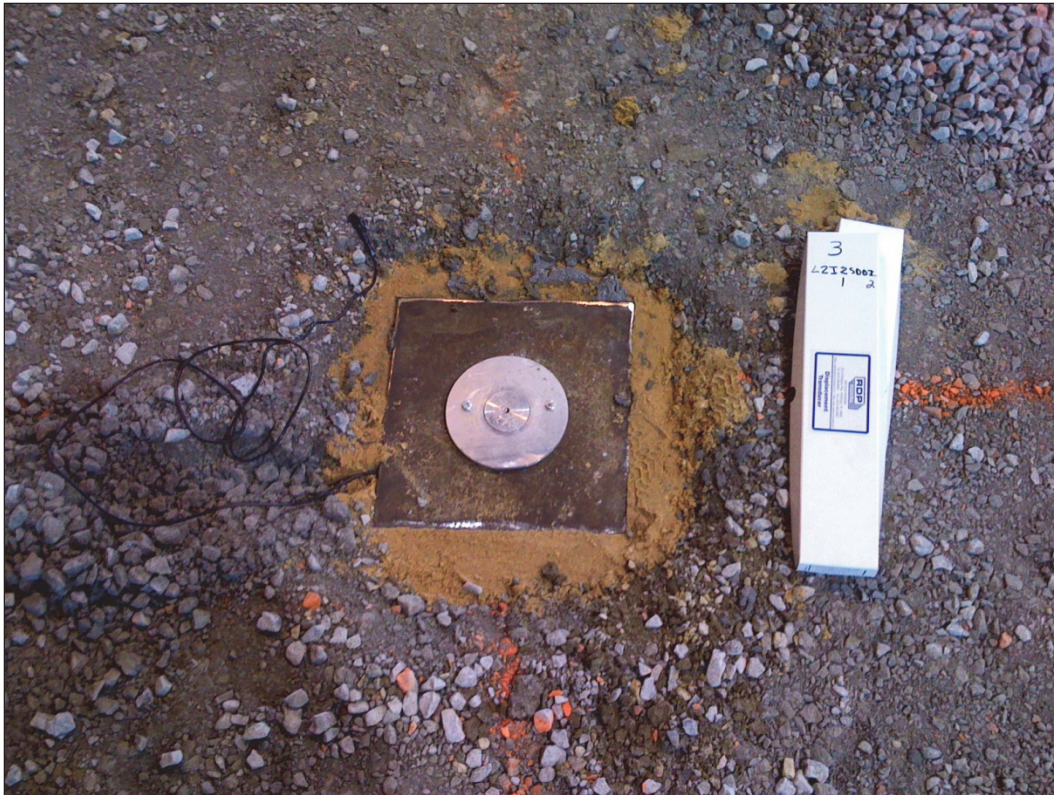
Figure 36. SDD after installation.

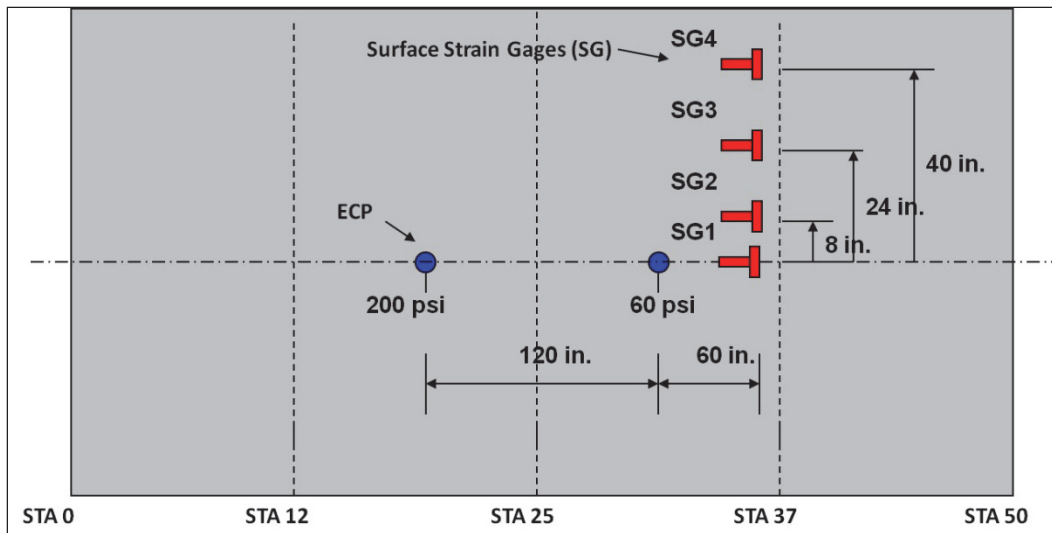
Eight surface strain gauges were positioned on Lane 1, Item 4: four were parallel to traffic and four were transverse to traffic. Figure 37 shows the position of the gauges on the pavement surface. The 2-in.-long gauges were manufactured by Vishay, Precision Group, Wendell, North Carolina. The strain gauges were serviceable only during the rolling tests prior to trafficking the lane item. The impact of the high pressure tire moving over the gauges limited gauge functionality.

Figure 37. Strain gauge locations on Lane 1 Item 4.

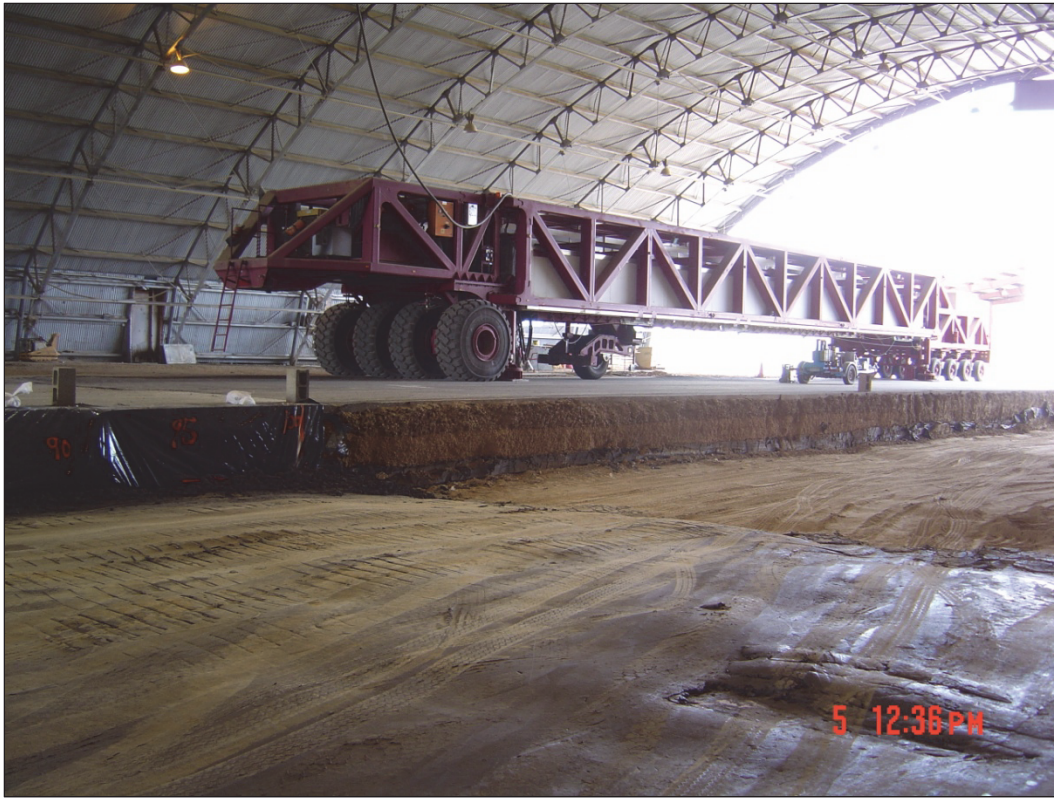
Figure 38. Heavy Vehicle Simulator (HVS-A) used for traffic testing.

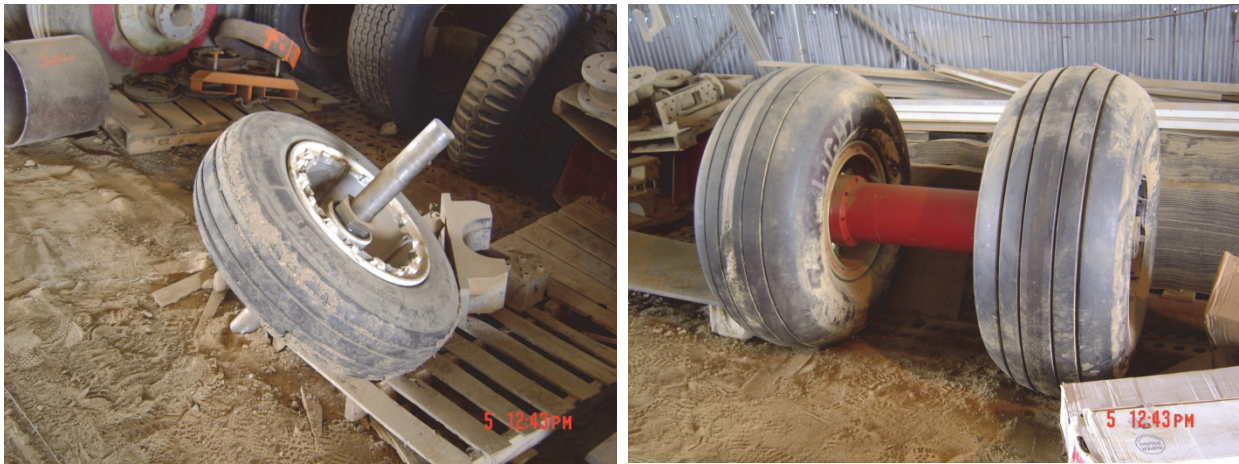
items. The test section was divided into three traffic lanes to apply traffic with the F-15E single tire, the C-17 single tire, and the C-17 dual-tire gear. The nominal widths were 5 ft, 10 ft, and 5 ft for traffic lanes 1, 2, and 3, respectively, with 5 ft of buffer strip between each lane and a 5-ft clearance at each end of the test section. Figures 5 and 39 show the section layout with an indication of the traffic lanes. Figure 40 shows the single- and dual-tire assemblies used for the testing.

Figure 40. Single F-15E gear (left) and dual C-17 gear (right) tire assemblies.

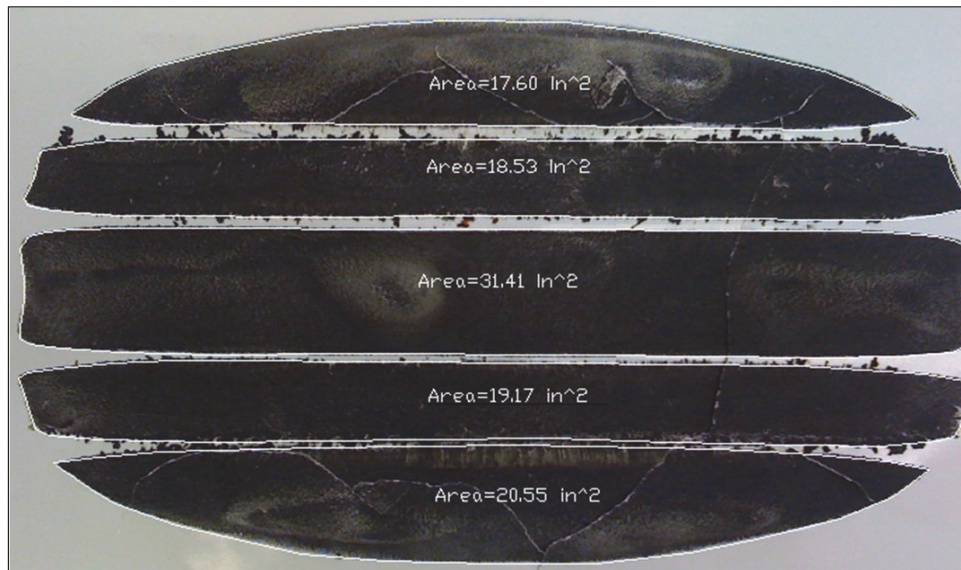
Lane 3 was trafficked with the F-15 tire. The tire was loaded to 35,235 lb with an internal tire pressure of 325 psi. This loading and tire pressure yielded a computed contact area of 108 in². The measured contact area had a width of 8.8 in. and a length of 15 in. The computed area, based on the assumption of an elliptical shape, was 104 in². The contact area for this tire was slightly squarer than an ellipse; thus, the computed elliptical area would be slightly lower than the actual contact area (Figure 41). Nevertheless, it was concluded that the approach of using the tire load and tire pressure to compute an elliptic contact area was sufficiently accurate for design and evaluation.

Figure 41. F-15 tire imprint.
