Reformulation of the CBR Procedure

Report II: Design, Construction, and Behavior Under Traffic of the Pavement Test Sections

Carlos R. Gonzalez, Walter R. Barker,
and Alessandra Bianchini

December 2013

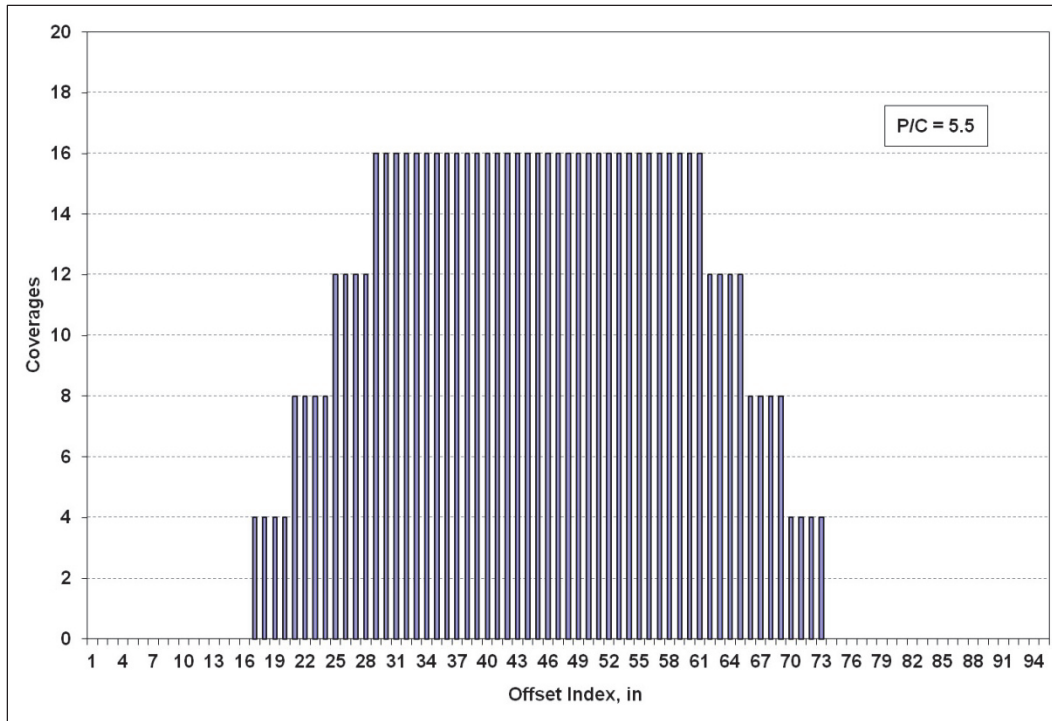
For each lane, the trafficking was applied in a laterally distributed pattern. A pattern is a completely repeatable set of tire or gear movements across a pavement. For Lane 3, the traffic pattern was over a lateral wander width of 4 ft and bidirectional in the longitudinal direction. The 4-ft wander width resulted in a 64.8-in. width of pavement being trafficked. The traffic pattern began with the tire located at one corner of the traffic lane. Four longitudinal passes were made along the first tire path. After completion of the four passes, the tire was moved laterally 8 in. The process was repeated until the carriage reached the opposite side of the traffic lane. The sweep across the traffic lane resulted in seven wheel paths (28 tire passes), which resulted in four coverages for 100% of the traffic lane. After reaching the opposite side of the traffic lane, the tire was lifted and moved laterally 4 in. (1/2 of a wheel path) back toward the beginning side to establish the beginning of the second sweep. The second sweep was one wheel path less than the previous sweep and included six wheel paths. This sweep resulted in an additional four coverages for the center 48.8 in. of the traffic lane. The process of moving the tire laterally 4 in. toward the center area, narrowing the trafficked area at every sweep, was repeated to obtain sweeps of five and four wheel paths. The completion of the sweep for the four wheel paths completed the traffic pattern and resulted in a total of 88 passes for 16 coverages over the center 40.8 in. of the traffic lane. Since the 88 passes resulted in 16 coverages, the pass-to-coverage ratio for the traffic pattern was 5.5. Figure 42 shows a graphical depiction of the traffic pattern used for the single-tire F-15 traffic lane.

Figure 42. Normally distributed traffic pattern for the F-15 single tire.

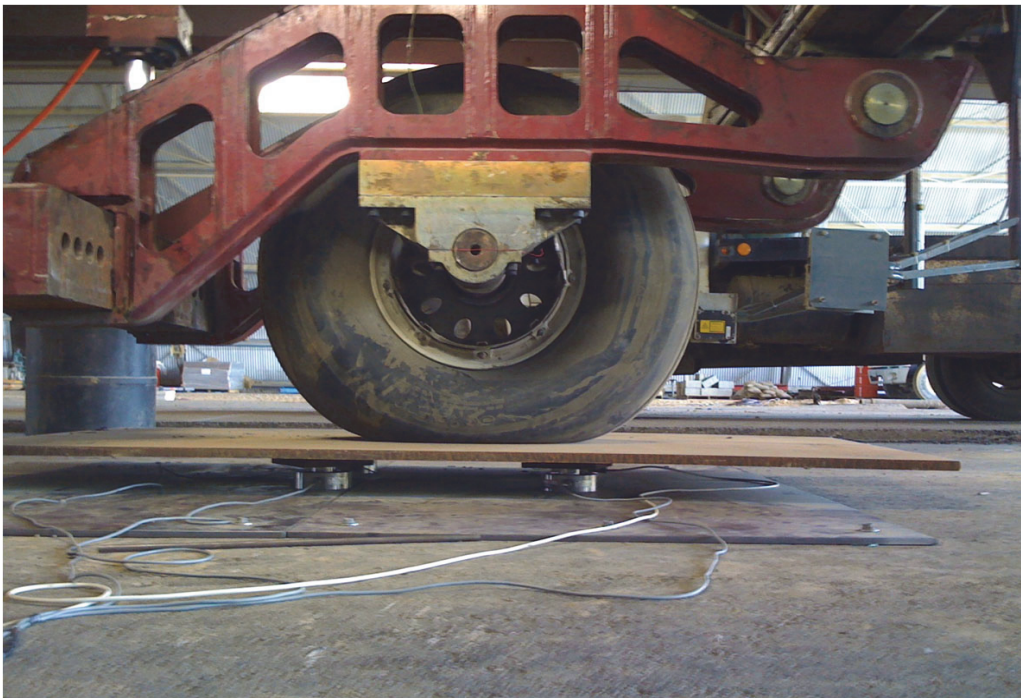
The HVS-A was calibrated prior to traffic to ensure the correct loading was applied (Figure 46). The HVS-A applies the load through a hydraulic ram and lever arm system.

Figure 46. HVS-A calibration.

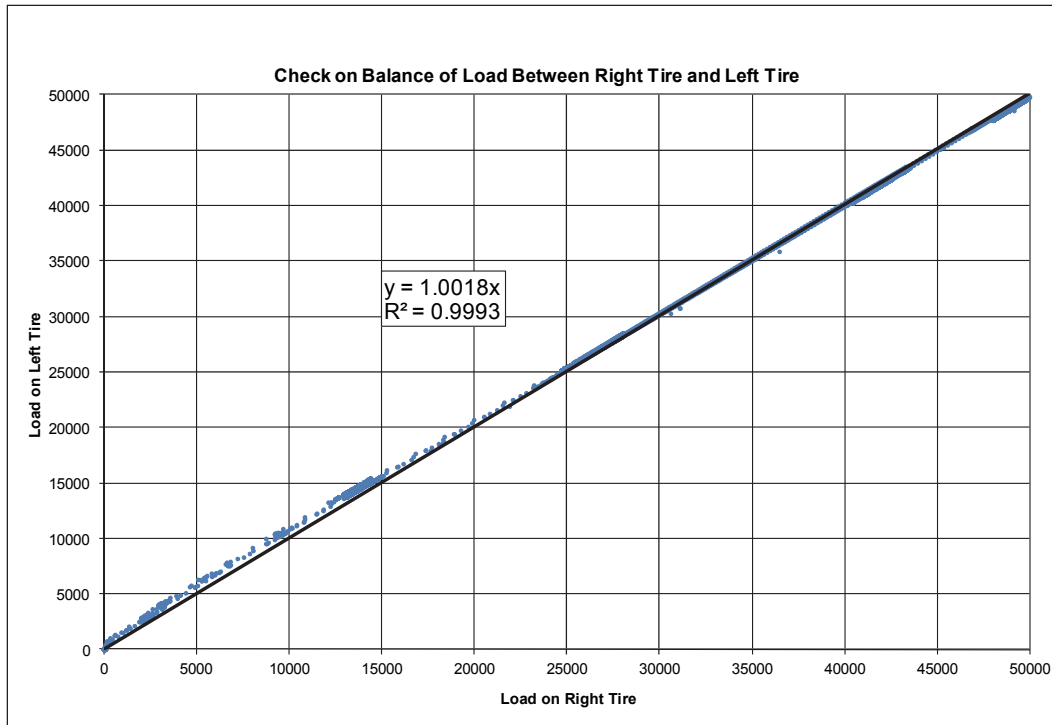
For the C-17 tire, four load cells were arranged such that two cells measured the load on the left tire, and two cells measured the load on the right tire. This load cell arrangement allowed verification of the load distribution between the tires. Figure 50 shows the calibration results to verify that the load applied to the dual tires was evenly distributed between the two tires. Figures 51 and 52 illustrate the data used for calibrating the strain gauges attached to the carriage and to the axles. Figure 53 shows the strain gauge arrangement on the carriage. With this gauge setting and calibration procedure, it was possible to measure the load applied to the pavement as the wheel traversed the test section. Figure 54 shows the HVS-A final calibration correlated to the HVS-A load setting.

Figure 50. Load balance check between the C-17 dual tires.

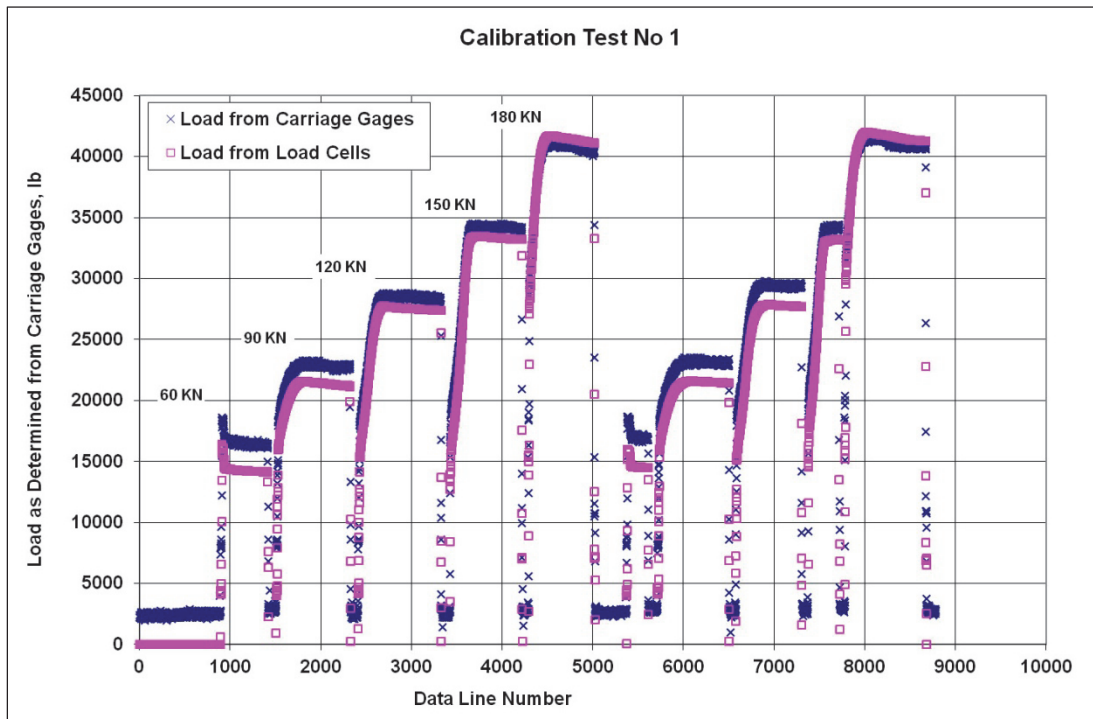
Figure 51. Load check for HVS-A carriage and axle.

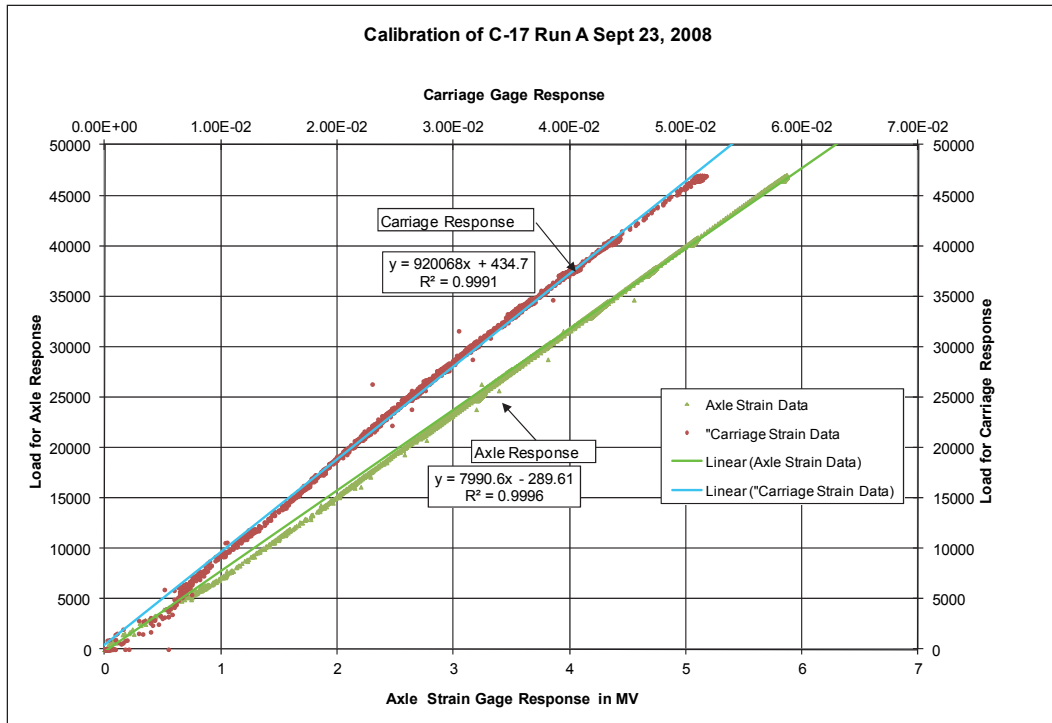
Figure 52. Carriage and axle load responses.

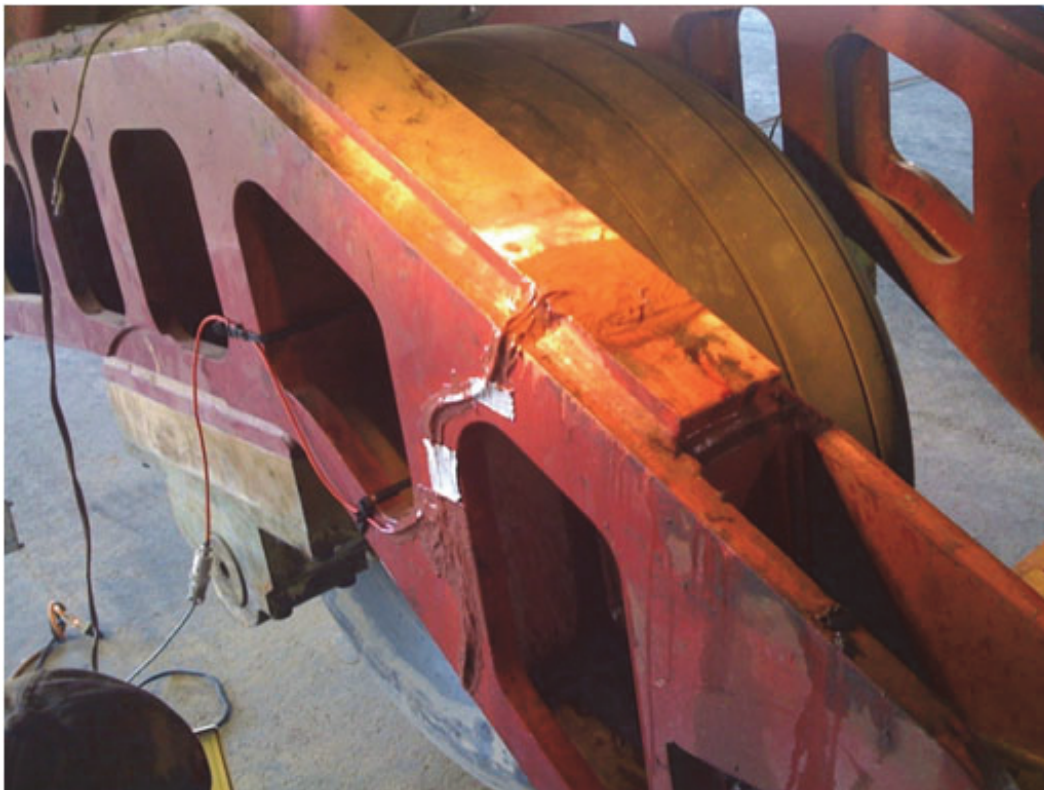
Figure 53. Carriage strain gauge arrangement.

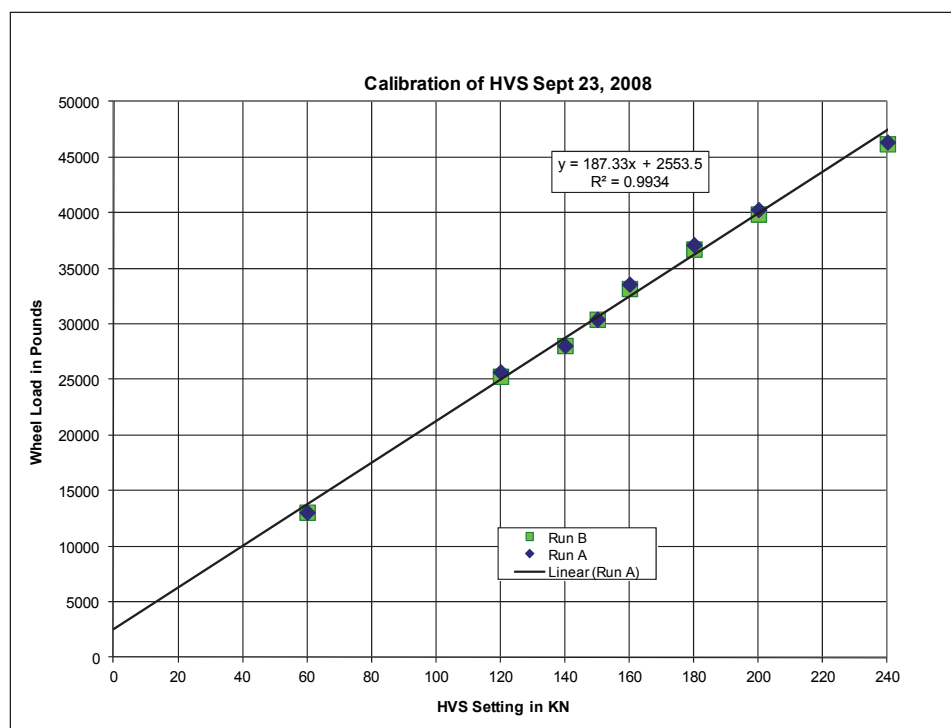
Figure 54. HVS-A load calibration.

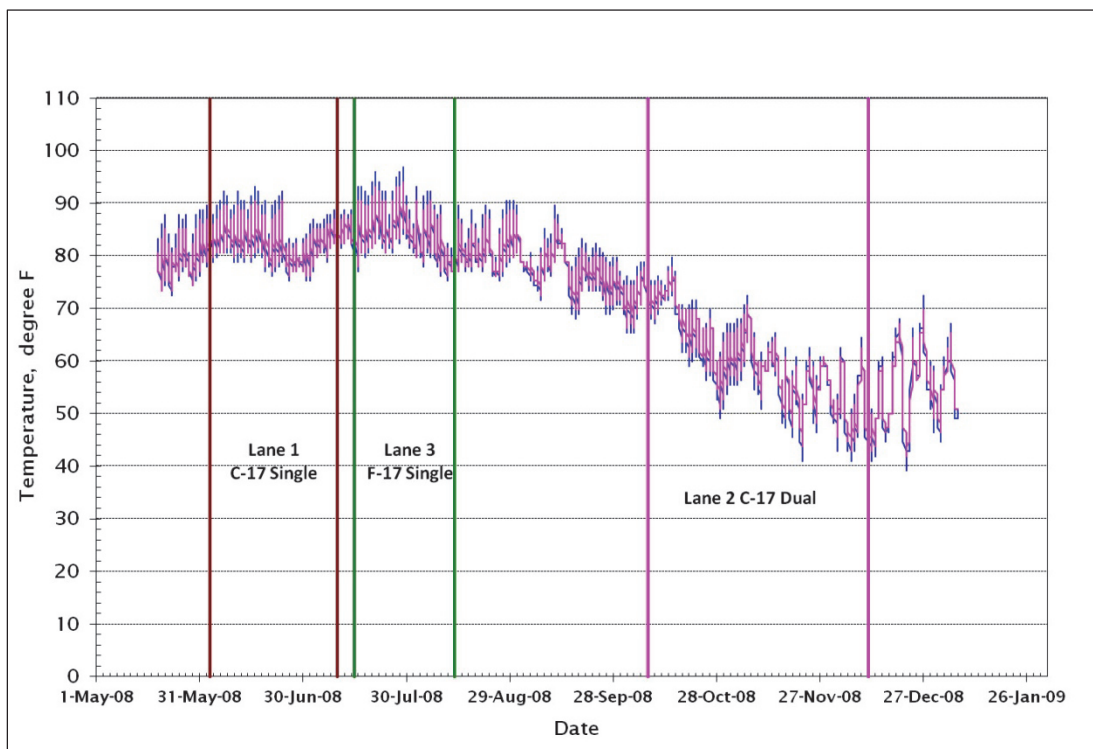
Figure 55. Pavement temperature recording during traffic.

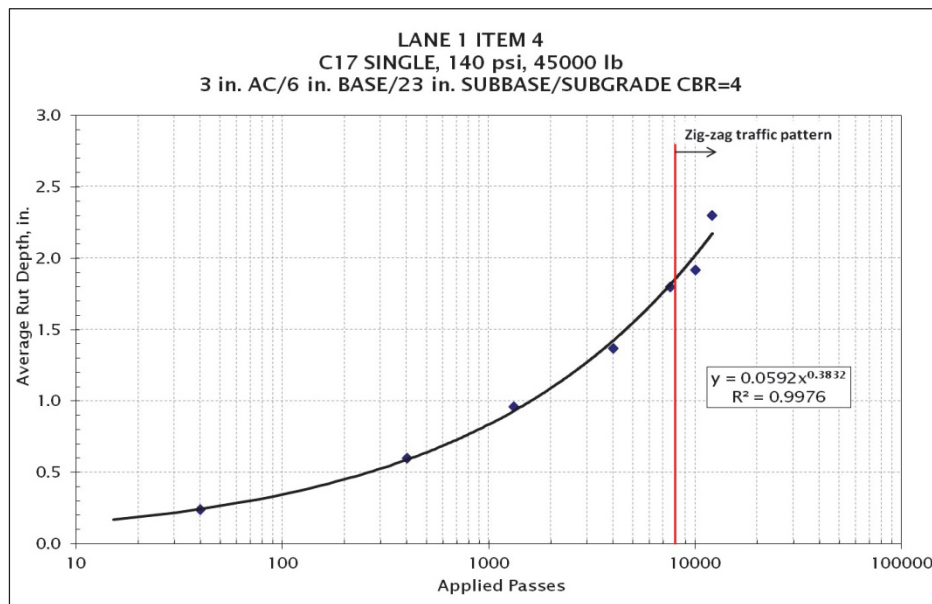
The first crack on the asphalt surface appeared after a total of 1,720 passes; the crack was less than 1/16 in. wide. After 4,143 passes, the crack had not propagated any further and had not gotten any wider. After 6,456 passes, new cracks had appeared on the surface, and the very first crack had propagated. On June 13, due to an HVS-A malfunction in lifting the tire for repositioning, a zigzag traffic pattern was applied in order to complete traffic testing on the lane item and to limit testing delays (data not included in Table 11). The P/C ratio for this pattern was 2.412. Since the applied passes were already in the order of the thousands, the change in the traffic pattern did not seem to have any influence on the permanent deformation (rutting) of the pavement section. Figure 56 summarizes the rutting development as a function of the number of total passes applied to Lane 1 Item 4.

Figure 56. Rutting development on Lane 1 Item 4.

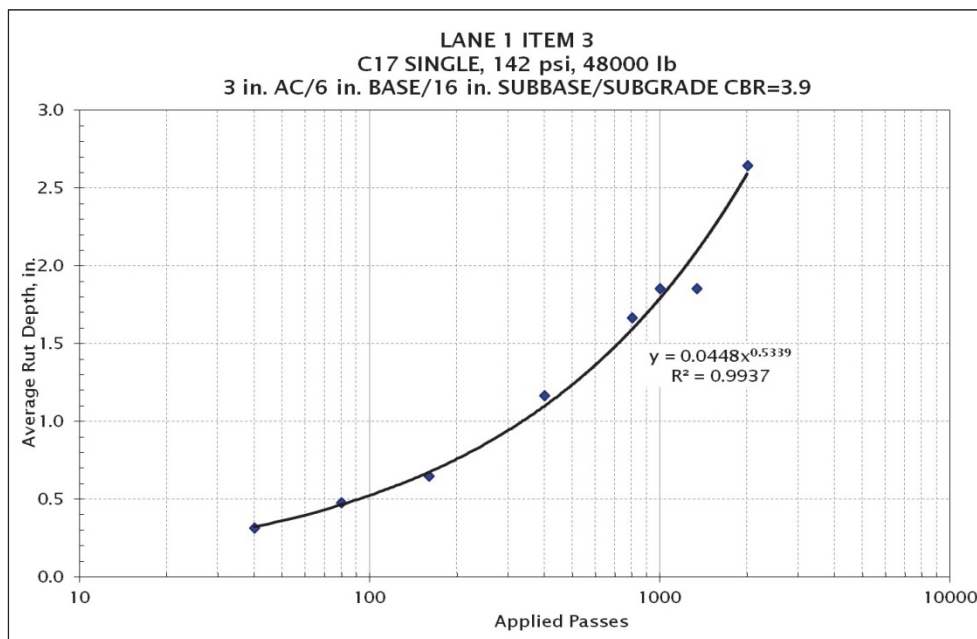
Figure 57. Rutting development on Lane 1 Item 3.

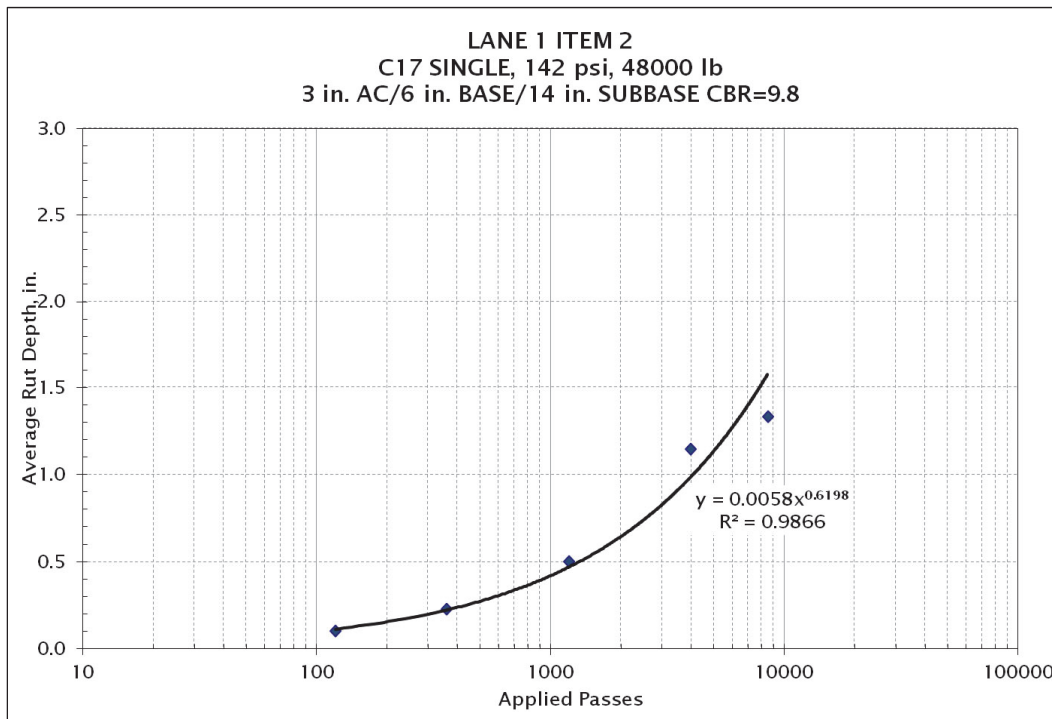
Testing of Lane 1 Item 2 started 1 Jul2008. The C-17 single tire with a tire pressure of 142 psi and loaded to 45,000 lb was applied to the pavement. After the completion of 3,960 passes, the rut depth at the center of the traffic area was 1.25 in. There was no visible cracking. After 8,354 passes, a crack had formed along the southeast edge of the traffic lane outside the wheel path. Additional hairline cracks had appeared after 12,000 passes. Table 13 and Figure 58 show the rutting data as a function of the number of passes up to 8,473 passes.

Figure 58. Rutting development on Lane 1 Item 2.

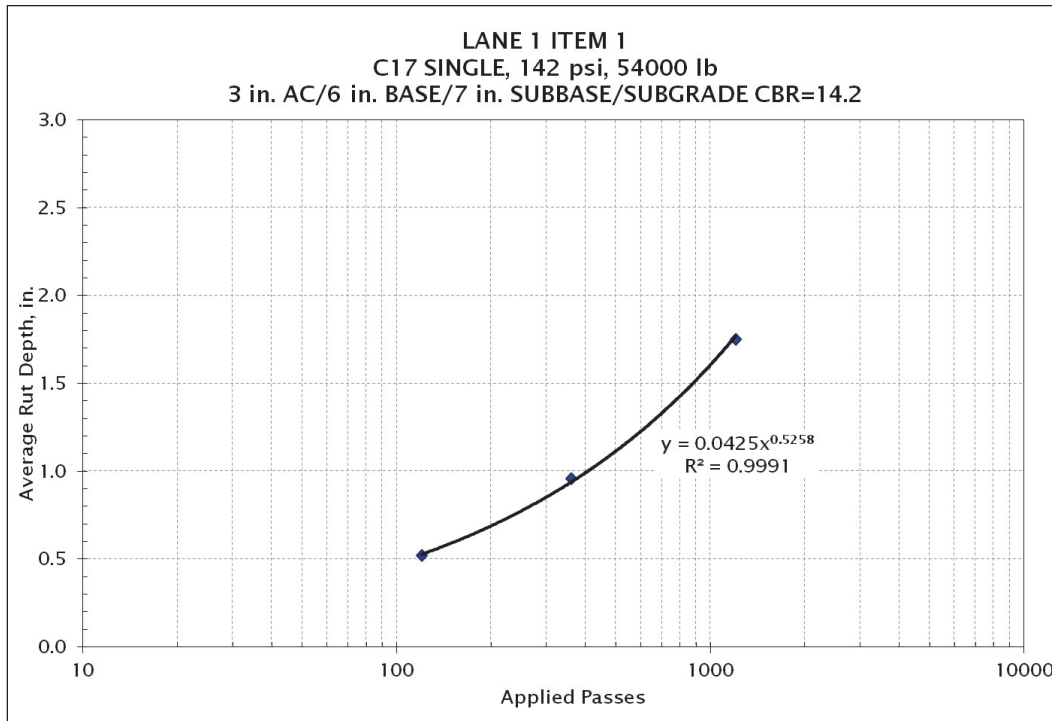
Testing of Lane 1 Item 1 started 11 Jul 2008. The C-17 single tire with tire pressure set at 142 psi and loaded to 45,000 lb was applied to the pavement. After the completion of 1,200 passes, the rut depth at the center of the area was 1.75 in. There were no visible cracks. Table 14 and Figure 59 show the rutting data as a function of the number of passes.

Figure 59. Rutting development on Lane 1 Item 1

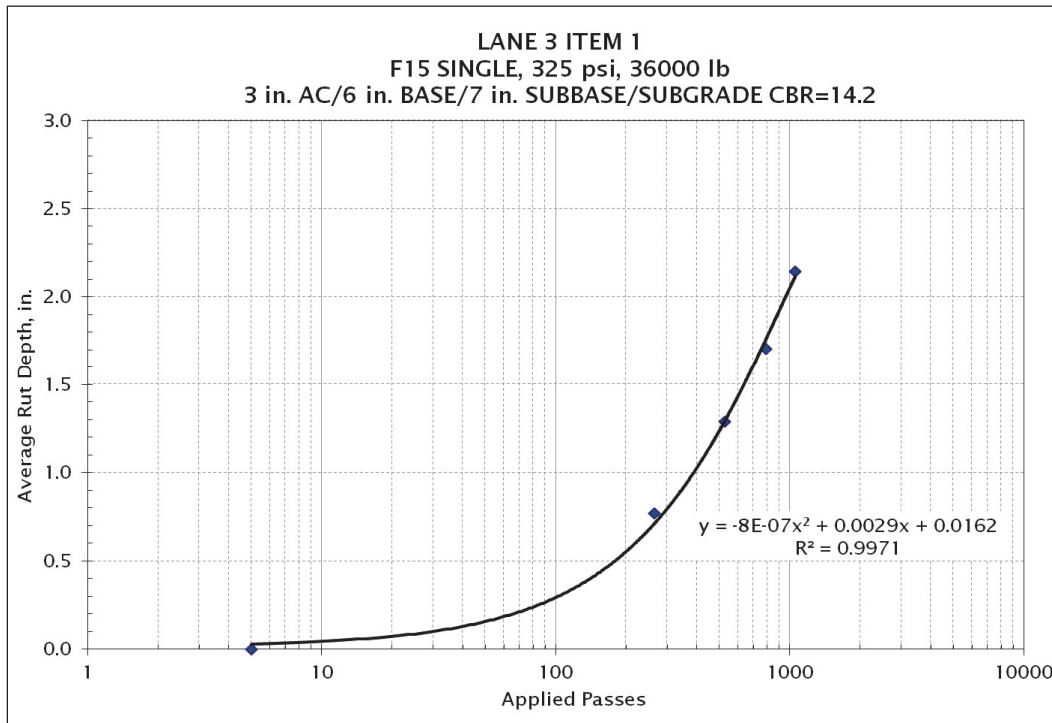
Testing of Lane 3 Item 1 started 15 Jul 2008. The F-15 single tire with a tire pressure set at 325 psi and loaded to 35,000 lb was applied to the pavement. After the completion of 264 passes, the rut depth at the center of the trafficked area was 1.0 in. There was visible cracking in the center of the test item. With the addition of 264 more passes for a total of

528 passes, multiple longitudinal cracks had developed throughout the test item. The average rut depth was 1.5 in. and increased to 1.7 in. after 792 passes. Traffic was concluded after 1,056 passes with the pavement having an average rut depth of 2.146 in. Table 15 and Figure 60 show the rutting data as a function of the number of passes.

Figure 60. Rutting development on Lane 3 Item 1.

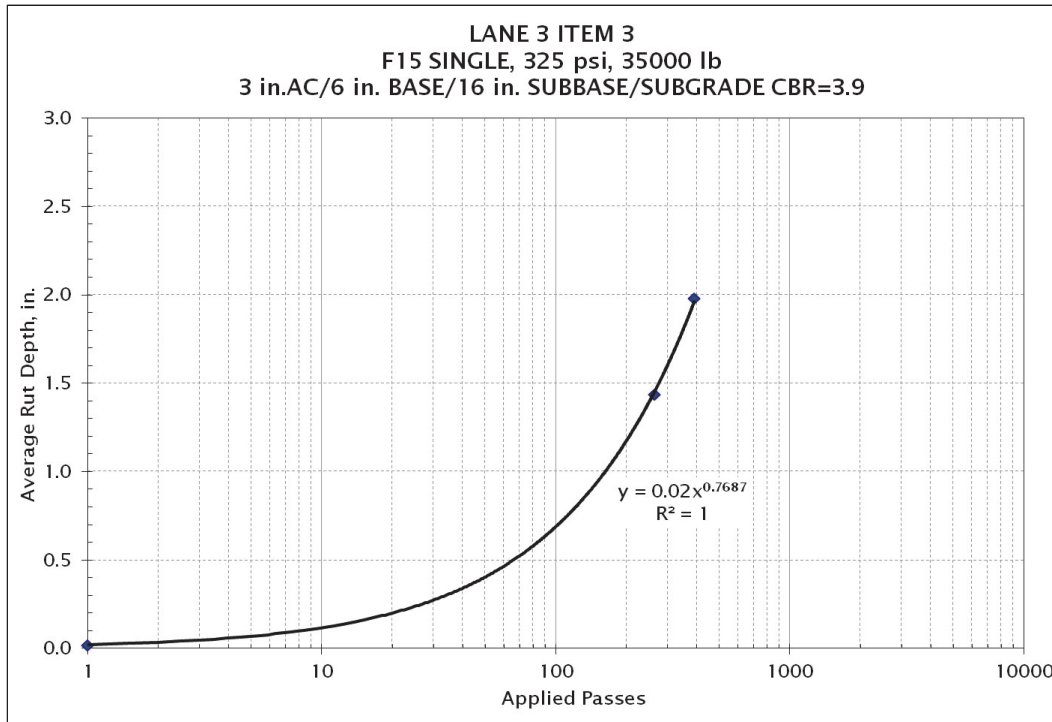
Testing of Lane 3 Item 3 started 22 Jul 2008. The F-15 single tire with a tire pressure set at 325 psi and loaded to 35,000 lb was applied to the pavement. After 264 passes, multiple cracks appeared in the asphalt surface. The total number of passes applied to this item was 390. Table 16 and Figure 61 show rutting depth in relation to the number of passes.

Figure 61. Rutting development on Lane 3 Item 3.

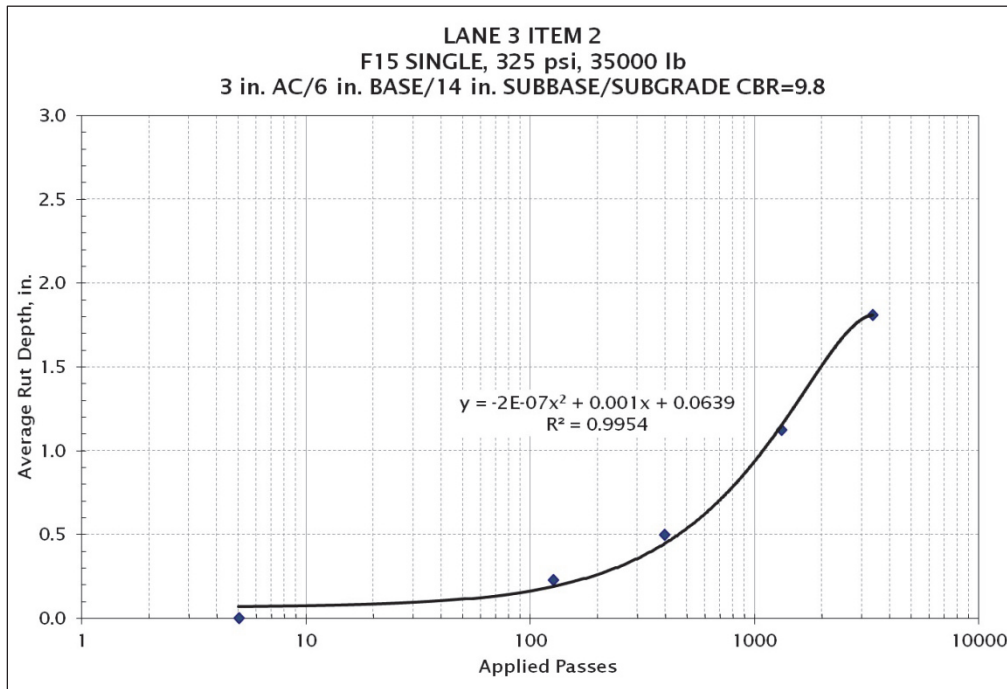
Testing of Lane 3 Item 2 started 24 Jul 2008. The F-15 single tire with a tire pressure set at 325 psi was applied to the pavement. The load was reduced from 35,235-lb to 33,800 lb with the intention of increasing the expected traffic level. In addition, the initial traffic pattern was changed from 12 passes per wheel location to 6 passes per wheel location in order to better capture the initial deterioration curve. After 1,320 passes, the rut depth was 1.13 in., and few cracks had appeared on the asphalt surface. The total number of passes applied to this item was 3,350, causing an average rut depth of 1.813 in. Table 17 and Figure 62 show rutting depth in relation to the number of passes.

Figure 62. Rutting development on Lane 3 Item 2

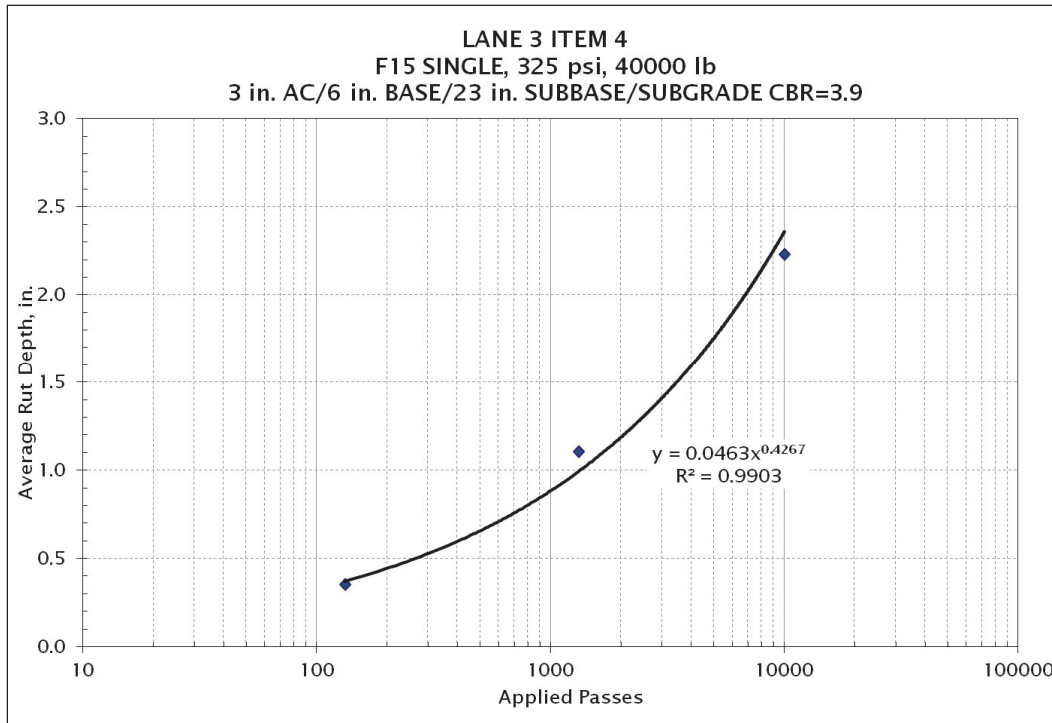
Figure 63. Rutting development on Lane 3 Item 4.

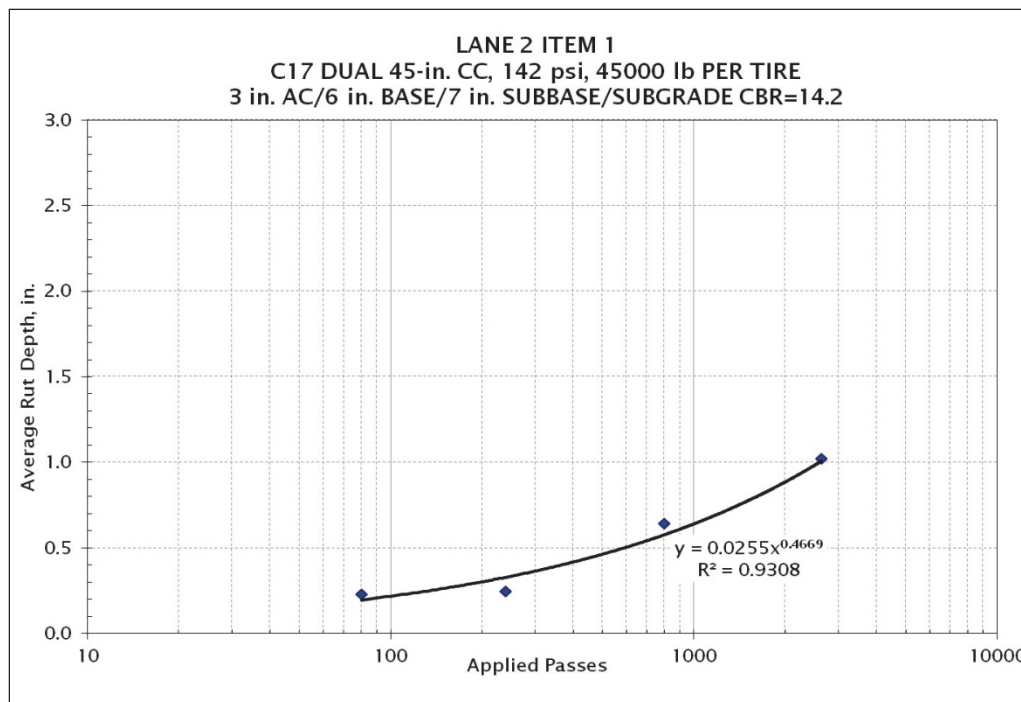
Testing of Lane 2 Item 1 started 7 Oct 2008. The C-17 dual tires with a tire pressure of 142 psi and loaded to 45,000 lb per tire was applied to this section item. The rut depth after 2,640 passes was 1.021 in. On the other hand, cracking had appeared on the pavement surface after 800 passes; after 2,500 passes, cracks had progressed considerably, existing cracks had widened, and new cracks had appeared on the pavement surface. Table 19 and Figure 64 show rutting depth in relation to the number of passes.

Figure 64. Rutting development on Lane 2 Item 1.

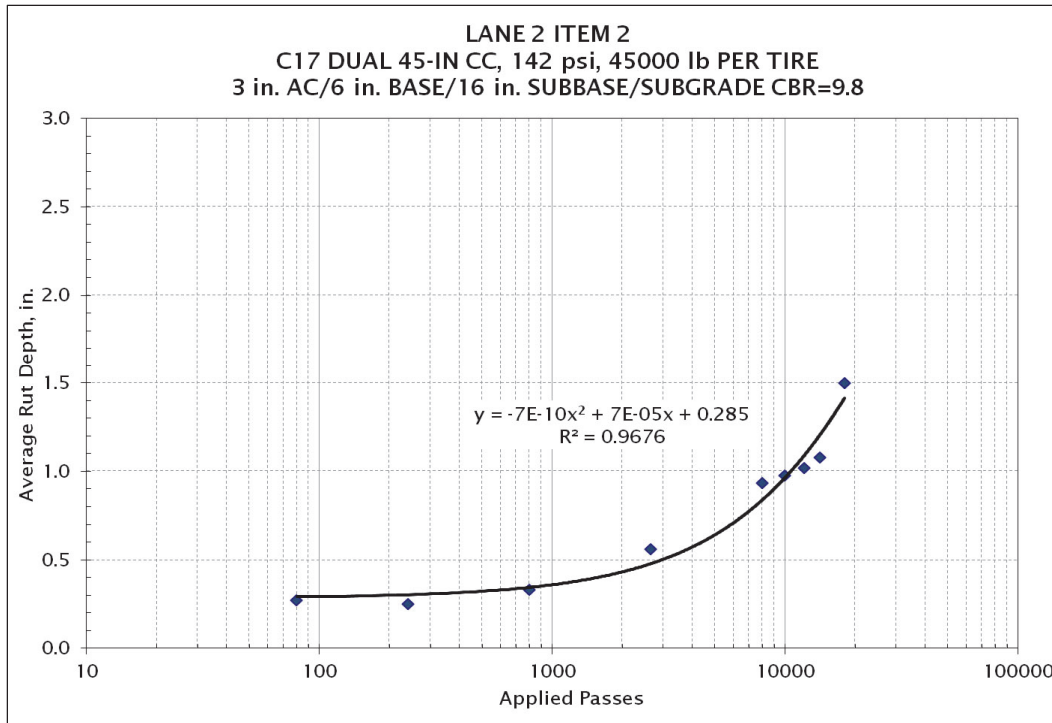
Testing of Lane 2 Item 2 started 21 Oct 2008. The C-17 dual tires with a tire pressure of 142 psi and loaded to 45,000 lb per tire was applied to this section item. Only 40 passes were applied the first testing day. On 23 Oct 2008, 240 passes were completed, and the rut depth was 0.25 in. No cracks were detected. After the completion of 10,000 passes, the maximum rut depth was 1 in., and fine cracks had appeared on the pavement surface. Additional passes were applied and, at 14,600 passes, rut depth was 1.125 in. and more cracks affected the test item. Table 20 and Figure 65 show rutting depth in relation to the number of passes.

Figure 65. Rutting development on Lane 2 Item 2.

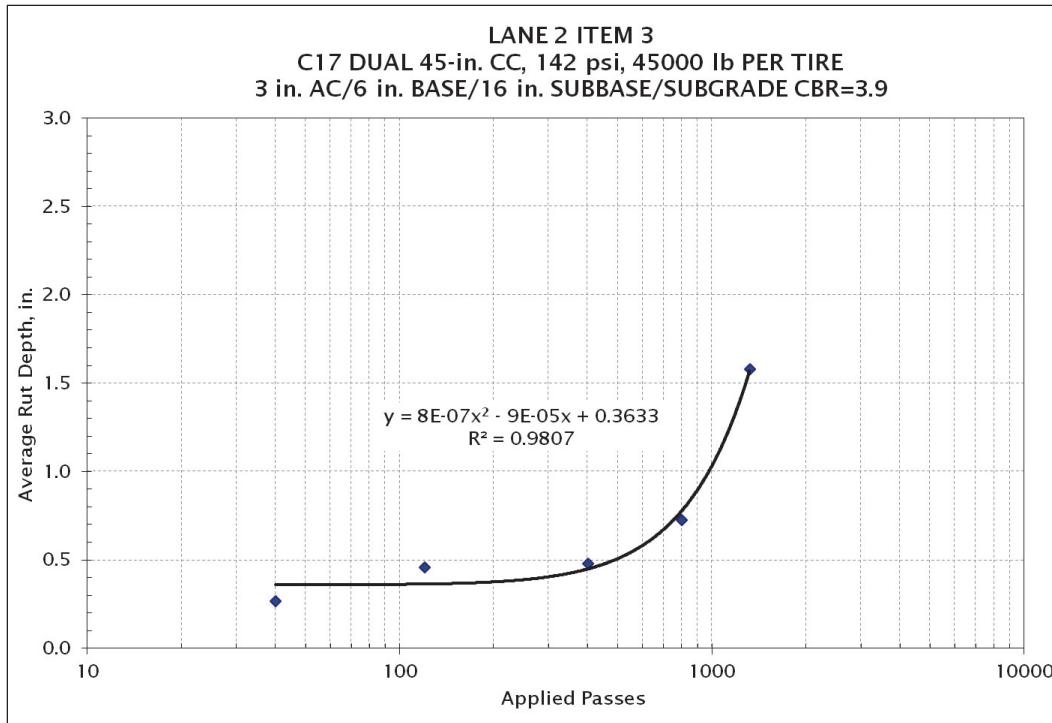
Testing of Lane 2 Item 3 started 17 Nov 2008. The C-17 dual tires with a tire pressure of 142 psi and loaded to 45,000 lb per tire were applied to this section item. The first 40 passes caused rutting of 0.063 in. After 400 passes, rutting was 0.25 in., and multiple fine cracks had appeared on the pavement surface. At 1,320 passes, the section was considerably cracked; the cracks extended for the full length of the test item. The maximum rut depth was 2 in. Table 21 and Figure 66 show rutting depth in relation to the number of passes.

Figure 66. Rutting development on Lane 2 Item 3
