**US Army Corps  
of Engineers®**  
Engineer Research and  
Development Center

## **Unbonded Aggregate Surface Roads**

Final report

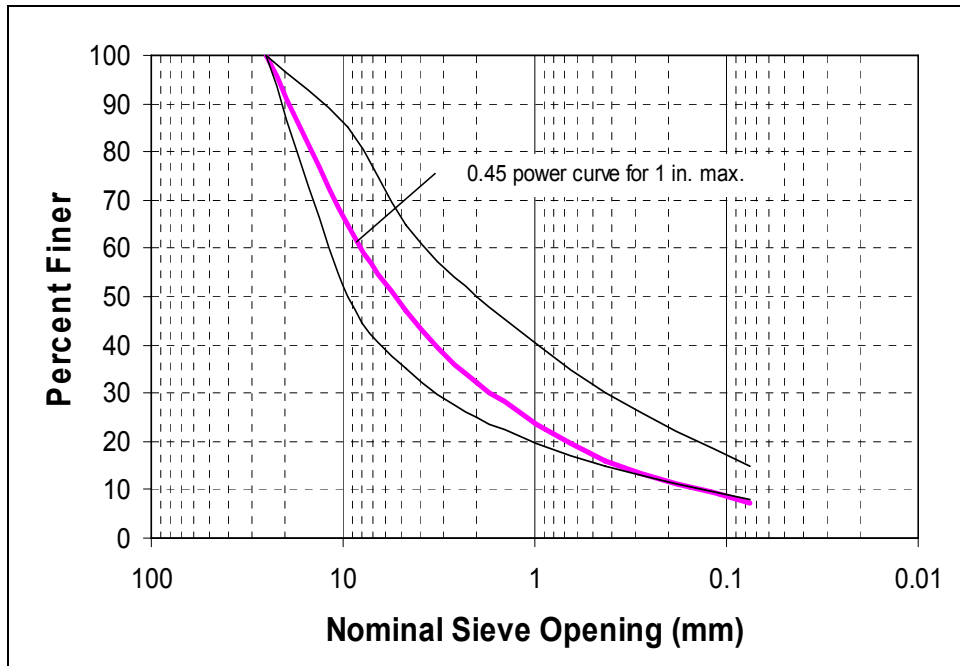
Figure 1. USACE gradation No. 1

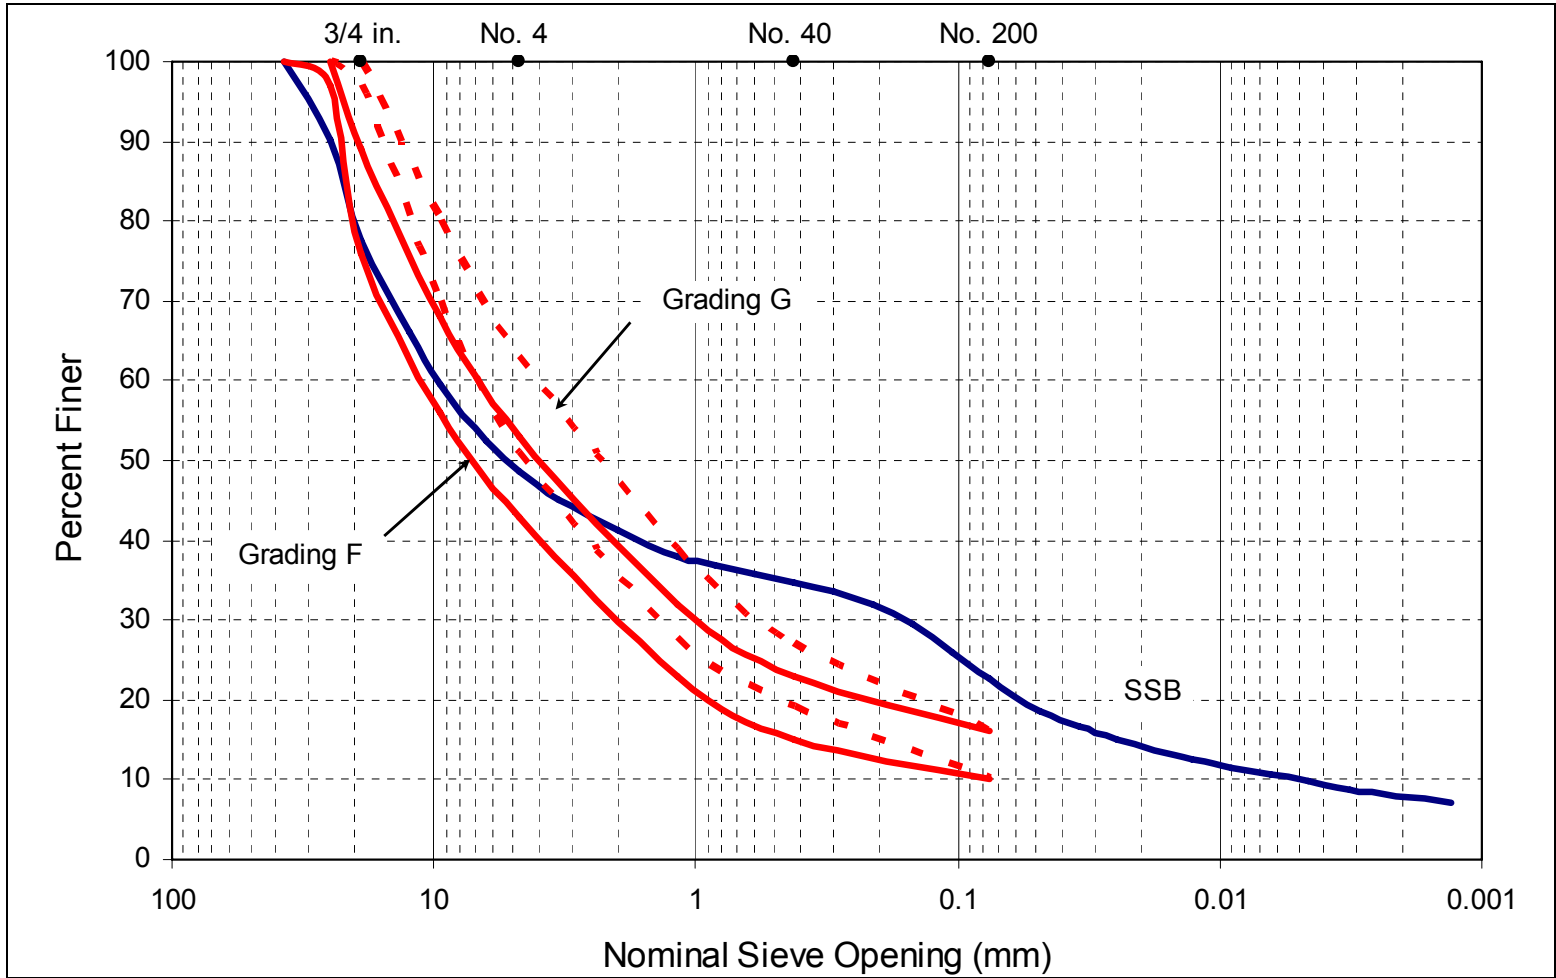
Figure 52. Comparison of as-received SSB grading to USFS specifications

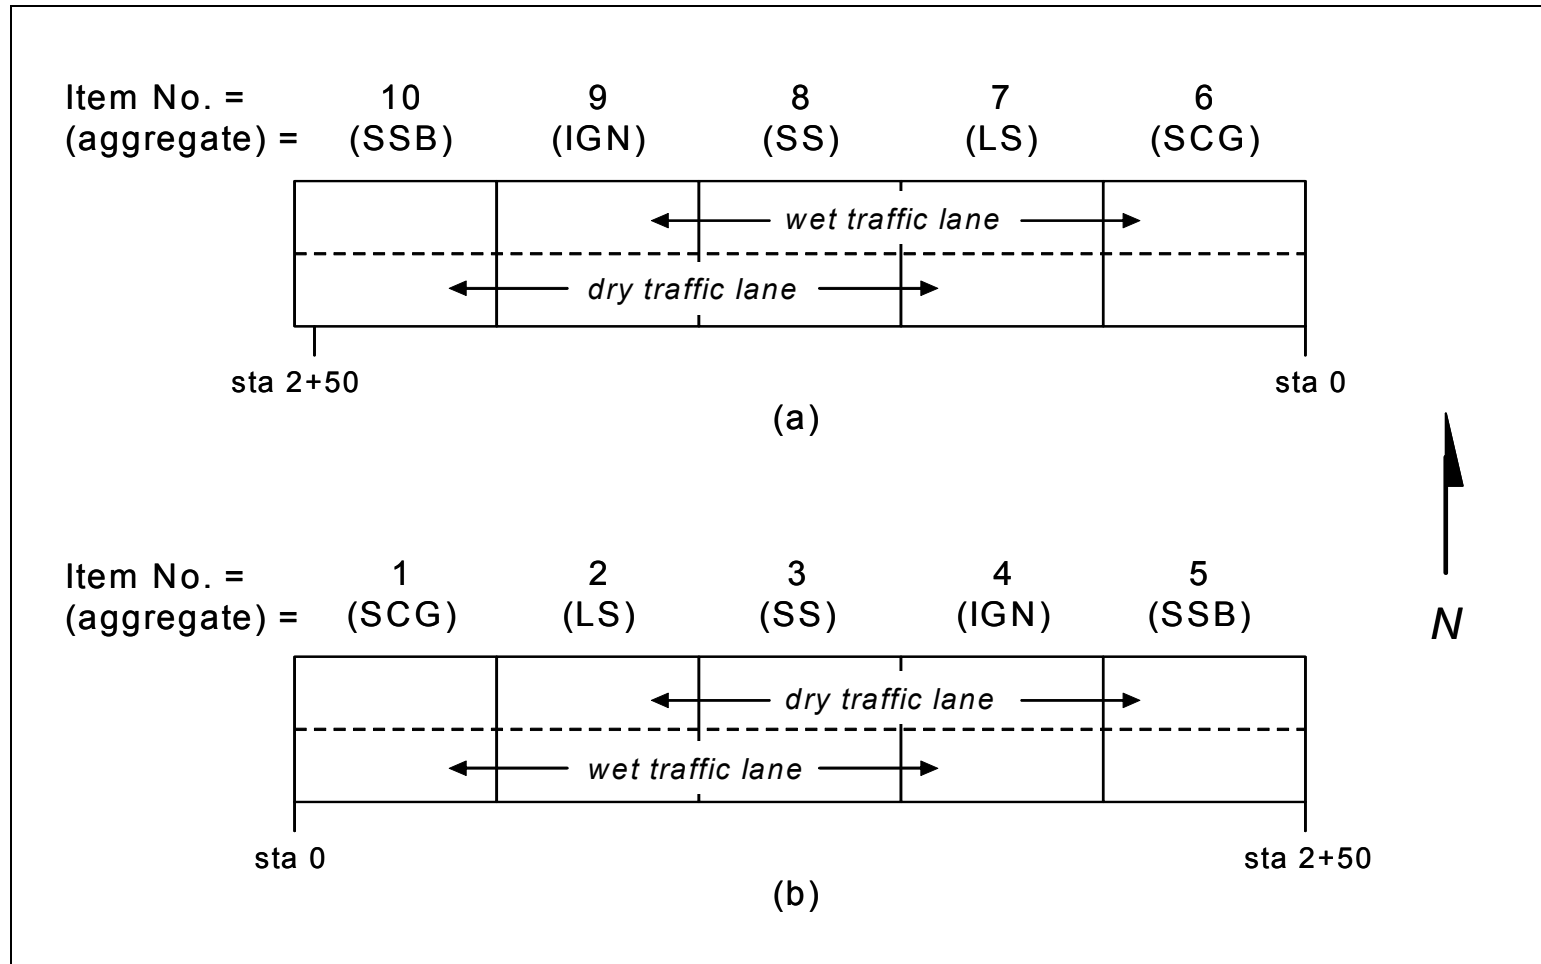
Figure 55. Test item layout for the (a) construction and (b) maintenance test sections
