MISCELLANEOUS PAPER HL-88-3

SCOUR PROTECTION FOR DAM NO. 7 MONONGAHELA RIVER, PENNSYLVANIA

Hydraulic Model Investigation

April 1988 Final Report

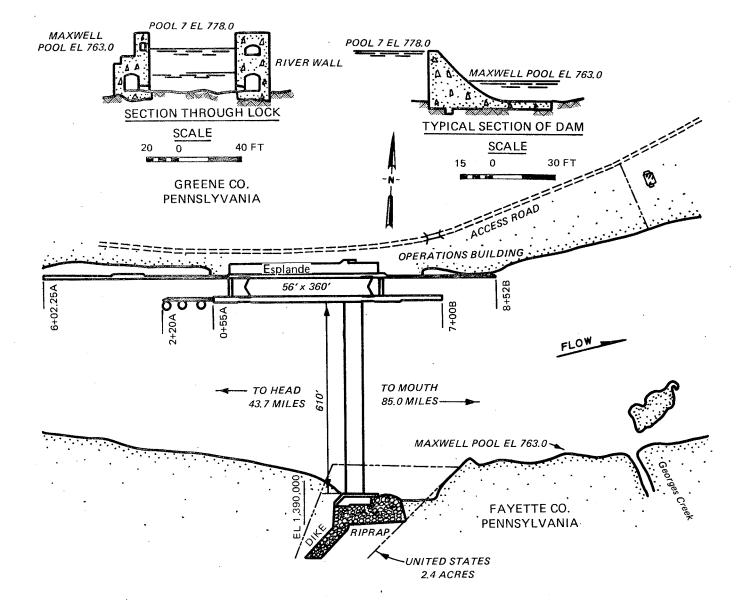
Figure 2. Plan and elevation view

1. Lock and Dam No. 7, Monongahela River is located 85 miles* from the mouth of the river near the Pennsylvania-West Virginia state line (Figure 1). The overall length of the dam from the river wall of the lock to the abutment is 610 ft. It is an unreinforced concrete dam with a shear key channeled into the foundation near the upstream face as shown in Figure 2.

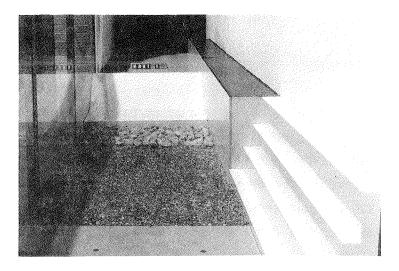
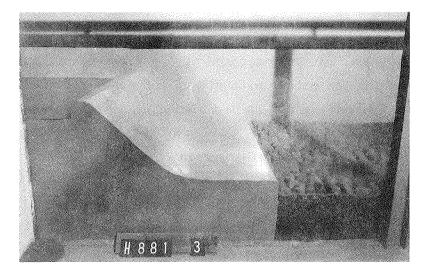
Figure 3. General view of model

a. Looking upstream

b. Side view

c. Looking downstream

4. The model (Figure 3) was constructed to an undistorted scale of 1:25 and reproduced a 78-ft-long section of the uncontrolled fixed-crest weir and spillway apron, and a 22-ft-wide section of the river wall of the lock. Approximately 200 ft of the river wall of the lock was constructed upstream from the dam and 300 ft downstream from the dam. A 200 ft length of topography upstream from the dam, the proposed riprap protection, and 400 ft of the exit channel downstream from the dam were also reproduced. The fixedcrest weir, spillway apron, and a portion of the downstream side of the river wall of the lock were fabricated of sheet metal. The upstream topography and the remaining portions of the river wall of the lock were constructed of plastic-coated plywood. A 50-ft-section of the exit channel immediately downstream of the dam was molded with riprap and sand, followed by 140 ft of pea gravel and the remaining 210 ft reproduced with plastic coated plywood.

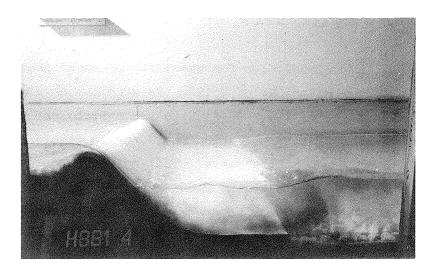
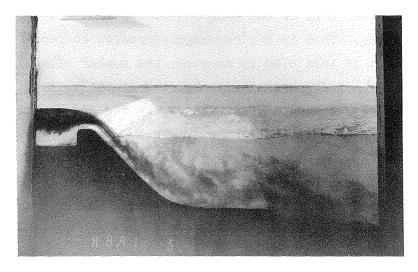
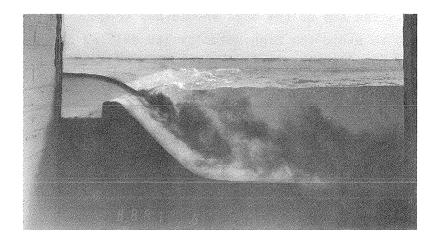
a. Discharge 20,000 cfs, tailwater el 769.7

b. Discharge 50,000 cfs, tailwater el 776.5

c. Discharge 85,000, tailwater el 783.5Photo 1. Plunging jet flow conditions

7. Initial tests were conducted with the type 1 riprap plan shown in Plate 1. This plan consisted of 3- to 4-ft-diameter stones placed horizontally for 50 ft downstream from the end of the spillway apron. The bottom of the rock was placed at el 748*, with the top of the rock offset a minimum of 2 ft below the top of the spillway apron, el 754. A high velocity plunging jet exiting the spillway apron was observed for discharges up to 85,000 cfs (unit discharge, q, of 139.3 cfs/ft). Discharge rating curves are shown in Plate 2.

This plunging jet flow continued over the type 1 riprap causing instability of the stone protection for discharges between 20,000 and 85,000 cfs. The worst flow condition for riprap stability appeared to be with a discharge of around 85,000 cfs. Several stones were unstable and some were displaced from the riprap bed. Plunging flow conditions with the type 1 riprap plan for discharges of 20,000 cfs (unit q of 32.8 cfs/ft), 50,000 cfs (unit q of 82.0 cfs/ft), and 85,000 cfs (unit q of 139.3 cfs/ft) are shown in Photo 1 and riding jet flow conditions for discharges of 100,000 cfs (unit q of 164.0 cfs/ft) and 160,000 cfs (unit q of 262.3 cfs/ft) are shown in Photo 2. Once the riding jet flow occurred, the attack on the area downstream from the dam was reduced and the type 1 riprap plan remained stable. Velocities measured for these flow conditions are shown in Plates 3-7. Maximum velocities observed over the stone protection occurred with a discharge of 85,000 cfs and ranged from 9.0 to 11.0 ft/sec. These velocities and associated turbulence were sufficient to displace the stones in the type 1 riprap plan.

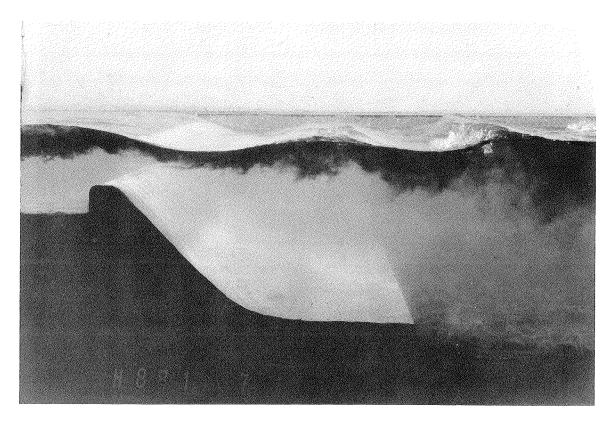
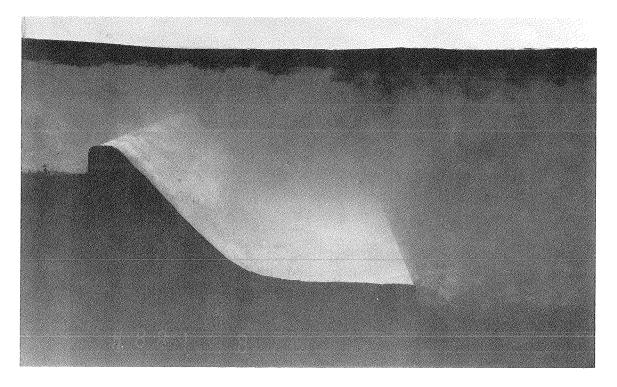
a. Discharge 100,000 cfs, tailwater el 786.5

b. Discharge 160,000 cfs, tailwater el 796.5Photo 2. Riding jet flow conditions

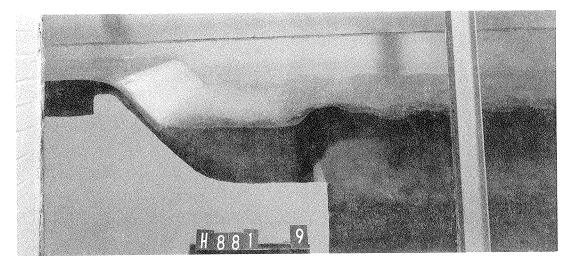
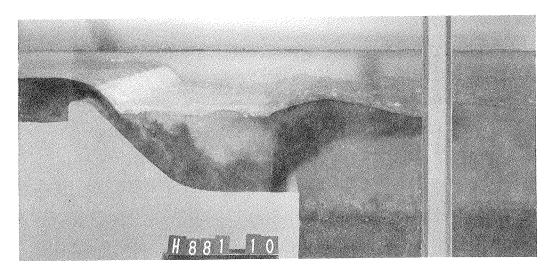
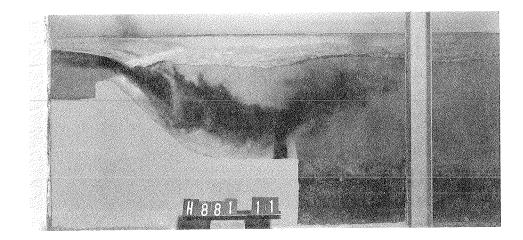
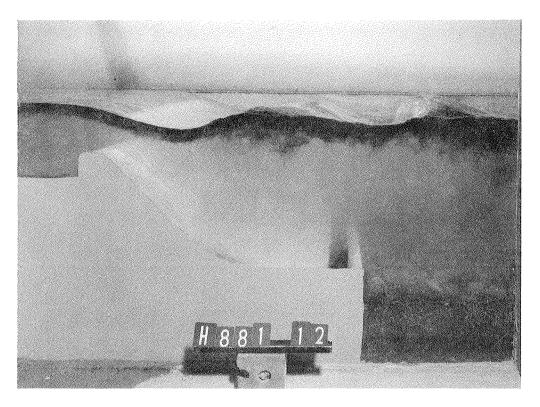
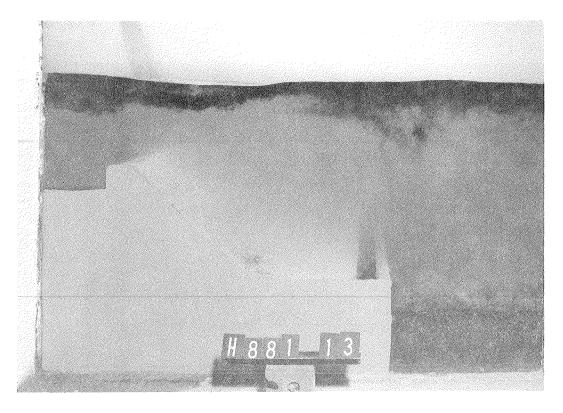
a. Discharge 20,000 cfs, tailwater el 769.7

b. Discharge 50,000 cfs, tailwater el 776.5

c. Discharge 85,000 cfs, tailwater el 783.5 Photo 3. Flow conditions with type 5 scour protection plan (Continued)

d. Discharge 100,000 cfs, tailwater el 786.5

e. Discharge 160,000 cfs, tailwater el 796.5

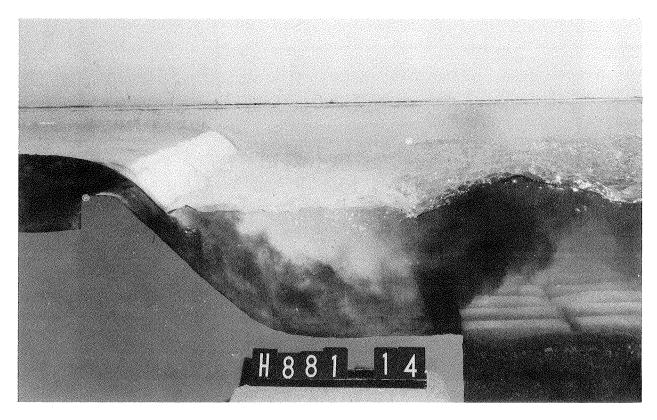
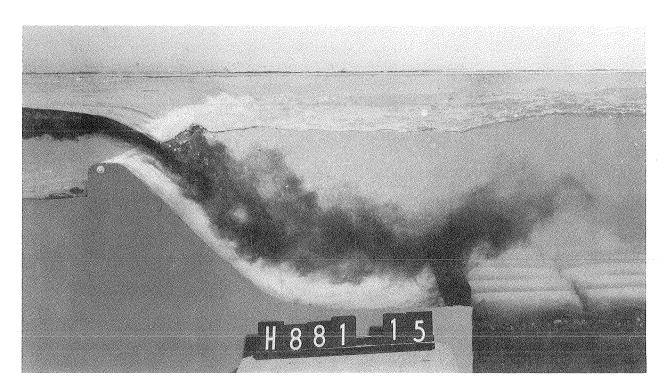
a. Discharge 50,000 cfs, tailwater el 776.5

b. Discharge 85,000 cfs, tailwater el 783.5Photo 4. Flow conditions with the type 10 scour protection plan

15. The type 10 scour protection plan consisted of the same bag configuration as the type 9 plan, with the addition of a 3-ft-high sloping end sill placed at the end of the spillway apron, Plate 18. With this design in place, the bags remained stable for all discharges and for the flow transition at 85,000 cfs. Flow conditions with the type 10 scour protection plan for discharges of 50,000 and 85,000 cfs are shown in Photo 4. The bags also

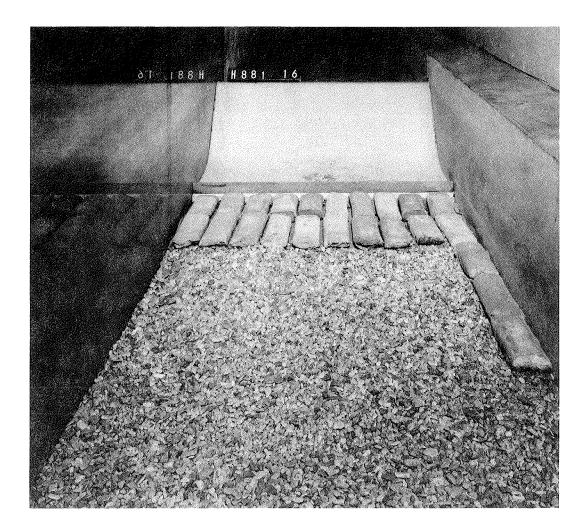
Photo 5. Type 14 scour protection plan

19. The type 14 scour protection plan shown in Plate 26 incorporated the elements of the type 10 plan with the addition of 3 bags placed along the river wall of the lock. The number of bags placed along the river wall will depend on the location and extent of the existing scoured areas. If certain areas along the wall are severely scoured, bags should probably be used to repair these areas. The addition of the end sill significantly reduced the velocities along the base of the river wall. Three bags were placed along the lock wall downstream of the protection below the dam in the type 14 scour

protection plan to observe scouring tendencies adjacent to and at the termination of the bags. The plan was tested and remained stable for all discharges. Photo 5 shows the exit channel after 7.5 hours (prototype) with a discharge of 20,000 cfs, and 10 hours (prototype) with a discharge of 85,000 cfs. Only slight scour of the model bed downstream of the bags was observed and virtually no model scour occurred around the bags along the lock wall.
