Nonlinear, Incremental Structural Analysis of McAlpine Lock Replacement for Chamber, Miter Gate, and Culvert Valve Monoliths

by Barry D. Fehl, Guillermo A. Riveros, Sharon Garner

Technical Report ITL-97-4
May 1997

Final report

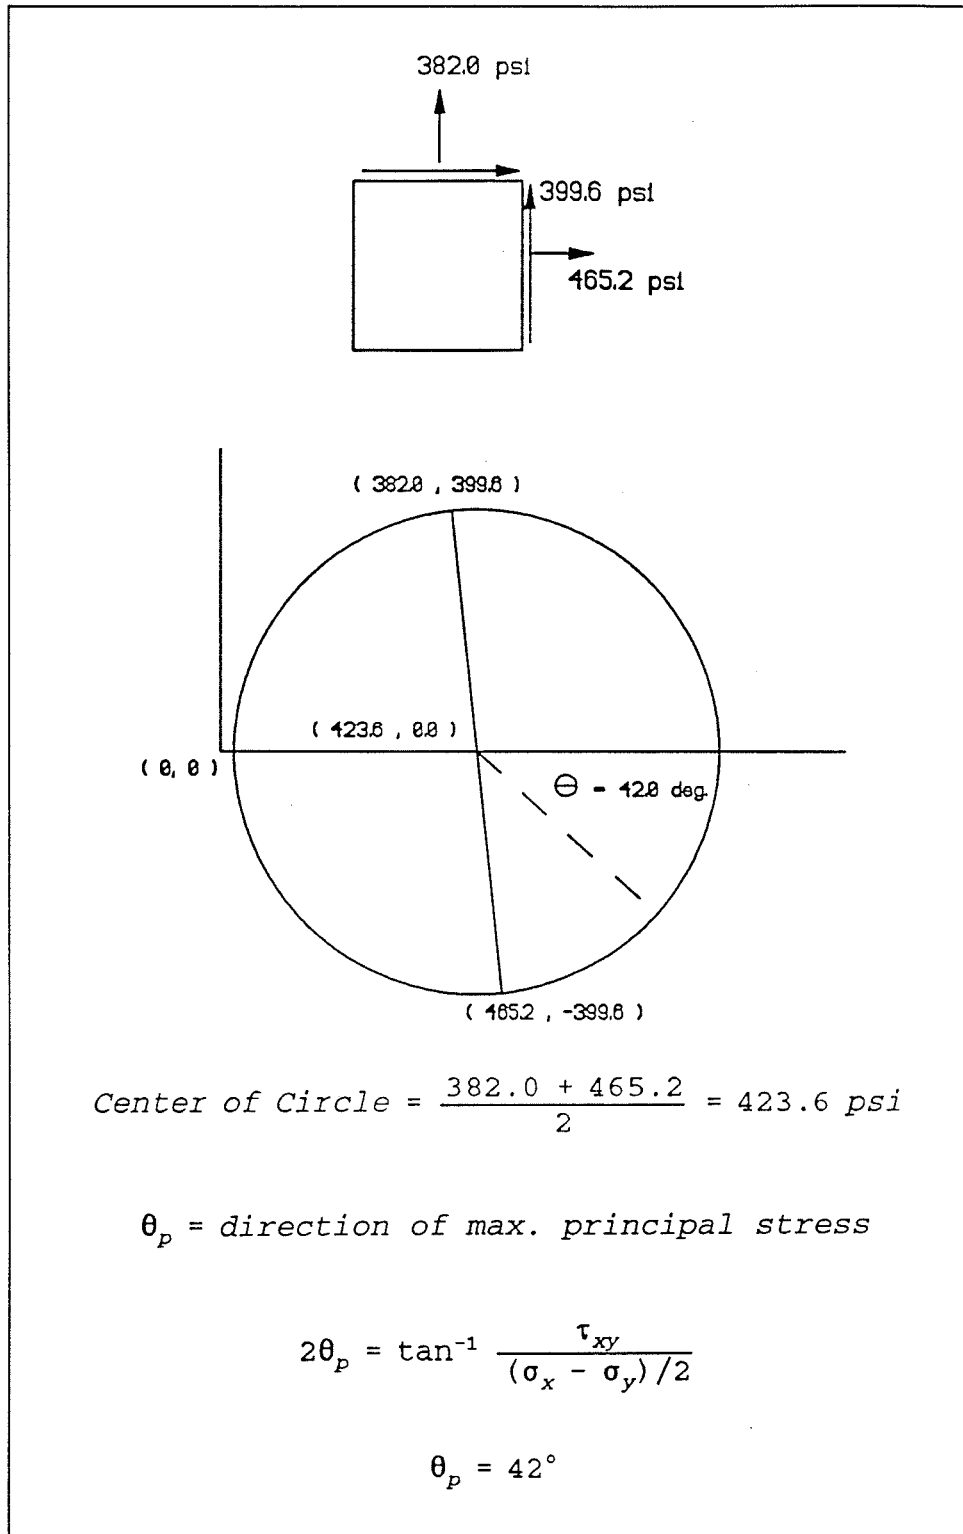
Figure 74. Mohr's circle of stress for stresses at the lower left-hand corner of the base at day 110
