US Army Corps
of Engineers

Technical Report ITL-95-3
June 1995

Three-Dimensional, Nonlinear, Incremental Structural Analysis of a Culvert Valve Monolith Wall, Olmsted Locks

Prepared for U.S. Army Engineer District, Louisville
Louisville, KY 40201-0059

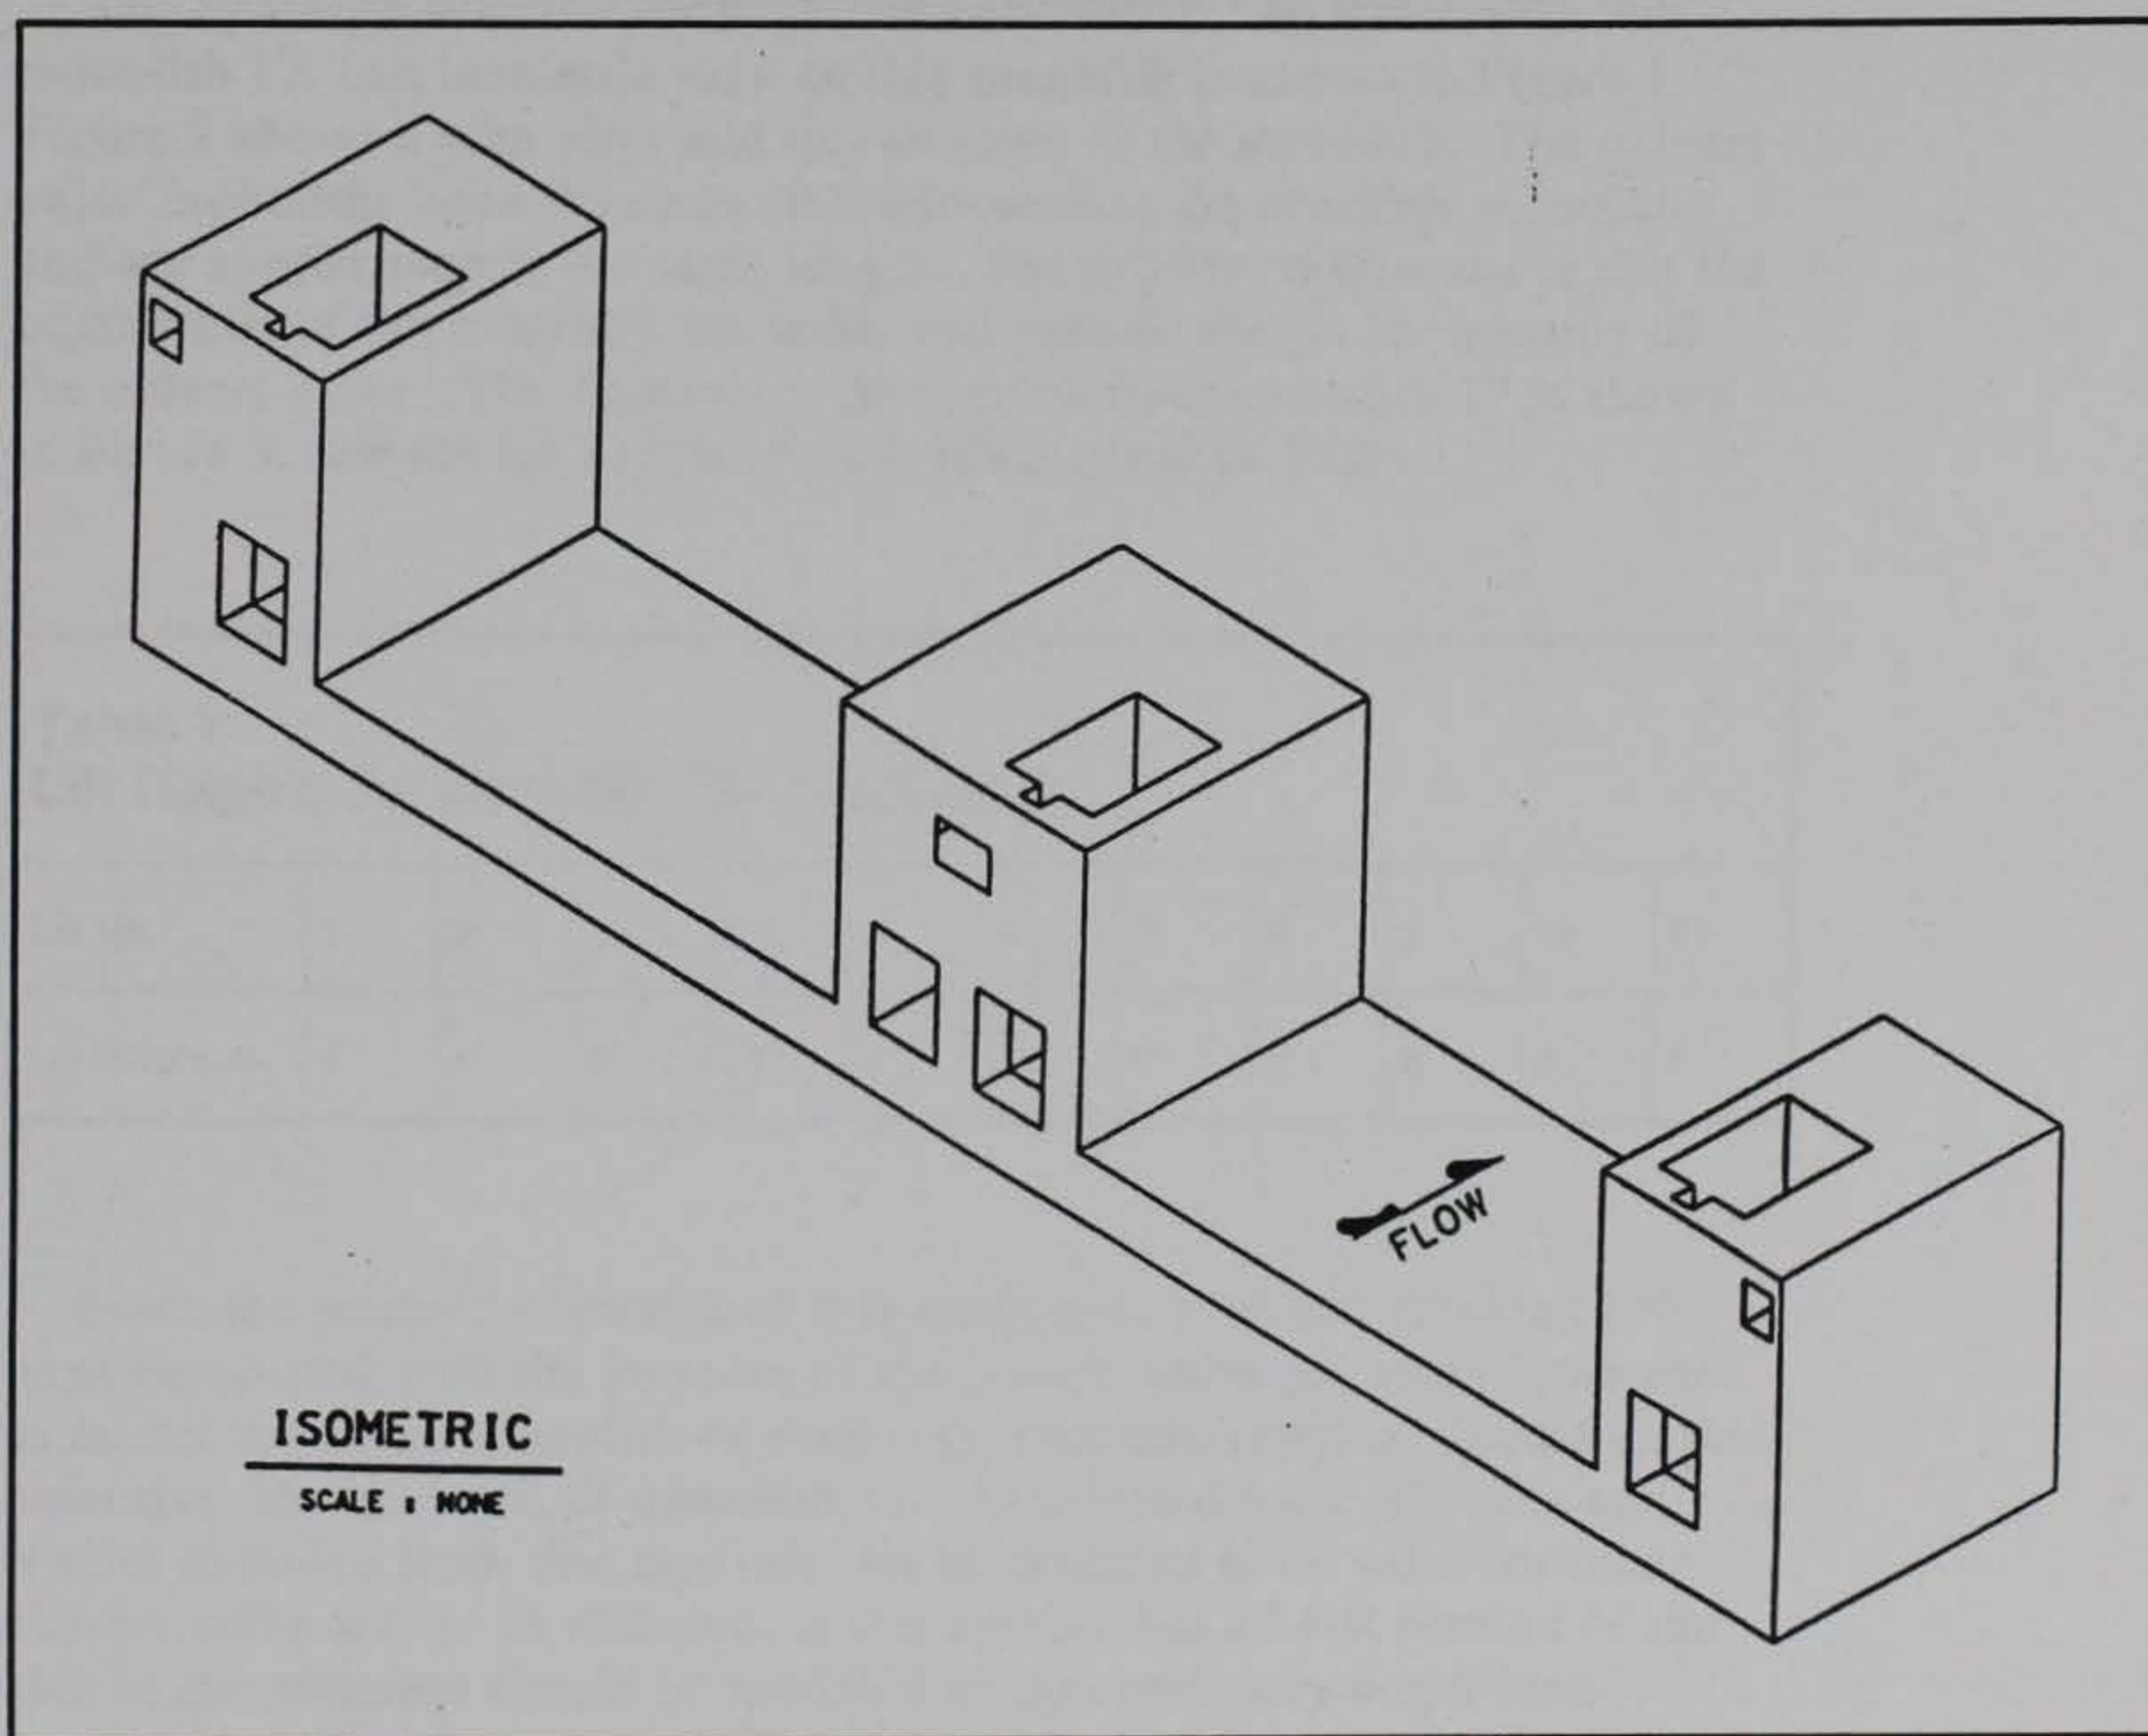
Figure 1. Isometric view of monolith 17

The analysis performed in this study was performed using monolith 17. An isometric view of the monolith is shown in Figure 1, and the landwall on the right side of the monolith, looking downstream, was analyzed. As part of the model of the wall of monolith 17, a 24-ft section of the base slab in the chamber was included. While the primary interest in this analysis was the behavior of the wall, it was agreed that a portion of the slab should be modeled to ensure that the boundary conditions used did not effect behavior in the wall. Since evaluation of cracking is a primary objective of this analysis, reinforcing will be included in the model so that if cracking does occur, the benefits of the reinforcement present can be measured. The reinforcing was modeled using a smeared type of reinforcing as opposed to using discrete truss elements and is discussed in further detail in a WES report entitled "Use of Reinforcement in a Nonlinear, Incremental Structural Analysis" (Fehl and Merrill in preparation).

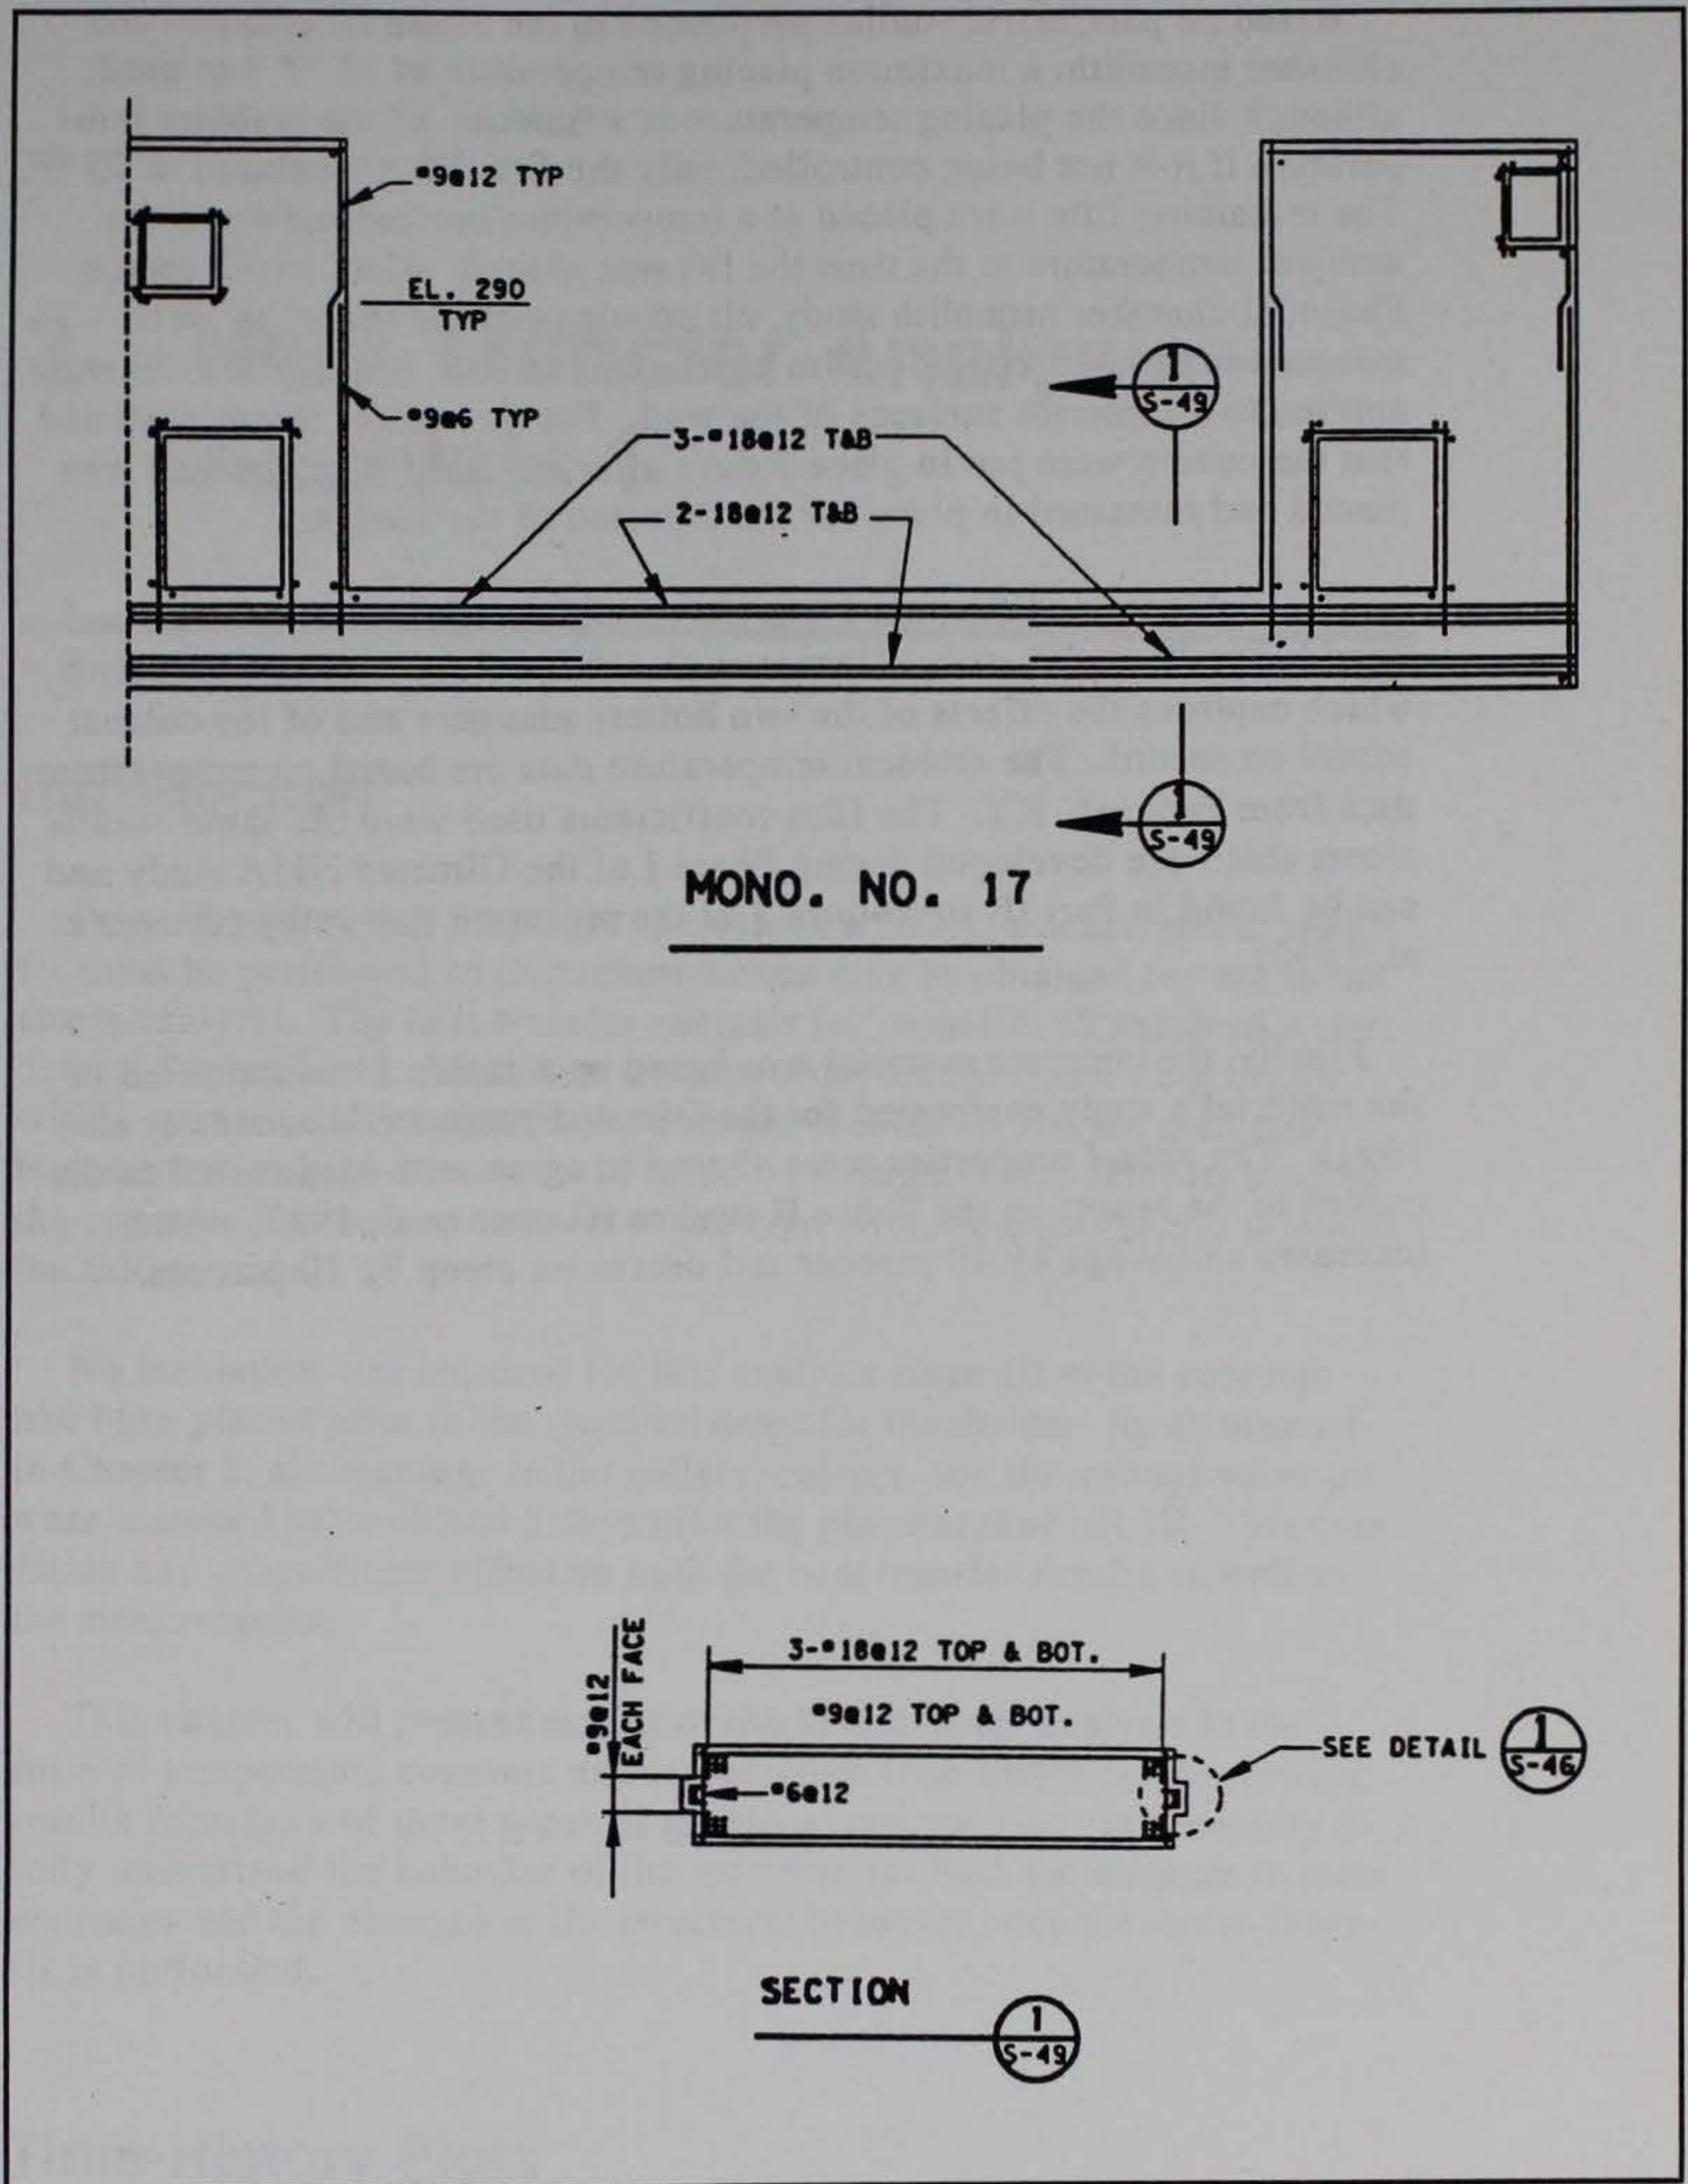
Figure 6. Reinforcing layout for monolith 17

Since there is a relatively high likelihood that cracking could occur in the culvert valve monolith, it was important that reinforcing be included in the model. Reinforcing was placed in the model according to the drawing shown in Figure 6. For areas that are not specifically called out it was assumed that #9 bars at 12-in. spacing were used. In addition, #9 bars at 12-in. spacing were placed diagonally at the each corner of the culvert valve pit for the entire height of the pit. It was felt that this was important, since diagonal bars at corners are the most beneficial for arresting cracks.

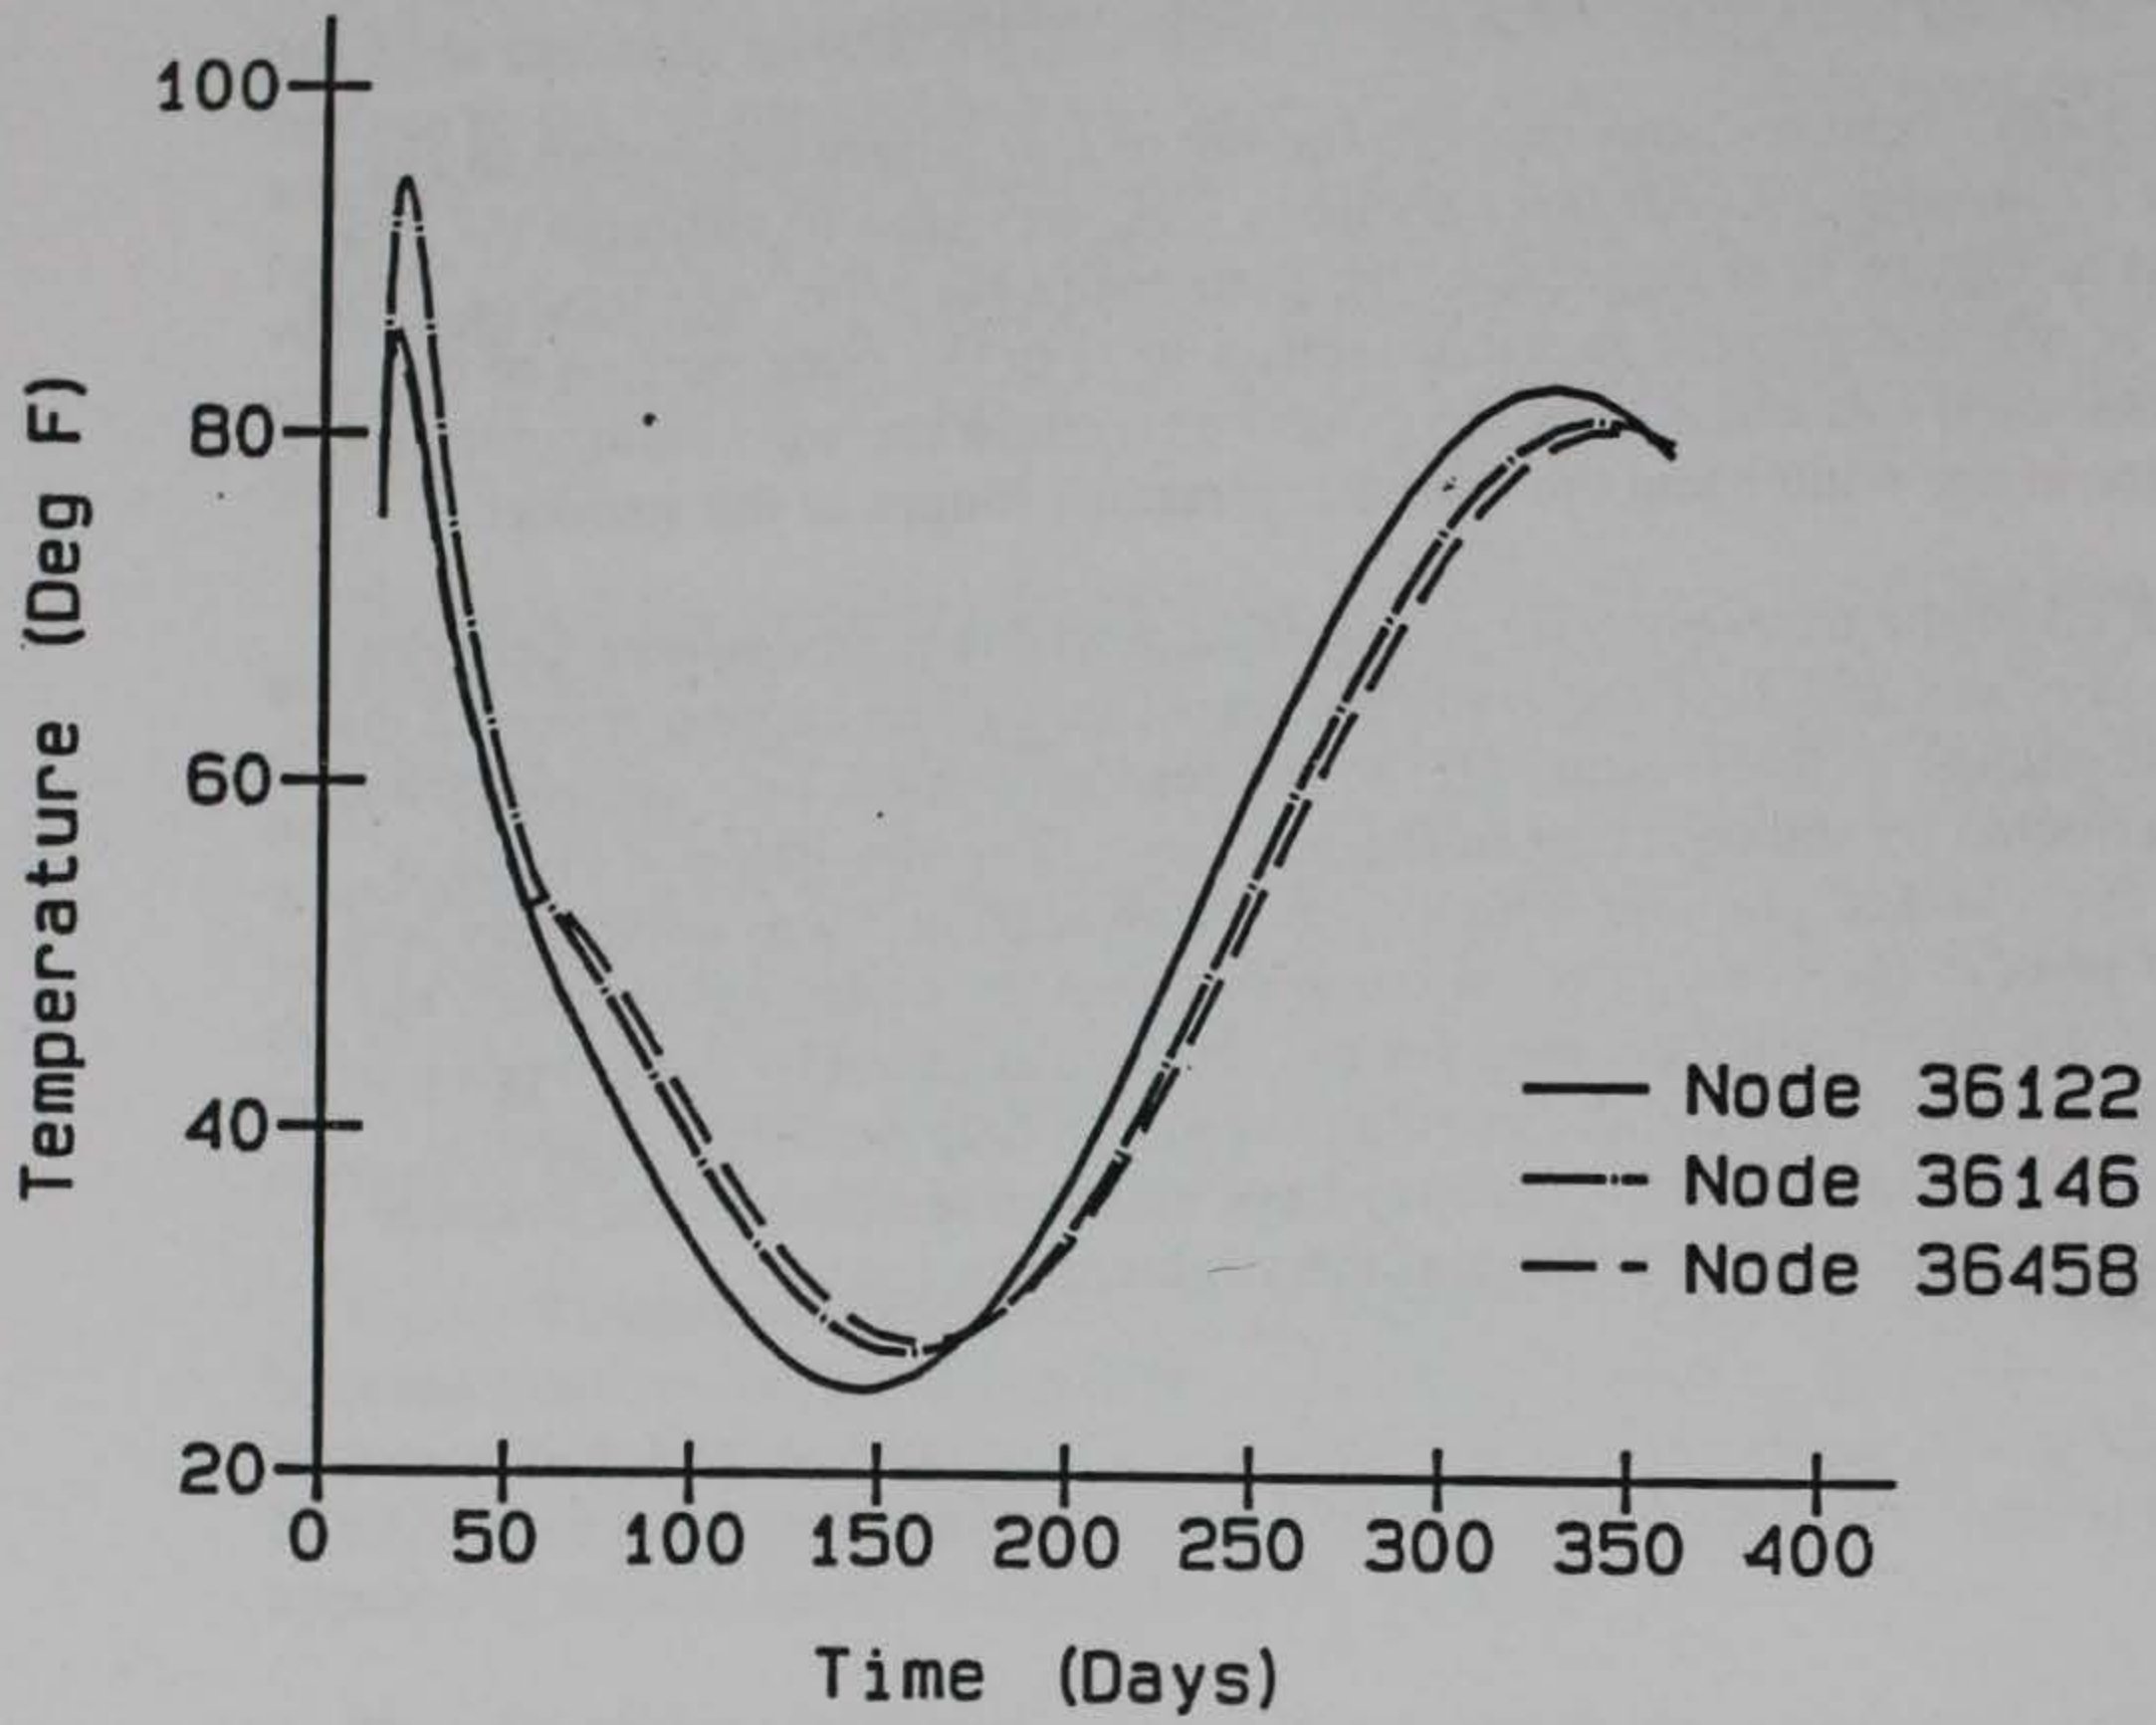
Figure 7. Temperature time-history at section 1

In all of the time-histories it should be noted that somewhere between 150 days and 250 days the gradients across any given section reversed due to the change in the season. Of the sections presented, only section 3 was not affected by the covering of the openings. The significance of this is that the reversed gradient which occurred in section 3 was noticeably less at its peak in the summer when compared with its winter counterpart, but this is not necessarily the case for the sections affected by the covering of the openings. Covering the openings seems to help moderate temperatures in the winter months but may have an adverse affect in the summer by keeping the interior portion of the structure too cool.

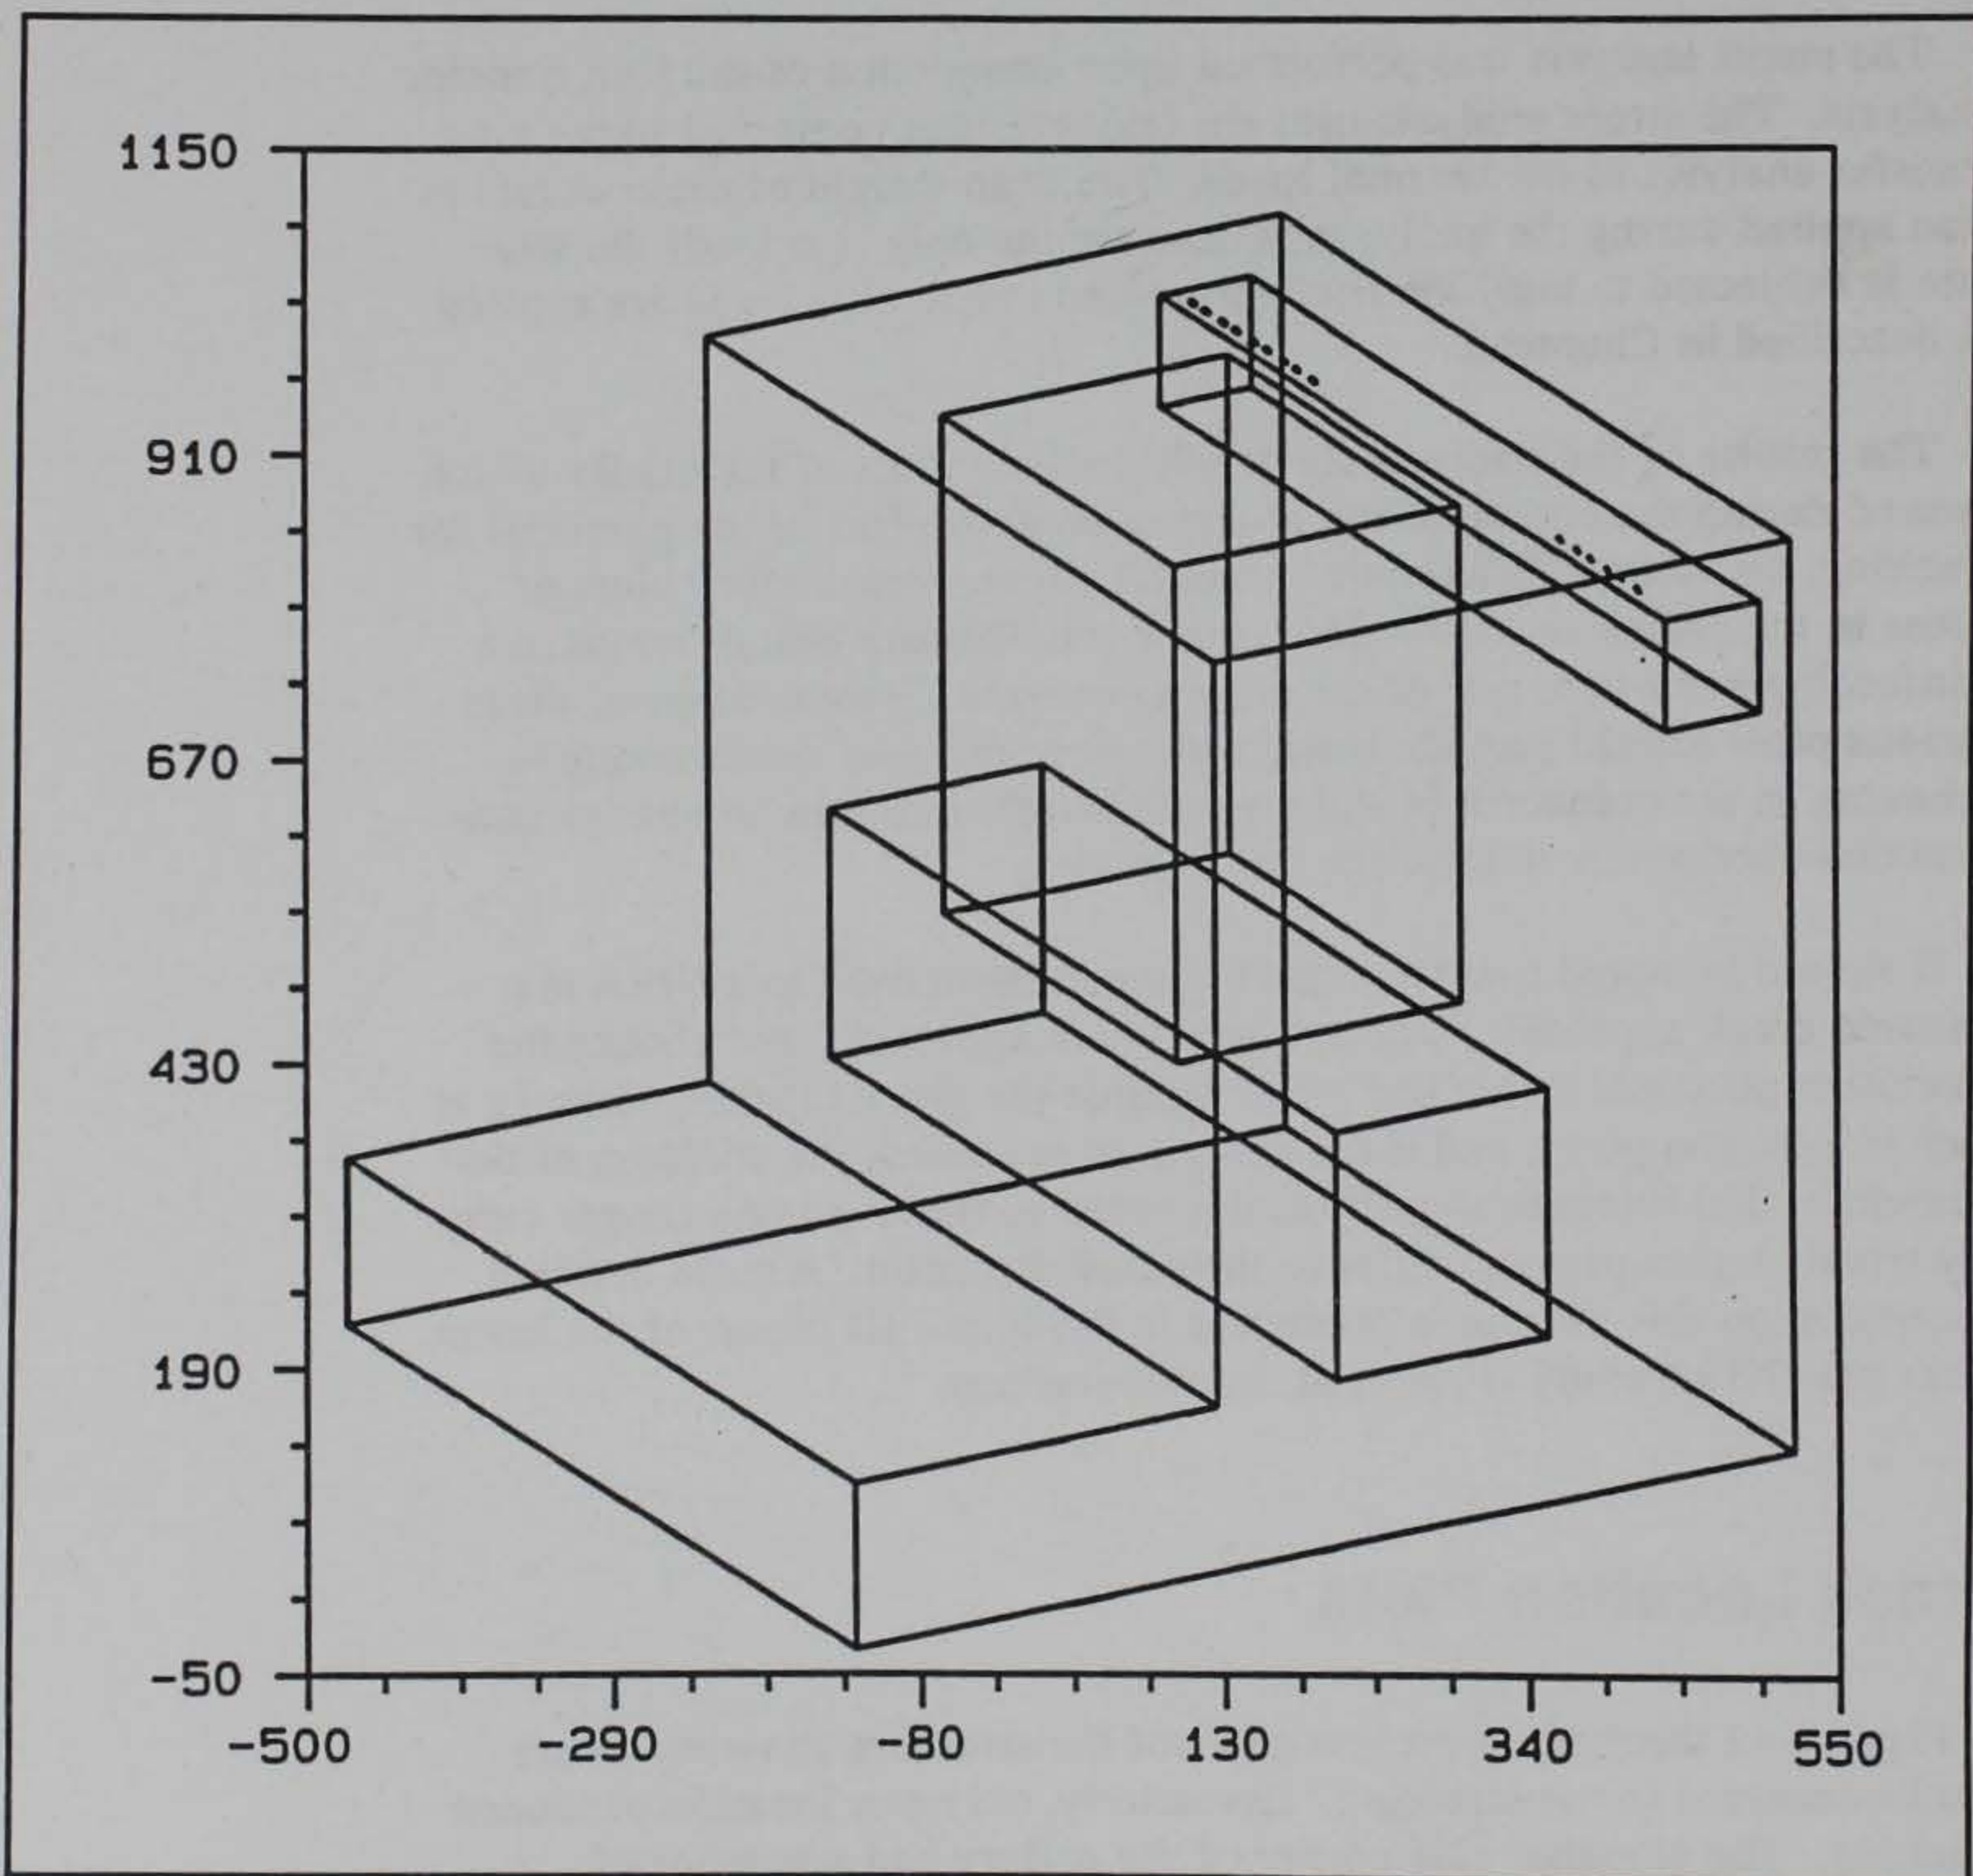
Figure 41. Crack plot, isometric view at day 209

Figures 41 through 55 present plots of the structure showing where cracks occurred in the structure. Essentially, only one location produced cracking. The chamber side corner of the gallery had a number of

integration points crack indicating a single crack of significant magnitude. While the crack in the gallery is quite extensive, it does not threaten the overall integrity of the structure. Despite this fact, strong consideration should be given to making changes which would alleviate this cracking.

Cracking in the gallery started at day 209 of the analysis and continued through day 289. By the time the cracking stopped, cracks had formed at 111 integration points above the given corner of the gallery and extended almost the entire length of the gallery. Integration points in two different longitudinal strips of elements cracked. The total number of integration points which are located in the planes where the cracking occurred is 240, and therefore, nearly half of the integration points in the plane of the crack are cracked. Table 2 gives the total number of cracked integration points through time.

Figure 41 shows an isometric view of the monolith at day 209 when the cracking started. Figures 42, 43, and 44 are a plan view, a front elevation, and a side elevation, respectively. The front elevation in Figure 43 shows that this the crack angles away from the corner of the gallery to some degree. Also, in Figure 44 the crack locations are shown as circles in this view, because the surface of the crack is nearly parallel to this plane.
