US Army Corps
of Engineers

Technical Report ITL-95-3
June 1995

Three-Dimensional, Nonlinear, Incremental Structural Analysis of a Culvert Valve Monolith Wall, Olmsted Locks

Prepared for U.S. Army Engineer District, Louisville
Louisville, KY 40201-0059

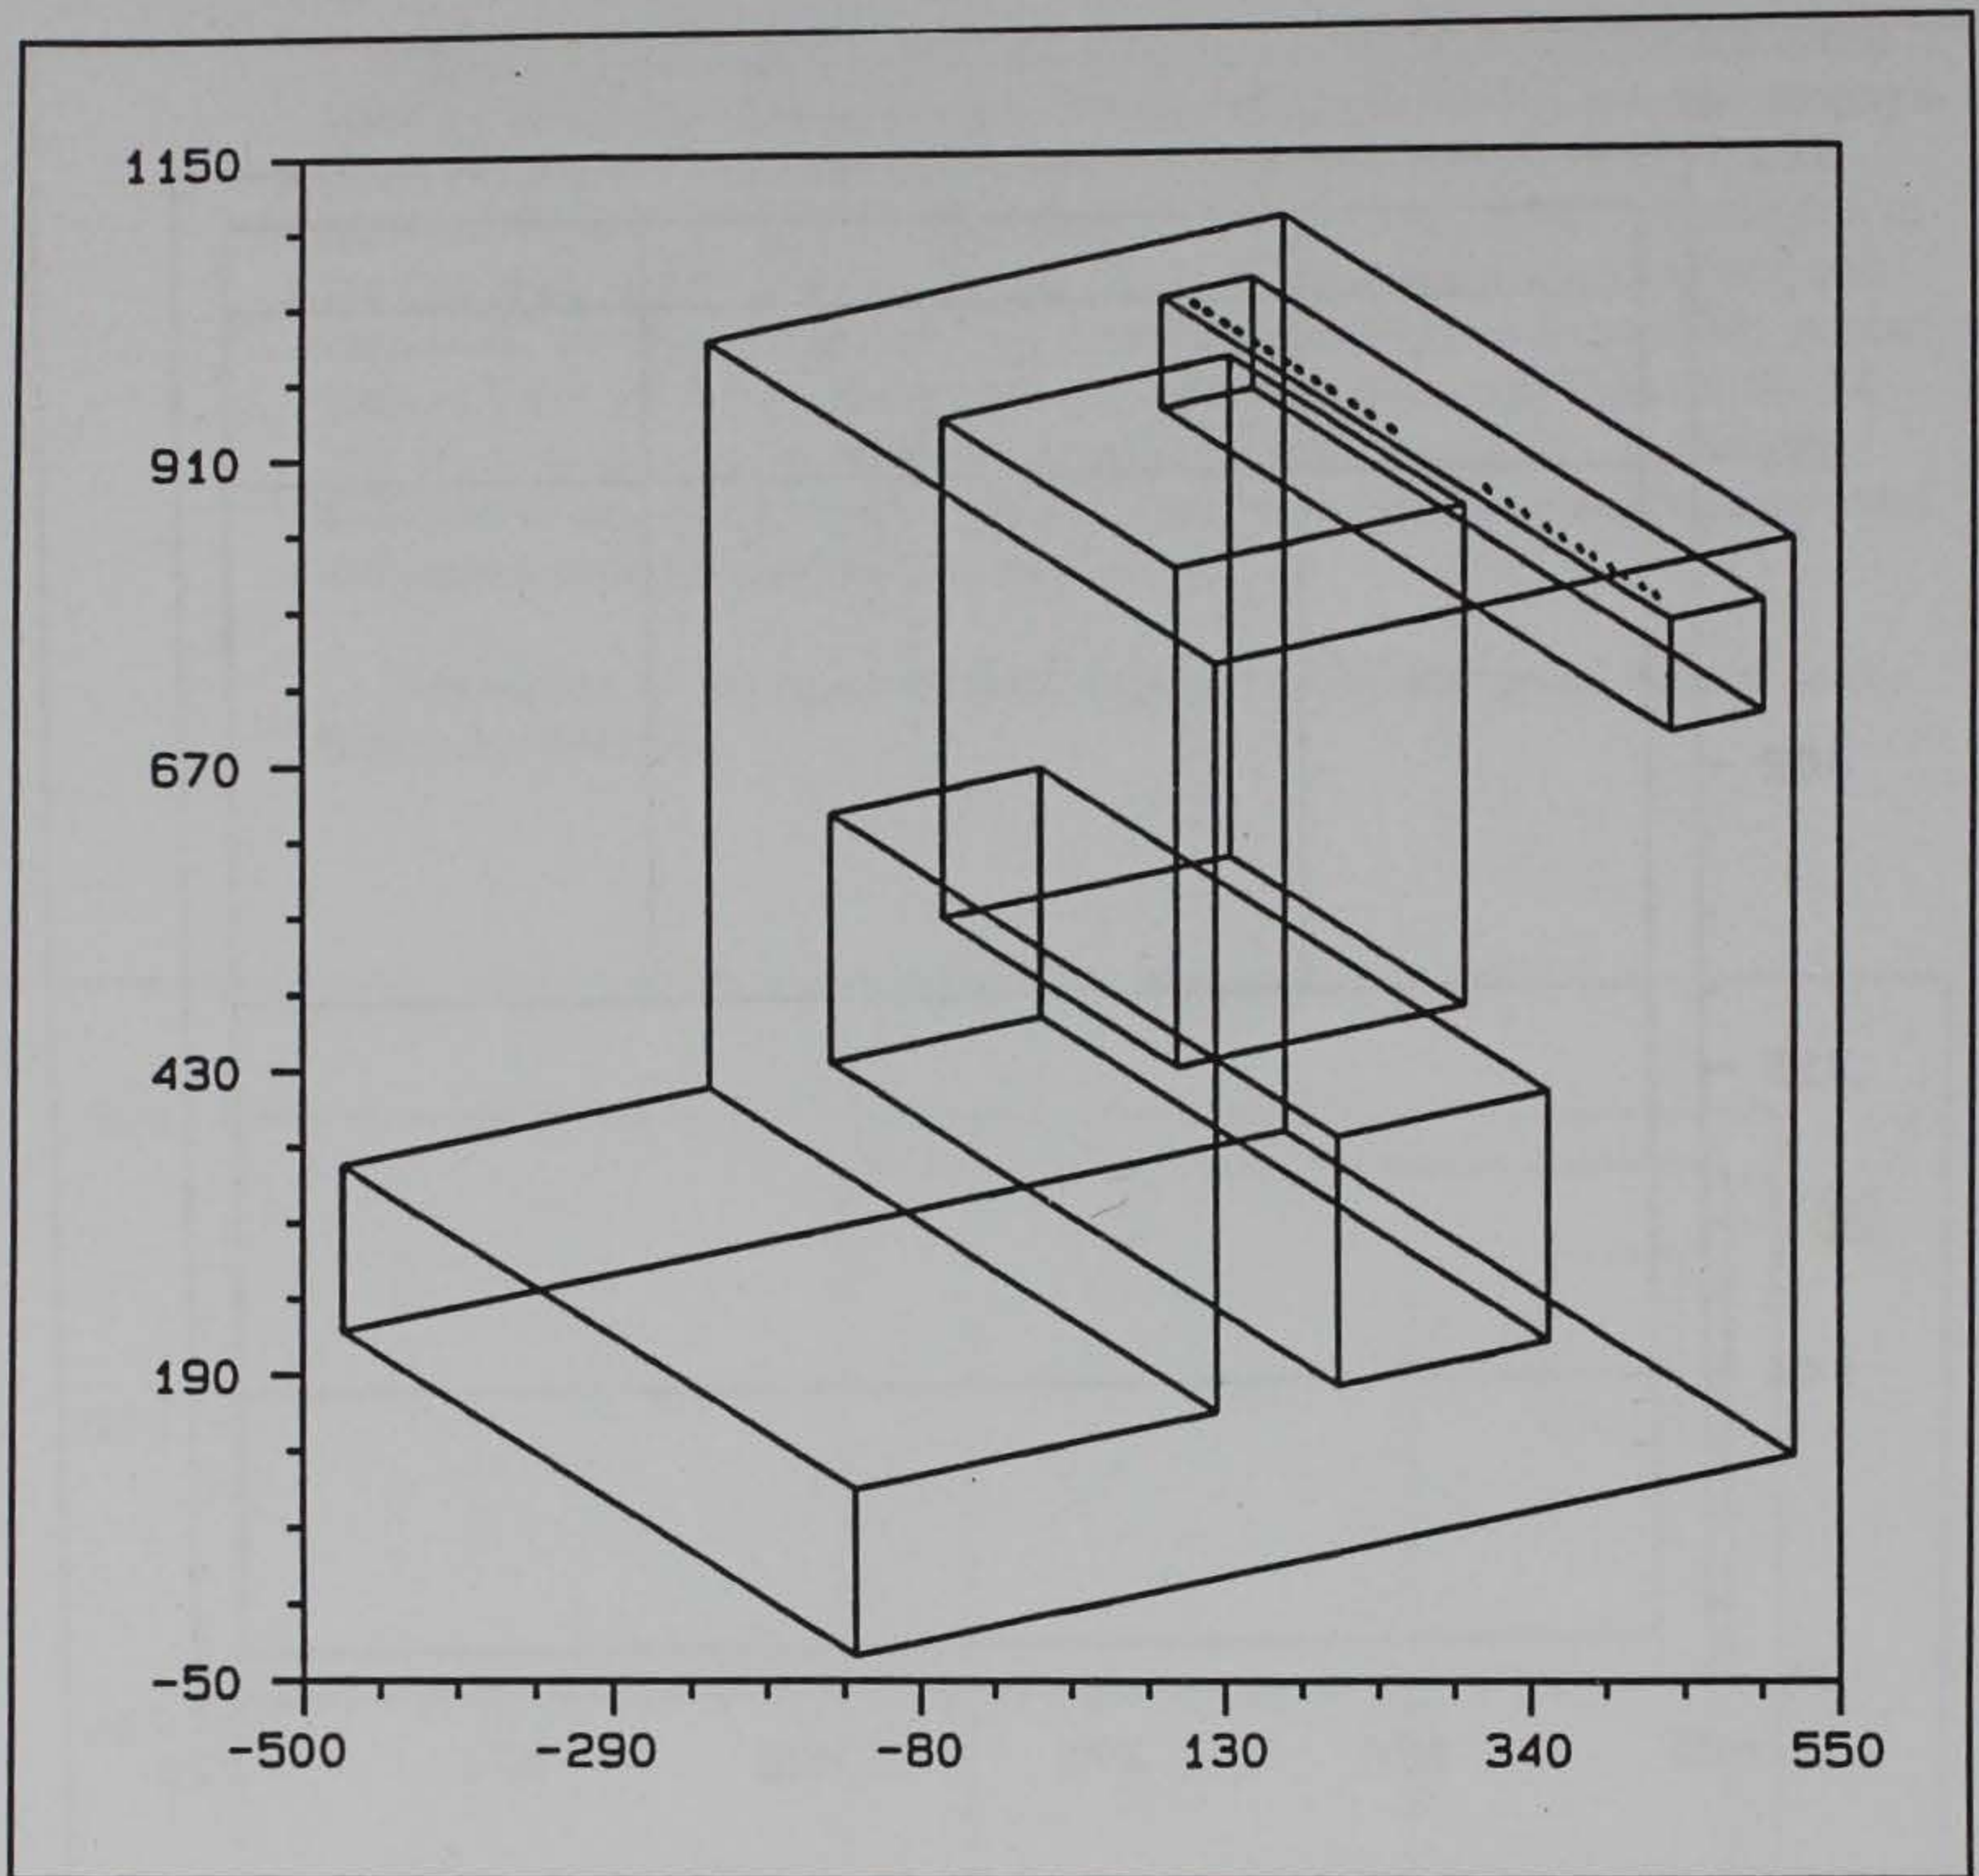
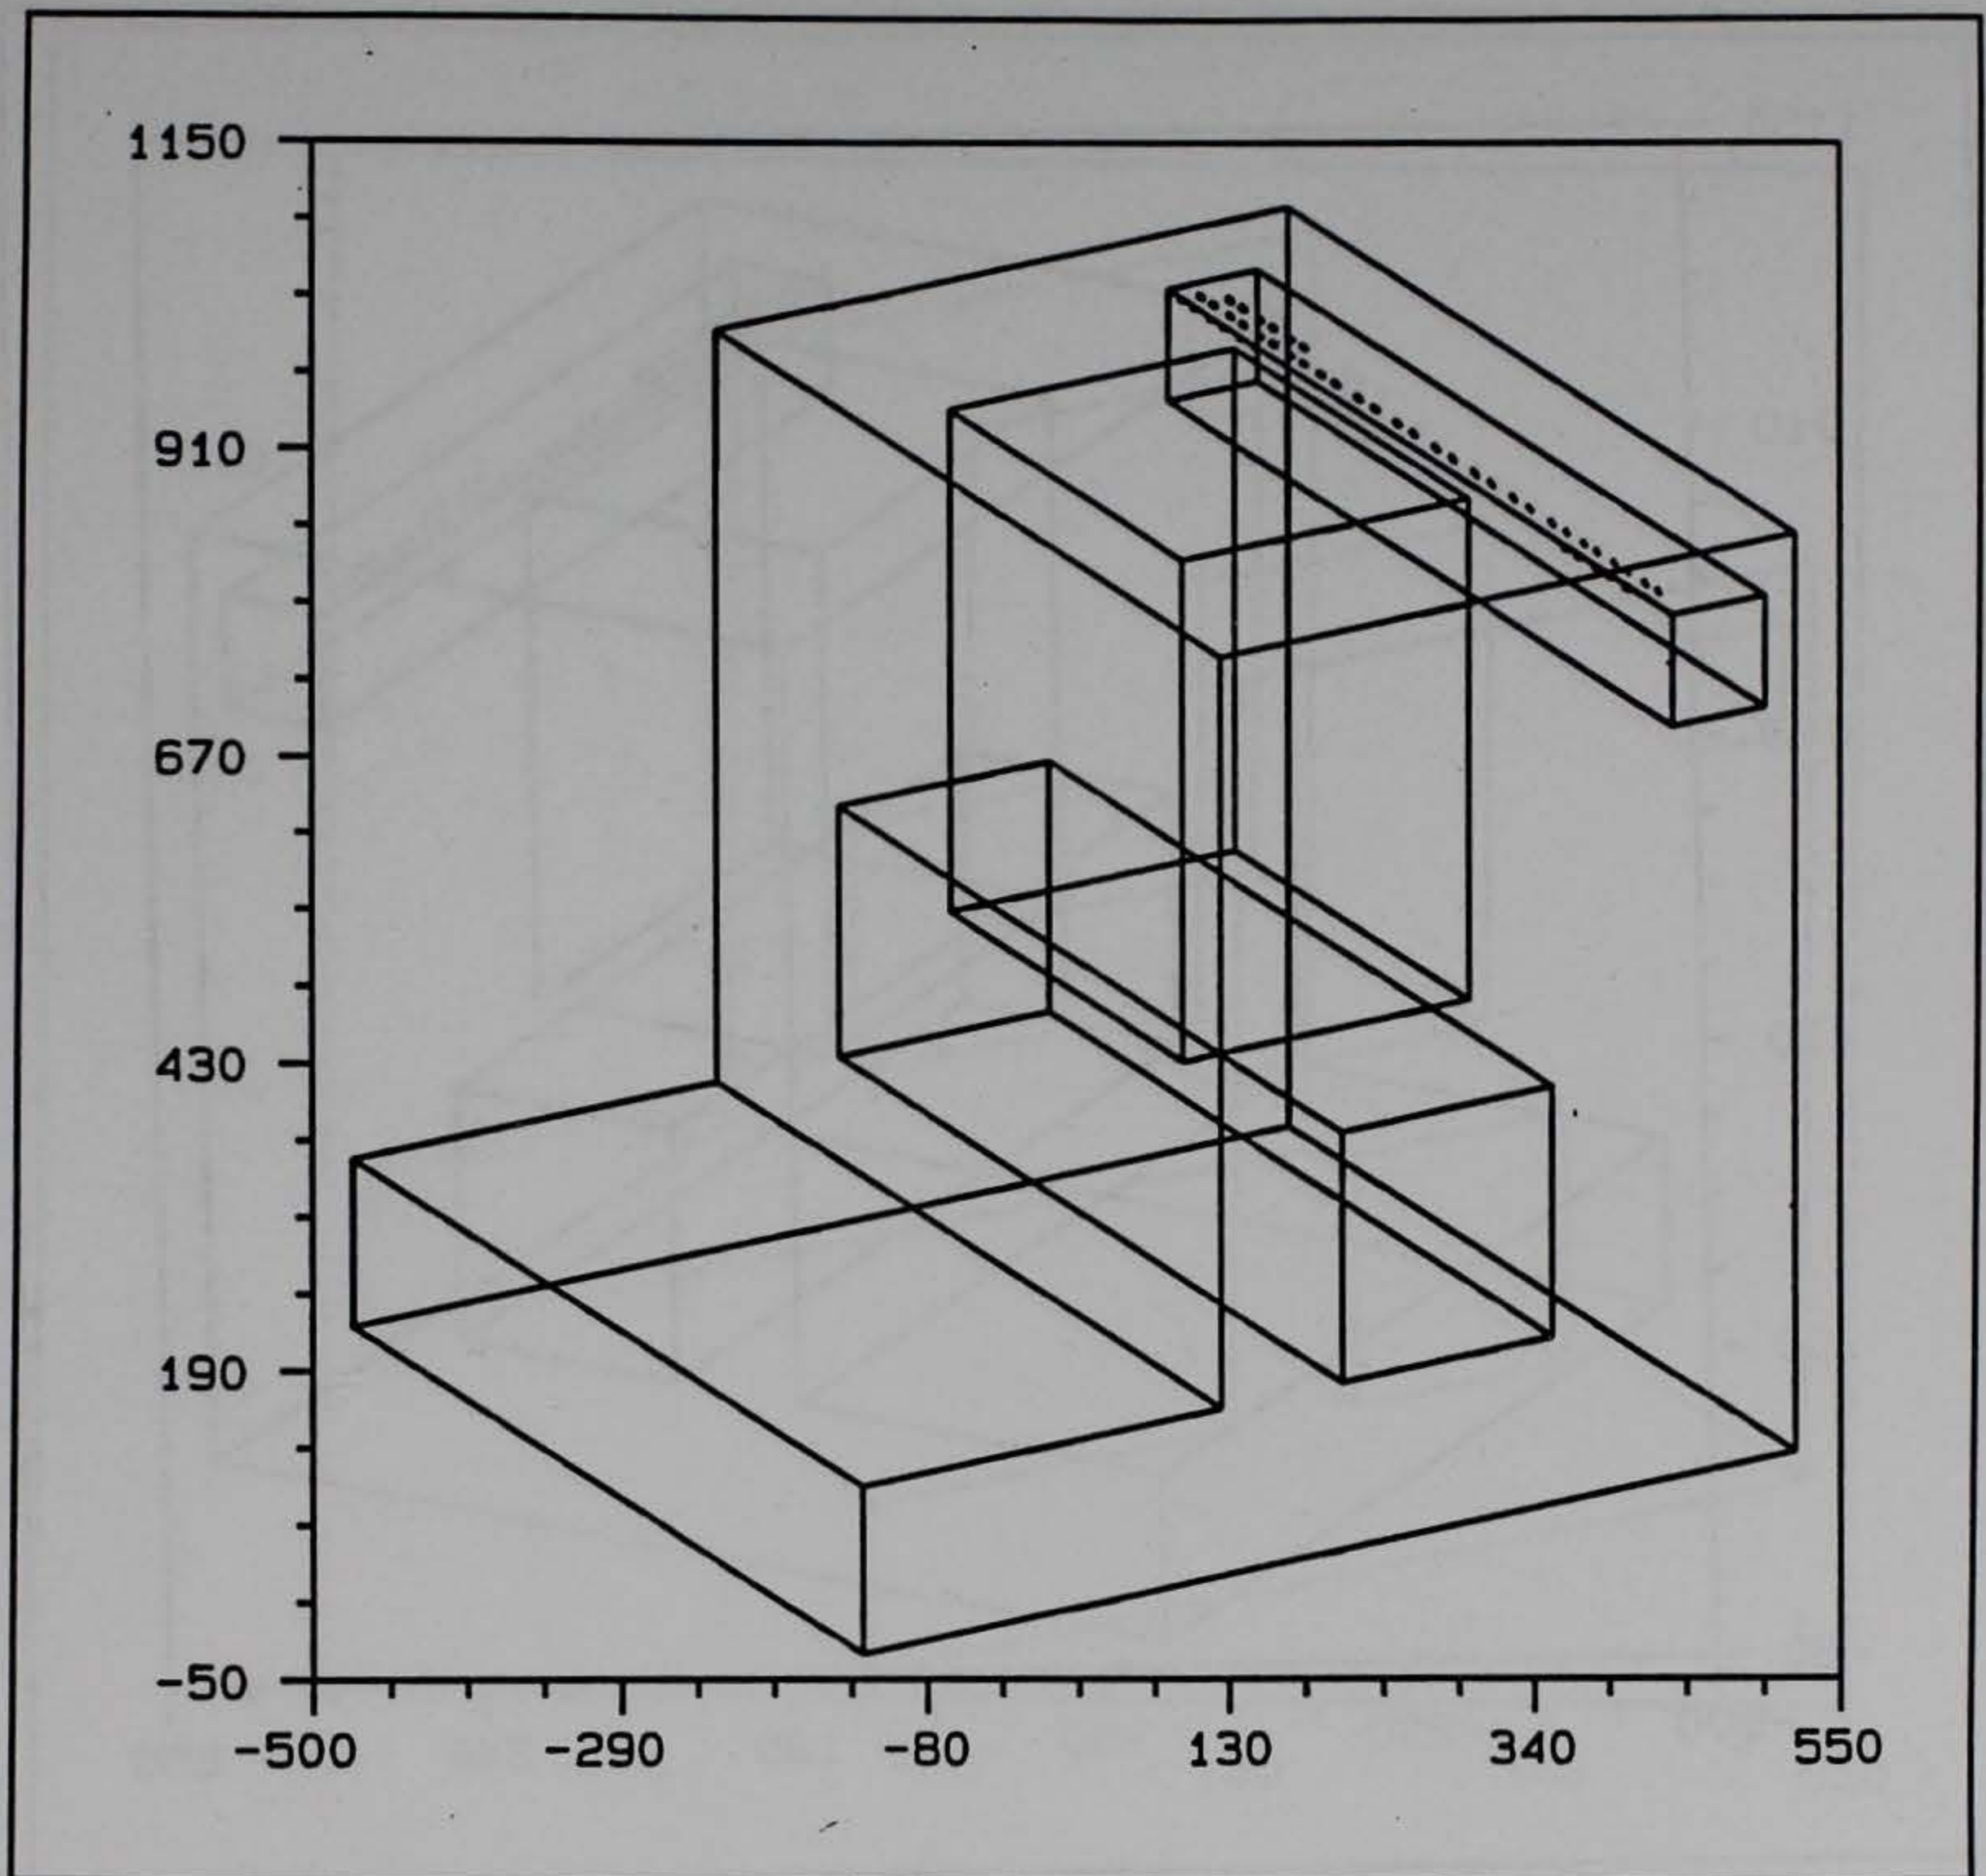
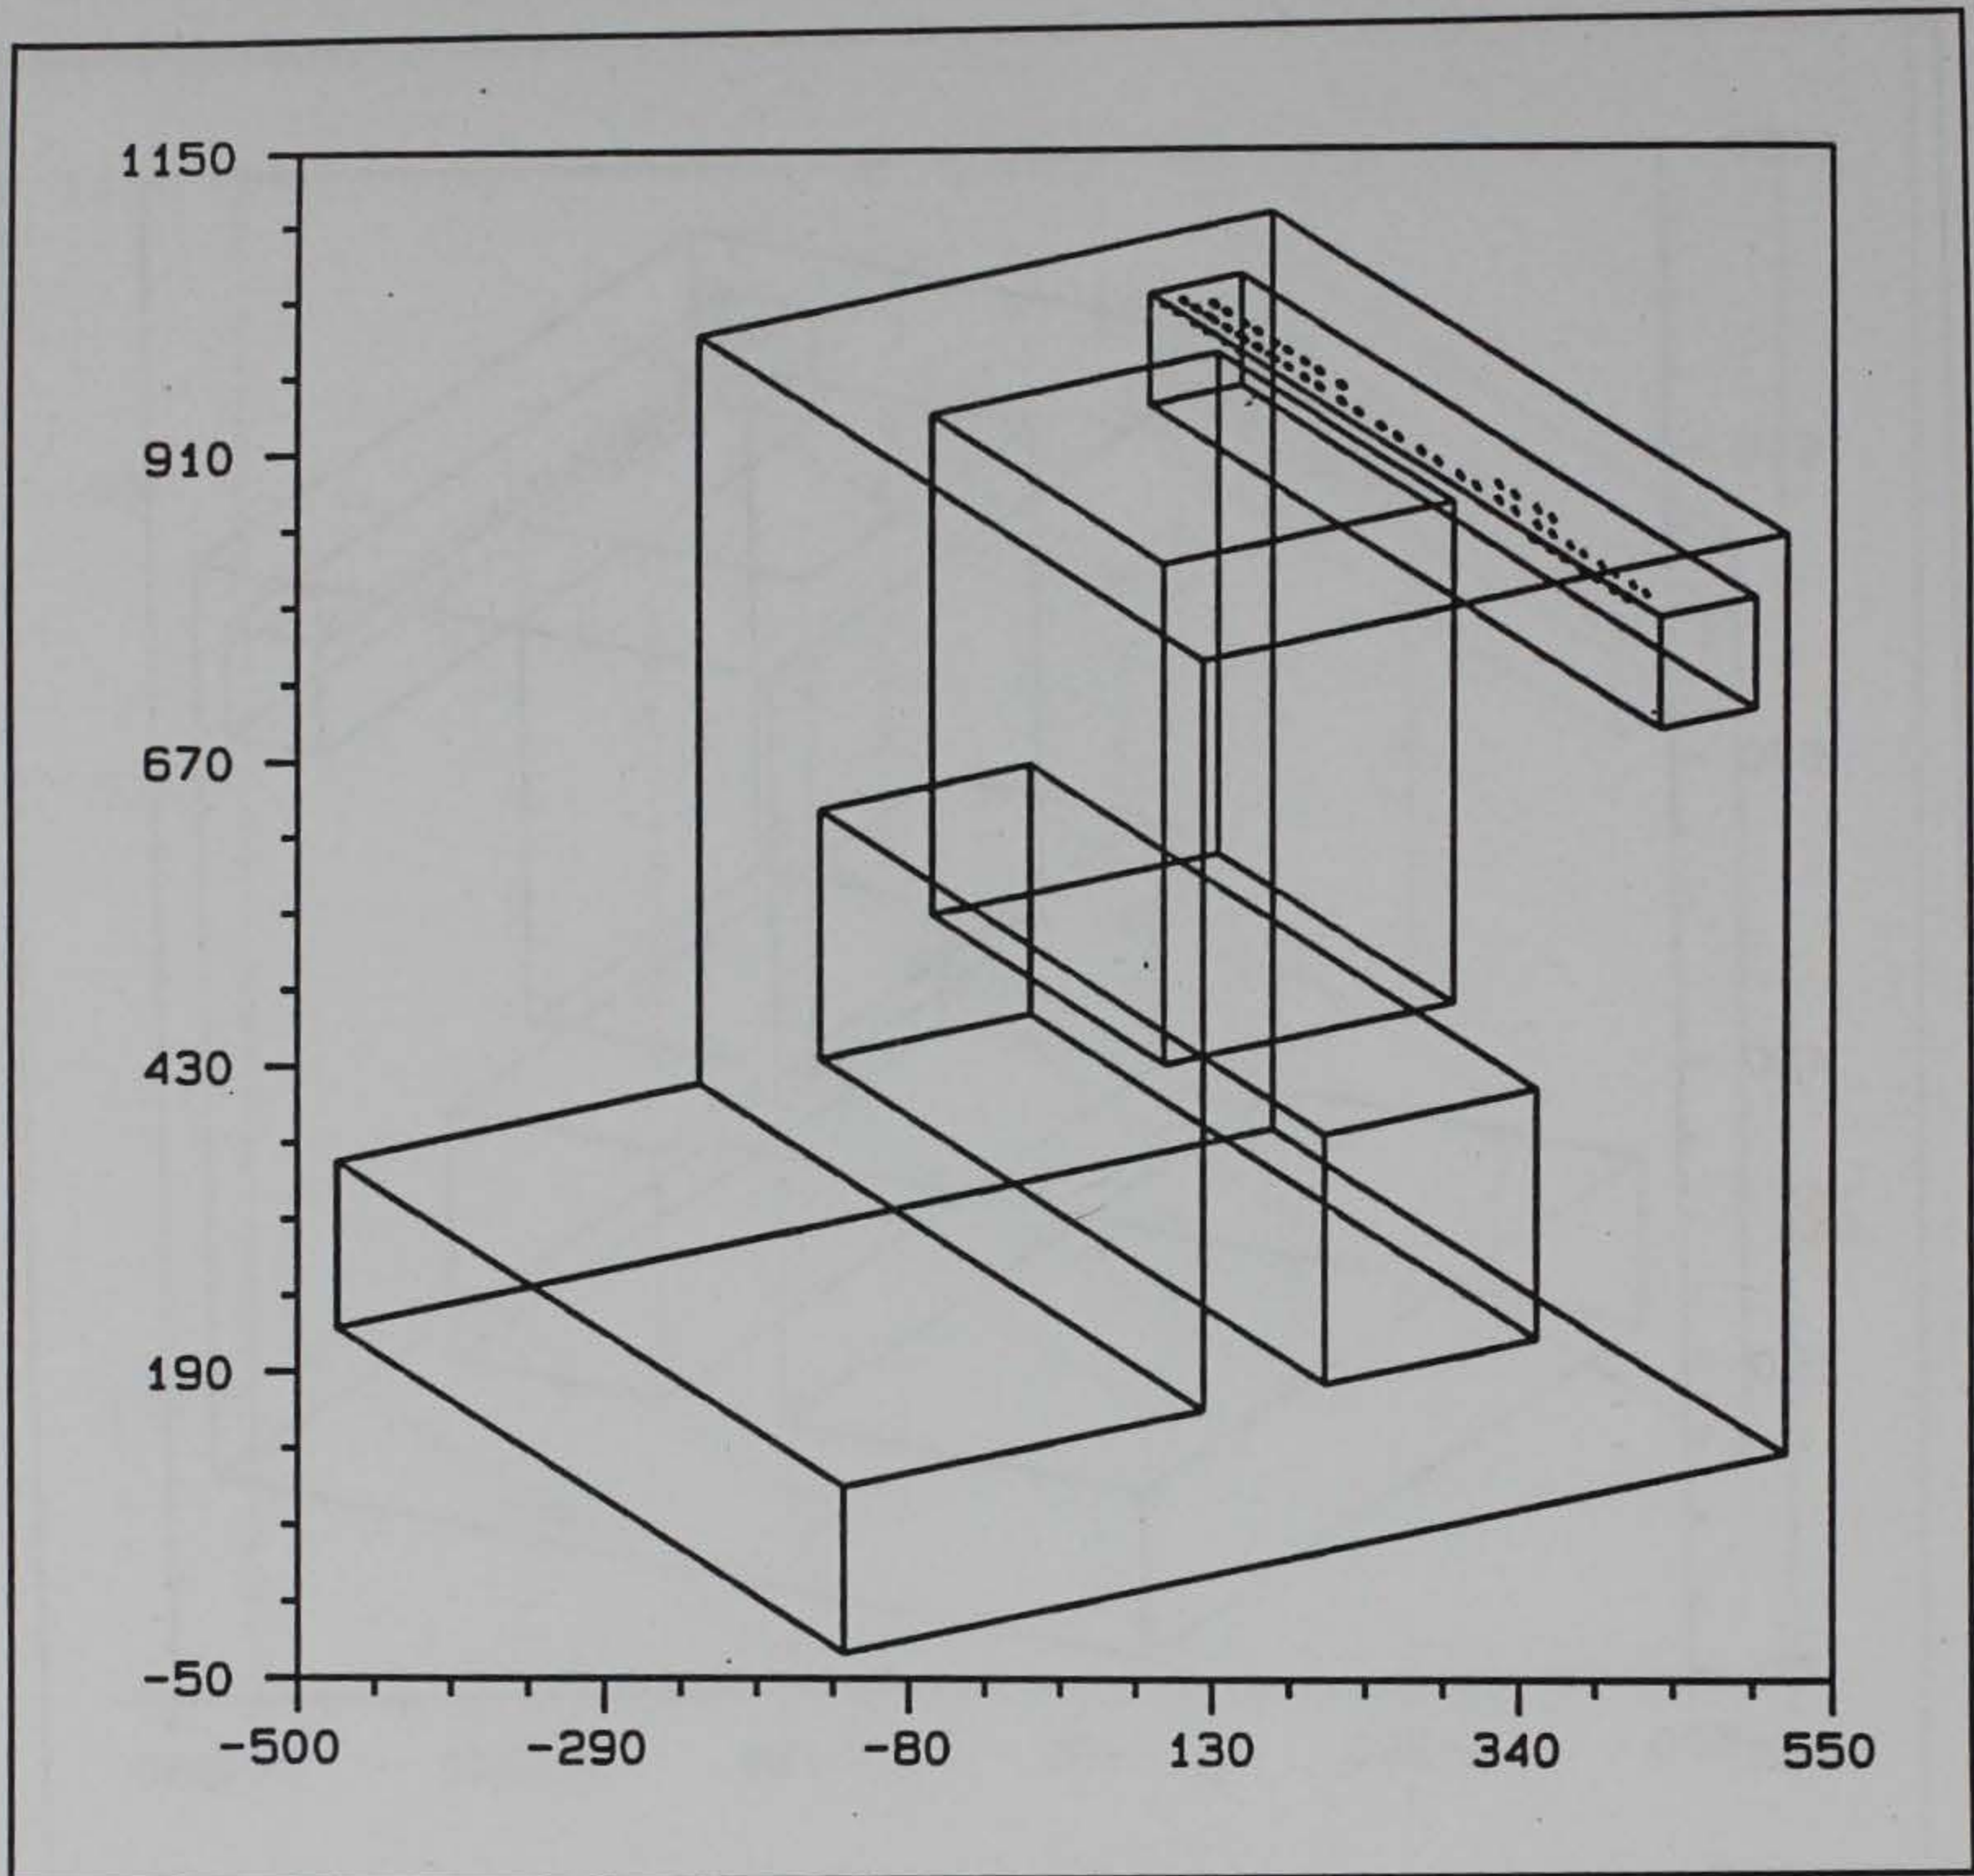
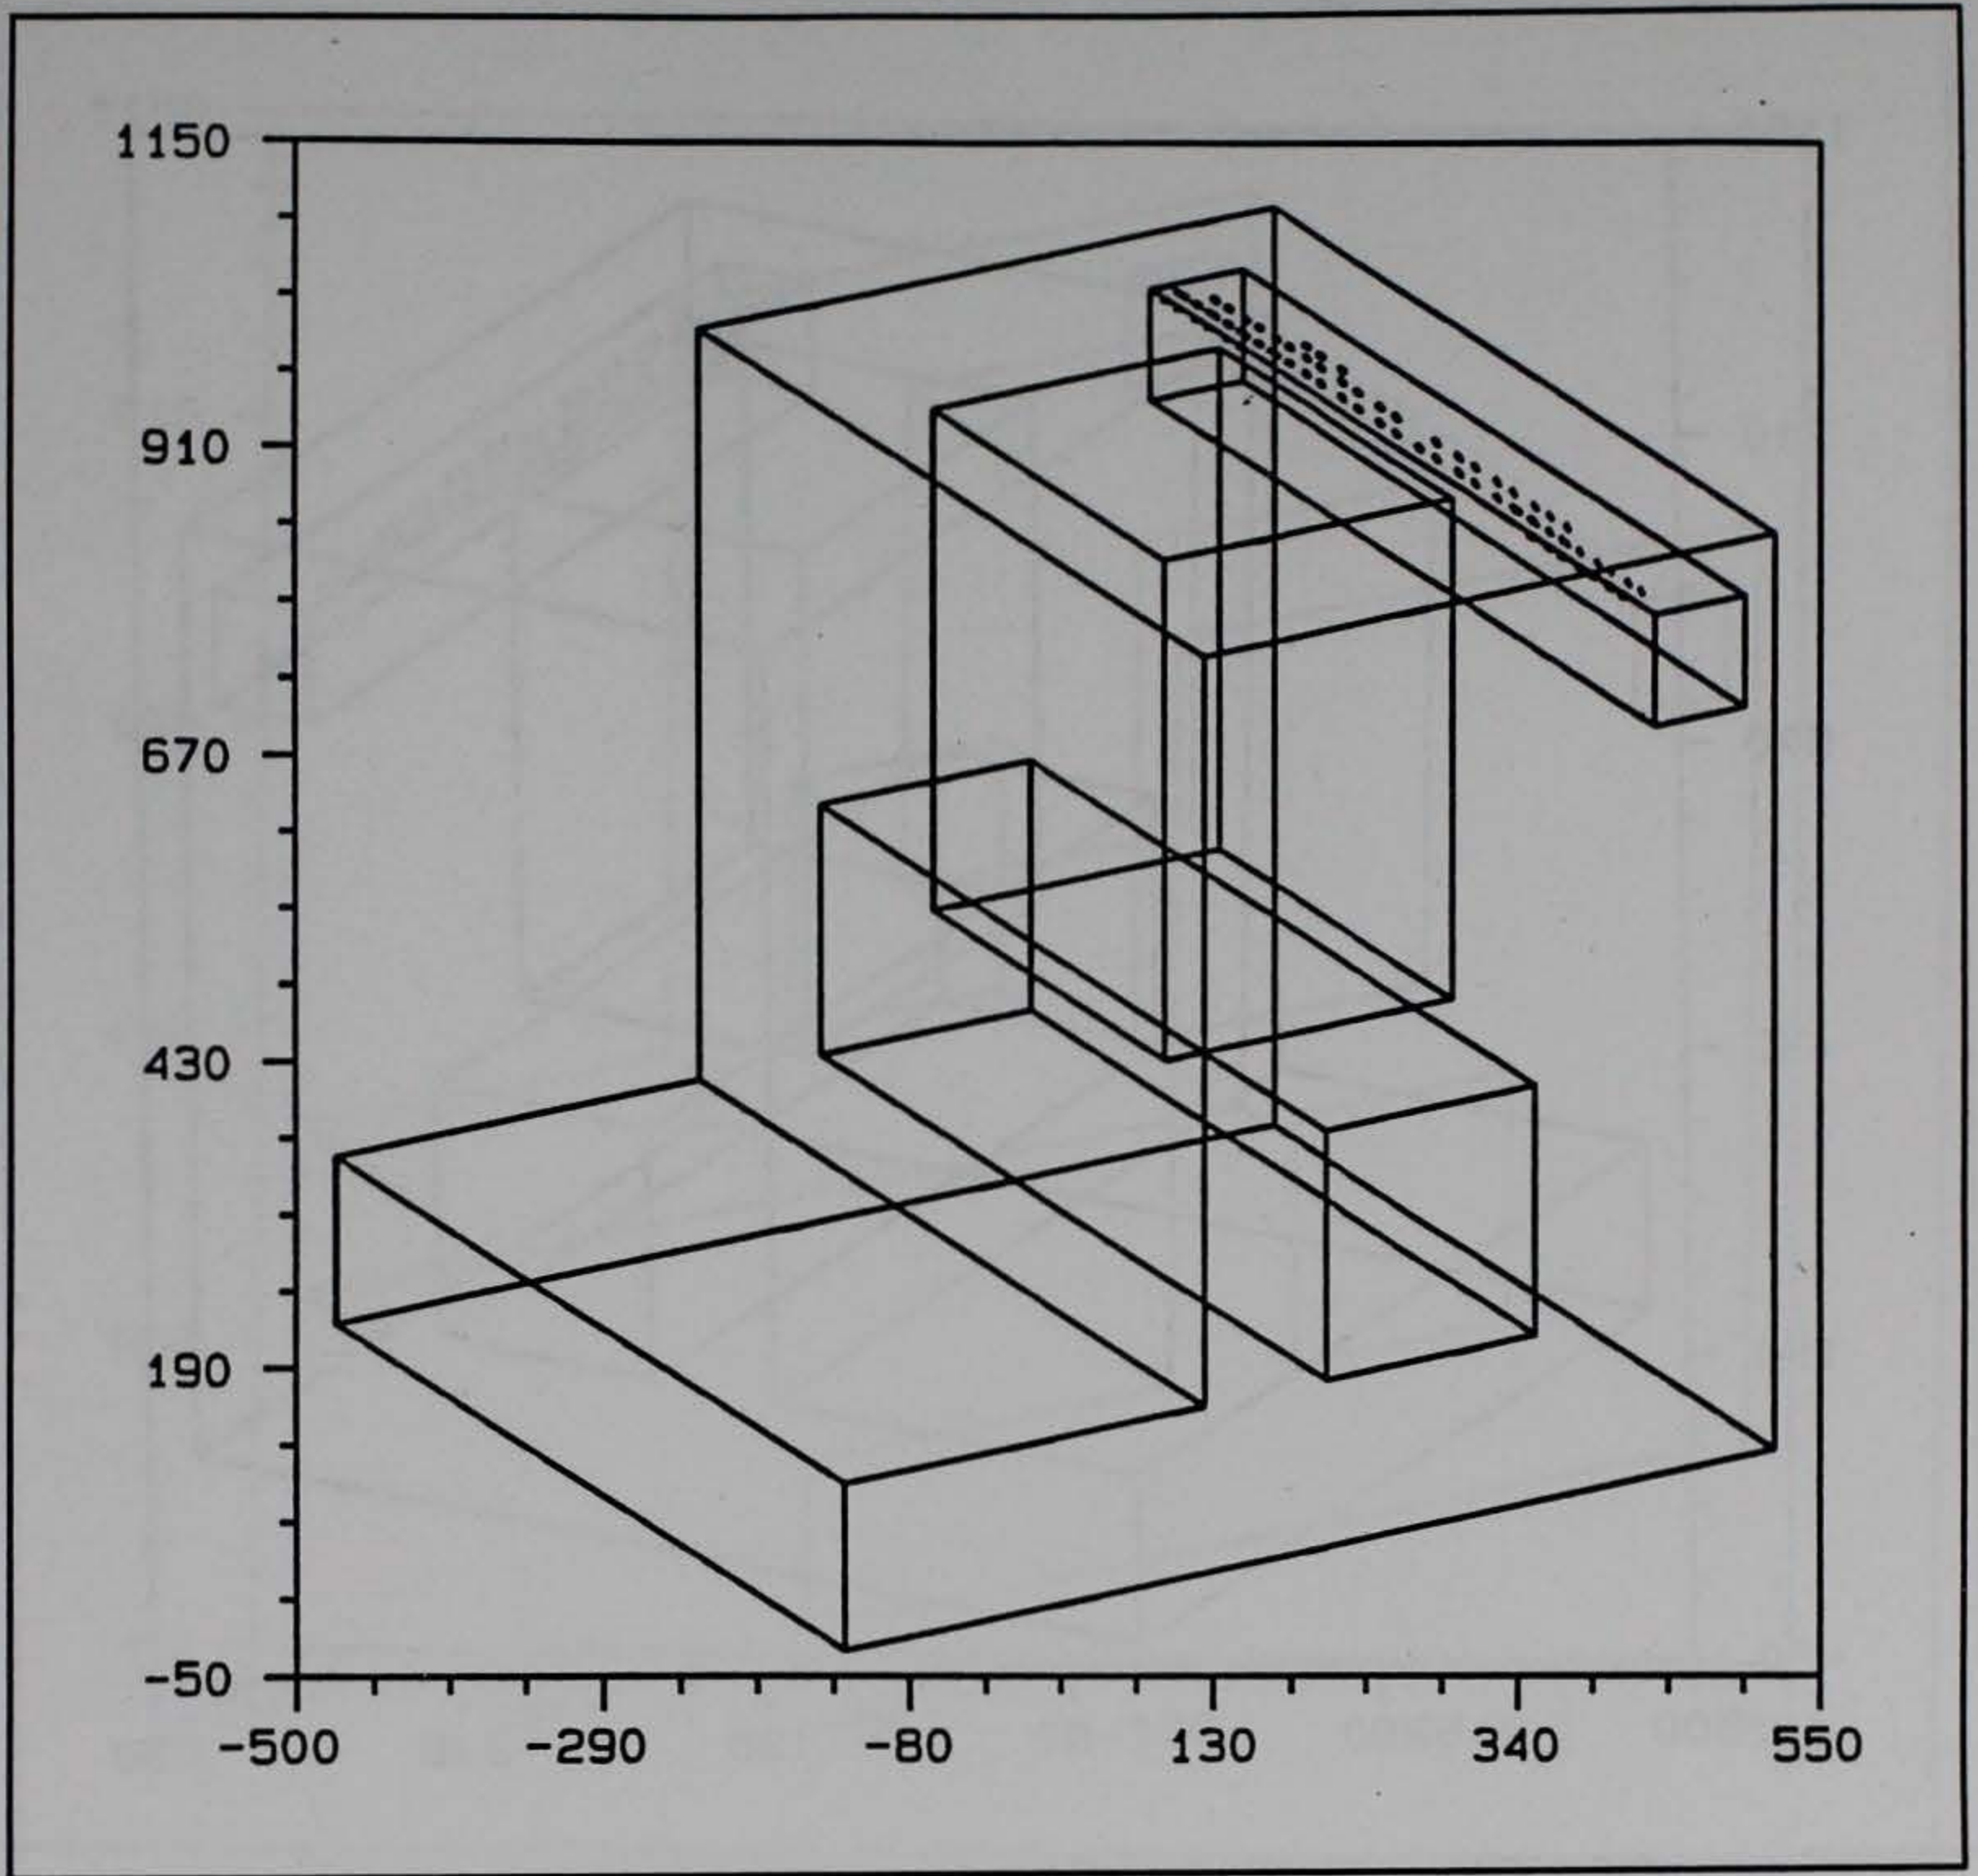
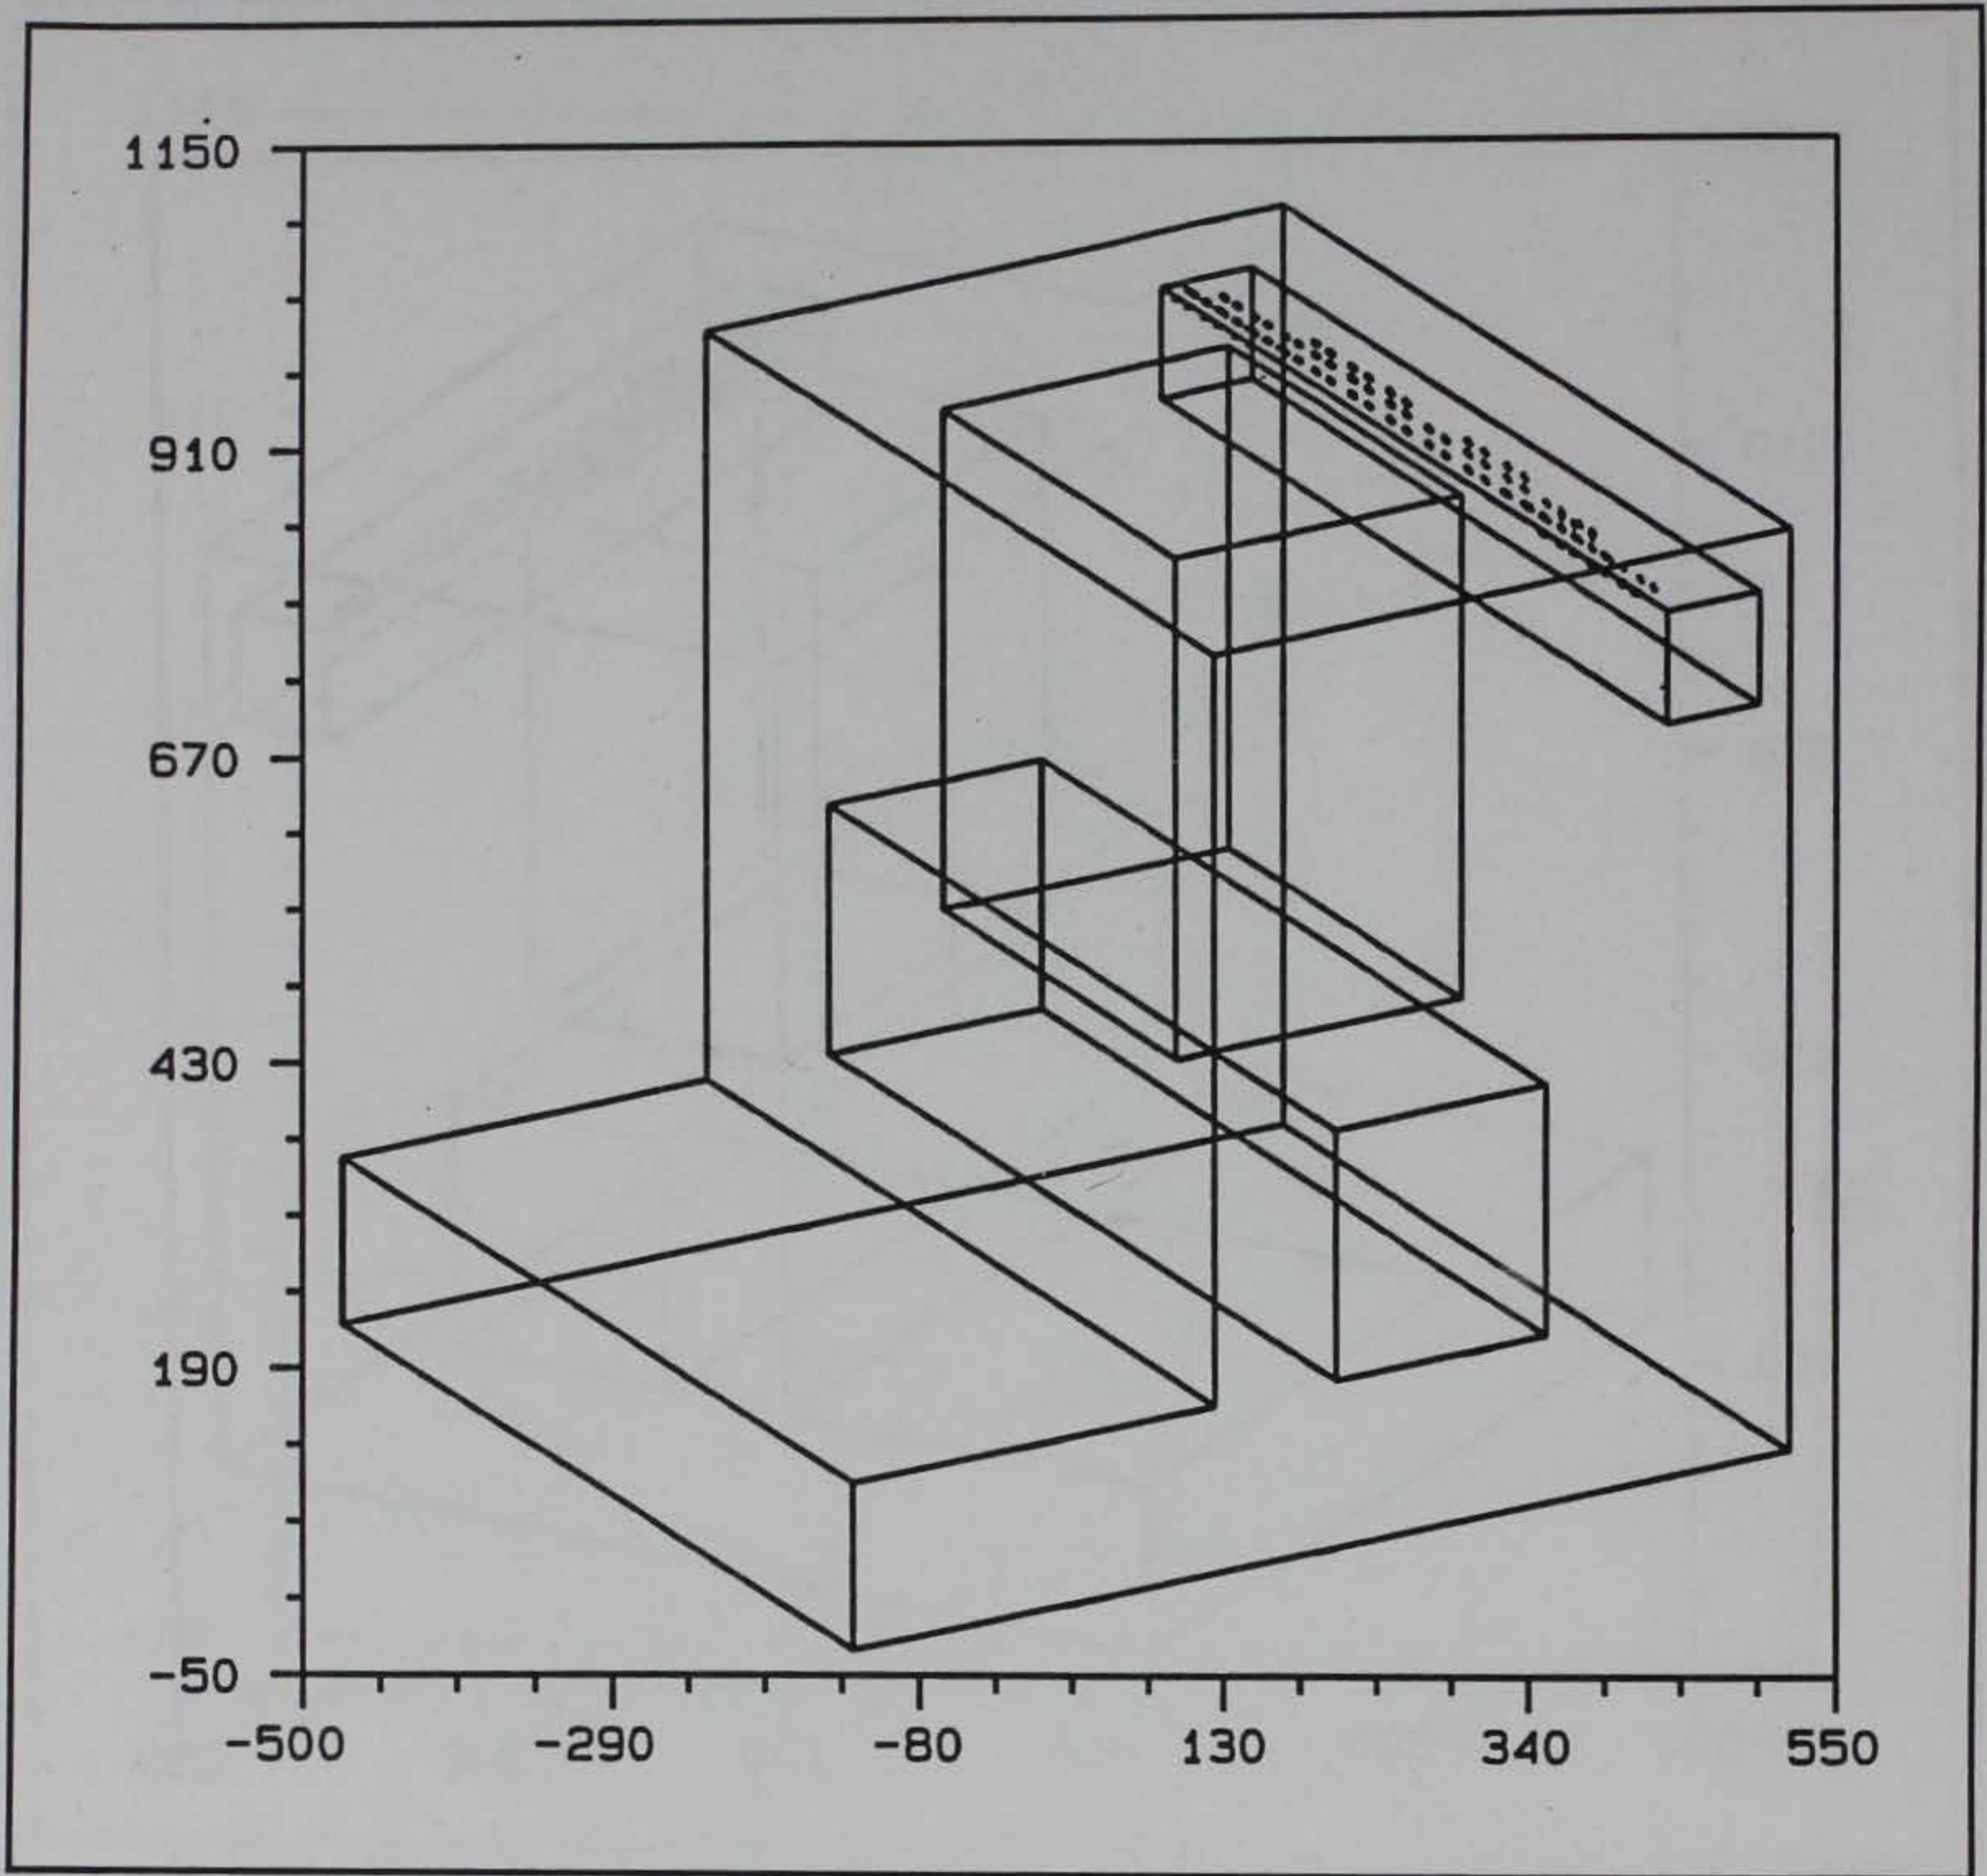
Figures 45 through 52 show the progression through time of the crack forming using the isometric view. Paging through the figures, the propagation of the crack is easily identifiable in Figures 45 through 50, but between Figures 50 and 52, the change is not as noticeable. This is due to the fact that by day 269 (Figure 50) most of the cracks have formed, and therefore, the new cracks are hard to identify in Figures 51 and 52. A plan view, a front elevation, and a side elevation are shown in Figures 53, 54, and 55, respectively, to show the final layout of the cracks. Again, the direction of the cracks can be seen in Figure 54, and they angle away from the corner initially and then propagate up.

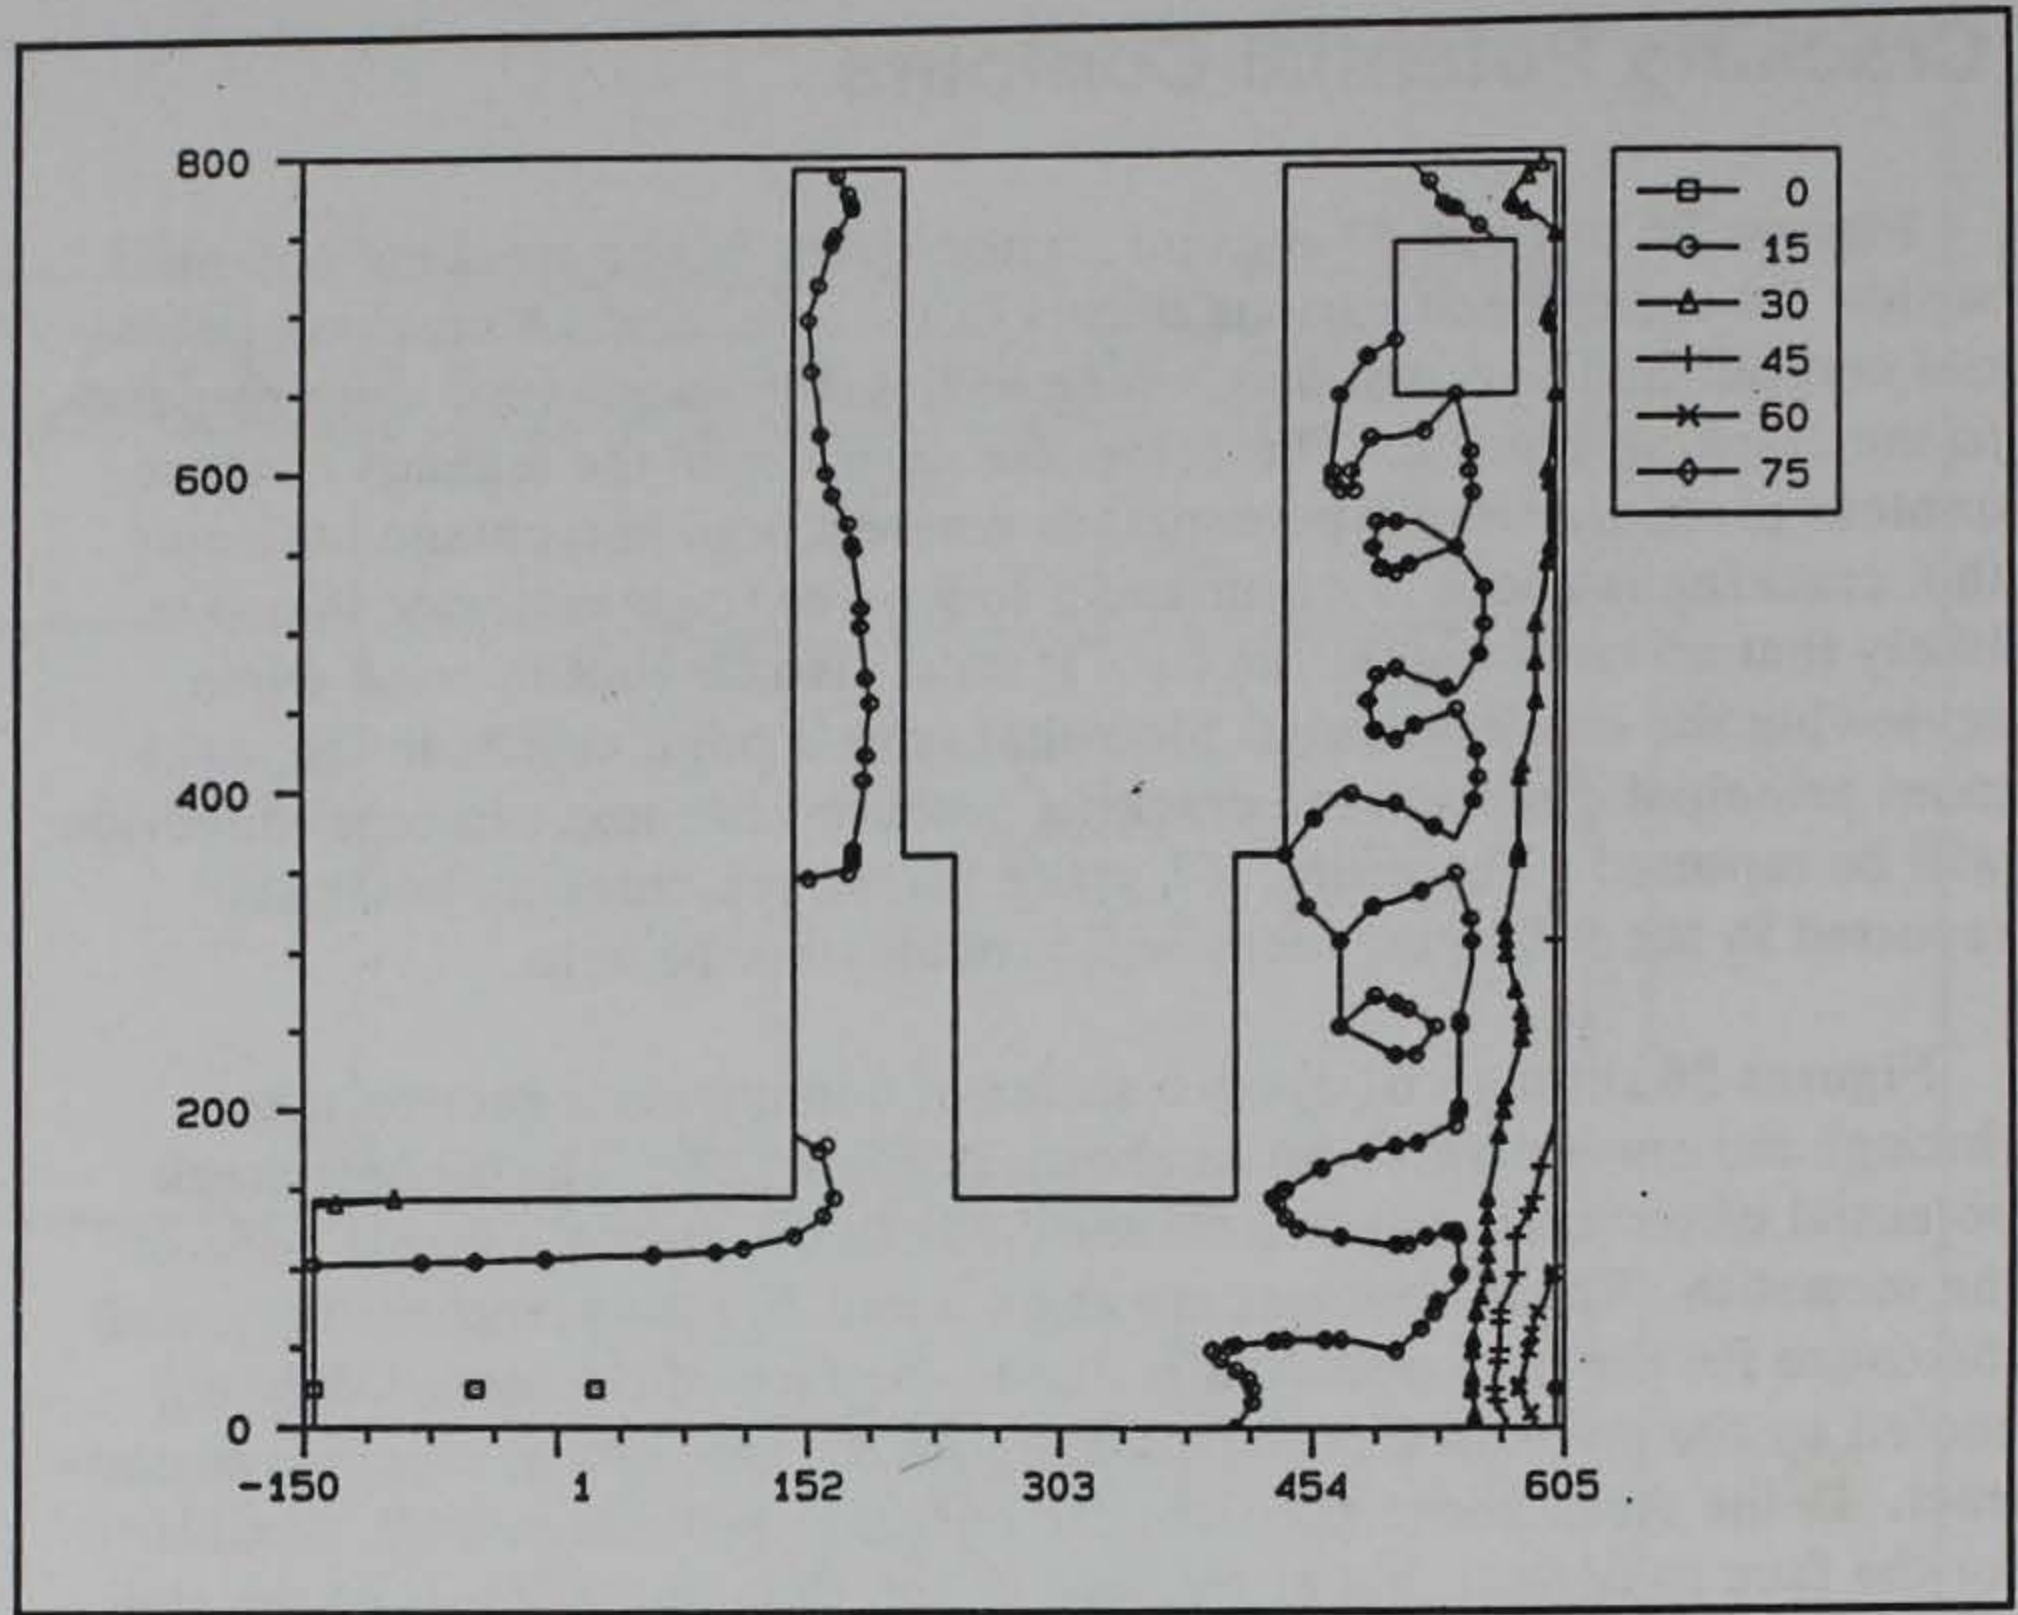
Figure 56. Crack potential contours, transverse section through valve pit at day 64.5

Figures 56 through 61 show a series of contours at a section taken through the culvert valve pit as shown in Figure 20. The highest crack potential observed in Figures 56 and 57 is in the bottom outside edge of the monolith. These contours are at 64.5 and 104 days, respectively, and the cause for the high potential is due to the face of the monolith being cooled by the ambient air temperature. As the face cools, it begins to contract. In the areas above the slab, the openings provide enough flexibility for the face to deflect, but at the base of the slab, the stiffness of the slab in the horizontal direction restrains the face from deflecting and induces a stress which causes the high cracking potentials seen in the two figures.
