US Army Corps
of Engineers

Technical Report ITL-95-3
June 1995

Three-Dimensional, Nonlinear, Incremental Structural Analysis of a Culvert Valve Monolith Wall, Olmsted Locks

Prepared for U.S. Army Engineer District, Louisville
Louisville, KY 40201-0059

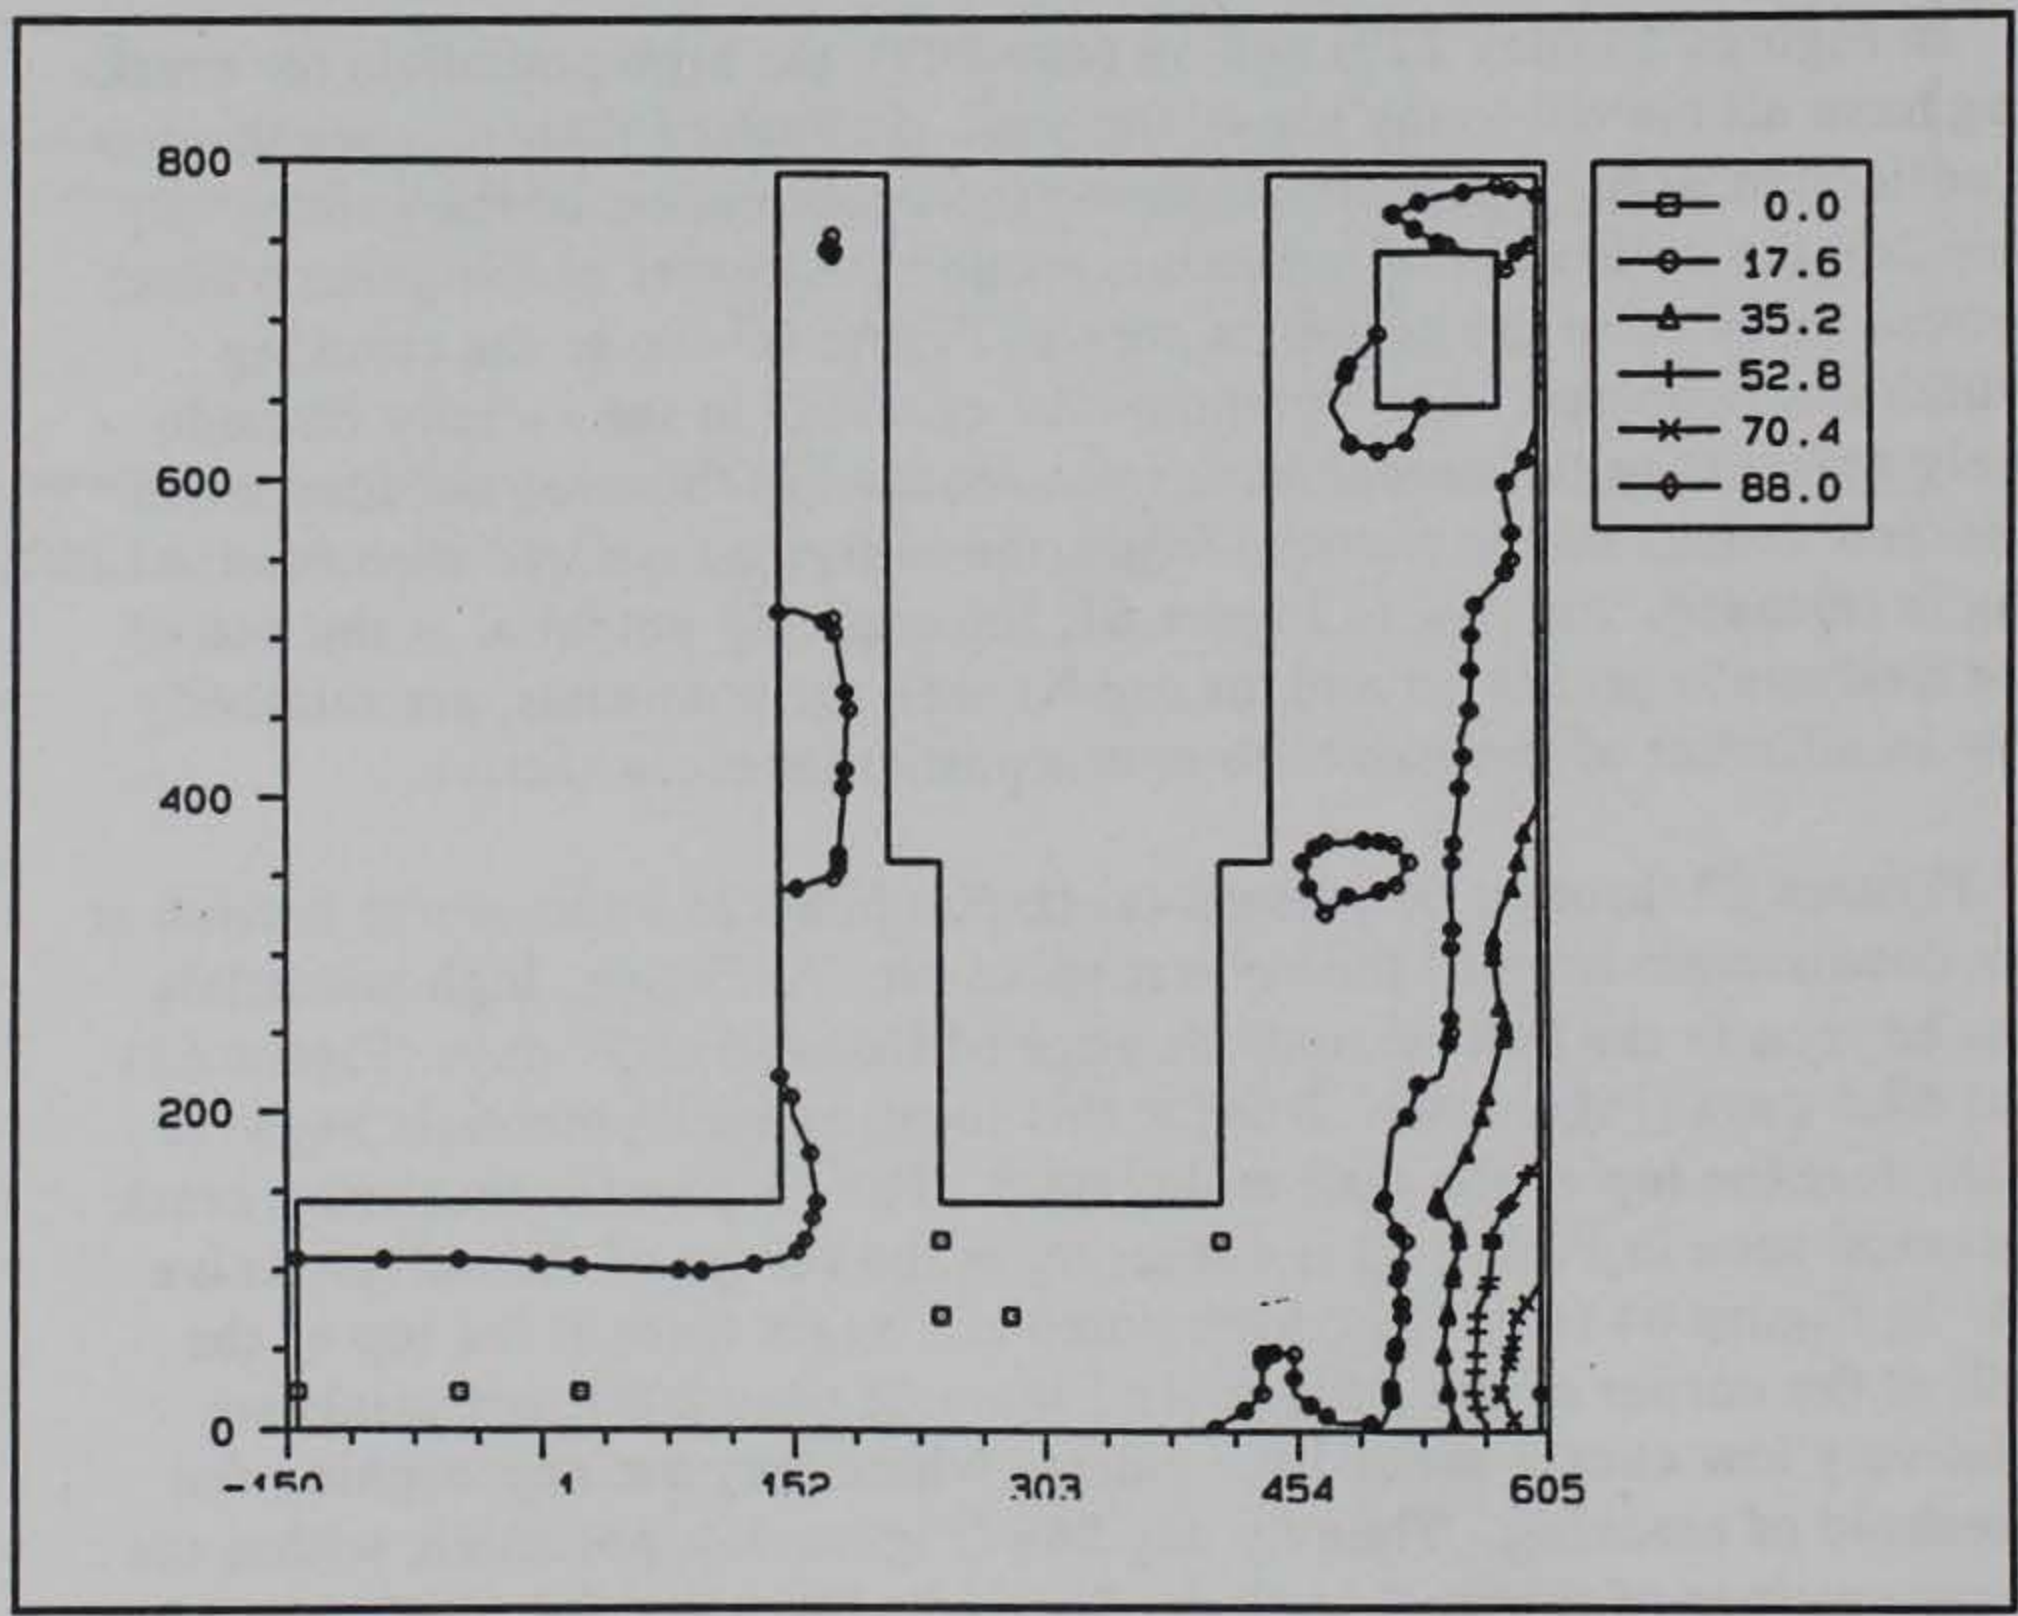
Figure 57. Crack potential contours, transverse section through valve pit at day 104

Figures 56 through 61 show a series of contours at a section taken through the culvert valve pit as shown in Figure 20. The highest crack potential observed in Figures 56 and 57 is in the bottom outside edge of the monolith. These contours are at 64.5 and 104 days, respectively, and the cause for the high potential is due to the face of the monolith being cooled by the ambient air temperature. As the face cools, it begins to contract. In the areas above the slab, the openings provide enough flexibility for the face to deflect, but at the base of the slab, the stiffness of the slab in the horizontal direction restrains the face from deflecting and induces a stress which causes the high cracking potentials seen in the two figures.

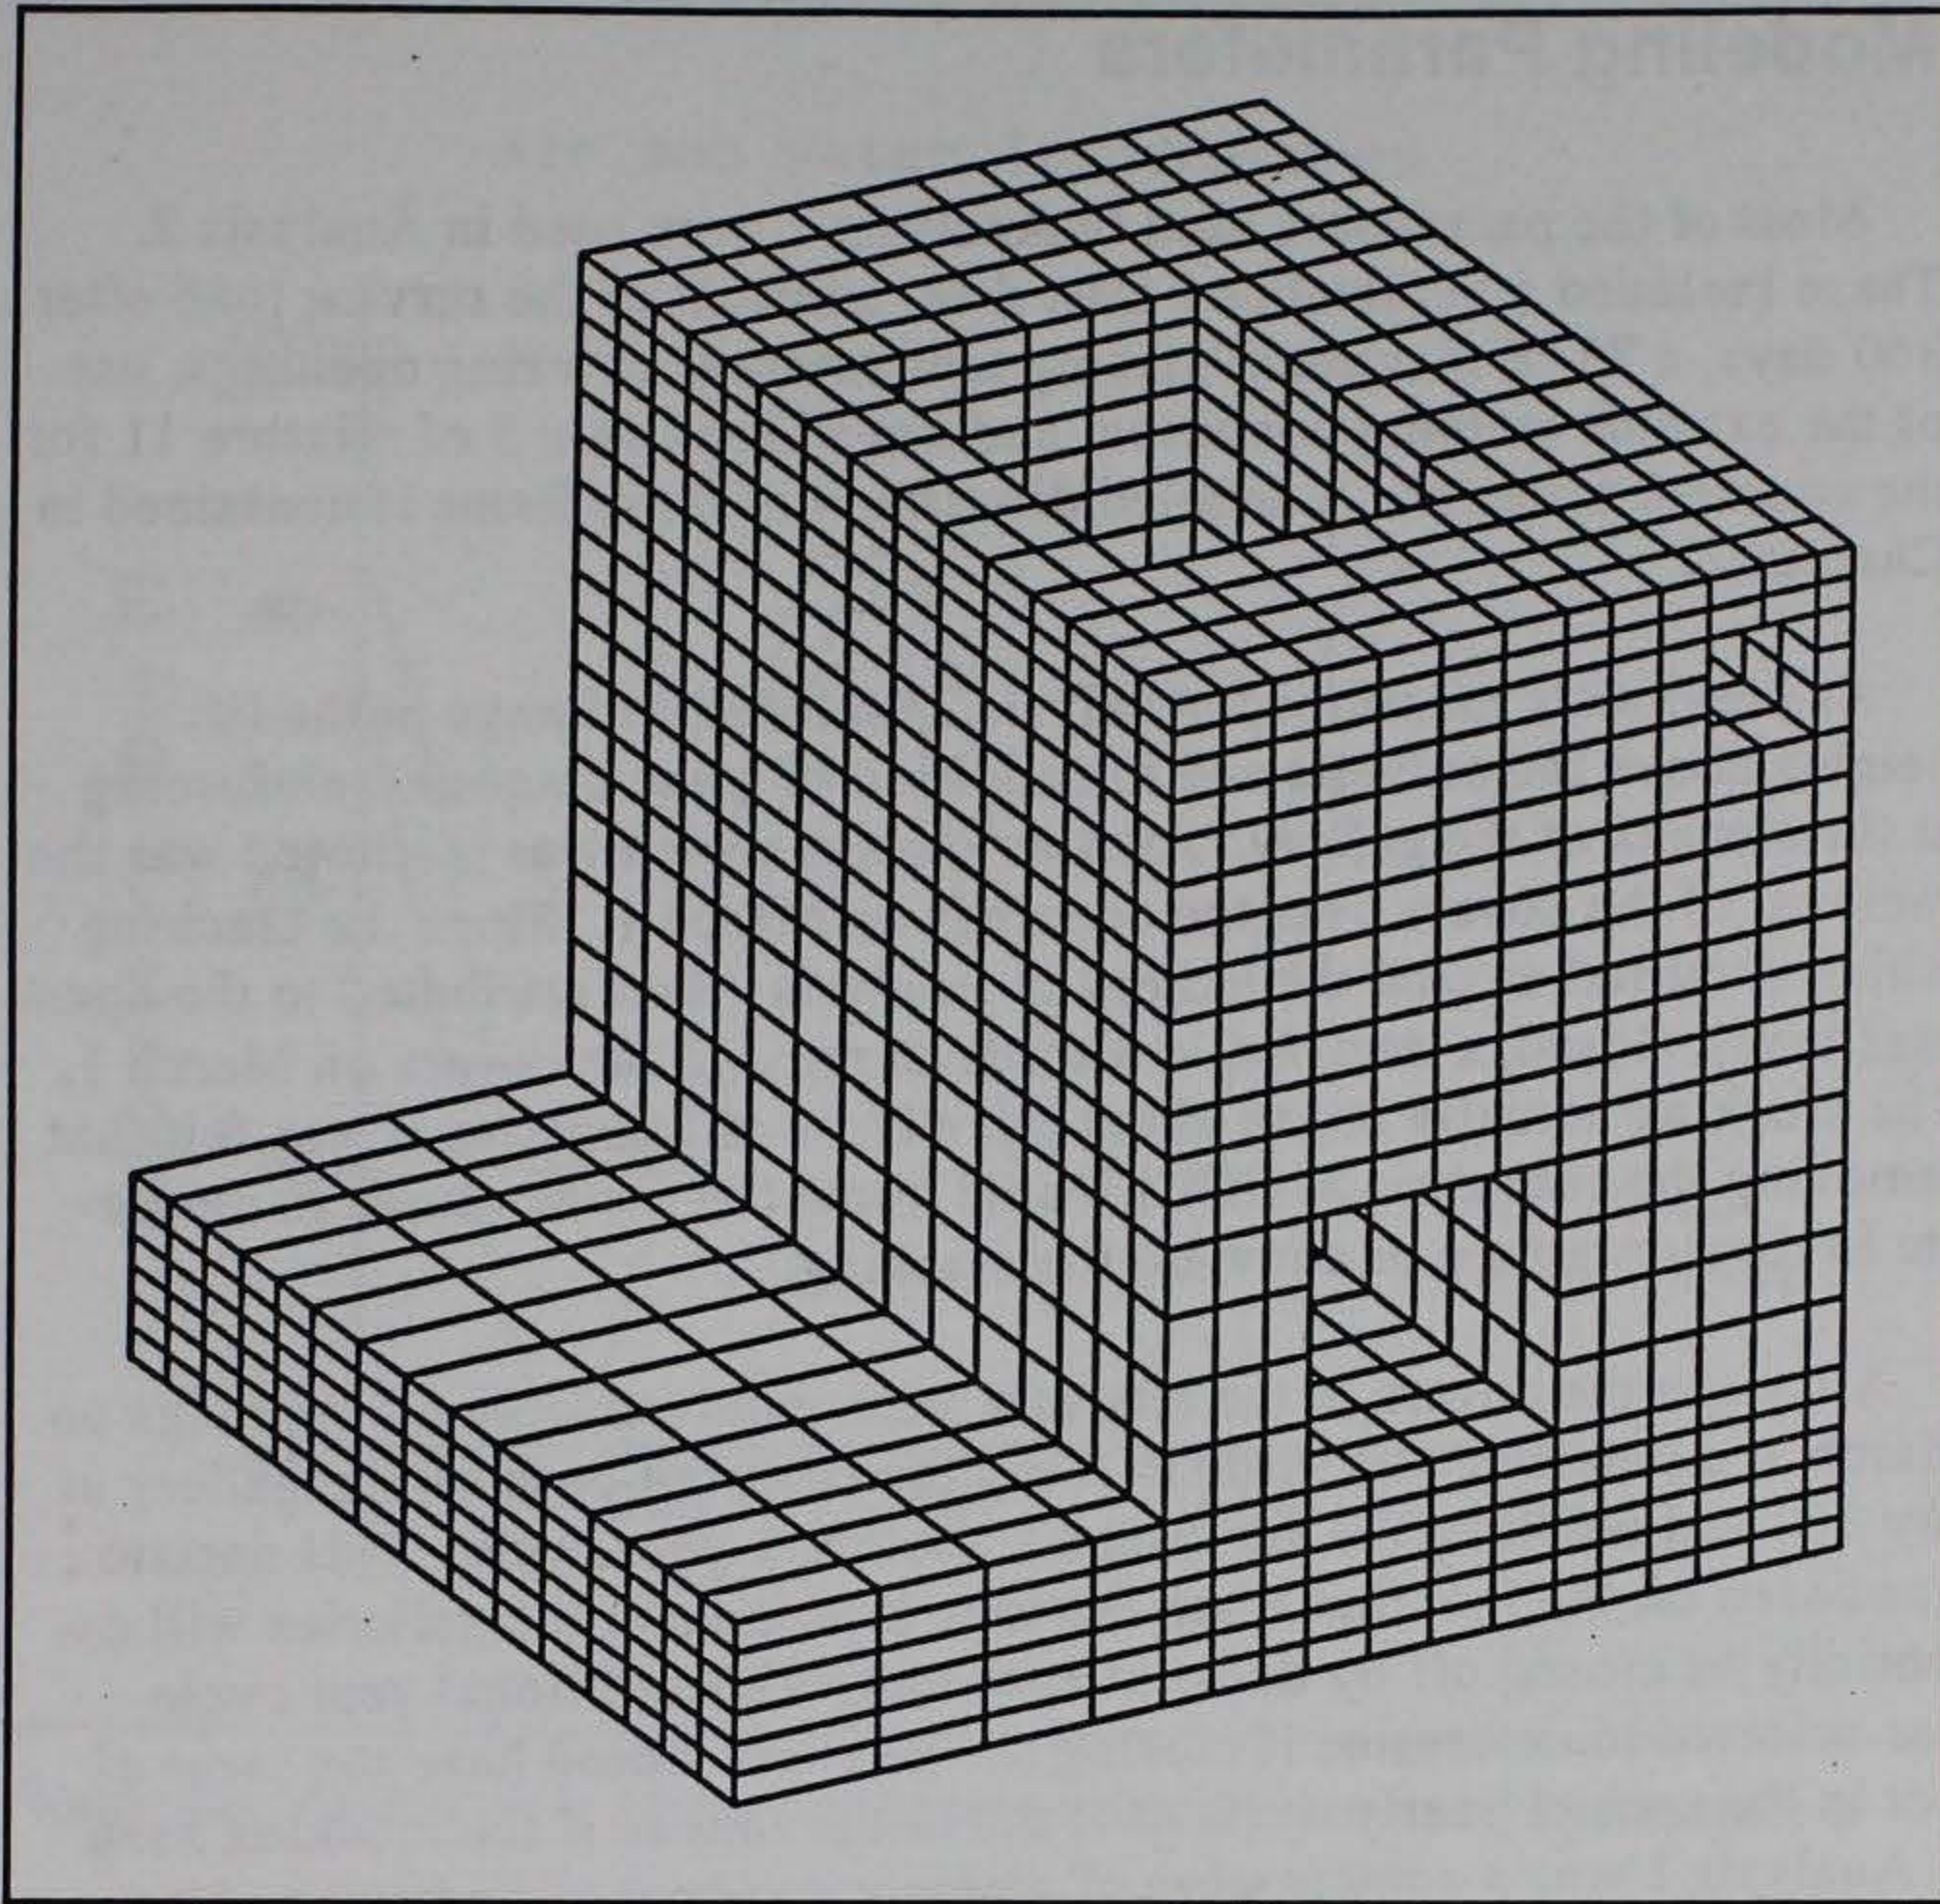
Figure 84. Isometric of the finite element mesh used for monolith 17

Due to the change in lift heights, a change in the mesh was required for the portion of the monolith above the culvert. This change resulted in a model requiring 4,047 three-D elements which is 447 elements more than were used in Analysis 1 and is shown in Figure 84. Although the Analysis 2 mesh contains more elements than the mesh from Analysis 1, many of the elements exceed the element size limit prescribed in ETL 1110-2-324 (HQDOA 1990). Since none of the elements in Analysis 2 are larger than the elements in Analysis 1, the comments regarding exceeding the element size limitations given in Chapter 2 still apply.

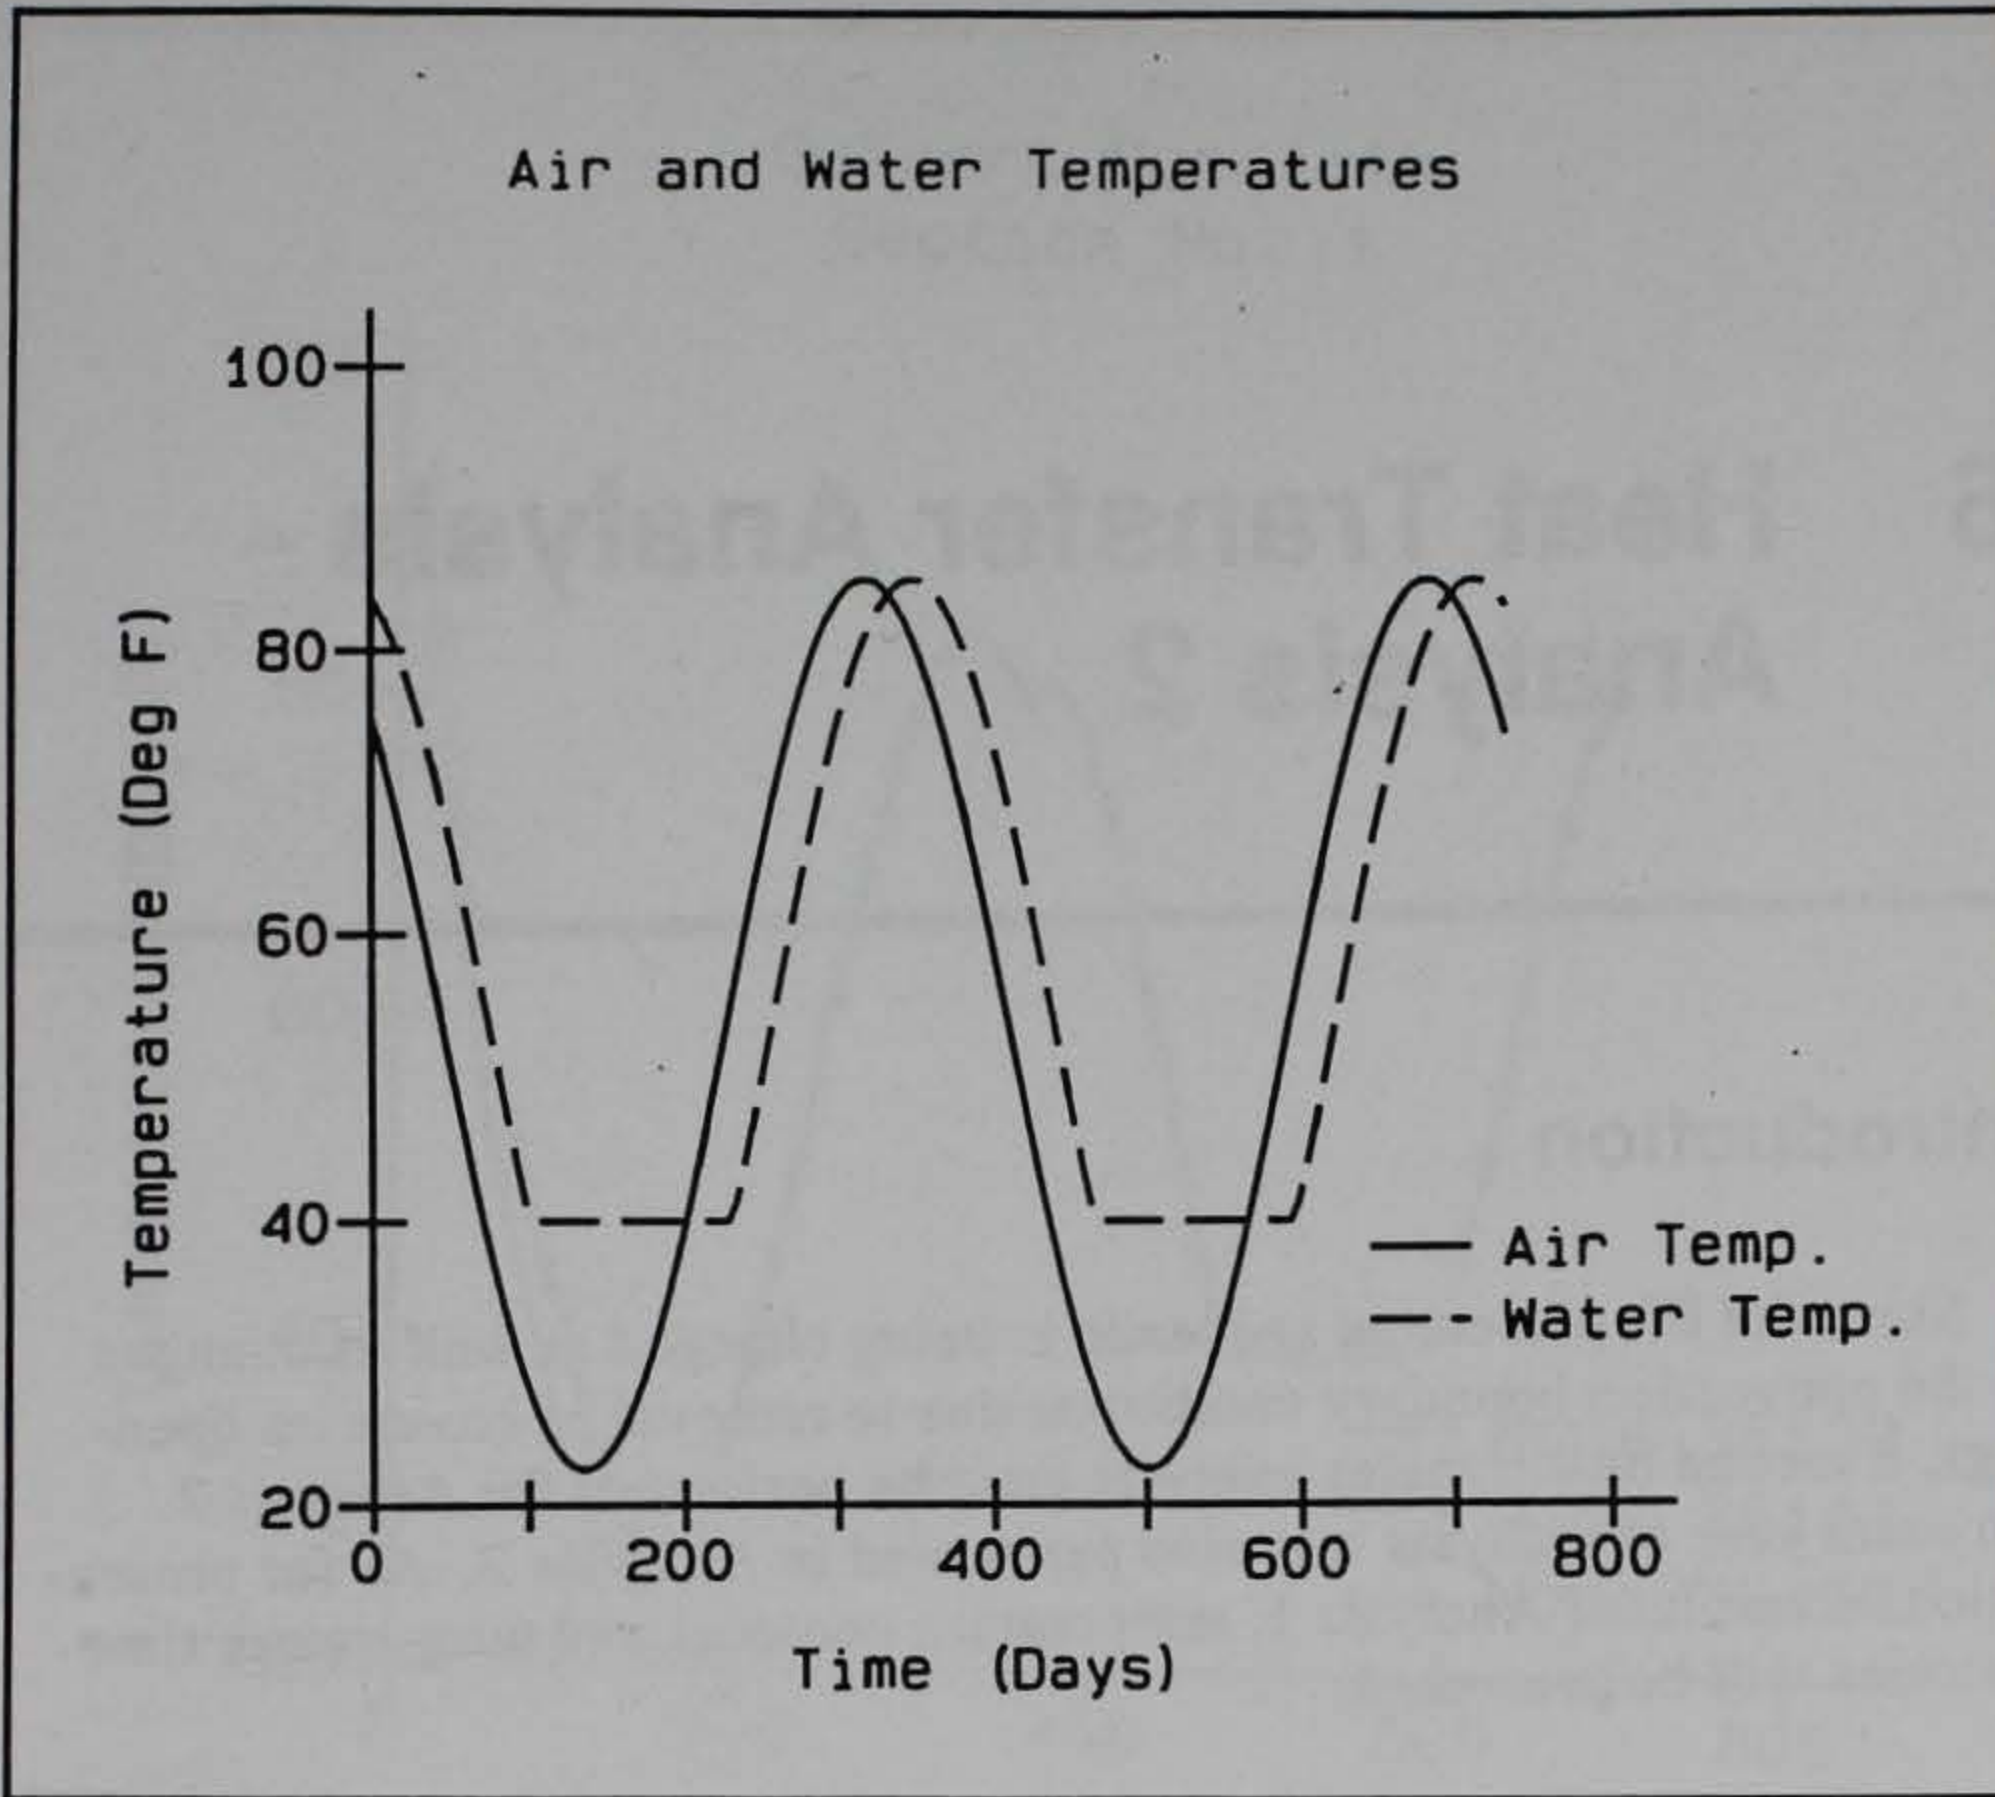
Figure 85. Ambient air and water temperature cycles used in Analysis 2

In addition to placing covers back on the gallery openings, the service loads were left in place and water was added to the heat transfer analysis for the additional 1-year cycle. To model the water, a film coefficient was applied to the elements which were in contact with water and water temperature cycle was applied as described in the Phase I and II Olmsted report (Garner et al. 1992). The water temperature cycle is essentially the same as the ambient air temperature cycle with a shift of 30 days, and the minimum temperature of the water never drops below 40 °F. A plot of the ambient air temperature and water temperature cycles is shown in Figure 85. The film coefficient was calculated based on boundary layer theory (Ozisik 1985) assuming the water moving at a velocity of 1 mph. The 1-mph velocity was chosen as an average since during filling and emptying the velocity will be much higher, particularly in the culverts, but between lockages the velocity will likely be near zero. The resulting value was 14.5 Btu/(day-in.²-°F). In addition, a reduced value of 0.145 Btu/(day-in.²-°F) was used on the ends of the monolith where water could be expected to seep into.

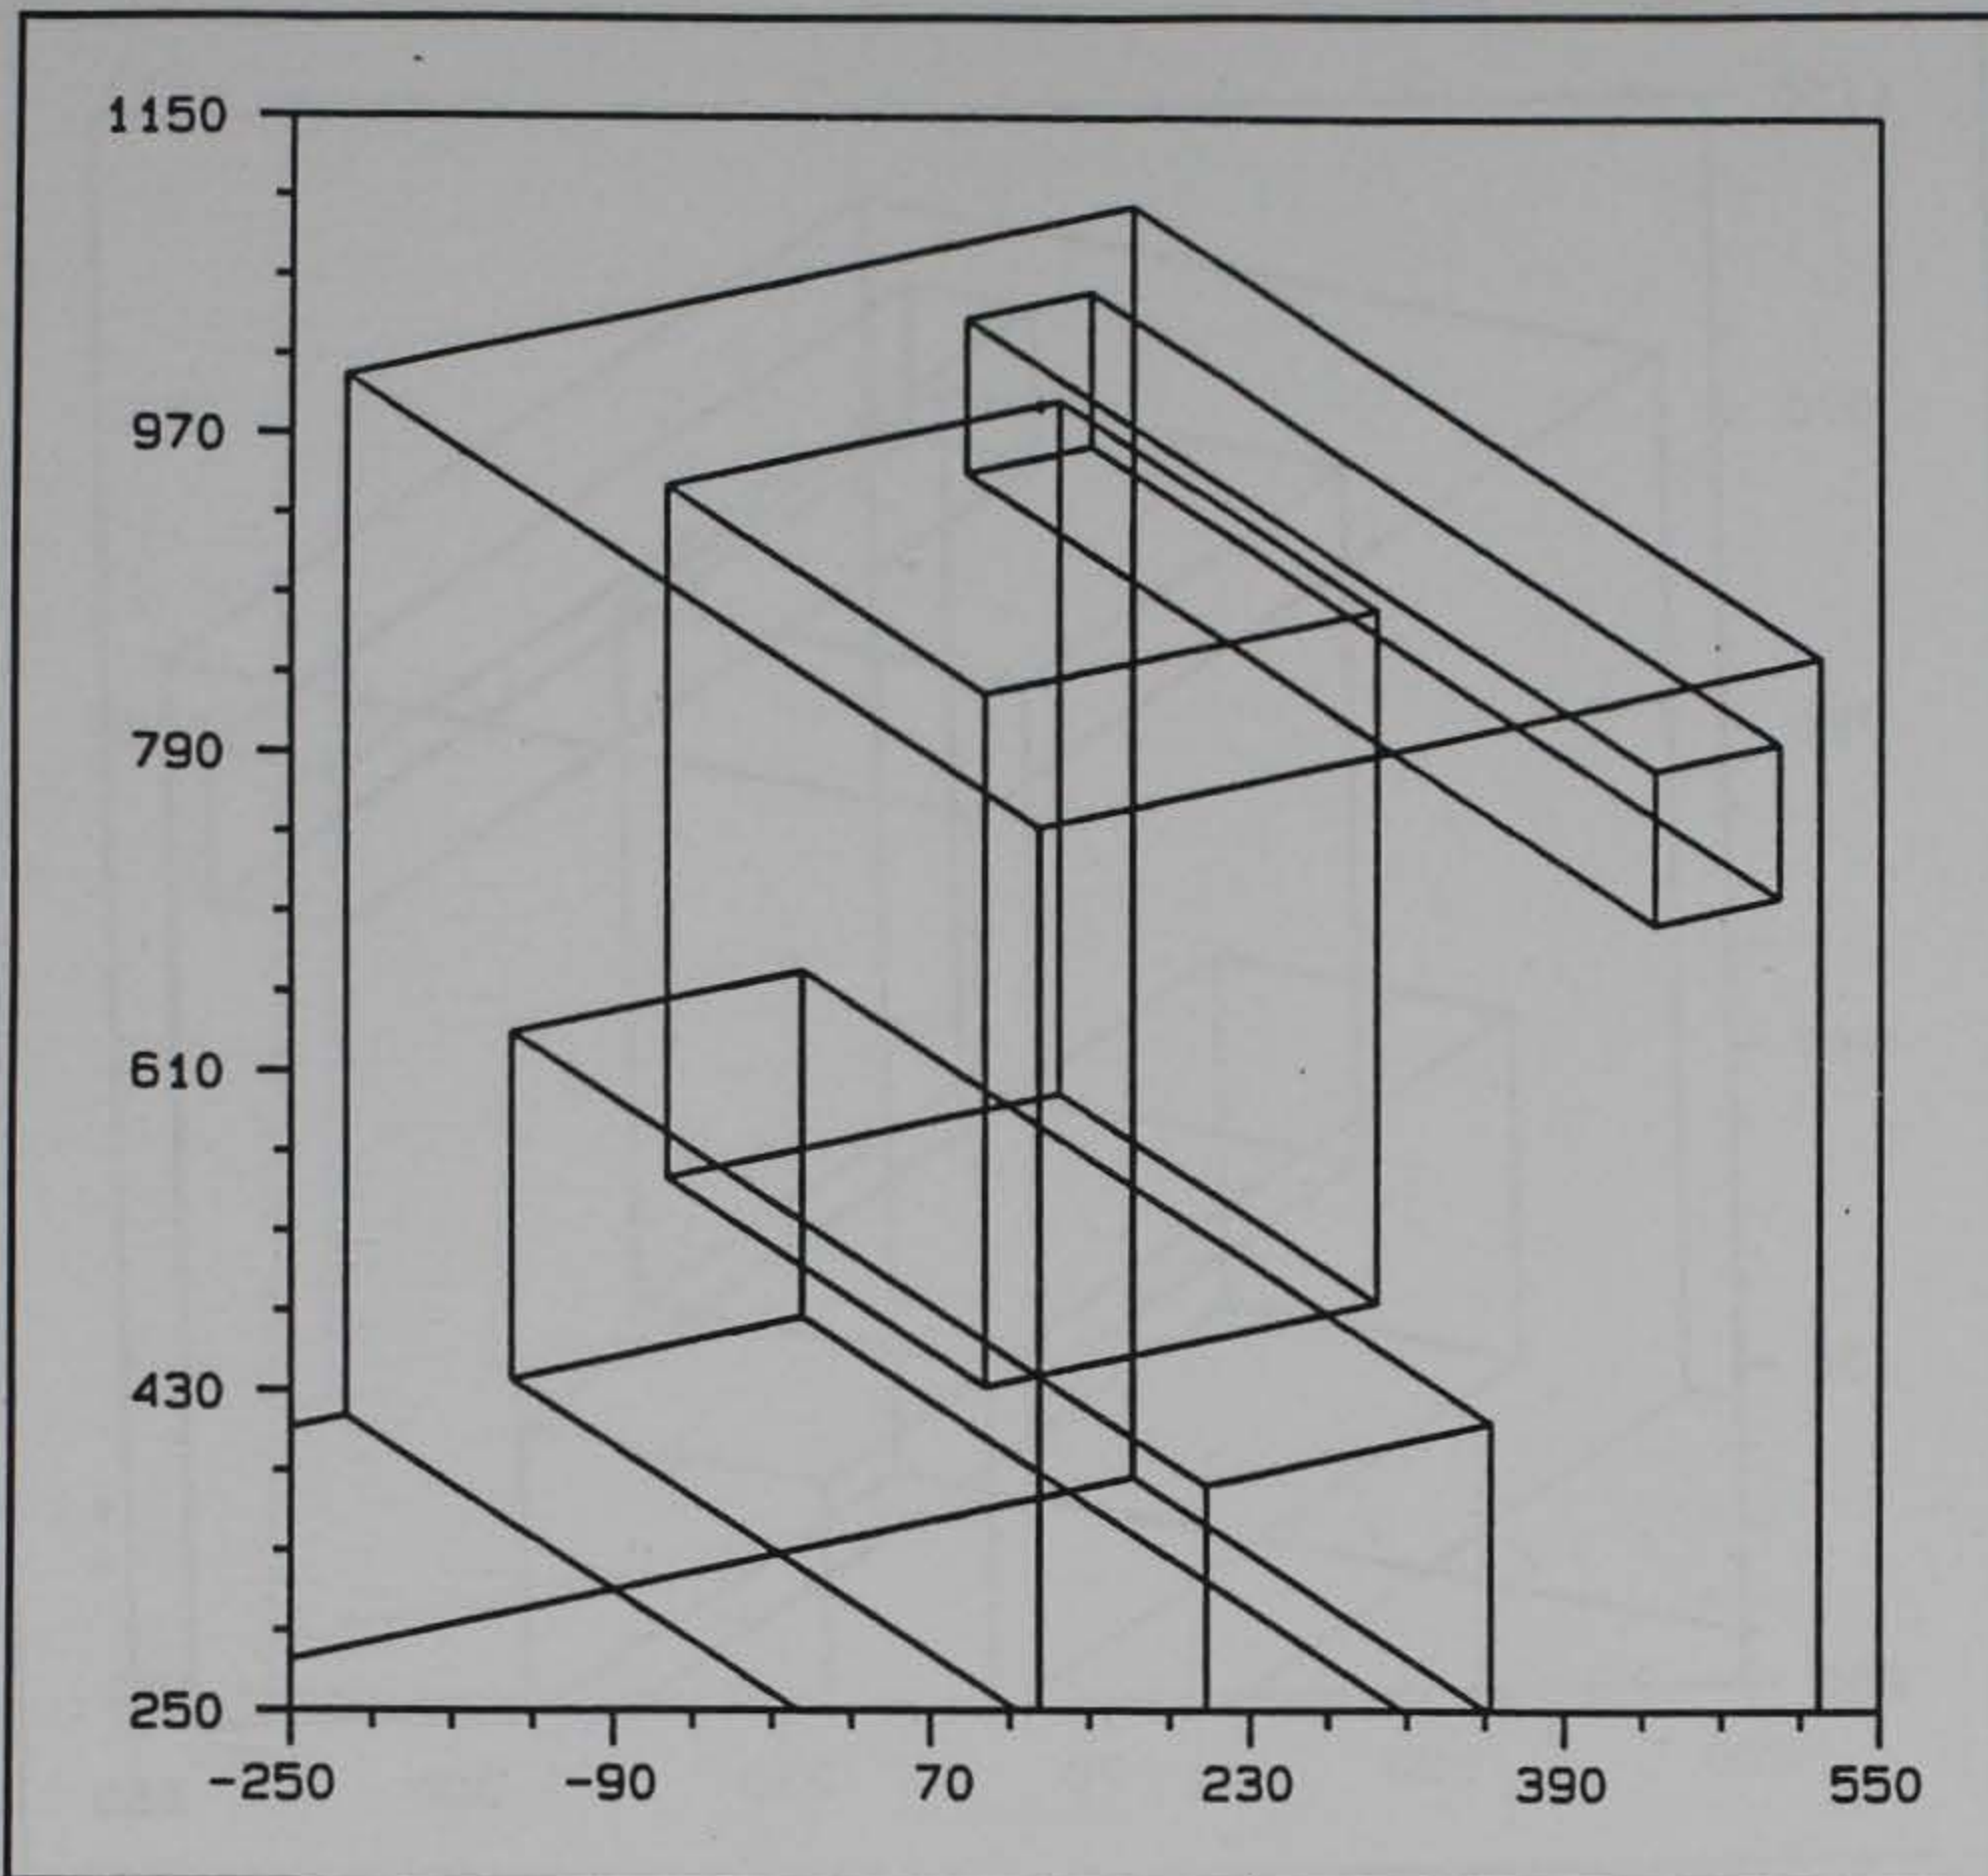
Figure 115. Crack plot, partial isometric view at day 65

Crack plots for Analysis 2 are presented in Figures 115 through 120. The changes made for Analysis 2 resulted in the elimination of the large crack above the gallery. A total of three integration points cracked during the course of the analysis. Isometric views of the wall portion of the monolith are shown in Figures 115, 116, and 117 at times which are shortly after the integration points have cracked. The first point to crack was at the downstream, outside corner of the culvert valve pit and occurred on day 62. Figure 115 is shown at day 65. Figures 116 and 117 are taken at days 69 and 73, respectively, and coincide with the time in the analysis when the points at the top, outside corners of the culverts cracked. Presented in Figures 118, 119, and 120 are the front elevation, side elevation, and plan view, respectively, of the monolith wall to provide a better understanding of the crack directions and crack locations. In Figure 118 it can be seen that the crack is extending somewhat at a diagonal

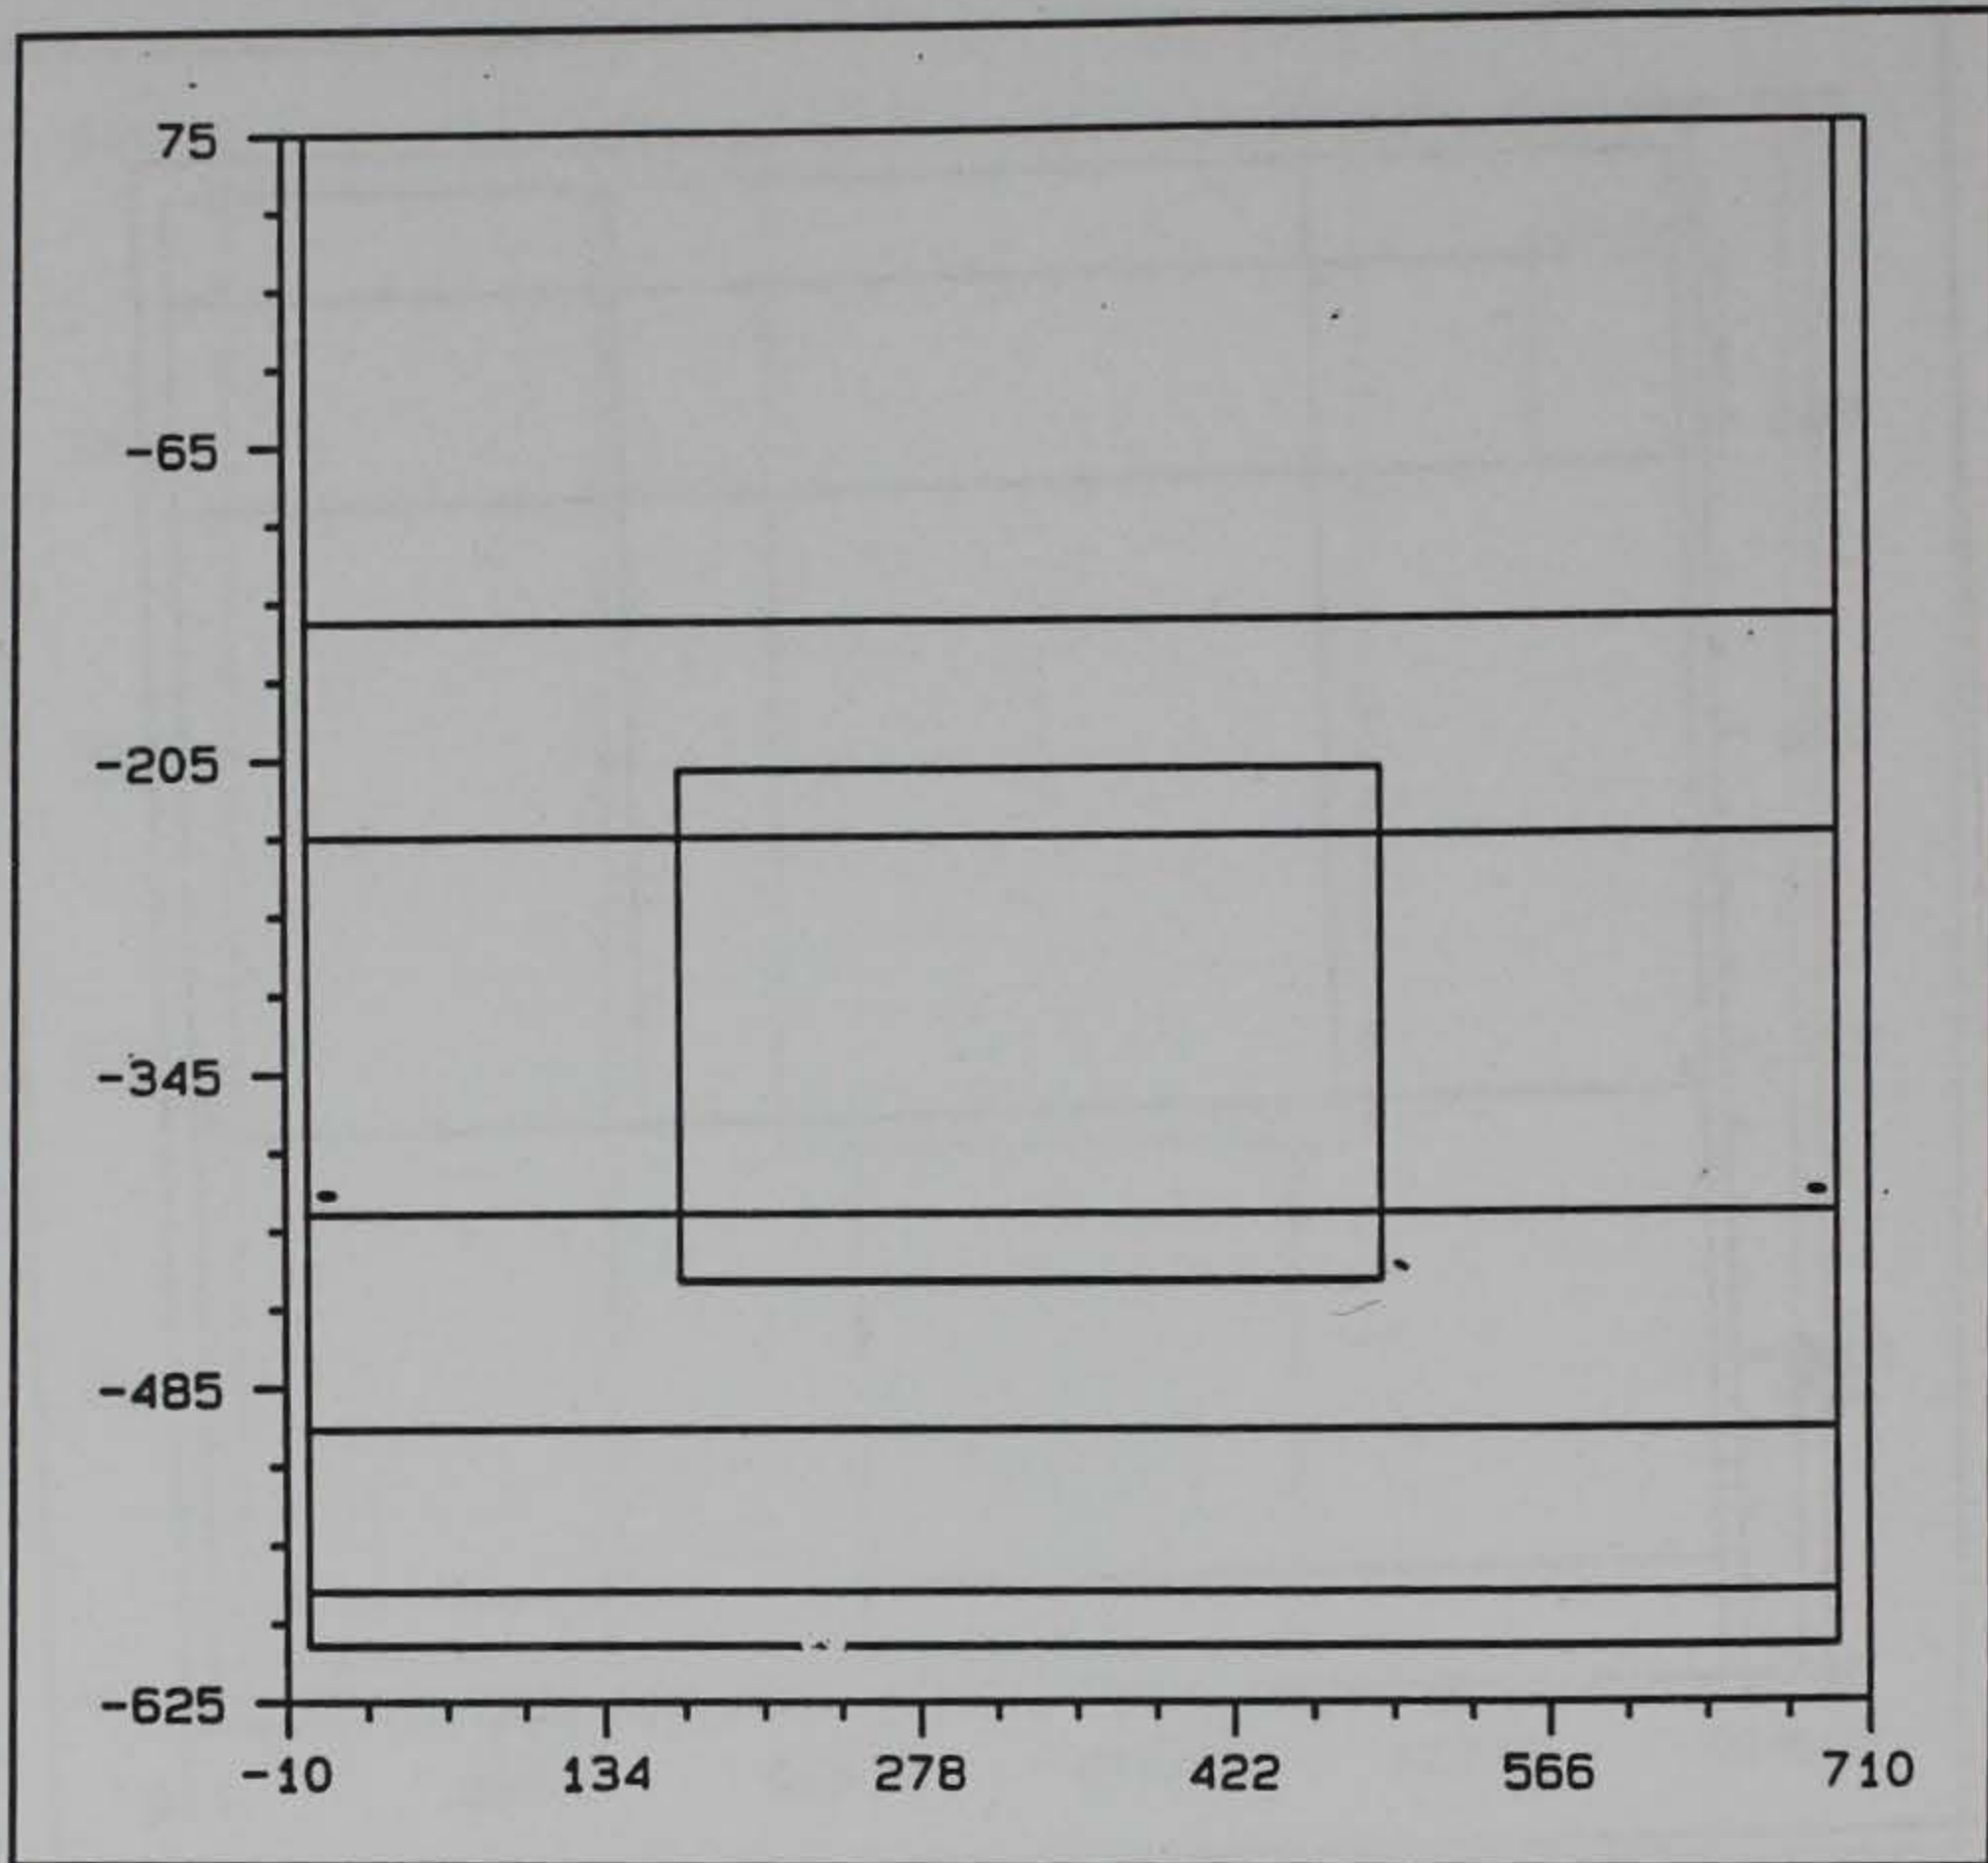
Figure 120. Crack plot, plan view at day 73

away from the corner of the culvert. Likewise, in Figure 120 the crack at the corner of the culvert valve pit angles away from the corner as well.

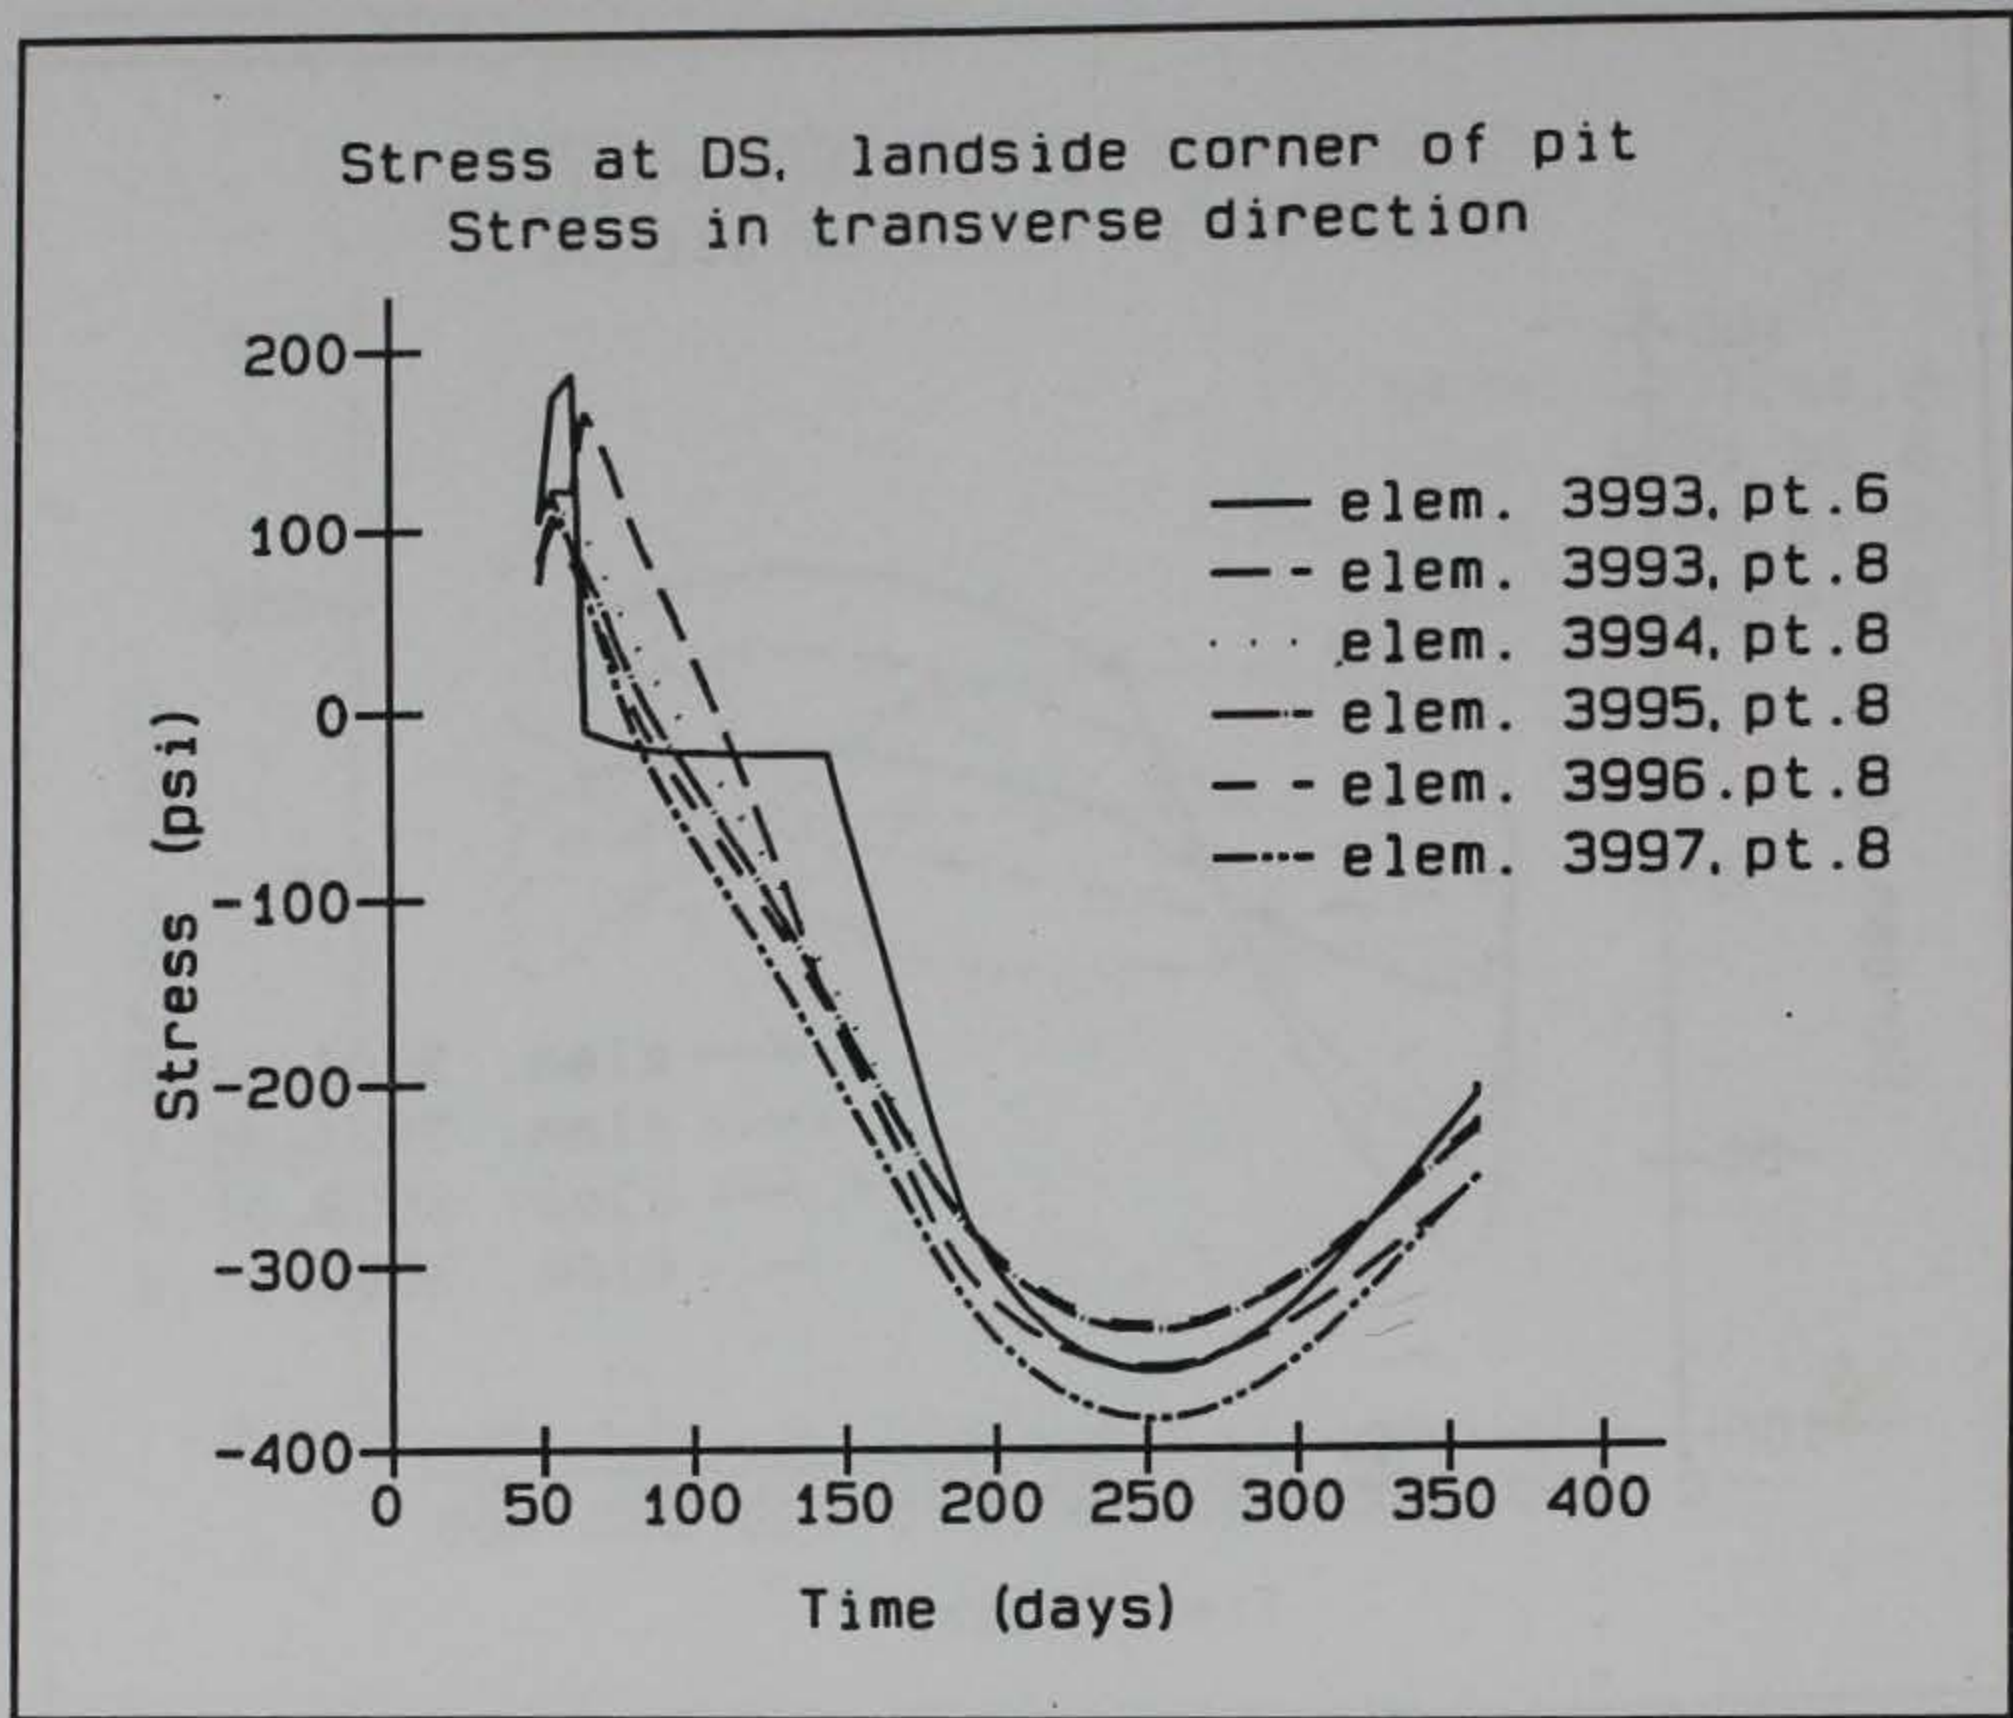
Figure 141. Time-history plot of transverse stress at the downstream, landside corner of the valve pit

The fact that the change in the lift placing sequence produced such a positive effect can be attributed to the initial compression which was introduced in Analysis 2. This initial compression effect can be seen most readily when comparing Figure 140 of Analysis 2 to Figure 81 of Analysis 1. The difference can be attributed to the fact that the changes occurring in Analysis 2 in the vicinity of this corner are all occurring to one
