MISCELLANEOUS PAPER SL-82-1

DURABILITY OF REINFORCED CONCRETE BEAMS EXPOSED TO MARINE ENVIRONMENT

Structures Laboratory

April 1982
Final Report

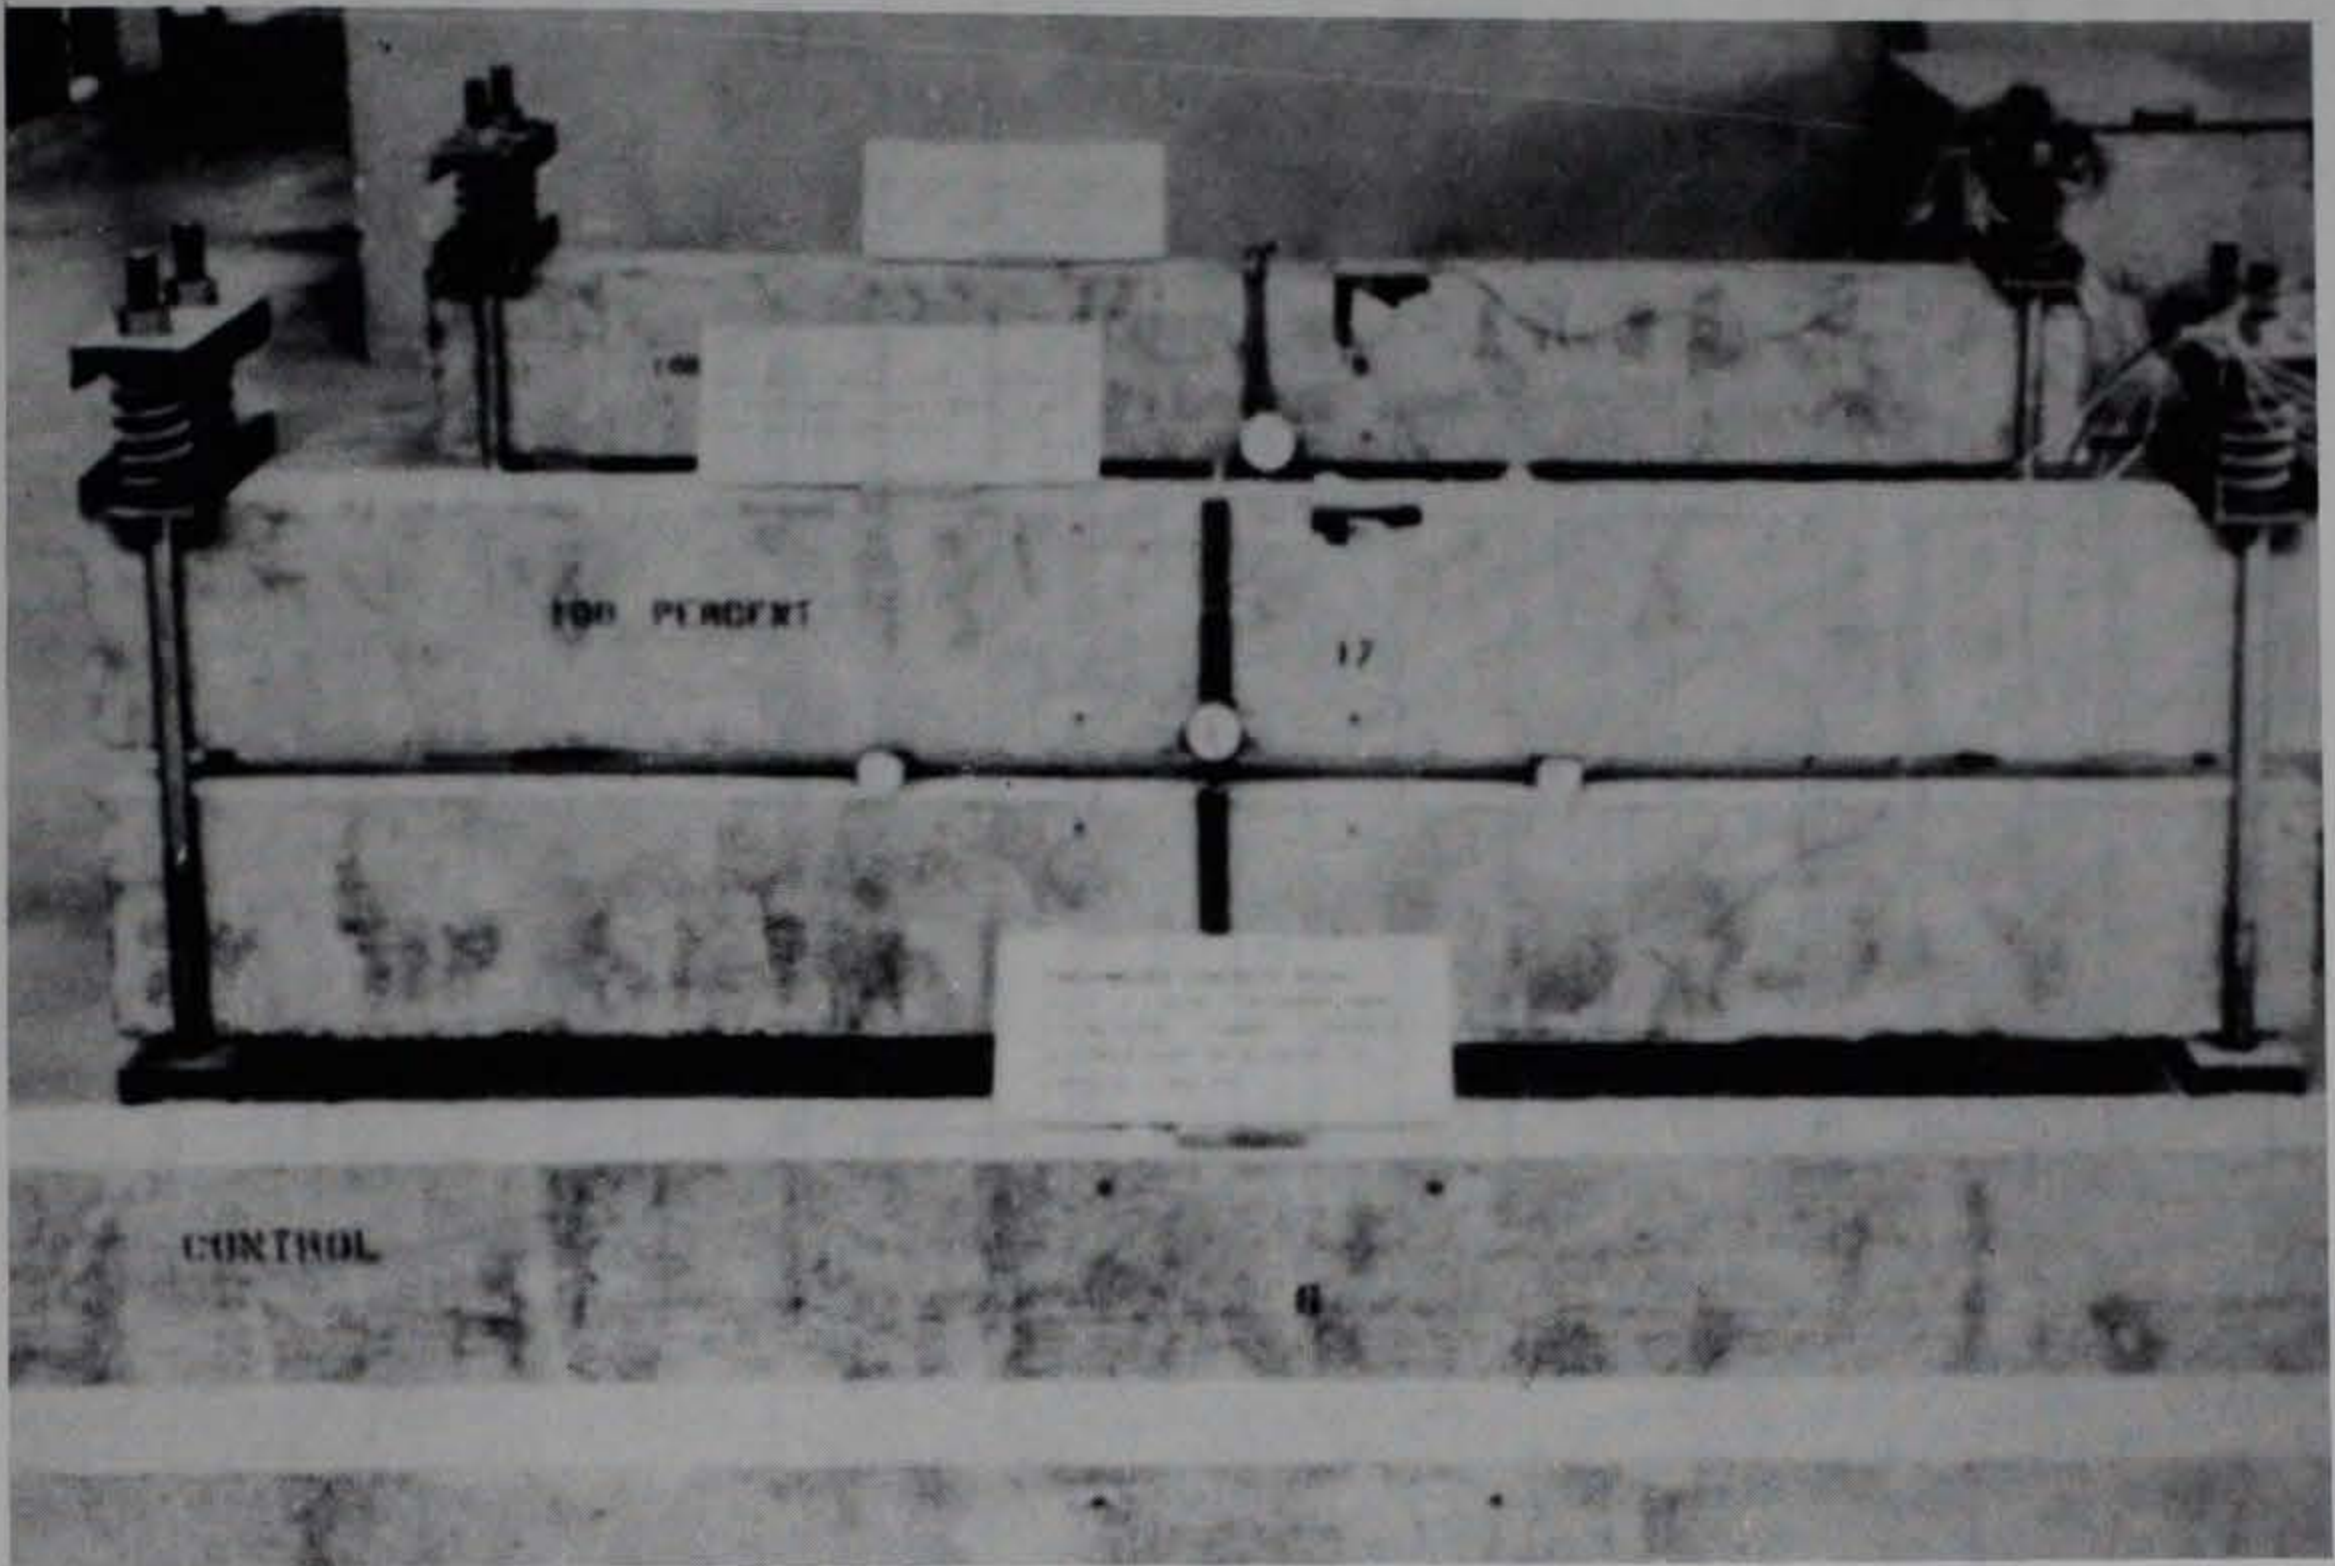
Figure 1. Typical beams as prepared for exposure

The loading of the beams caused them to be cracked in their tensile zones, as shown in Figure 1, of two beams in their loaded, yoked condition. This cracking was a potential source for the ingress of salt water into the beam and a condition for accelerated corrosion to the steel.

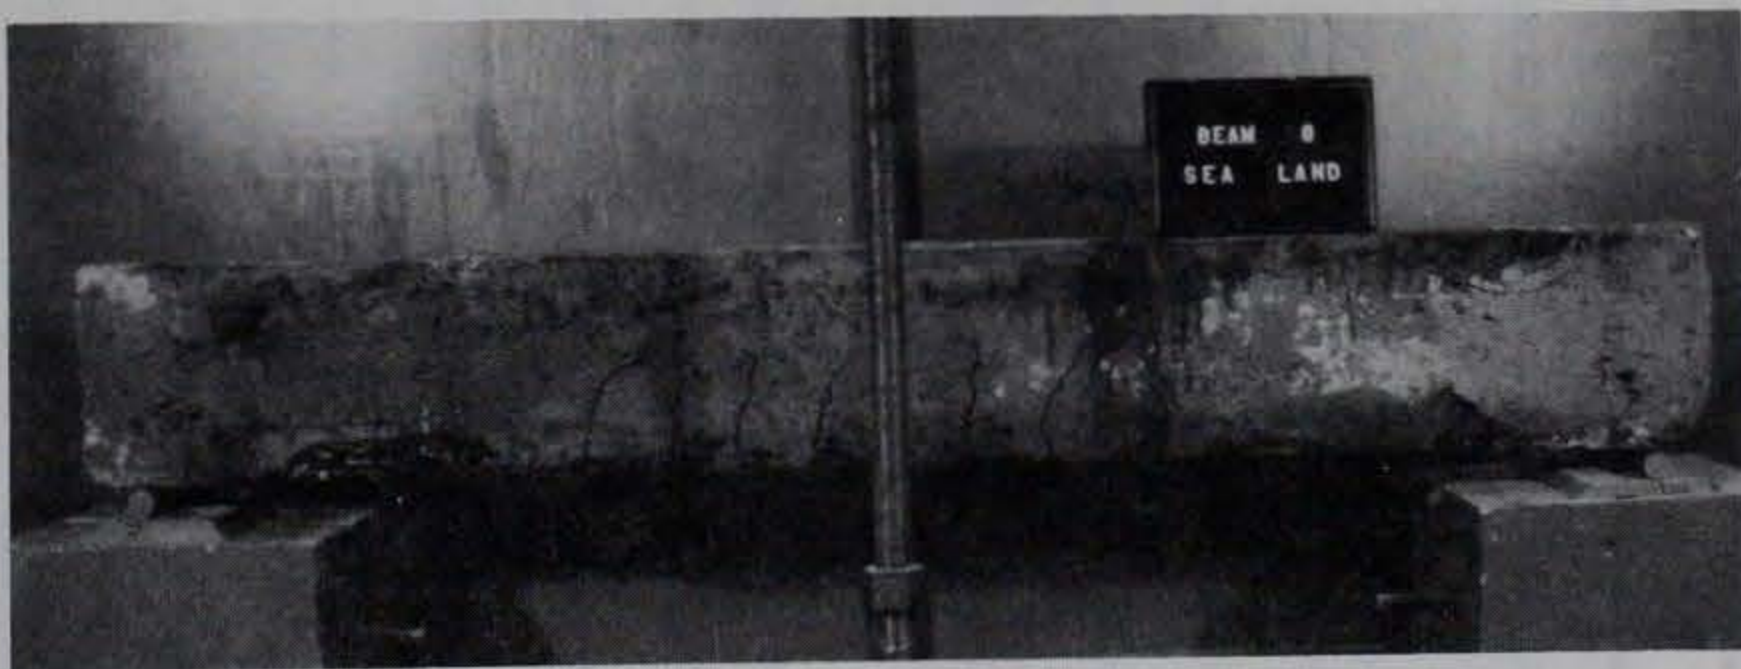
Figure 2. As received condition of a typical beam

At the conclusion of the exposure period in December 1975, 13 of the 18 air-entrained beams were still in testable condition. Eleven of these 13 beams were returned to the WES for structural testing and autopsy to evaluate the condition of the beams after 25 years of exposure. A typical beam as it was received in the laboratory is shown in Figure 2.

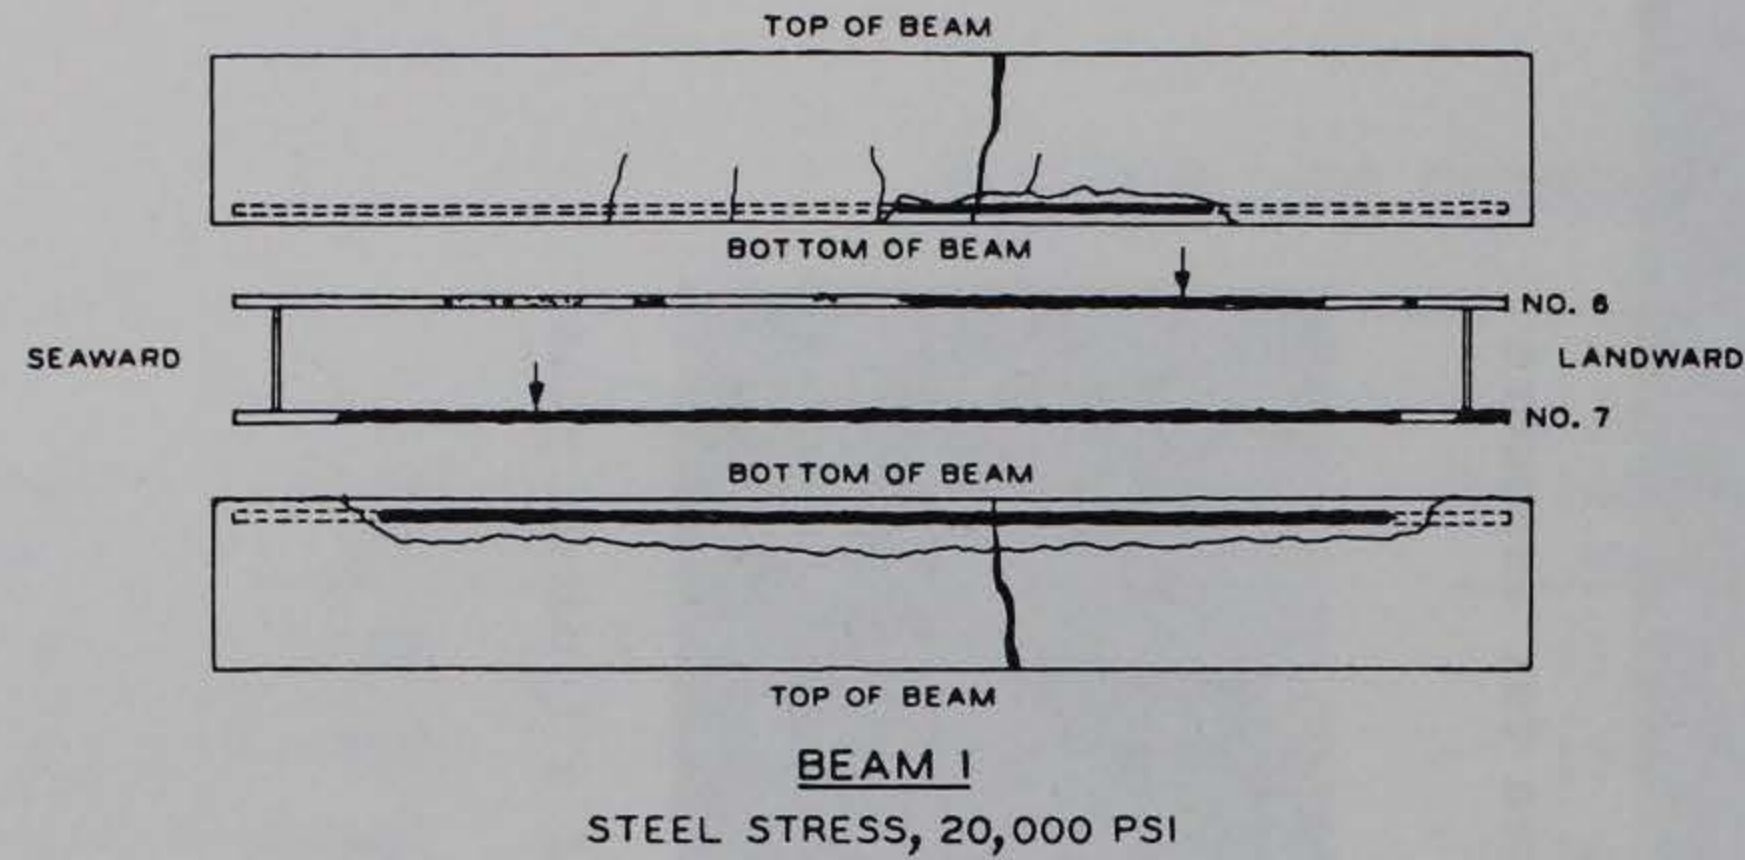
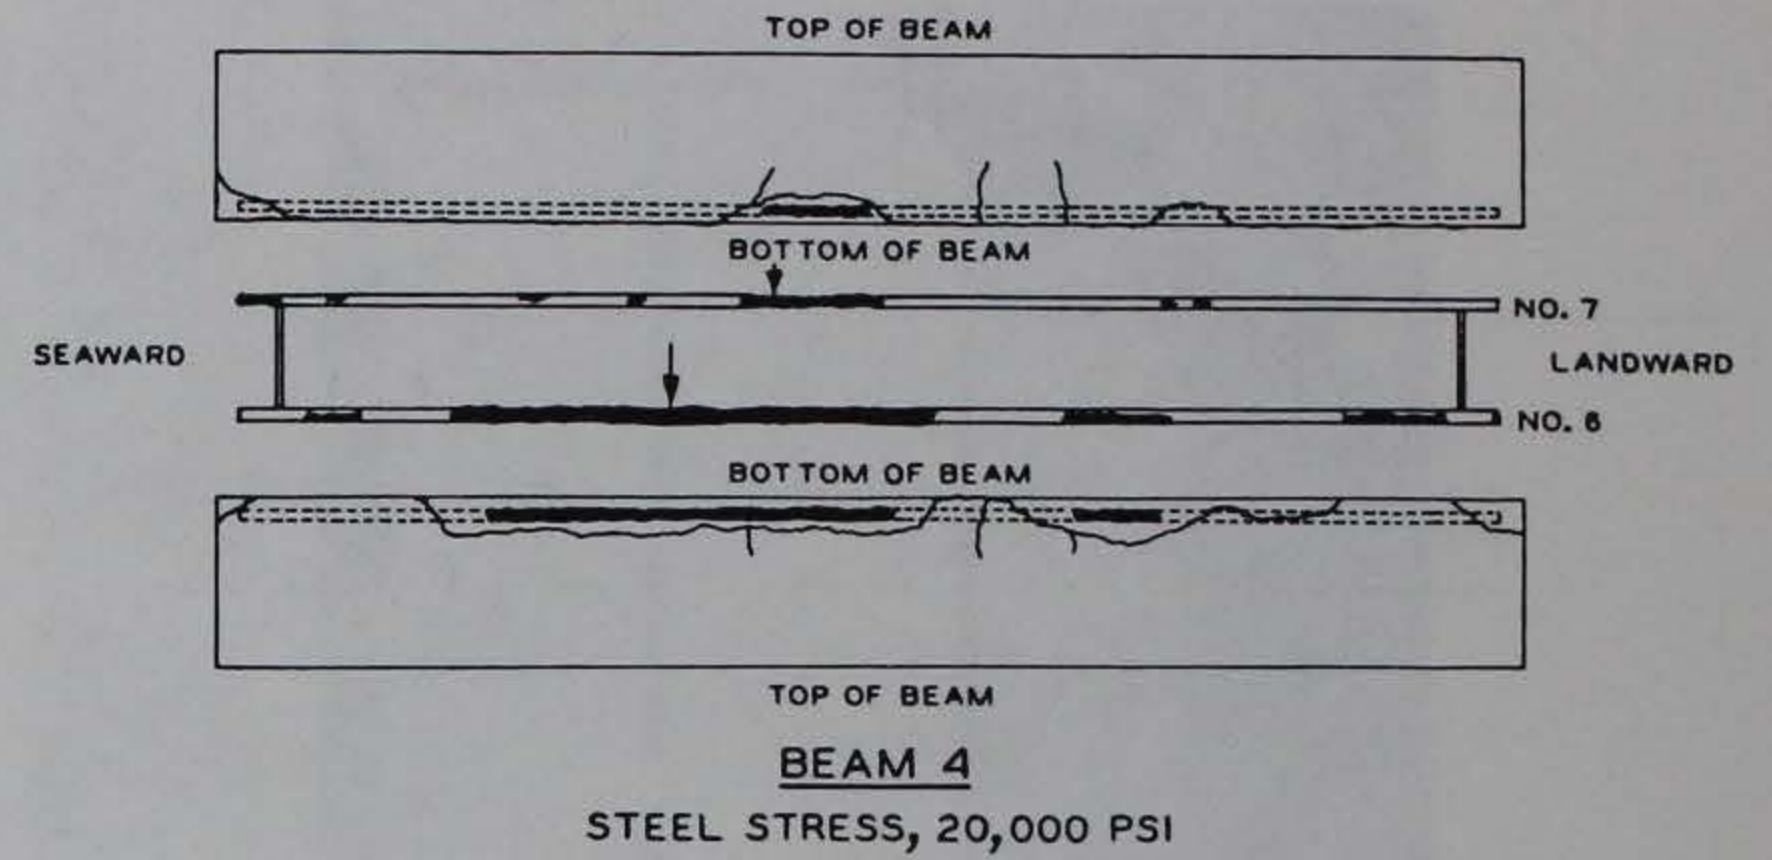
Figure 3. Graphic representation of cracking and corrosion, beams 1 and 2

The beams were examined to determine the amount of corrosion to the reinforcing steel. When they were received in the laboratory, sketches were made to show the extent of spalling of the reinforcement cover. The length of the concrete spall, the length of exposed steel, and the distance from the end of the beam were recorded. A sketch of the flexural cracks and their dimensions and locations was recorded. The cover over the steel was then broken away and the steel removed from the beam. Sketches of the corrosion to the steel were recorded to be matched to the crack locations of the concrete (Figures 3 through 8).

Figures 3 through 8 are graphic representations of the beams in the "as received" condition. Each figure shows both faces of the beam and all areas of the reinforcement that were exposed. They also show the longitudinal and flexural cracks, spalled areas, and corrosion to the reinforcement. The sketch between the faces of the beams shows the condition of the reinforcement after it was removed from the concrete. The darkened areas on the bars represent the corroded areas. The figures show that the number and depth of flexural cracks increased with the increase in steel stress. They also show that the corrosion on the bars does not align with the flexural cracks in the concrete at lower steel stress levels. The corrosion on the bars that were stressed in the 138-MPa stress range was, in general, at different locations than the flexural cracks. The corrosion at spalled areas was confined to the area of the steel directly exposed to water and oxygen; however, where there were flexural cracks and the concrete was not spalled, the bars beneath remained free from corrosion. In the higher stress ranges, 207 and 276 MPa, the corroded areas of the steel more generally matched the location of the flexural cracks (Figures 6 and 7).

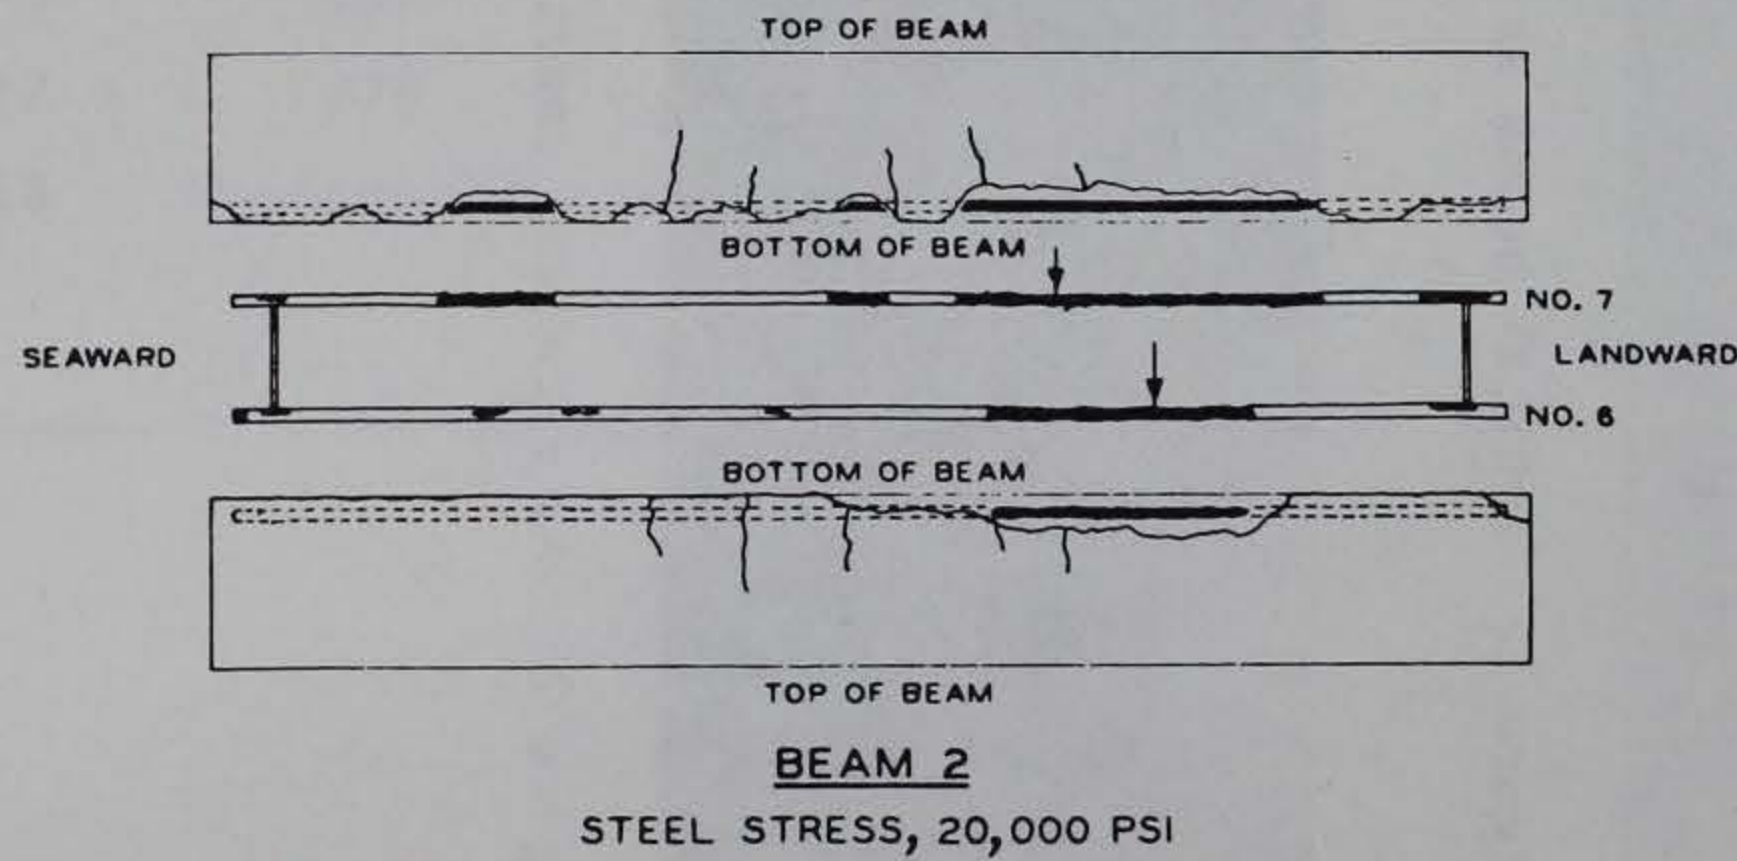
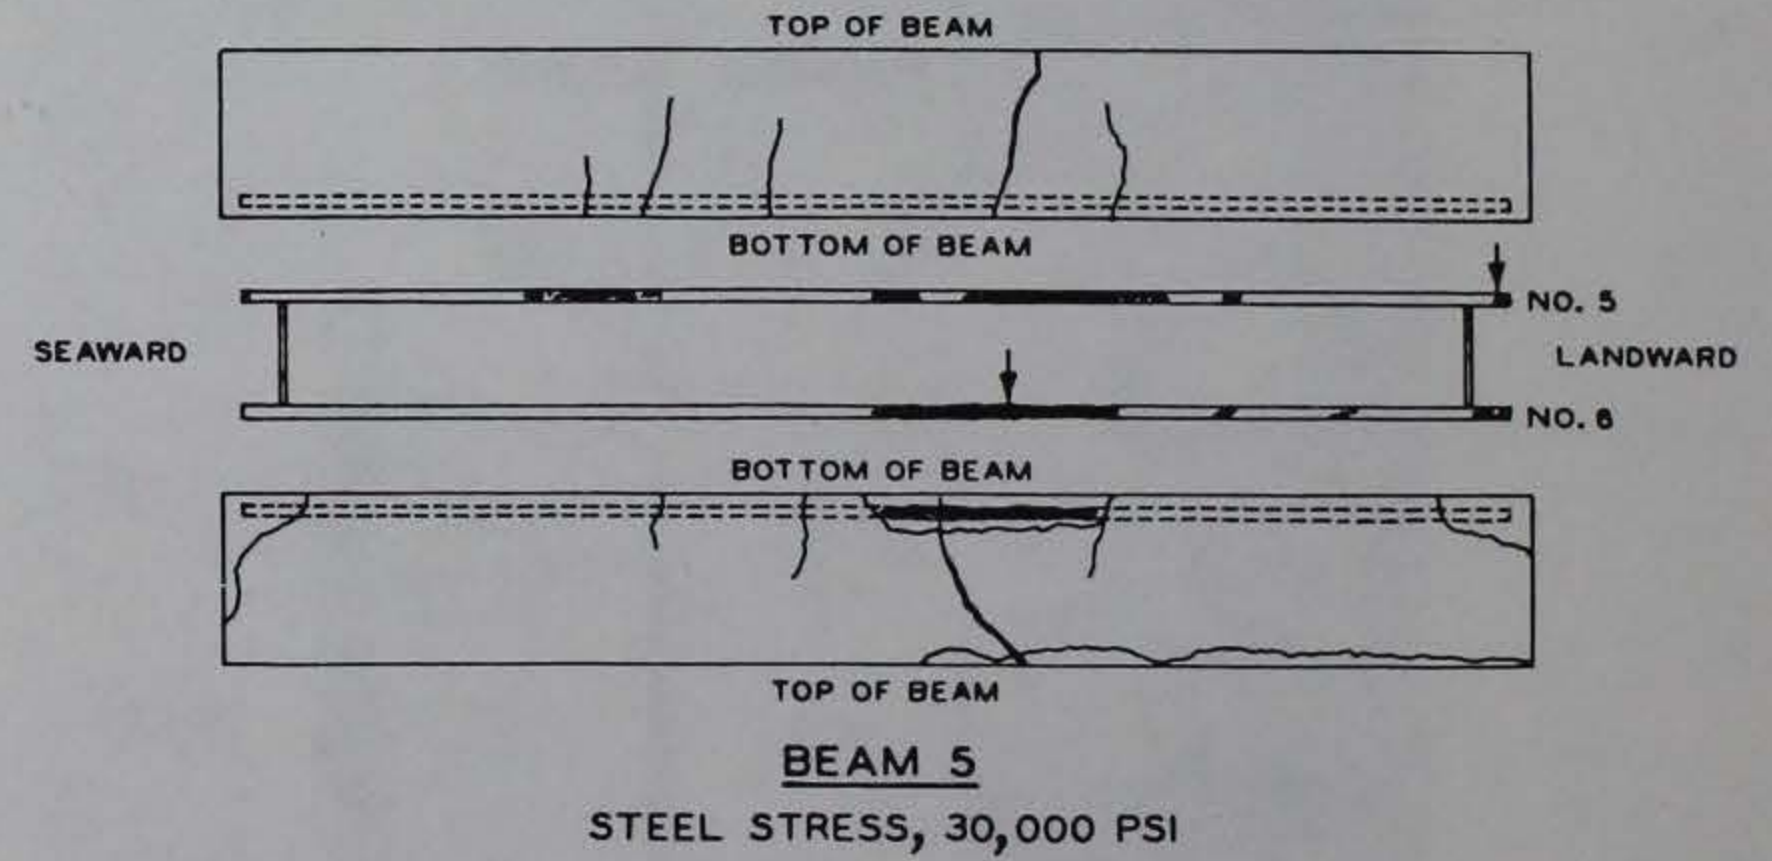
Figure 4. Graphic representation of cracking and corrosion, beams 4 and 5

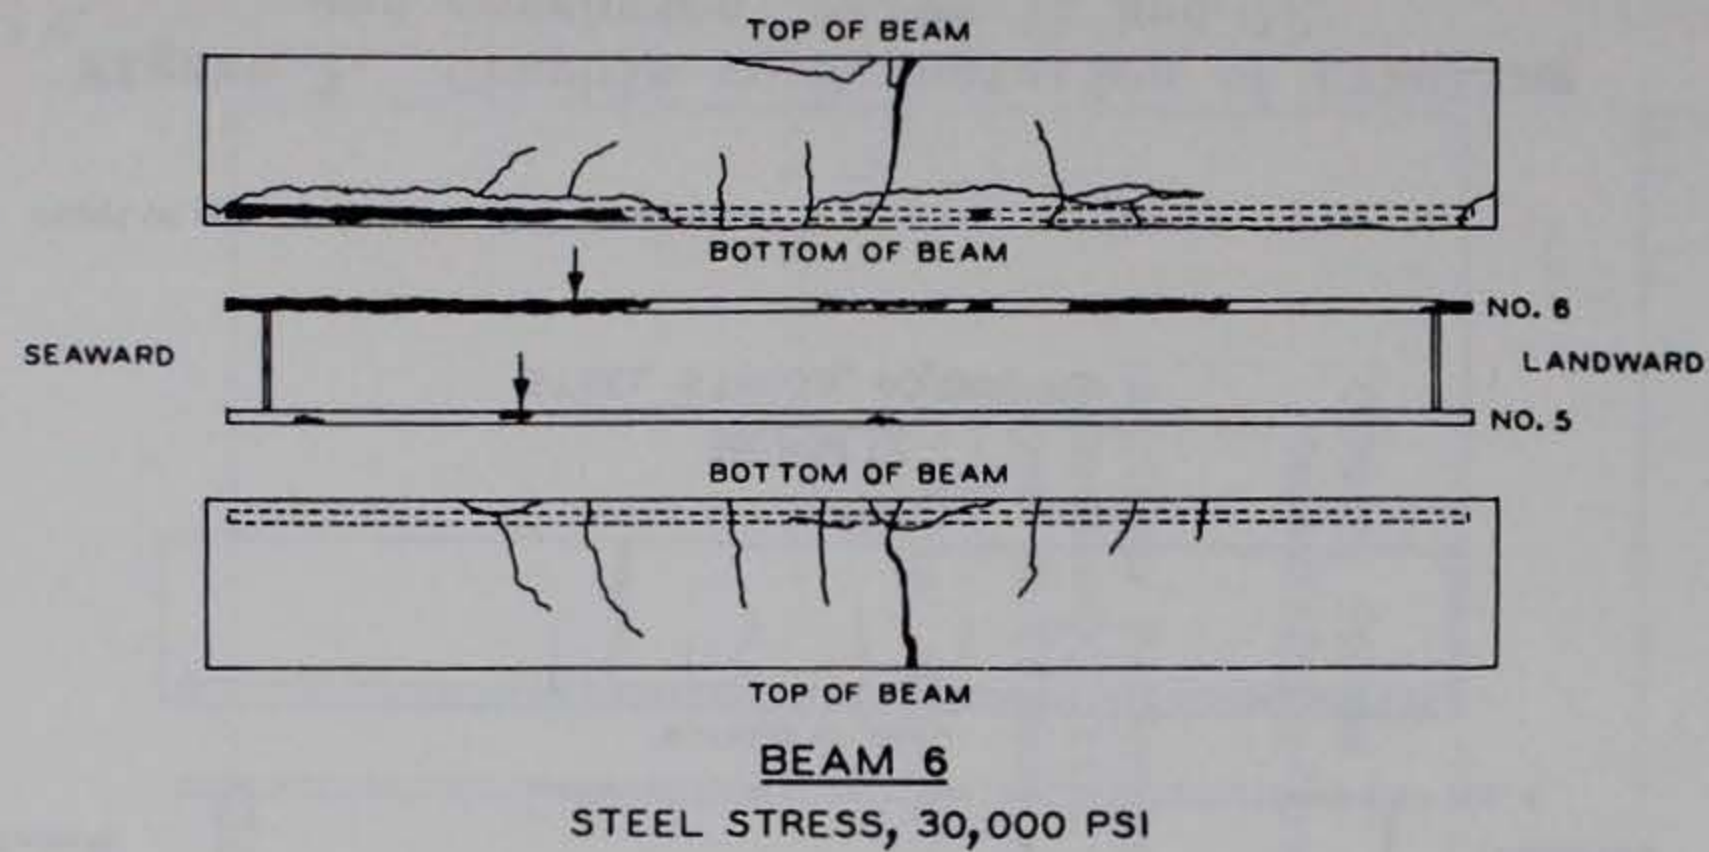
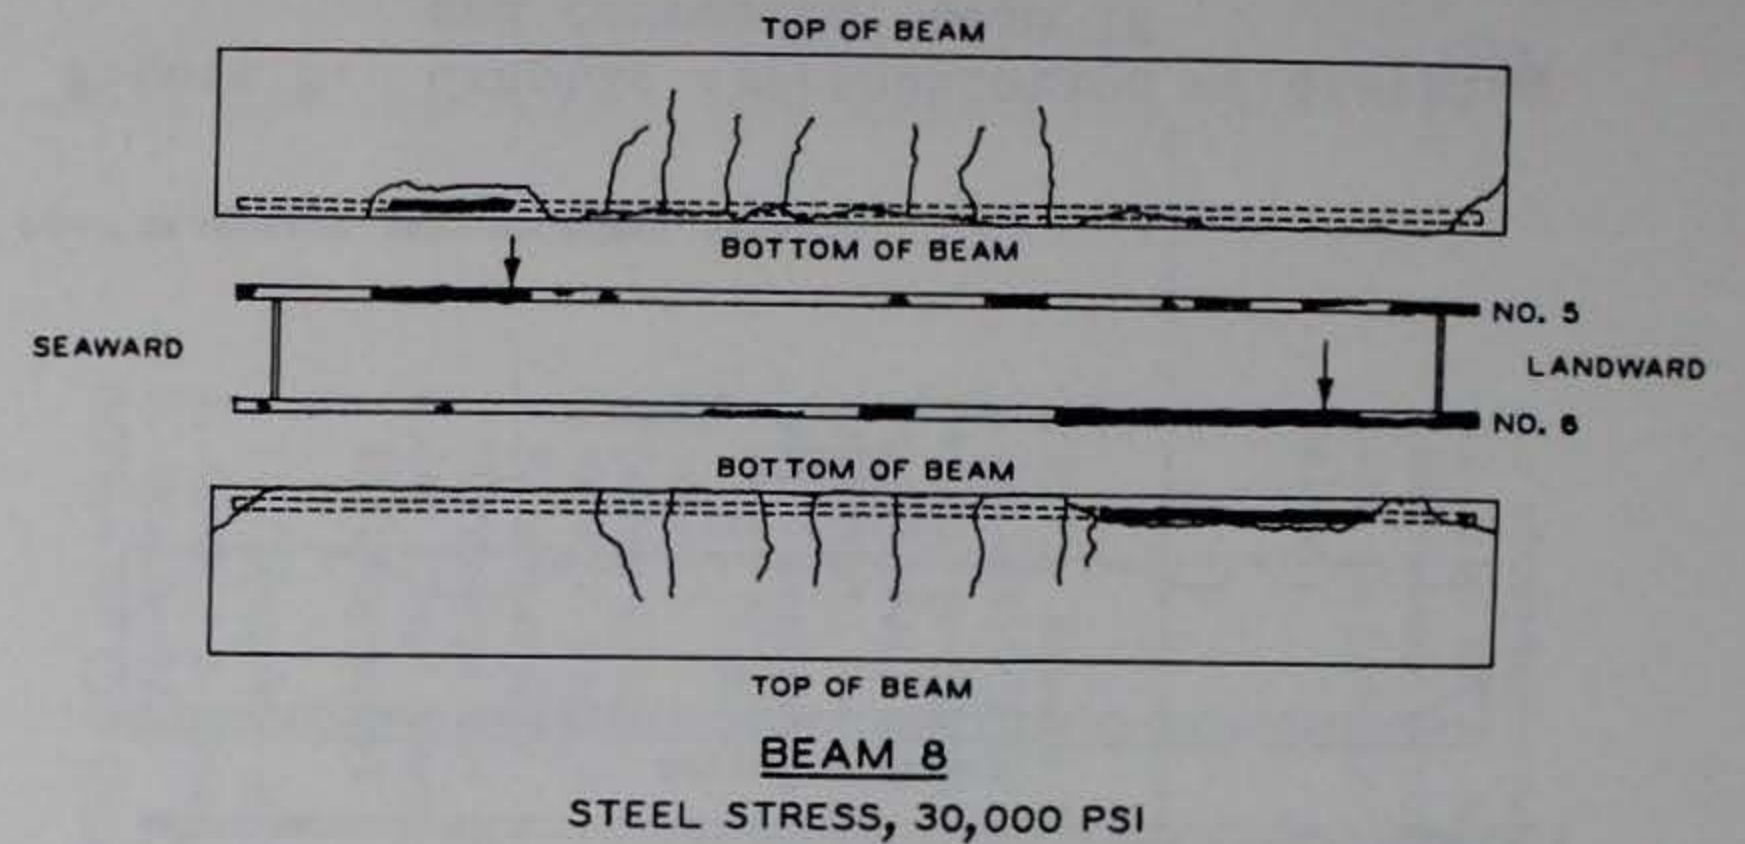
Figure 5. Graphic representation of cracking and corrosion, beams 6 and 7

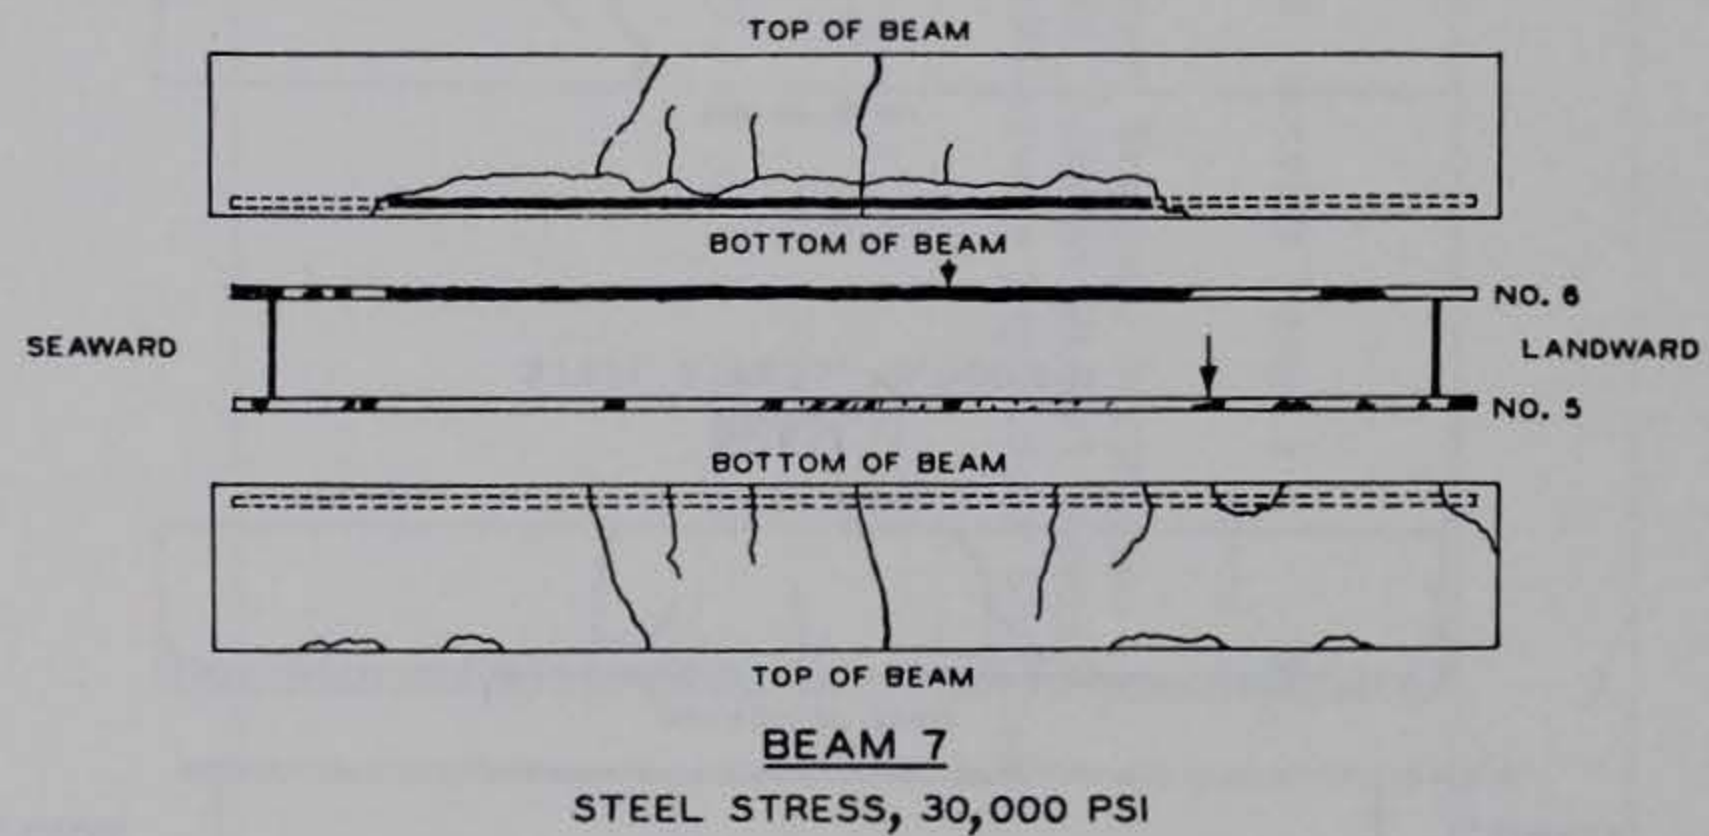
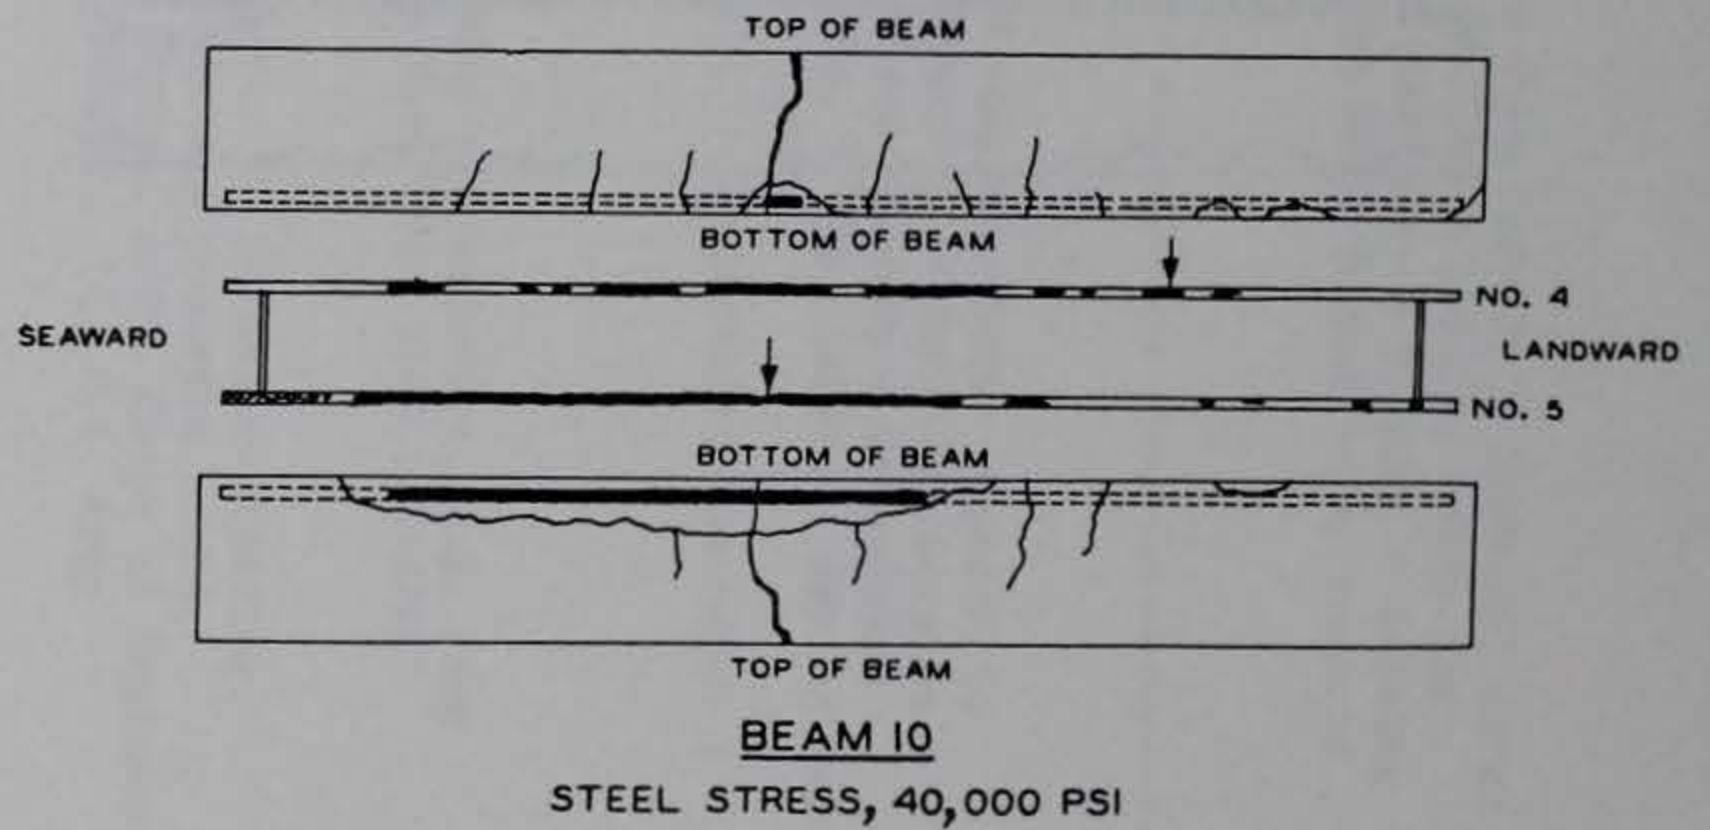
Figure 6. Graphic representation of cracking and corrosion, beams 8 and 10

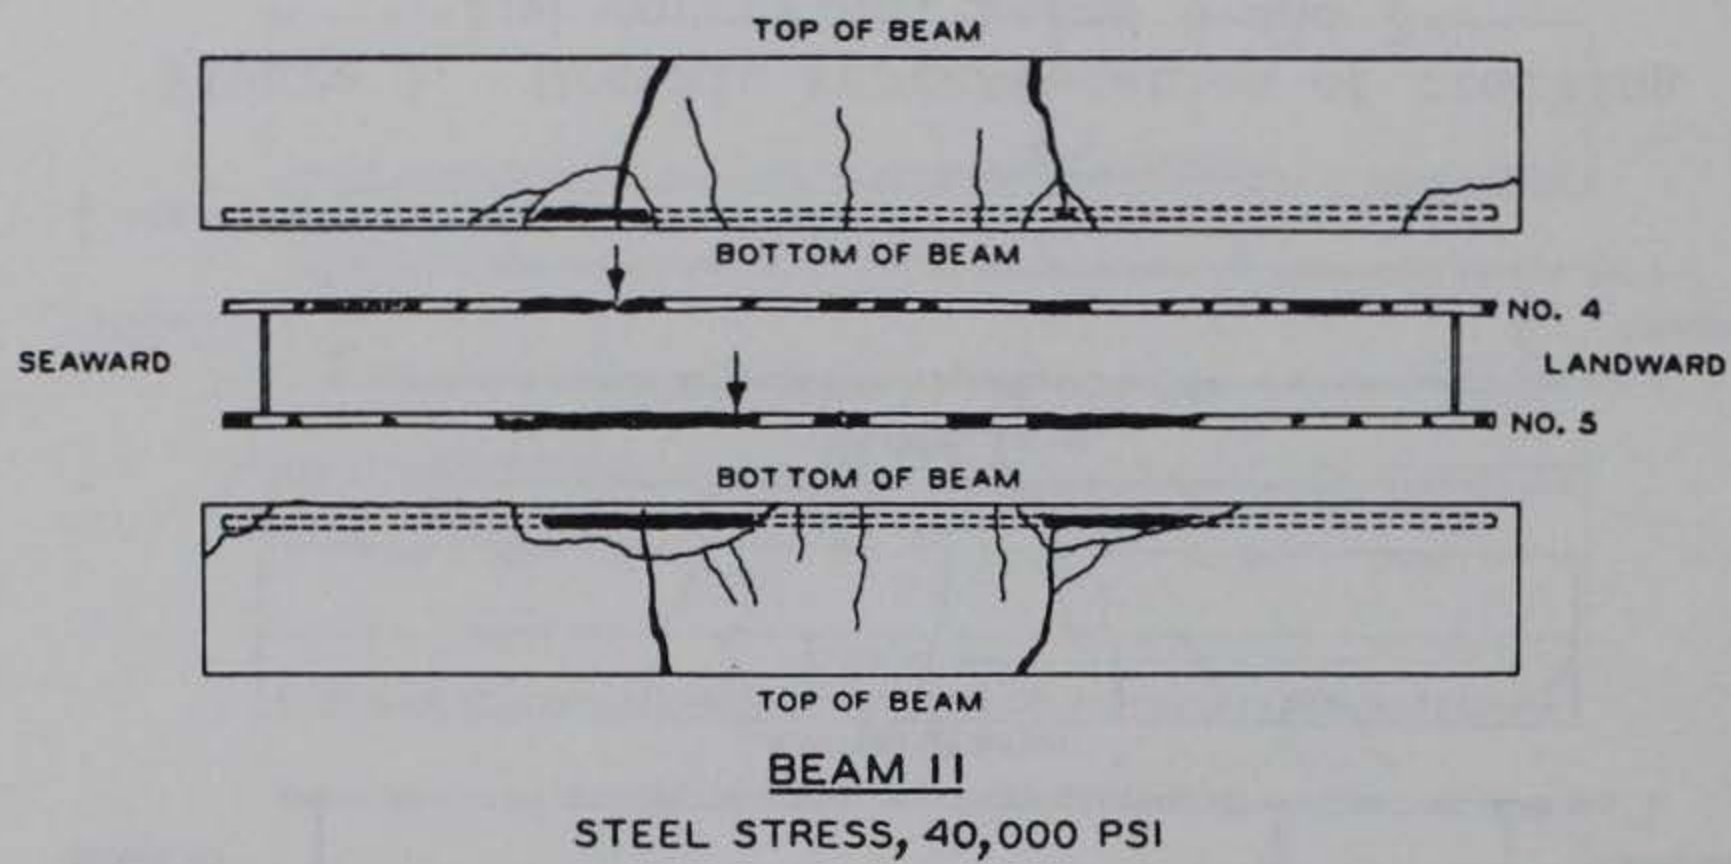
Figure 7. Graphic representation of cracking and corrosion, beams 11 and 12

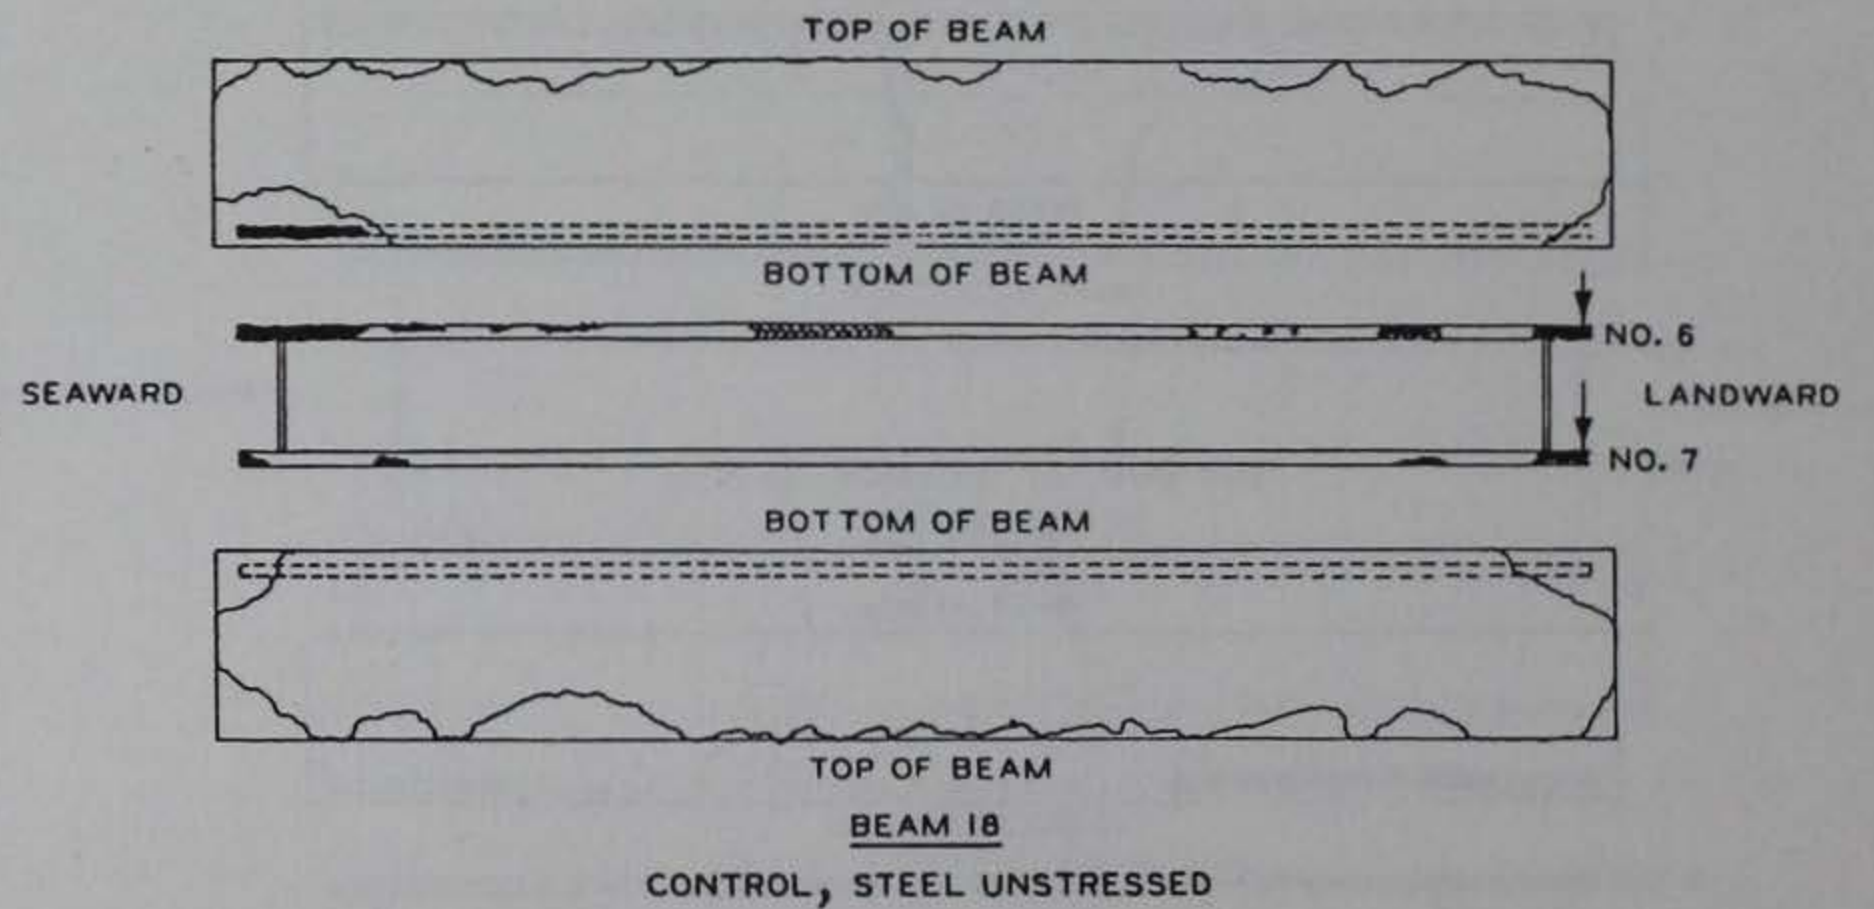
Figure 8. Graphic representation of cracking and corrosion, beam 18
