MISCELLANEOUS PAPER SL-79-20

THE STRUCTURAL AND DURABILITY PROPERTIES OF VARIOUS CONCRETE REPAIRS

Carl E. Pace

September 1979

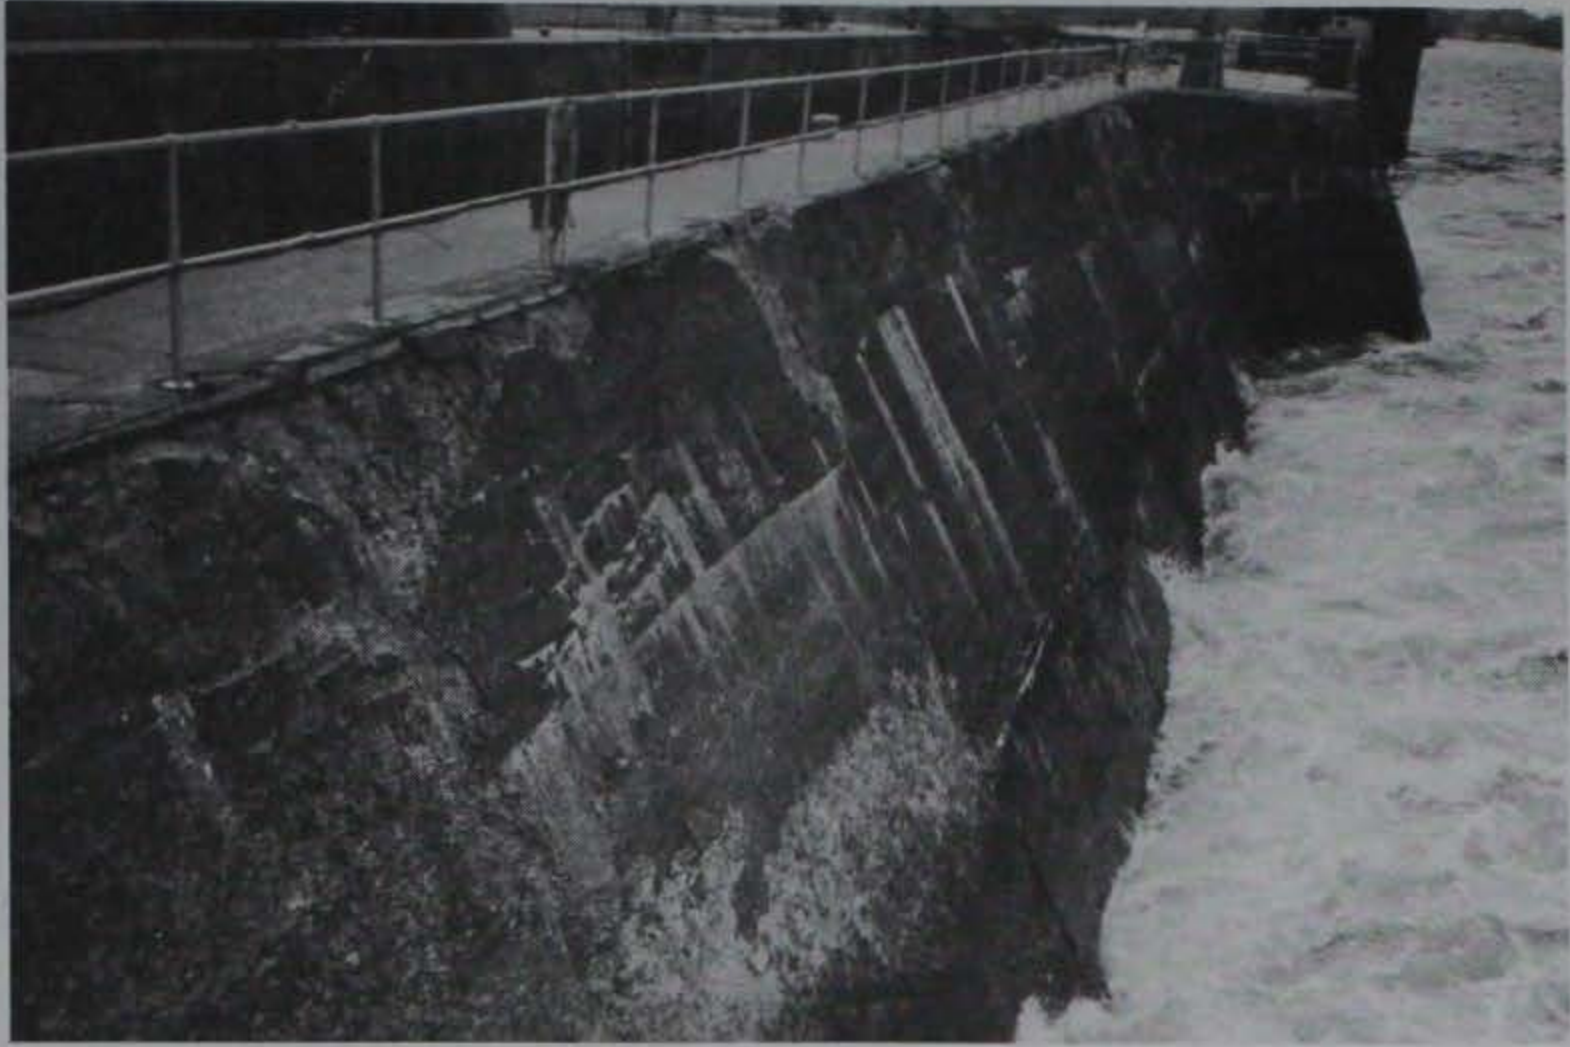
Figure 1. Deteriorated surface concrete,
Troy Lock and Dam, Hudson River,
Troy, New York

3. A few examples of deteriorated locks and dams are given in Figures 1 through 7.

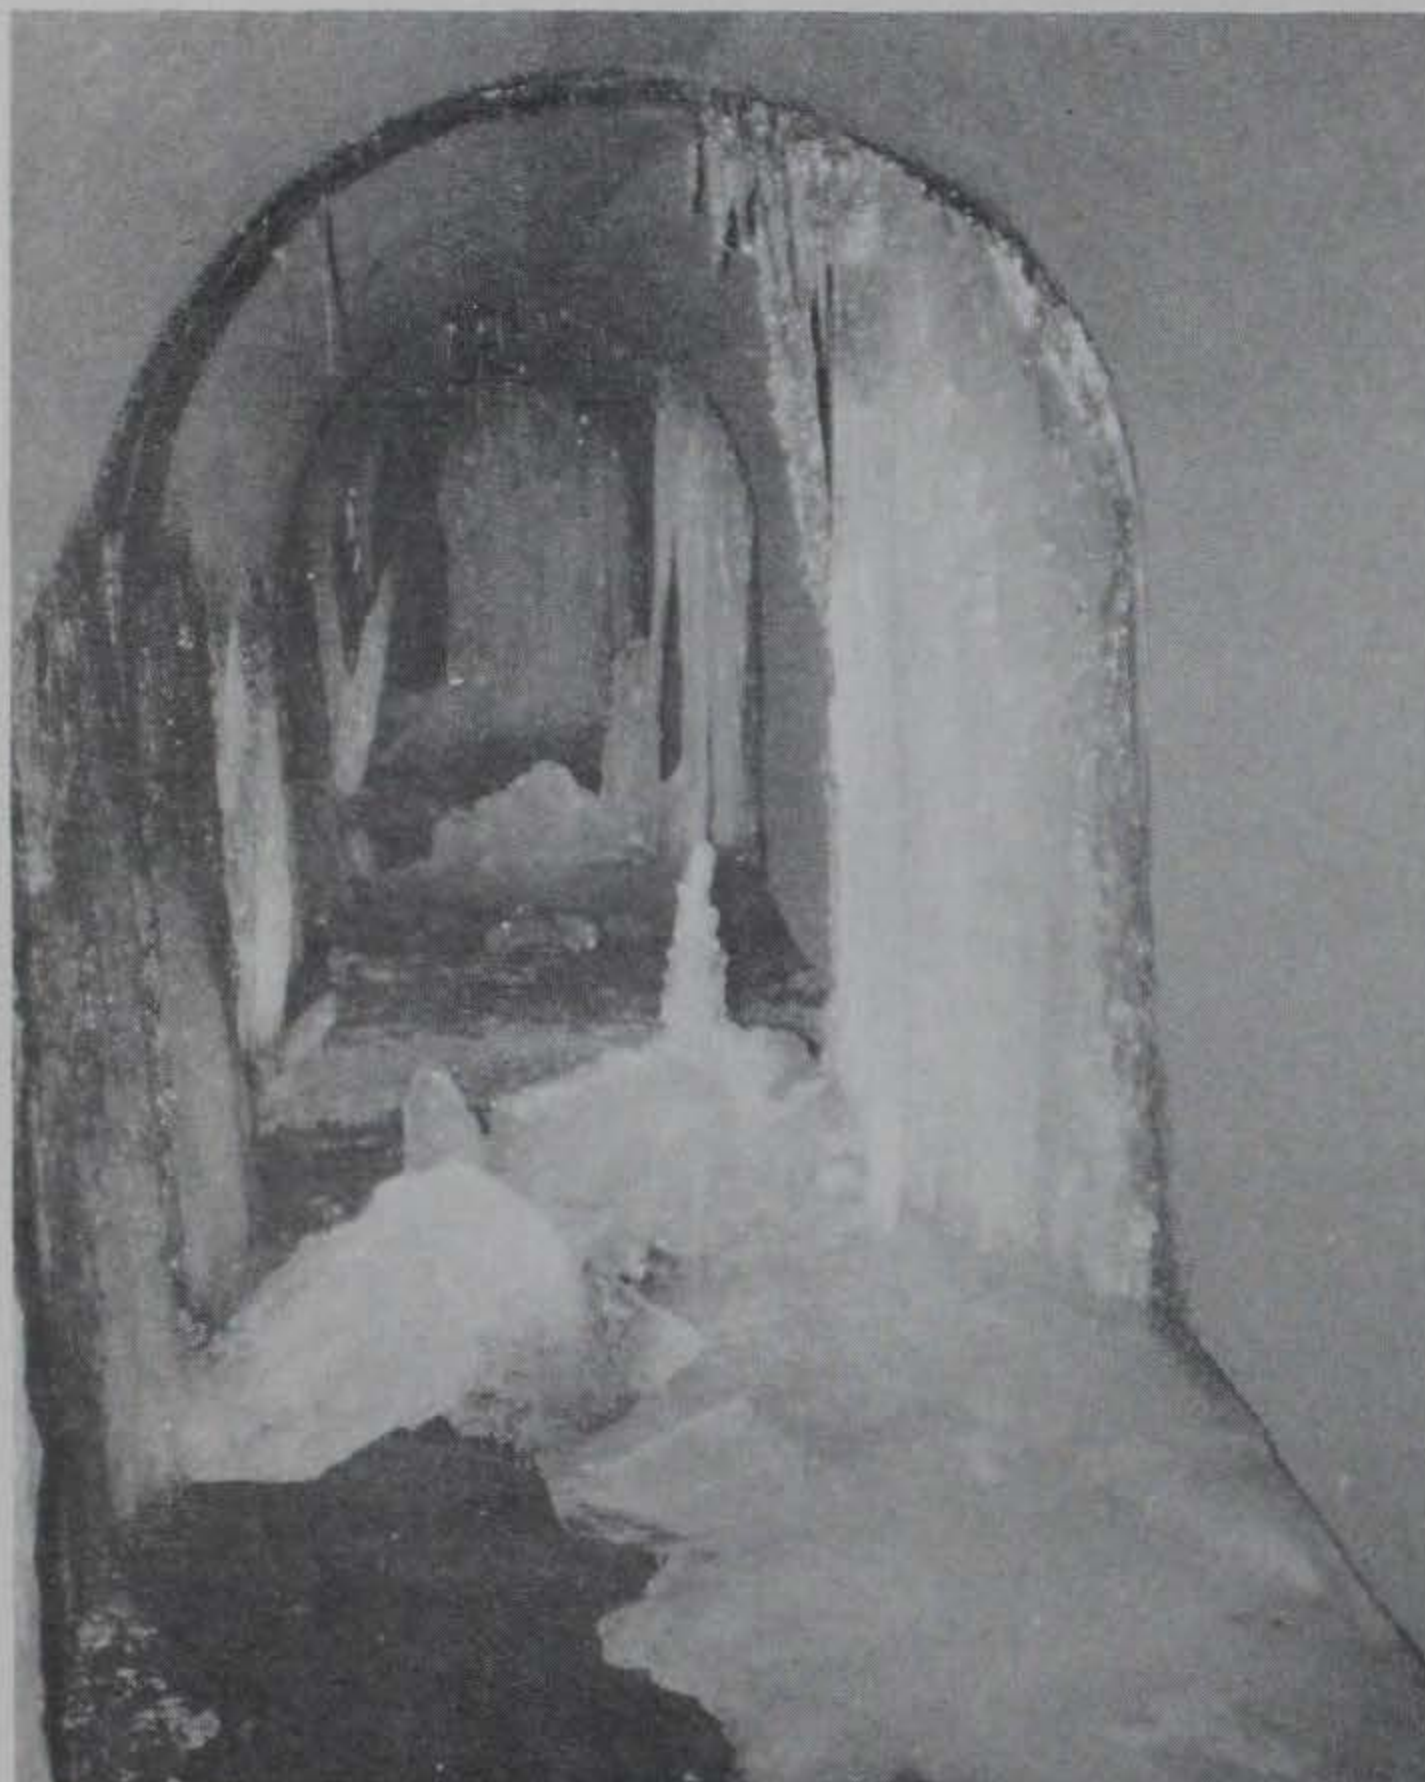
a. Seepage through construction joints and monolith walls, land wall filling, and emptying culverts

Figure 6. Troy Lock and Dam, Hudson River, Troy, New York

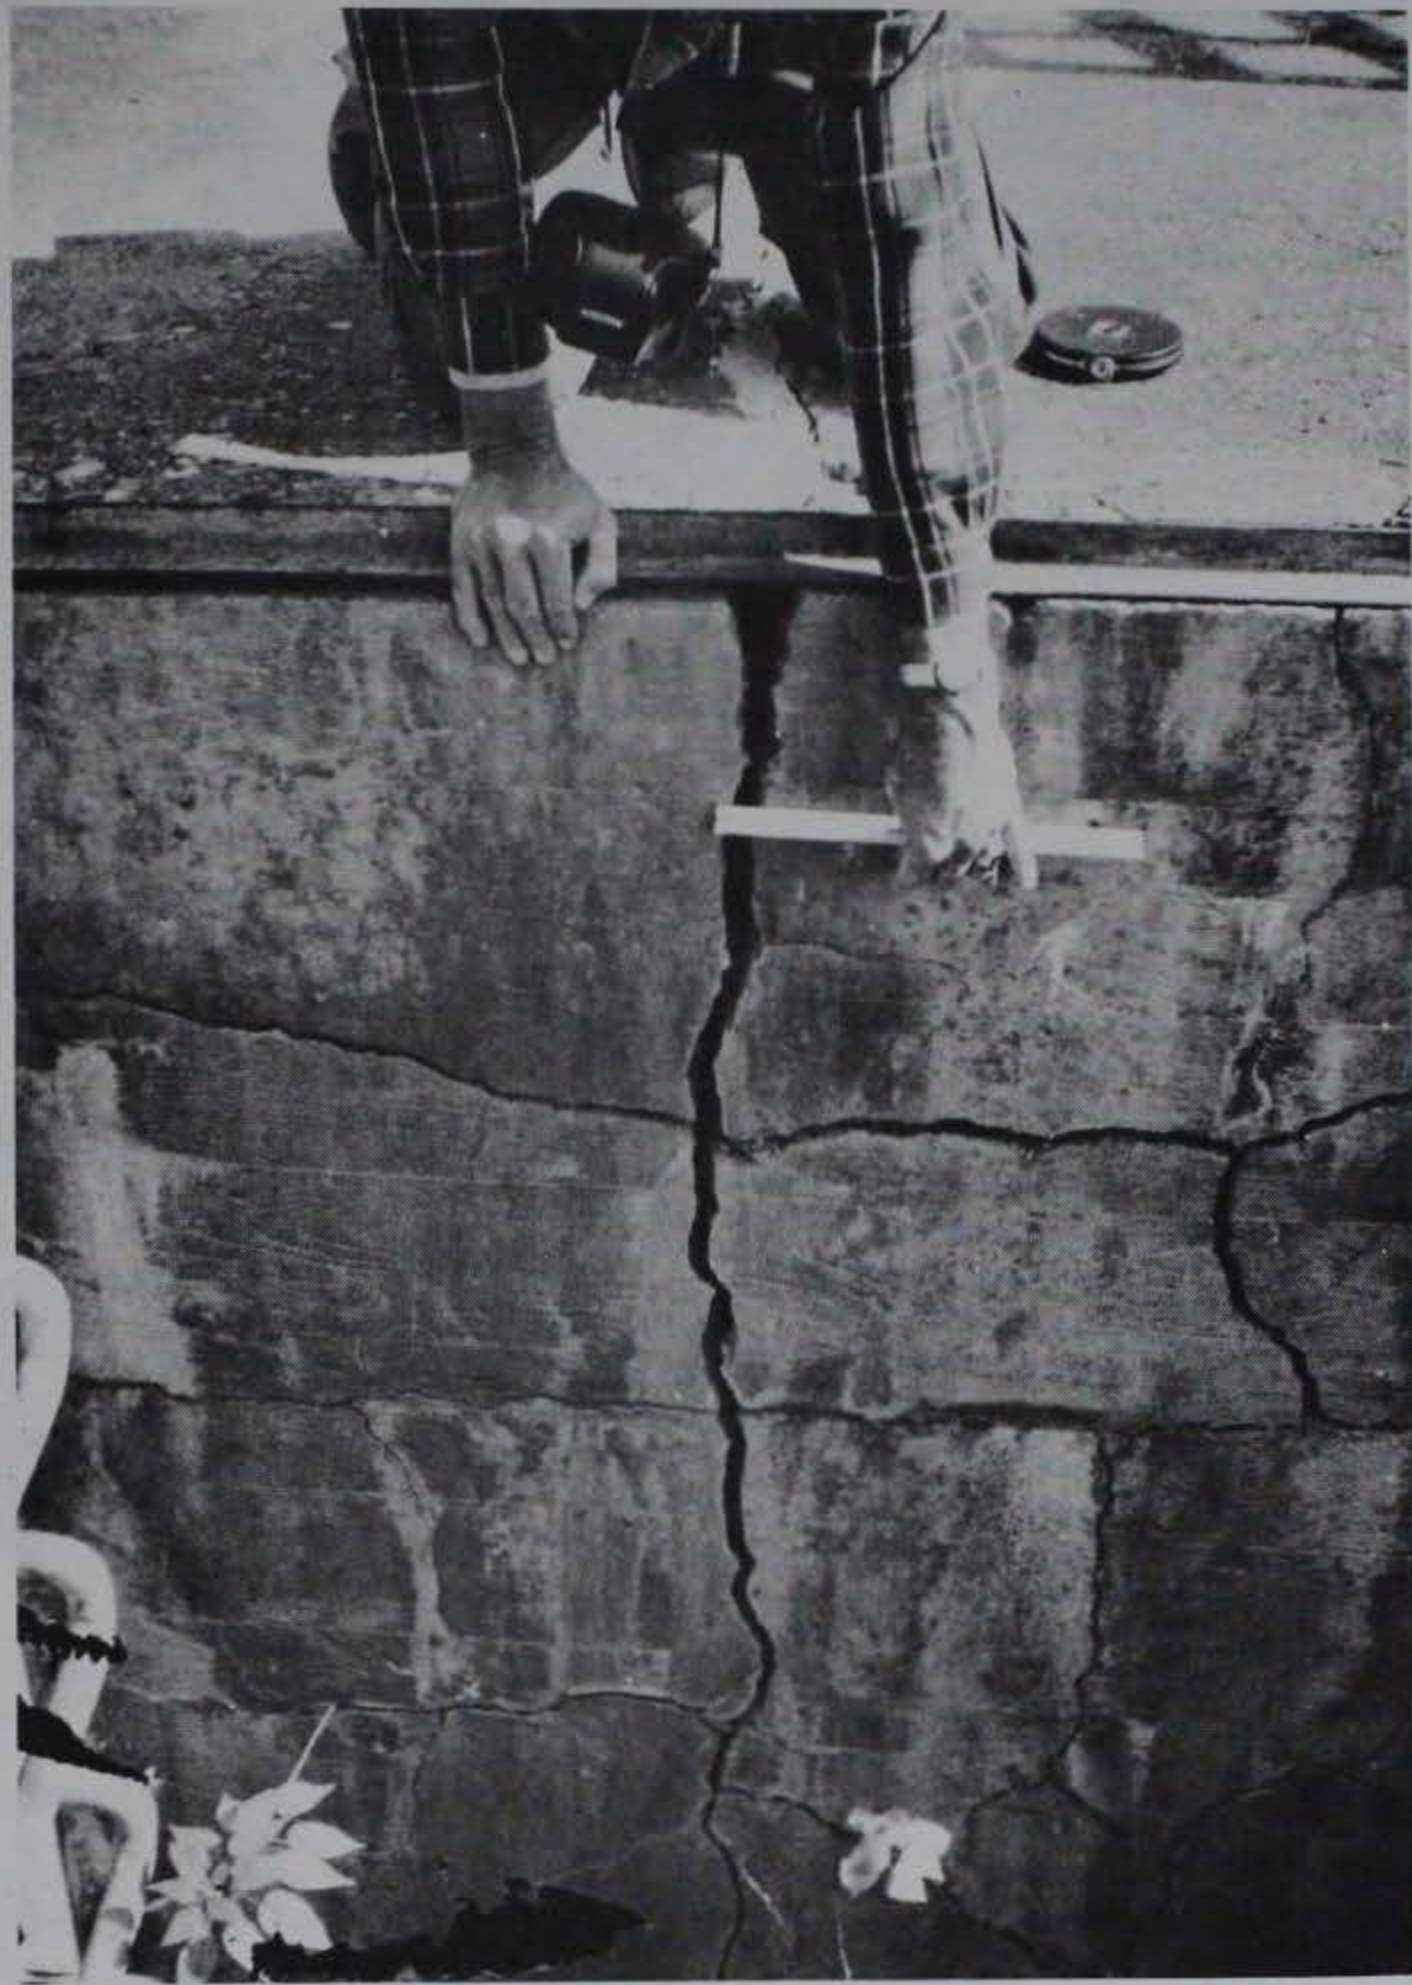
Figure 7. Cracked lock wall, Oliver Lock, Tuscaloosa, Alabama

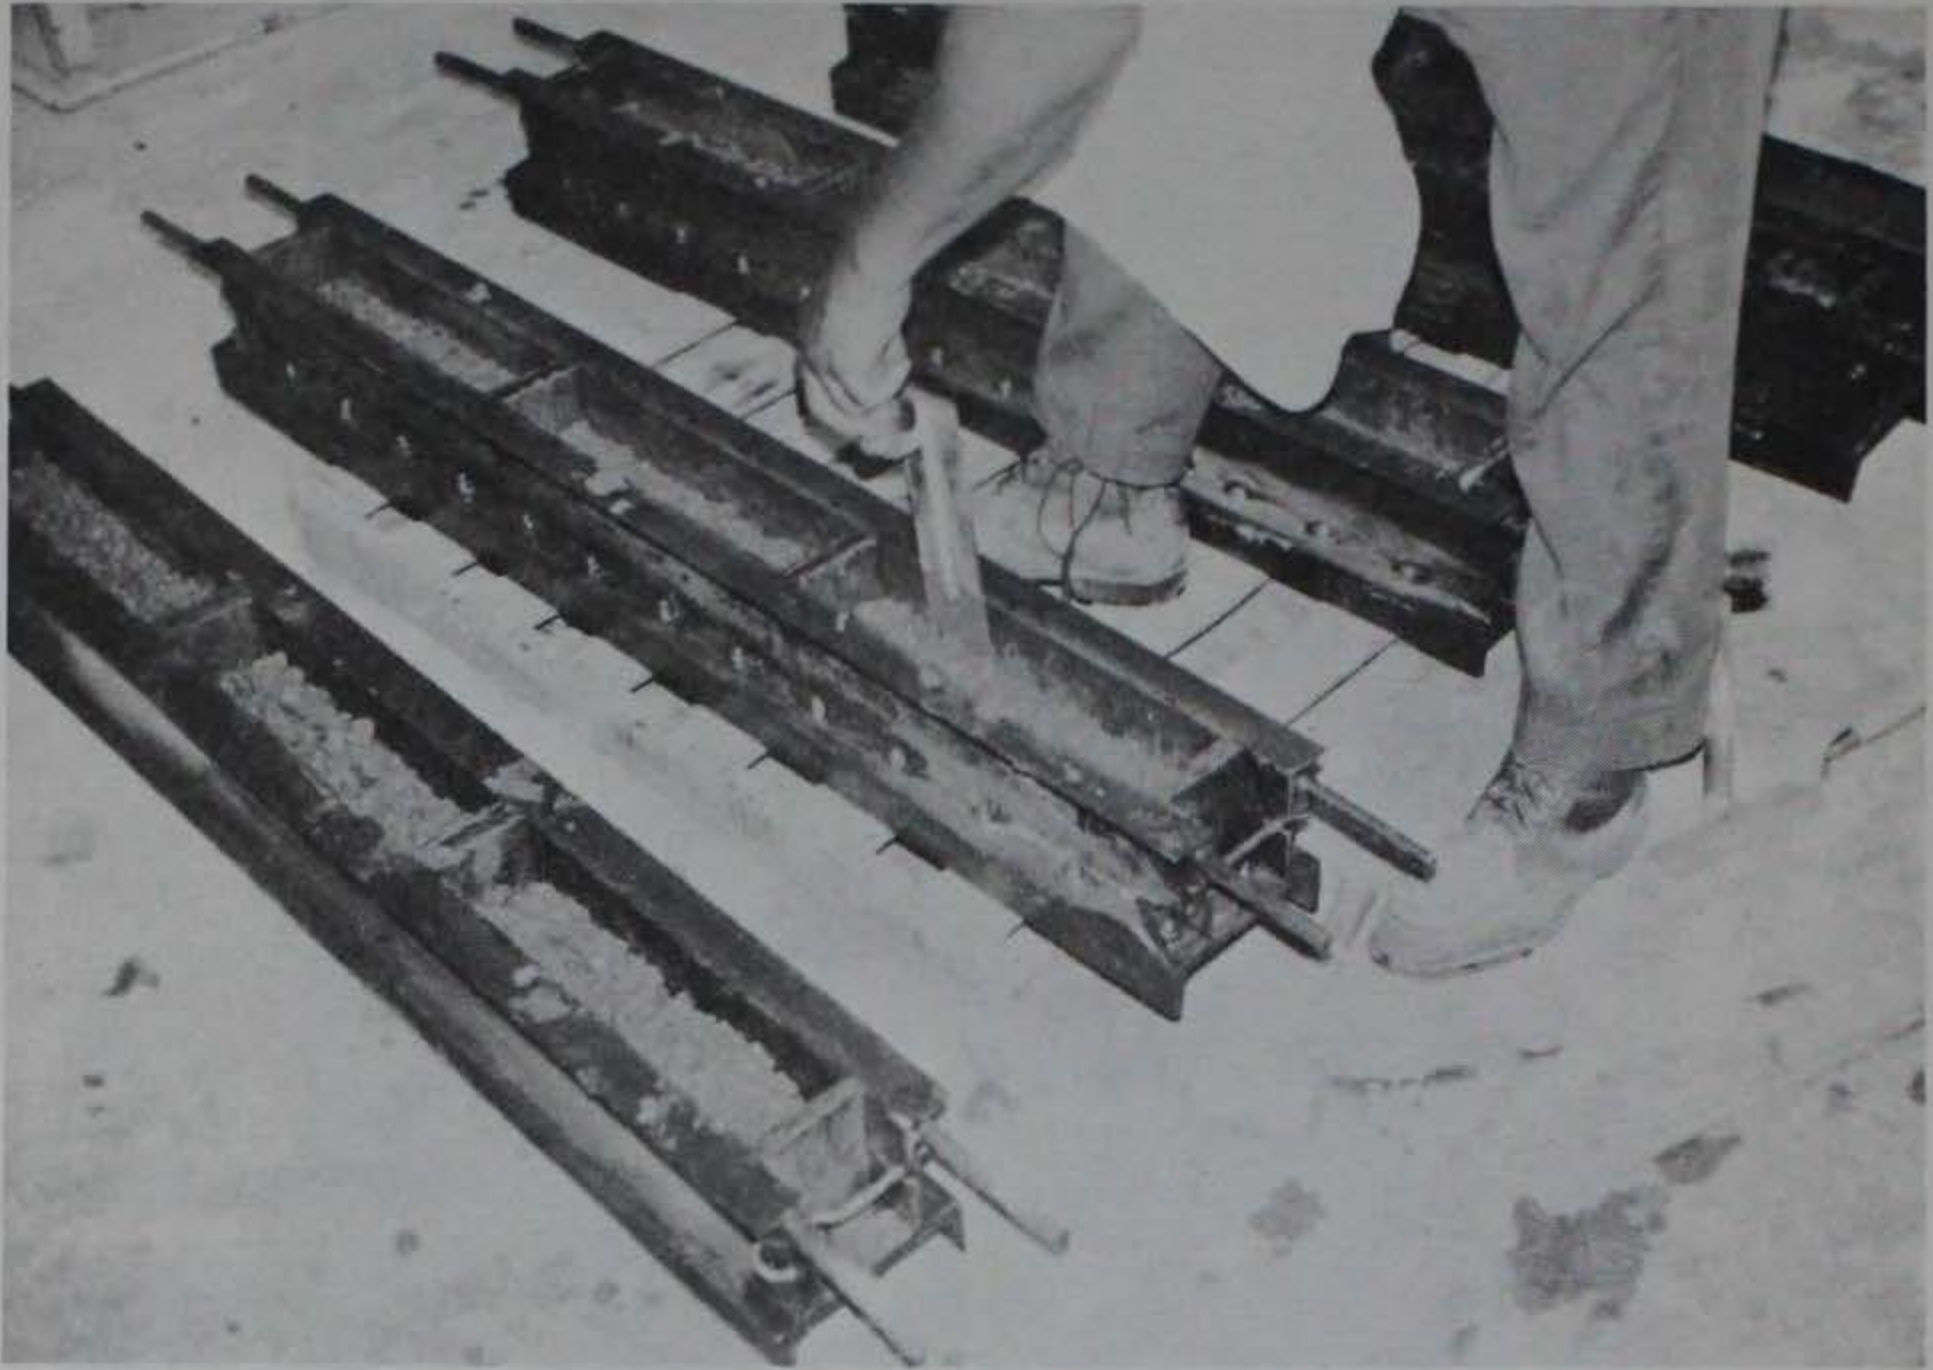
a. Consolidation of first placement

Figure 8. First placement of specimens to evaluate overlay performance
