MISCELLANEOUS PAPER SL-88-5

WALL ARMOR PULLOUT TESTING

Willie E. McDonald

Prepared for US Army Engineer District, St. Louis
St. Louis, Missouri 63101-1986

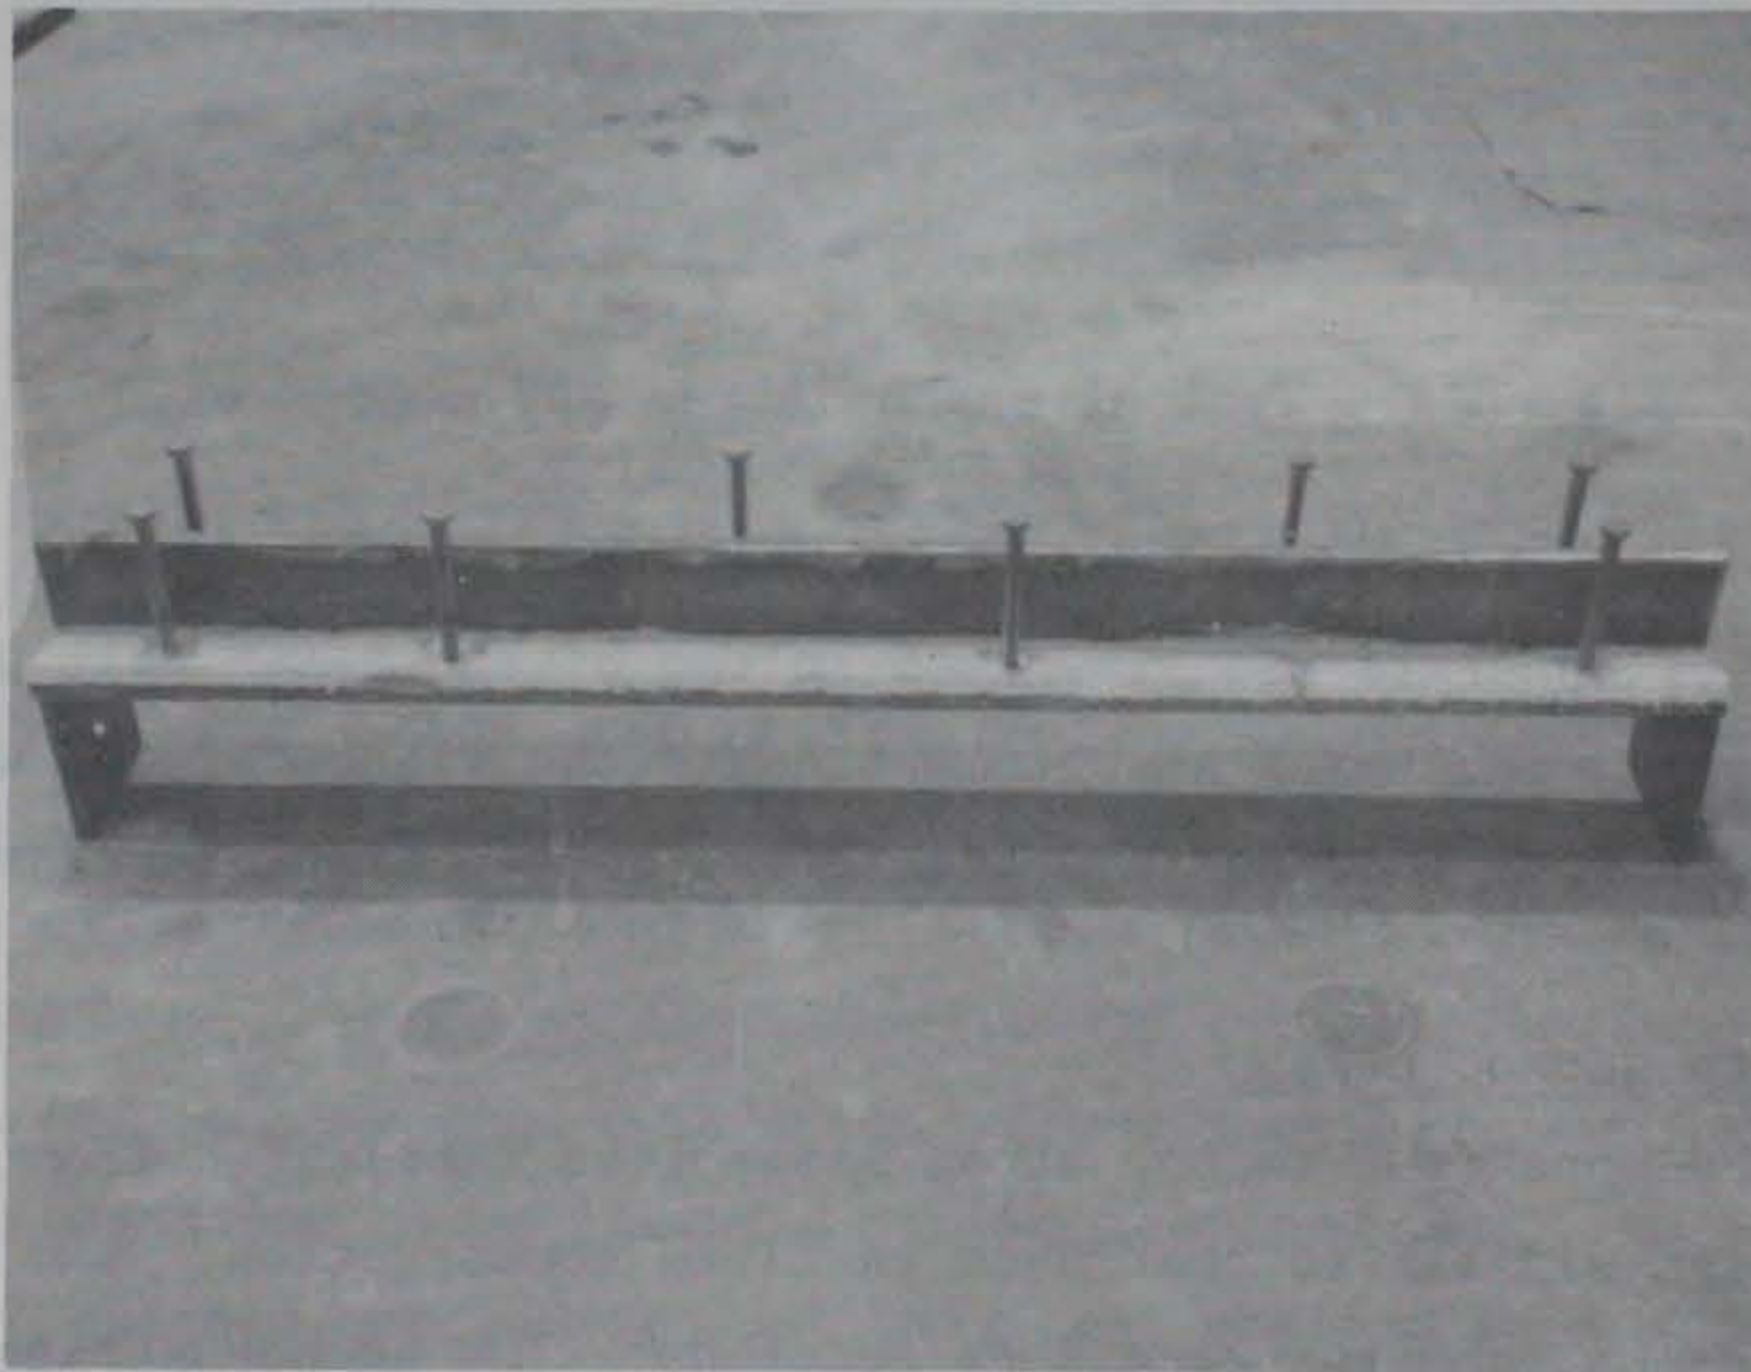
Figure 2. Placement of 1-in.-thick styrofoam beneath flange of wall armor to simulate erosion of concrete

Deterioration of concrete was simulated in two of the 6-ft* wall armor assemblies by placing 1-in.-thick styrofoam beneath the flange of the wall armor to prevent concrete from filling into this area, and to simulate erosion (Figure 2).

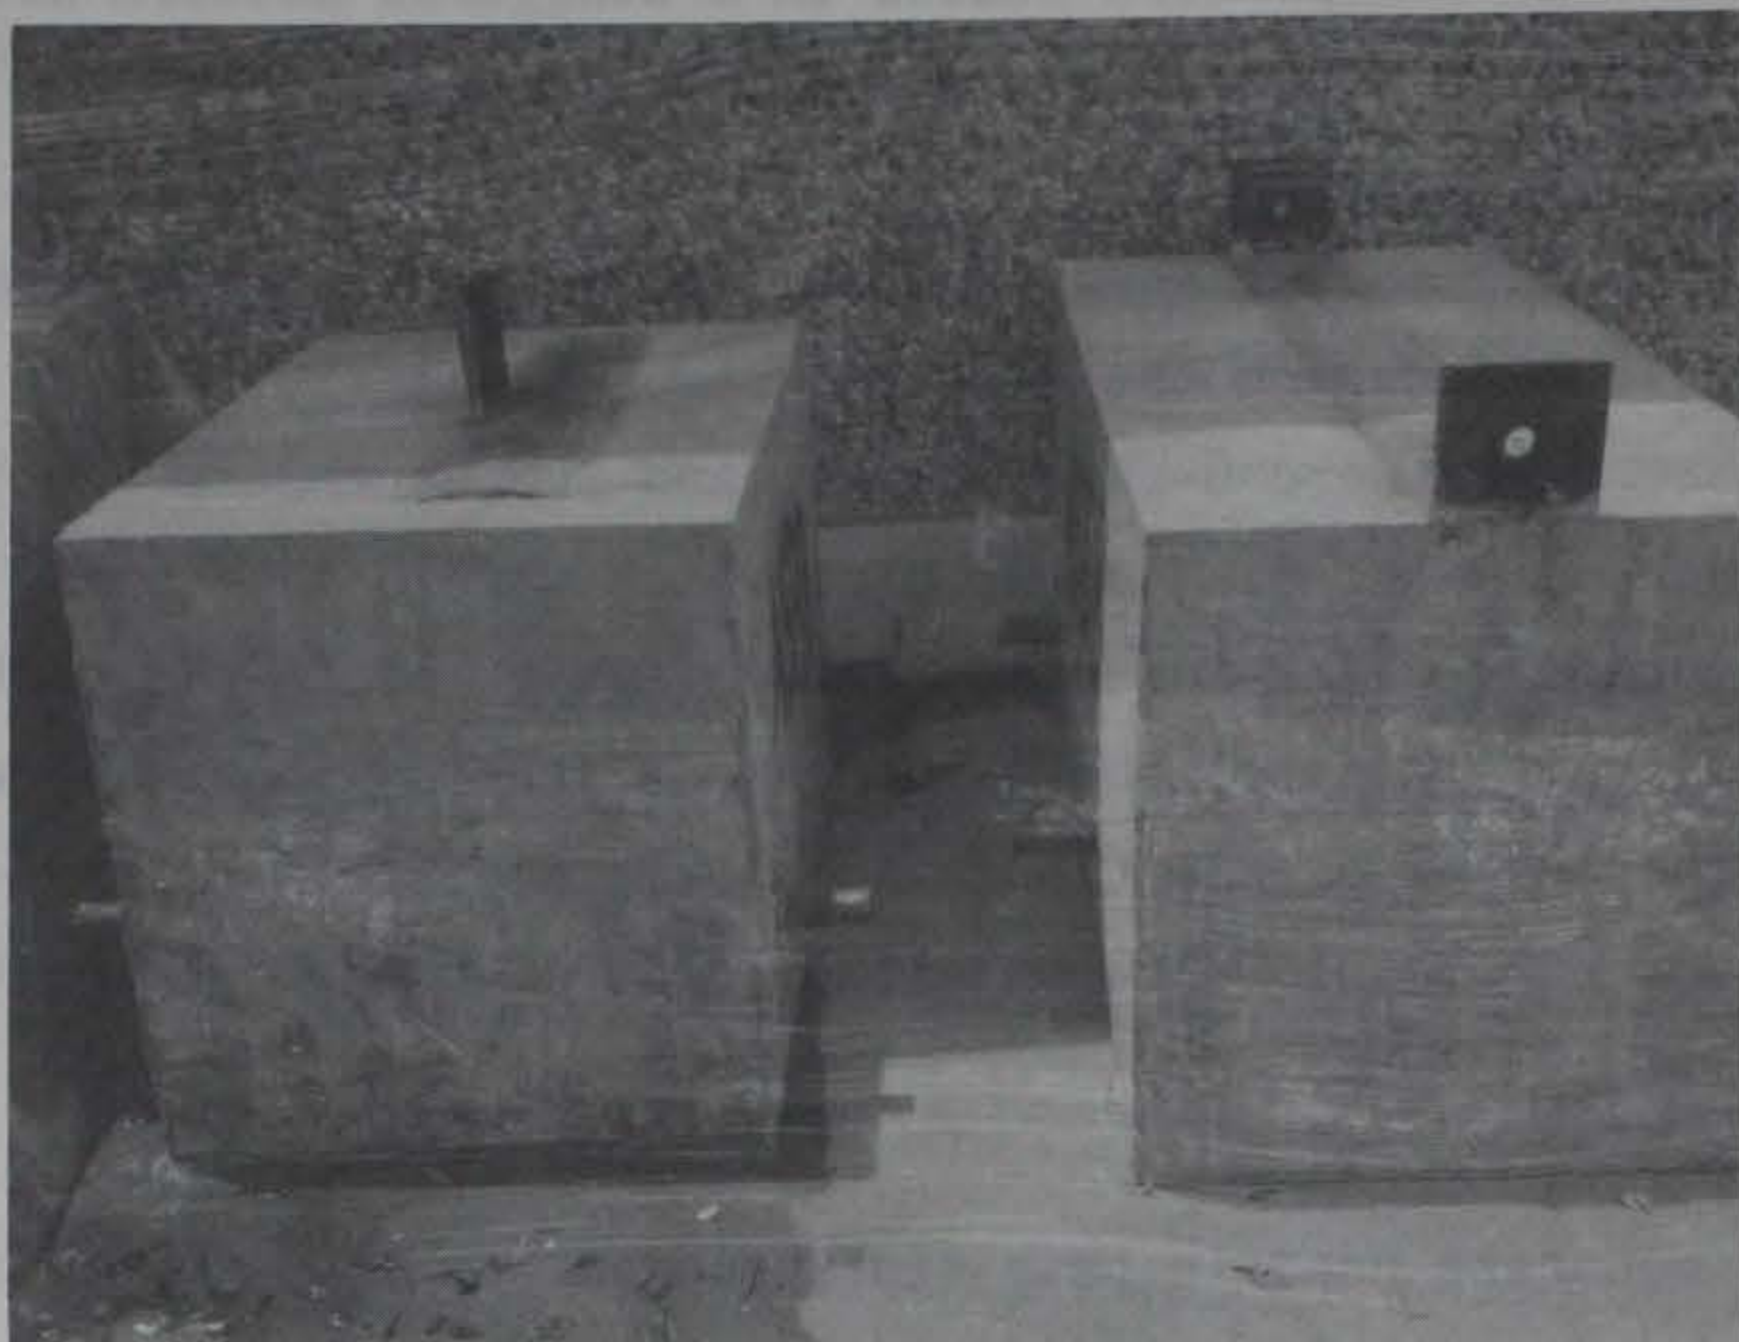
Figure 3. Wall armor assemblies embedded in concrete specimens

9. Eight concrete specimens were cast during the test program. Four of these specimens measured 2 ft 9-1/2 in. in width, 6 ft in length, and 3 ft in height. The remaining four specimens were similarly dimensioned with the exception of being 4 ft in length. In each specimen wall armor assemblies were embedded such that only the flanges of the wall armor remained exposed as shown in Figure 3. For specimen anchorage to the test floor, four 2-in.-diam steel bars, 12-3/4 in. long, were embedded to a depth of 12 in. in each of the 4-ft-long concrete specimens, 10 in. in height from the bottom of the test blocks. In the 6-ft-long concrete specimens, two 2-in.-diam bars were embedded throughout the width of the test blocks with an overhang of 5-3/4 in. on either side of the test blocks. These were also positioned 10 in. in height from the bottom of the test blocks. These bars are visible in Figure 3. Also, in each 6-ft-long concrete specimen, six No. 8 reinforcement bars were

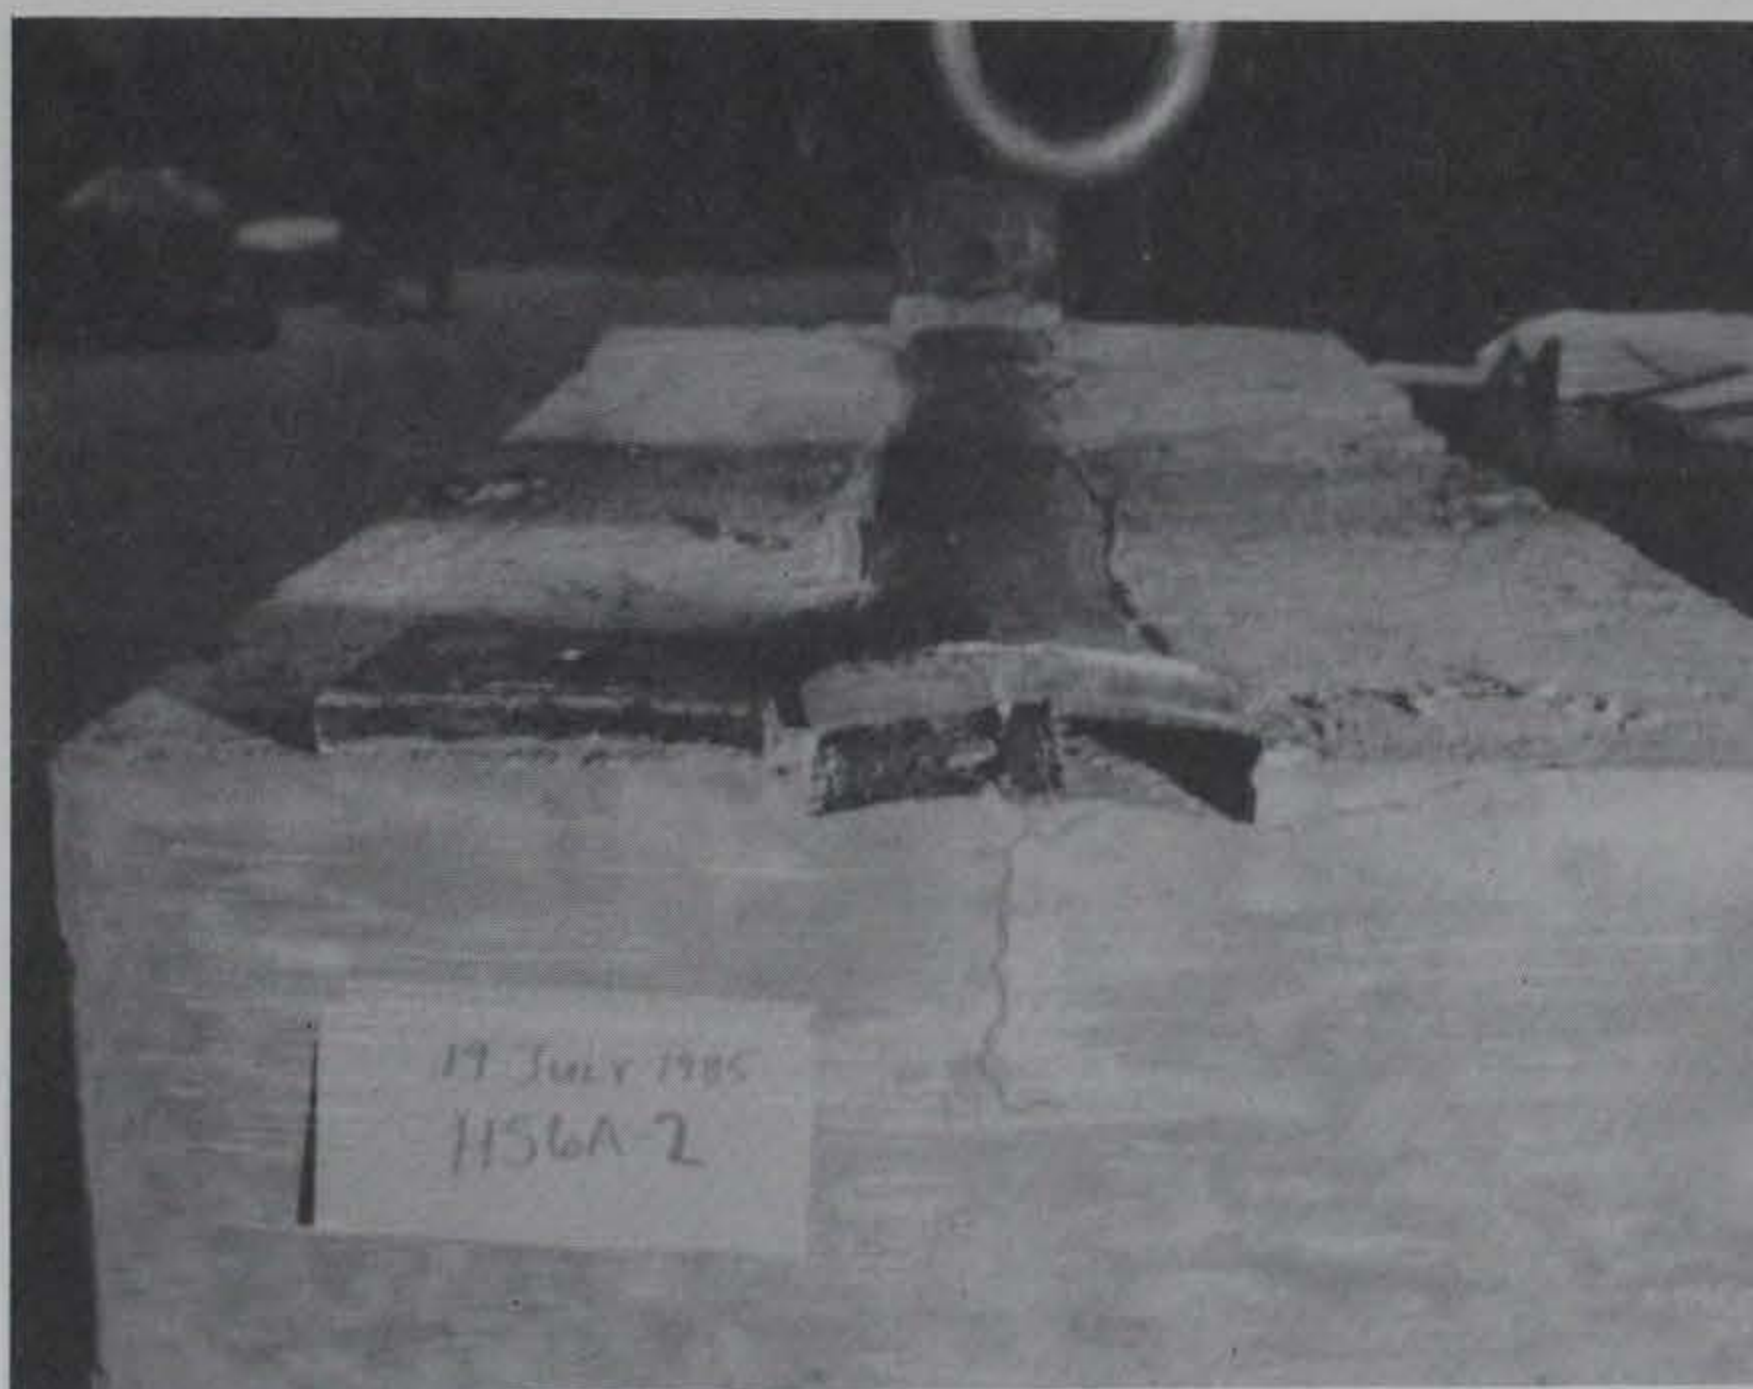
Photo 2. Wall armor test failure, assembly HS6A-2

| <u>Identification</u> | <u>Load, lbf</u> | <u>Failure Mechanism</u> |
|---|---|---|
| HS6A-2 | 45,000 | Rupture of weld joints |

15. All of the successful tests conducted on the 6-ft assemblies failed first by producing failure cones in the concrete. Photos 1-8 show these failures. Plates 3-10 contain the raw data from the load versus deflection test plots. In the failure of the 6-ft assemblies, concrete rupture was followed by pullout of the wall armor with the exception of assembly AS6B-2. In this assembly, failure near the top surface of the concrete test block was impending (as evident by the presence of failure cracks) when rupture of the concrete occurred at the level of the anchor bar inclusion mentioned in paragraph 9. The loading range and the pattern of the failure cracks were the same as with the other 6-ft anchor strap tests at failure. Therefore, this was also considered a good test. The boundaries of the failure cones for the headed stud assemblies were at a depth close to the depth of the headed studs. For the anchor strap assemblies, the failure plane was very near the top surface of the concrete test blocks. The anchor strap wall armor tests realized the higher pullout resistance with a loading range from 64,000 to 82,000 lbf for an average of 72,000 lbf. The headed stud assemblies provided

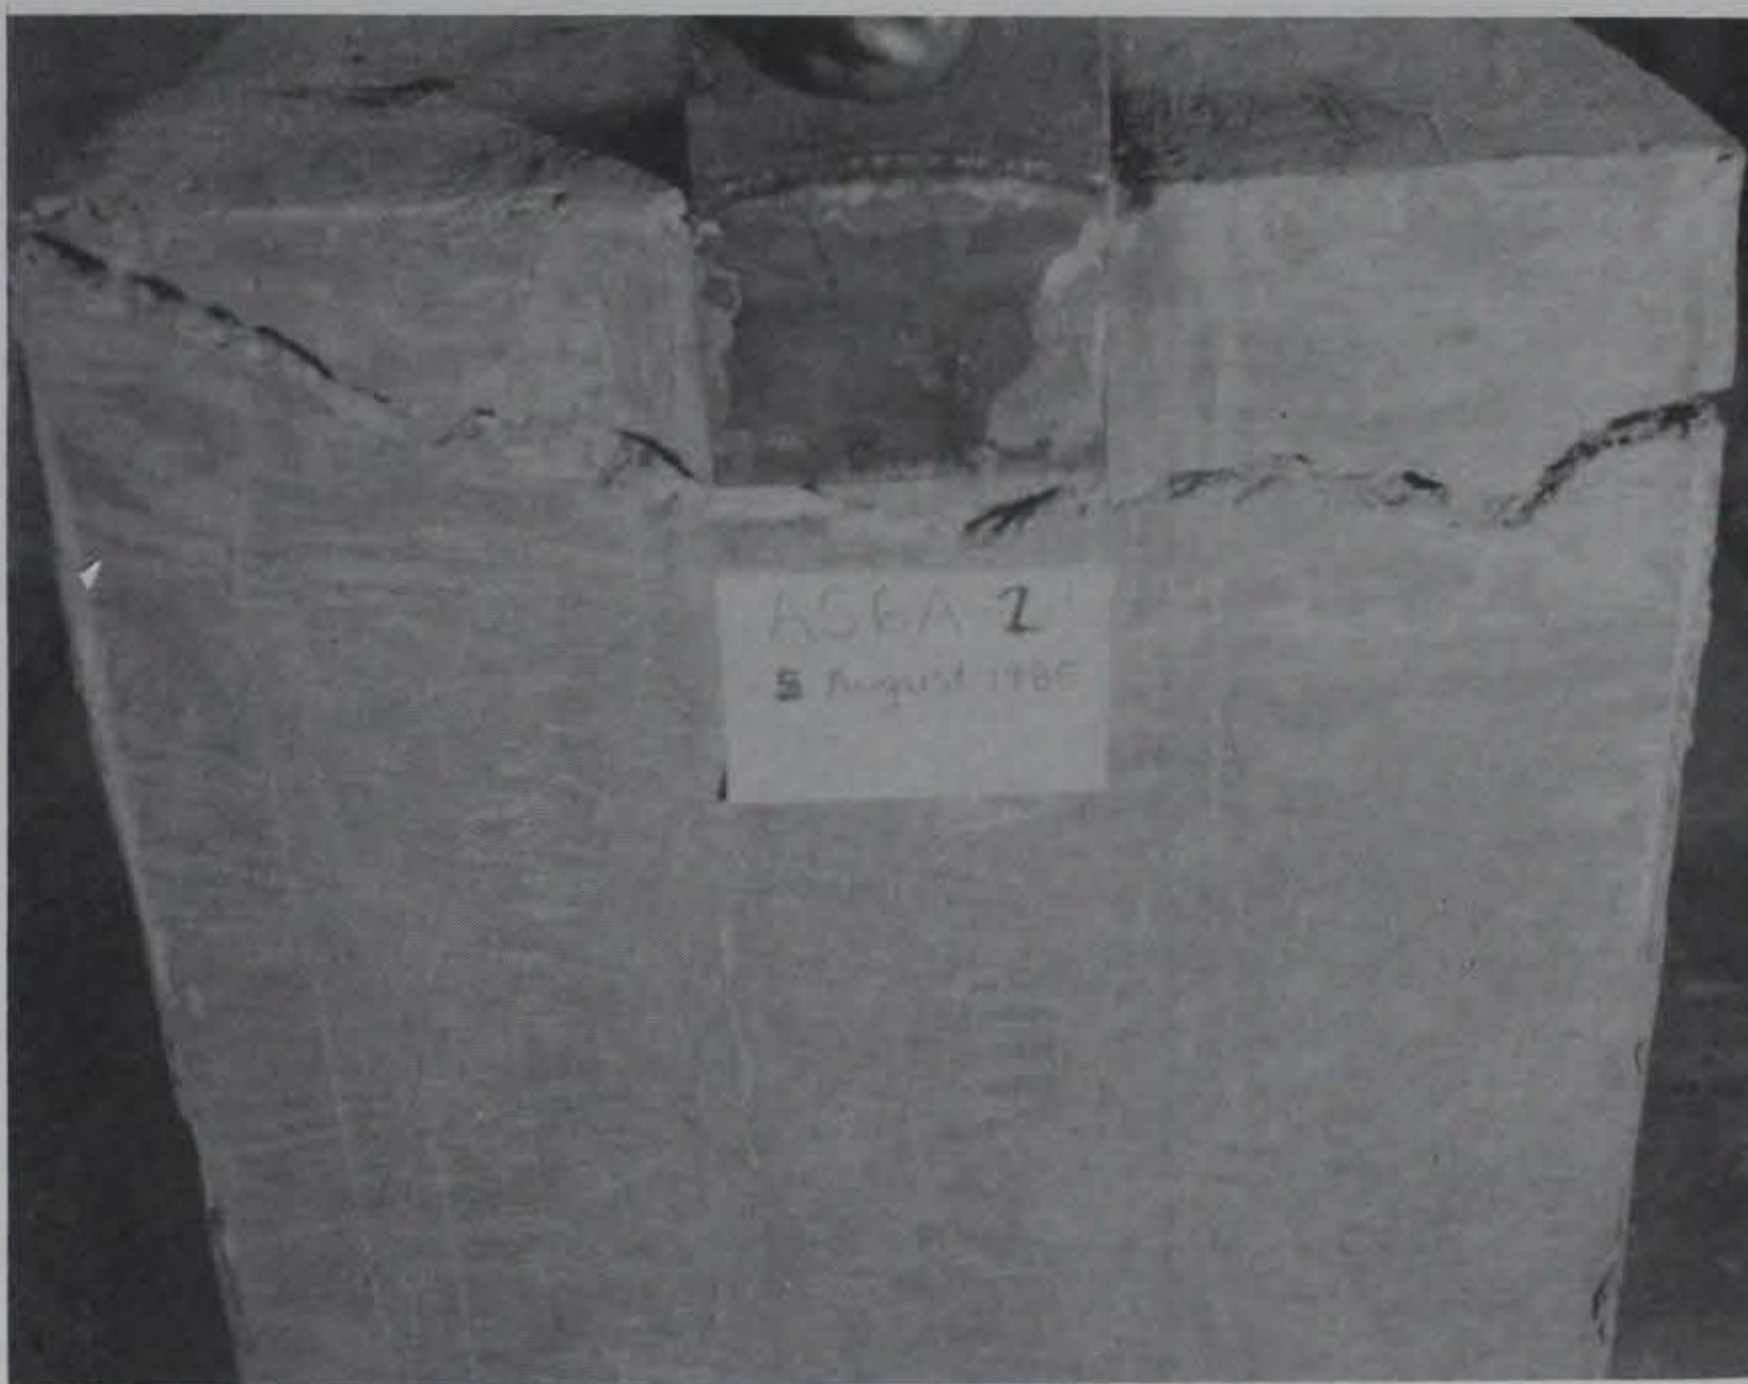
Photo 6. Wall armor test failure, assembly AS6A-2

| <u>Identification</u> | <u>Load, lbf</u> | <u>Failure Mechanism</u> |
|---|---|---|
| AS6A-2 | 65,000 | Rupture of concrete |

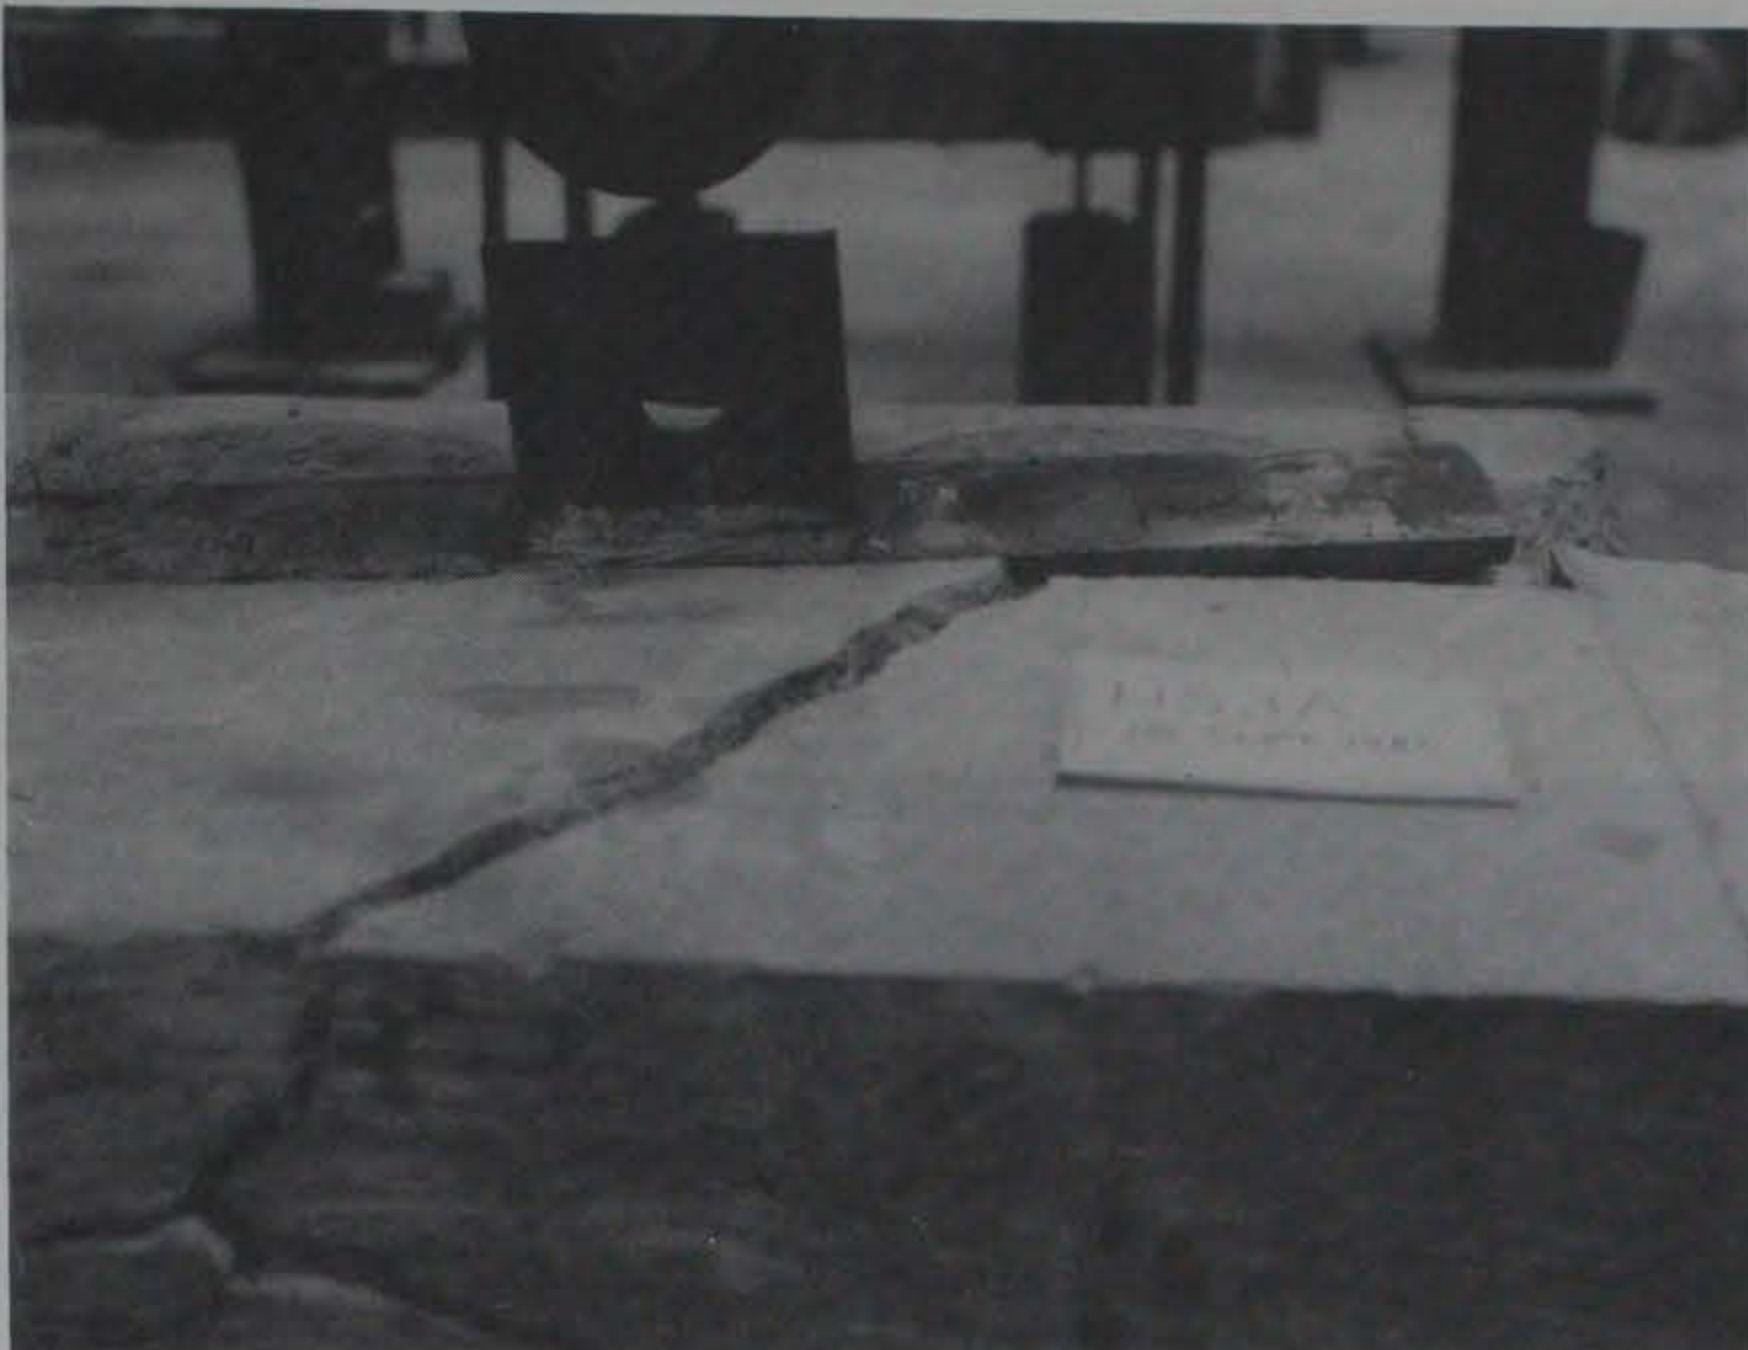
Photo 9. Wall armor test failure, assembly HS3A

| <u>Identification</u> | <u>Load, lbf</u> | <u>Failure Mechanism</u> |
|---|---|---|
| HS3A | 84,500 | Rupture of concrete |

16. Of the tests conducted on the 3-ft assemblies, only the two headed stud assemblies failed in a mode which was expected. Photographs of these failures are given in Photos 9-11. Raw data from load versus deflection test plots can be found in Plates 11-15. As with the 6-ft assemblies, failure of the 3-ft headed stud assemblies was the rupture of the concrete followed by pullout of the wall armor. The failure was across the top and side faces of the concrete at loadings of 84,000 and 78,700 lbf, respectively.

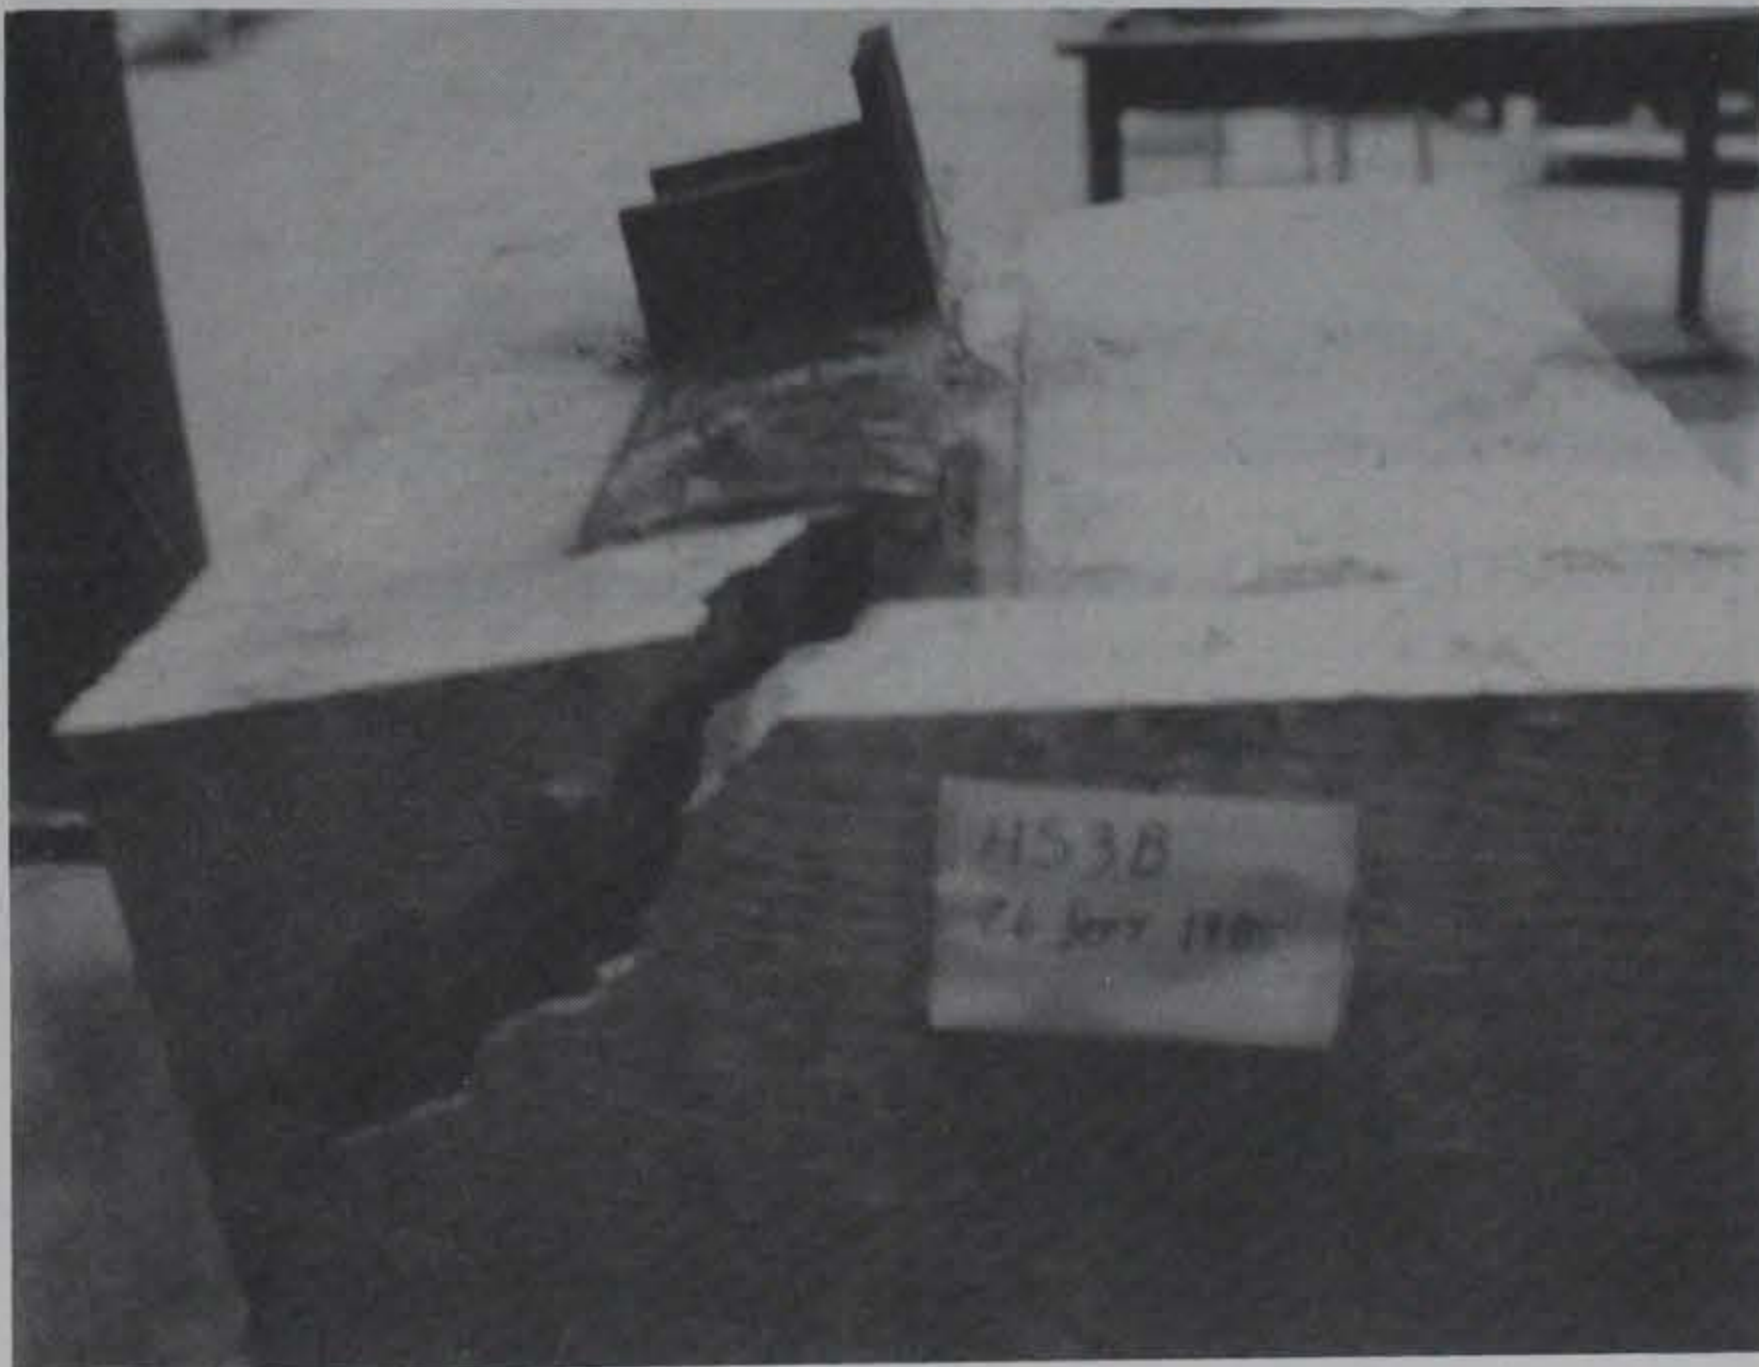
Photo 10. Wall armor test failure, assembly HS3B

| <u>Identification</u> | <u>Load, lbf</u> | <u>Failure Mechanism</u> |
|---|---|---|
| HS3B | 78,000 | Rupture of concrete |

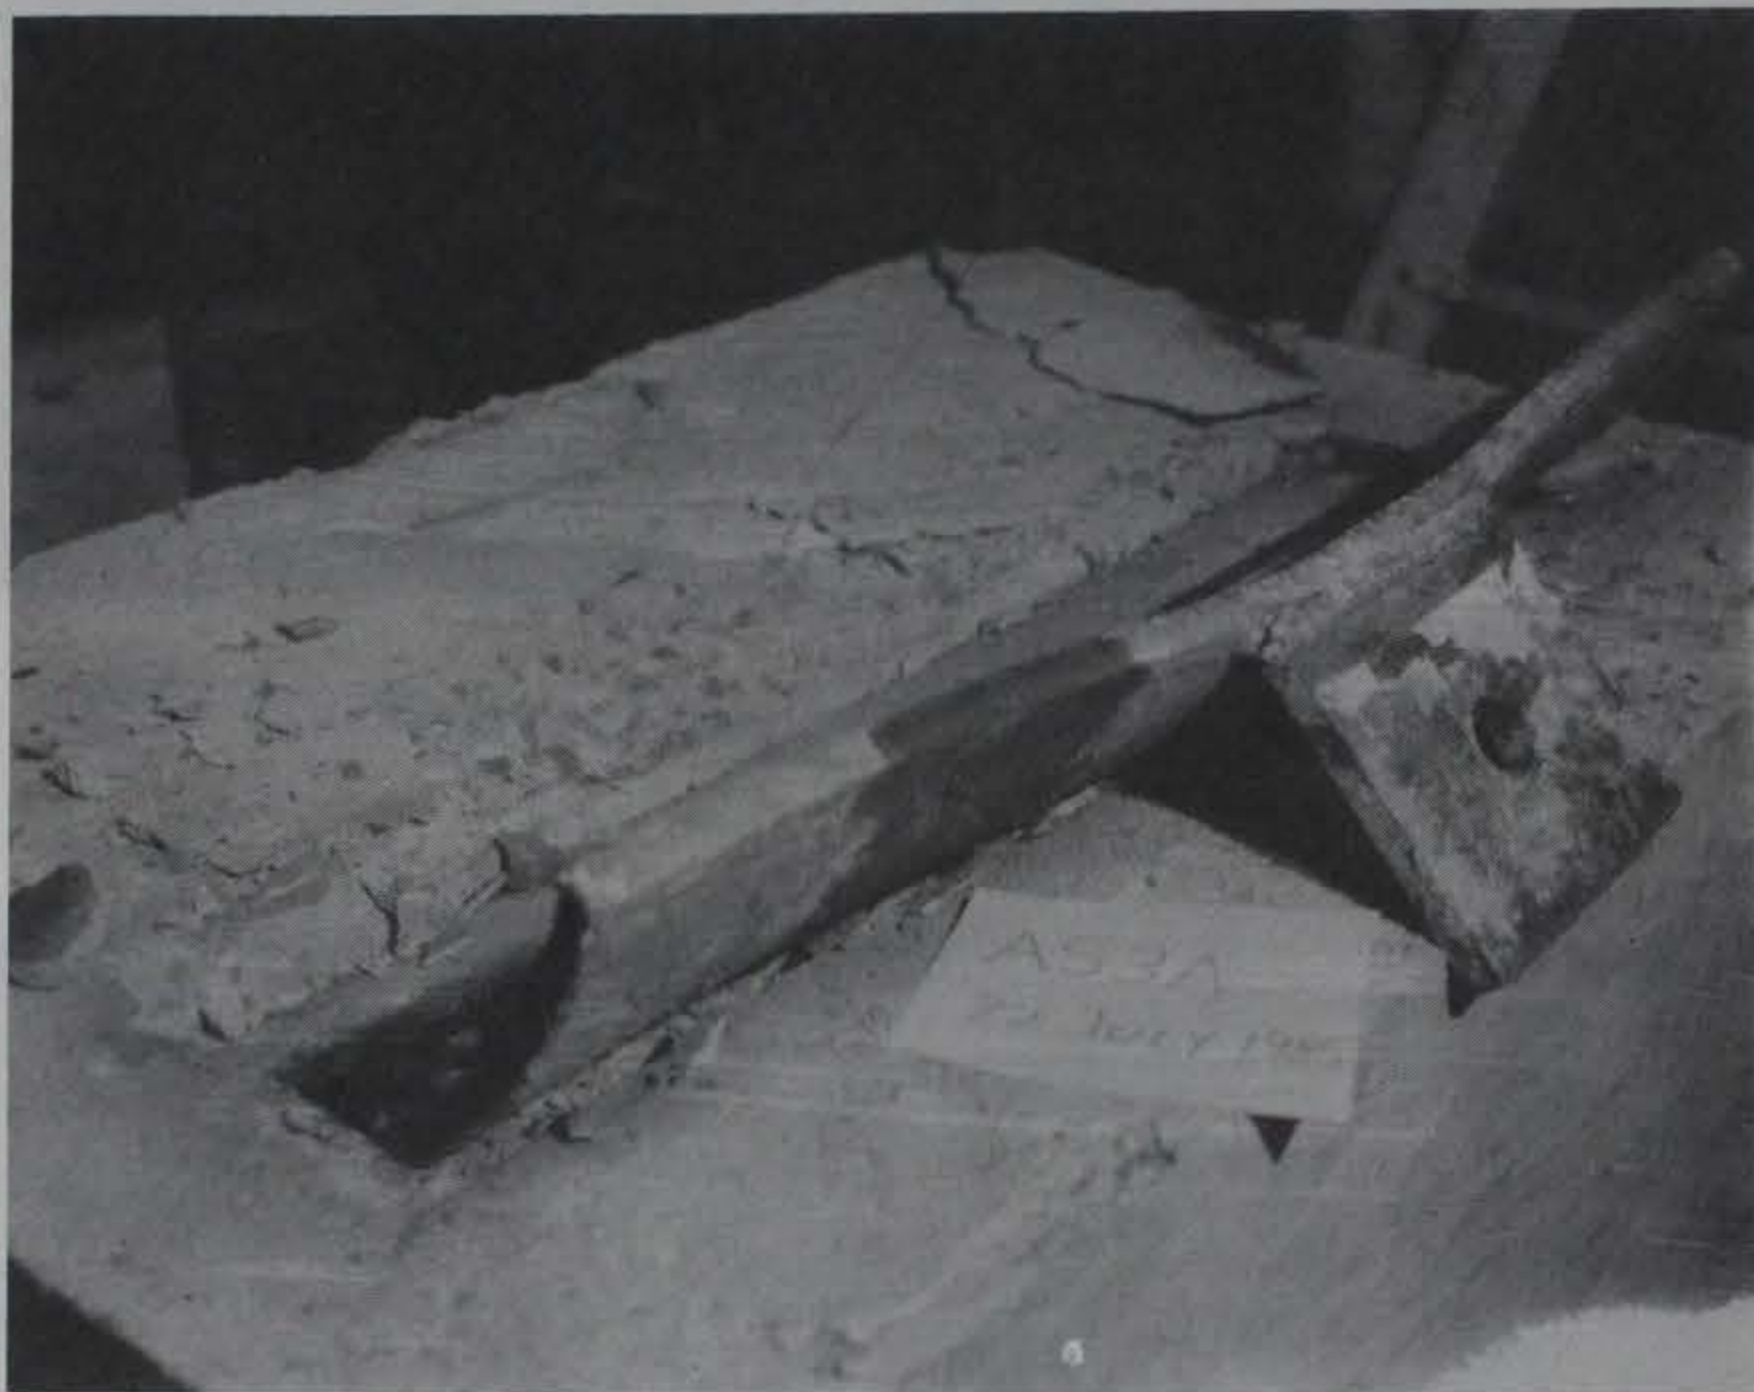
Photo 11. Wall armor test failure, assembly AS3A

| <u>Identification</u> | <u>Load, lbf</u> | <u>Failure Mechanism</u> |
|---|---|---|
| AS3A | 62,000 | Rupture of weld joints |

17. Testing of the two 3-ft anchor strap assemblies resulted in the first of the two (AS3A) failing by rupture of the weld joint between the flange and the web of the tee. There were two tests performed on the second of the two assemblies (AS3B). In the first of these two tests, loading of 94,000 lbf was attained when failure of the connection between the eyebolt and the actuator foot interrupted testing. Since no visible damage was apparent to the concrete or to the wall armor, it was retested. The second testing of this assembly resulted in rupture of the concrete in the lower plane at the depth of the anchor bar inclusion at a load of 92,000 lbf. However, failure in a mode similar to that of the 3-ft headed assemblies did not occur.
