MISCELLANEOUS PAPER SL-87-5

ALKALI-CARBONATE ROCK REACTION AT CENTER HILL DAM, TENNESSEE

G. Sam Wong

Structures Laboratory

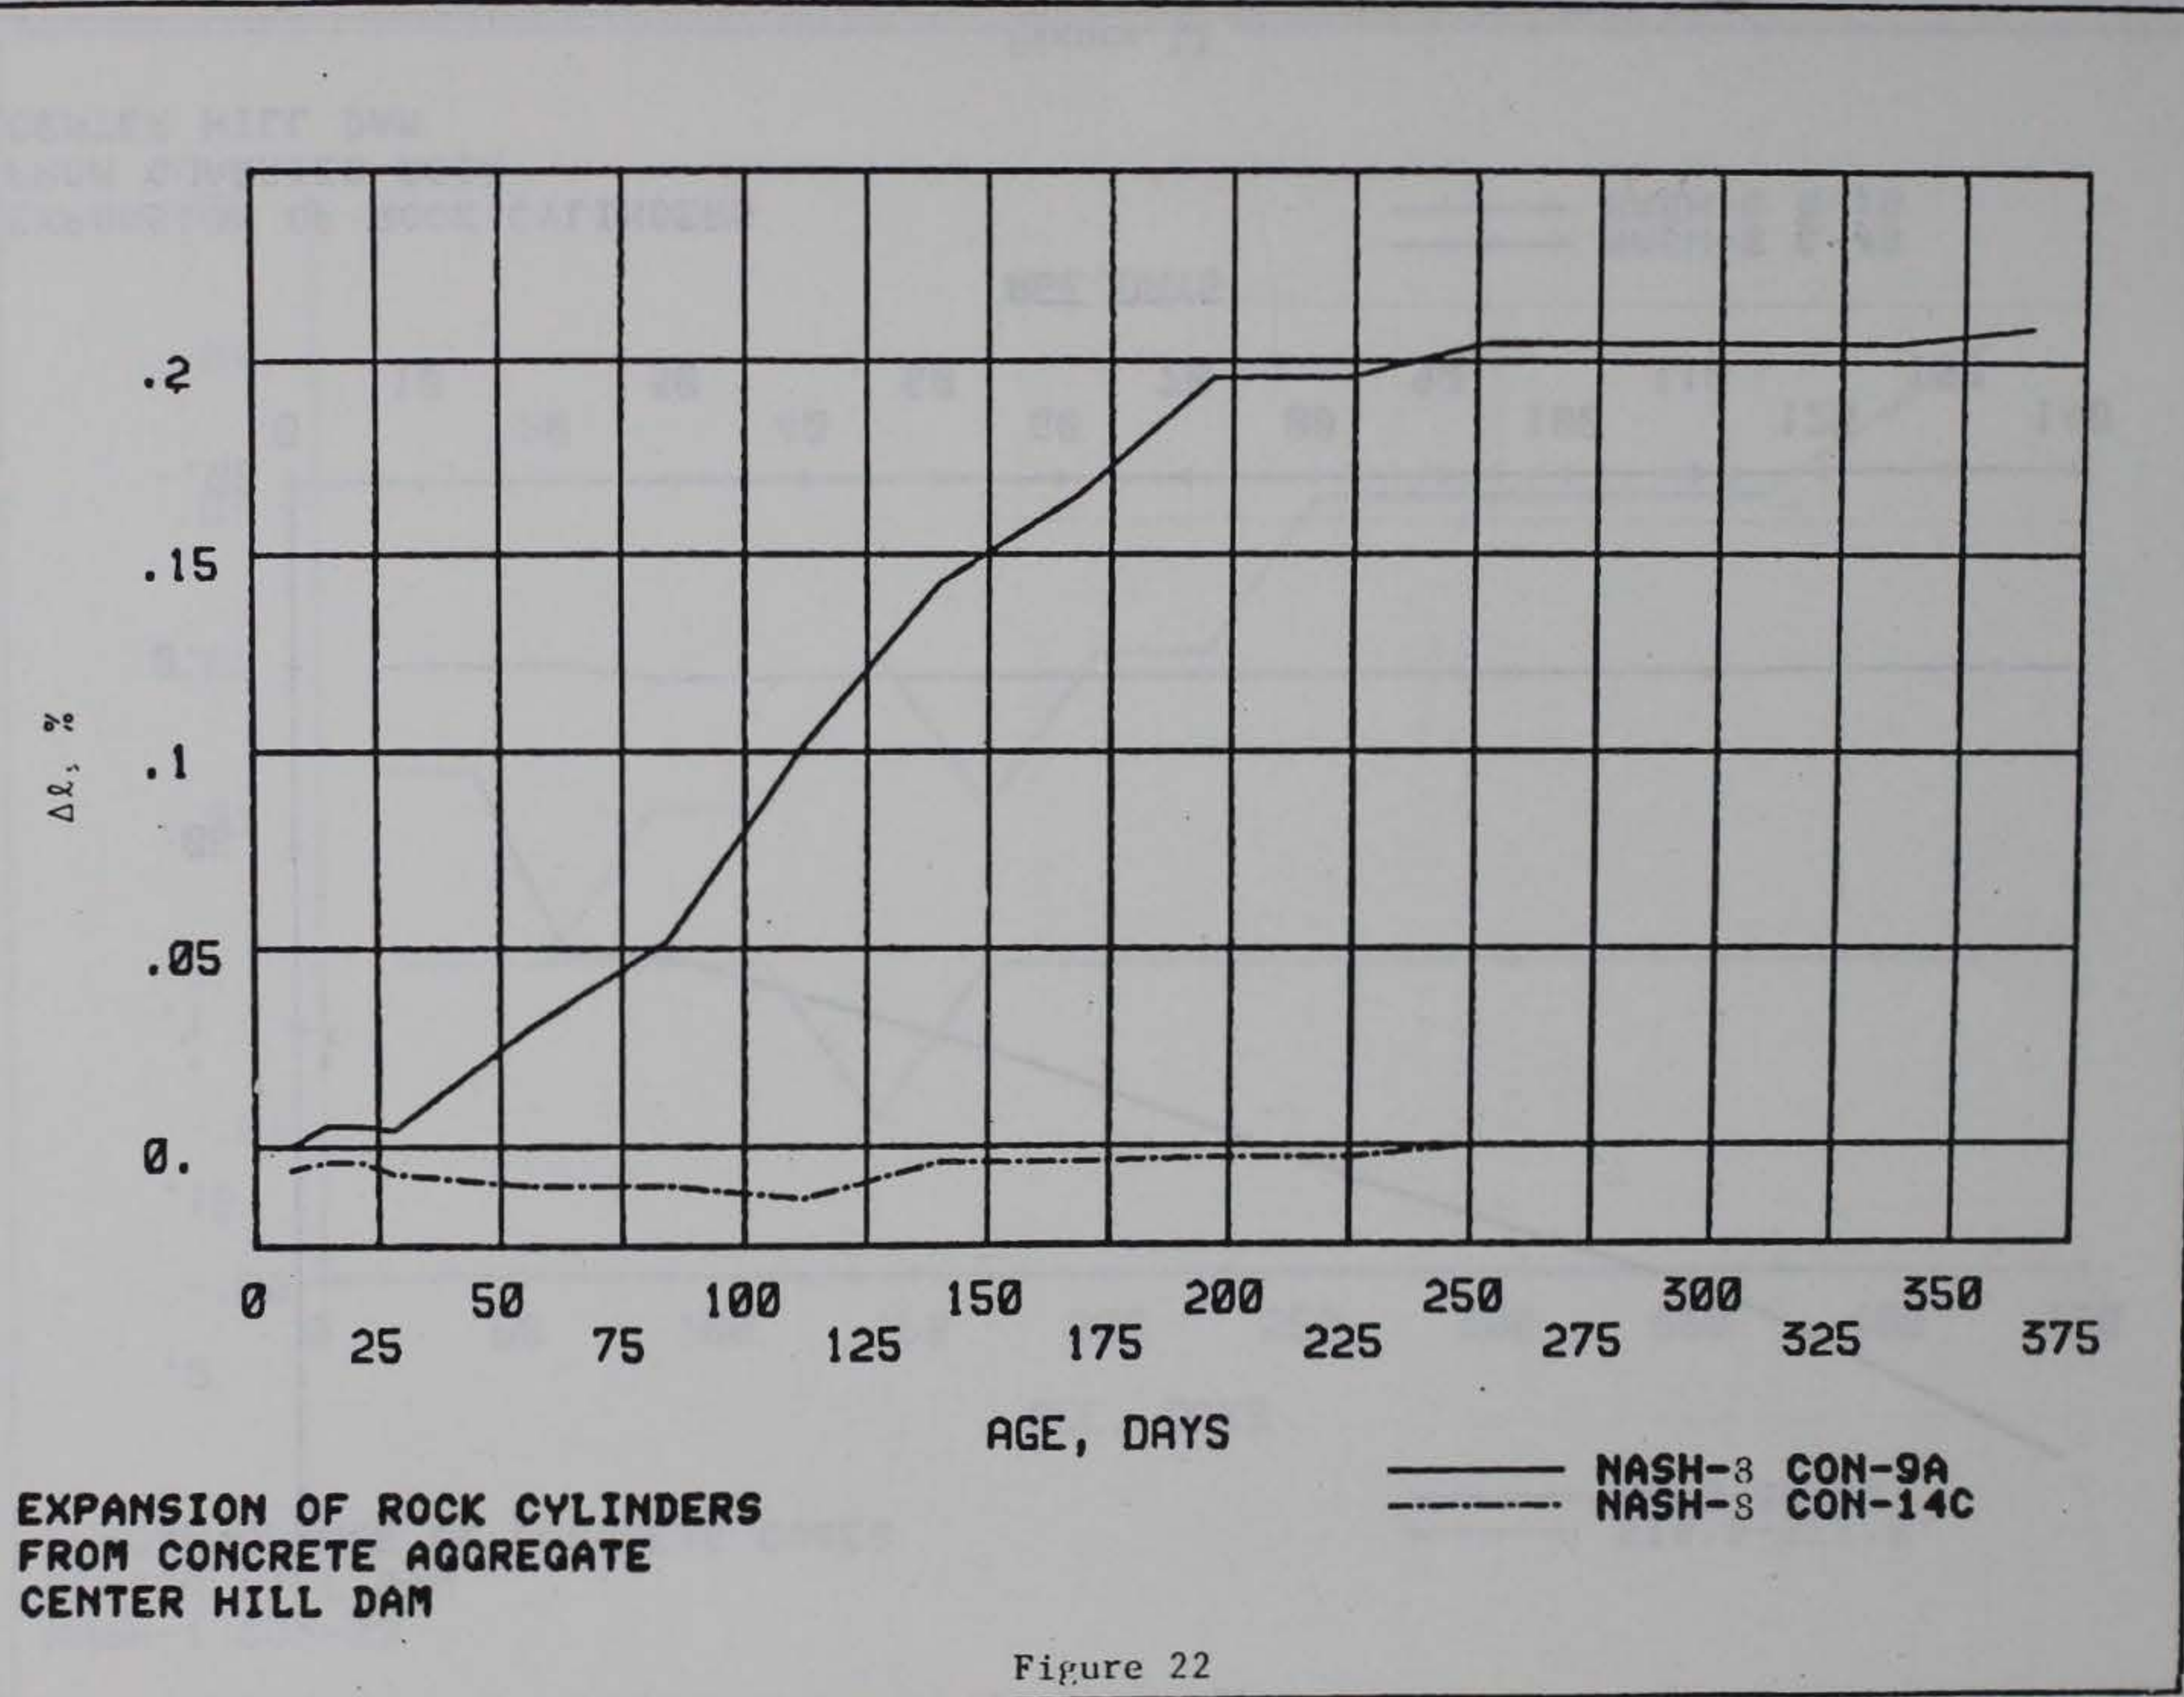
expanded to more than 0.2 percent (Table I and Figure 22) indicating that the aggregate was potentially reactive using the criteria of the Corps of Engineers (1982). The specimens that were obtained for this testing were necessarily shorter than test requirements. Rock cores taken from rock from the abandoned quarry were obtained and tested in an effort to verify these expansions.
