**US-CE-C** Property of the  
United States Government  
MISCELLANEOUS PAPER SL-87-1

# FROST RESISTANCE OF HIGH-STRENGTH CONCRETE

Alan D. Buck, Jerry P. Burkes, Joyce C. Ahlvin  
Structures Laboratory

April 1987  
Final Report

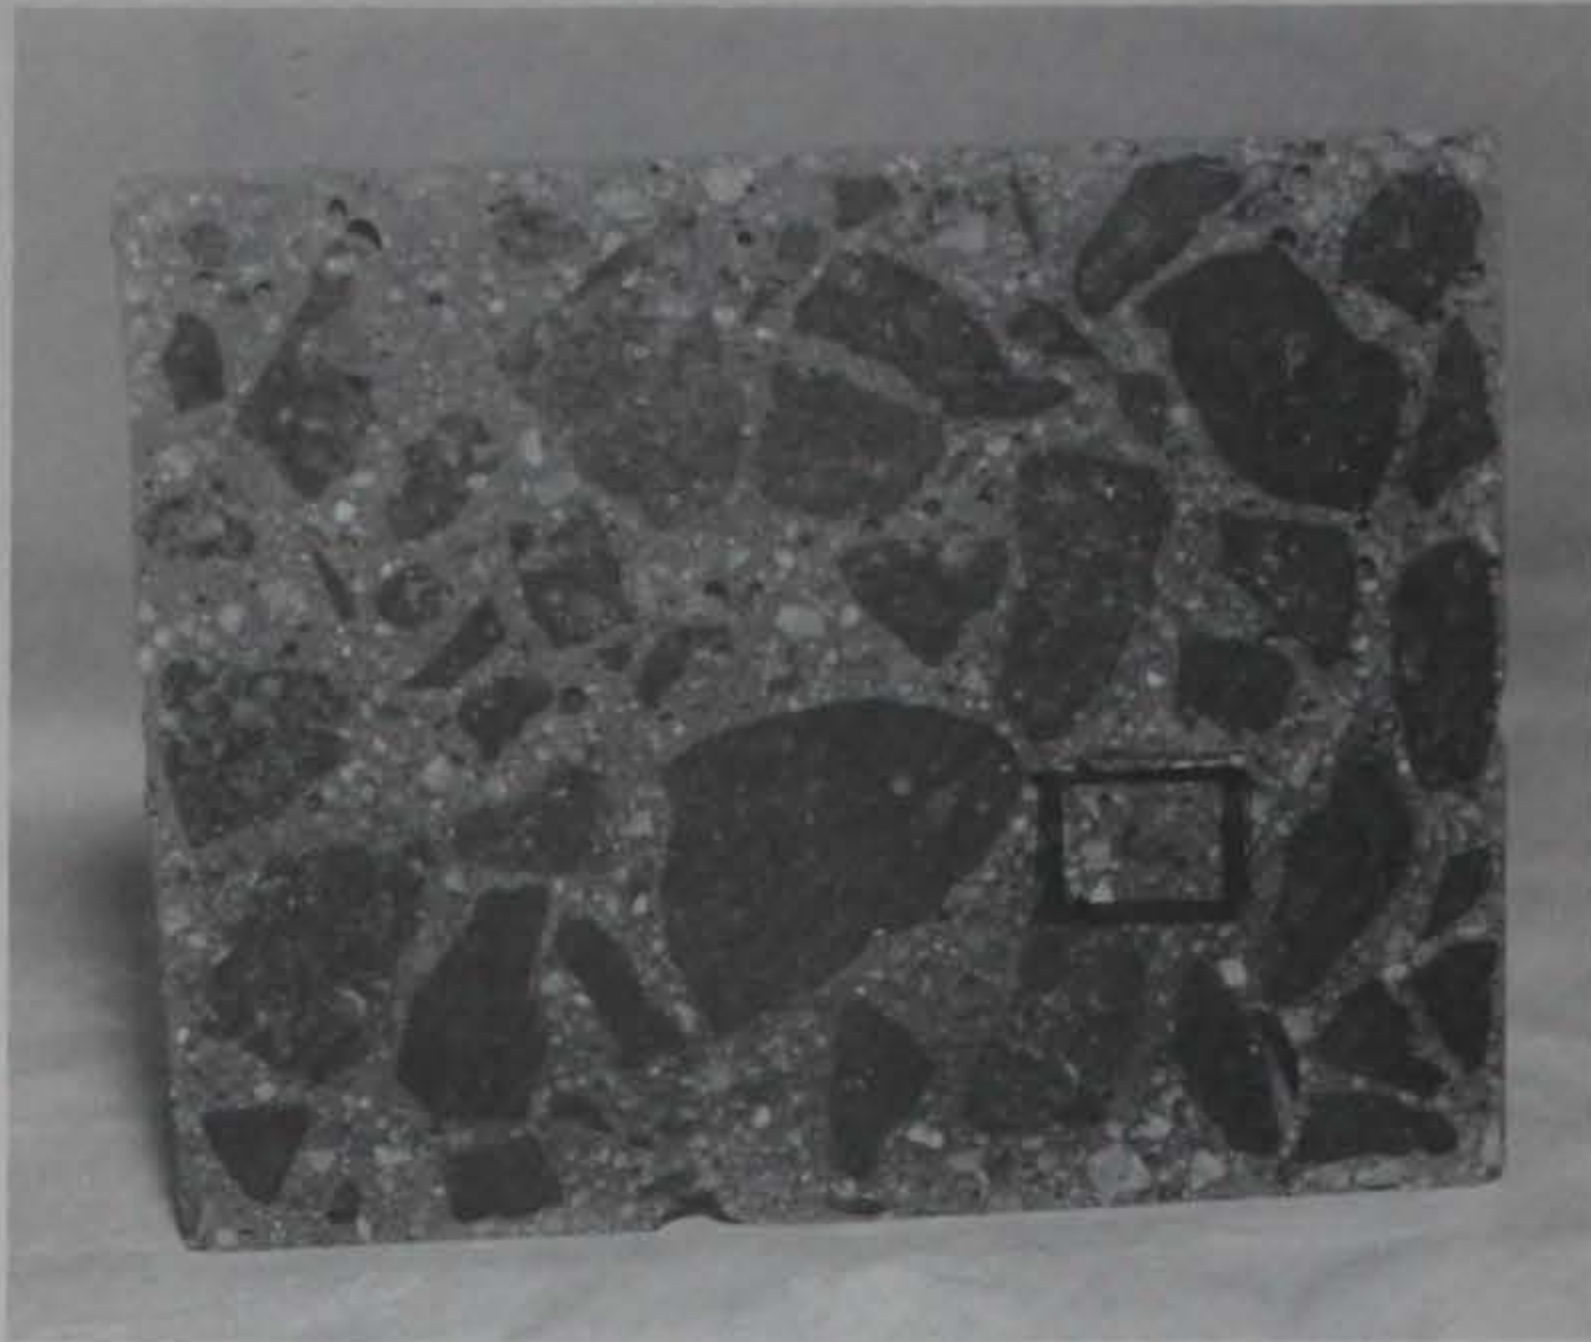
Figure 3. Sawed and ground surface of granite coarse aggregate beam 9784 with air, average DFE<sub>300</sub> 92. Top, ~0.7X. Bottom, enlargement of lower right area (outlined), ~6X. No microcracks are evident, but entrained air voids can be seen.

4. Figure 1 shows the typical appearance of beams after several cycles of freezing and thawing. While these are dilation specimens rather than specimens tested by ASTM C 666, the scaling they show is typical. By contrast note the excellent condition of the two granite coarse aggregate concretes in Figure 2; each of these beams had been through more than 400 cycles of freezing and thawing. Figures 3 and 4 show interior surfaces of the same two granite coarse aggregate concretes. The major item to be noted is the lack of cracking even in the enlarged views. This lack of cracking in the nonair-entrained mixture was confirmed during examination of the entire smooth surface for air-void data at a magnification of 70X. By comparison note in Figure 5 the microcracks that are evident in the non air-entrained limestone aggregate concrete.

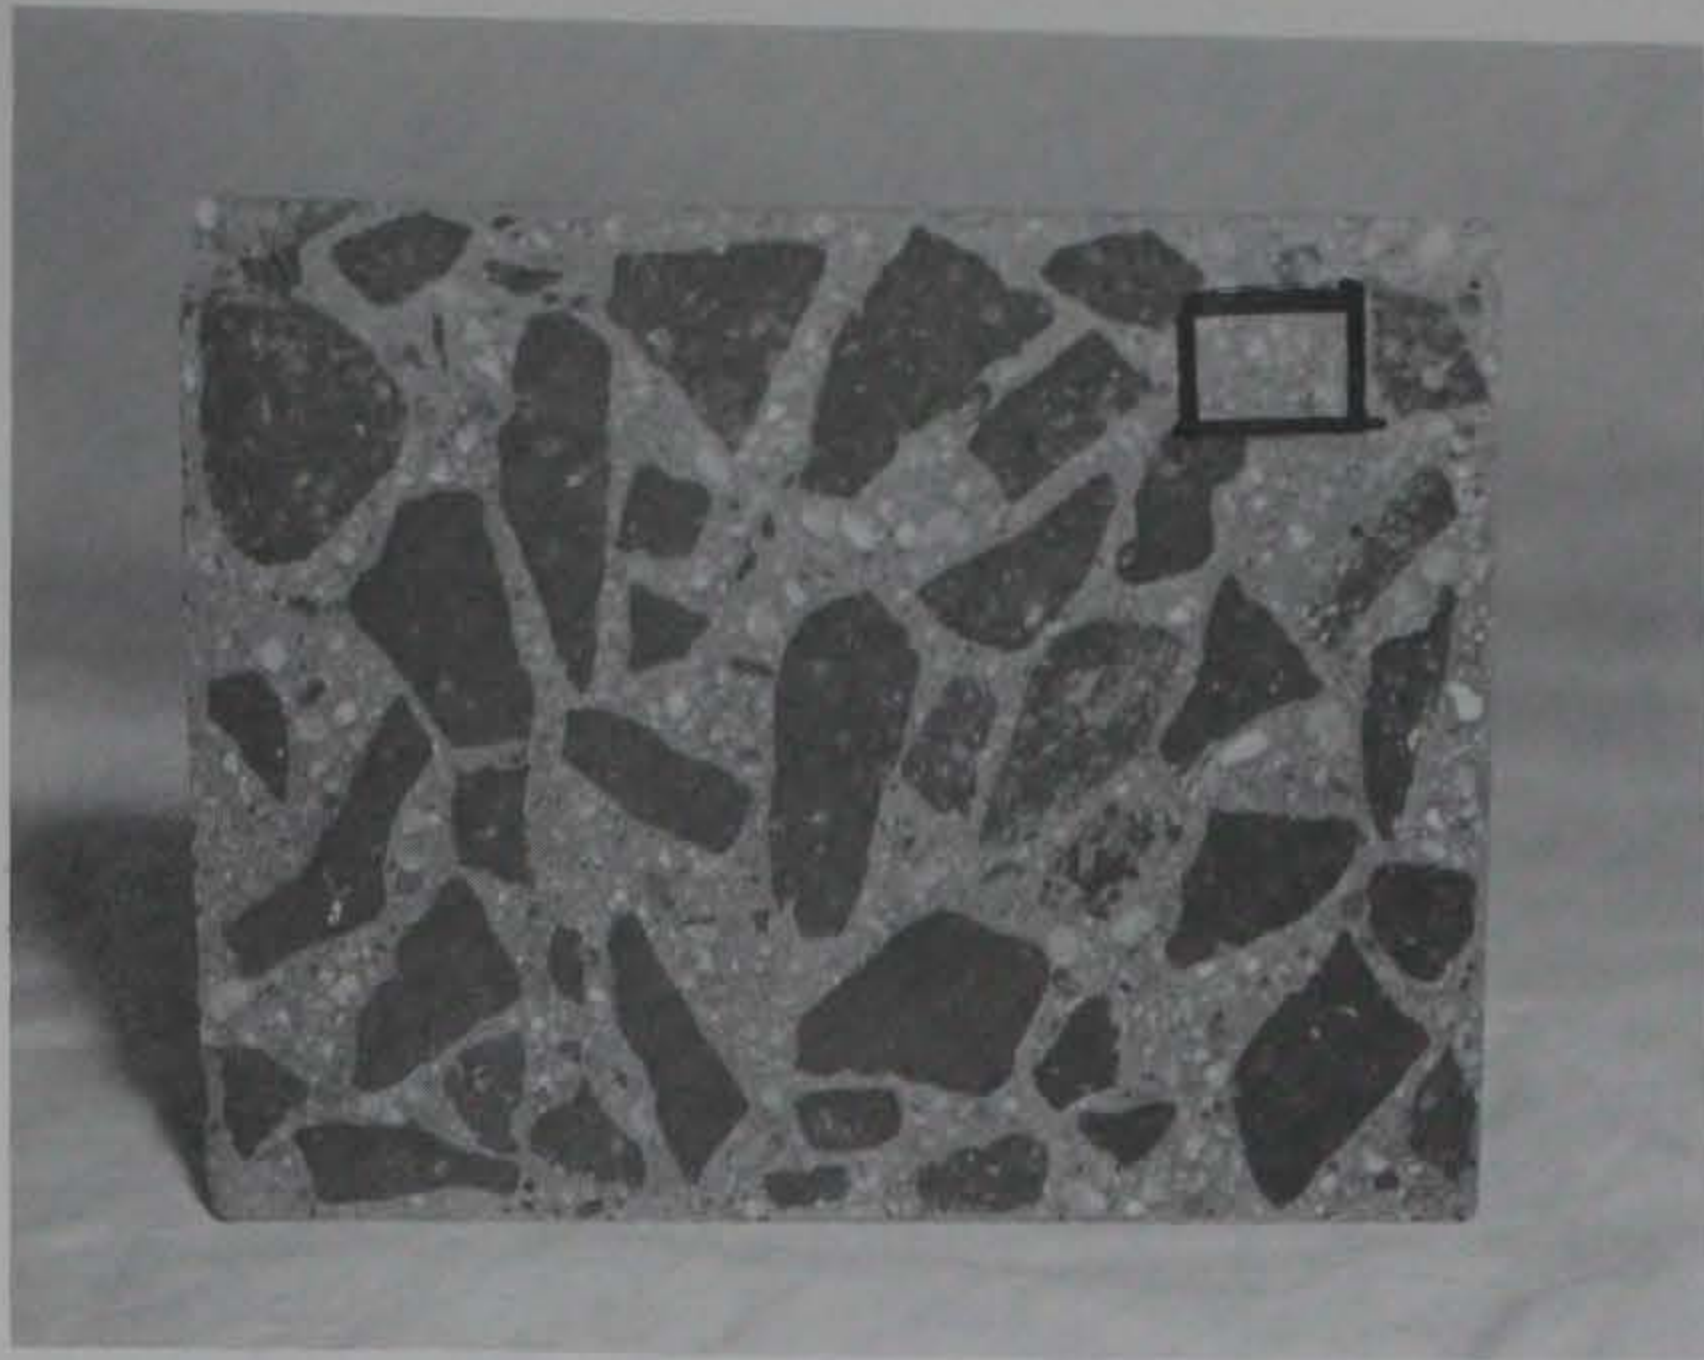
Figure 4. Sawed and ground surface of granite coarse aggregate beam 9789 without air, average  $DFE_{300}$  95. Top,  $\sim 0.7X$ . Bottom, enlargement of upper right area (outlined),  $\sim 6X$ . No microcracks are evident.

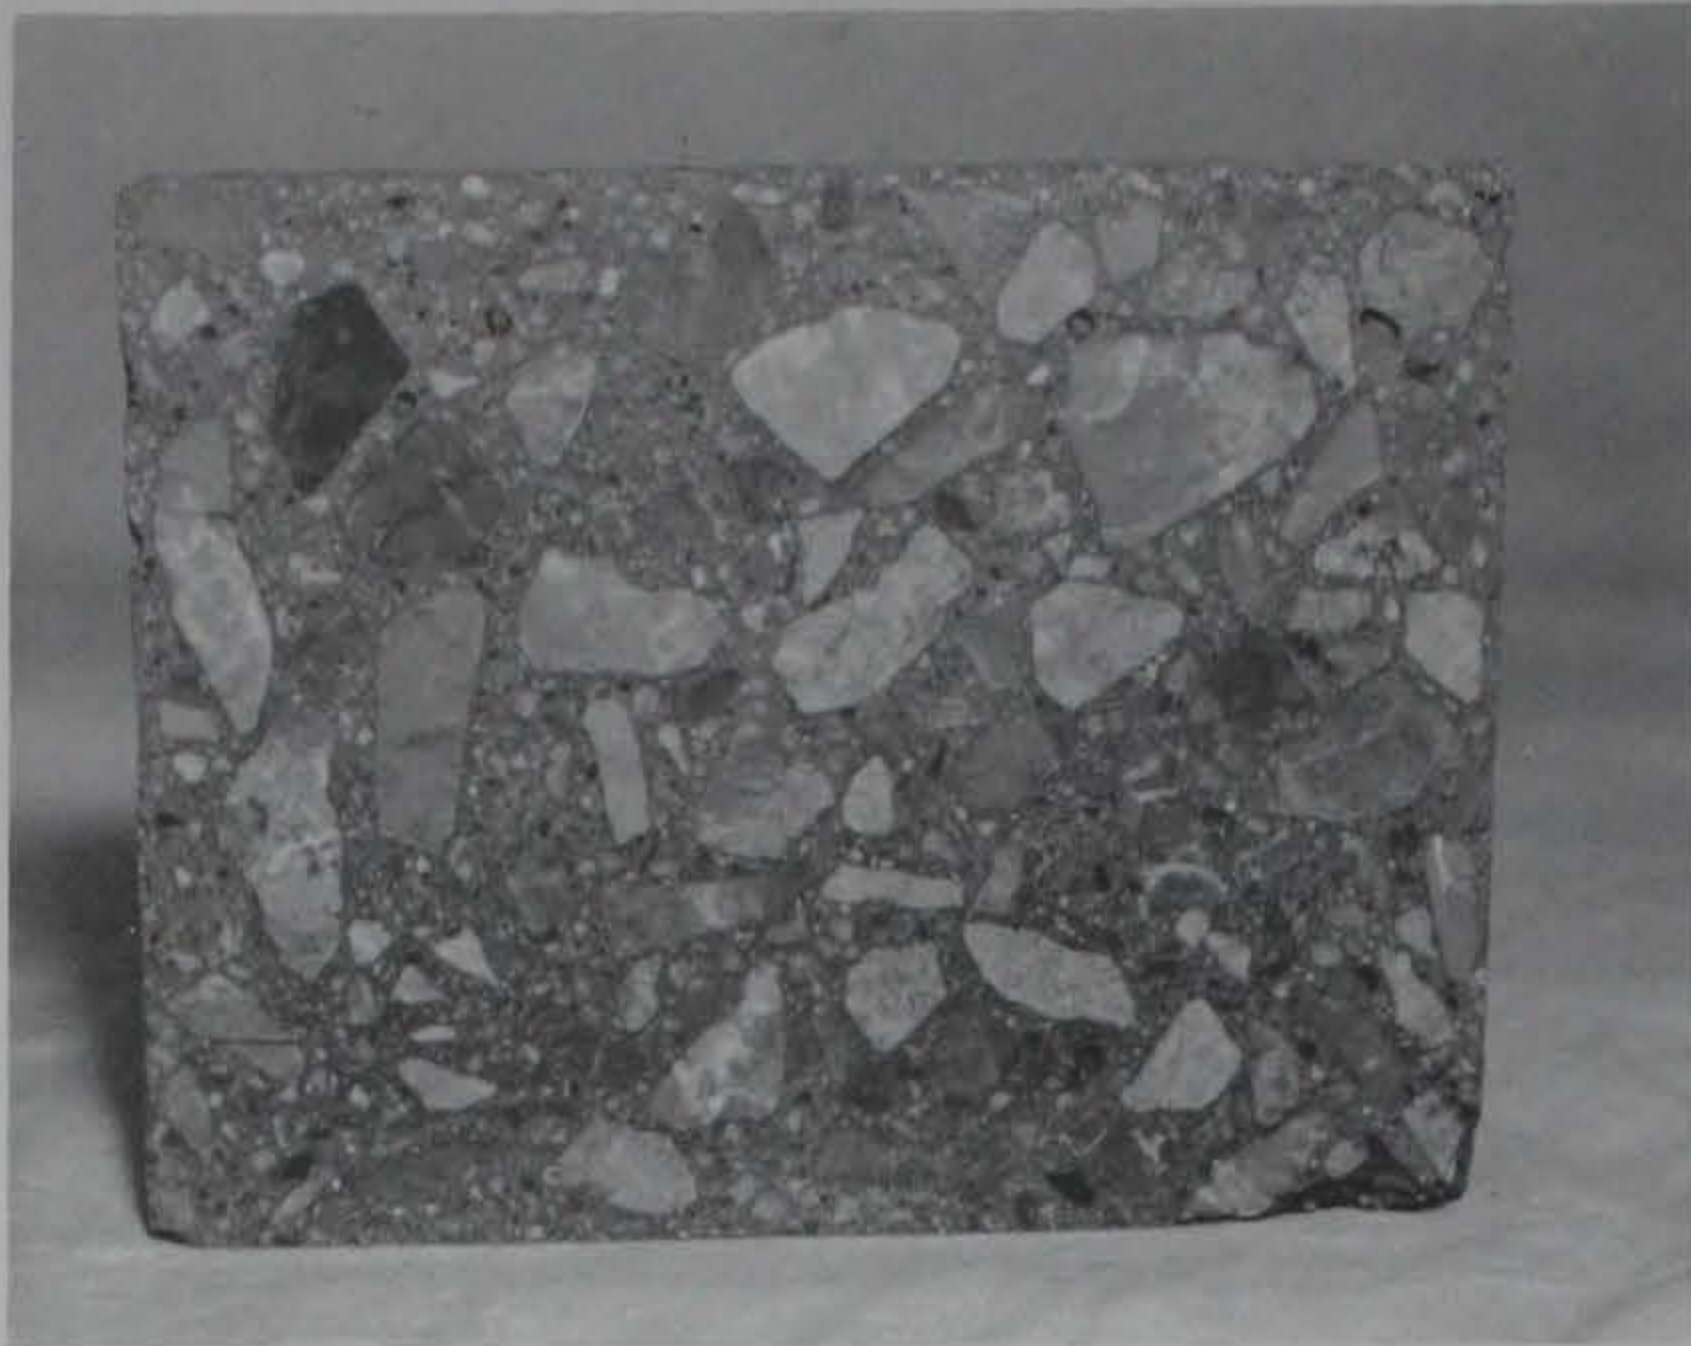
Figure 5. Sawed and ground surface of limestone aggregate beam 9779 without air, average  $DFE_{300}$  17. Top,  $\sim 0.7X$ . Bottom, enlargement of lower right area showing microcracks due to freezing damage,  $\sim 10X$ .
