MISCELLANEOUS PAPER SL-85-5

SYSTEMS AND MATERIALS TO PREVENT FLOODWATERS FROM ENTERING BUILDINGS

Carl E. Pace

DEPARTMENT OF THE ARMY
Waterways Experiment Station, Corps of Engineers
PO Box 631
Vicksburg, Mississippi 39180-0631

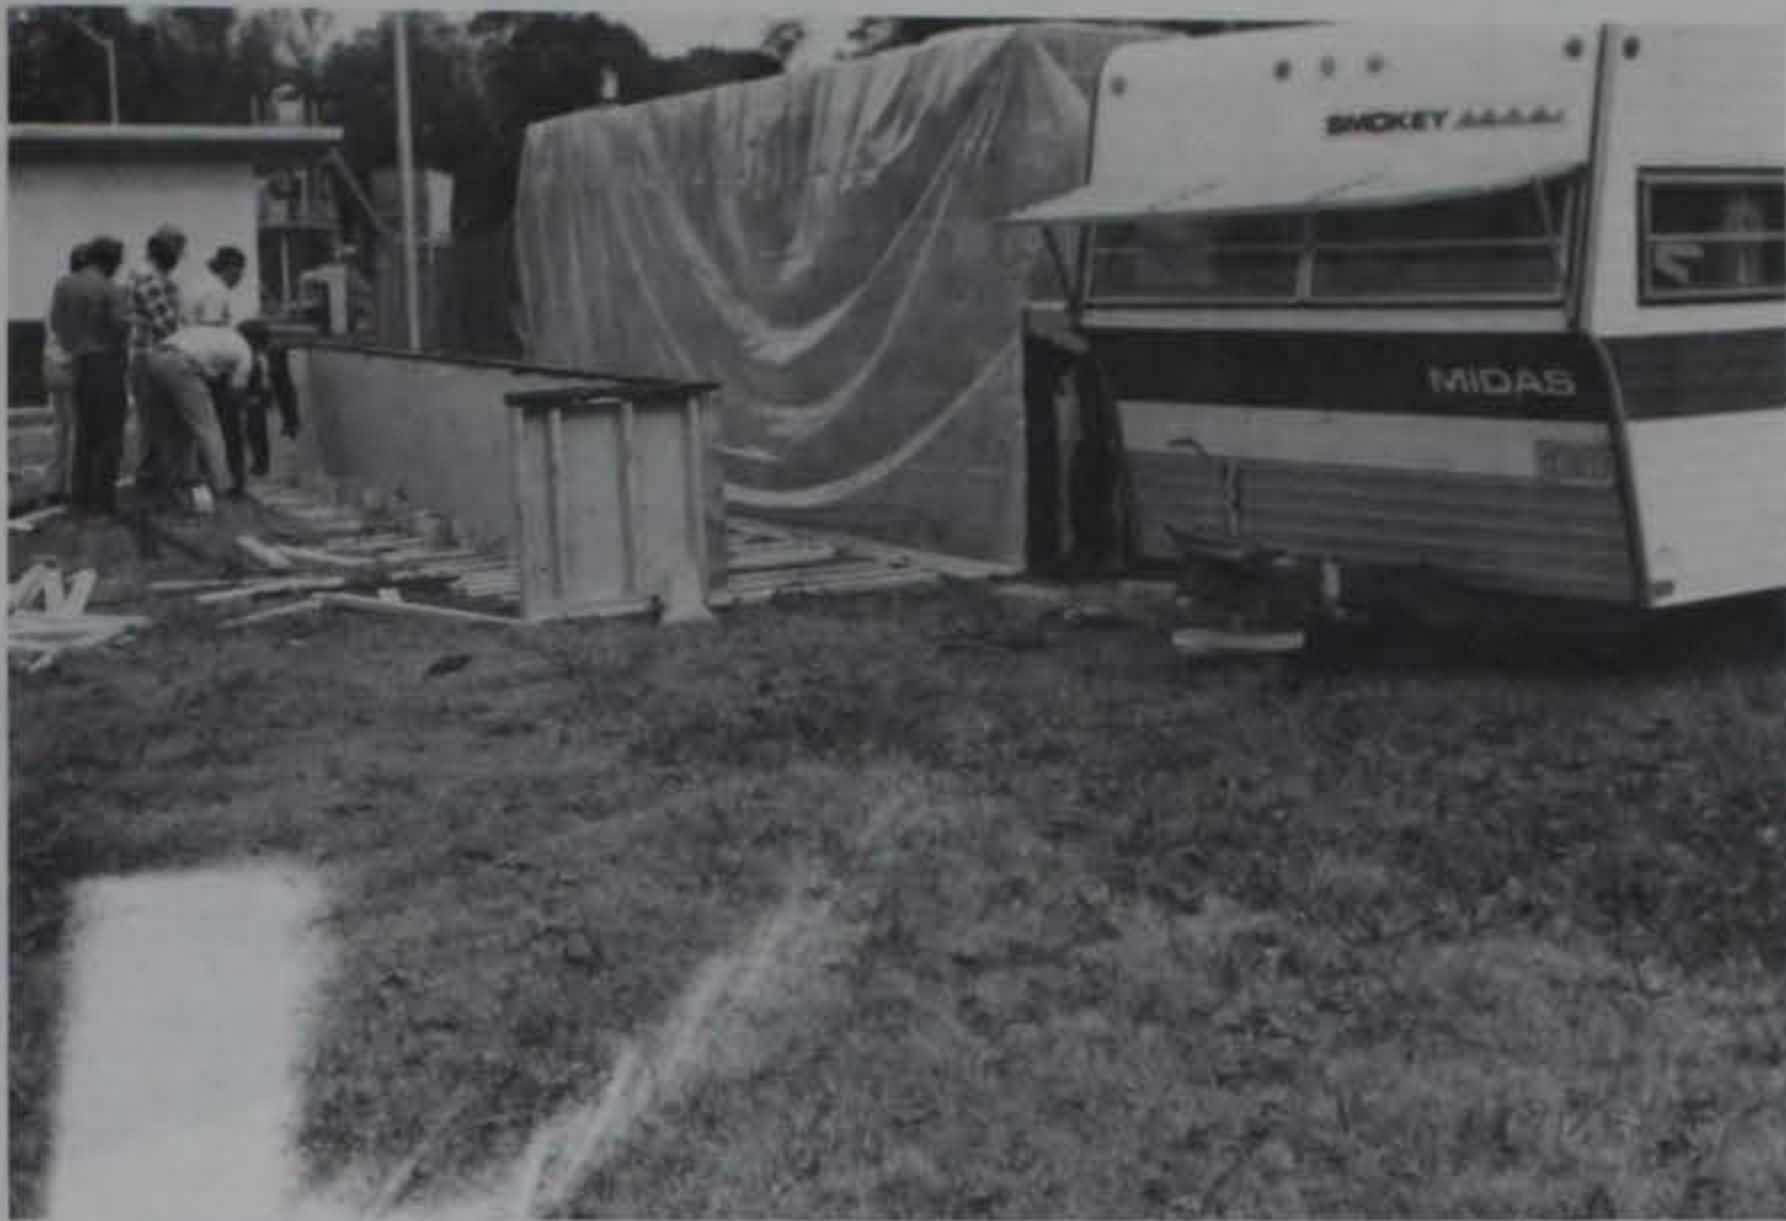
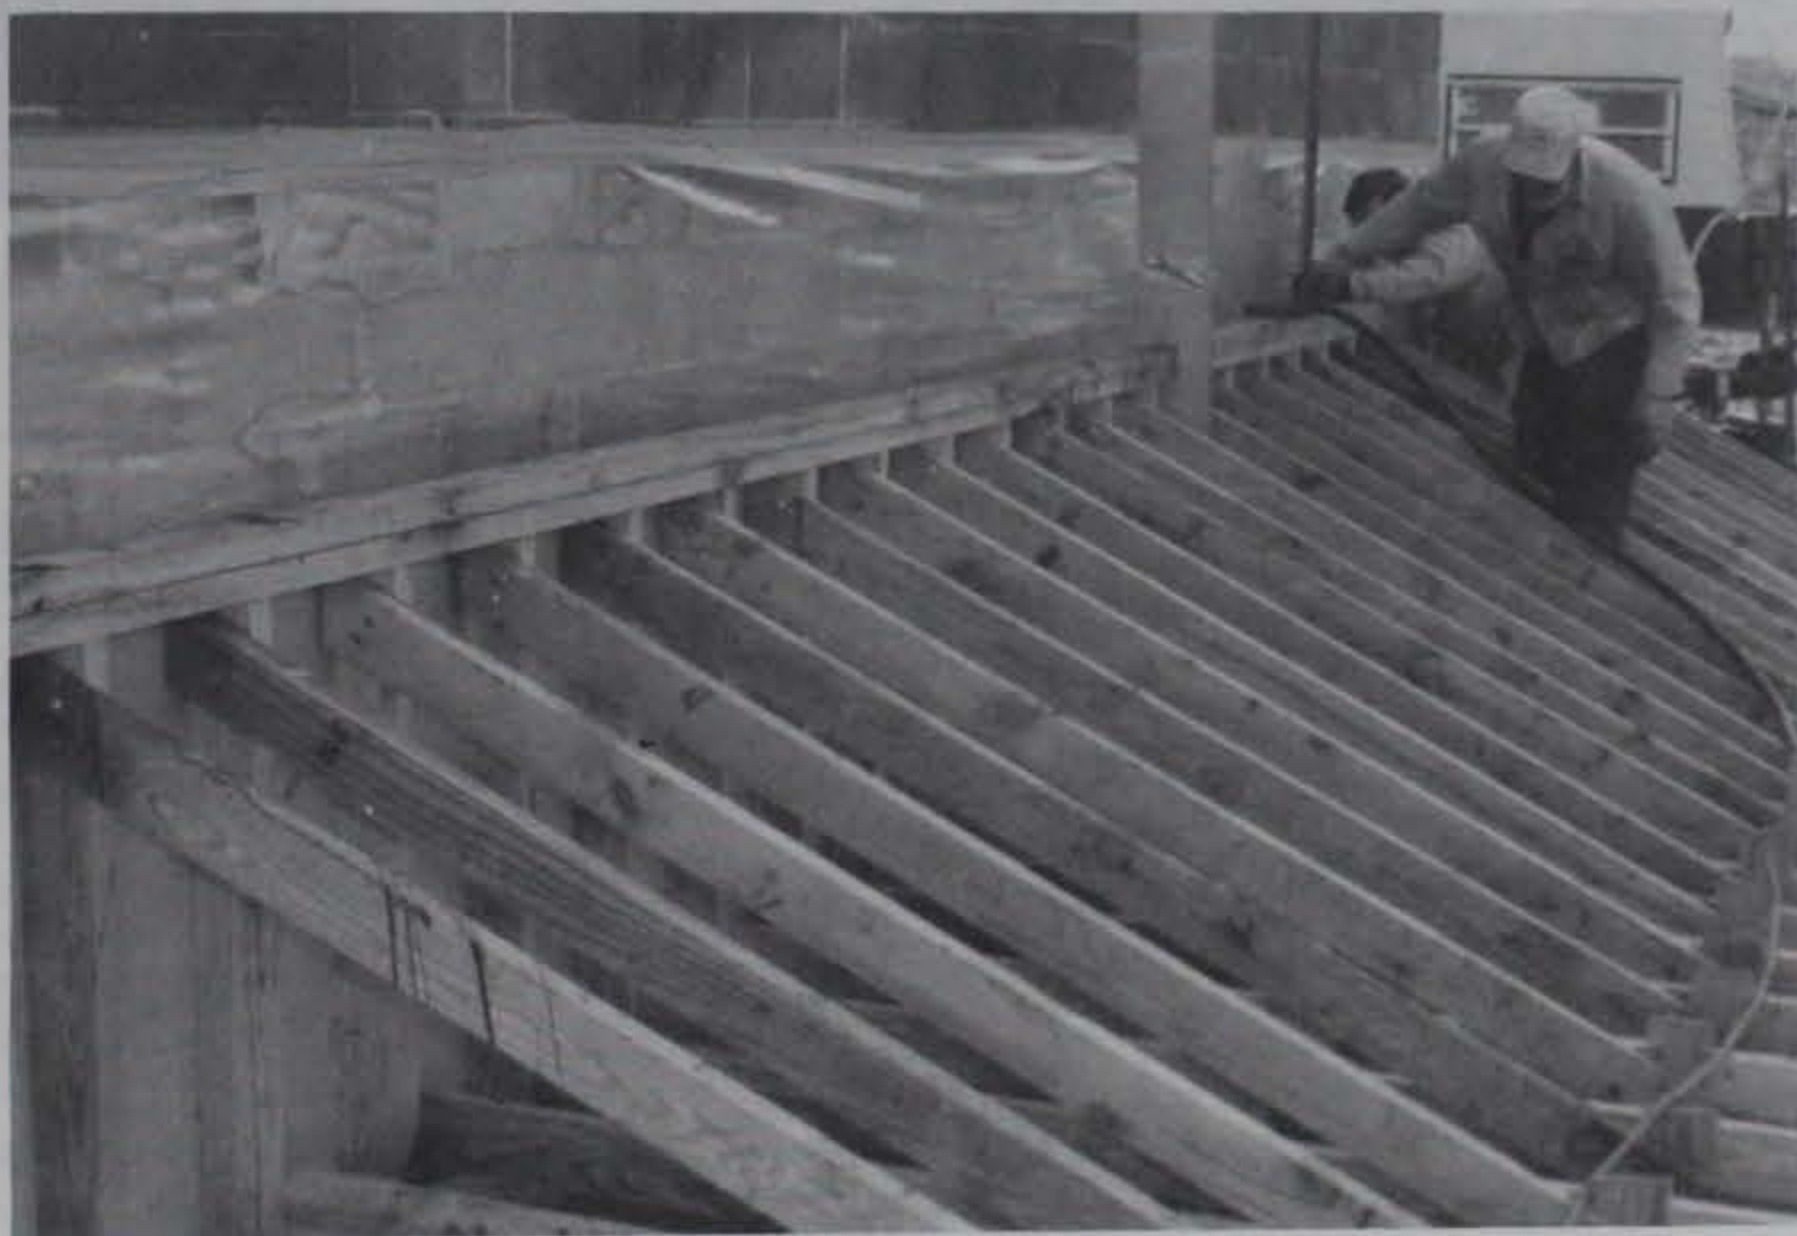
Figure 4. Block wall 2

a. Being prepared for testing

b. Being tested

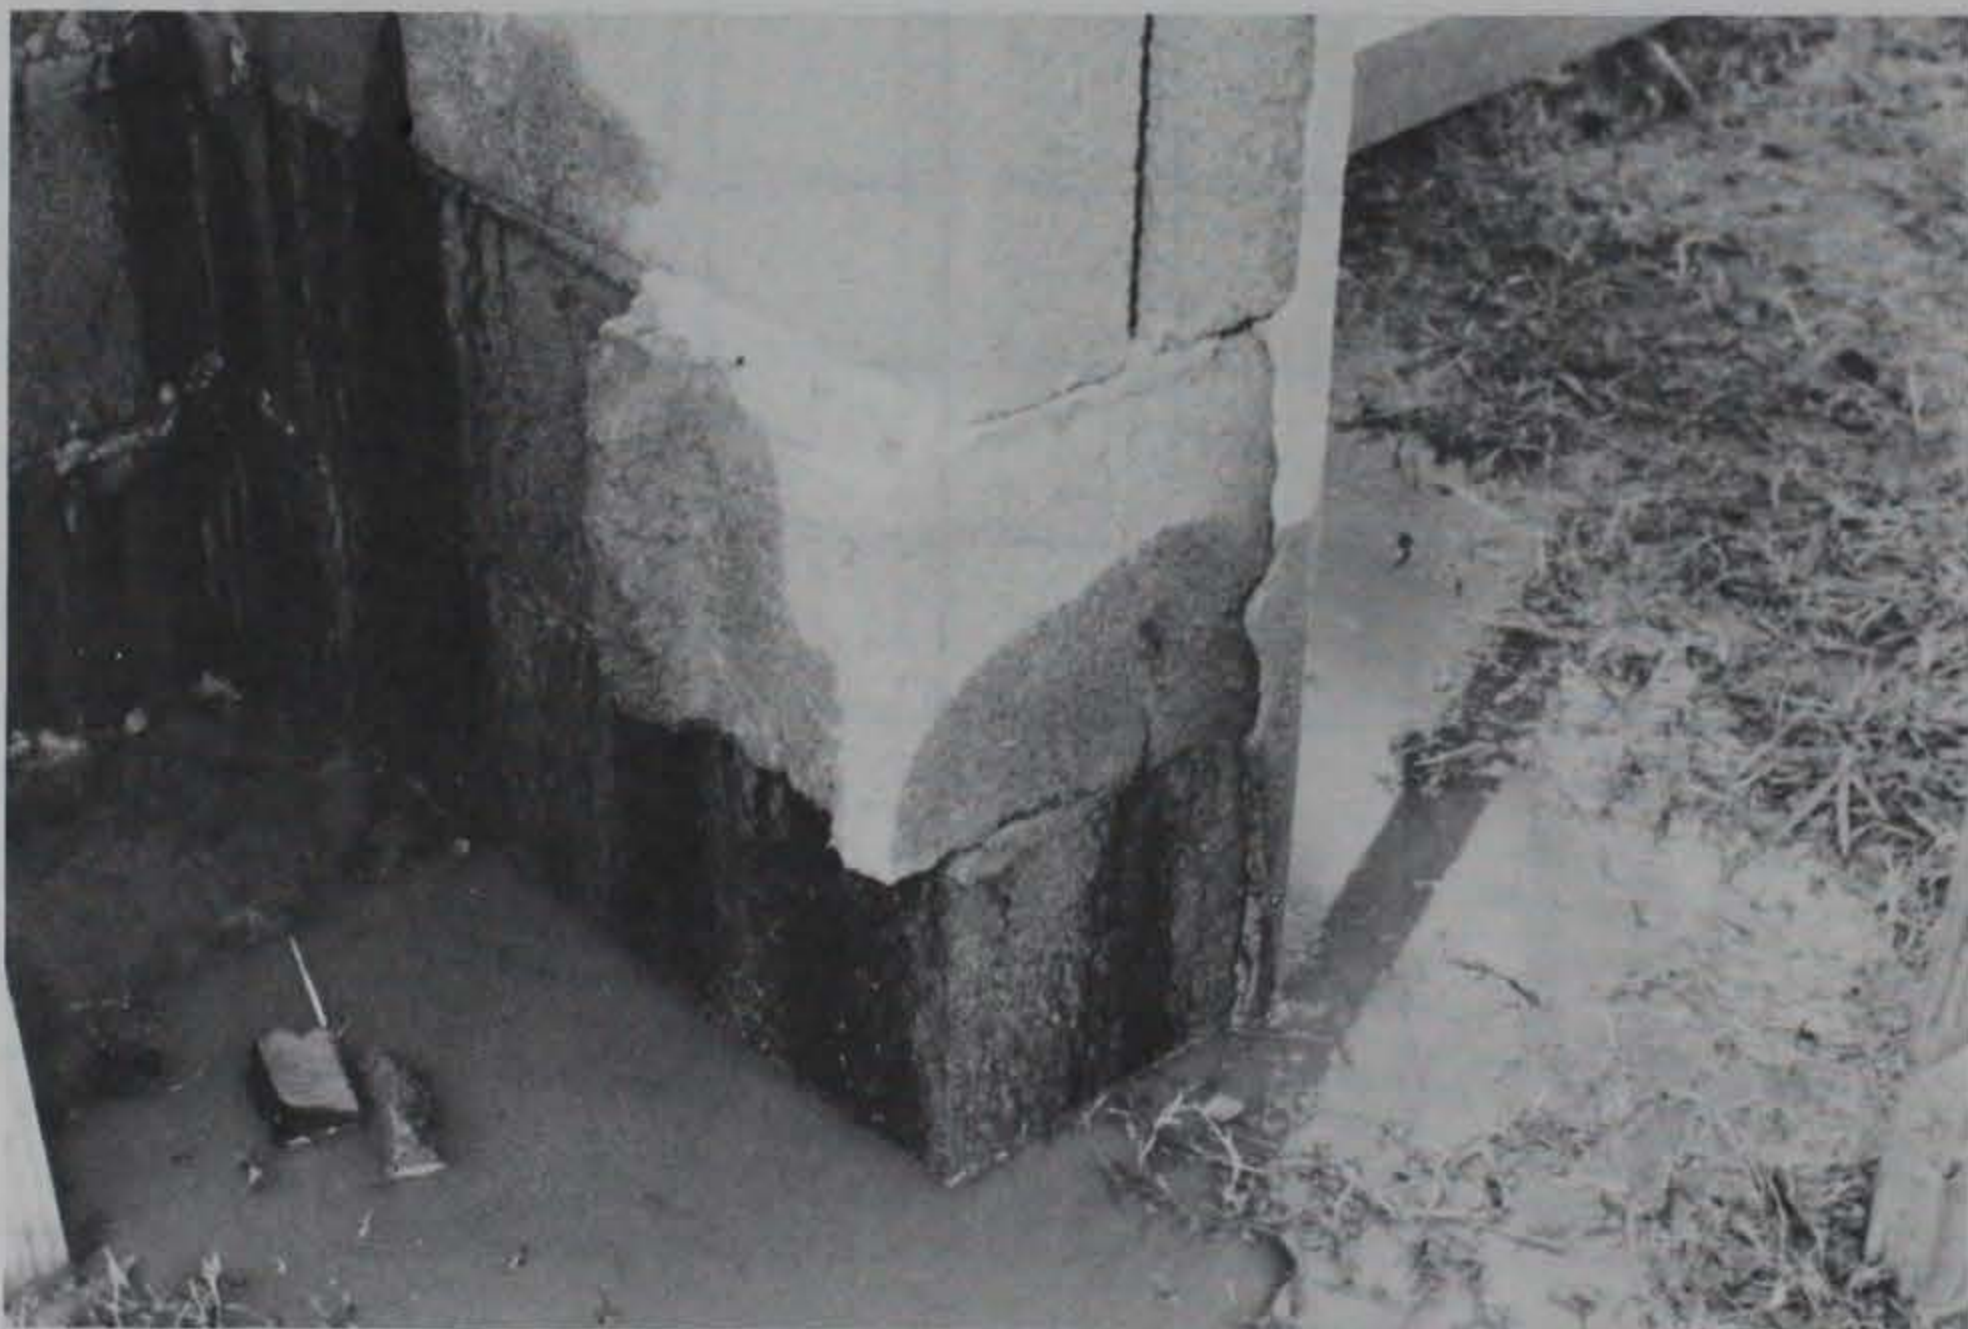
Figure 9. Leakage through block wall

b. Base of wall

the fire hydrant. Water flowed through the cracks faster than it could be put into the trough. Photographs of the leakage are shown in Figure 9.

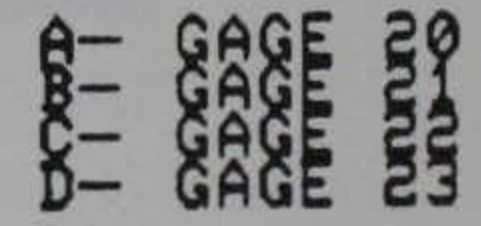
Figure 18. Wall deflections, gages 20, 21, 22, and 23

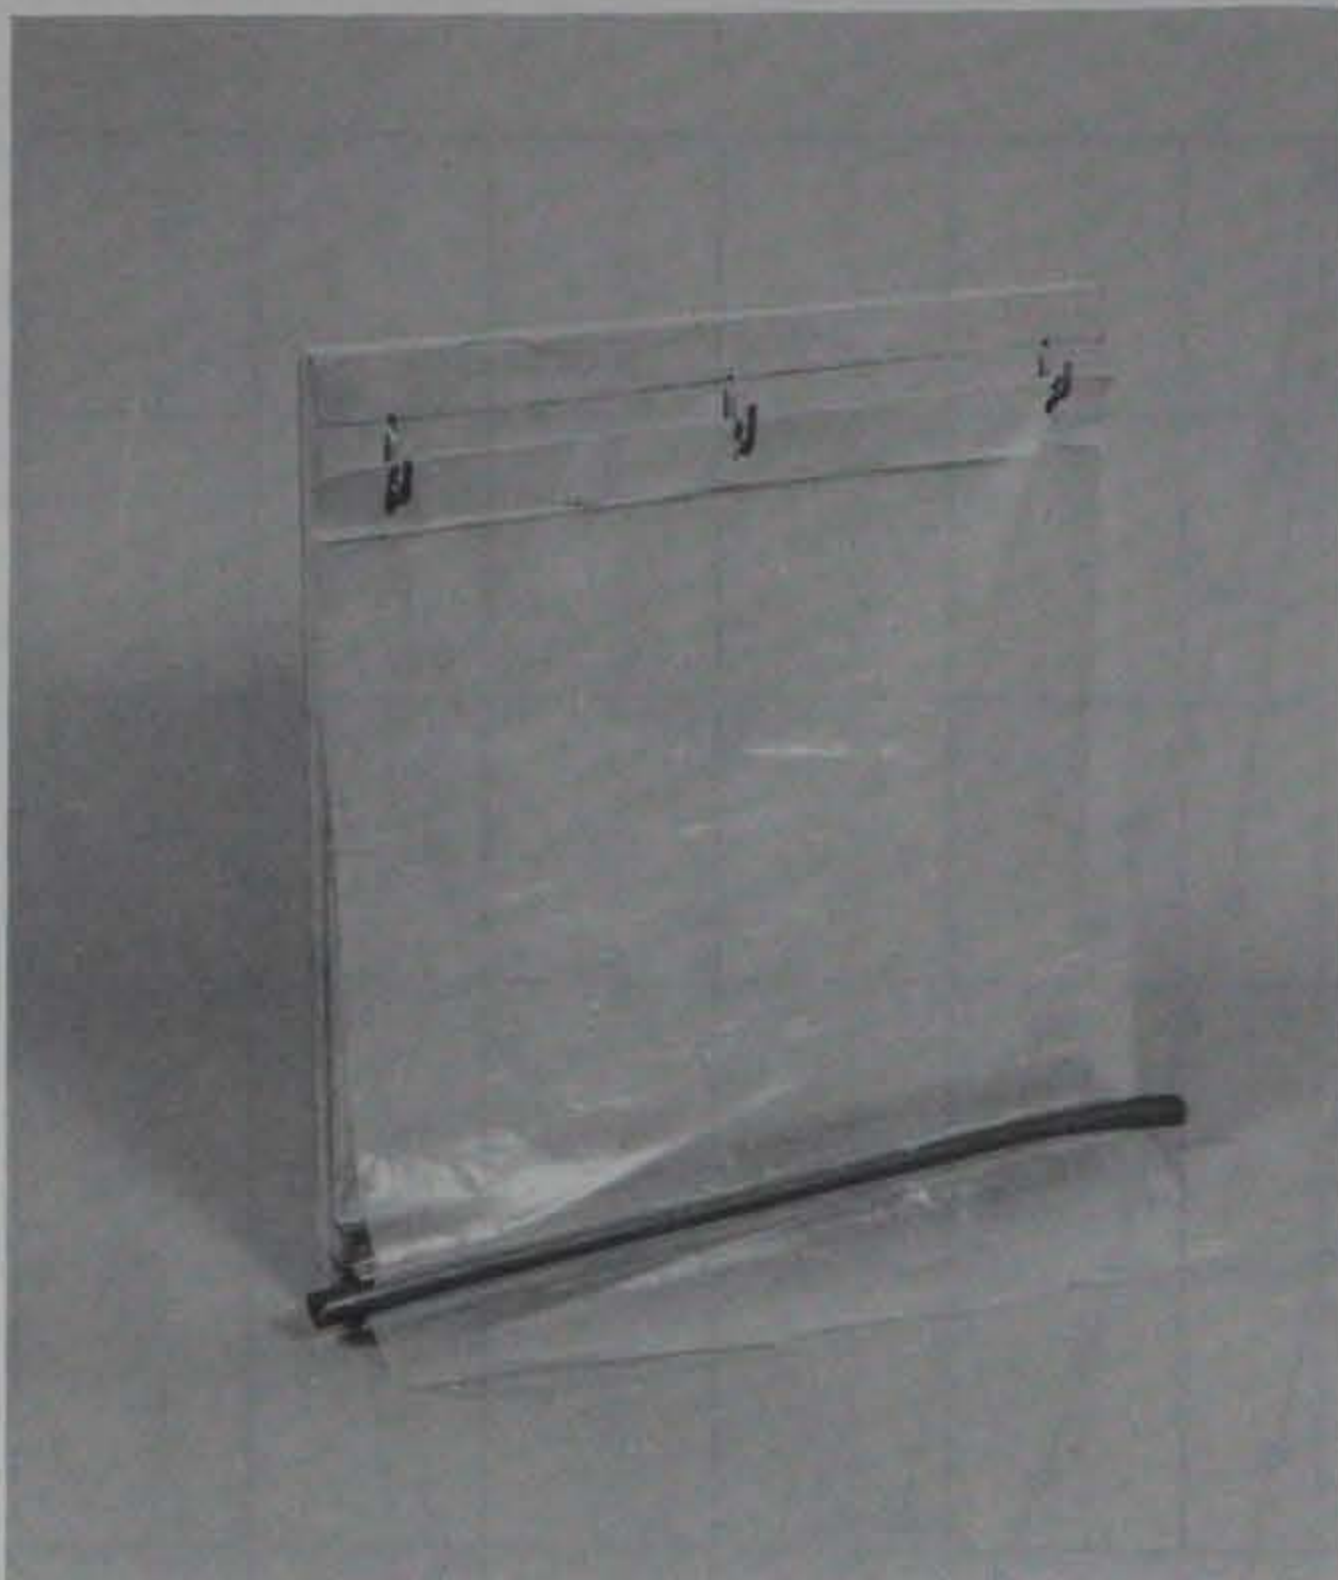
Figure 19. Tubular seal

19. The second test evaluated vinyl sheeting attached with a tubular seal and also determined the deflected shape of the wall. The third test on block wall 2 was to again test the effectiveness of the tubular seal. The tubular seal (Figure 19) was constructed as follows:

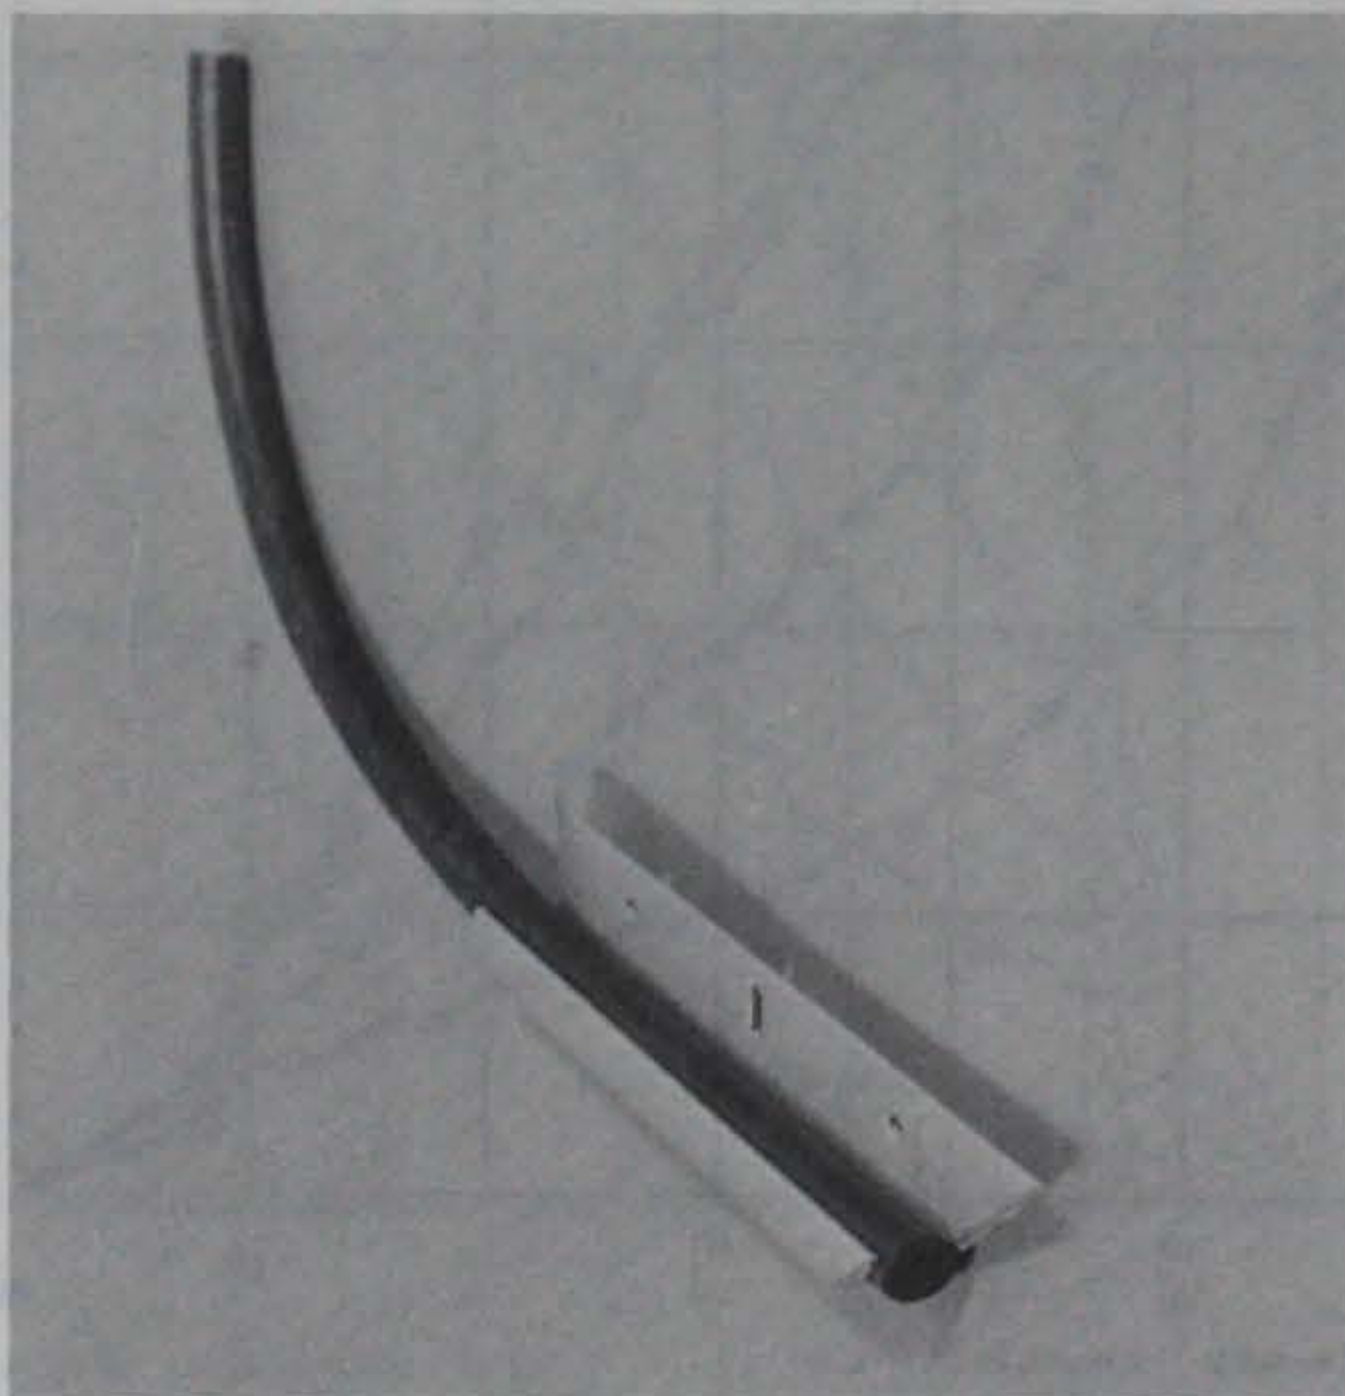
Figure 20. Aluminum seal

22. An aluminum seal (Figure 20) was used in test 4. There was some leakage with the aluminum seal, and there was some difficulty in fitting the rubber O-ring against the plastic and into the L-shaped aluminum extrusion. The O-ring could be fitted into the aluminum extrusion, but the process was slow.

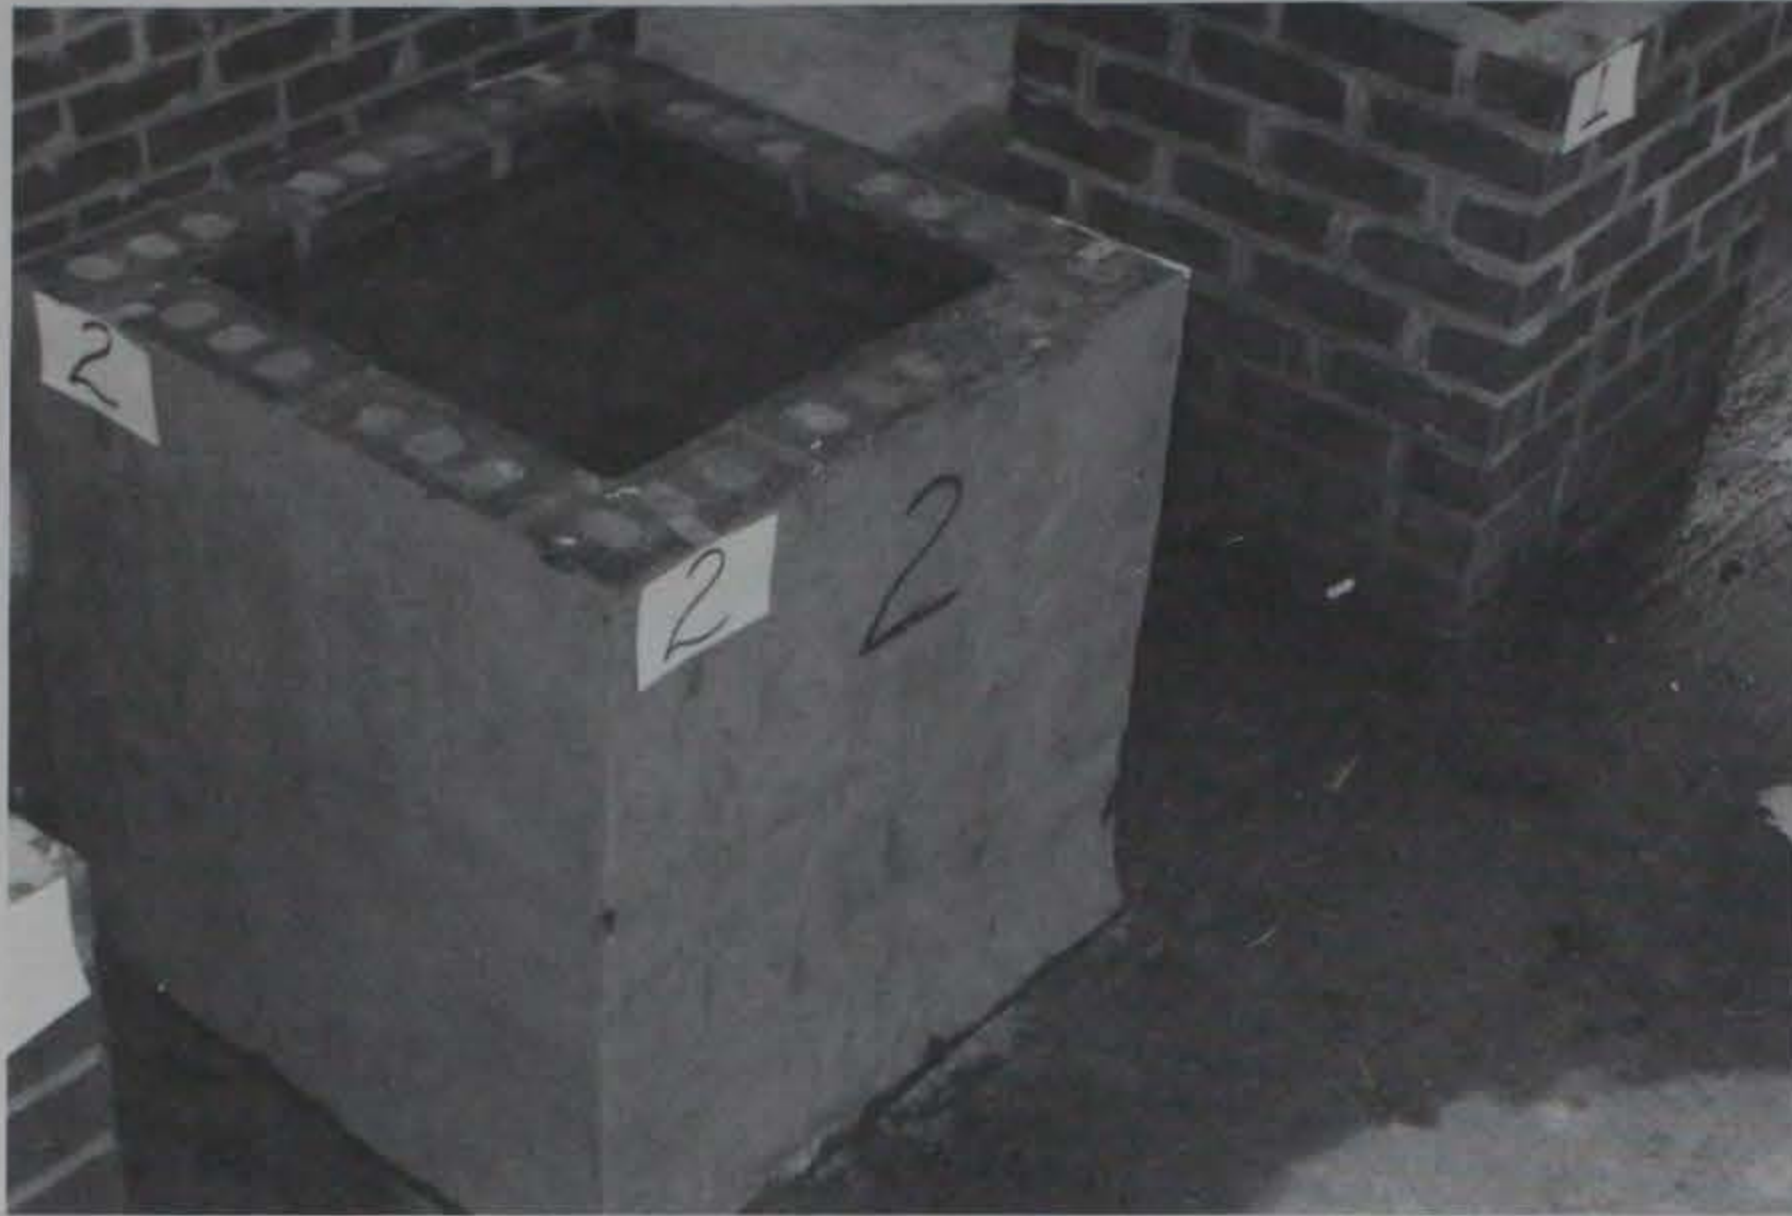
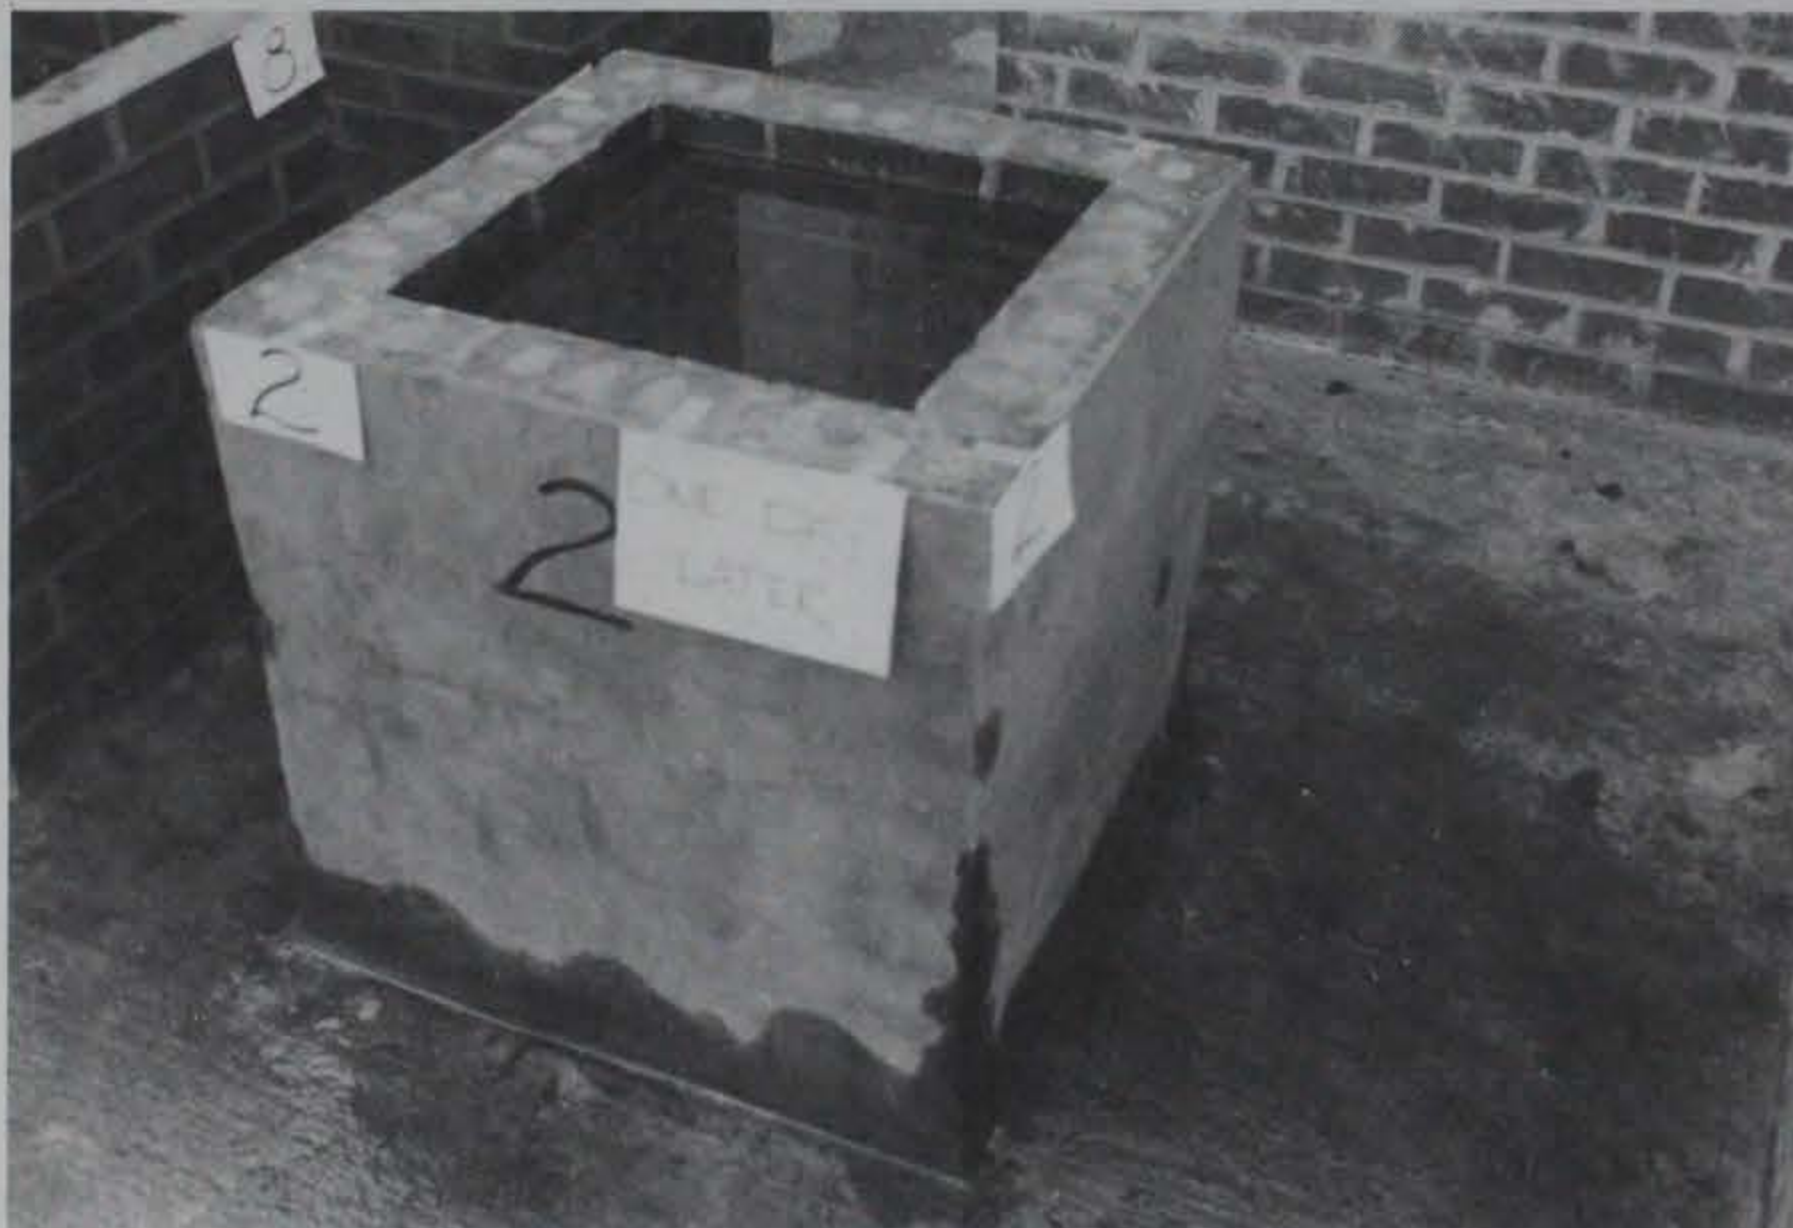
Figure 22. Initial testing of coating 4

a. Two hours after cube was filled with water

b. One day after cube was filled with water

time-consuming and thus increased the expense. It is highly desirable to use a material which can be brushed on the wall. The trowelled-on coating (coating 4) sealed the cube against a water head with only a small leak mainly at the cube-foundation interface (Figure 22). Coating 4 was not successful in terms of durability. It expanded, cracked, and began to come off the wall 3 months after it was applied (Figure 23).

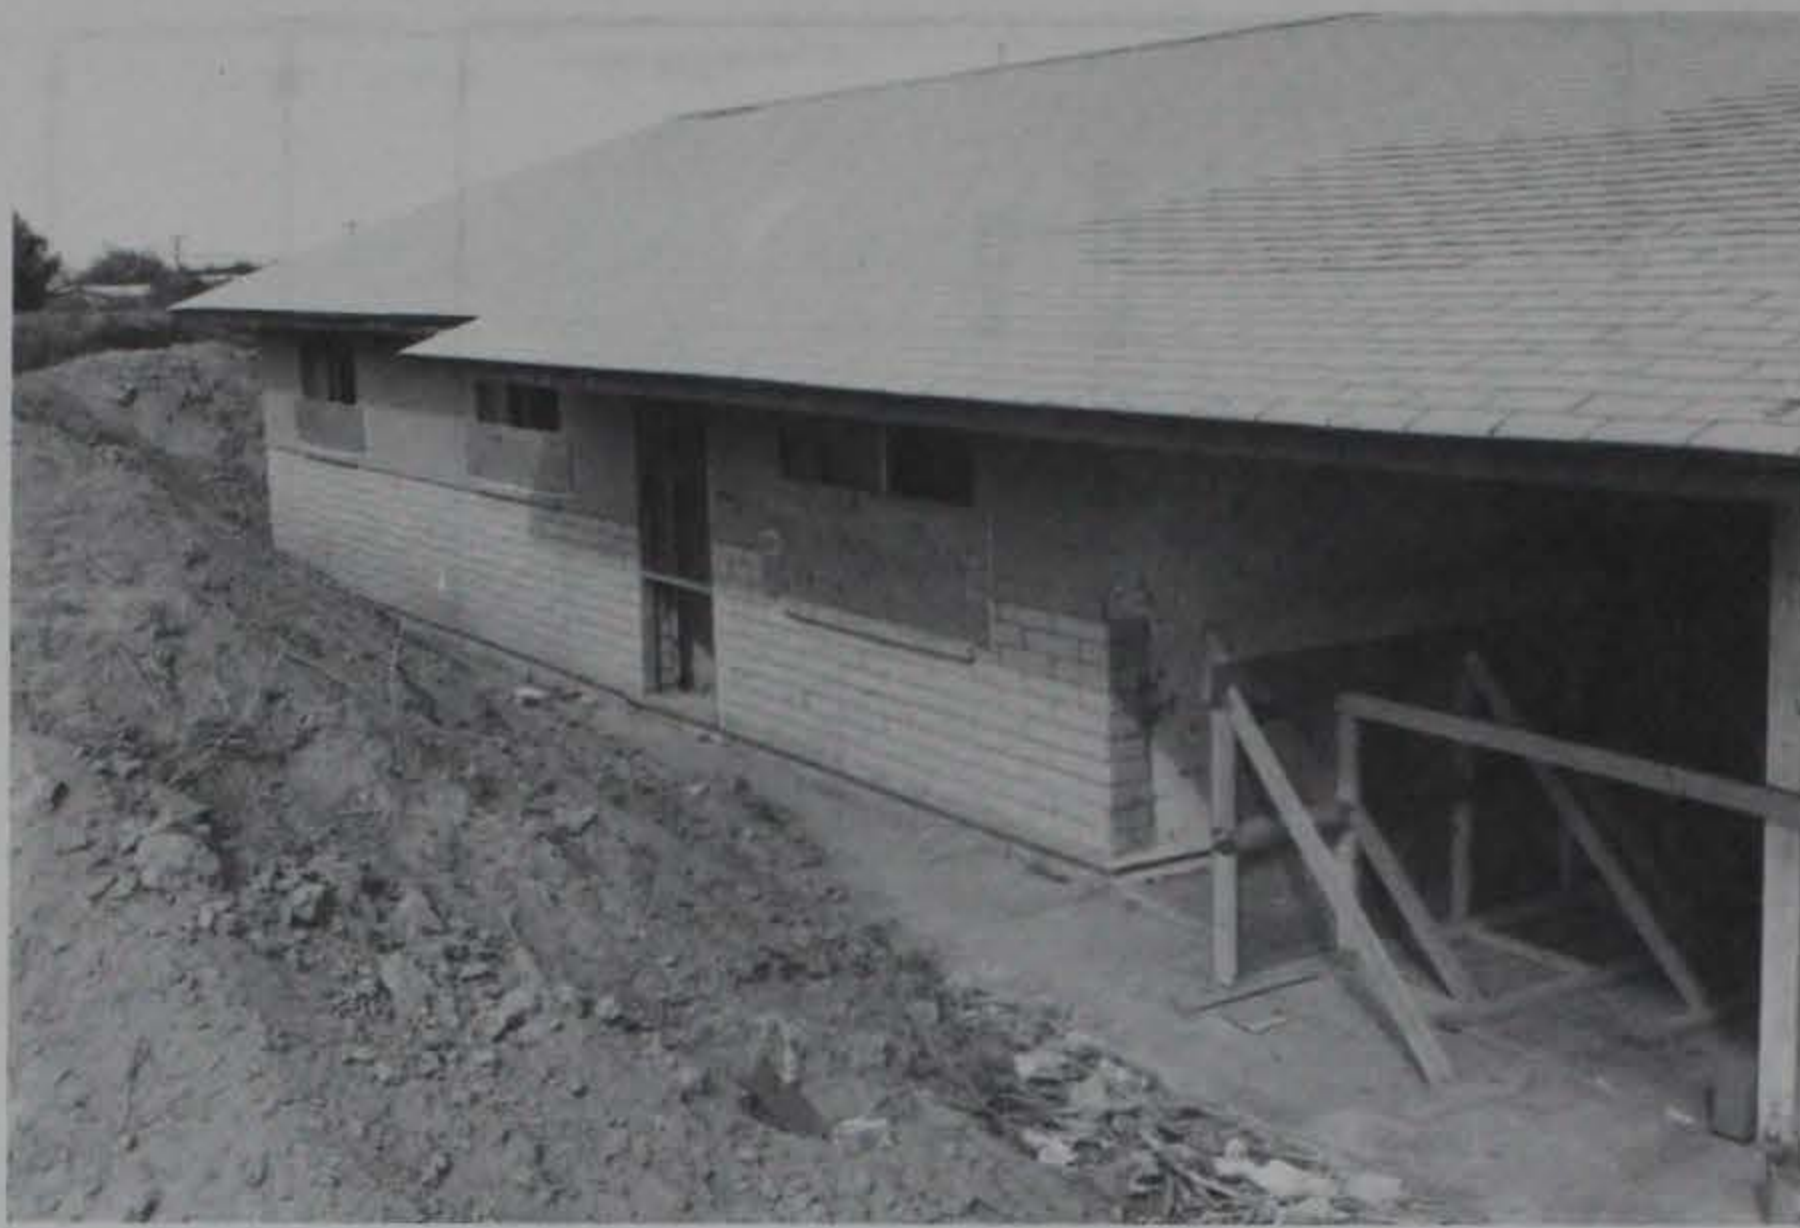
Figure 26. Front view of house to be made resistant to floodwaters

43. The floor plan of the house is presented in Figure 25. The garage of the house (Figure 26) was not included in the testing. A plywood bulkhead was constructed across the garage along the side of the house, as shown in Figure 27. An earth berm was constructed around the rest of the house and tied into the plywood bulkhead (Figure 28). The earth berm and plywood bulkhead were used to retain a slowly increased water level. A plastic sheet was placed over the earth embankment and plywood bulkhead and extended downward and under an aluminum channel (Figures 20 and 29) which was to act as a bottom seal for the flood-resistant system (Figure 30). The aluminum channel was attached to the house with screws and plastic inserts. The rest of the

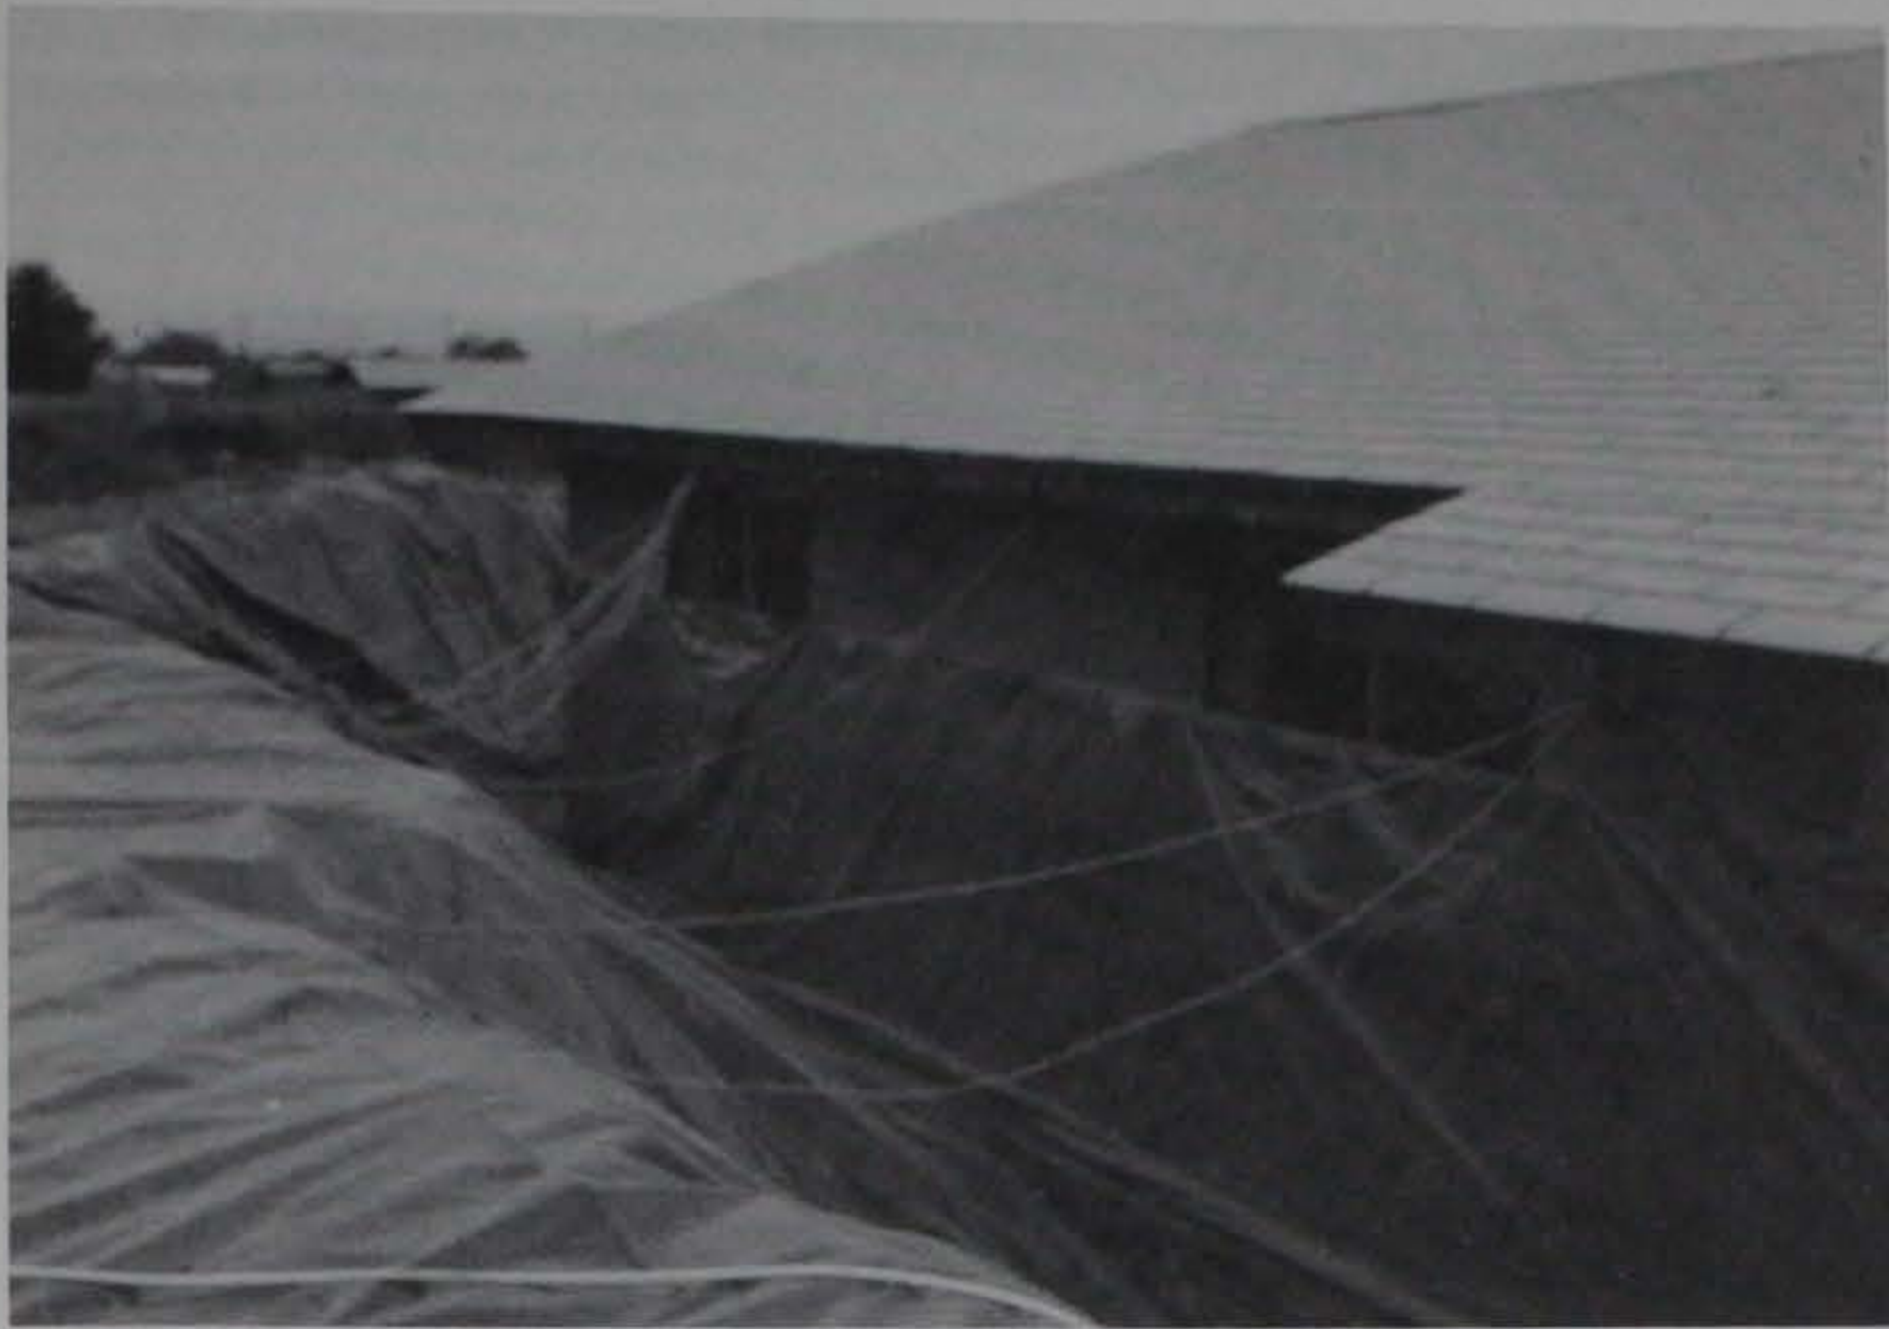
Figure 28. Earth berm and plywood bulkhead

a. Earth berm

b. Plywood bulkhead

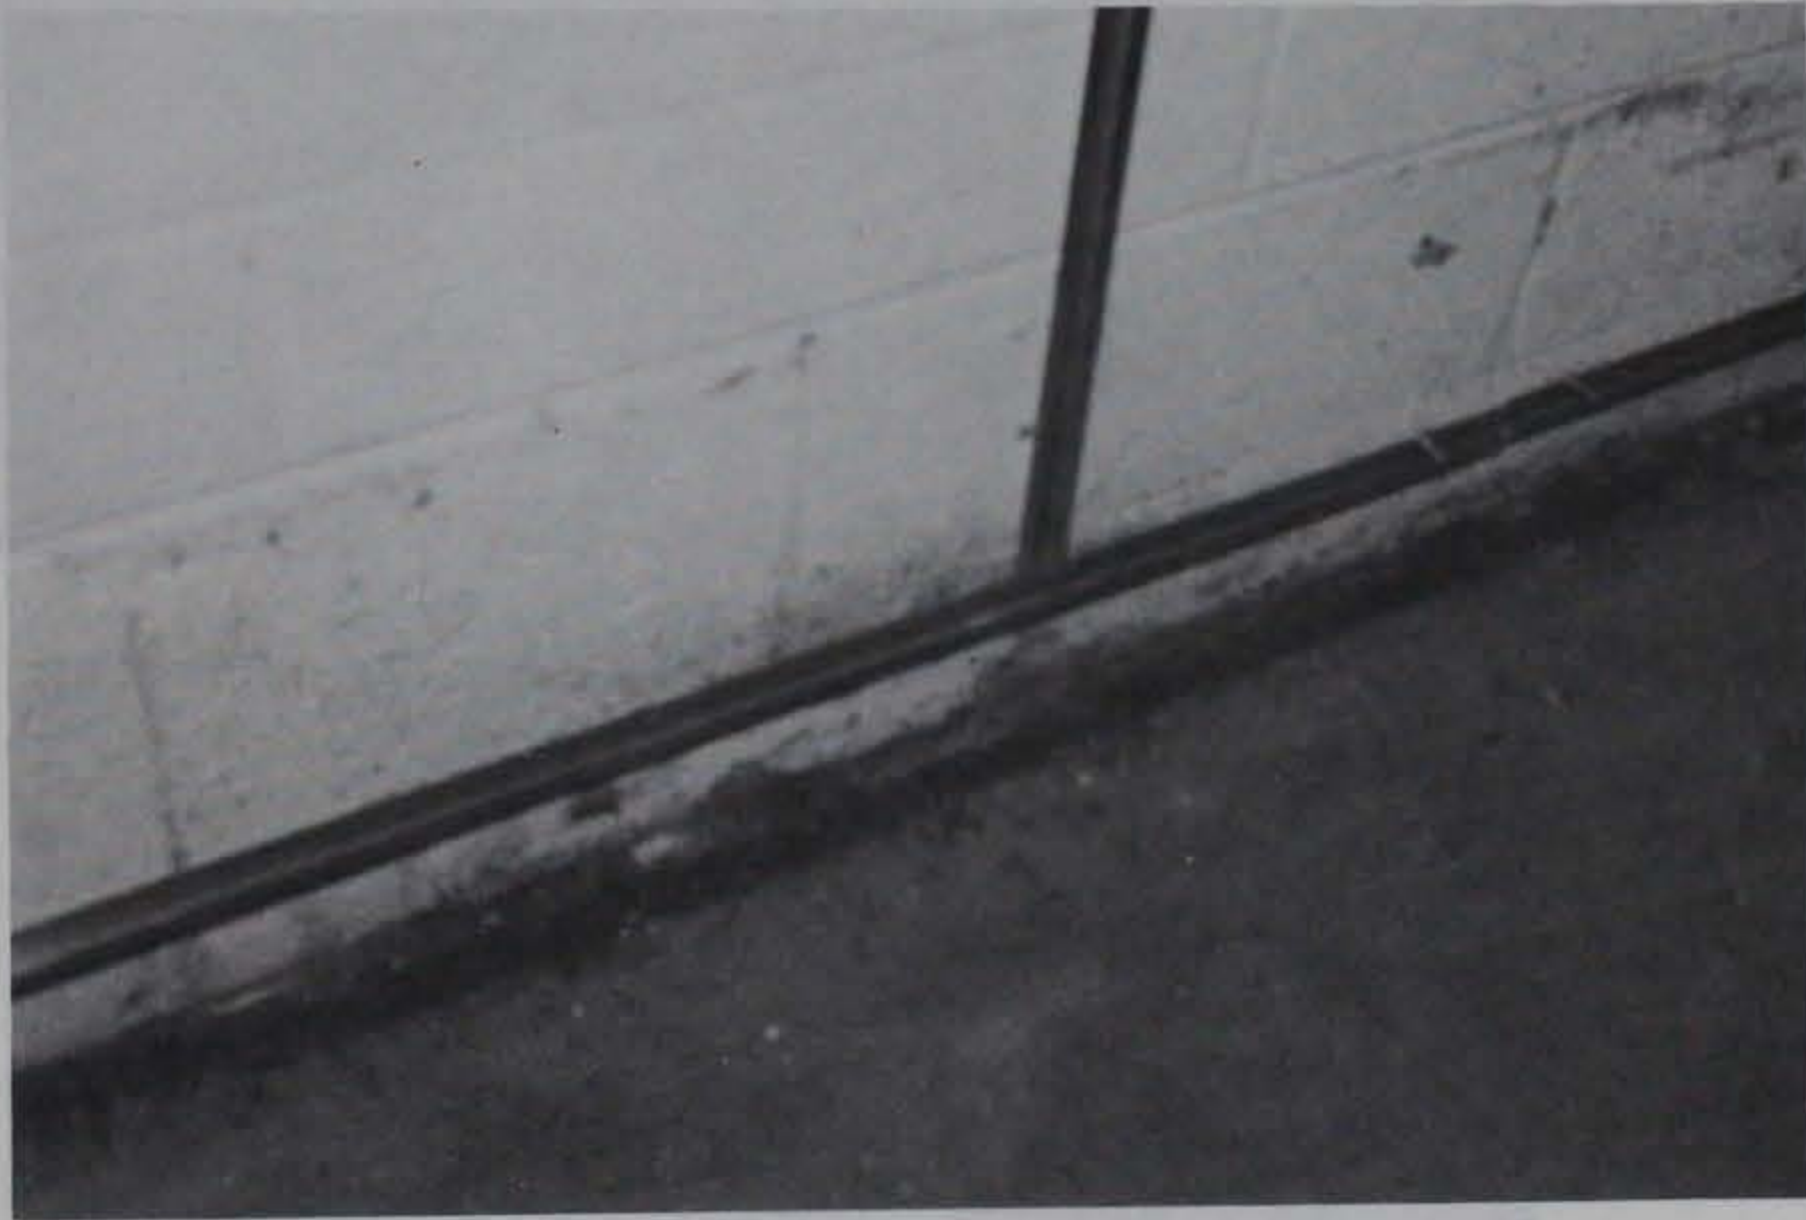
Figure 30. Aluminum strip around base of house

b. Close-up

50. Plastic was placed over the earth berm and under the aluminum strip to prevent water loss through the highly pervious soil during the test. Some of the leakage problems occurred because of this installation. It was discovered that a weatherstripping material did not stick to the plastic where it was placed at the intersection of the plastic and aluminum strip. However, it should be noted that the plastic under the aluminum strip would not be present in an actual flood-resistant construction.
