MISCELLANEOUS PAPER SL-85-5

SYSTEMS AND MATERIALS TO PREVENT FLOODWATERS FROM ENTERING BUILDINGS

Carl E. Pace

DEPARTMENT OF THE ARMY
Waterways Experiment Station, Corps of Engineers
PO Box 631
Vicksburg, Mississippi 39180-0631

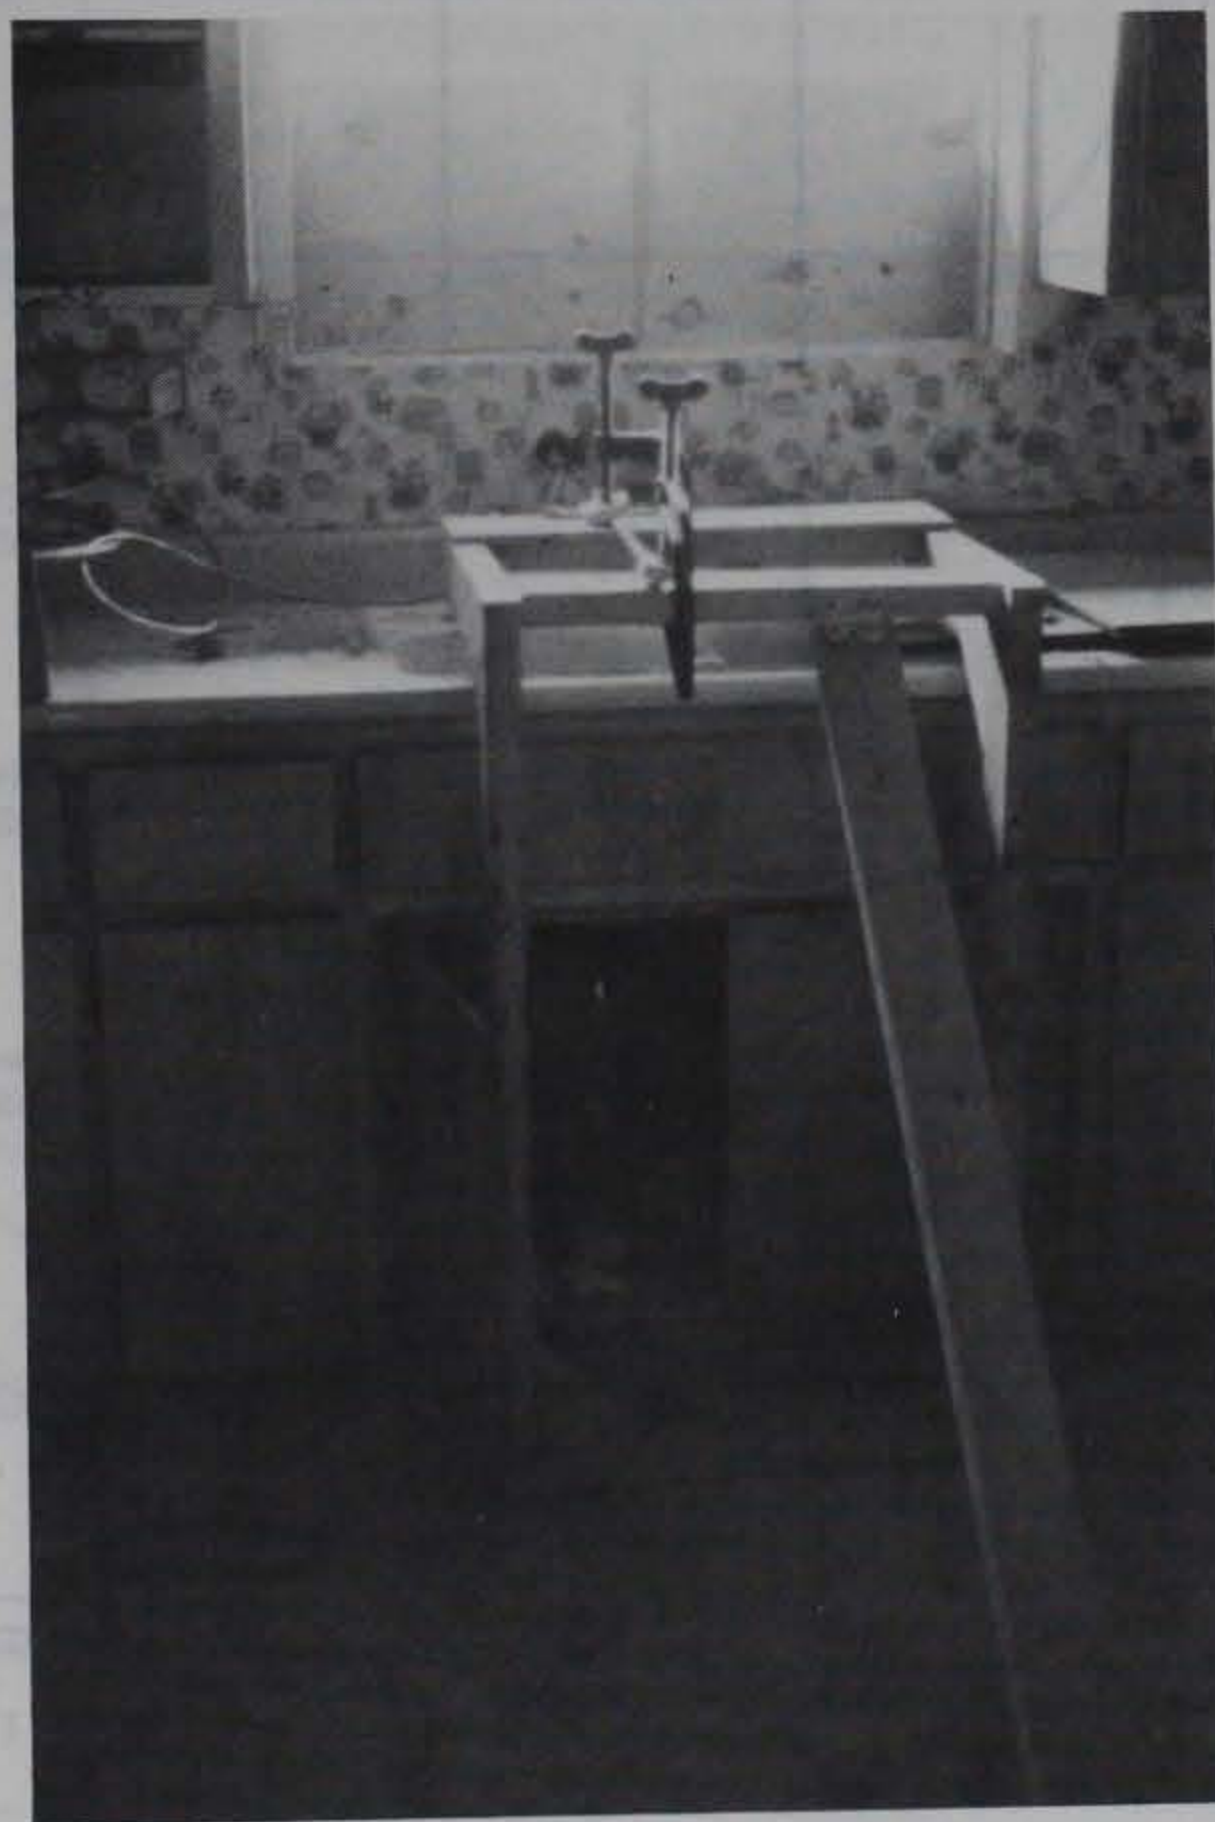
Figure 32. Gage placement

b. Gage placement in kitchen

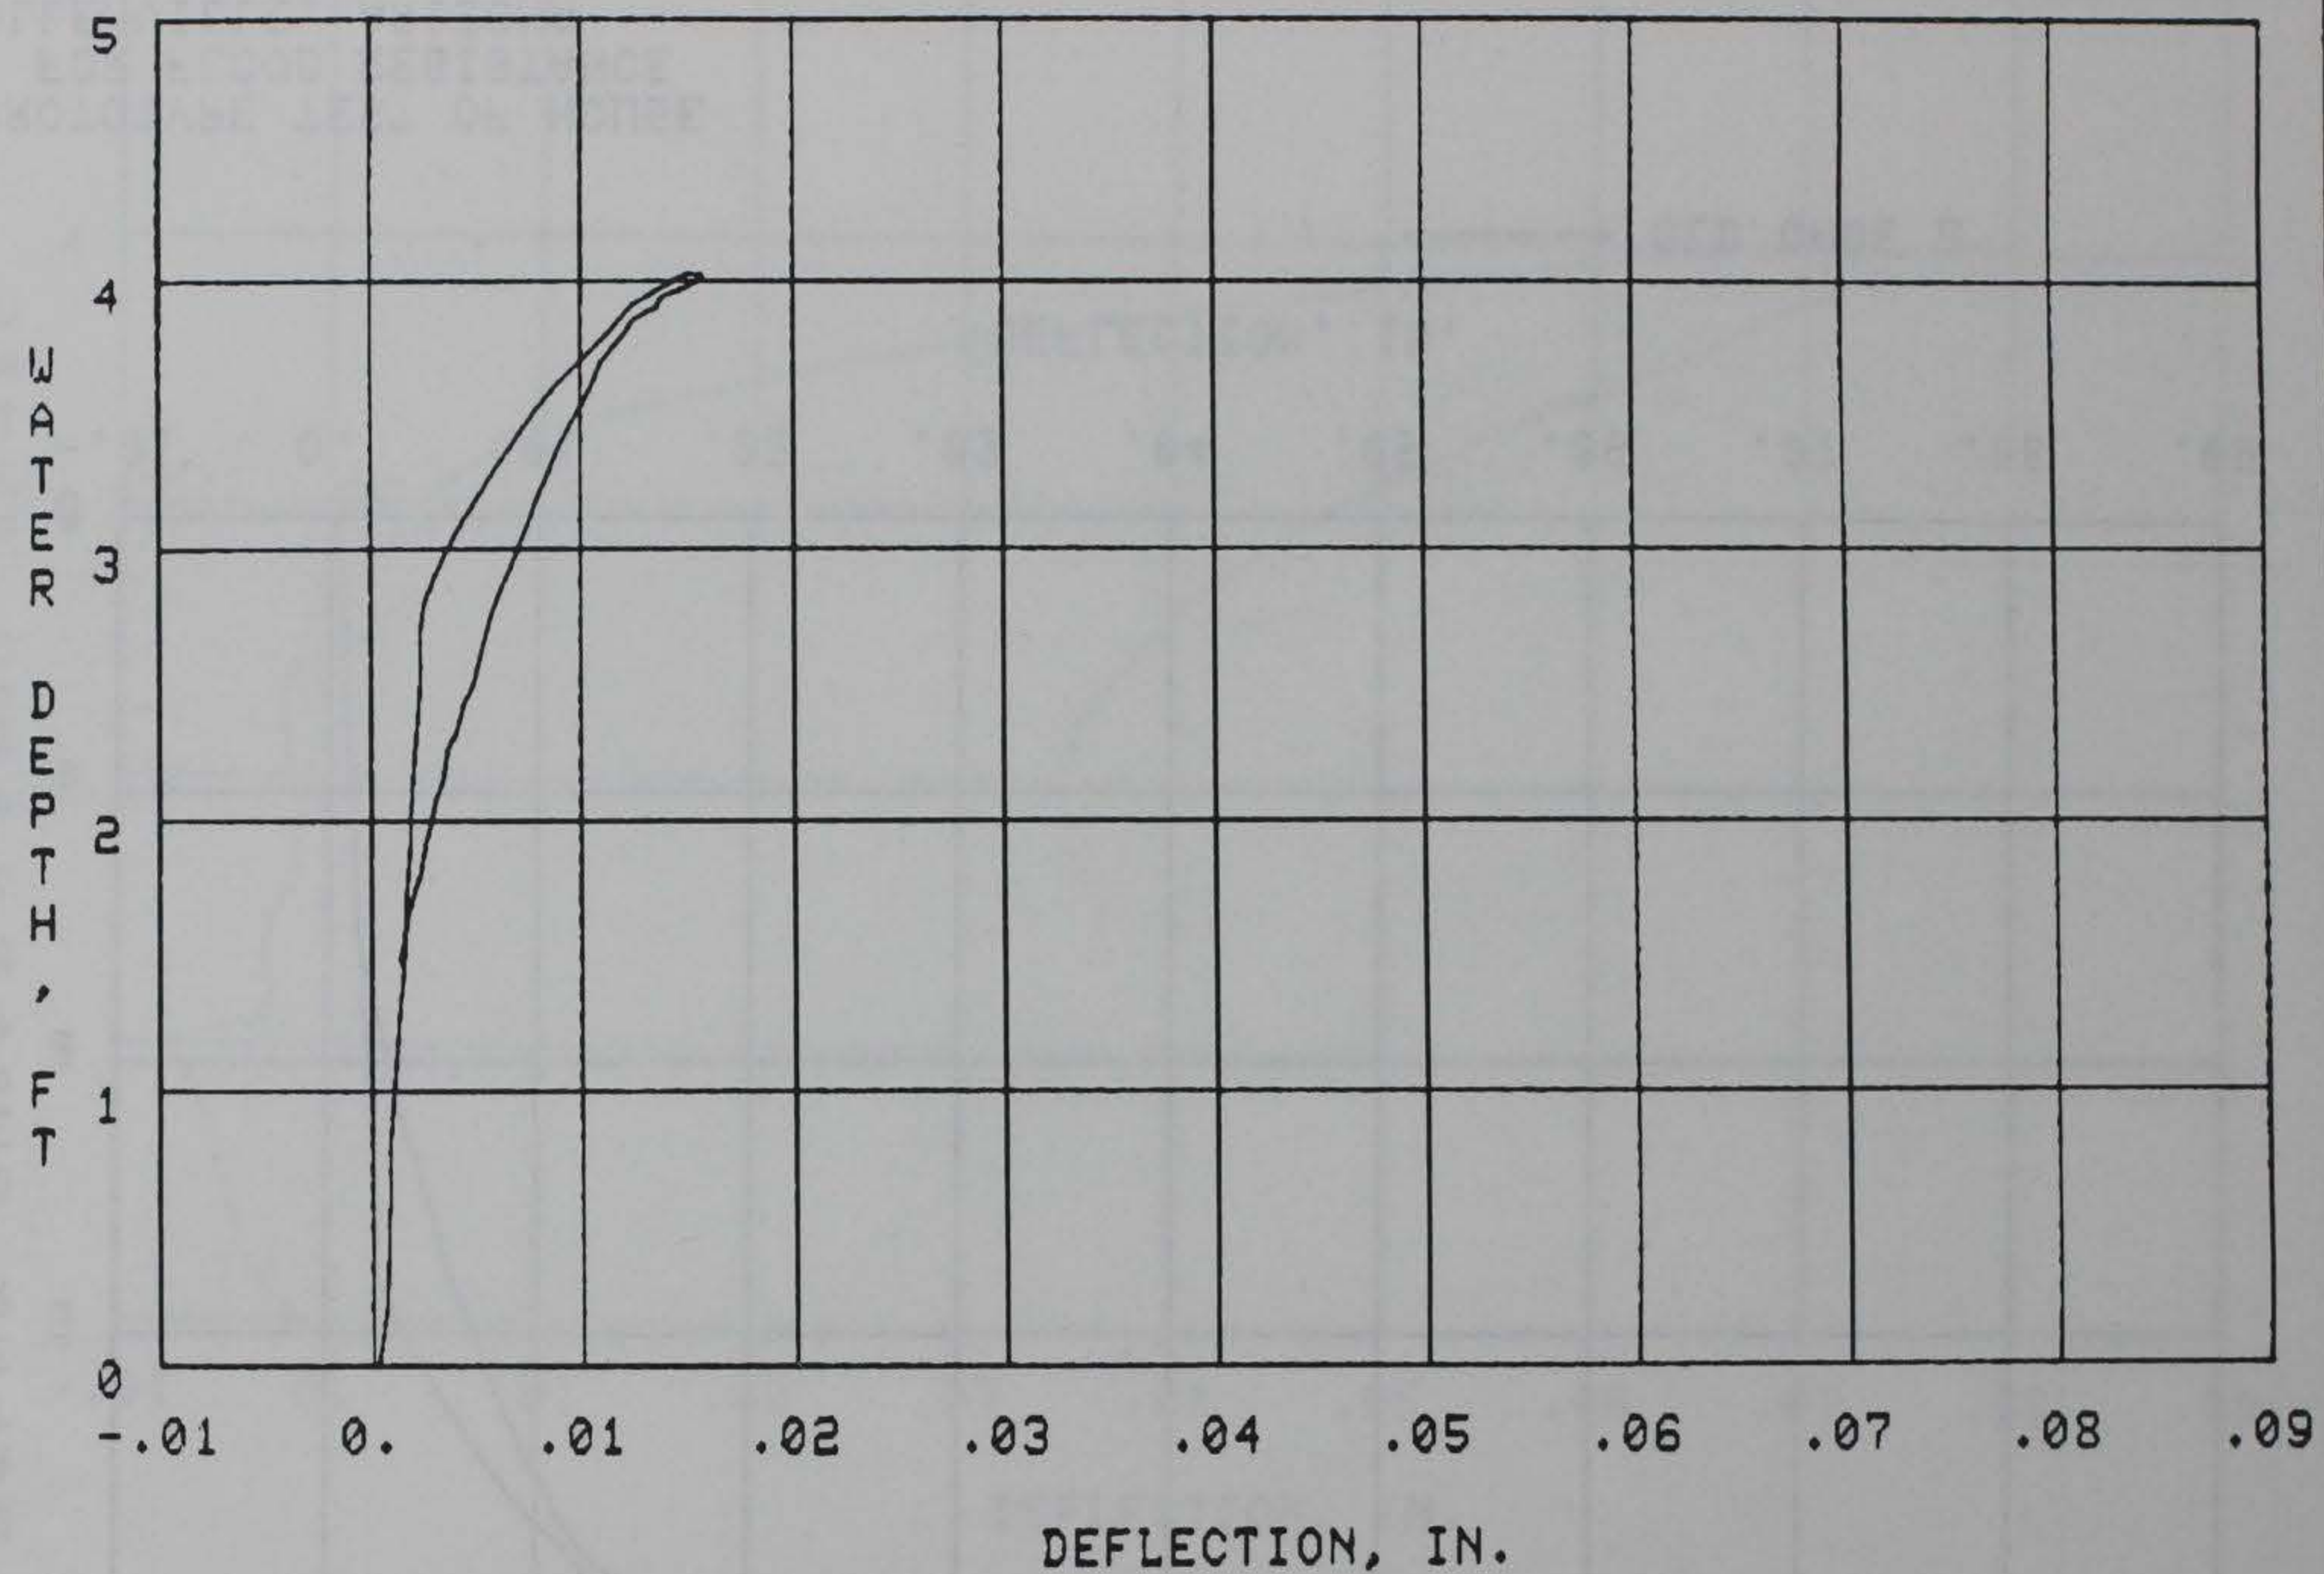
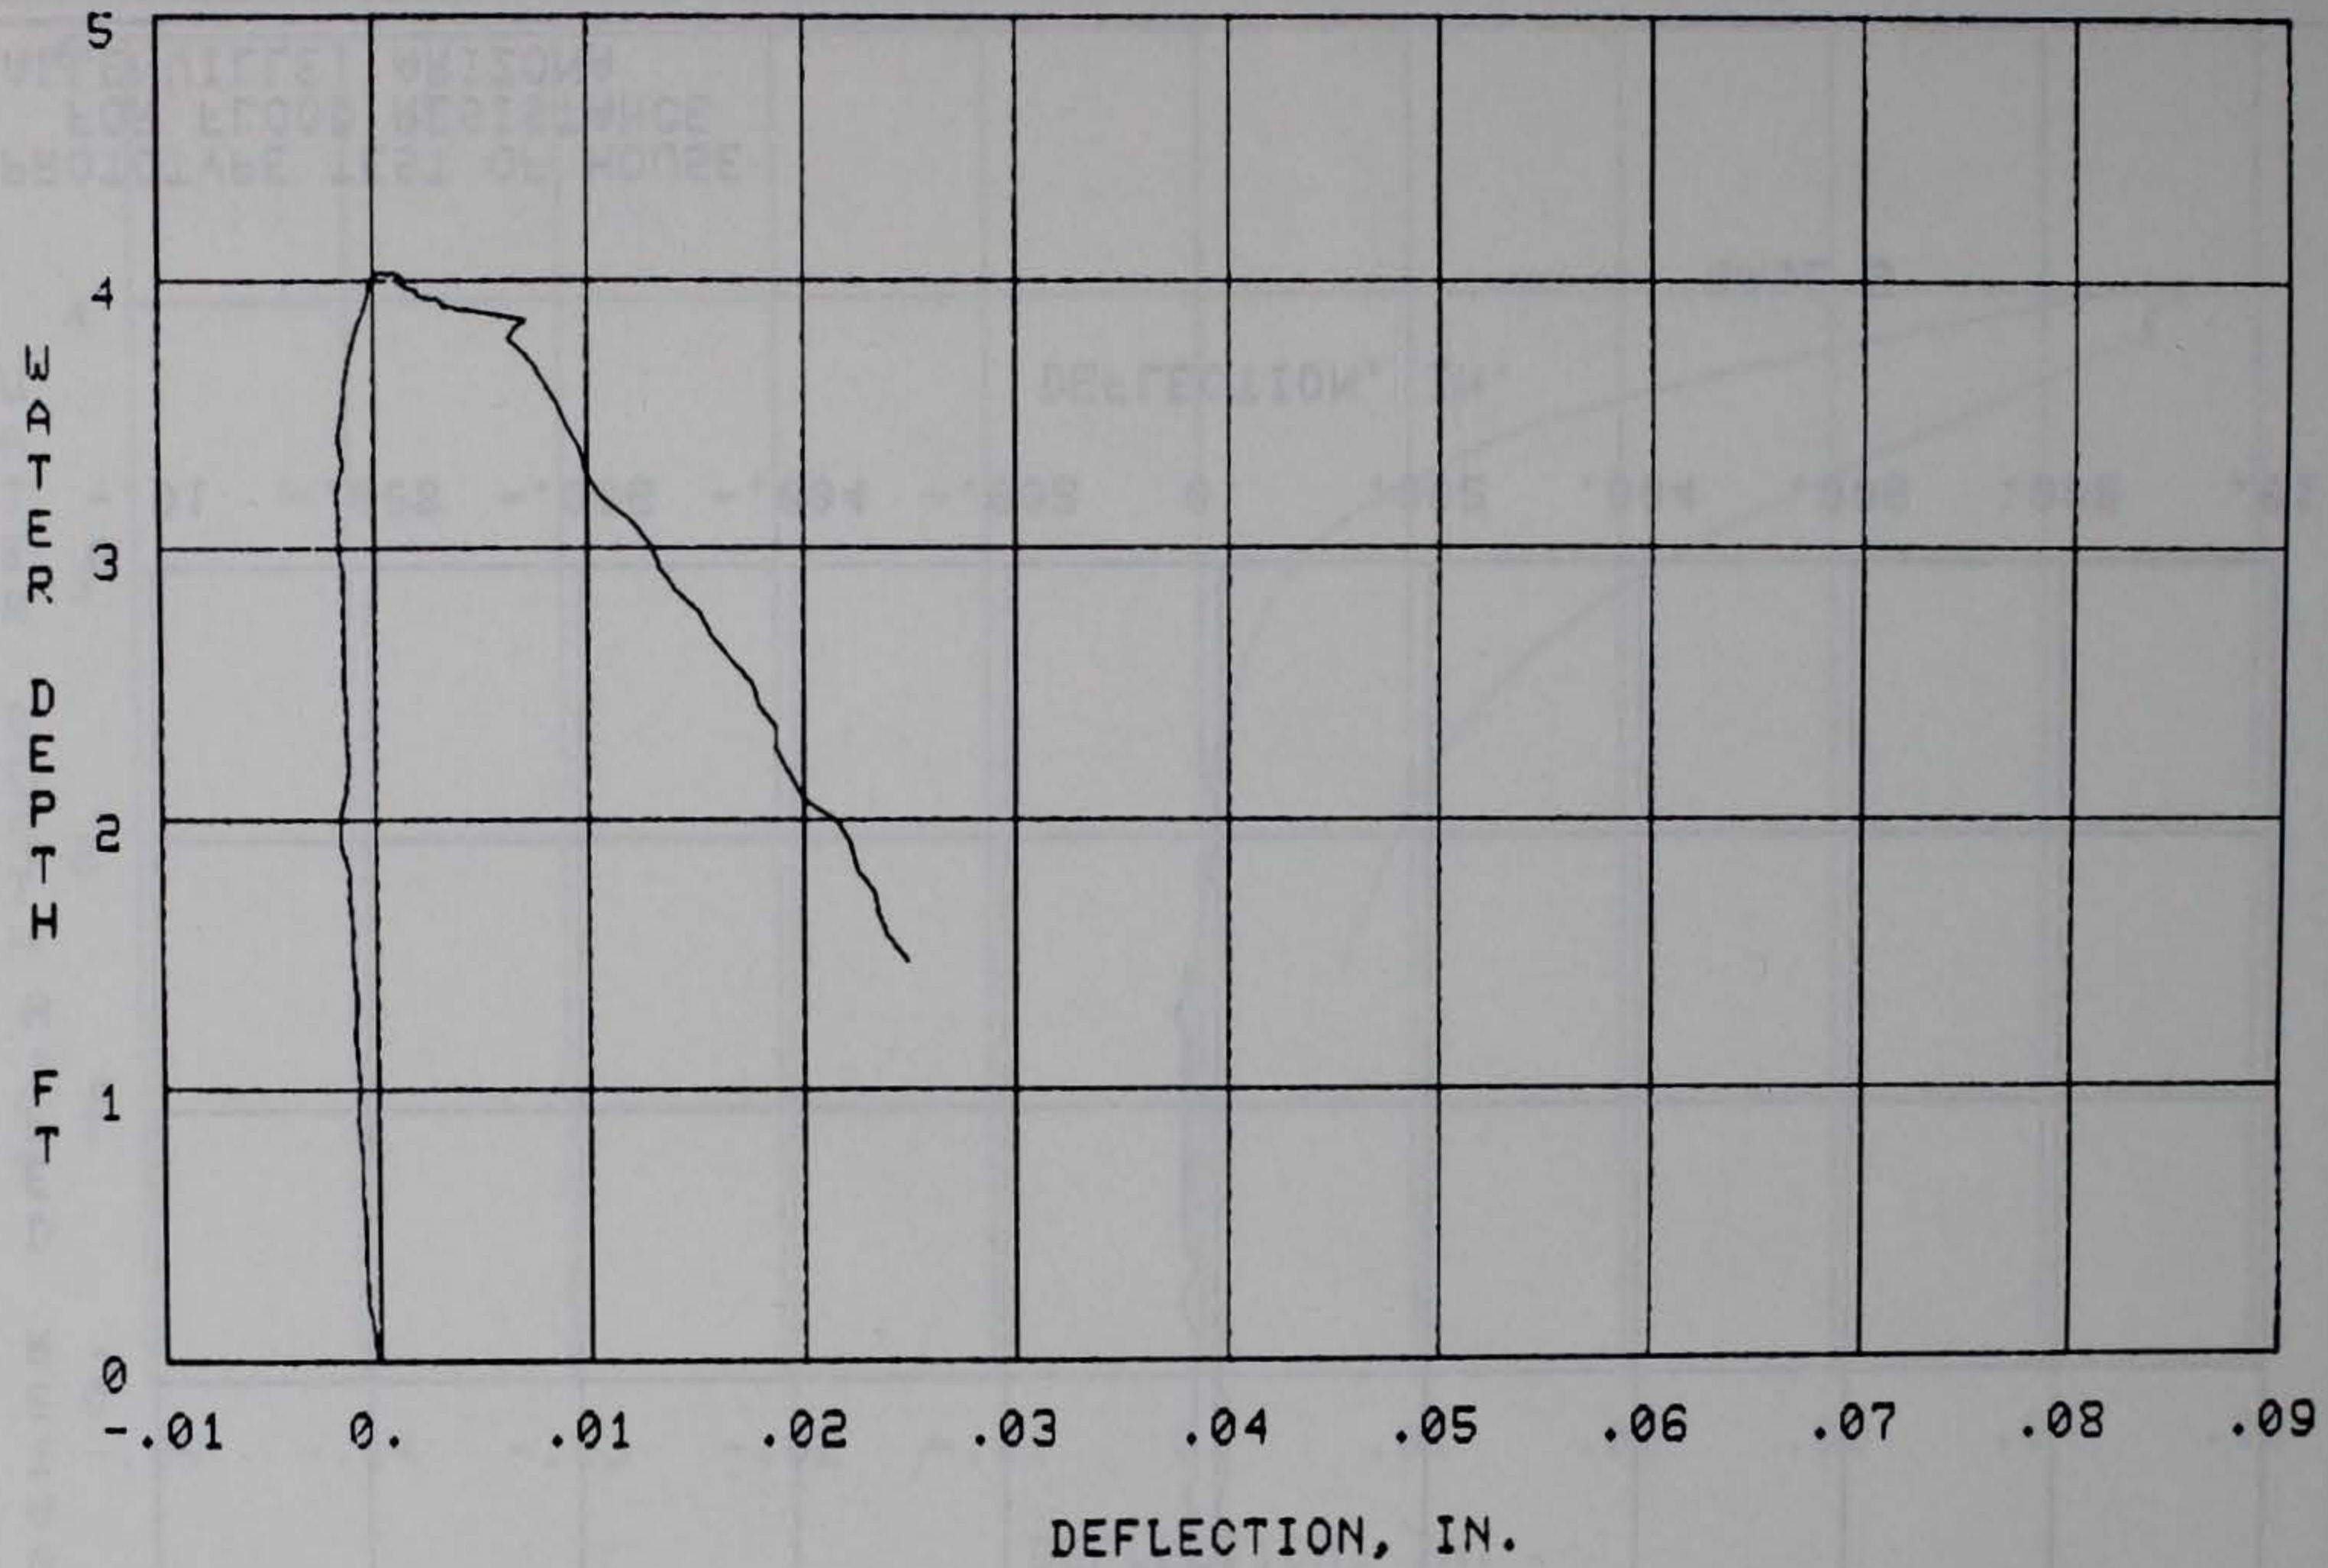
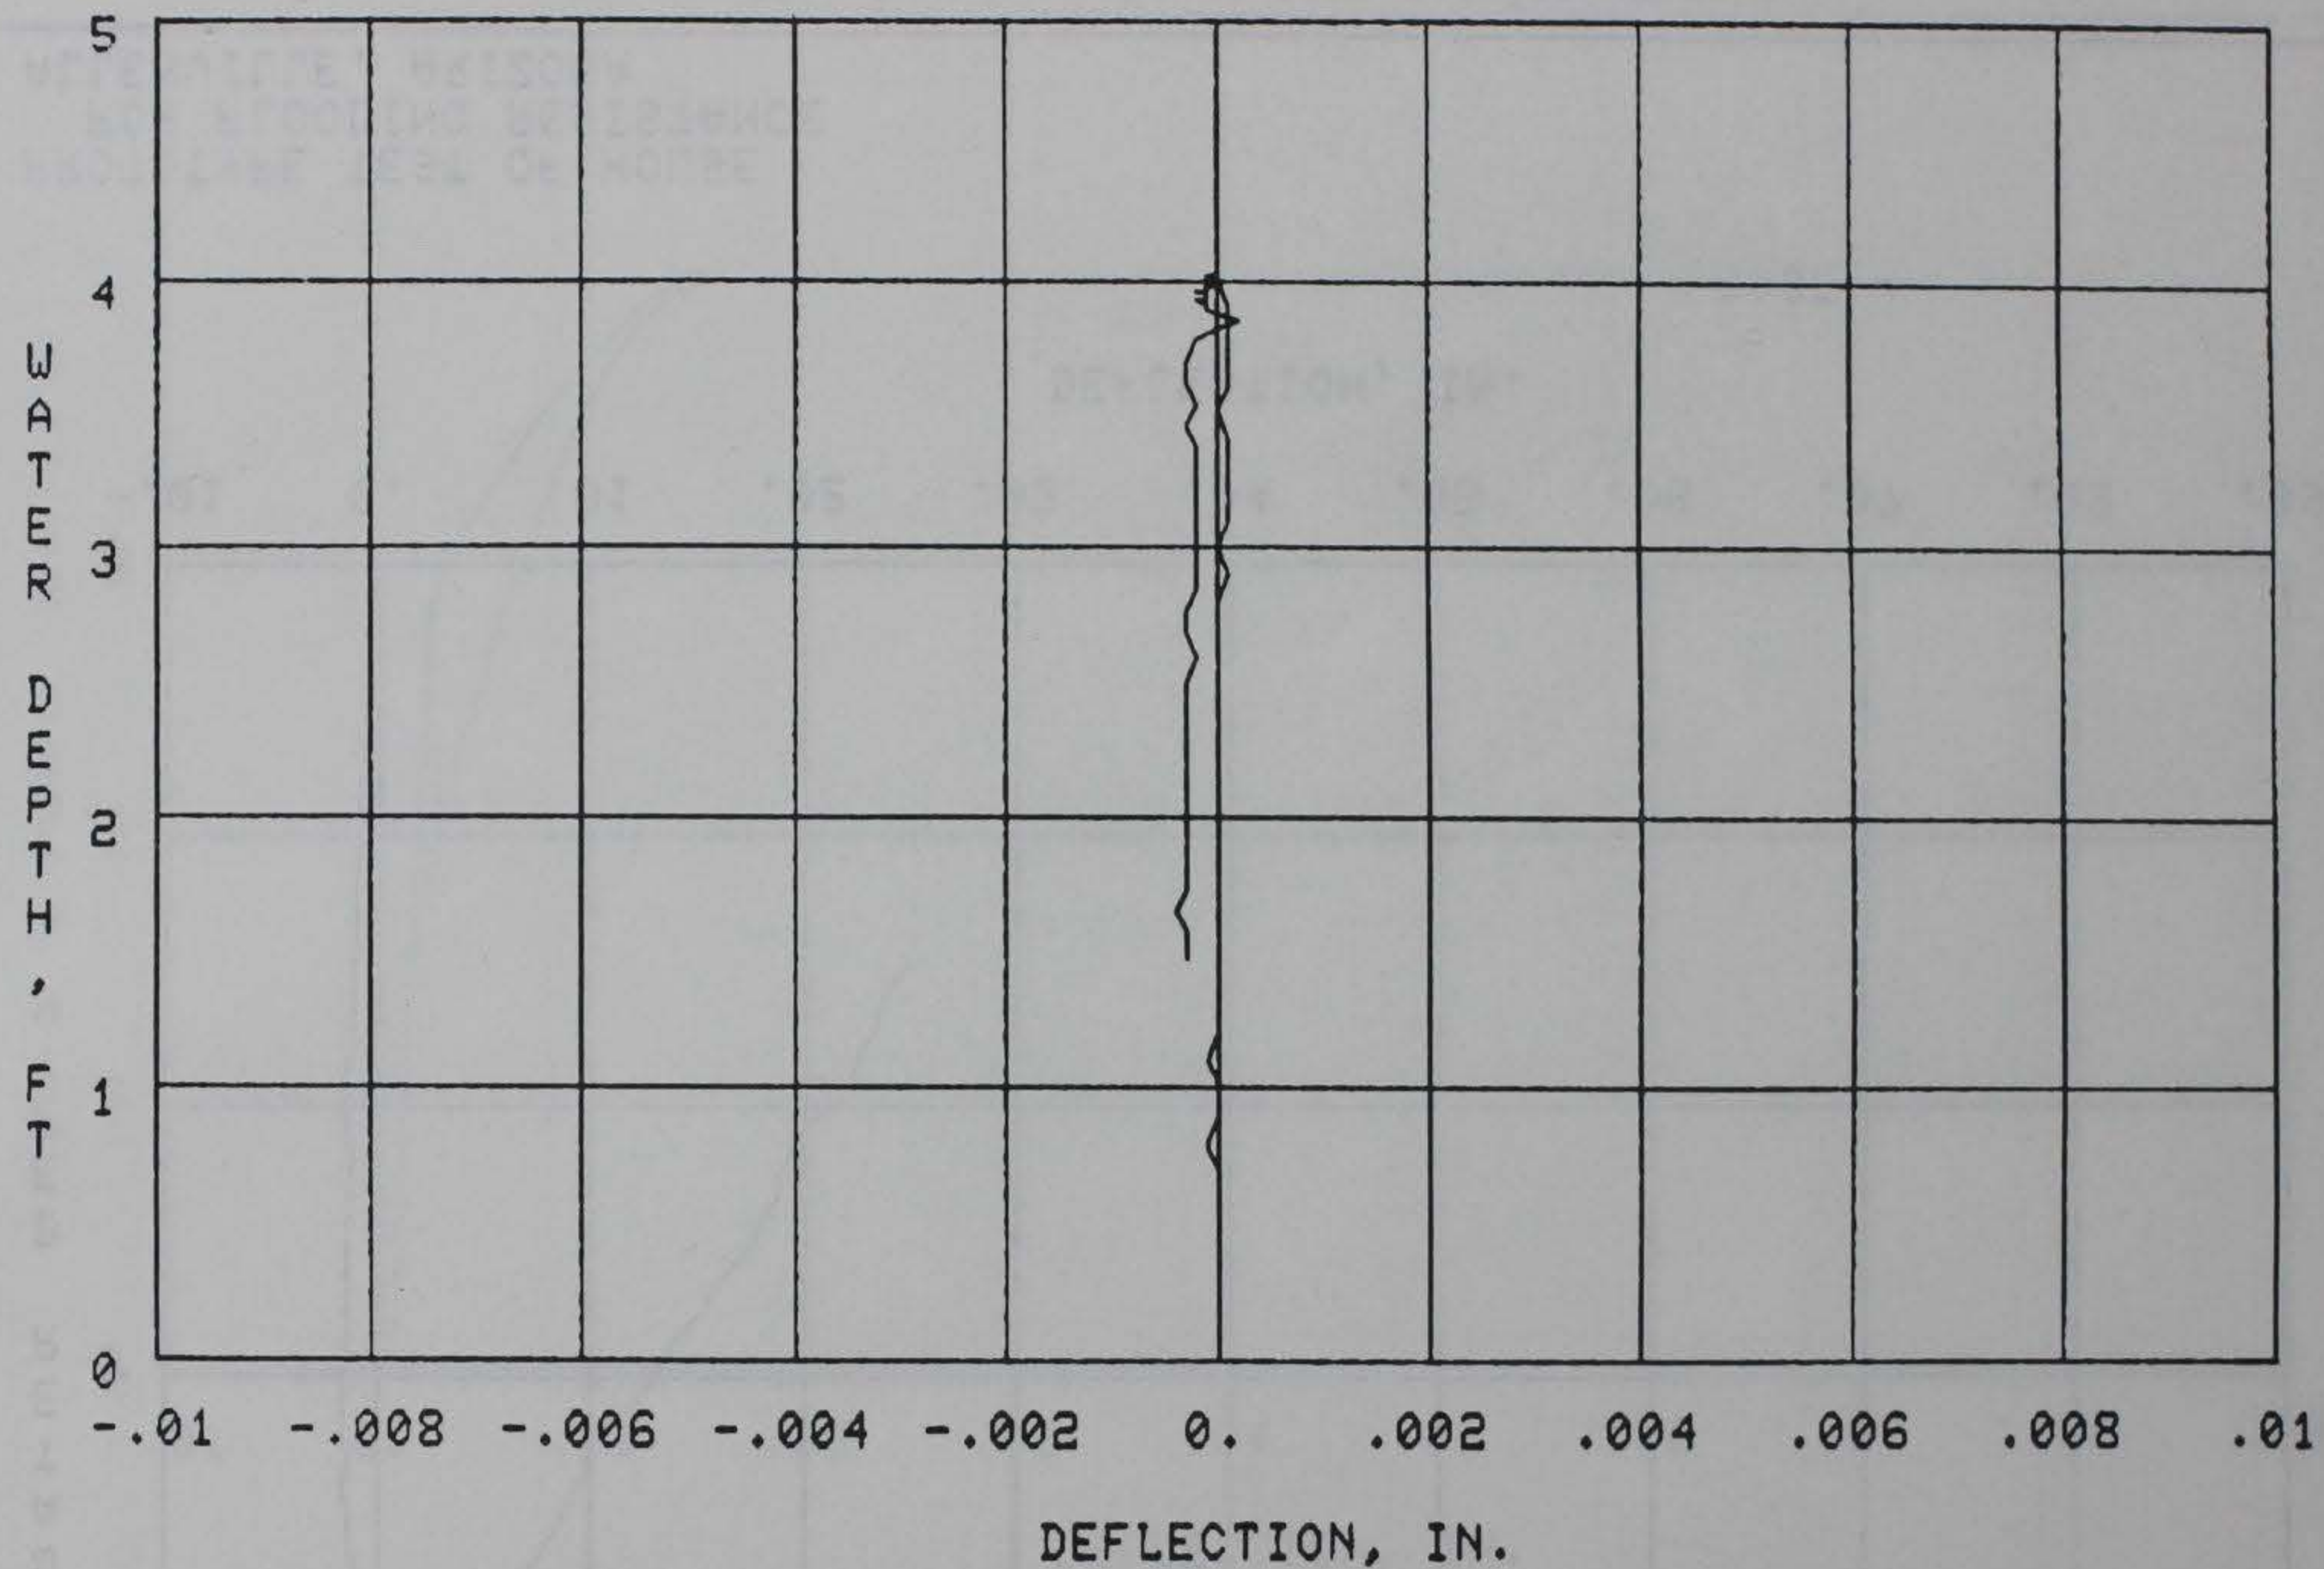
Figure 33. Prototype house test results, gage 1

Figure 34. Prototype house test results, gage 2

Figure 35. Prototype house test results, gage 3

Figure 36. Prototype house test results, gage 4

Figure 37. Prototype house test results, gage 5

Figure 38. Prototype house test results, gage 6

49. The walls of the house were damaged by a 4-ft water head. This damage is indicated by the test data in Figures 33-47. The unloading curves show permanent deformation in the walls. An inspection the next morning after the water load had been removed revealed that the brick wall had visual cracks in the mortar joints.

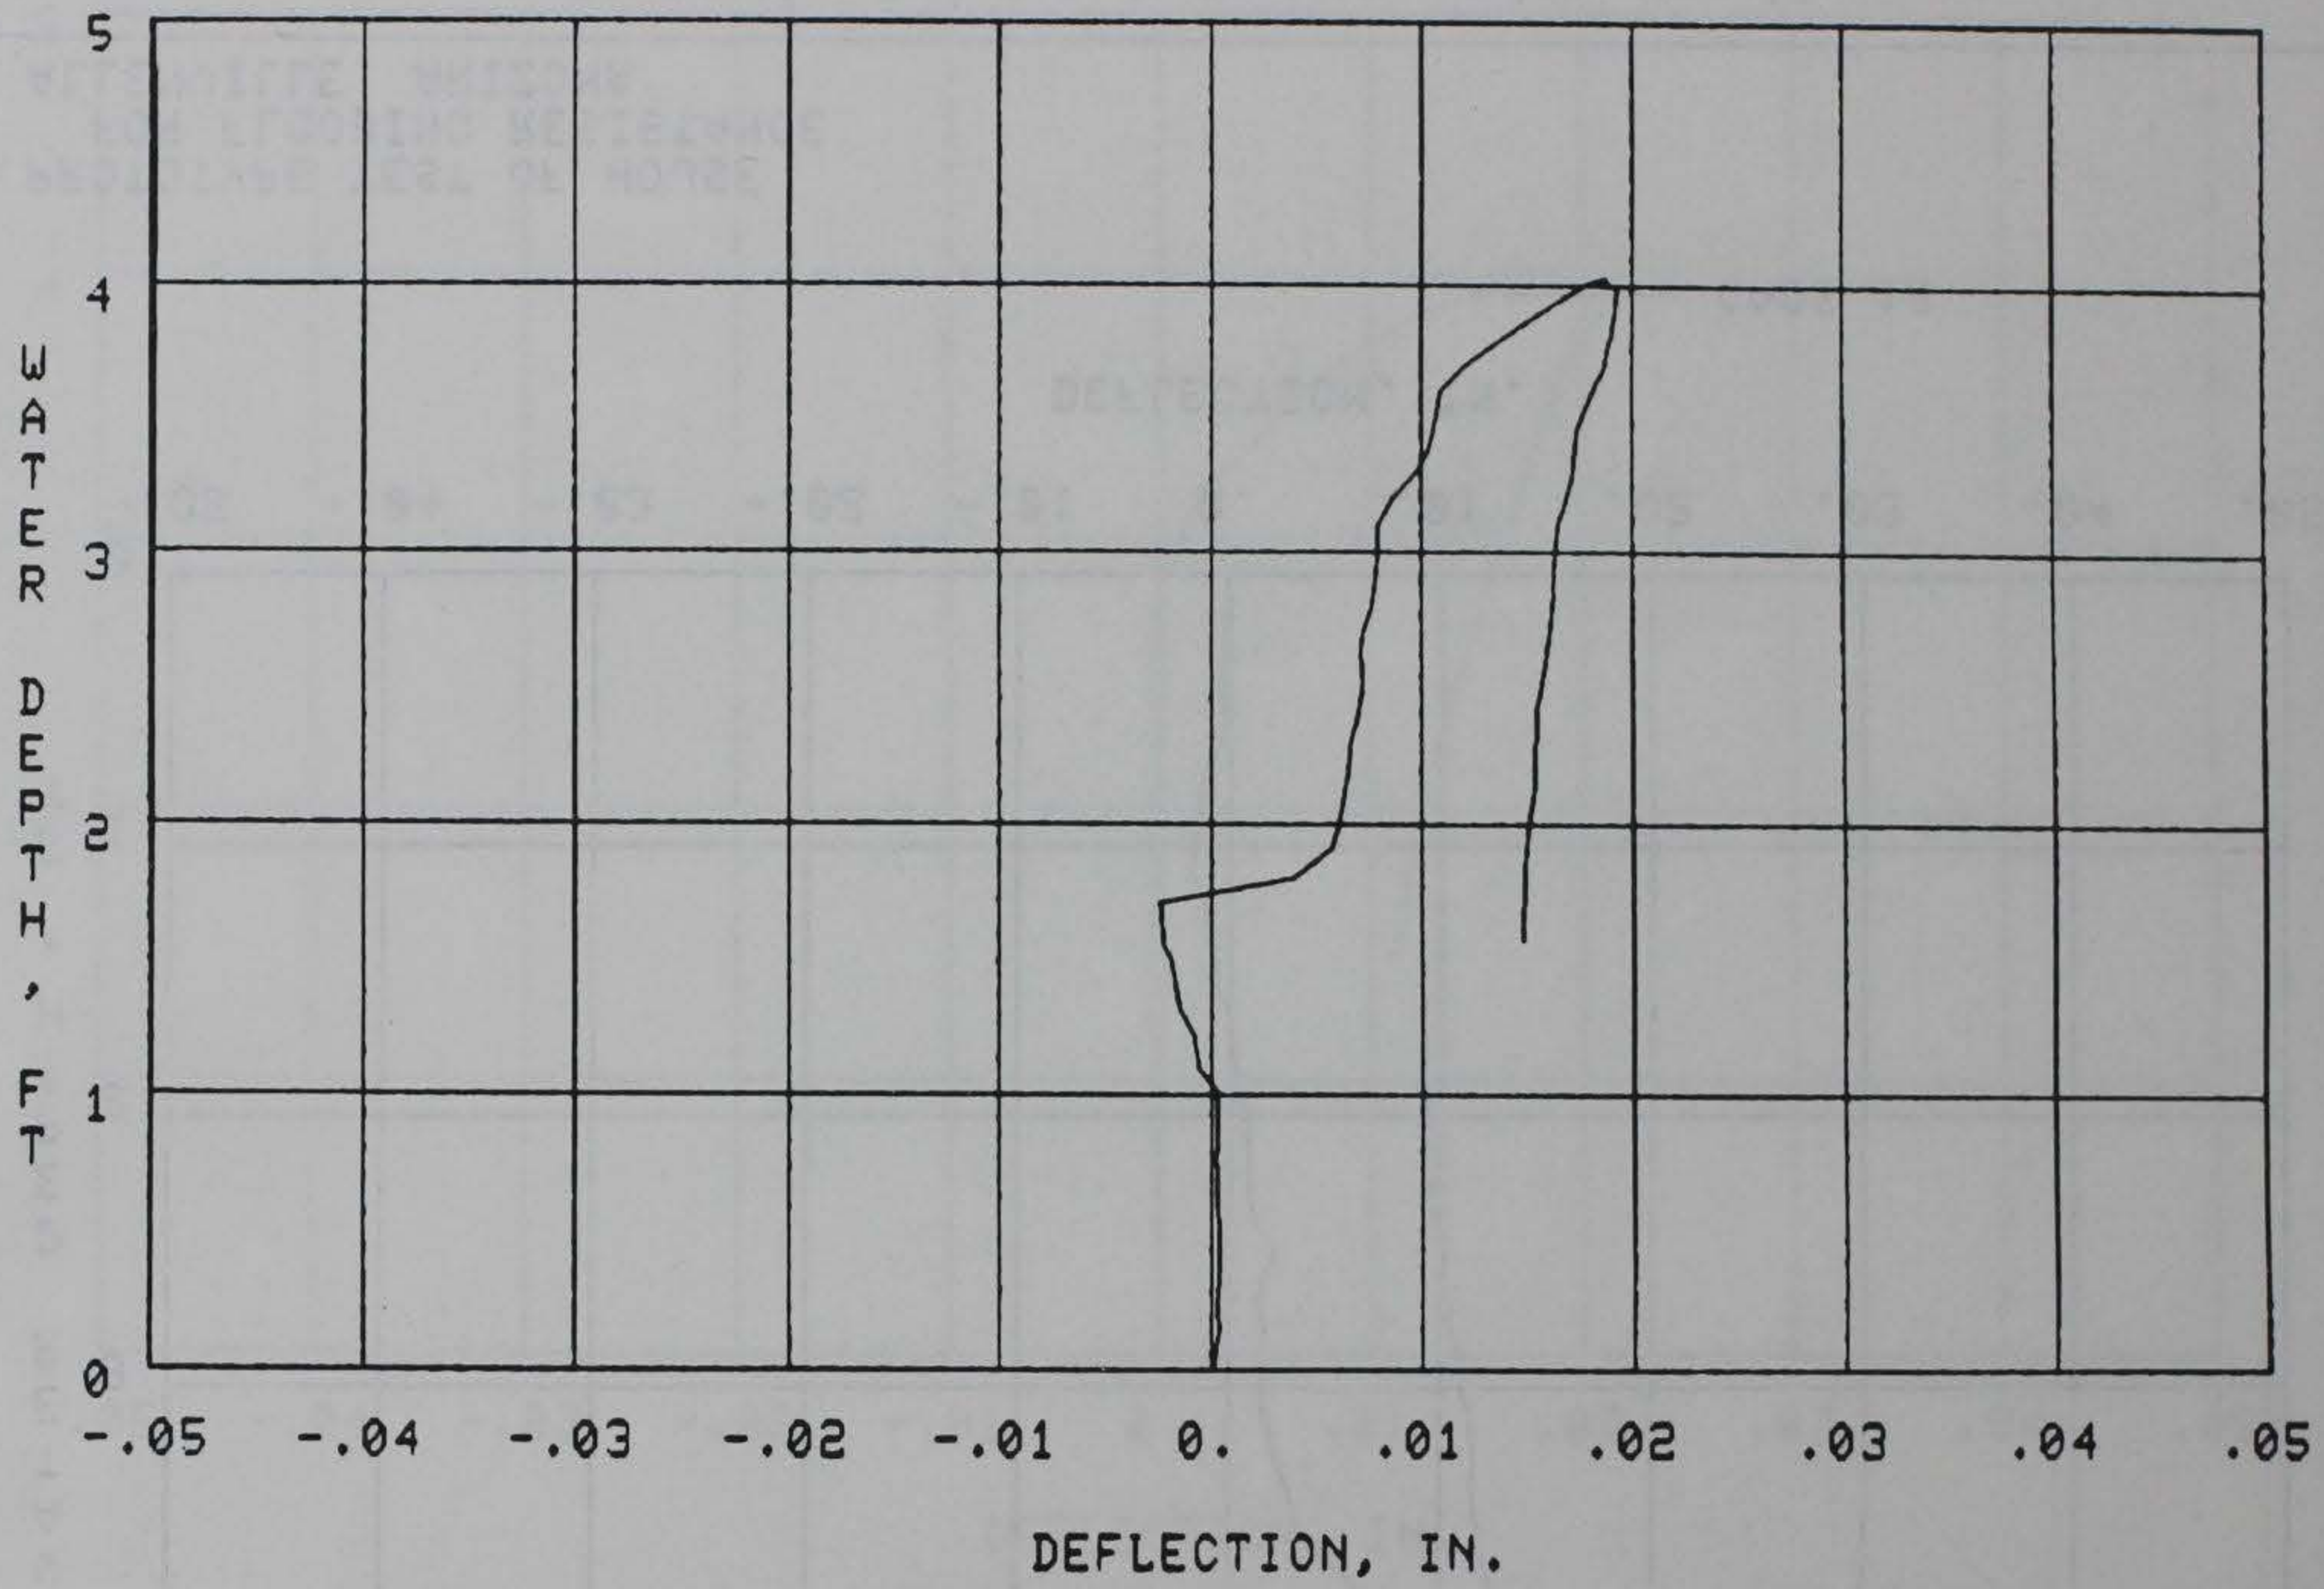
Figure 45. Prototype house test results, gage 13

Figure 46. Prototype house test results, gage 14

Figure 47. Prototype house test results, gage 15

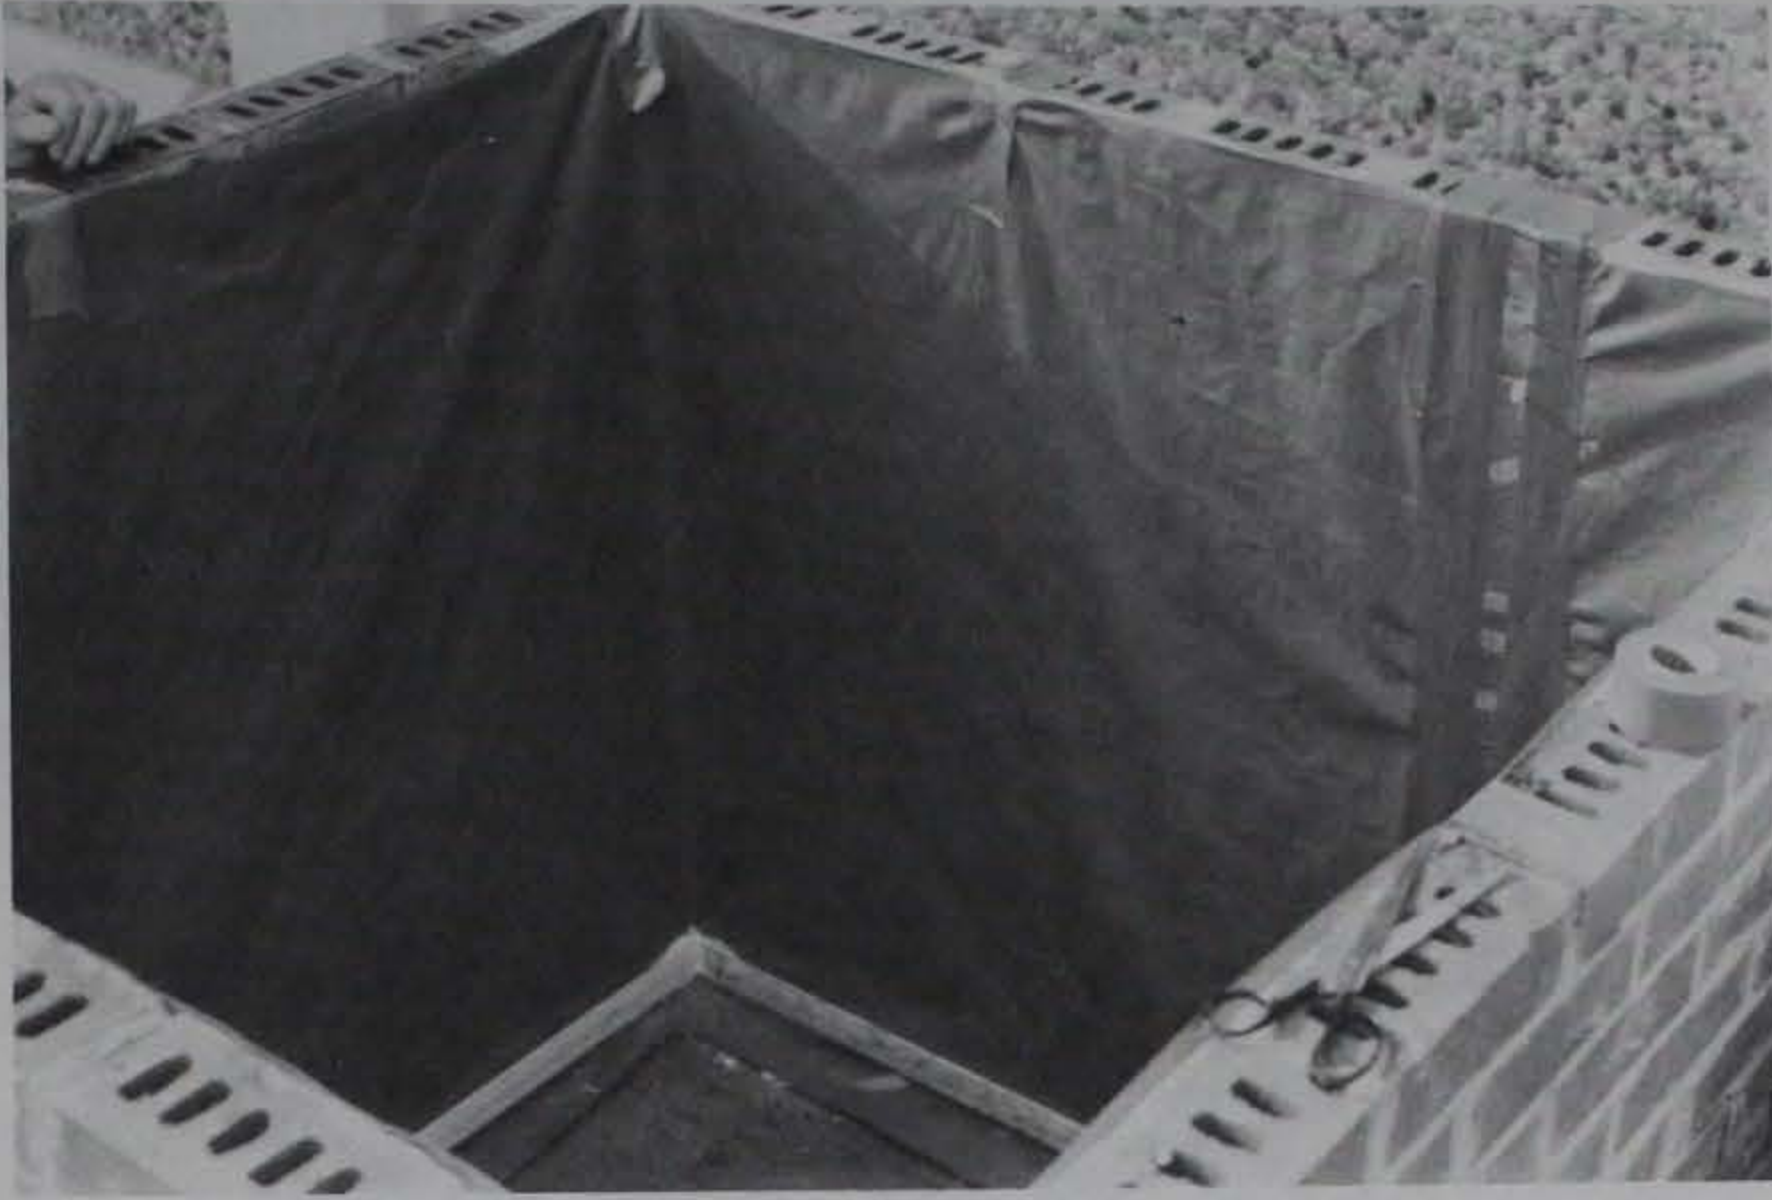
a. Seal strip corner

57. Five tests were made with the system using the specially designed seal strip. Photos of the tests are shown in Figures 50 and 51. It was found that care must be taken in attaching the permanent part of the seal strip to the house. If any adhesive material adheres and stays in the snap area, it will hold the expedient snap open and allow water to enter behind the plastic.

58. It was thought that the corners (Figures 50 and 51) could be easily sealed. The one small place where there was a possibility of water entry was at the corner where the snap comes together. This was to be sealed by placing silicone caulk under the snap and at the intersection of the plastic and snap on the under side of the plastic. This solution seemed entirely logical, but in practice it turned out to be extremely difficult to keep the corners from leaking.

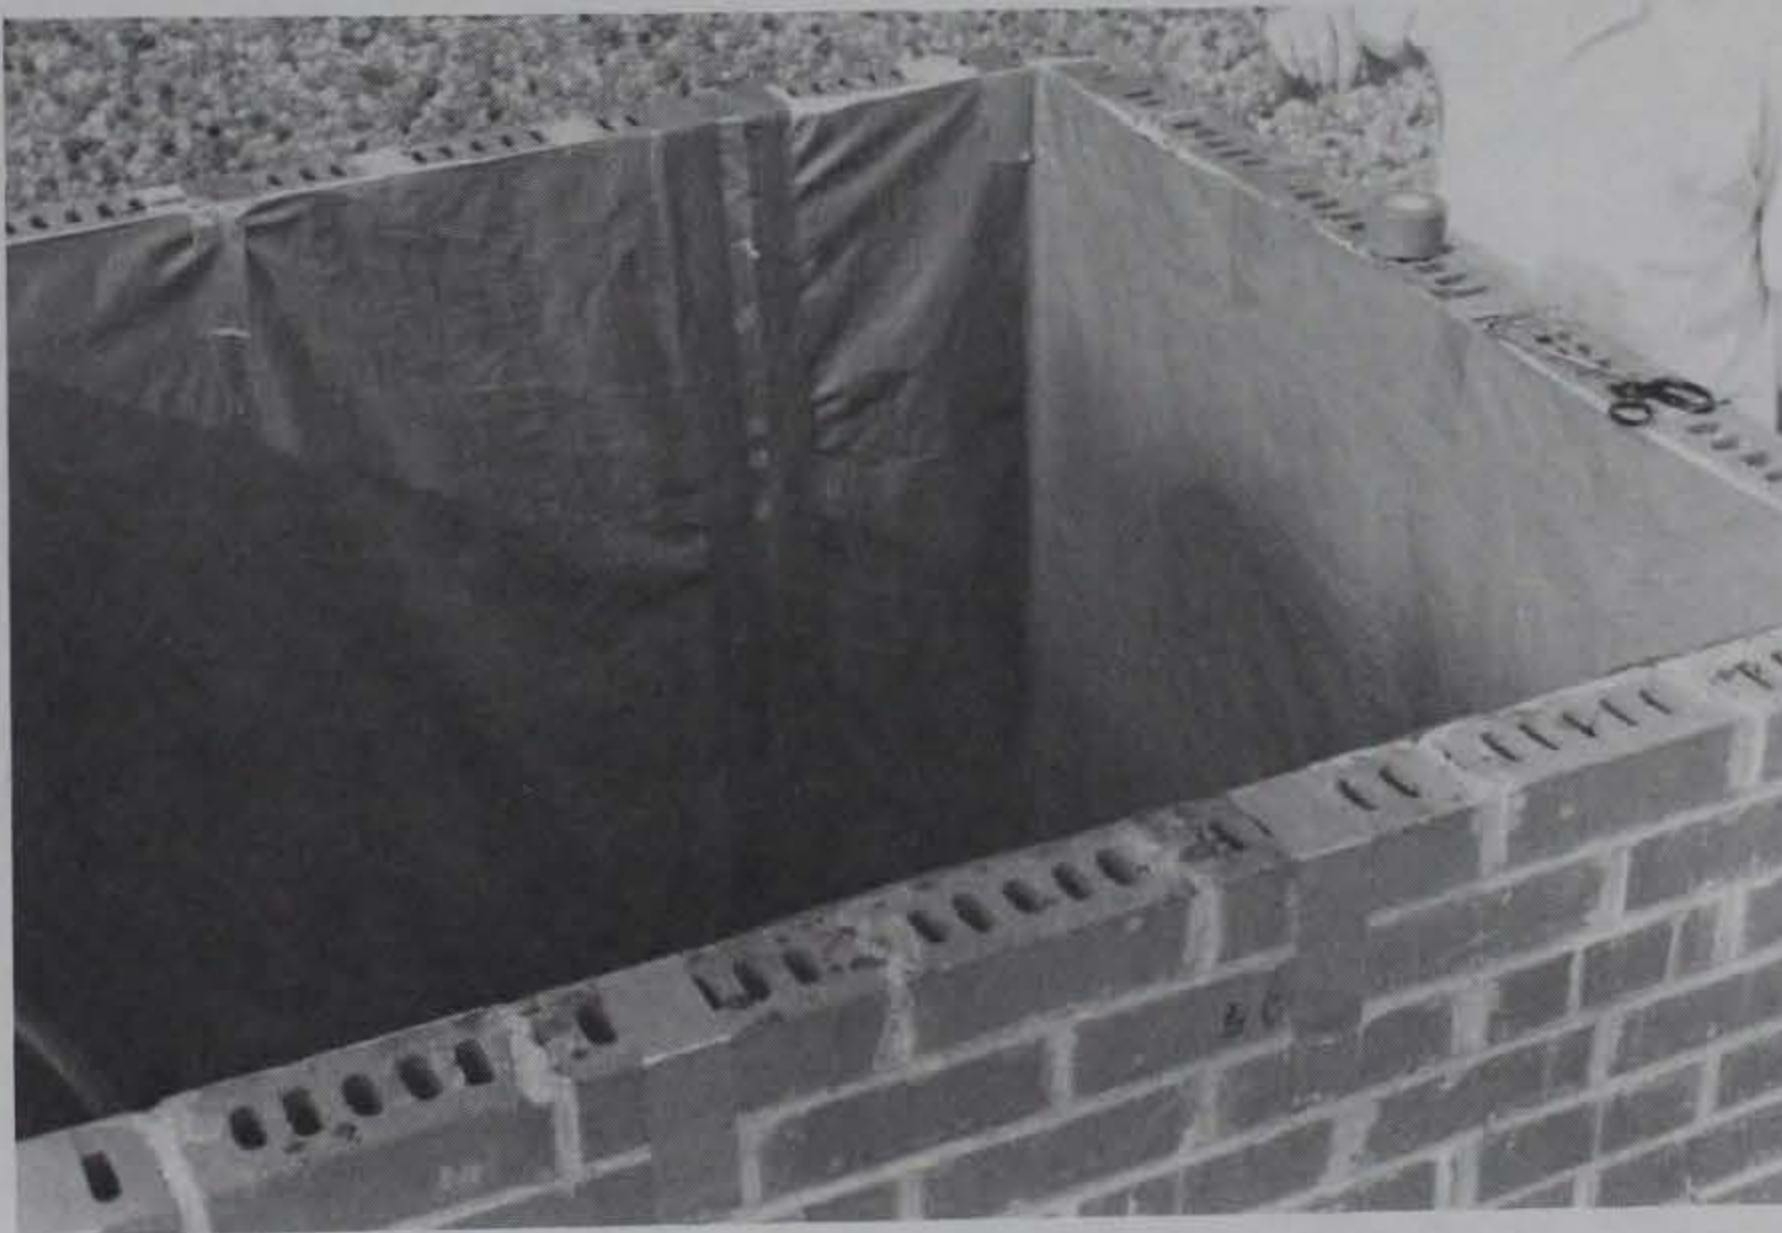
Figure 51. Plastic sheeting and seal strip

b. Plastic sheeting covering brick wall
