MISCELLANEOUS PAPER SL-85-5

SYSTEMS AND MATERIALS TO PREVENT FLOODWATERS FROM ENTERING BUILDINGS

Carl E. Pace

DEPARTMENT OF THE ARMY
Waterways Experiment Station, Corps of Engineers
PO Box 631
Vicksburg, Mississippi 39180-0631

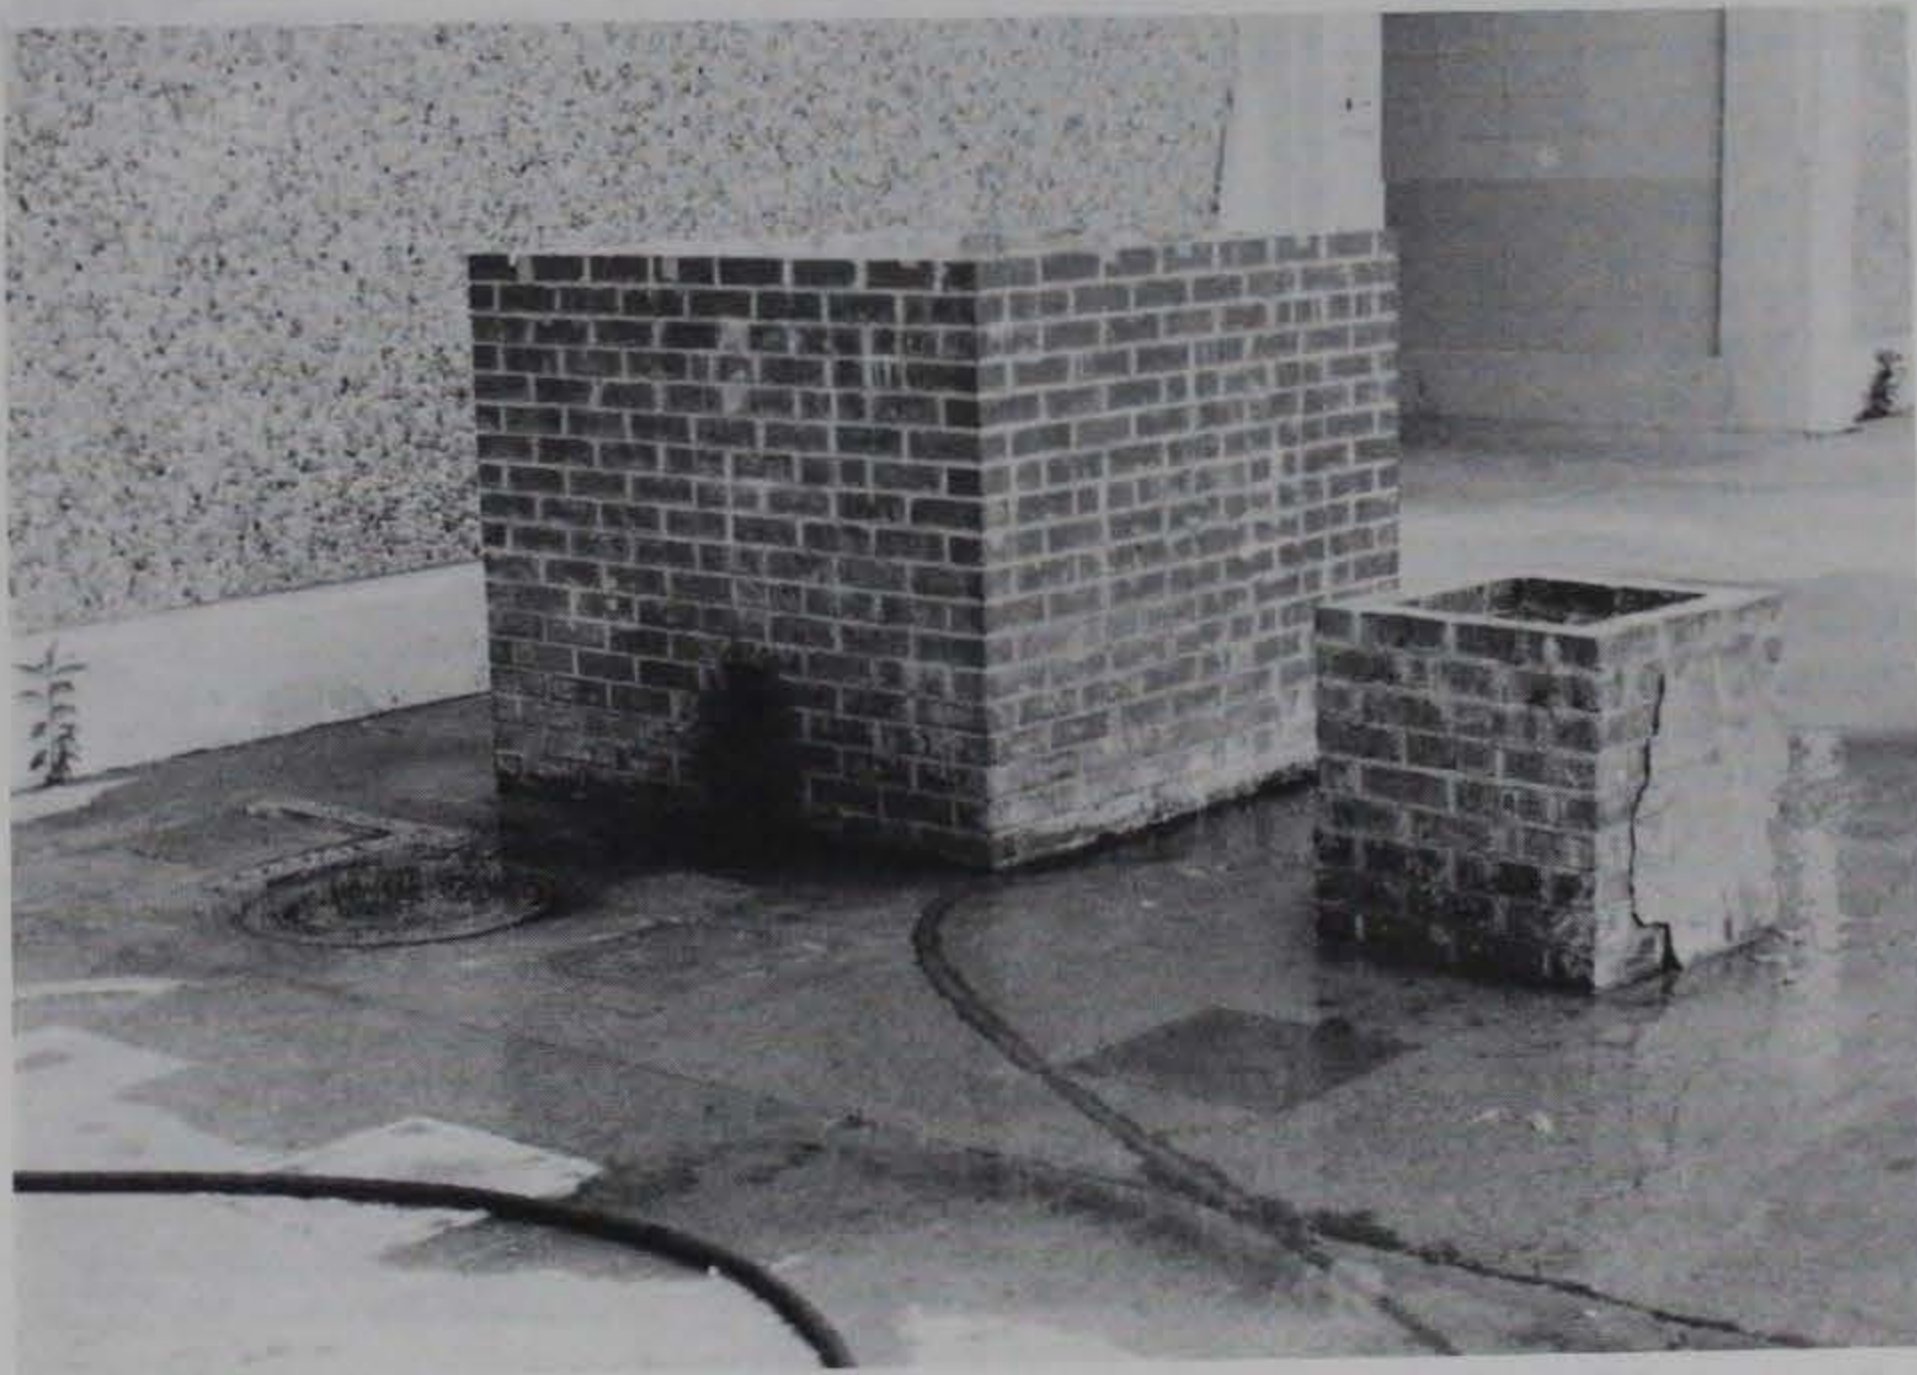
Figure 53. Dye in water leaking from large brick cube

a. Front view

b. Side view

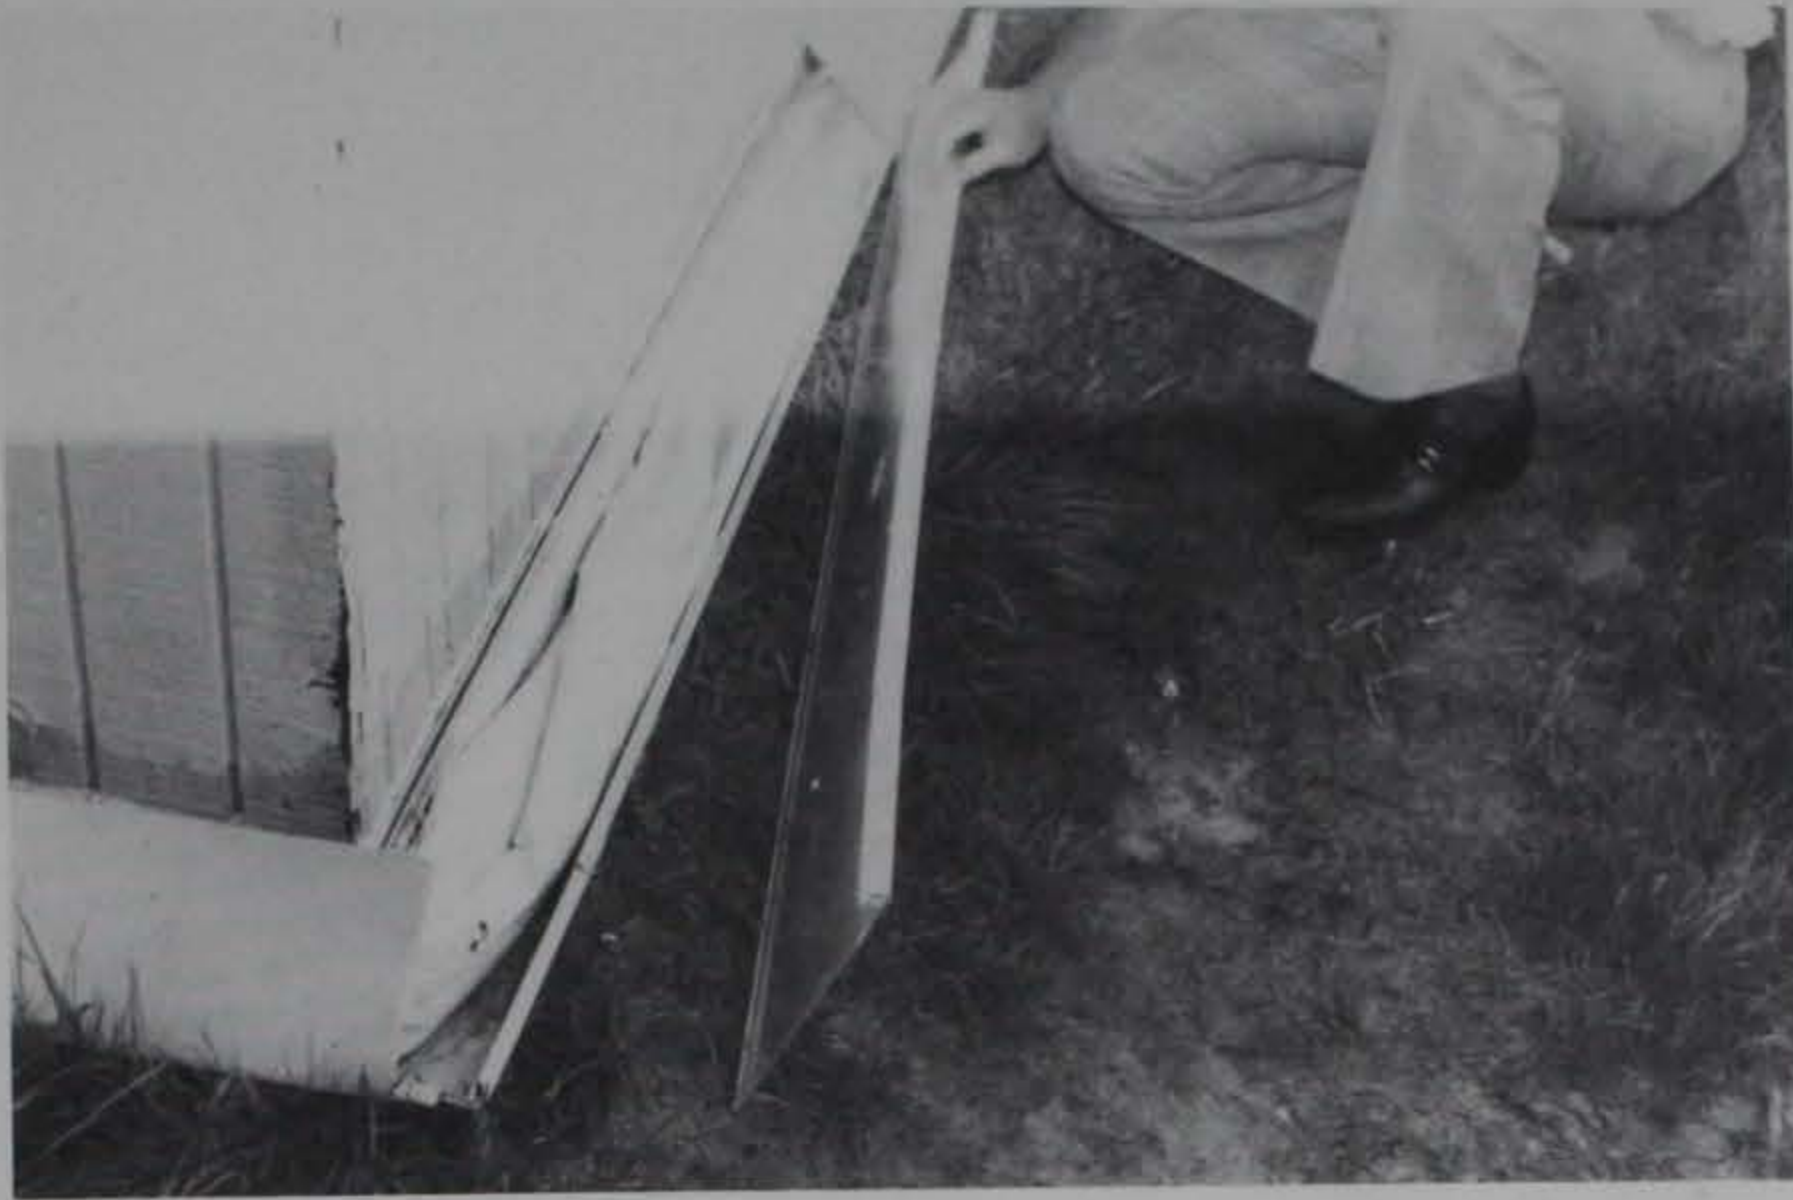
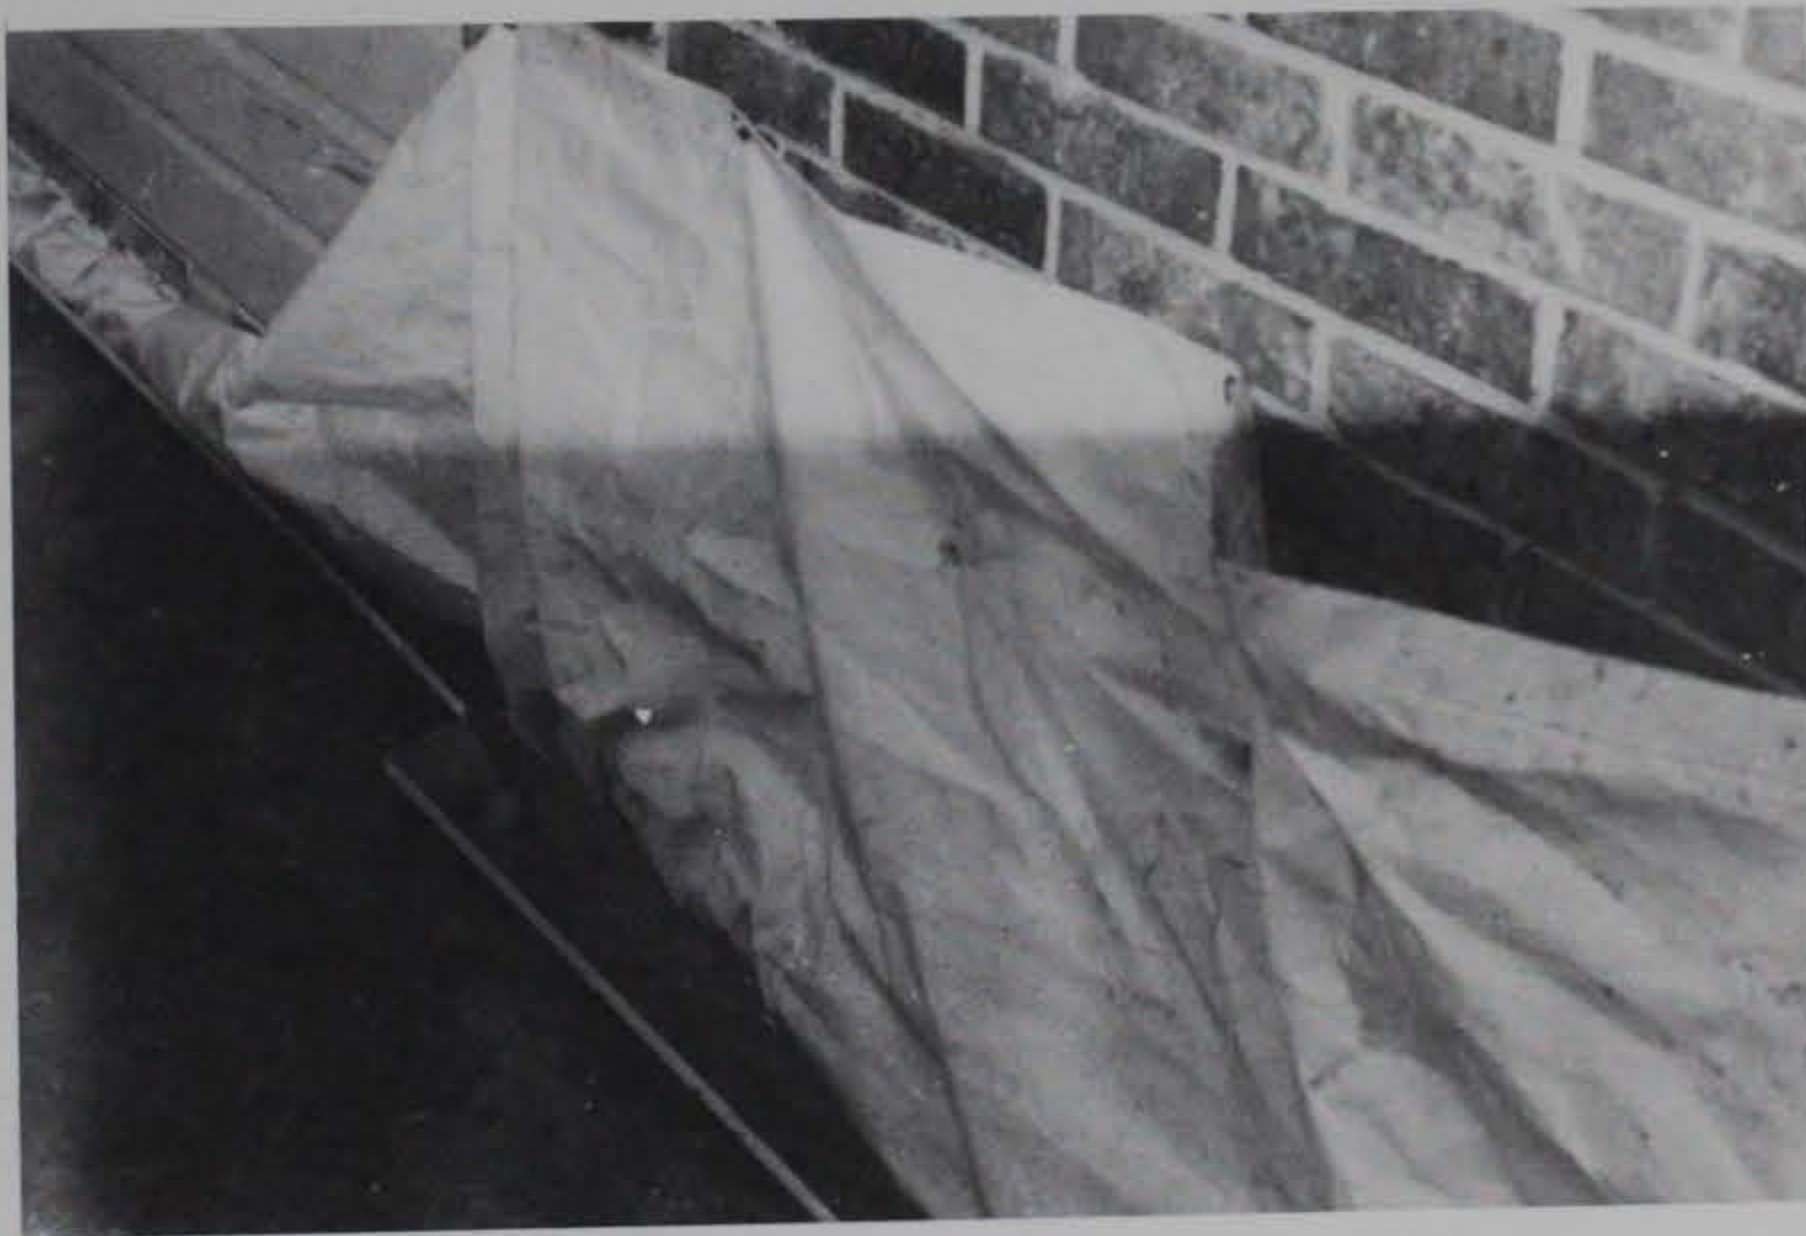
Figure 66. Flood-resistant system

a. Storage of waterproof membrane

b. Membrane being pulled up and connected to house
