Technical Report SL-94-24
November 1994

Shear Reinforcement in Deep Slabs

by Stanley C. Woodson

U.S. Army Corps of Engineers
Waterways Experiment Station
3909 Halls Ferry Road
Vicksburg, MS 39180-6199

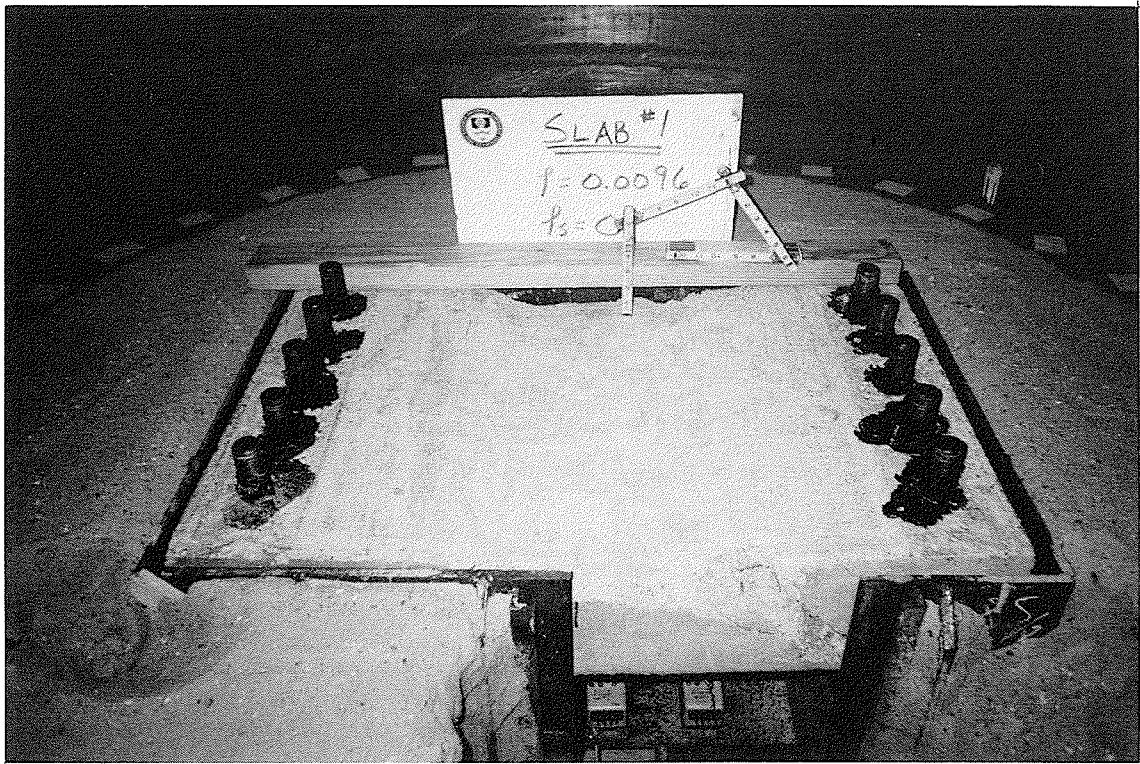
Figure 38. Posttest View of Slab No. 1

Posttest measurements and inspection provided a data check and damage assessment of each slab prior to removal from the reaction structure. Figures 38 through 50 show the posttest condition of each slab. Except for slab no. 4, Figures 38 through 50 show the slab immediately after removal of the neoprene membrane. For slab no. 4, Figure 41 shows the slab after removal from the reaction structure. Slab no. 4 was only slightly damaged and, therefore, could be safely removed from the reaction structure prior to photography. Figure 41 provides a better view of the side crack pattern than was allowed while the slab remained in the reaction structure.

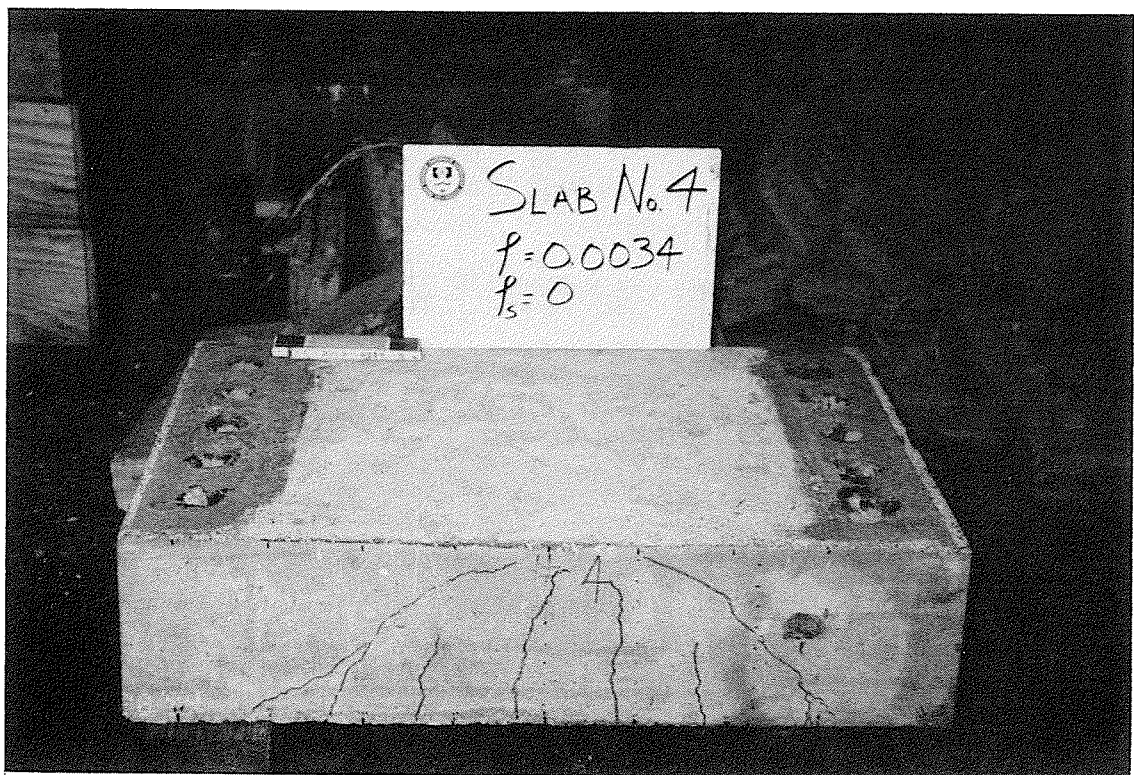
Figure 41. Posttest View of Slab No. 4

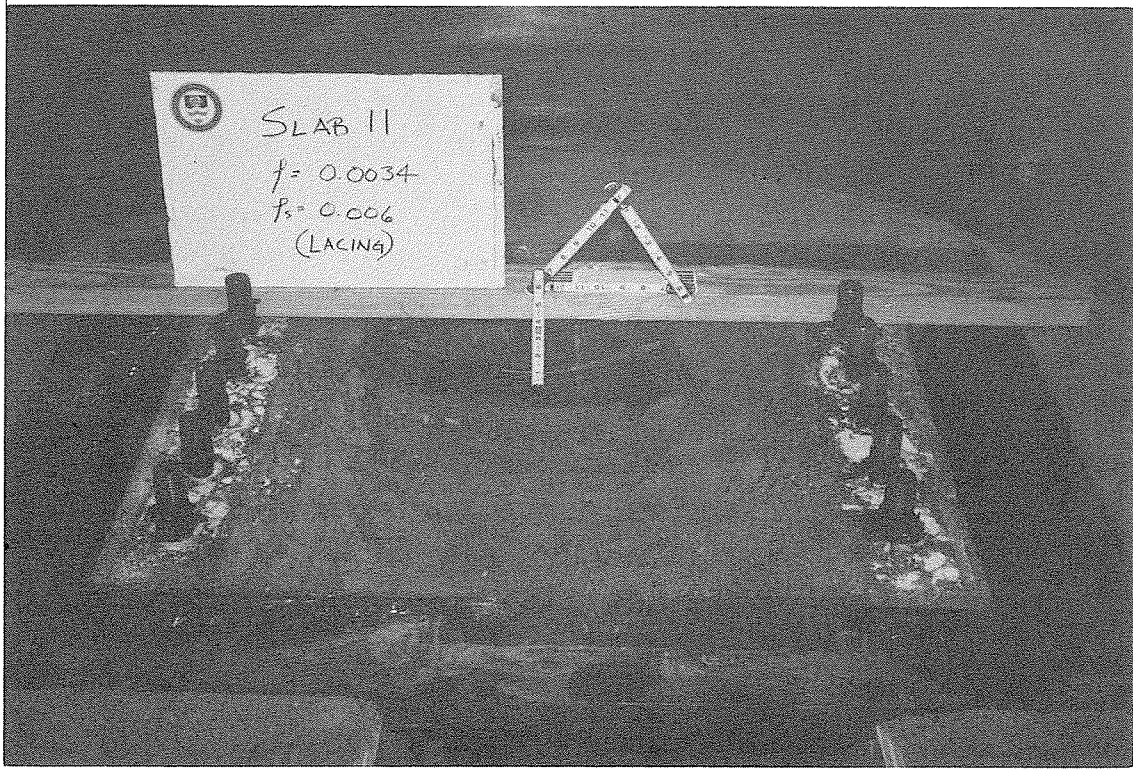
Figure 48. Posttest View of Slab No. 11

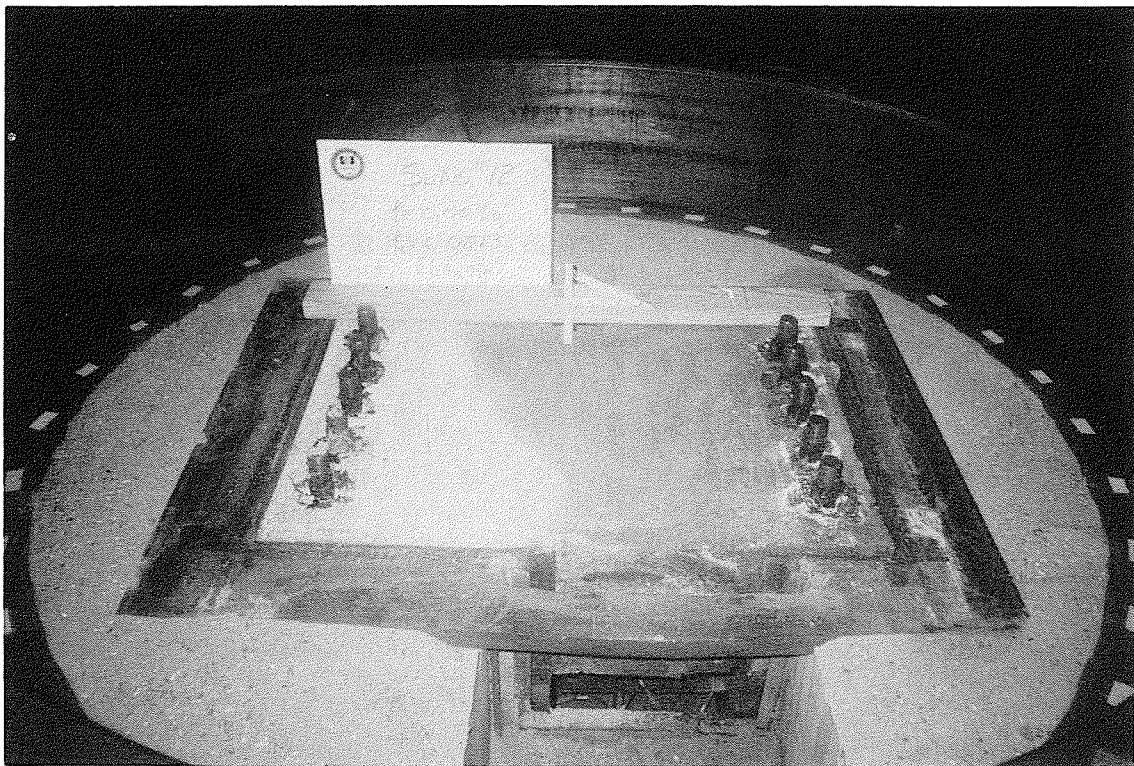
Figure 49. Posttest View of Slab No. 12
