MISCELLANEOUS PAPER C-78-13

# ALKALI-SILICA REACTION IN CONCRETE FROM THE NEW SAVANNAH BLUFF LOCK AND DAM, GEORGIA-SOUTH CAROLINA

Alan D. Buck

September 1978

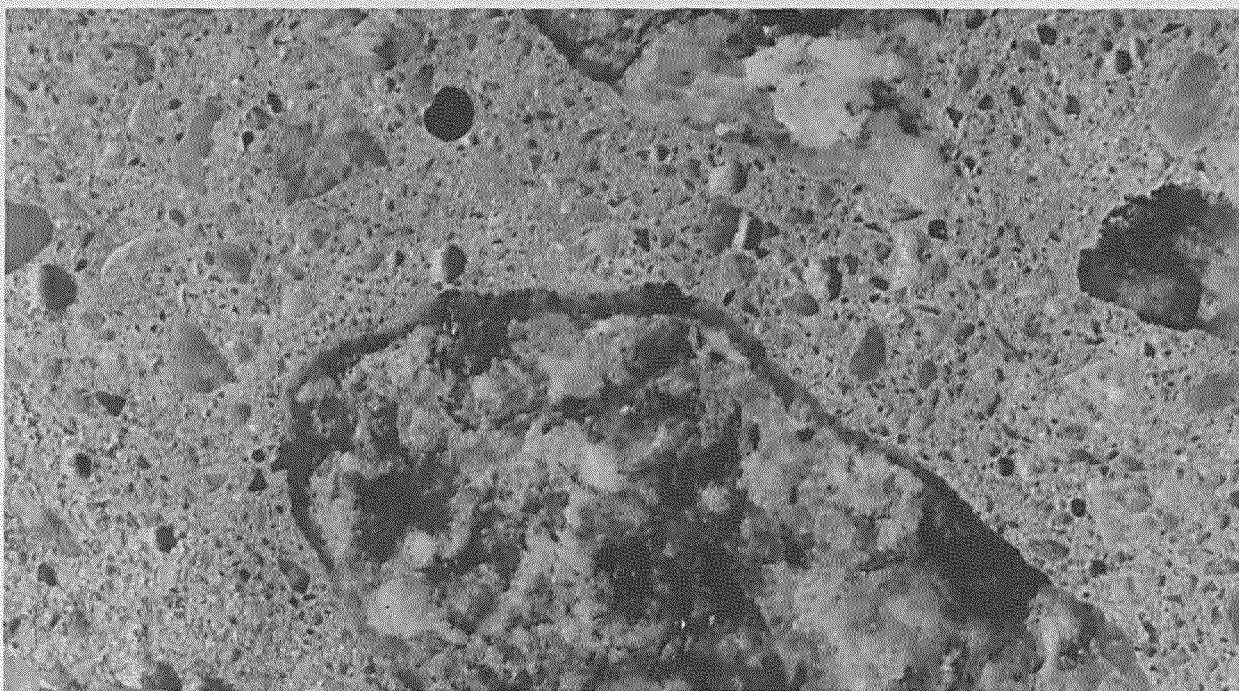
Photograph 2. Enlargement of granite gneiss particle on left side of core in Photograph 1, about 3.5X. The reaction rim is apparent.
