MISCELLANEOUS PAPER C-77-5

AN INVESTIGATION OF CONCRETE CONDITION, WILLIAM BACON OLIVER LOCK AND SPILLWAY

James E. McDonald, Roy L. Campbell

June 1977

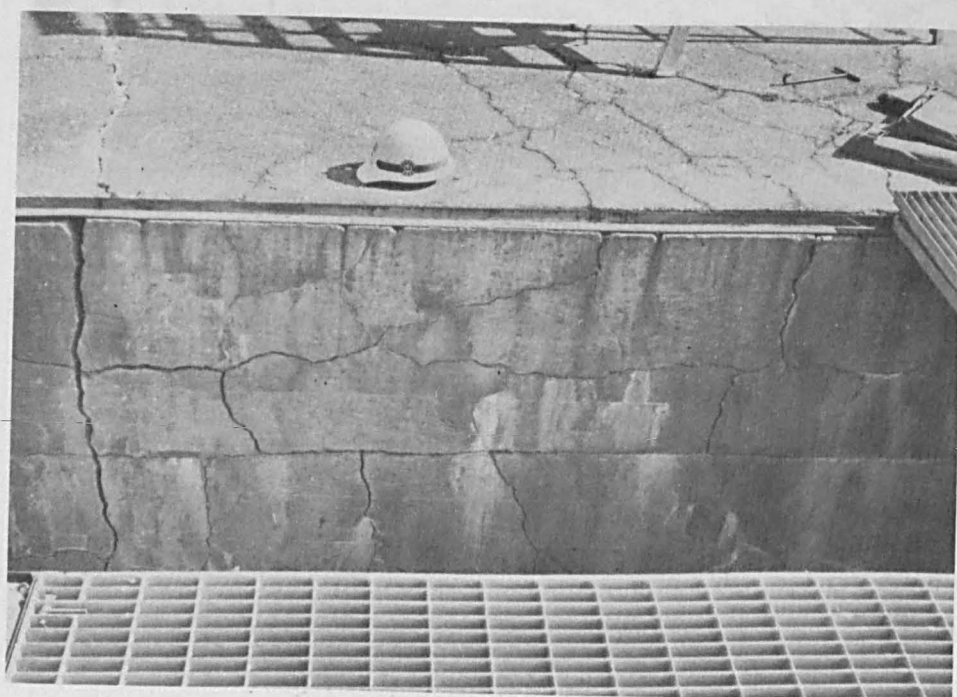
In general, monoliths cast entirely with concrete containing the higher alkali cement exhibited the most severe cracking. Of these, Monolith Nos. 8, 16, and 20 had the most extensive surface cracking (Figs. 11-18). Monolith No. 5 also had extensive cracking but slightly less severe than the other three monoliths (Figs. 19-20). While the number of cracks for a given surface area was comparable for all

Fig. 12 Cracking, Monolith No. 16.

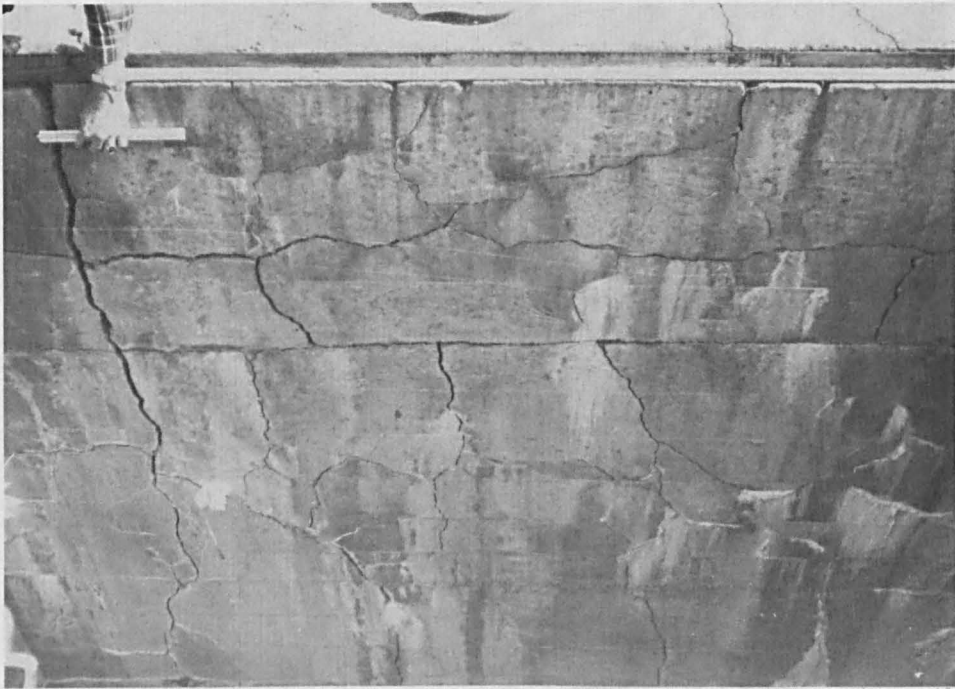
The intensity of surface cracking in the lock wall monoliths generally decreased with distance from the surface, and, for the most part, was limited to the upper 20 ft of the monoliths. Moisture and temperature conditions in these areas were probably more conducive to alkali-silica reaction. It should be noted that significant cracking was located in some instances at greater depths, particularly in the bulkhead recess, Monolith No. 16 (Fig. 13).

Fig. 13 Cracking in upstream face of bulkhead recess, Monolith No. 16.

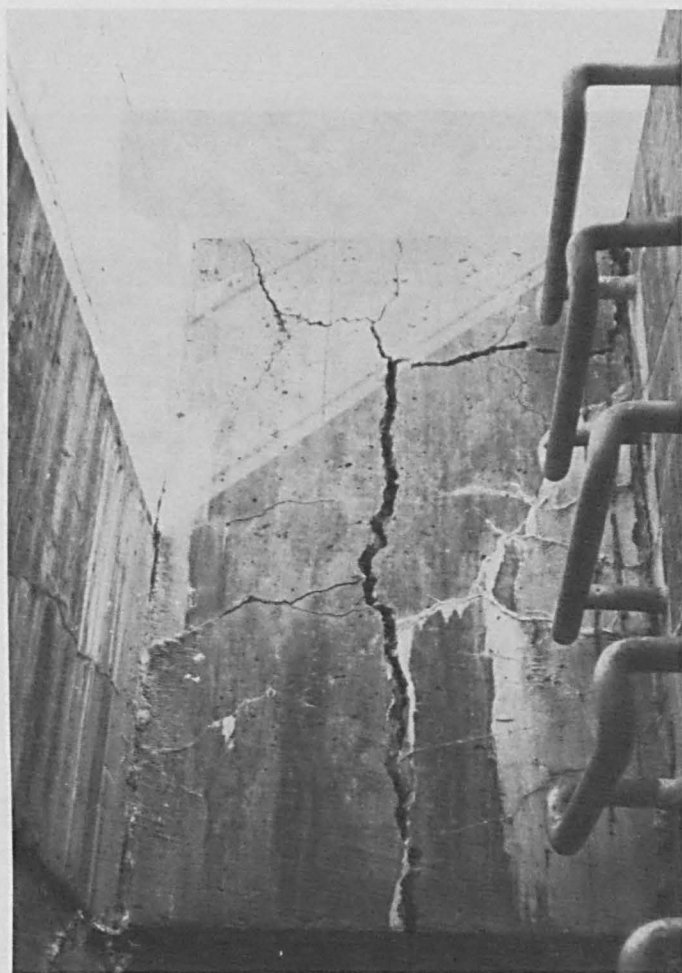
Fig 16 Cracking in Monolith No. 20 as seen from gallery looking upstream.

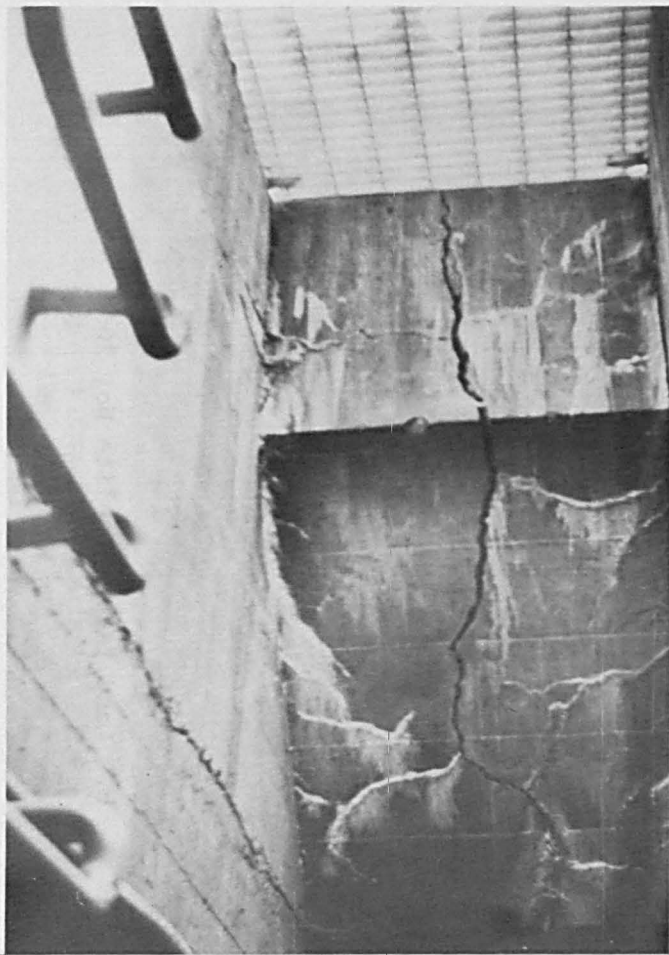
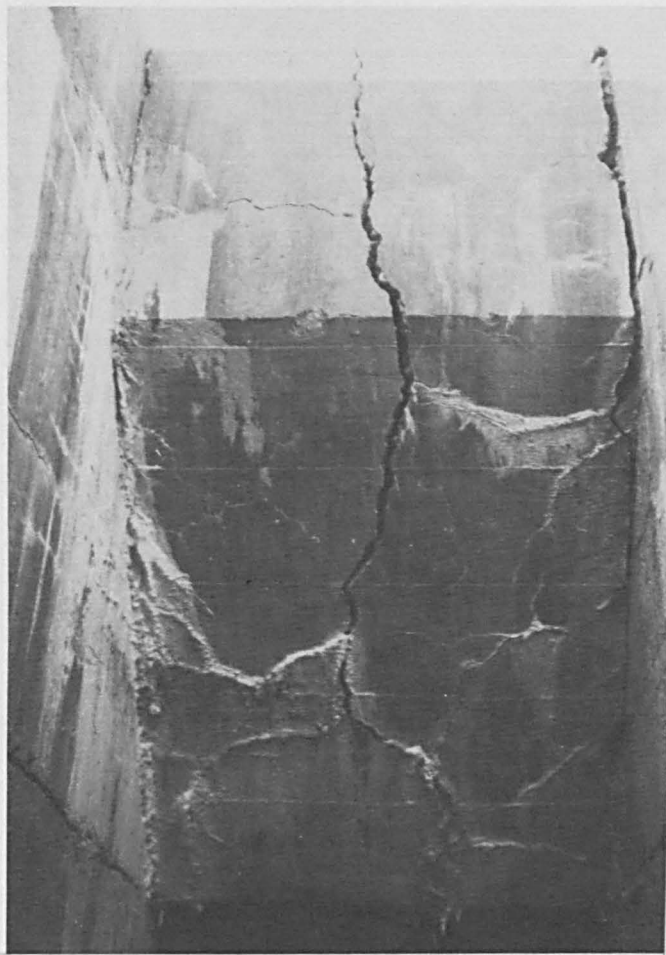
Fig 17 Cracking in Monolith No. 20 as seen from gallery looking downstream.

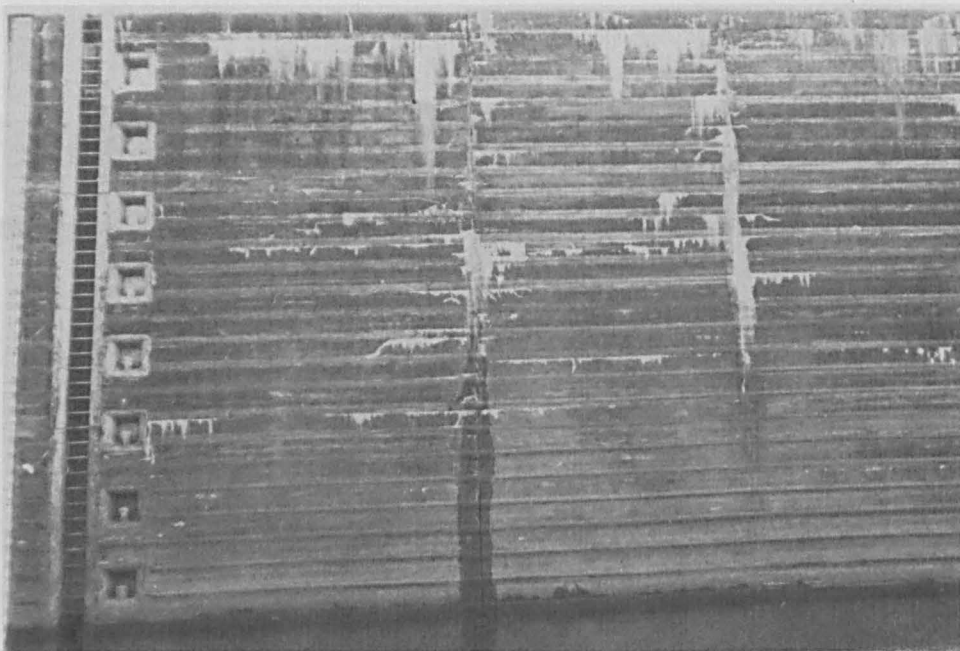
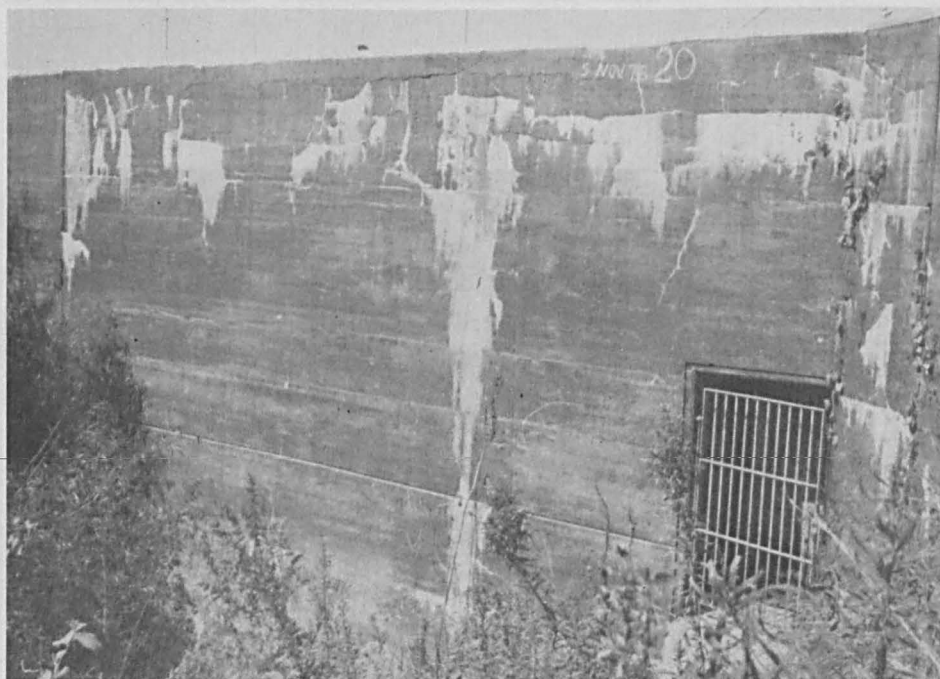
Fig. 18 Lower guide wall deterioration.

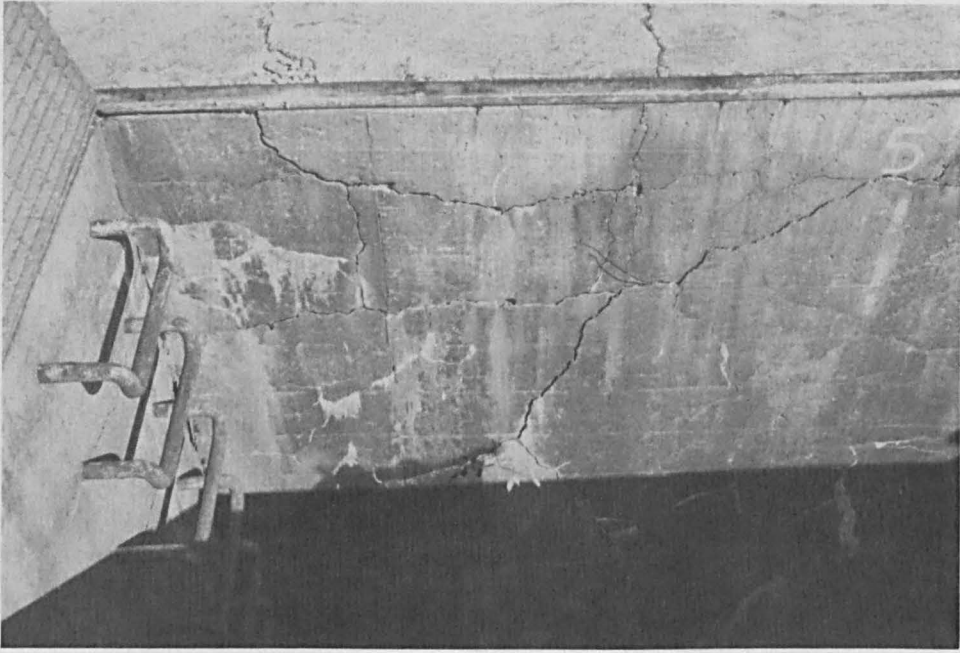
The upstream land wall gate monolith (No. 5) received particular attention during the condition survey because it had the most extensive surface cracking of the four gate monoliths and was built entirely with the higher-alkali cement. The current condition of surface cracking in selected areas is compared to the condition of the same areas in 1948 (Figs. 21-31). A number of the cracks located in 1948 are not evident currently; however, the major cracks appear to be slightly wider at present than they were in 1948. Also, there is surface spalling along the edges of the current cracks which was not apparent in 1948. It is suspected that most of these changes occurred during the period shortly after 1948, since the current inspection indicated almost all of the cracks have been inactive for some time. While differences in camera positions, focal distances, etc., make exact comparisons of crack conditions impossible, crack patterns and widths do not appear to have changed significantly during the past 28 years.

Fig. 20 Cracking in upstream face at bulkhead recess, Monolith No. 5.

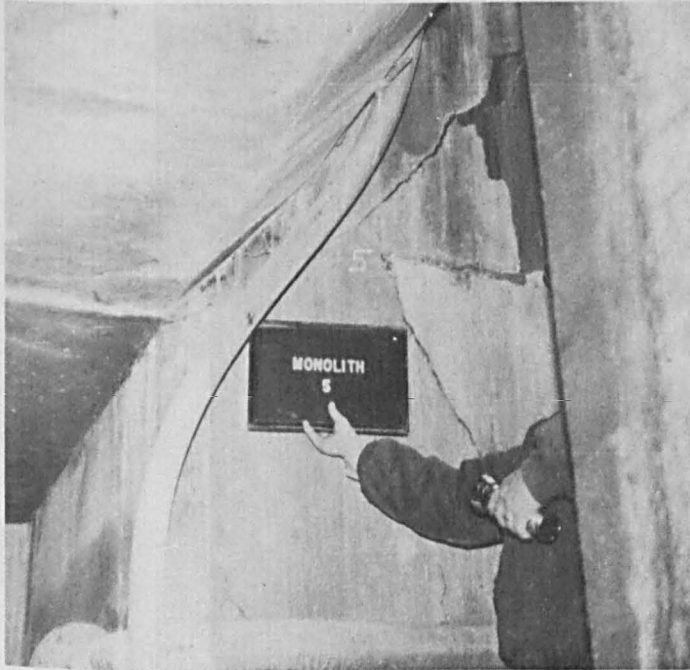
In general, cracking was less extensive in the inspection galleries than on the monolith surfaces. Examples of this type of cracking are shown in Fig. 35. Deposits of gel resulting from the alkali-silica reaction were evident on gallery surfaces within a number of monoliths (Fig. 36). There were only a very few instances, such as Monolith No. 13, where leaching appeared to be a current process.

Fig. 36 Examples of cracking in inspection galleries.

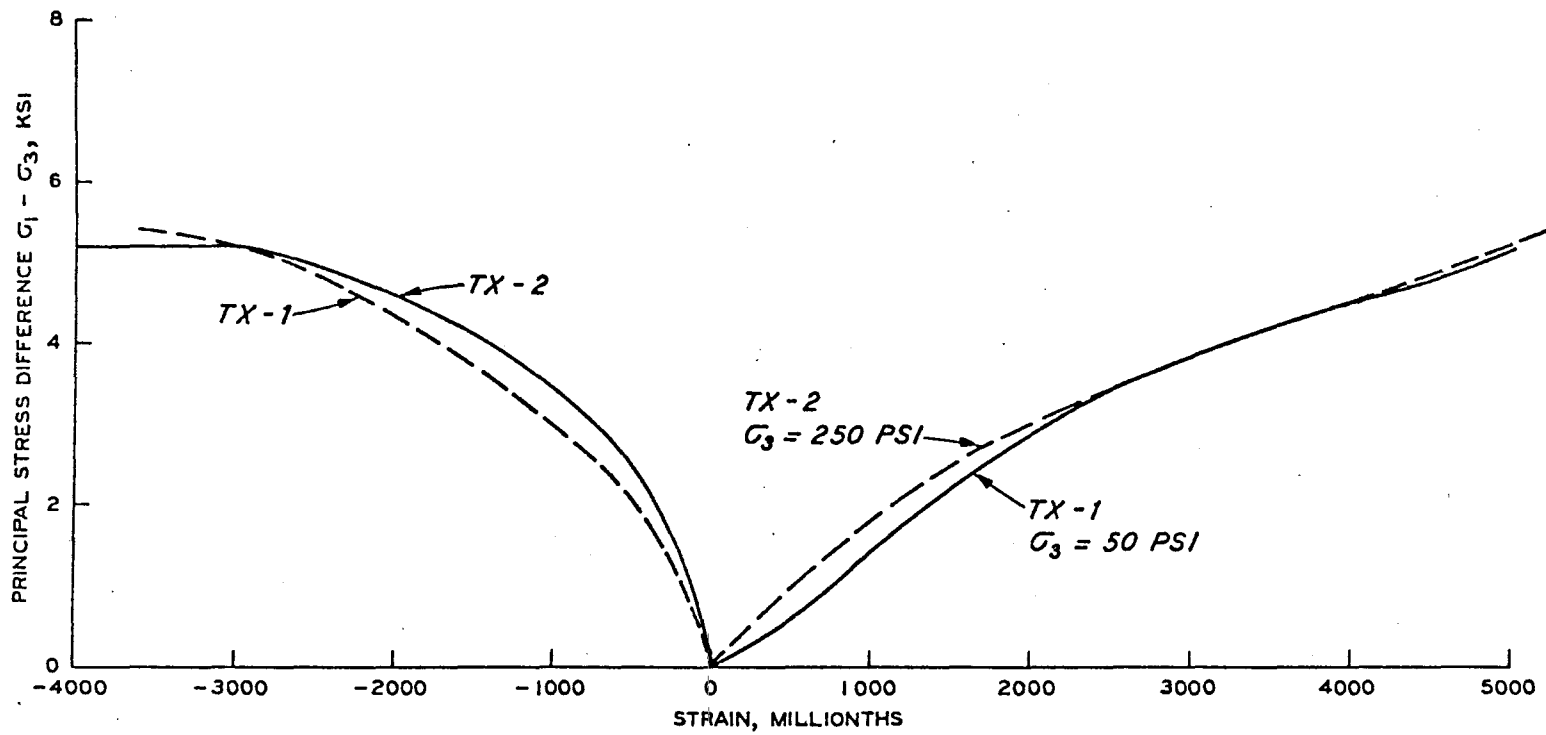
Figure 60. Triaxial test results, foundation cores, monolith No. 5.

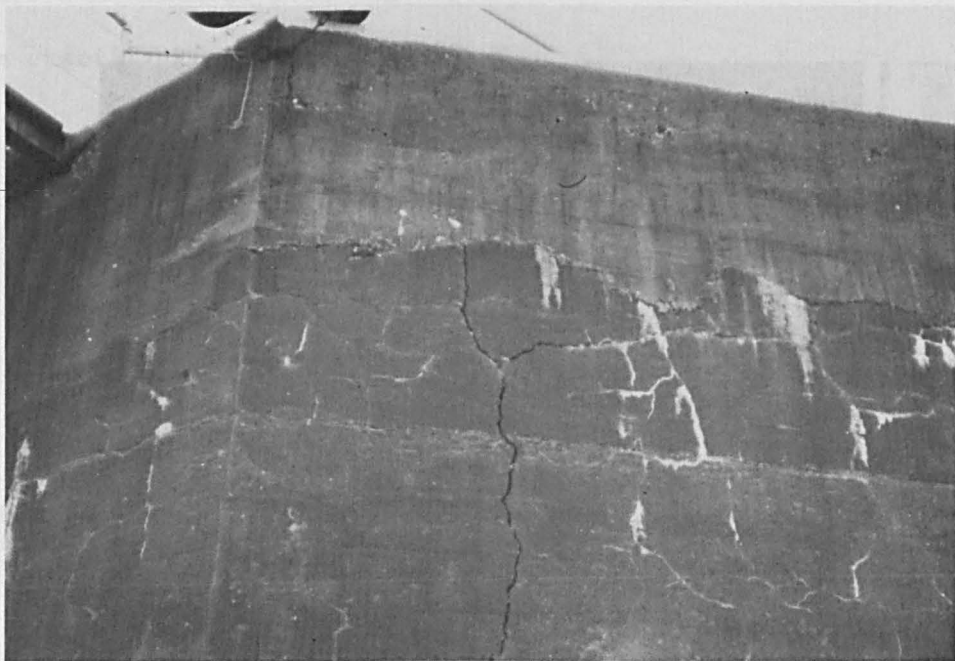
Fig. 78. Portions of Monolith No. 51 repair after approximately 20 years.

Extensive repairs and/or rehabilitation of the existing 460-ft lock chamber do not appear necessary at the present. Specific points identified through continuing systematic inspections as requiring maintenance would be exceptions. In such cases a procedure similar to that previously employed to repair a portion of Monolith No. 51 is recommended (Fig. 77). This procedure involves removing approximately 1-3 ft of surface concrete, depending on the extent of deterioration, and replacing it with a new reinforced concrete cap block. After 20 years the repair to Monolith No. 51 exhibits only two small cracks, despite significant cracking in the unrepaired portion of the monolith (Fig. 78). The difficulty involved in arresting a propagating crack should be recognized; and the fact that the repair has a minimum of cracking may be further evidence of chemical reaction stabilization as much as 20 years ago.

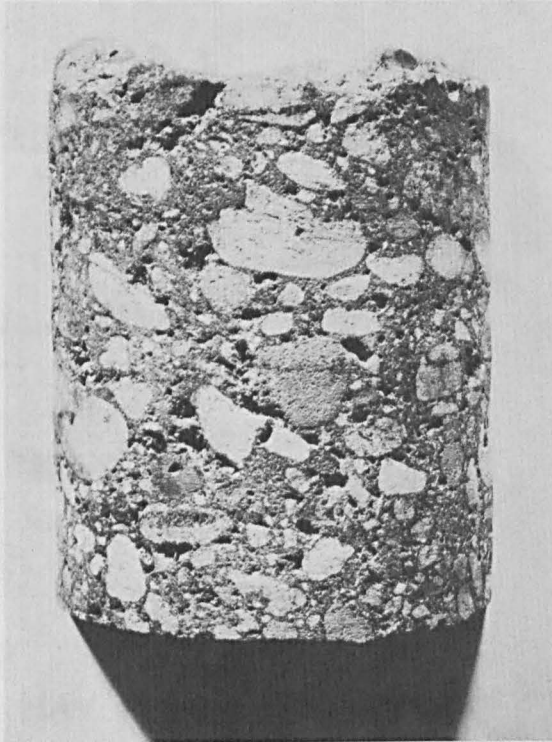
CONCRETE WITH NUMEROUS LARGE VOIDS, DEPTH ABOUT 33 FT., CORE 5-1. THE SURFACE IS TYPICAL OF THE CORE FROM 14.5 FT. TO 39.6 FT. DIRECTION OF PLACEMENT TOWARDS BOTTOM OF PHOTOGRAPH. THE VOIDS ARE MORE FREQUENT ADJACENT TO COARSE AGGREGATE PARTICLES.

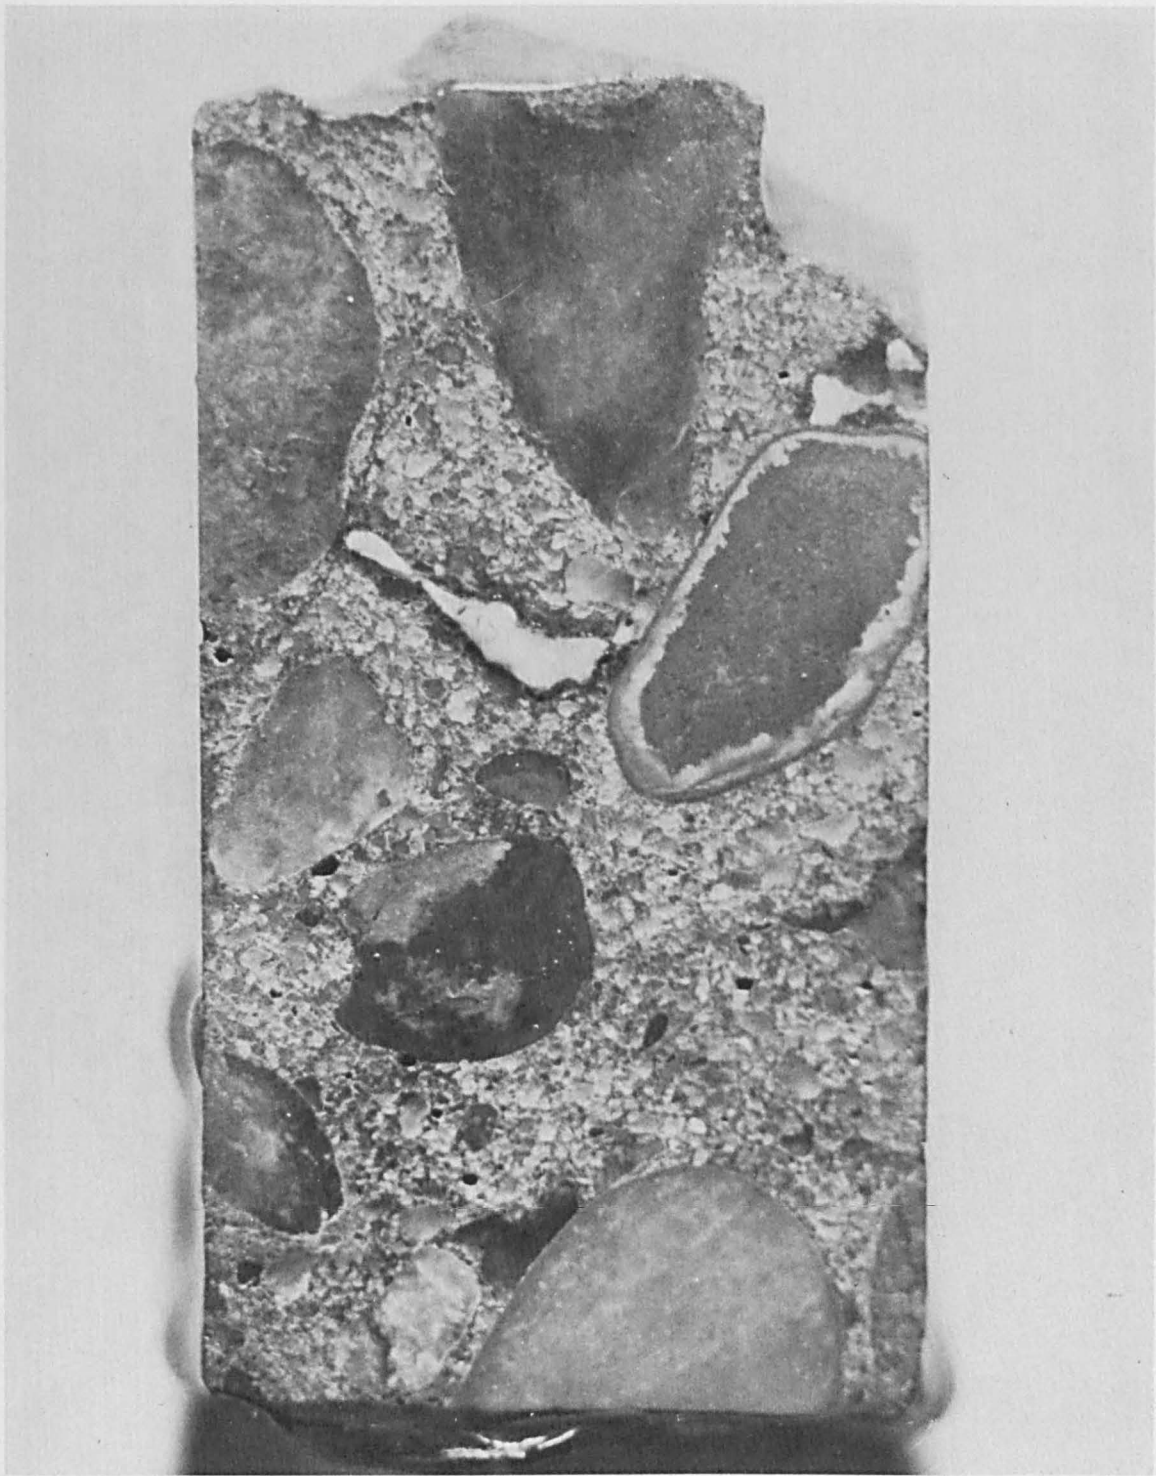
THIN SECTION BLANK IMPREGNATED WITH RESIN, GROUND, EXPOSED TO WARM HUMID AIR FOR ABOUT 36 HRS. MAGNIFICATION 4X, PHOTOGRAPHED ABOUT 23 AUGUST 1949. TWO LARGE GEL POCKETS (UPPER RIGHT AND UPPER CENTER) HAD TAKEN UP MOISTURE AND SWELLED. THE CHALCEDONIC PEBBLE (LOWER LEFT CENTER) HAD TAKEN UP MOISTURE, AND THERE WAS A WET SPOT ON A SAND GRAIN AT THE LOWER LEFT.

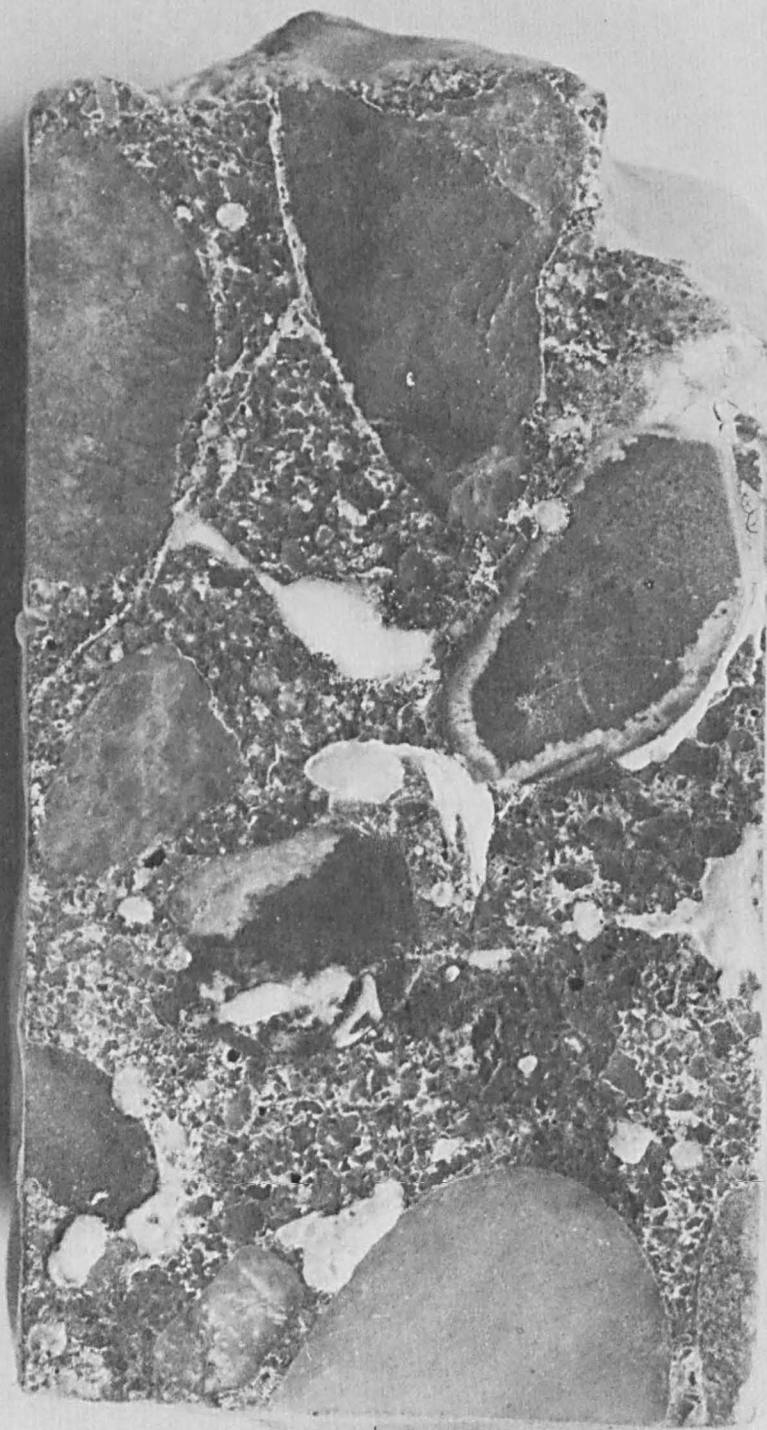
SAME SPECIMEN AFTER STORAGE OVER WATER AT ROOM TEMPERATURE BETWEEN 24 AUGUST 1949 AND 18 OCTOBER 1949. THE GEL POCKETS SHOWN IN THE PREVIOUS PHOTOGRAPH HAVE ENLARGED; MANY MORE HAVE APPEARED; CRACKS WHICH WERE NOT OBVIOUS BEFORE ARE NOW TRACED IN REACTION PRODUCT.
