Environmental Monitoring and Performance Evaluation of Roller- Compacted Concrete Pavement Conley Terminal, Boston, Massachusetts

Special Report 91-25

**U.S. Army Corps
of Engineers**
Cold Regions Research &
Engineering Laboratory

Prepared for
OFFICE OF THE CHIEF OF ENGINEERS

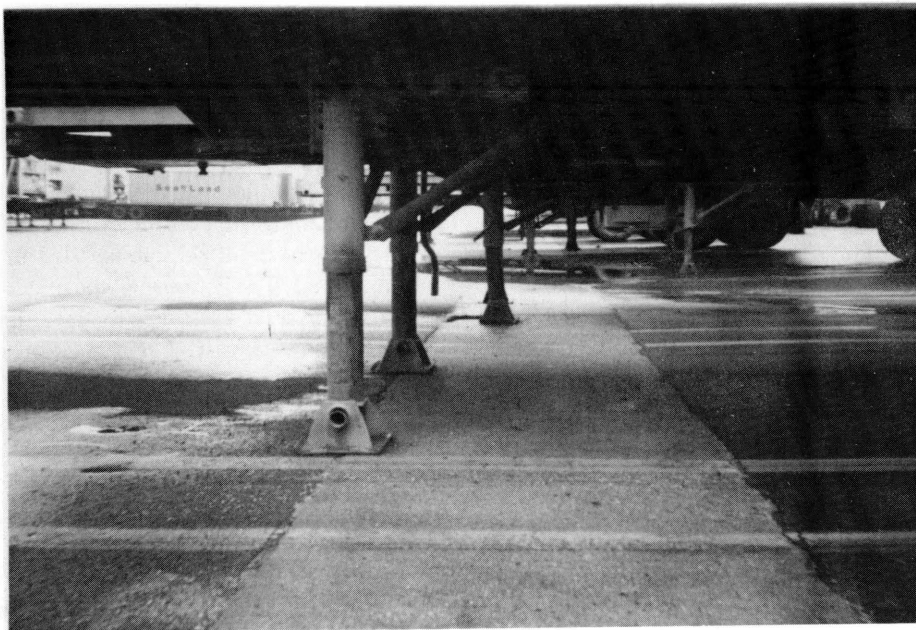
Figure 2. PCC strip in asphalt pavement.

The Paul W. Conley Terminal, a shipyard owned by the Massachusetts Port Authority, is located at Castle Island, South Boston, Massachusetts (Fig. 1). The pavement at Conley Terminal is used for short-term storage of heavy freight containers mounted on trailer beds. The heavy load of the containers is typically transferred to the pavement through a tire tandem and two steel shoes. In the past, asphalt pavement was used because of its lower construction cost, but it did not last long enough. The load that is concentrated at each steel shoe was commonly large enough to cause the steel shoe to penetrate the asphalt pavement, leading to premature deterioration. One way of solving the problem was by using wood blocks under the steel shoes to distribute the load onto a larger area. This solution proved to be difficult to implement because it required the cooperation of every truck driver using the facility, increased the need for supervision and slowed down the operations. A second approach was to cast a strip of PCC at the expected location of the steel shoes, and to pave the rest of the area with flexible pavement. This option was tried at Conley but did not work as expected because the drivers frequently placed the steel shoes at the

asphalt-PCC joints or totally on the asphalt pavement (Fig. 2), which led to joint and asphalt pavement damage.

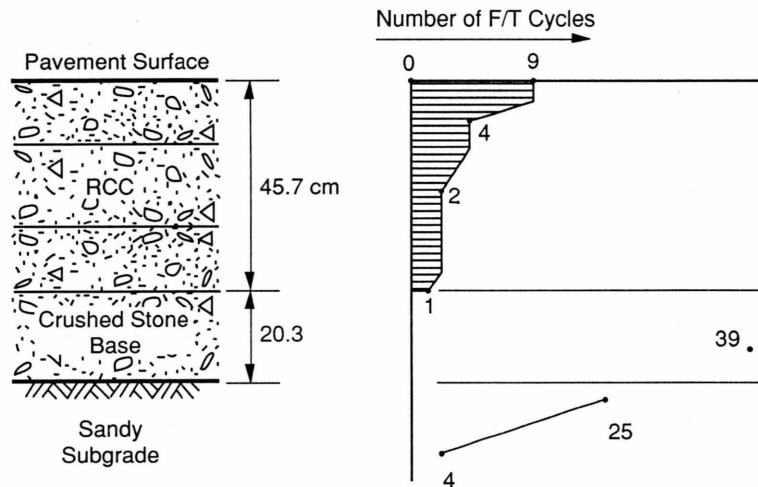
Figure 4. Conley RCC pavement freeze-thaw cycle profile, 1989-90 winter. (The number of freeze-thaw cycles in the air was 61.)

Figure 4 shows a profile of the number of F/T cycles

that occurred at several depths through the RCC slab, the base course and the subgrade. Notice that while 61 F/T cycles were recorded in the air, only nine cycles occurred at 3 mm below the pavement upper surface.

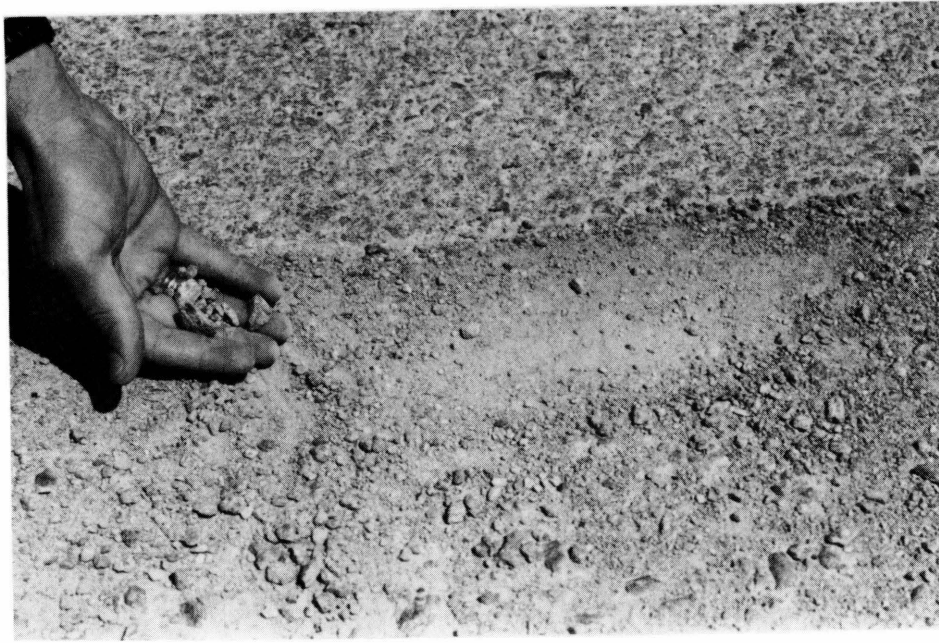
Figure 5. Loose pavement material at the vicinity of cold joints when opened to traffic.

As stated earlier, the Conley RCC pavement was constructed in two construction seasons. In both instances, the pavement was open to traffic one month after construction. At those times, no major distress was identified. Shrinkage cracks occurred naturally at intervals between 15–23 m (49–75 ft) along the pavement lanes. Fine cracks also developed along the construction joints between lanes. No joint was saw cut on this project. The width of the cracks ranged from 0.5 to 2 mm (0.020 to 0.079 in.). The surface texture was relatively rough and apparently sound. However, we observed that at the vicinity of the cold joints (i.e., the longitudinal construction joints between lanes where the last lane was placed 60 min or more later than the adjacent lane),

there was a substantial quantity of loose material on the surface (Fig. 5). The loose material was always located on the side of the lane that was placed first.

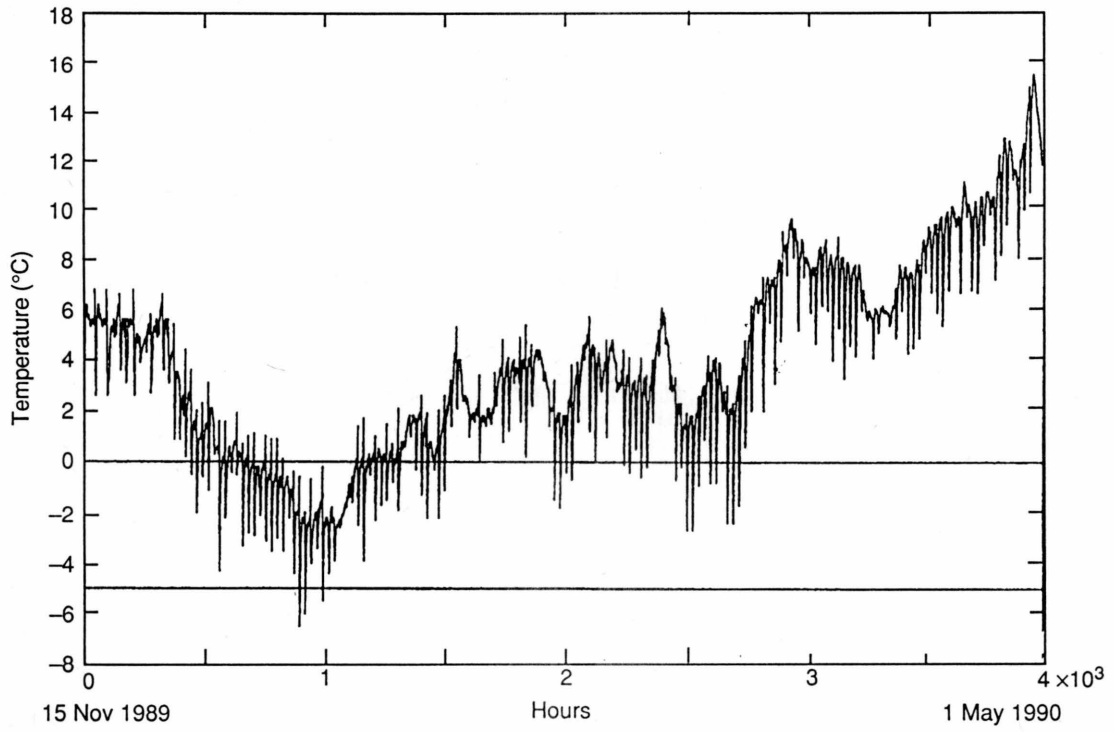
Figures A3-A7 show the temperatures and number of F/T cycles at several depths inside the concrete during the mentioned winter. Figure A8 shows data from a temperature sensor embedded in the concrete at only 6 mm above the RCC/base interface. Only one F/T cycle was recorded at this point during the 1989-90 winter. Figure A9 shows data from a sensor embedded in the crushed-stone base course. For the moisture inside a granular soil, a F/T cycle occurs when the temperature falls below -0.5°C , and then rises to above 0°C . Thirty-nine F/T cycles were recorded at this point during the mentioned winter.

A8. Pavement temperature at the bottom of the RCC slab.
