Technical Report CERC-95-12  
August 1995

# Reef Breakwater Wave-Attenuation and Stability Tests, Burns Waterway Harbor, Indiana

by Robert D. Carver, Brenda J. Wright

Prepared for U.S. Army Engineer District, Chicago

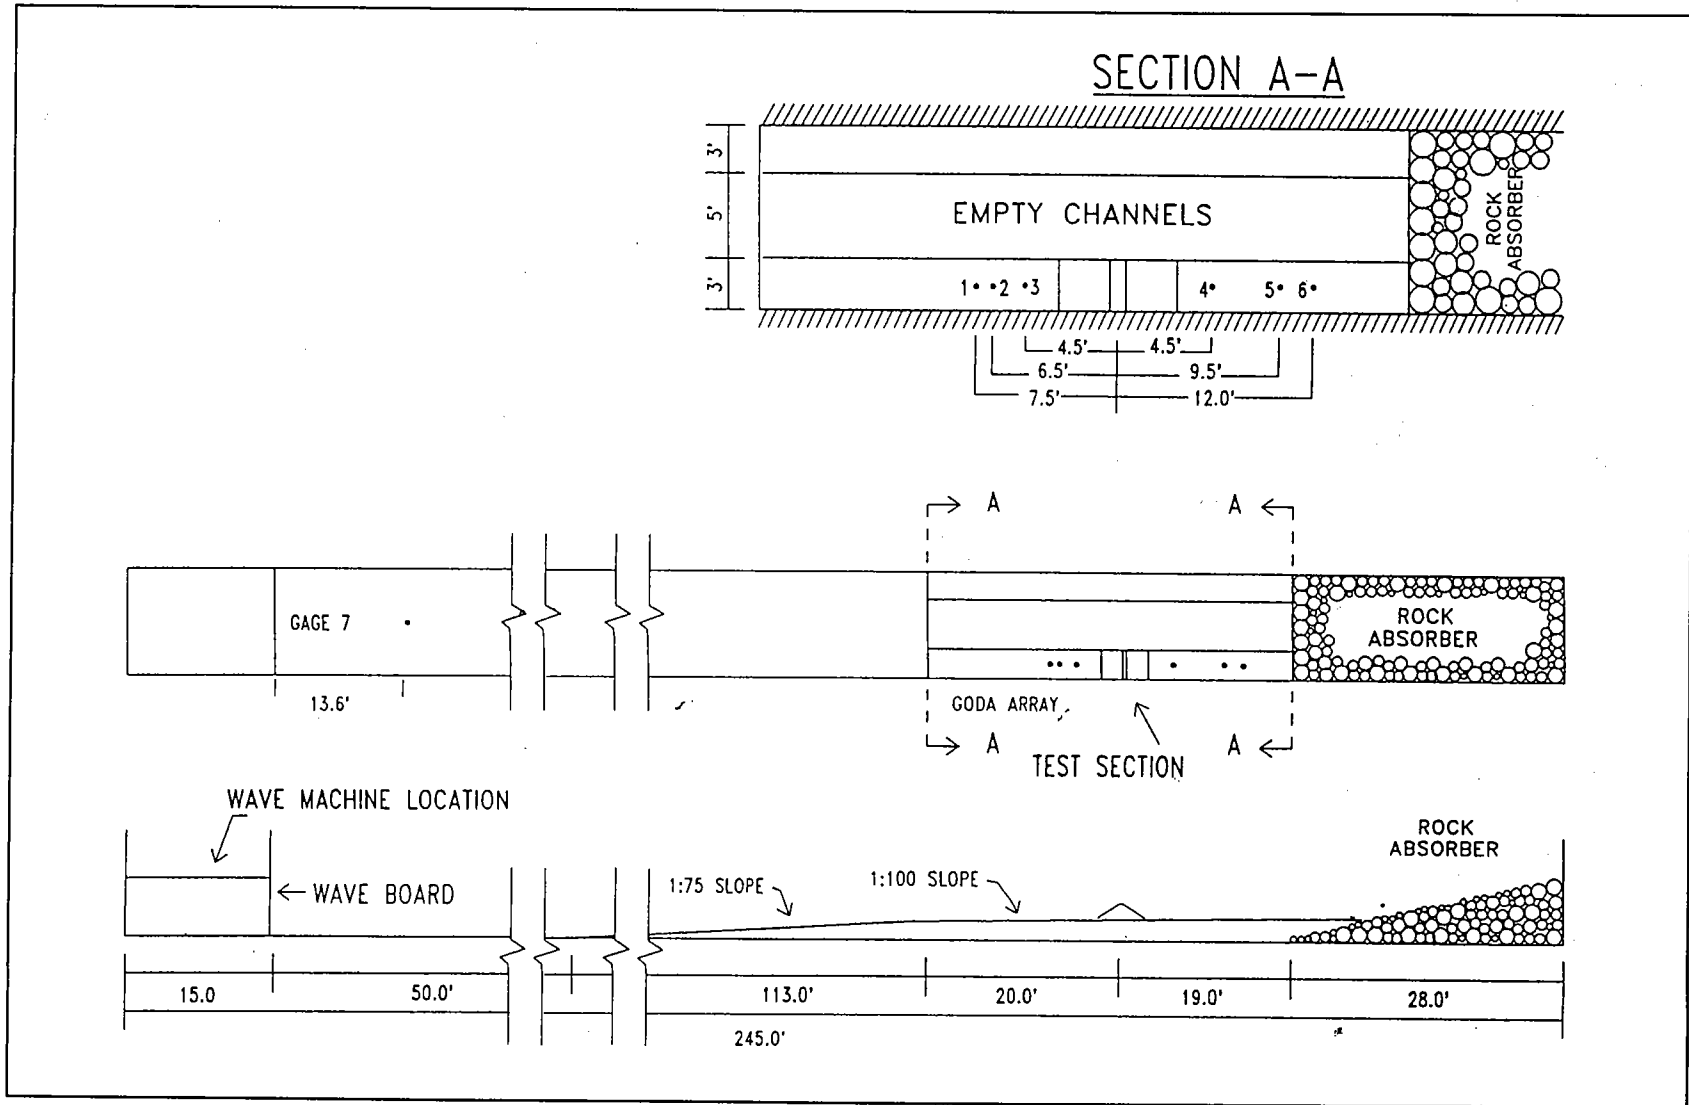
All tests were conducted in a 3-ft-wide portion of a concrete wave flume 11 ft wide and 245 ft long (Figure 2). A 1V:100H slope, representative of the existing prototype lake bottom, was molded lakeward of the test section. Irregular waves were generated by a hydraulically actuated piston-type wave machine.

Figure 2. Wave tank cross section

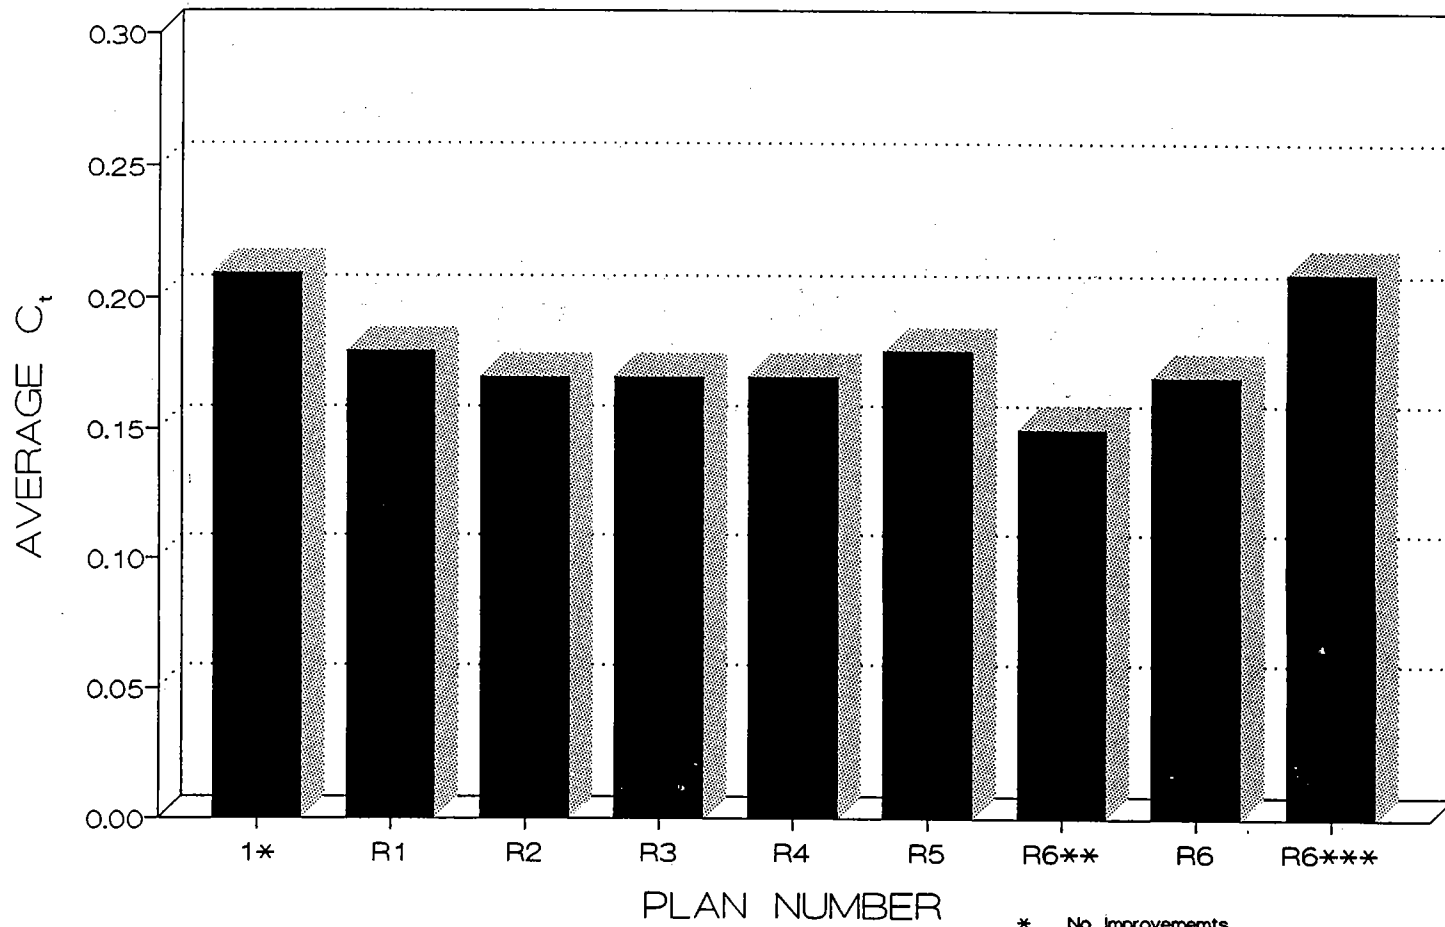
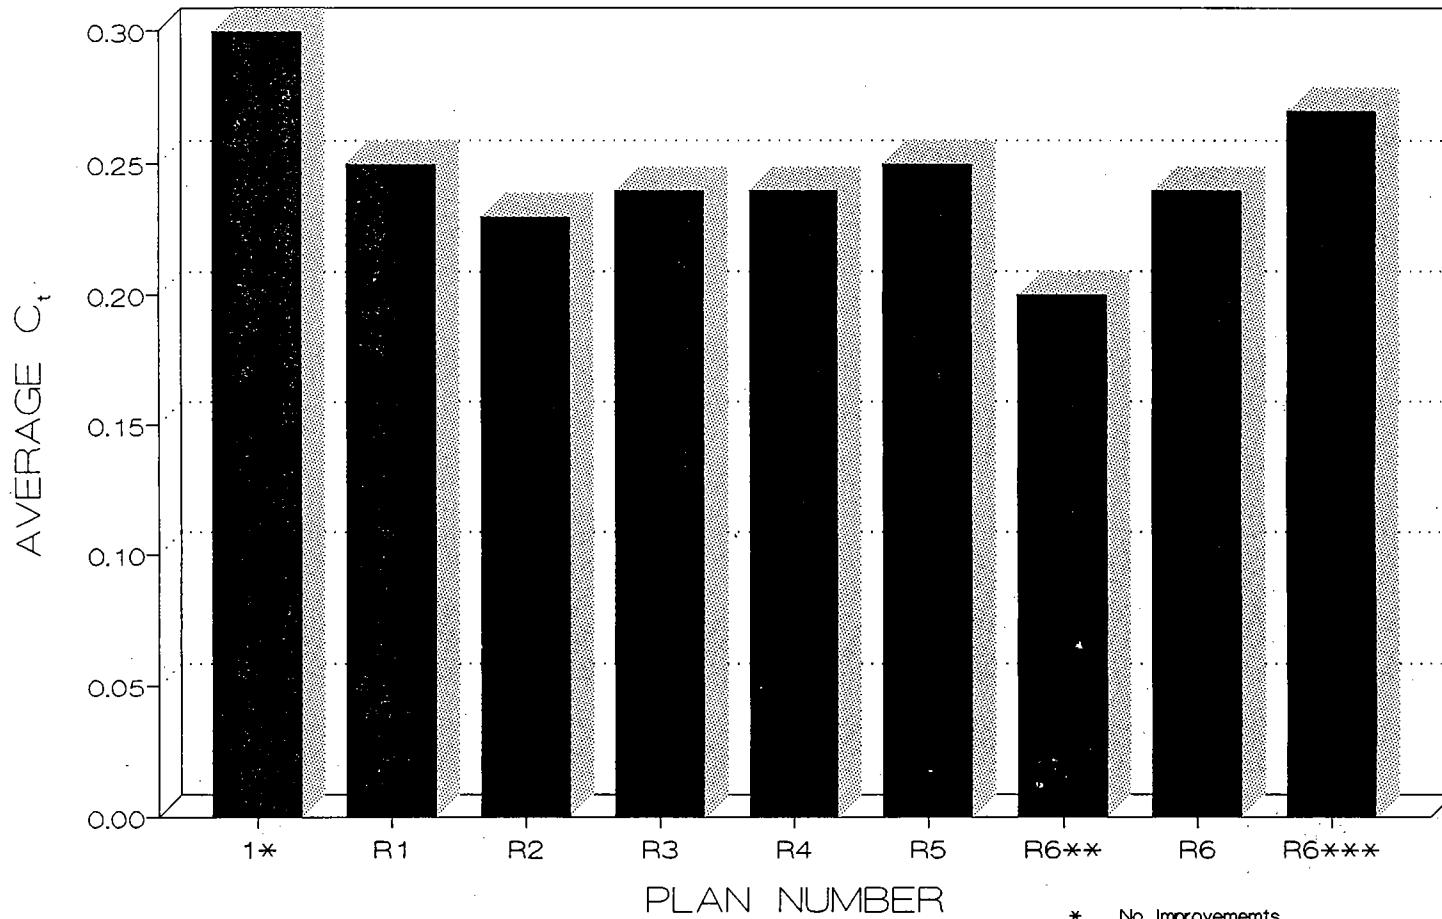
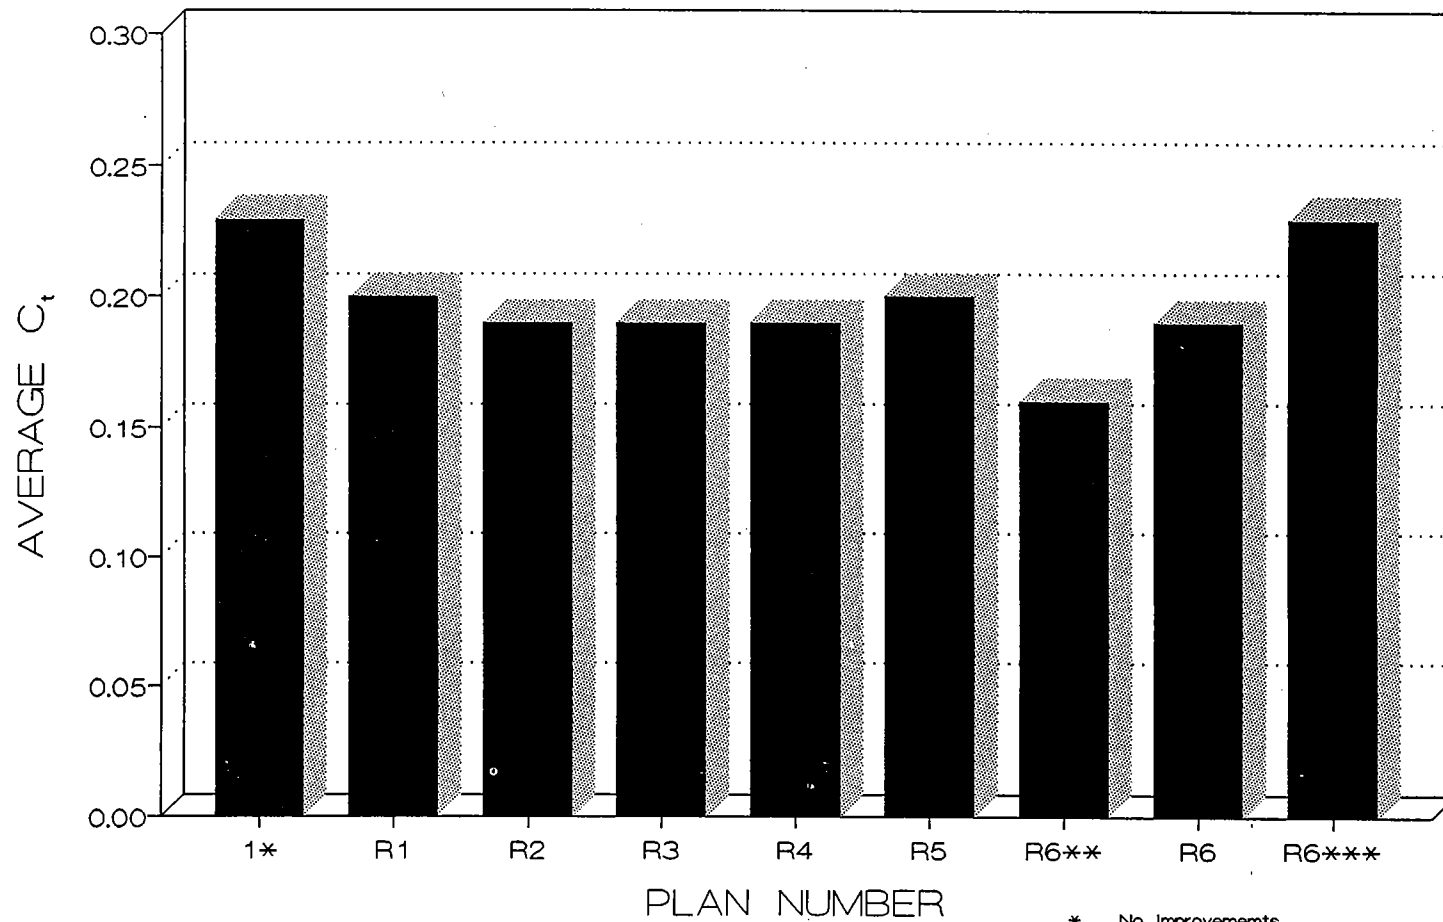
The data in the previous table, graphically presented in Figures 21-24, show that Plans R2, R3, R4, and R6 yielded similar results. Plan R5, the same as Plan R4 except the toe-to-toe spacing from the existing breakwater was increased from 75 to 100 ft, produced slightly larger transmitted wave heights than were observed for Plan R4.

Figure 21. Average values of  $C_t$ ; 7-sec wave period

Figure 22. Average values of  $C_t$ ; 9-sec wave period:

Figure 23. Average values of  $C_t$ ; 11.6-sec wave period.

Figure 24. Average values of  $C_t$ ; all wave periods

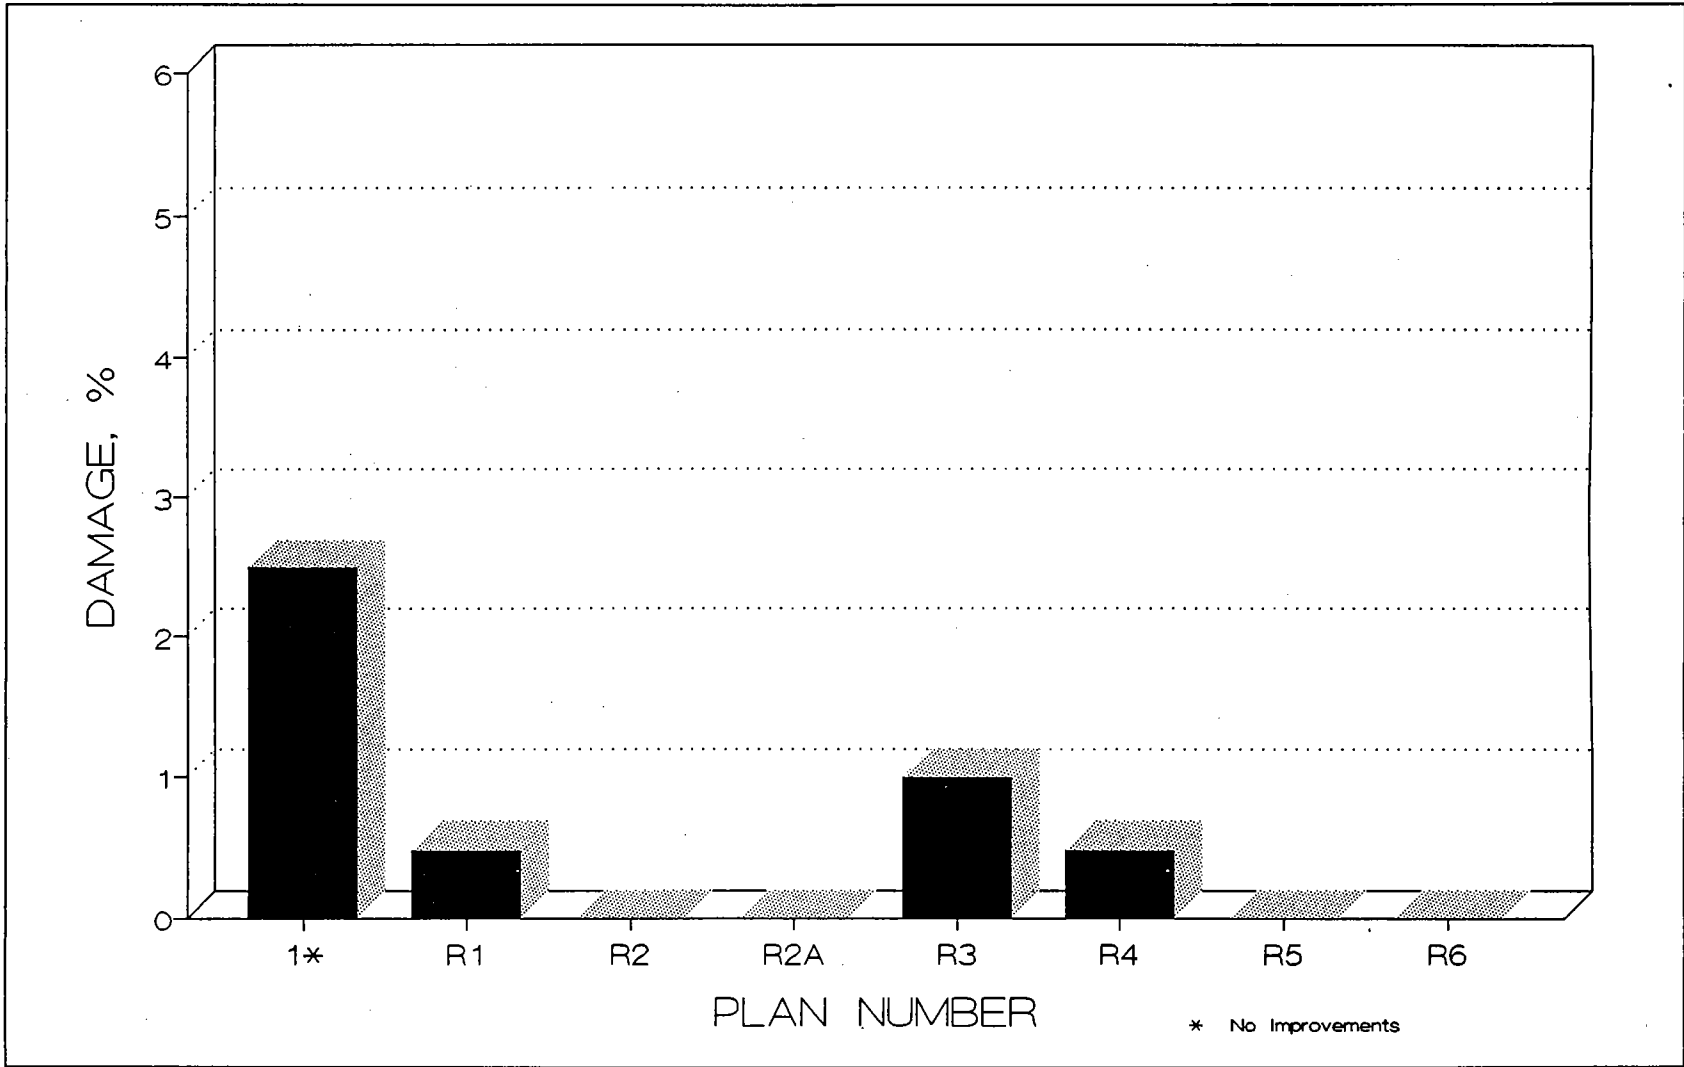
Lakeside and harbor-side damages are also presented in Figures 25 and 26. These data show that all improvement plans reduced damages to an acceptable level, i.e., 2 percent or less by number of the primary armor stone placed.

Figure 25. Percent damage incurred by lakeside armor

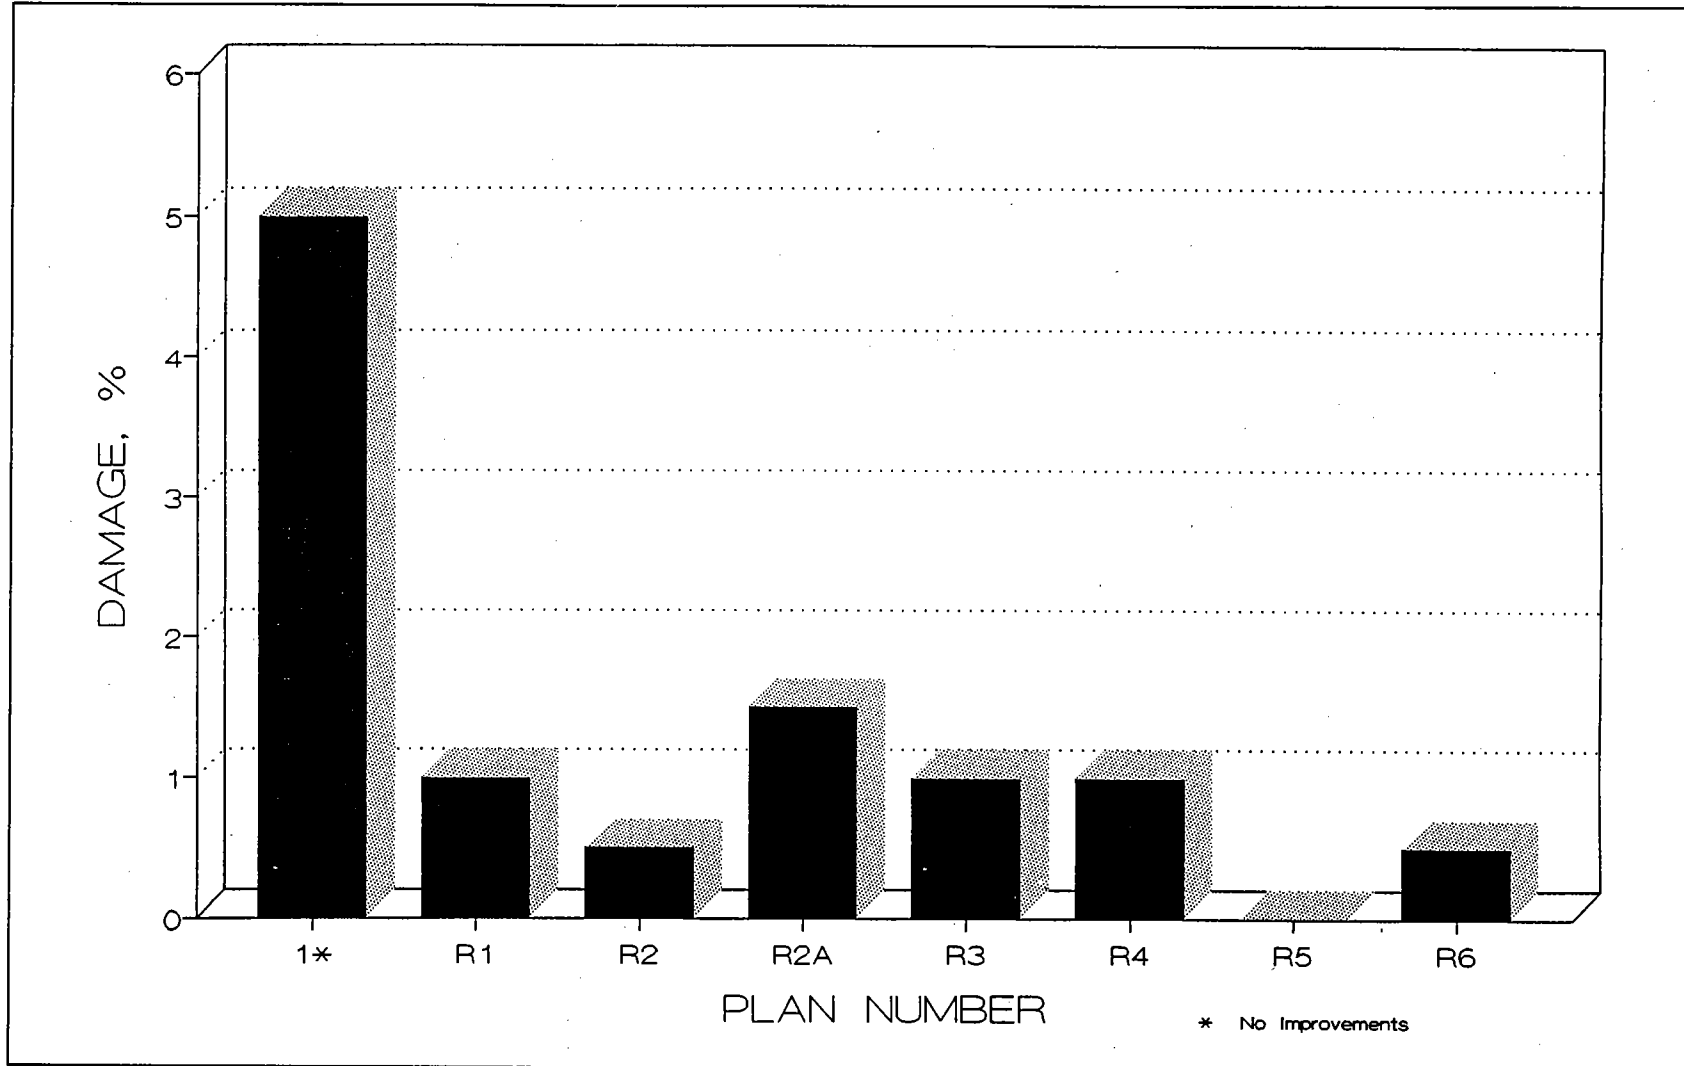
Figure 26. Percent damage incurred by harbor-side armor

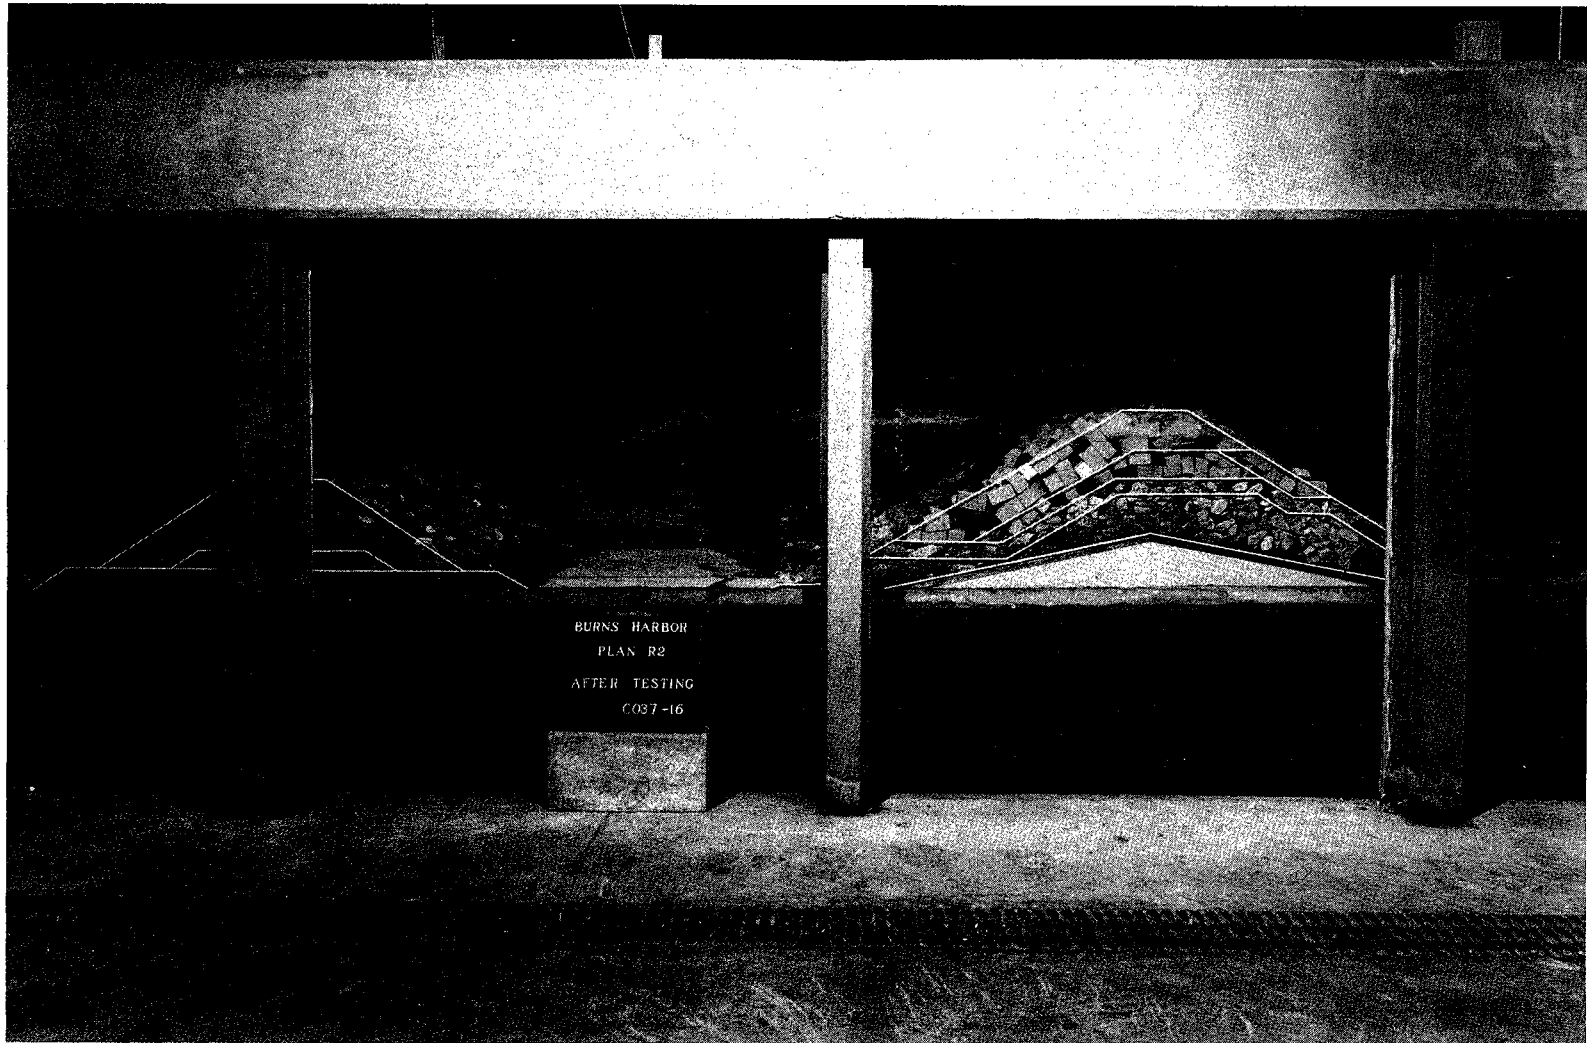
As shown above and in Figure 9, Plan R2 yielded results similar to Plan R1 for the lower wave heights and improved performance for the larger wave heights. The reef was stable (Photo 5) and stability of the existing breakwater was acceptable (Photo 6) with a few armor stones displaced from the harbor side.

Photo 5. End view of Plan R2 after wave attack

Photo 6. End view of Plan R2 (reef and existing breakwater) after wave attack

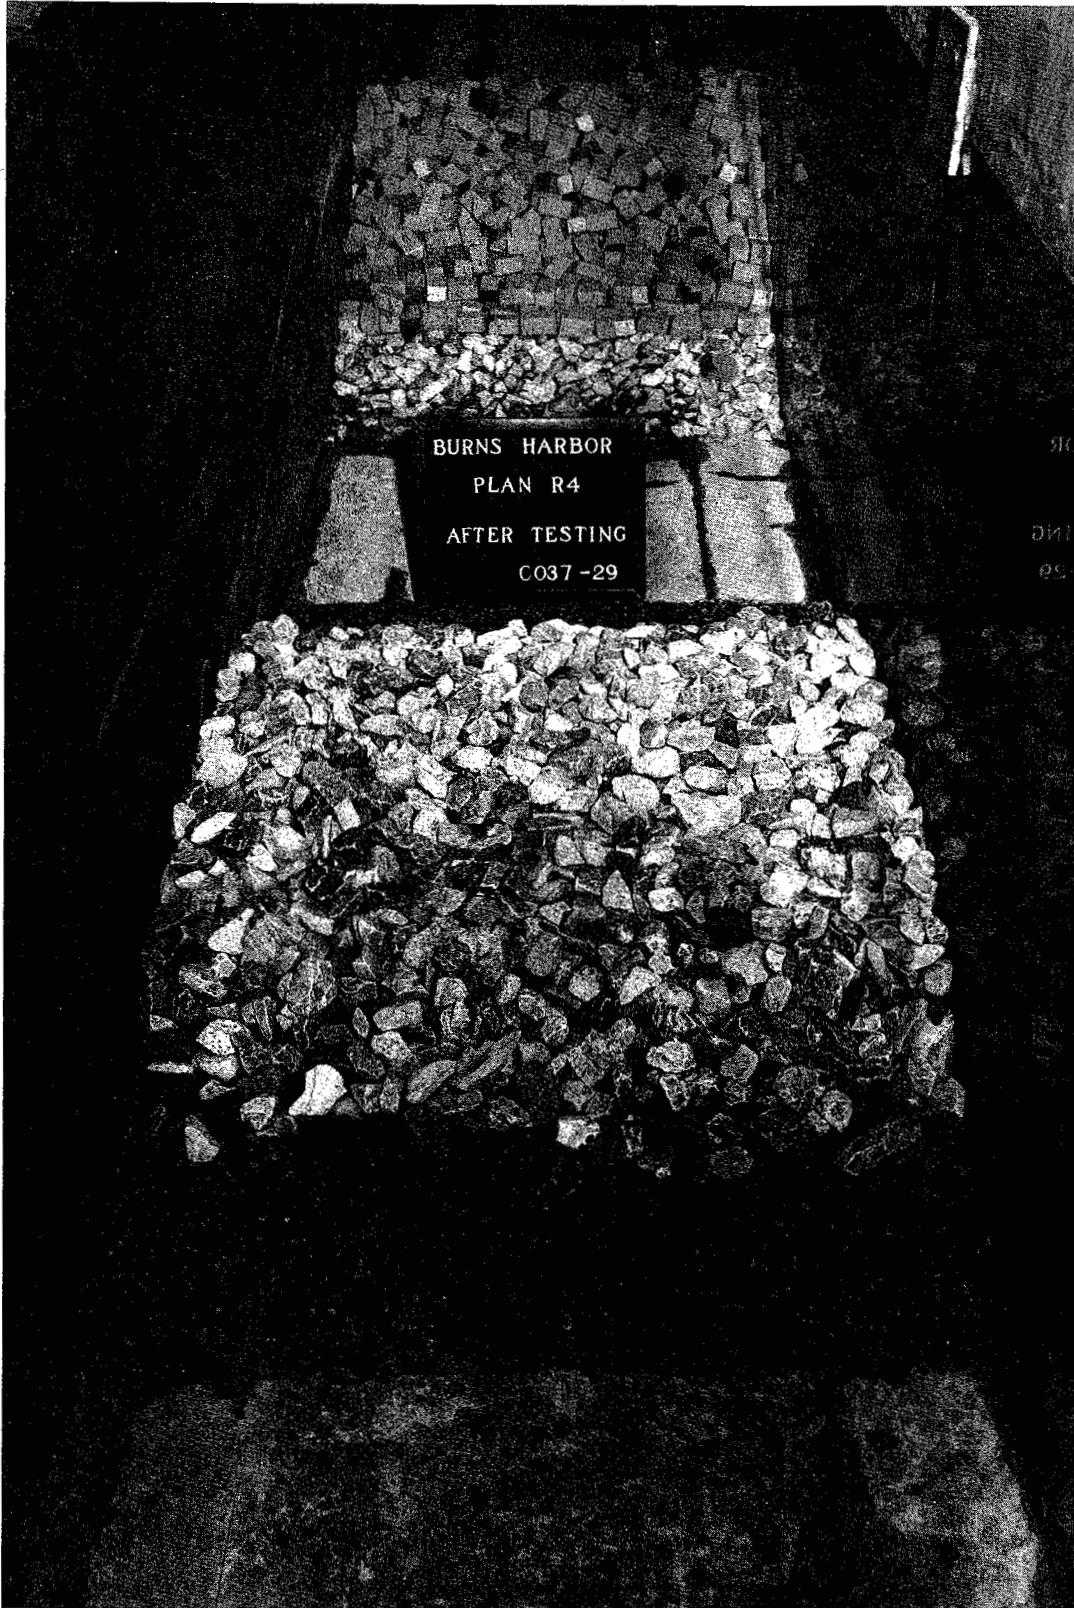
As expected and shown in Figure 15, Plan R4 produced transmission results very similar to Plan R3. The 1- to 5-ton stone used to armor the reef showed more movement than the 3- to 5-ton stone used in Plan R3 (Photos 12 and 13); however, this movement amounted to only about 3 to 4 percent of the original stone volume and was considered acceptable. One lakeside and three harbor-side armor units were displaced from the existing breakwater (Photo 14).

Photo 12. Lakeside view of Plan R4 (existing breakwater in background) after wave attack

Photo 13. End view of Plan R4 after wave attack

Photo 14. End view of existing breakwater as protected by Plan R4

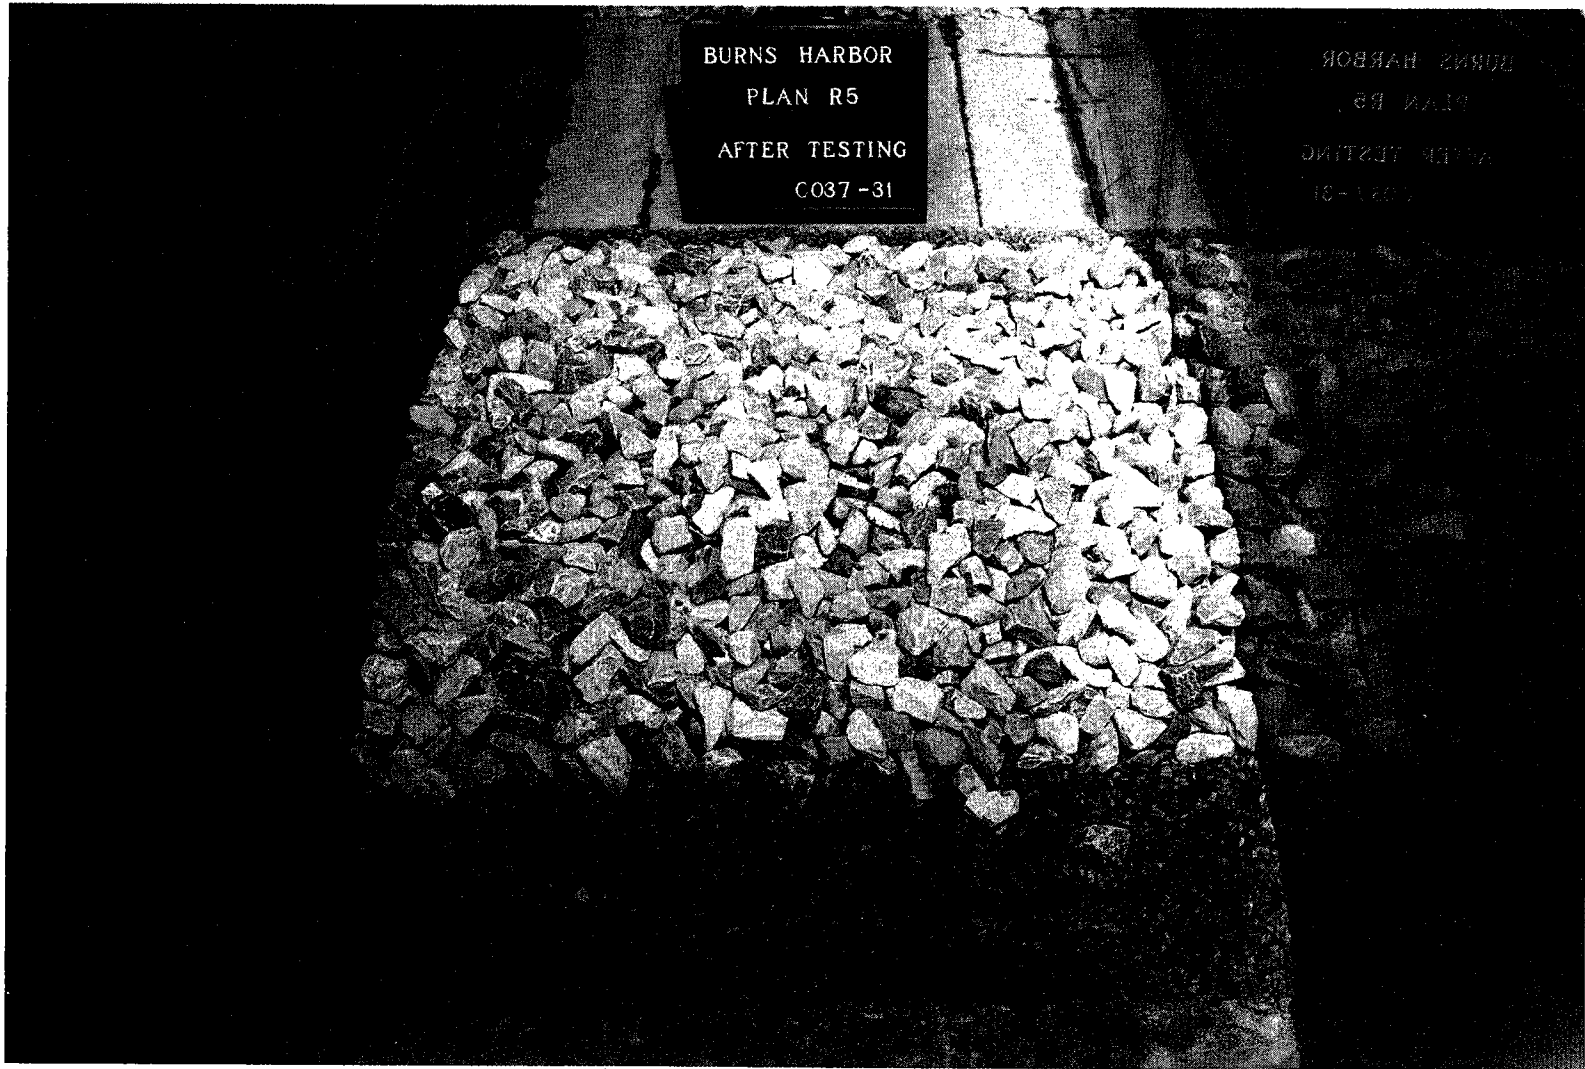
As shown above and in Figure 16, Plan R5 produced slightly larger transmitted wave heights than were observed for Plan R4. Stability of the 1- to 5-ton stone used to armor the reef was very similar to Plan R4 and again considered acceptable with about 3 to 4 percent of the original stone volume being displaced (Photo 15). The existing breakwater did not experience any armor displacement (Photo 16).

Photo 15. End view of Plan R5 after wave attack

Photo 16. Lakeside view of Plan R5 after wave attack
