Technical Report GL-93-29
November 1993

Geophysical Investigation at U.S. Army Materials Technology Laboratory, Massachusetts

*by José L. Llopis, Janet E. Simms
Geotechnical Laboratory*

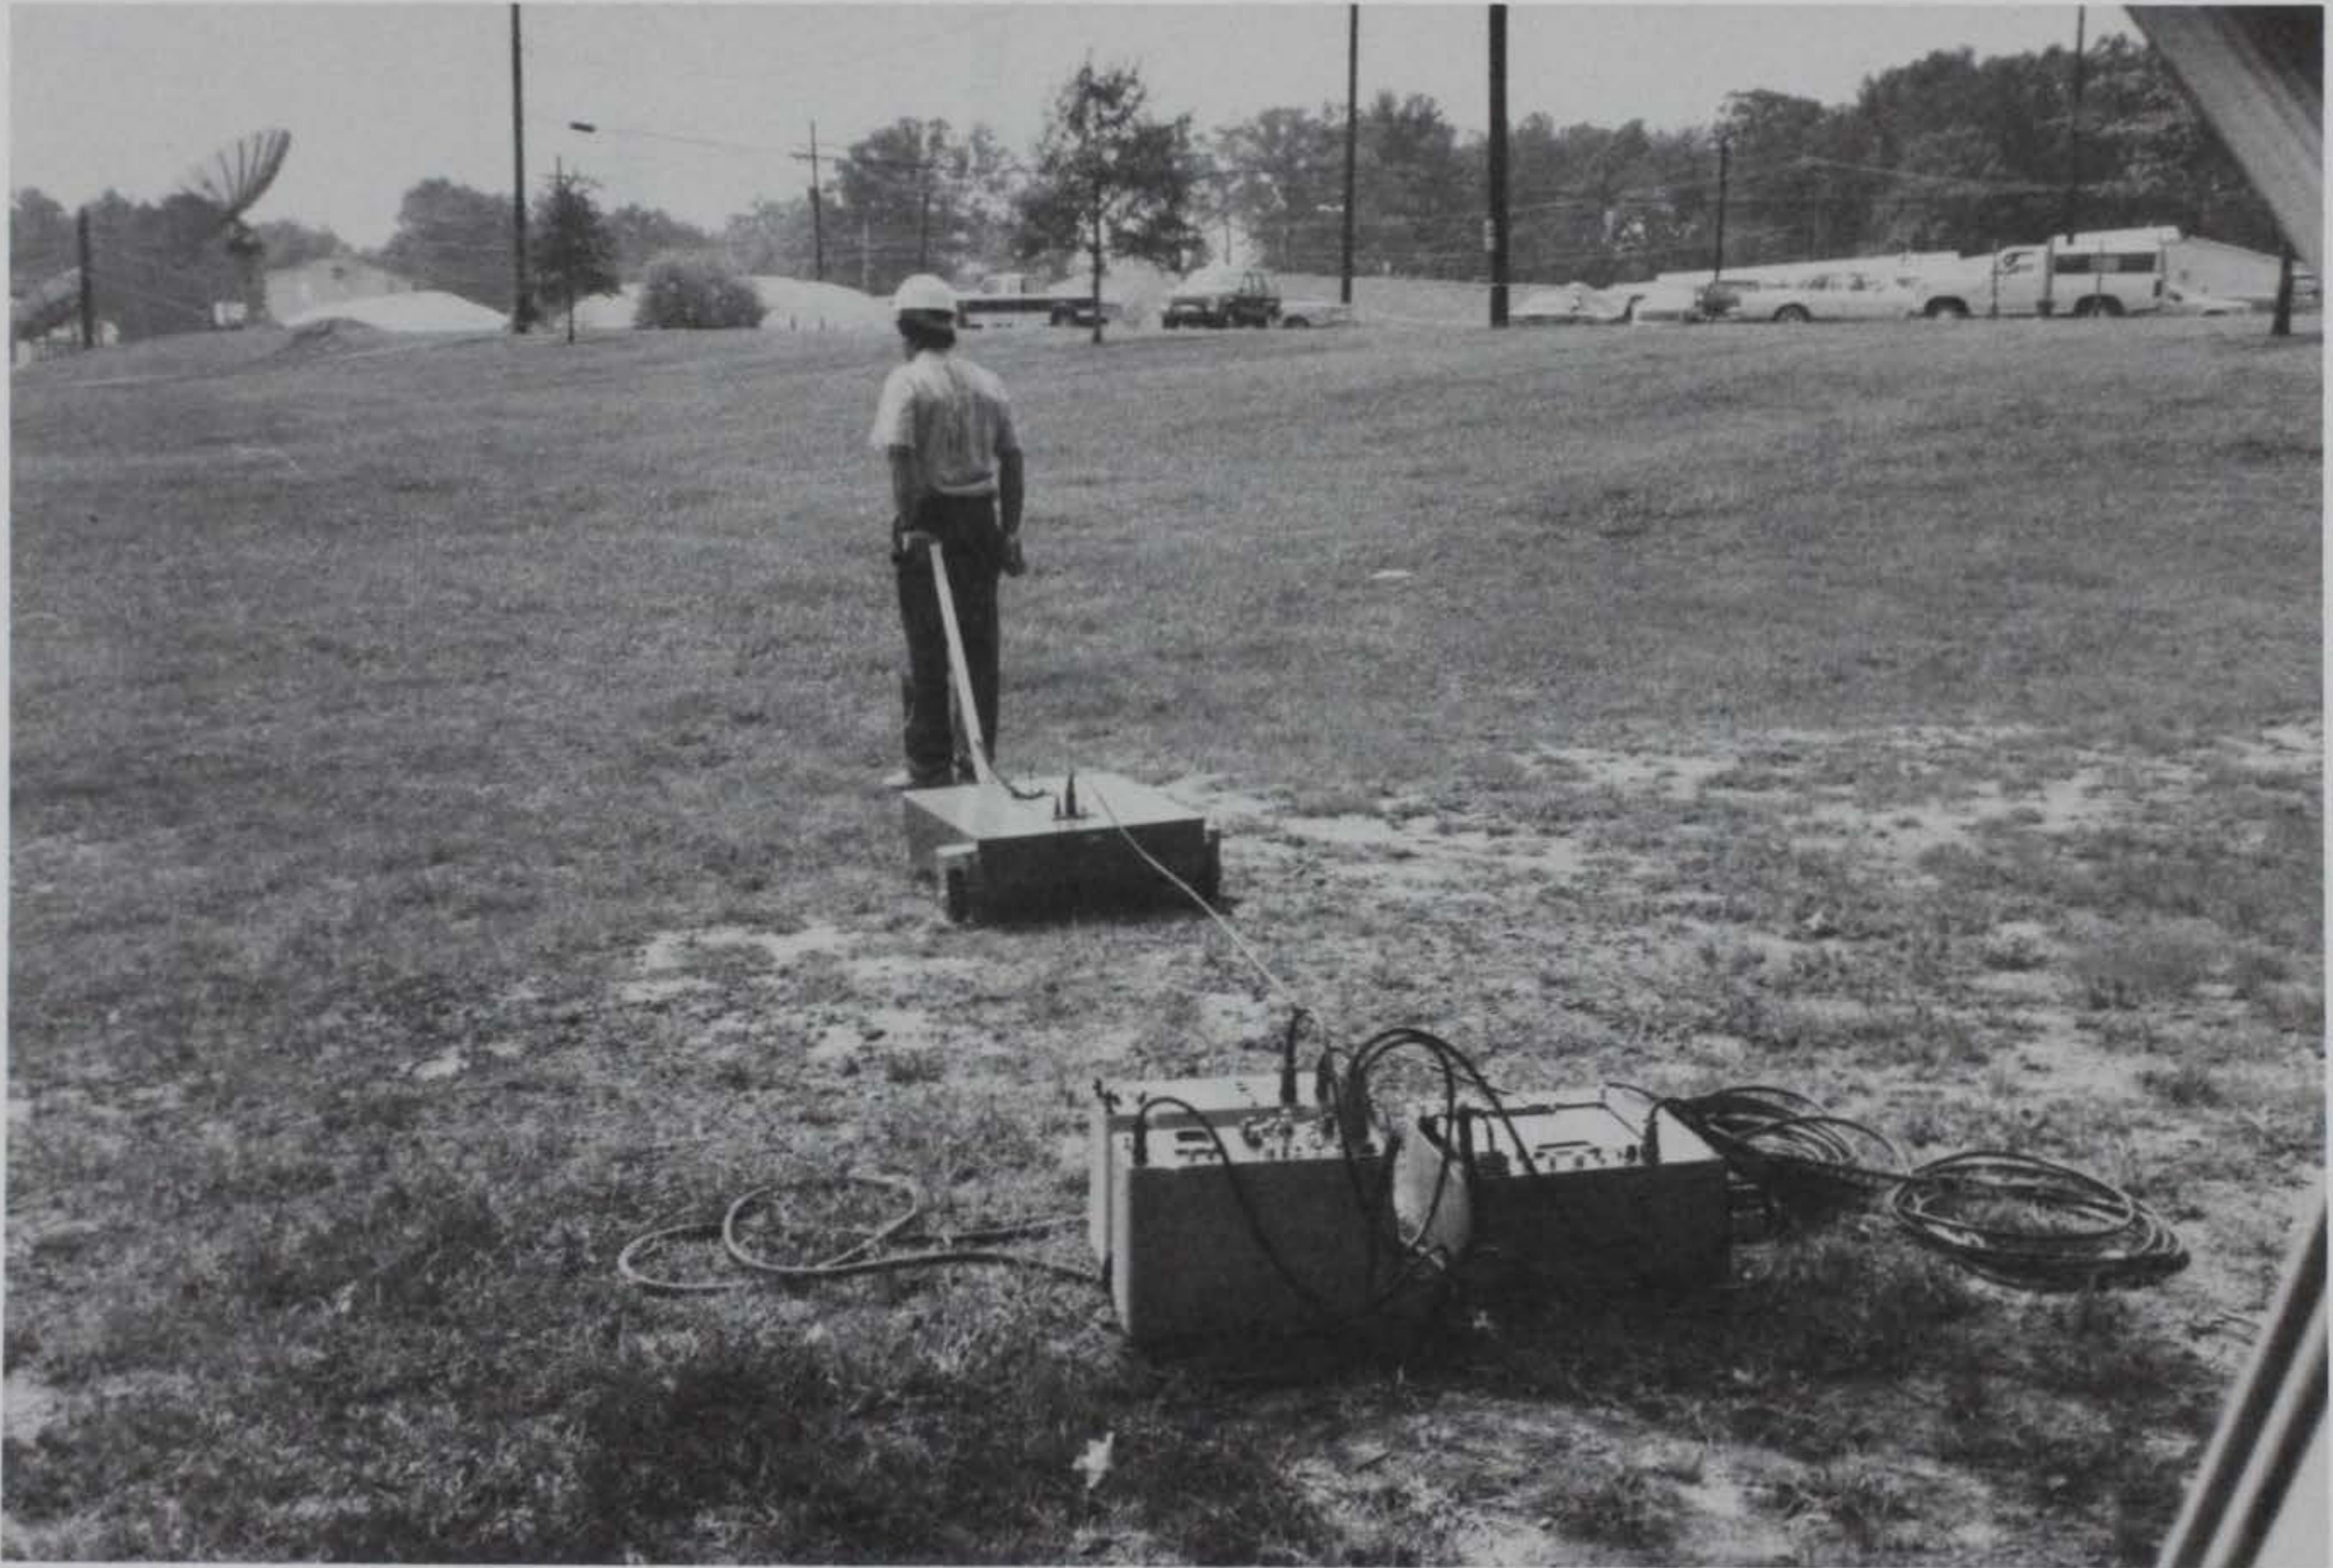
Figure 6. GSSI System 8 GPR with 300 Mhz antenna

A Geophysical Survey Systems, Inc. SIR System-8 radar with a 300 Mhz antenna as shown in Figure 6 was used to conduct the GPR surveys. A graphic recorder was used with the SIR System-8. The graphic recorder accepts the analog signal from the receiver and produces a continuous, permanent chart on electro-sensitive paper. By recording a vertical intensity modulated scan for every few inches of antenna travel, a continuous profile is developed showing reflections from subsurface strata and anomalies within the strata.

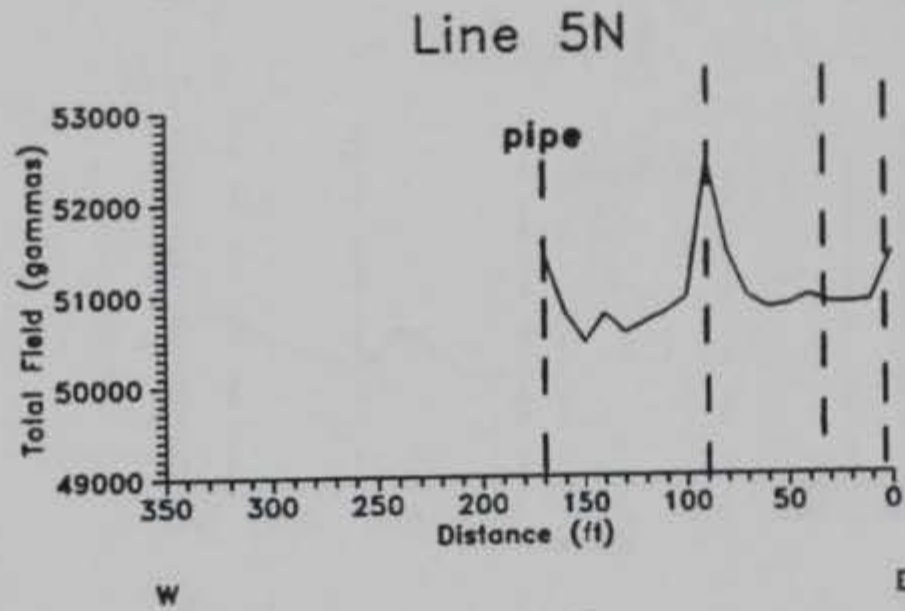
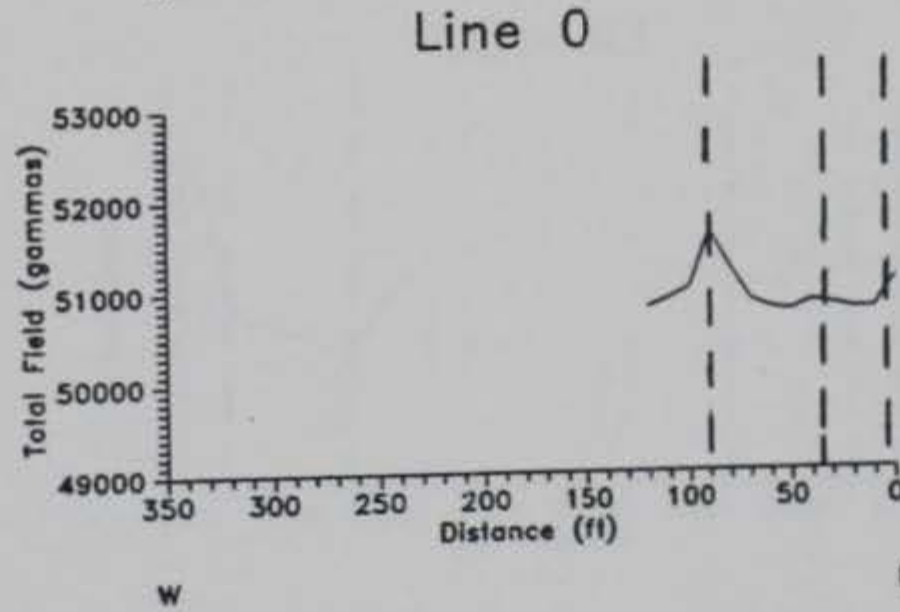
Figure 15. Results of magnetic total field survey, Site 2

Figures 15 through 17 present the magnetic, conductivity, and in-phase data, respectively, for Site 2. The figures have been annotated indicating the location of buried lines, manhole covers, monitoring wells, and other features which might affect these readings. The graphed data show many anomalies as indicated by the peaks and valleys. The majority of these anomalies can be attributed to interference from cultural features. Figure 18 was prepared to show the location of the anomalies as interpreted from the different tests and to indicate their relative position to cultural features. Also presented in Figure 18 are the interpreted anomalies from the GPR survey. Figure 18 shows that indeed, most of the anomalies occur in the vicinity of, and are being affected by underground lines, manhole covers, and monitoring wells. However, there are basically two anomalous zones that cannot be attributed to known cultural features. One zone consists of anomalous conductivity readings (Lines 00N, 05N, and 10N) located approximately 120 ft west of the survey line starting point. The other anomalous area is located on line 05N approximately 140-150 ft west of the survey line starting point where a small
