4. TITLE (and Subtitle) TRAFFIC TESTS OF EXPEDIENT AIRFIELD CONSTRUCTION CONCEPTS FOR POSSIBLE APPLICATION IN THE NATIONAL PETROLEUM RESERVE ALASKA (NPRA)		5. TYPE OF REPORT & PERIOD COVERED Final report

6. PERFORMING ORG. REPORT NUMBER
7. AUTHOR(s) Cecil D. Burns		8. CONTRACT OR GRANT NUMBER(s)
9. PERFORMING ORGANIZATION NAME AND ADDRESS U. S. Army Engineer Waterways Experiment Station Geotechnical Laboratory P. O. Box 631, Vicksburg, Miss. 39180		10. PROGRAM ELEMENT, PROJECT, TASK AREA & WORK UNIT NUMBERS

11. CONTROLLING OFFICE NAME AND ADDRESS Department of the Interior U. S. Geological Survey Menlo Park, Calif. 94025		12. REPORT DATE March 1979
		13. NUMBER OF PAGES 123

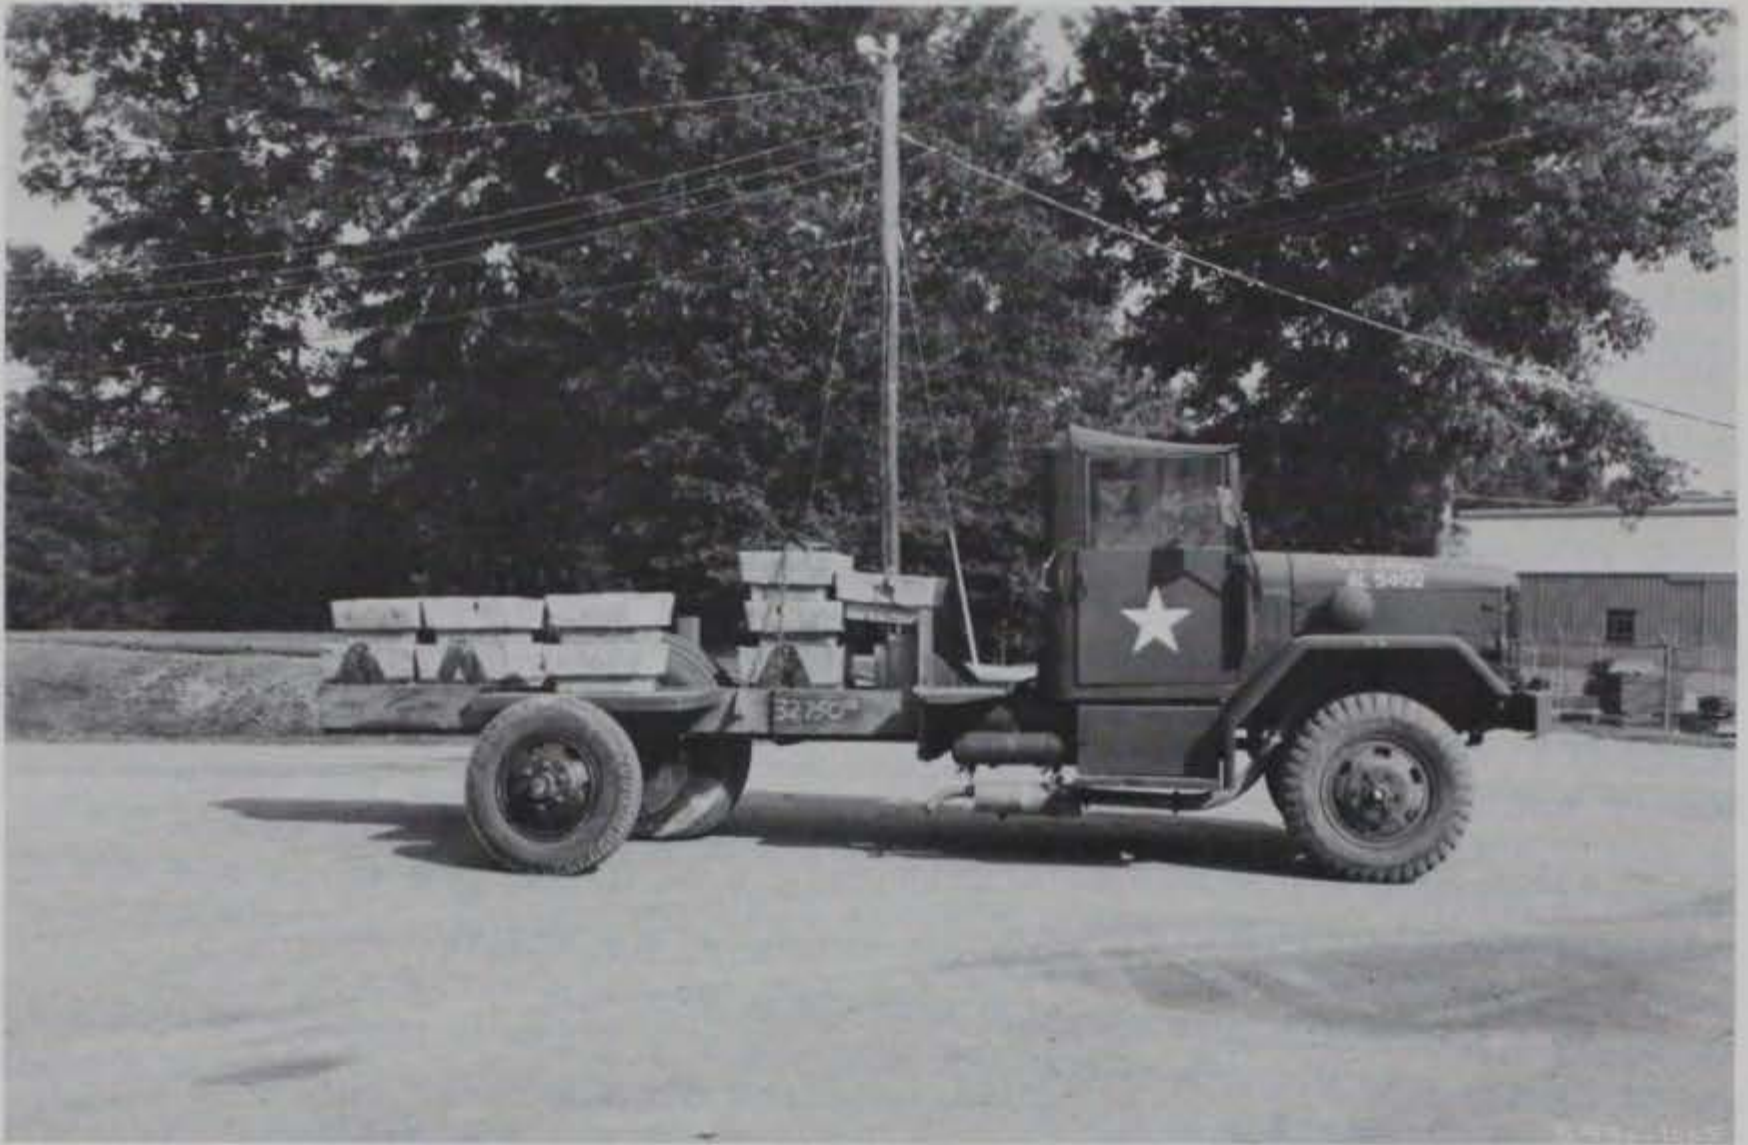
Figure 1. Thirty-five-kip single-wheel test cart

13. Two specially designed load carts were used in the application of traffic on the test sections. A single-wheel test cart (Figure 1) loaded to provide a single-wheel load of 35 kips was used to simulate the loading conditions of a C-130 aircraft for the traffic applied in Test Section No. 1 and the initial traffic in Test Section No. 2. For the final traffic in Test Section No. 2 and all simulated aircraft traffic in Test Sections Nos. 3, 4, and 5, a different load cart (Figure 2) was used. This latter cart was equipped with a single-tandem gear (one main gear of a C-130 aircraft) loaded to 70 kips. The load wheels of both carts were equipped with 20x20, 20-ply tires inflated to 100 psi.

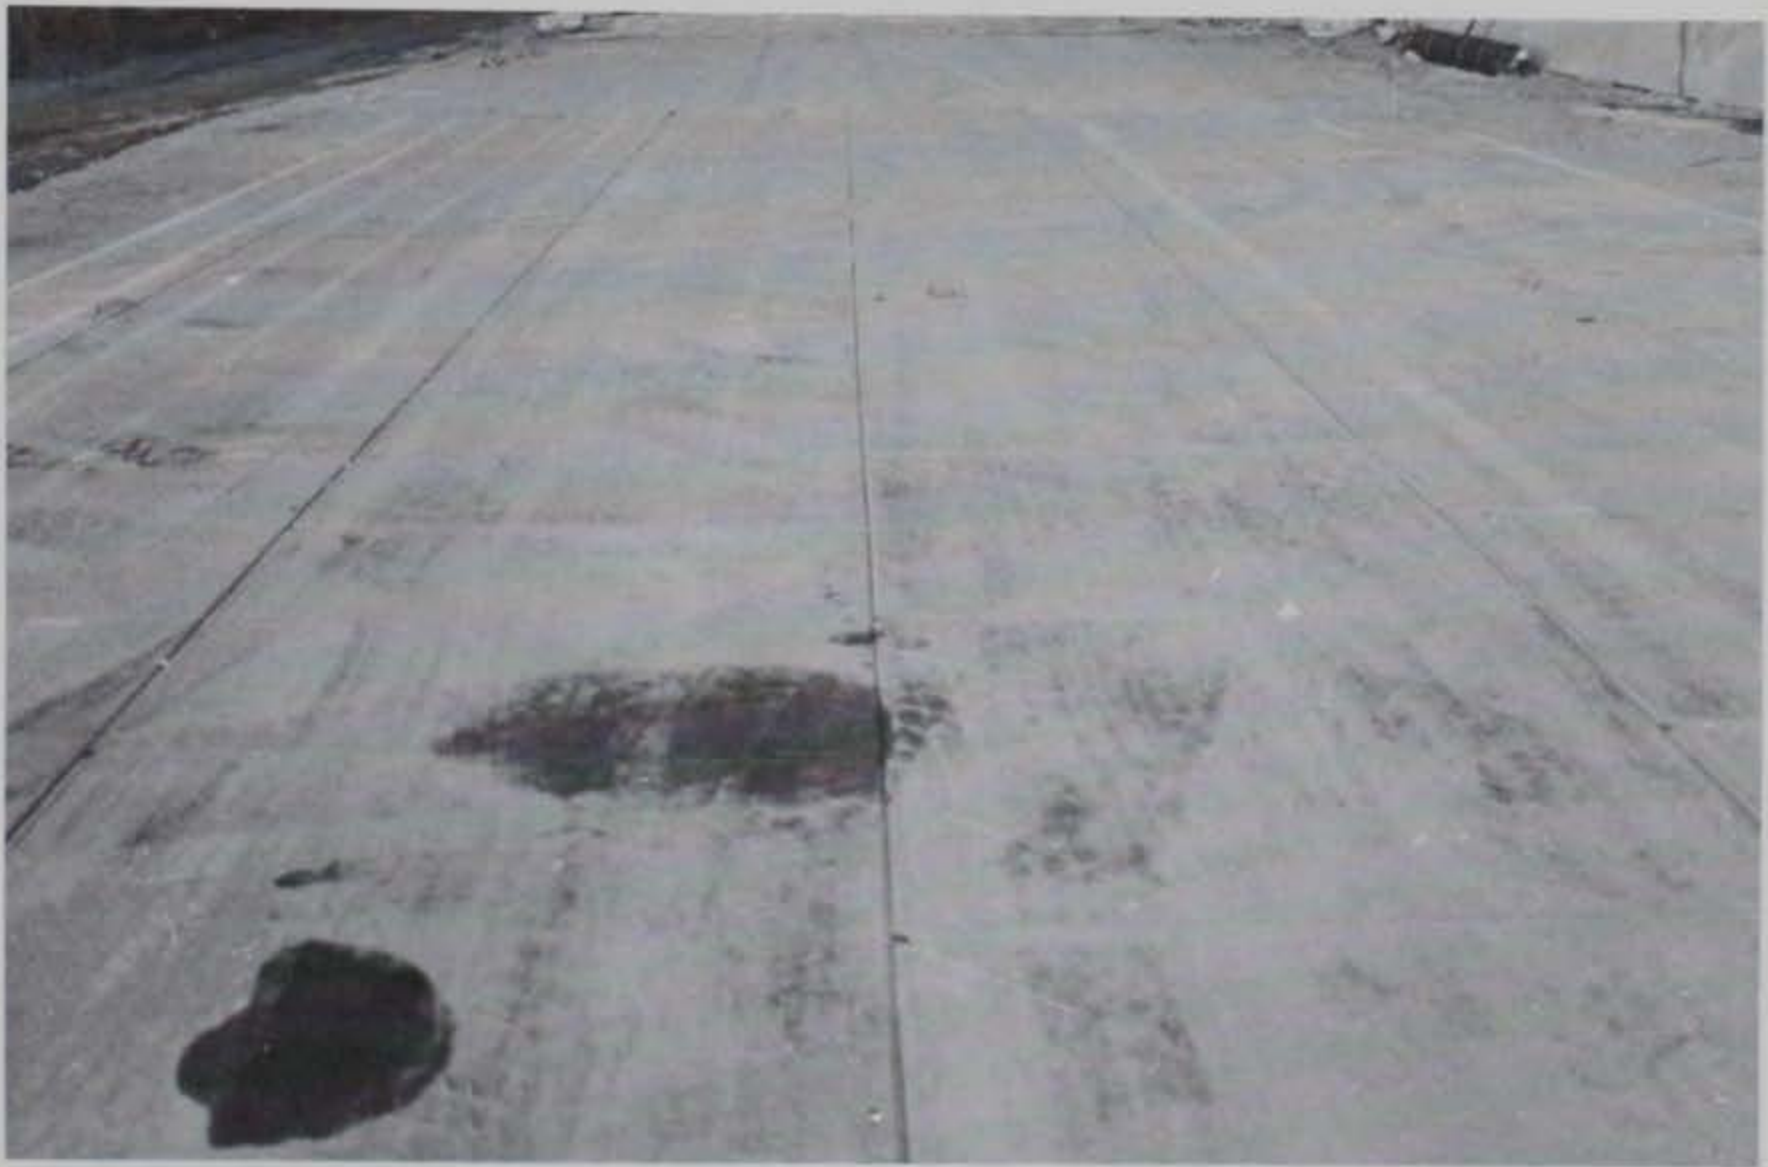
Photo 6. General view of XML9 landing mat, Test Section No. 1,
item 1, after traffic

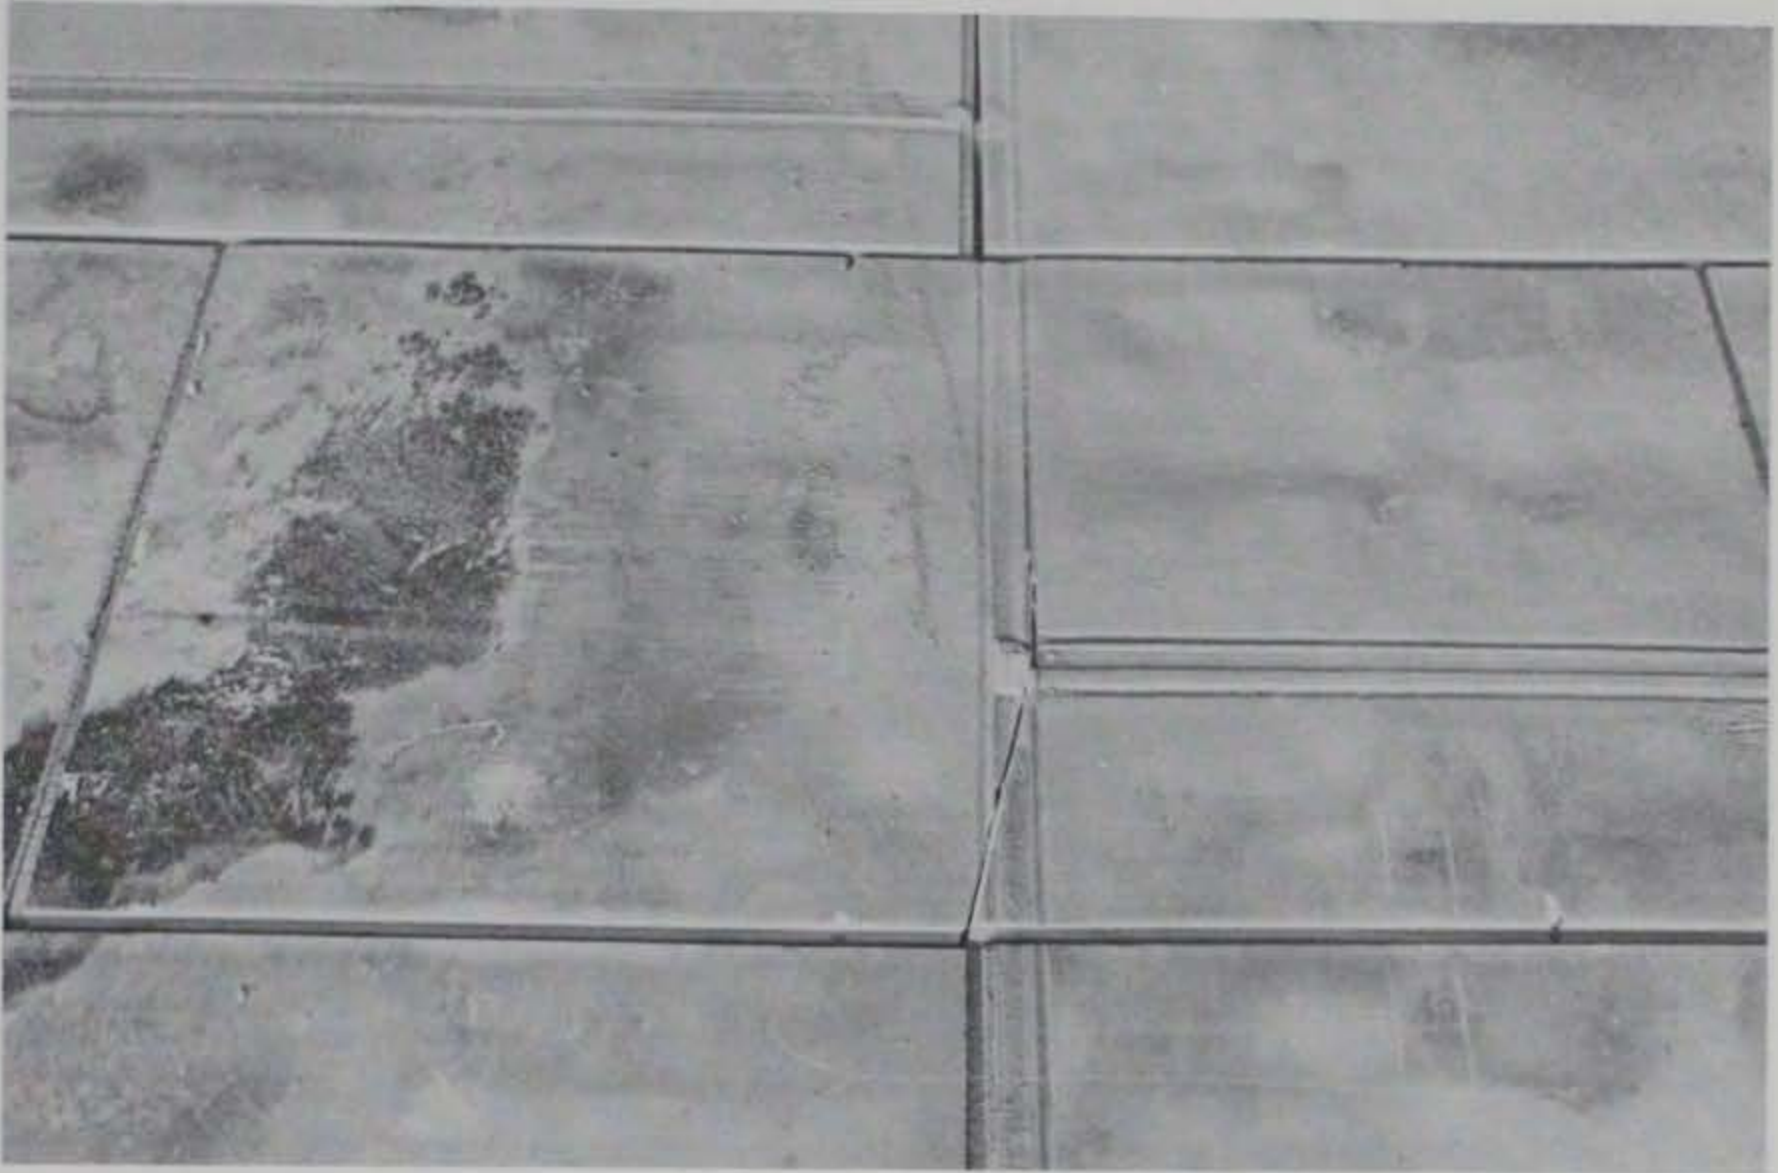
Photo 9. Closeup view of insulation in Test Section No. 1,
item 1, after traffic

23. At the end of the traffic, the mat was removed from item 1, and an excavation trench was made in item 2 to permit examination of the Styrofoam insulation material. It was determined that the insulation panels were still in place with no damage in either item. Photo 8 shows a general view of the insulation in test item 1, after traffic and removal of mat. As indicated in Photo 9, some slight grooving and ridges were formed in the insulation material by the joints and weld seams in the XM19 mat and a few cracks in the insulation material. However, it is believed that this would have no adverse effects on the insulation properties of the Styrofoam panels.

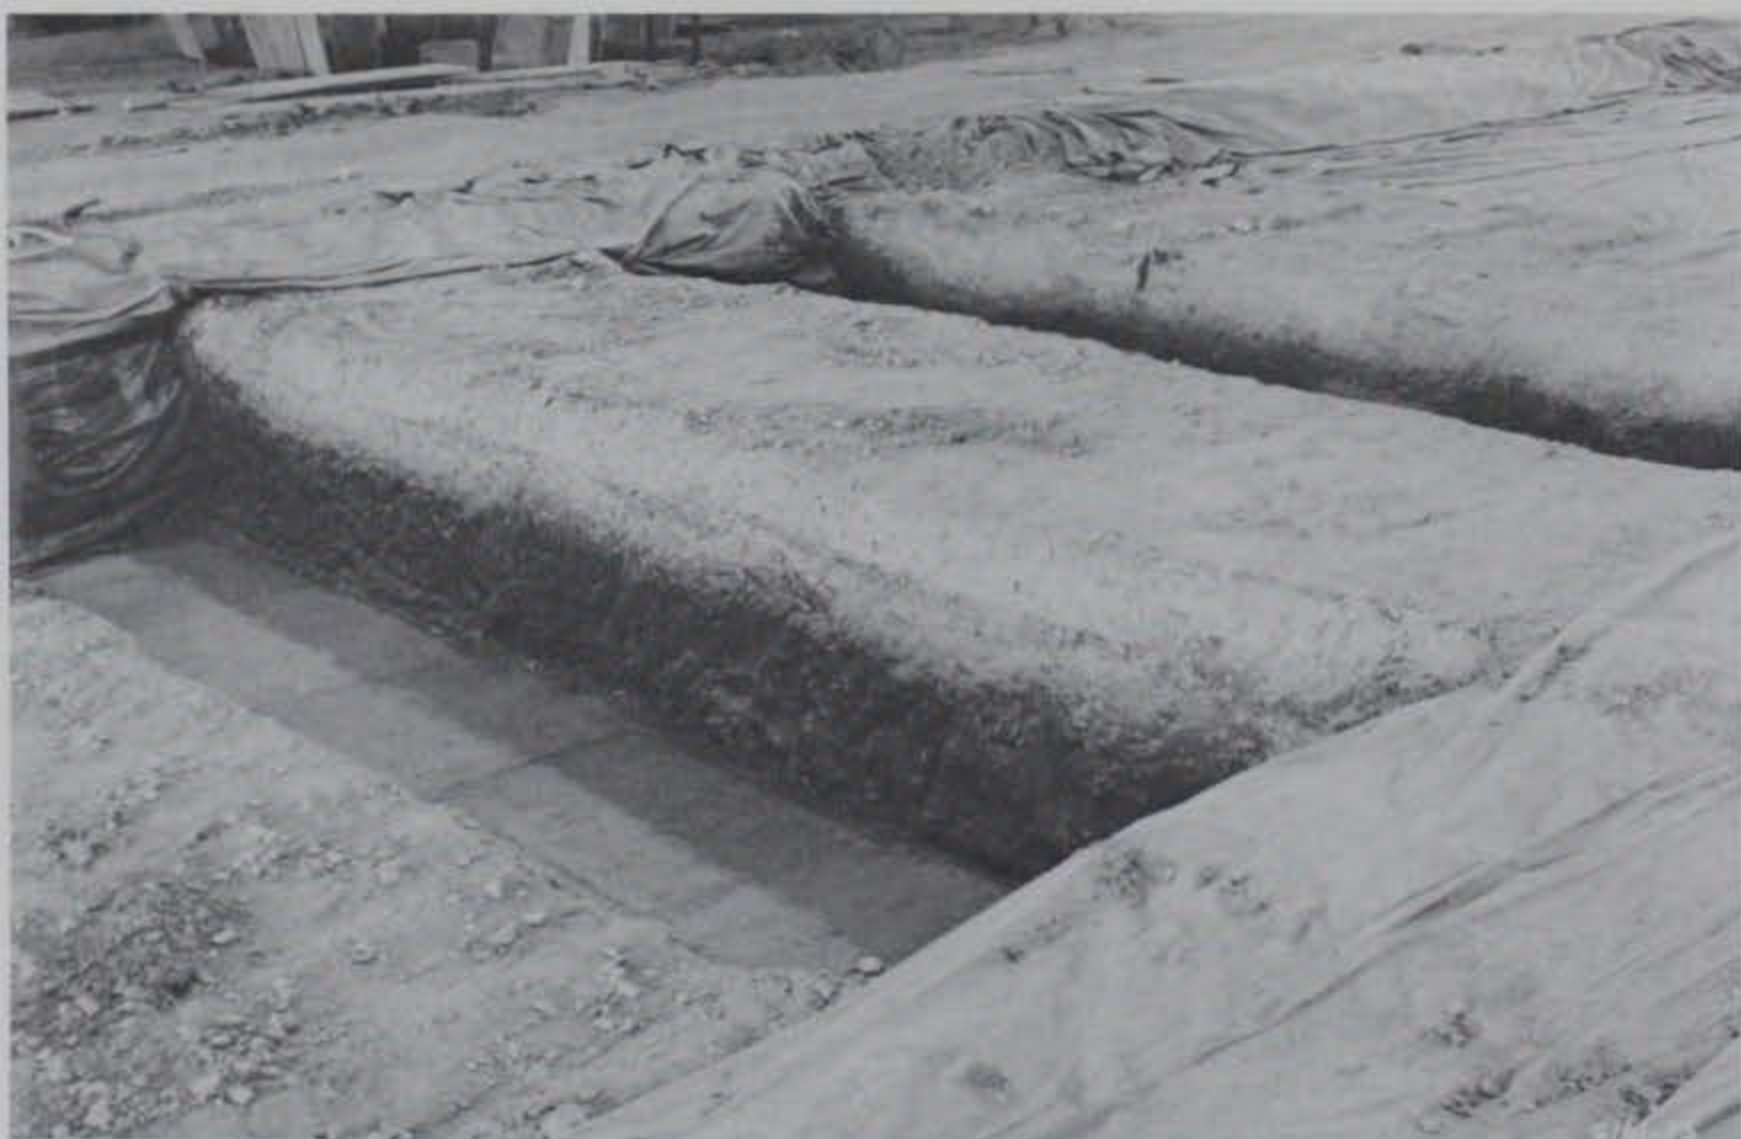
Photo 24. Eight-foot-wide trenches excavated in Test Section No. 3, item 4, to be backfilled with loose sand

pit-run sandy gravel, and the top 18 in. was stabilized with 6 percent portland cement. The gravel material was placed and then compacted in about 19-in.-thick compacted lifts over the entire 40-ft-long test item up to about 12 in. below final grade. After compaction of the stabilized base, two trenches 8 ft wide were excavated down to the surface of the filter fabric over the gravel blanket and the trenches were filled with loose uncompacted sand. Prior to placing the gravel, landing mats were placed over the filter fabric in the 8-ft-wide areas where the sandy gravel and mats would be later removed. The sandy gravel was then spread to the desired thickness and compacted with a pneumatic-tired roller. After construction of the high-strength base, the 8-ft-wide trenches were cut with a backhoe and the landing mat at the bottom of the trench was removed (Photo 24).

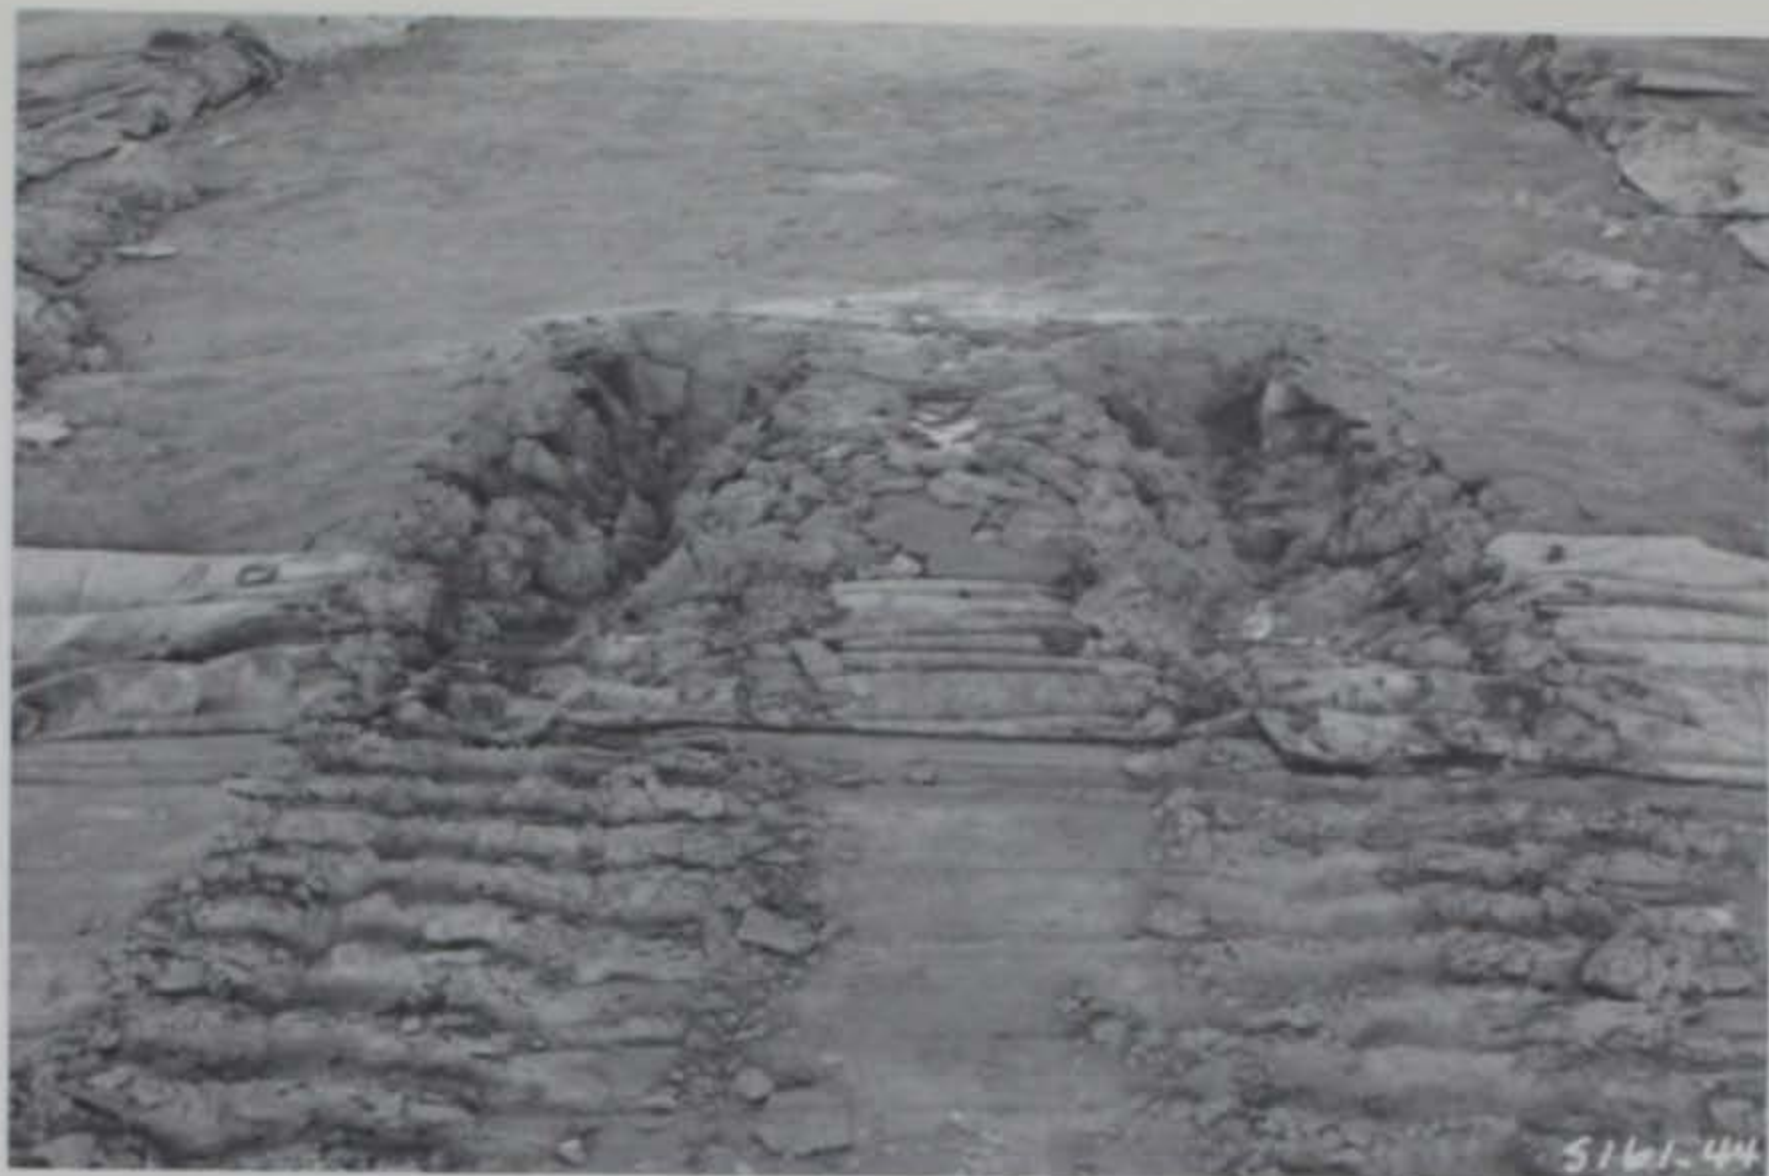
Photo 37. Closeup showing rutting and damaged grid from D-4 tractor

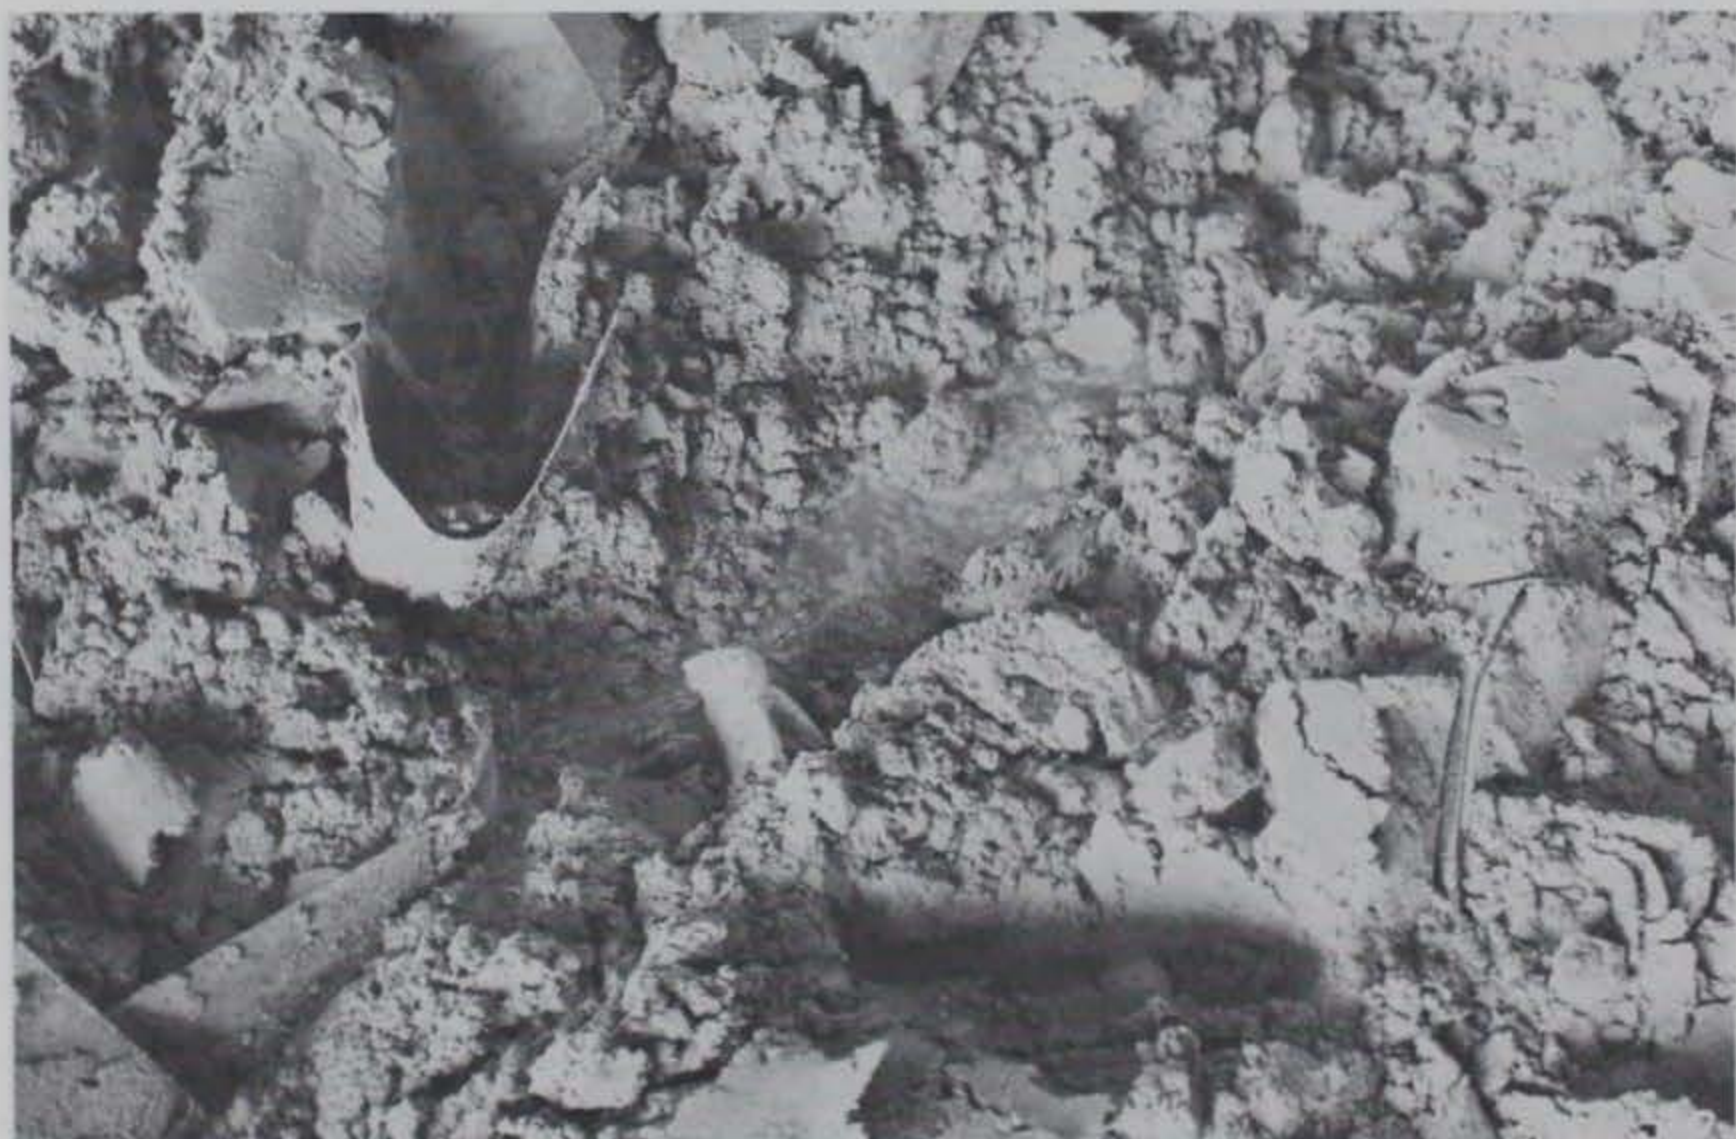
Photo 40. Closeup of damaged grid and water in ruts of Test Section No. 3, item 2

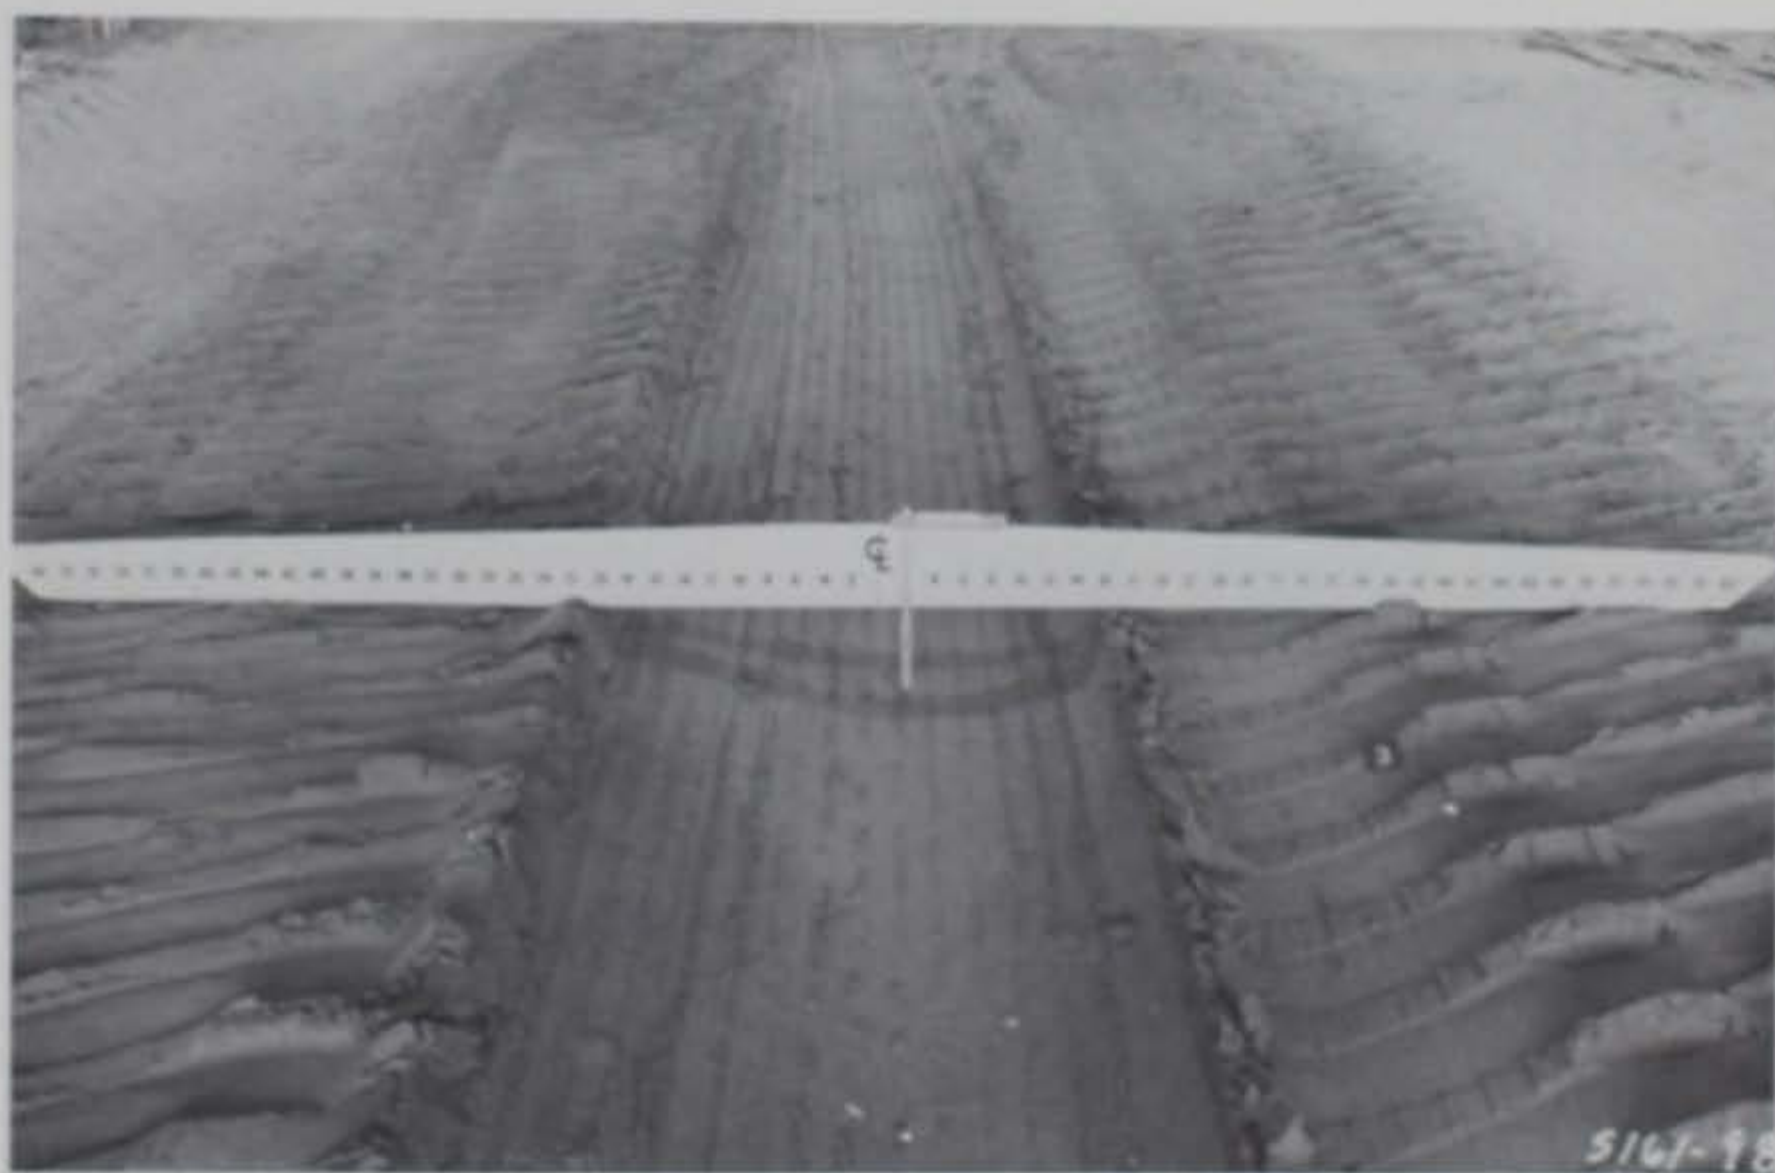
Photo 46. Test Section No. 3, item 3, after 100 coverages
of C-130 loading

59. The first two passes of the load cart, forward and backward, in the same track left a rut varying from about 2 to 4 in. deep for the full length of the test section (Photo 43). Photos 44, 45, and 46, respectively, show a closeup view of rutting in items 1, 2, and 3 at the end of 100 coverages of traffic. As can be noted, the deformation was fairly uniform in each item, and the depth of ruts averaged about 7.5 in. in item 1, 8.5 in. in item 2, and 6 in. in item 3. The average rut depth in item 4 over the high-strength, stabilized base was about 6 in. as

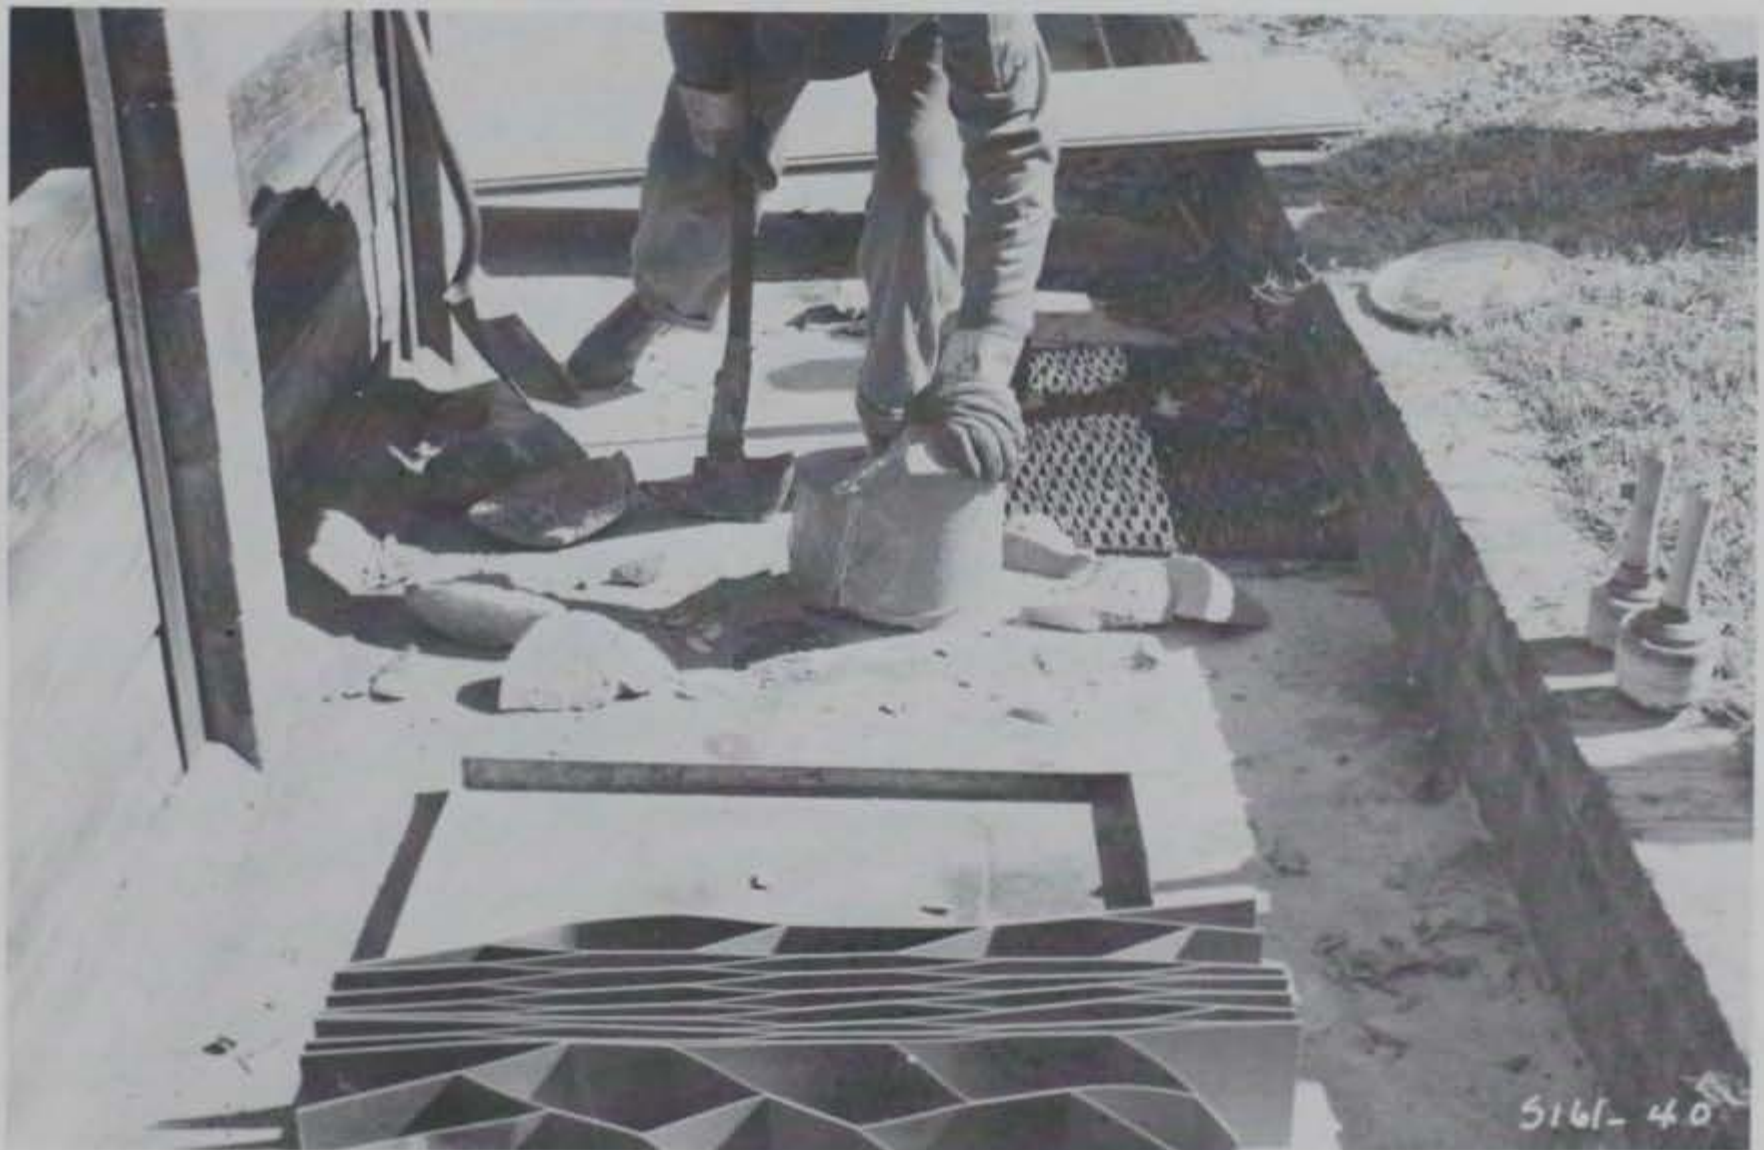
Photo 54. Breaking up frozen sand with ax

68. When removed from the freezing cabinet, the frozen sand resembled a block of ice (Photo 53). An ax was used to break the sand up into chunks (Photo 54), and the chunks were broken up to about 1-1/2-in. maximum size with a 10-lb compaction hammer. A small section of the 6- by 6- by 6-in. paper grid was expanded in a metal tray, and the crushed frozen material placed in the grids with shovels (Photo 55). There was only enough of the frozen material to fill about 12 of the grid compartments to about 1 in. above the top of the grid. After thawing, very little free water drained from the sand, and the thawed material settled about 1 in. into the grid but remained quite wet and soft for several days (Photo 56).

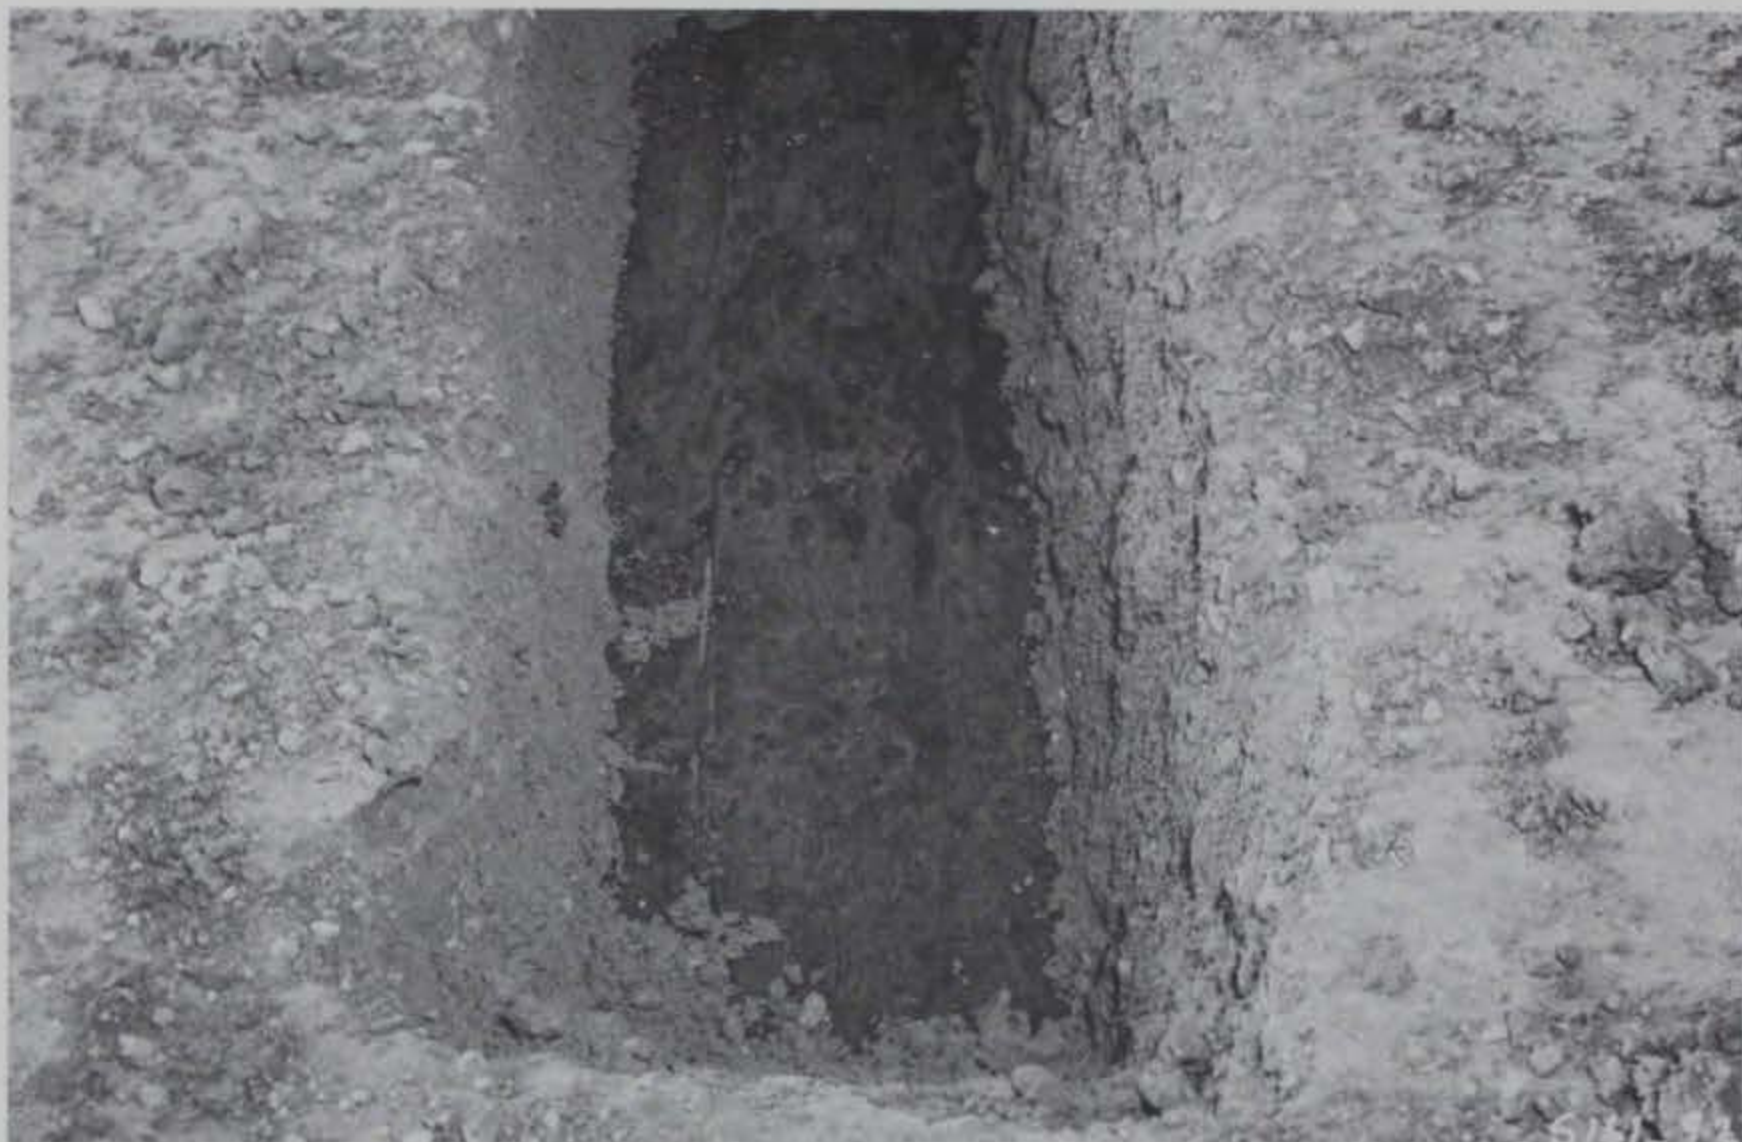
Photo 71. Trench in Test Section No. 4, item 1, showing condition of membrane after 480 passes

80. At this time, an observation pit was excavated in item 1 (15-in. thickness over insulation) to observe the condition of insulation. Photo 71 shows a view of the pit with gravel removed to the top of the membrane. It can be noted that the polyethylene membrane is intact with no visible holes or tears. The membrane was then removed to expose the Styrofoam insulation (Photo 72). The insulation appeared to be in good condition except for shallow pitting in the top of foam where gravel was embedded into the Styrofoam to a depth of 0.25 to 0.50 in. A section of the Styrofoam about 12 in. square was removed to measure the thickness. The overall thickness was found to still be about 2 in. or the original thickness as placed.

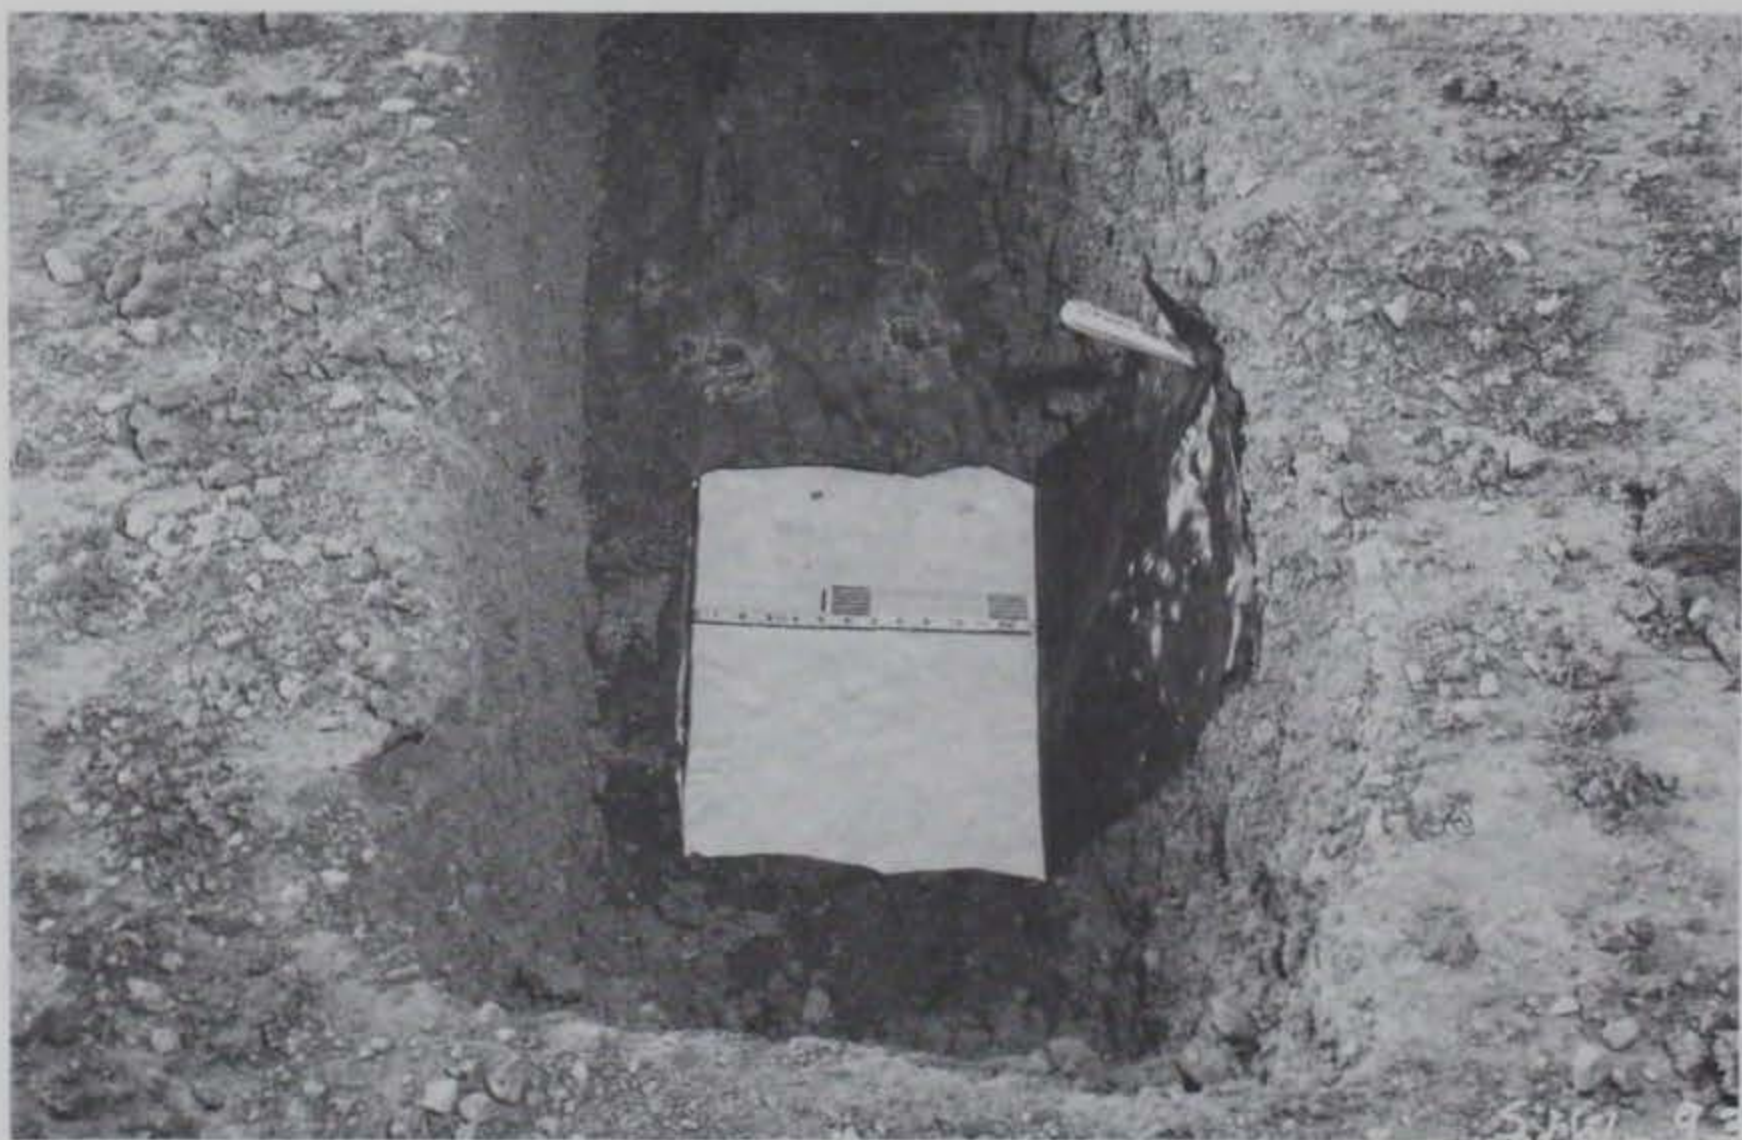
Photo 72. Surface of Styrofoam, Test Section No. 4., item 1, after 480 passes
