4. TITLE (and Subtitle) TRAFFIC TESTS OF EXPEDIENT AIRFIELD CONSTRUCTION CONCEPTS FOR POSSIBLE APPLICATION IN THE NATIONAL PETROLEUM RESERVE ALASKA (NPRA)		5. TYPE OF REPORT & PERIOD COVERED Final report

6. PERFORMING ORG. REPORT NUMBER
7. AUTHOR(s) Cecil D. Burns		8. CONTRACT OR GRANT NUMBER(s)
9. PERFORMING ORGANIZATION NAME AND ADDRESS U. S. Army Engineer Waterways Experiment Station Geotechnical Laboratory P. O. Box 631, Vicksburg, Miss. 39180		10. PROGRAM ELEMENT, PROJECT, TASK AREA & WORK UNIT NUMBERS

11. CONTROLLING OFFICE NAME AND ADDRESS Department of the Interior U. S. Geological Survey Menlo Park, Calif. 94025		12. REPORT DATE March 1979
		13. NUMBER OF PAGES 123

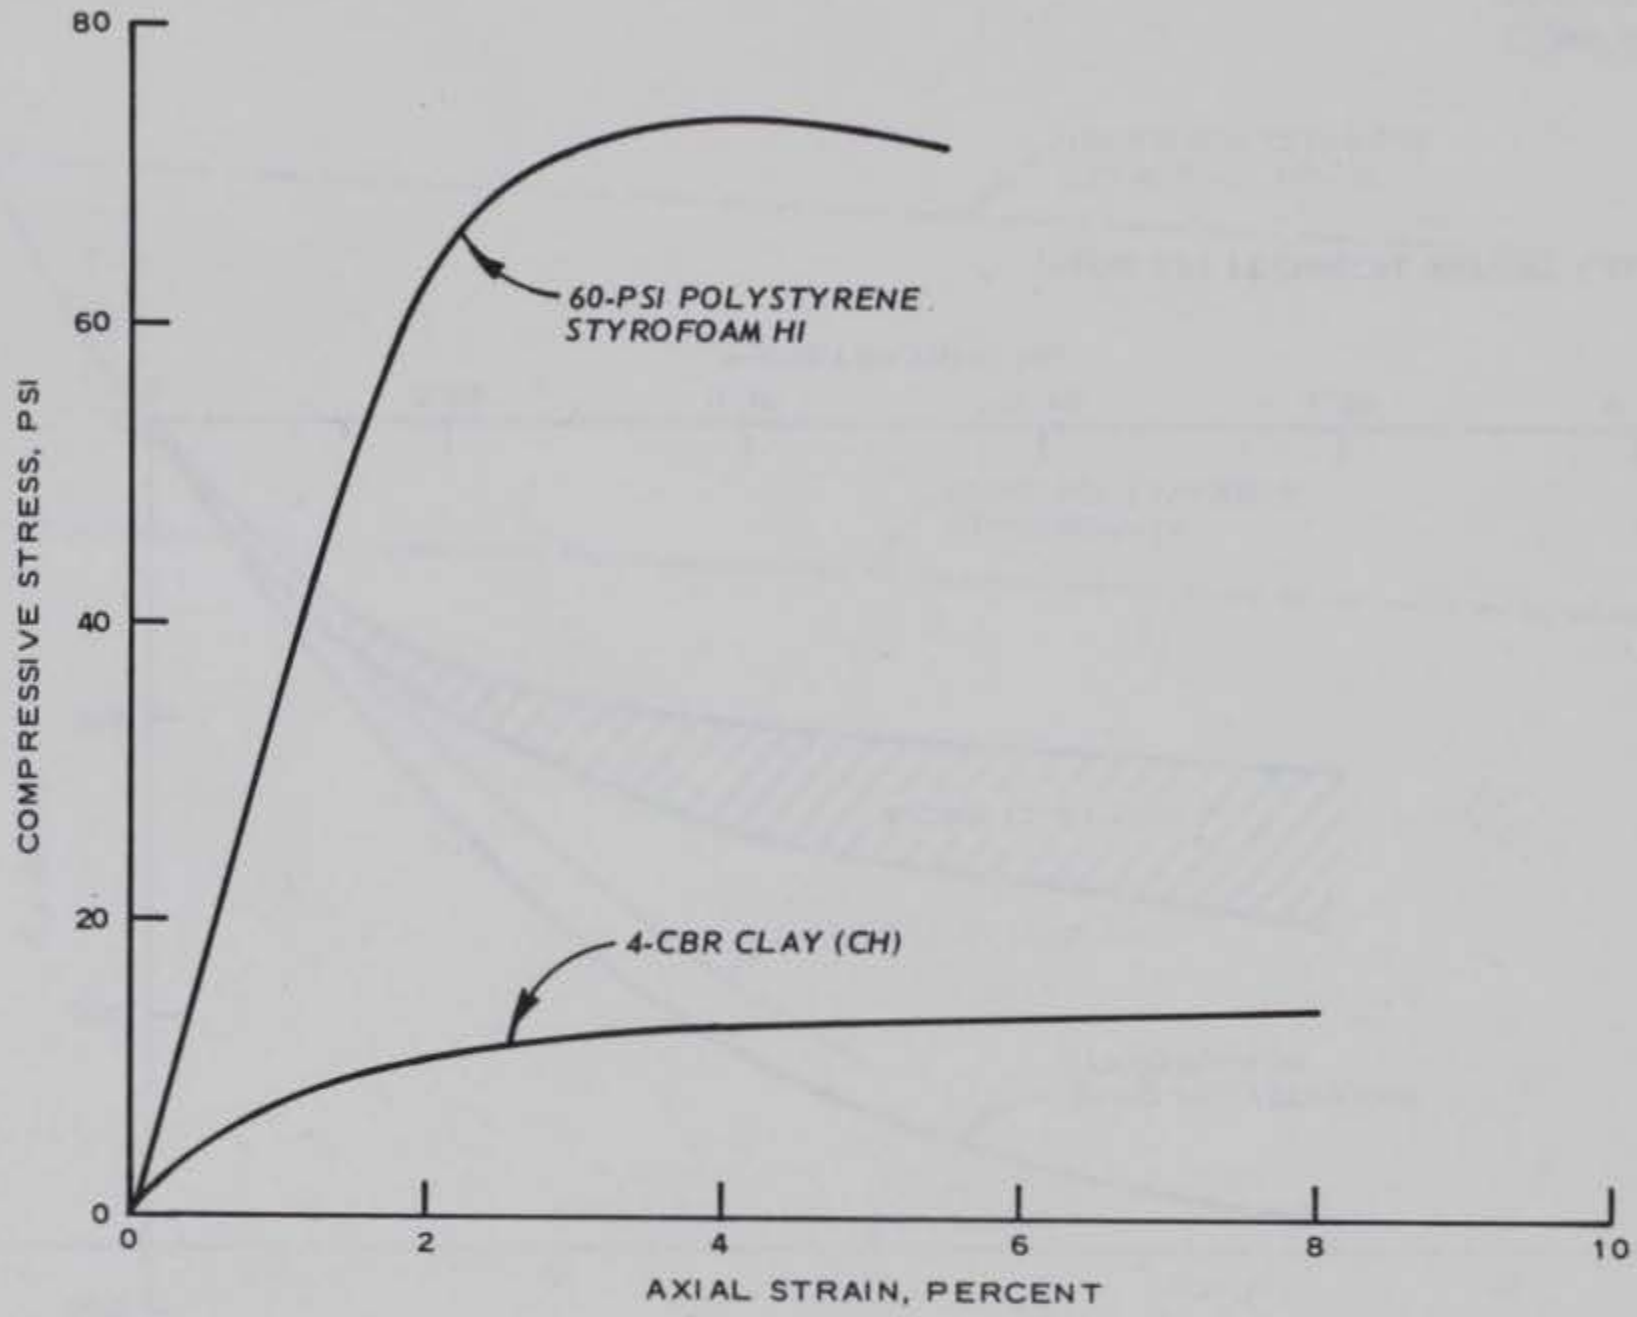
COMPARISON OF STRESS-STRAIN CURVE
FOR 60-PSI POLYSTYRENE AND
4-CBR CLAY (CH)

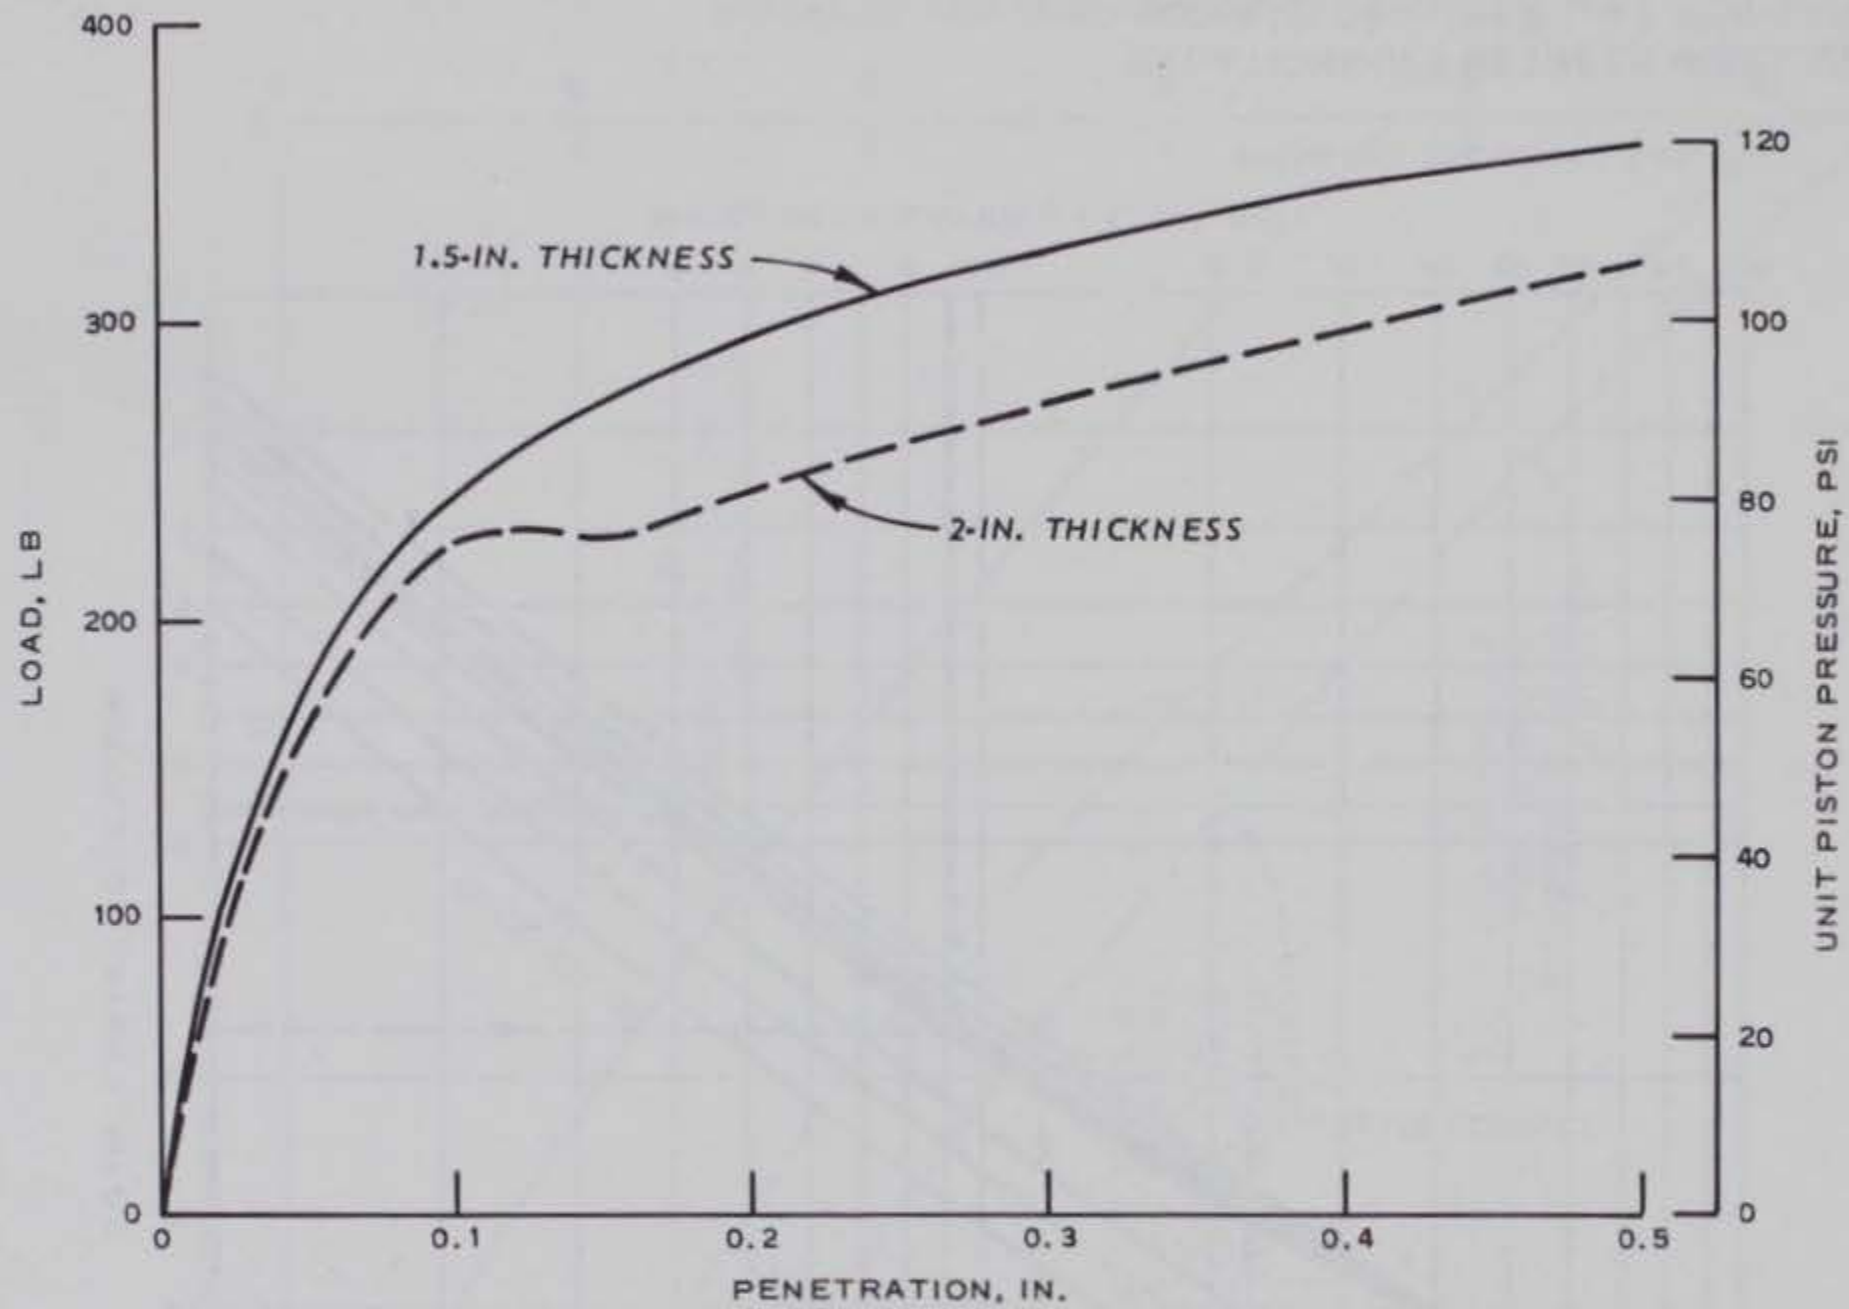
TYPICAL
 CBR LOAD - PENETRATION
 CURVES FOR STYROFOAM HI
