TECHNICAL REPORT GL-84-6

ENGINEERING CRITERIA FOR USE OF GEOTEXTILE FABRICS IN PAVEMENT AND RAILROAD CONSTRUCTION

Geotechnical Laboratory

June 1984

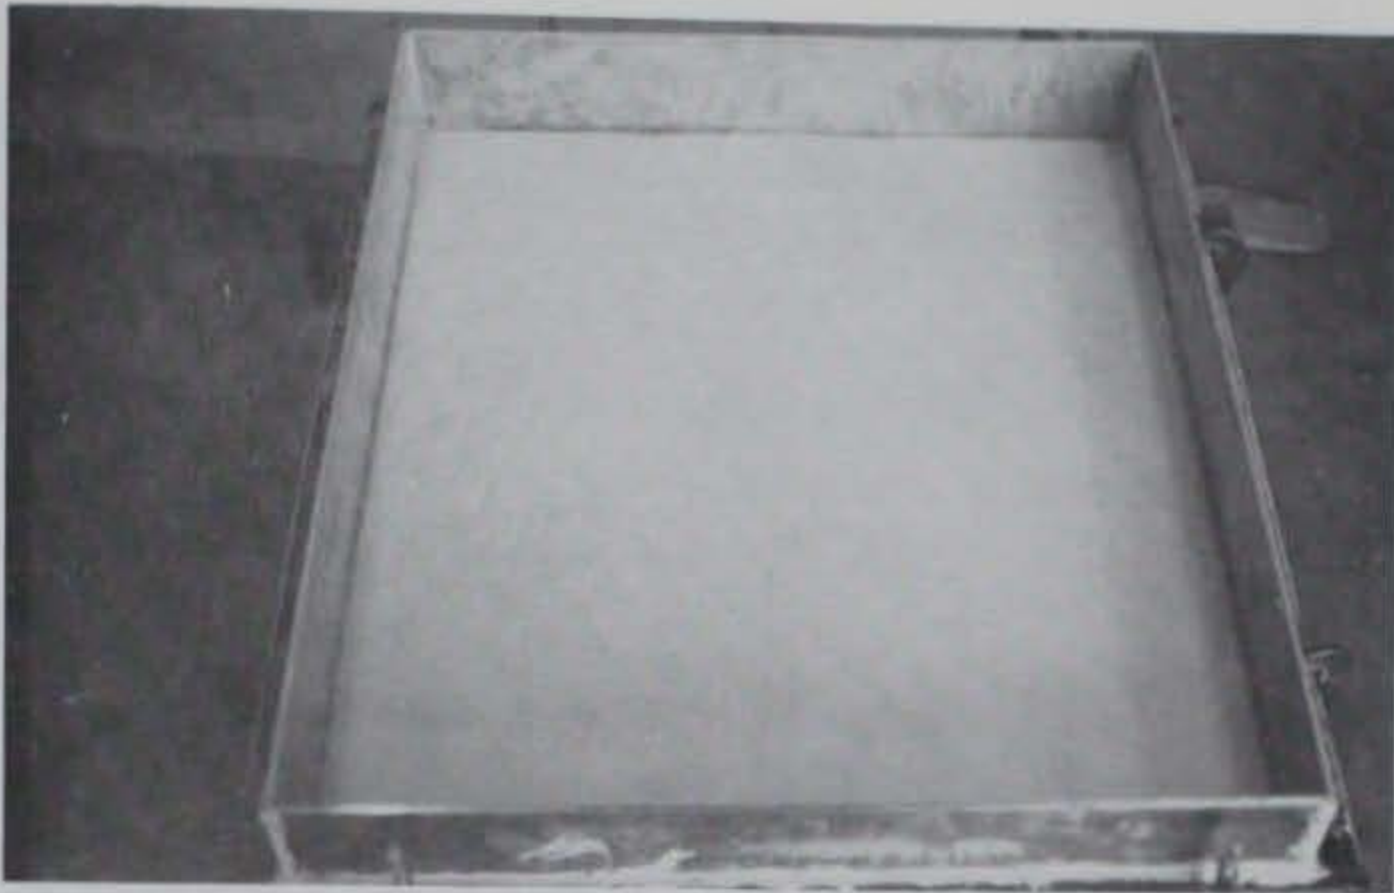
Photo 3. Six-inch-deep collar clamped in position

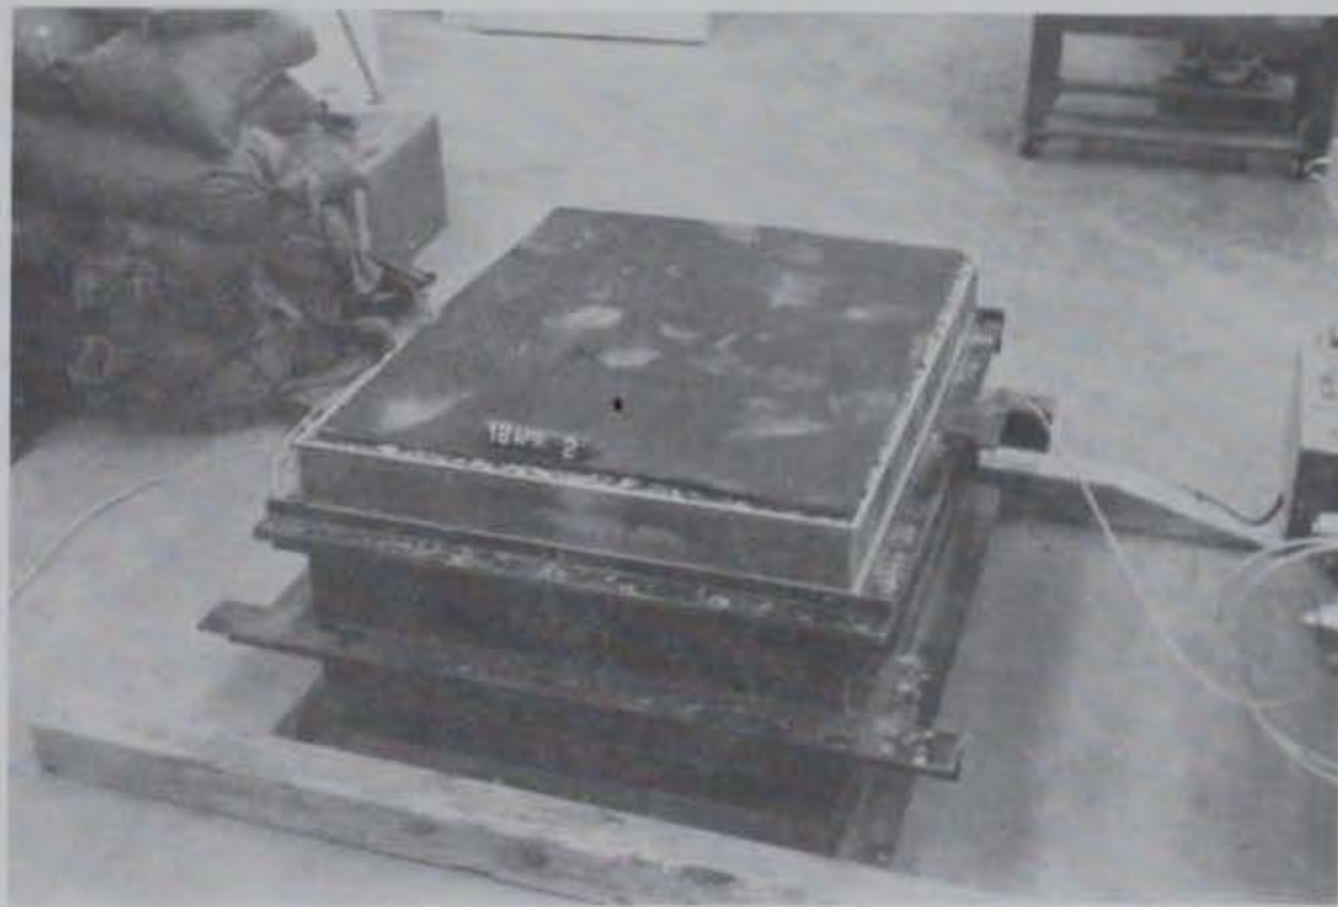
Photo 4. Pavement system prior to test

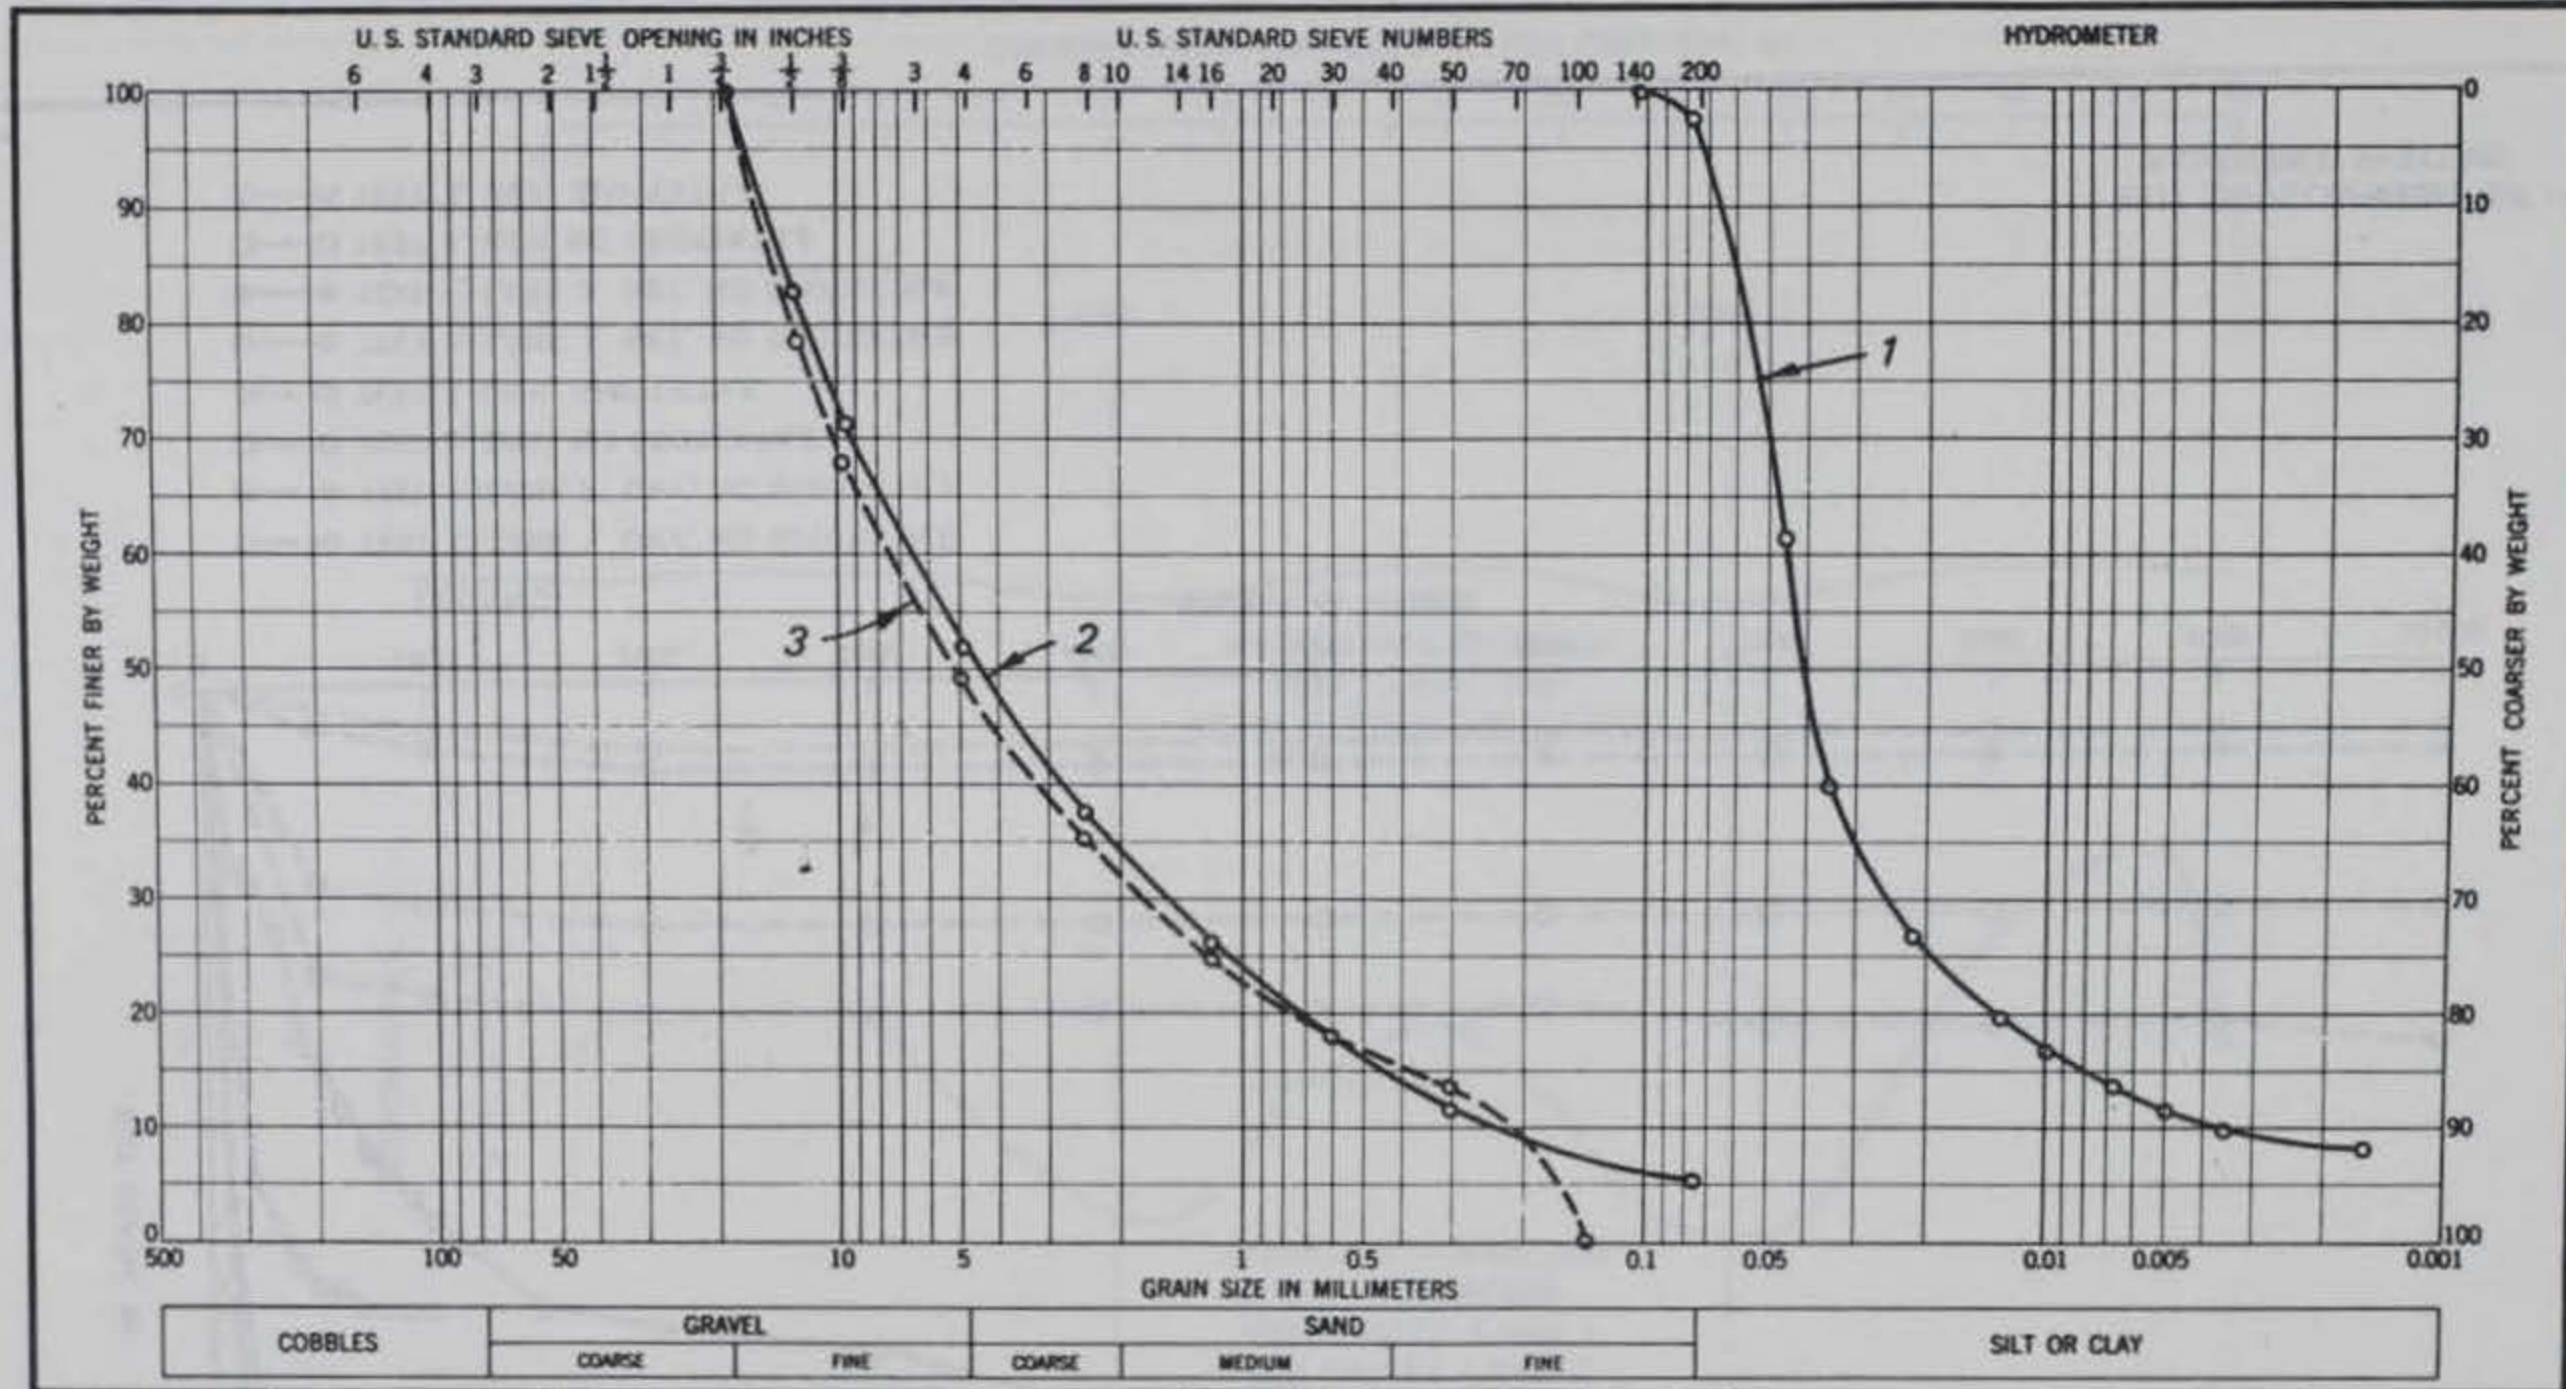
PLATE 1

Sample No.	Elev or Depth	Classification	Nat w %	LL	PL	PI
1	SUBGRADE	Clay (CL)		30	21	9
2	BASE, TEST 1	CRUSHED LIMESTONE				
3	BASE, TESTS 2 & 3	CRUSHED LIMESTONE

GRADATION CURVES

40. A clay (CL)* was used as the subgrade material for the tests. The liquid limit of the clay was 30 and the plastic limit was 21. The gradation curve for the clay is shown in Plate 1. Preweighed amounts of clay were placed in four lifts in the 12-in.-deep soil test box. After each lift was placed, it was compacted with a hand tamper. Samples of clay were obtained during the placement and compaction processes so that the moisture content of the material could be determined. The density of the compacted clay was calculated by dividing the weight of the clay placed in the soil test box by the volume of the test box. After compaction, the moisture content and dry density of the clay were also determined by the direct transmission techniques while using a Troxler Nuclear Densitometer. Comparison of the moisture and density results obtained by the two methods indicated a difference of 1 to

41. Crushed limestone which had a maximum aggregate size of 3/4 in. was used as the base course material. The gradation curve labeled 2 in Plate 1 represented the gradation of the aggregate used in test 1. The aggregate used in tests 2 and 3 are represented by the curve labeled 3 in Plate 1. The crushed limestone was placed and compacted in two lifts in the 6-in.-deep collar which was positioned and clamped to the top of the soil test box. Moisture and dry densities were obtained with a Troxler Nuclear Densitometer (Table 1).

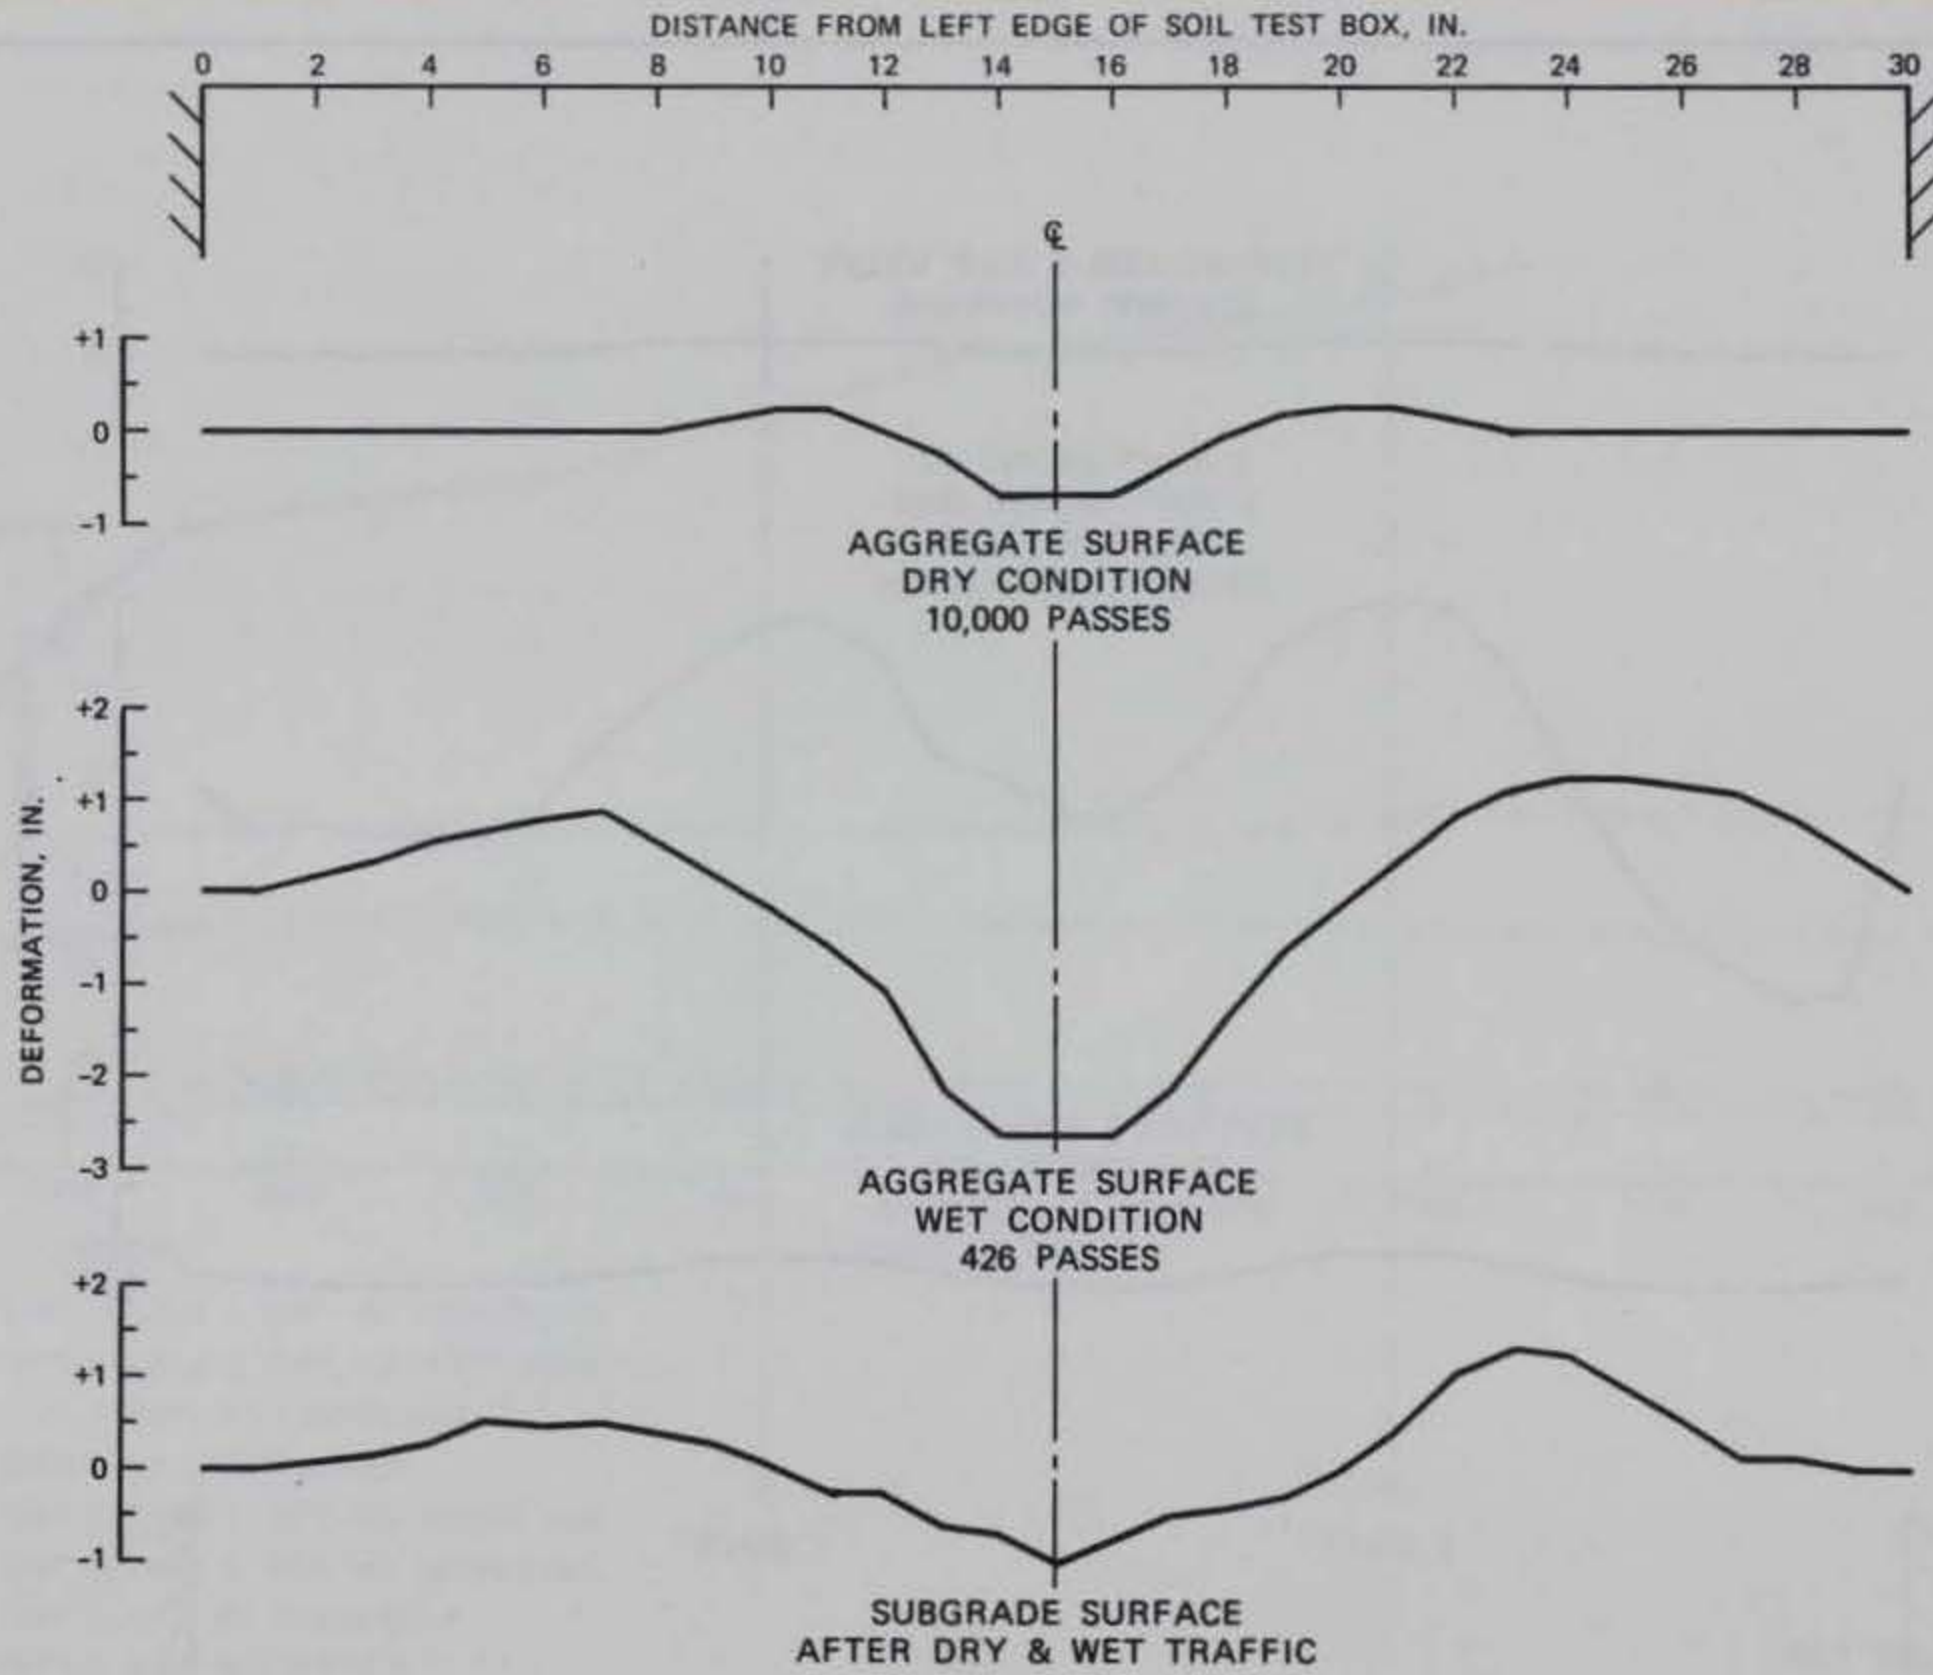
TEST 2
CROSS SECTIONS
