## Contingency Airfield and Road Construction Using Geosynthetic Fiber Stabilization of Sands

by Steve L. Webster, Rosa L. Santoni

Technical Report GL-97-4 April 1997

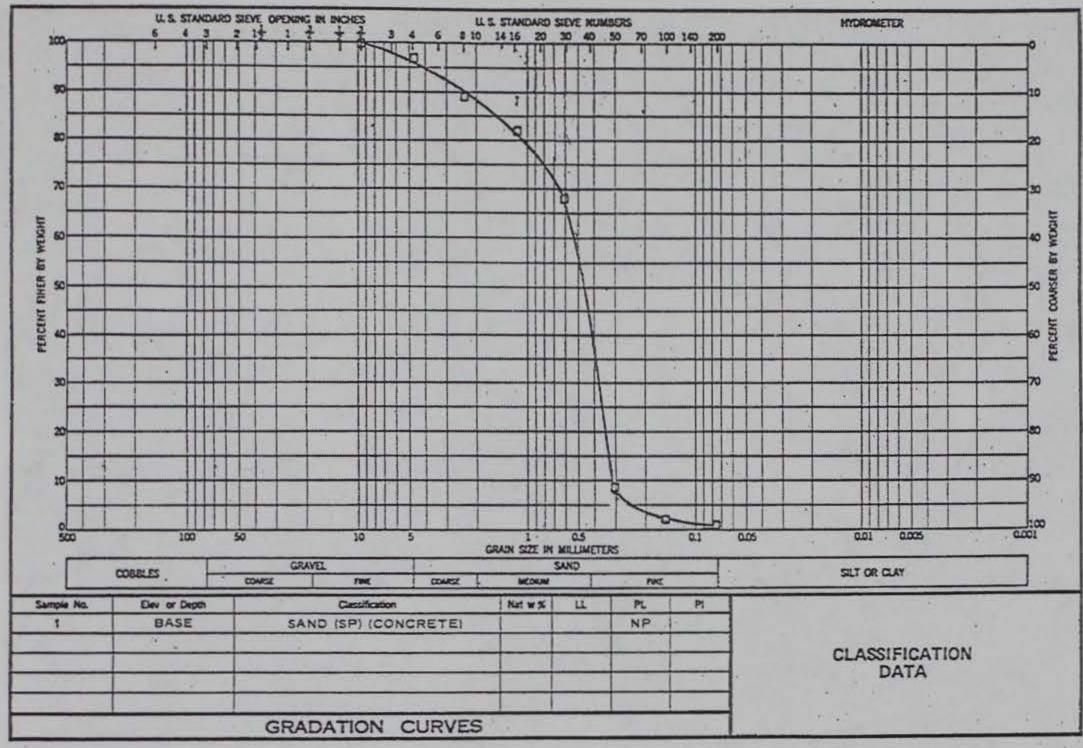
Figure 1. Sand classification data

Sand. The sand used for the initial experiment was a local Vicksburg, MS, sand normally used as fine aggregate in concrete. Classification data for this sand are shown in Figure 1. The sand was a pit-run washed sand containing approximately 4 percent gravel sizes and no minus No. 200 U.S. standard sieve size material. It was classified as a poorly graded (SP) sand, American Society for Testing and Materials (ASTM) D 2487 (ASTM 1992). Additional data for the sand are provided in Table 1 (dry unit weights were tested using ASTM D 4253.

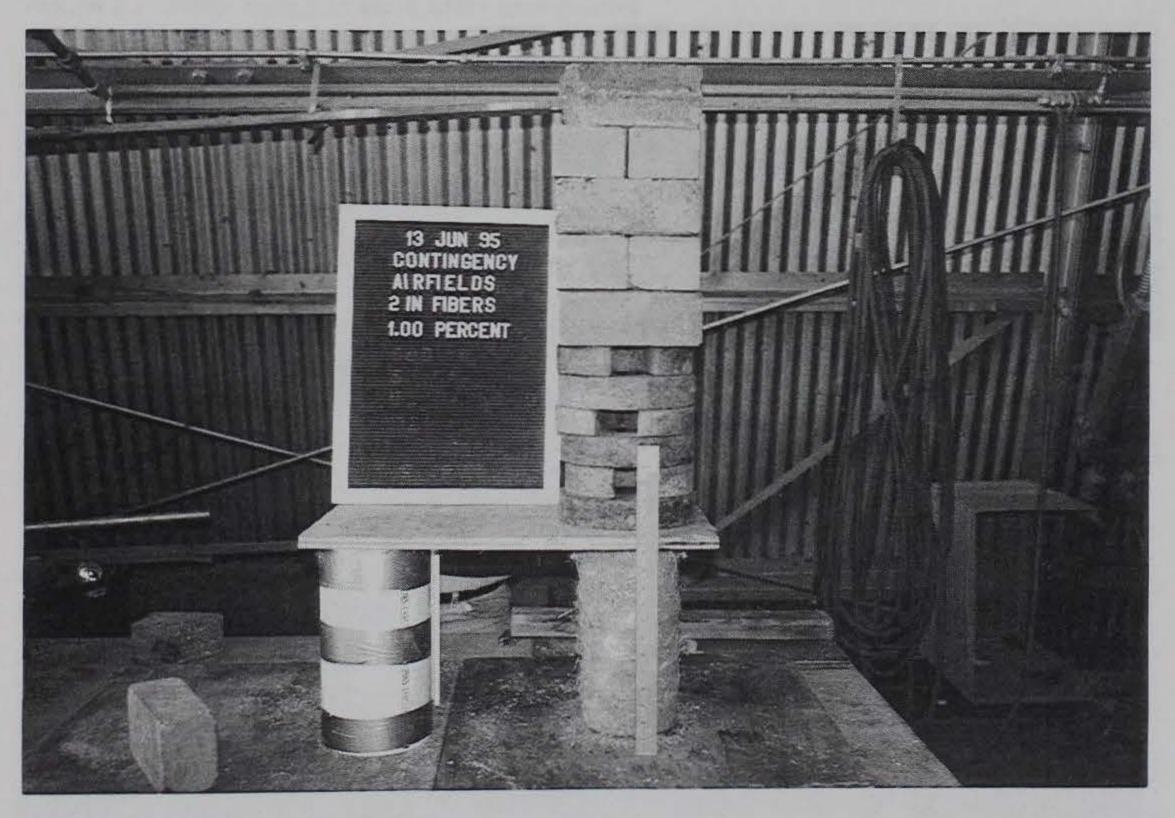
Figure 2. Sand-fiber sample with 201-lb loading

Table 3 summarizes the result of the initial sand-fiber tests. The control sample (no fiber) collapsed with an 8.5-lb brick load. The sand-fiber specimens produced higher resistance to deformation than the control sample. The sample containing 2 percent fibers had more initial deformation than the sample with 1 percent fibers. The increased deformation at a lower load caused the test load to tilt and fall.

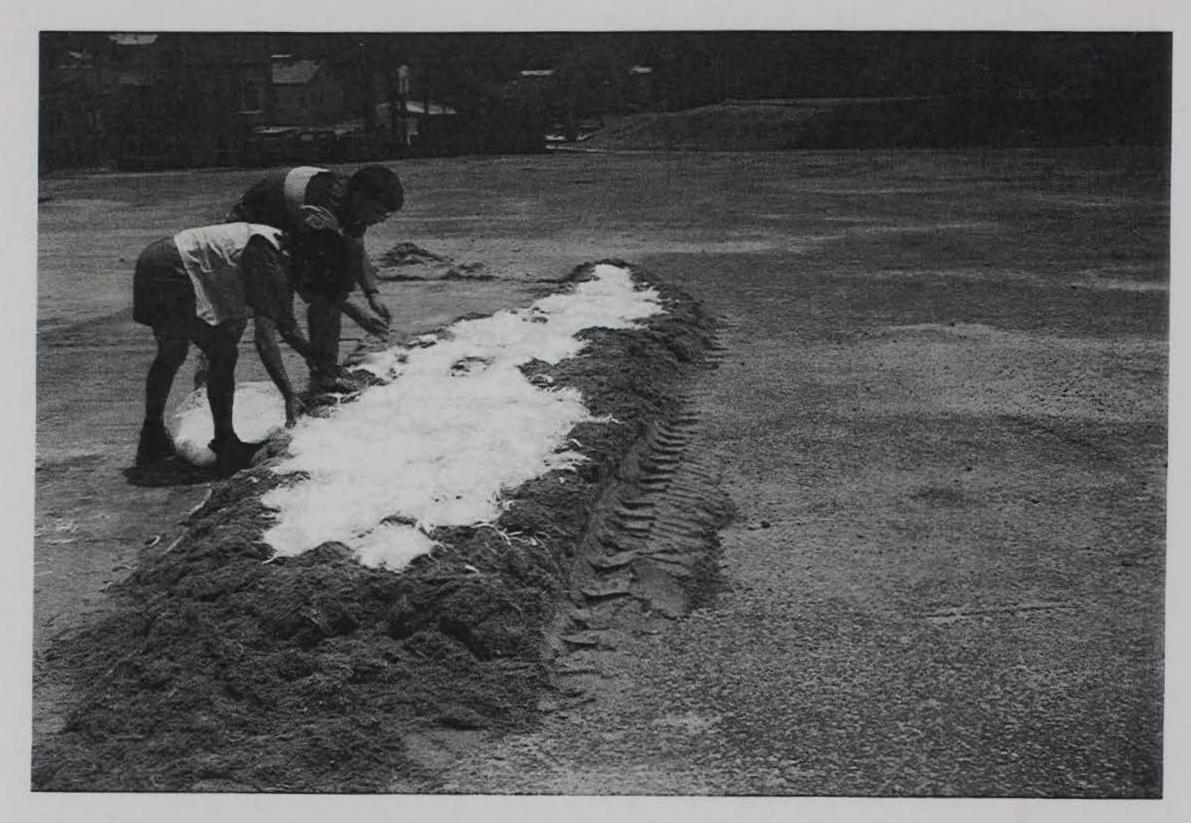
Figure 3. Monofilament fibers on sand surface

The field mixing procedure consisted of spreading the fibers on the sand surface and making repeated passes with the rotary mixer as shown in Figures 3 and 4. Visual observations indicated that four passes were required to separate the yarn into individual fibers and uniformly mix them throughout the sand layer. Figures 5 and 6 show the uniformity of the sand-fiber mix after four passes with the self-propelled rotary mixer.

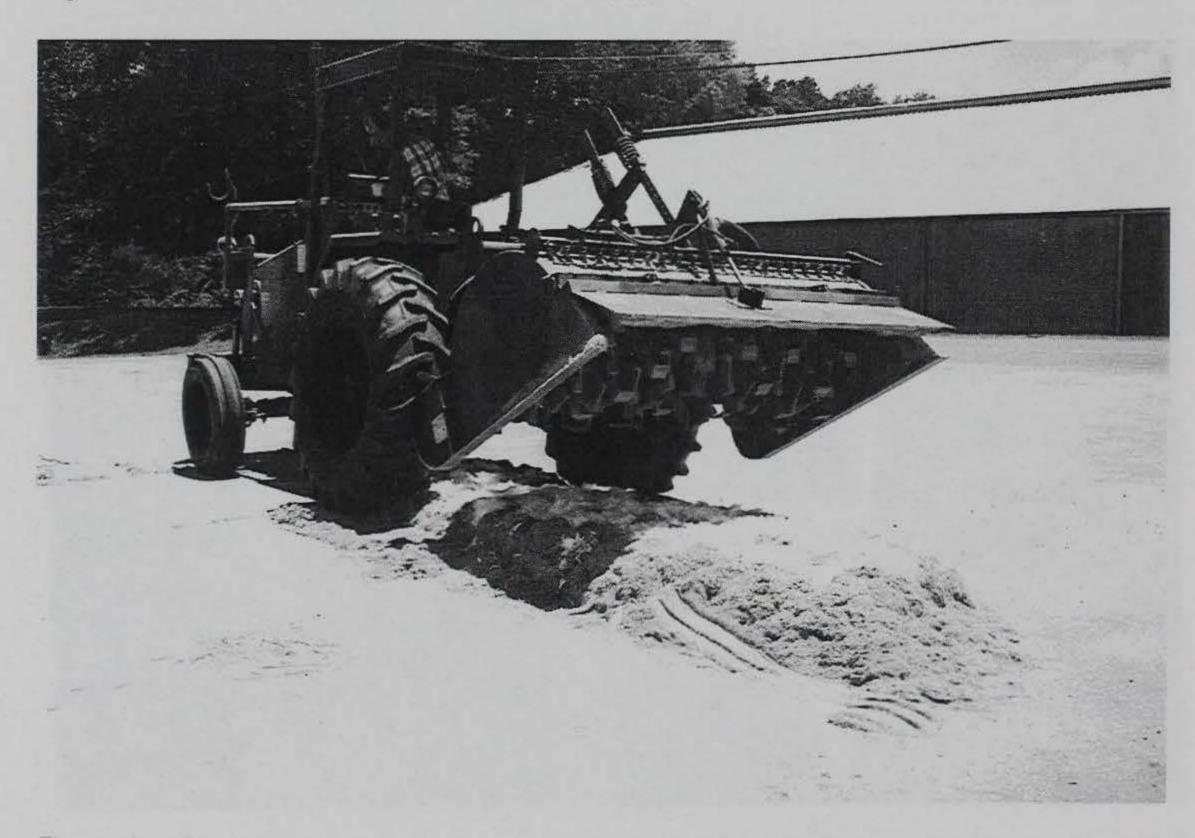
Figure 4. Field mixer equipment

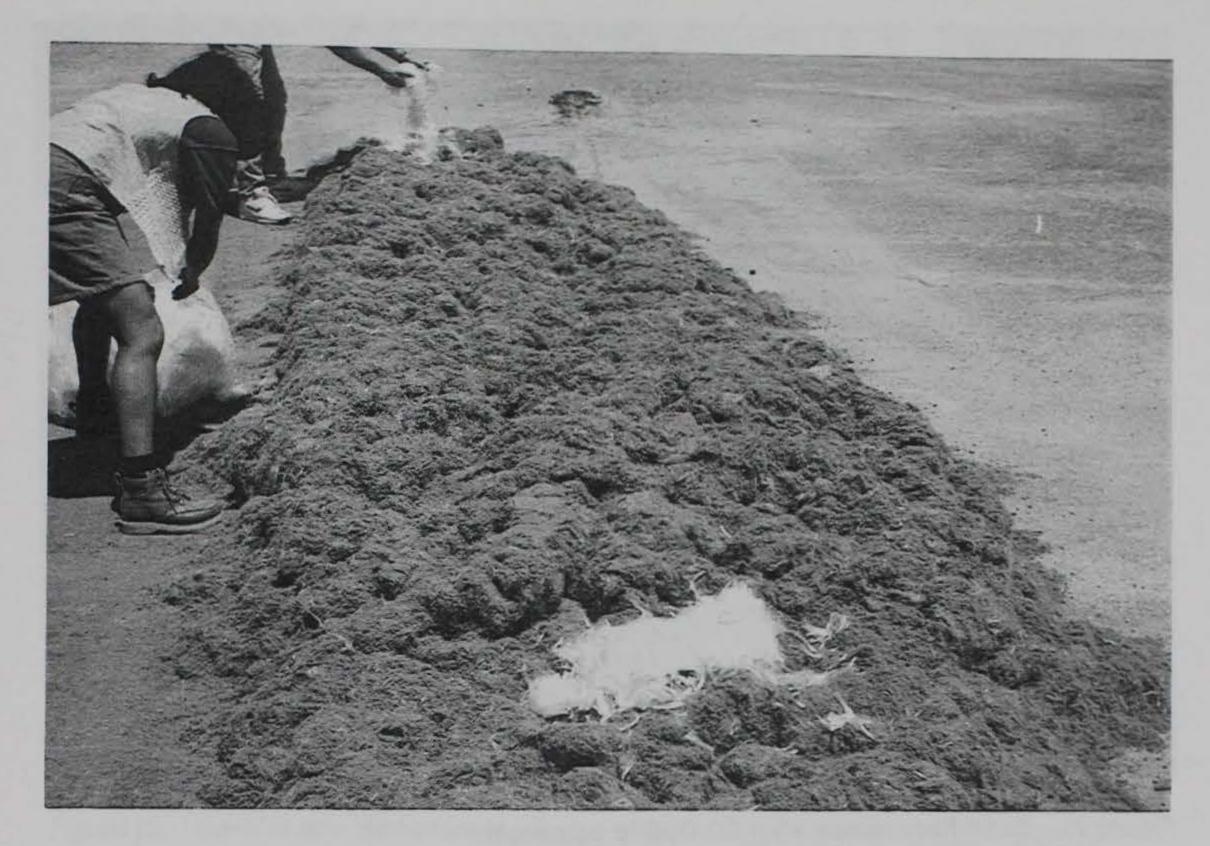
Figure 5. Fiber mixed in sand after four passes

The field mix of sand and fibers consisted of 3,600 lb of moist concrete sand (SP). The sand had an average moisture content of 6 percent. The amount of fiber used was 80 lb which was 2.4 percent (based on dry weight of the sand) of fiber in the mix. A total of 80 lb of fiber (2.4 percent based on dry weight of the sand) was mixed into the sand. First, 0.2 percent of the fiber was mixed into the sand using four passes of the mixer. The fiber content was then increased to 0.5, 1, and finally 2.4 percent. In all the cases, the fibers in the field mixed material looked very uniformly distributed after four passes of the mixer.

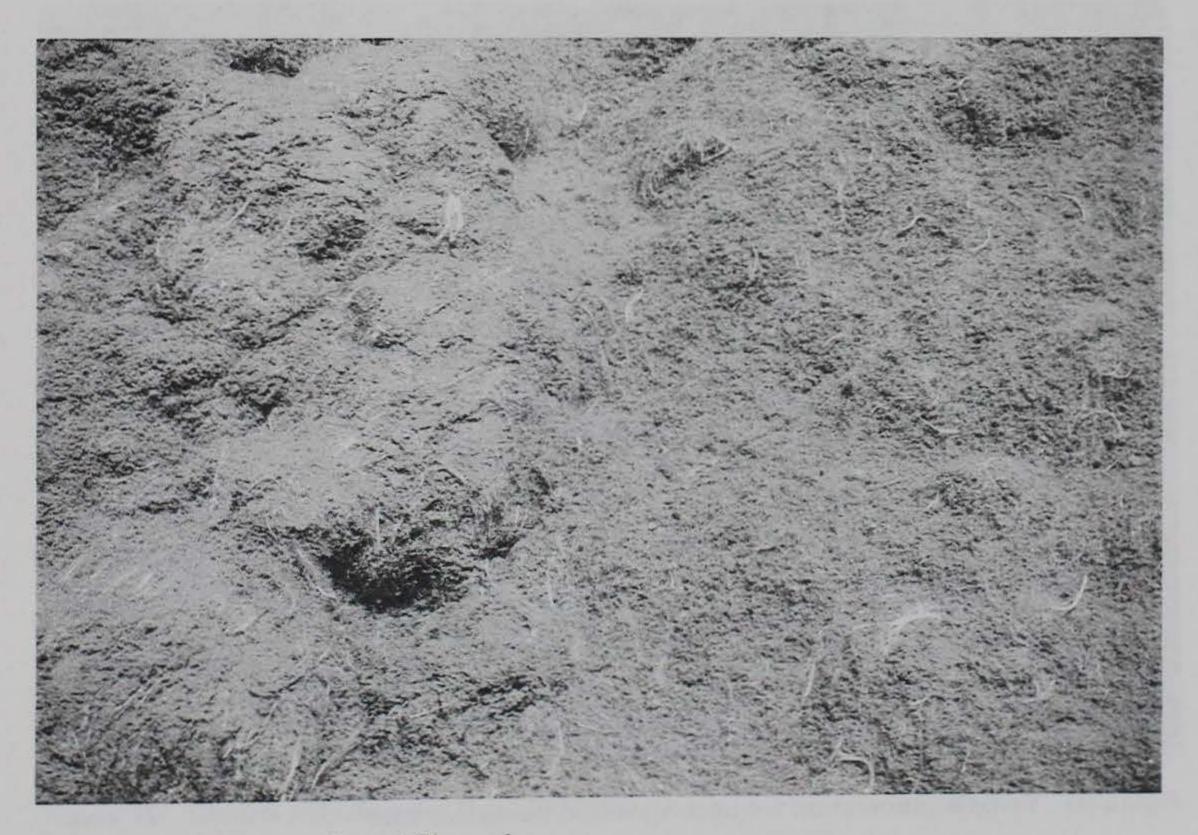
Figure 6. Close-up of sand-fiber mix

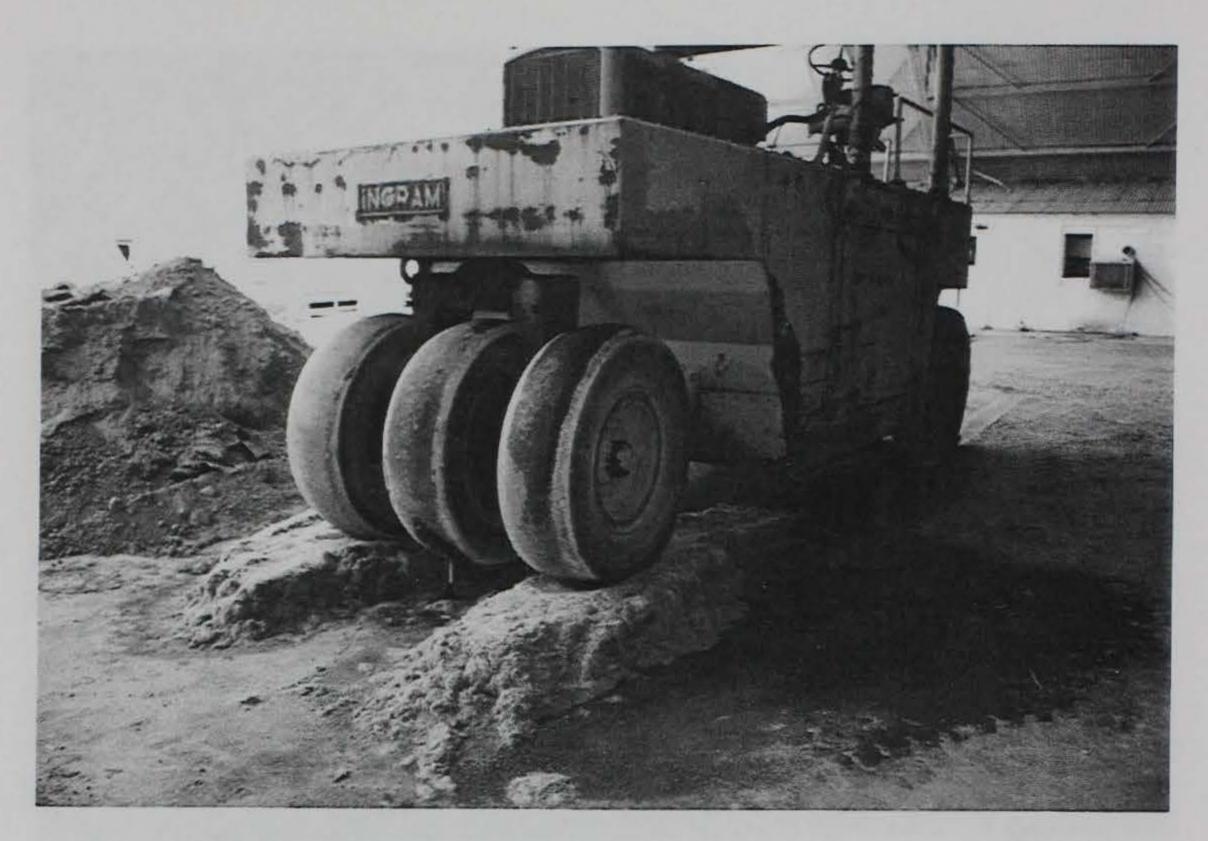
Figure 7. Sand-fiber ramps with 50,000-lb compactor

The self-propelled rotary mixer produced a uniform distribution of the sand-fiber mix during the field mixing evaluation. Sand-fiber mixing can be easily accomplished using existing military construction equipment. A 50,000-lb compactor was positioned over two sand-fiber ramps to evaluate the field sample load-carrying capacity of the field mixed material (Figure 7). The sand-fiber ramps supported the heavy weight without significant deformation.

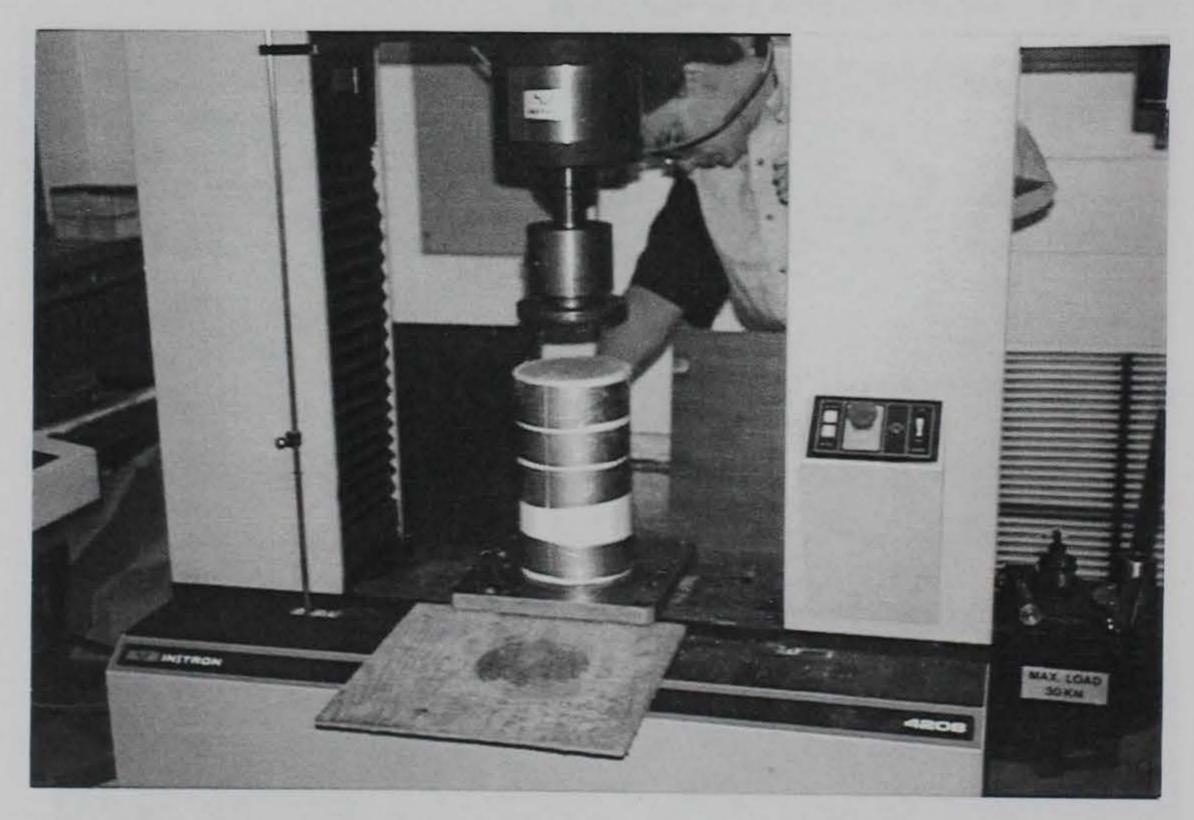
Figure 8. Sample preparation for unconfined compressive test

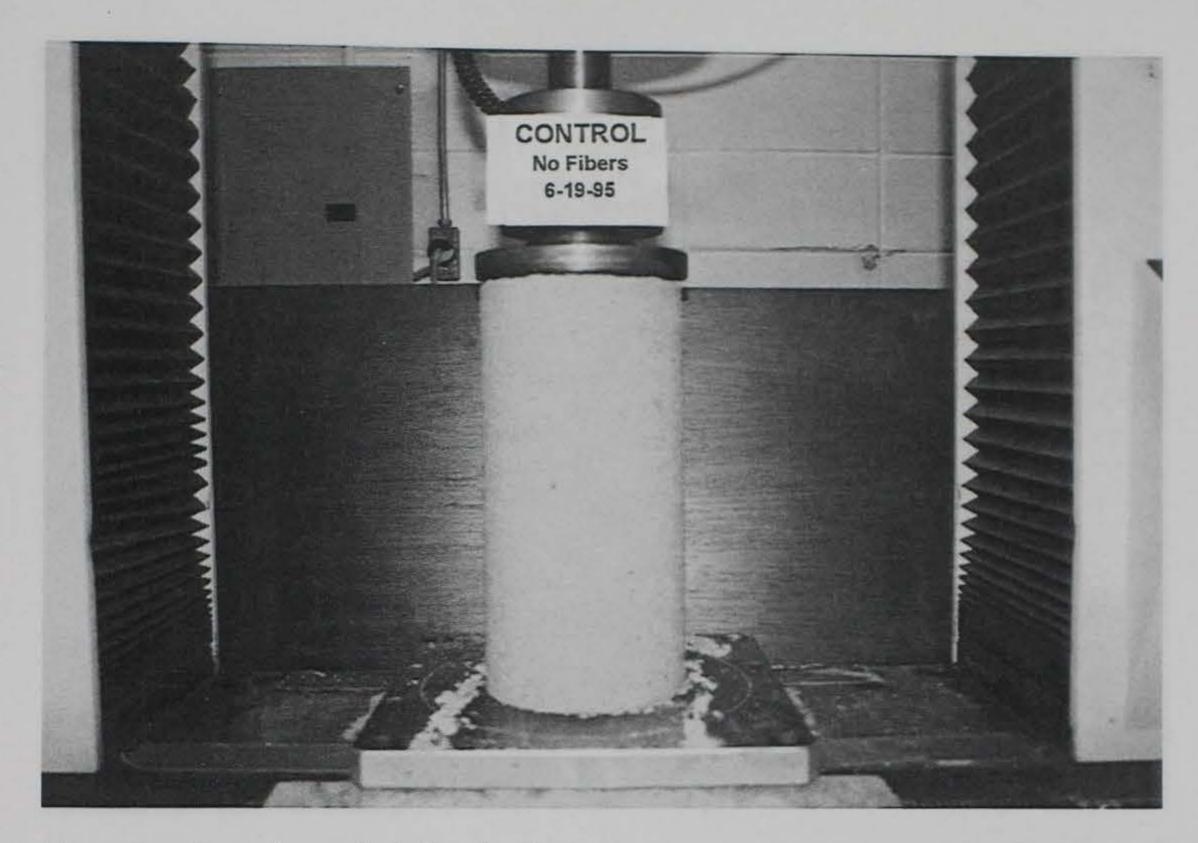
Figure 9. Control sample before loading

Figures 9 and 10 show the control sample (no fibers) before loading and after loading. The control sample collapsed under a load of 9.67 lb.

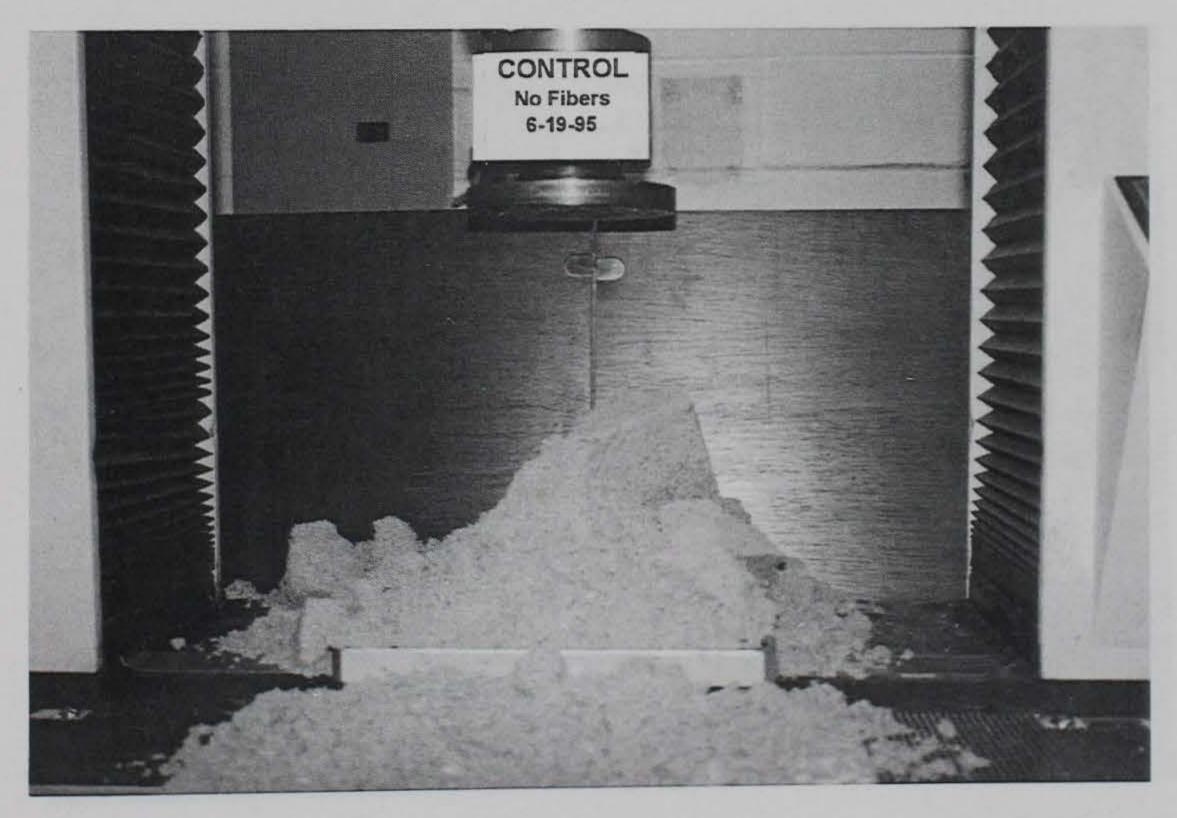
Figure 10. Control sample after 9.67-lb load

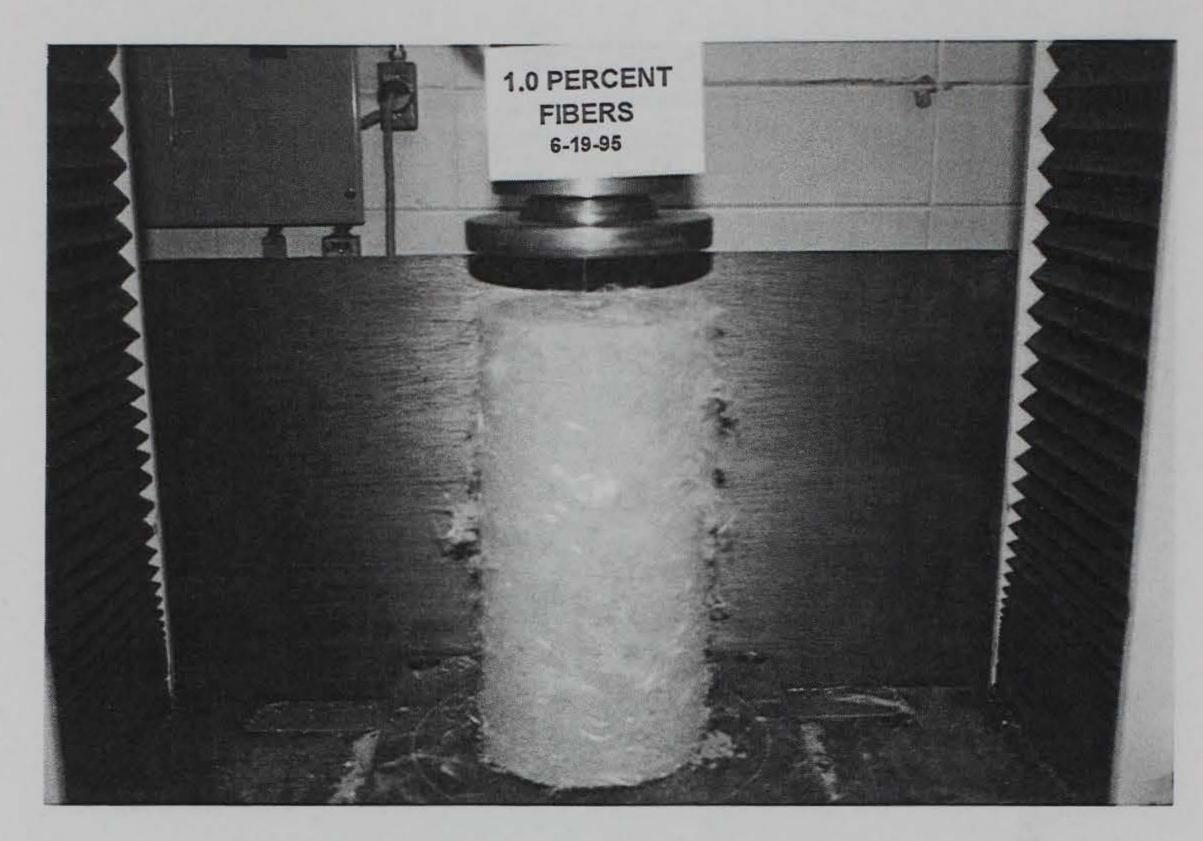
Figure 11. Sand-fiber sample with 1 percent of fiber before loading

Significant load improvement results were found for the sand-fiber samples. Figures 11 and 12 show the 1 percent fiber sample before loading and after the application of 750 lb of load with a permanent deformation of 1.5 in. The sample was then subjected to a continuous load increase until 6 in. of deformation occurred under a total load of more than 4,000 lb (Figure 13). Very little sand had fallen from the specimen.

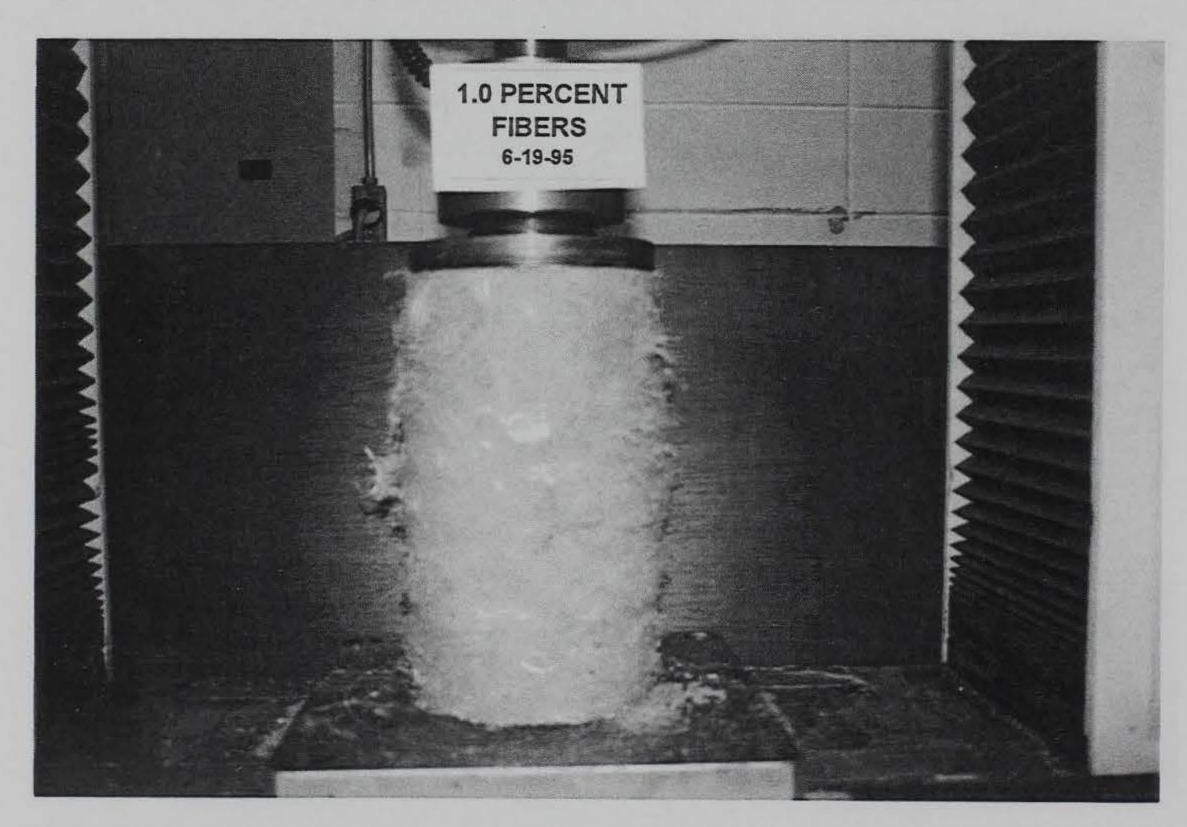
Figure 12. Sand-fiber sample (1 percent) after 750-lb load

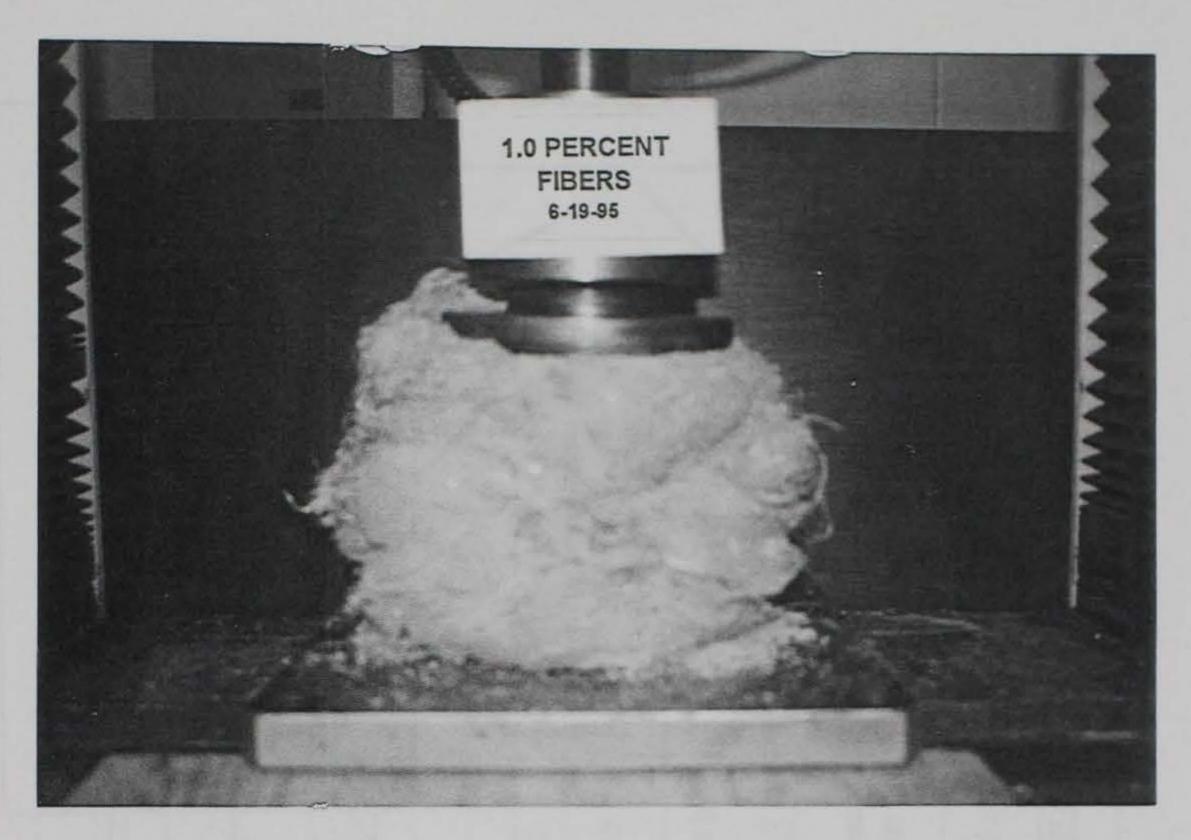
Figure 13. Sand-fiber sample (1 percent) after 4,000-lb load

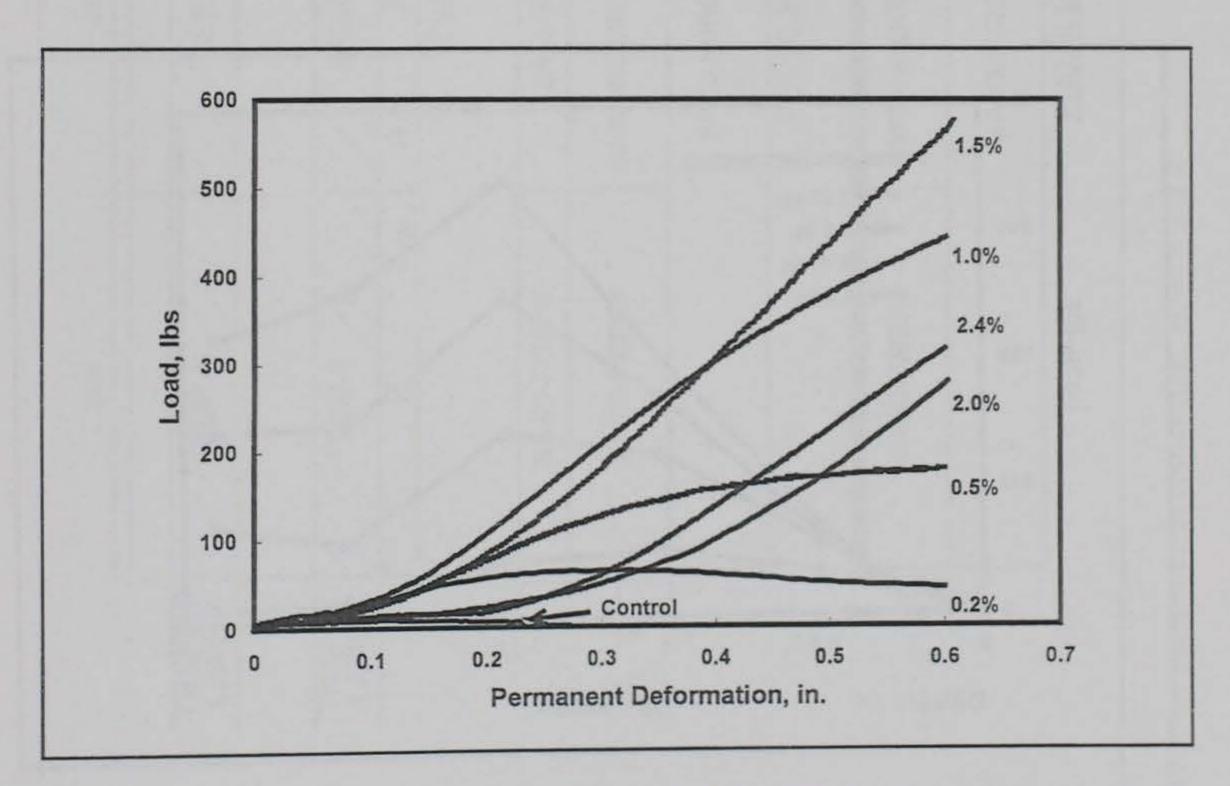
Figure 14. Relationship between percent of fiber and permanent deformation

Figure 14 shows plots of the load-deformation data for all test specimens for deflection ranges from 0 to 0.6 in. The plots show that there are optimum fiber contents for maximum loads within this deformation range. For example, from 0 to 0.4 in. of deformation the optimum fiber content of approximately 1 percent produced the maximum loads. Higher fiber contents of 1.5 to 2.4 percent show slow initial strength gain at low deformations with more rapid strength gains at higher deformations. Excess amounts of fiber may interfere with the grain-to-fiber contact that results in a spongy sample that must be compressed before the beneficial grain-to-fiber interaction occurs.

Figure 14 also shows that the field mixed sample (2.4 percent fiber) performed in a similar pattern as the 2.0 percent laboratory prepared specimen. The results showed that the laboratory mixing adequately replicated the field mixing procedure. In both cases, the mix was uniform and the fibers were randomly distributed. It is seen that for this granular soil (SP), a significant improvement in load-carrying capacity was obtained for each sample.

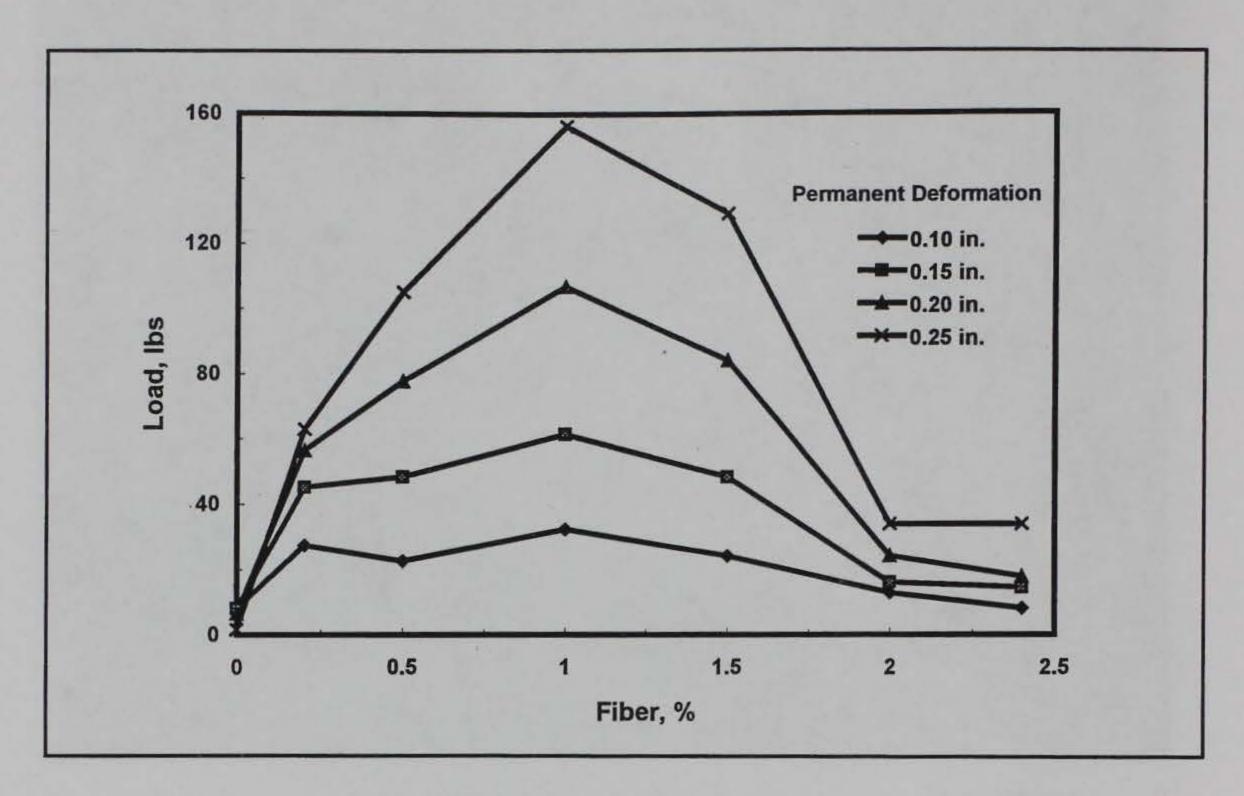
Figure 15. Optimum percent of fibers (0-to 0.25-in. deformation)

Optimum fiber content. Figures 15 and 16 show plots of load versus fiber content for permanent deformation ranges of 0.10 to 0.25 in. (Figure 15) and 0.25 to 1.0 in. (Figure 16). Figure 15 shows that for low deformations the optimum fiber content is approximately 1 percent (based on dry weight of sand). For larger deformations up to 1.0 in., the optimum fiber content increases to 1.5 percent. Since low deformations are desirable under traffic wheel loads, 1 percent fiber was selected optimum for use in the field experiments.

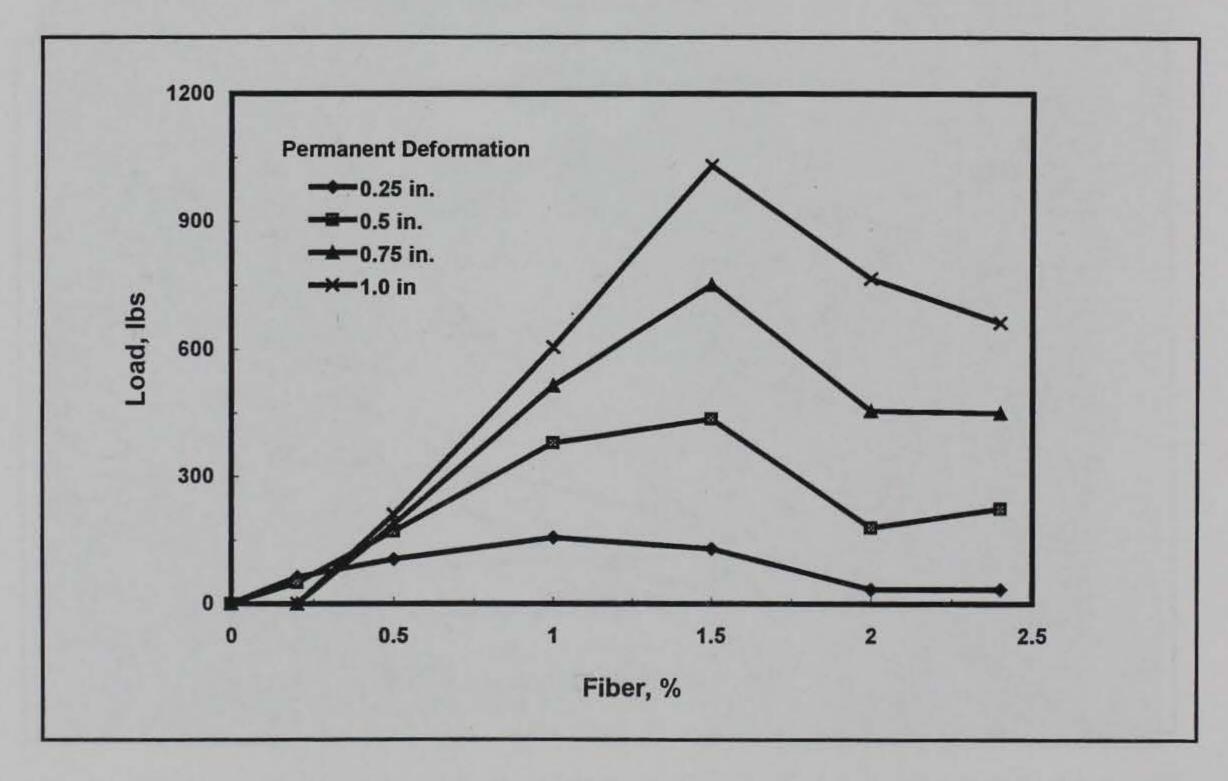
Figure 16. Optimum percent of fibers (0.25-to 1.0-in. deformation)

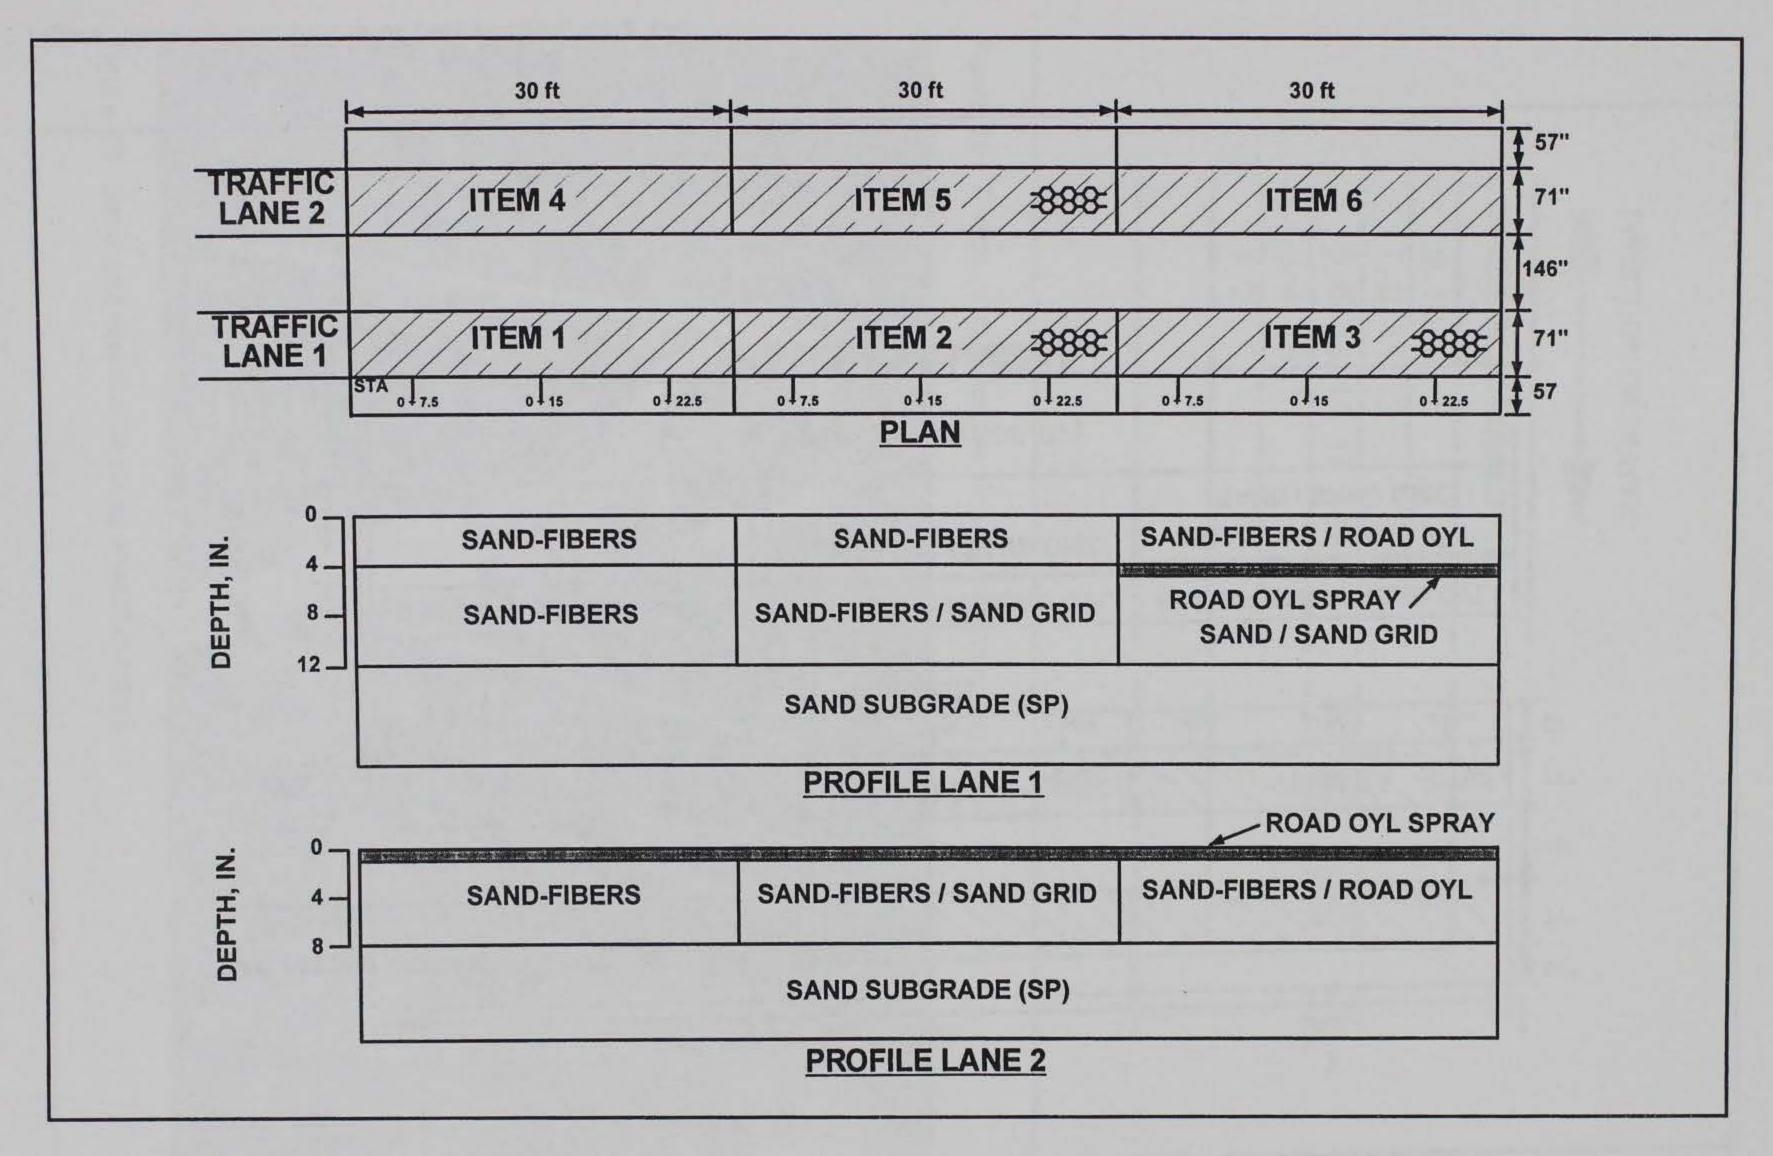
Figure 17. Plan and profile of test section, lanes 1 and 2

A plan and profile of the test section is shown in Figures 17 and 18. The test section was designed to test the load-carrying capability of various fiber-reinforced sand test items under C-130 aircraft with wheel loads of 30,000-lb and 100-psi tire pressure. All test items were constructed on an 18-in.-thick sand subgrade. The test section contained two traffic lanes. Each traffic lane contained three test items. Both traffic lanes utilized a distributed type traffic (Figure 19) over a width of five wheel paths (71 in.). After traffic tests were completed on lane 1, the items were reconstructed as shown in the profile in Figure 18. Test items in traffic lane 2 were 8 in. thick, and items in traffic lanes 1 and 1A were 12 in. thick. Sand grid was included in some test items to provide additional stability to the base layer. Road Oyl (a resin modified emulsion bonding agent) was included in some items to provide additional base stability and a wearing surface for the C-130 wheel loads.

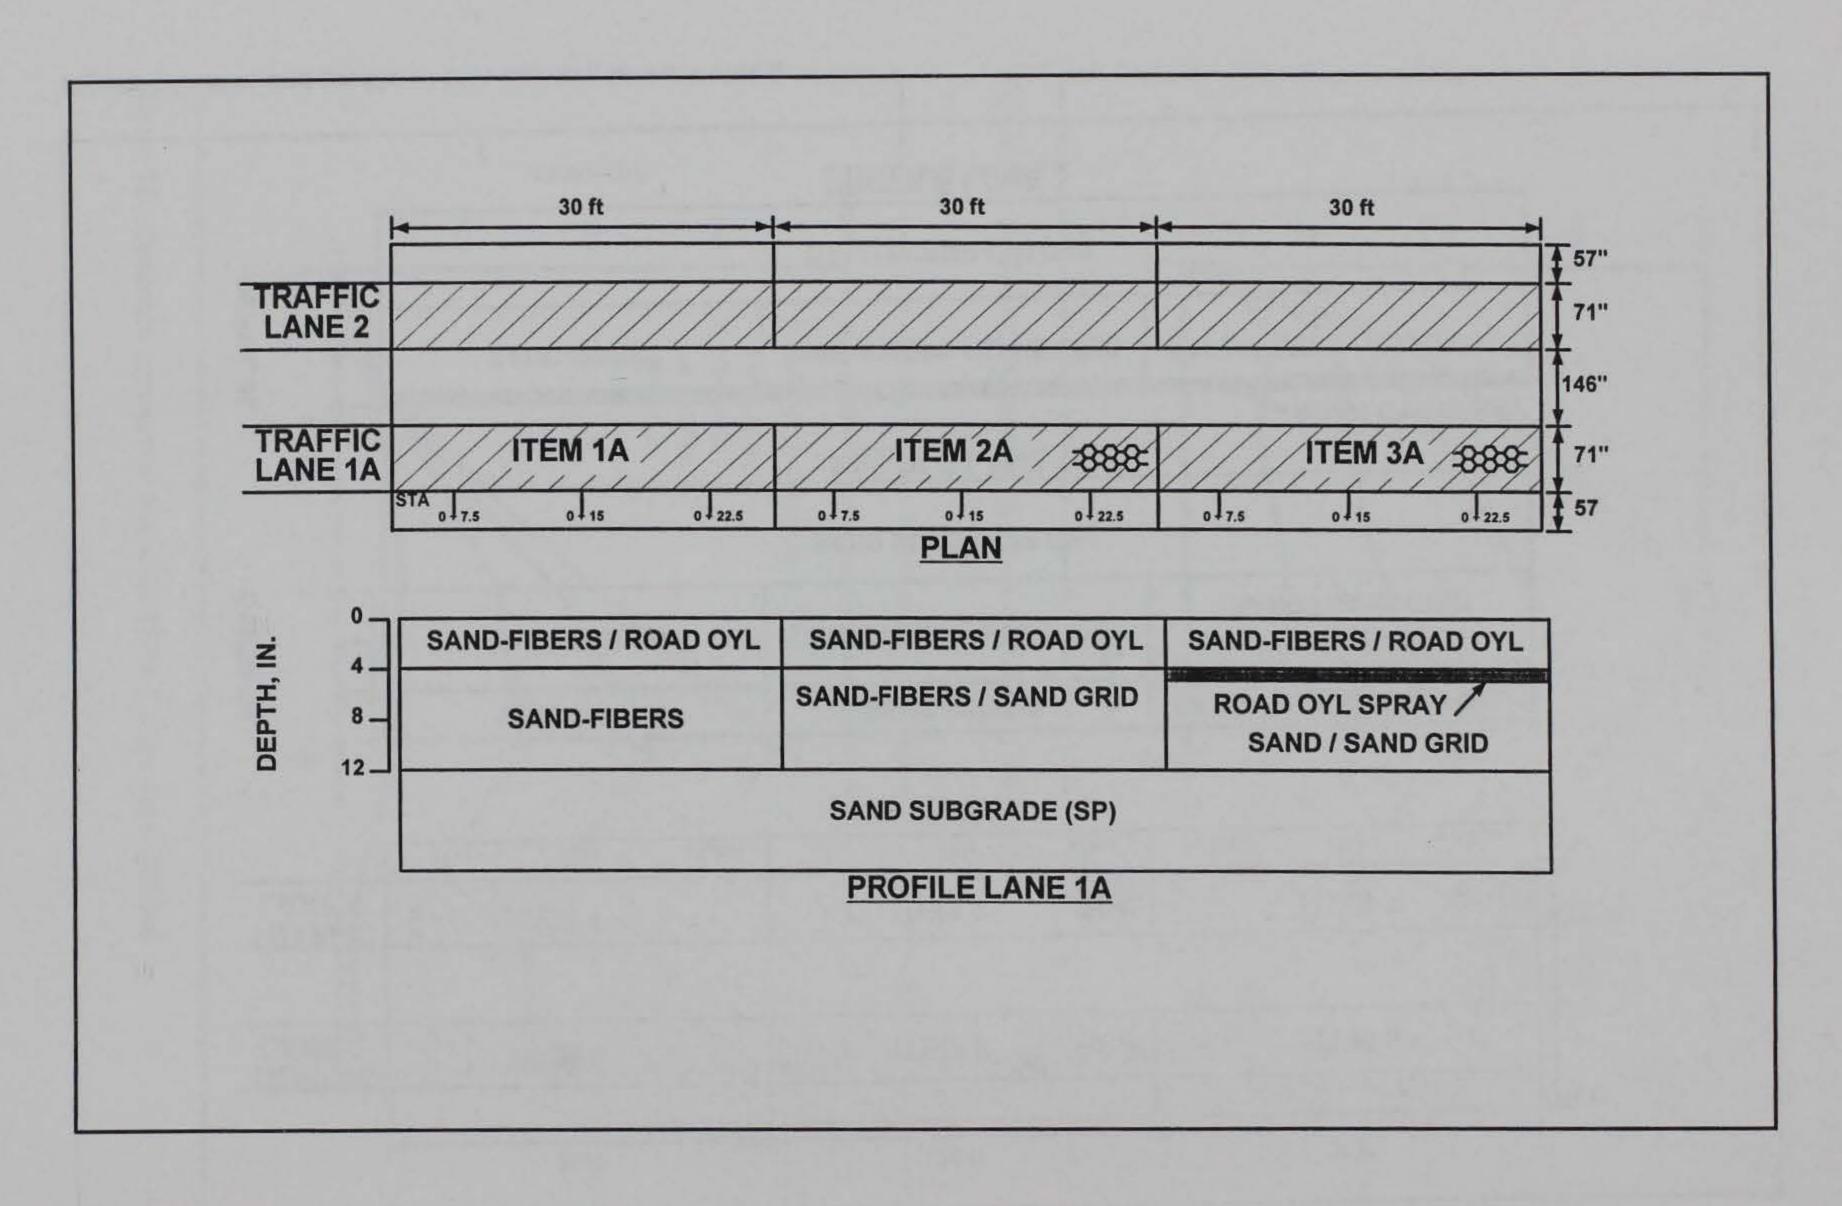
Figure 18. Plan and profile of test section, lane 1A

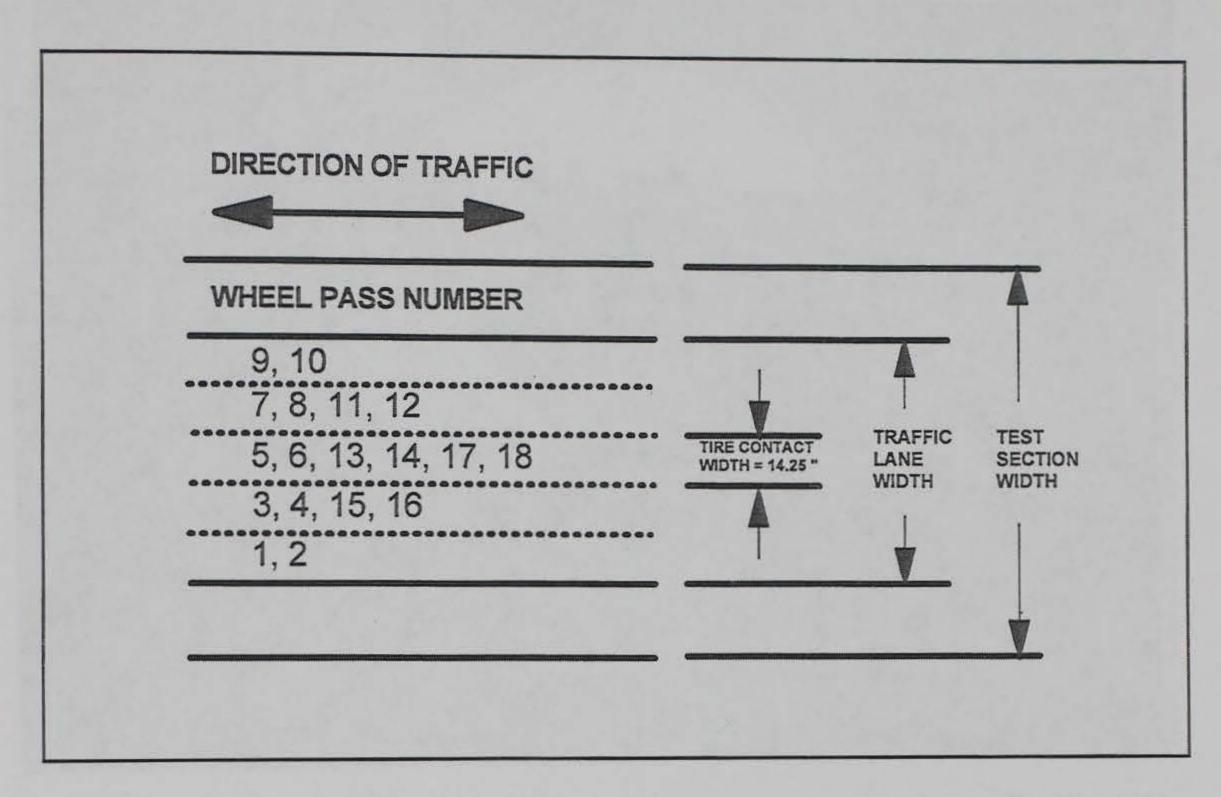
Figure 19. Traffic pattern for the single-wheel test cart
