## Contingency Airfield and Road Construction Using Geosynthetic Fiber Stabilization of Sands

by Steve L. Webster, Rosa L. Santoni

Technical Report GL-97-4 April 1997

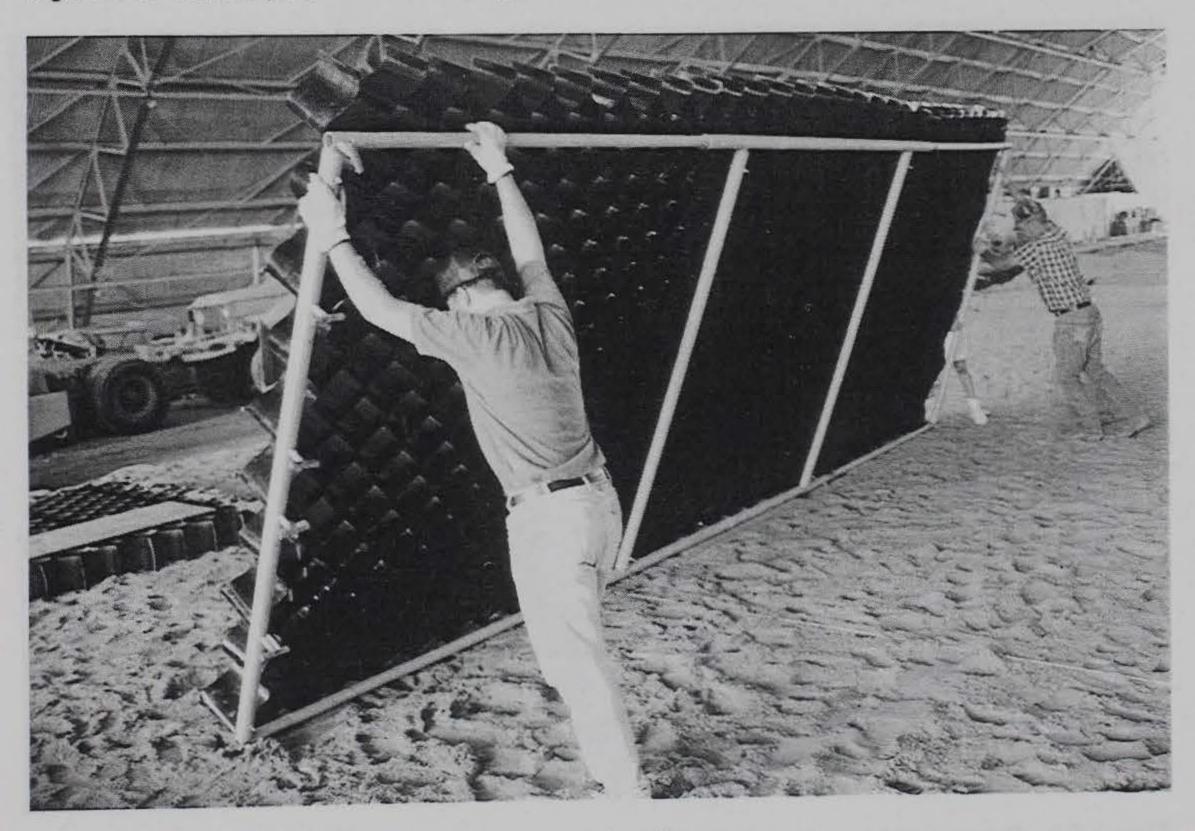
Figure 20. Sand grid installation using stretcher frame

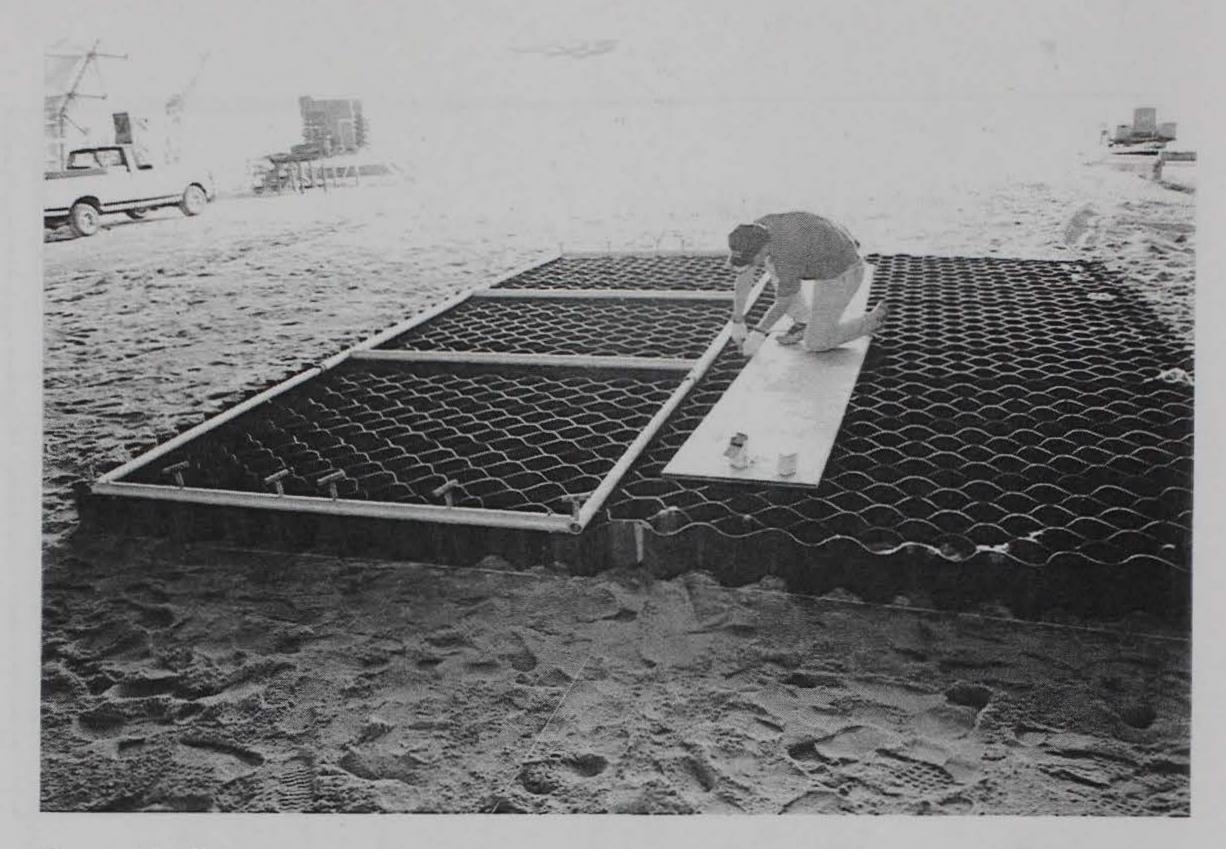
Figure 21. Connecting sections of sand grid using hog rings

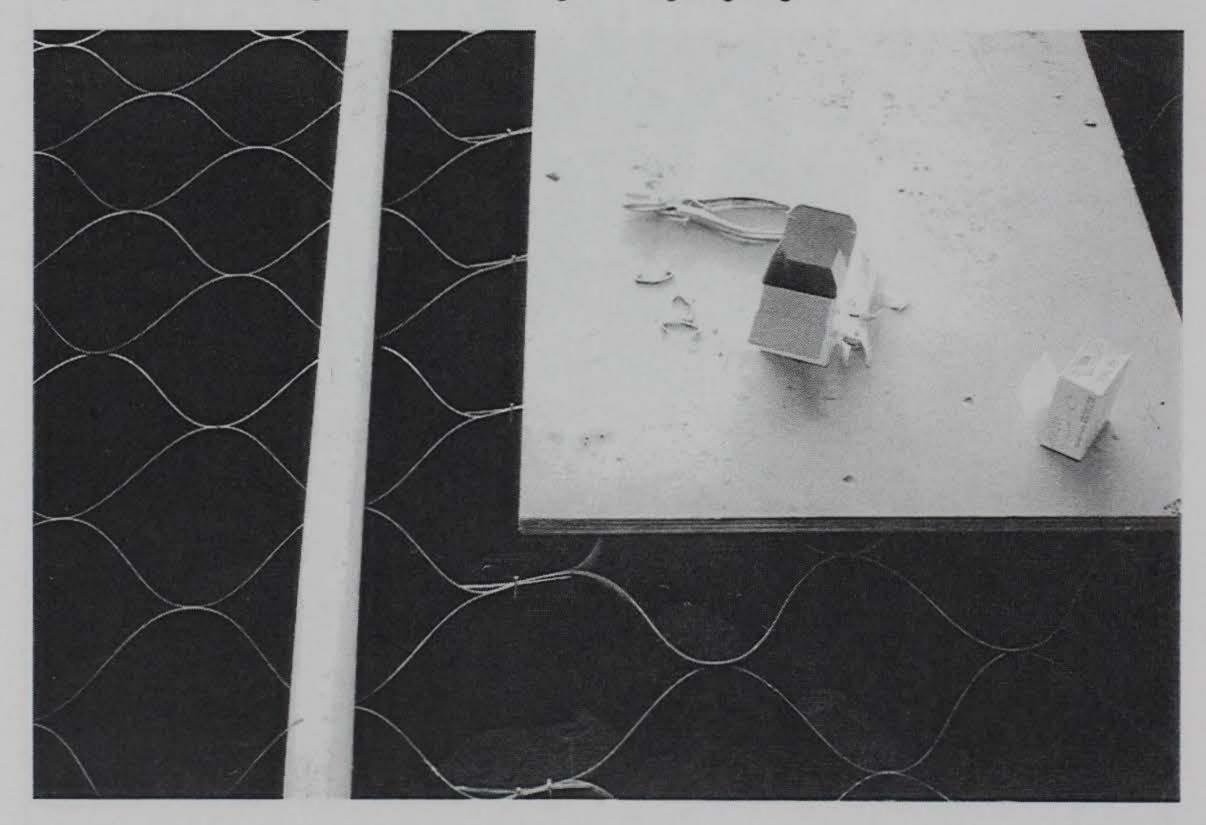
Figure 22. Close-up of hog ring connections

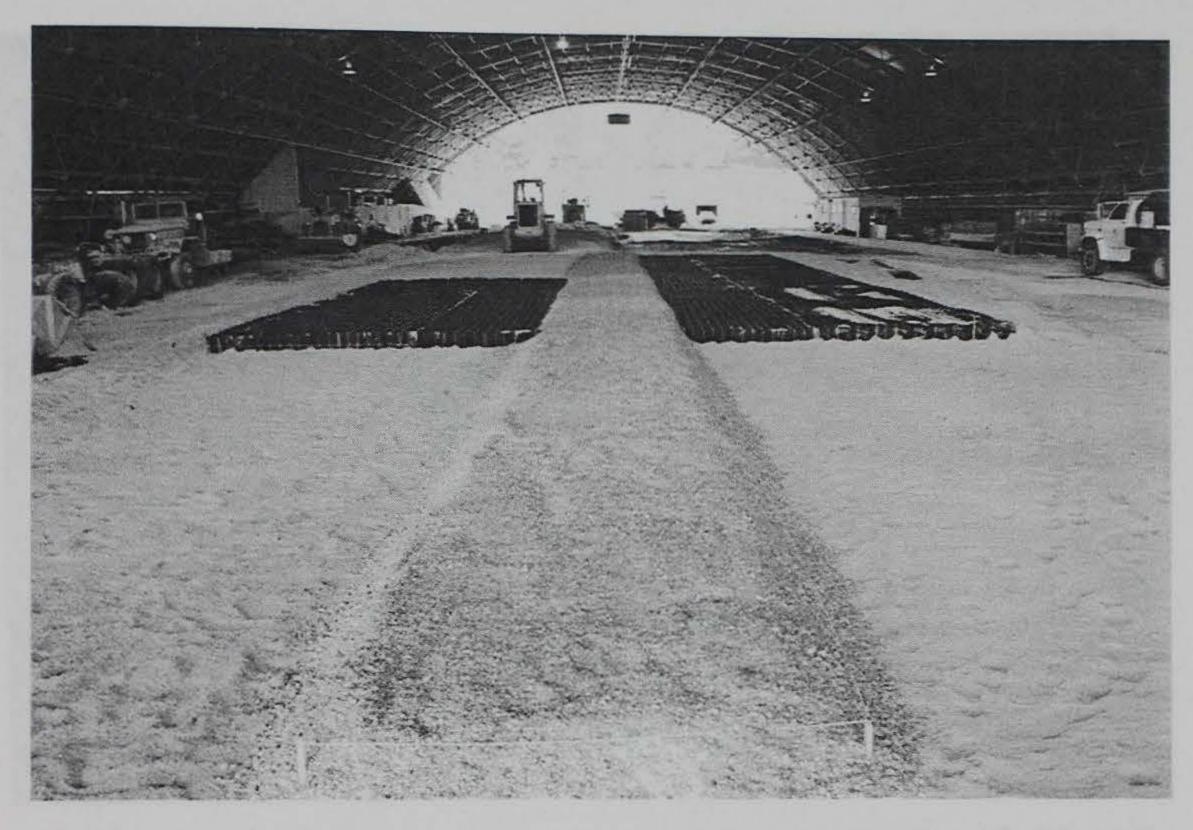
Figure 23. Completed sand grid installation

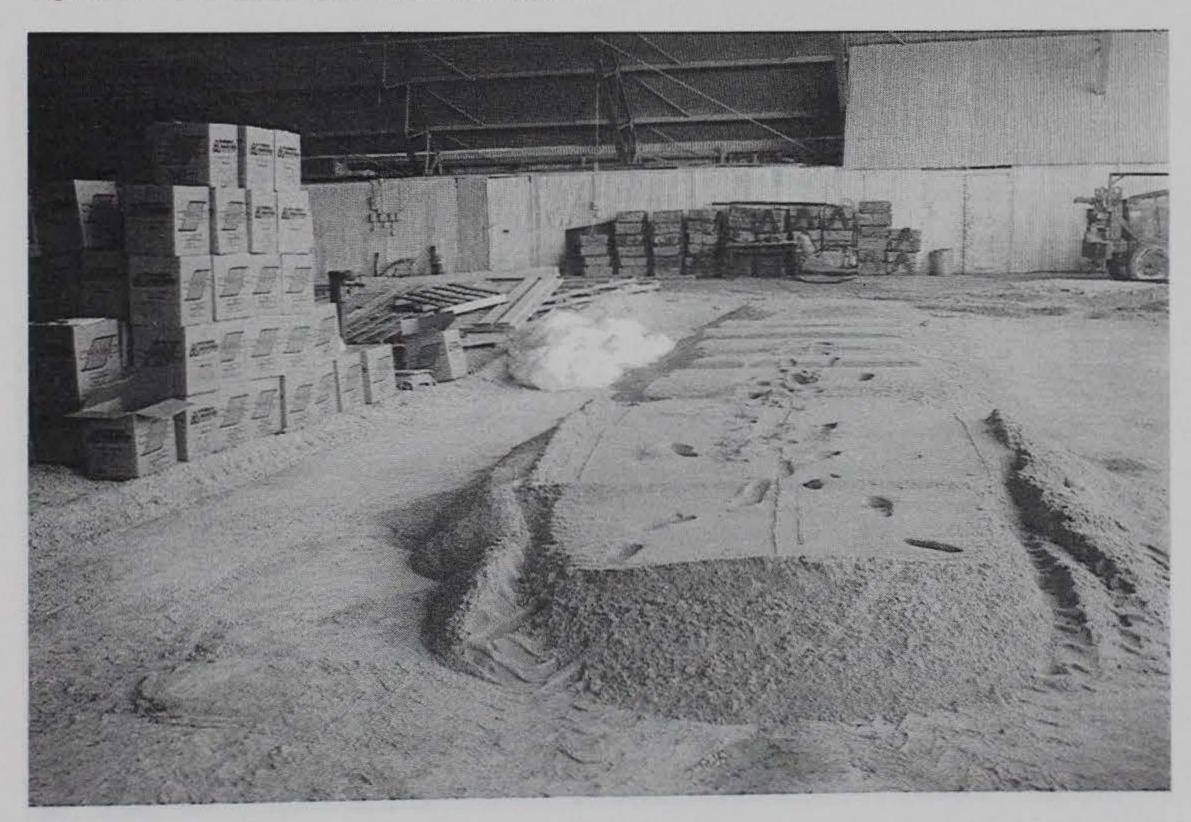
Figure 24. Sand for typical item, prior to adding fibers

The sand-fiber mixture used in items 1, 2, 4, and 5 was mixed at a working area adjacent to the test section site. After mixing, the sand-fiber material was installed and compacted in the test section. Figure 24 shows the sand for one of the test items prior to adding the fiber stabilization. The moisture content of the sand was approximately 4 percent. A total of 1 percent fibers (by weight) was mixed into the sand. Figure 25 shows spreading one-half the required fibers on the sand layer. Figure 26 shows a close-up of the fibers on the sand. Each clump of fibers contained several hundred individual fibers each about the diameter of fine human hair. The fibers were mixed into the sand using 4 passes with the self-propelled rotary mixer used by U.S. Army Engineers (Figure 27). The sand-fiber layer was then turned over using a front-end-loader and the remaining fibers were placed and mixed using four passes of the rotary mixer to ensure a uniform sand-fiber mixture for the whole layer. Figure 28 shows the sand-fiber mixture after the final 4 passes with the rotary mixer. Most of the clumps of fibers had disappeared and the hair-like fibers were uniformly mixed throughout the sand.

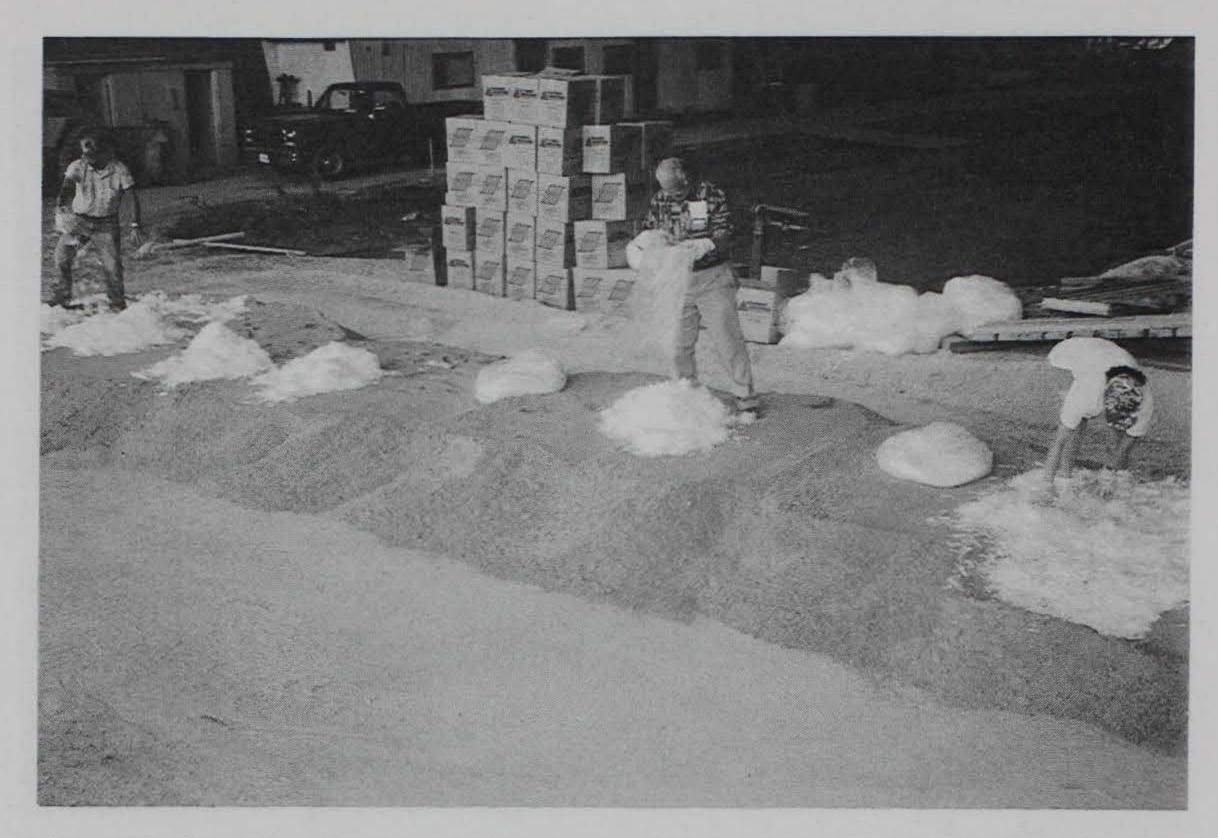
Figure 25. Spreading fibers on sand

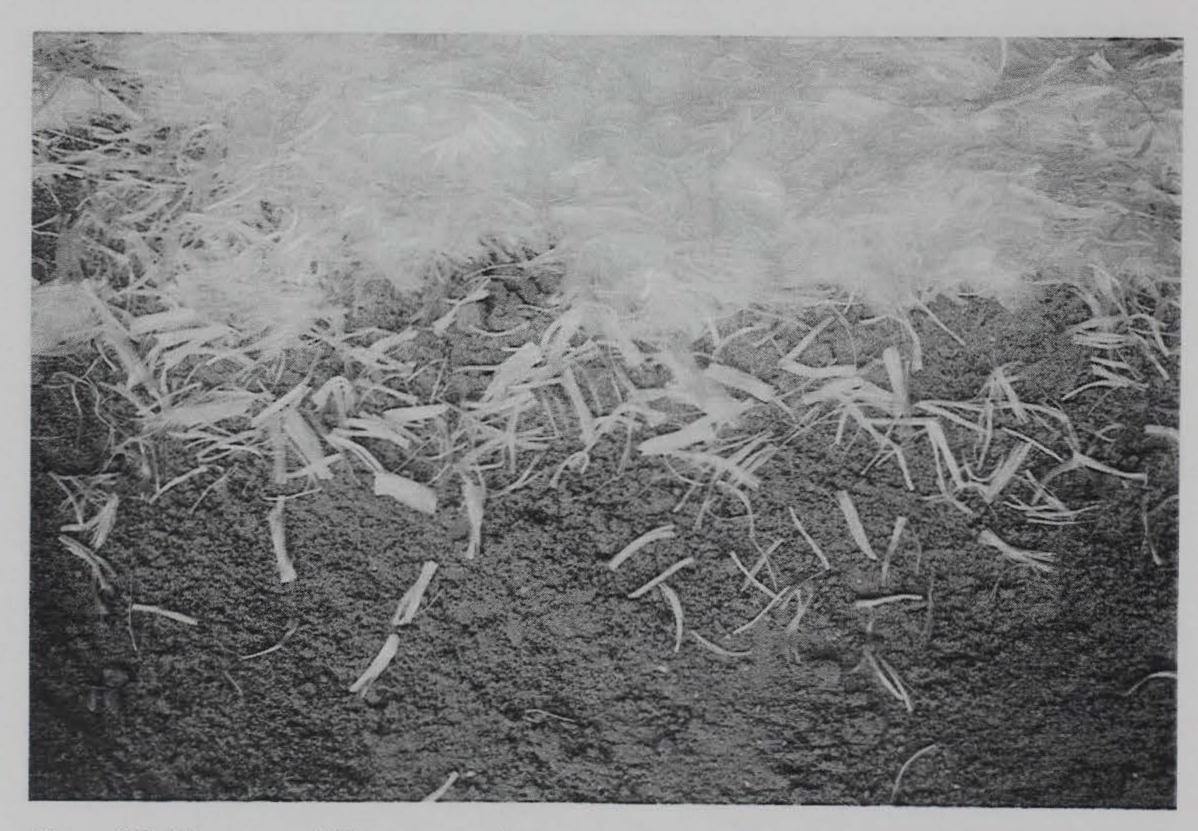
Figure 26. Close-up of fibers on sand

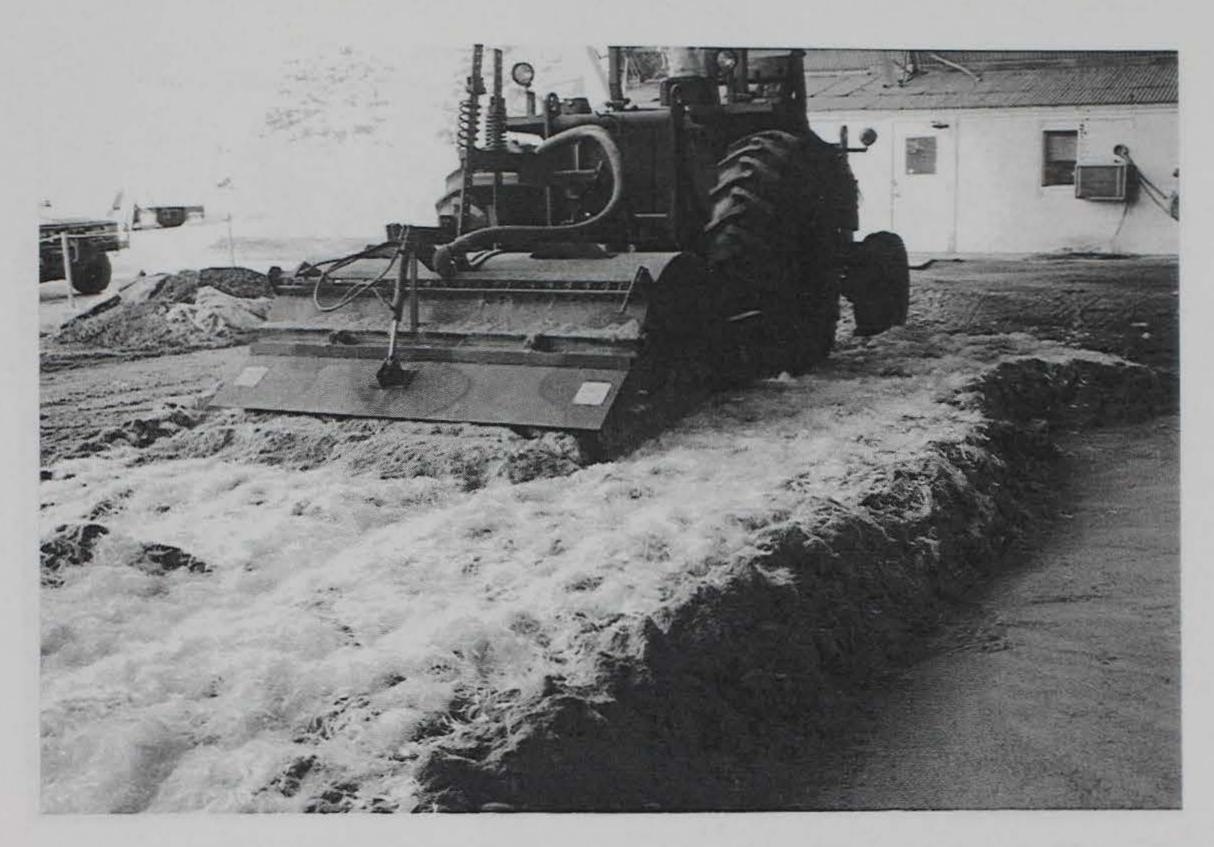
Figure 27. Mixing fibers into sand using rotary mixer

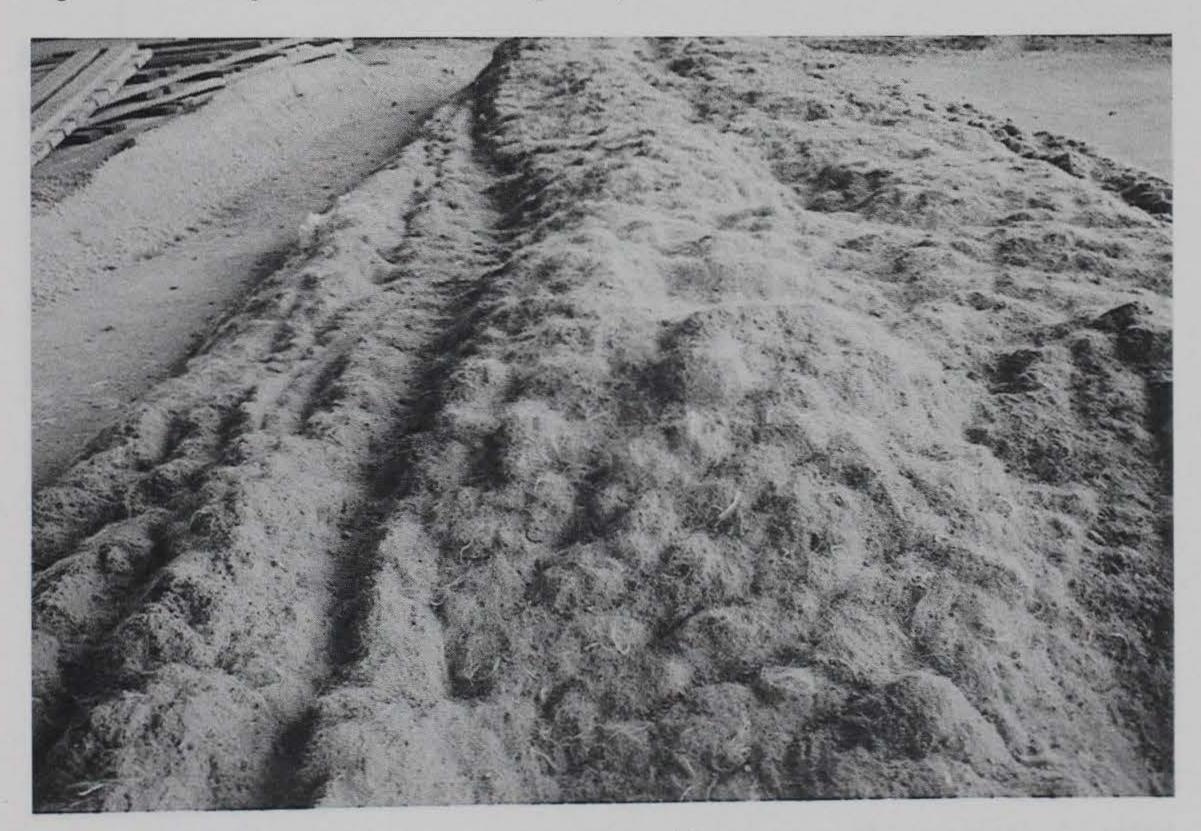
Figure 28. Sand-fiber mixture after four passes with mixer

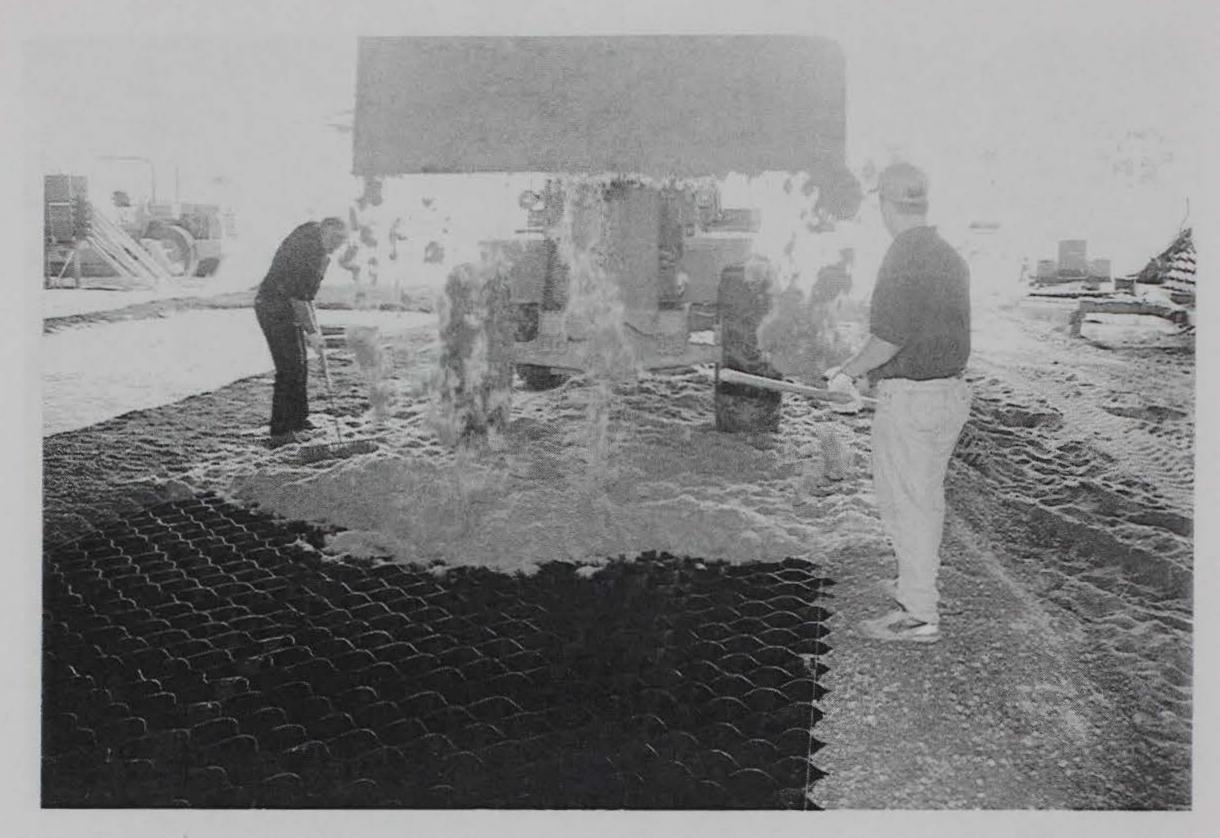
Figure 29. Installing sand-fiber mixture into sand grid

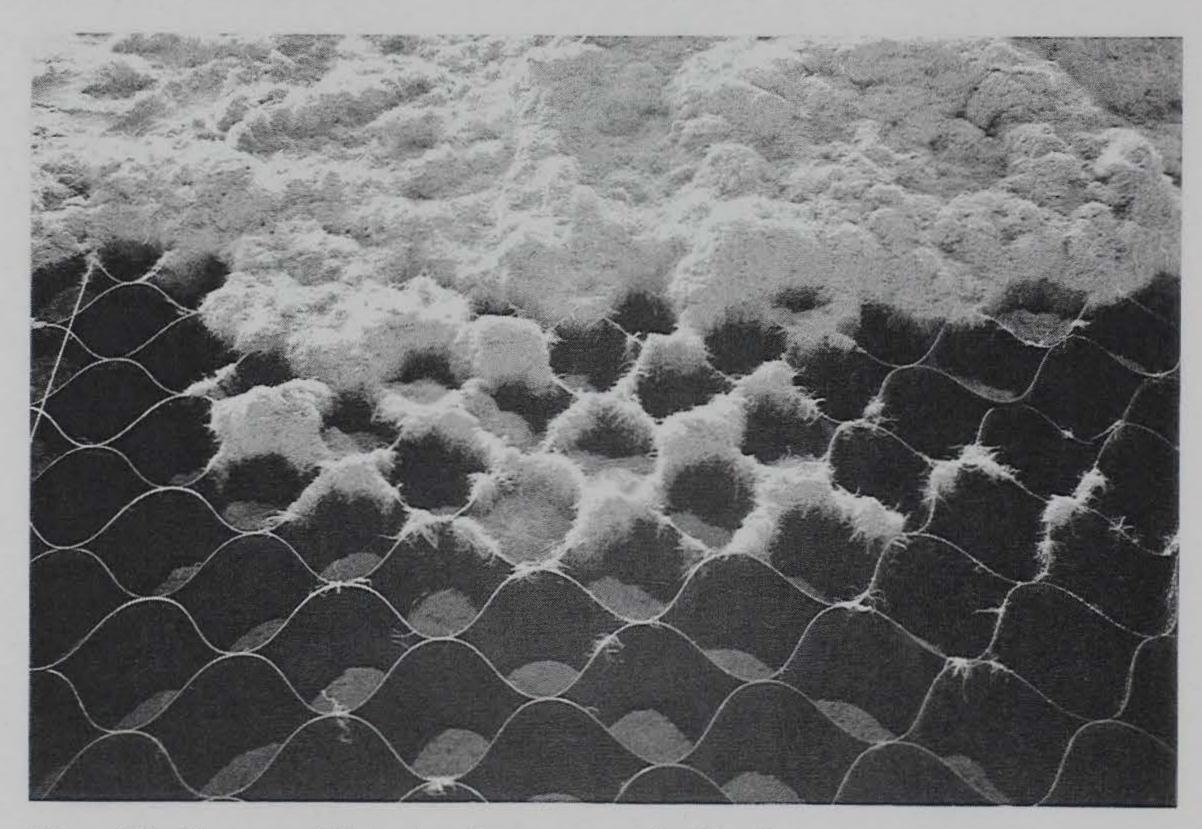
Figure 30. Close-up of fibers hanging up on sand grid cells

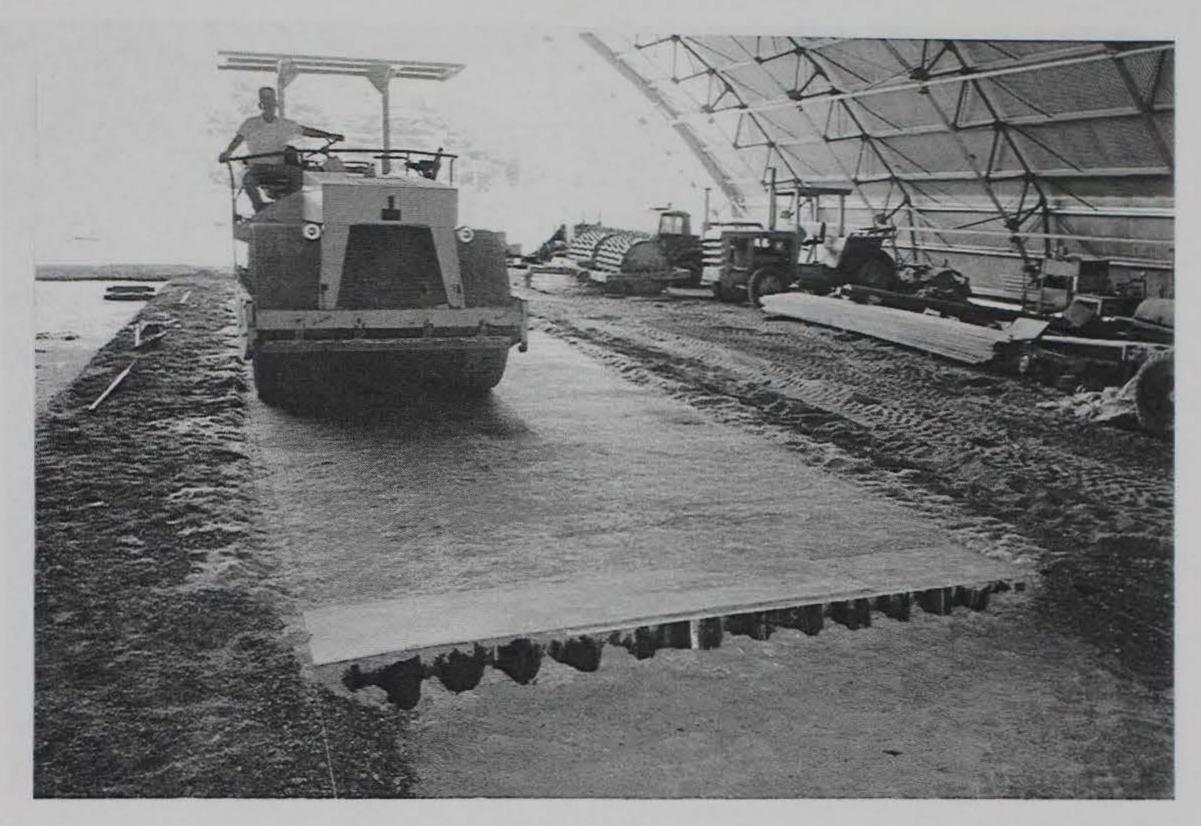
Figure 31. Compacting sand-fiber mixture into sand grid cells

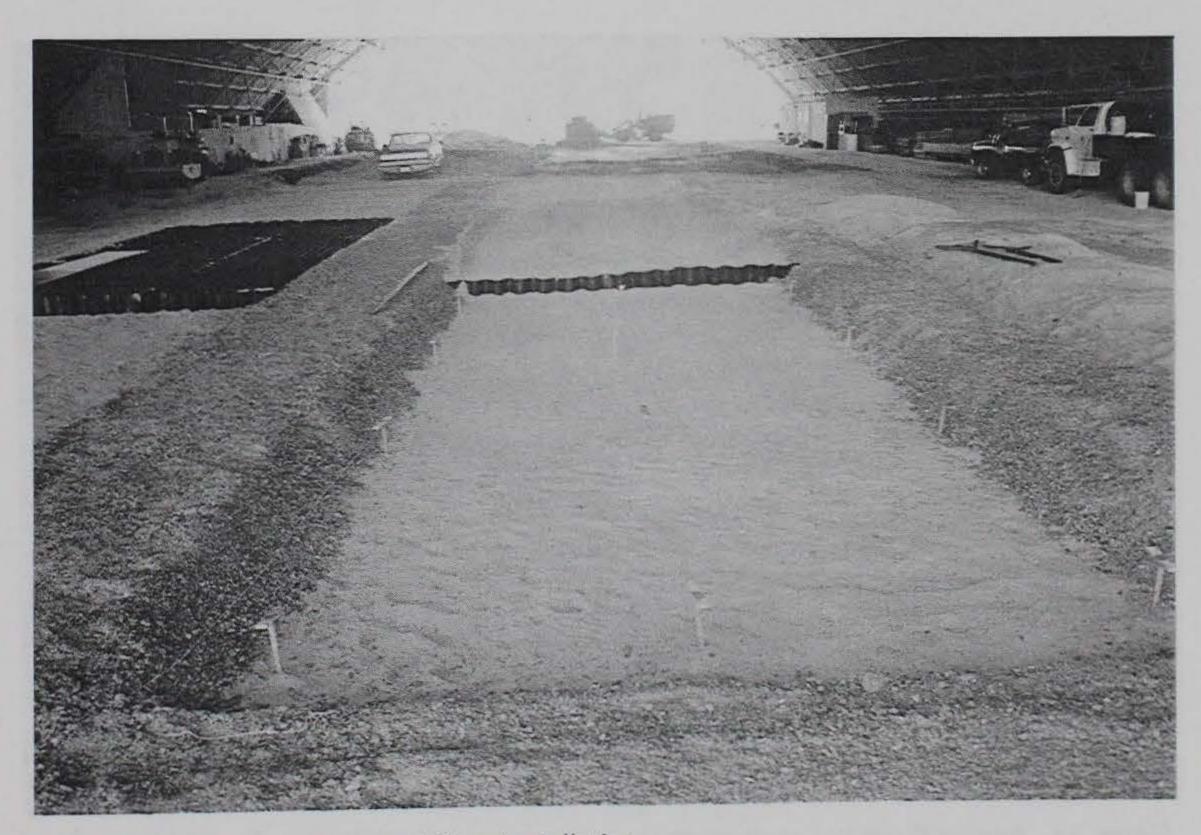
Figure 32. Item 1 before sand-fiber installation

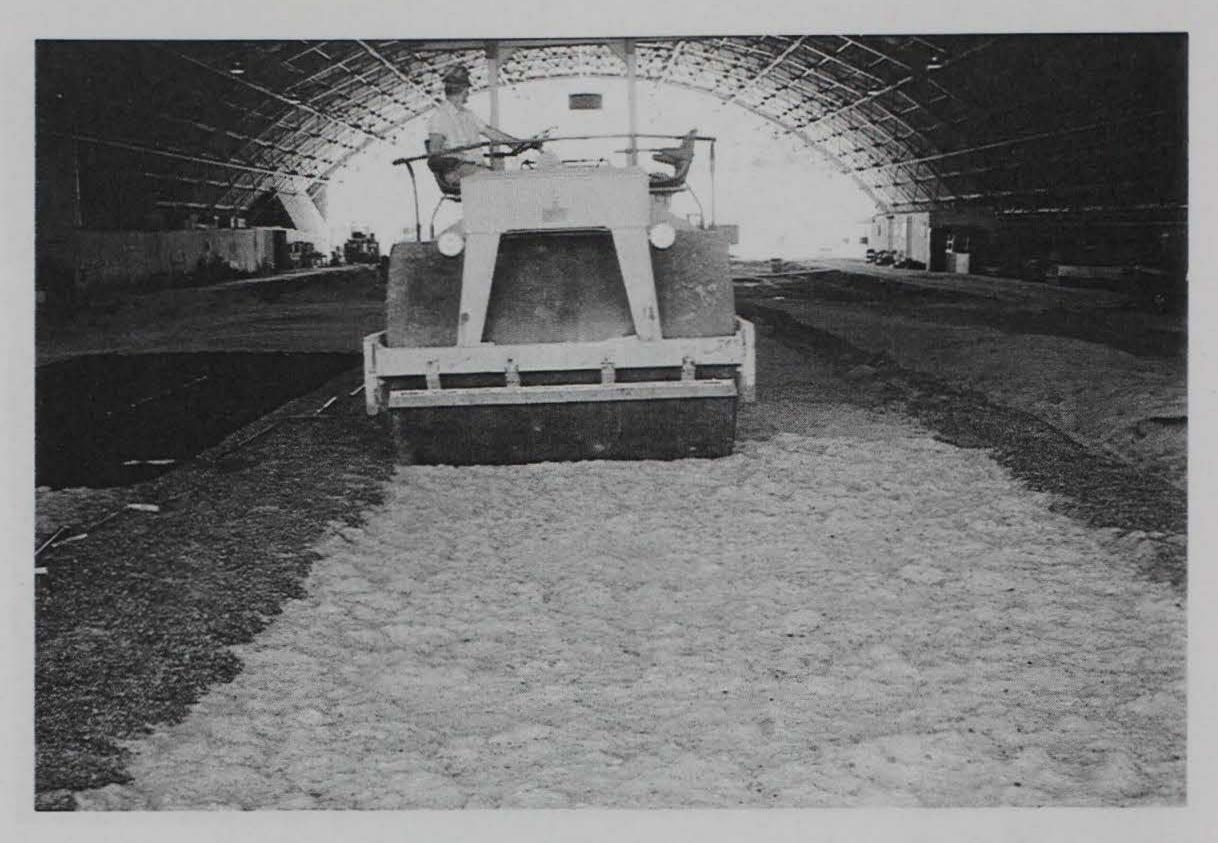
Figure 33. Sand-fiber surface prior to compaction

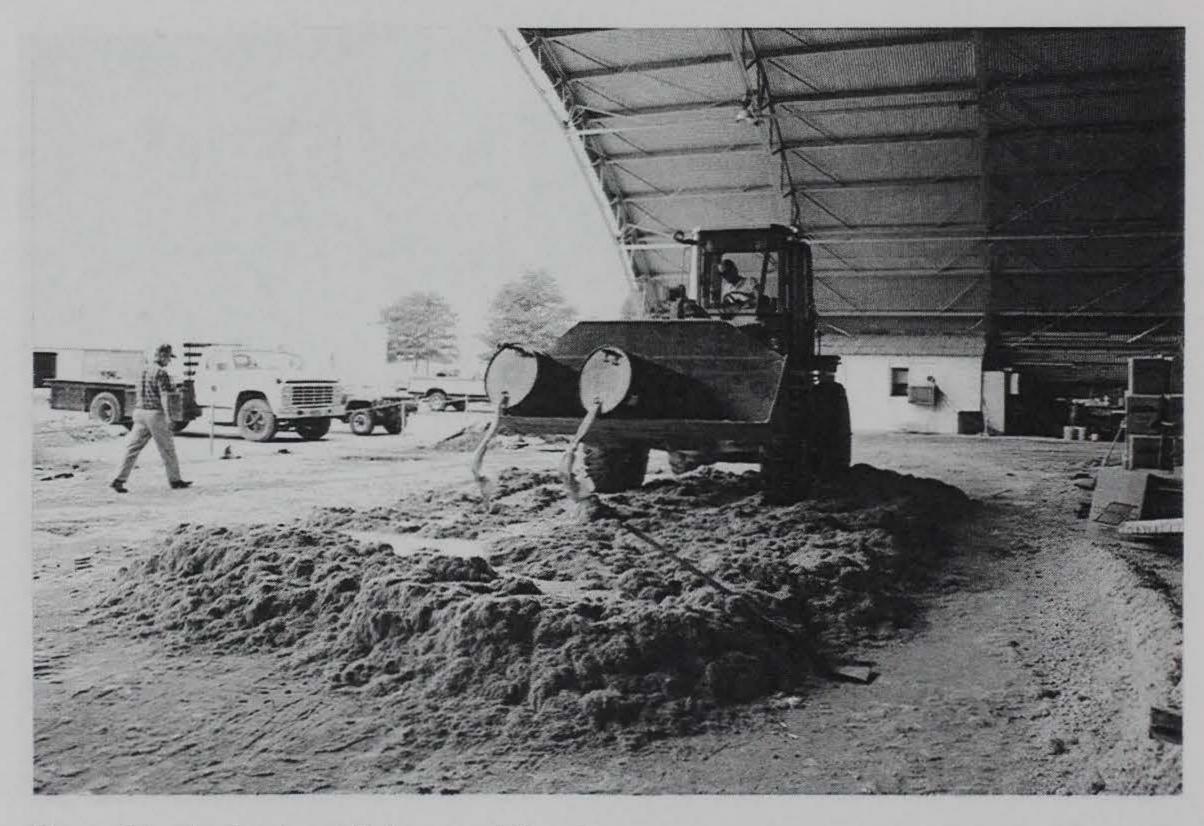
Figure 34. Adding Road Oyl on sand-fiber layer

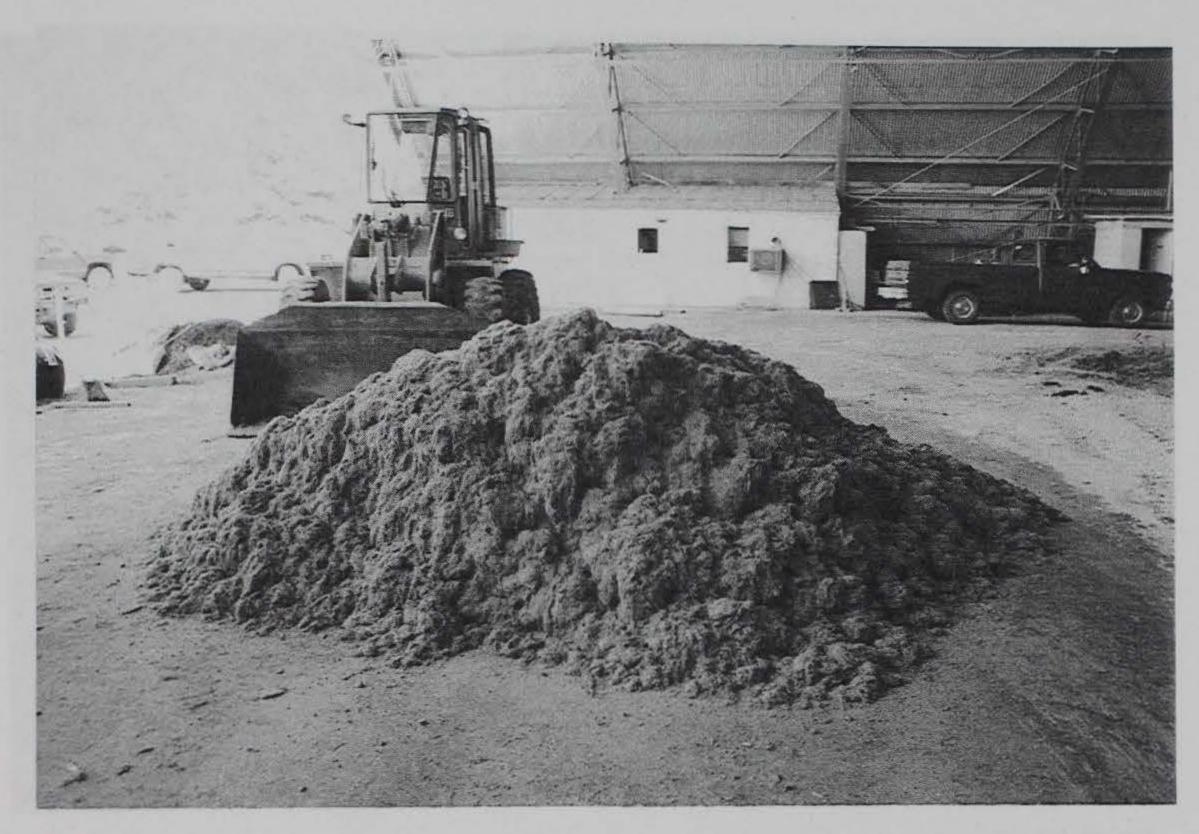
Figure 35. Mixture of sand-fiber and Road Oyl prior to installation

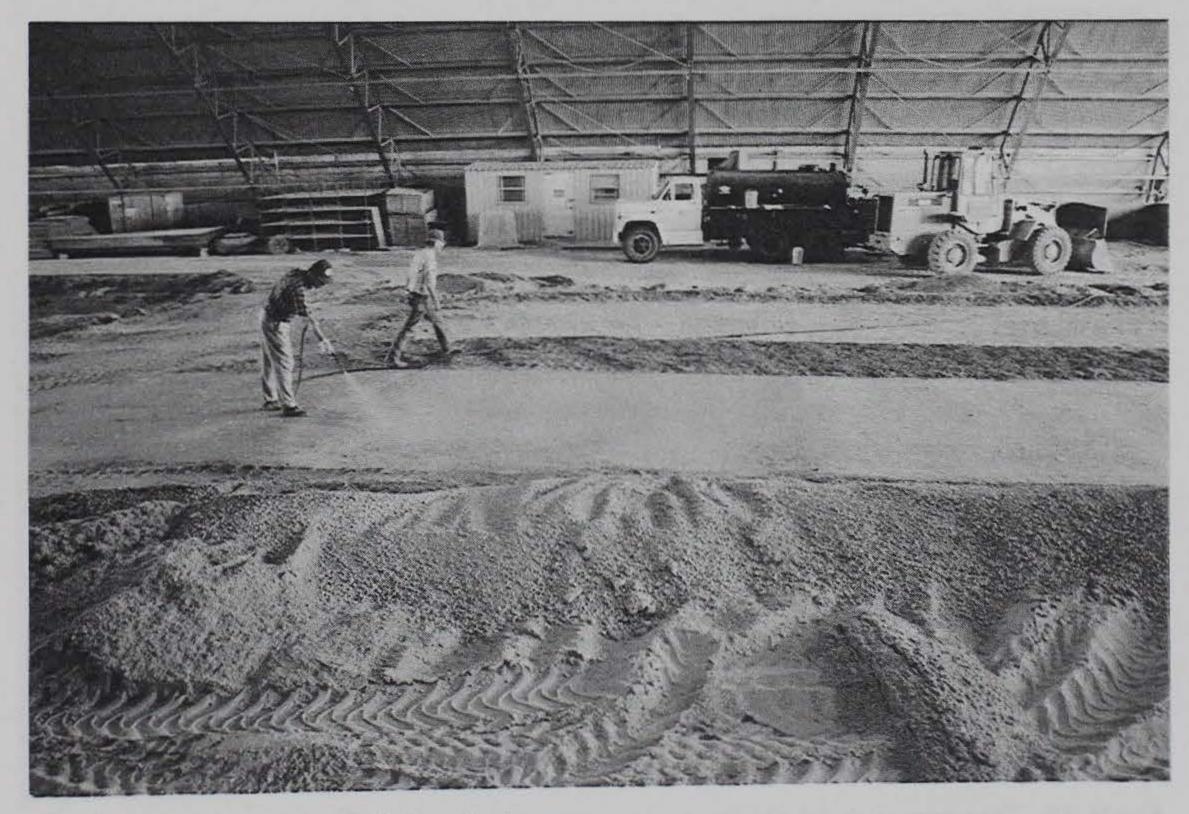
Figure 36. Spraying Road Oyl surfacing

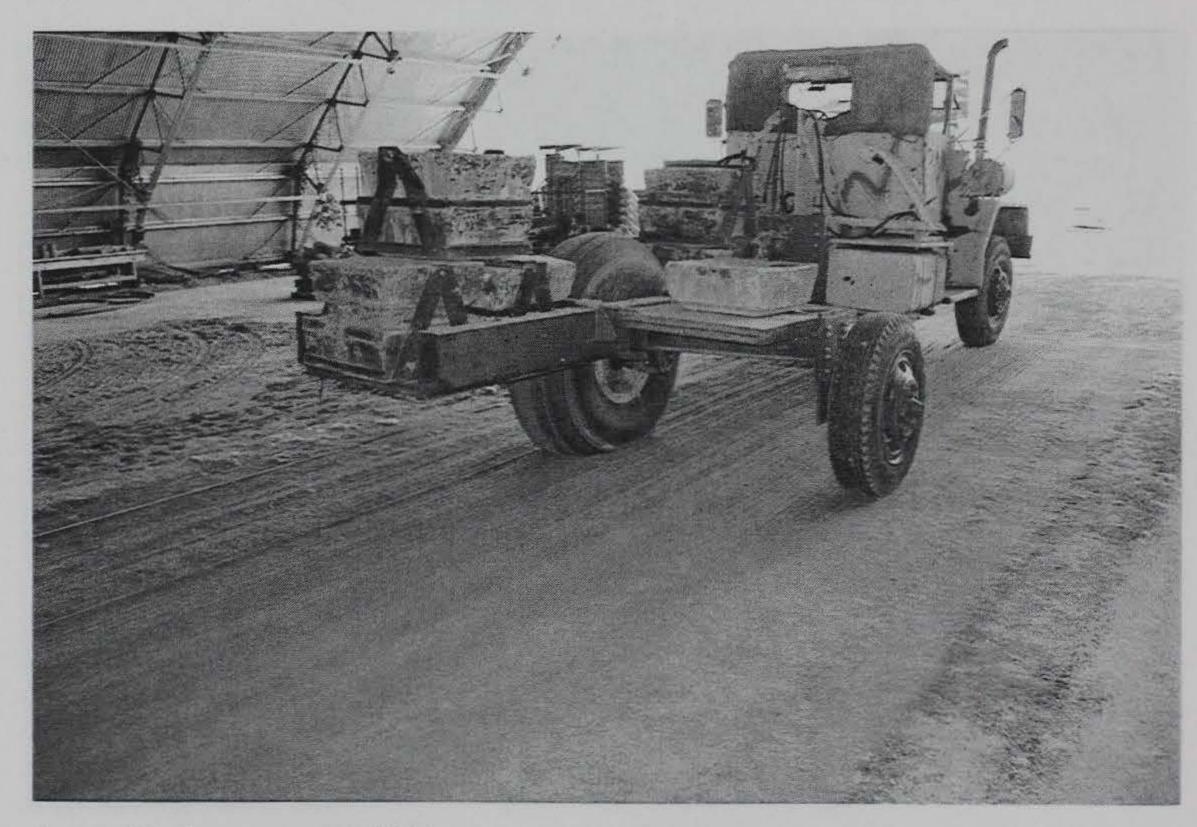
Figure 38. Test cart with 30-kip single-wheel-assembly

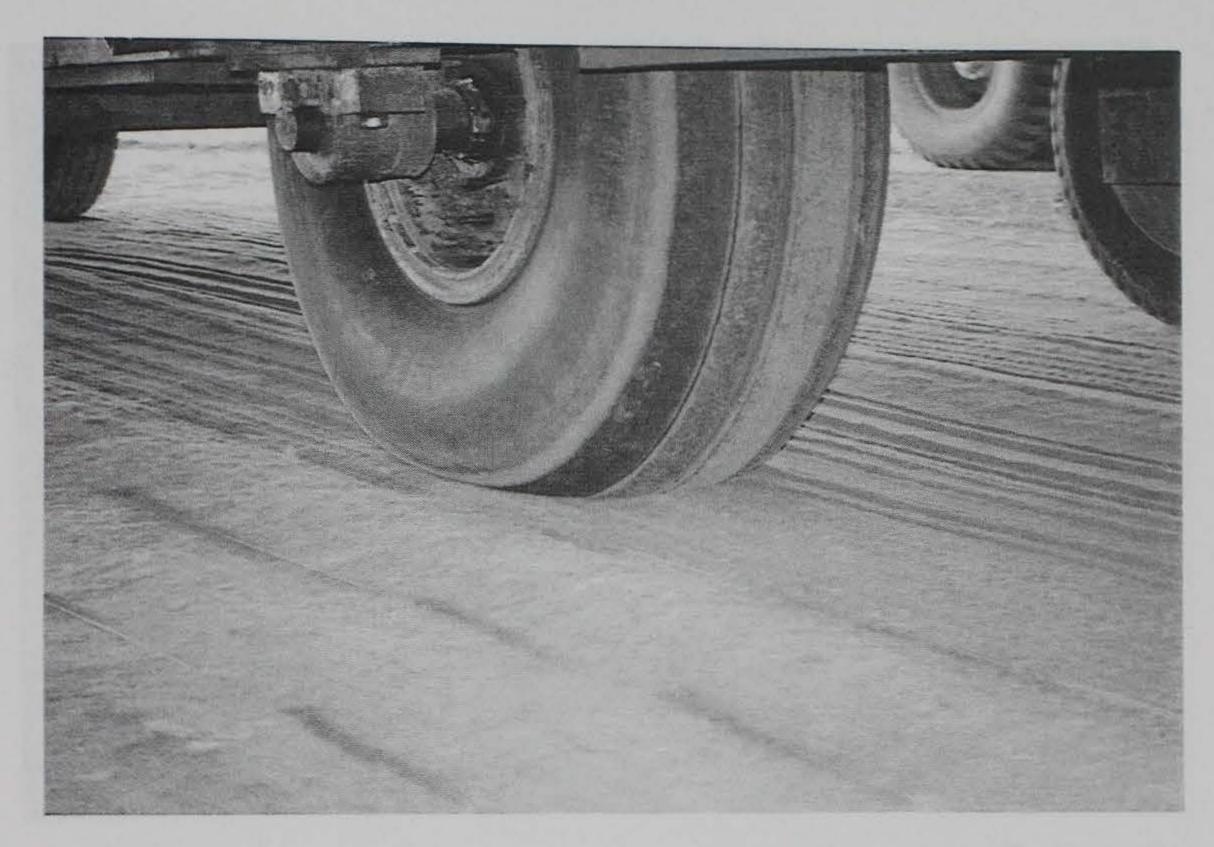
Figure 39. Close-up of loaded tire on item 1

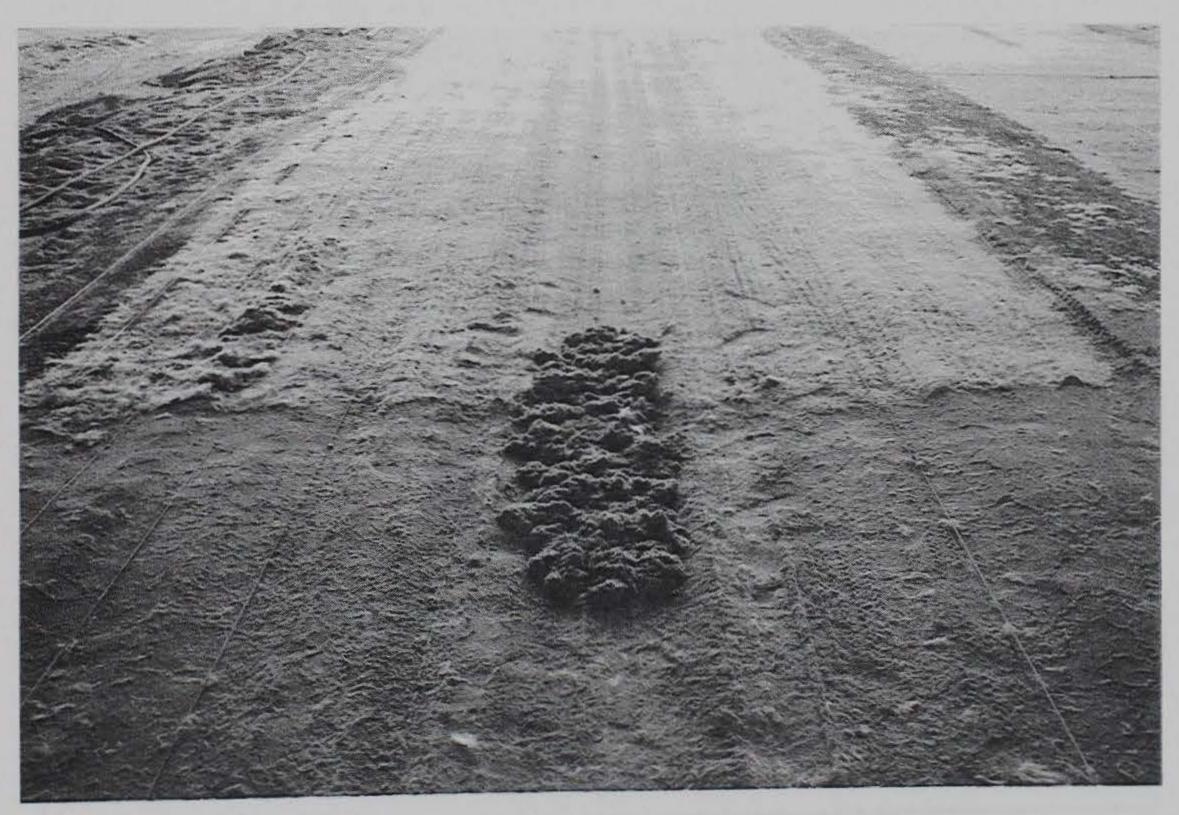
Figure 40. Patching material on small rut between items 2 and 3

Small amounts of sand-fiber (used in item 2) or sand-fiber-Road Oyl (used in items 3, 5, and 6) patching material were used to repair spot locations where 3- to 4-in. ruts developed. Figure 40 shows how some patching material was used to repair a spot rut that developed at the transition between items 2 and 3. A pitch fork worked much better than a shovel when handling the patch material. The fibers prevent a shovel from penetrating into a pile of patch material. Figure 41 shows the patched area after traffic compacted the patch. The patched area bonded with the item surface and stayed in place during additional traffic passes. Patching sand-fiber layers with like material was easy and effective.

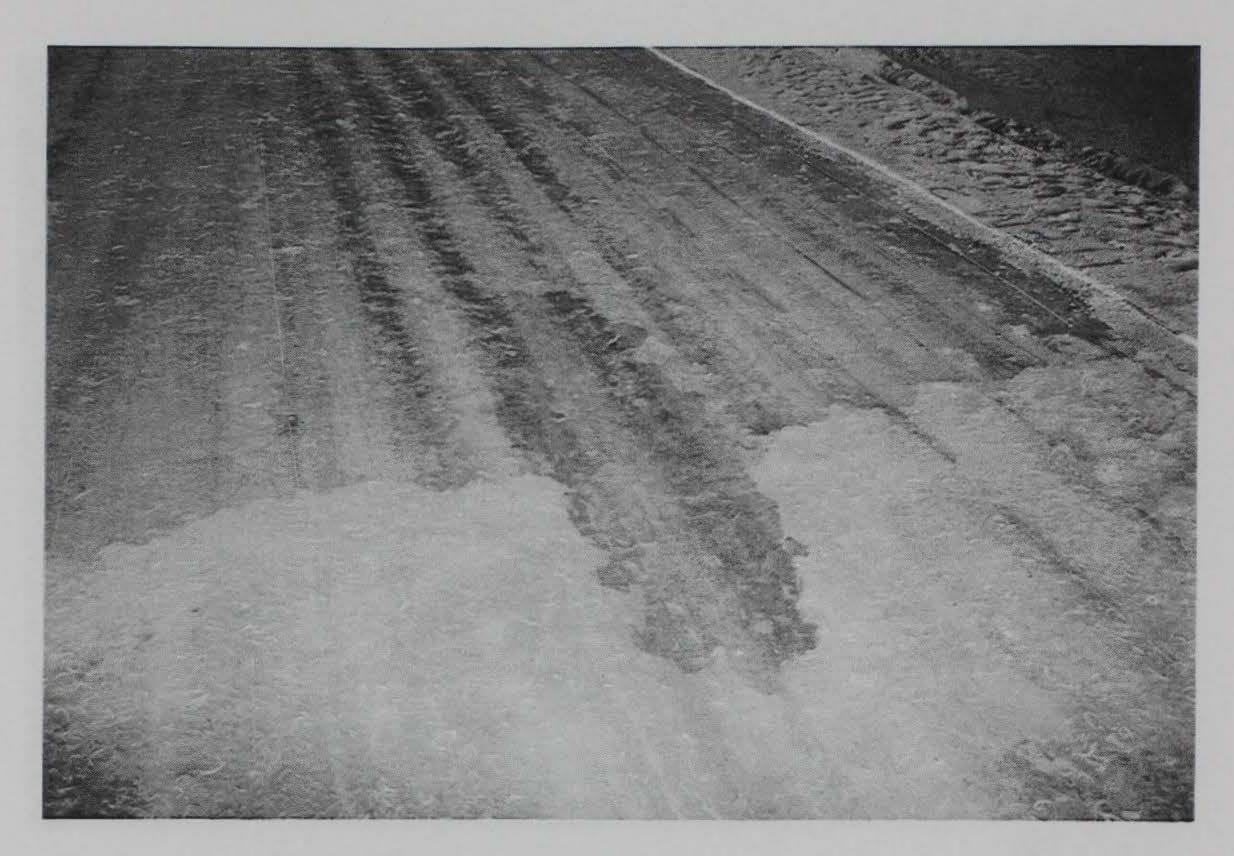
Figure 41. Patched area after traffic compacted the patch

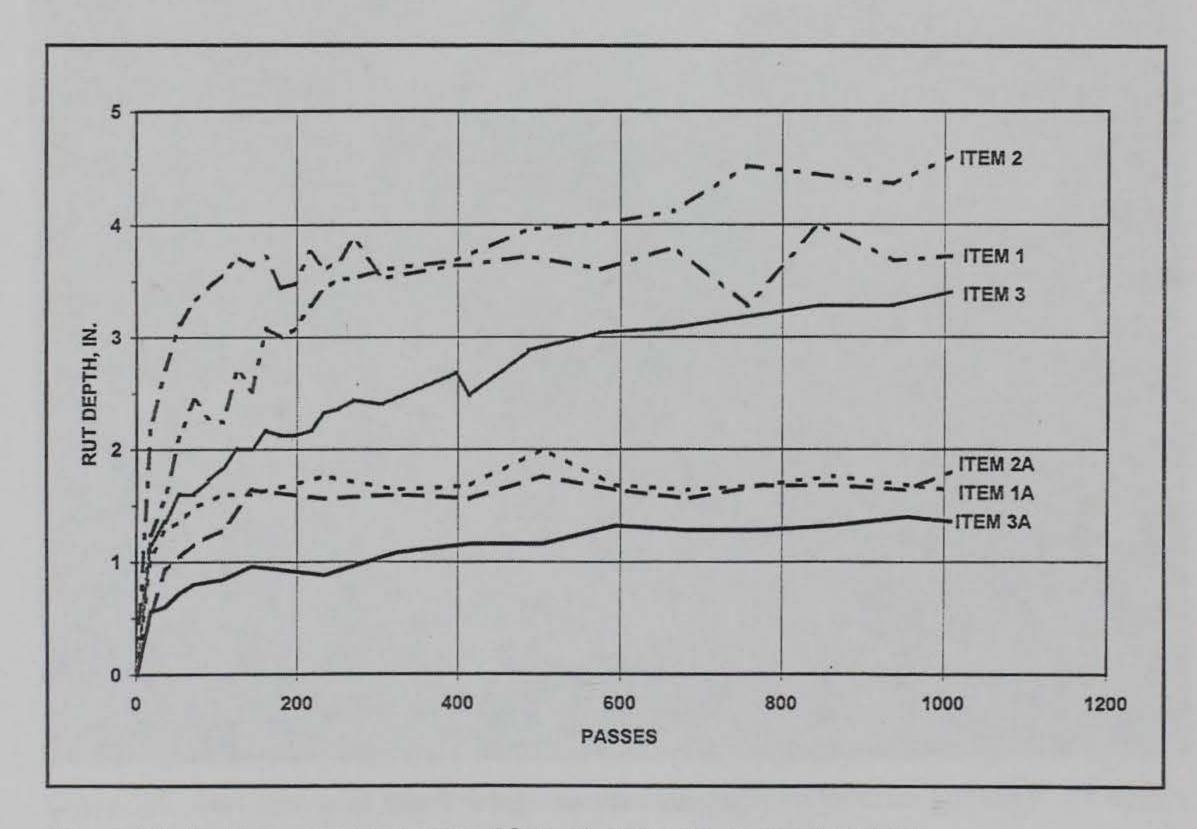
Figure 42. Rutting versus passes, 12-in.-thick items, lanes 1 and 1A
