## Contingency Airfield and Road Construction Using Geosynthetic Fiber Stabilization of Sands

by Steve L. Webster, Rosa L. Santoni

Technical Report GL-97-4 April 1997

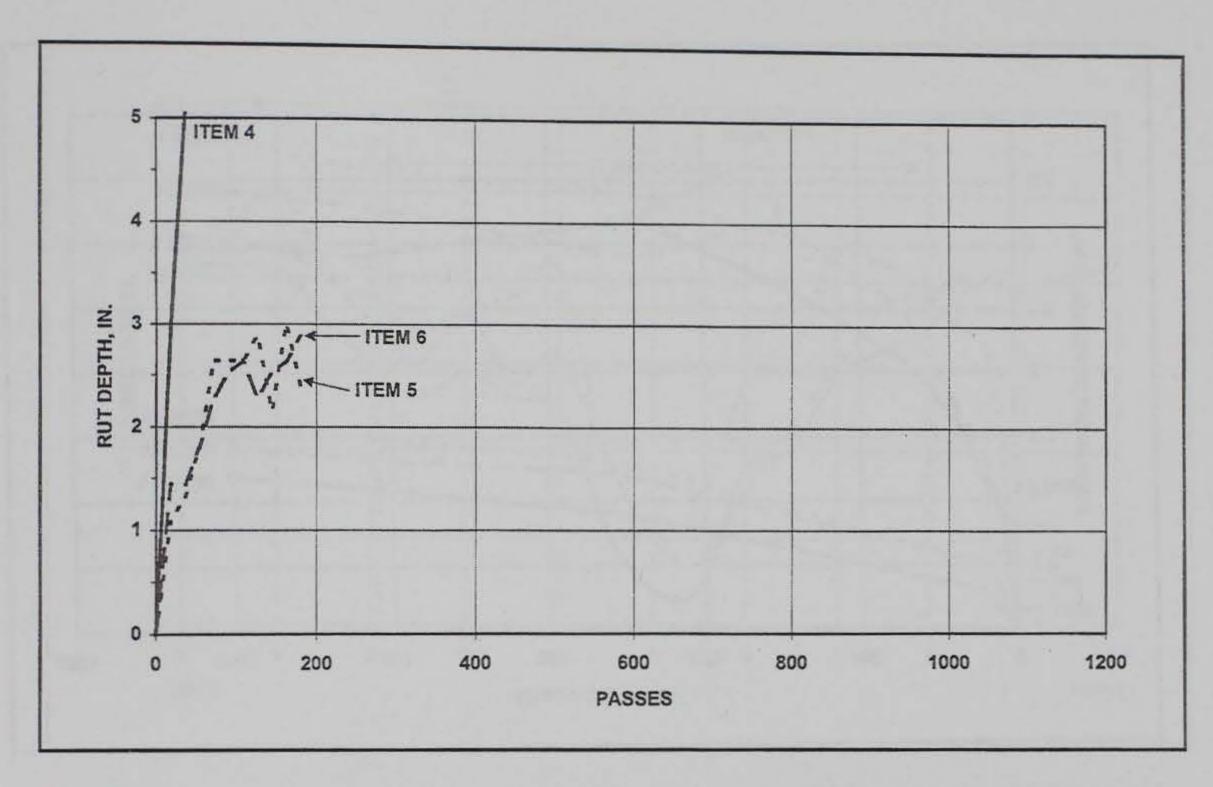
Figure 43. Rutting versus passes, 8-in.-thick items, lane 2

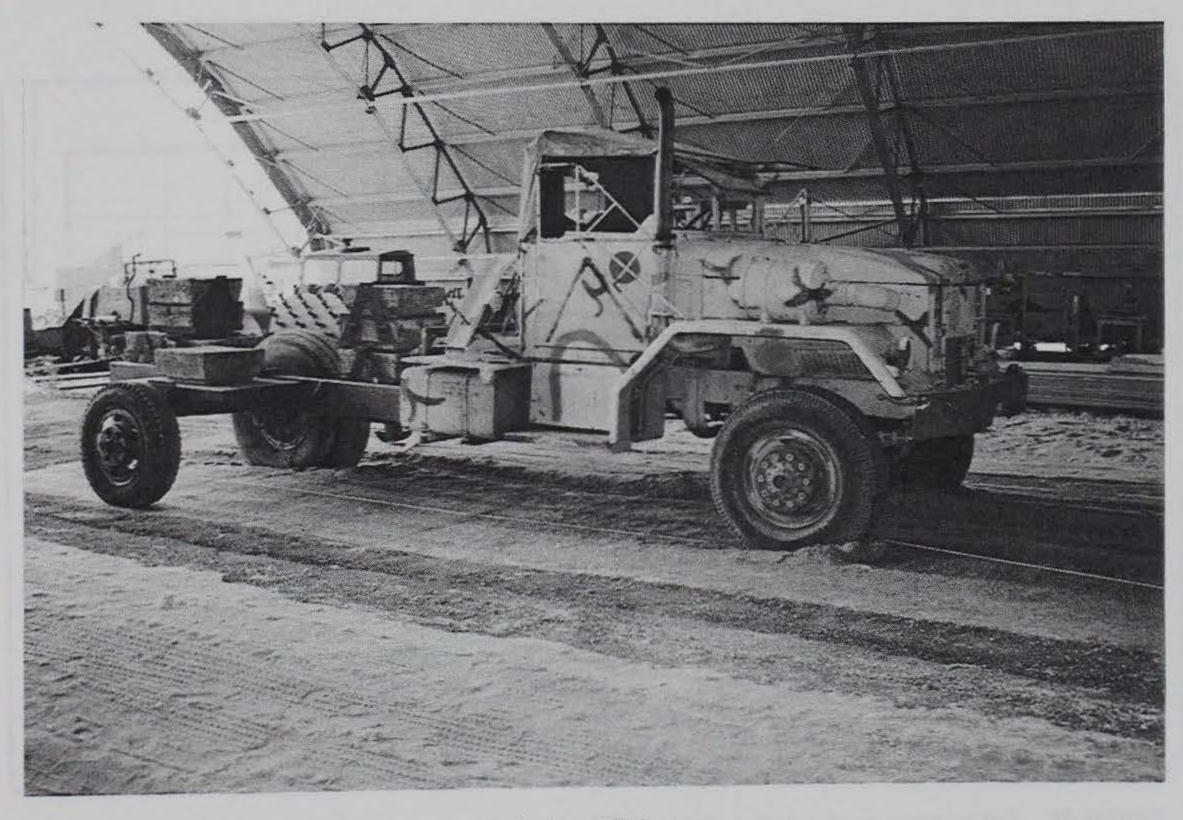
Figure 44. Stuck load cart on item 4 during 25th pass

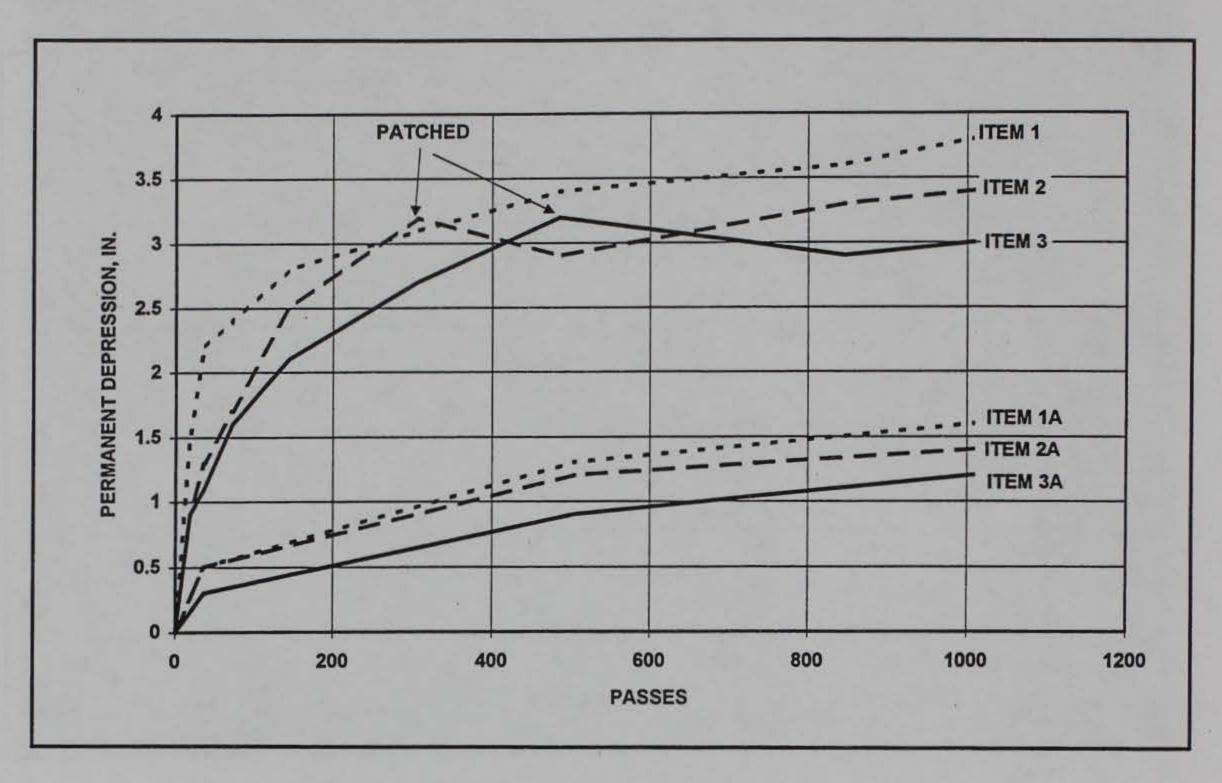
Figure 45. Permanent surface depression, 12-in.-thick items

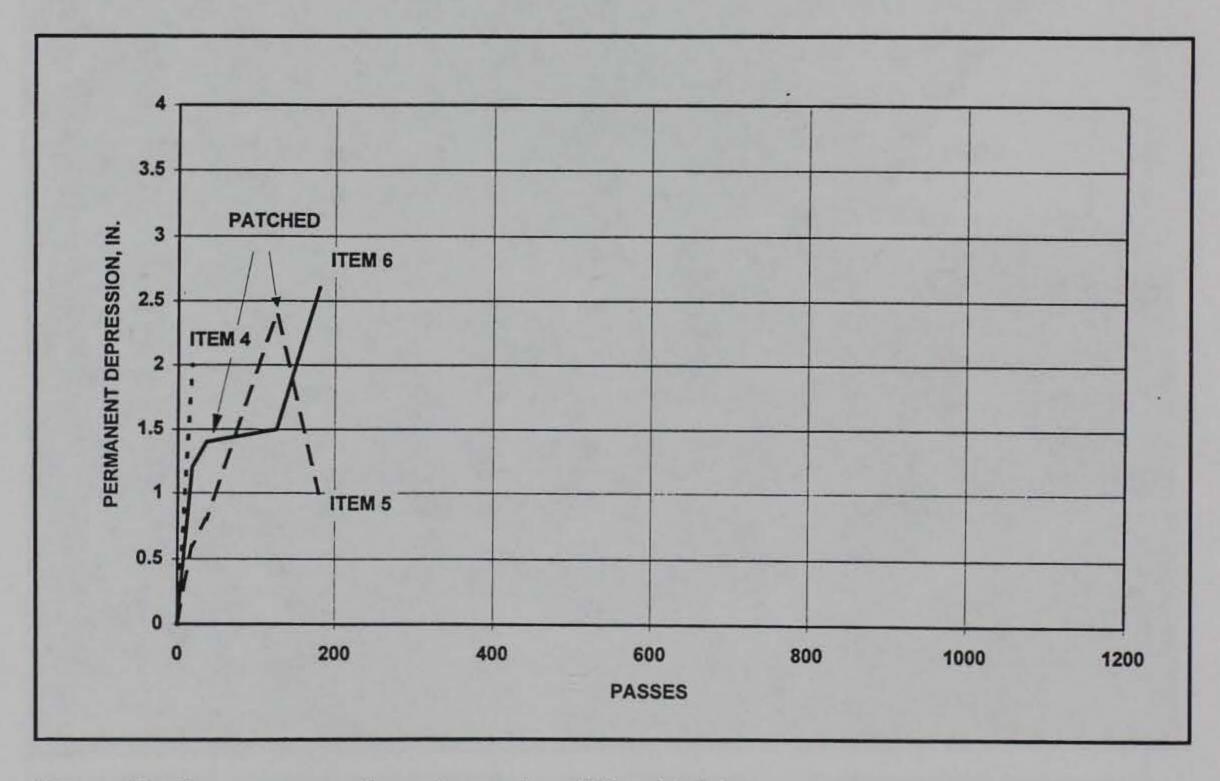
Figure 46. Permanent surface depression, 8-in.-thick items

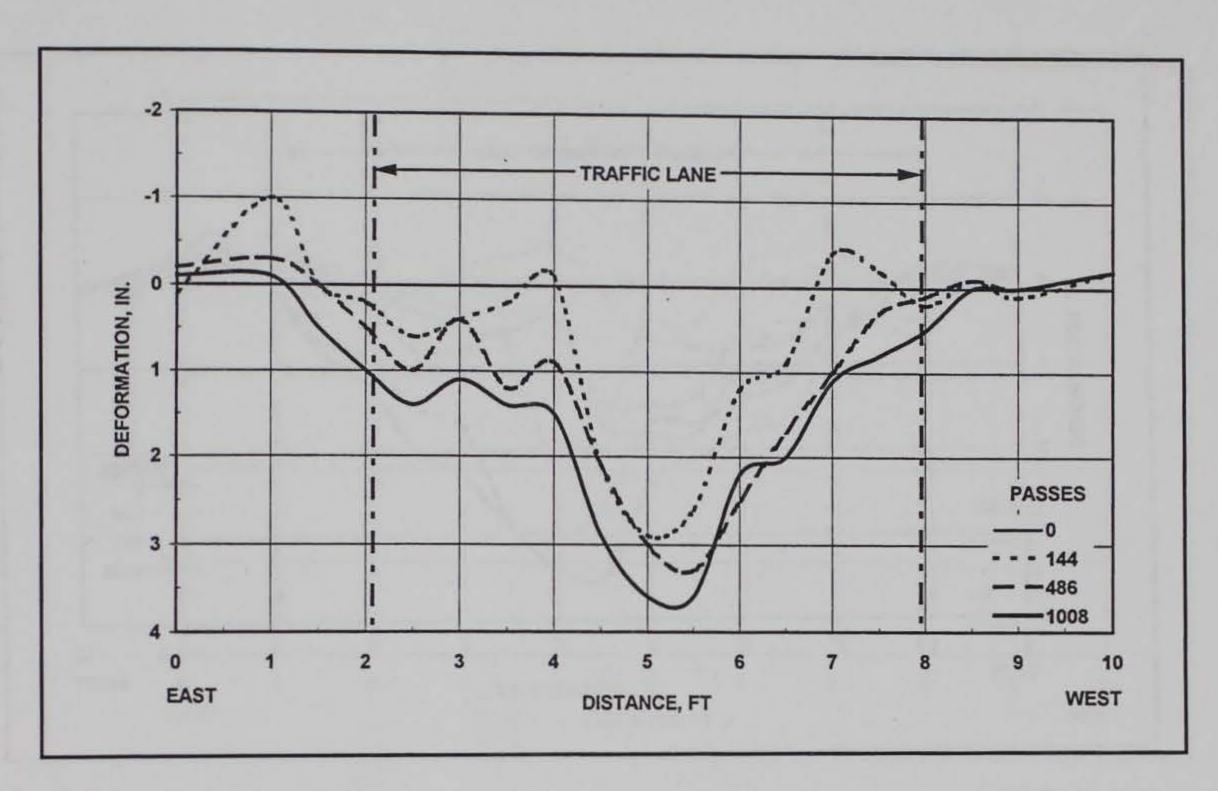
Figure 47. Typical cross sections of permanent deformation, item 1

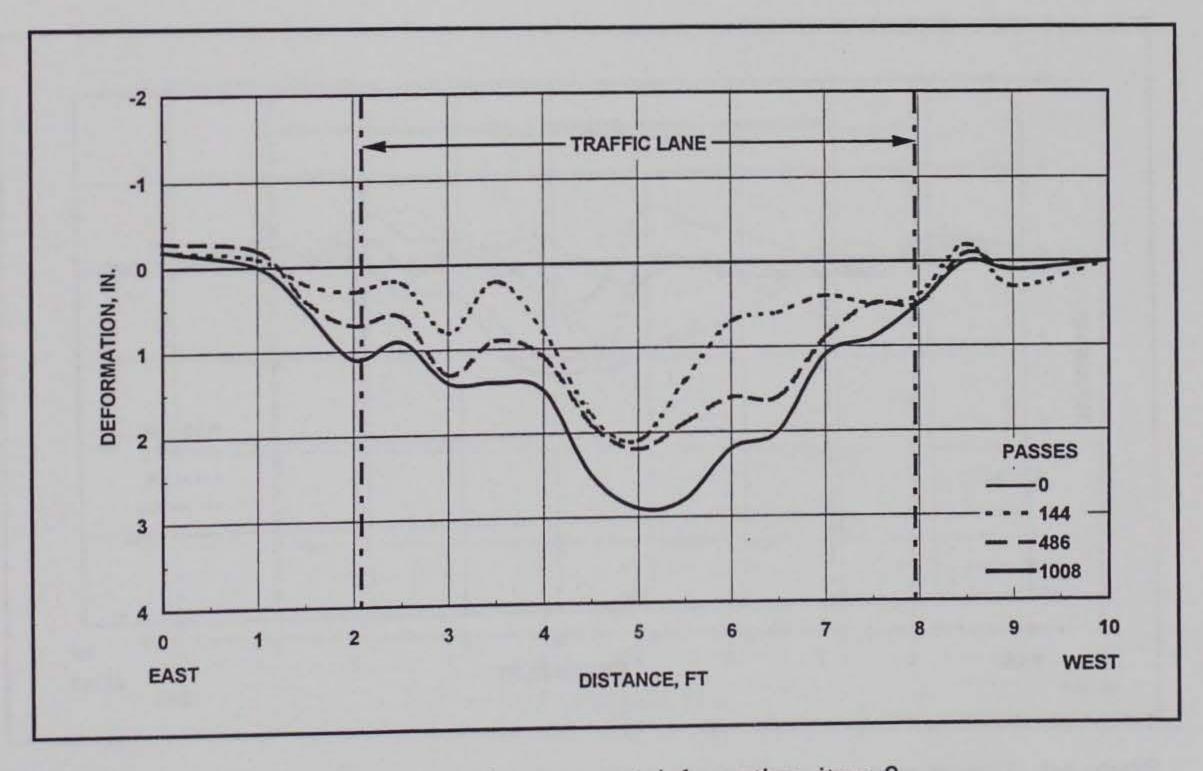
Figure 48. Typical cross sections of permanent deformation, item 2

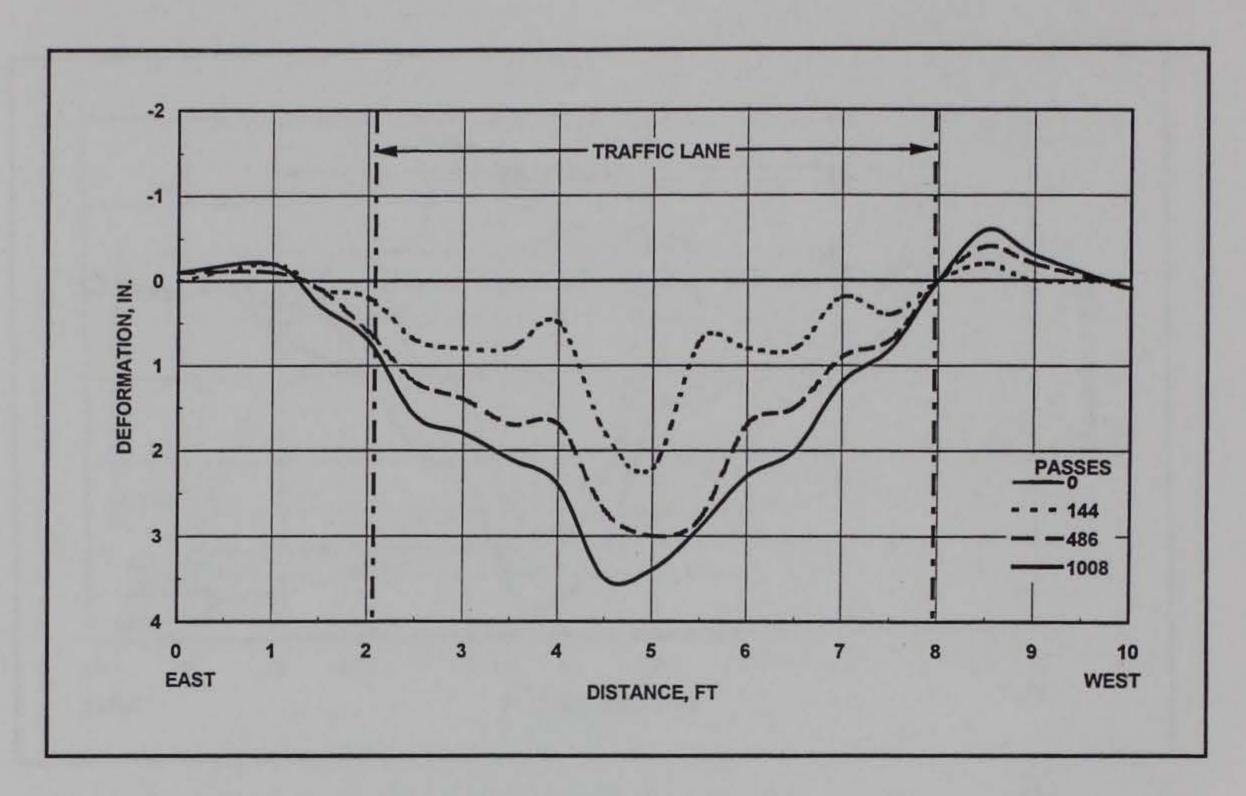
Figure 49. Typical cross sections of permanent deformation, item 3

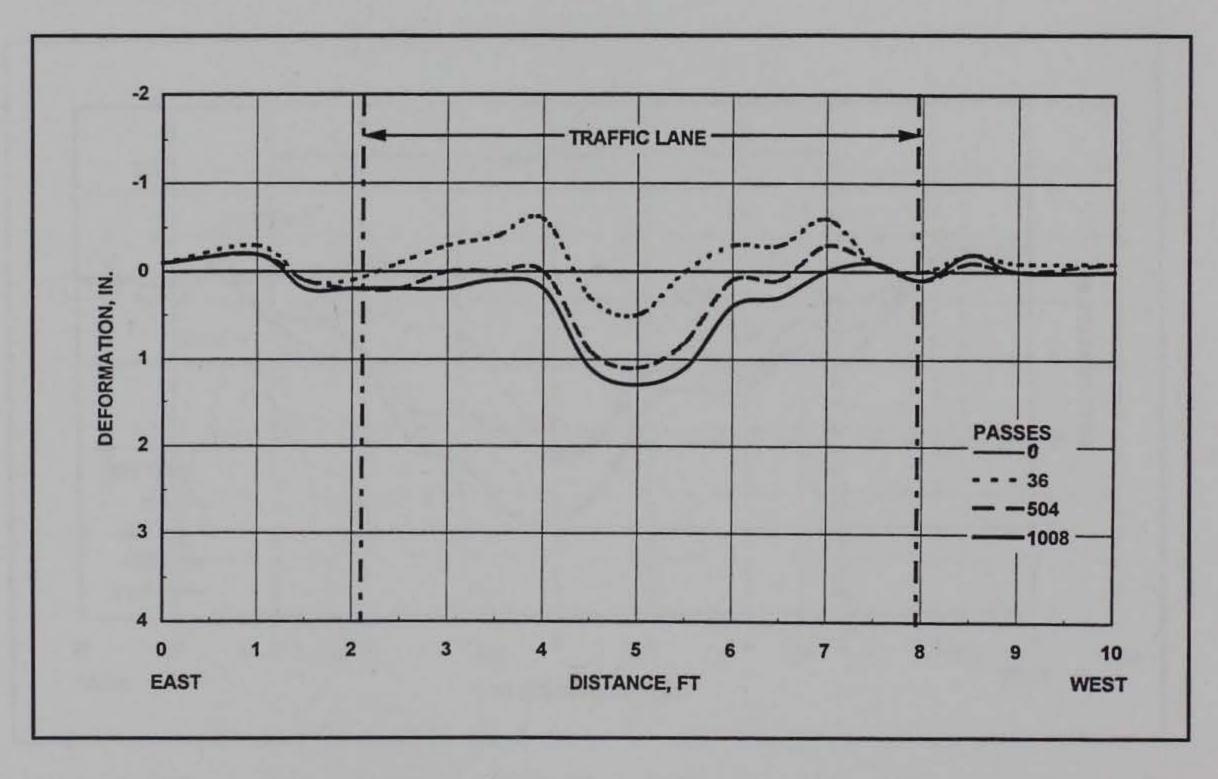
Figure 50. Typical cross sections of permanent deformation, item 1A

1A-3A over items 1-3 was probably due to the increase in base and subgrade compaction caused by traffic loads on items 1-3. Figures 53 through 55 show the permanent deformations for the 8-in.-thick items 4 through 6. Figure 53 shows the poor condition of item 4 after only 18 passes. The load cart sheared through this item on the 25th pass and became immobilized. Figure 54 shows the permanent deformation in item 5. The center wheel path of this item was patched the full length of the item after 126 passes. Upheaval outside the traffic lane on the west side after 180 passes was caused by rutting in the subgrade under the 8-in.-thick sand grid layer. Figure 55 shows the deformation pattern for item 6. The permanent deformation data showed that all the 8-in.-thick items were too thin to support the tire loads applied.

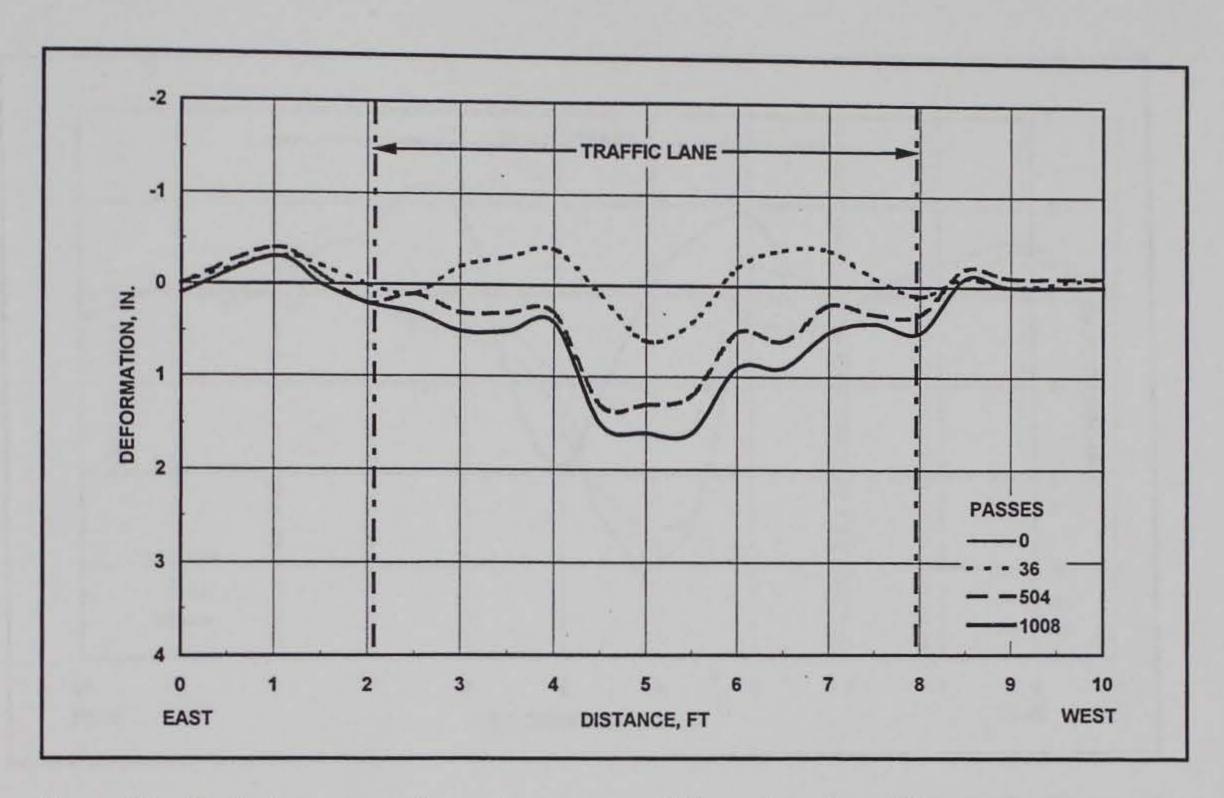
Figure 51. Typical cross sections of permanent deformation, item 2A

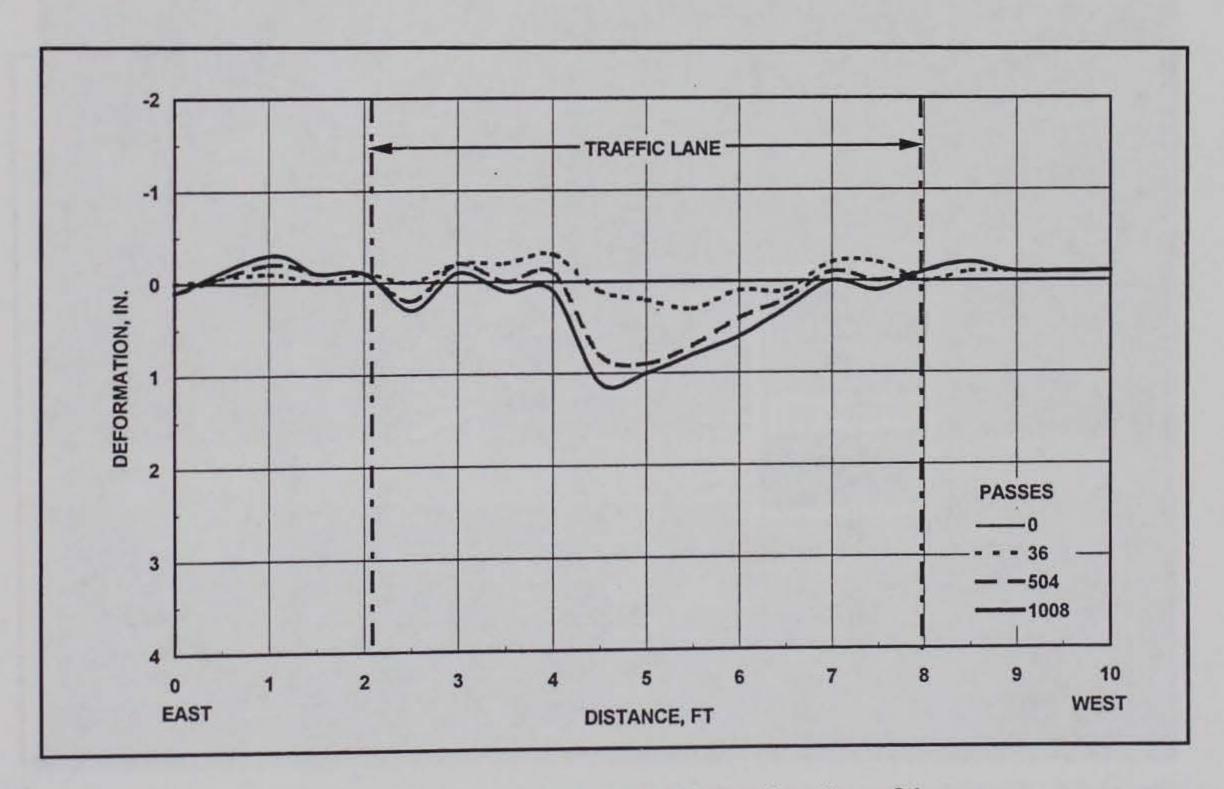
Figure 52. Typical cross sections of permanent deformation, item 3A

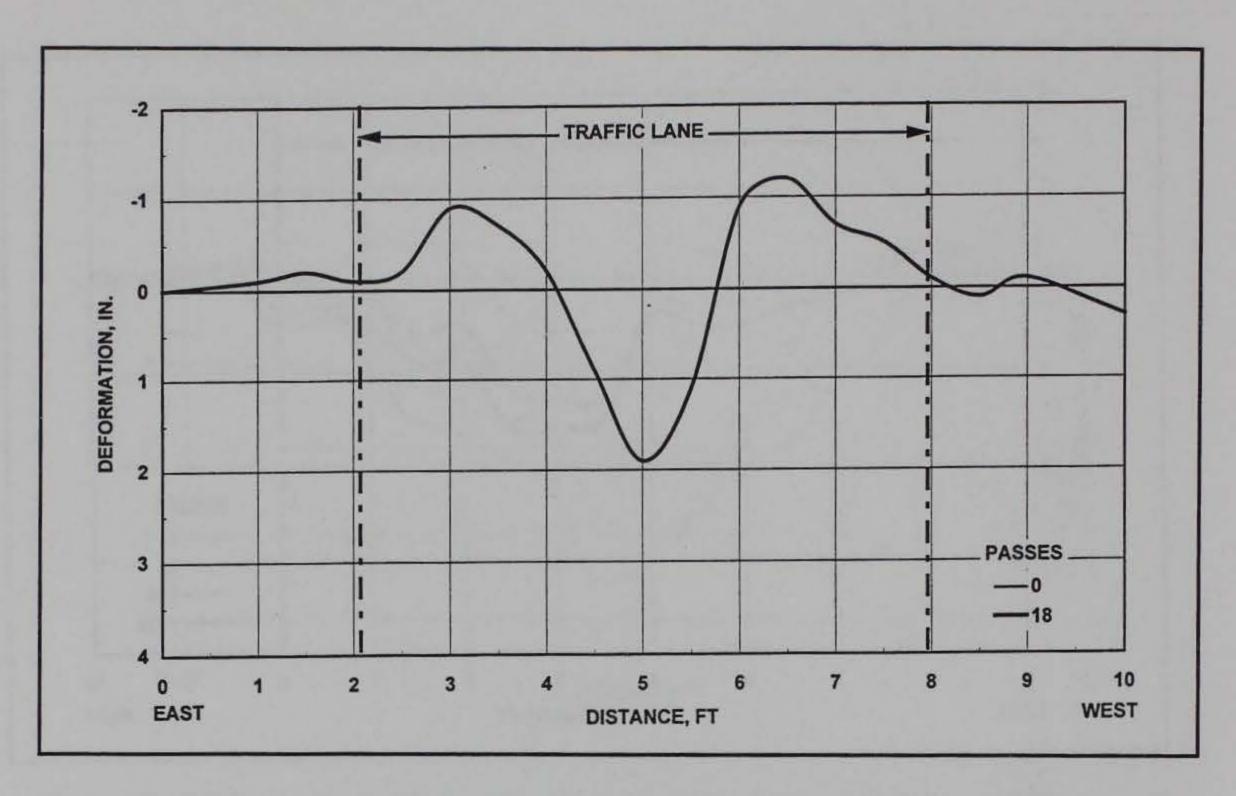
Figure 53. Typical cross sections of permanent deformation, item 4

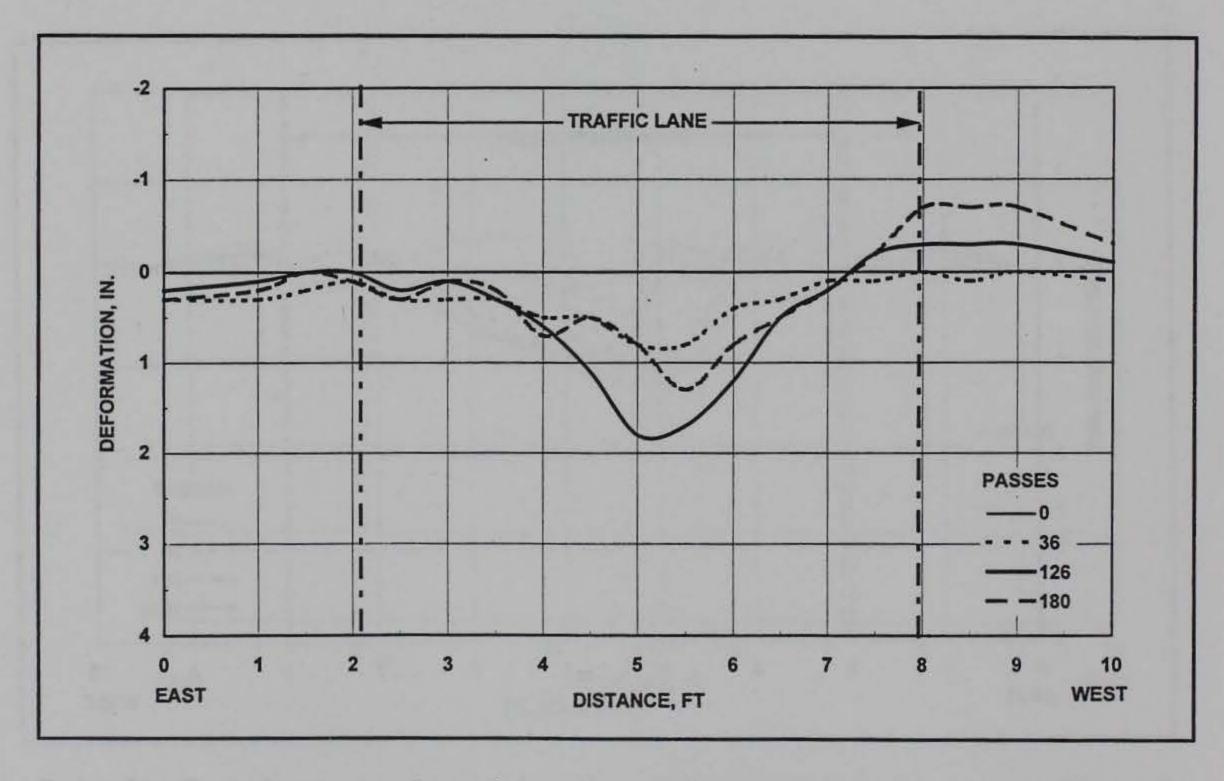
Figure 54. Typical cross sections of permanent deformation, item 5

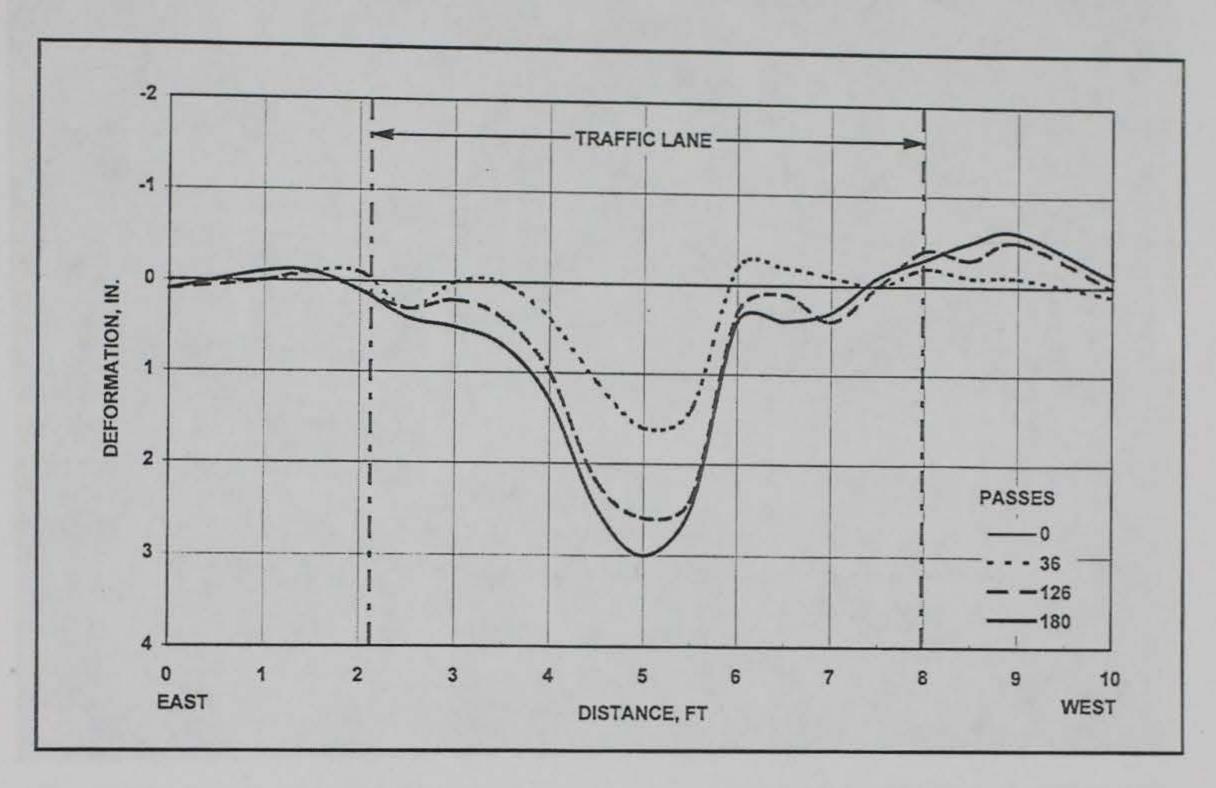
Figure 55. Typical cross sections of permanent deformation, item 6

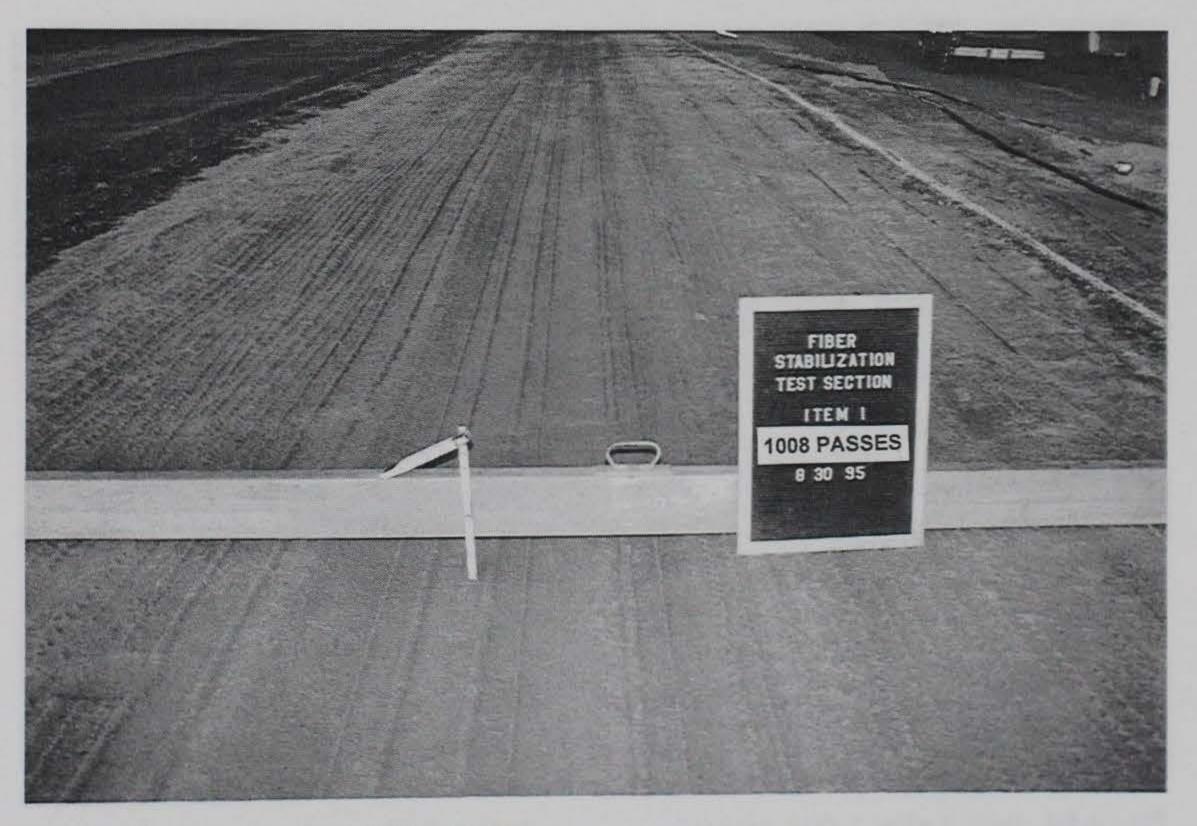
Figure 56. Item 1 after 1,008 passes

Figures 56 through 61 show the condition of each item after 1,008 passes of traffic. Even though items 1 through 3 had rutted over 3 in., their surface condition was still good with very little upheaval outside the traffic lane. The condition of items 1A through 3A was excellent after 1,008 passes. Rut depths in these items was less than 2 in.

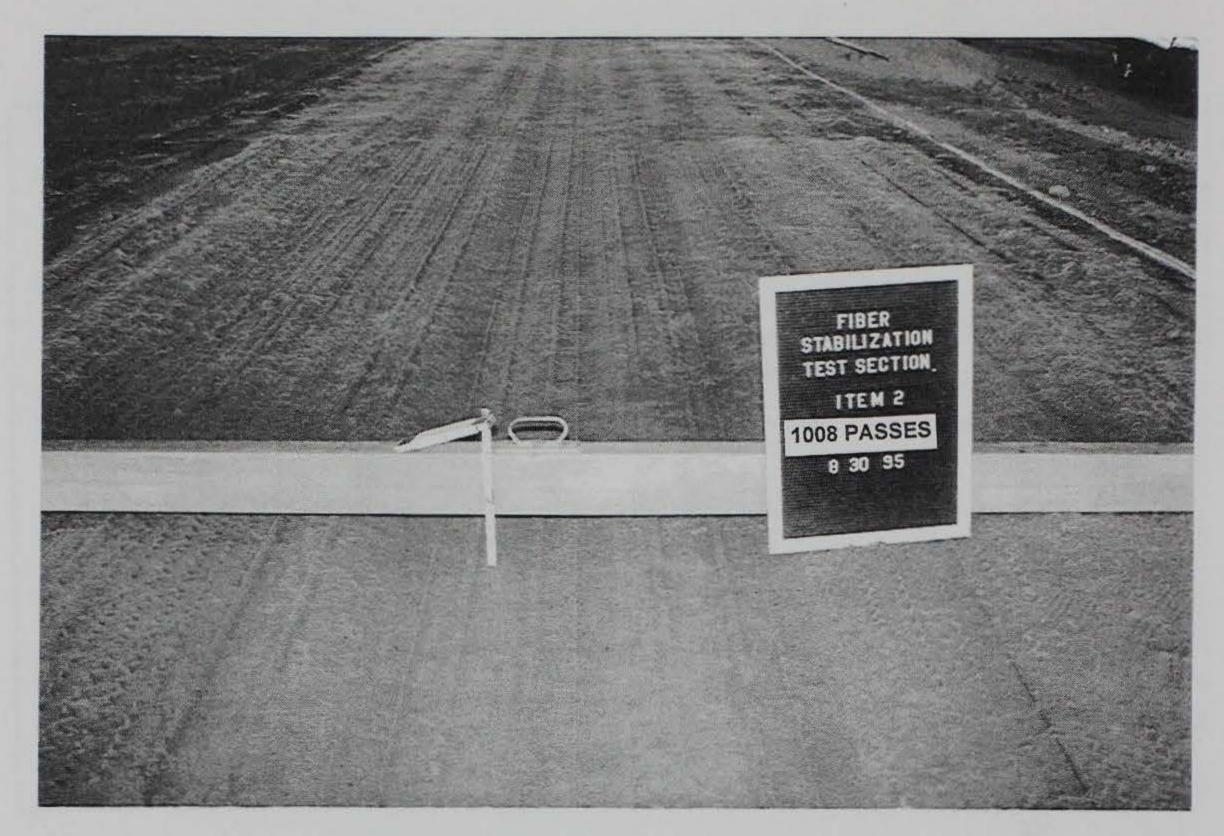
Figure 57. Item 2 after 1,008 passes

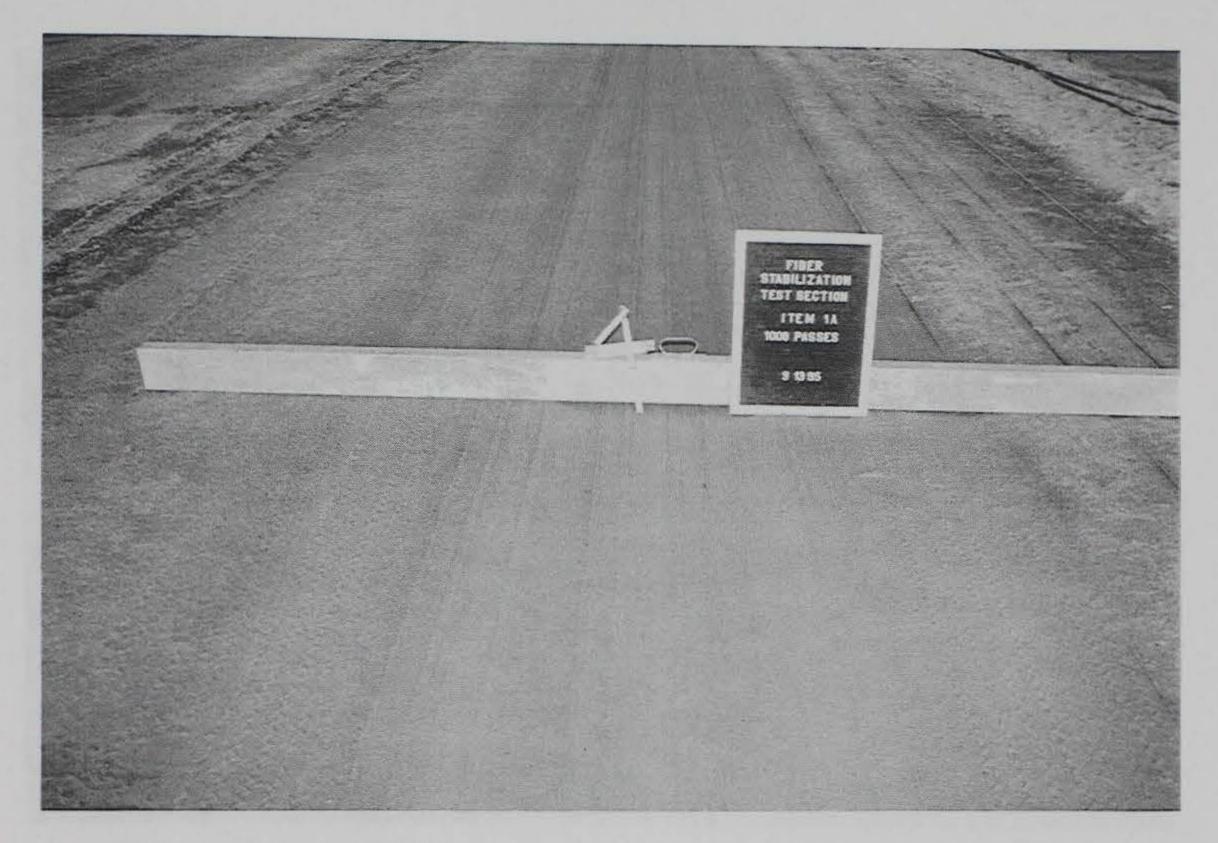
Figure 59. Item 1A after 1,008 passes

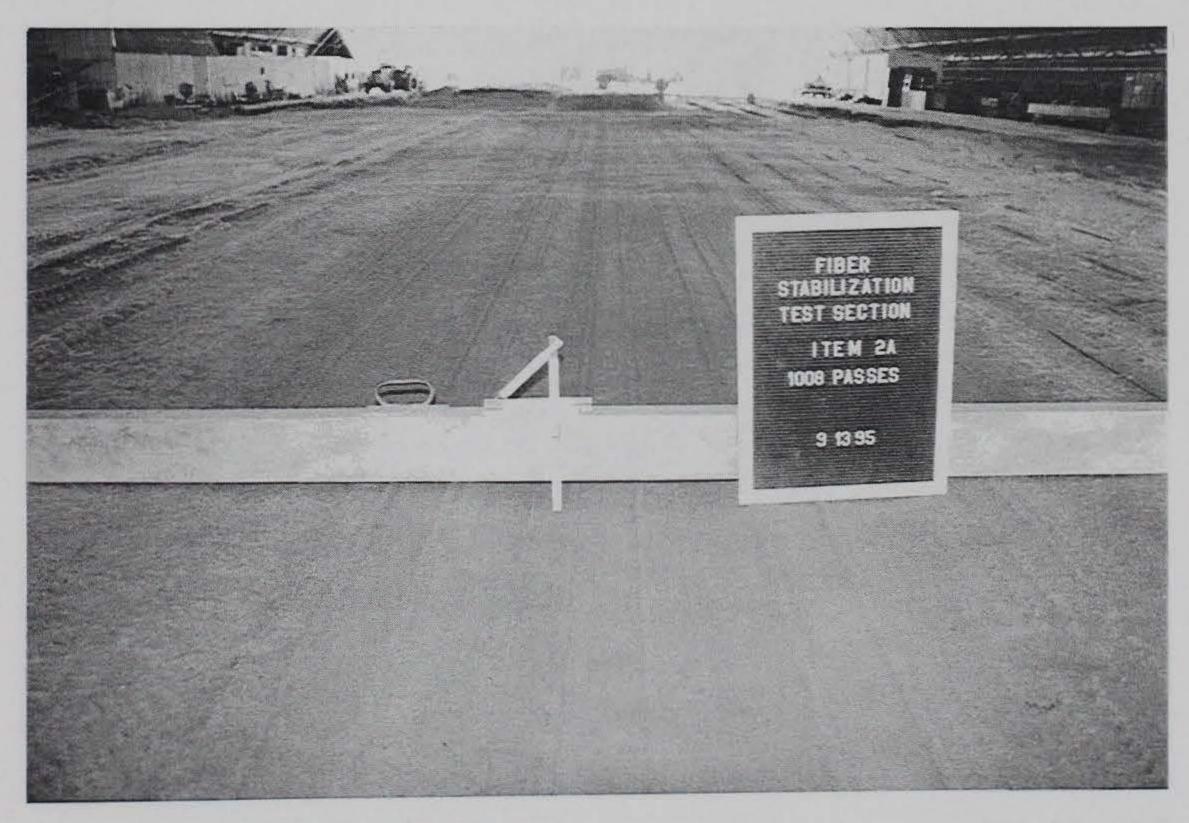
Figure 60. Item 2A after 1,008 passes

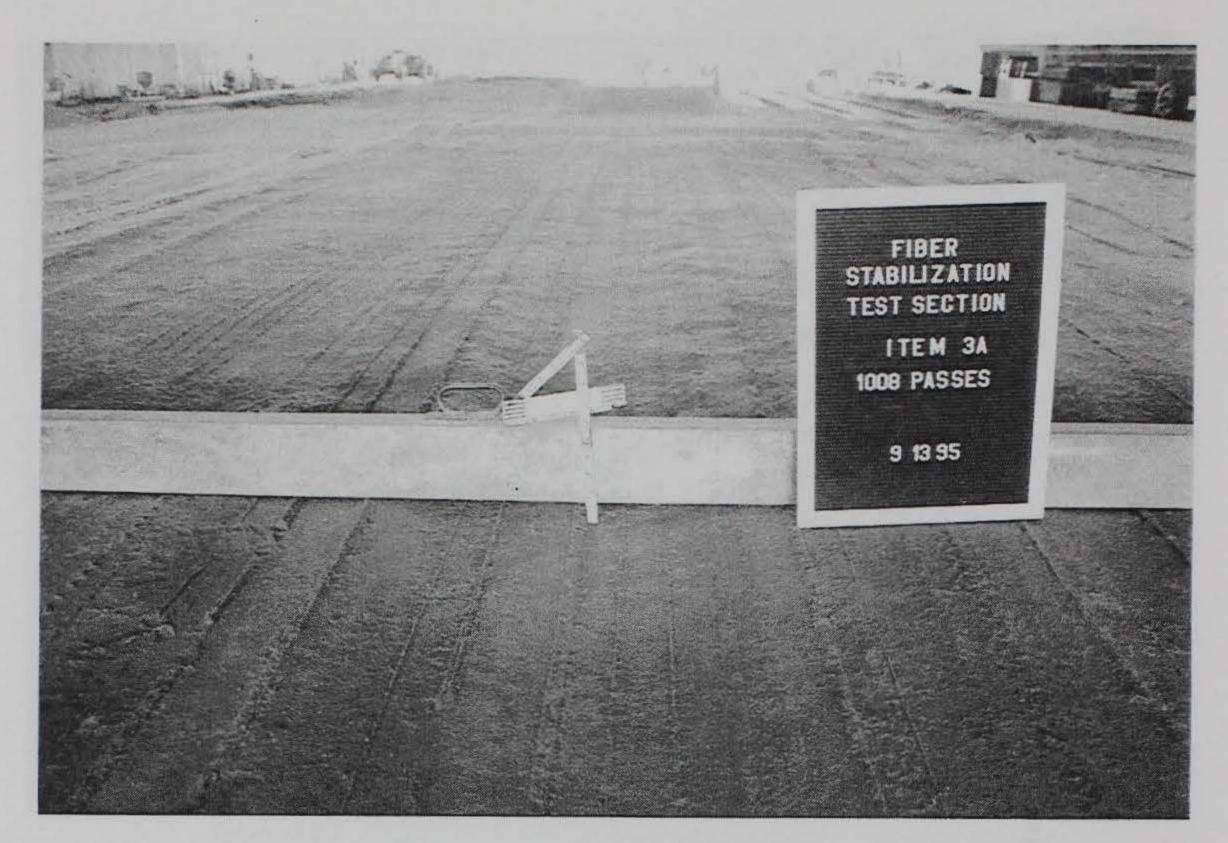
Figure 61. Item 3A after 1,008 passes

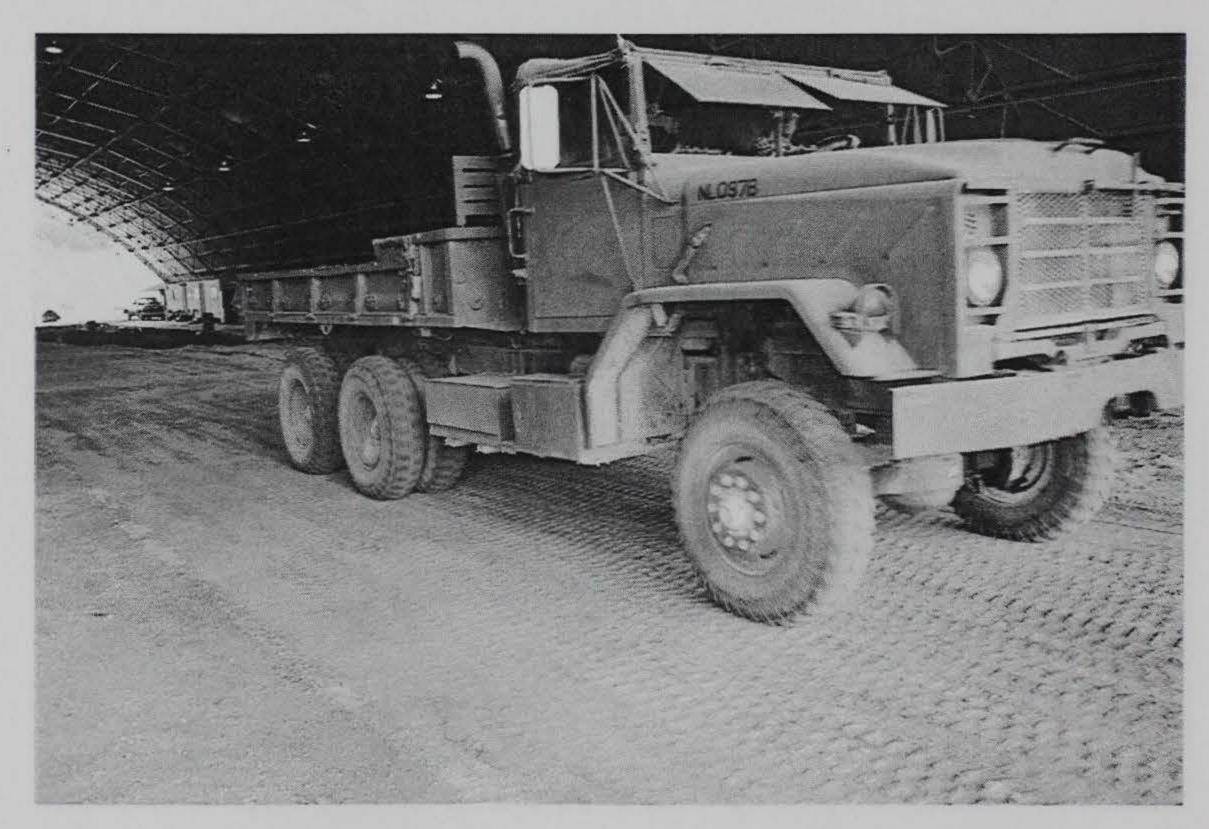
Figure 62. Military truck traffic on test section

After the C-130 load cart tests were completed, truck traffic was applied to test items 1A through 3A and items 5 and 6. A 5-ton military cargo truck loaded to a gross weight of 41,600 pounds was used. A total of 120 truck passes were applied to items 5 and 6 and 1,000 passes were applied to items 1A through 3A. Figure 62 shows the truck on item 1A and Figure 63 shows the condition of item 1A after 500 truck passes (item 1A looked the same after 1,000 passes). A uniform traffic distribution was applied over the entire 12-ft-wide test surface in items 1A through 3A. The truck traffic was beneficial in that it smoothed out the rutting caused by the load cart tests. Items 1A through 3A could have supported substantial amounts of additional truck traffic. Figure 64 shows the truck on items 5 and 6 after 120 passes. These limited test results indicated that the 8-in.-thick items could easily support large amounts of truck traffic. Test results also indicated that a simple spray-on application of Road Oyl makes an excellent wearing surface for sand-fiber base layers for truck traffic.

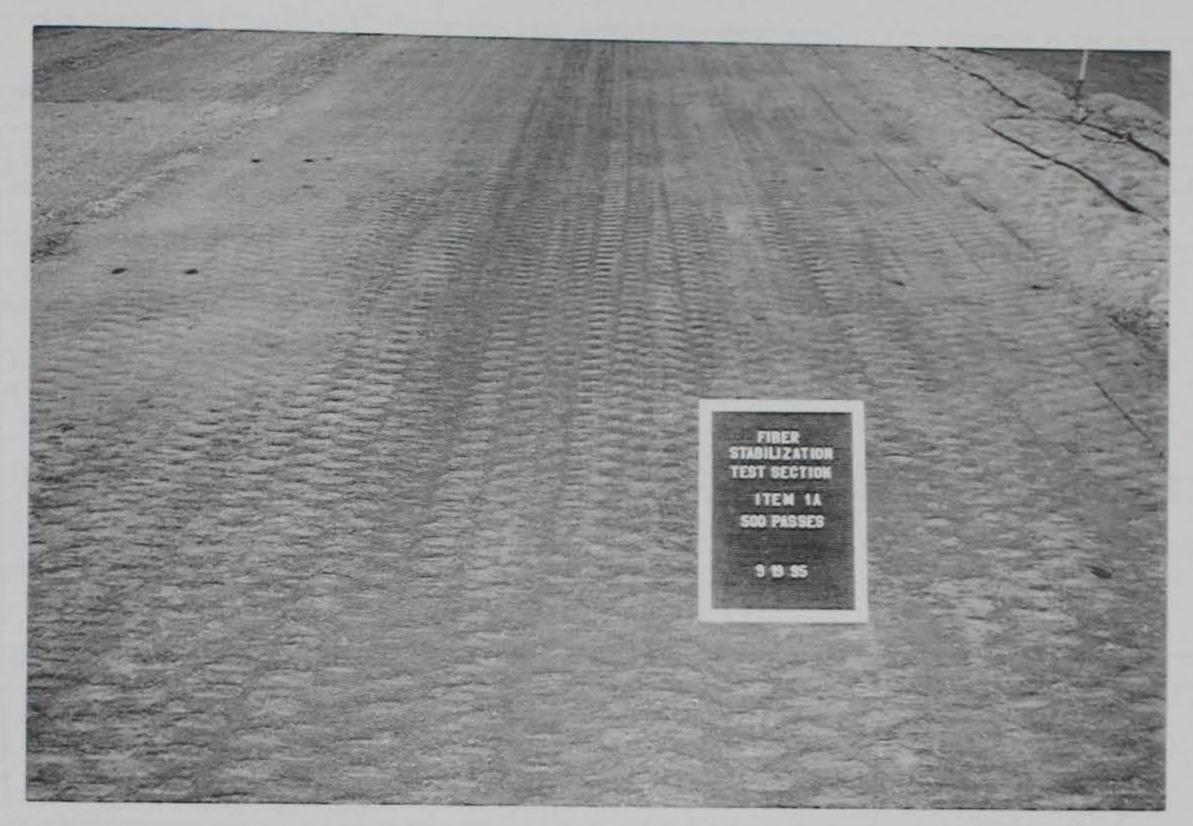
Figure 63. Item 1A after 500 truck passes

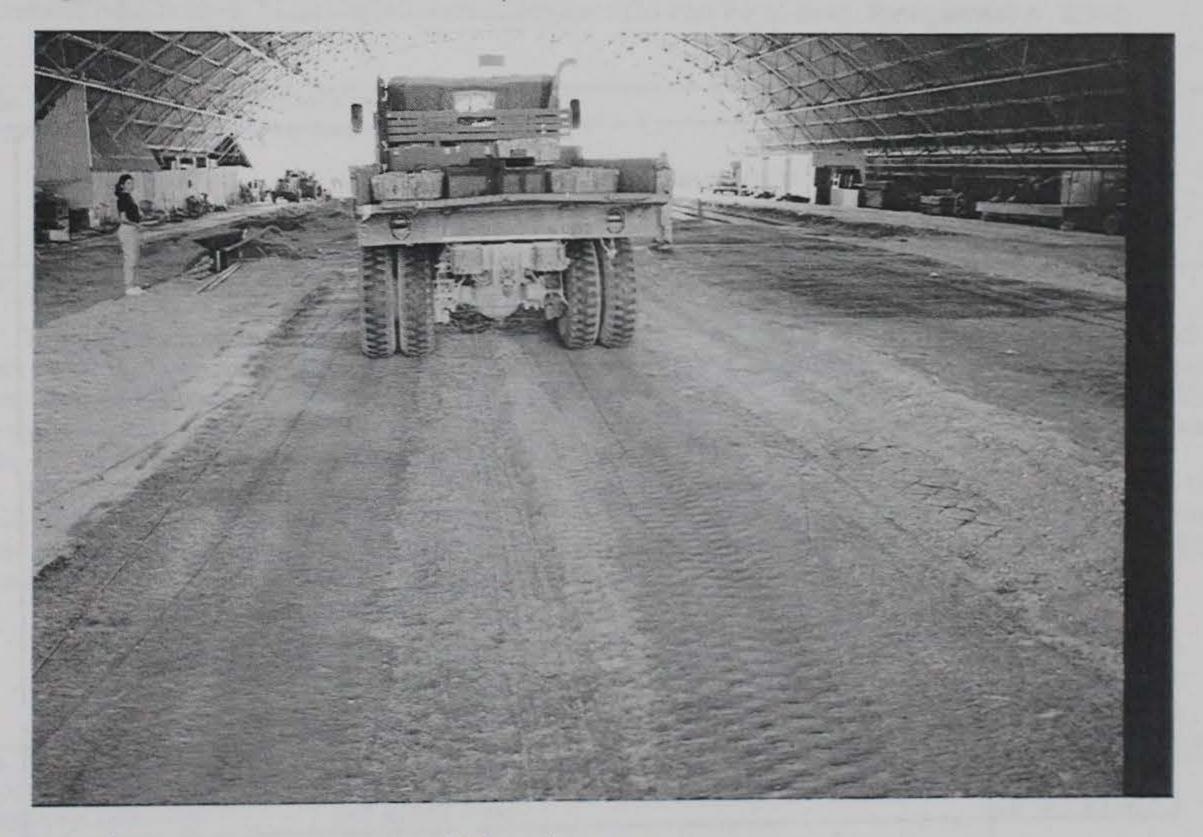
Figure 64. Items 5 and 6 after 120 truck passes

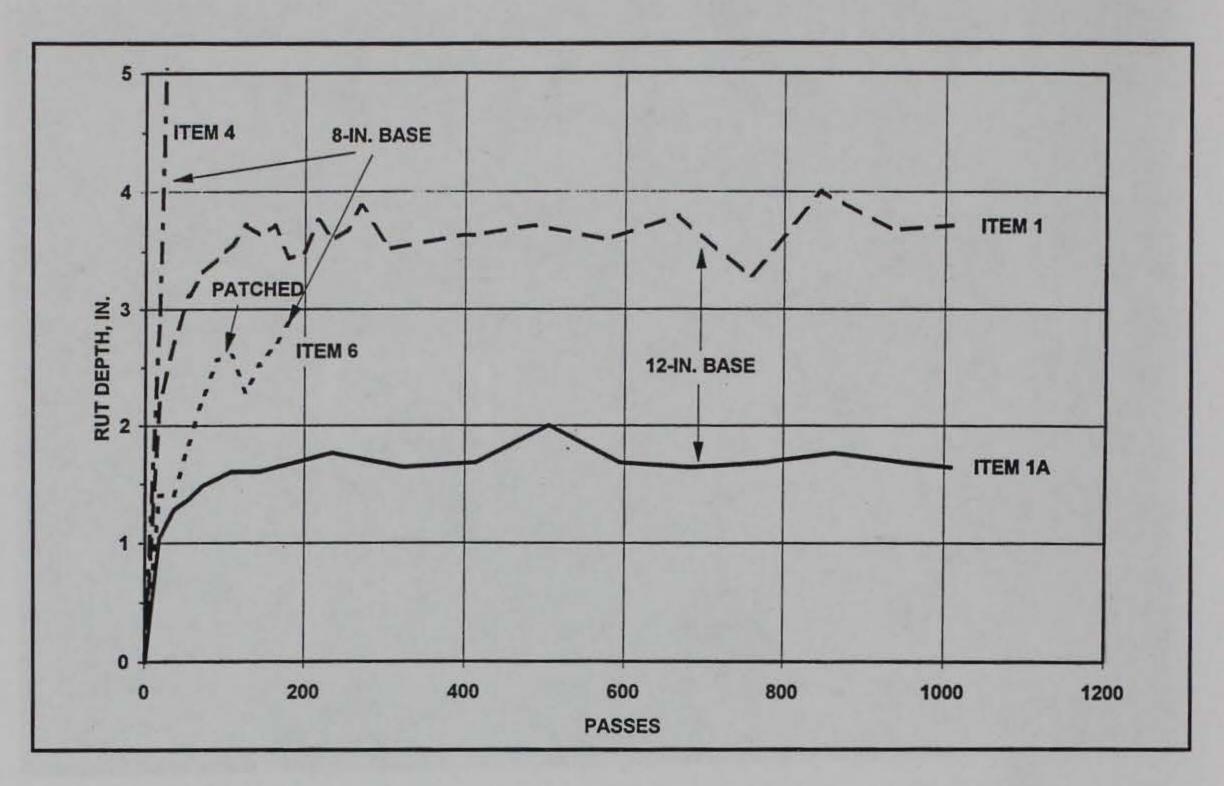
Figure 65. Rutting versus passes for load cart traffic, 8-in.- and 12-in.-thick sand-fiber items
