## Contingency Airfield and Road Construction Using Geosynthetic Fiber Stabilization of Sands

by Steve L. Webster, Rosa L. Santoni

Technical Report GL-97-4 April 1997

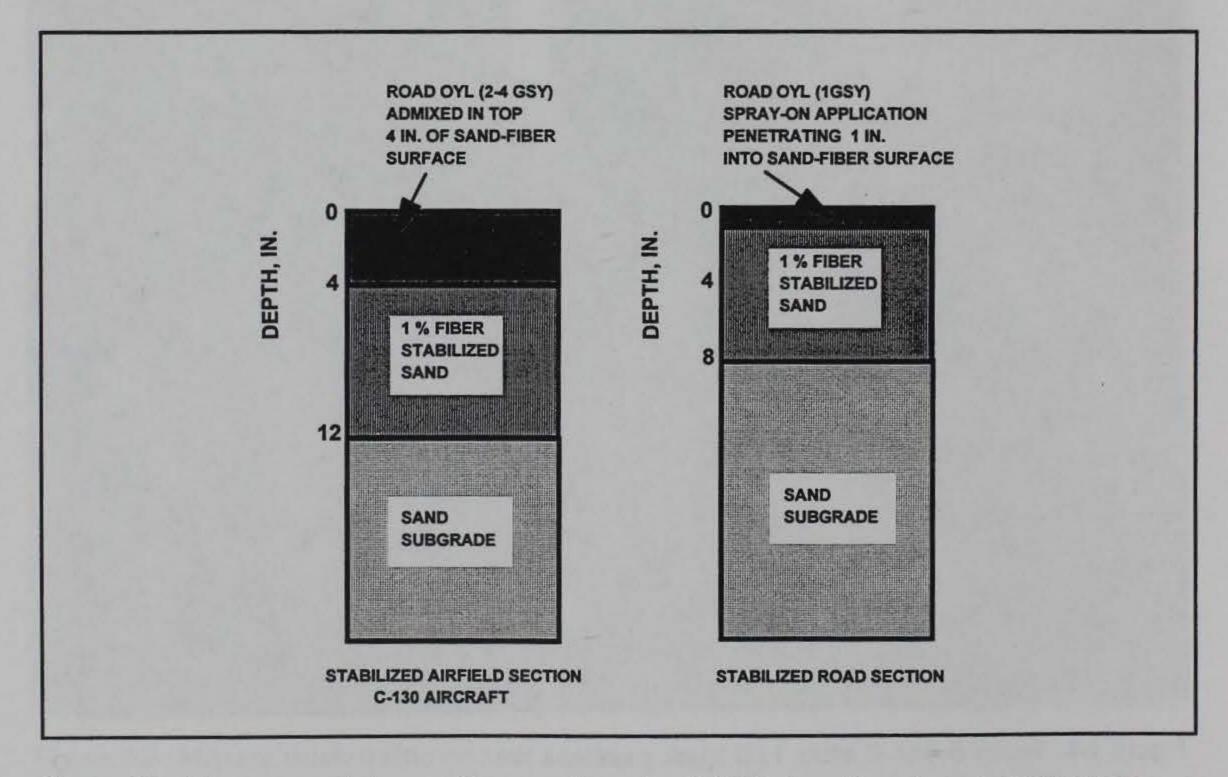
Figure 66. Recommended sand-fiber sections for C-130 aircraft and road applications

Based on the tests conducted, Figure 66 shows recommended stabilized sand-fiber pavement sections for C-130 aircraft and military roads over sand subgrades. Although not tested, a gravel surfacing or emulsified asphalt could probably be substituted for the Road Oyl.
