TECHNICAL REPORT GL-82-7

MEMBRANE-SOIL COMPOSITE LAYERS IN THE DESIGN, CONSTRUCTION, AND PERFORMANCE OF AN EXPEDIENT BRIDGE AND APPROACH

September 1982

Final Report

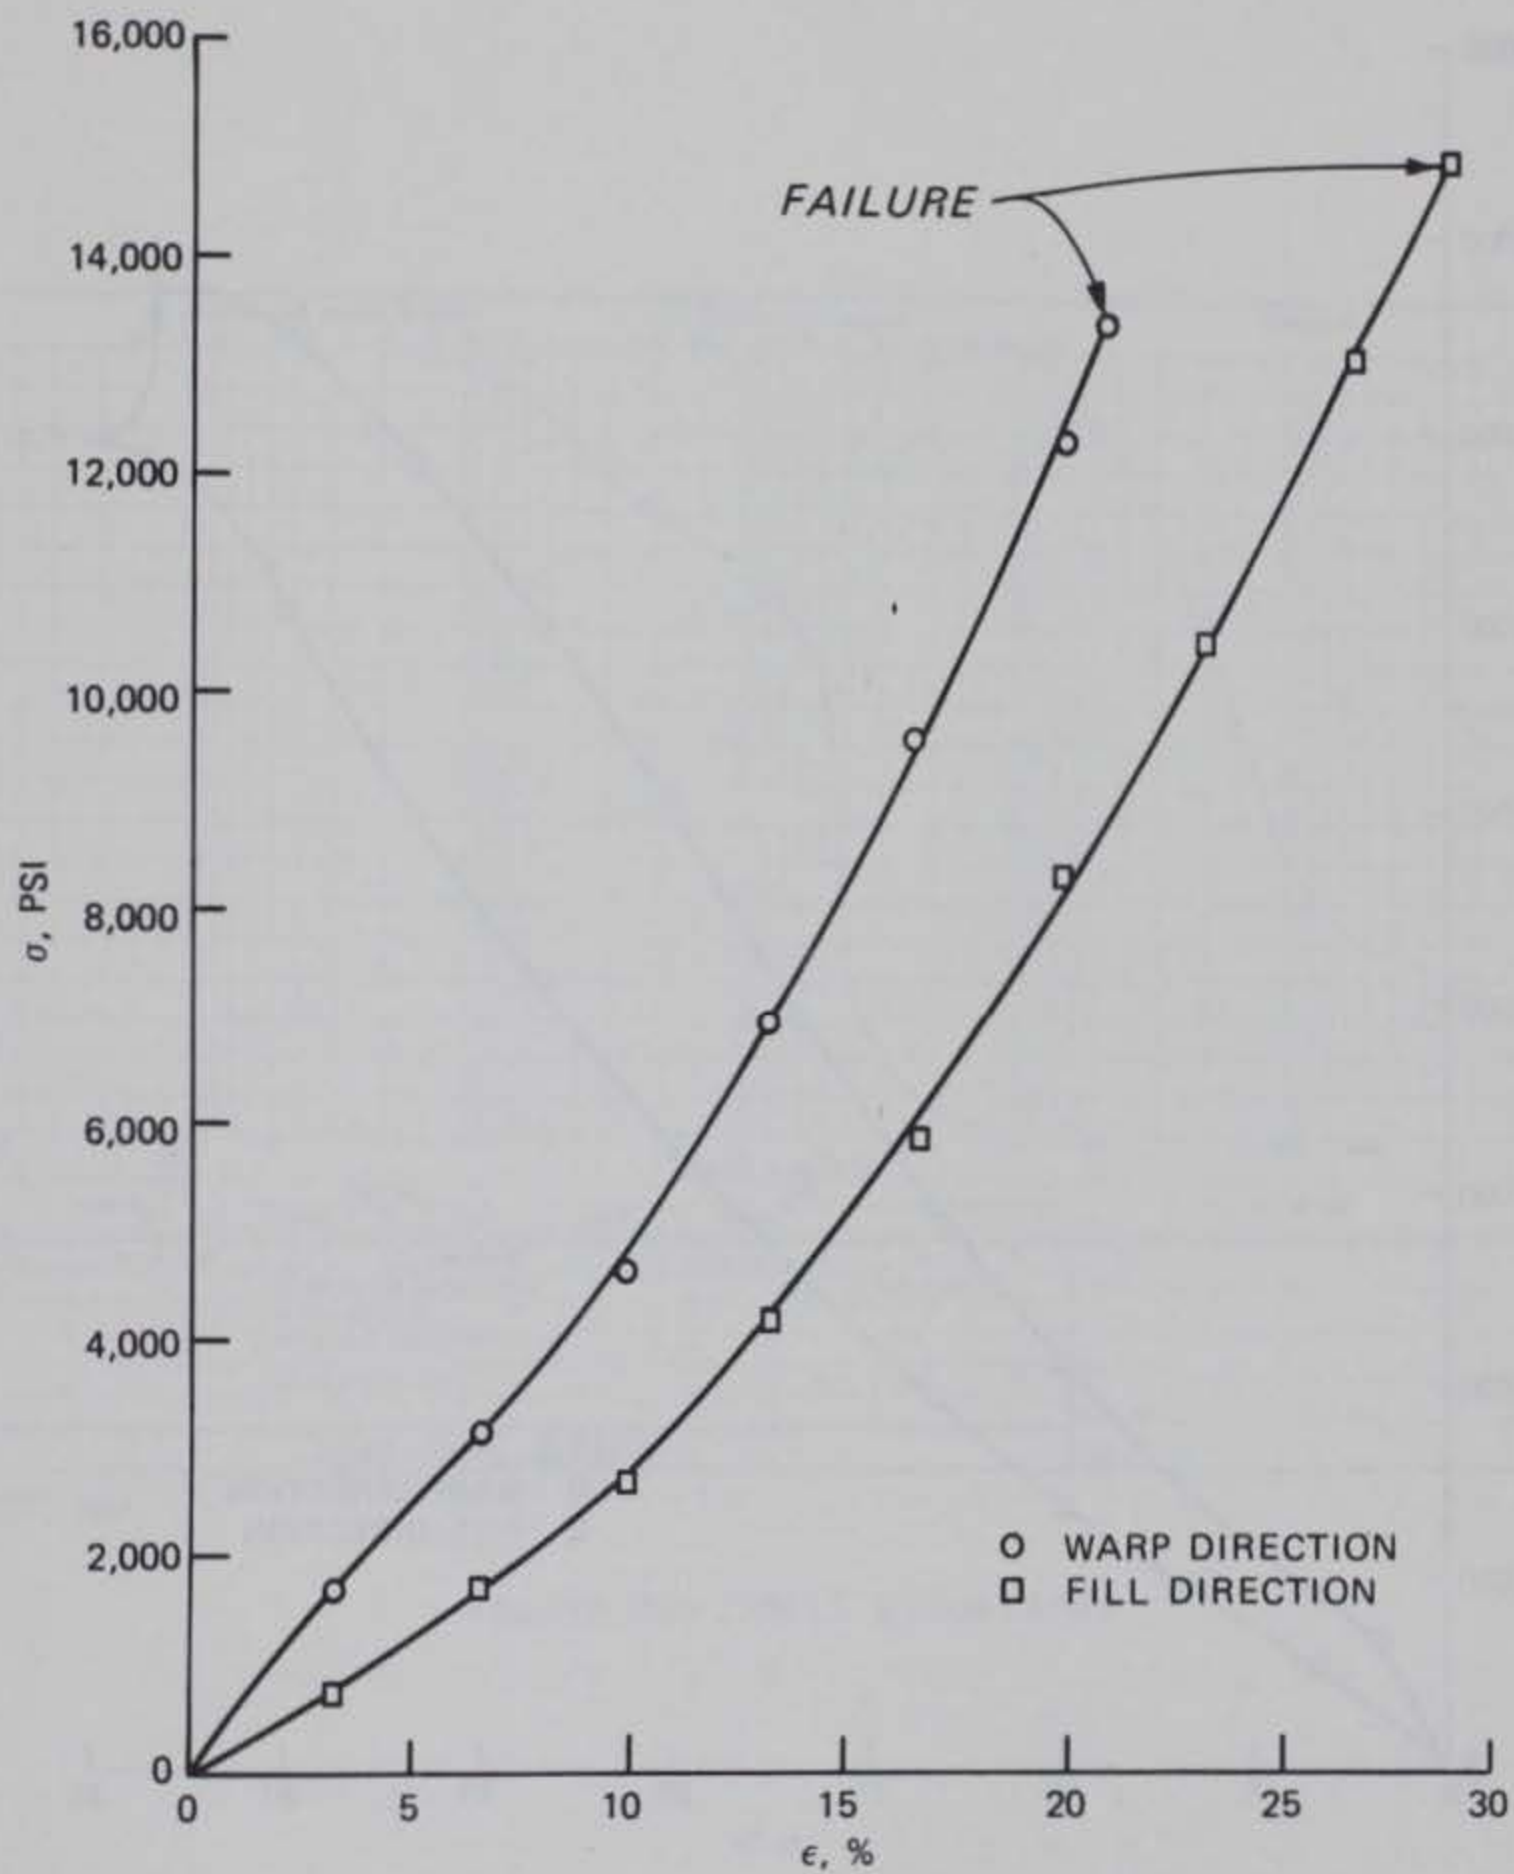
Figure 8. Uniaxial stress-strain characteristics of T-16 membrane (2-in. cut strip)

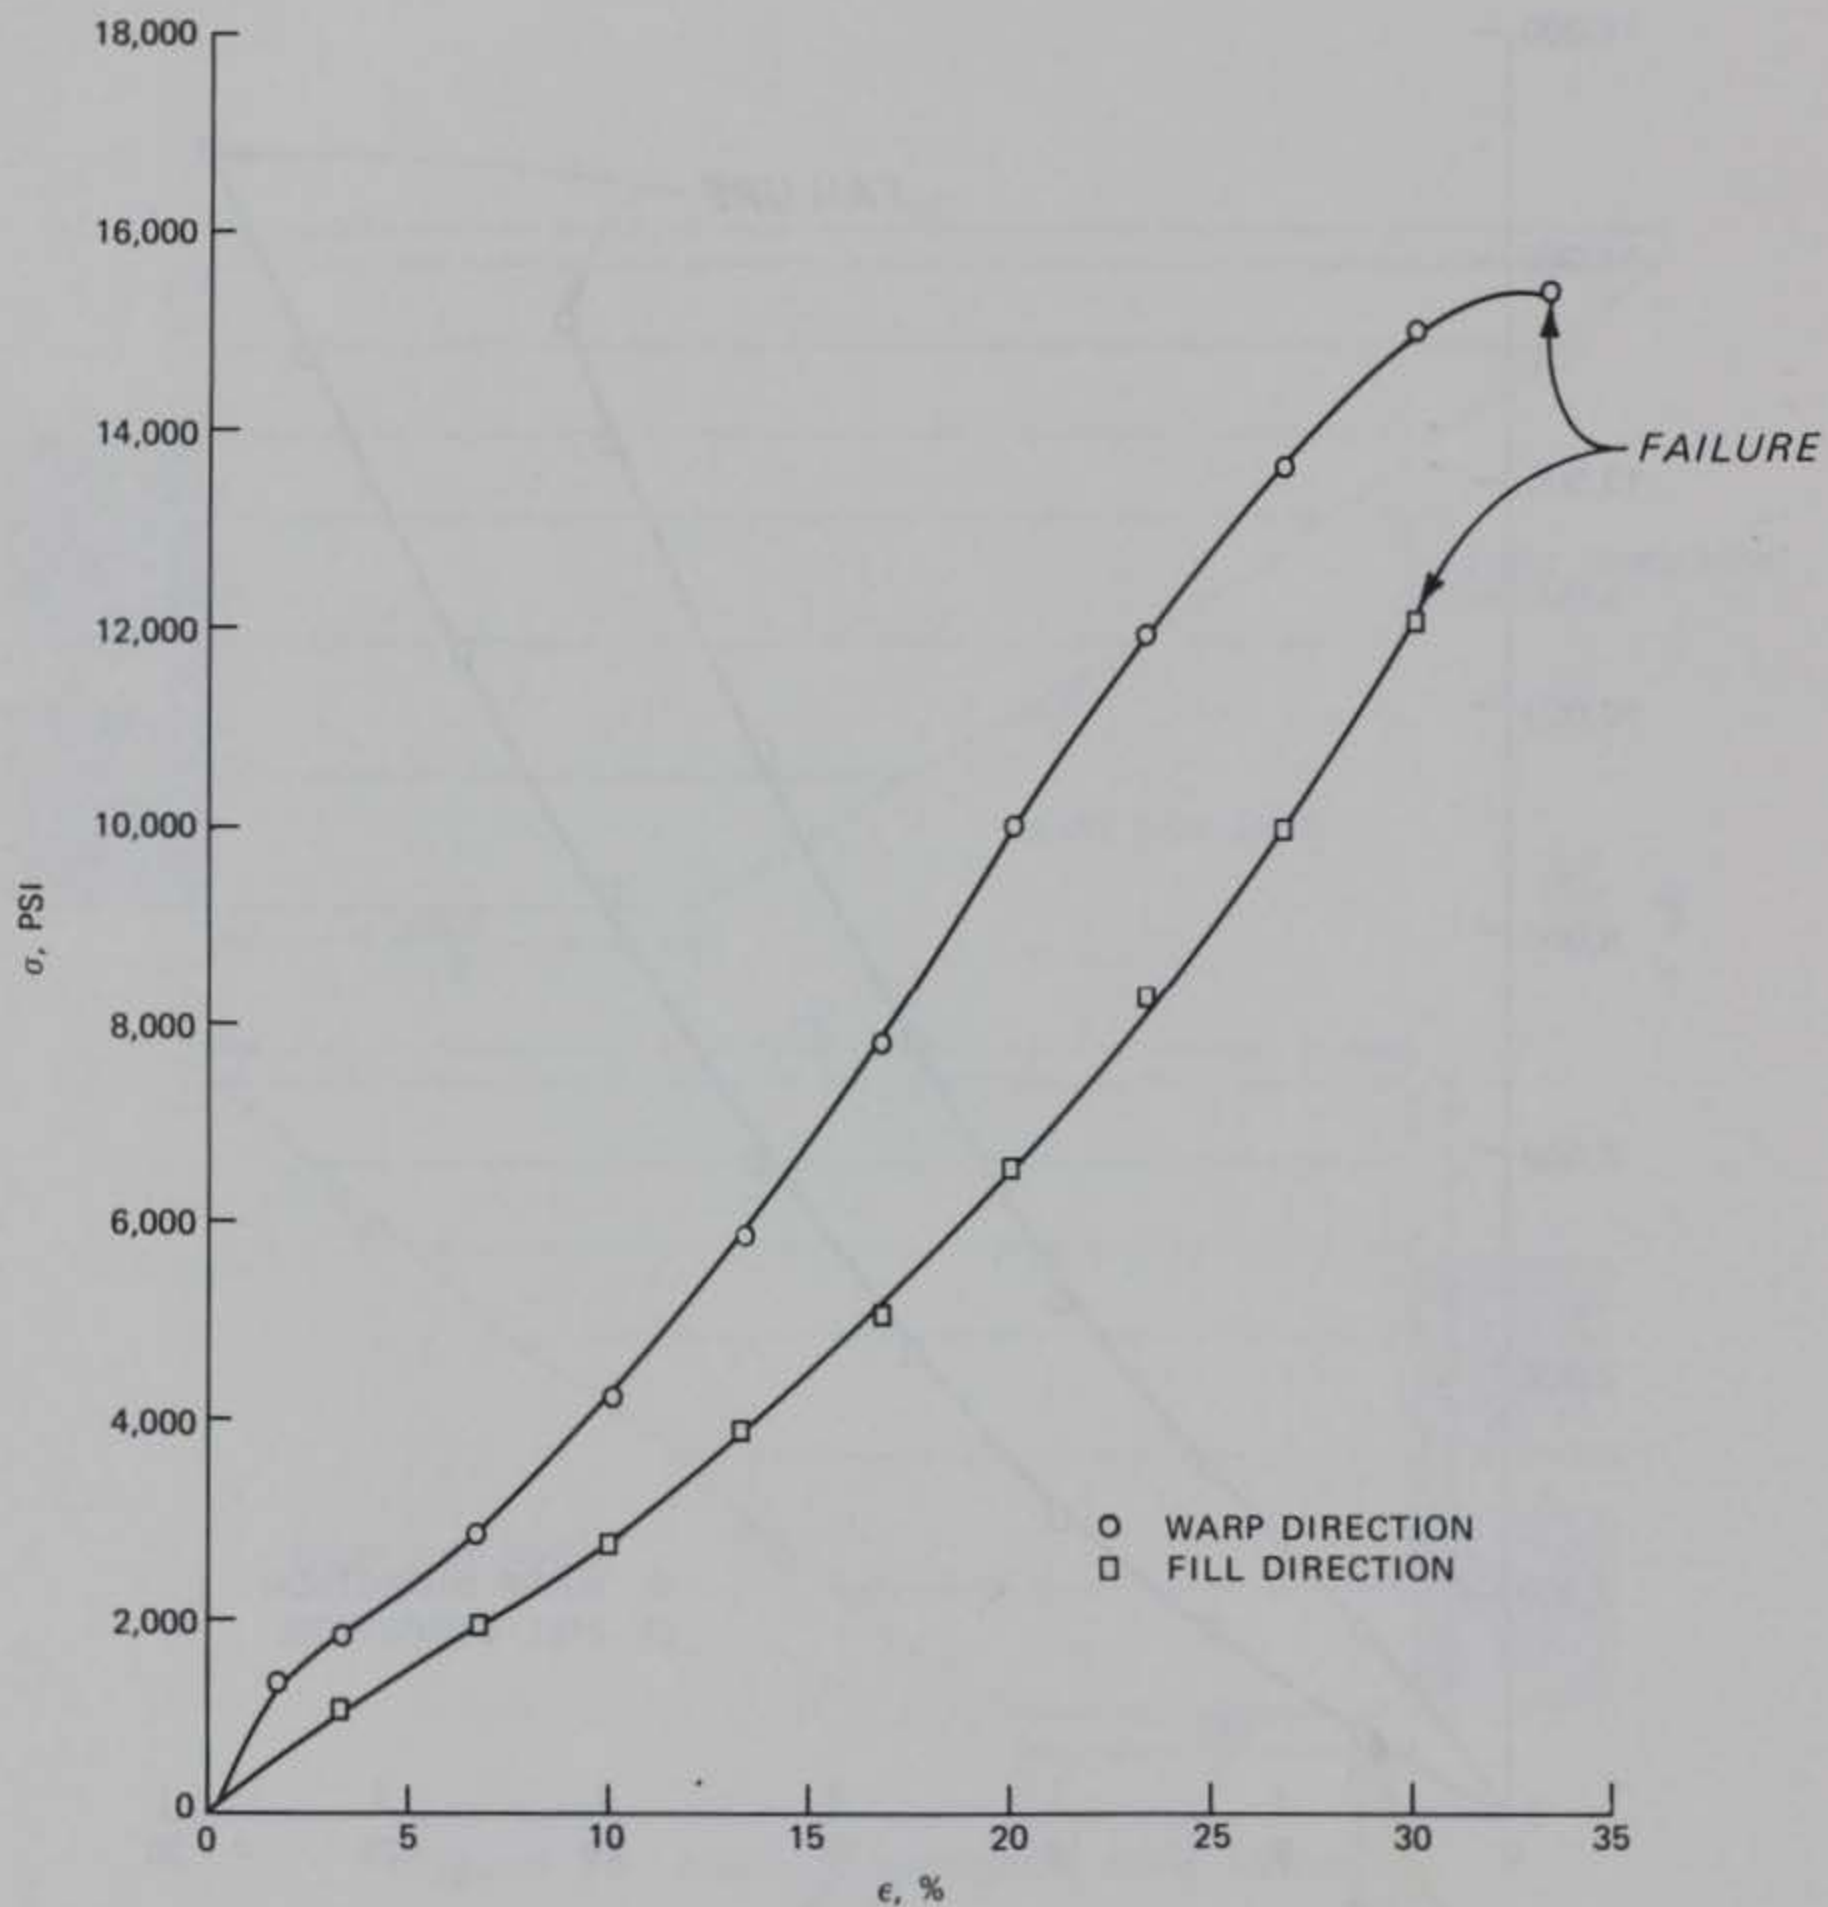
Figure 9. Uniaxial stress-strain characteristics of T-17 membrane (2-in. cut strip)

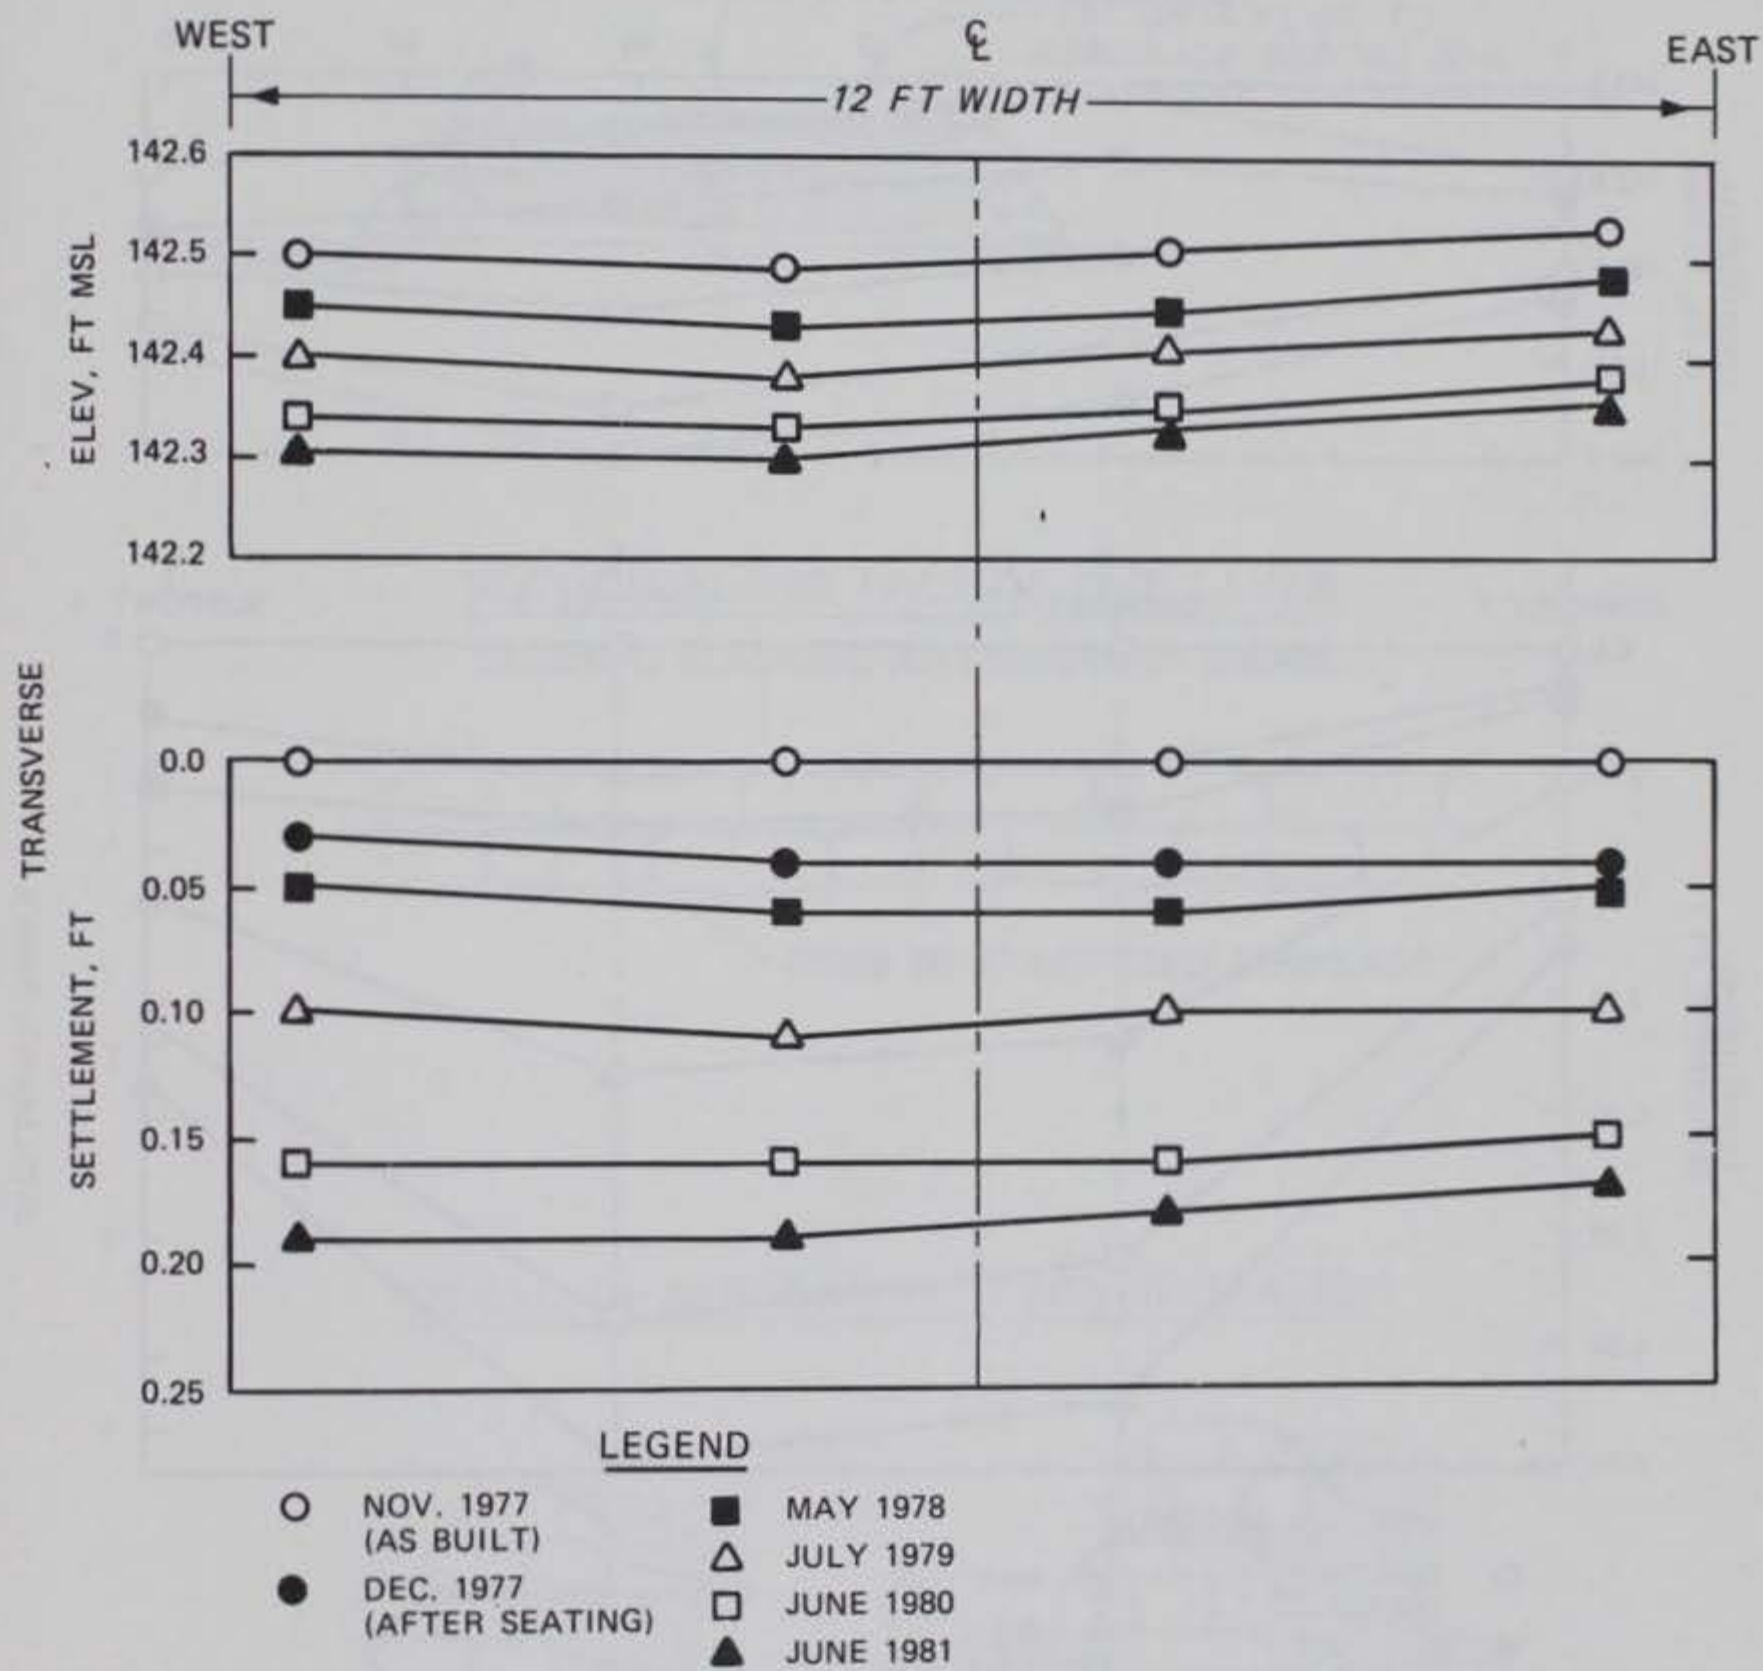
Figure 18. Tread above support 4

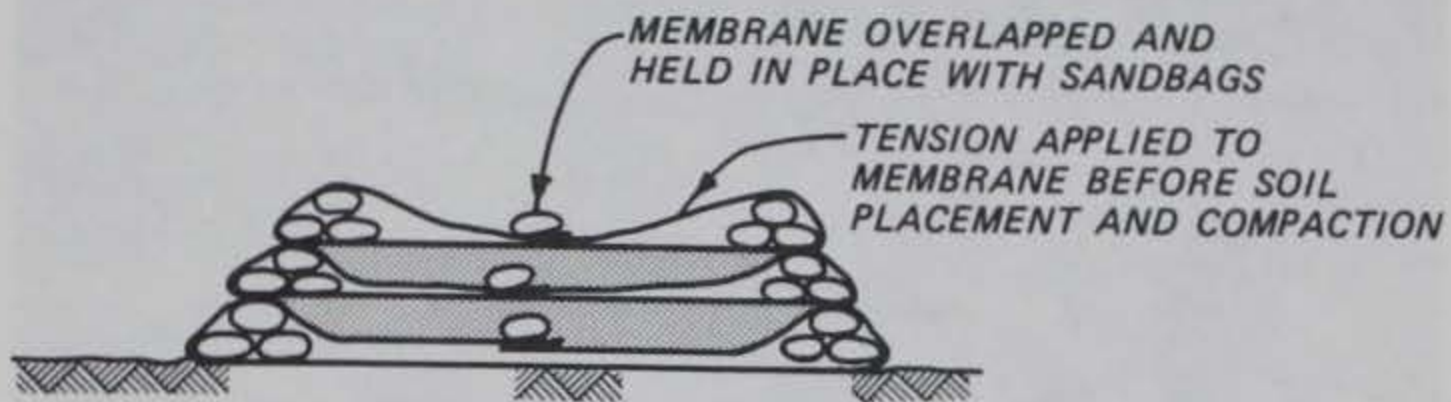
APPROACH CROSS SECTION

SECTION ALONG FACE OF ONE LAYER SANDBAG STACKING ARRANGEMENT SHOWN

DETAIL OF SANDBAG FACE CONFIGURATION

OR SIMILAR STABLE VARIATIONS MAY BE USED.

Figure 20. Recommended construction technique and sandbag configuration for layered approaches

- c. Construction and performance of similar structures designed for load class 60, high-volume traffic should be evaluated.
 - d. In design and construction of layered approaches, a modified technique, consisting of a more stable sandbag arrangement along the facing, should be used. A recommended facing technique, using staggered sandbags, is shown in Figure 20.

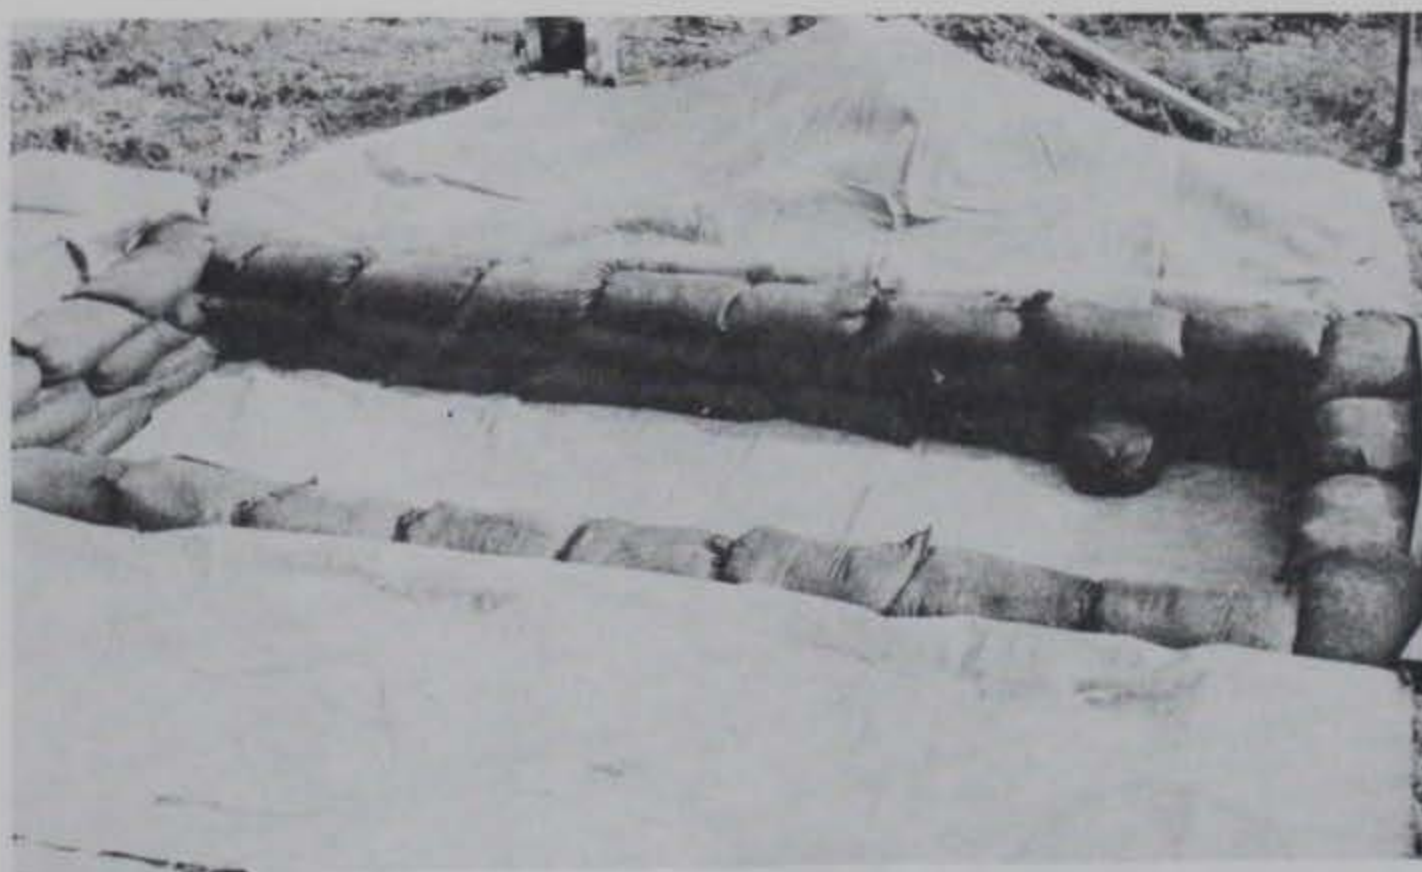
Photo 8. Typical first support layer showing sandbag form (note membrane flaps)

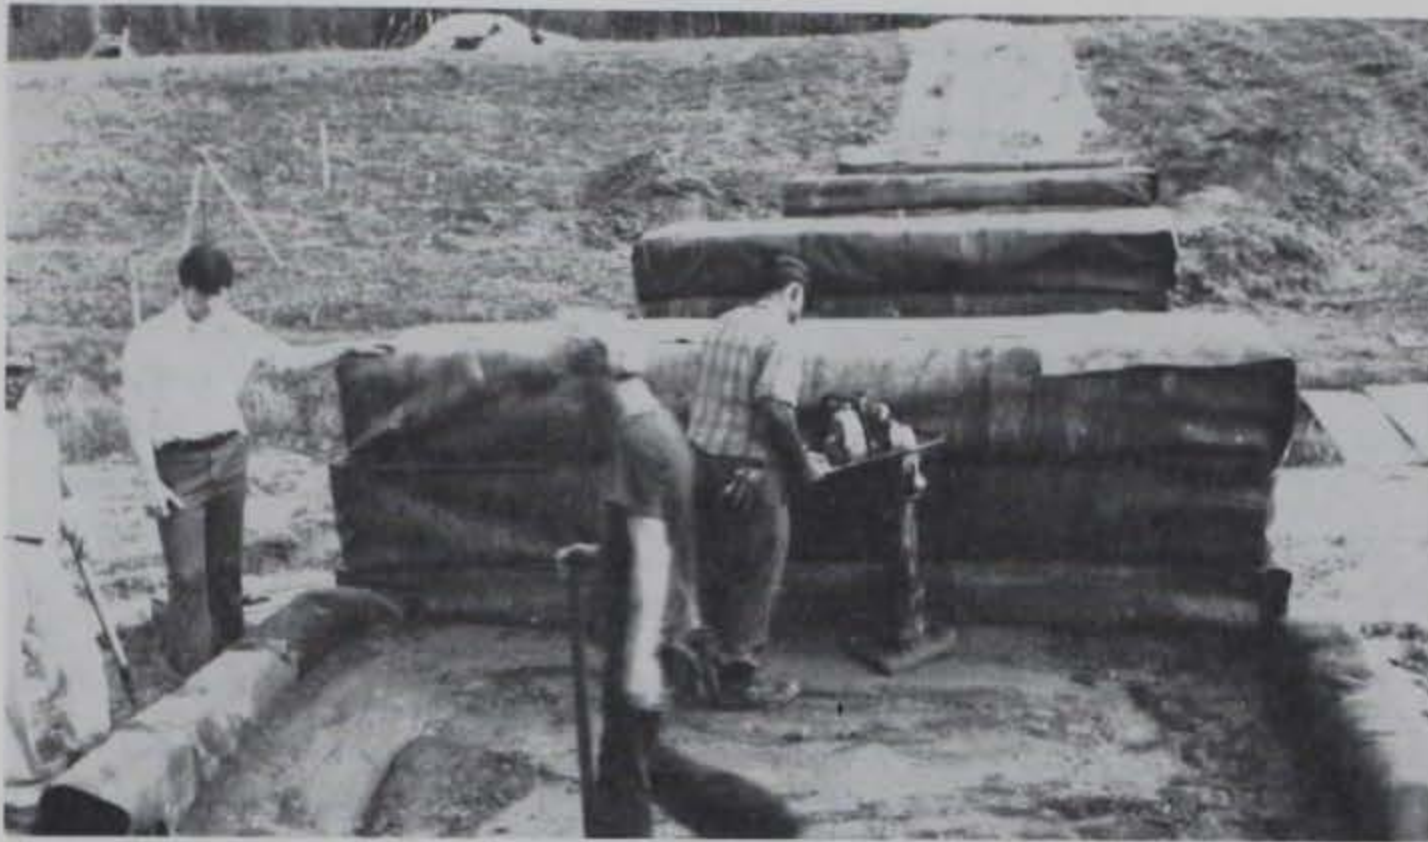
Photo 23. Constructing layered approach
using Technique 1

43. The preceding general steps were followed; however, construction problems led to the use of two building techniques on the north approach. In the first technique, shown in Figure 14, facing sandbags were stacked three layers high, membrane was not overlapped at the interior, and inner sandbags were placed adjacent to facing sandbags to hold membrane in place. This technique was used on the lower three layers. As the approach was built higher by filling and compacting the lean clay soil, more outward leaning and lateral movement of the wall faces was observed. Technique 1 and the effect of using Technique 1 can be seen in Photos 23 and 24, respectively.

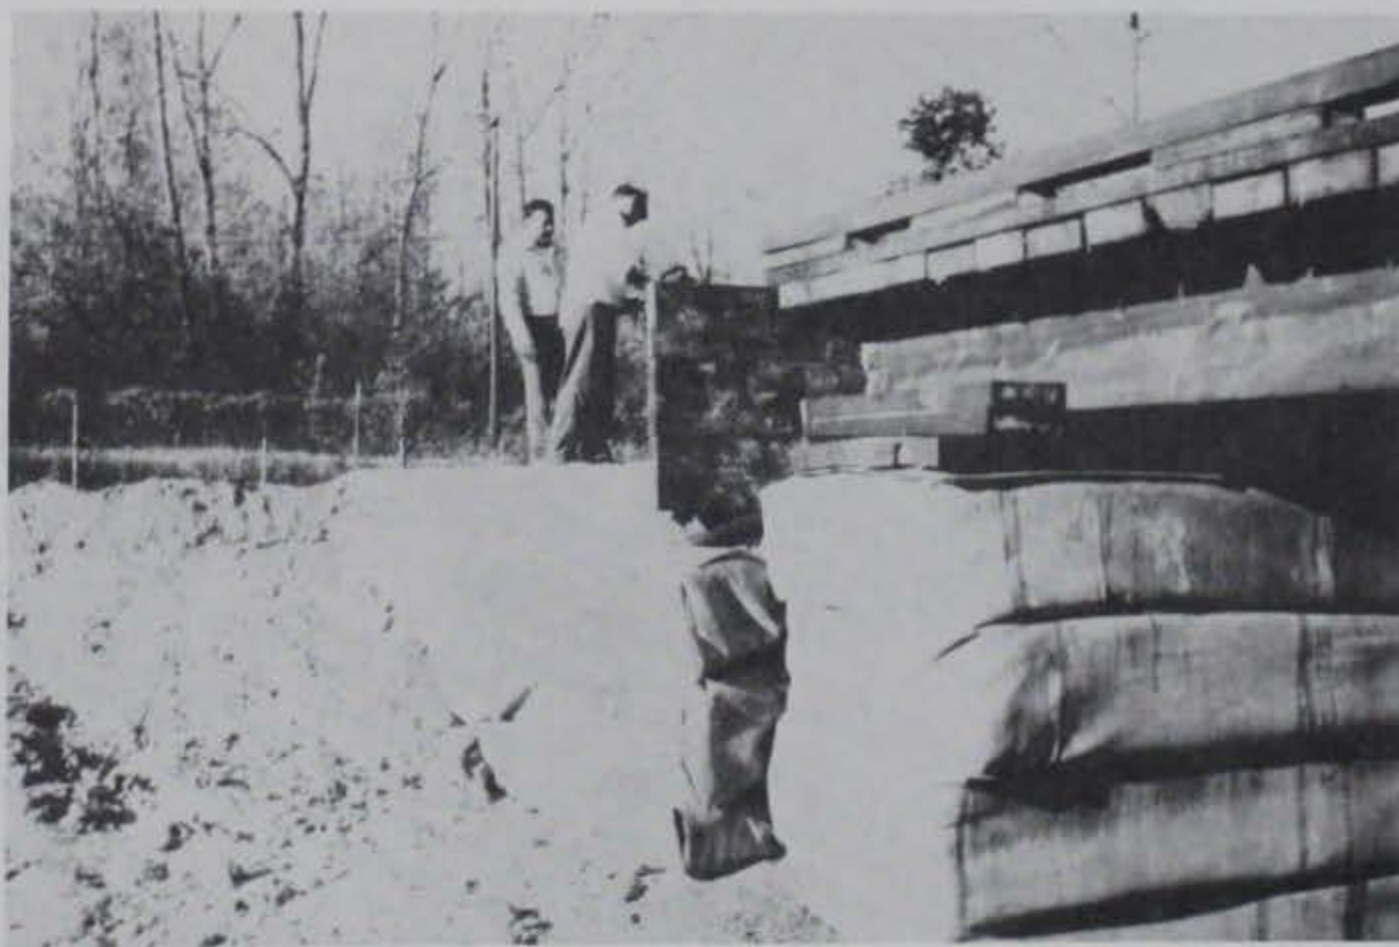
Photo 24. Layered approach construction
north of support 4

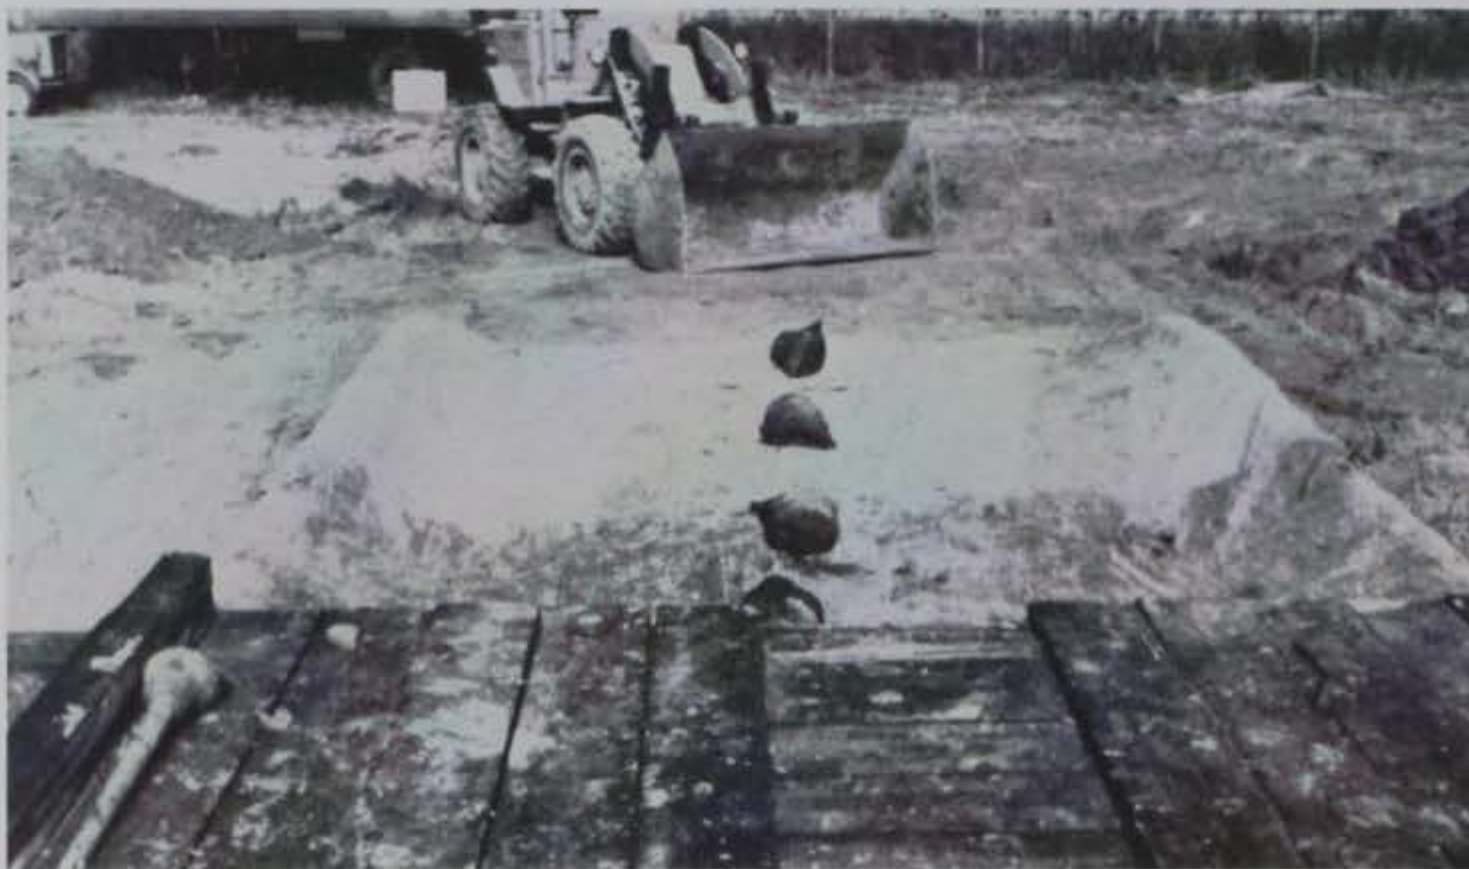
Photo 25. Layered approach using Technique 2
(before soil placement)

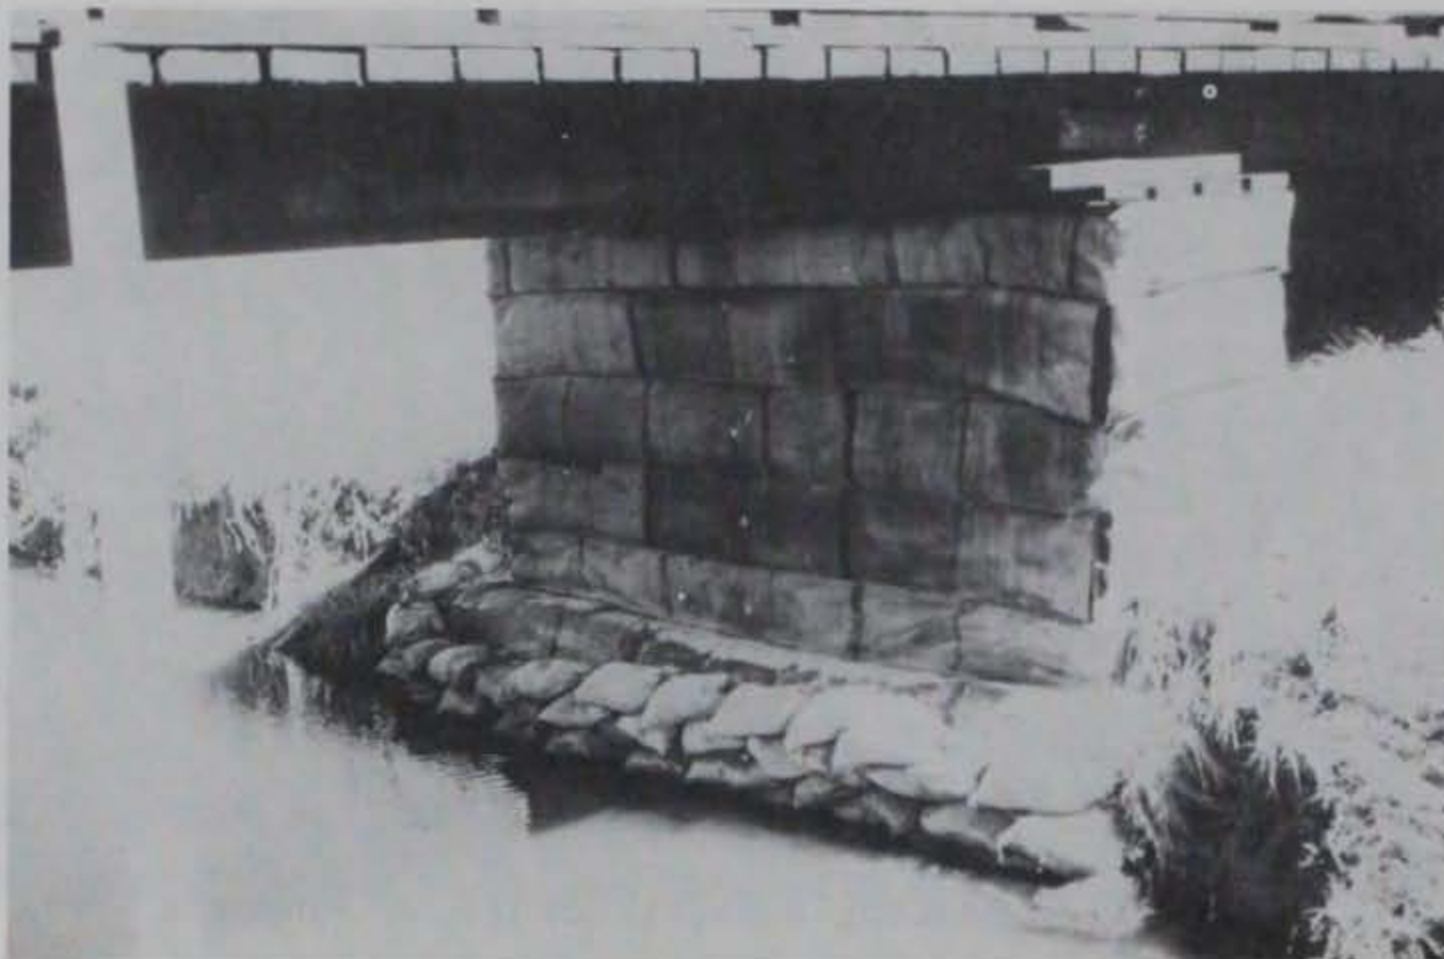
Photo 29. Scour protection at support 2
(March 1981)

49. During the evaluation period, scour/erosion was a continuing problem on the upstream end and the sides of supports 2 and 3. Sandbags filled with a mixture of cement and clay gravel were placed in the affected areas twice during the evaluation period due to frequent downstream movement of the protective sandbags caused by runoff currents. During the evaluation period, the scour/erosion did not adversely affect bridge performance, but it did require maintenance to prevent major damage.

51. Erosion continued on an intermittent basis during periods of high runoff. At the end of the performance period, it had widened the creek about 7 ft between supports 2 and 3; this caused the creek to extend from one support to the other. Scour had also deepened the creek in this area. Photo 28 shows the creek and bridge at the end of construction. Support 2 was built about 4 ft north of the creek edge and support 3 was built about 3 ft south of the creek. Photo 29 shows erosion effects at support 2 toward the end of the evaluation period.
