Miscellaneous Paper CHL-98-6
August 1998

Toussaint River Unexploded Ordnance (UXO) Demonstration Dredging Project

*by Timothy L. Welp, James E. Clausner, WES
Raymond L. Pilon, Buffalo District*

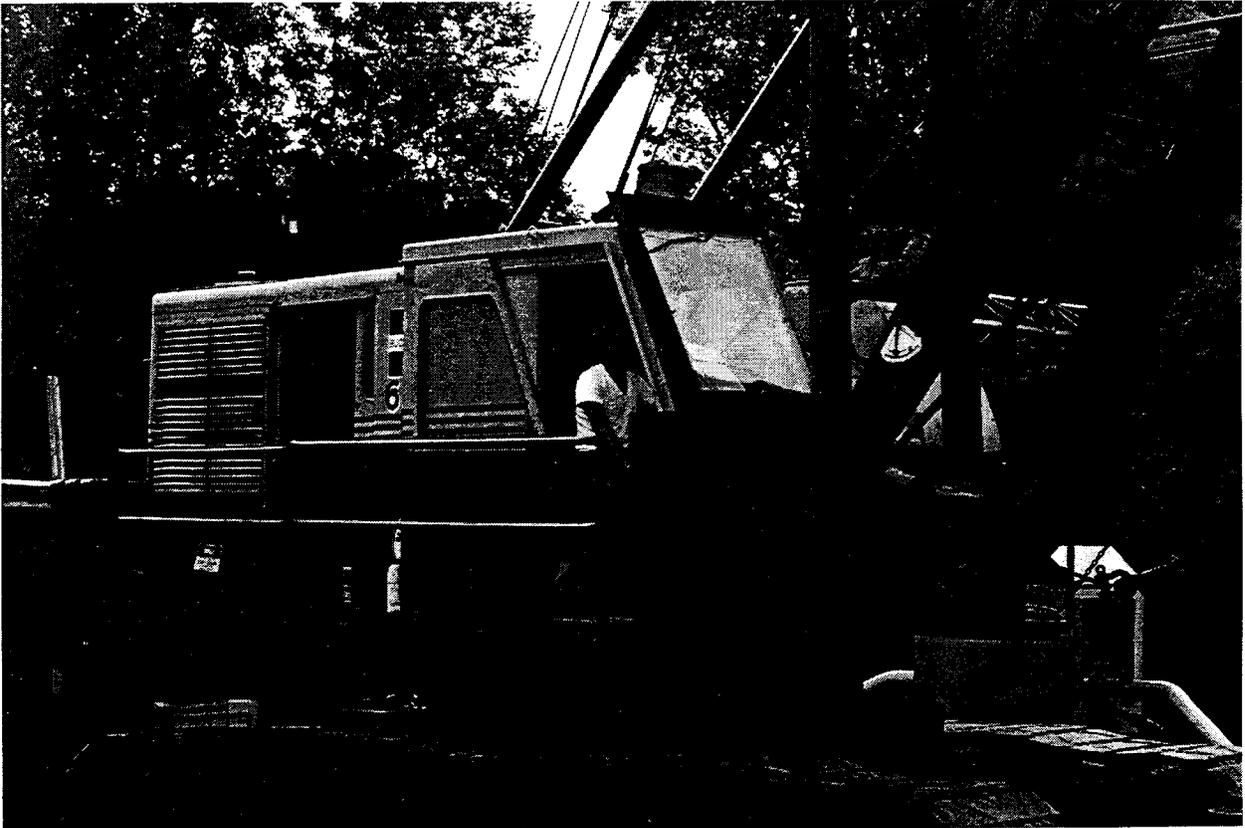
Figure 2. Crane operator's protective barrier

Engineering controls to counter health hazards due to potential UXO detonation consisted of enclosing the crane operator's booth with a 6.4-mm- (0.25-in.-) thick steel plate protection barrier with a viewport consisting of 64-mm- (2.5-in.-) thick polycarbonate laminate. This viewport provided the equivalent resistance of

6.4-mm- (0.25-in.-) thick mild steel plate (Figure 2). The 24-m (80-ft) crane was required because it allowed a minimum separation distance of 16 m (52 ft) between the operator and the clamshell bucket (also a protective barrier). The Huntsville Division designed the appropriate safeguards, including the protective barrier and the separation distance, using the computer program CONWEP to analyze effects of a potential detonation (i.e., equivalent weight of TNT, peak overpressure, fragmentation, etc.). This analysis was based on a 106-mm anti-tank round, the maximum-sized UXO perceived as a threat.

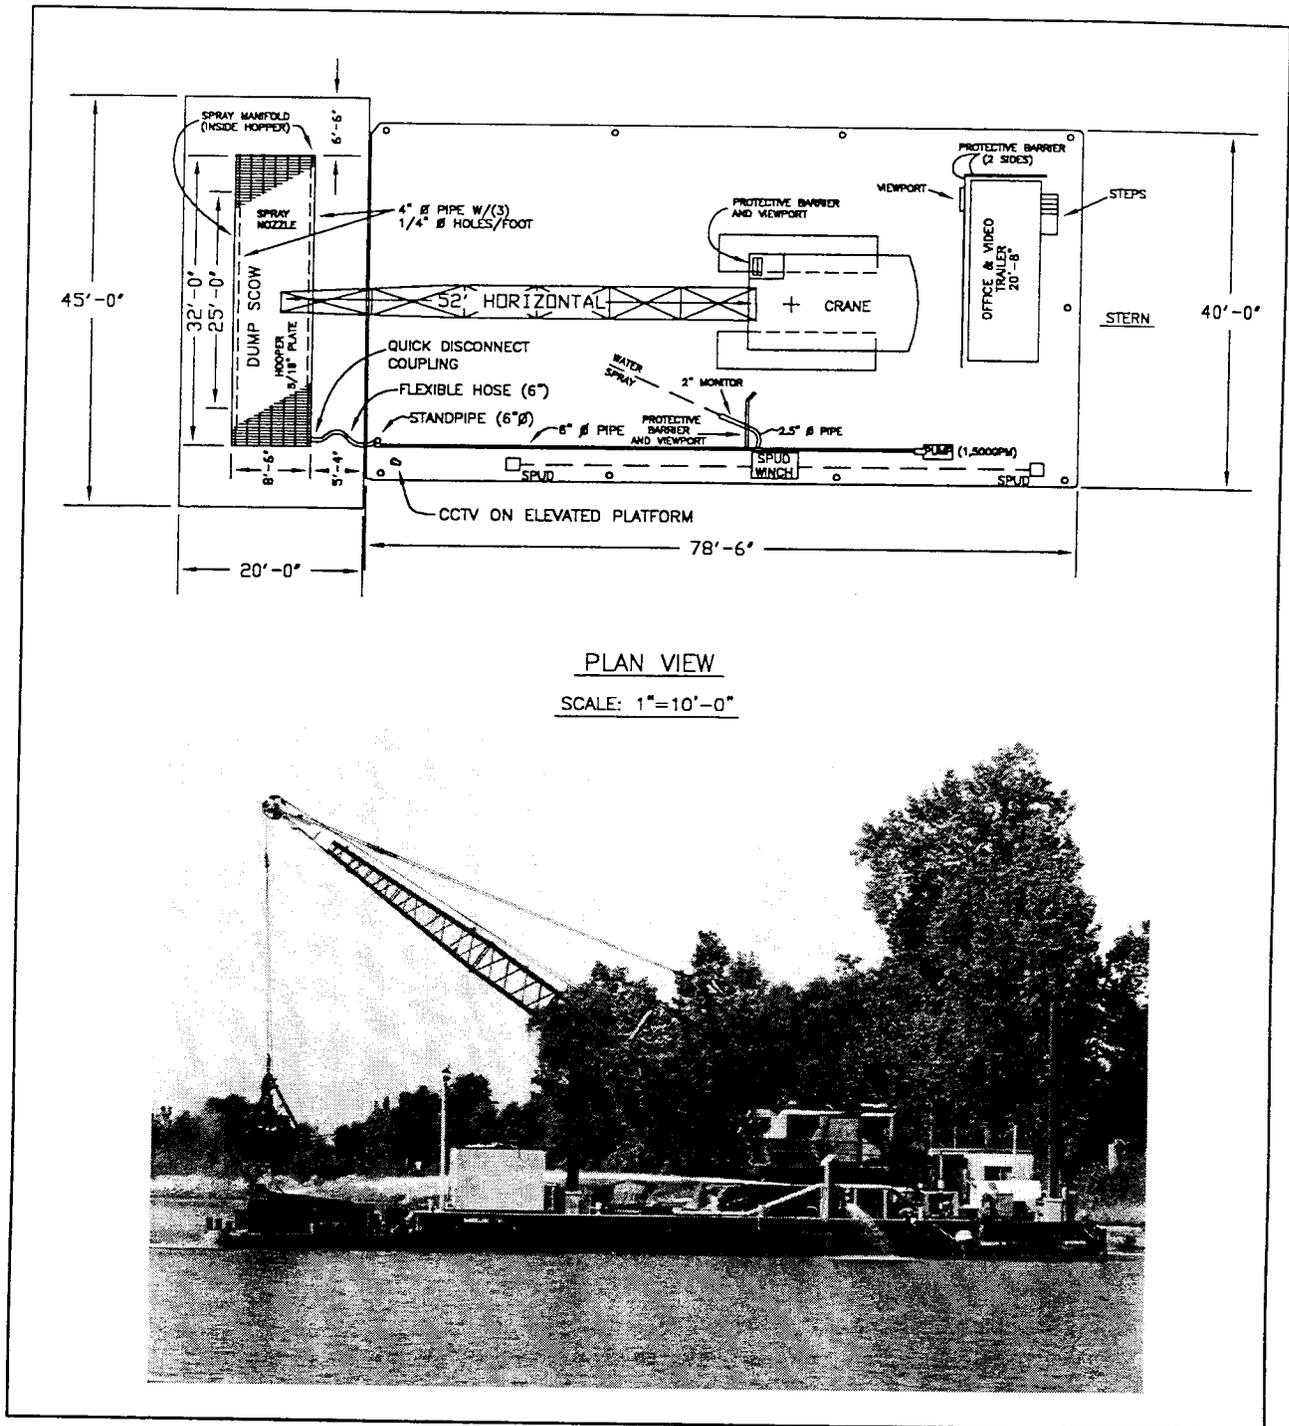
Figure 3. Deck layout (Courtesy of Shoreline Contractors, Inc.) and photograph of UXO dredging system

The clamshell excavated medium-sized sand (average d_{50} of 1.2 mm) from the navigation channel and dumped onto the scow secured “alongside” as shown in Figure 3. The project used two 65-m³ (85-yd³) capacity bottom-dump scows 14 m by 6 m by 2 m (45 ft by 20 ft by 6 ft) to transport dredged material to the disposal site. These scows were pushed with the work boat *Falcon*, an 11-m by 4-m by 0.8-m (36-ft by 12-ft by 2-1/2-ft) motor vessel equipped with pusher knees and propelled by a 350-hp diesel engine. The shallow drafts of the *Shoreline 785*, *Falcon*, and both scows allowed dredging to be conducted in water depths as shallow as 1.2 m (4 ft).

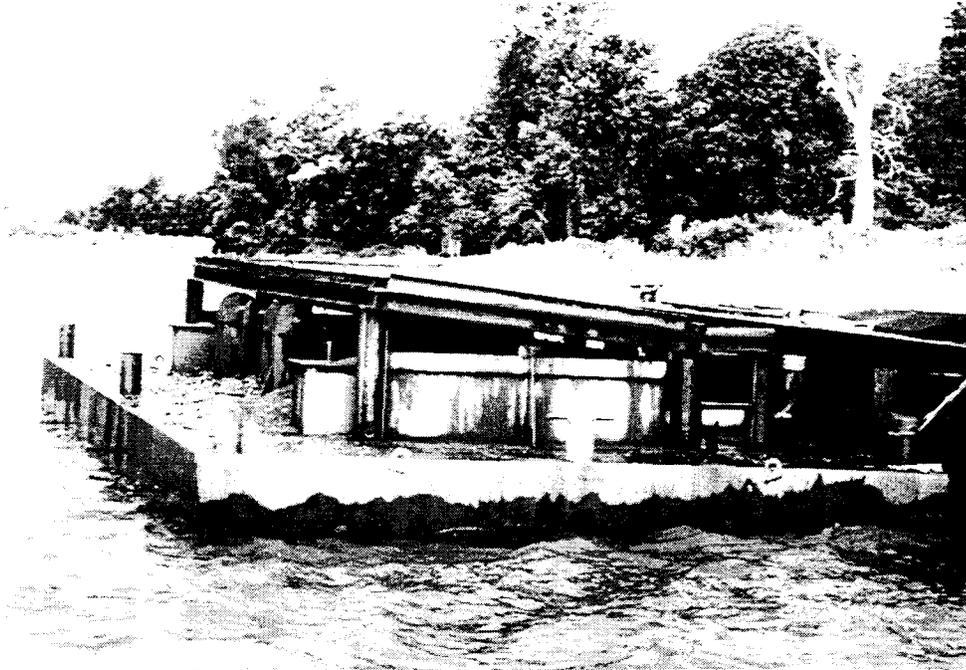
Figure 4. Scow and separation screen

The separation screen was mounted over each scow on an I-beam support structure welded to the deck and inclined approximately 10 deg from the horizontal plane (Figure 4). In the event of a detonation, the screens were

designed and constructed to allow damaged sections to be replaced or repaired. Each screen's 25-m² (272- ft²) total surface area was divided into two equal sections, 5 m by 2.6 m (16 ft by 8-1/2 ft) each that were removable to facilitate repair of detonation-induced damage and also to clean debris by lifting one side with the crane. The contract specifications required that the maximum screen opening dimensions be 19 mm (0.75 in.) in one direction and 127 mm (5 in.) in the other direction. These dimensions were based upon the design objective of retaining 20-mm projectiles. The screens used by the contractor initially consisted of coal-tar epoxy-coated bar grating with 19-mm by 114-mm (0.75-in. by 4.5-in.) openings that were 19 mm (0.75 in.) deep, but these dimensions were later modified as the project progressed (these changes are discussed later in the paper). Contract specifications required that the screen be constructed such that the maximum allowable opening dimensions were not to be exceeded even when it (the screen) was fully loaded with a design load of 4.6 m³ (6 yd³) of dredged material (approximately 8 tonnes (9 short tons)).

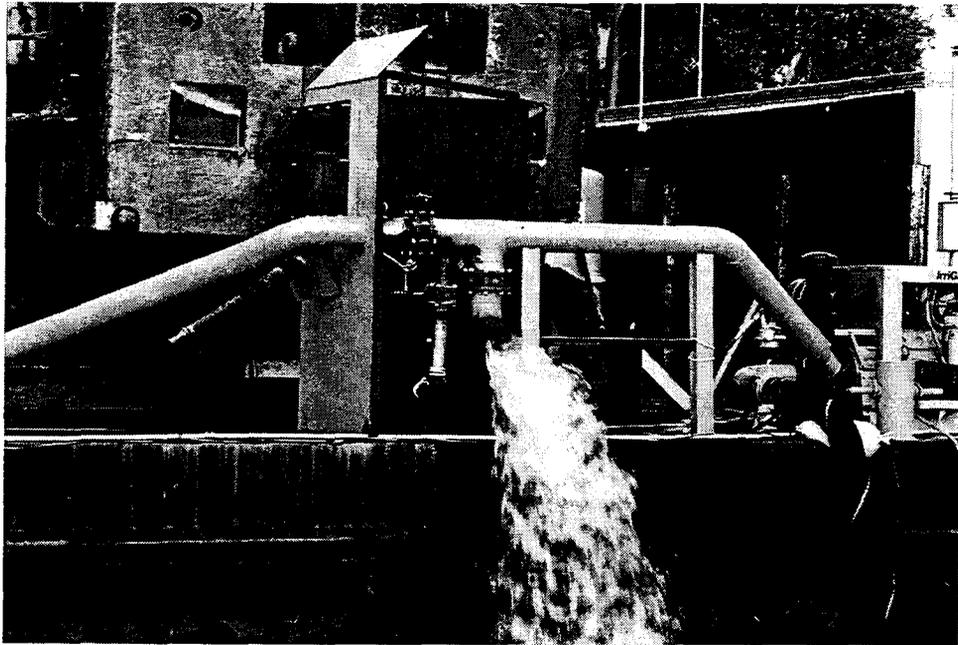
Figure 5. Fluidization valve-control system

As the clamshell operator dumped dredged material onto the screen, a jet of water was manually directed into the dredged material from the water cannon station. This water jet facilitated screen throughput by fluidizing sediment and disintegrating the more cohesive clumps. The spraying system used a 100-mm (4-in.) (discharge) fire pump rated for 95 L/sec (1,500 gpm) at 24 bars (350 psi). This pump's discharge was coupled to a 152-mm (6-in.) expansion pipe system with a three-valve flow control system that regulated flow to the water cannon, excess overboard discharge, and the scow's internal spray system (Figure 5). The

water cannon control valve regulated flow through a 64-mm (2.5-in.) flexible hose that was connected to a fire-fighting nozzle with a 64-mm- to 25-mm- (2.5-in. - to 1-in.-) diam reducer configuration (Figure 5). The water cannon operator was protected from potential UXO detonation by a protective barrier with the same construction materials and thicknesses as the crane operator's enclosure previously described. The nozzle was set in a gimbaled mount located immediately below the viewing port and provided with a 6.4-mm- (0.25 in.-) thick steel rectangular protective barrier to cover the gimbal opening (Figure 6). This mount, comprised of two concentric swivels, provided the water cannon operator with two degrees of freedom to direct the water jet to any location on the entire screen surface.

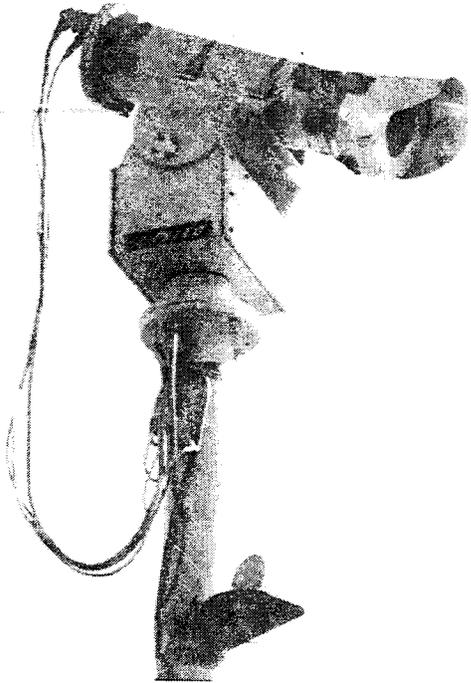
Figure 7. 10X zoom lens with remote-controlled pan and tilt

an explosion-proof and waterproof enclosure equipped with remote-controlled pan and tilt capabilities (Figure 7).

The screening process was visually monitored by EOD personnel in the observation trailer (OBST). Human Factors Applications Incorporated (HFA) of Holicong, Pennsylvania, provided EOD support during the demonstration in the form of equipment and personnel to locate, identify, recover, transport, and dispose of ordnance encountered. The OBST was equipped with a steel protective barrier and polycarbonate viewport on the side facing the screen (Figure 3). During the actual dredging, all personnel except the water cannon and crane operators were stationed inside the OBST. A closed-circuit television (CCTV) high-resolution camera lens was mounted on a 4.6-m (15-ft) mast near the screening area. The camera's 10X f1.8 motorized zoom lens with auto iris was housed in

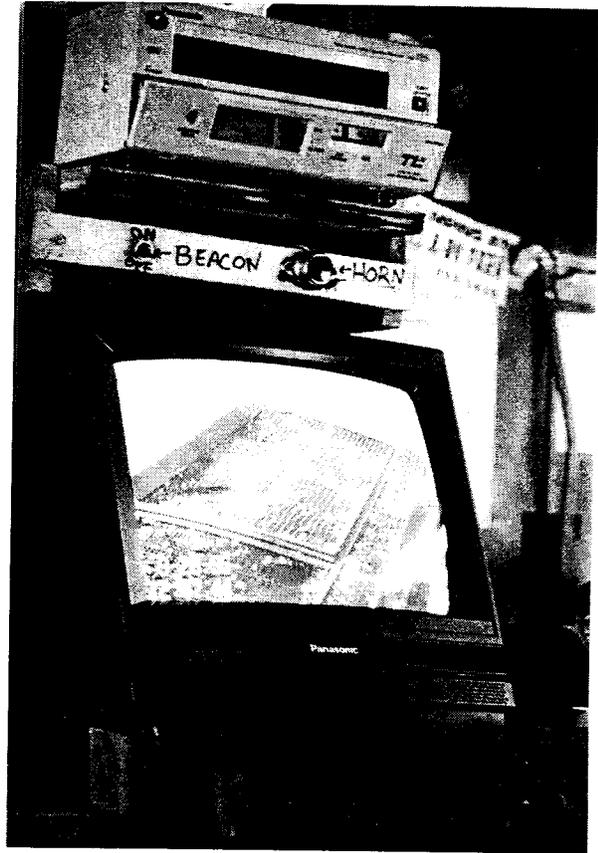
Figure 8. CCTV control station inside the OBST (lens zoomed out)

An operator in the OBST controlled the camera's zoom, pan, and tilt functions. A color video monitor and time-lapse recorder were connected to the camera via a fiber-optic link to provide color-corrected professional-quality images (Figure 8). The CCTV field of view provided coverage of the entire screen surface. As a surveillance system backup, one EOD person monitored the screening process by looking out the view port with binoculars.

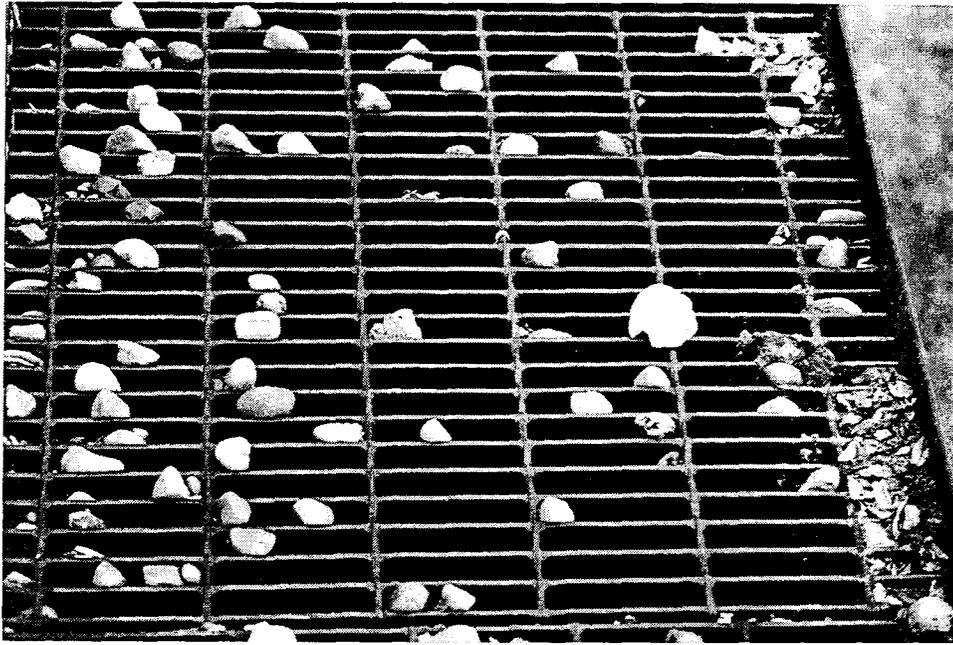
Figure 9. Blinded-off bar grate separation screens

Soon after dredging commenced, it became obvious that, even with the combination of water cannon jet and scow internal spray acting on the sediment, the screen's 19-mm by 114-mm (0.75-in. by 4.5-in.) rectangular openings were becoming excessively clogged (blinded off) by clamshells and rounded coarse gravel (Figure 9). Cleaning the debris that were wedged between the grates proved to be a very time-consuming, labor-intensive job. As the clamshell excavated deeper into the sediment, unexpected amounts of clay (brown-gray with medium high plasticity) and peat were encountered. This clay further decreased production due to the water spraying systems' inability to disintegrate the more cohesive clumps.

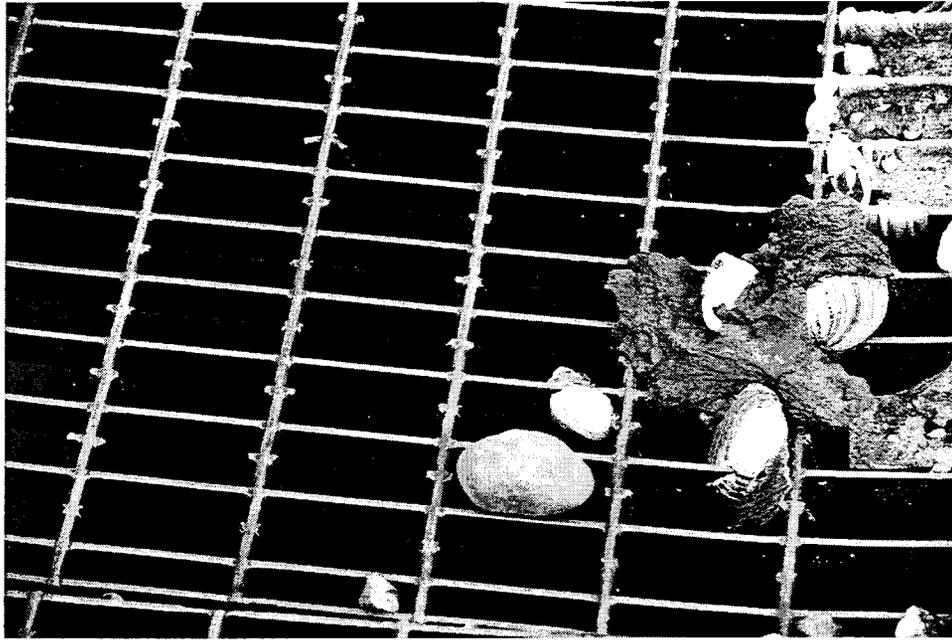
Figure 10. Modified bar grate screens

These increased amounts and types of debris remaining on the screen surface after the scow was full, would, in turn, increase the time required by EOD personnel to safely inspect and clear. With approval from the Huntsville Division, it was decided to expand the screen opening area by cutting out every other lateral grate bar. Removal of these laterals increased the rectangular dimensions to 38 mm by 114 mm (1.5 in. by 4.5 in.) (Figure 10). This modification dramatically increased screen throughput by allowing more clamshells and coarse gravel to pass through (less blinding), but, when encountered, the more cohesive clumps of clay and peat still remained troublesome.

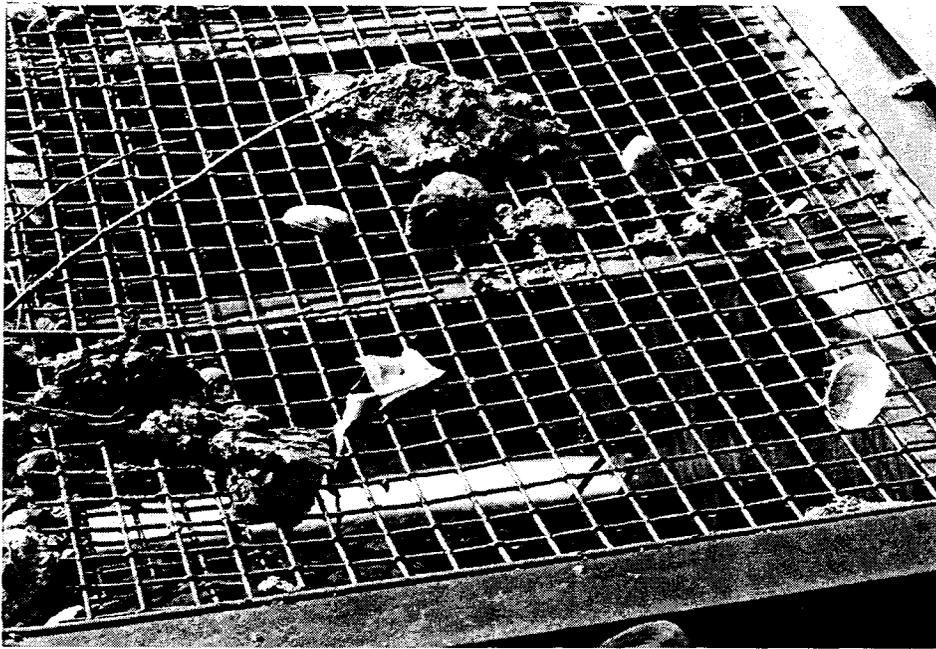
Figure 11. Space cloth separation screen

"Space cloth" made from 6.4-mm- (0.25-in.-) diam round stock with 50-mm by 50-mm (2-in. by 2-in.) square openings was used to replace the more damaged grate sections (Figure 11), but the use of this type of screen required welding

additional I-beam cross members into the screen frame for support. After this modification, no significant difference in throughput rates was noticed for the space cloth as compared to the modified bar grate.

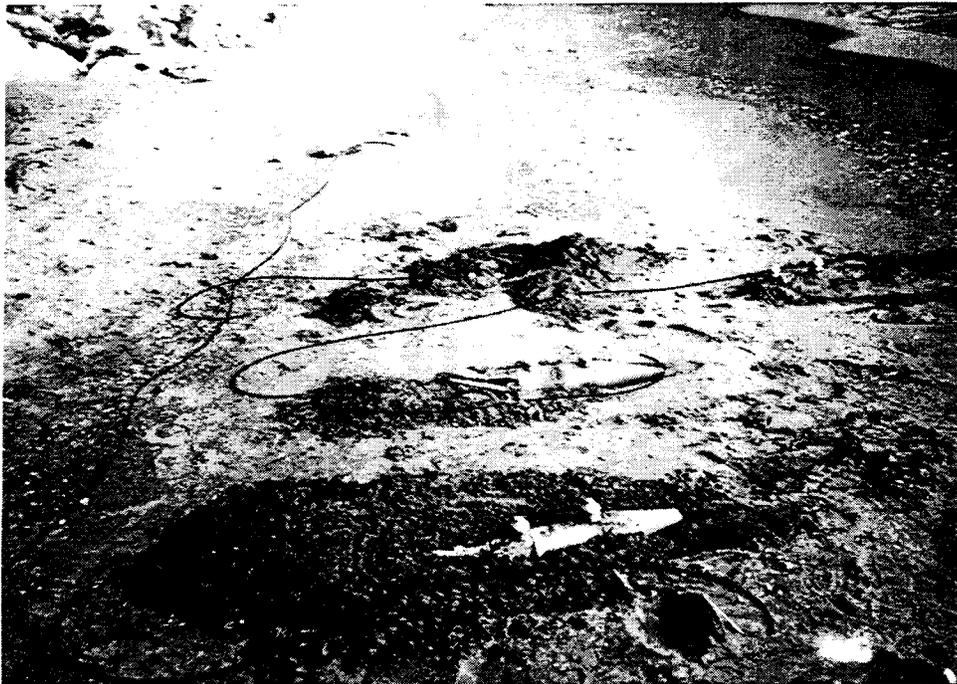
Figure 12. Ordnance prepared for disposal detonation

If the target was ordnance, as it was after the 8th day of dredging (a smoke grenade and 106-mm projectile), a 5-m (16-ft) diesel-powered (reduced fire hazard) boat piloted by another EOD specialist would be brought up alongside and the ordnance would be sand-bagged, and transported to shore. At the disposal site, the ordnance was laid in a shallow pit and shaped charges were fastened to its casing (Figure 12). Detonation cord was used to initiate the shaped charges and the focused energy of the explosion breached the ordnance's casing. Only after a casing was breached could an item be conclusively classified as UXO or inert ordnance.

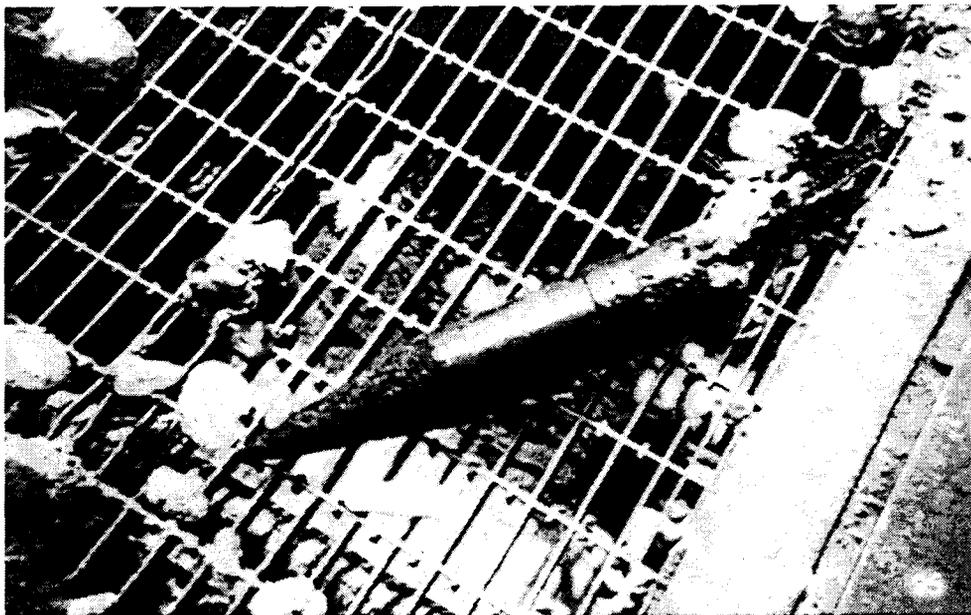
Figure 13. 106-mm projectile on the separation screen

During the 79-work-day duration of the demonstration project, 14,757 m³ (19,300 yd³) of material was removed from the authorized channel limits (as determined by hydrographic survey) during 72 actual days of dredging. The remaining 7 days were spent conducting various tasks such as altering screens, repairing the dredge plant, etc. A total of 37 pieces of ordnance were recovered from the separation screens and properly disposed of (resulting in 568 lb of scrap metal). From this total, 31 pieces were classified as inert ordnance, and the remaining 6 as UXO (HFA Inc. 1996). In Figure 13, a 106-mm projectile can be seen in the condition that it was recovered from the screen. Table 1 classifies the total amount of ordnance recovered during the demonstration and Figure 14 shows several different types of ordnance recovered during the demonstration (note condition of 60-mm mortar in lower right-hand corner after being breached by shaped charge).

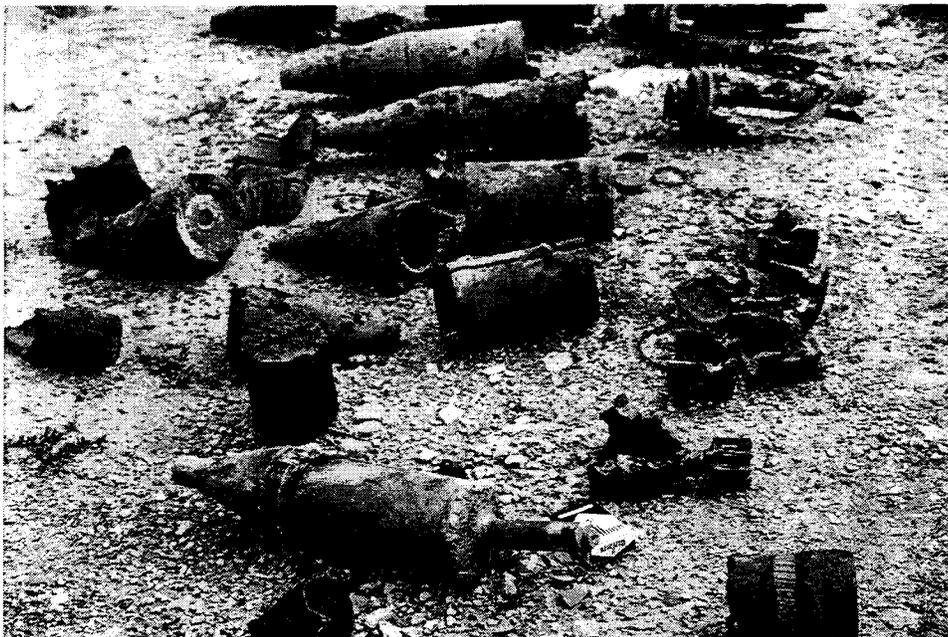
Figure 14. Several examples of recovered ordnance
