Installation Technology Transition Program (ITTP)

Integrated Water Planning for Army Training Areas

Final Report

Specific recommendations were made to improve water conservation practices at Camp Atterbury, IN.

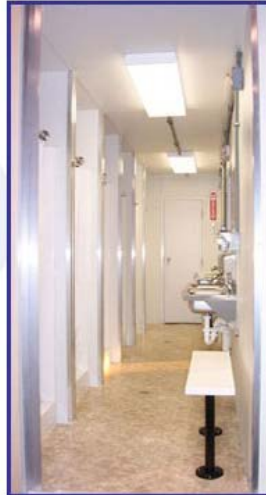
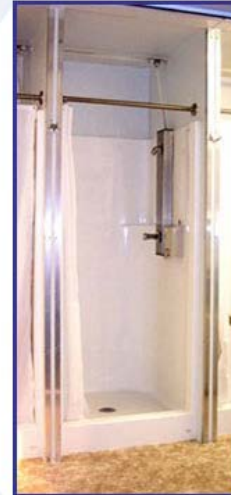
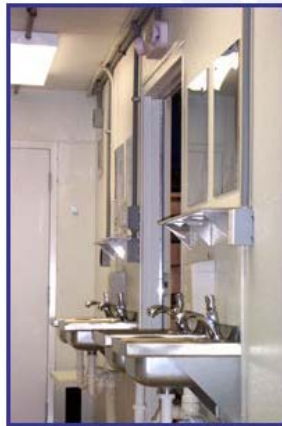
Figure 7. ReMS connex (Precision Products Inc.).

12-Shower Unit with Mechanical Room, Utility Room and Additional/Optional Features

Sample 12 Stall Floor Plan with Mechanical and Utility Rooms

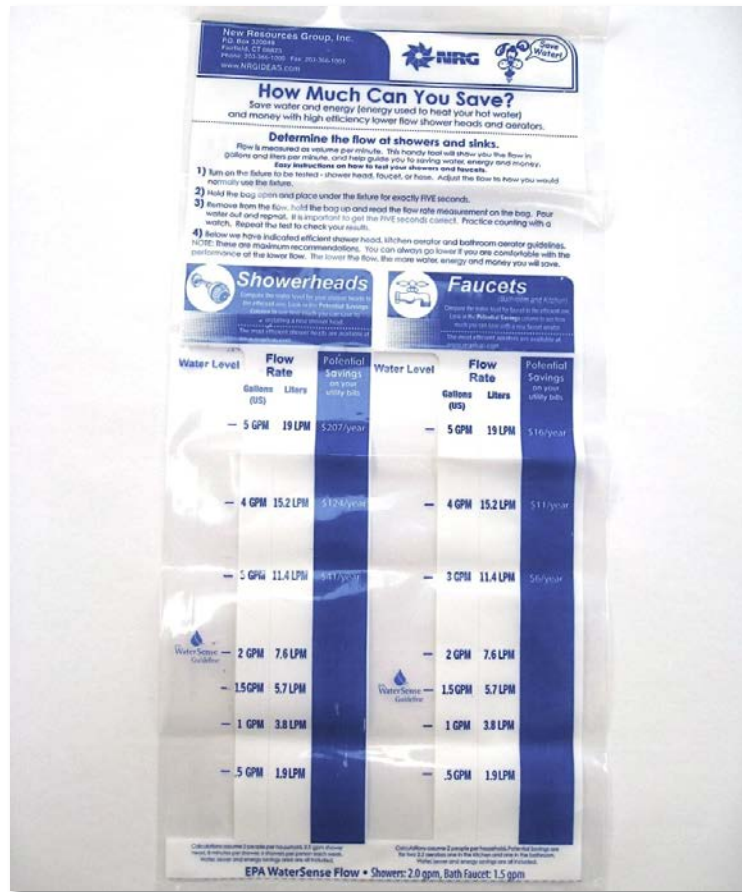
Figure 10. Fixture flow measurement bag.

- data collection forms for showerheads (Figure 8)
- data collection forms for faucets (Figure 9)
- fixture flow measurement bag (Figure 10)
- leak measurement ruler (Figure 11)
- fixture inspection mirror, magnifying glass, and flashlight (Figure 12)
- digital camera.

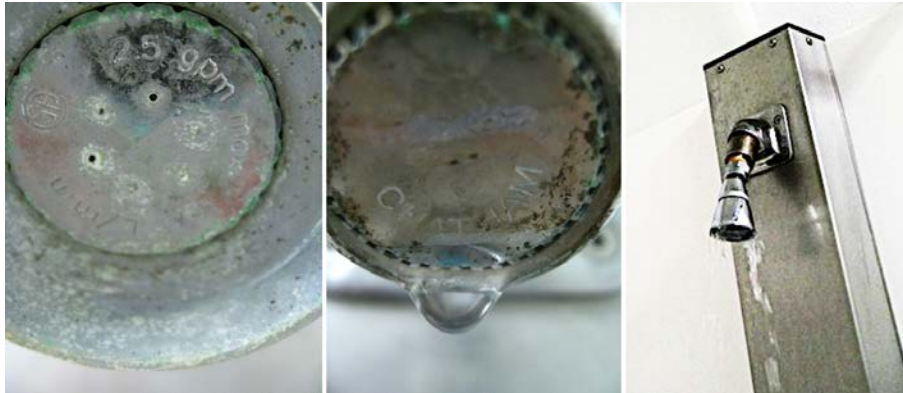
Excessive mineral deposits of calcium and lime due to local hard water conditions were visible in many of the fixtures evaluated. Figures 13 and 14 show commonly observed calcium/lime and in some cases rust deposits on showerheads and faucet aerators.

Figure 13. Examples of excessive mineral (calcium/lime) buildup in showerheads, showerhead leaks, and malfunctions.

Camp Atterbury in general, and the FOBs in particular, have hard water. During the October 2011 pre-retrofit site evaluation and technology assessment phase of the project, it was found that calcium and lime buildup required the removal and cleaning of the water fixtures at all three connexes as often as once per week, sometimes more often under heavy usage. This level of regular maintenance was carried out by the staff. Significant local water quality problems caused by hard water resulted in excessive mineral buildup in the fixtures at all six connexes at FOBs 1, 2 and 3. During the technology assessment, excessive calcium/lime scale in the fixtures was found to cause poor flow volumes and distorted sprays for many of the fixtures at all three of the FOBs. As a result, the pre-retrofit (October 2011) fixture flow measurements recorded are likely *not* representative of the types of flows that would occur under normal water quality conditions.

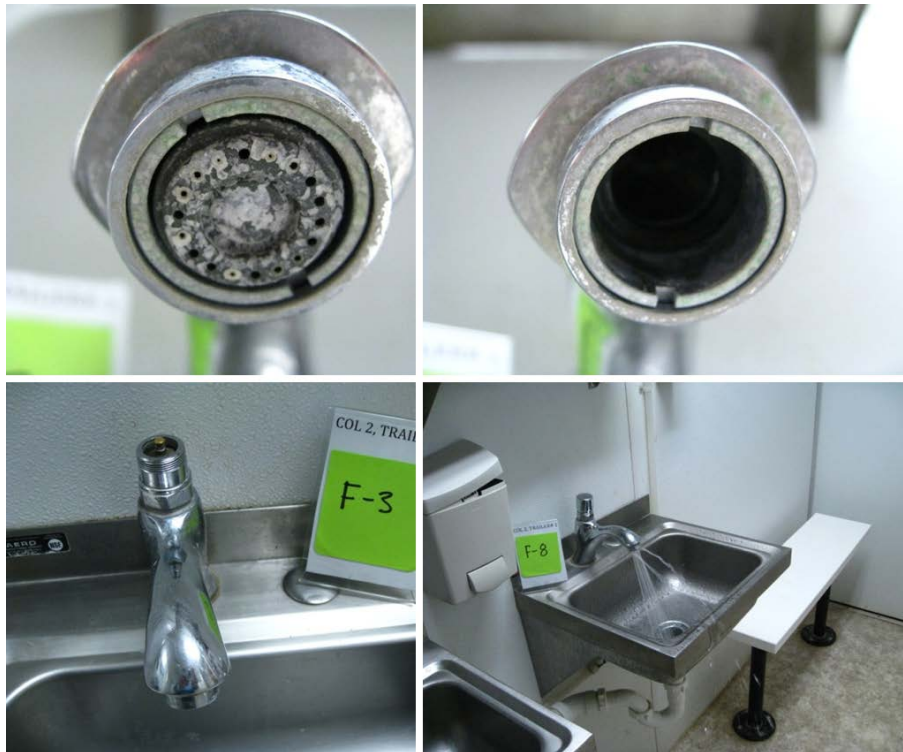
Figure 14. Examples of excessive mineral (calcium/lime) buildup in faucets, broken faucets, and sink overspray.

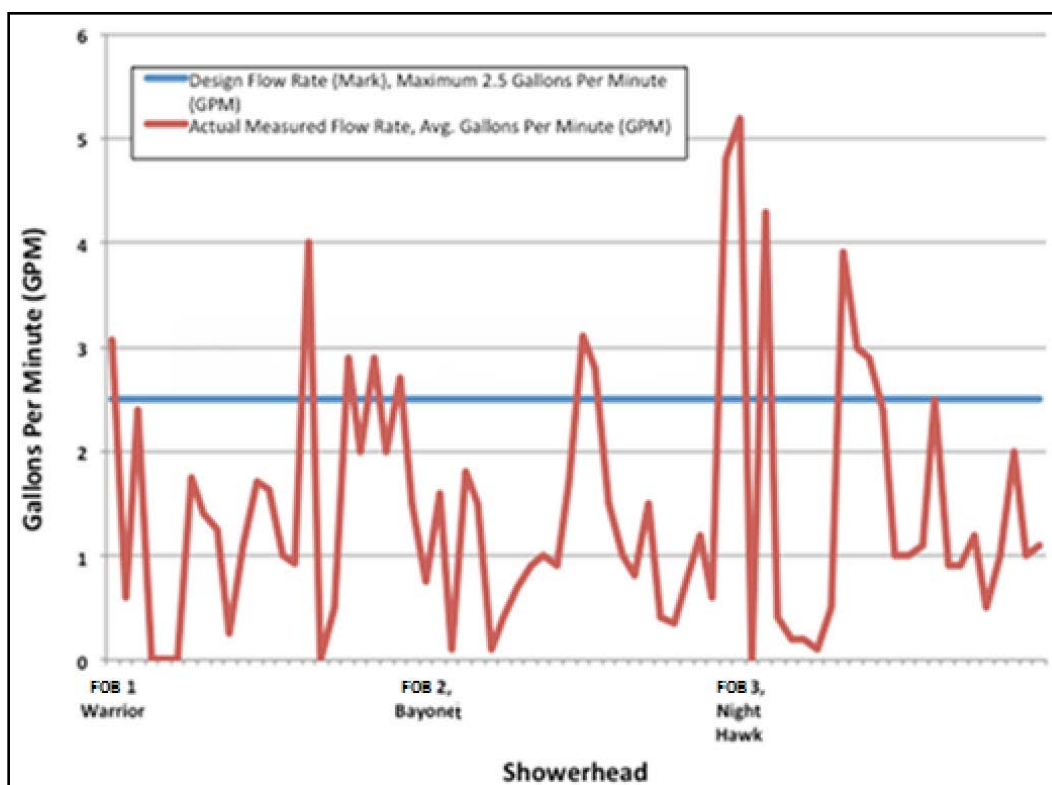
Figure 15 shows the measured flow rates for all 72 showerheads, including the manufacturer's fixture design flow rate of a maximum of 2.5 gpm, in the six connexes at the three FOBs. Figure 16 shows the same measured flow rates, presented from lowest to the highest. The measured flow rate for all 72 showerheads averaged 1.43 gpm—about 0.57 gpm less than the showerheads' design maximum rated flow of 2.5 gpm.

Figure 15. Design flow rate and actual measured flow rates of 72 showerheads in FOBs 1, 2, and 3 (average gpm).

The measured showerhead flow rates, which average over 20% below their maximum rated flow, and their spray force and spray pattern, were generally found to be very poor. The low flow volumes measured are neither a reflection of water efficiency nor inefficiency, but rather fixture clogging and malfunction due to excessive calcium/lime buildup inside the fixture and in the metal spray pores (openings). The data in Table 1 show that only a small portion of the showerheads (15%) were found to be operating within the acceptable flow range for a conventional showerhead, i.e., from 1.70 gpm to 2.5 gpm (Vickers 2001).

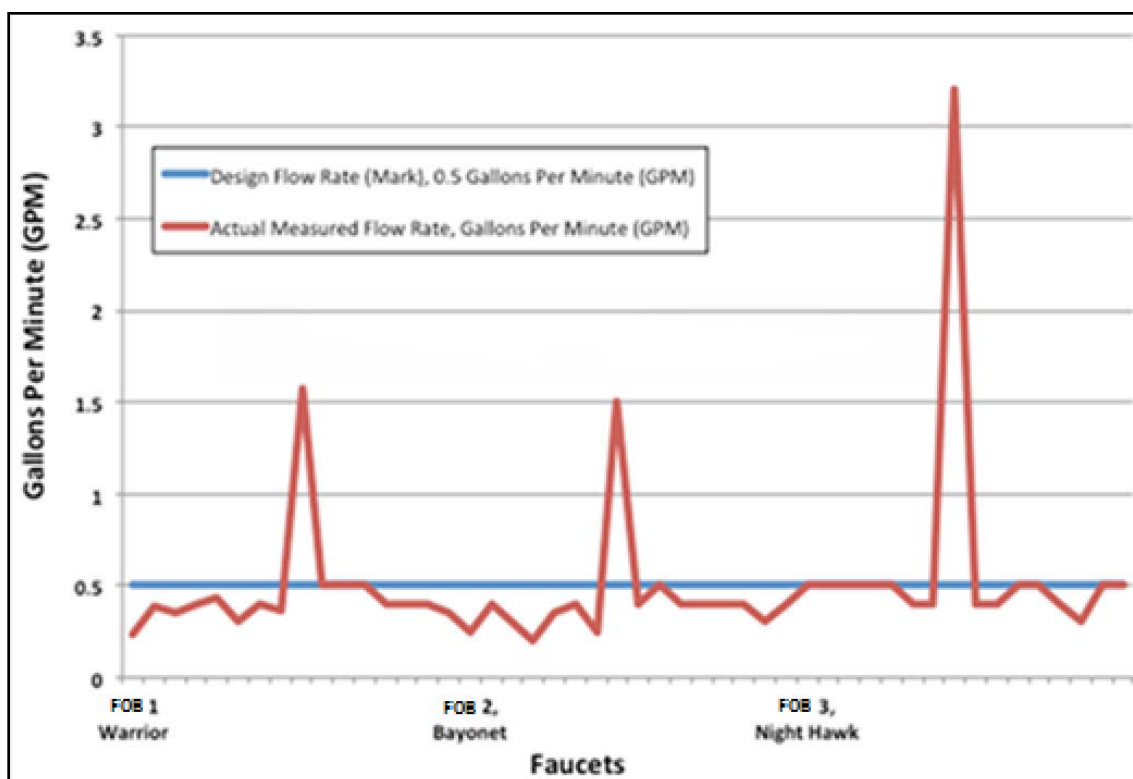
Figure 17. Design flow rate and actual measured flow rates of 48 faucets in FOBs 1, 2, and 3 (gpm).

The measured faucet flow rates were generally found to be poor. This condition was attributed to the calcium/lime mineralization problem, with many having very low or minimal flows and a small number with very high flows. Only 3 faucets (6%) were found to be operating within the acceptable 0.35 gpm to 0.5 gpm flow range for a metering faucet (Table 3). Too low, minimal flow, and in some cases no flow conditions were found at 42 (87%) of the faucets. Users of these faucets likely have to activate the handle multiple times to get sufficient water while using the sink.

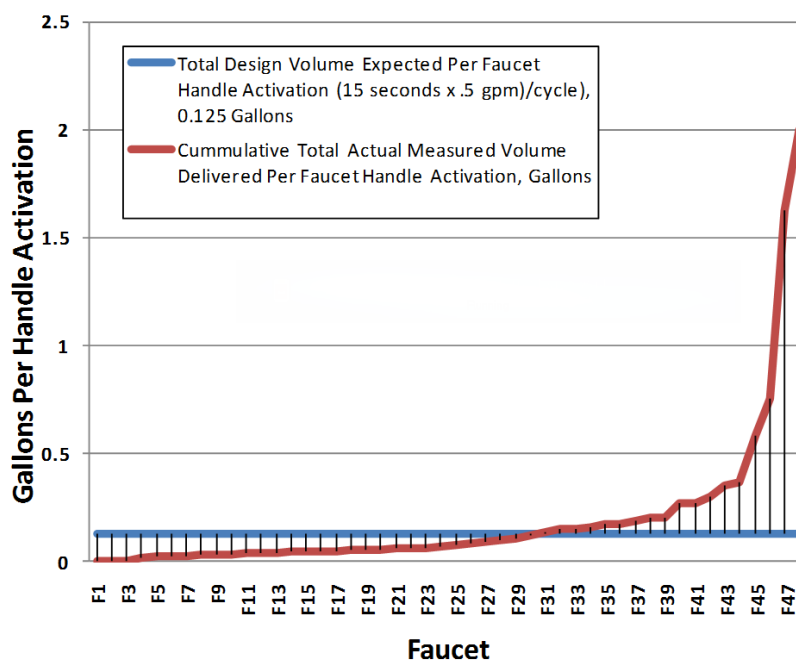
The measured volume of water delivered for all faucets averaged 0.20 gal per handle activation, which is 0.075 gal higher than the 0.125 gal normally delivered per 15-second handle activation of a 0.5 gpm metering faucet. The average volume of water delivered per faucet varied from less than 0.1 to about 2.0 gal (Figure 18). The wide range in volume of water delivered by the faucets—which average very close to their design flow rate of 0.5 gpm—is due to the wide range in the length of preset flow cycles (seconds) found among the faucets, which range from a few seconds to over 5 minutes (Figure 19). The average length of flow per handle activation was 26.0 seconds; the factory preset for this faucet type is usually a maximum of 15 seconds (Delta Faucet Co. Undated).

Figure 18. Design total volume and cumulative actual volume delivered per handle activation; 48 faucets in FOBs 1, 2, and 3 (gal).

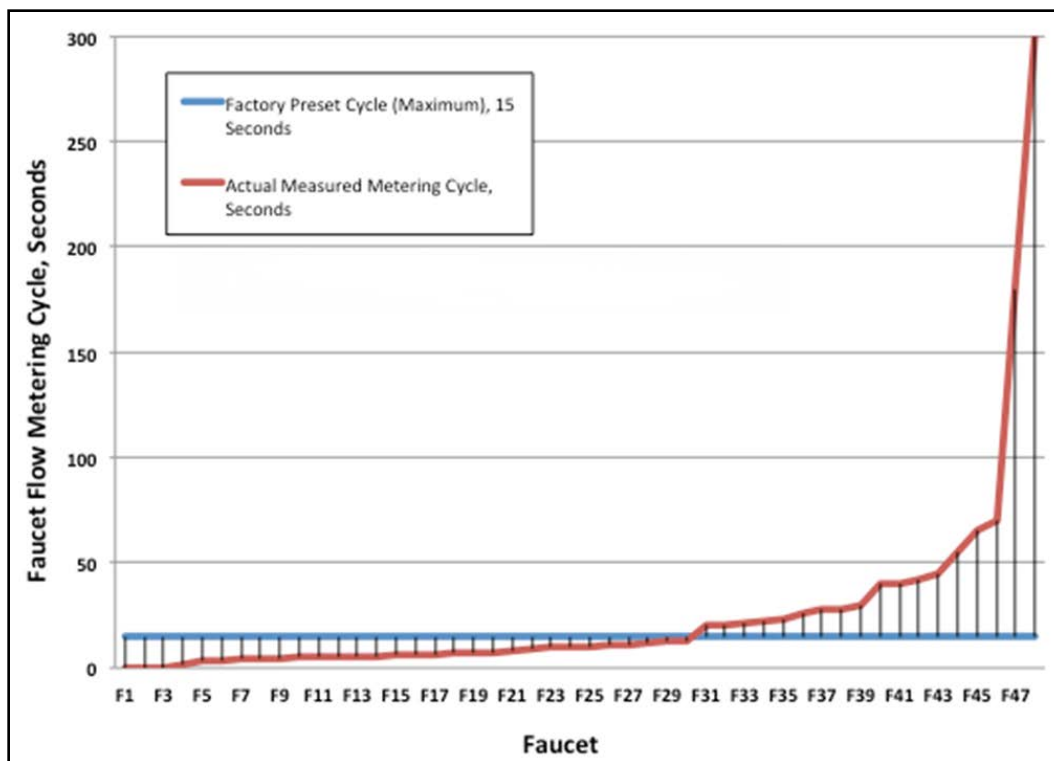
The sink faucets installed in the connexes are *metering* faucets. Metering faucets, unlike manually operated sink faucet taps found in homes and some nonresidential facilities, deliver water for a preset length of time or cycle. When the faucet handle is activated (pressed), water flows for a preset length of time and then automatically shuts off. (Users can reactivate the handle for another cycle of water flow.) Cycle lengths for metering faucets are factory preset to run typically for less than a minute. Thus, the volume of water delivered by a metering faucet is determined by the length of time water flows after the handle is activated. Cycle lengths of metering faucets can be adjusted; over time or with fixture malfunction cycle lengths may also change.

Figure 19. Design (factory preset) flow metering cycle and cumulative actual flow cycles of 48 faucets in FOBs 1, 2, and 3 (seconds).

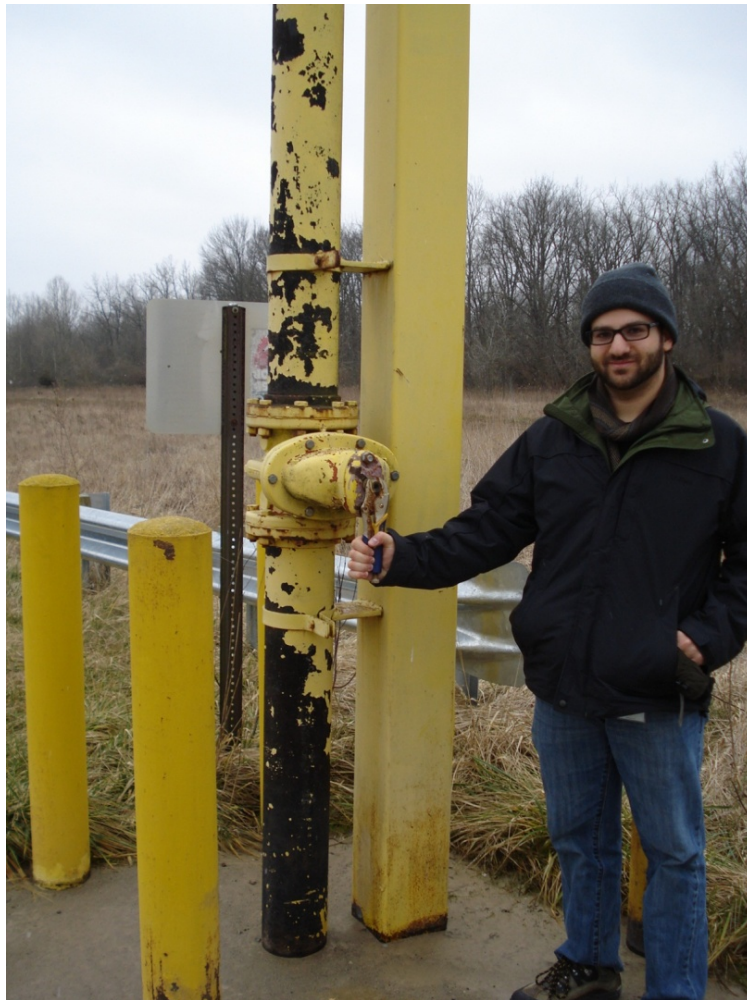
The field survey revealed that access to all the water stations is unrestricted and that water consumption is not monitored at any of the stations. Consequently, there is no good understanding of how much water is used to support training compared to other uses throughout the installation. There is therefore not a good estimate of potential water savings through bulk water control. Discussions with Camp Atterbury personnel determined that the bulk water station on the Schoolhouse Road was the primary water point used by training units to supply water to the ranges. Thus this water point (Figures 18 and 19), was chosen for the retrofit.

Figure 21. Bulk water station at Schoolhouse Road before retrofit.

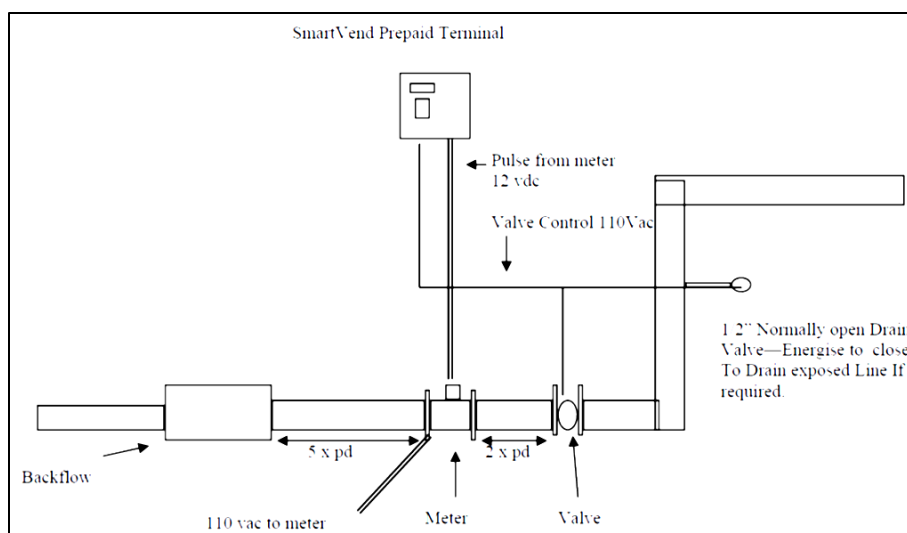
Figure 24. Schematics of smart bulk water delivery system.

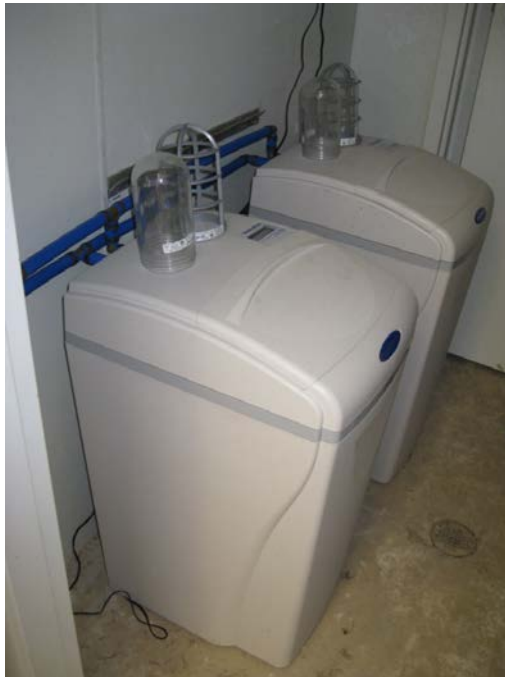
The water softeners were not all immediately operational due to delays in acquiring salt supplies for the softeners, and some softener units fell into disuse when supplies ran out. By early April 2012 the FOBs were understood to have a steady supply of conditioning salt so that the softeners could operate continuously.

Figure 28. Water softener as seen in ReMS utility room.

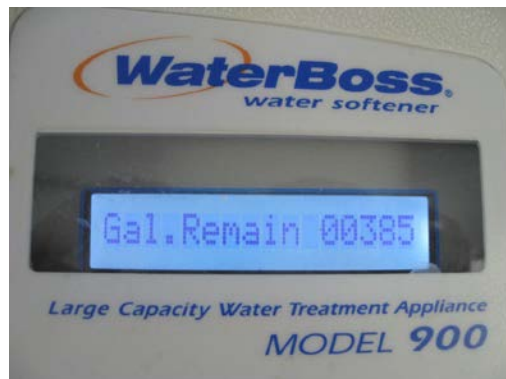
Figure 29. WaterBoss softener display.

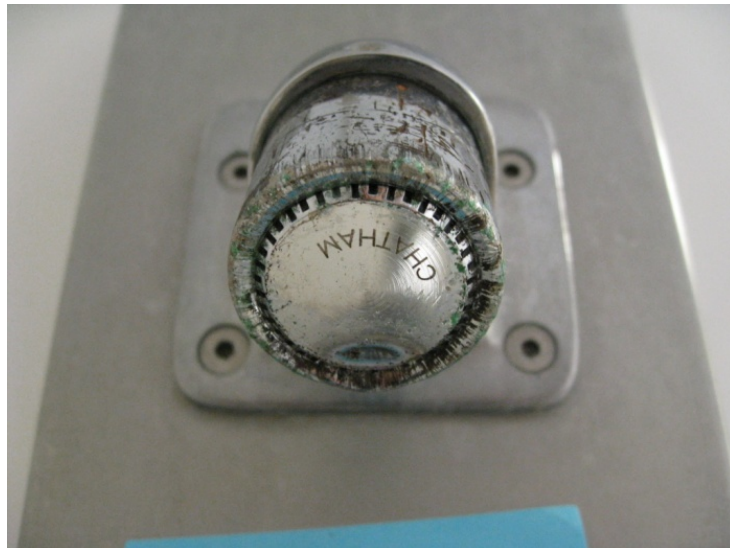
Figure 30. Showerhead after installation of water softener.

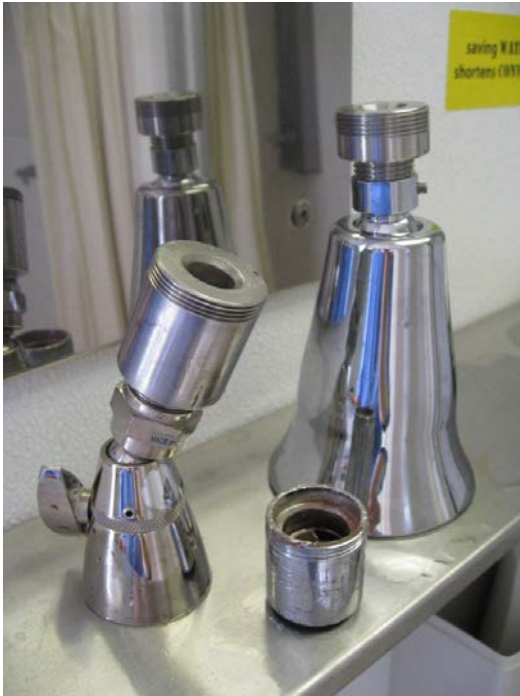
Figure 31. New showerheads showing adapter.

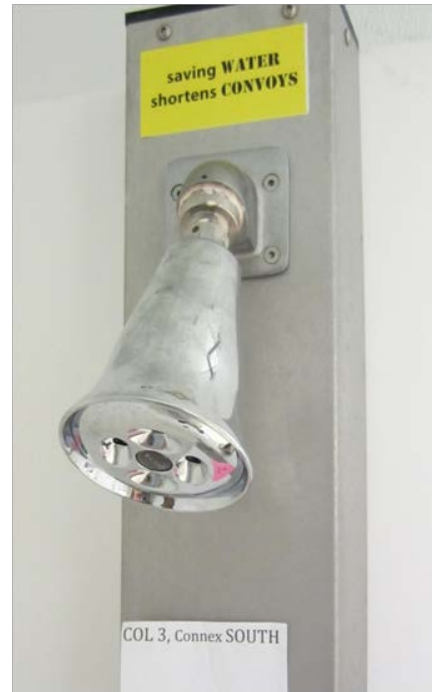
Figure 32. New showerhead installed at FOB 3.

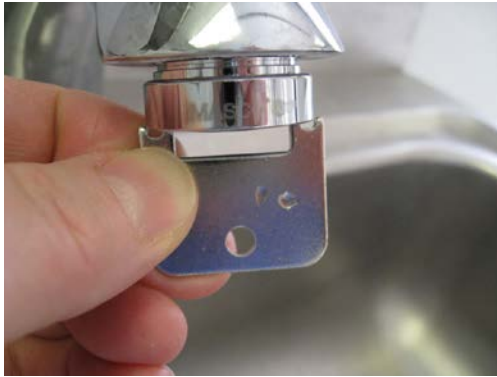
Figure 33. Installation of new aerator.

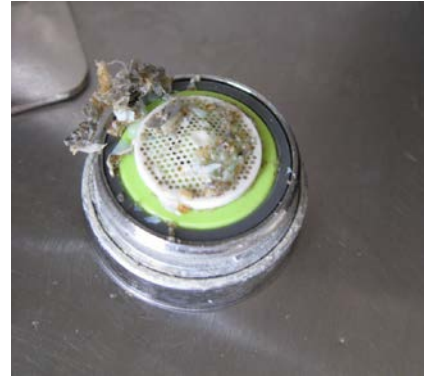
Figure 34. Corroded 0.5 gpm faucet aerator.

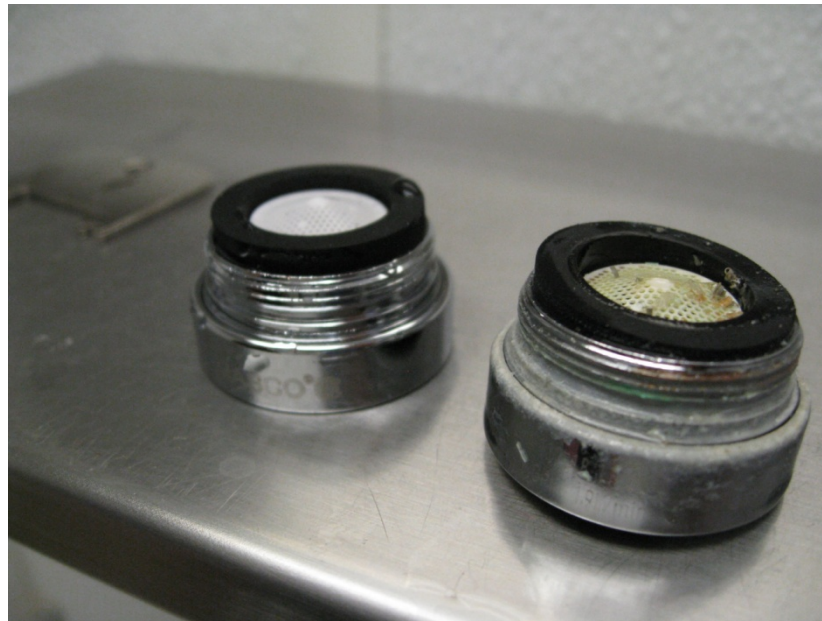
Figure 35. New 0.35 gpm and old 0.5 gpm faucet aerators.

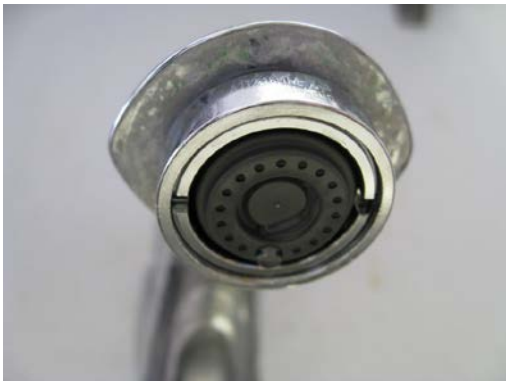
Figure 36. New 0.35 gpm aerator installed.

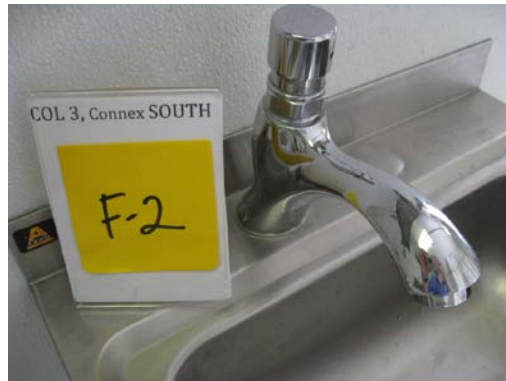
Figure 37. Retrofitted metering faucet.

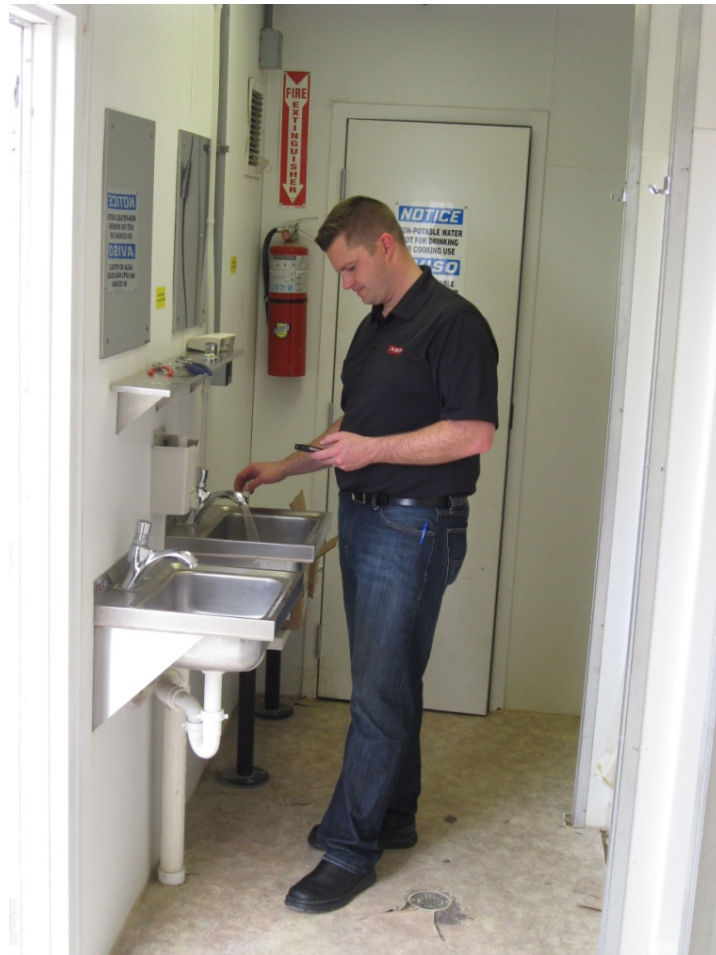
Figure 38. Checking the flow cycle.

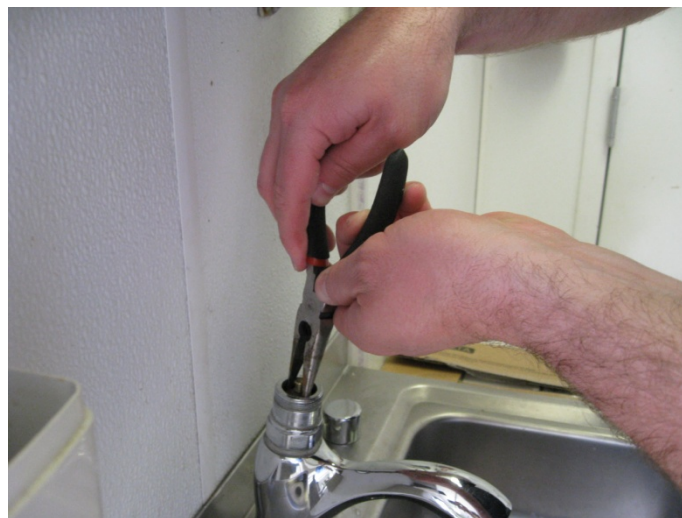
Figure 39. Making timing adjustments.

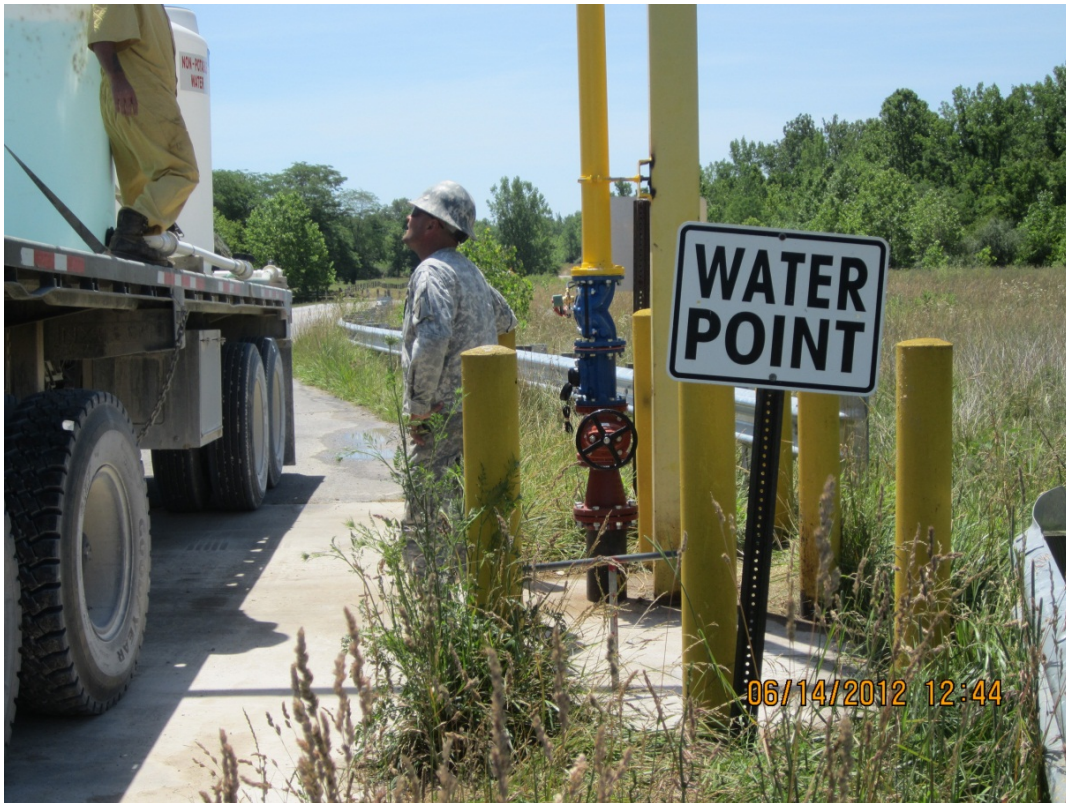
Figure 40. Bulk water station after first phase retrofit.

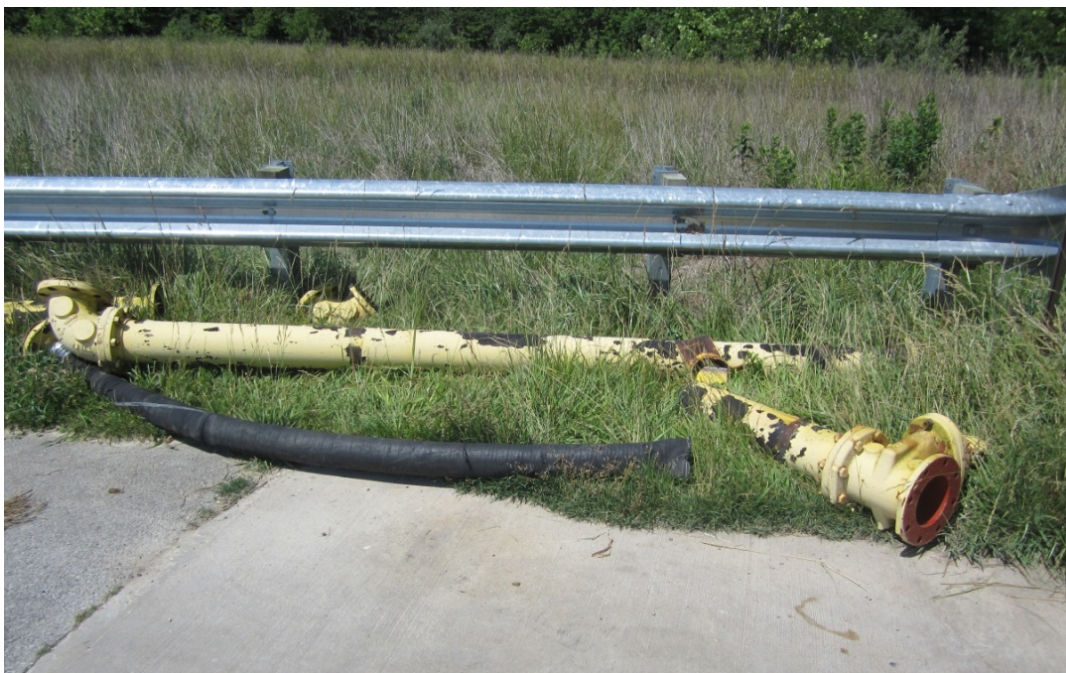
Figure 41. Six-inch pipe replaced due to poor condition at bulk water station.

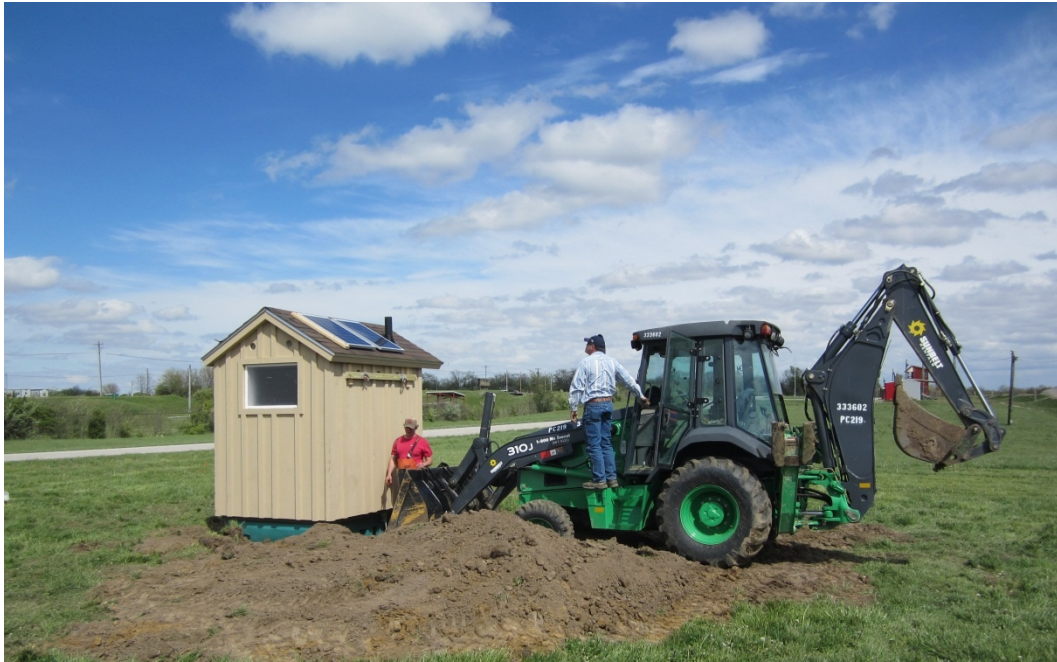
Installation of the M54 Composting Toilet system took 2 days during April 2012. The unit order was finalized after site selection was confirmed and the color of the above ground housing was chosen by Camp Atterbury staff (Figure 42). Since the installation, Clivus Multrum has received additional training data to schedule their maintenance. Camp Atterbury has taken the responsibility of maintaining the toilet paper stock. Current feedback from installation staff regarding the composting toilet has been positive and no smell has been noted during use. However, the usage is lower than was expected (Mills 2012). The unit's housing is so different from the typical portable latrines that it is possible that soldiers may not know that it is for their use. Additionally it must compete with more convenient portable latrines that are located directly adjacent to the road connecting the ranges at the Camp. The composting toilet's exact location is in the grassy area between fire ranges and not next to the fire ranges so soldiers are required to walk further to use it than to use the portable latrines adjacent to the ranges.

Figure 42. Composting toilet installation.

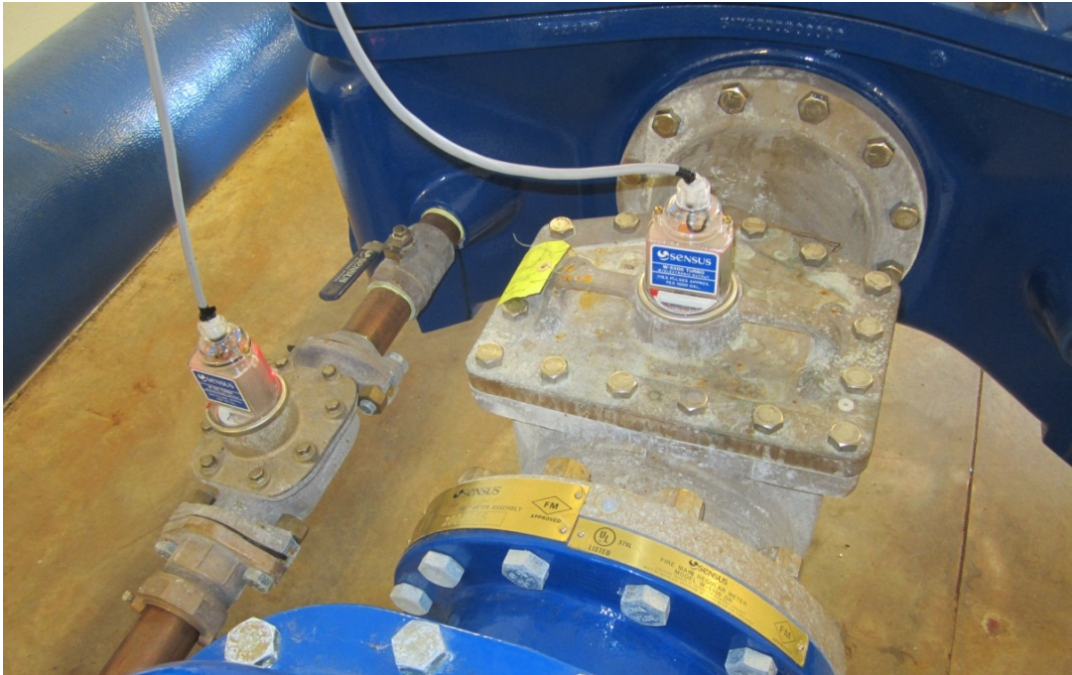
Figure 50. Main meter set composed of two meters.

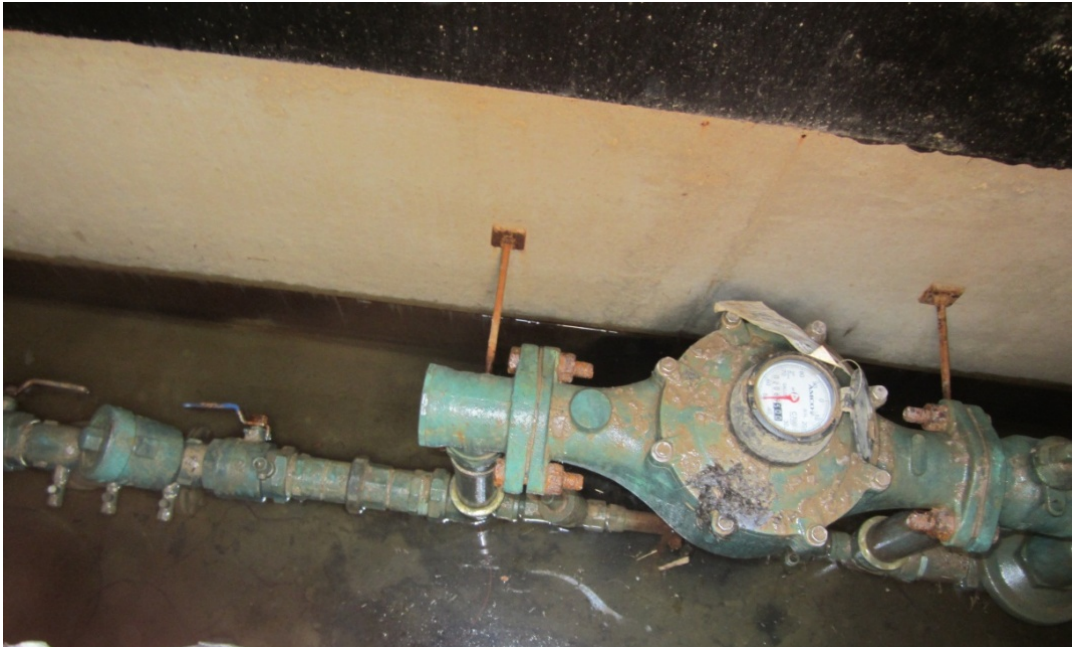
Figure 51. FOB 3 meter.

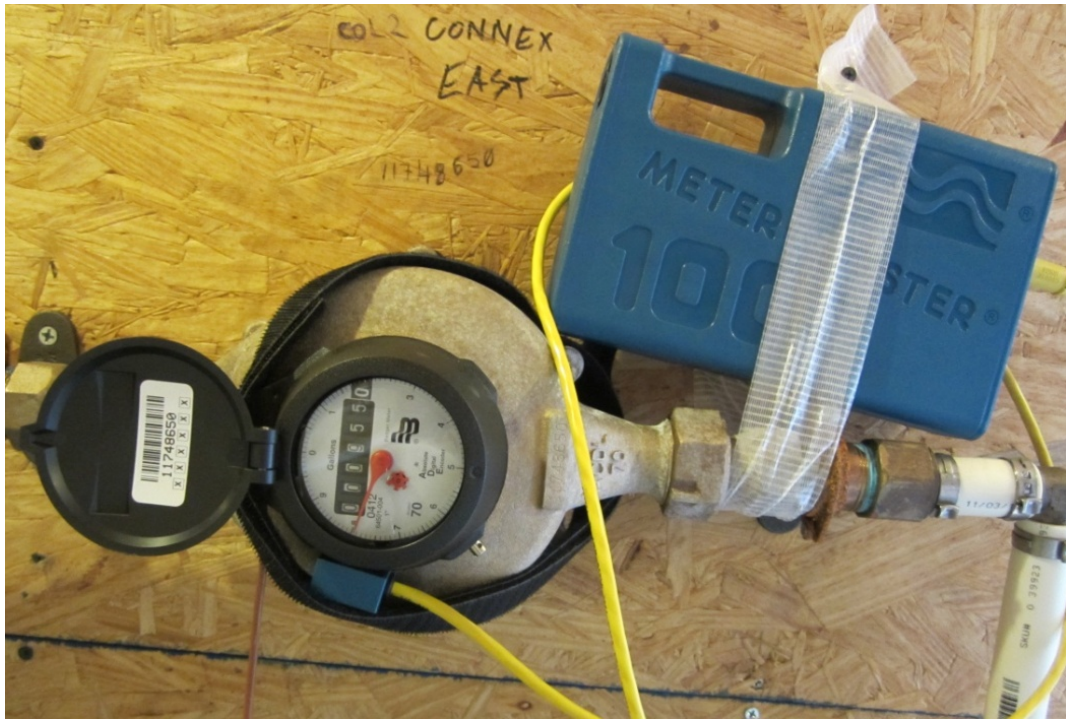
Four Meter Master 100EL Flow Recorders were installed to monitor the four Badger water meters installed at the connexes (Figure 52). The flow recorders can hold up to 30 days of data, and were set to record every 10 seconds. Data was downloaded using Master-Meter Model 100 Software. A fifth recorder was installed at the Schoolhouse Road bulk water station to monitor water consumption between Phase I and Phase II of the retrofit (Figure 53). Finally, a sixth flow recorder was installed at a water meter located in FOB 3 (Figure 54).

Figure 52. Flow recorder attached at badger meter in FOB.

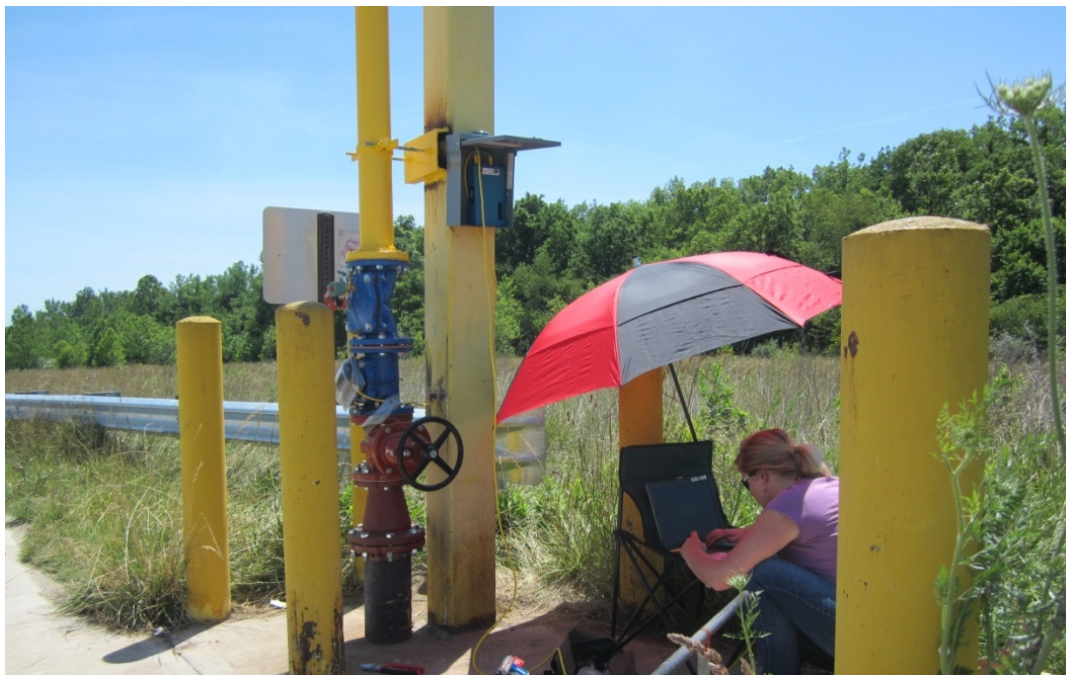
Figure 53. Flow recorder installed at bulk water station.

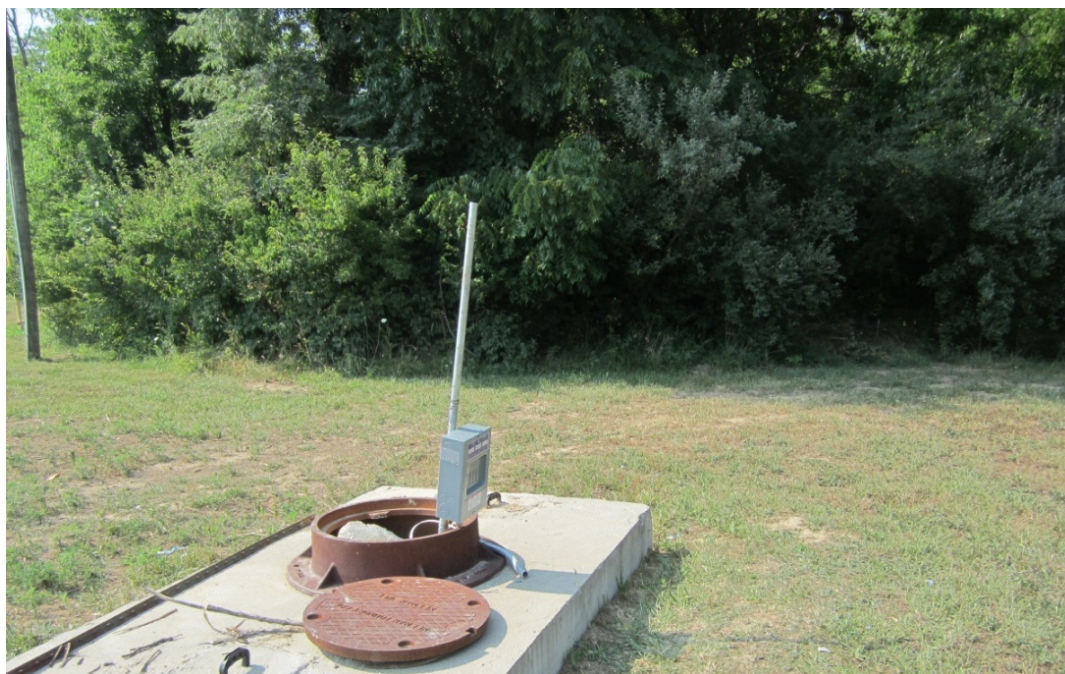
Figure 54. Flow recorder installed at the FOB 3 water meter.

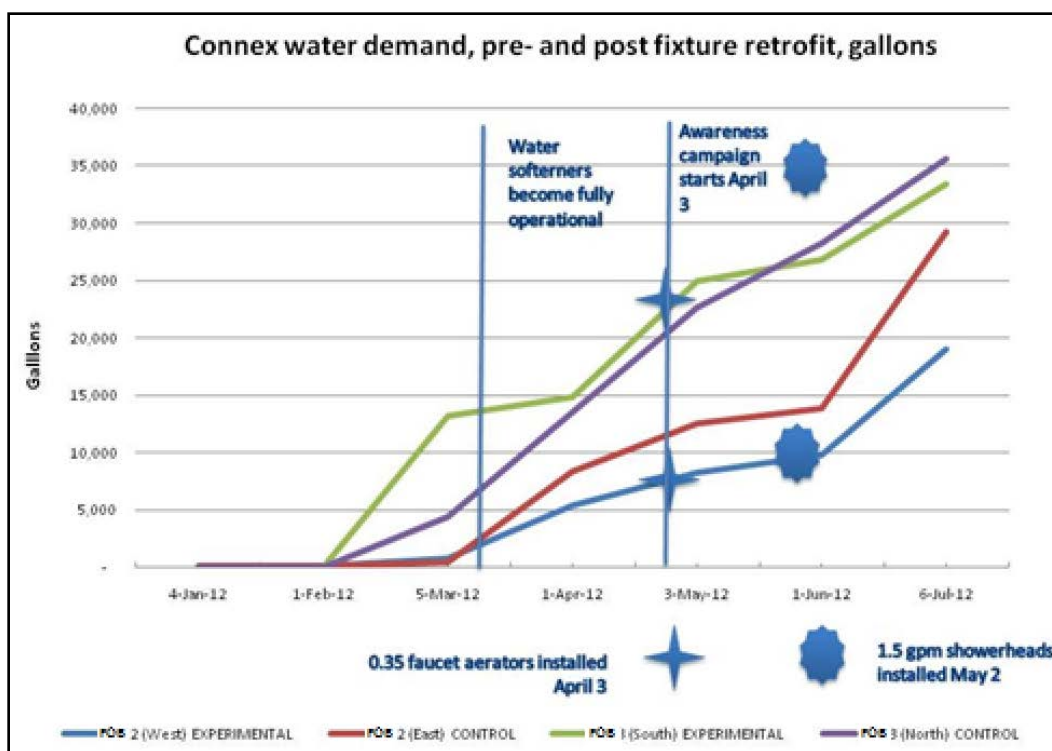
Figure 55 shows fixture retrofit installation dates and connex water demands at FOBS 2 and 3.

Figure 55. Connex water demand, before and after fixture-retrofit (gal).

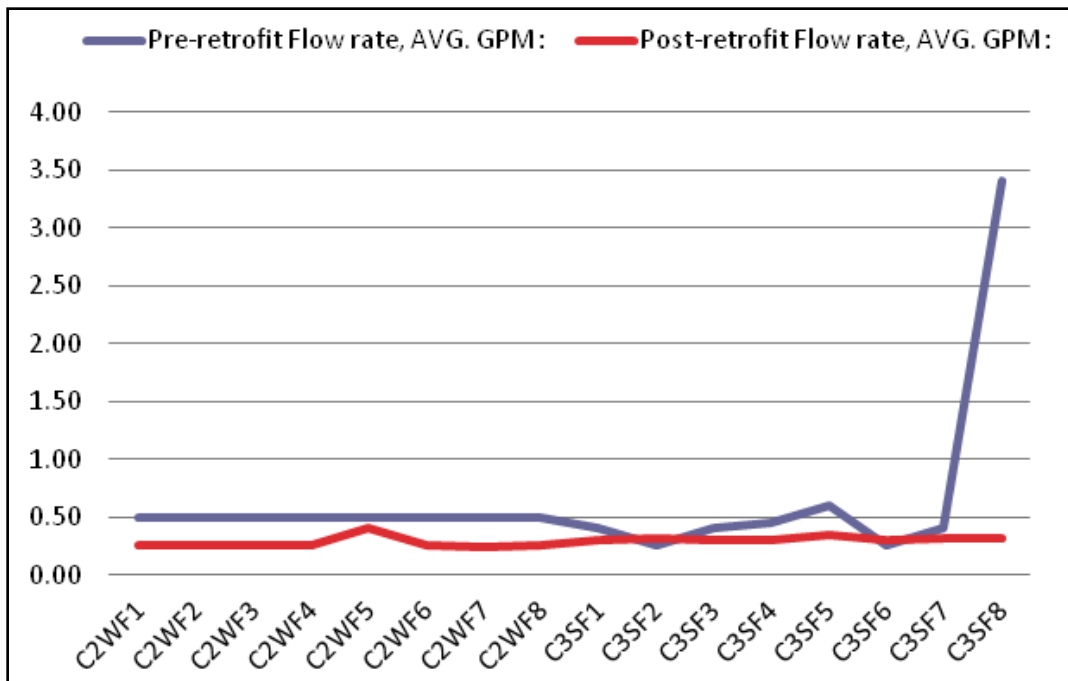
Figure 56. Pre-and post-retrofit flow rates for faucet aerators (gpm).
