## **Cultural Landscape Analysis of Existing Historic Districts**

Picatinny Arsenal, New Jersey

Final report

Under Project 201221, "Cultural Landscape Analysis, Picatinny Arsenal, New Jersey"

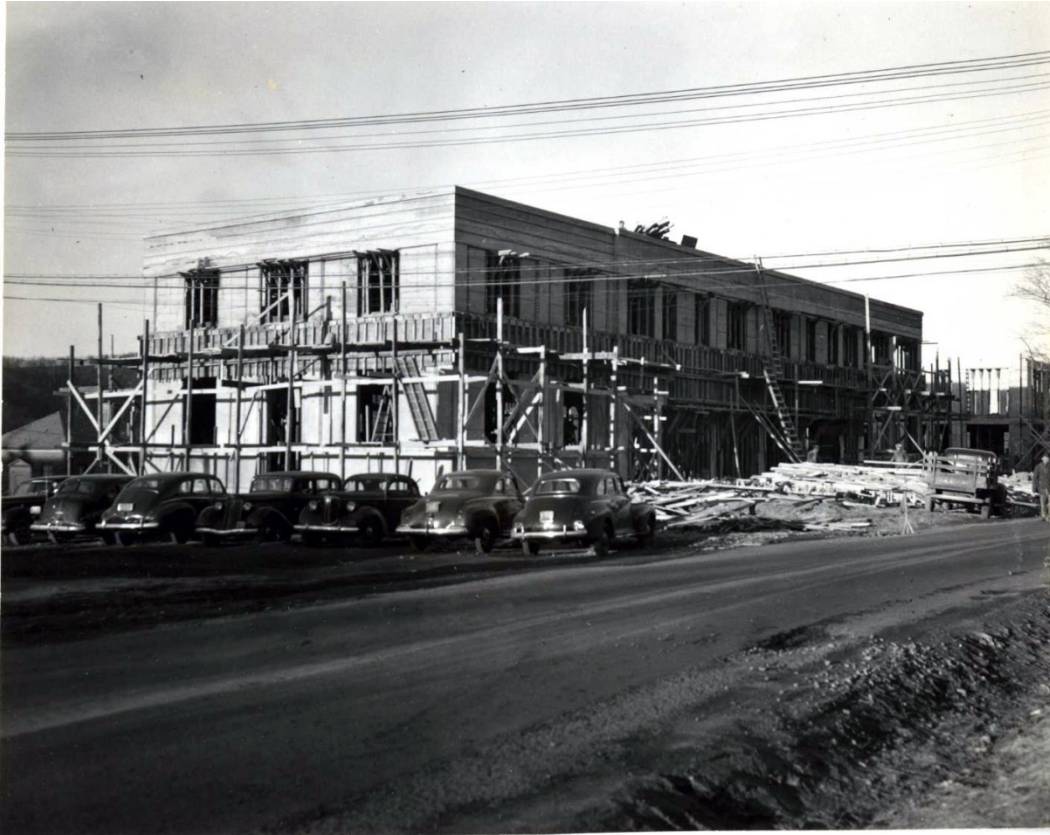
Figure 18. Construction of Building 173, 1942 (PICA Cultural Resources Office).

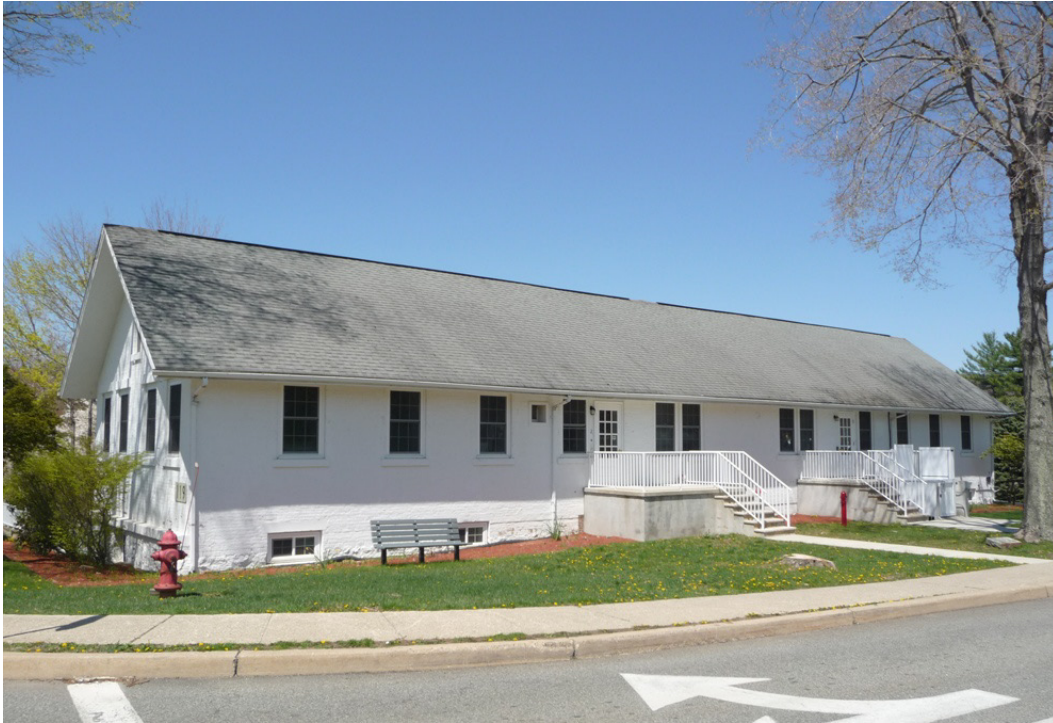
Figure 22. Building 119 after addition of wheelchair lifts in 2010 (ERDC-CERL, 2013).

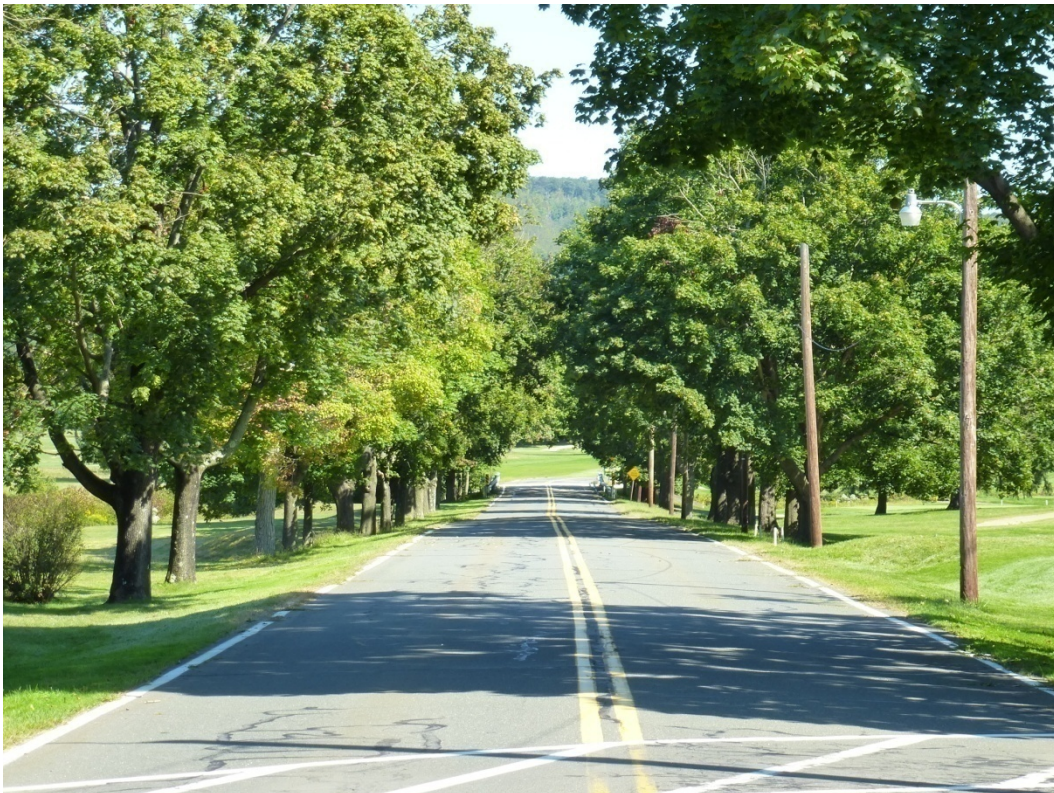
Today, Parker Road provides access to the Administrative and Research District from the installation's main entrance at Route 15. The road runs north-south starting at the installation boundary with the Cannon Gates and terminates at Farley Avenue and Building 151 (original post headquarters; Figure 33). The road crosses through the golf course and is lined on either side with a row of street trees (Figure 34).

Figure 34. Looking north along Parker Road (ERDC-CERL, 2012).

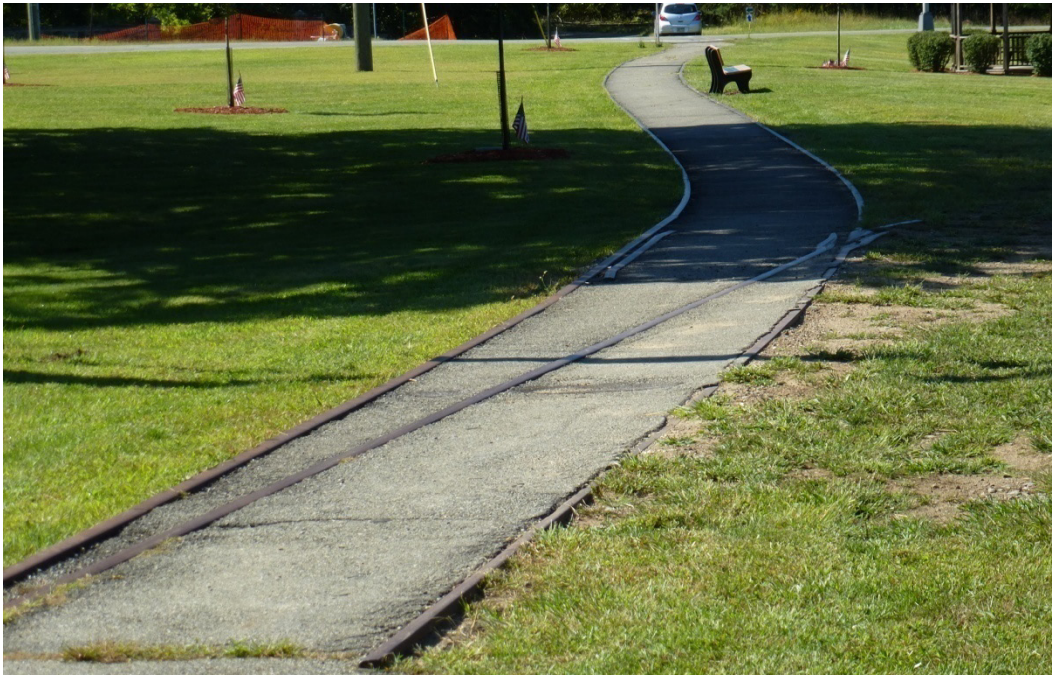
course (Figure 40–Figure 41). The railroad system is noncontributing to the Administrative and Research Historic District.<sup>41</sup>

Figure 40. Looking south near the intersection of 1st Street and Parker Road at the modified railroad track, now used as a walking path (ERDC-CERL, 2012).

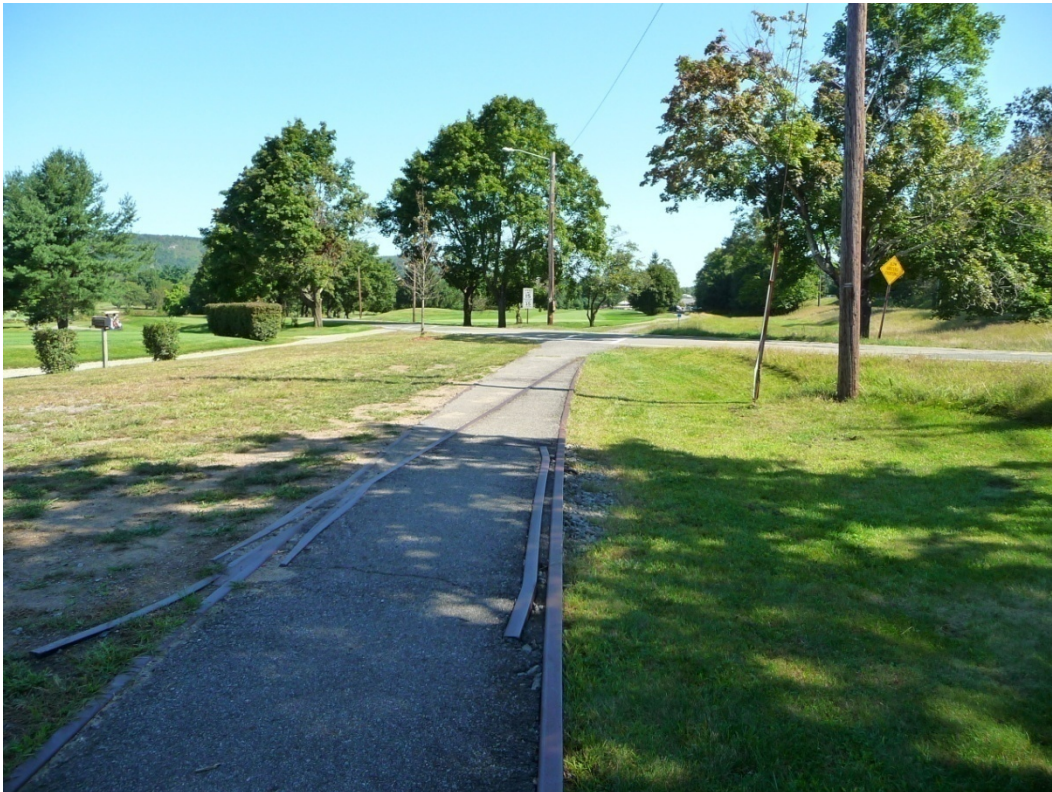
Figure 41. Looking eastward near the intersection of 1st Street and Parker Road at the modified railroad track, now used as a walking path (ERDC-CERL, 2012).

Today portions of the railroad system are found throughout the Administrative and Research District (Figure 39). The earliest portions of the system, which ran roughly down Parker Road, are now completely covered in asphalt, used as walkways, or torn up to accommodate the golf

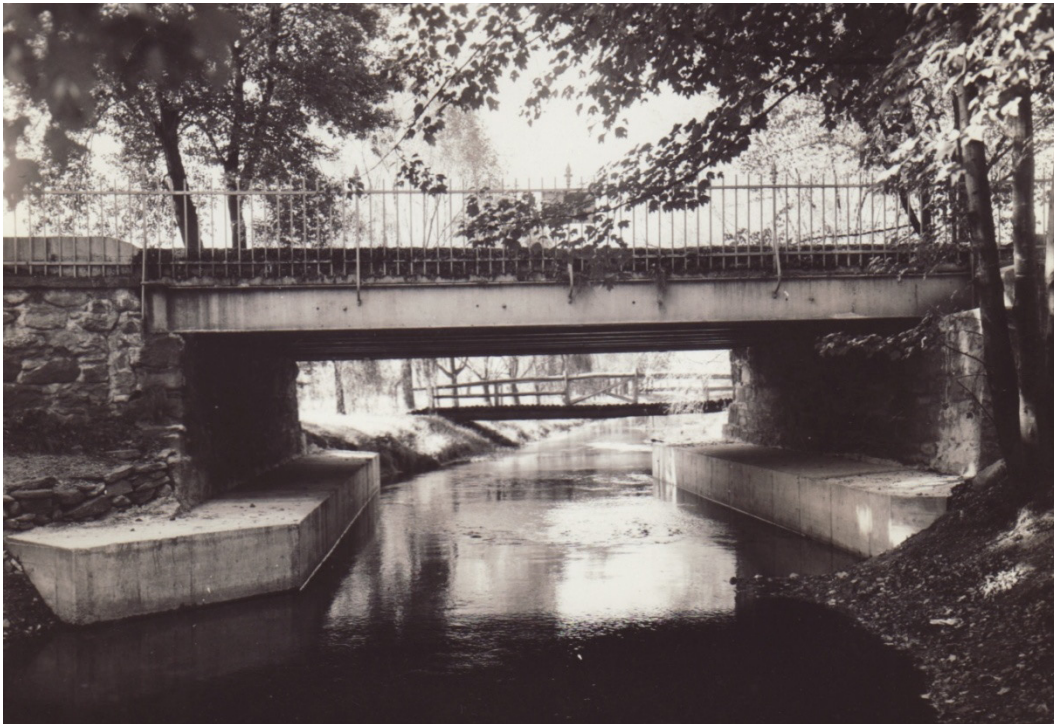
Figure 42. Historic photograph of the stone bridge (Bridge B-4) by Building 151, circa 1930 (PICA Cultural Resources Office).

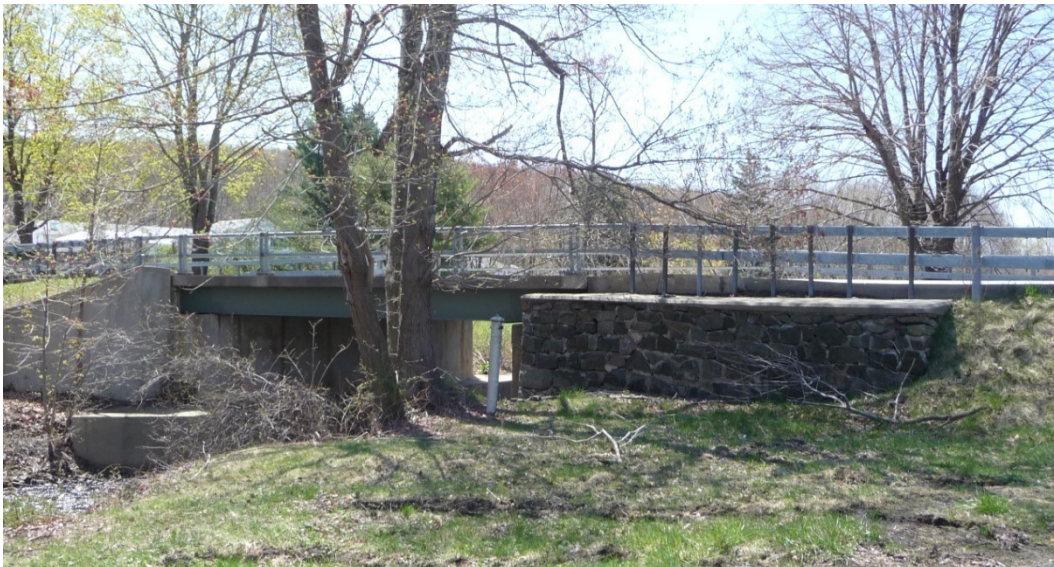
Figure 43. Current stonework for Bridge B-4; note that stonework on one side (left in this photo), has been replaced with concrete (ERDC-CERL, 2013),

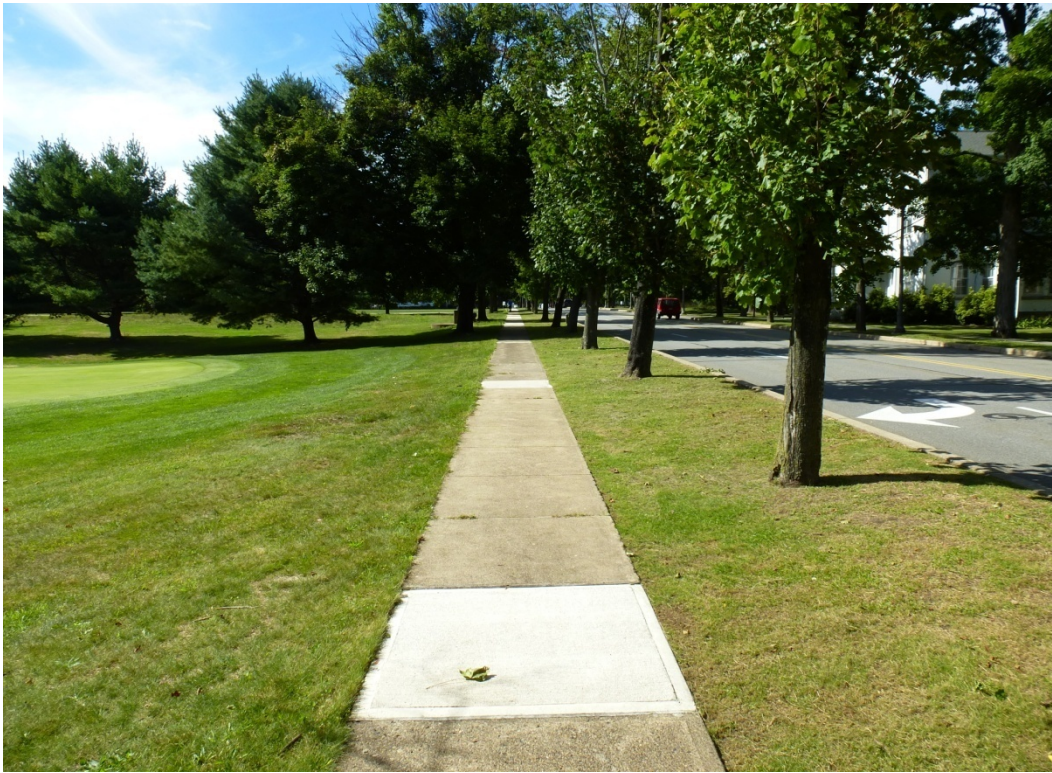
Concrete sidewalks exist throughout the historic district along Farley Avenue (Figure 45 and Figure 46), Kibler Road, and Buffington Roads. Walkways also exist connecting Building 151 to Chemistry Row.

Figure 45. Sidewalk on the north side of the golf course looking northwest along Farley Avenue (ERDC-CERL, 2012).

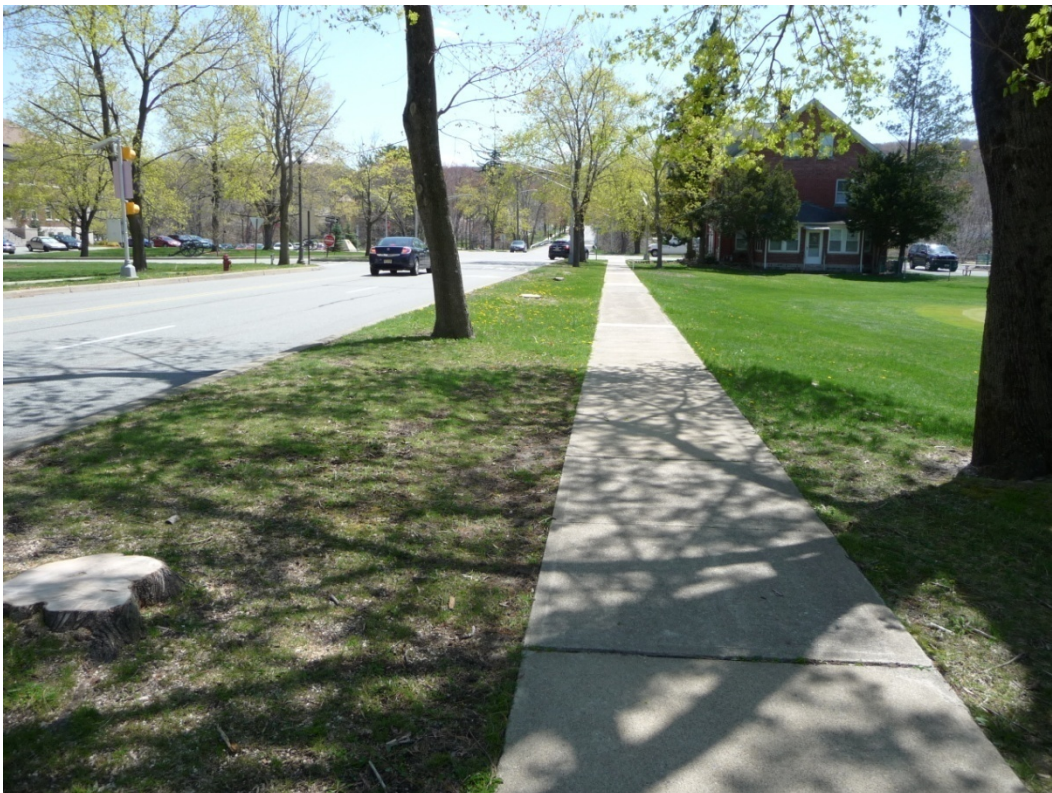
Figure 46. Sidewalk along Farley Avenue, looking northeast (ERDC-CERL, 2013).

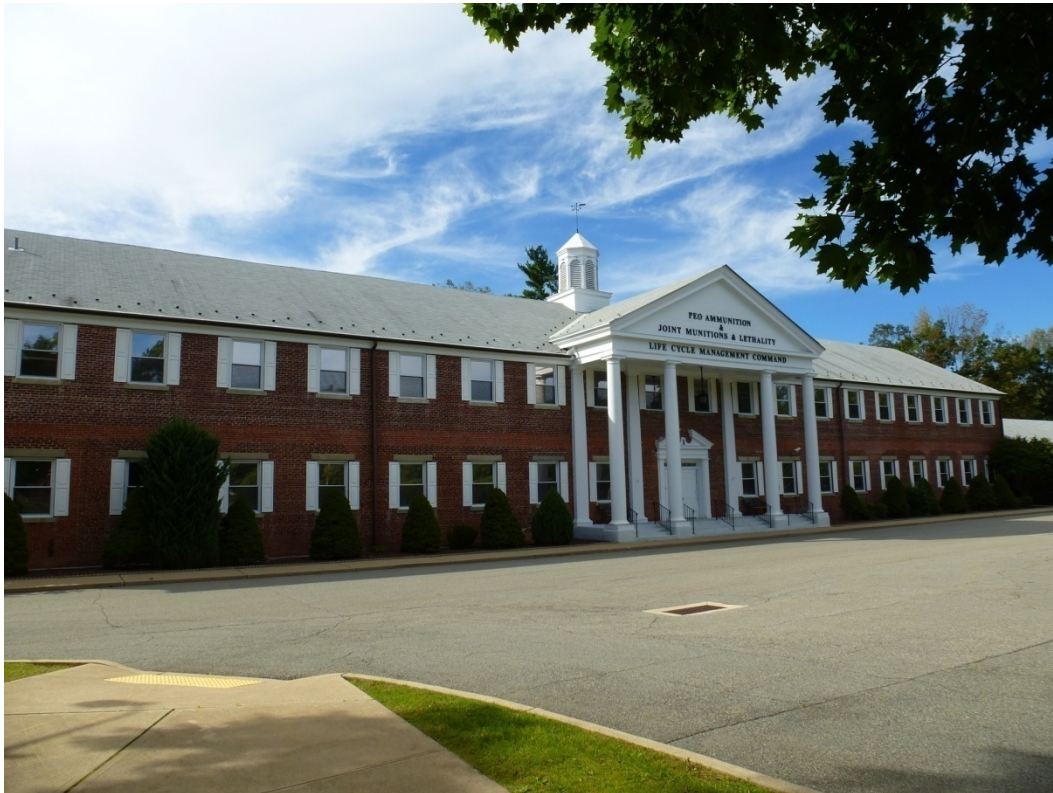
Figure 50. Building 1, Administration Building/Post Headquarters (ERDC-CERL 2012).

The current Building 1 (formerly Building 171) is an extremely large, long, two-story brick structure that presents a relatively flat facade broken in the center by a front pediment, two-story porch supported by Doric columns (Figure 50). The long line of the roof is broken by a hexagonal cupola that sports a weather vane. The window features concrete sills and pediments and are surrounded by decorative shutters. While the start date of the building's construction is uncertain, a blueprint detailing the structure's front door shows that this building was in existence by June 18, 1940. Portions of the exterior of the building are remnants of Magazine No. 2, which was built circa 1885. The building is approached off Buffington Road through an oval driveway system.<sup>49</sup>

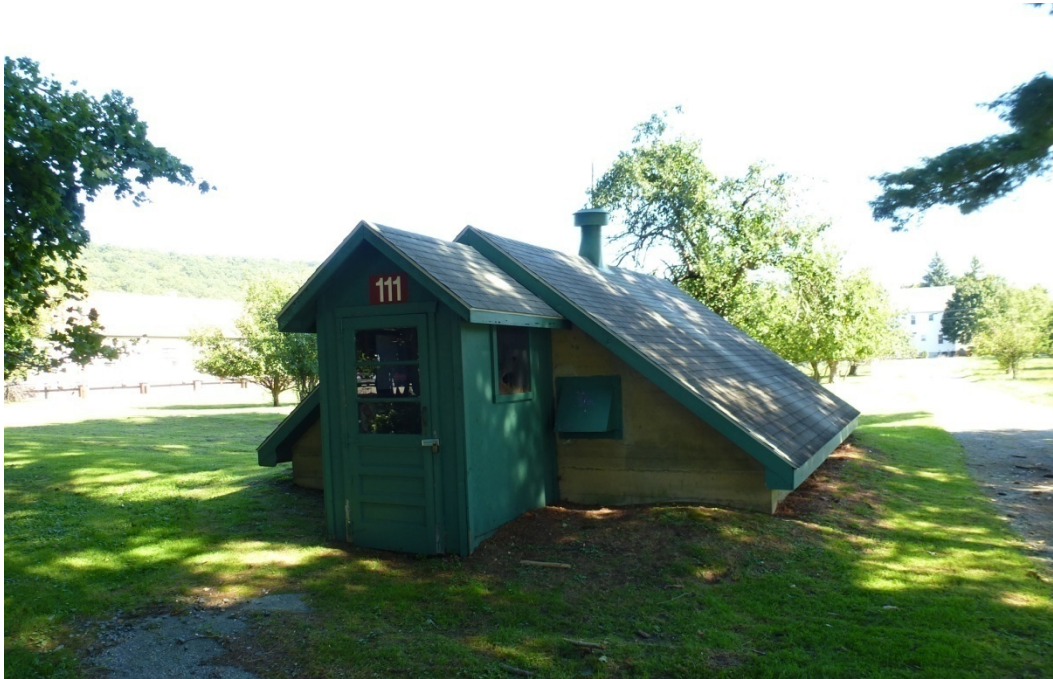
Figure 51. Root storage (ERDC-CERL, 2012).

Building 111 is a small, one-story building, with a concrete foundation, masonry bearing walls, an overhanging, gable roof with composition shingles and a square footprint. Concrete steps lead down into the semi-subterranean interior. Constructed in 1909, Building 111 served as a root house for the Commanding General's House. In 1938, the building was rehabilitated by the WPA. The building retains original siting, massing, and construction and has an enclosed wooden entry on the south side (Figure 51).<sup>50</sup> This building is listed for demolition.

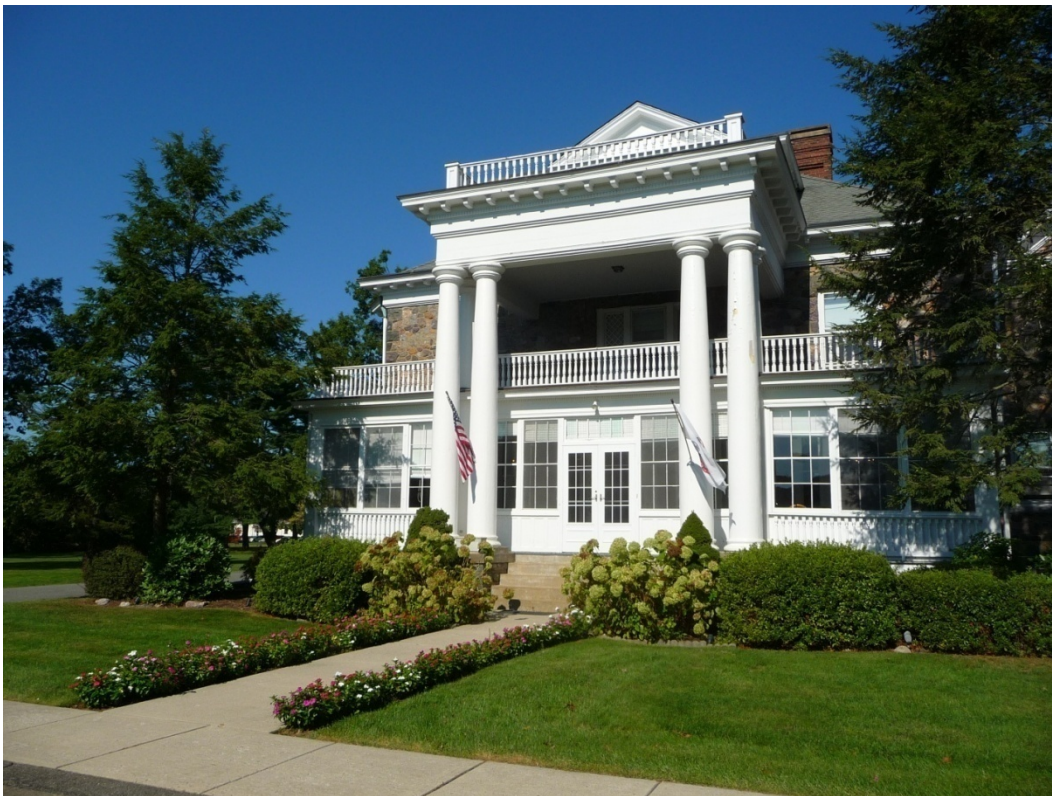
Constructed from locally-quarried pudding stone, this Colonial Revival residence has a central four-square plan with adjacent, gable-front side ell. The house was built in 1909 and has served continuously since 1911 as the Commanding General's Quarters. Building 112 is intact with limited alterations. It has a two-story front portico; rough-finished puddingstone facade with dressed pudding stone window surrounds; hipped, dormered central roof with flared ends; flared gables on side ell; enclosed front and rear porches and bay windows (side and rear elevations); and a glass-enclosed conservatory. Both exterior (Figure 52) and interior are richly embellished with decorative architectural elements. The original floor plan remains, except for alterations to the kitchen, bathrooms and enclosed porch.<sup>51</sup>

Figure 52. East elevation of Building 112 (ERDC-CERL, 2012).

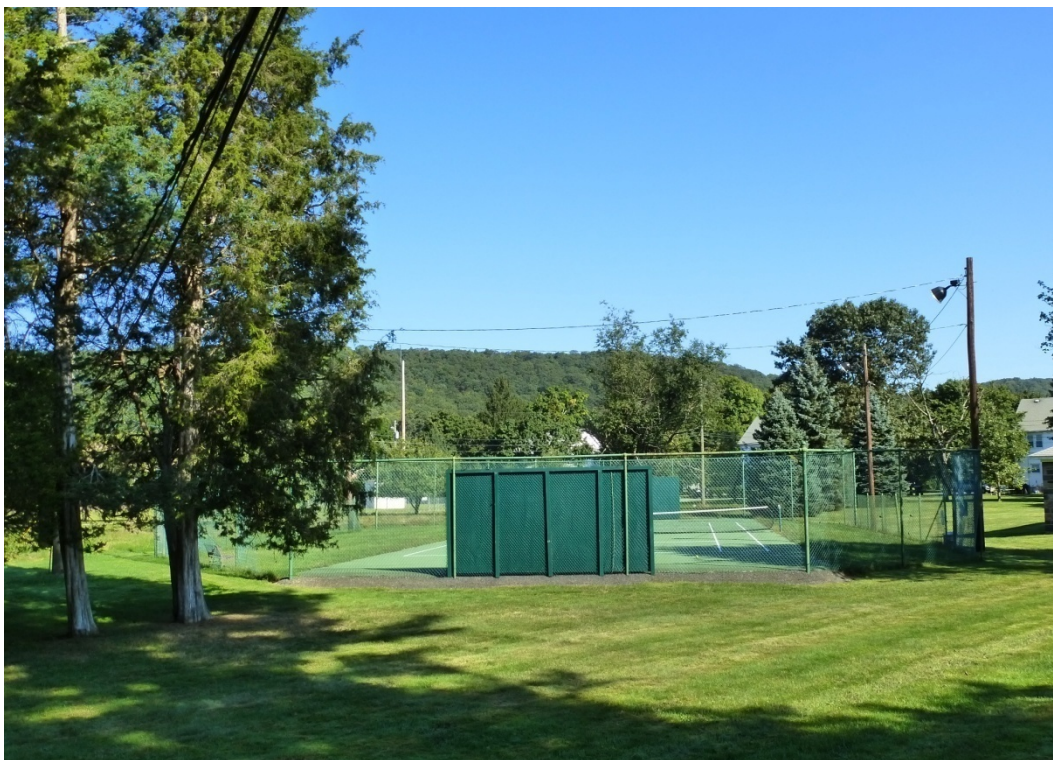
Building 112A is located between the two pergolas that are near Buildings 112 and 113. The tennis court is oriented north to south, is finished with green asphalt surface, and surrounded with a chain-link fence (Figure 53). A tennis court is depicted on a golf course map from 1925 (Figure 29). The court is seen in its current location and configuration in aerial maps from 1931. It is likely that the court began as a lawn court before it was covered with asphalt.<sup>52</sup>

Figure 53. Looking north towards Building 112A, Tennis Courts (ERDC-CERL, 2012).

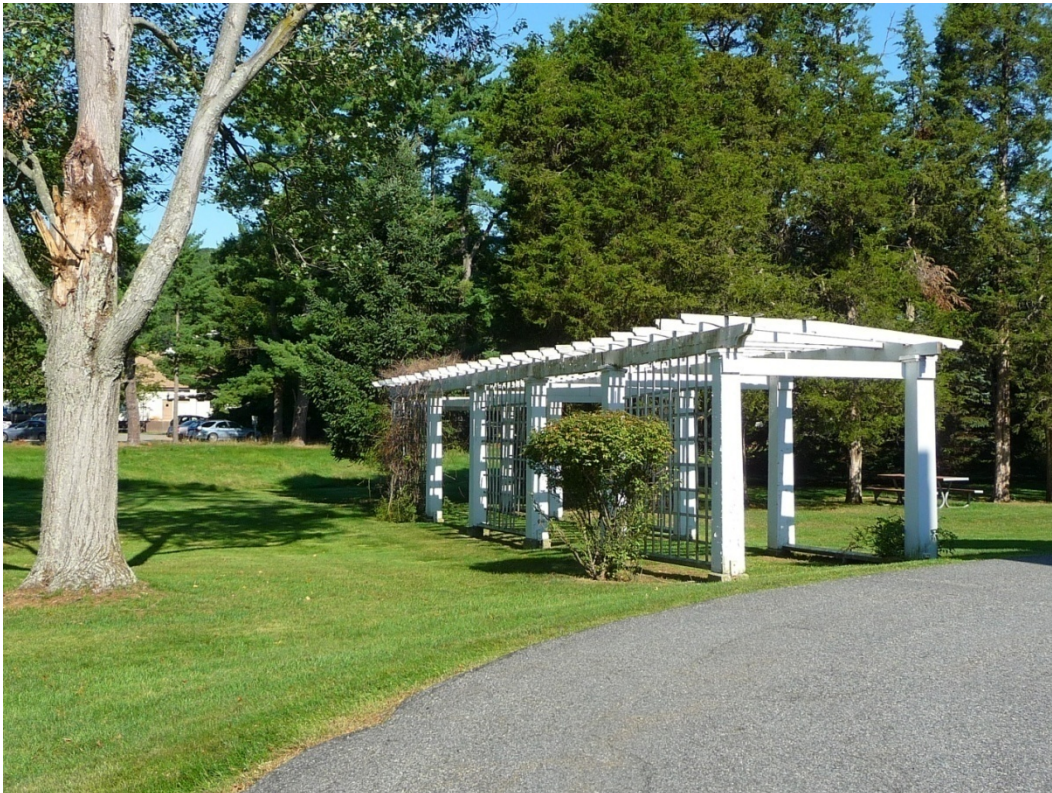
Building 112B is located north of the Commanding General's Quarters (Building 112). It has six pairs of tapered square wood piers that are bolted onto concrete footers. The tops of the piers feature simple, square capitals. Two bays are open, while three bays are enclosed with square-pattern wood lattice (Figure 54). The piers support double-board beams that are bolted together along the length of the structure. The beams support rafters with decorative ends. Cross beams span the width of the structure at each end and are bolted to the piers below the capitals. A similar pergola is seen in the same location but with rounded piers in a 1911 photo. It is possible the original structure was damaged in the 1926 explosion and was rebuilt on the same site.<sup>53</sup> This structure was demolished in 2015 with SHPO consultation. Mitigation included completed architectural drawings so structure could be rebuilt in future depending on funding.

Figure 54. View of Building 112B, pergola (ERDC-CERL, 2012).

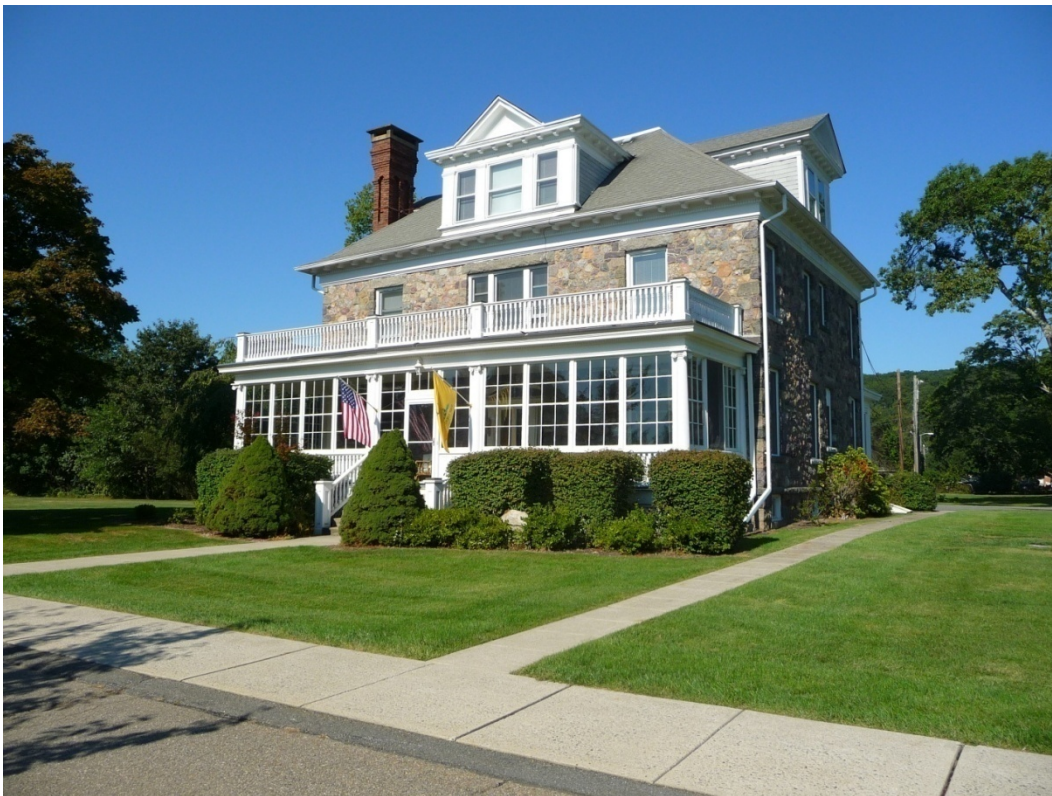
Building 113 is a Colonial Revival structure built in 1909 of locally quarried pudding stone, with a shingled roof (Figure 55). Originally constructed in 1909 as an Assistant Officer's residence, the house was used for many years as a general's residence. Building 113 remains intact with limited alterations. The exterior walls are coursed puddingstone; the shingled hipped roof has flat roof dormers with central pediment (front and rear elevations), and pedimented dormers (north and south elevations). Windows are double-hung and there is an oval window at the head of the maid's stairway. It has an enclosed front porch, balustrade second floor balcony, and conservatory. Building 113 has its original floor plan, except for alterations to the bathroom.<sup>54</sup>

Figure 55. East elevation of Building 113 (ERDC-CERL, 2012).

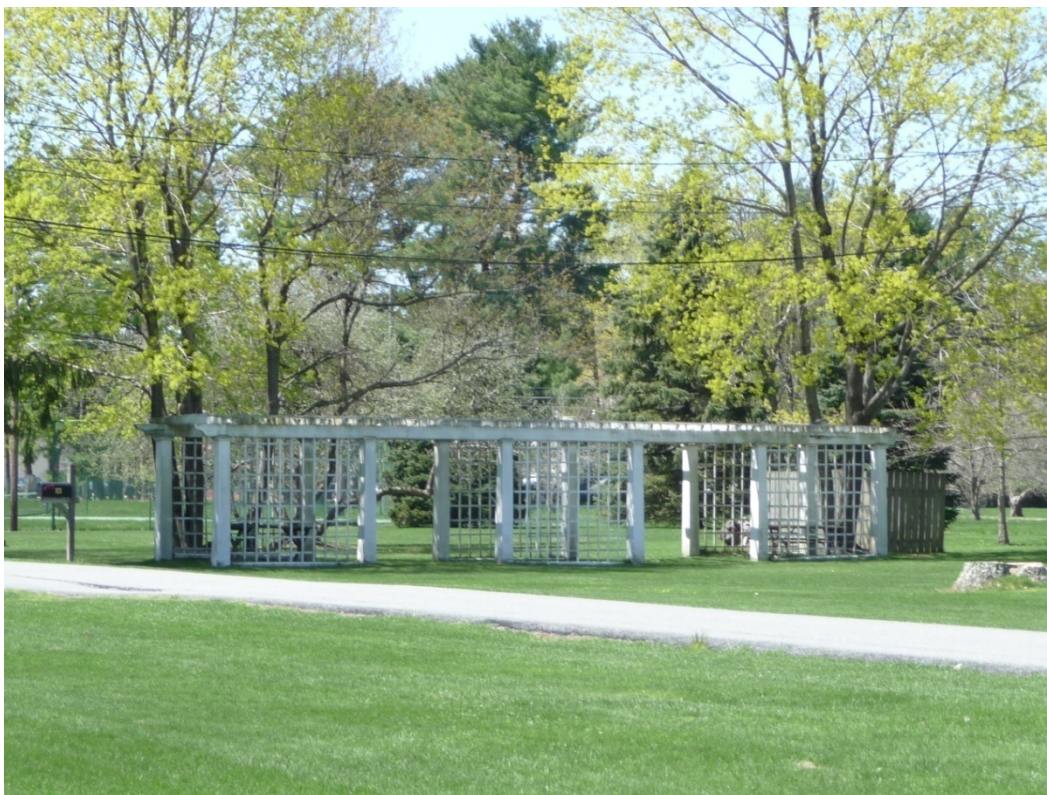
Figure 56. Building 113A (ERDC-CERL, 2013).

Building 113A is located north of the Assistant Officers' Quarter (Building 113) and is similar to the pergola near Building 112. It is possible that this pergola was constructed in the 1930s at the same time that pergola 112A was replaced. The pergola has six pairs of tapered square wood piers that rest directly on the ground. The tops of the piers feature simple square capitals. Two bays are open, while three bays have wood lattice between the piers (Figure 56). The piers support double-board beams that are bolted together along the length of the structure. The beams support raters with decorative ends.<sup>55</sup> This structure was demolished in 2015 with SHPO consultation. Mitigation included completed architectural drawings so structure could be rebuilt in future depending on funding.

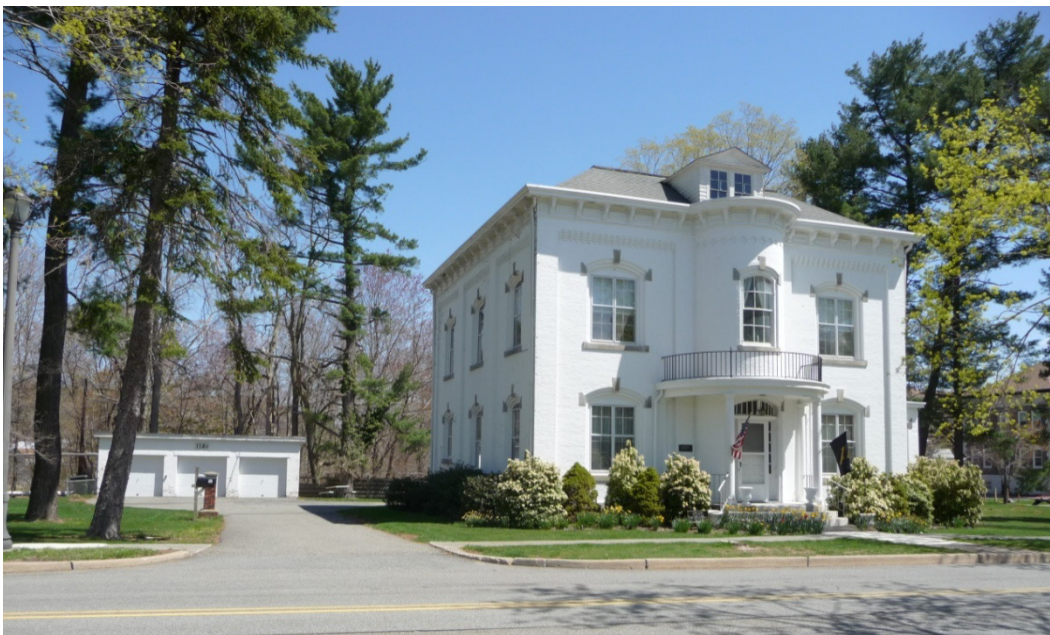
Figure 57. Southwest elevation of Building 114 (ERDC-CERL, 2013).

Building 114 is intact with limited alterations. Its eclectic architectural style combines Second Empire decorative elements and proportions with Colonial Revival hipped and dormered roof and central projecting bow (Figure 57). Each facade is divided into three bays by the articulation of brick pilasters and recessed, corbelled panels. Remaining from the original structure are the steel-frame arched windows; decorative brickwork (recessed window surrounds and brick corbelling); and curved, central projecting bay with front porch, segmented arch transom, and side lights at the front entrance. The structure's 1913 interior layout is intact, with finishes and woodworking dating from 1938.<sup>56</sup>

Building 114 is a two-story brick building. It was built in 1884 to serve as the Arsenal's administrative headquarters but was converted to officer's quarters in 1912. The Commanding Officer lived here in 1937-38 while Building 112 was being renovated. Then in 1938-39, the WPA remodeled Building 114. A wooden porch that extended along the front facade was removed, the back porch was replaced, a chimney was removed, and an east-wing sunroom was added. The interior was also refurbished.

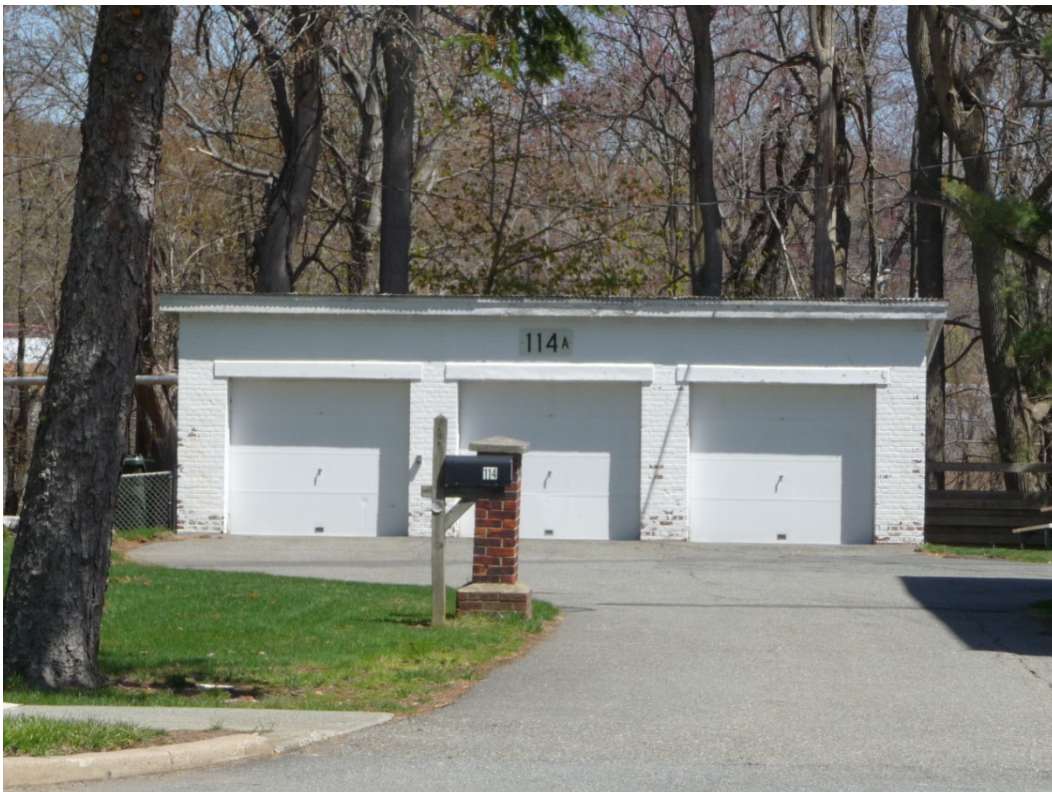
Figure 58. Southwest elevation of Building 114A (ERDC-CERL, 2013).

Building 114A is a small, one-story, three-door garage for Building 114. It sits on a concrete foundation and has galvanized iron on a wood roof (Figure 58). The garage was built in 1937 in connection with other improvements to Building 114.<sup>57</sup>

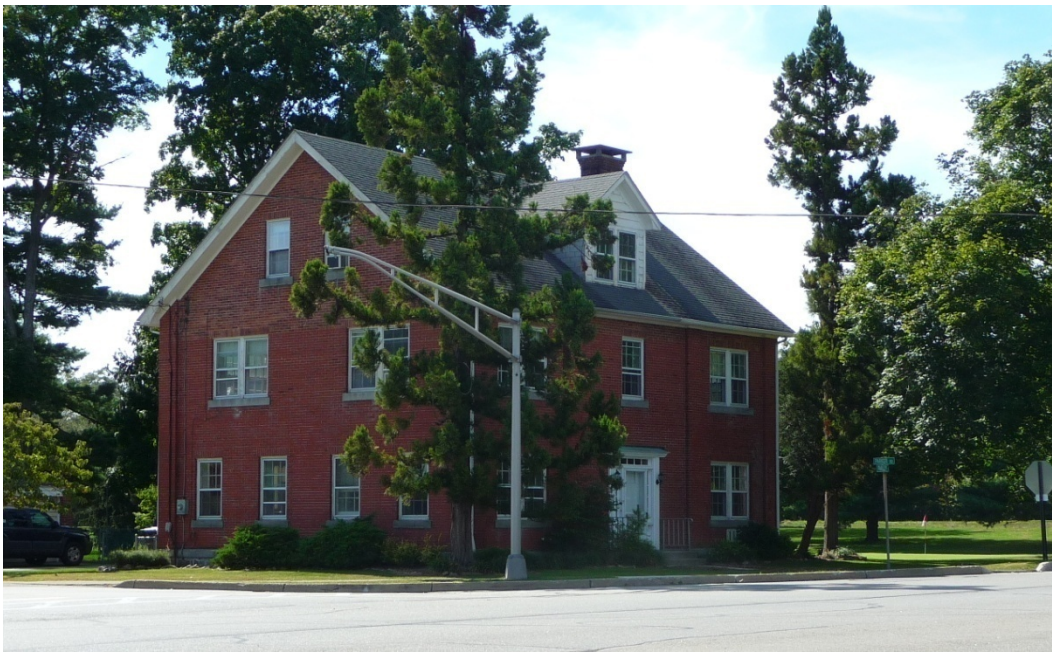
Figure 59. Northeast oblique of Building 115 (ERDC-CERL, 2012).

Built in 1884 as Building No. 1, Building 115 was successively a guard house, a fire engine house, a school house (for Rockaway Township during World War I) and then officers' quarters. It was one of the earliest administrative structures built at Picatinny. However, it was damaged in the 1926 explosion and was gutted, with most of the third floor removed. In the early 1930s, the third floor was rebuilt above the second story and has since been used for officers' quarters. Building 115 is located at the intersections of Farley Avenue and Parker Road. An added gable on the front façade gives extra height to the structure. Building 115 is a two-and-one-half-story, rectangular, pitch roof, brick building (Figure 59).<sup>58</sup>

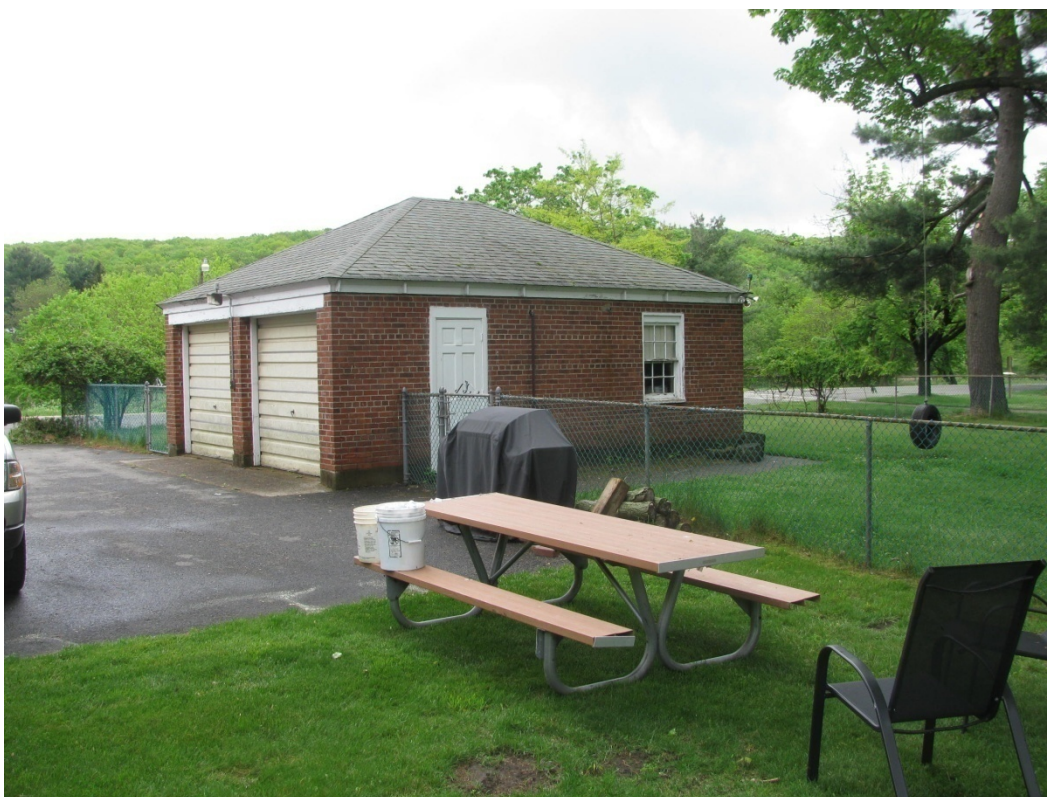
Figure 60. Northwest oblique of Building 115A (PICA Cultural Resources Office).

Building 115A is a one-story, rectangular, gable roof, two-car garage (Figure 60) situated near Building 115. It was built in 1943 as a garage and is still used as such. It has a number of Colonial Revival style features including a hipped roof, common bond brick construction, and 6/6 double-hung windows (vinyl replacement windows per SHPO consultation). The building has wood sills, wood lintels, and two new aluminum roll-up garage doors on the north side.<sup>59</sup>

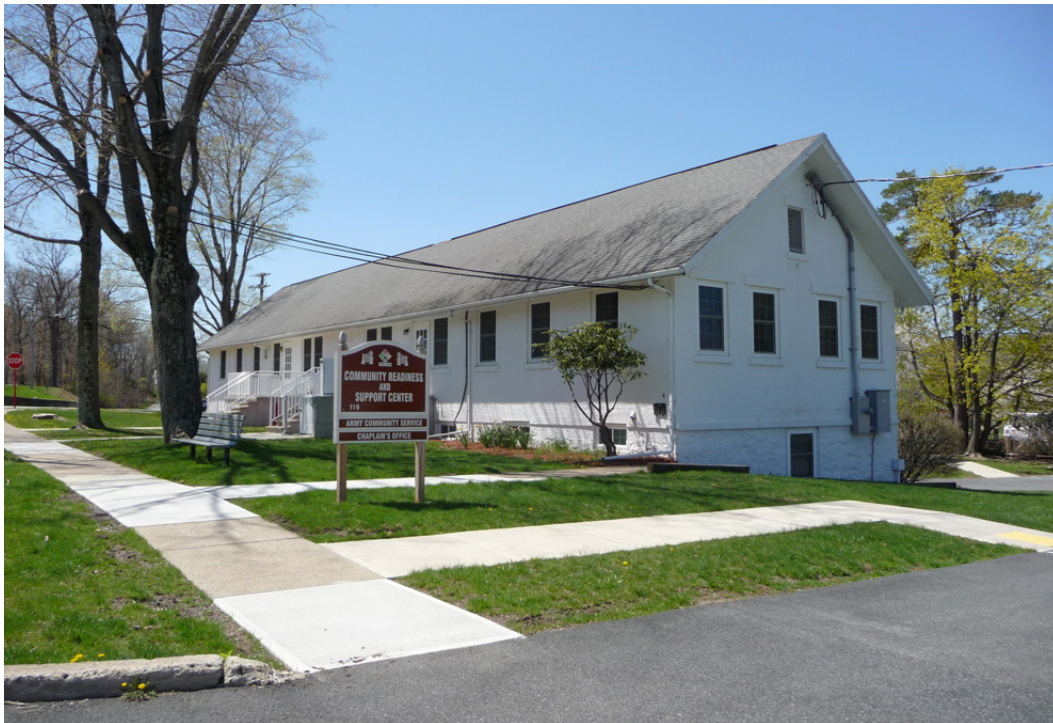
Figure 61. Southeast oblique of Building 119 (ERDC-CERL, 2013).

Building 119 is a large two-and-one-half-story, T-plan building, which is built with brick bearing walls upon a stone foundation (Figure 61). The building has a pitched roof clad with asphalt shingles and is painted white. It was built as a shell filling house in 1887. It was converted to a hospital for the 1918 influenza epidemic. Although damaged in the 1926 explosion, it was used for temporary offices until the completion of Building 151 in 1930. It then became enlisted quarters and a furniture storehouse until the 1930s WPA renovation for multi-family quarters. It was previously used for military housing, but is now used for administration of Army Community Services and contains the Chaplain's office. Building 119 retains its original siting, massing, and construction, including brick exterior walls and 6/6 wood sash windows (recently replaced with SHPO concurrence). A number of minor changes appear to have been introduced ca. 1940, including new concrete stair platforms, new concrete water table, and new garage doors at the rear.<sup>60</sup> More recent changes include wheelchair lifts added in 2010, fencing along Farley Avenue, and sidewalk upgrades.

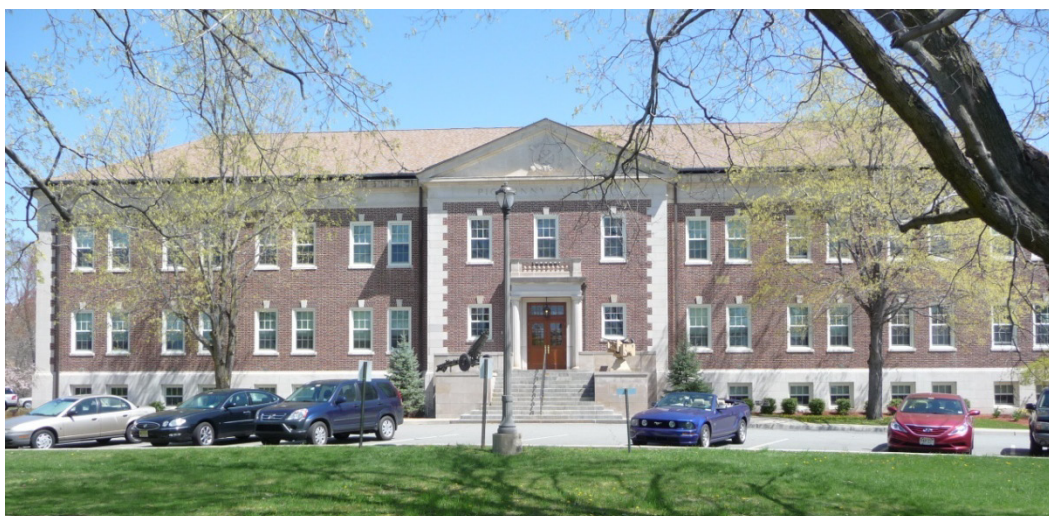
**Figure 62. Southwest elevation of Building 151 (ERDC-CERL, 2012).**

Building 151 is a large, two-story plus basement, red brick, hip roof, H-plan building. The front (south) “I” portion of the building was built in 1929 as the major Administration Building at Picatinny Arsenal. Two linear additions were built to the north in 1941 by Francisco and Jacobus, Architects and Engineers of New York and Chicago, giving the building its present H-plan configuration. The building is still used for administrative and office use. Building 151 retains original siting, massing, and most of it is original construction. Important Colonial Revival architecture features include Flemish bond patterning in the brickwork, limestone quoining at the corners, a formal plan with symmetrical composition, central pavilion at the front entrance, front portico, Colonial Revival style lanterns (front and back), “PICATINNY ARSENAL” sign in Roman block letters, ornamented Classical pediment in the front pavilion, hipped roof, and six-over-six windows (Figure 62). The 1941 additions were sympathetic to the original in design and style, setting a precedent that allowed for further expansion in the future. The building has recently had some alterations to its original roof profile, as well as insertion of replacement windows with filler panels and snap-in mullions.<sup>61</sup> Other recent changes include new doors (to match historic doors), awnings over side doors with lighting, and solar lights currently being installed in parking lot (black poles to blend with the other existing poles).

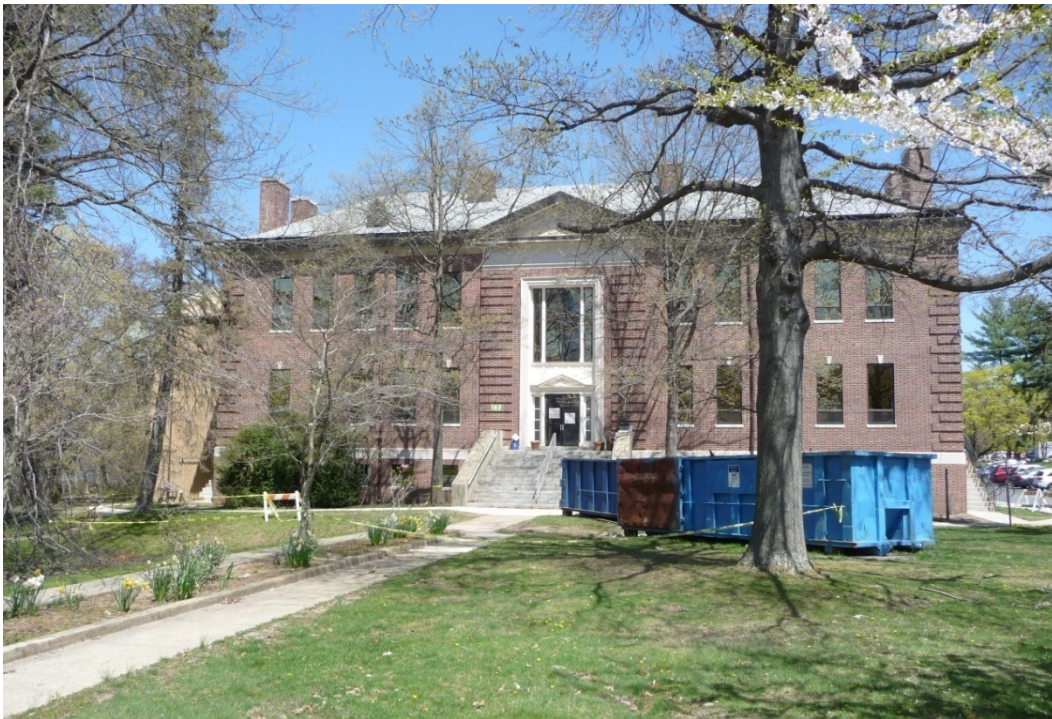
Figure 63. South elevation of Building 162 (ERDC-CERL, 2013).

Building 162 is a large, H-shaped building with one-, two-, and three-story sections. It is in the Georgian style, with a concrete foundation, brick walls, and hipped roofs (Figure 63). It was built in 1930, and the link and rear additions apparently date from 1942. It was renovated in 1980. Building 162 is mostly intact, except for some features changed in the 1980 rehabilitation. The building had brick quoins and cast stone entrance surrounds, string courses, keystones, cornices, and pediment. The sills are cast concrete, and the flat arches are brick. The many chimneys are brick with cast stone capping. The stairs at each of the four side entrances are granite with iron railings (currently being replaced), with lantern lights hanging in front of some of the entrance doors. The entrance screen at the main entrance appears to be glazed cast iron. Replacements include asphalt shingles to the roof (originally slate). Metal windows (probably double-hung wood, originally), anodized aluminum entrances doors, concrete stairs at the main entrances, and a two-story metal addition on the front left-hand side.<sup>62</sup>

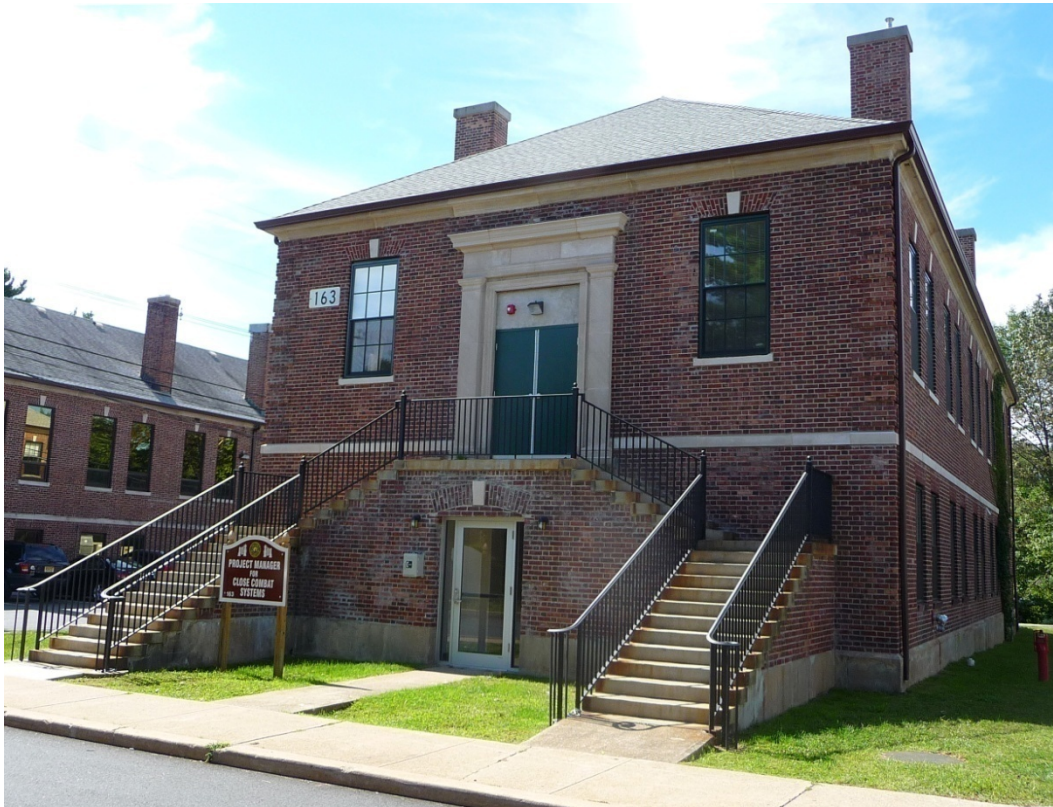
Figure 64. Southeast elevation of Building 163 (ERDC-CERL, 2012).

Building 163 is a two-story, hip-roofed, brick building with stone trim and details (Figure 64). It was built in 1930 as a chemistry laboratory building and was recently used as a photographic laboratory; its new use is administration. Building 163 retains original siting, massing, and construction. Significant Colonial Revival-style architectural features include the formal, symmetrical composition; Flemish bond brick exterior; hipped roof; six-over-six replacement windows; double exterior granite stairways; wrought iron replacement railings with brick repointing; and stone keystones.<sup>63</sup>
