## **Cultural Landscape Analysis of Existing Historic Districts**

Picatinny Arsenal, New Jersey

Final report

Under Project 201221, "Cultural Landscape Analysis, Picatinny Arsenal, New Jersey"

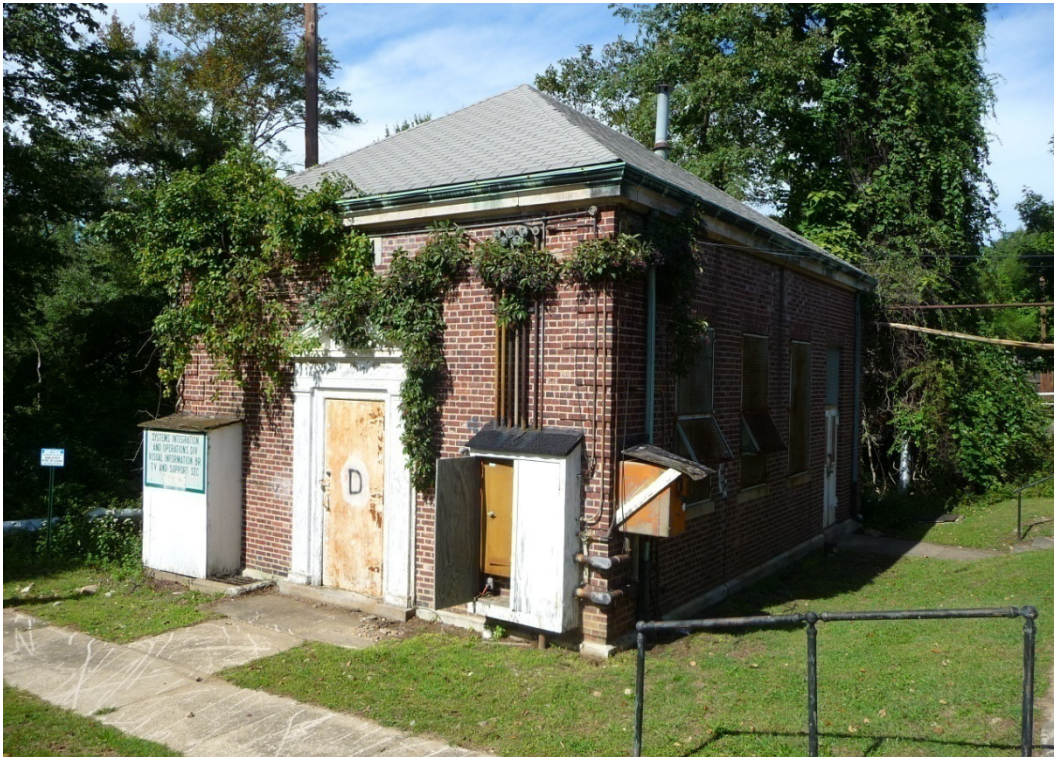
Figure 65. Southwest elevation of Building 164 (ERDC-CERL, 2012).

Building 164 was built during 1928–30 as part of the Arsenal's rehabilitation project following damage from the 1926 explosion. Like the other buildings of "Chemistry Row," it was designed in the Colonial Revival style, featuring a symmetrical facade, hipped roof, Flemish bond brickwork, brick quoins at the corners, copper gutters and flashing, six-over-six windows, splayed lintels, a formal Georgian pedimented front door (Figure 65). In addition, the building had a granite sill on the south side and a wrought-iron stair railing on the west side. The east and west sides each had a door and three windows, and a concrete exterior stairway and fourth door were located on the north side. The large front (south) room contained a lab bench with a continuous fume hood along the west side and a lab table in the center. The sample preparation room was behind this room at the northwest corner of the building. A third room, containing a sink, had no access to the other rooms and was entered from the east side exterior door.<sup>64</sup> It was demolished recently per consultation with the NJ HPO.

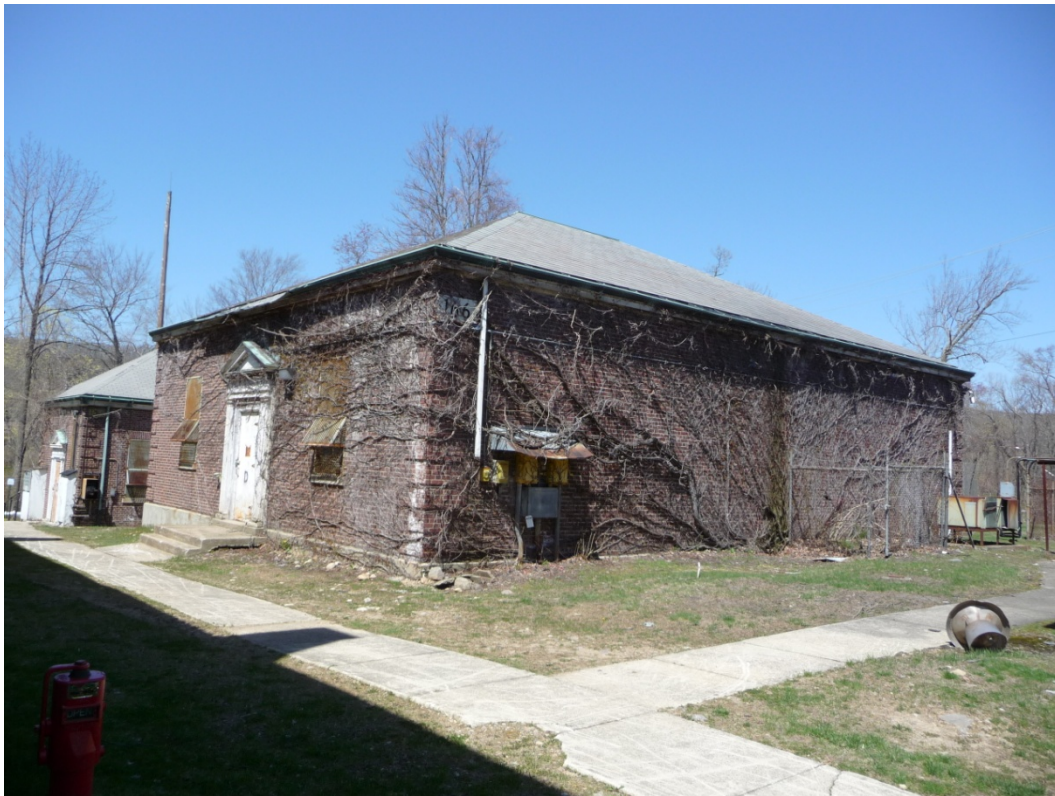
Figure 66. Southeast oblique of Building 166 (ERDC-CERL, 2013).

Building 166 was designed in 1941 and built in 1943, during the wartime expansion of research facilities at Picatinny. The 1941 plans called for a second structure identical to Building 166 (to be Building 197), which would eventually be built adjacent to Building 166. Like its neighbors on what would come to be called “Chemistry Row,” Building 166 was designed in the Colonial Revival style (though somewhat simpler overall). The design features a symmetrical façade, Georgian door surrounds on both the front and rear doors, Flemish bond brickwork, and hipped roof (Figure 66). The east and west façades (front and rear) had central doorways with windows to each side. The interior consisted of control rooms at front and rear, connected by a narrow passageway with four windows along one side of the building and a large, central space containing four self-contained, double-walled, circular surveillance chambers with reinforced concrete ceilings, each with its own entrance.<sup>65</sup> It was demolished recently per consultation with the NJ HPO.

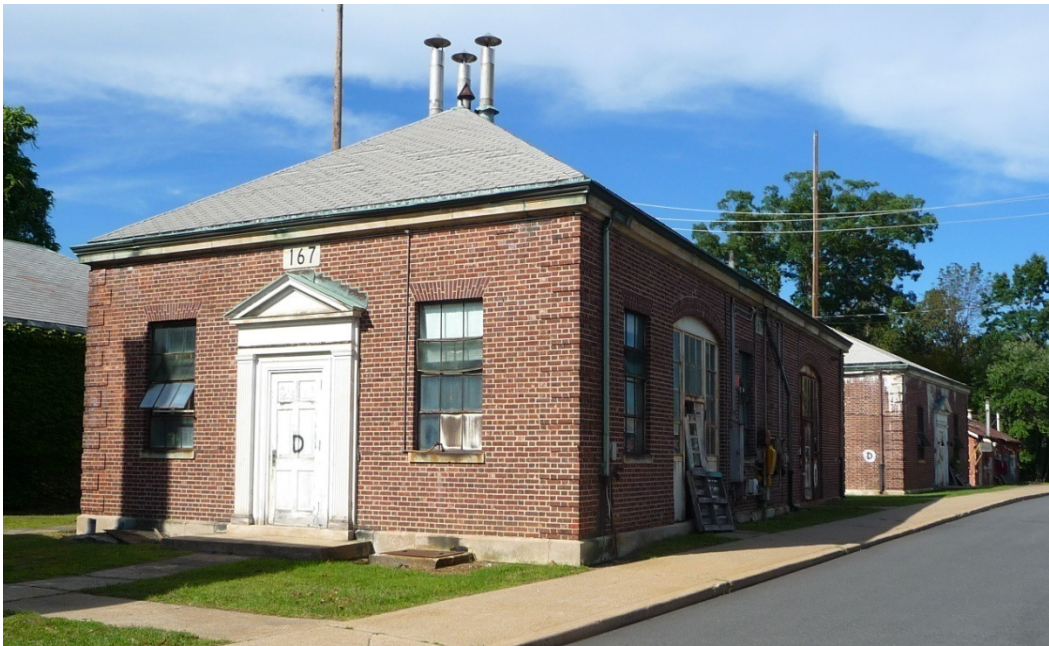
Figure 67. Southeast oblique of Building 167 (ERDC-CERL, 2012).

Building 167 (originally Building 256) was an experimental preparation and testing laboratory for explosives, designed in 1928 as part of the Arsenal's rehabilitation project following the 1926 explosion and completed in 1930. The style was Colonial Revival to match its neighboring buildings and featured a symmetrical south facade with a Georgian door surround, hipped roof, Flemish bond brickwork, brick quoins at the corners, copper gutters and flashing, and six-over-six windows. A 1938 remodeling included an addition to the structure, and the proportions and scale were further altered when the building was enlarged around 1948. The design was fairly faithful to the original style, with the new north bay on the street façade matching the original one, though the ridged hipped roof was not carried across (Figure 67). In 1951, the building was repurposed to function as a nuclear chemistry research laboratory, due to the United States having entered the Cold War era and Picatinny turning to innovative, high-tech research. New ventilation stacks protruded from the original roof line, but otherwise the exterior was little changed.<sup>66</sup> It was demolished recently per consultation with the NJ HPO.

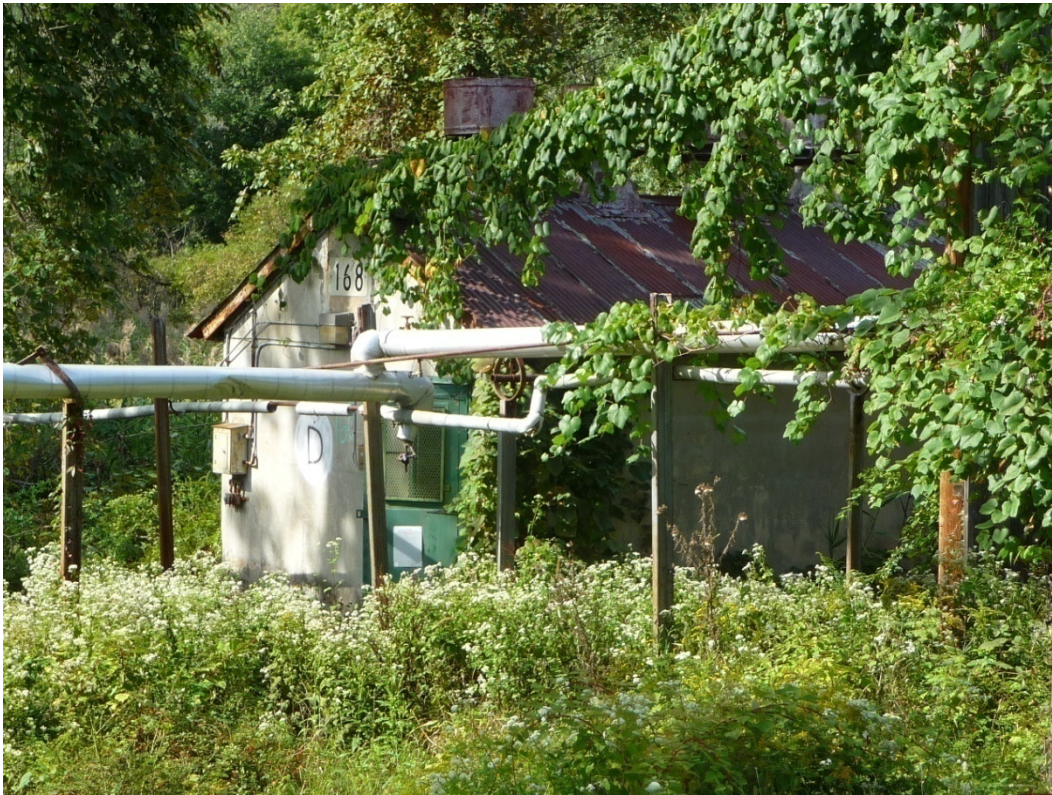
Figure 68. Look north at Building 168 (ERDC-CERL, 2012).

Building 168 was constructed in 1930 as an ammunition and explosives magazine. It was a one-story, pitch-roofed, concrete and hollow clay tile building with corrugated asbestos-covered metal roofing and concrete foundations (Figure 68). It contained five small storage chambers, which were separated into two areas by concrete, blast-resistant, divider wall. The building had five metal vents on the roof, concrete loading docks on each end (north and south), and was separated from others buildings to the north and east by a V-shaped barricade constructed of vertical telephone poles and vertical board siding, attached by wood framing.<sup>67</sup> The building was located in the area north of the row of chemical laboratories that front to Kibler Road. It was demolished recently per consultation with the NJ HPO.

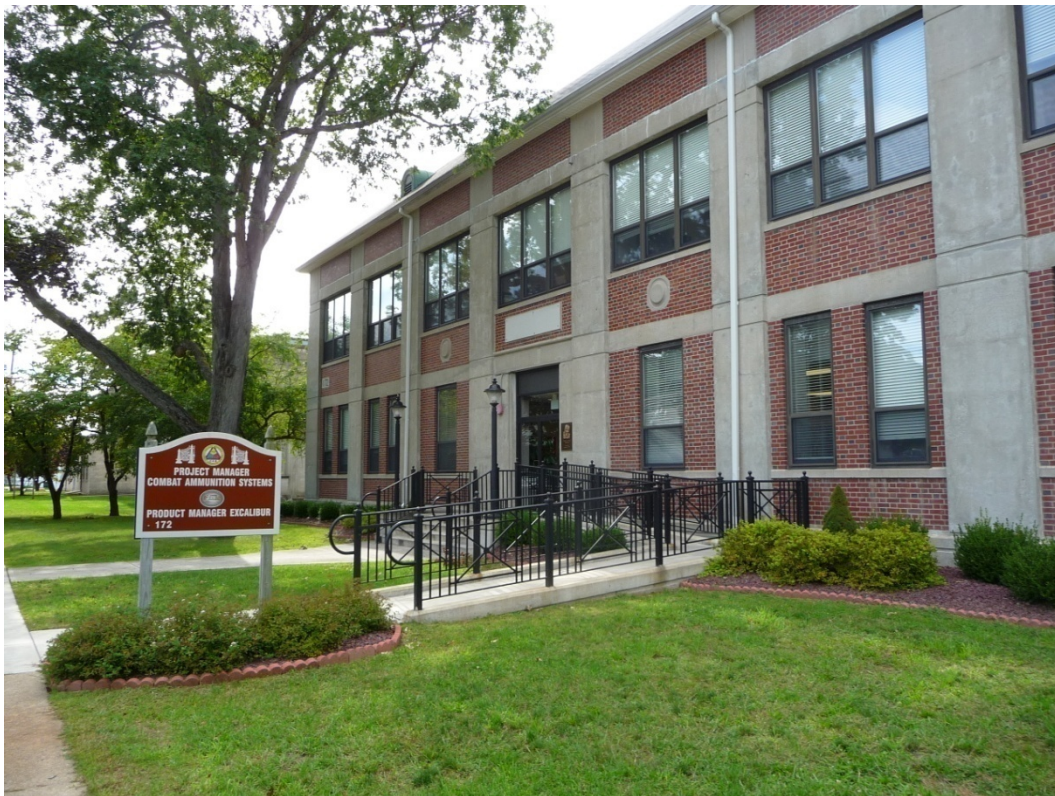
Figure 69. East elevation of Building 172 (ERDC-CERL, 2012).

Building 172 is a two-story building and basement, with a concrete foundation, structural steel frame encased in concrete, brick walls, and a hipped roof. It was built in 1942 by Francisco and Jacobus, Architects and Engineers of New York and Chicago, as an ordnance administration building, and it continues to be used for administrative purposes. Building 172 is mostly intact. The building has a concrete foundation, a structural steel frame encased in concrete forming piers and beams, brick spandrels and panels, and metal windows with cast stone sills (Figure 69); the hipped roof is covered with asphalt shingles, and there are two copper-clad dormer vents front and back. The front entrance stairs are concrete, with iron railings and standard lamps topped with eagles. The handicap walkway, rear wheelchair lift, and the awning were installed in 2008. Modifications to the original building include aluminum entrance doors, anodized aluminum windows, metal gutters and downspouts, and a metal entrance canopy at the basement entrance. The interior has been renovated.<sup>68</sup>

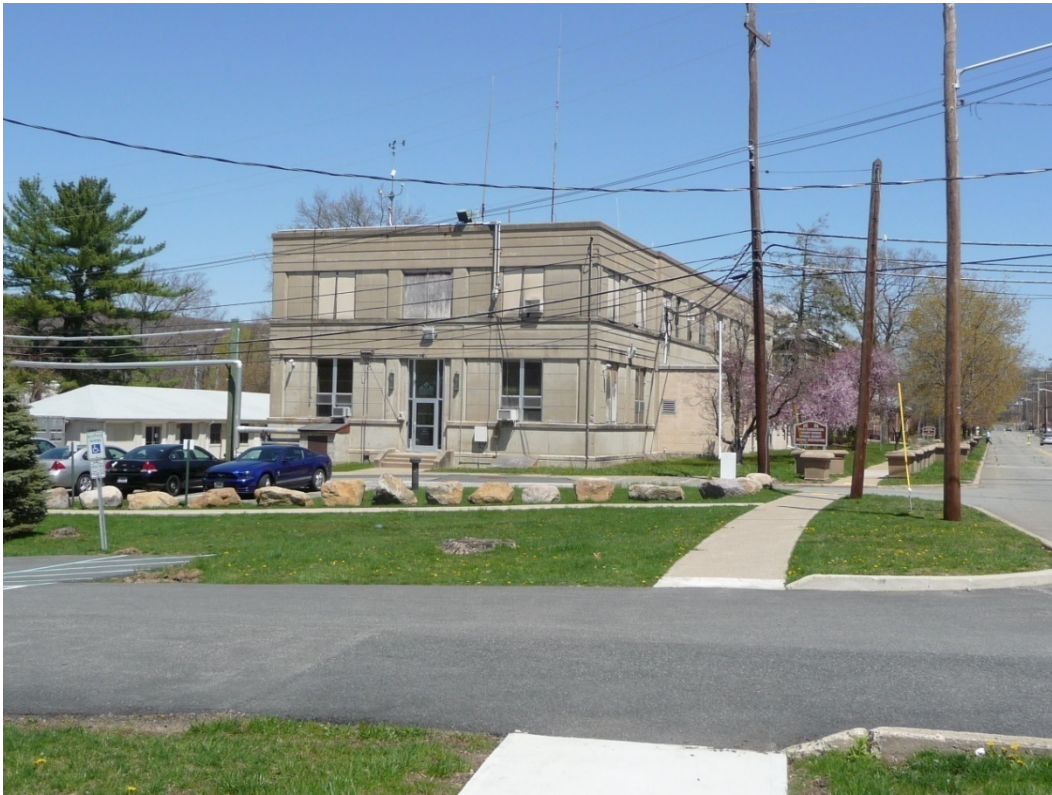
Figure 70. Southeast oblique of Building 173 (ERDC-CERL, 2012).

Building 173 is a two-story, flat-roofed, concrete structure which occupies a central position at Picatinny Arsenal. Building 173 was built in 1942 as a transformer station. It was later used as a fire station, before Picatinny Arsenal acquired the Navy property. It currently is used both as a police station (main building) and a communications center (concrete block addition on the east side). Building 173 retains original siting, massing, and construction (Figure 70). The building has a large, concrete block addition on the east, three small additions on the west, and a group of new HVAC chillers on the north. Many of the original windows openings have been filled in with concrete panels. Many of the original wood elements (sash windows and doors) have been replaced with aluminum doors and windows.<sup>69</sup>

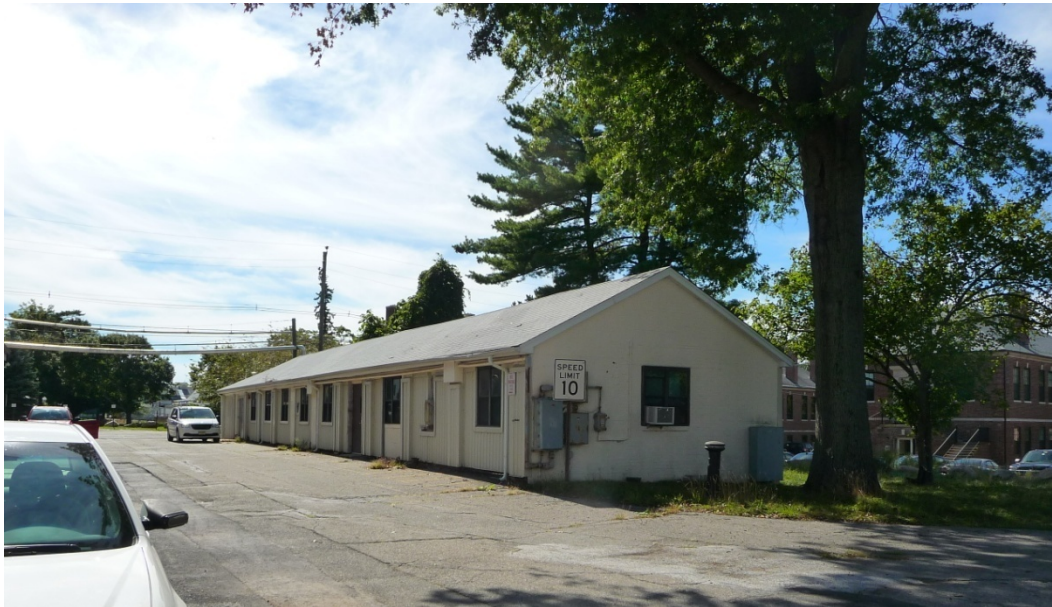
Figure 71. East elevation of Building 174 (ERDC-CERL, 2012).

Building 174 was built in 1942 as a service magazine. It is an eleven-bay building with a concrete foundation, load-bearing brick and hollow tile construction, covered with metal siding (Figure 71). There are replacement doors and windows and a gable roof. While recently used for administrative offices, it is currently vacant and awaiting funds for renovation. Building 174 retains original siting, massing, and construction. There are wooden eaves with ventilated soffits. One end elevation is gabled; the other is hipped.<sup>70</sup>

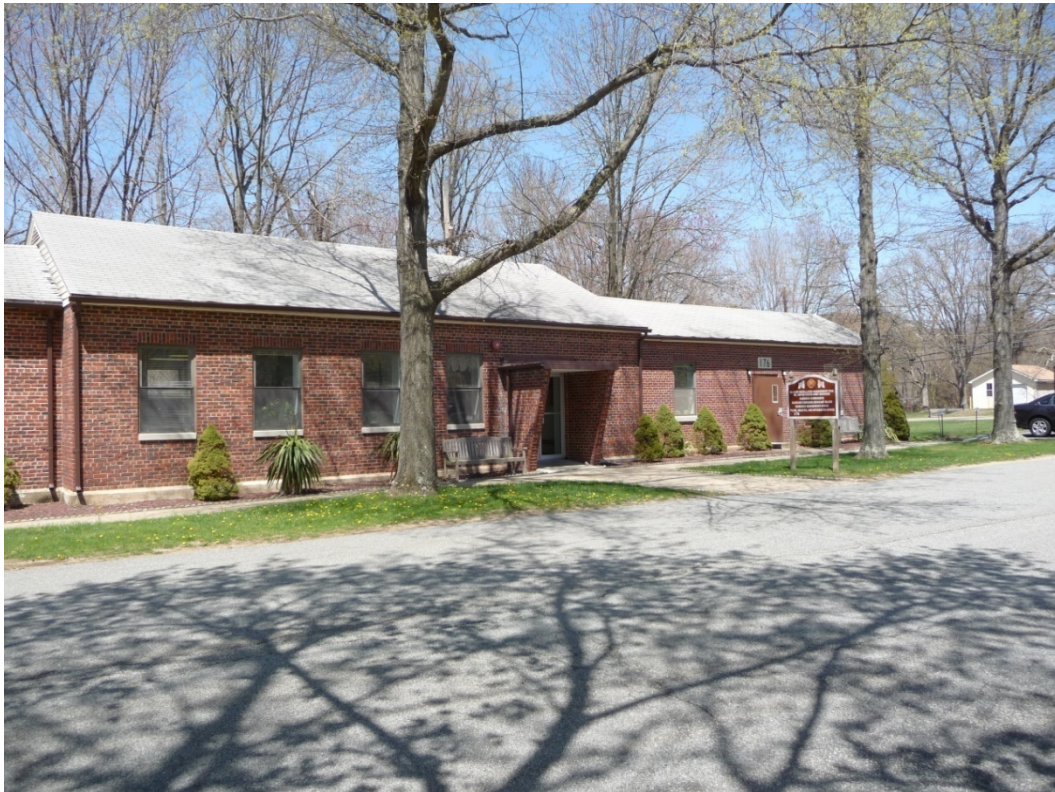
Figure 72. East elevation of Building 176 (ERDC-CERL, 2013).

Building 176 is a single-story building with nine bays, load-bearing brick walls laid in common bond, and concrete block additions with vinyl siding. There are replacement windows, a central doorway, and a gabled roof. It was built in 1944 as a laboratory and for sampling batches of ammunition. Additions were built in 1959, 1961, and 1962. The building is now used for administration. Building 176 retains its original siting, massing, and construction (Figure 72). There is no longer a wooden walkway connecting Building 176 to Building 1 (formerly Building 171).<sup>71</sup>

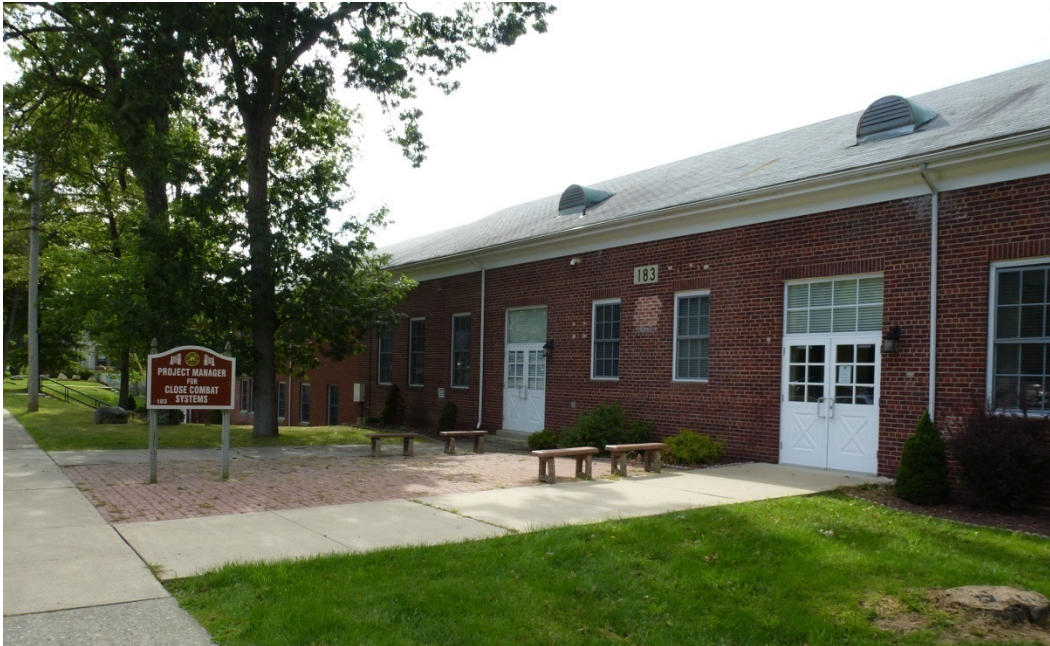
Figure 73. Southeast elevation of Building 183 (ERDC-CERL, 2012).

Building 183 is a combined building of an older one-story section and newer, T-shaped, two-story section; both sections have brick walls and gable roofs. The older section of Building 183 was built in 1943 as the Steam Meter Flow House with an addition in 1963 (designed by Lawrence Picone and Associates of Metuchen, New Jersey). The building is now used as a materials facility and for administrative purposes. The older section of Building 183 is a Georgian style with a concrete foundation, brick walls, six-over-six double-hung replacement sash windows, brick sills and soldier-course lintels, and a gable roof covered with asphalt shingles (Figure 73). The east facade has two sets of double wood doors with five-light rectangular transoms; the west facade had a central entrance with double wood doors topped with a semicircular fanlight, all set in a pedimented entrance bay. The newer section of the building has brick walls, metal windows with soldier brick lintel and concrete sills, spaced similarly to those on the original building, and a gable roof. A metal stairway leads to the upper doorway in the gable end.<sup>72</sup> The building was fully renovated in the early 2000s and in 2010, when a handicap access and a pushbutton door were added.

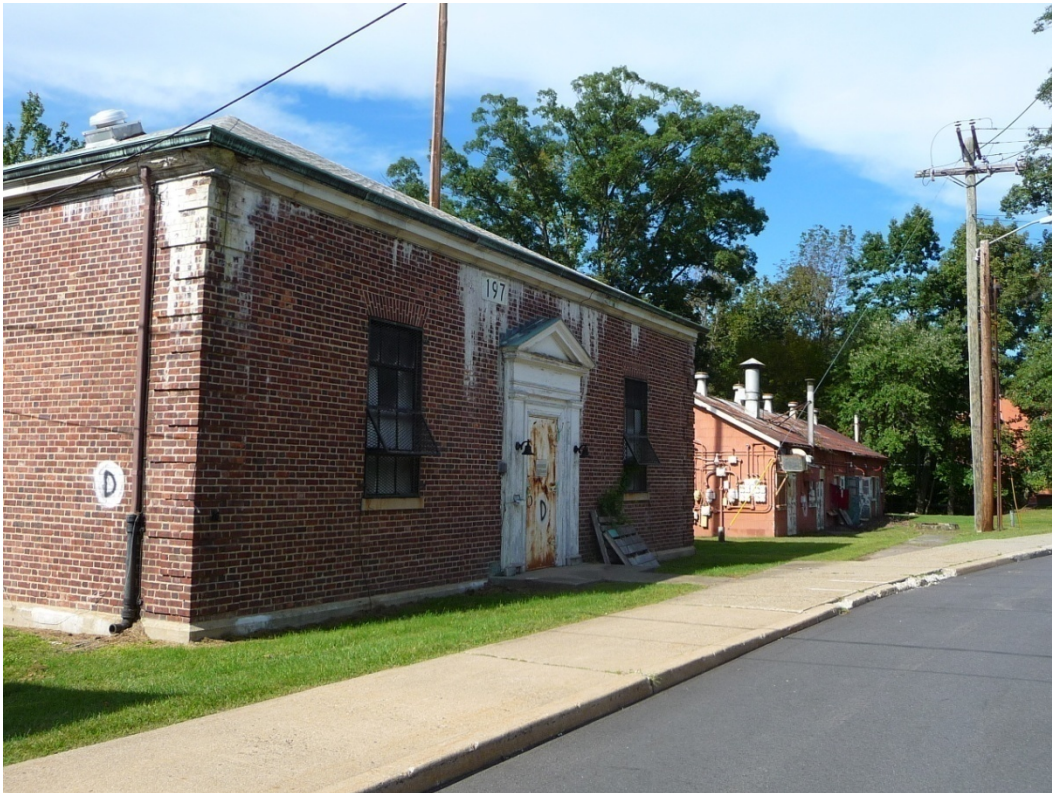
Figure 74. East elevation of Building 197 (ERDC-CERL, 2012).

Building 197 was designed in 1941 but was not built until 1945. It was essentially identical to Building 166 except for its shingle roof. Like its earlier neighbors at “Chemistry Row,” Building 197 was designed in the Colonial Revival Style (though somewhat simpler overall), featuring a symmetrical facade, Georgian door surrounds on both front and rear doors, Flemish bond brickwork, and a hipped roof. The front and rear facades had central doorways with windows to each side (Figure 74), and the longer side walls had four windows each. The interior consisted of control rooms at front and rear connected by a narrow passageway with four windows along one side of the building, and a large central space containing four self-contained, double-walled circular surveillance chambers with reinforced concrete ceilings, each with its own entrance.<sup>73</sup> It was demolished recently per consultation with the NJ HPO.

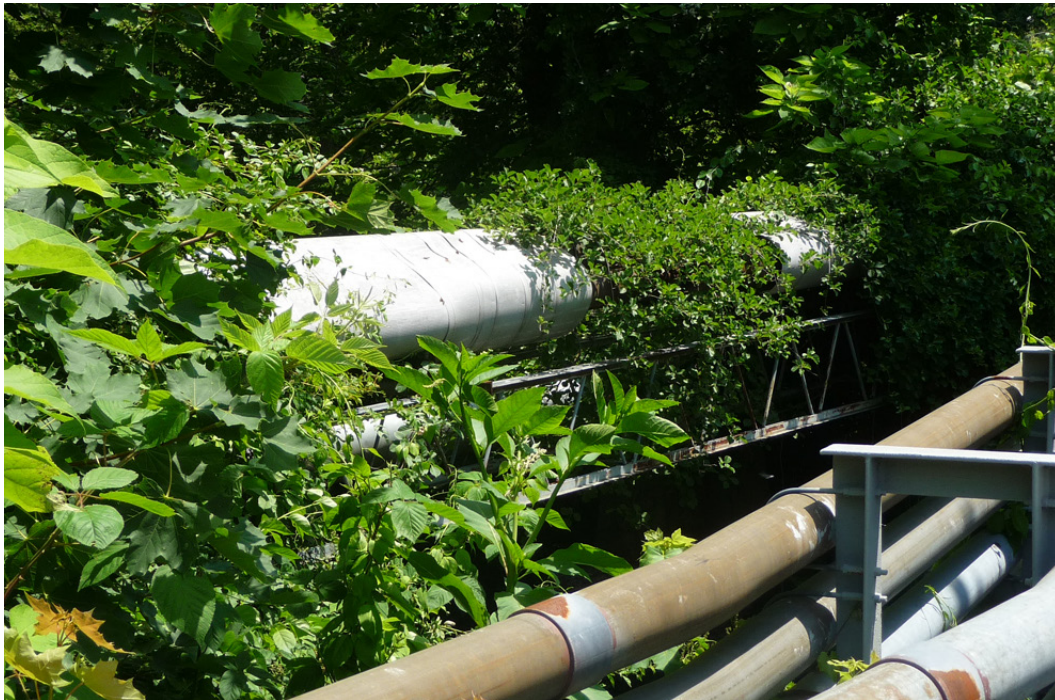
The steam distribution system is a network of metal or asbestos-protected metal (APM) conduit that run above and below ground from the power plants throughout PICA. A centralized system of steam throughout Picatinny Arsenal and the Lake Denmark NAD provided a source of heating and allowed production facilities throughout the installation to use pressurized steam as a sparkless form of energy. The steam was created as a by-product of electricity production at the Power Plant (Building 506), built in 1906 and the Boiler House (Building 3013), built in 1901. Water from Picatinny Lake was heated, and the resulting steam forced through turbines to produce energy. Pressurized steam was then sent to production facilities via conduit. On site buildings were fitted with pressure-reducing valves and steam-powered equipment, which reduced the risk of explosion. Overall, the Steam Distribution System consists of a network of conduit, supporting structures, and pressure-reducing valves. Most of the system that was visible has been replaced, but there are remnants of an earlier system of conduit supported on cast stone pier such as the example in Figure 75–Figure 77.<sup>74</sup> A map of steam lines is shown in Figure 78.

Figure 75. Steam line infrastructure, center, behind Building 151 (ERDC-CERL, 2012).

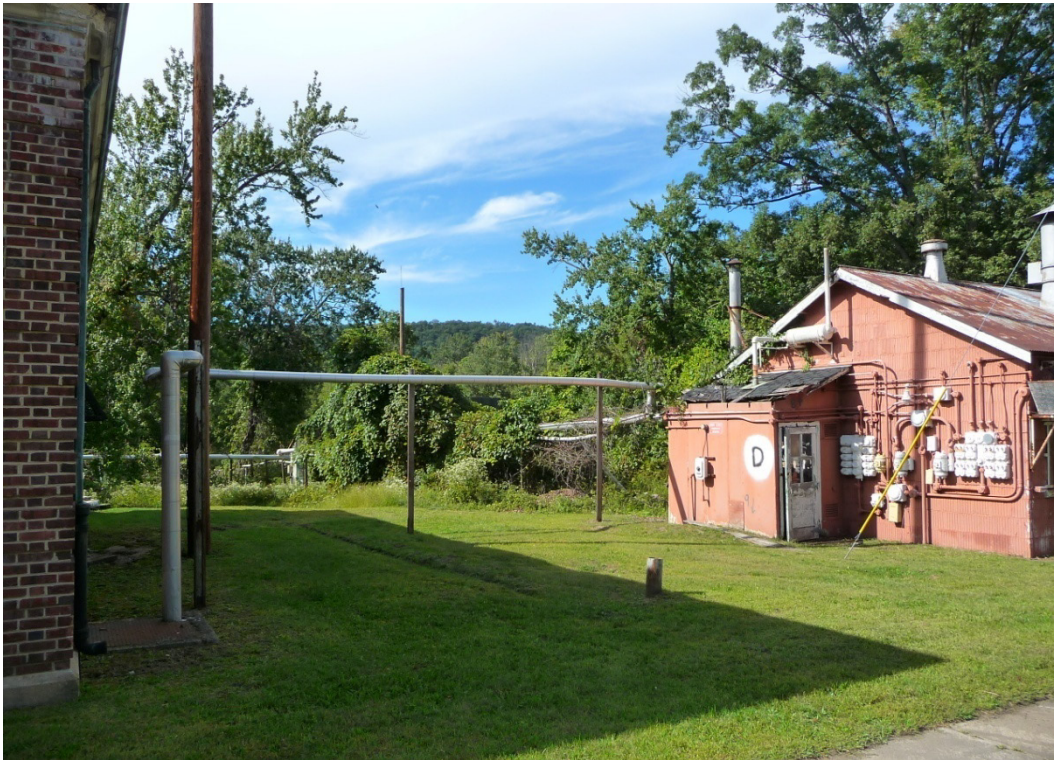
Figure 76. Steam line infrastructure between Buildings 197 and 178, which has been removed since this photo was taken (ERDC-CERL, 2012).

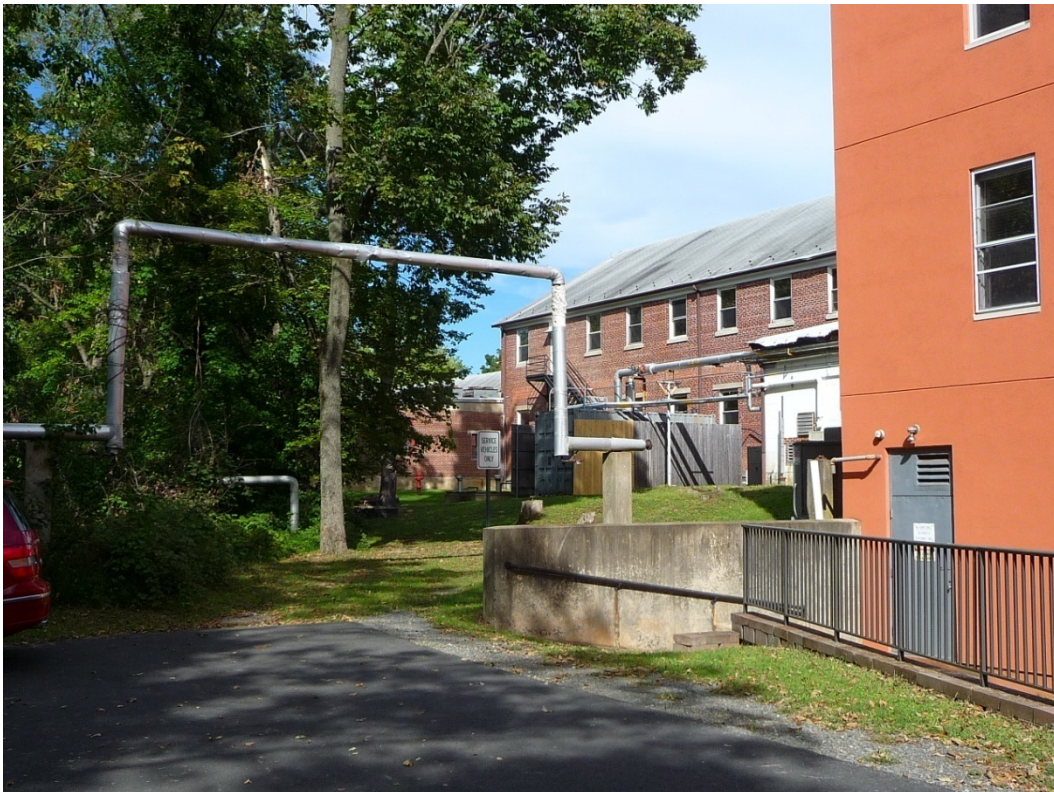
Figure 77. Steam line infrastructure behind Building 1 (ERDC-CERL, 2012).

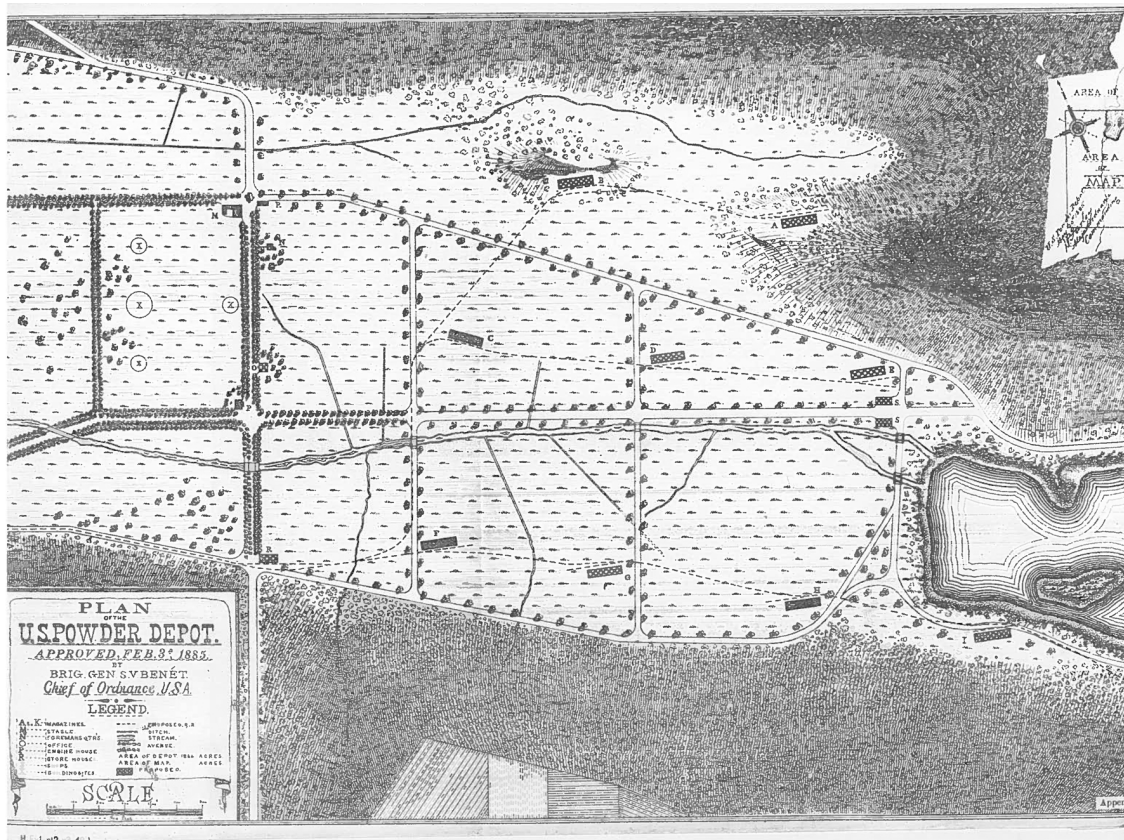
Figure 80. 1885 Plan for US Powder Depot showing heavily planted street trees along Parker Road and Farley Avenue (PICA Cultural Resources Office).

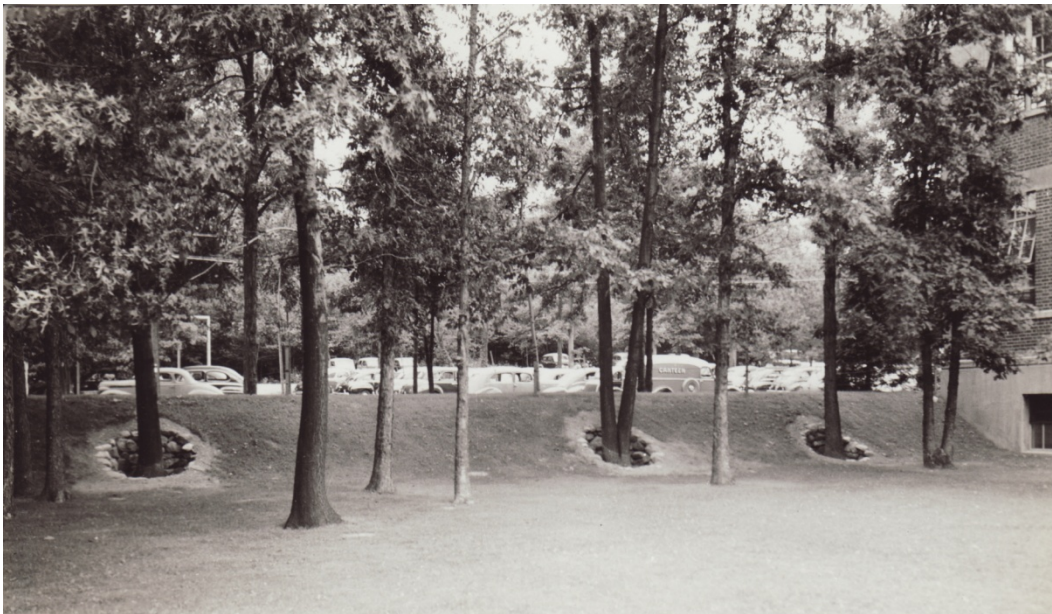
Figure 90. Historic photo of typical tree wells for tree protection on north side Building 172, 1943 (PICA Cultural Resources Office).

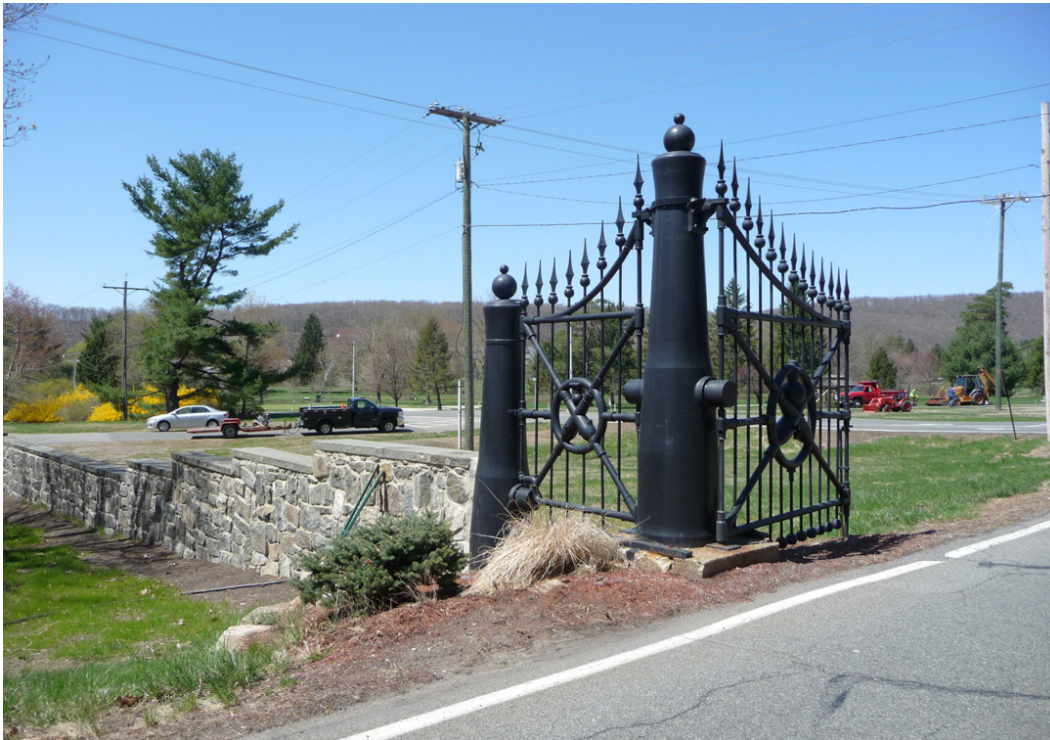
Figure 92. Cannon Gates (ERDC-CERL, 2013).

Cannon Gates located at the main entry on the south side of PICA (Figure 92). Cannon Gates provided an appropriate entrance for the initial plan of

the Picatinny Powder Depot that included storage magazines, stable, foreman's quarters and office, engine house, store, shop, and other sites planned for future buildings.<sup>75</sup> The Cannon Gates were manufactured by the Cornell (NY) Iron Works in 1885 and used a heavy cannon mounted on stone foundation as the post for the wrought-iron gates. The gate insignia is the badge of the Ordnance Corps. The gates are bordered by a 3 ft stone wall (Figure 93), but two entrances break up the wall – one for the tracks of the Wharton & Northern Railroad and Picatinny's rails, the other for a road paralleling the tracks. The road went to a former housing area, Spicertown, along Parker Road that today is just a wooded area.<sup>76</sup> Gates were widened when the three lane entrance road was built 1941. The wall was rebuilt using the existing stone with matching mortar in 2012. The wall behind the Gunpowder Grill is dry-laid, as was the original wall prior to being moved.

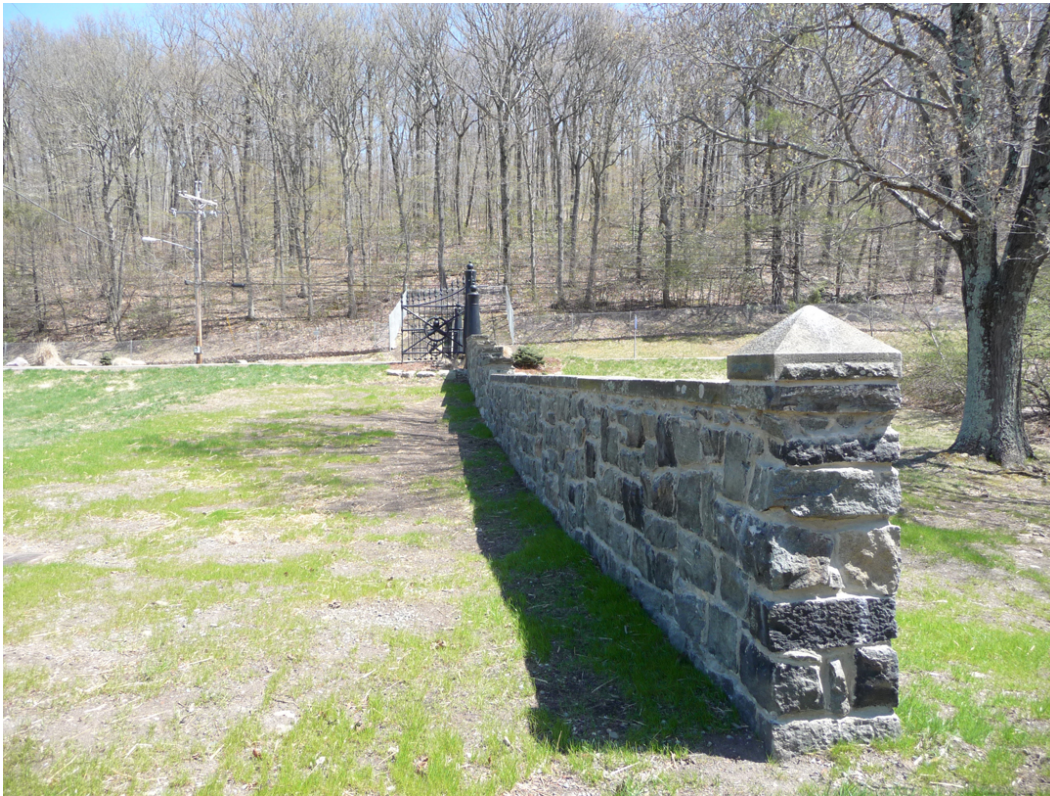
Figure 93. The west portion of the stone wall adjacent to Cannon Gates (ERDC-CERL, 2013).

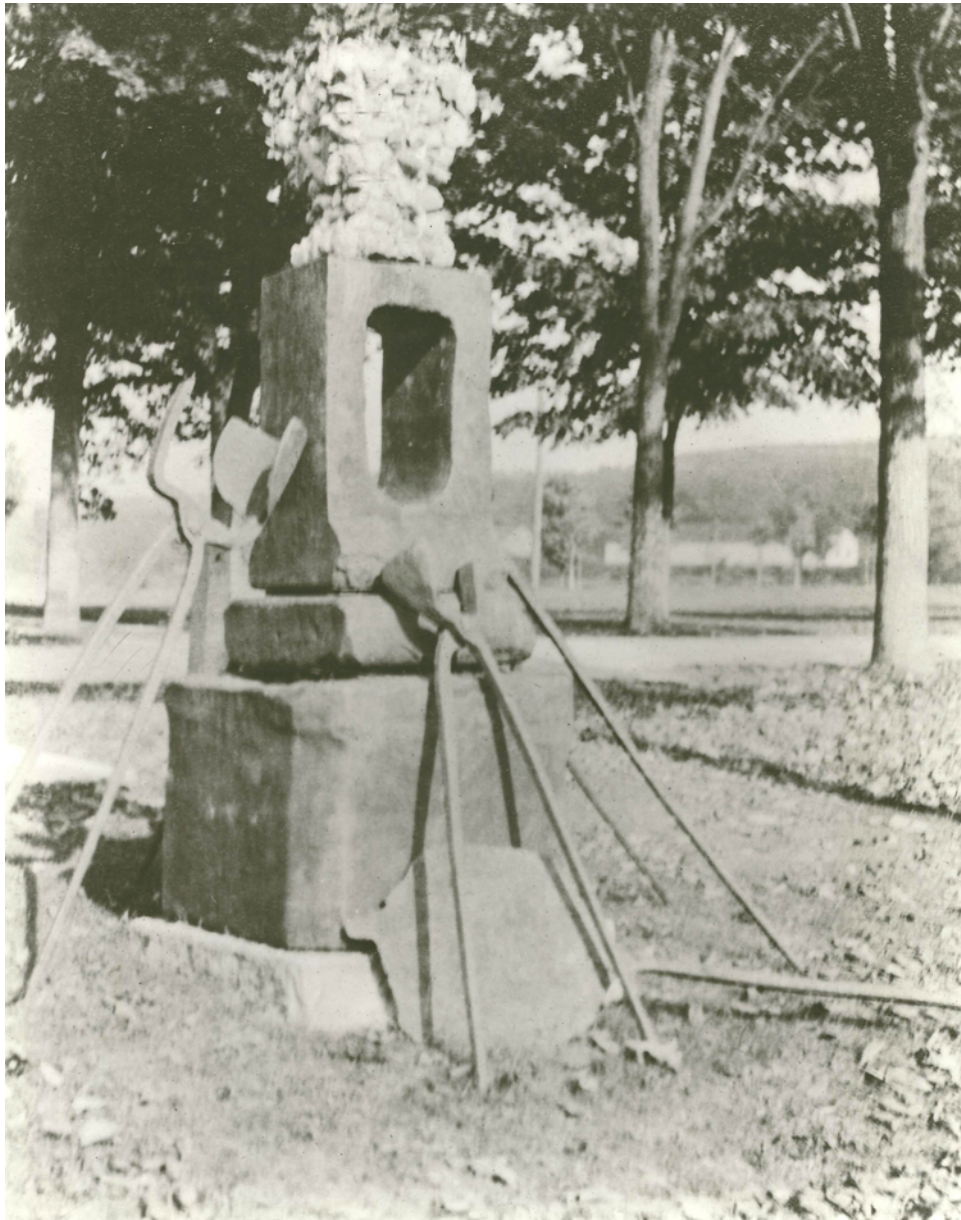
Figure 94. Middle Forge Monument in a 1912 photograph at an undocumented, unknown location (PICA Cultural Resources Office).

The Middle Forge Monument and memorial (151M) is located within the landscaped area of the Administrative and Research Historic District and in front of Building 151 at the intersection of Parker Road and Farley Avenue (Figure 95 and Figure 96). It was previously located in front of Building 114 adjacent to the golf course, in almost the same location as 114M (discussed below). The monument is an Army memorial that commemorates the history of the Middle Forge with a display of eighteenth-century ironworking tools.<sup>77</sup> The forge and tools in the monument were recovered at the actual Middle Forge site which was operational from 1749 to 1880 near Picatinny Peak. The Middle Forge supplied ordnance material to the Continental Army during the American Revolution. The monument is first seen in a 1912 photograph as configured in Figure 94 at a location that is

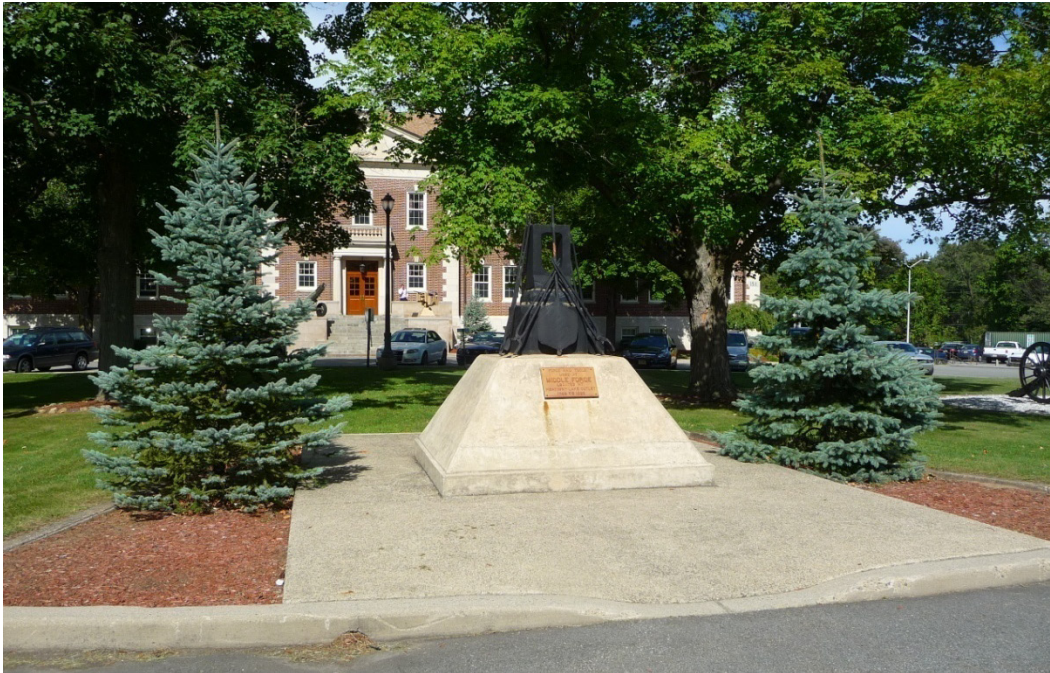
Figure 95. Current location of the Middle Forge Monument (151M) in front of Building 151. Monument's configuration and base have changed with new location. (ERDC-CERL, 2012).

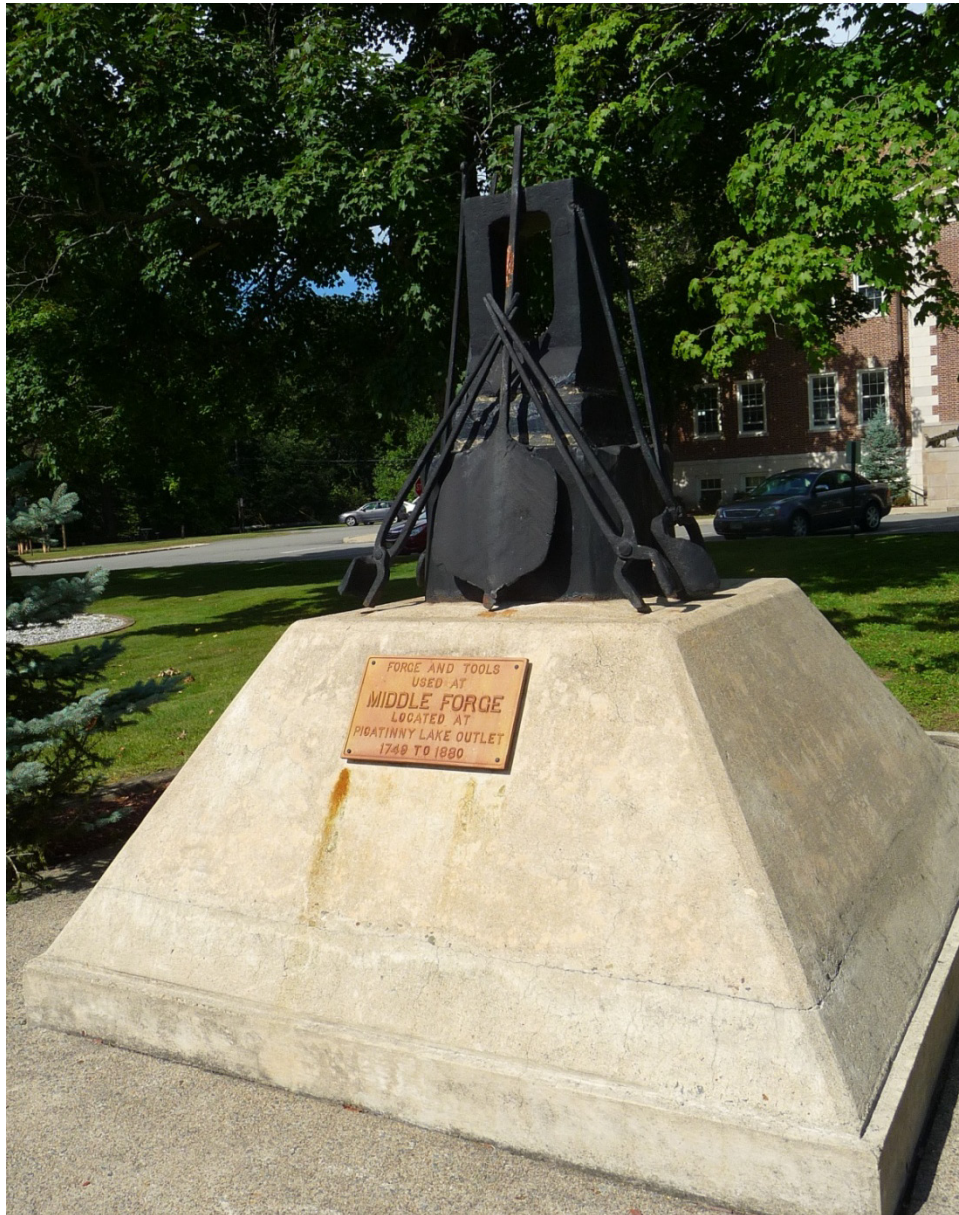
Figure 96. Close view of Middle Forge Monument (ERDC-CERL, 2012).

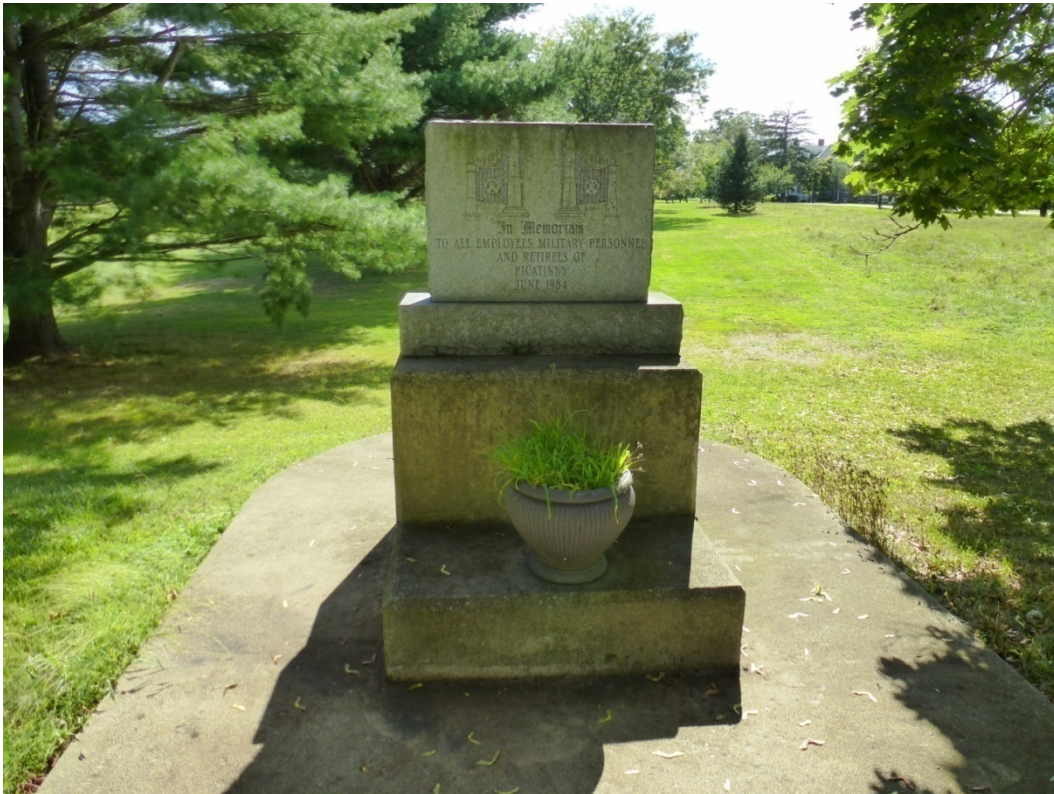
Figure 97. Monument 114M, located on sidewalk adjacent to Farley Avenue (ERDC-CERL, 2012).

Monument 114M is located on the north side of the former parade grounds along Farley Avenue (Figure 97). It is a memorial to all employees, military personnel, and retirees of Picatinny, date June 1984. Monuments 153M and 154M are located in front of Building 161 on either side of the Middle Forge Monument (Figure 98). They are Civil War-era, six-pound Napoleon cannons from Frankford Arsenal which was located in northeast Philadelphia. Field cannons were used by the U.S. Artillery until 1868. This type of gun was the most common Army field piece used during the Mexican-American War and at the start of the Civil War. It is unknown when they were moved to this location but they have been at PICA since 1911 when they were relocated from Rock Island Arsenal.

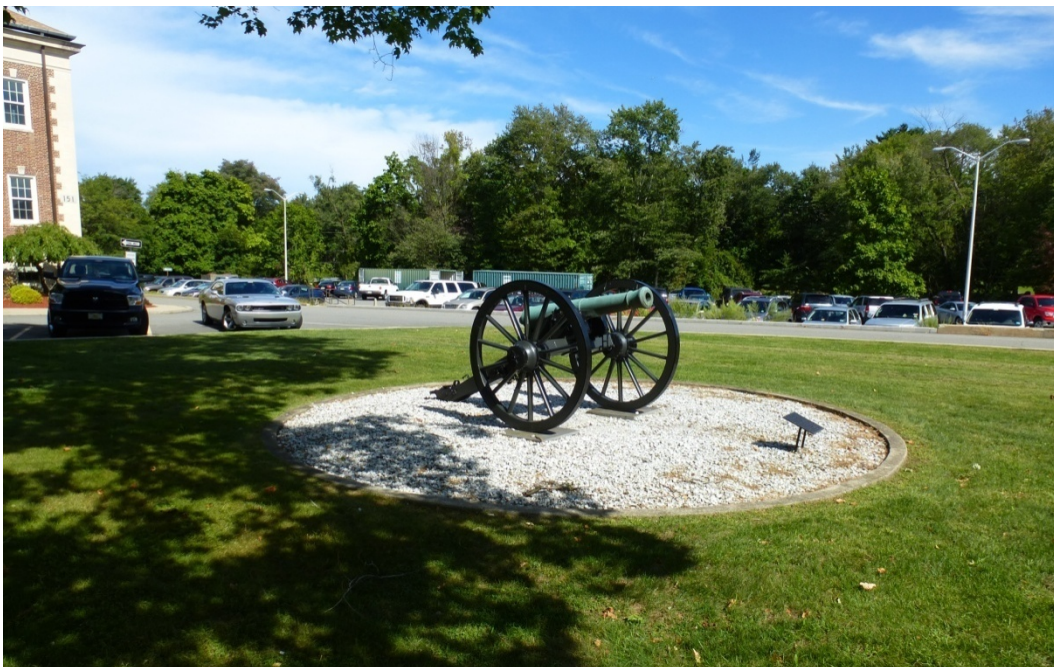
Figure 98. One of the two cannons that comprise Monuments 153M and 154M, located in front of Building 151 (ERDC-CERL, 2012).
