## **Cultural Landscape Analysis of Existing Historic Districts**

Picatinny Arsenal, New Jersey

Final report

Under Project 201221, "Cultural Landscape Analysis, Picatinny Arsenal, New Jersey"

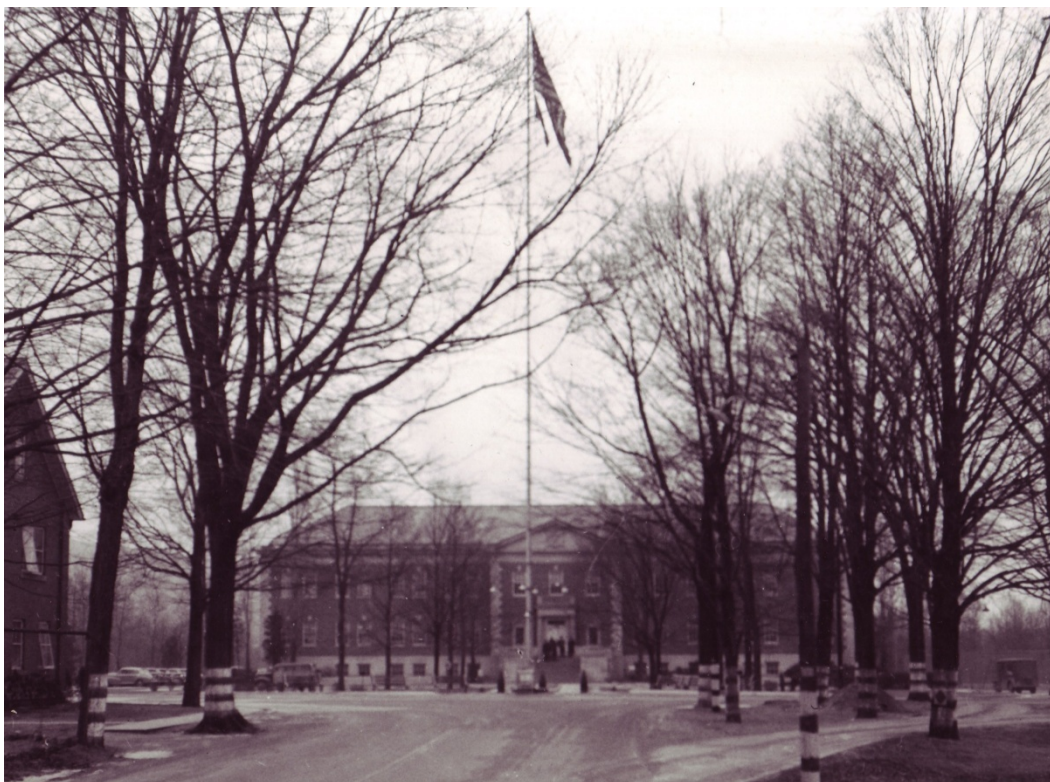
**Figure 99. Flagpole in front of Building 151 (original headquarters building), no date (PICA Cultural Resources Office).**

The flagpole is a significant feature within the historic district (Figure 99–Figure 100). It is also a military tradition that the flagpole be placed in front of the headquarters building. The flagpole at PICA was originally located at the intersection of Farley Avenue and Parker Road in front of Building 151 (the original headquarters building). When the headquarters was moved to Building 1 (formerly Building 171), the location of the flagpole was also moved.

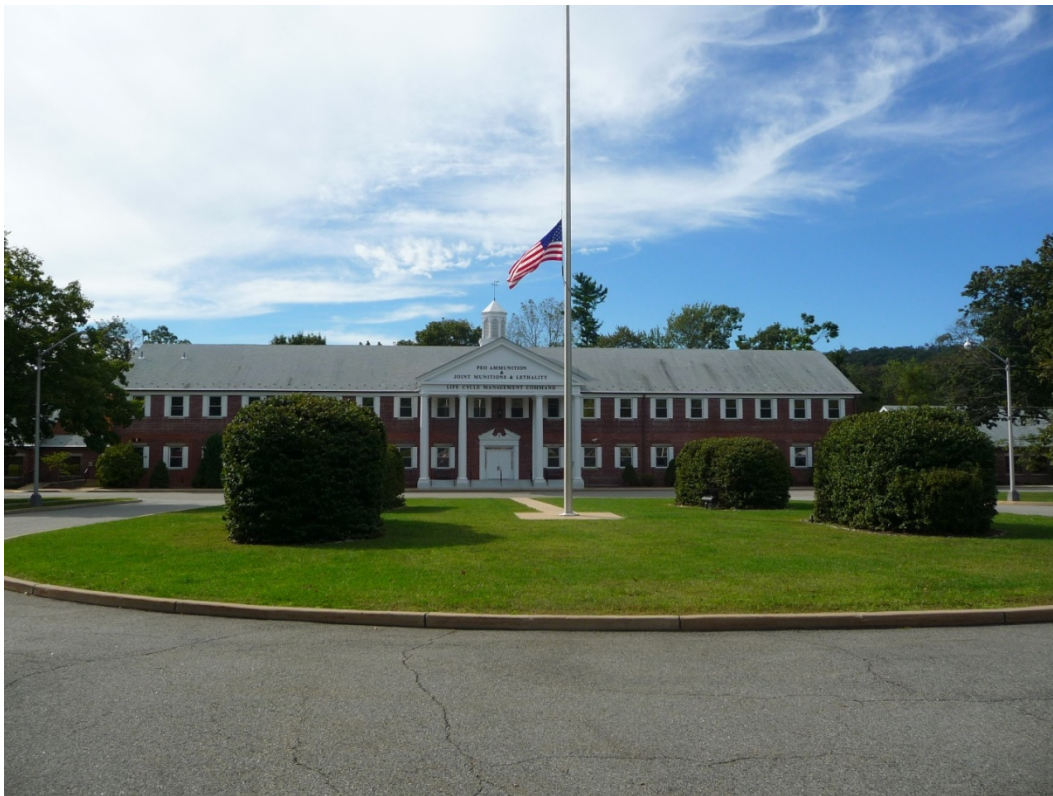
Figure 100. View of the flagpole in front of Building 1 (current headquarters) (ERDC-CERL, 2012).

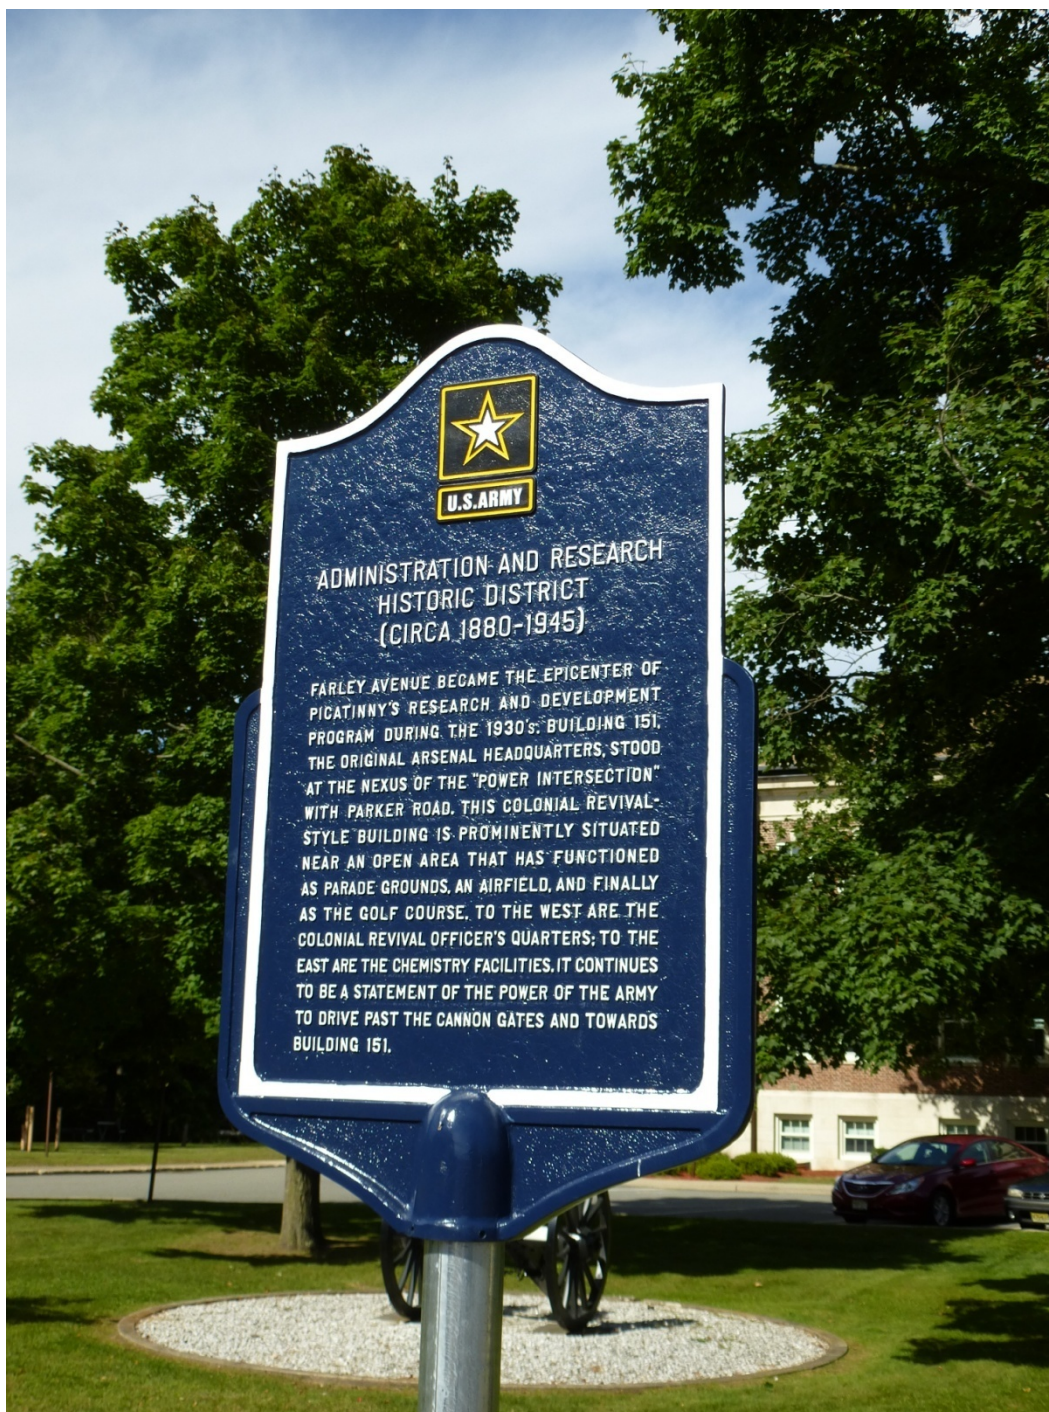
Figure 101. Historic marker identifying the Administrative and Research Historic District (ERDC-CERL, 2012).

A historic marker for the NRHP-eligible historic district is used to identify and highlight significant areas (Figure 101). The marker allows for military and civilian personnel and installation visitors to be more aware of the installation's historical heritage and to ensure the long-term preservation of its significant areas. The marker was funded by the Environmental Affairs Division of PICA and produced by Lake Shore Industries of Erie, Pennsylvania. Text was developed by Cultural Resources Manager (CRM), NJ HPO, and the Morris County Heritage Commission. The marker was put in place in 2012.

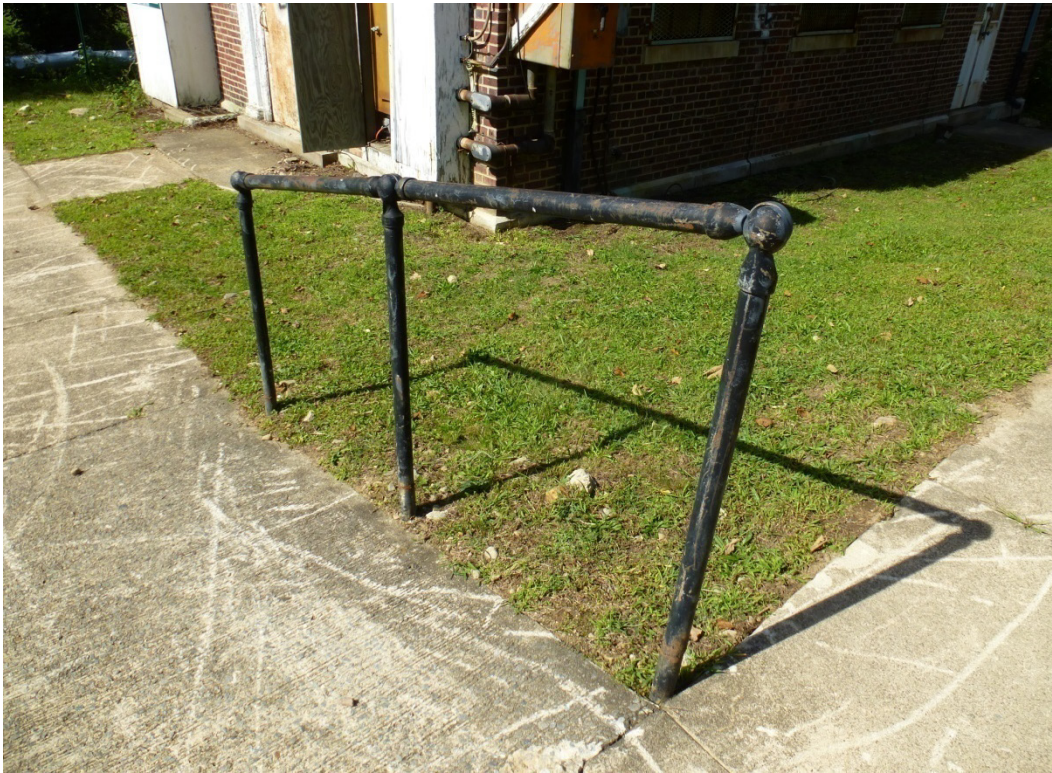
Figure 102. Original cast-iron handrails located in Chemistry Row in the Administrative and Research Historic District (ERDC-CERL, 2012).

Other miscellaneous features around the historic district include railings, posts, street lamps, granite posts, and stone and brick garage door openers (Figure 102–Figure 105).

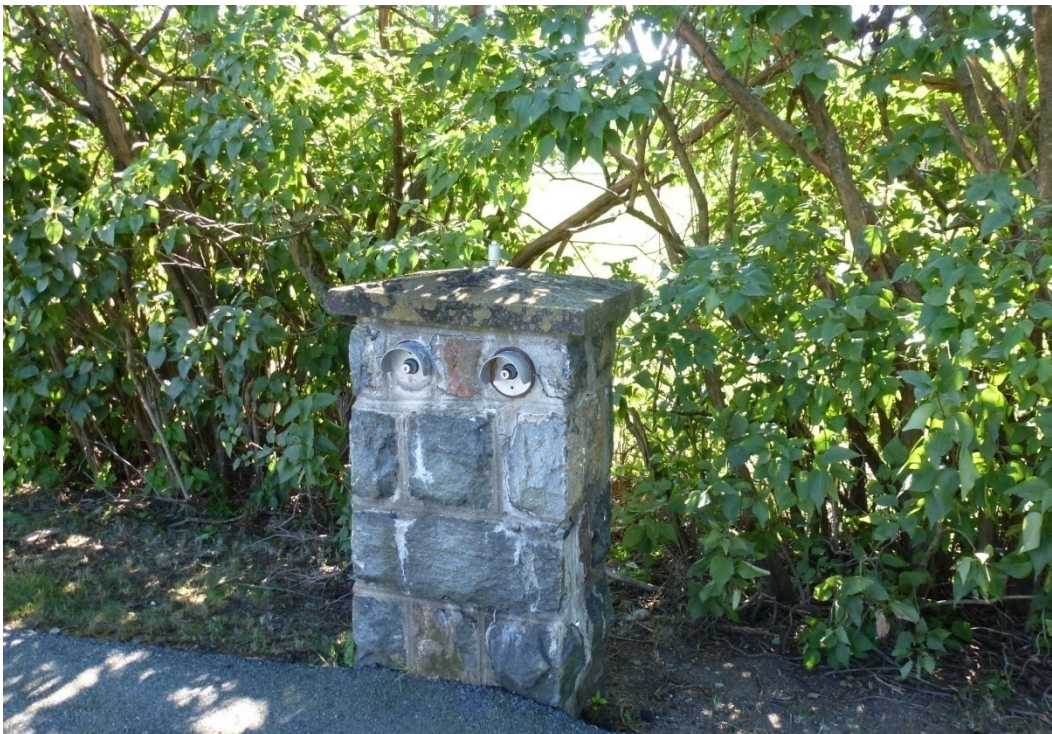
Figure 103. Garage door openers embedded in post located behind Quarters 112 and 113 (ERDC-CERL, 2012).

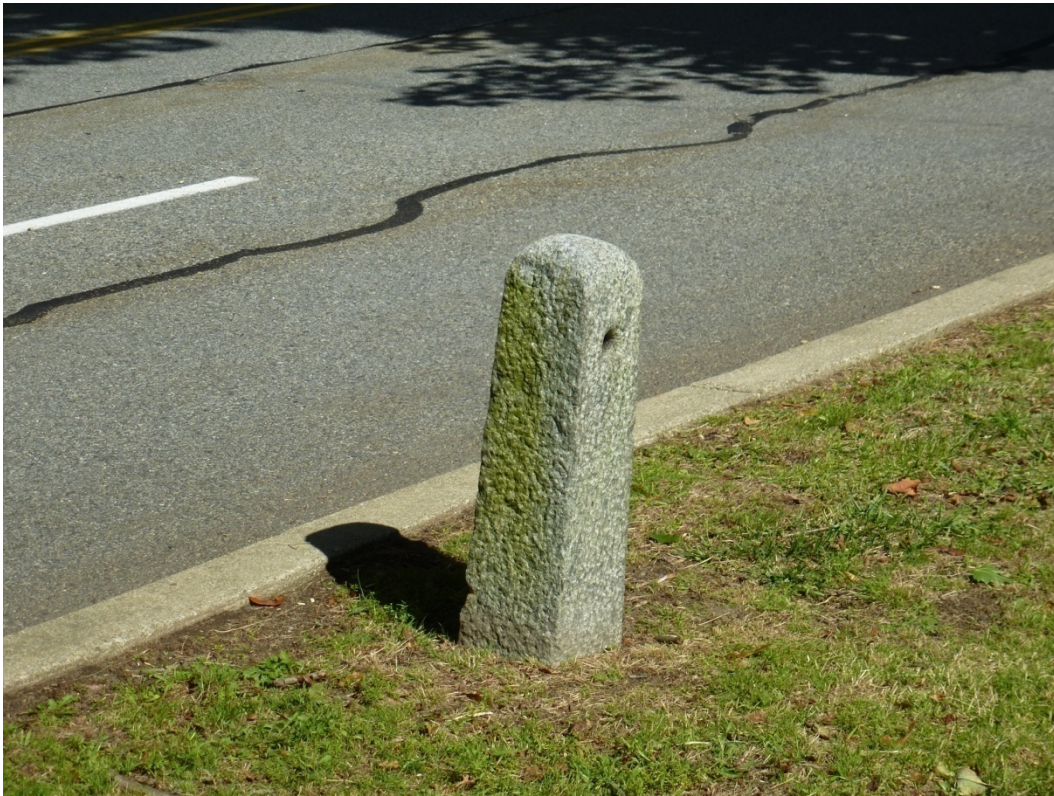
Figure 104. Granite post along west side of Farley Ave by former parade grounds (ERDC-CERL, 2012).

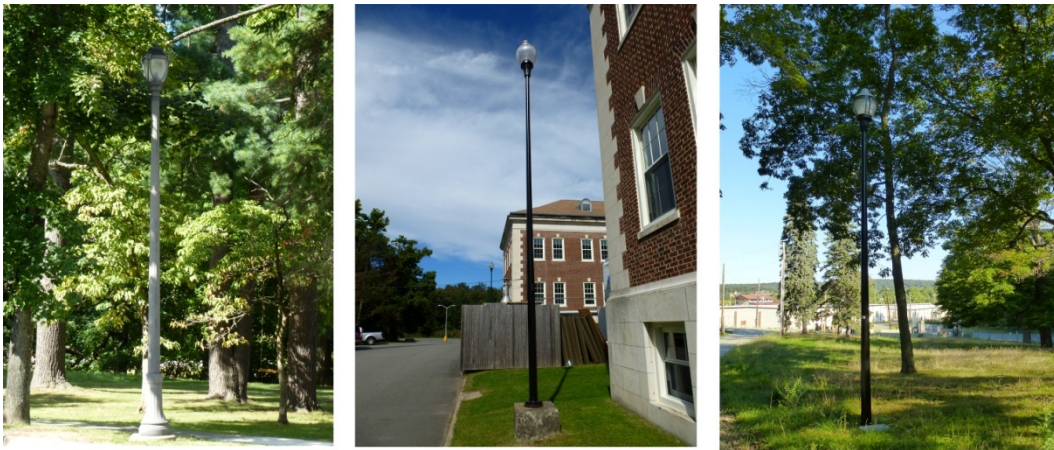
Figure 105. Various styles of lamp posts found throughout the Administrative and Research Area Historic District (ERDC-CERL, 2012).

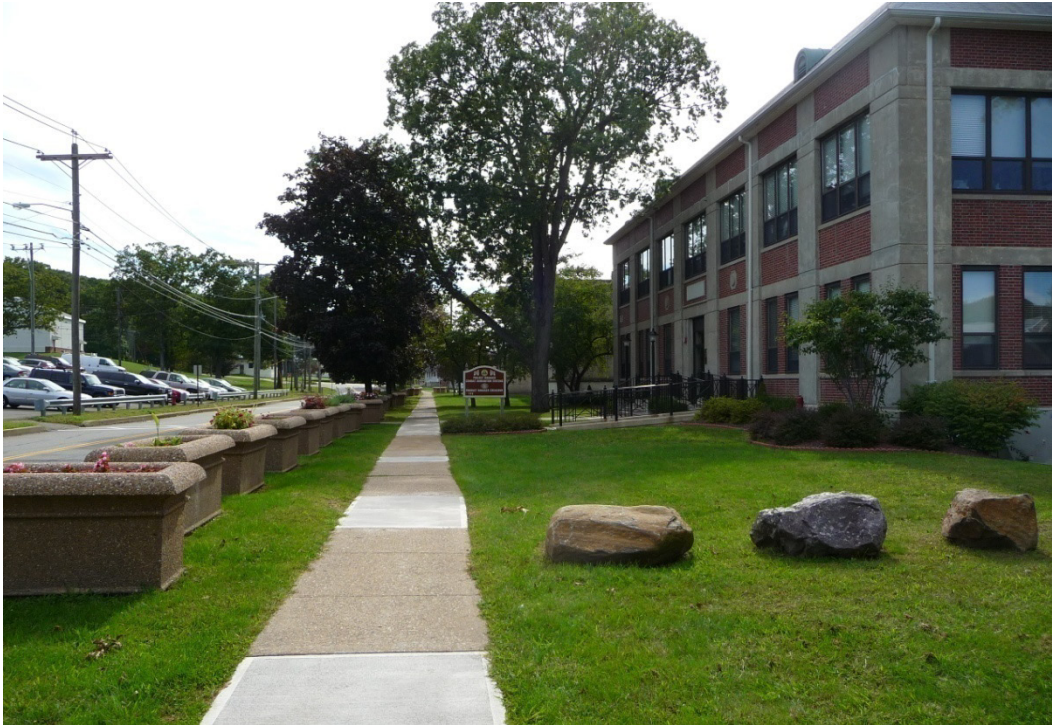
Figure 106. Force protection planters in front of Building 172 (ERDC-CERL, 2012).

In 2009, planters and large boulders were added along Buffington Road in front and along the sides of Buildings 172, 173, and 174 to comply with Antiterrorism Force Protection (ATFP) requirements (Figure 106–Figure 107). Remote-controlled drop gates were also added for access to the front

and rear of Building 173. These are not historic features, and there is no precedent in the historic district for such materials.

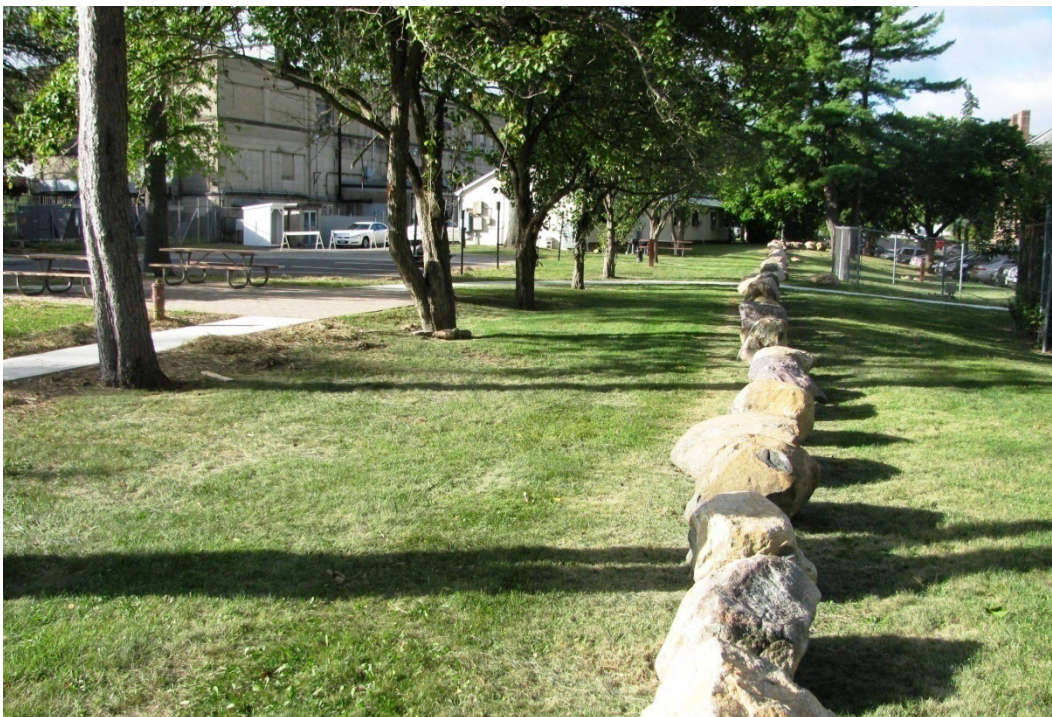
Figure 107. Force-protection boulders that are located near Buildings 172, 173, and 174 (PICA Cultural Resources Office).

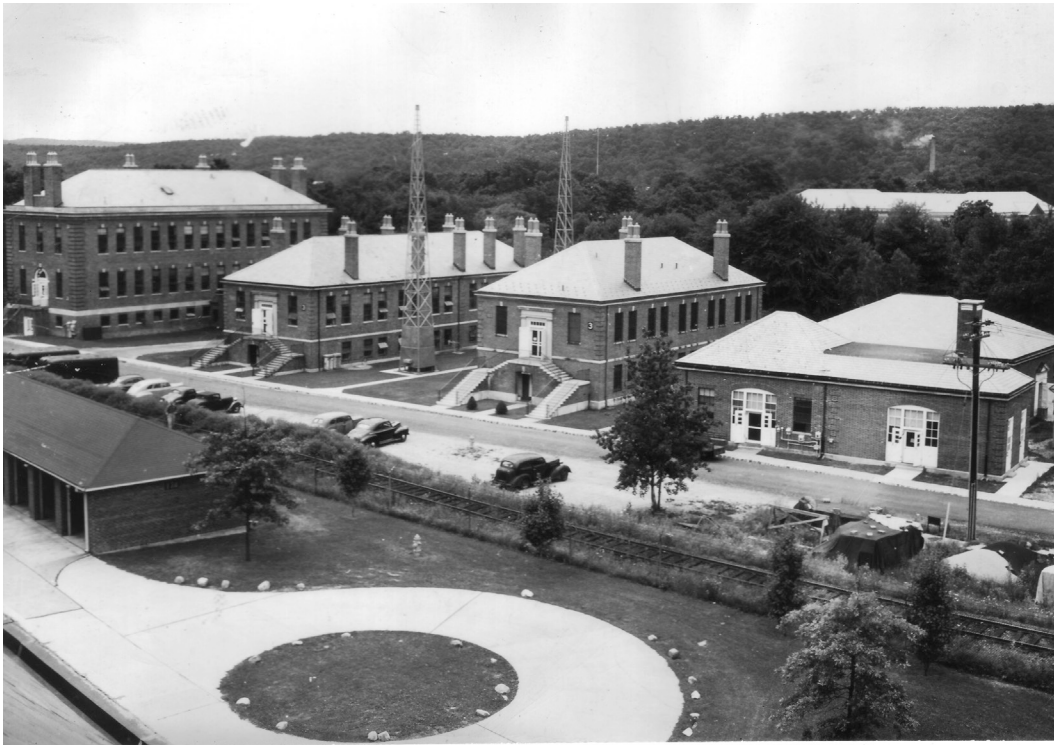
Figure 137. Chemistry Row, looking north showing the east sides of Buildings 167 (left) and 197 (right) along Kibler (ERDC-CERL, 2012).

The views along “Chemistry Row” are characterized by: closely-set buildings adjacent to Kibler Road that are of Georgian and Colonial Revival style architecture and brick in material (Figure 135–Figure 139). A sidewalk lines the road, with neatly mowed strips of lawn as the only vegetation in front of the buildings. There are some shade trees on the east side of Kibler Road, adjacent to parking, which appear in historic photographs below. Building 163 is virtually identical to the north portion of Building 162 which stands parallel and nearby on the south; both are prominent structures in the historic “Chemistry Row.”

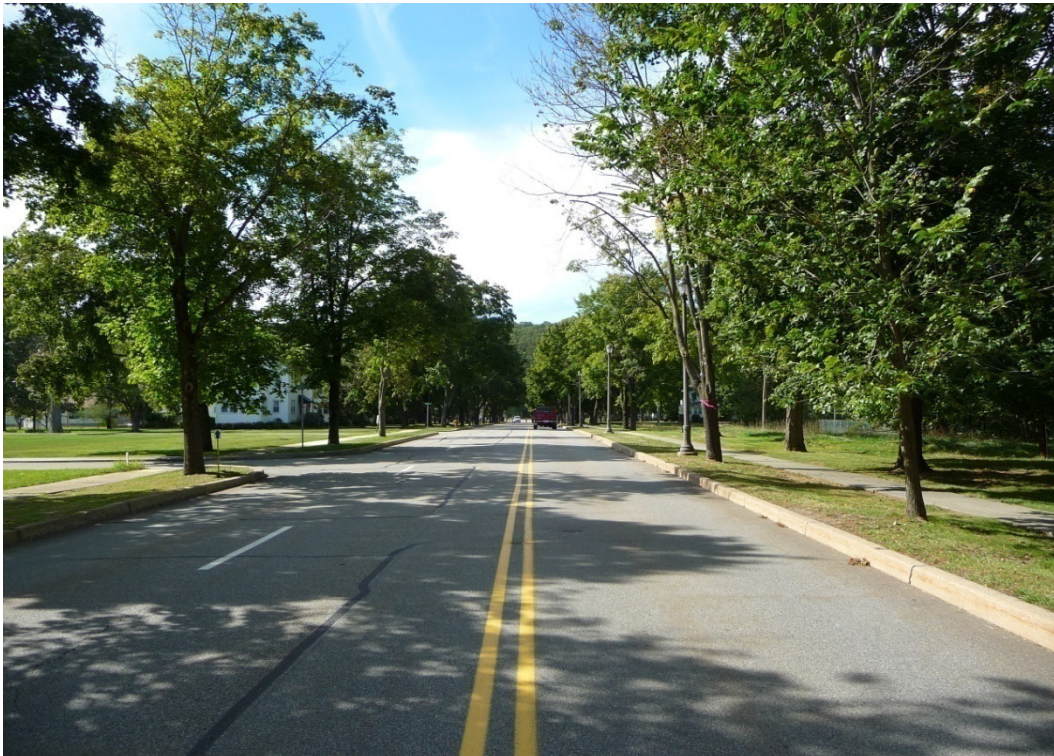
Figure 144. Looking west down Farley Avenue at the tree-lined street (ERDC-CERL, 2012).

*Street trees:* Originally, the street trees were oak (Figure 143); currently they are Norway Maple (Figure 144). To maintain the historic character of

the historic district, the street trees along Farley Avenue, Parker Road, and Buffington Road (ideally, Farley Lane as well) should be replaced whenever they have been removed due to poor condition (Figure 145–Figure 146). It is recommended that they be replaced with a native oak species that does well in the area—one with no pest or disease problems and a tolerance to road salt. Removal and replacement should be spaced in time to best maintain a consistent canopy.

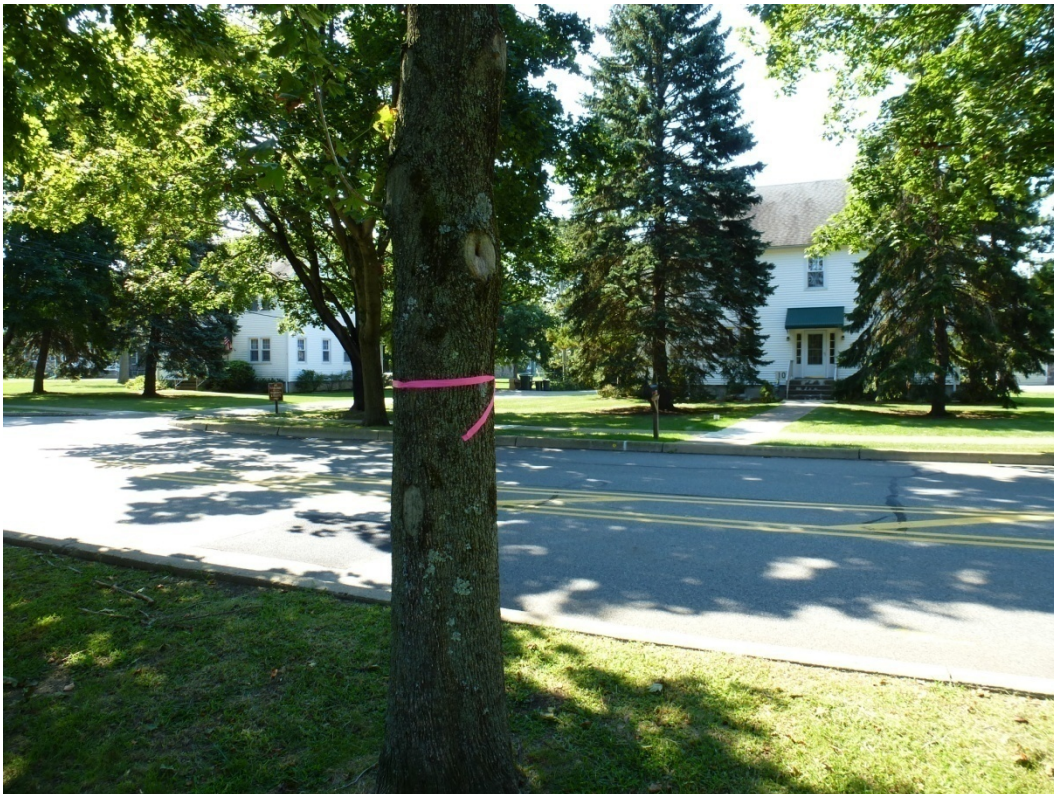
Figure 145. A tree located along Farley Avenue that is tagged for removal should be replaced with a native oak tree (ERDC-CERL, 2012).

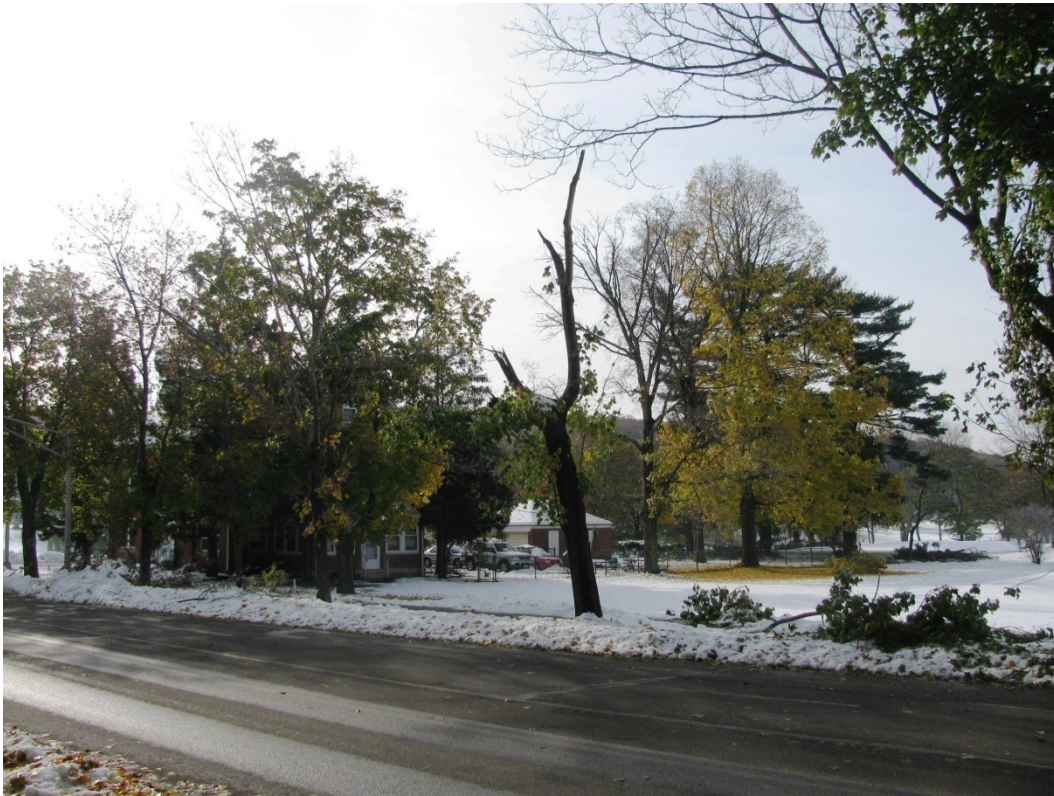
Figure 146. An example of a damaged or dead tree in the historic district that should be replaced (PICA Cultural Resources Office).

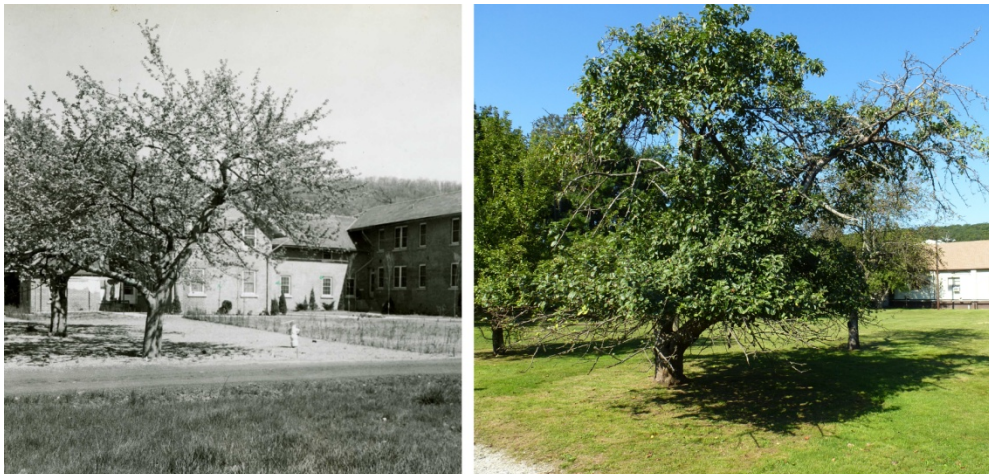
Figure 147. Left: 1938 photograph showing a corner of the apple orchard (website). Right: current condition of apple trees in the orchard (ERDC-CERL, 2012).

*Orchard and root cellar area:* Only a few apple trees remain in the orchard located behind Quarters 113 and adjacent to the root cellar. Those trees that do remain are in poor condition and are deteriorating (Figure 147). Existing trees should be maintained or mitigated with NJ HPO.

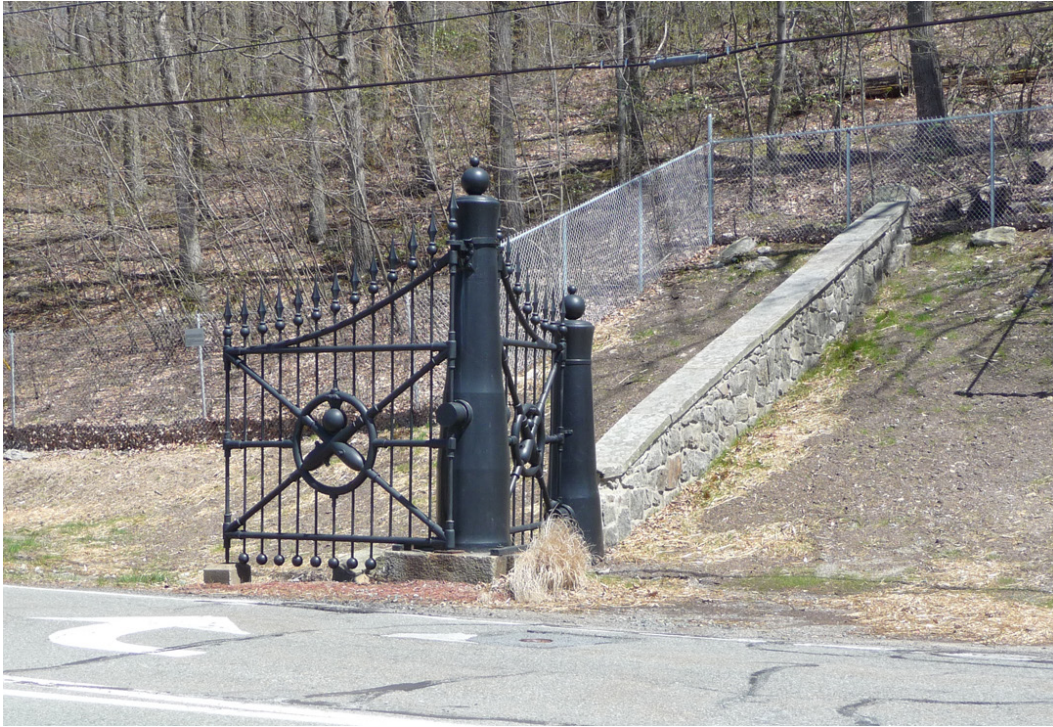
Figure 149. East side of Cannon Gate structure (ERDC-CERL, 2012).

*Cannon Gates and wall:* Street trees along Farley Avenue were removed during projects to widen the street and intersection (Figure 148); the trees should be replaced in this area to maintain the historic character of the area surrounding the Cannon Gates. Wall visible by motorists has been repaired along First Street (Figure 149). Weeds should be removed south of gate and wall (Figure 150).

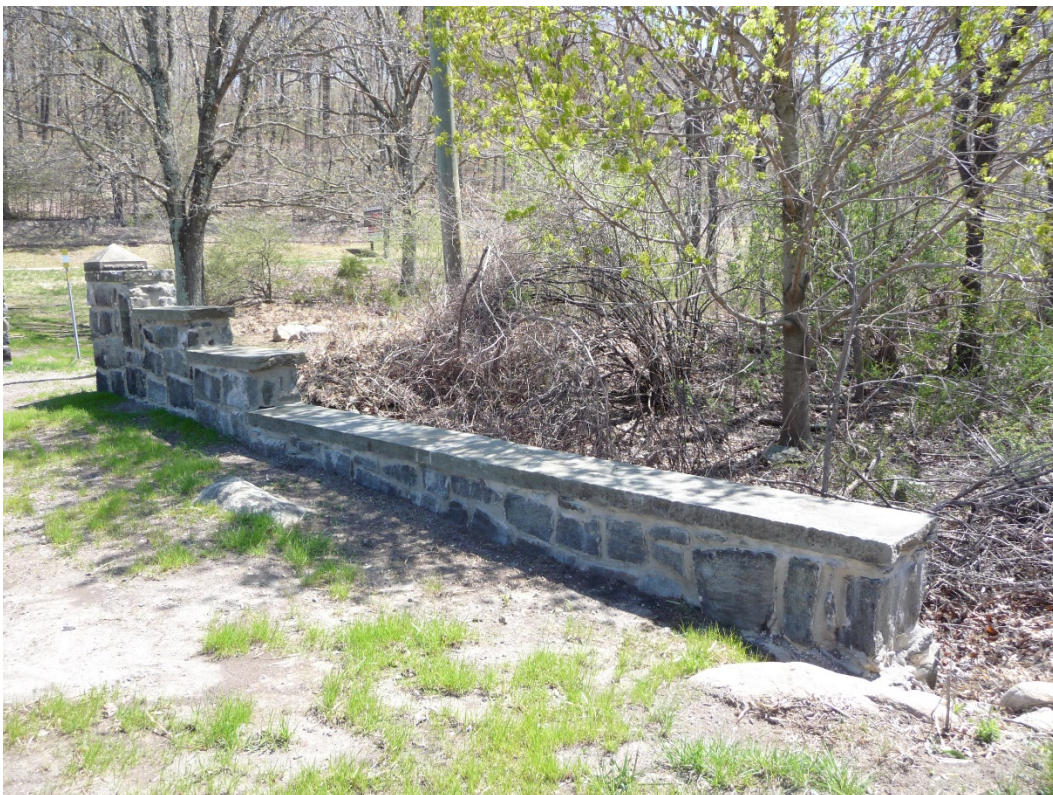
Figure 150. Stone wall that extends west from Cannon Gates along First Street (ERDC-CERL, 2012).

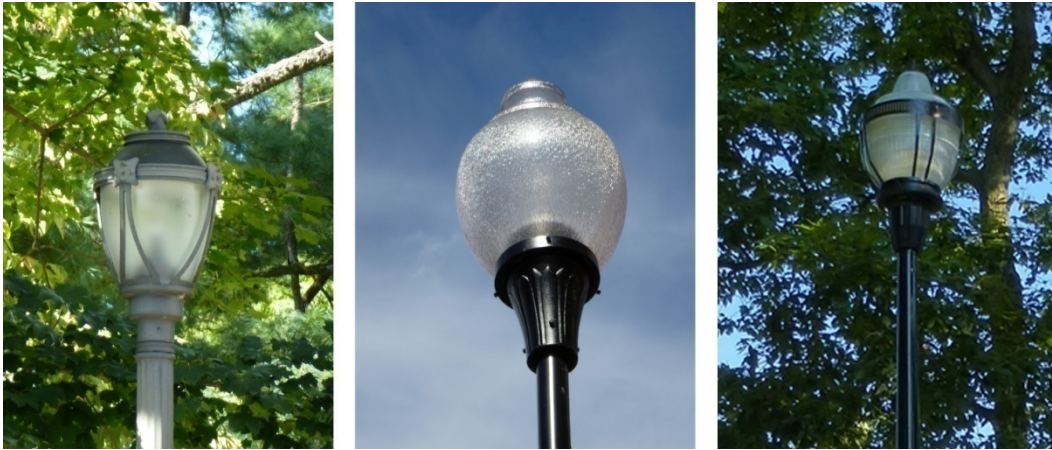
**Figure 151.** Various styles of replacement street light fixtures are located in the Administrative and Research district (ERDC-CERL, 2012).

*Street lamps:* Many different street lamp styles exist throughout the historic district (Figure 151). A single style should be chosen for consistency.

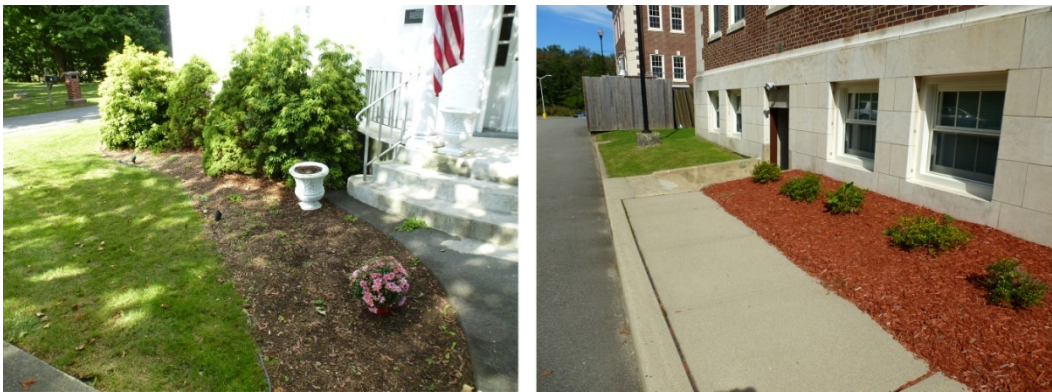
**Figure 152.** Replacement planting and mulch (ERDC-CERL, 2012).

*Vegetation:* A consistent palate of plants and mulching types is needed throughout this historic district. A cohesive plan is needed for removal and replacement of the vegetation in the historic district (Figure 152).

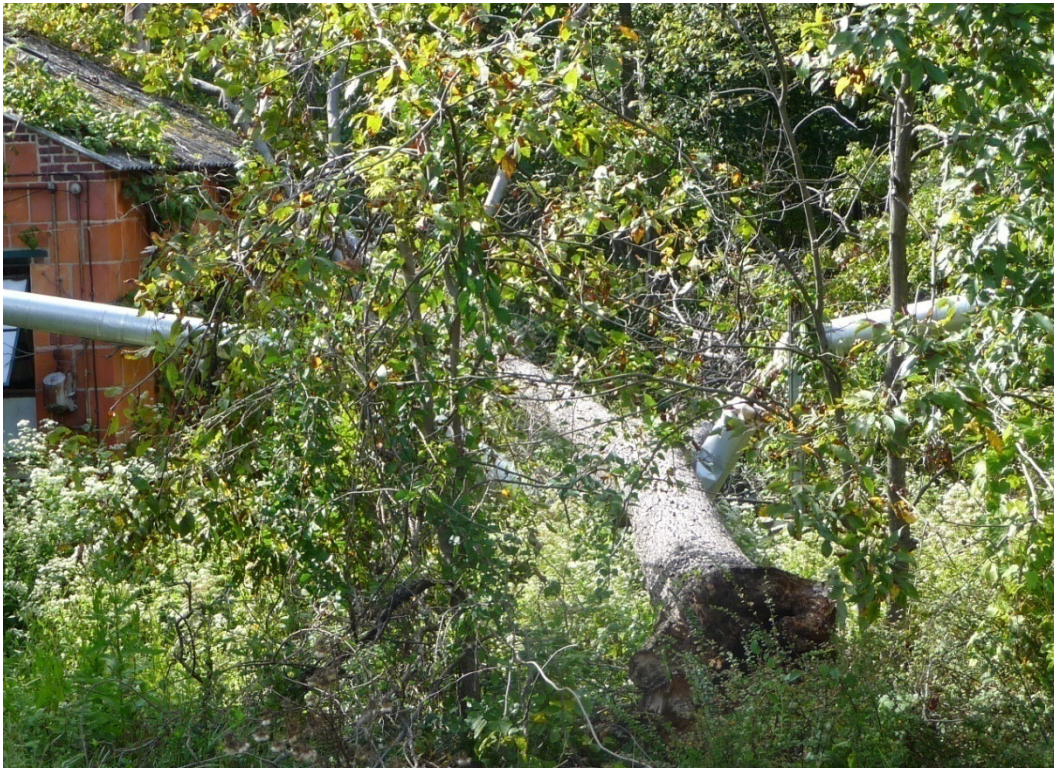
Figure 153. Fallen tree damaging elevated steam line near Building 154 (ERDC-CERL, 2012).

*Steam lines:* While the vegetation needs to be cleared and removed off and around exposed and elevated steam lines in the historic district, these lines are no longer in use (Figure 153 and Figure 154). These lines will be documented in whole as part of this report, and their removal will be completed as part of the Real Property Master Plan and Facility Reduction Program (FRP) Programmatic Agreement (PA).

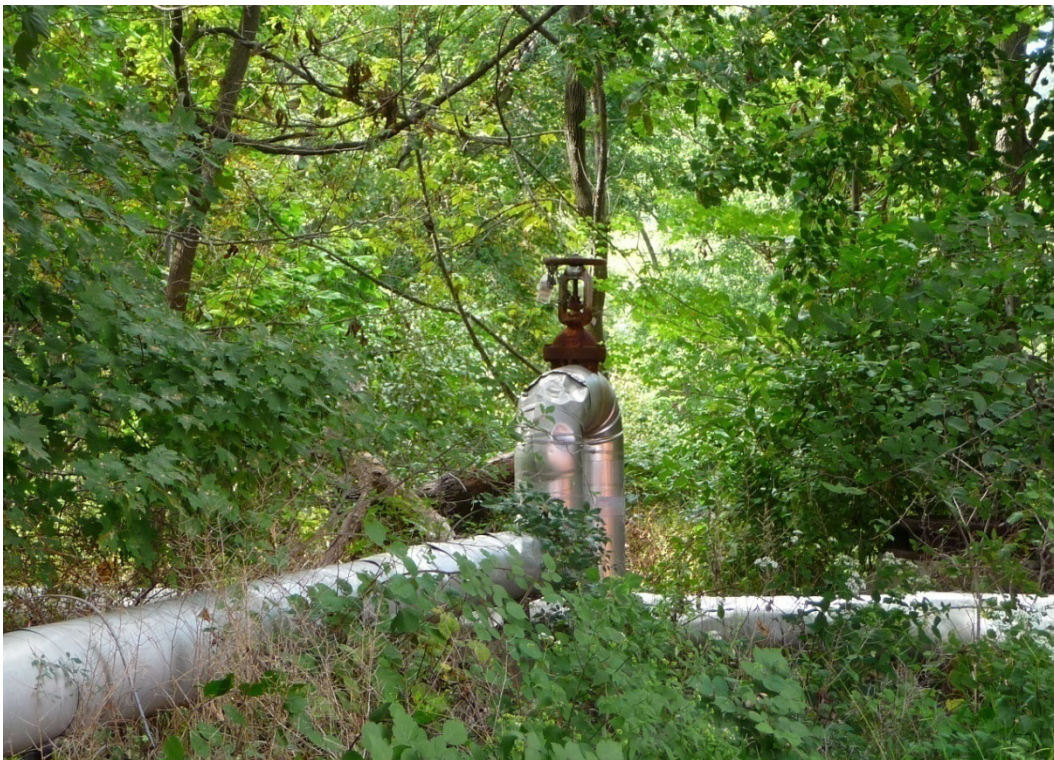
Figure 154. Overgrown vegetation around the steam lines in the Administrative and Research Historic District (ERDC-CERL, 2012).

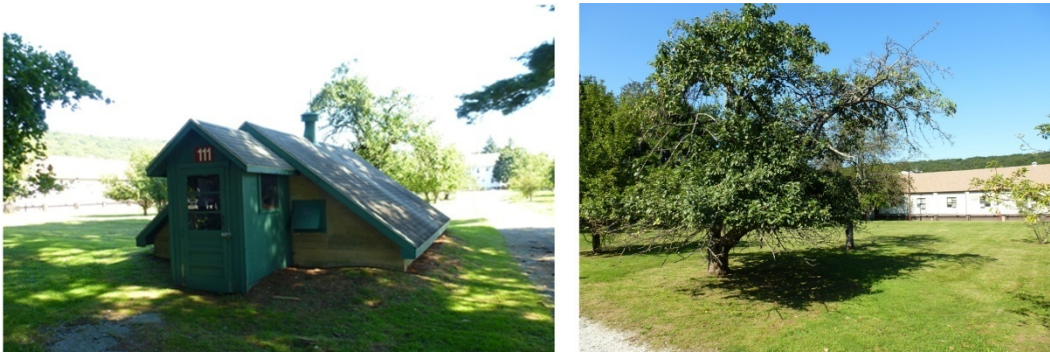
Figure 159. Root cellar (Building 111) and orchard located behind Building 112 (ERDC-CERL, 2012).

Also included in the historic district should be the orchard and root cellar located in the backyards of Quarters 112 and 113 (Figure 159). This garden area is a historic landscape feature associated with the quarters. The remaining trees are in declining health but should be maintained. While other current vegetation behind Quarters 112 and 113 visually separates the quarters' "rear yards" from this garden landscape, much of this vegetation was most likely a result of the increase in size and development of the golf course during the 1950s and 1960s, so it does not fall within the period of significance of the district and is not contributing (Figure 160 and Figure 161). Although the noncontributing vegetation serves as a separation between the root cellar and the orchard, those areas are still an important character-defining feature.

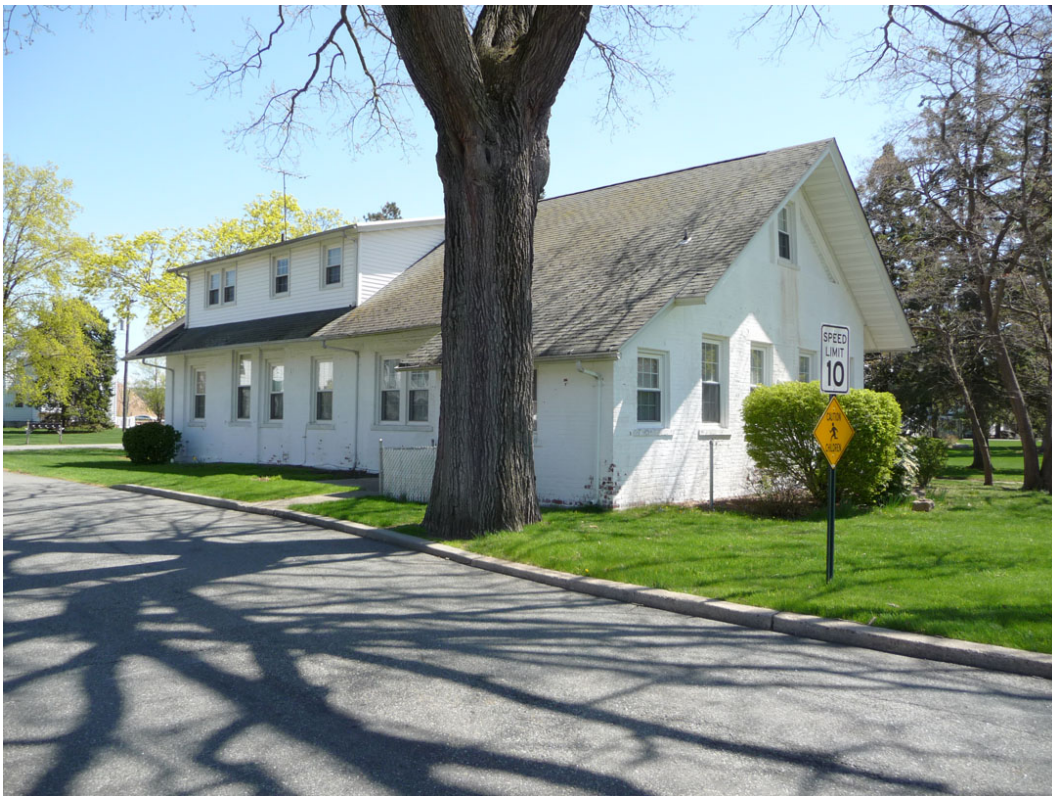
Figure 163. View of front and northwest facades of Building 108, former storehouse (ERDC-CERL, 2013).

In addition, Buildings 108 and 117, while outside the current historic district, are clearly seen on early historic maps and it is recommended that they be reevaluated for eligibility based on their historic significance and dates of construction. Building 108, which dates to 1882, was the original

storehouse (Figure 163). Circa 1922 it was converted for use as a schoolhouse before becoming quarters in 1936. It was recommended as contributing in earlier assessments<sup>85</sup>.

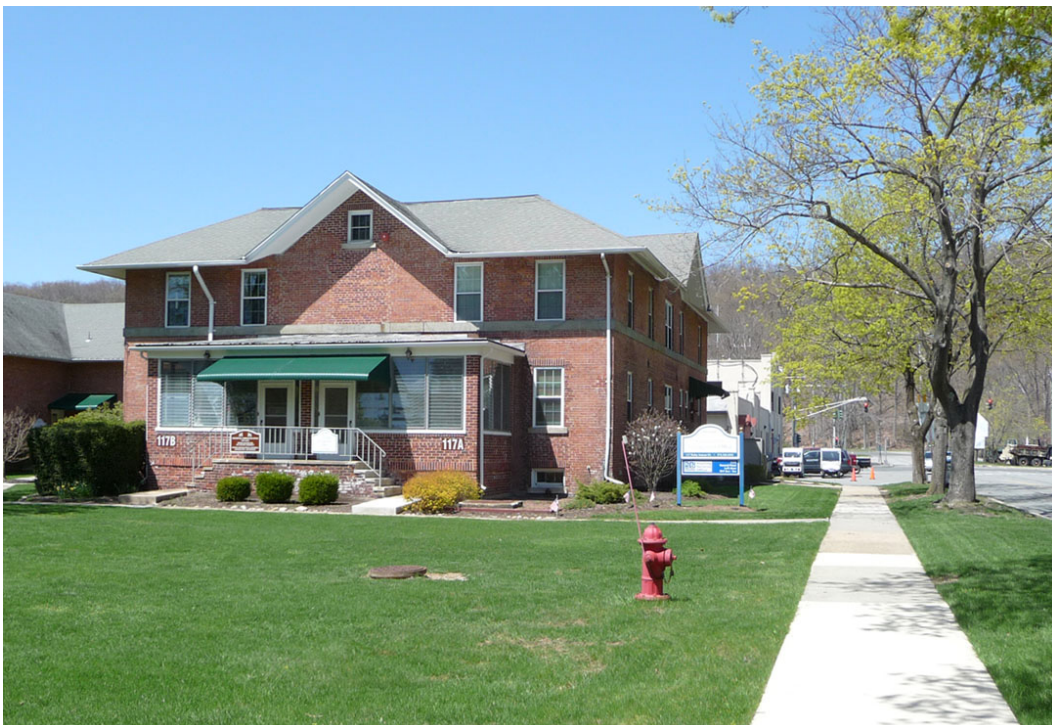
Figure 164. View of front of Building 117, former stables (ERDC-CERL, 2013).

Building 117 was originally built as a stable, coach house, wagon shed and scale house (Figure 164). Later it was used as a storehouse, as noted in a 1931 publication. In 1937, a sun porch was added on the south end of the building, and it was assumed converted to quarters at this time. It was also recommended as contributing in earlier reports<sup>86</sup>. If determined contributing, these two historic buildings from the start of the arsenal would create the northern boundary of the historic district. The southern boundary would be Building 119, the former shell filling house, and the eastern boundary would be the Cannon Gates, all from the same period of construction.

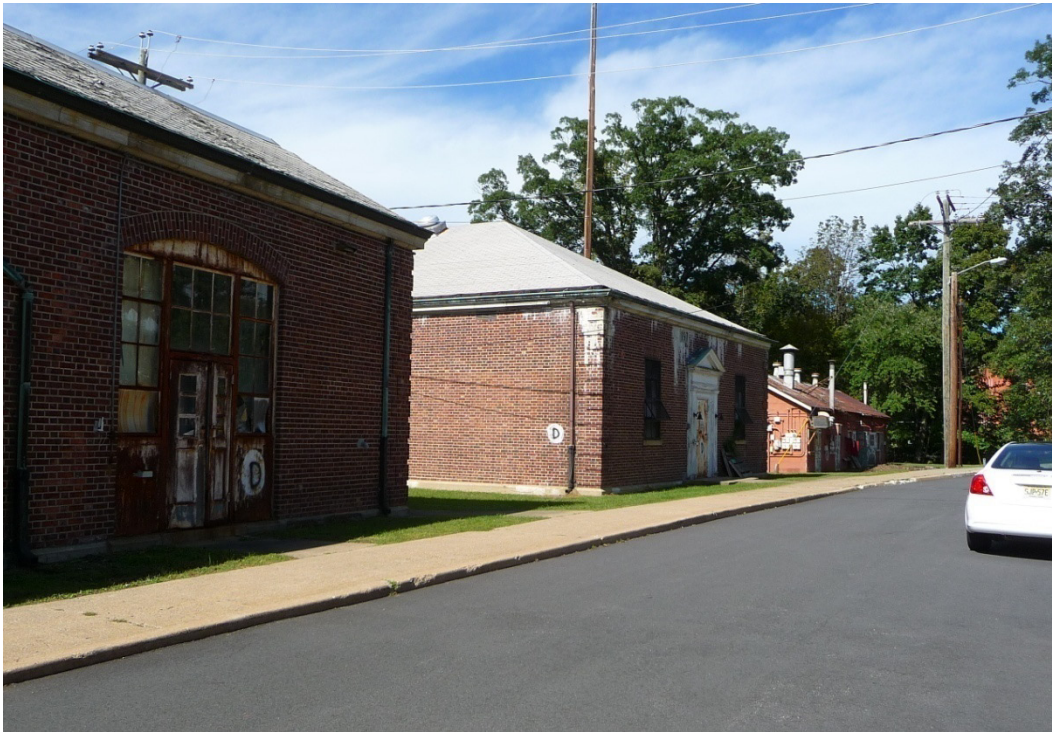
Figure 166. Buildings 167 and 197 located in the Chemistry Row area of the district have been recently demolished. (ERDC-CERL, 2012).

Several smaller buildings along Chemistry Row were recently demolished (Figure 166). Loss of these buildings affects the integrity of this area as well as the viewsheds. Any replacement buildings should be of consistent mass, style, craftsmanship, and materials to the remaining buildings.

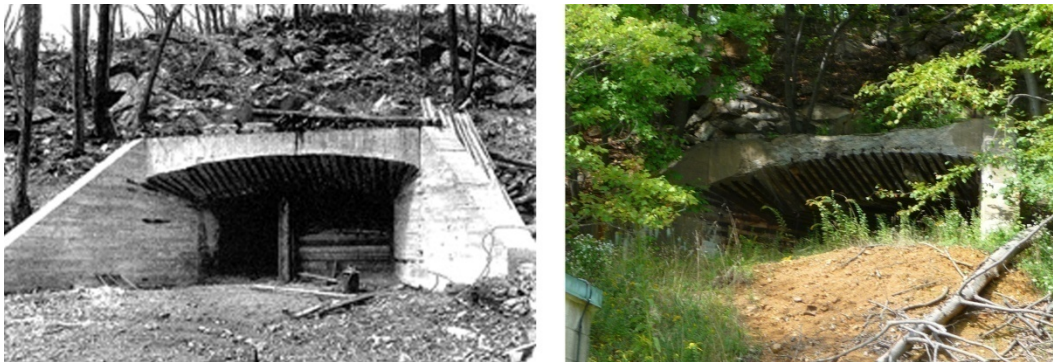
**Figure 184. Comparison photographs of a slug butt (611B); on the left is historic photograph (taken from Picatinny website, undated), and on the right is a current photograph of the same structure which is now partially obstructed by debris (ERDC-CERL, 2012).**

The portion of the 600 Area that makes up the historic district includes a wide range of specialized structures, including fragmentation tub buildings, a drop tower, wind and fuze test tunnels, a “bull pen” for exploding ordnance, slug butts (Figure 184), and an indoor firing range.<sup>101</sup>

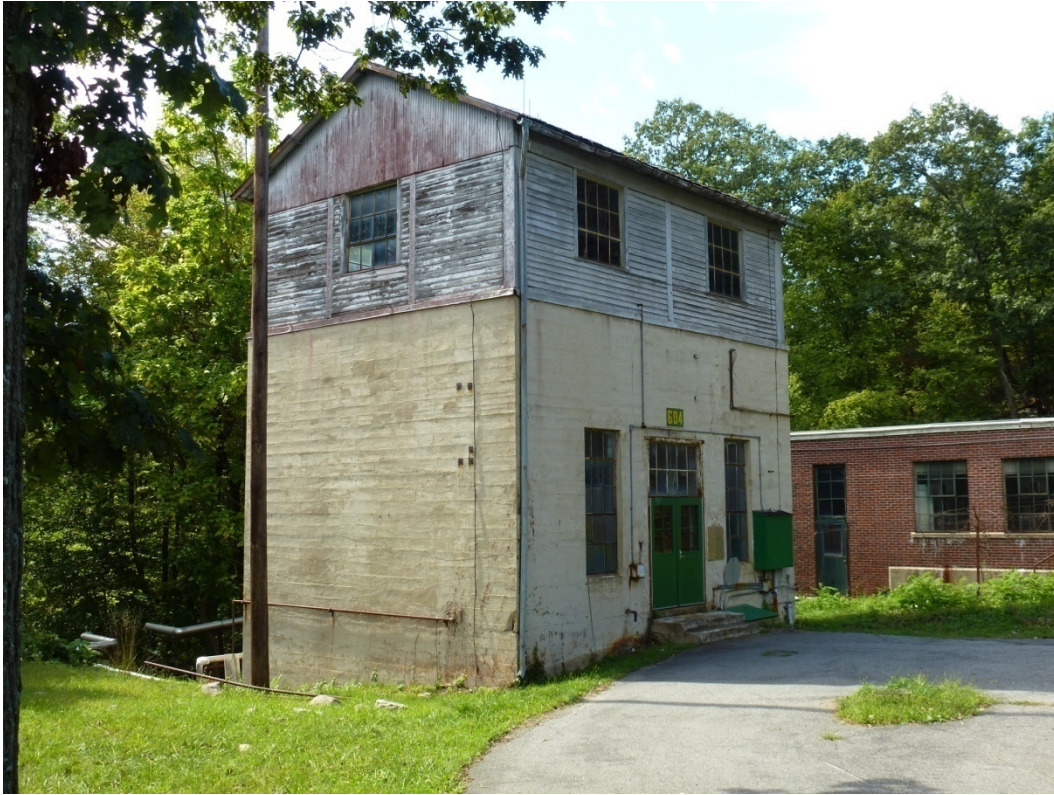
Figure 187. Building 604, northeast oblique (ERDC-CERL, 2012).

Building 604 is of concrete (first floor) and wood frame (second floor) construction on a concrete foundation that includes a basement (Figure 187). Constructed in 1928 and similar to Buildings 607 and 621, Building 604 originally contained a fragmentation tub supported by steel columns and concrete piers in the basement. Live shells were detonated inside the hopper which was filled with sand to absorb the shock of the blast, and the shell fragments were retrieved by a screen for examination. The sand, which could be reused, was stored in the basement and lifted to the hopper by means of a bucket elevator. In 1943, the fragmentation tub and the elevator were removed, and the louvered (which served to alleviate structural stress during explosions) on the second floor were replaced by wooden lap siding. The building is currently used for storage.<sup>103</sup>
