## **Cultural Landscape Analysis of Existing Historic Districts**

Picatinny Arsenal, New Jersey

Final report

Under Project 201221, "Cultural Landscape Analysis, Picatinny Arsenal, New Jersey"

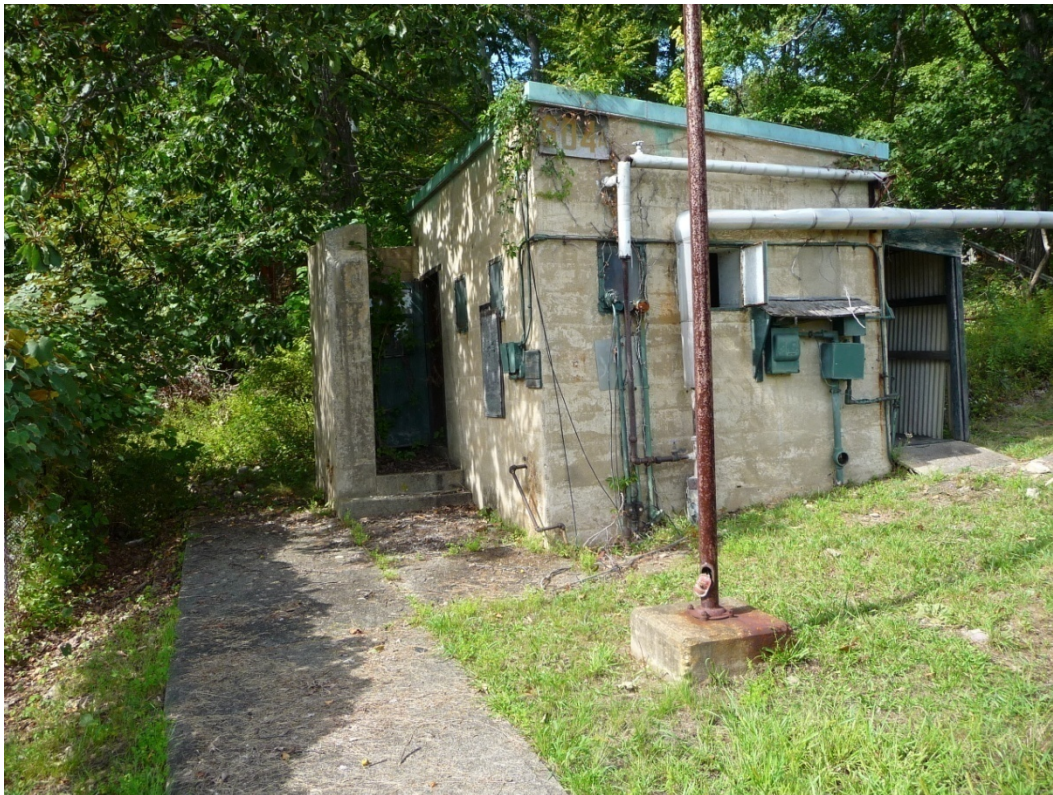
Figure 188. East elevation of Building 604A (ERDC-CERL, 2012).

Building 604A is a one-story, rectangular structure with a concrete foundation, concrete walls, and a concrete with tar and gravel low shed roof (Figure 188). It was constructed in 1928 as a control house for Building 604D, the drop tower. The interior and exterior are intact, with original wood door and windows. An L-shaped concrete barricade shields a door on the south side; a half-story above-grade basement with concrete walls and a concrete shed roof is attached to the west. A cable runs from an opening in the basement to Building 604D (the drop tower) via a wood A-frame with pulleys that elevate the cable.<sup>105</sup>

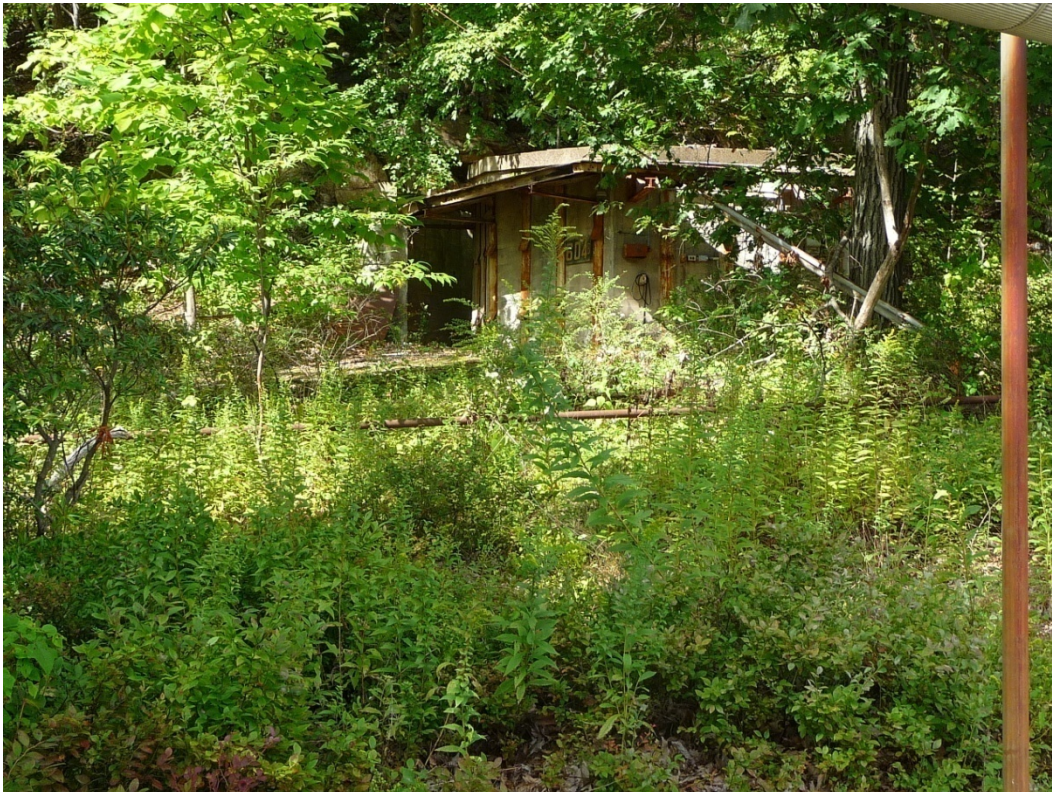
Figure 189. South elevation of Building 604B (ERDC-CERL, 2012).

Building 604B is a one-story, irregularly shaped hexagonal structure with a concrete foundation, tie rod-reinforced concrete walls, and a flat concrete roof (Figure 189). It was constructed in 1932 as a detonating chamber to test explosives. The entire structure of Buildings 604B is intact and unaltered. The roof projects on two sides to form an overhang supported by steel brackets. The entrance to the chamber is shielded on the outside by a concentric concrete wall and on the inside by a concrete barrier wall.<sup>106</sup>

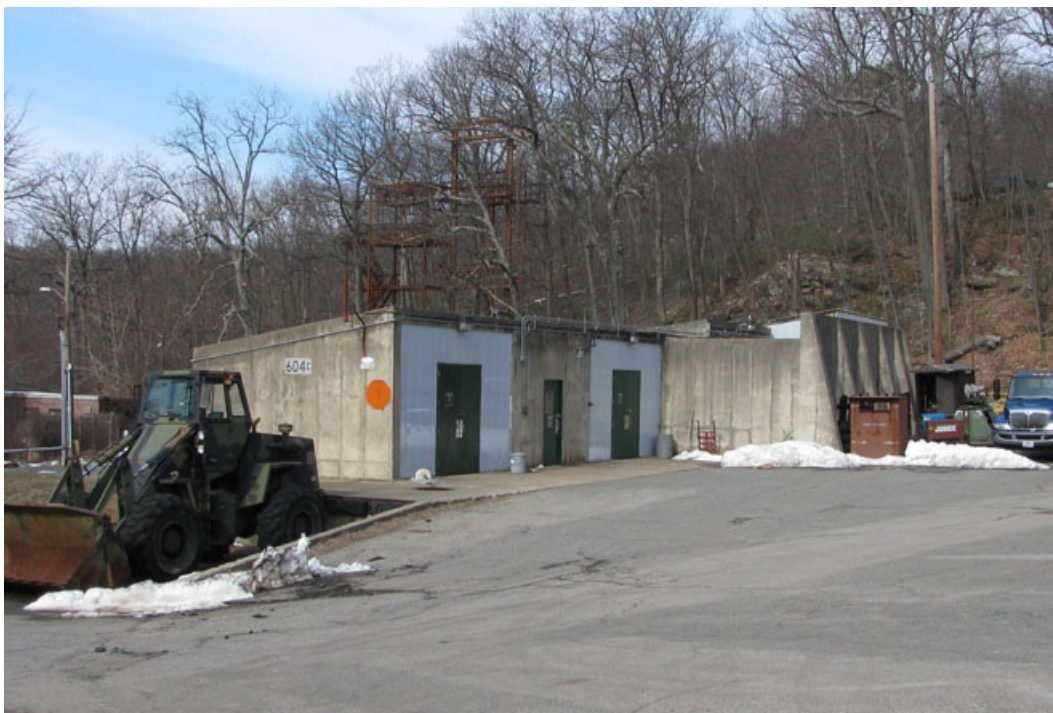
Figure 190. North elevation of Building 604C, Sectioning Chamber; drop-tower is visible behind it (PICA Cultural Resources Office, 2011).

Building 604C is a row of one-story operating rooms with concrete foundations, concrete walls, and concrete shed roofs (Figure 190). It was constructed in 1928 as a teardown facility for the disassembly of ammunition. It consisted of a control room flanked by two operating rooms, and a separate chamber to the west that housed a lathe. In 1942, a saw room with its own control room was added and in 1958, a milling machine room was added. Both additions, with their buttressed concrete blast walls, unified Building 604C into one structure. Its interior and exterior are intact. The original building's two operating rooms which open to the north are faced with wood-framed cel-o-glass blowout walls.<sup>107</sup>

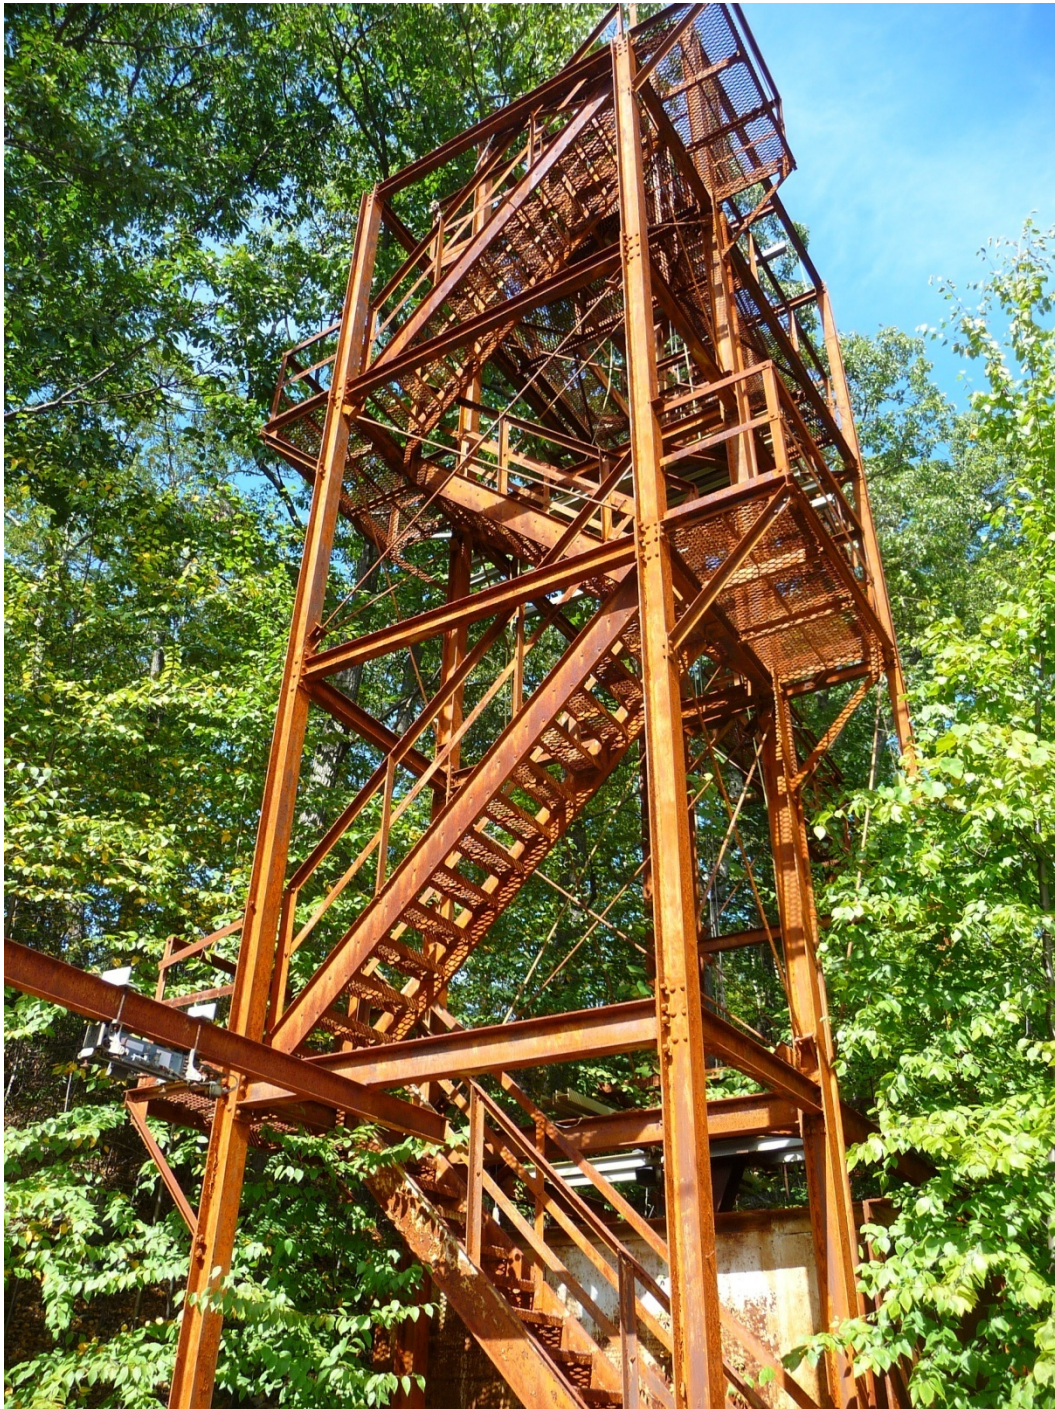
Figure 191. Building 604D, Drop Tower (ERDC-CERL, 2012).

Building 604D consists of two connected drop towers (Figure 191). The original drop tower was constructed in 1928 for artillery detonation testing. In 1946, an enclosed multiple-impact test chute was inserted in the middle of the tower; the chute contained several steel plates placed at varying heights to interrupt the fall of the object being tested. Each plate ledge could be accessed from the exterior by a sliding steel gate. In 1949 another tower was built, with a steel-walled detonating enclosure at its base. The entire structure of Building 604D is intact, including the monitoring shed. The original tower has a concrete foundation, concrete blast wall at its base, open steel frame, three platforms accessible by a ladder running up the north end, and a multiple drop chute that rises to the third platform which is 47 feet above grade. The second tower has a concrete foundation, steel-walled drop chamber at its base, open steel frame, and two platforms accessible by stairs. The second platform is 40 feet above grade. An enclosed monitoring shed, with a metal frame and transite and Cel-O-Glass walls, is located beneath the original tower.<sup>108</sup>

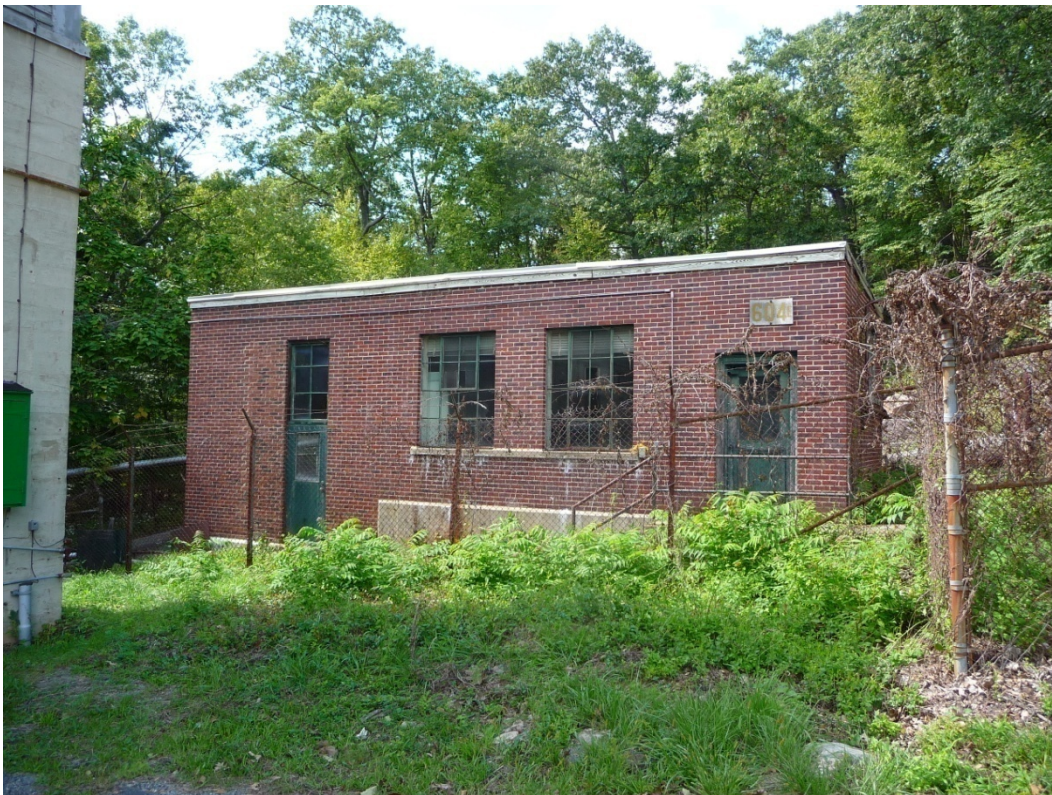
Figure 192. Southeast elevation of Building 604E (ERDC-CERL, 2012).

Building 604E is a one-story, rectangular structure with a concrete foundation, load-bearing brick walls, and a flat roof of tar and gravel (replaced in kind, 2013; Figure 192). It was constructed in 1942 as a wind tunnel but was converted to an office structure in 1961. The building is intact with multi-pane metal windows.<sup>109</sup> Doors replaced in 2013 to meet safety standards with NJ HPO approval.

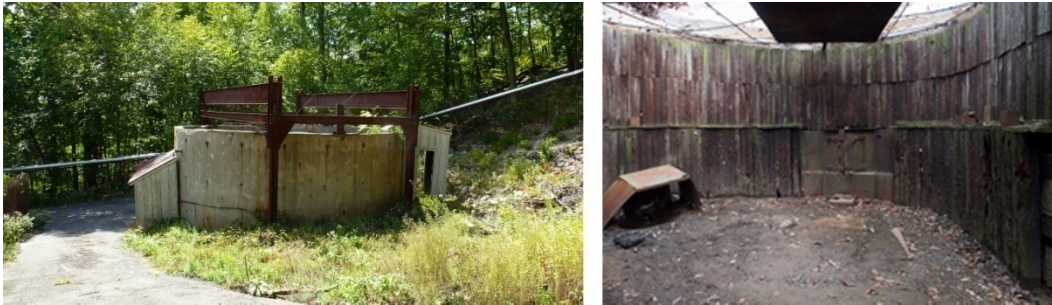
Figure 193. Images of a “bull pen” in the 600 Area (ERDC-CERL, 2012 [left] and Picatinny Arsenal, 2011 [right]).

Building 604F is a one-story, round structure with a concrete foundation, concrete walls (lined on the inside with tarred timber, replaced continuously as needed for explosives testing), and an open roof that is protected by a steel-wire mesh hung from the walls. It was constructed in 1928 as a firing chamber.<sup>110</sup> A “bull pen” is a structure that contains a test explosion within its thickly reinforced concrete circular walls lined on the interior with heavy oak timbers allowing shrapnel to embed in the wood (Figure 193).<sup>111</sup> Building 604F, as well as the metal superstructure, was painted Concrete Gray in 2013 with SHPO concurrence. Also with SHPO concurrence, the shed in front was replaced.

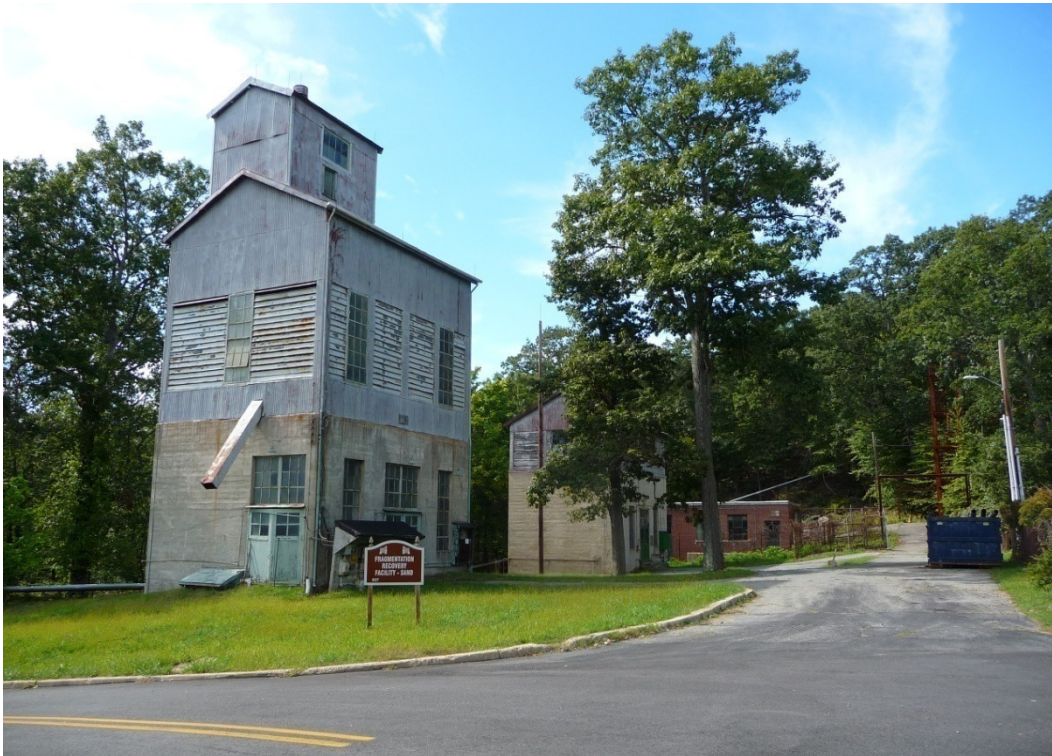
Figure 194. Northeast oblique of Building 607 (ERDC-CERL, 2012).

Building 607 is a two-story gable-roofed structure, with elevator head-houses projecting above the roof (Figure 194). The building has a steel frame, with concrete walls on the first floor and corrugated metal above. The upper floor contains large panels of metal louvers. Building 607 was built in 1940 as part of Picatinny Arsenal's testing program. Shells to be tested were placed in a large hopper surrounded by sawdust, and the shells were detonated. During the blast, the metal louvers ("blast louvers") opened. The roof of the building was reportedly built on flanges so that it could expand with the detonation. After the detonation, the sawdust was sifted and the metal fragments recovered for examination. A further magnetic process recovered small fragments that had passed through the sieve. Then the sawdust was collected in buckets on a conveyor belt and lifted to the top of the building where it was dumped into a storage hopper above the fragmentation tubs, ready for re-use. Building 607 was designed for shells up to 105 mm. The building is intact with limited alterations.<sup>112</sup>

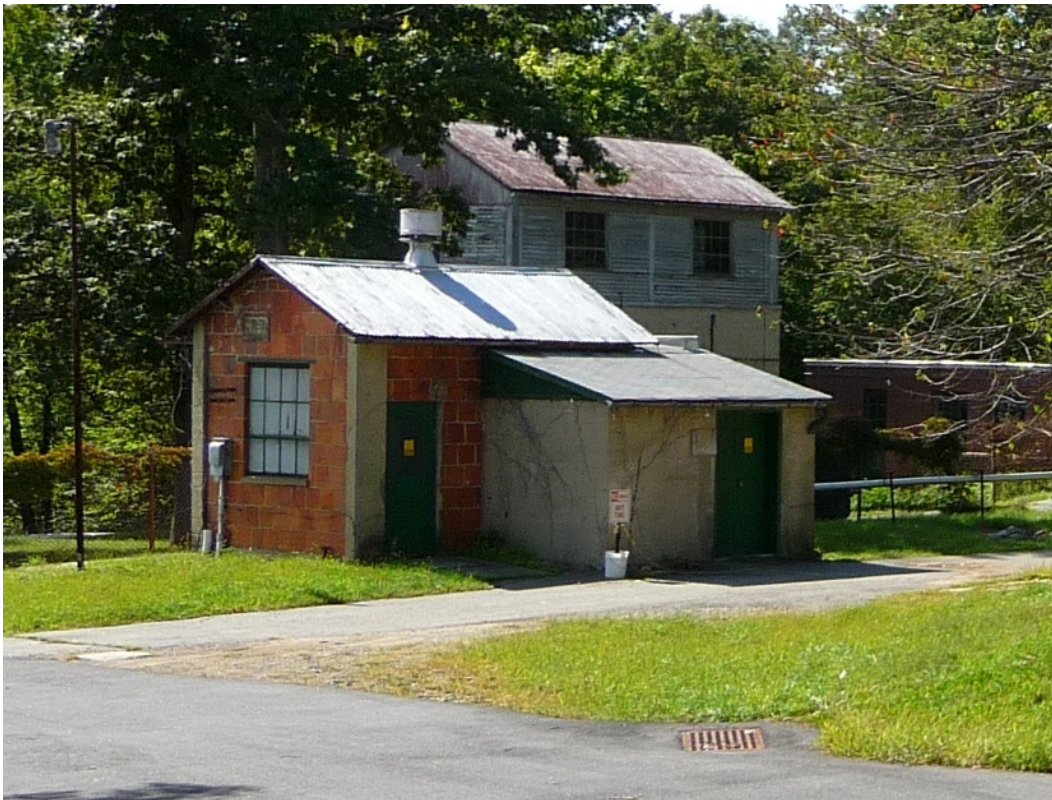
Figure 195. Northeast oblique of Building 607A (ERDC-CERL, 2012).

Building 607A is a one-story, pitched-roof building constructed with a concrete foundation, steel frame encased in concrete, hollow-tile infill, and an APM roof on a steel frame (Figure 195). It was built in 1938 as a testing facility in conjunction with Building 607. Building 607A retains original siting, original massing, and construction.<sup>113</sup>

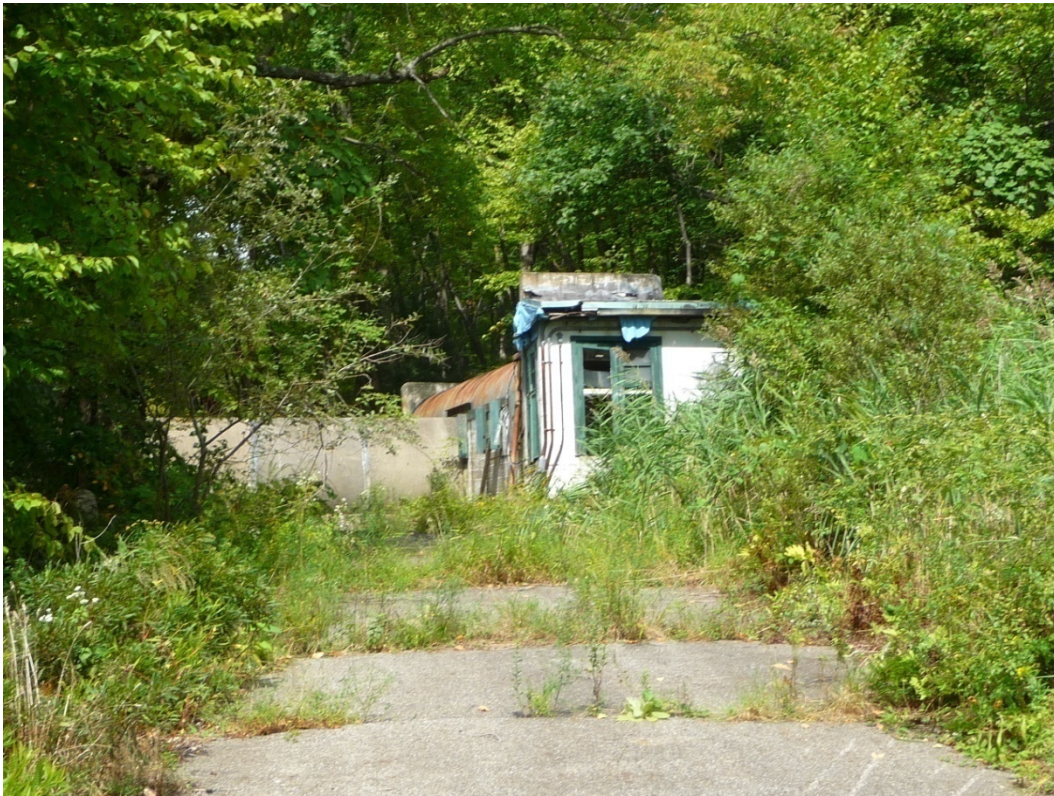
Figure 196. Looking north at Building 611B, Gas Gun Test Tunnel (ERDC-CERL, 2012).

Building 611B originally consisted of a one-story, rectangular firing range (373 ft.9 in. long) with a concrete foundation, low concrete walls, and a semicircular, corrugated metal roof that gave way to a series of wood barricades mounted on top of the walls (Figure 196 and Figure 197). It was constructed in 1929 as a test tunnel for firing artillery rounds. A drawing from 1955<sup>114</sup> shows a 75-mm gun and labels the structure as a “fuze test tunnel,” and it calls for repairs to the wood barricades, liners, and concrete walls. In 1959, a gas gun was installed and a concrete barricade end wall with sand fill was inserted into the tunnel, dramatically decreasing the length of the range. That same year another tunnel was constructed, and an instrumentation room was added to the front of the old structure. Building 611B retains its original siting, massing, and construction. There are angled barricades that acted like fixed louvers to absorb the force of the shell’s impact and direct it up and away from the walls into the open air. The test tunnel walls were lined with timber and the end of the range was filled with sand. A second tunnel addition (40 feet long), constructed of five sections of concrete sewer pipes, intersects the original tunnel from the west. A wood-framed instrumentation room, on concrete piers with a shed roof and two double wood loading doors, fronts the original tunnel from the south.<sup>115</sup>

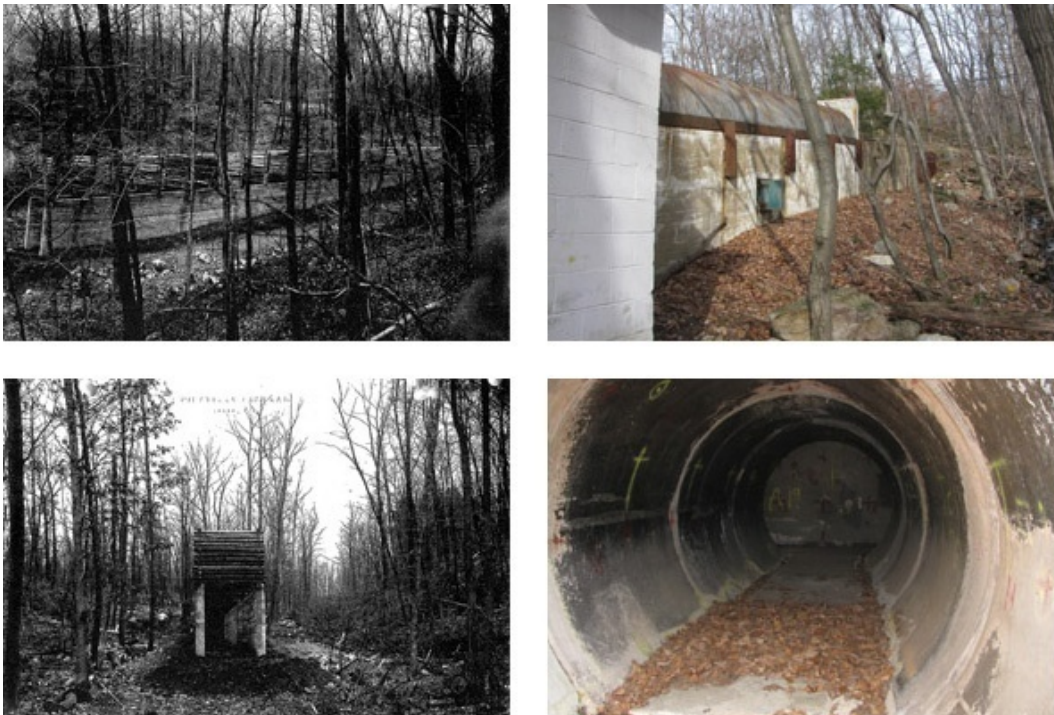
Figure 197. Comparison photographs of the original fuze test tunnel to the altered test tunnel (PICA Cultural Resources Office).

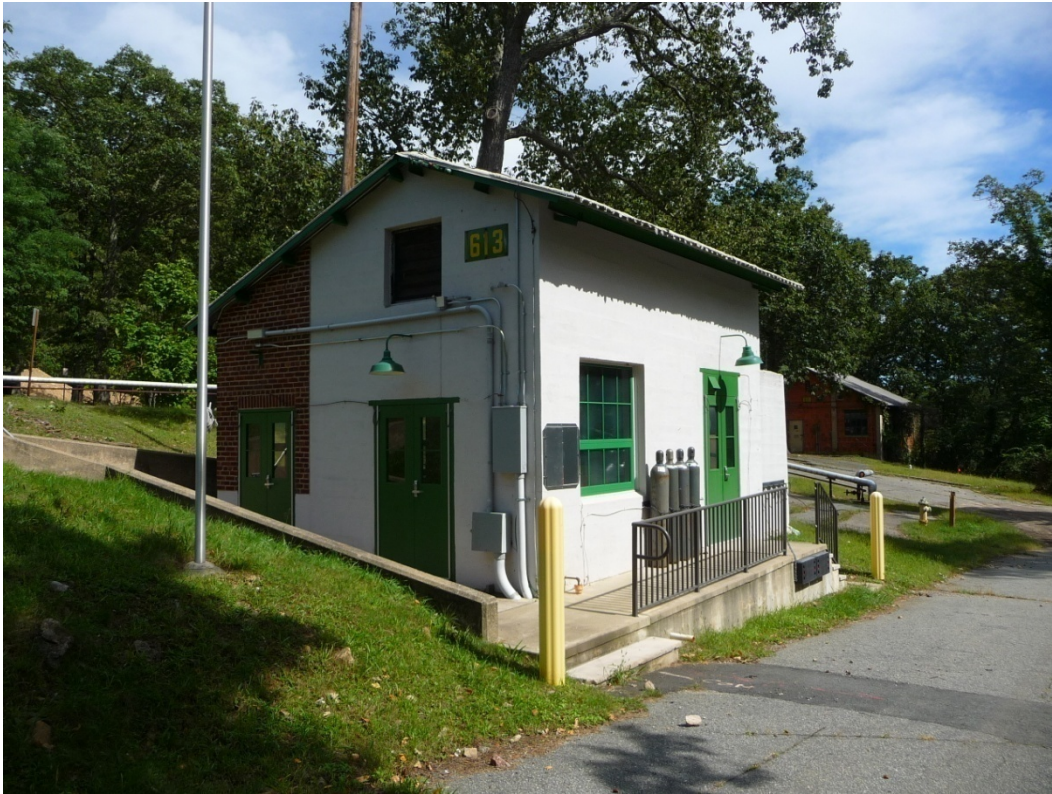
Figure 198. Southwest oblique of Building 613 (ERD-CERL, 2012).

Building 613 is a one-story, rectangular structure with a concrete foundation, brick and concrete load-bearing walls, and a corrugated asbestos protected metal saltbox roof supported by a steel truss and covered in spray foam in 2008 (Figure 198). A small concrete shed with a concrete roof is attached to the main building on the east side. It was constructed in 1928 for Ballistics Mortar Testing. Plans indicate overhead mortar support beams inside, and the walls and floor of the concrete shed are lined with wood planks; more research is needed to determine the function of Building 613 regarding these interior features. In 1944, a brick addition was constructed on the north side, giving the structure its current saltbox shape. The building retains its original siting, massing, and construction. There are metal double loading doors, a concrete loading dock, and metal awning windows.<sup>116</sup> Doors and windows recently replaced with NJ HPO consultation.

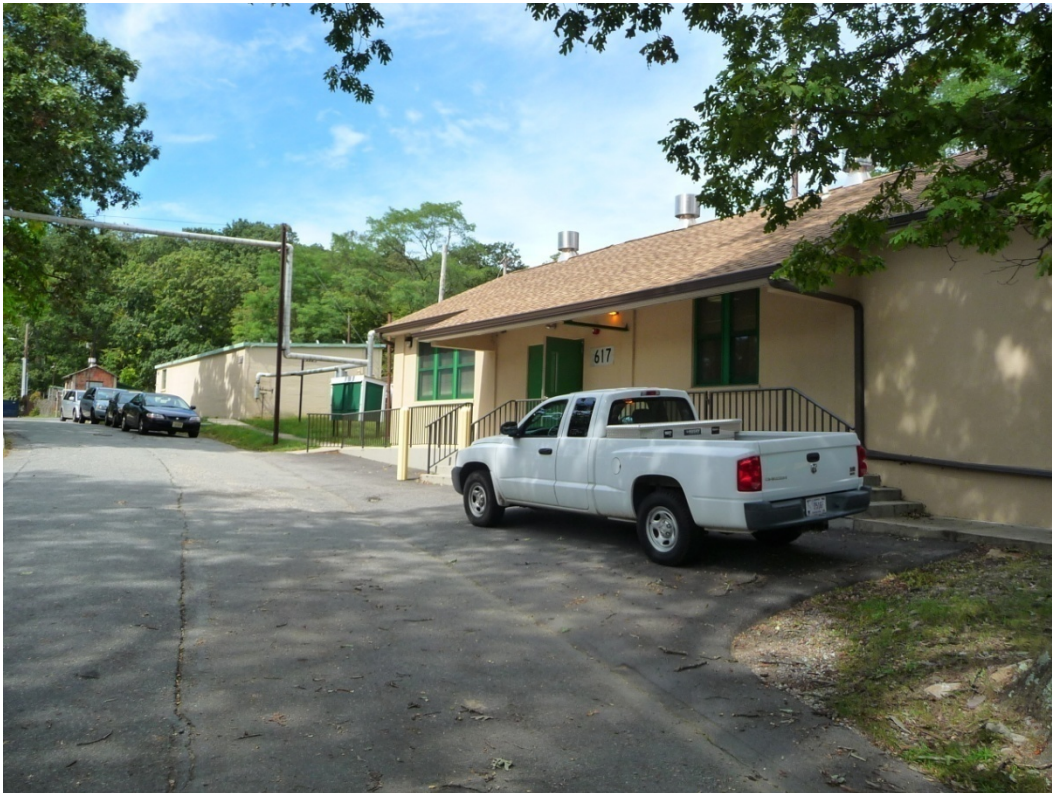
Figure 199. South elevation of Building 617 (ERDC-CERL, 2012).

Building 617 is a one-story, H-plan building with a concrete foundation, load-bearing hollow clay tile walls, and a gable roof covered with asphalt shingles and supported by steel purlins (Figure 199). Stucco covers the old hollow clay tile of the structure similar to 171A. The east-facing courtyard contains a concrete moat which is used to direct rainwater away from the site. It was constructed in 1928 as a Fragment Cleaning, Reconstruction, and Photography Building. It is currently used as an Administrative Office Building. Building 617 retains original siting, massing, and construction. The building has lightning protection. Alterations include new windows and metal siding for the exterior, and 2 x 4 ft-tile suspended acoustical ceiling for the interior.<sup>117</sup> Building was renovated in 2009-10 and a new HVAC area was added in the rear.

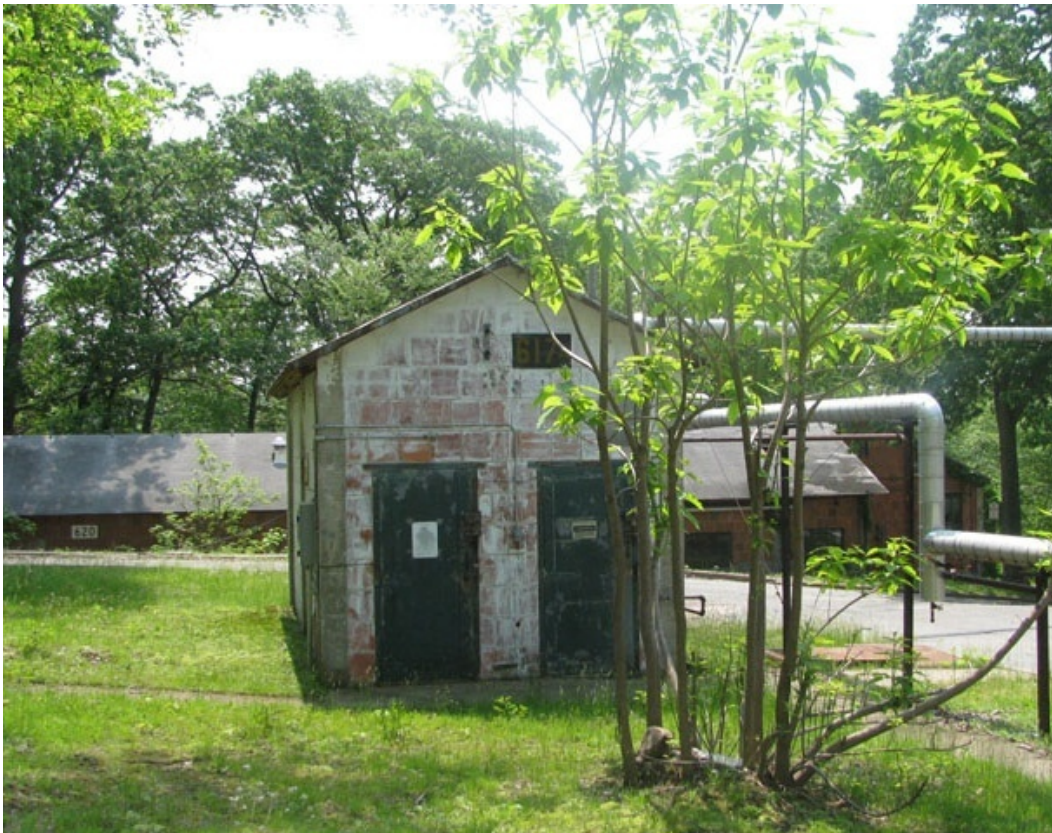
Figure 200. West elevation of Building 617A (PICA Cultural Resources Office).

Building 617A is a small, one-story, white building with a concrete foundation, steel frame enclosed in concrete, hollow clay-tile walls, and a gable roof supported by steel frame and covered with corrugated asbestos (Figure 200). It was constructed in 1928 as a high explosives magazine, but it is currently used for storage. Building 617A retains original siting, massing, and construction. There are steel-sash windows, painted galvanized metal doors, and lightning rods. There are also exterior electric controls, exterior steam heater controls, and an unused concrete pad adjacent to the south end of the building.<sup>118</sup> Recently painted adobe red to match original tile with NJ HPO approval.

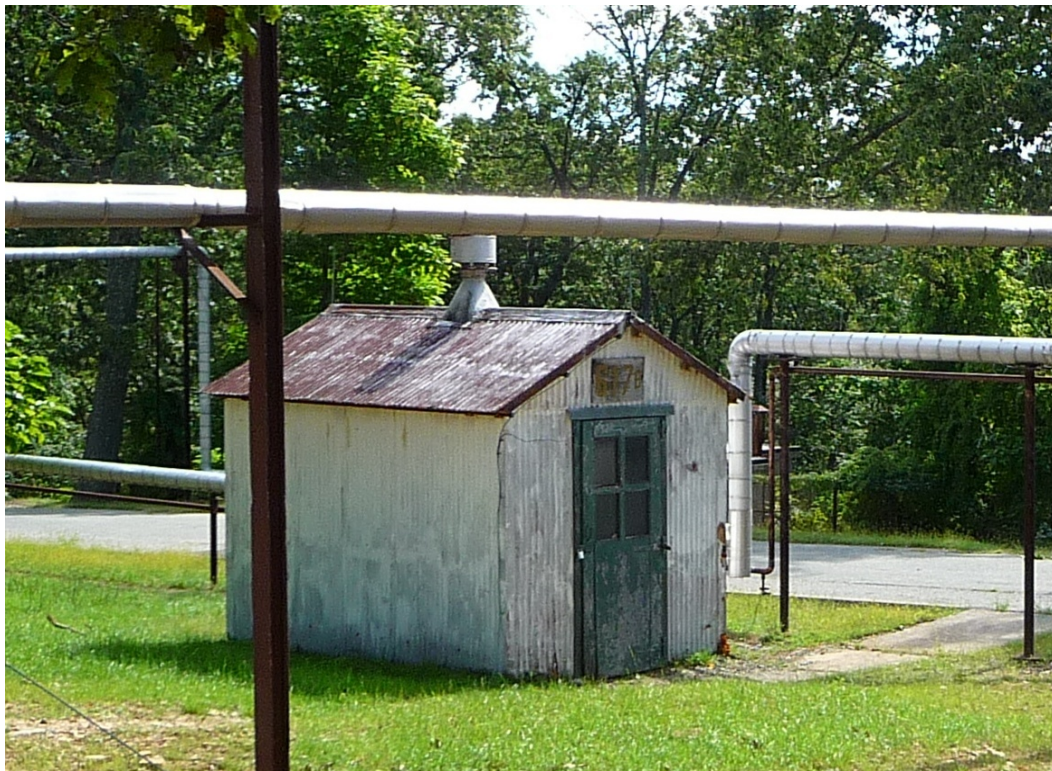
Figure 201. Northwest oblique of Building 617B (ERDC-CERL, 2012).

Building 617B is a small, one-story white building with a concrete foundation, steel frame, corrugated asbestos walls, and a gable roof covered with corrugated asbestos (Figure 201). It was constructed in 1928 for use as a smokeless powder magazine, but it is currently used for general storage. Building 617B retains its original siting, massing, and construction. The building has a rooftop ventilator, a single steel-sash window, and a painted galvanized metal door with wire-glass vision lights. It has two lightning rods on the roof.<sup>119</sup>

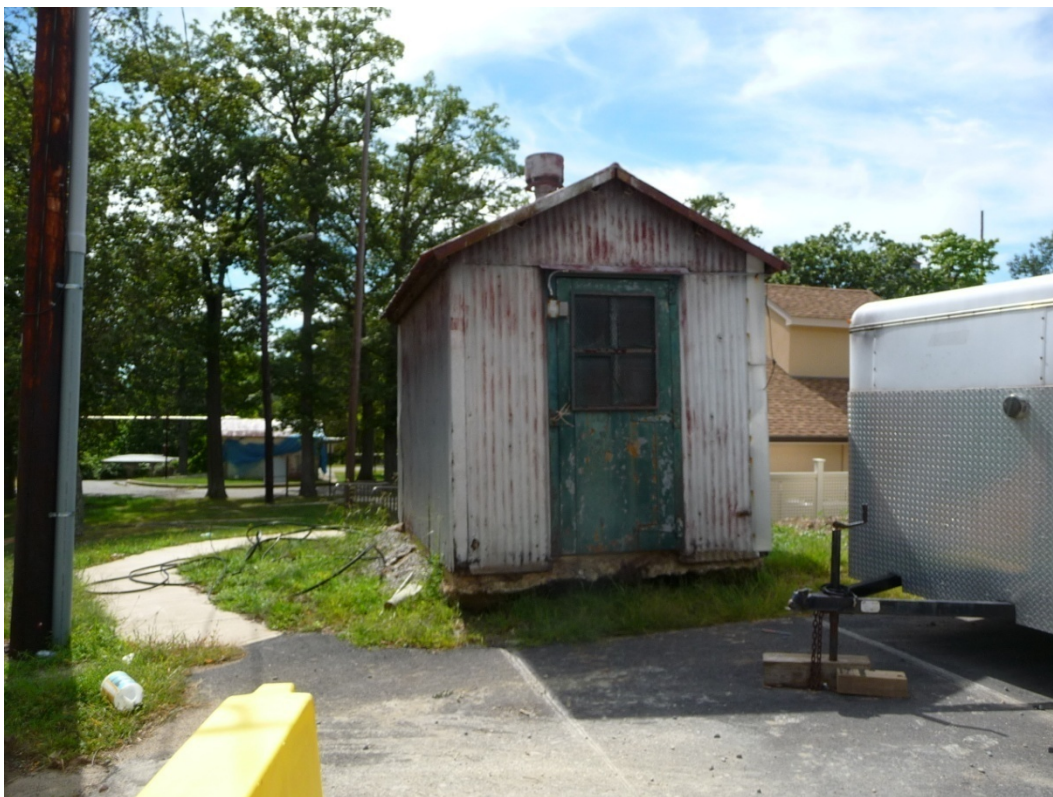
Figure 202. North elevation of Building 617F (ERDC-CERL, 2012).

Building 617F is a small, one-story white building with a concrete foundation, steel frame, corrugated asbestos walls, and a gable roof covered with corrugated asbestos (Figure 202). It was constructed in 1928 as a magazine, but it is currently used for storage. Building 617F was relocated adjacent to 621B in 2012. The building has a rooftop ventilator, a single steel-sash window, and a painted galvanized metal door with wire-glass vision lights.<sup>120</sup>

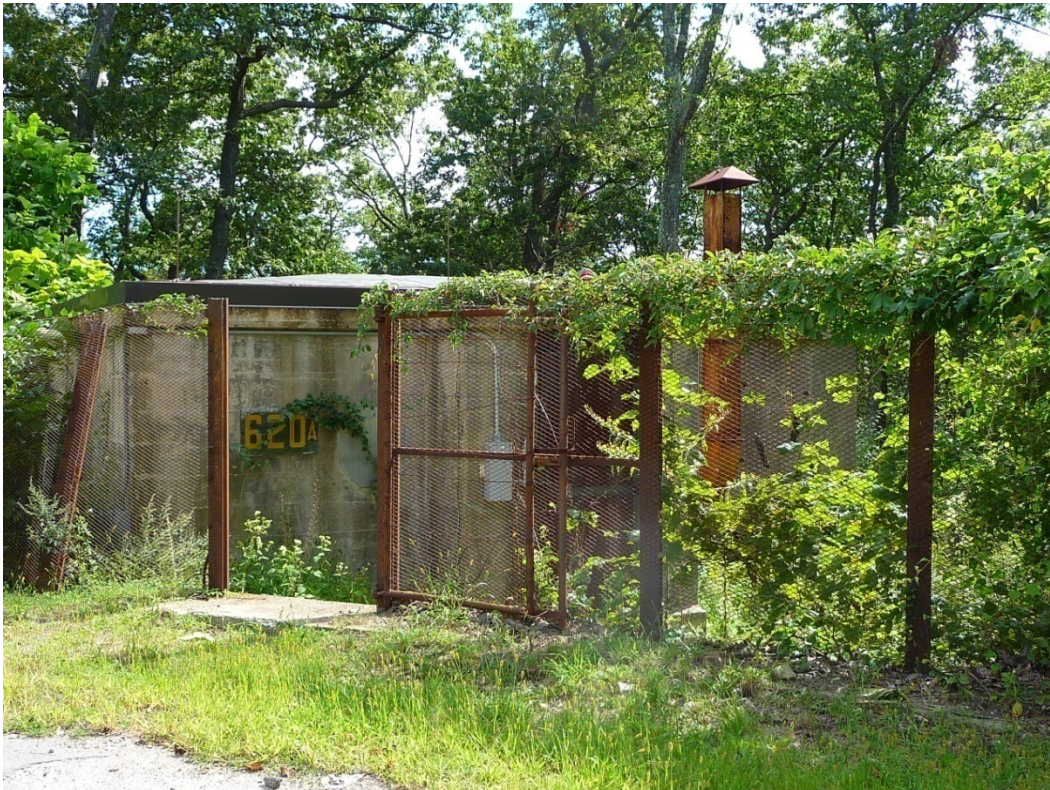
Figure 203. Northeast elevation of Building 620A (ERDC-CERL, 2012).

Building 620A is a one-story, structure with a concrete foundation, tie-rod-reinforced concrete walls, and a flat concrete roof (Figure 203). The building is partially depressed in the side of the hill and fenced off. The building is currently unused and is covered in vines.

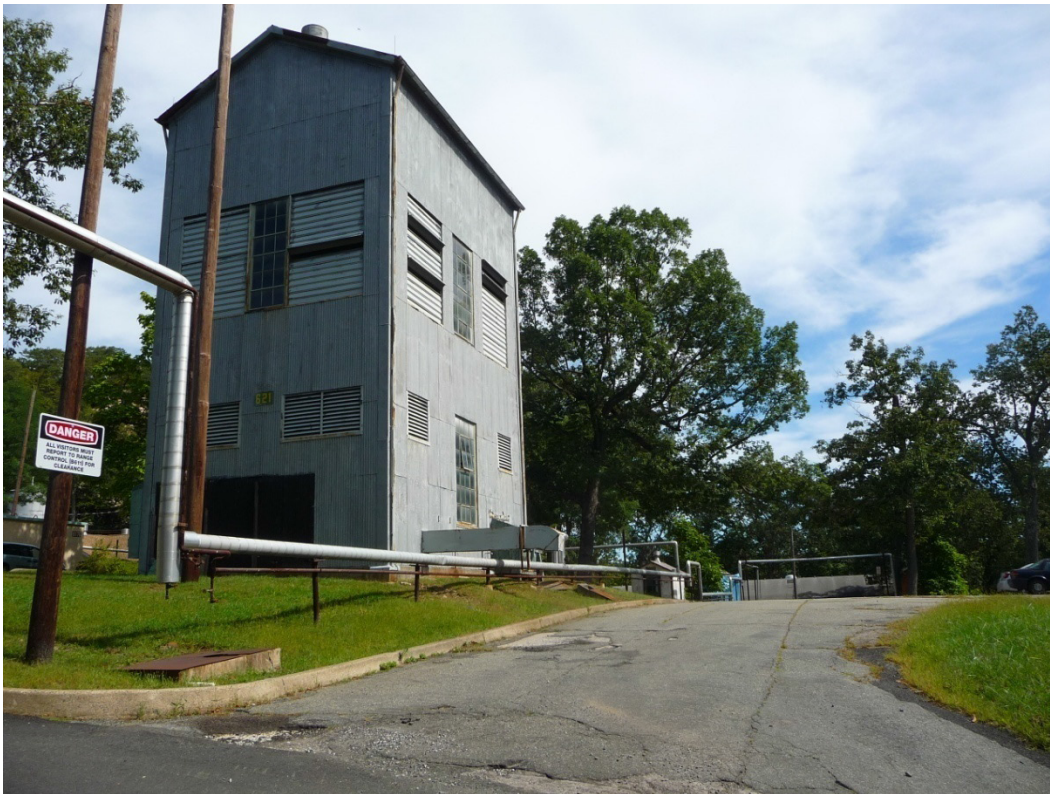
Figure 205. Southwest oblique of Building 621 (ERDC-CERL, 2012).

Building 621 is a two-story gable roofed structure, with elevator head-houses projecting above the roof (Figure 205). The building has a steel frame, with concrete walls on the first floor and corrugated metal above. The upper floor contains large panels of metal louvers. It was built in 1941 as part of the Arsenal's testing program. Shells to be tested were placed in a large hopper surrounded by sand, and the shells were detonated. During the blast the louvers ("blast louvers") opened. The roof of the building was reportedly built on flanges so that it could expand with the detonation. After the detonation, the sand was sifted and the metal fragments reverved for examination. A further magnetic process reverved small fragments that had passed through the sieve. Then the sand was collected in buckets on a conveyor belt and lifted to the top of the building where it was dumped into a storage hopper above the fragmentation tubs, ready for re-use. Building 621 was designed for shells up to 105 155mm.<sup>123</sup>

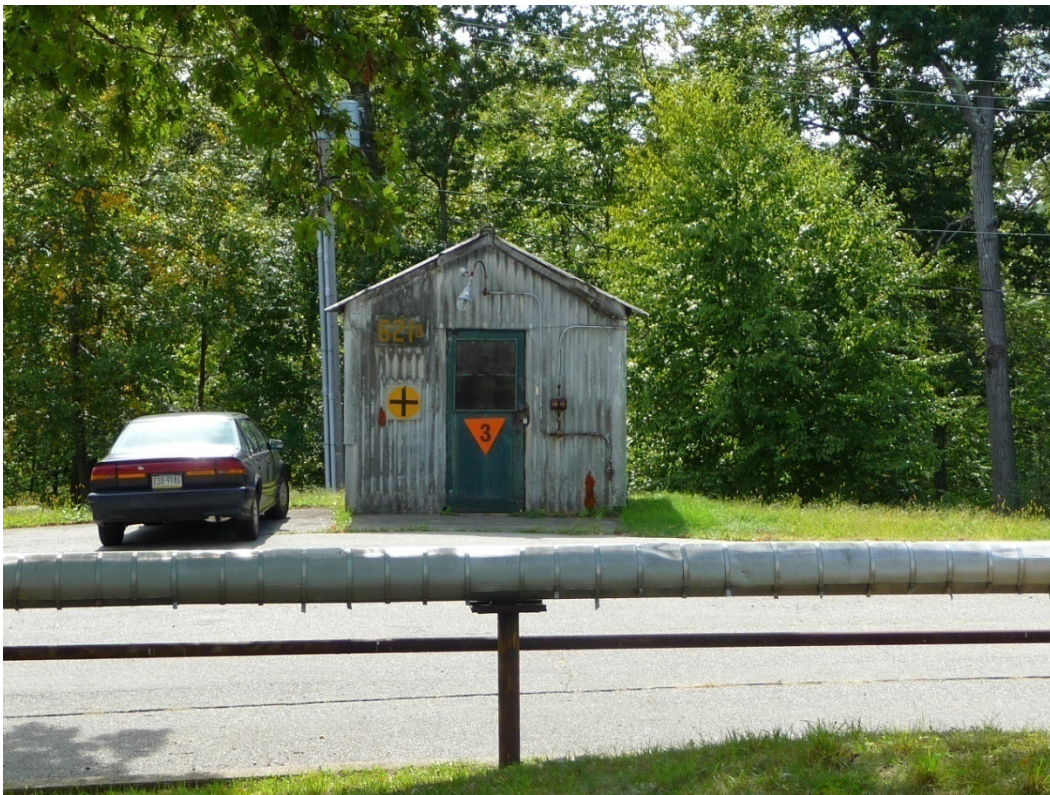
Figure 206. View of front façade of Building 621B (ERDC-CERL, 2012).

Building 621B is a one-story, rectangular structure with concrete foundation, corrugated asbestos walls on a steel frame and corrugated, APM gable roof (Figure 206). It was constructed in 1914 for the storage of ammunition and used as a shipping and receiving facility for the 600 Test Area. It retains its original siting, massing, and construction. Its exterior includes: concrete foundation; steel frame; asbestos walls; and a gable roof covered with APM.<sup>124</sup>

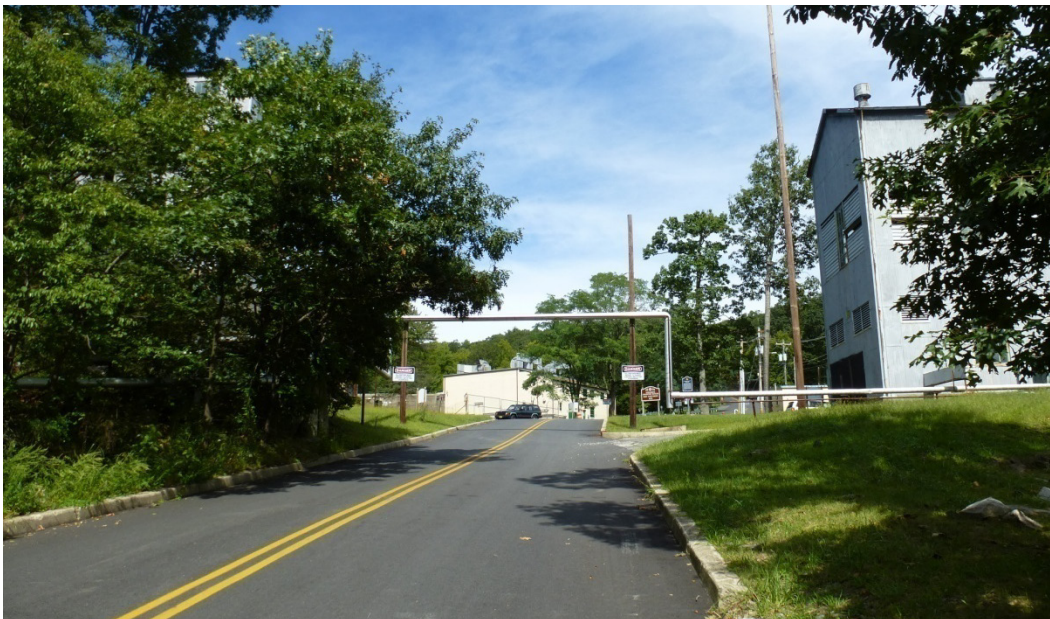
Figure 207. Elevated steam lines stretch over 20<sup>th</sup> Avenue (ERDC-CERL, 2012).

The steam distribution system is a network of metal or APM conduit that run above and below ground from the power plants throughout PICA. A centralized system of steam throughout Picatinny Arsenal and the Lake Denmark NAD provided a source of heating and allowed production facilities throughout the installation to use pressurized steam as a sparkless form of energy. The steam was created as a by-product of electricity production at the Power Plant (Building 506), built in 1906 and the Boiler House (Building 3013), built in 1901. Water from Picatinny Lake was heated, and the resulting steam forced through turbines to produce energy. Pressurized steam was then sent to production facilities via conduit. On site, buildings were fitted with pressure reducing valves and steam powered equipment, which reduced the risk of explosion. Overall the Steam Distribution System consists of a network of conduit, supporting structures, and pressure-reducing valves. Most of the system visible has been replaced, but there are remnants of an earlier system of conduit supported on cast stone pier.<sup>126</sup> Steam lines exist throughout the 600 Area (Figure 207—Figure 209).

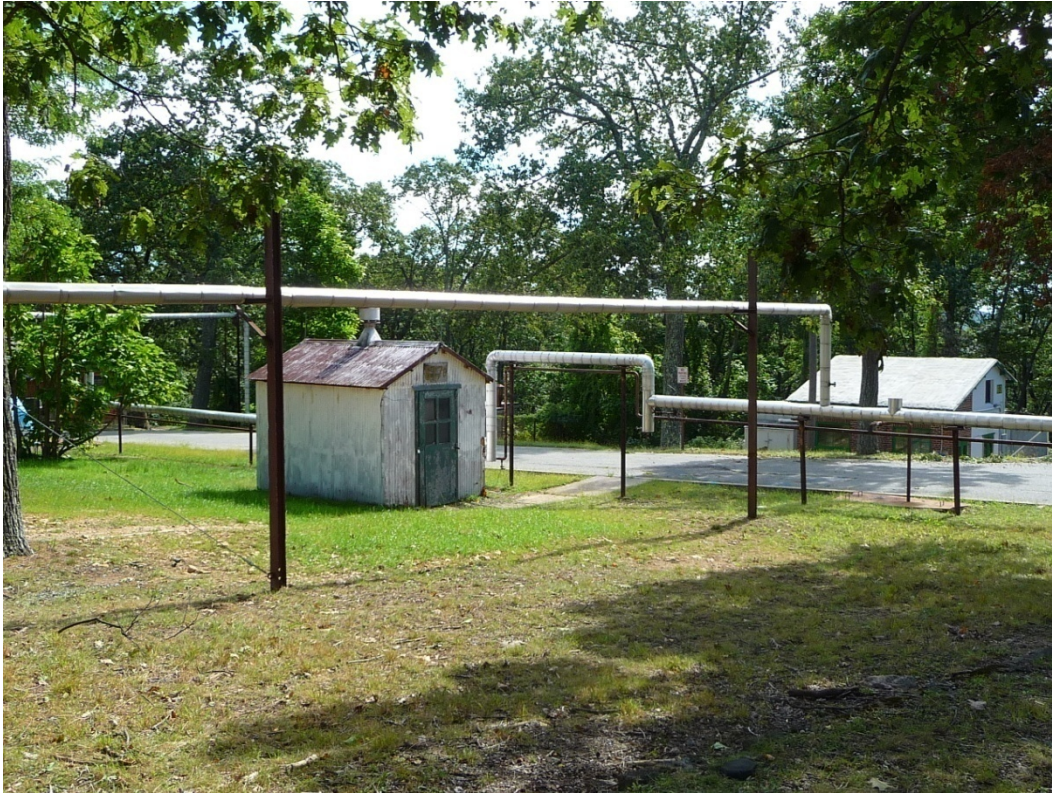
Figure 208. Steam lines located throughout the 600 Test Area (ERDC-CERL, 2012).

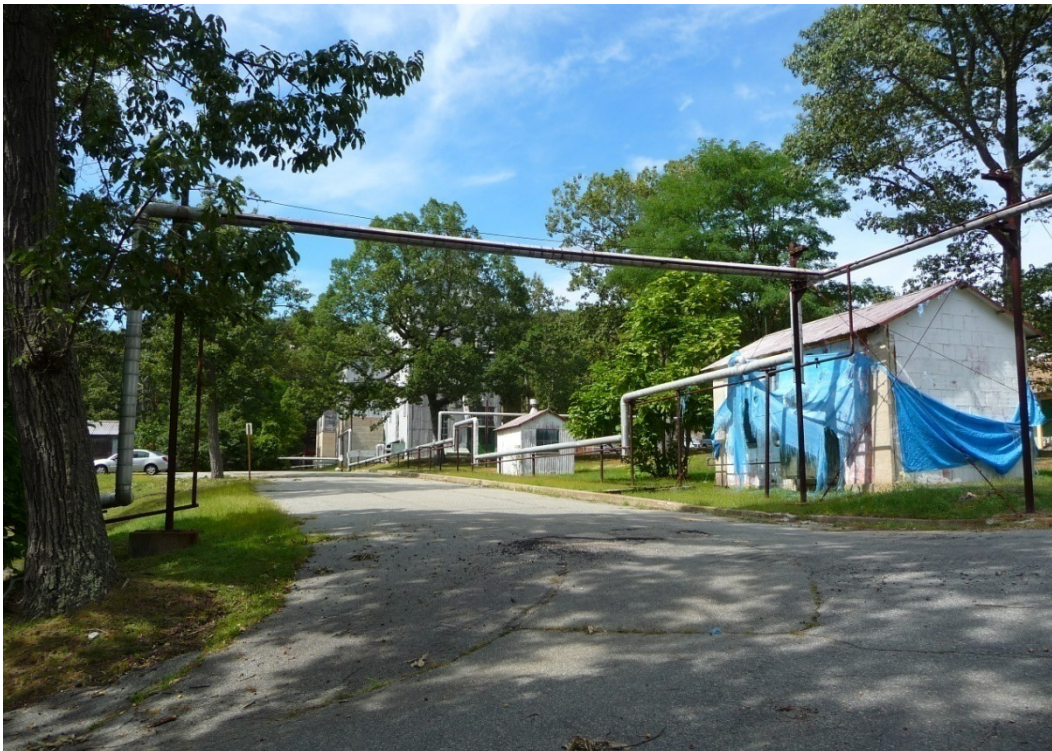
Figure 209. Replacement steam lines placed high above the paved roads in the 600 Test Area (ERDC-CERL, 2012).

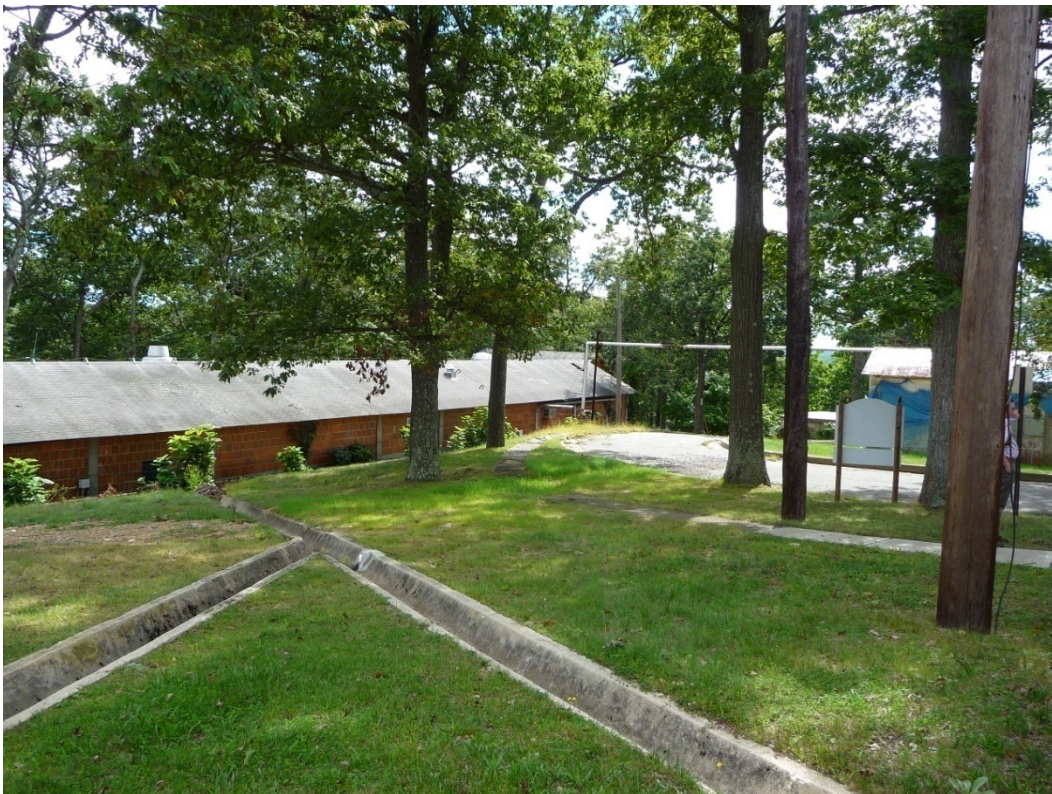
Figure 212. Drainage swales (ERDC-CERL, 2012).

The 600 Area is nestled on the hillside and surrounded by wooded land. The vegetation located inside the boundary of the 600 Area is minimal. The landscape is dotted with mature deciduous trees concentrated mainly around the court area on either side of 20<sup>th</sup> Court. Grasses surrounding the buildings are kept mowed (Figure 211 and Figure 212).
