## **Cultural Landscape Analysis of Existing Historic Districts**

Picatinny Arsenal, New Jersey

Final report

Under Project 201221, "Cultural Landscape Analysis, Picatinny Arsenal, New Jersey"

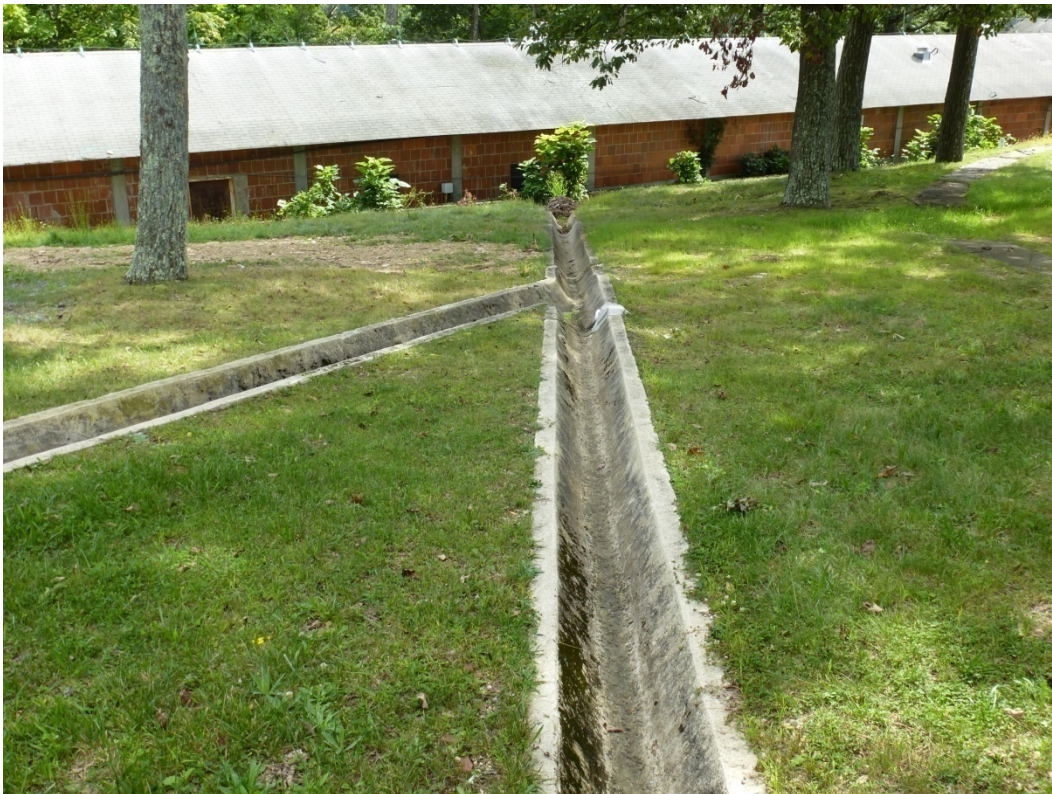
Figure 213. Drainage swales (ERDC-CERL, 2012).

Concrete-formed drainage swales are found around Buildings 620 and 617 (Figure 213). The swales were designed and incorporated into the original layout and function of the area. While the 600 Area is built into the side of a steep hill, no documentation was found detailing the need for extensive swales in this area. These swales were removed during the demolition of Building 620, and a new parking lot was installed with sidewalks leading to Building 617.

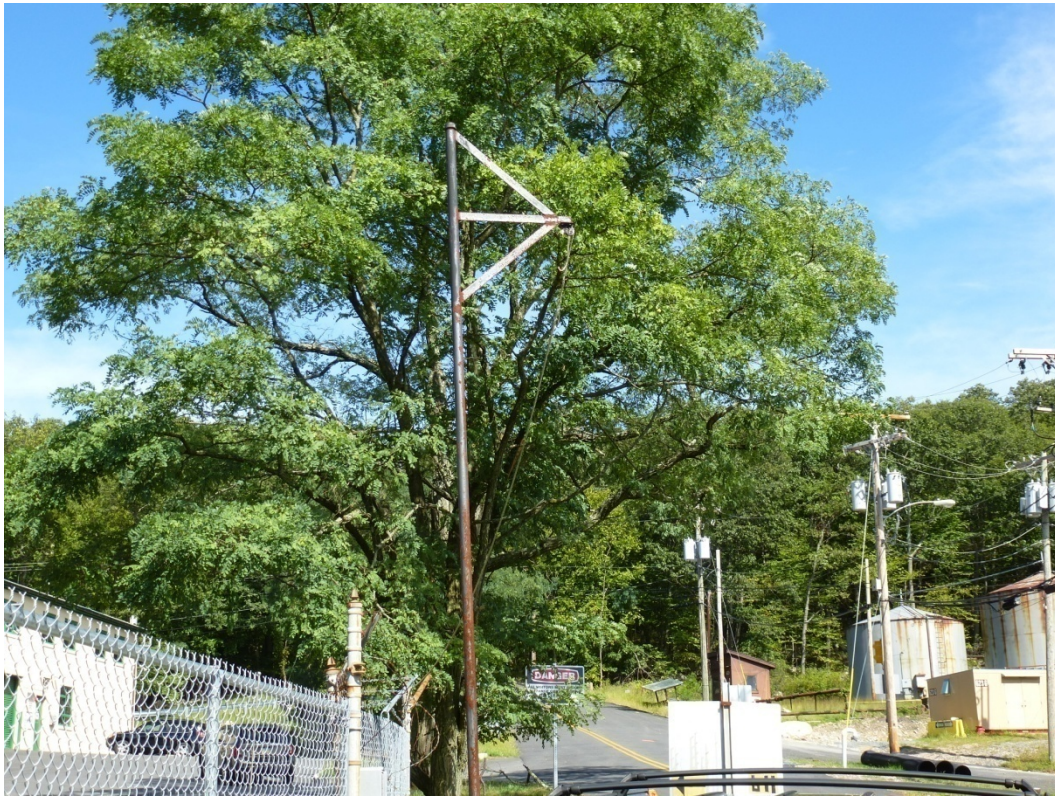
Figure 214. Testing flagpole (ERDC-CERL, 2012).

The significance of the flagpole located at the entrance into the 600 Area (Figure 214) is that it alerts people of testing being conducted within the buildings.

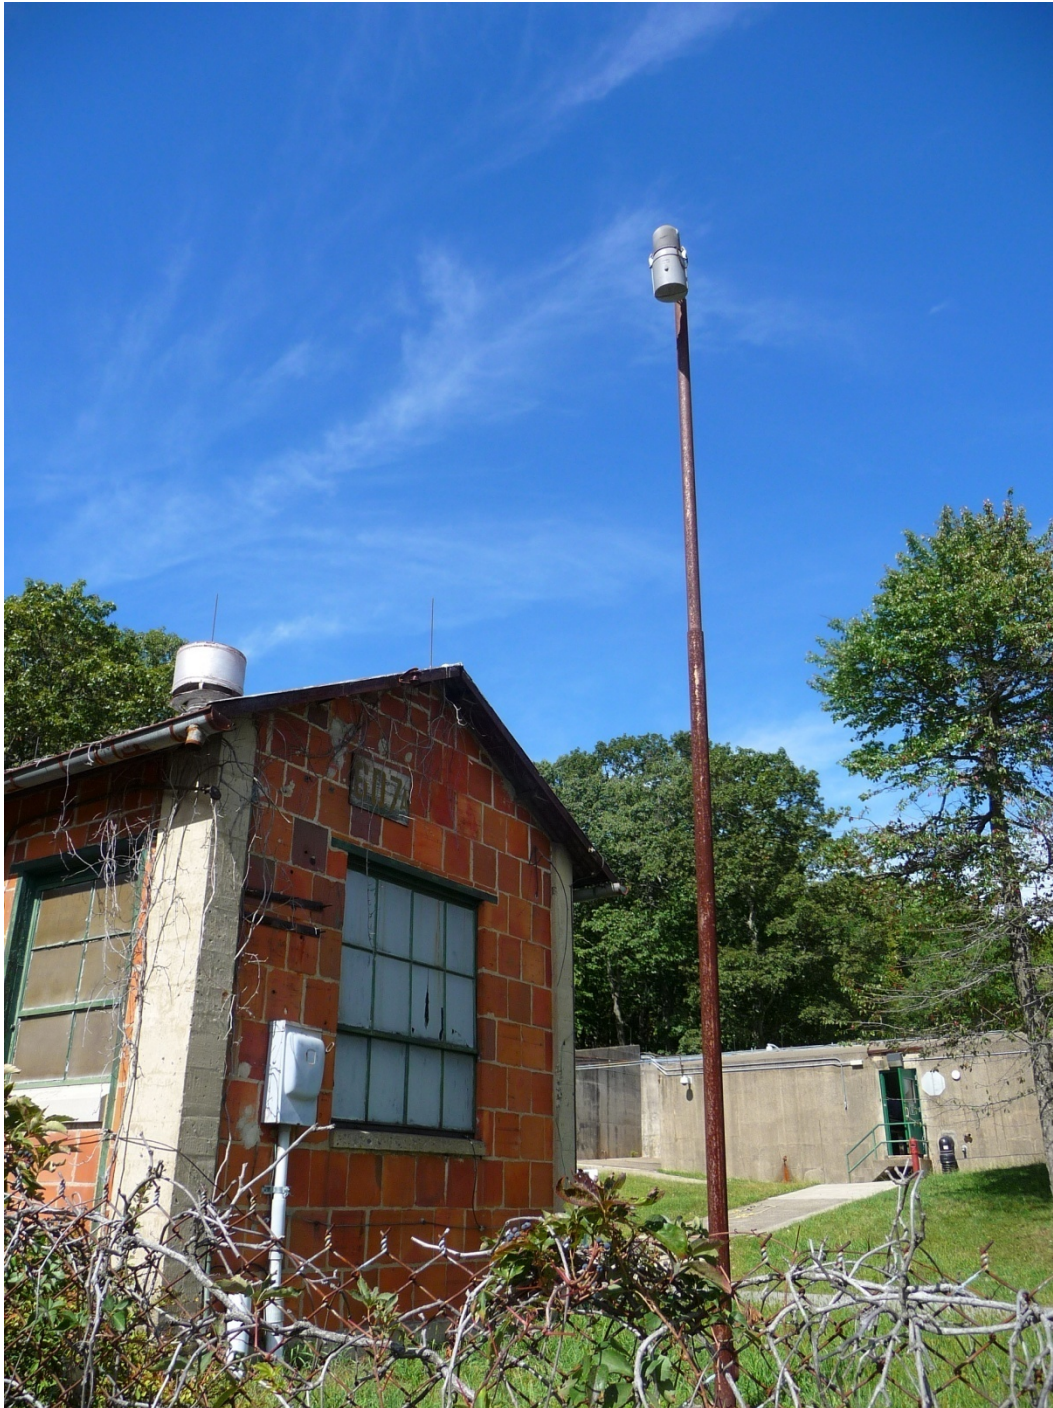
Figure 215. Large lightning rod adjacent to Building 607A (ERDC-CERL, 2012).

Lightning rods are located adjacent to or on all buildings within the 600 Area (Figure 215).

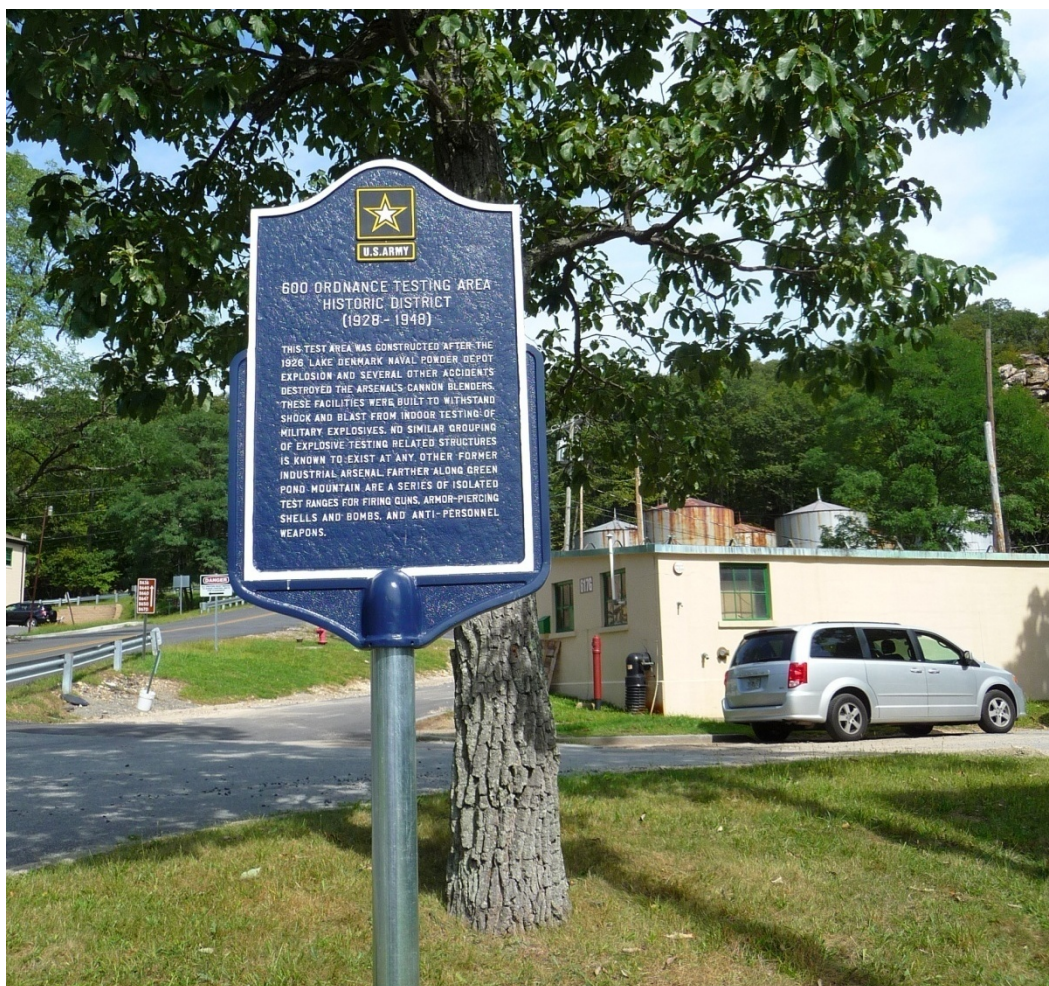
Figure 216. Historic marker identifying the 600 Area (ERDC-CERL, 2012).

A historic marker is located along 20<sup>th</sup> Avenue, describing the significance of the 600 Area Ordnance Testing Historic District (Figure 216). The historic markers for the NRHP-eligible historic district are used to identify and highlight these significant areas. The markers allow for military and civilian personnel and visitors to the installation to be more aware of the installation's historical heritage to ensure the long-term preservation of these significant areas. The markers were funded by the Environmental Affairs Division and produced by Lake Shore Industries. Text was developed by CRM, NJ HPO, and the Morris County Heritage Commission. Placement of the markers was carried out in 2012.

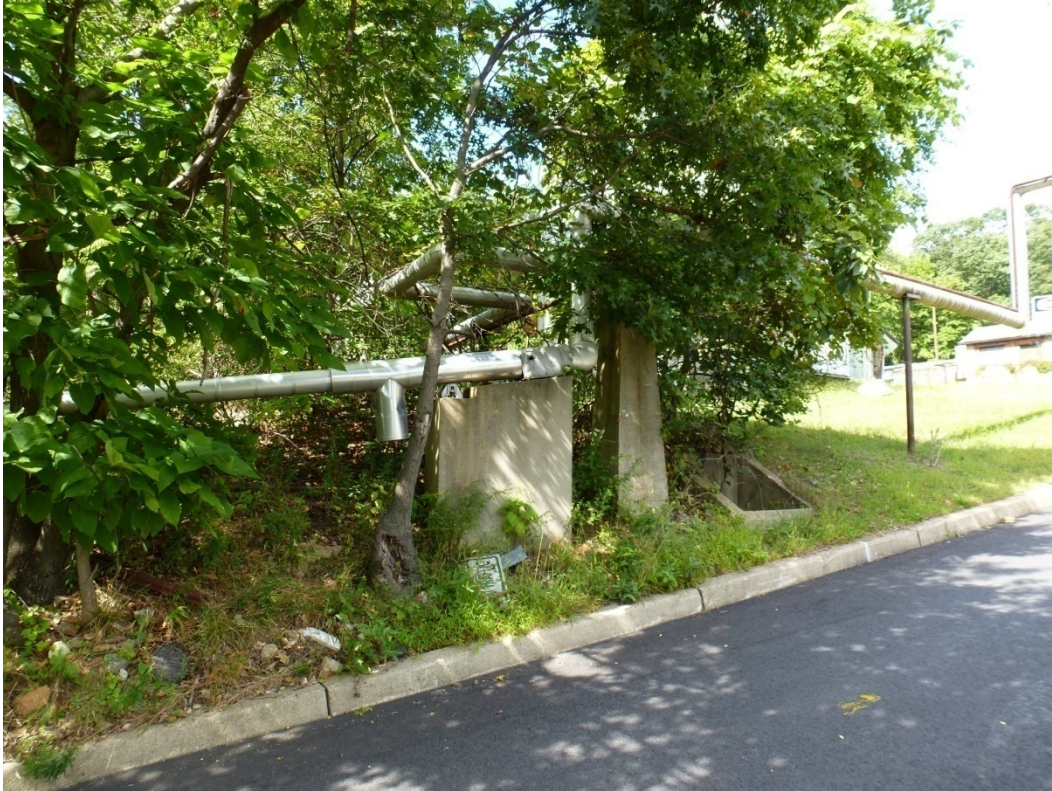
Figure 217. Remove vegetation from steam lines (ERDC-CERL, 2012).

*Steam lines:* the vegetation needs to be cleared and removed off and around exposed and elevated steam lines (Figure 217). Their alignment, stanchions, and steam stations are significant.

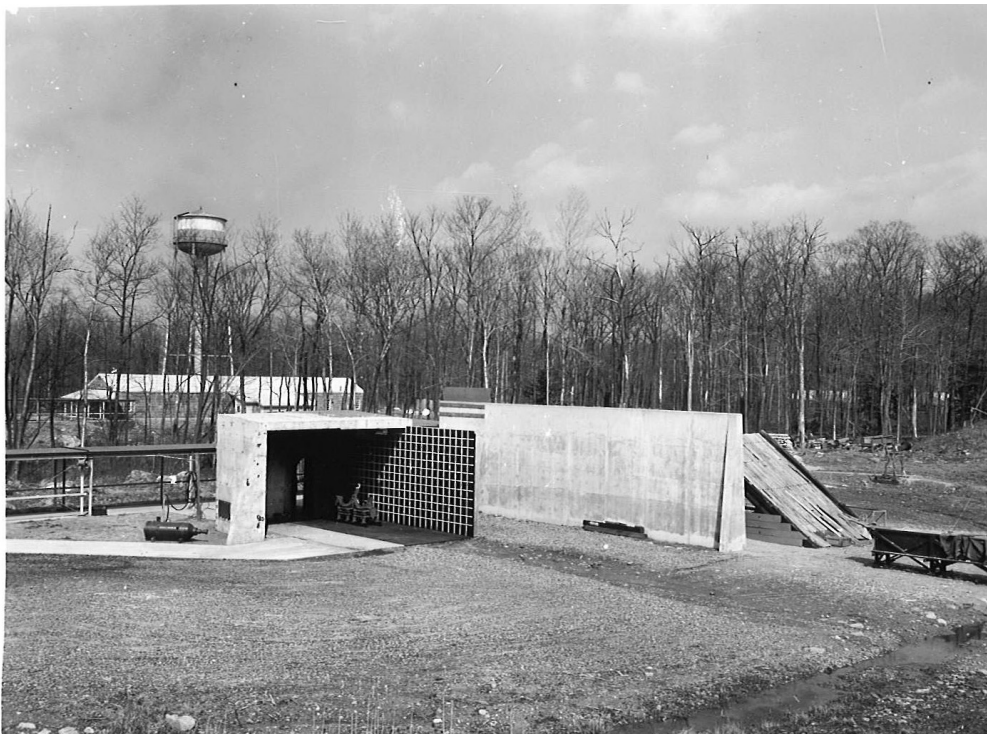
A wooded area to the south of the buildings separates buildings and structures from a number of pyrotechnic magazines (Figure 224 and Figure 225). The wooded area serves as a type of blast protection and helps delineate the use areas within the 1500 Area.

Figure 225. Historic photograph of the placement of the Rocket Test Area with a row of trees for protection, May 1951 (PICA Cultural Resources Office).

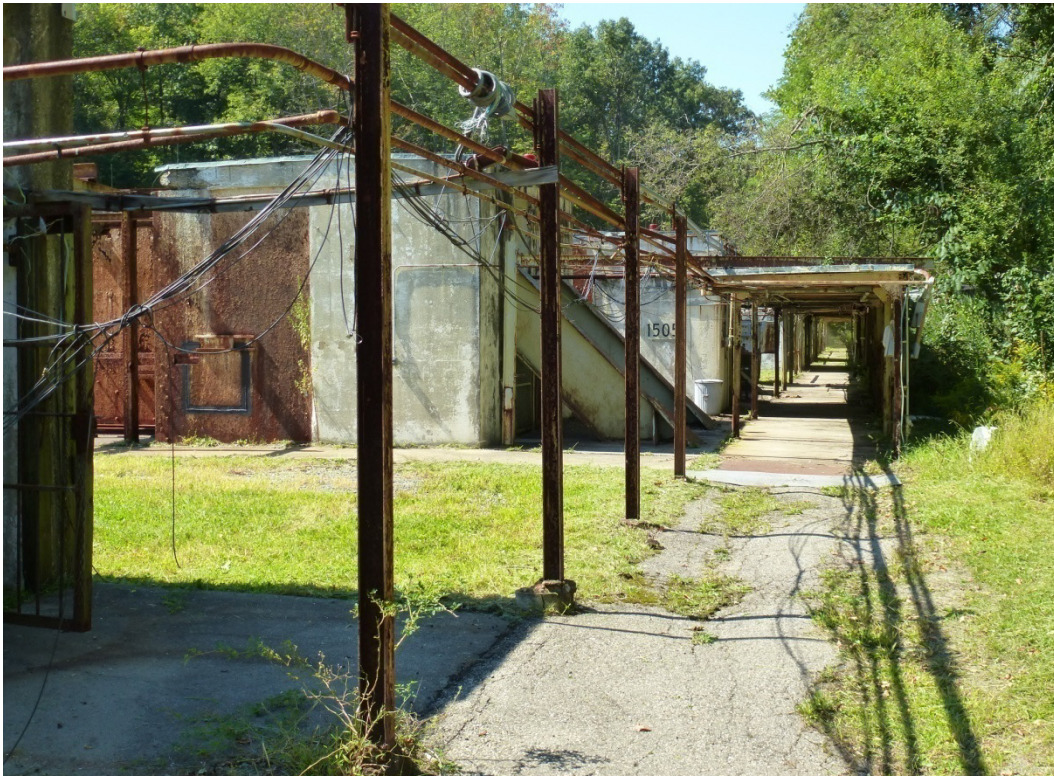
A single road, Hart Road, provides access from Lake Denmark Road to the 1500 Area (Figure 226 through Figure 228). Today, access to the 1500 Area is through a gate on Hart Road, but historic maps depict a guard house which is no longer extant. No rail lines were discovered during field work. Walkways (some covered) connect the buildings and testing areas (Figure 229 and Figure 230).

Figure 229. Concrete walkways connect the test stands in the Testing Area of the historic district (ERDC-CERL, 2102).

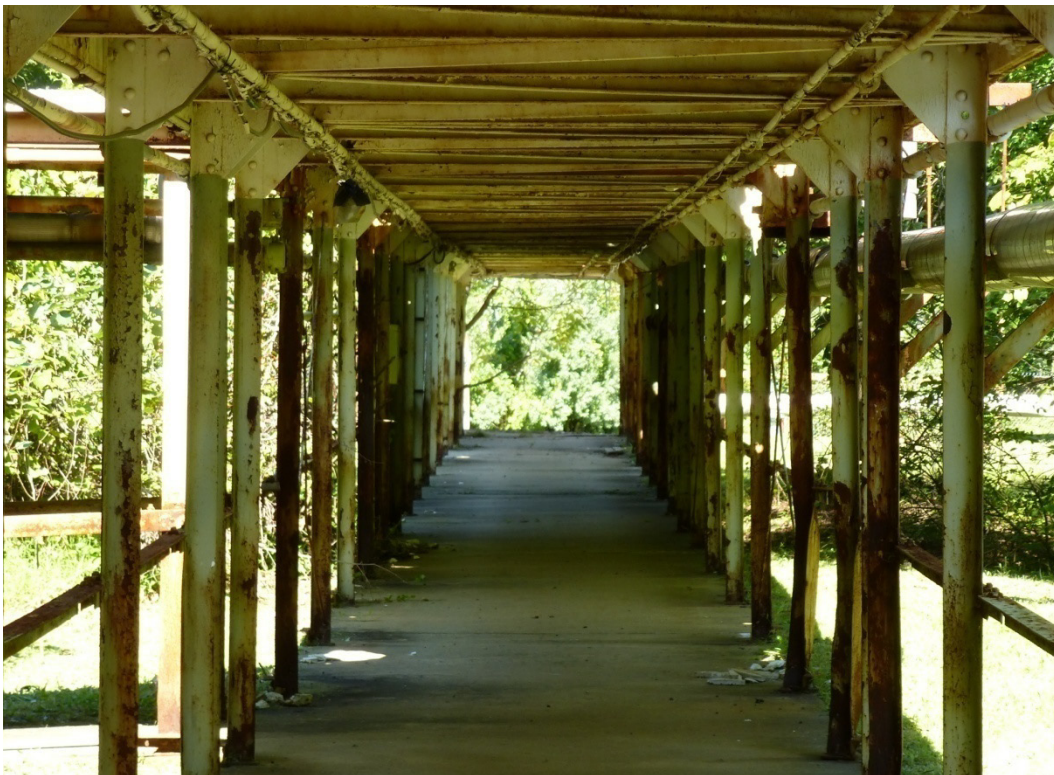
Figure 230. Covered walkways near the test stand area in the Testing Area of the historic district (ERDC-CERL, 2012).

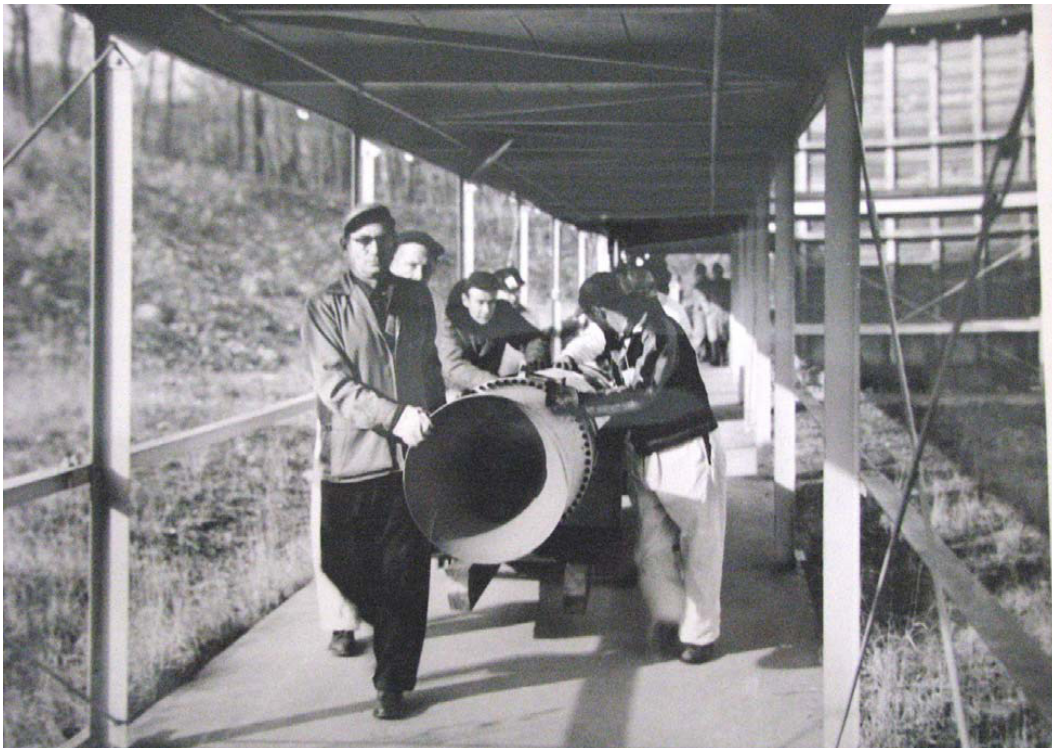
In the 1500 Area, rockets were moved from buildings to be placed in test positions in the firing test bays. The design of the covered walkways was a typical industrial feature within this area (Figure 231).

Figure 231. An Honest John rocket is carried down a covered walkway near Building 1503 in 1953 (PICA Cultural Resources Office).

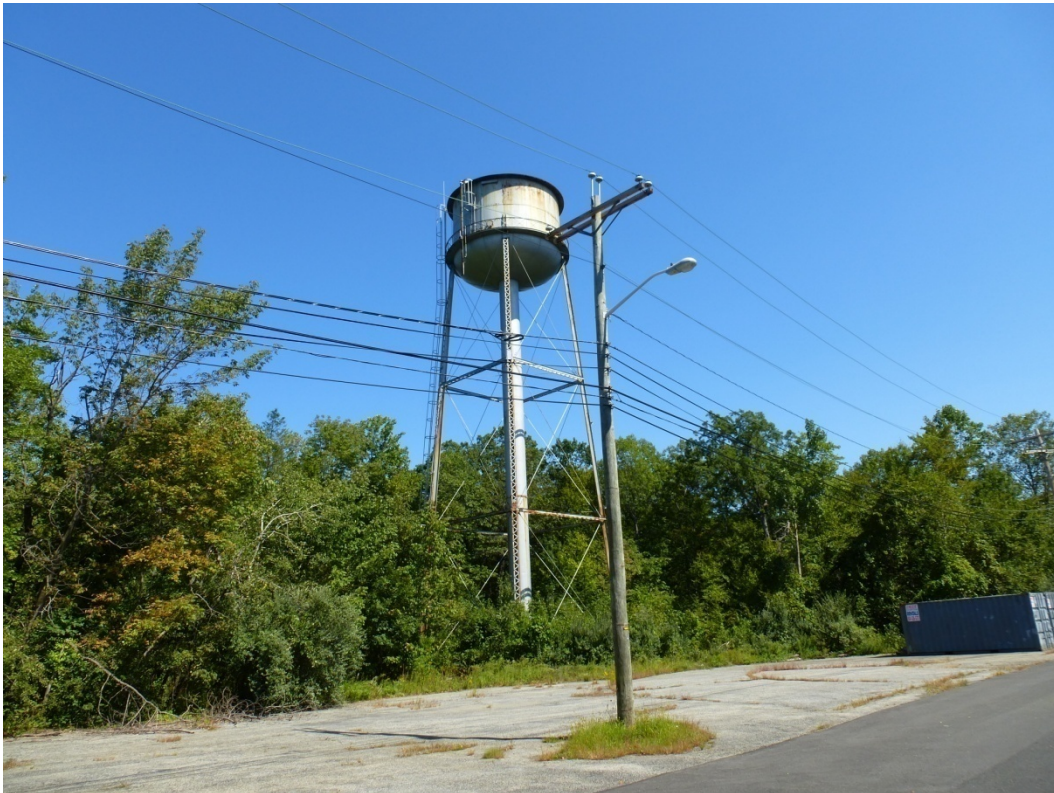
Figure 236. Current condition of the water tower, Building 1500 (ERDC-CERL, 2012).

The water tower originally had a red-and-white-checked pattern painted on the metal surface. It is located off Hart Road and is a steel tank on a steel frame (Figure 236).

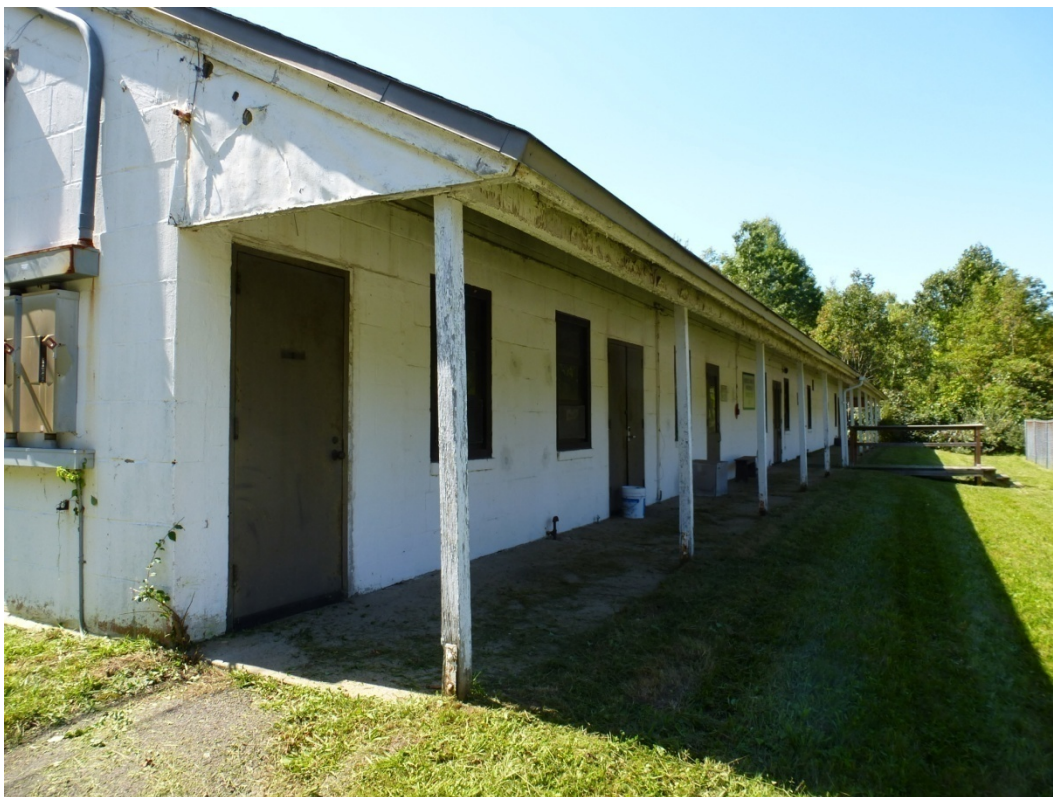
**Figure 237. Left side of the north elevation of Building 1501 (ERDC-CERL, 2012).**

Building 1501 was constructed in 1948 and is located along Hart Road (Figure 237). It was previously used as an electronic equipment building, R&D administration building, equipment material facility, service building, and office. It is a long, rectangular, gable-roofed structure with a covered walkway incorporated under the main roof line. The building sits on a concrete foundation, has concrete-block walls, and a roll roof.<sup>147</sup>

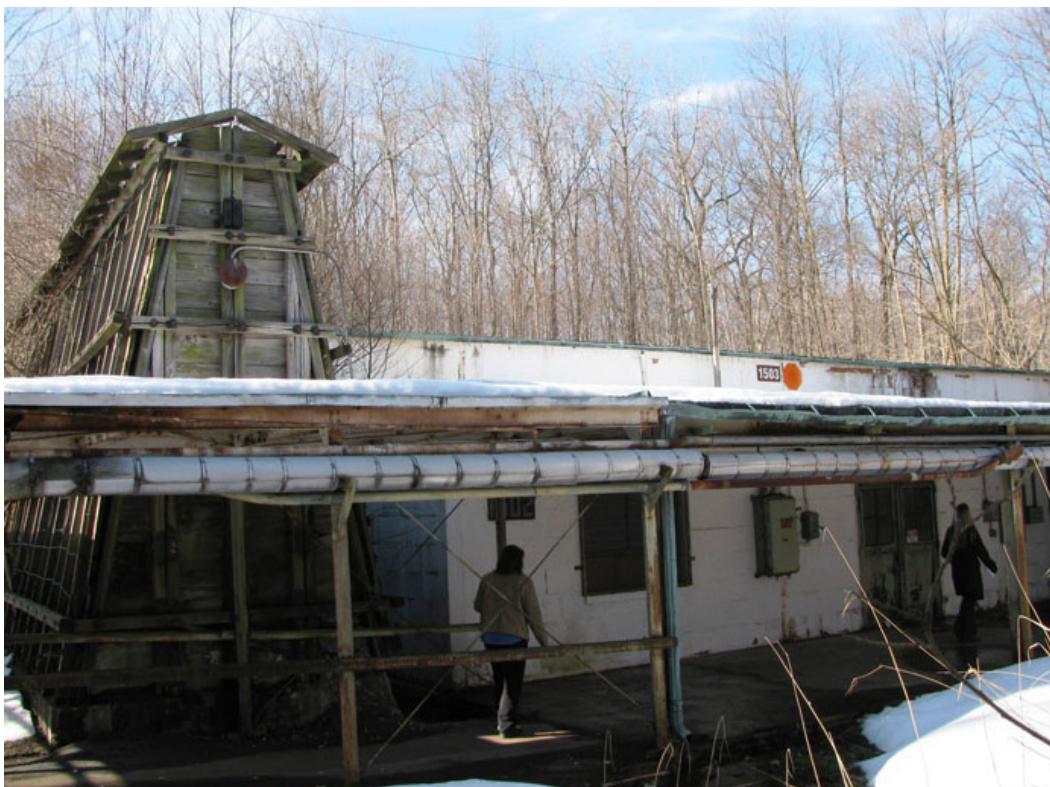
**Figure 238. Northeast side of Building 1502 (PICA Cultural Resources Office).**

Building 1502 was constructed in 1948. It was previously used as powder conditioning service building, ordnance facility, and altitude chamber plant compressor. Located off Hart Road, it is a long, rectangular, flat-roofed structure along a covered walkway. The building sits on a concrete foundation, has hollow tile walls, and built-up roof (Figure 238).<sup>148</sup>

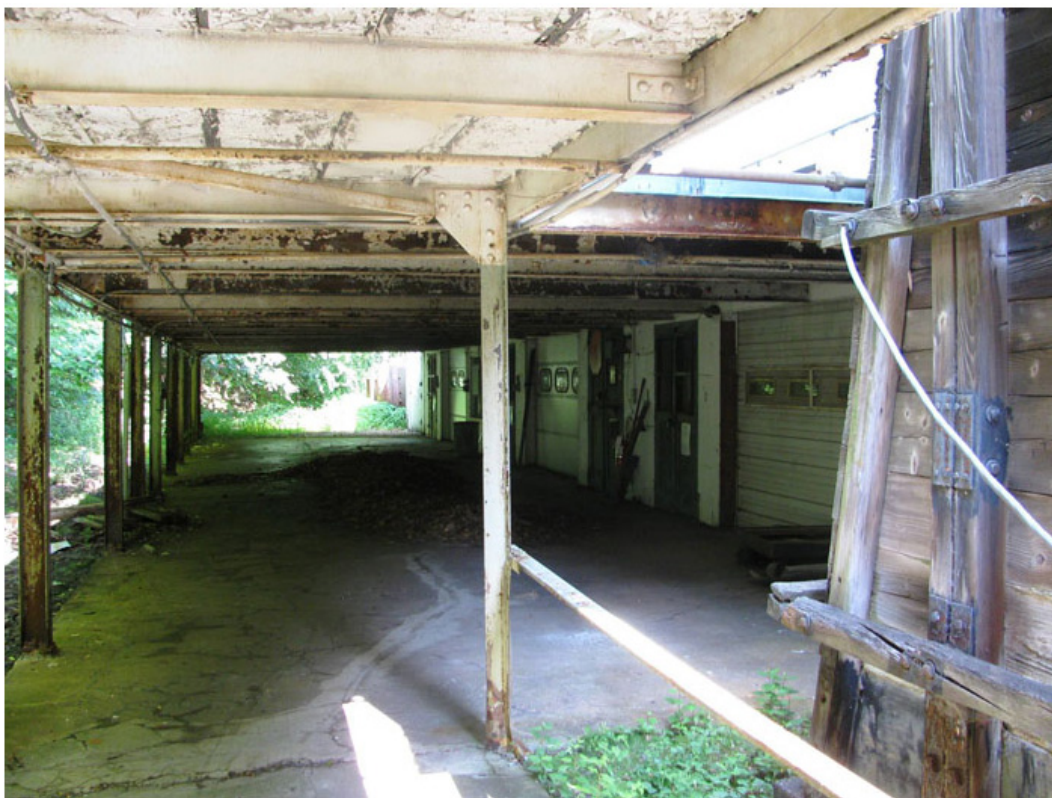
**Figure 239. Southwest side of Building 1503 (PICA Cultural Resources Office).**

Building 1503 was constructed in 1948. It was previously used as powder conditioning building and ordnance facility. Located off Hart Road, it is a long, rectangular, flat-roofed structure with a covered walkway (Figure 239). The building sits on a concrete foundation, has concrete block walls, and a roll roof.<sup>149</sup>

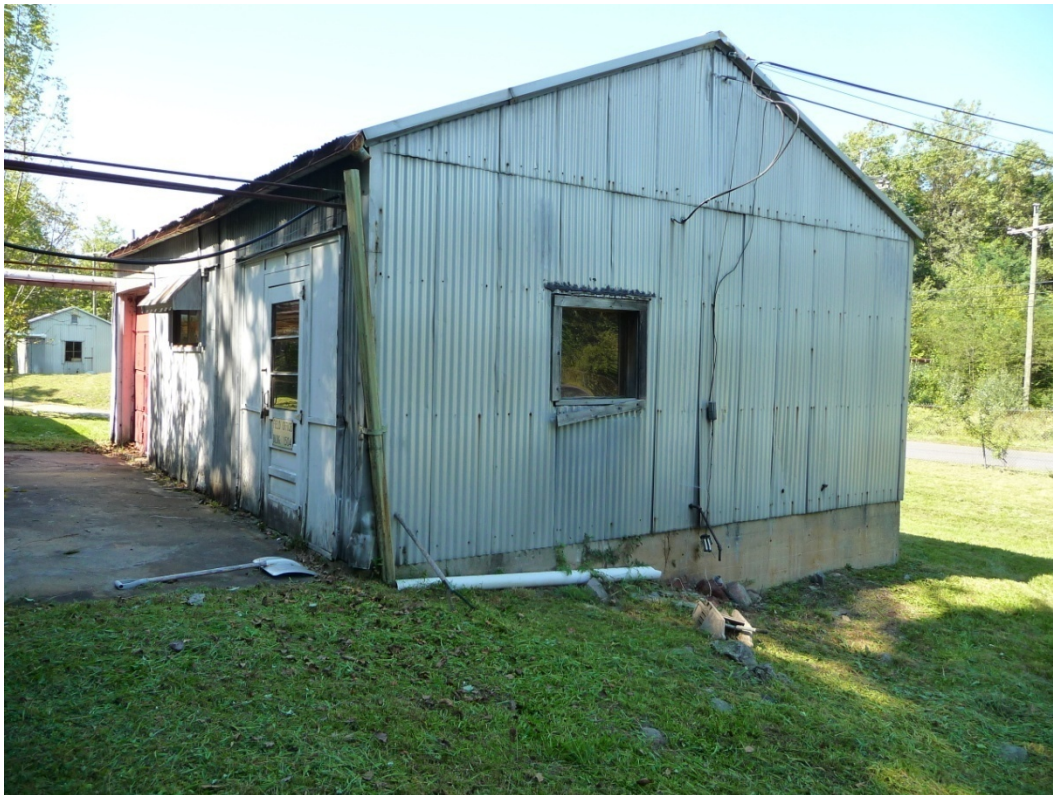
**Figure 240. West elevation of Building 1504 (ERDC-CERL, 2013)).**

Building 1503 was constructed in 1948. It was previously used as an ordnance facility, and a repair and storage shed. Situated along Hart Road, it is a long, rectangular, gable-roofed structure. The building sits on a concrete foundation, has corrugated aluminum walls, and a corrugated aluminum pitched roof (Figure 240).<sup>150</sup>

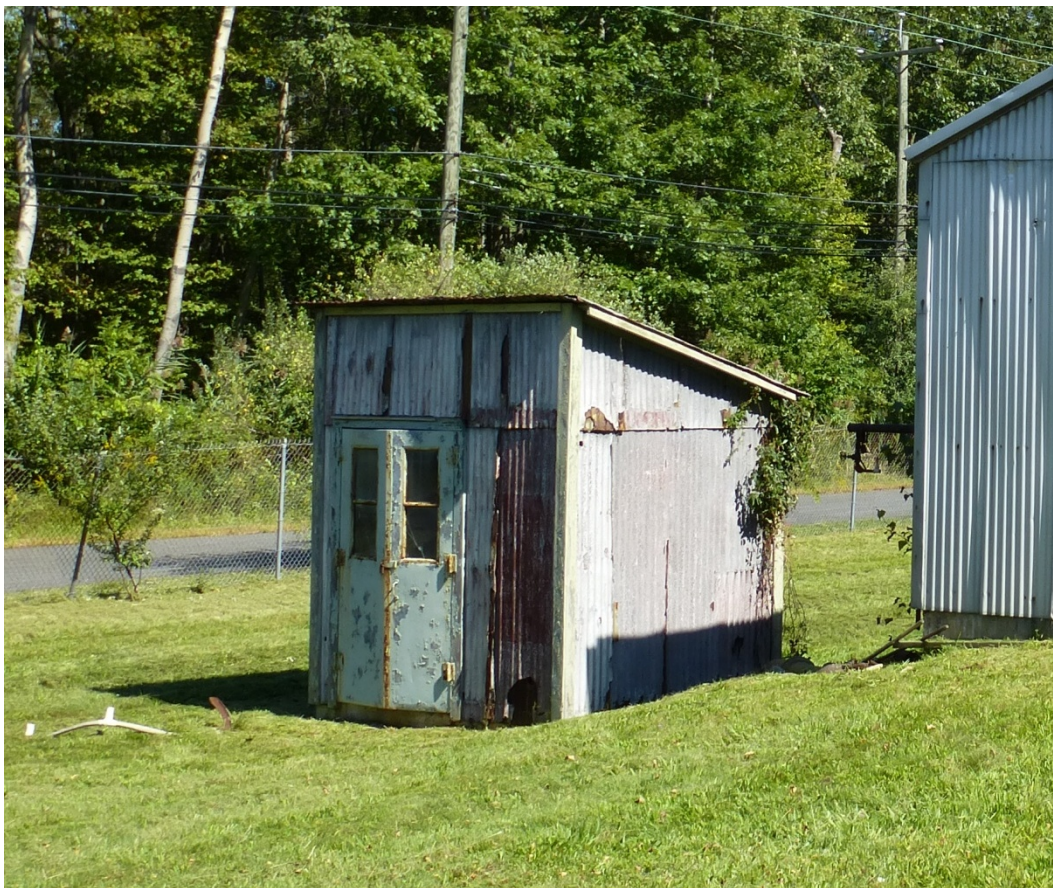
**Figure 241. Southwest oblique of Building 1504A [Building 1504 is to right] (ERDC-CERL, 2012).**

Building 1504A was constructed in 1948. It was previously used as test stand #3, high pressure storage bottle stand and manifold, general purpose warehouse, storage shed, and ordnance facility. Located off Hart Road, it is a small, square, shed-roofed structure with double doors. The building sits on a concrete foundation, has APM walls, and an APM corrugated-aluminum roof (Figure 241).<sup>151</sup>

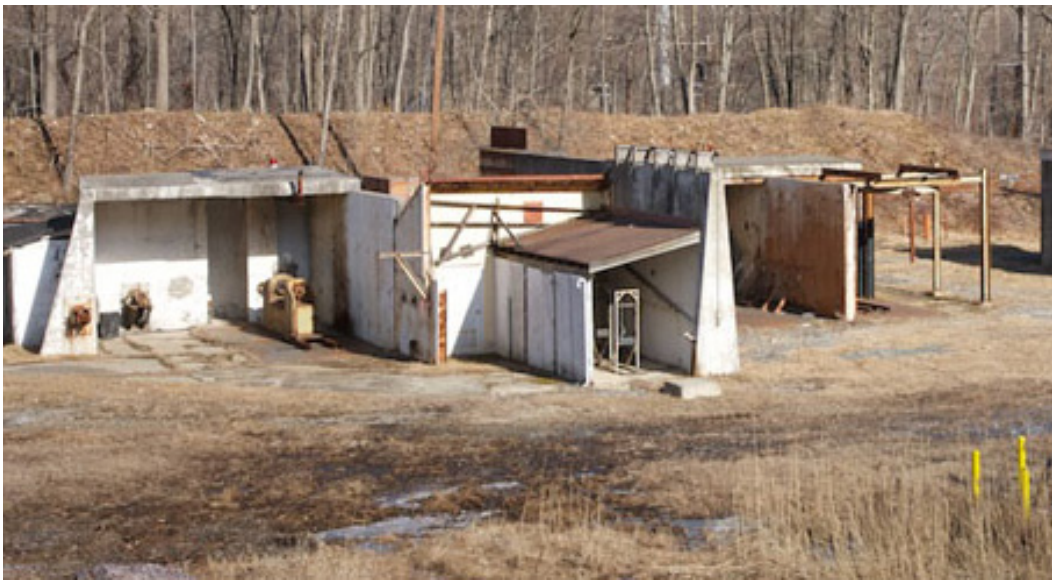
Figure 242. South elevation of Building 1505 (PICA Cultural Resources Office).

Building 1505 was constructed in 1948. It was previously used as an ordnance facility and a rocket static test building. Located off Hart Road, it is rectangular, flat-roofed structure with a covered walkway along the north side. The building sits on a concrete foundation, has concrete walls, and a built-up roof (Figure 242). To the rear of the building is a rocket-test bay with concrete walls.<sup>152</sup>

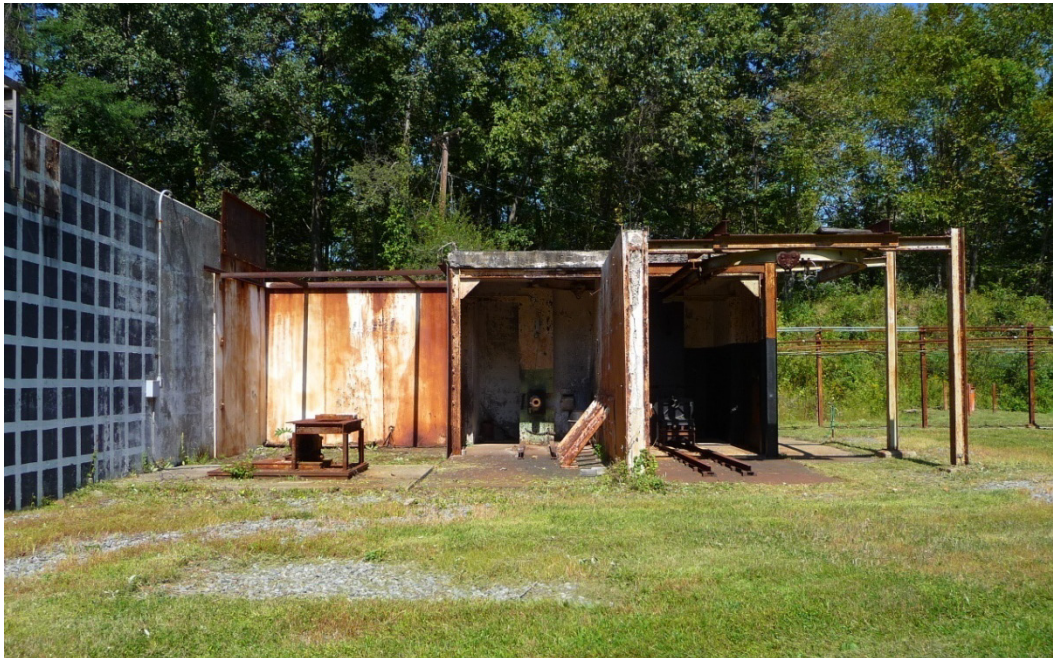
Figure 243. Building 1505A (left) and Building 1505B (right), Test Cells (ERDC-CERL, 2012).

Building 1505A was constructed in 1948 as a test cell. It is a rectangular, flat-roofed structure located along a covered walkway. The building sits on a reinforced concrete foundation, has reinforced concrete and steel, open-back wall, and a reinforced concrete and steel roof. To the rear of the building is a rocket test bay with concrete walls. Building 1505B was constructed in 1948 as test cell. It is a rectangular, shed-roofed structure supported by two I-beams. The building sits on a reinforced concrete foundation, has a reinforced concrete and steel, open-back wall, and a reinforced concrete and steel roof (Figure 243). To the rear of the building is a rocket test bay with concrete walls.

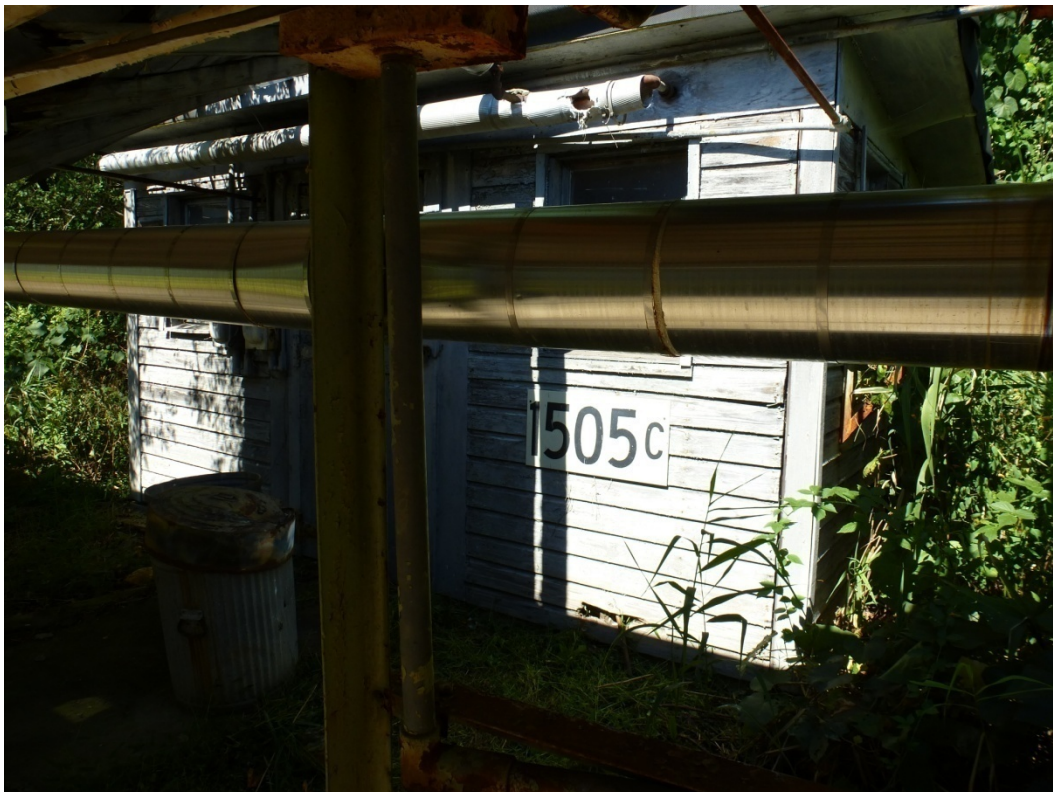
Figure 244. Building 1505C (ERDC-CERL, 2012).

Building 1505C was constructed in 1958 as a control house. It is a rectangular, shed-roofed structure with a central entry flanked by two one-over-one windows. The building sits on a concrete foundation, has wood walls, and a rolled roof (Figure 244).<sup>154</sup>

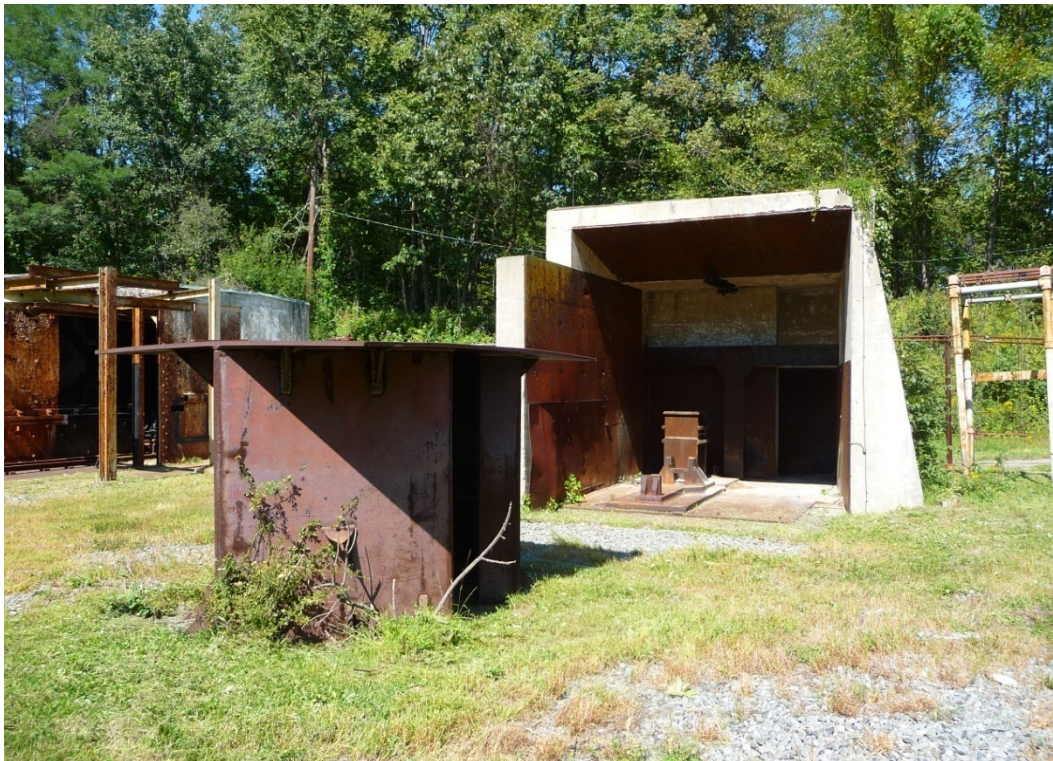
Figure 245. Building 1505D, Test Cell (ERDC-CERL, 2012).

Building 1505D was constructed in 1965 as a test cell off Hart Road, is a rectangular, flat-roofed structure supported by two I-beams. The building sits on a reinforced-concrete foundation, has a reinforced-concrete and steel open-back wall, and a reinforced-concrete and steel roof (Figure 245). To the rear of the building is a rocket-test bay with concrete walls.<sup>155</sup>

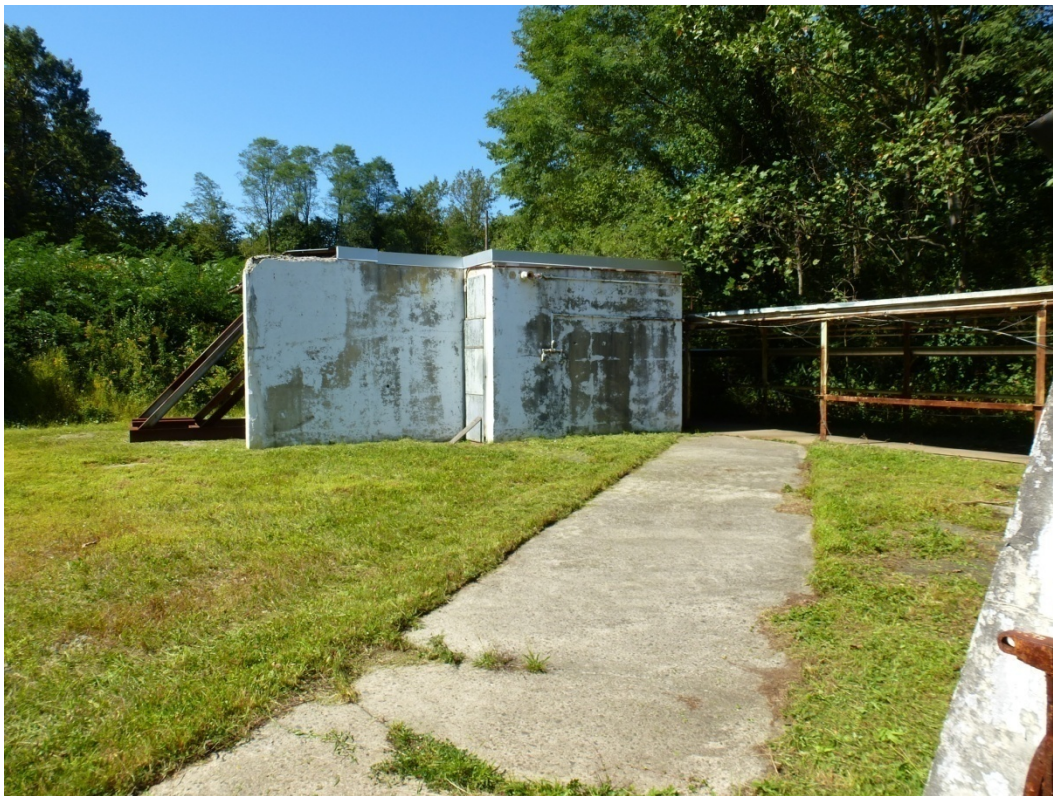
Figure 246. East elevation of Building 1505E and covered walkway (ERDC-CERL, 2012).

Building 1505E was constructed in 1966 as a control spin room. It is a rectangular, gable-roofed structure. The building sits on a concrete foundation, has corrugated-aluminum walls, and a corrugated-aluminum roof which was recently replaced in kind (Figure 246).<sup>156</sup> Building is still in use today.

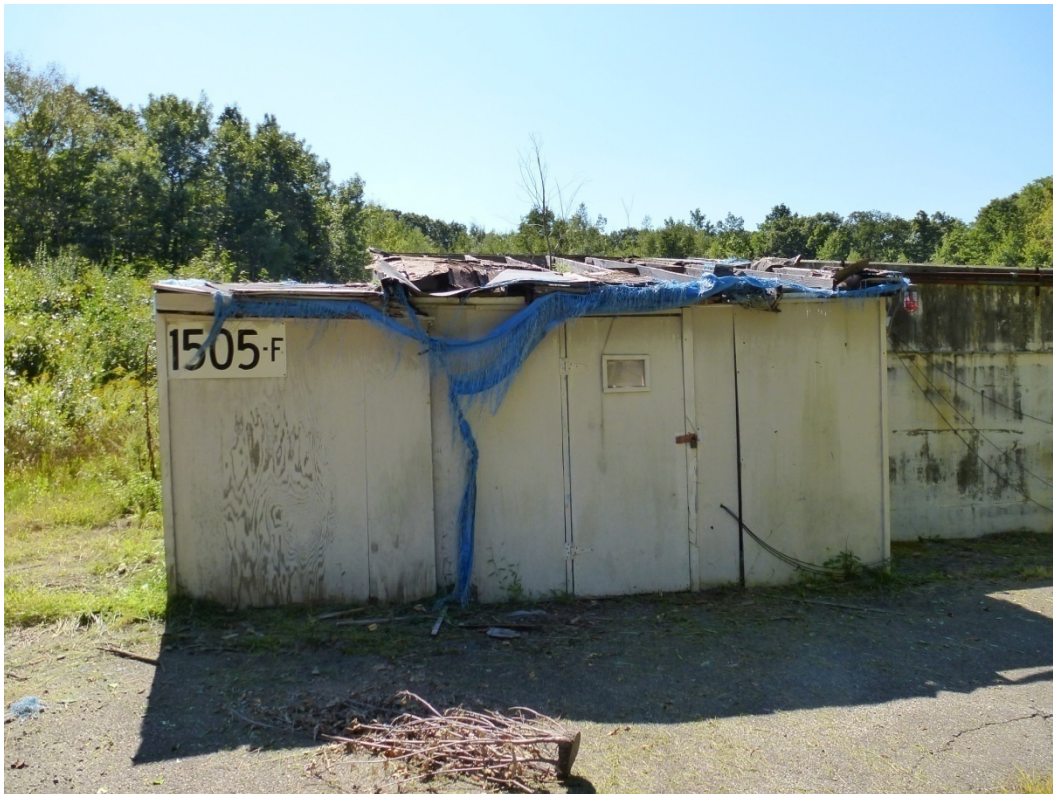
Figure 247. North elevation of Building 1505F (ERD-CERL, 2012).

Building 1505F was constructed in 1959 as a storage facility. A rectangular, shed-roofed structure along a concrete blast wall, the building sits on a dirt foundation, has wood walls, and a wood and asbestos roof (Figure 247).<sup>157</sup>

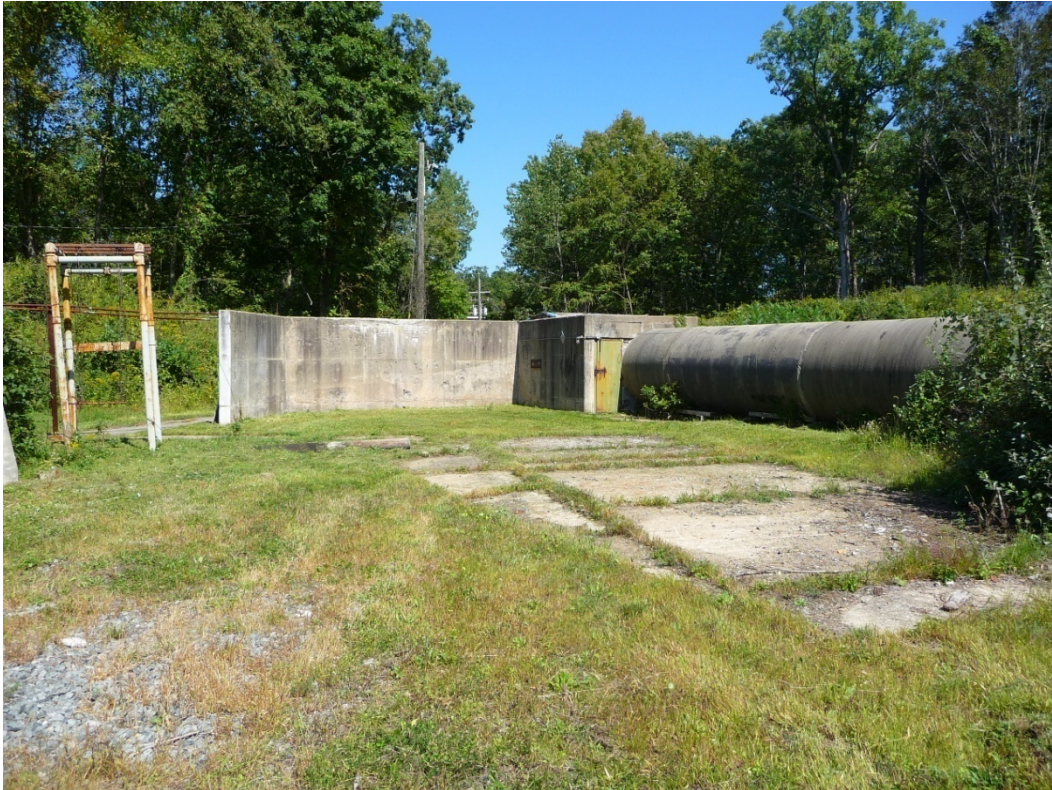
Figure 248. Building 1505N, Storage Building and Wind Tunnel (ERDC-CERL, 2012).

Building 1505N was built in 1948 as an open top and back-blast area. It is a three-sided structure with a reinforced-concrete foundation, reinforced-concrete walls (Figure 248).<sup>158</sup>

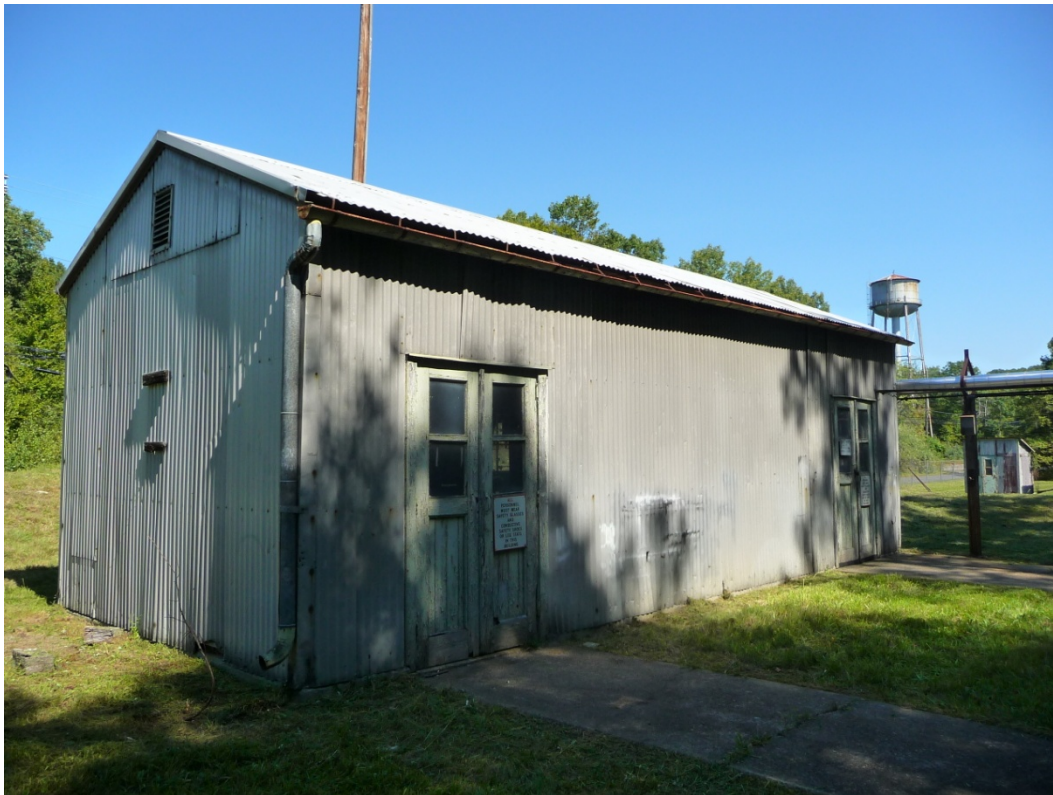
Figure 249. Southwest oblique of Building 1506 (ERDC-CERL, 2012).

Building 1506, an ordnance facility and a loading and assembly building, was moved to this site in 1946 from the Loki Test Facility. The initial construction date is unknown. It is a rectangular, gable-roofed structure that sits on a concrete foundation, has corrugated-aluminum walls, and a corrugated-aluminum pitched roof (Figure 249).<sup>159</sup>

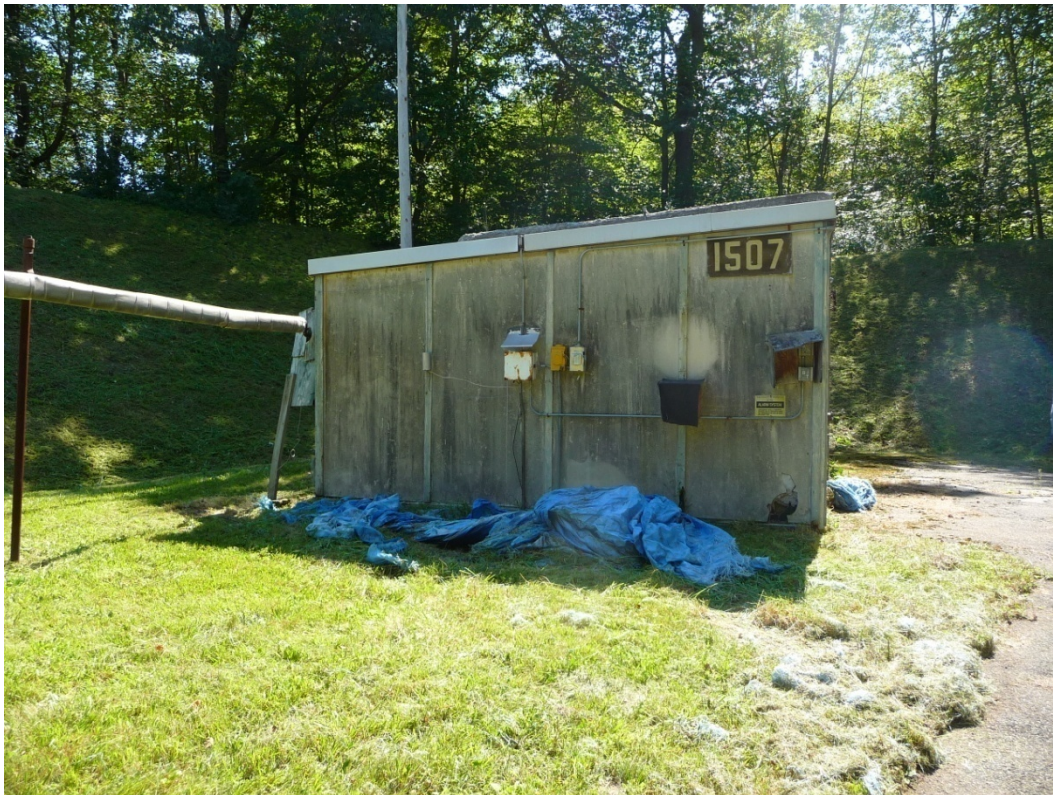
Figure 250. North elevation of Building 1507 (ERDC-CERL, 2012).

Building 1507 was constructed in 1946. It was previously used as a high explosive (HE) and general purpose magazine. The building is a rectangular, flat-roofed structure with interior blast walls extending above the main roof line. The building sits on a concrete foundation, has transite walls, and a tar paper on wood roof (Figure 250).<sup>160</sup>
