## **Cultural Landscape Analysis of Existing Historic Districts**

Picatinny Arsenal, New Jersey

Final report

Under Project 201221, "Cultural Landscape Analysis, Picatinny Arsenal, New Jersey"

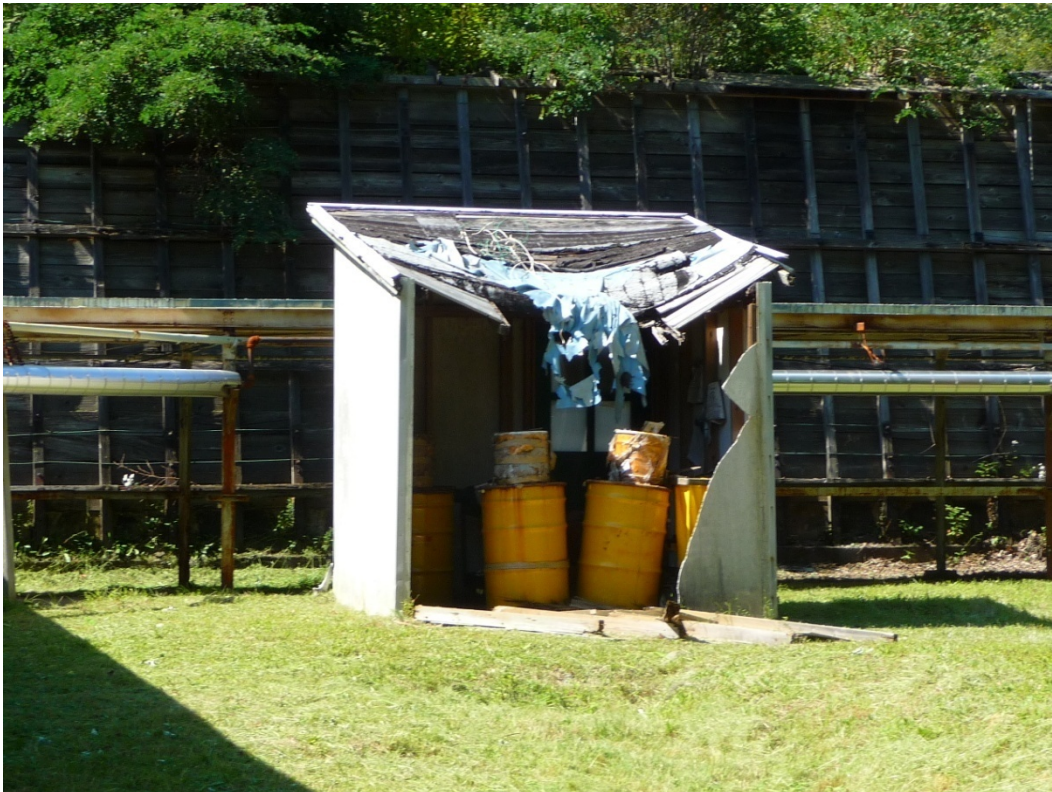
**Figure 251. Building 1508, High Explosives Magazine (ERDC-CERL, 2012).**

Building 1508 was constructed in 1952 as a boiler house for Building 1505. It was located to the east of 1505. In 1963 it was relocated near 1505E and reserviced for Class 9 inert storage. In 1967, it was moved to its current location adjacent to 1502 and 1503 and used for Class 7 powder storage. It was recently damaged in a wind storm and is slated for demolition. The building is a rectangular, shed-roofed structure that sits on a concrete foundation, has transite walls, and a transite roof (Figure 251).<sup>161</sup>

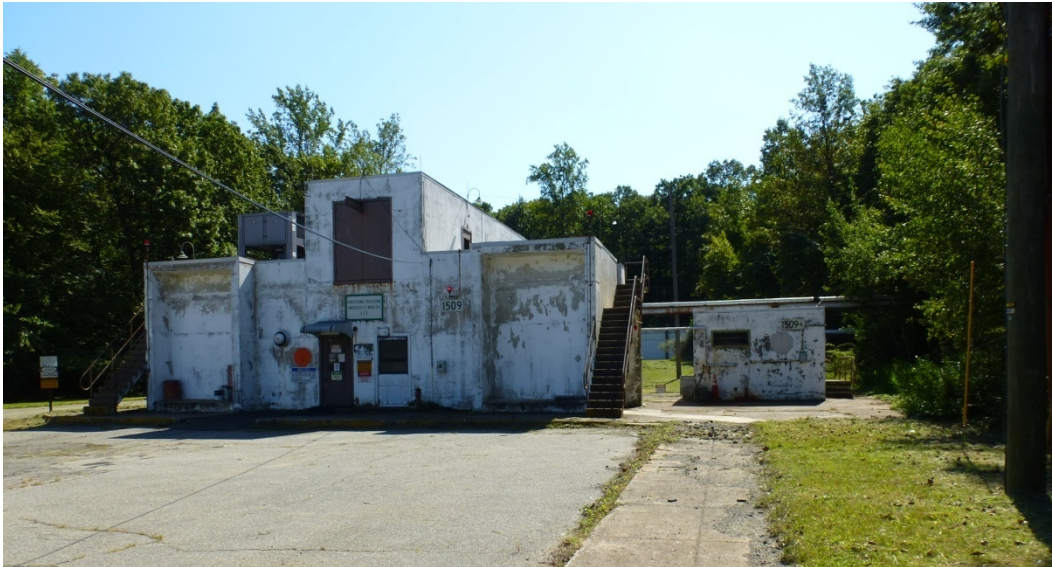
Figure 252. North elevation of Building 1509 (ERDC-CERL, 2012).

Building 1509 was constructed in 1950. It was previously used as an ordnance facility and a pyrotechnic pressing (placing under pressure [literally pressing] explosive elements so that they would detonate evenly and with great force) building and laboratory off Sage Place. It is a rectangular, flat-roofed structure, with two one-story bays with exterior stairs that flank the main two-story entrance. A series of blast bays with the blast walls extending above the one-story roofline is south of the building. The building sits on a reinforced-concrete foundation, has reinforced-concrete walls, and a build-up reinforced-concrete roof (Figure 252).<sup>162</sup>

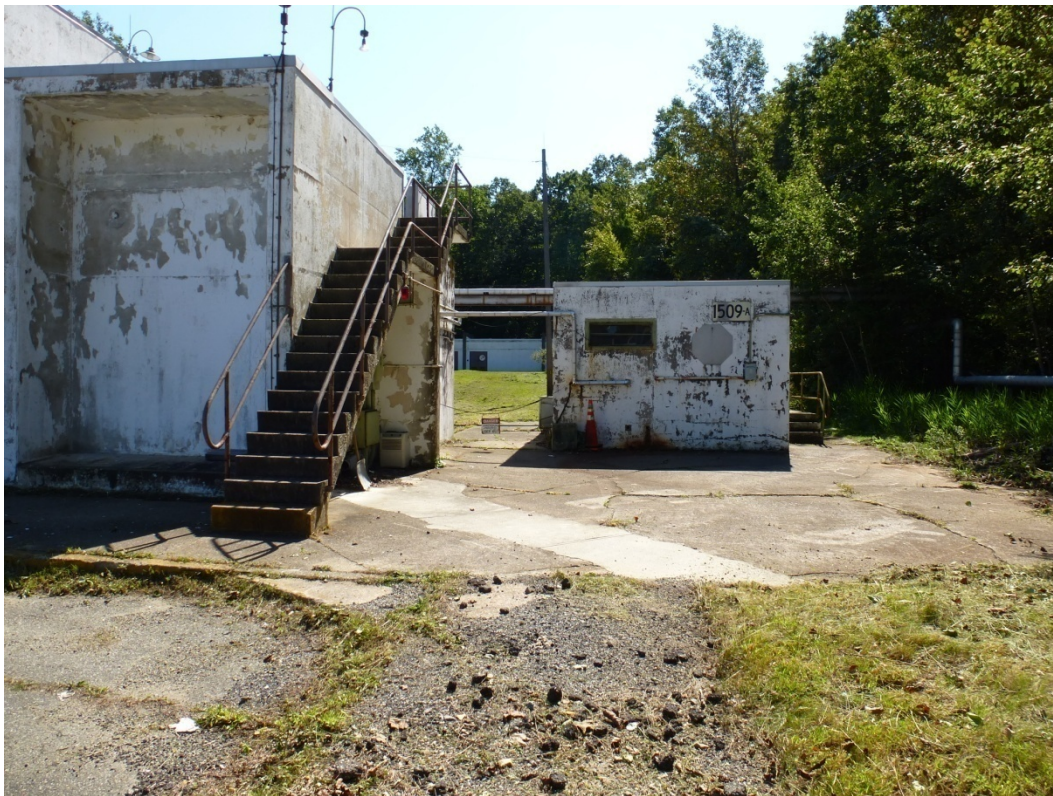
Figure 253. North elevation of Building 1509A (right), with pipes connecting it to Building 1509 (left) (ERDC-CERL, 2012).

Building 1509A is associated with Building 1509, an Ordnance Test Facility, that had been used at various times for pyrotechnic pressing, a laboratory, and as a general ordnance facility. Building 1509A is the heating building for 1509, and it is connected by a series of shared pipes (Figure 253).<sup>163</sup>

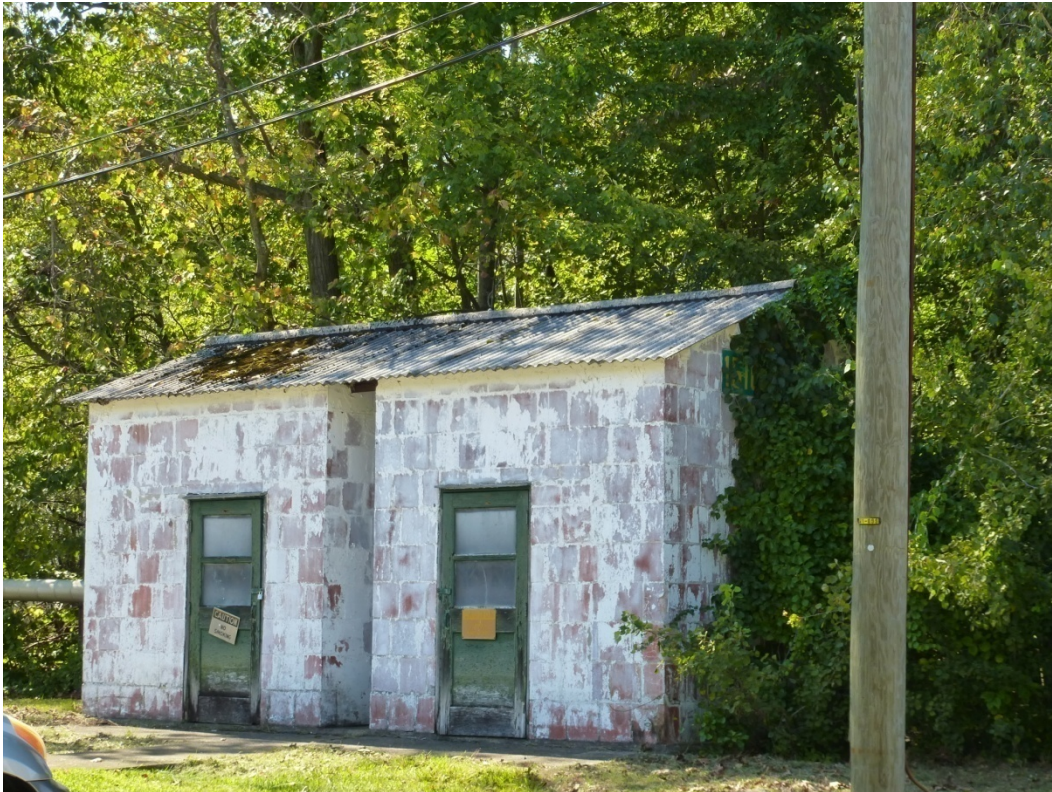
Figure 254. East elevation of Building 1510A, which was recently demolished (ERDC-CERL, 2012).

Building 1510A was a storage facility for the pyrotechnics laboratories and was constructed in 1960 to replace two temporary storage buildings that stood in the same general location (these were labeled 1510A and 1510B). It was demolished recently. The building consisted of two separate, mirror-image, hollow-tile structures that shared a common roof (Figure 254). It was oriented toward Buildings 1512 and 1515 across the parking area, and a concrete walkway led from the parking area to doors that were slightly offset toward each other on the east façade of each section. Six-pane windows were set centrally in the west façade of each section. The interior of each section consisted of a single room lined with plywood shelving.<sup>164</sup>

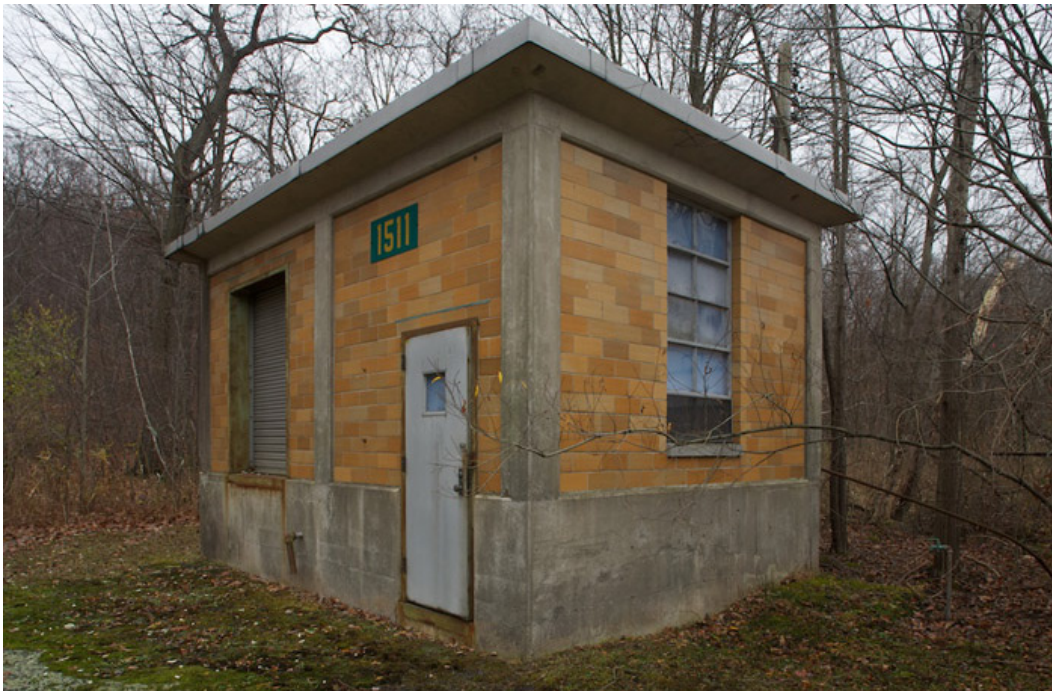
Figure 255. Northwest oblique of Building 1511 (PICA Cultural Resources Office, 2012).

Building 1511 was a small, rectangular, flat-roofed structure (Figure 255), located at the far eastern end of the district and behind Building 1512. It was listed as a conditioning building and a storehouse on building records, and was identified as a neutralizing and pump station in the architectural survey. A door was located in the west bay of the north façade (front) of the building, and the adjacent east bay had a raised opening with a roll-up steel door (a loading dock). Windows were located in each bay of each of the other sides of the building. The east half of the building interior had an upper level, labeled as a "high pressure laboratory" on a 1976 electrical plan. It had exterior access via the loading dock door, and inside access via a set of metal steps and a door located just to the left of the building entryway. Steps also led down from the entryway into the semi-subterranean basement level, which extended the entire length of the building. A small stream flows through the district just east of the building, causing flooding in the basement.<sup>165</sup> Building is slated for demolition.

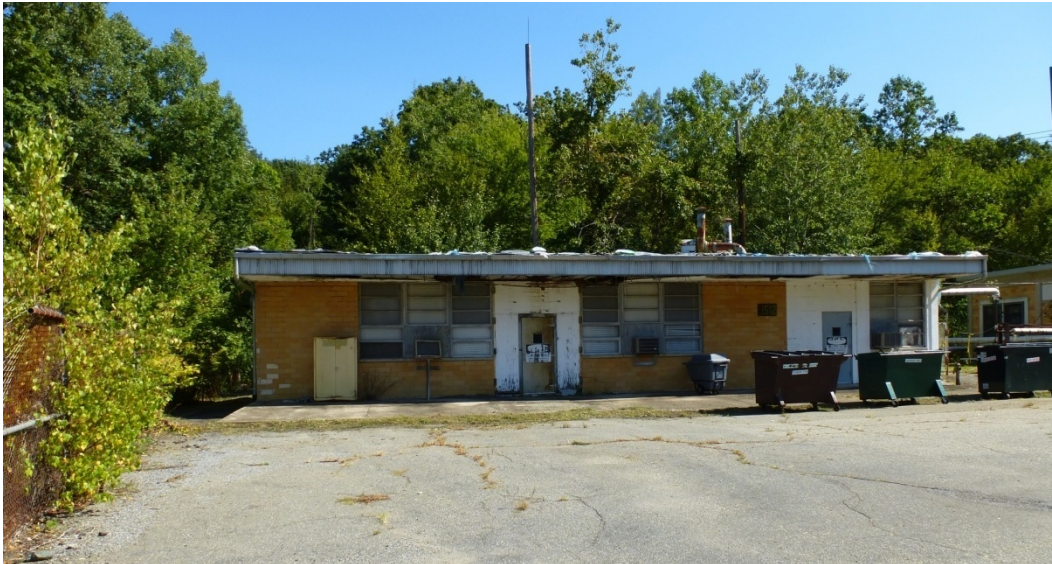
**Figure 256. Building 1512, Physics Laboratory northwest elevation (ERDC-CERL, 2012).**

Building 1512 was built in 1956 to house an additional laboratory for the existing pyrotechnics R&D facility. It is rectangular shaped with a concrete foundation and glazed-tile walls. The building has a central double doorway on the west (front) façade (later replaced with a single door), flanked by large windows, plus windows at the rear. The building contained four laboratory rooms equipped with fume hoods, an office, and a small conference room. In 1964, an extension was built on the south side, adding two additional laboratory rooms, each with an exterior entrance door and window. A bin for storing gas cylinders was later added to the south side of the addition. Building 1512 housed chromatography and spectroscopy instrumentation in the 1950s and 1960s but circa 1970, the majority of the building was in use as a laser laboratory. Laser technology, developed at the end of the 1950s and first operated successfully in 1960, was soon under study in the military for use in igniting pyrotechnic devices (as well as for weapons guidance systems). Building 1512 was being used for equipment storage prior to being vacated for demolition (Figure 256).<sup>166</sup> Building 1512 is slated for demolition.

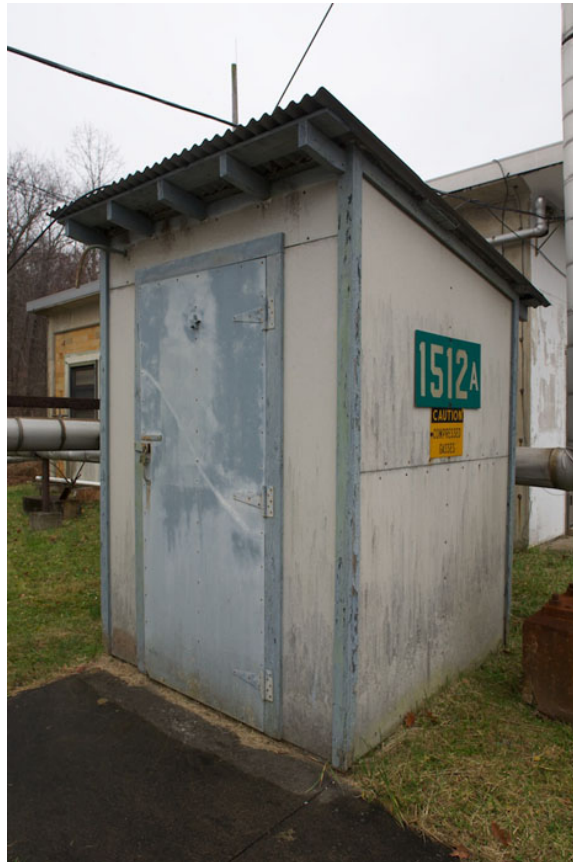
Figure 257. View south of Building 1512A, General Purpose Storehouse (PICA Cultural Resources Office, 2012).

Building 1512A was built in 1958 for flammable materials storage. It is a small square building with a central doorway and a louvered vent on one side. The building once stood at the rear of Building 1512 near its south corner. When the extension was built on the south side of Building 1512 in 1964, Building 1512A had to be moved; it was placed between Buildings 1512 and 1513, with its door oriented to Building 1512 (Figure 257). As was typical at Picatinny, flammable or explosive materials were stored separately from the laboratories where they were used for experiments.<sup>167</sup> Building is slated for demolition.

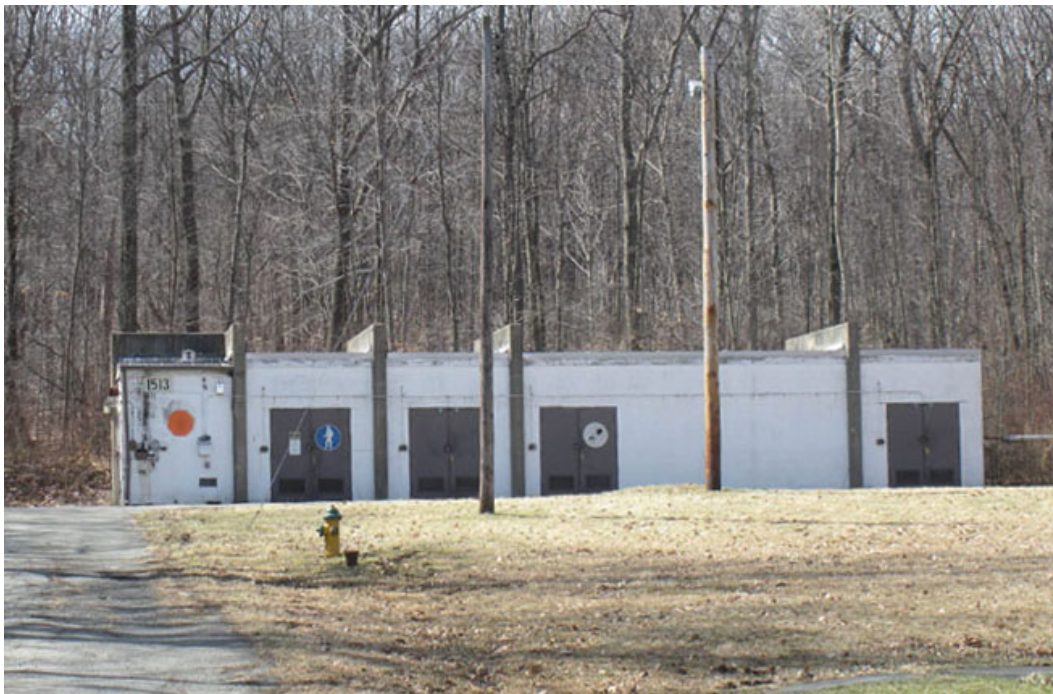
**Figure 258. View south at Building 1513, General Purpose Magazine (PICA Cultural Resources Office, 2012).**

Building 1513 was constructed in 1968. It was previously used as a general purpose magazine, pyrotechnic R&D laboratory, and an engineering laboratory. Located off Sage Place, it is a long, rectangular, flat-roofed structure with interior blast walls extending above the main roof line. The building sits on a reinforced-concrete foundation, has concrete-block walls, and a build-up on wood roof (Figure 258).<sup>168</sup>

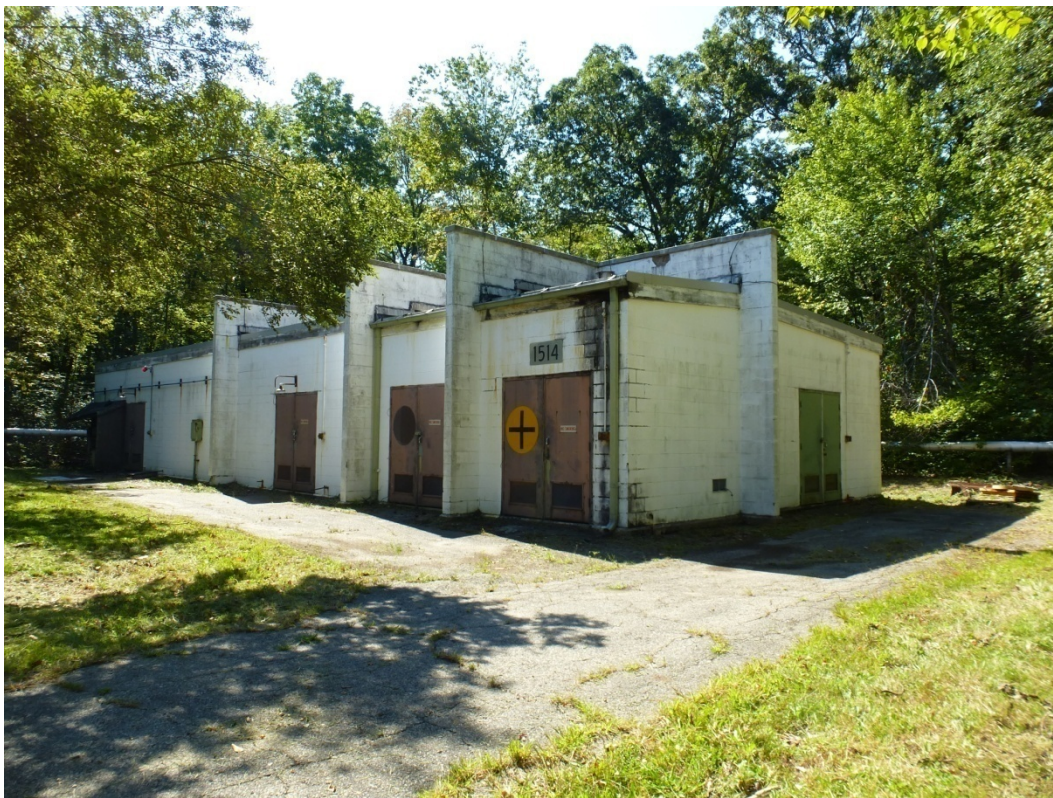
**Figure 259. View south of Building 1514, Pyrotechnic R&D Laboratory (ERDC-CERL, 2012).**

Building 1514 was constructed in 1968. It was previously used as a liquid storage non-propellant flame and incendiary trajectory dissemination facility, pyrotechnic R&D laboratories, and flammable materials storehouse. Situated off Sage Place, it is a long, rectangular, flat-roofed structure with interior blast walls extending above the main roof line (Figure 259). The building sits on a reinforced-concrete foundation, has concrete-block walls, and a build-up on wood roof. An addition was made in 1968 by Rouse, Dublin & Ventura Architect and Engineers of New York.<sup>169</sup>

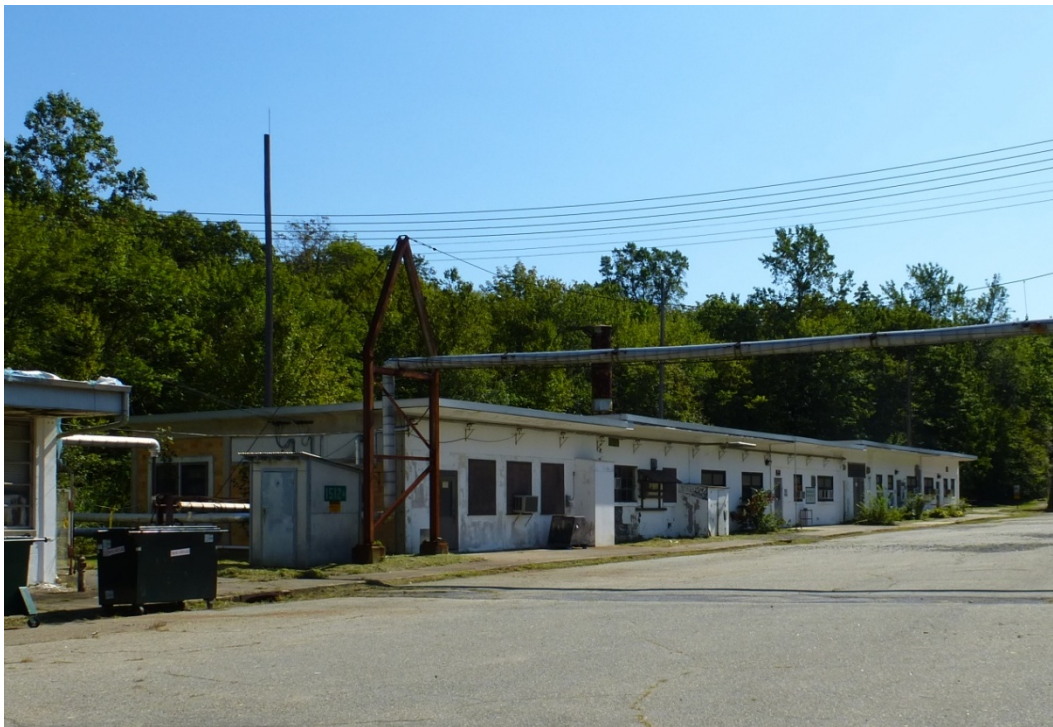
Figure 260. View south of Building 1515 (ERDC-CERL, 2012).

Building 1515 was built in 1961 and previously used as a laboratory, propellant mixing station, and electrical equipment facility. Located along Sage Place, it is a long, rectangular, flat-roofed structure with a central smokestack. The building sits on a reinforced-concrete foundation, has concrete block walls, and a build-up on wood roof (Figure 260). An addition was made in 1968 by Rouse, Dublin & Ventura Architect and Engineers of New York.<sup>170</sup>

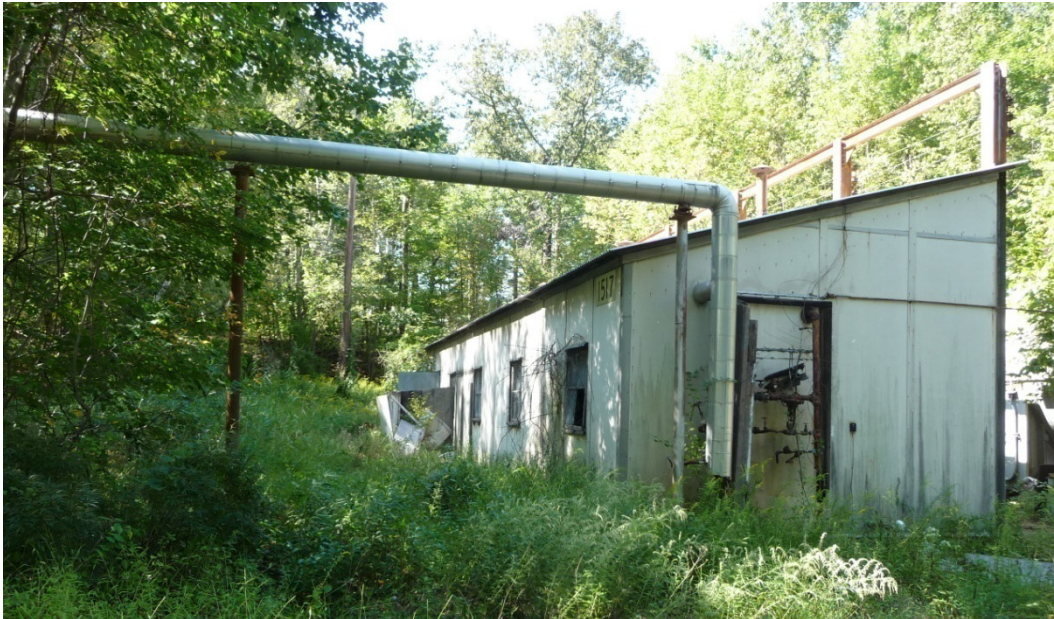
This pyrotechnics testing complex sat in a well-protected location surrounded by natural berms, just inside the Former Rocket Test Area Historic District. Reflecting the military's Cold-War era readiness agenda, the facility was designed to simulate conditions of high-altitude flight. It consisted of two steel cone-shaped altitude test chambers, and the buildings housing the pumps and instrumentation used to operate the chambers and monitor the tests conducted in them. The first structures, erected in 1956 (based on plans drawn in 1953–54), included one 75 ft-long test chamber (Chamber No. 1) and the long, narrow pump room adjacent to its south side (both were considered Building 1517; Figure 261); a frame instrument room behind the chamber (Building 1518; Figure 262); a frame electrical control room (later referred to as 1517A) adjacent to the instrument room and abutting the rear corner of the pump room; and small magazines set off in the woods nearby (Buildings 1519 and 1520; Figure 263) (see building inventory in Table 7). Six vacuum pumps were installed in the pump room and connected to the chamber. A conditioning room, to house equipment used to bring test items to temperature specifications, was added immediately behind the pump room in 1957 or 1958. This structure, sometimes labeled as Building 1517A (but not to be confused with the adjacent electrical control room), was no longer standing at the time the complex was surveyed for historic architecture in 2007. Plans for a second steel test chamber, Chamber No. 2, were drawn up in 1957, and construction was completed circa 1960. At that time, the instrument room at the rear was expanded to encompass the back of the second chamber. In 1964 a new concrete-block observation room (Building 1518A) was constructed between the two test chambers, toward the front. A new exhaust system for the chambers was installed in 1968, including a dome on Chamber No. 2 to facilitate the dispersion of smoke and powder from flare tests.<sup>171</sup>

**Figure 261.** Building 1517, now demolished, consisted of two large, connected chambers and a number of associated, connected buildings (ERDC-CERL, 2012).

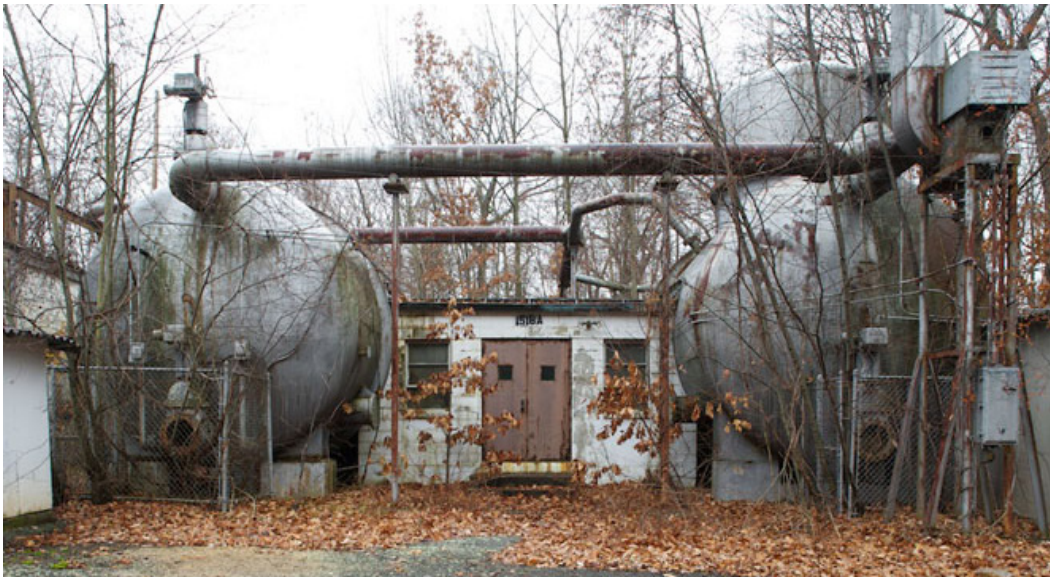
**Figure 262.** Building 1518, now demolished, connected Chambers #1 and #2 with Building 1517A in the middle (PICA Cultural Resources Office, 2011).

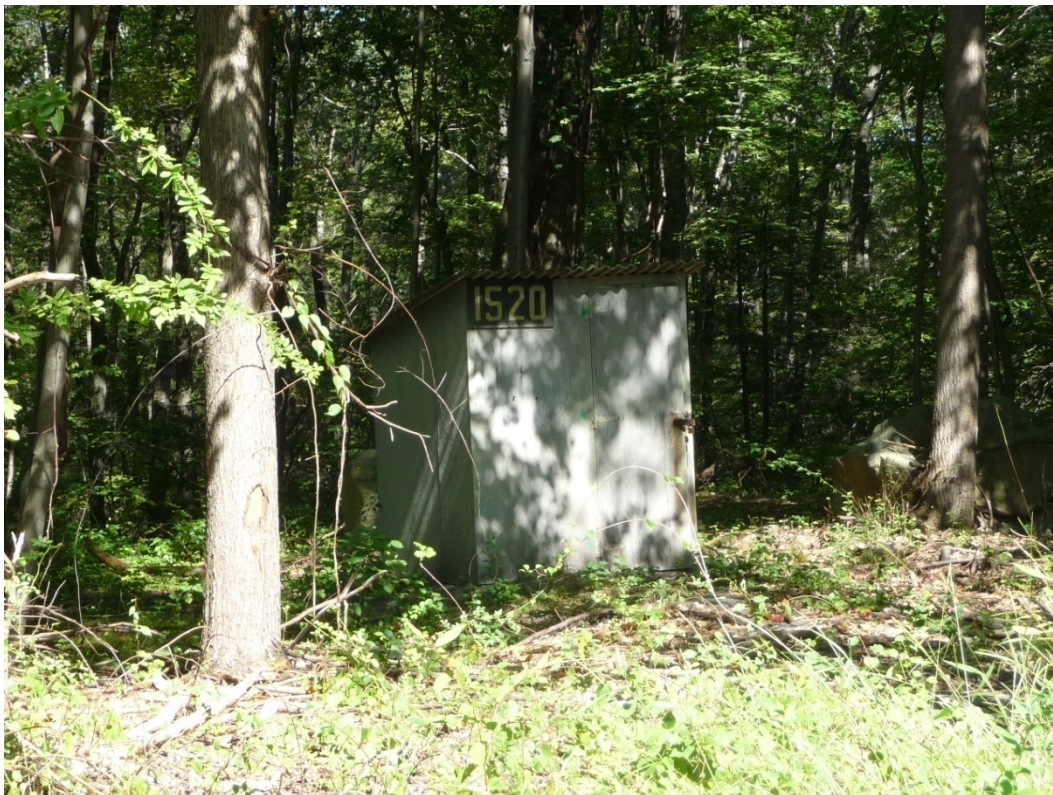
Figure 263. Building 1520, now demolished, was identical to 1519 (ERDC-CERL, 2012).

These small, square structures were built in 1956 for use as ready magazines to store items being tested in the high-altitude chambers. Records indicate that these buildings were part of the original complex, though not typically shown on plans. The buildings were sited in the woods, well away from the test chambers for safety; Building 1519 stood 72 feet north of the front of the Chamber No. 1, and Building 1520 (Figure 263) stood 80 feet to the northeast.<sup>173</sup>

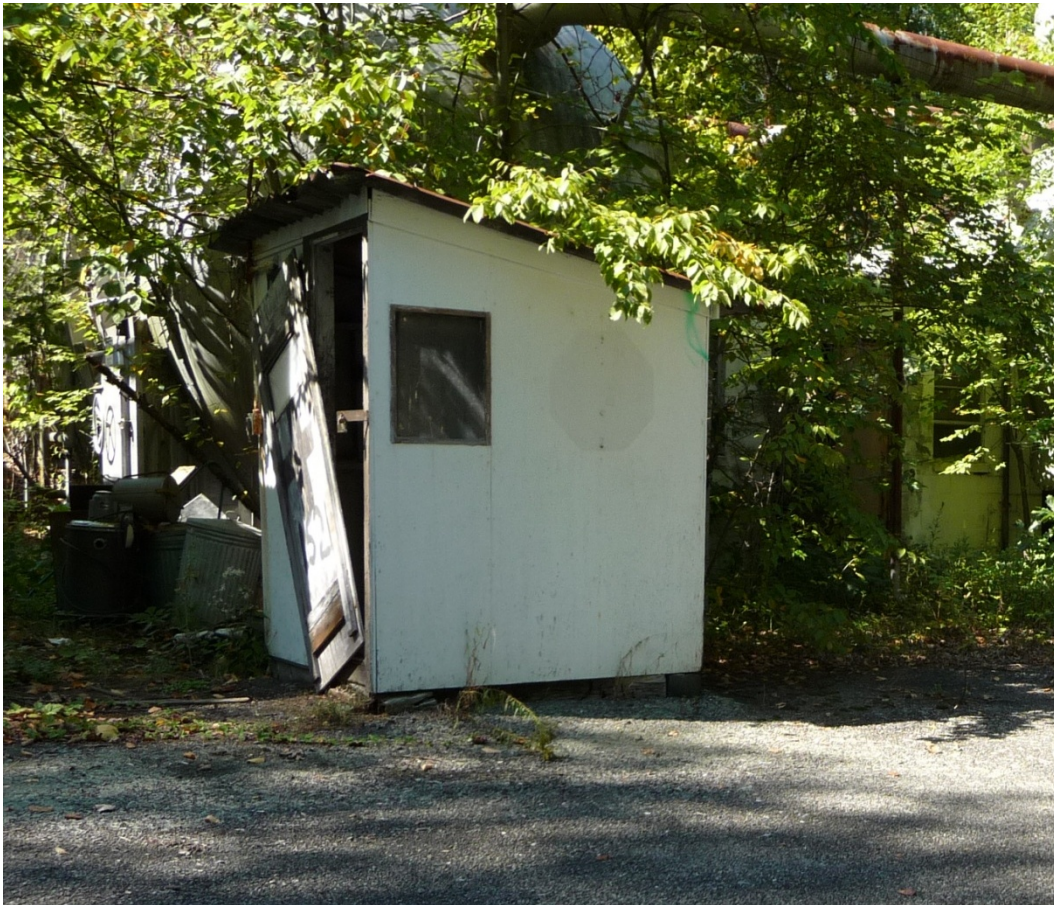
Figure 264. Building 1521, now demolished (ERDC-CERL, 2013).

Building 1521 was a salvaged ordnance shed placed in front of Chamber No. 1 in 1960 and used for preparing pyrotechnic components for testing. It was a small, square, plywood structure with a shed roof, a door and two windows, and an electrical connection for lighting (Figure 264).<sup>174</sup>

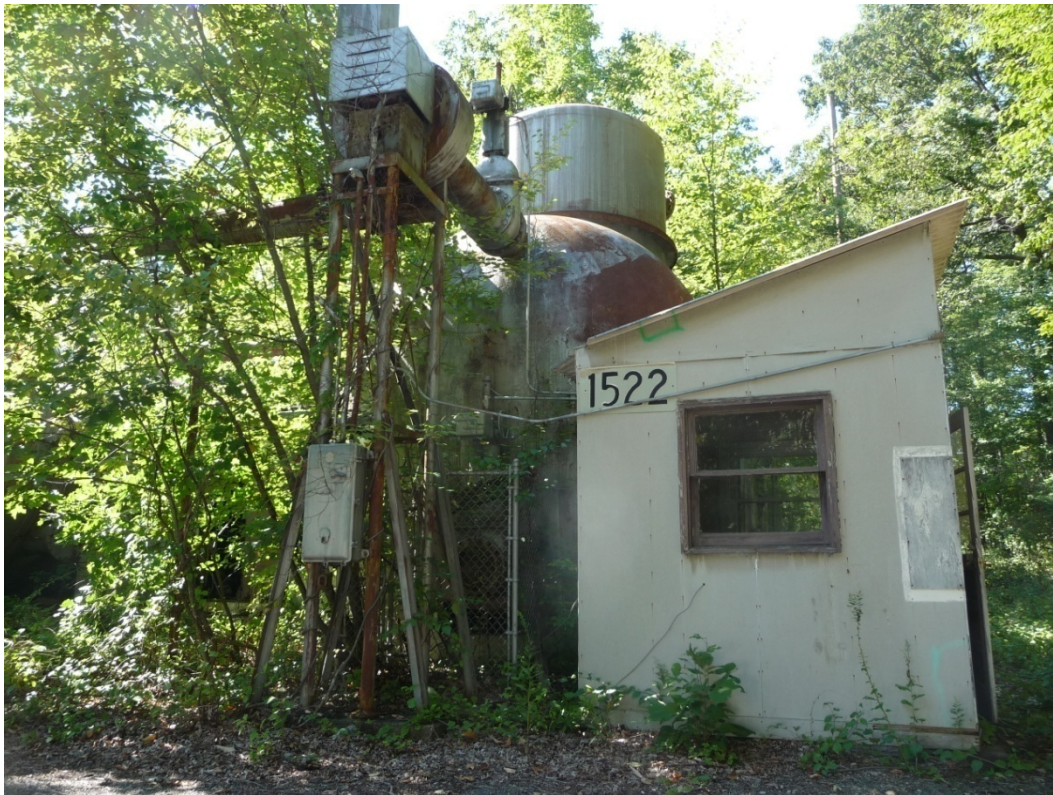
Figure 265. East elevation of Building 1522, now demolished (ERDC-CERL, 2012).

Like Building 1521, Building 1522 was an ordnance shed salvaged from elsewhere on the base. It was placed in front of Chamber No. 2 in 1970 and used for preparing pyrotechnic components for testing. The small, square, shed-roofed structure had a door on the north (front) elevation and windows on the east and west sides (Figure 265).<sup>175</sup>

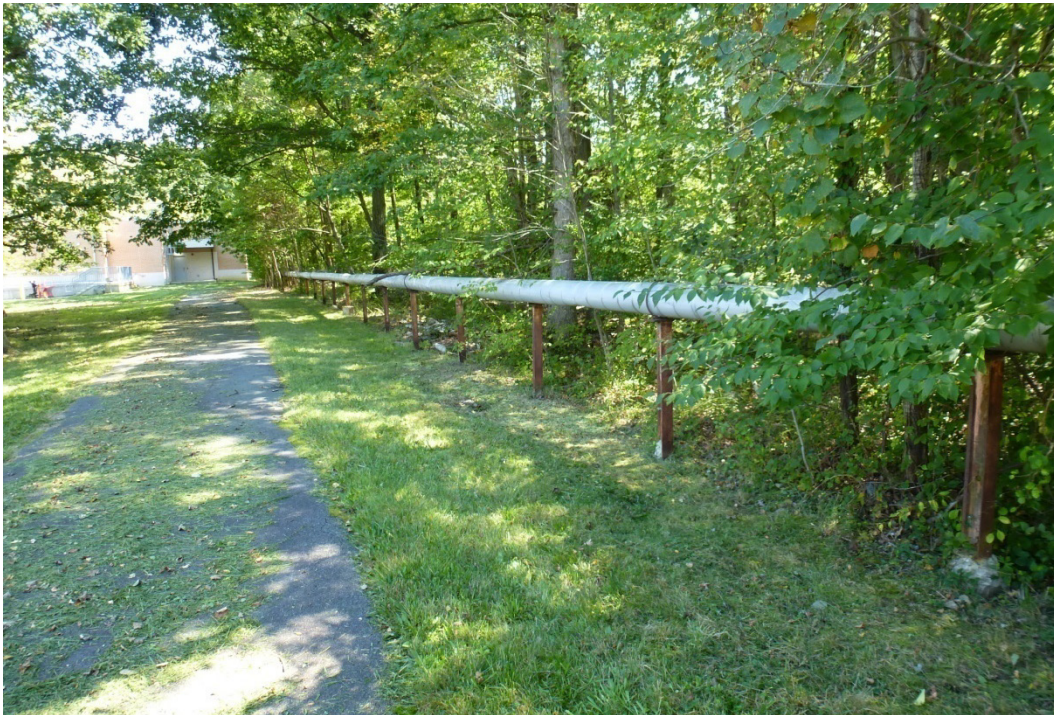
The Steam Line Distribution System is a network of metal or asbestos-protected metal conduit running above ground from the power plants throughout PICA. A centralized system of steam throughout PICA and the Lake Denmark NAD provided a source of heating and also allowed production facilities throughout the installation to use pressurized steam as a sparkless form of energy. The steam was created as a by-product of electricity produced at the Power Plant (Building 506, originally Building 1906) and the Boiler House (Building 3013, originally Building 1901). Water from Picatinny Lake was heated, and the steam was forced through turbines to produce energy. Pressurized steam was then sent to production facilities via metal conduit. On site, buildings were fitted with pressure-reducing valves and steam-powered equipment to reduce the risk of explosion. Overall, the Steam Line Distribution System consists of a network of metal conduit, supporting structures, and pressure-reducing valves. Most of the system visible has been replaced, but there are remnants of an earlier system of conduit supported on cast stone piers and on metal structures when crossing over roads (Figure 266 and Figure 267).<sup>176</sup>

Figure 266. Remnants of steam conduit supported on cast stone piers (ERDC-CERL, 2012).

<b>Steam lines</b>	Steam lines existed historically throughout installation	<ul style="list-style-type: none"> <li>• Still in use</li> <li>• Has been replaced as needed</li> </ul>	Yes
<b>Testing flagpole</b>	Flagpole is located along the main road to warn of testing.	<ul style="list-style-type: none"> <li>• Rusted</li> </ul>	Yes
<b>Fencing and sidewalk</b>	Built to restrict access for security and safety.	<ul style="list-style-type: none"> <li>• Entrance gate is newer; entire area fenced.</li> </ul>	Yes

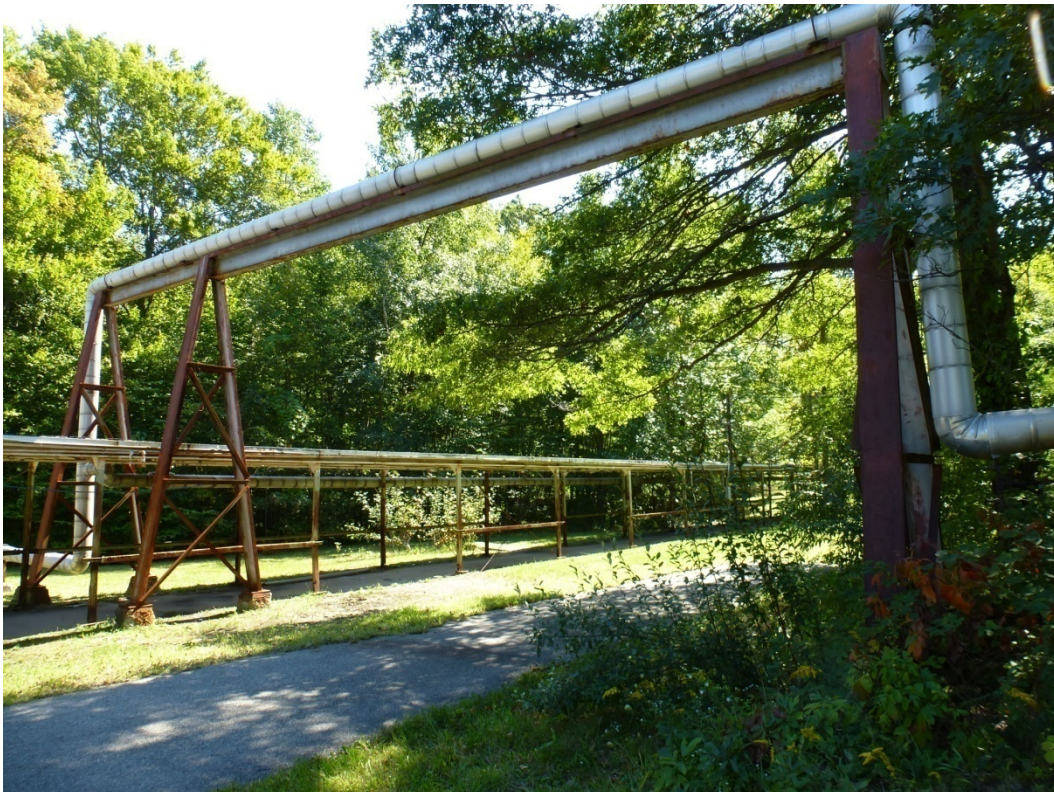
Figure 267. Steam lines supported by metal structure over the paved road (ERD-CERL, 2012).

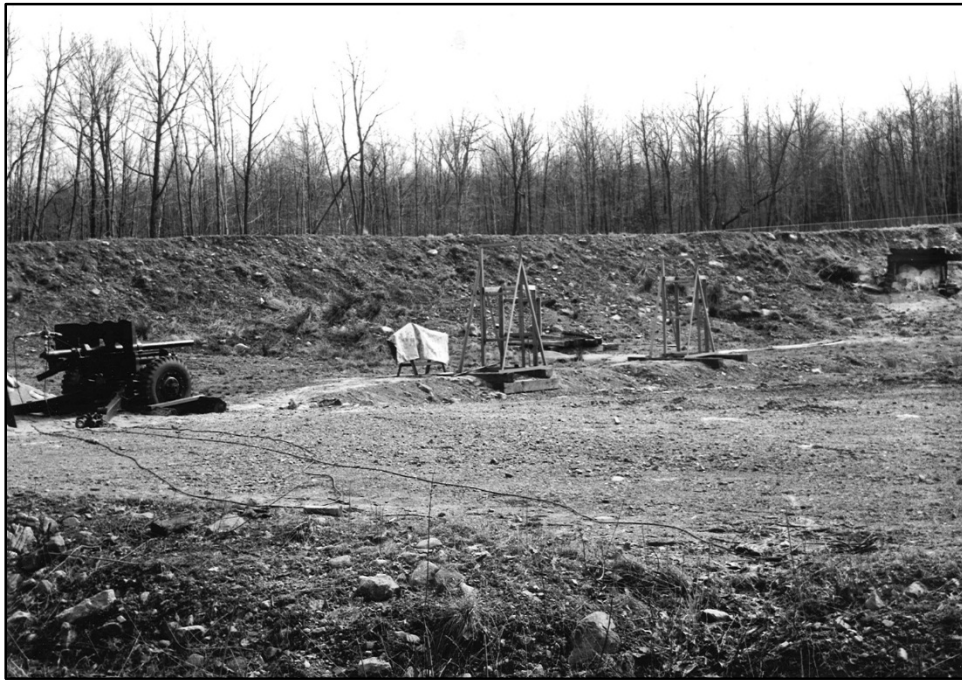
Figure 269. Arrangement of velocity screens for use with 57 mm gun at range at Building 1505, 1951 (Picatinny Arsenal Cultural Resources).

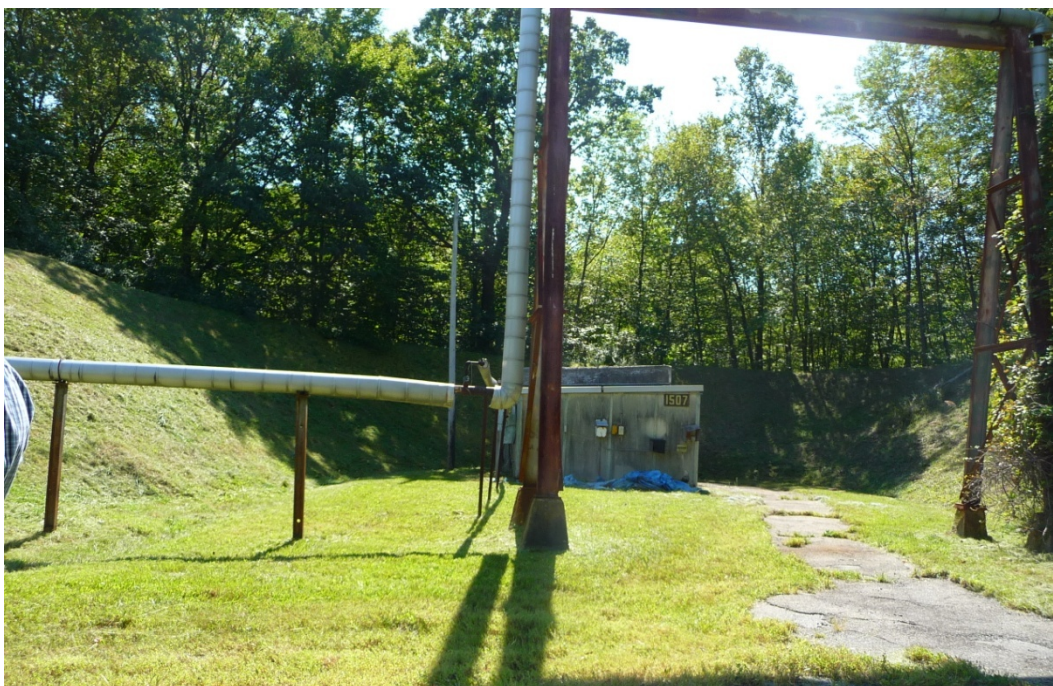
Earth barricades or berms were built for protection. They were found in the test area and were constructed around propellant magazines (Figure 272 through Figure 274).

Figure 273. Earth barricades around Building 1507 (ERDC-CERL, 2012).

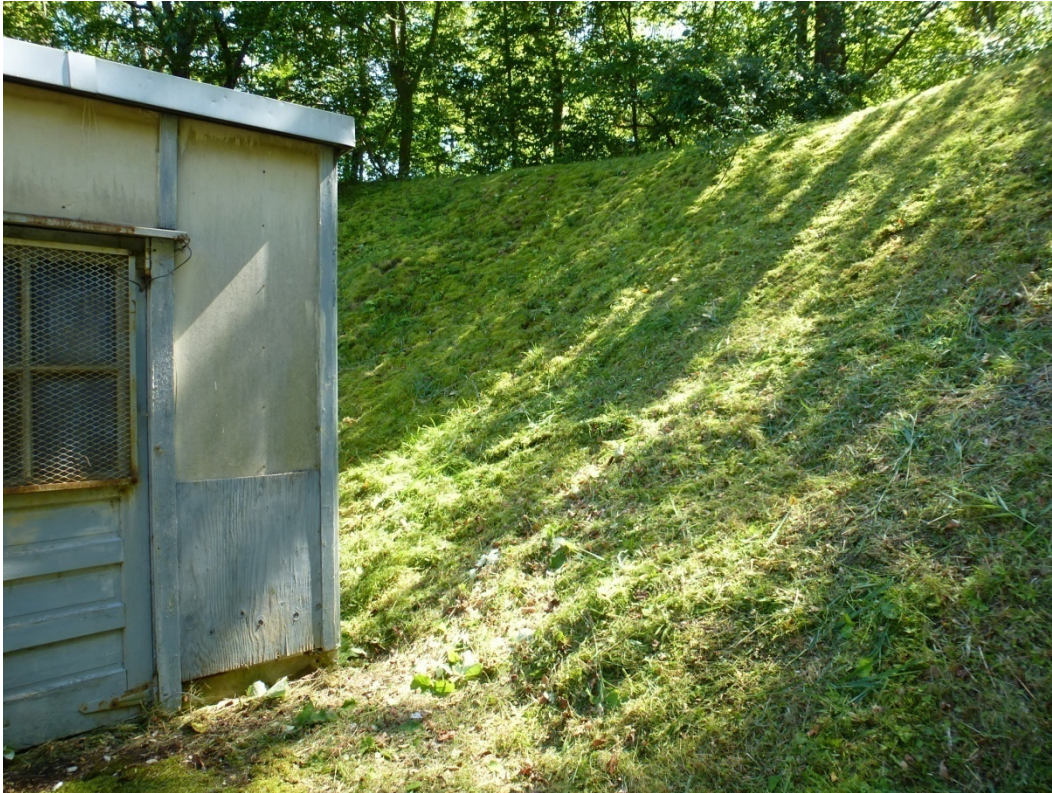
Figure 274. Relationship of building and earth barricade (ERDC-CERL, 2012).

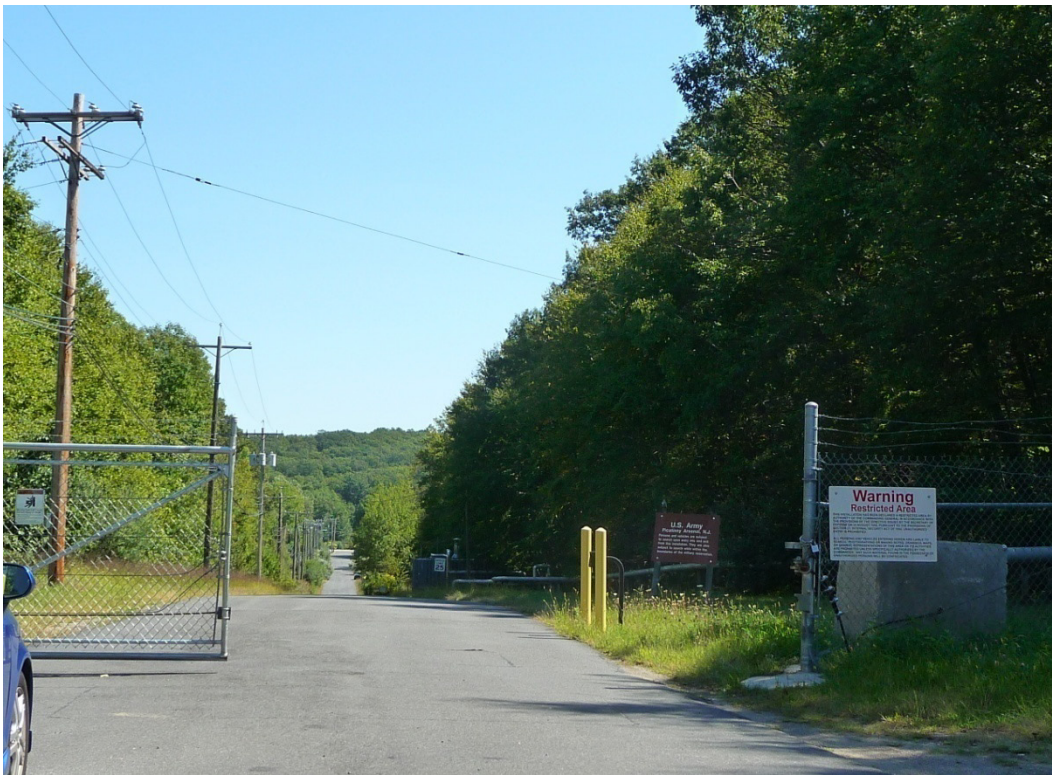
The entire 1500 Area is fenced. Controlled entry to the area is at the intersection of Lake Denmark Road and Hart Road (Figure 275). Once inside the 1500 Area, the Testing Area is also fenced to restrict access for security and safety purposes (Figure 276).

Figure 275. Main entry point into the Rocket Test Area through gate off Lake Denmark Road (ERDC-CERL, 2012).

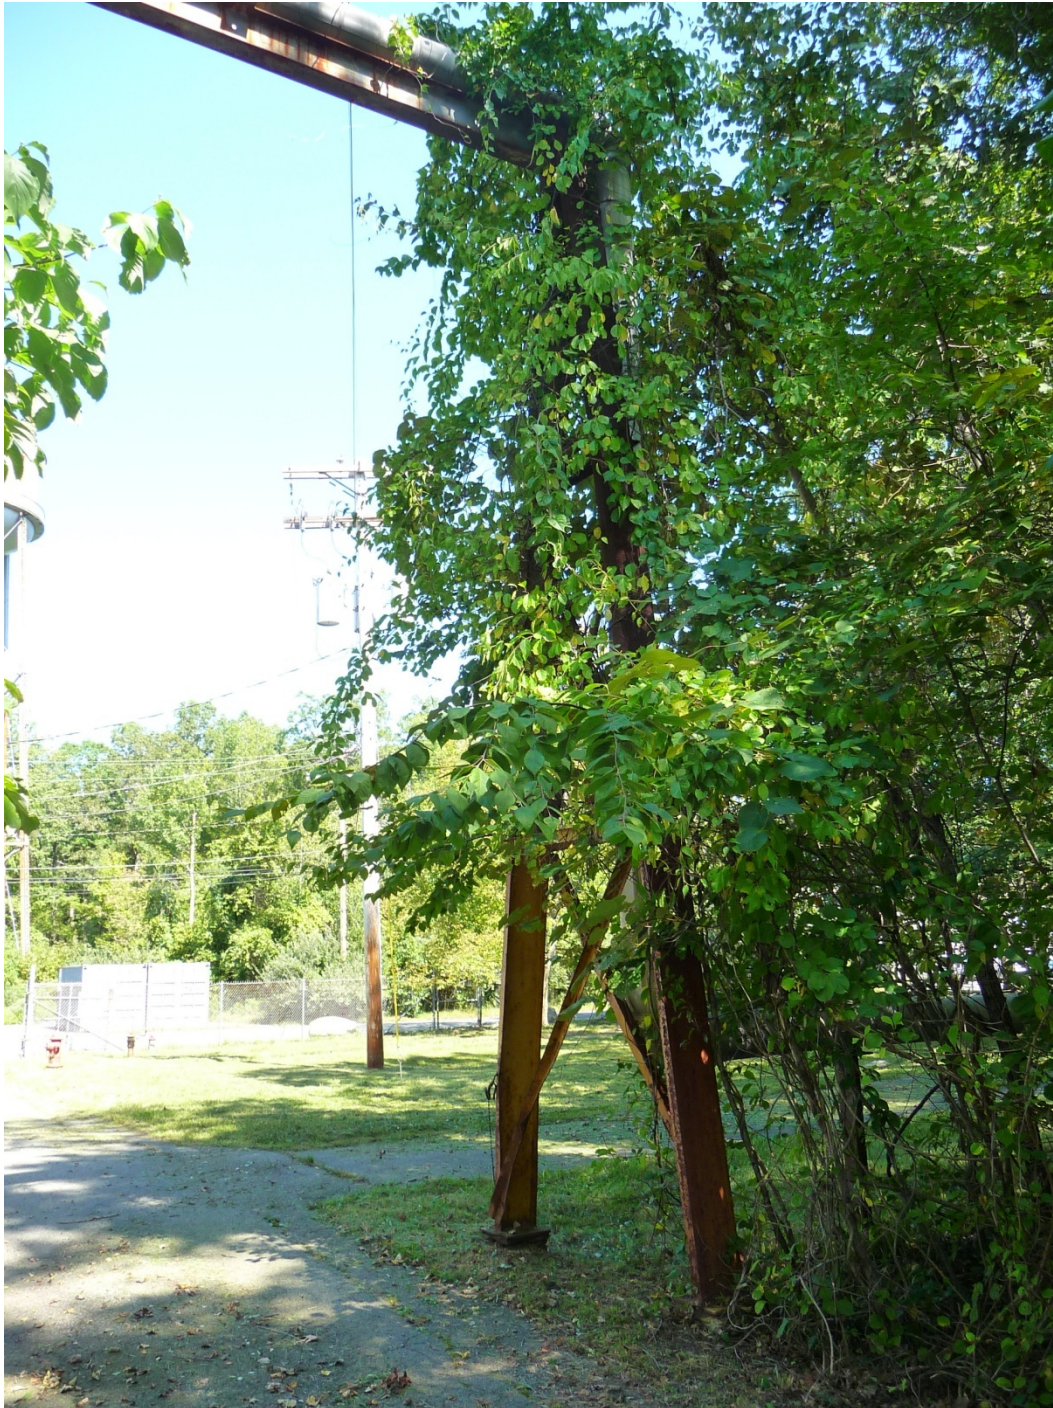
Figure 278. Overgrown vegetation on structure for steam line distribution pipes (ERDC-CERL, 2012).

The area at the time of this investigation was mostly overgrown with vegetation and run down (Figure 278). Some of the buildings and structures

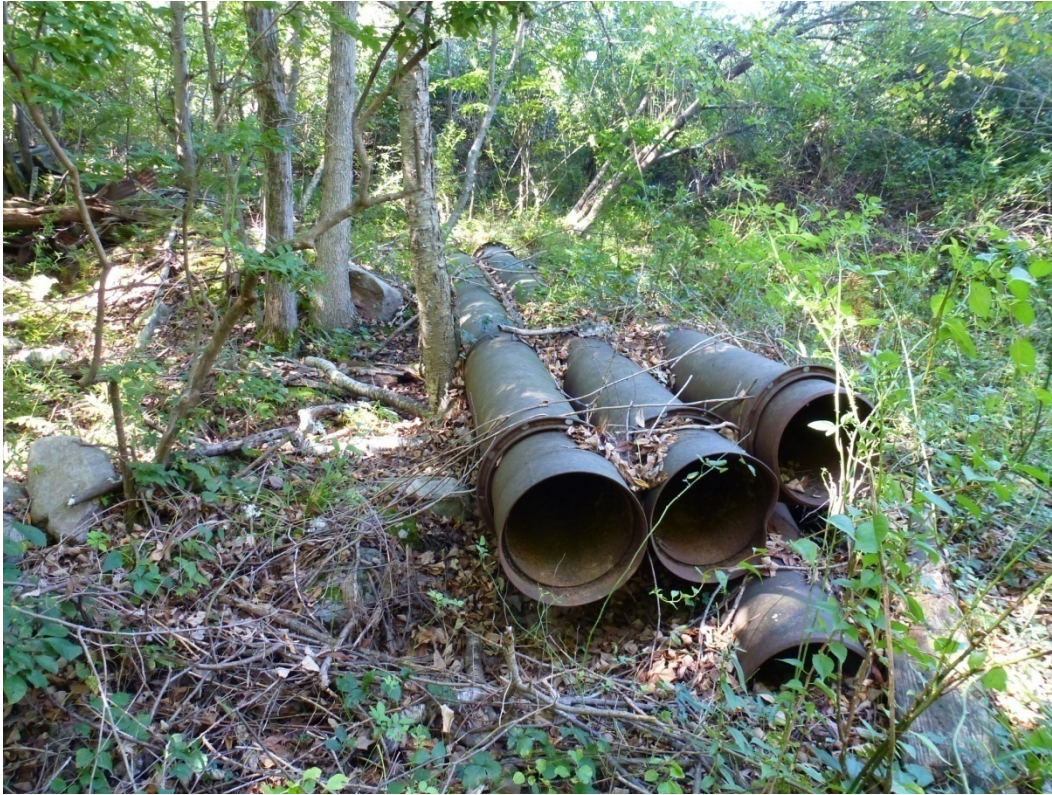
Figure 279. Remnant testing materials in the landscape (ERDC-CERL, 2012).

are derelict, but some portions of the area are still used for testing today. Old testing equipment is strewn all over the wooded area (Figure 279).
