## **Cultural Landscape Analysis of Existing Historic Districts**

Picatinny Arsenal, New Jersey

Final report

Under Project 201221, "Cultural Landscape Analysis, Picatinny Arsenal, New Jersey"

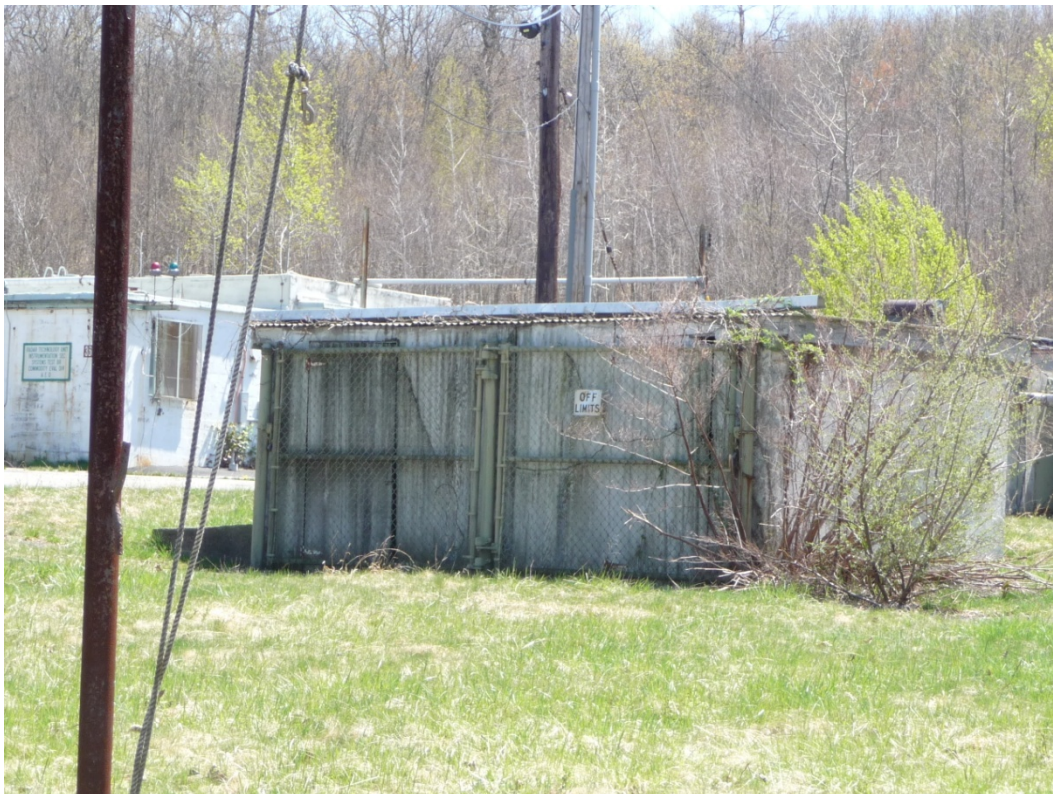
**Figure 294. Building 3602, NARTS Liquid Propellant Storage (ERDC-CERL, 2013).**

Building 3602 was constructed in 1952 as a NARTS Oxidizer Bunker. It is a small rectangular structure with metal walls and a flat corrugated-metal roof (Figure 294). Chain-link fencing surrounds the building.

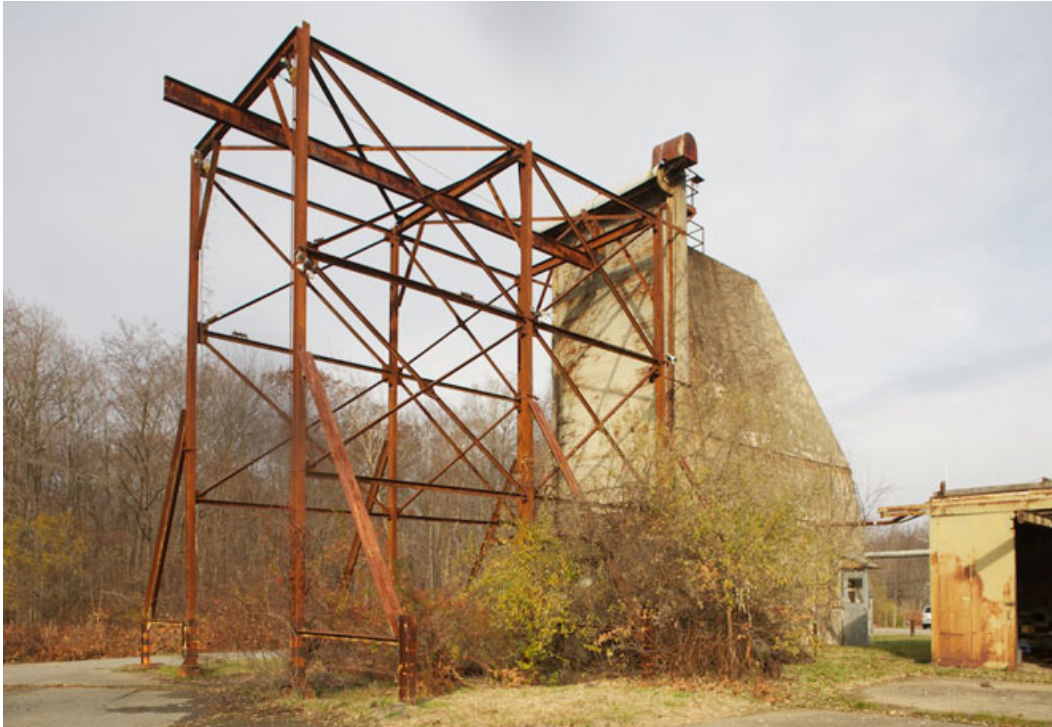
Figure 295. View west at Buildings 3603 (PICA Cultural Resources Office, 2010).

Built in 1949–1950, Test Stand D-1 was the largest rocket test stand and stood at the west end of Test Area D (Figure 295). It was a massively constructed reinforced-concrete structure standing 37 feet 9 inches tall. The stand had a working/utility floor at ground level and an upper firing floor. A concrete-block room attached to the north side contained an internal stairway which provided access to the firing floor via a double steel door. There was also an external ramp to the firing floor on the south side of the building. A large steel gantry crane was attached to the south side of the structure, and a 5-ton electric hoist mounted on the ceiling of the building was used to lift rockets into firing position. A rectangular fuel-neutralizing pit for receiving rocket exhaust during vertical test firings was built into the ground at the south side of the stand (beneath the gantry).

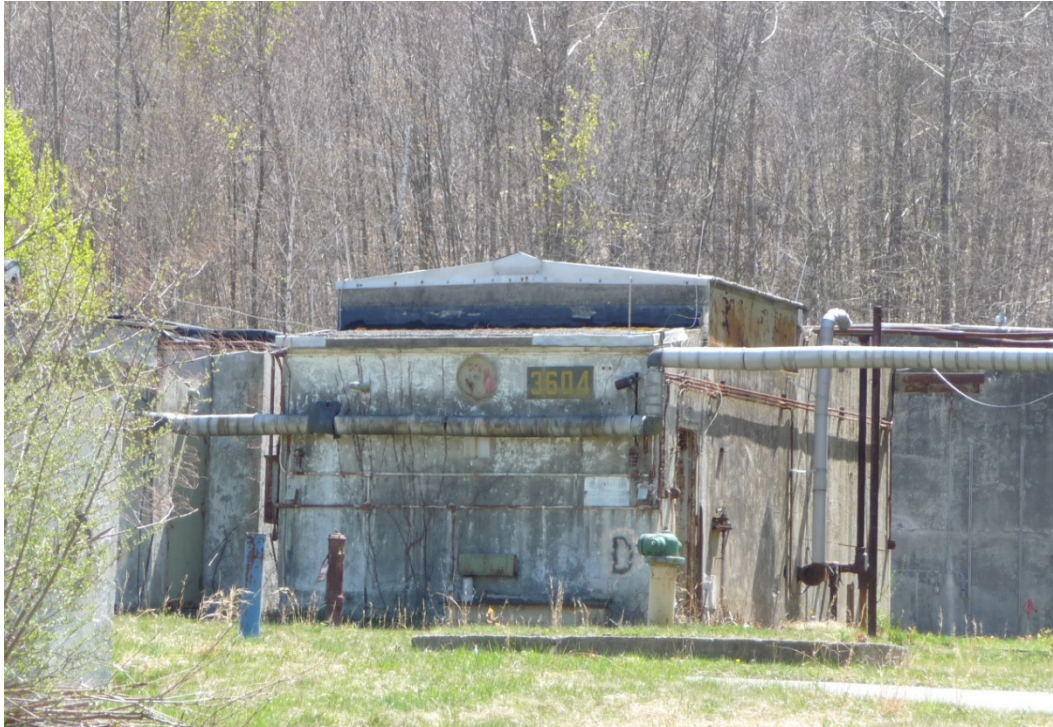
Figure 296. View south at Building 3604 (ERDC-CERL, 2013).

This test stand was built in 1953. It was 14 foot square and made of heavy reinforced concrete with large double doors which were opened for horizontal firings out the south side (Figure 296). Engine mounts were attached to steel rails in the floor during testing. Apparently firings in D-4 were controlled and monitored from the Central Control Room (Building 3607) for the first few years. Then in 1956, a new control room (Building 3605) and test stand (Building 3606, Test Stand D-6) were built immediately to the east, forming a three-building unit. In 1958, plans were drawn up to convert both D-4 and the adjacent large vertical test stand (D-1) to specialized stands for testing liquid-propellant engines. The conversion of D-1 was never carried out, but D-4 was altered substantially. An 18 foot, reinforced-concrete addition was built on the north side, resulting in two main sections. One large section (14 x 14 feet) was divided into two rooms, with a north-south wall separating them. The west bay was for fuel tanks, the east for oxidizer tanks. New wall pockets were cut into the concrete wall between the test bay and the tank rooms. Two smaller valve rooms (each 4 feet deep) were located on the north side of the tank bays with exterior doors at the sides, and there was a 5 feet-deep rectangular concrete-

block neutralization pit with a steel cover, located adjacent to the north exterior to provide access to piping. Tanks were pressurized with nitrogen that was piped throughout Test Area D. According to a ca. 1959 description of Test Stand D-4, it could be used for testing engines with up to 30,000 pounds of thrust.<sup>197</sup>

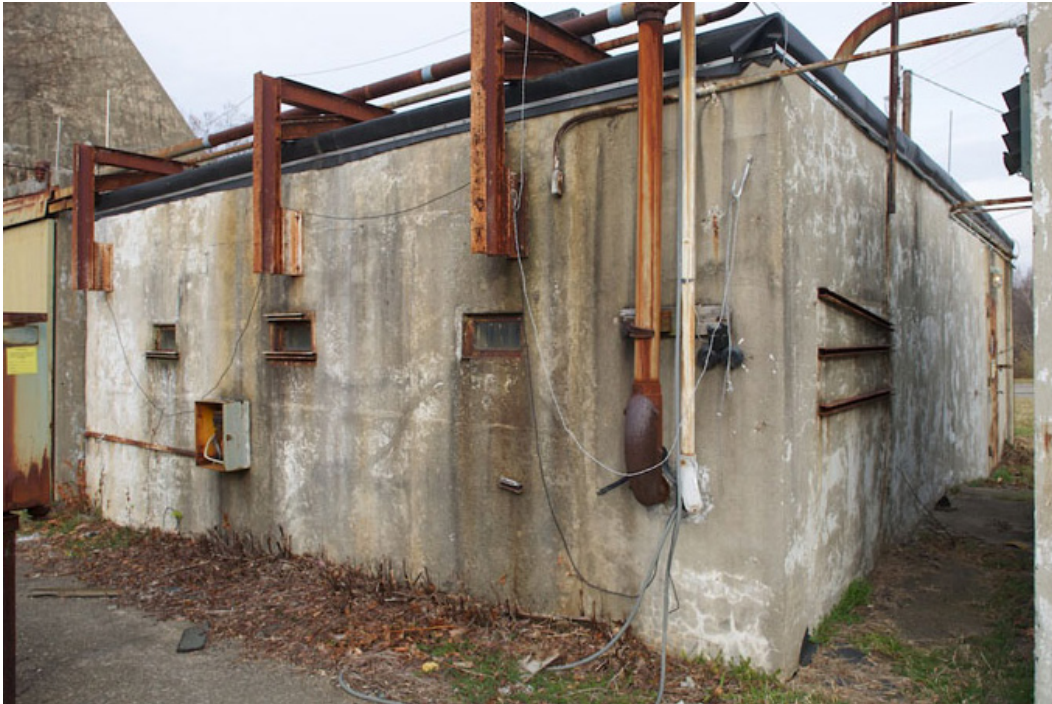
**Figure 297. Southeast oblique of Building 3605, NARTS Control House (PICA Cultural Resources Office, 2010).**

This control chamber (Figure 297), dating to 1956, was built along with Test Stand D-6, which stood immediately to the east. It was also connected to Test Stand D-4 which stood to the immediate west. From here, tests conducted at the flanking stands were controlled, monitored by closed-circuit TV, and recorded. The original building was 14 x 21 feet with concrete foundation and walls, a central rear (north) door, and a central viewing port on the south side. In 1958, as part of the conversion of Test Stand D-4 to liquid propellant testing, the control room was more than doubled in size when a 14 foot north extension was built, including a small (4 feet) ell. The new addition had two windows on the north facade and exterior doors on the east and west.<sup>198</sup>

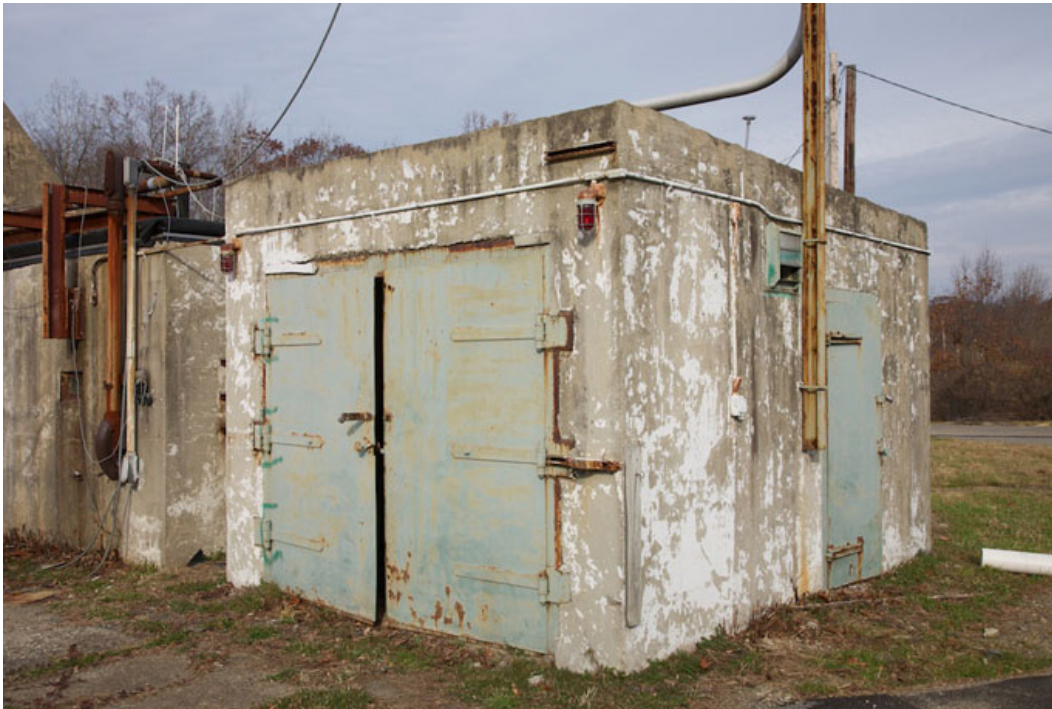
**Figure 298. Southeast oblique of Building 3606 (PICA Cultural Resources Office).**

This test stand was built in 1956 along with a control room immediately to the west (Building 3605). D-6 was a 12 x 14 ft reinforced concrete structure used for testing solid propellant motors and jet-assisted takeoff units (JATOs) up to a thrust capacity of 40,000 pounds. JATOs were mounted on a roller frame and bolted to rails imbedded in the floor. Firing was done horizontally or at slight angles using special mounts. The firing bay had double set of steel doors to the south that opened for testing. The interior was divided by 1/2-in. thick steel partitions into three rooms—a large full-width firing room and two smaller rooms behind it, each with an exterior door on the side. The roof was slightly pitched down to the north. There were small louvered vents situated high-up on each side of the firing bay. In 1960, Test Stand D-6 was destroyed in a failed liquid-fueled rocket motor test; evidently, the stand was completely rebuilt, though not until 1964 (Figure 298).<sup>199</sup> It was recently demolished.

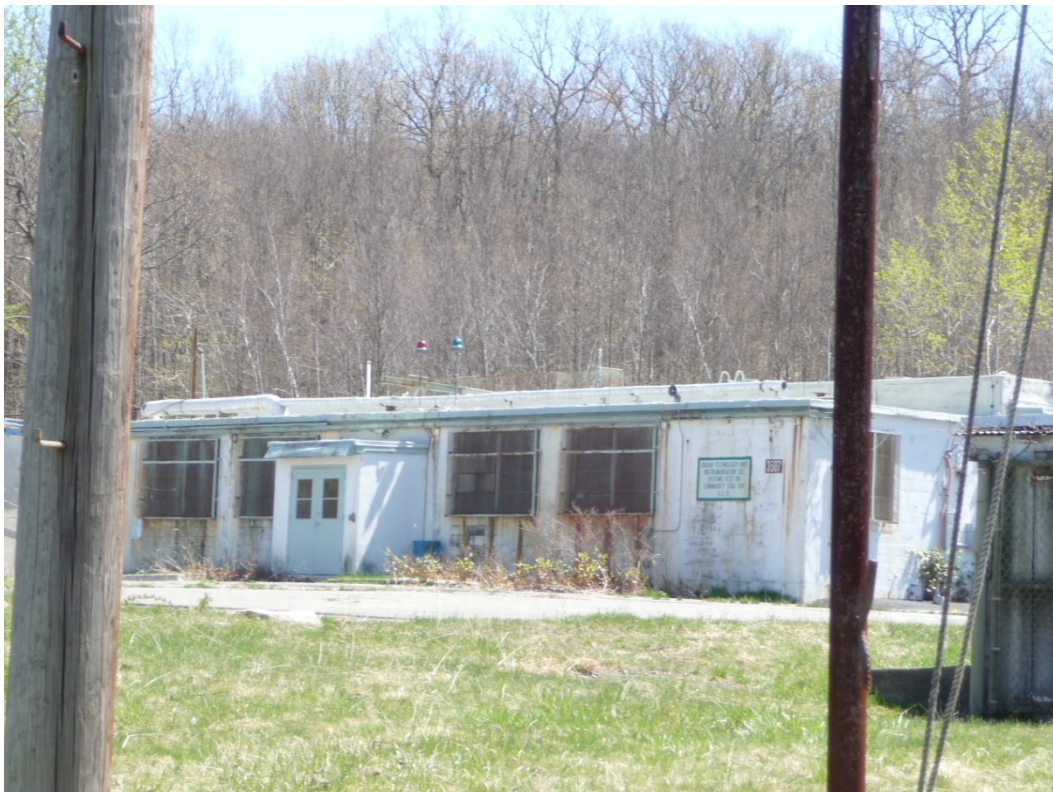
**Figure 299. Building 3607, Central Control Room (ERDC-CERL, 2013).**

Building 3607 was renovated in 2011 (Figure 299). New doors were added, and window was replaced on the western façade. The interior was renovated slightly for new control room uses.

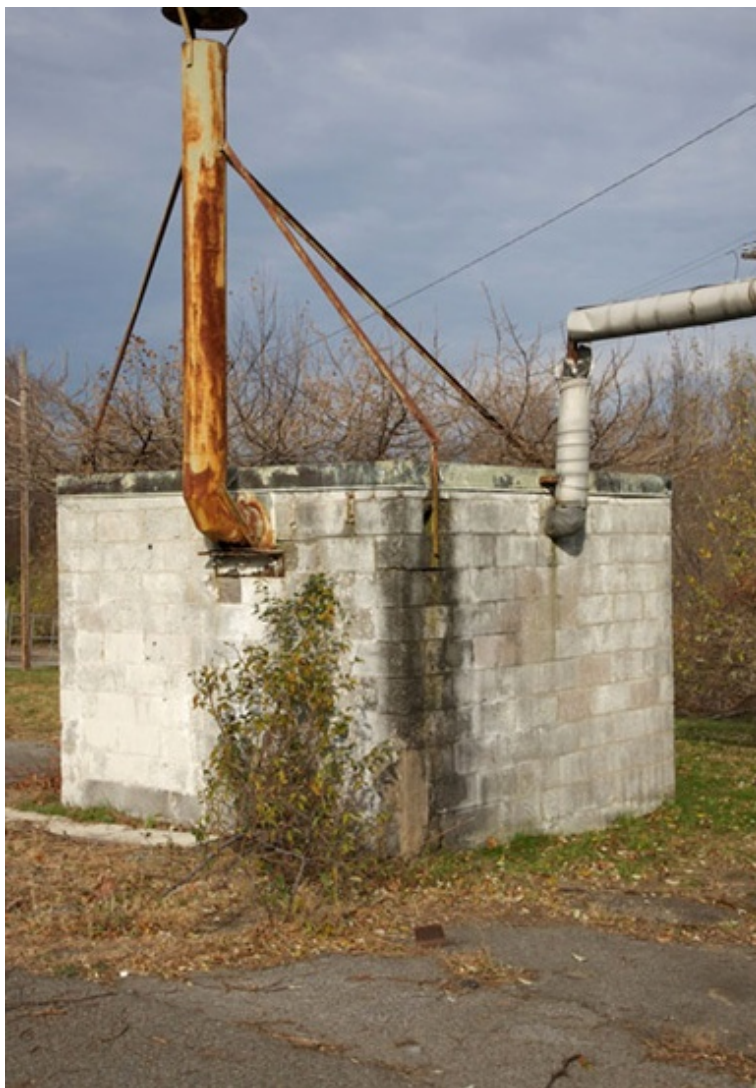
**Figure 300. Southeast oblique of Building 3608, NARTS Test Area D Boiler House (PICA Cultural Resources Office, 2010).**

Building 3608 was a small (10 sq ft) boiler room built in 1958 to service the adjacent Building 3609, a “Passivation Facility.” Building 3608 had a concrete foundation and slab floor, concrete block walls, flat roof, and a metal-framed door centered on the west side. A tall sheet-steel chimney pipe emerged from the south wall (Figure 300).<sup>200</sup>

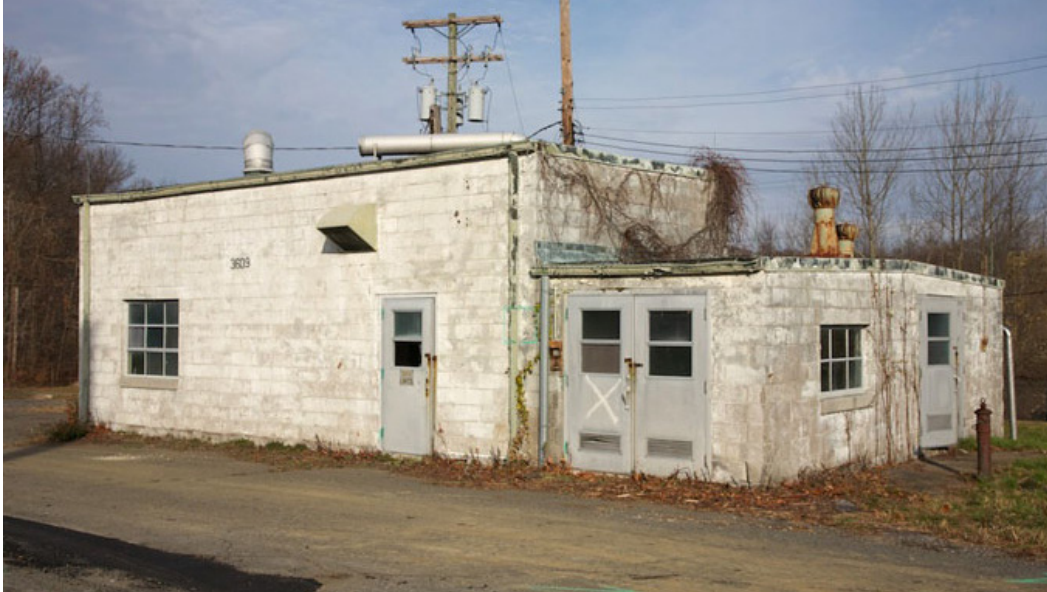
Figure 301. Building 3609, now demolished (PICA Cultural Resources Office, 2010).

The 1958 plans for this building call it a “Passivation Facility,” and a 1959 NARTS brochure refers to it simply as a new hazardous-propellant handling building. Passivation (also referred to as “pickling”) is the preparation of a metal surface with chemicals so that it becomes more passive (or resistant) to further chemical reactions that cause corrosion (e.g., from stored liquids). An important aspect of the work NARTS did on propellants involved finding ways to handle and store oxidizers and fuels that were potentially highly corrosive and combustible. The building also had facilities for conducting flow calibrations and small-scale hazardous blending tests, and it was equipped with two fume hoods. The L-shaped structure included the Passivation Room section (31 x 16 ft), which was oriented east-west, and two 11 x 12 ft storage bunkers on the east side (Figure 301). The latter held hydrogen peroxide used for treating metal. The height of the main section was 13 ft 4 in., and the height of the bunker rooms was 8 feet 10 in. The main section had a concrete entrance ramp on the west end, three evenly spaced windows on the north façade, and an entrance door and window on the rear (south) façade. A “monorail” (presumably for moving tanks) ran down the center of the floor, and the fume hoods stood against the north and south walls. The drainage system included a 6 foot-square neutralization pit built into the ground outside the north side of the building. In 1969, the building was converted to a water flow facility and two large cylindrical tanks (26 x 4 ft) were installed below ground on the north exterior. The Passivation Room became the Flow Room, the north bunker became the Pump Room, and the south bunker became the Control Room.<sup>201</sup>

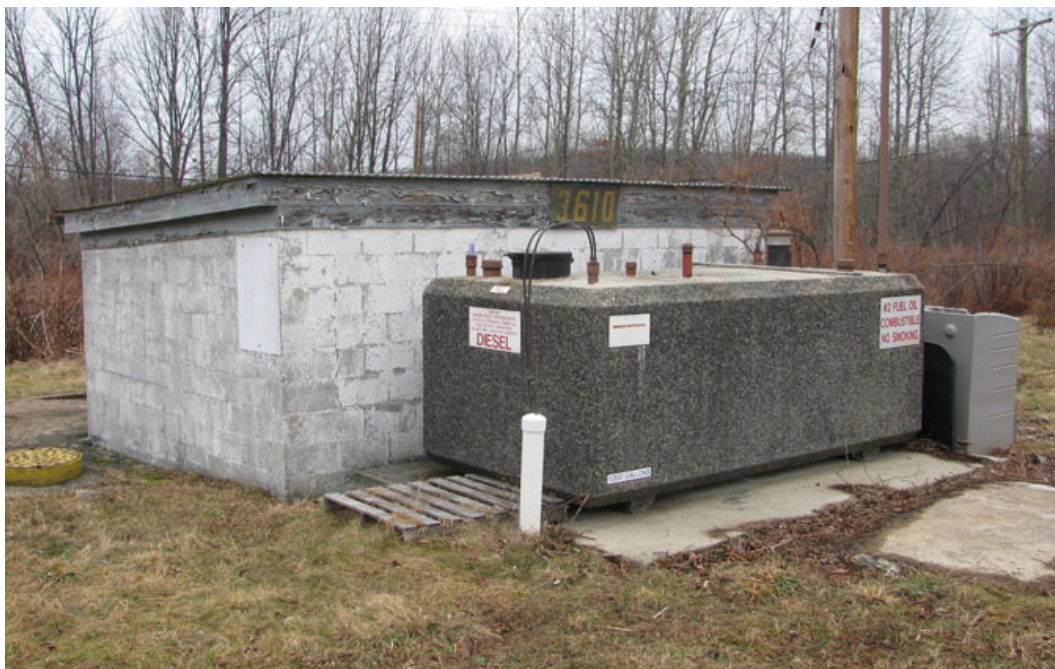
Figure 302. Building 3610, NARTS Liquid Propellant Storage (PICA Cultural Resources Office, 2010).

Building 3610 was constructed in 1952 as a NARTS Liquid Propellant Storage Bunker. It is a small rectangular structure with concrete block walls and a flat corrugated-metal roof (Figure 302).

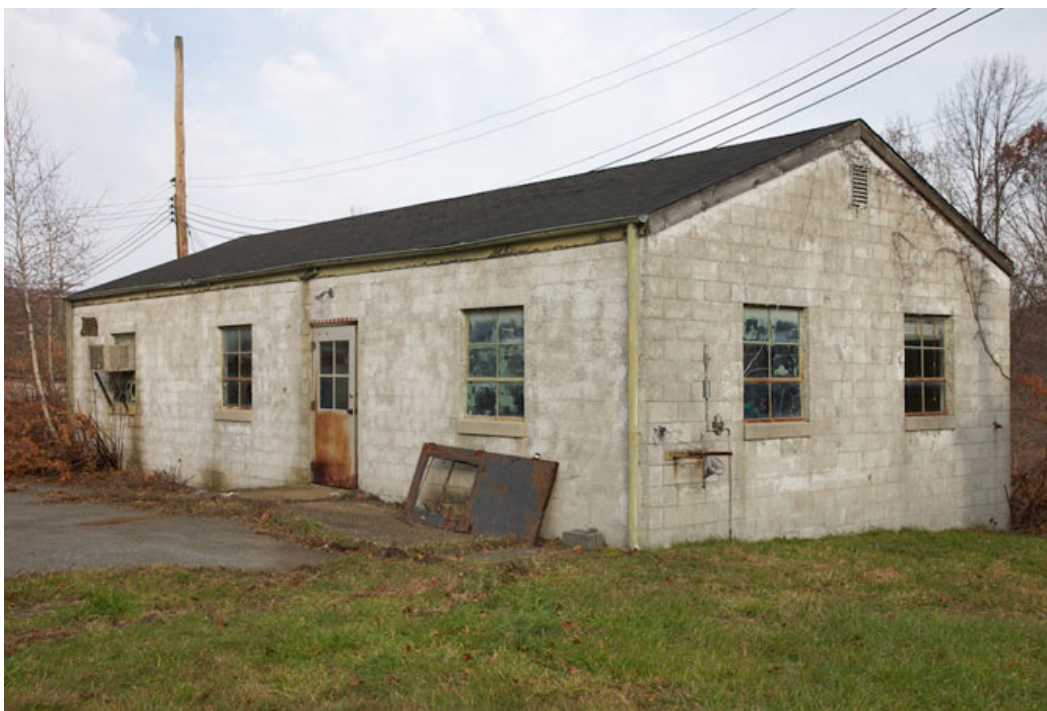
**Figure 303. Southeast oblique of Building 3611, NARTS Electronic Equipment Facility (PICA Cultural Resources Office, 2010).**

The Instrument Shop was built in 1956–1957. It contained an electronic workshop, storage room, instrument calibration room, office, and boiler room. The shop handled fabrication of instruments designed by the NARTS Instrumentation Branch and the repair, overhaul, and storage of all instruments and spare parts used for Test Area D static firing tests. The main section of the building was 49 ft 4 in. x 23 ft 4 in., constructed of concrete block. It had an entrance door and three windows on the south facade (Figure 303), two windows on the east, and four windows on the north. A small 10 x 12 ft ell on the west side contained the boiler room. Plans were drawn up for a small shed-roofed extension on the north side in 1963, but there is no evidence that this addition was built.<sup>202</sup> It was demolished recently.

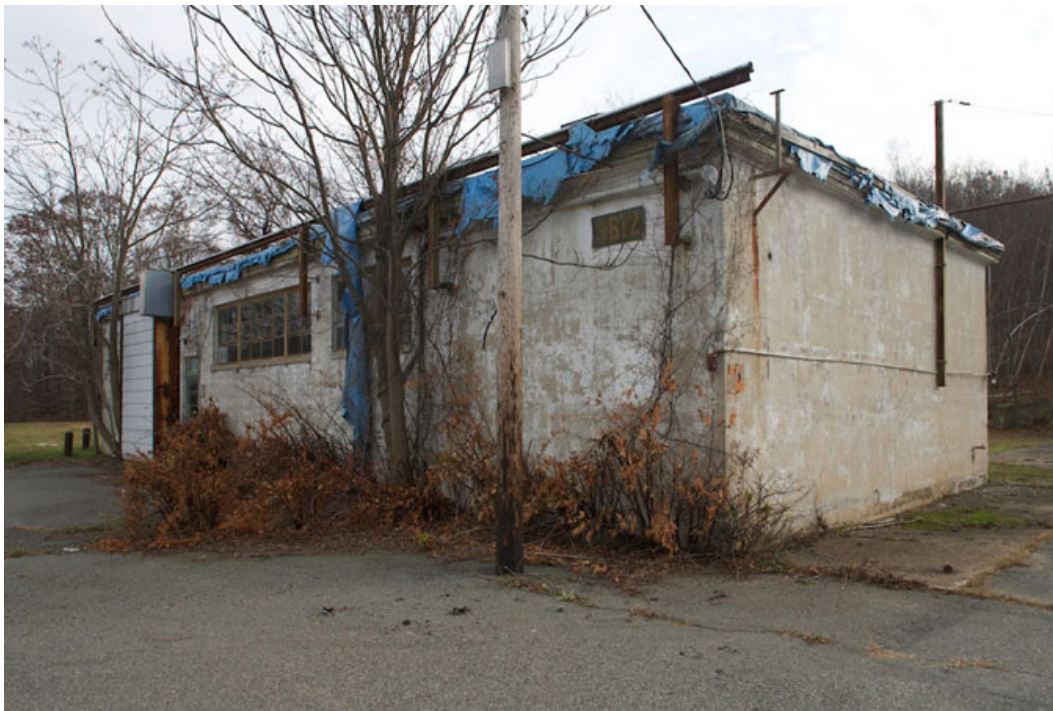
Figure 304. Building 3612, NARTS Components Testing (PICA Cultural Resources Office, 2010).

Also known as testing facility D-5, the 1953 Components Workshop was divided into nonhazardous and hazardous areas. The reinforced-concrete-walled hazardous portion was on the building's west side, in an L configuration. A 12 x 27 ft gas flow room spanned the width of the building, and a 14 ft x 7 ft 6 in.-high-pressure tank room lay perpendicular to it on the south side of the building. Tests of high-pressure inert gas equipment, ignition delay, and gas generator performance were conducted in this part of the building. The remaining nonhazardous section of the building, of concrete block construction, contained a large assembly-disassembly area, an office, and a storage room. This section was used for testing rocket engine components, and had a flow-test system that delivered water at pressures up to 1200 pounds per square inch (psi) and flow rates up to 500 gallons per minute (gpm). A centrally located instrument and control area served the entire building. Circa 1959, instruments typically in use in the building included six high-speed potentiometer chart recorders; oscillographs and other recorders were installed as needed.

There were no windows in the hazardous side of the building, but two sets of double doors on the south façade provided access to the gas flow room and the tank room. The nonhazardous side of the building had large windows on the north, south, and east sides, and on the north façade there was a doorway and a bay with an overhead roll-up steel door. The westernmost double door on the south side of the building as well as the roll-up door on the north side were later replaced with aluminum roll-up doors. Sometime before ca. 1960, an extension consisting of two concrete-block shed structures was added to the south side of the building at the east end. The function of this extension is not known. It was in place by the time of publication of the "All About NARTS" brochure (ca. 1959). A 1969 building list mentions "X-3612" as a barricade on the south side of Building 3612, and it is possible this actually refers to the extension, though "X" typically designated open storage.<sup>203</sup> Figure 304 shows one view of Building 3612 in 2010.

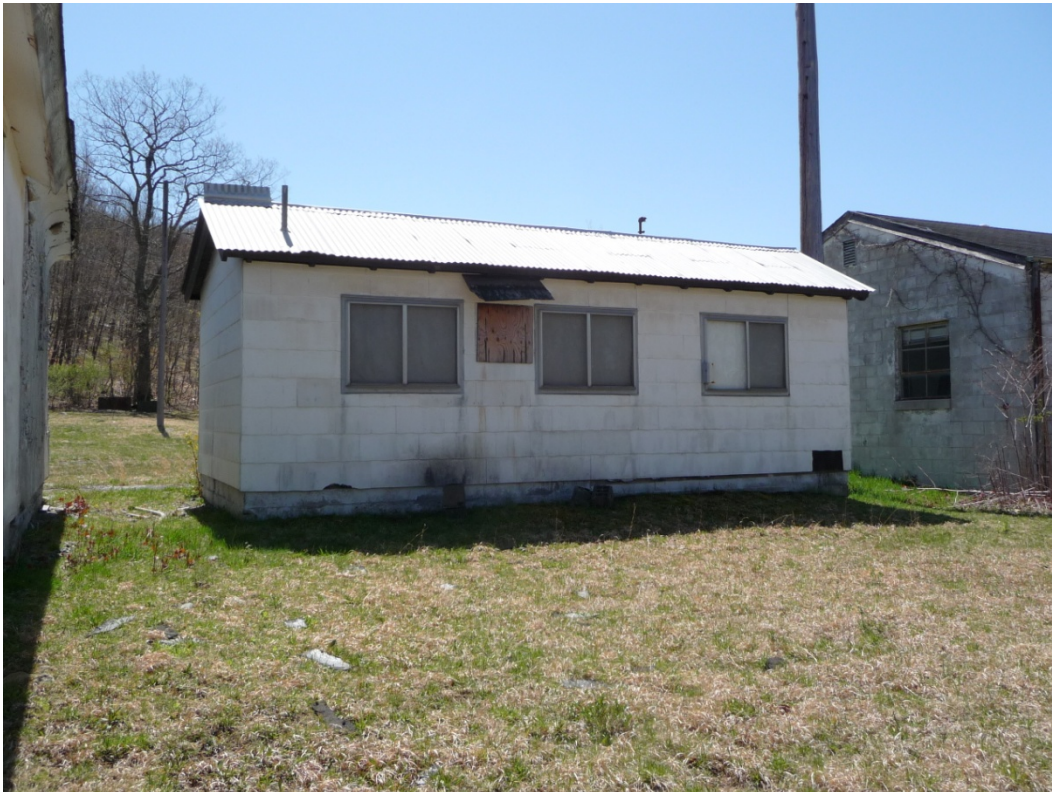
**Figure 305. North elevation of Building 3613, NARTS Area D Lunch Room (ERDC-CERL, 2013).**

This small structure is atypical for Test Area D. It is clad with asbestos shingles and has a side gable roof covered with sheet metal. The Army accessioned the building in 1960, but a plan drawing indicates it was moved to its latest recorded location at Test Area D in 1971, with a new foundation and slab poured at that time. It is a simple rectangle, with three bays (Figure 305). The south façade has a door and 2 windows, and the north façade has 3 windows. It is possible this building was kit-built.<sup>204</sup>

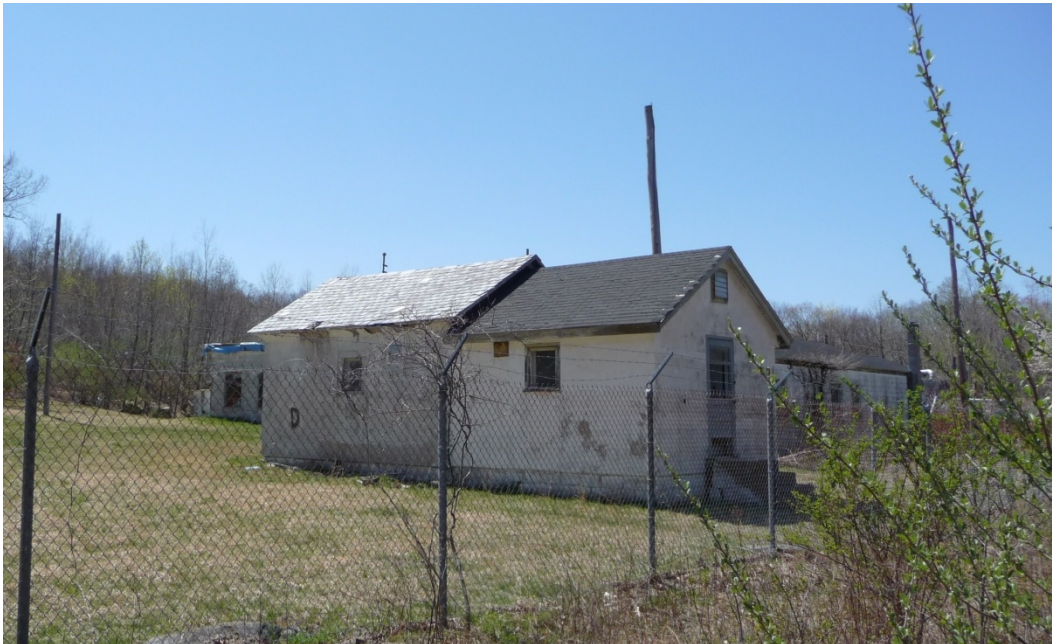
**Figure 306. Northwest oblique of Building 3615, NARTS Utility House (ERDC-CERL, 2013).**

The original date of construction for the building now designated 3615 is not known. It was not shown in a circa 1960 photograph of Test Area D dated ca. 1959. The building was present by 1962, however, as records indicate that it was transferred to the Army from the Navy in that year. It was front-gabled, with a concrete block foundation, stuccoed walls, and a slate roof. There was an entry door centered on the front (south) façade, and small, square windows on each of the other three sides. The building interior contained a sink, shower, and urinal, all against the rear (north) wall. In 1966, the building was nearly doubled in size with construction of a north addition. An interior connecting door was built in the center of the rear wall (the sink had to be relocated). The addition had a centrally-placed exterior door on the north side, and windows on the west and east sides. The addition's roof line was slightly below that of the original building (Figure 306).<sup>205</sup>

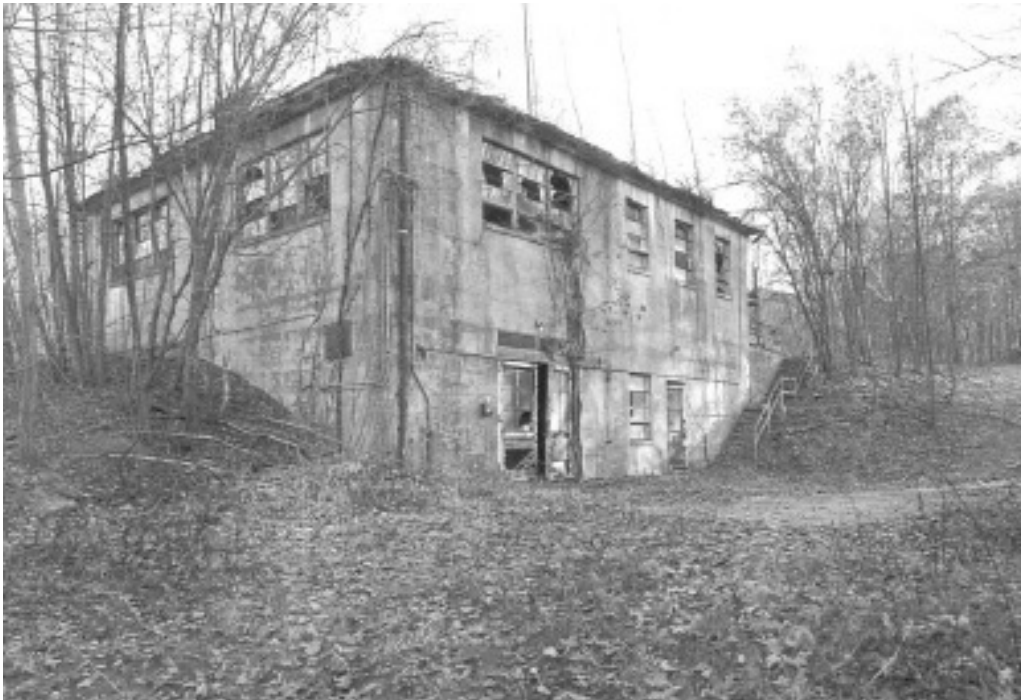
Figure 308. Oblique view of northwest and northeast elevations, Building 3617-  
Control House (Nolte et al. June 2009).

Building 3617 (Control House; Figure 308) and Building 3618 (Test Stand; Figure 309), while two separate buildings, had an efficacious relationship; both structures were conceived as essential components of the same operation: to test rockets and motors.<sup>208</sup> In addition to its two major buildings (3617 and 3618), the area also included the following noncontributing buildings and structures: the remnants of Building 3619, the LOX tank pad and remaining tank supports at the foot of the bridge portion of Building 3618; Buildings 3622 and 3623, a 400,000-gal Water Tower and attached support building; Building 3625, Maintenance Facility; Building 3626, Ordnance Facility; and Building 3627 (EID Control Room), made from an old Navy gun turret.

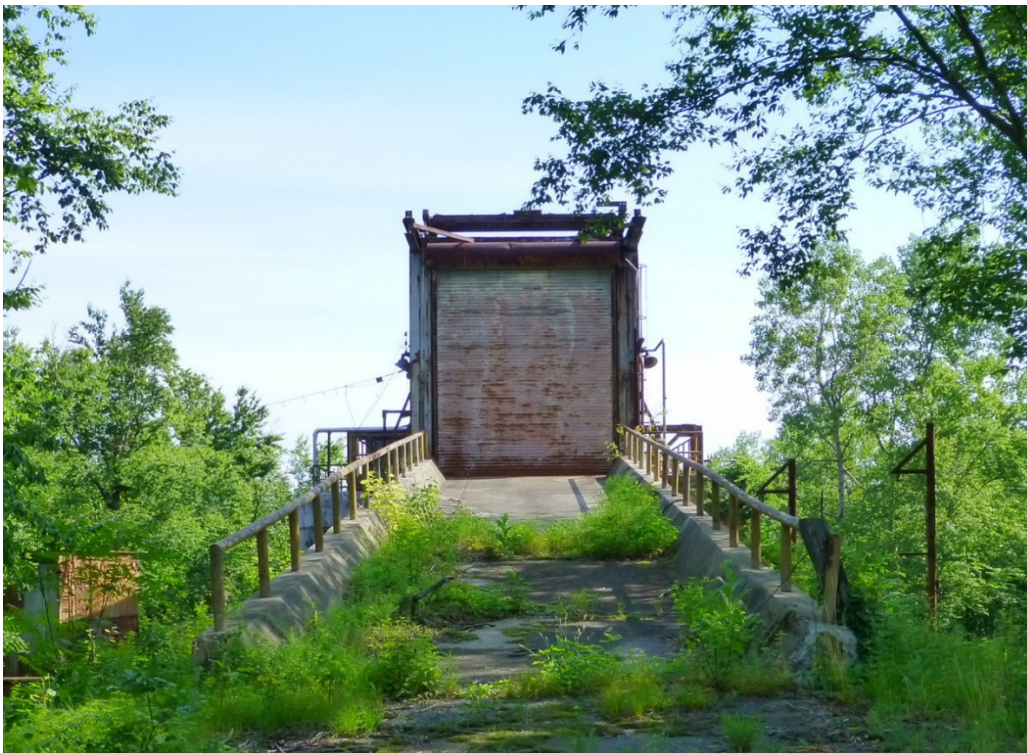
Figure 309. View of rear and southeast side of Static Rocket Test Stand (Building  
3618) (ERDC-CERL, 2013).

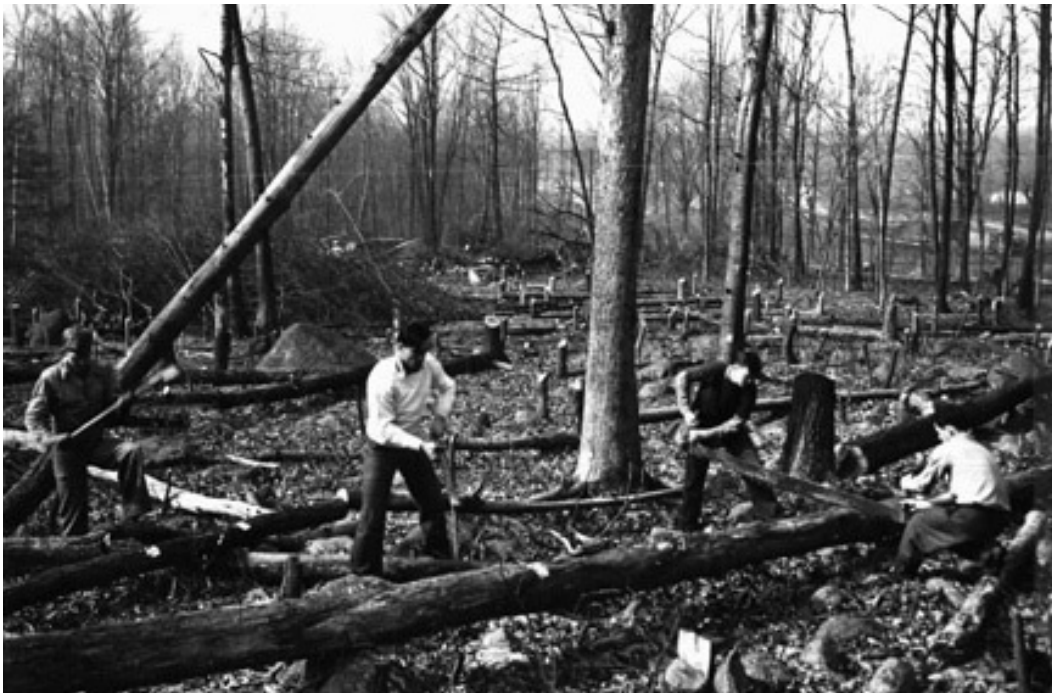
Figure 310. Historic photograph of men working to clear the land in NARTS Test Area D in preparation for building construction, January 1950 (PICA Cultural Resources Office).

The forested landscape was clear cut around the buildings in both NARTS Test Areas D and E (Figure 310). When completed and in use, the areas around the Test Stand and the Control House were completely devoid of trees and shrubs; anything that could burn or get in the way of observing an engine test was removed. The bare ground was probably seeded to prevent erosion, but everything else was cut down. The Control House (Building 3617) had a bituminous paved area on the southwest side of building and a concrete paved area on its northwest side.<sup>210</sup> However, currently the area is completely overgrown with vegetation, which makes it difficult to comprehend and understand the site as a whole.

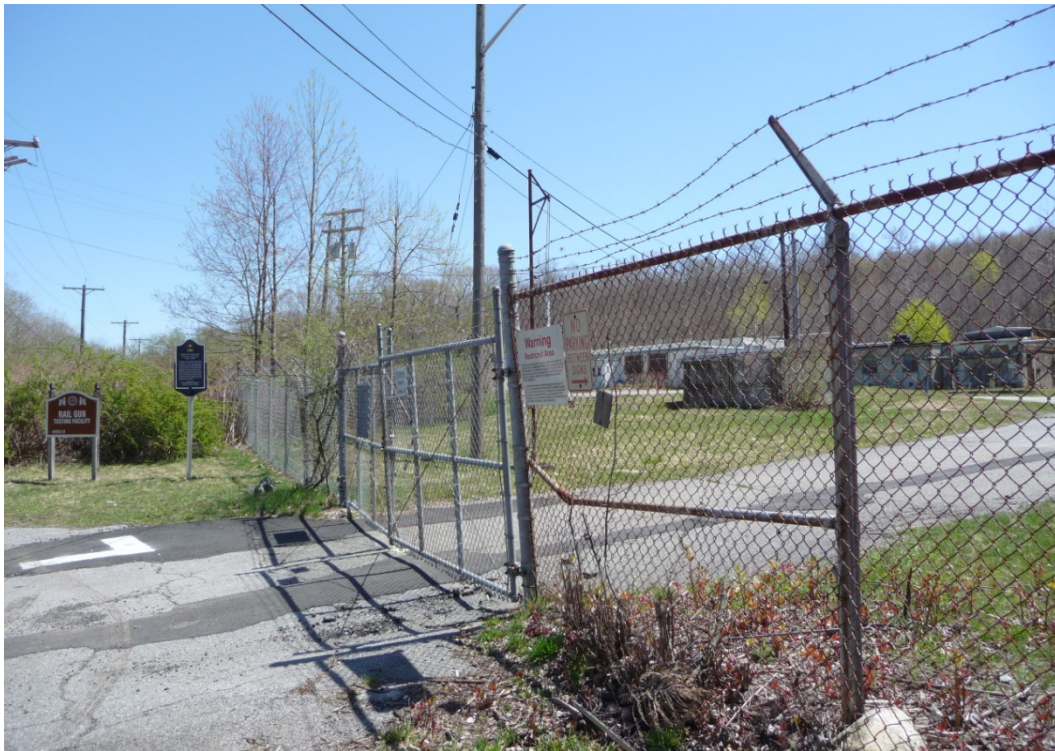
**Figure 311. Chain-link fencing and security gate at the entrance to NARTS Test Area D (ERDC-CERL, 2013).**

Fencing in both testing areas was used to restrict access for security and safety (Figure 311 and Figure 312).

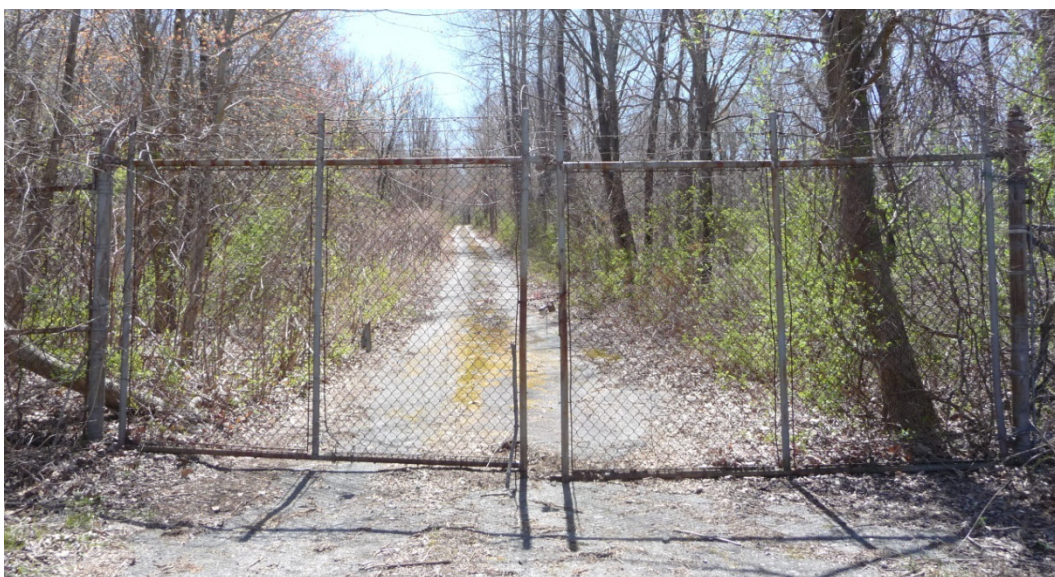
**Figure 312. Chain-link fencing and gate at the entrance to NARTS Test Area E (ERDC-CERL, 2013).**

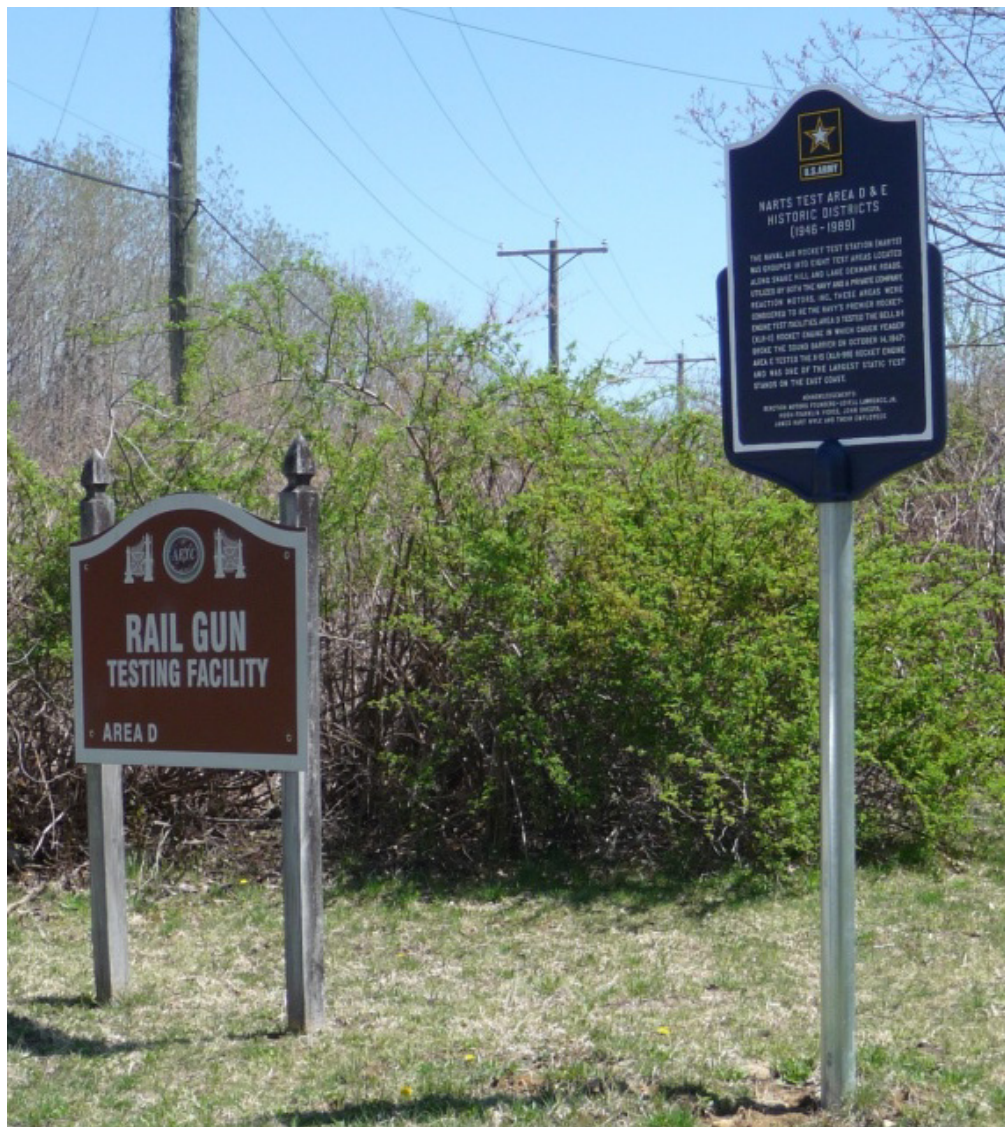
Figure 313. Historic marker located at the entrance to NARTS Test Area D & E Historic Districts (ERDC-CERL, 2013).

A historic marker is located outside the entrance to NARTS Test Area D along Snake Hill Road adjacent to the area's identification sign (Figure 313). Historic markers for the NRHP-eligible historic districts are used to identify and highlight these significant areas. The markers allow for military and civilian personnel and visitors to the installation to be more aware of the installations' historical heritage to ensure the long-term preservation of these significant areas. The markers were funded by the Environmental Affairs Division and produced by Lake Shore Industries. Text was developed by CRM, NJ HPO, and the Morris County Heritage Commission. Placement of the markers was carried out in 2012.

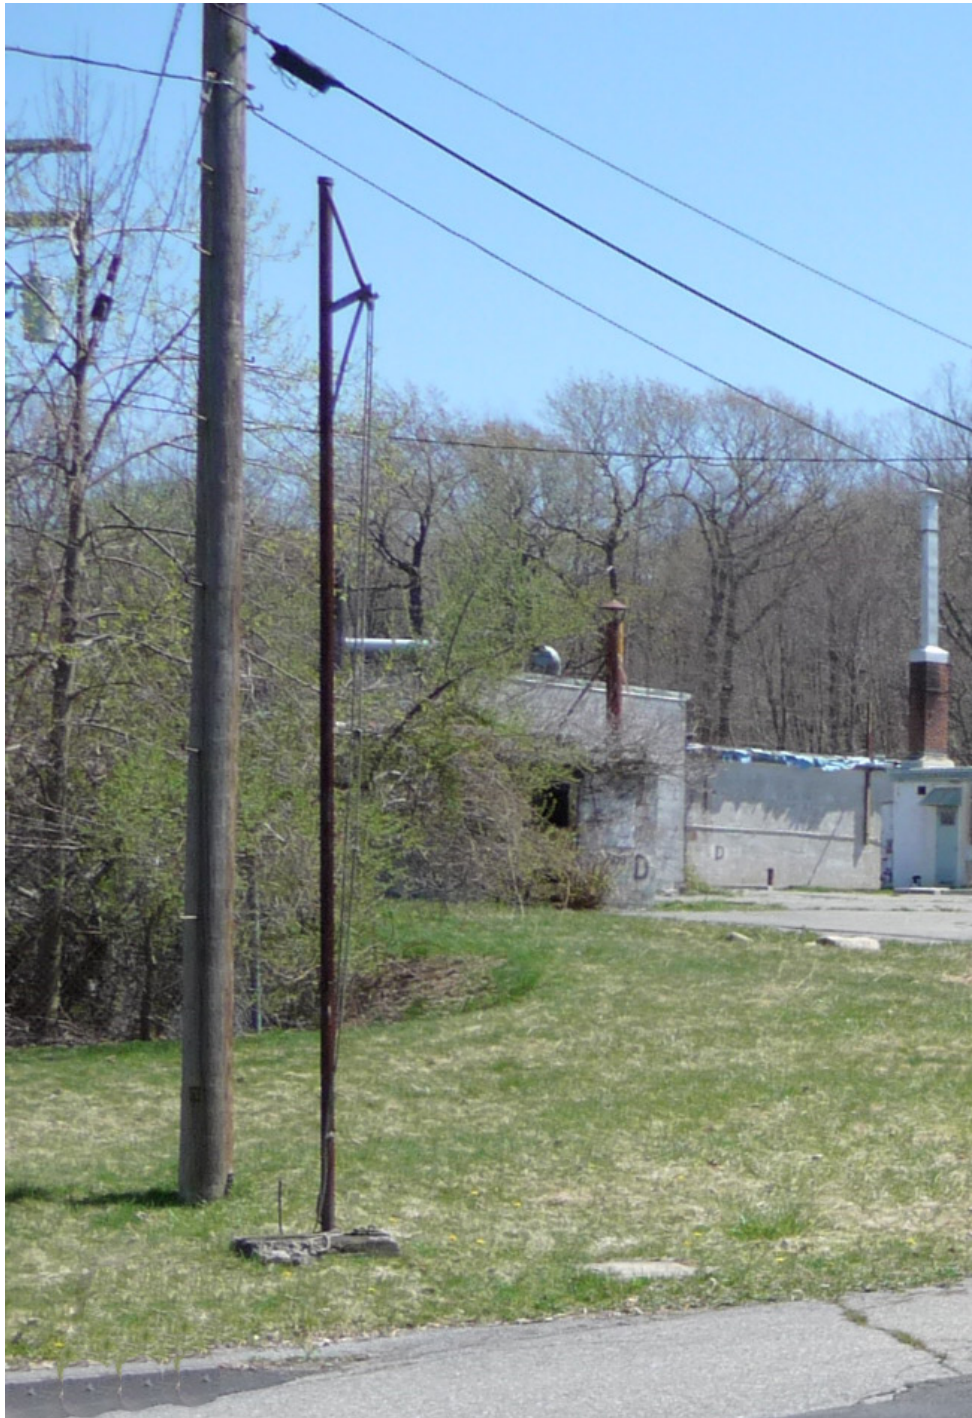
**Figure 314.** Flagpole located near entrance into the NARTS Test Area D (ERDC-CERL, 2013).

A flagpole is located immediately inside the fence at the entrance to NARTS Test Area D (Figure 314). The flagpole was initially used to alert people of testing being conducted within the buildings.

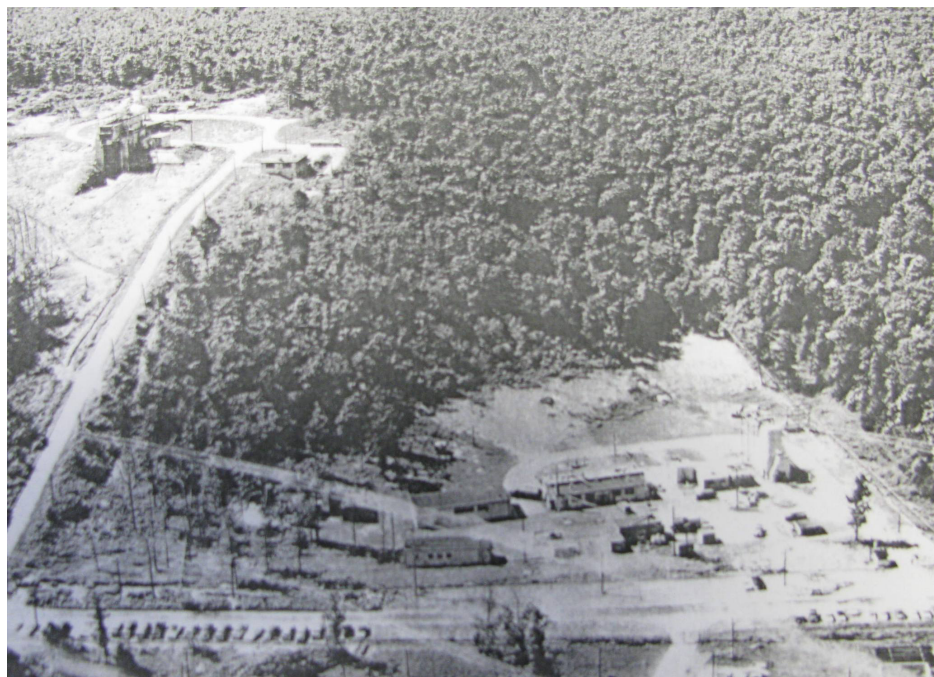
Figure 315. Aerial view of cleared landscape for NARTS Test Areas D (foreground) and E (background), no date (PICA Cultural Resources Office).

Views and vistas would not have been part of the design and layout of the NARTS Test Areas D and E (Figure 315). Mission-specific industrial areas on military installations rarely followed the design principles visible in the high-profile areas such as housing and administration.
