# Acoustic Nondestructive Testing And Measurement of Tension for Steel Reinforcing Members

Part 2 – Field Testing

by Michael K. McInerney

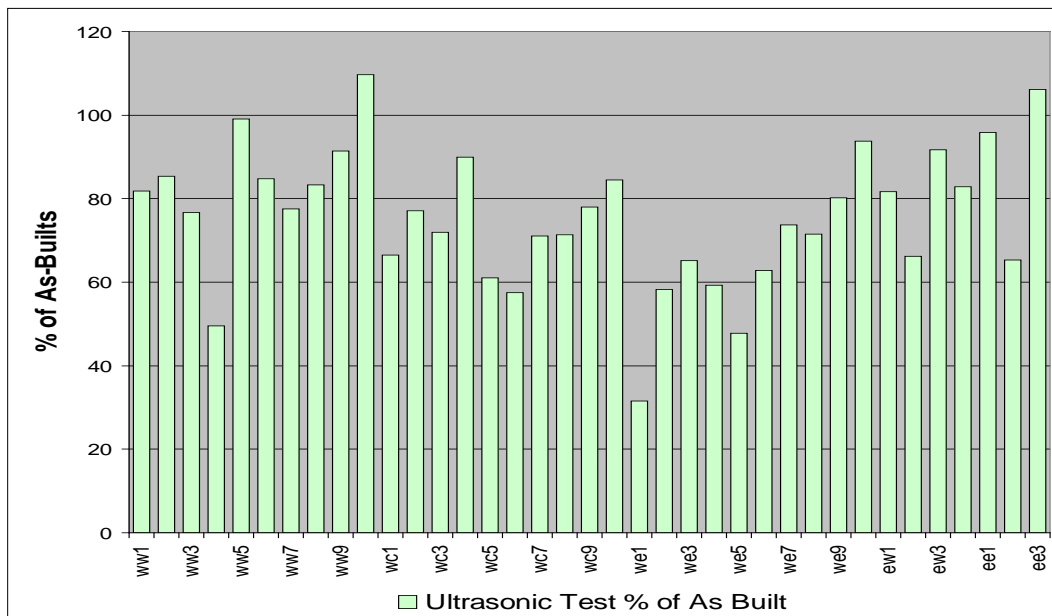
The second field test was conducted at West Point Dam in Georgia (see Figure 2 and Figure 5). On one pier, 37 rods measuring 38 – 48 ft were tested. (One rod, ee4 by our nomenclature, was broken and therefore not tested.) The filler material was grease. Both longitudinal and shear ultrasonic signals were obtained for all rods. Results of these measurements are shown in Figure 6 as a percentage of the design-specified rod tension.

Figure 6. Measured rod tension as percentage of design specification tension for West Point Dam.

There is quite a variance in the tension measurements. The average measured value was 85,038 lb. The average as-built value is 112,543 lb. The standard deviation of the measured values is 17,839 lb, while the standard deviation of the as-built values is 2,263 lb. One would expect the rods to change tension uniformly and without such extreme variance. We have high confidence in our measurements. Unlike the Keystone (Oklahoma) test, the acoustic signals were easily detectable. The difficulties in the Oklahoma test were because of shear wave attenuation. (The attenuation of the shear wave was four to ten times greater than that of the longitudinal wave.) We were able to obtain longitudinal and shear wave measurements on all 37 tested rods, but obtaining a shear measurement was difficult for a few of the 48 ft rods. This led us to conclude that our current instrumentation and transducers are suitable for use on rods up to 45 ft.
