PLANS FOR REDUCTION OF SHOALING  
AT THE ENTRANCE TO  
UMPQUA RIVER, OREGON

MODEL INVESTIGATION

TECHNICAL MEMORANDUM NO. 2-277

WATERWAYS EXPERIMENT STATION

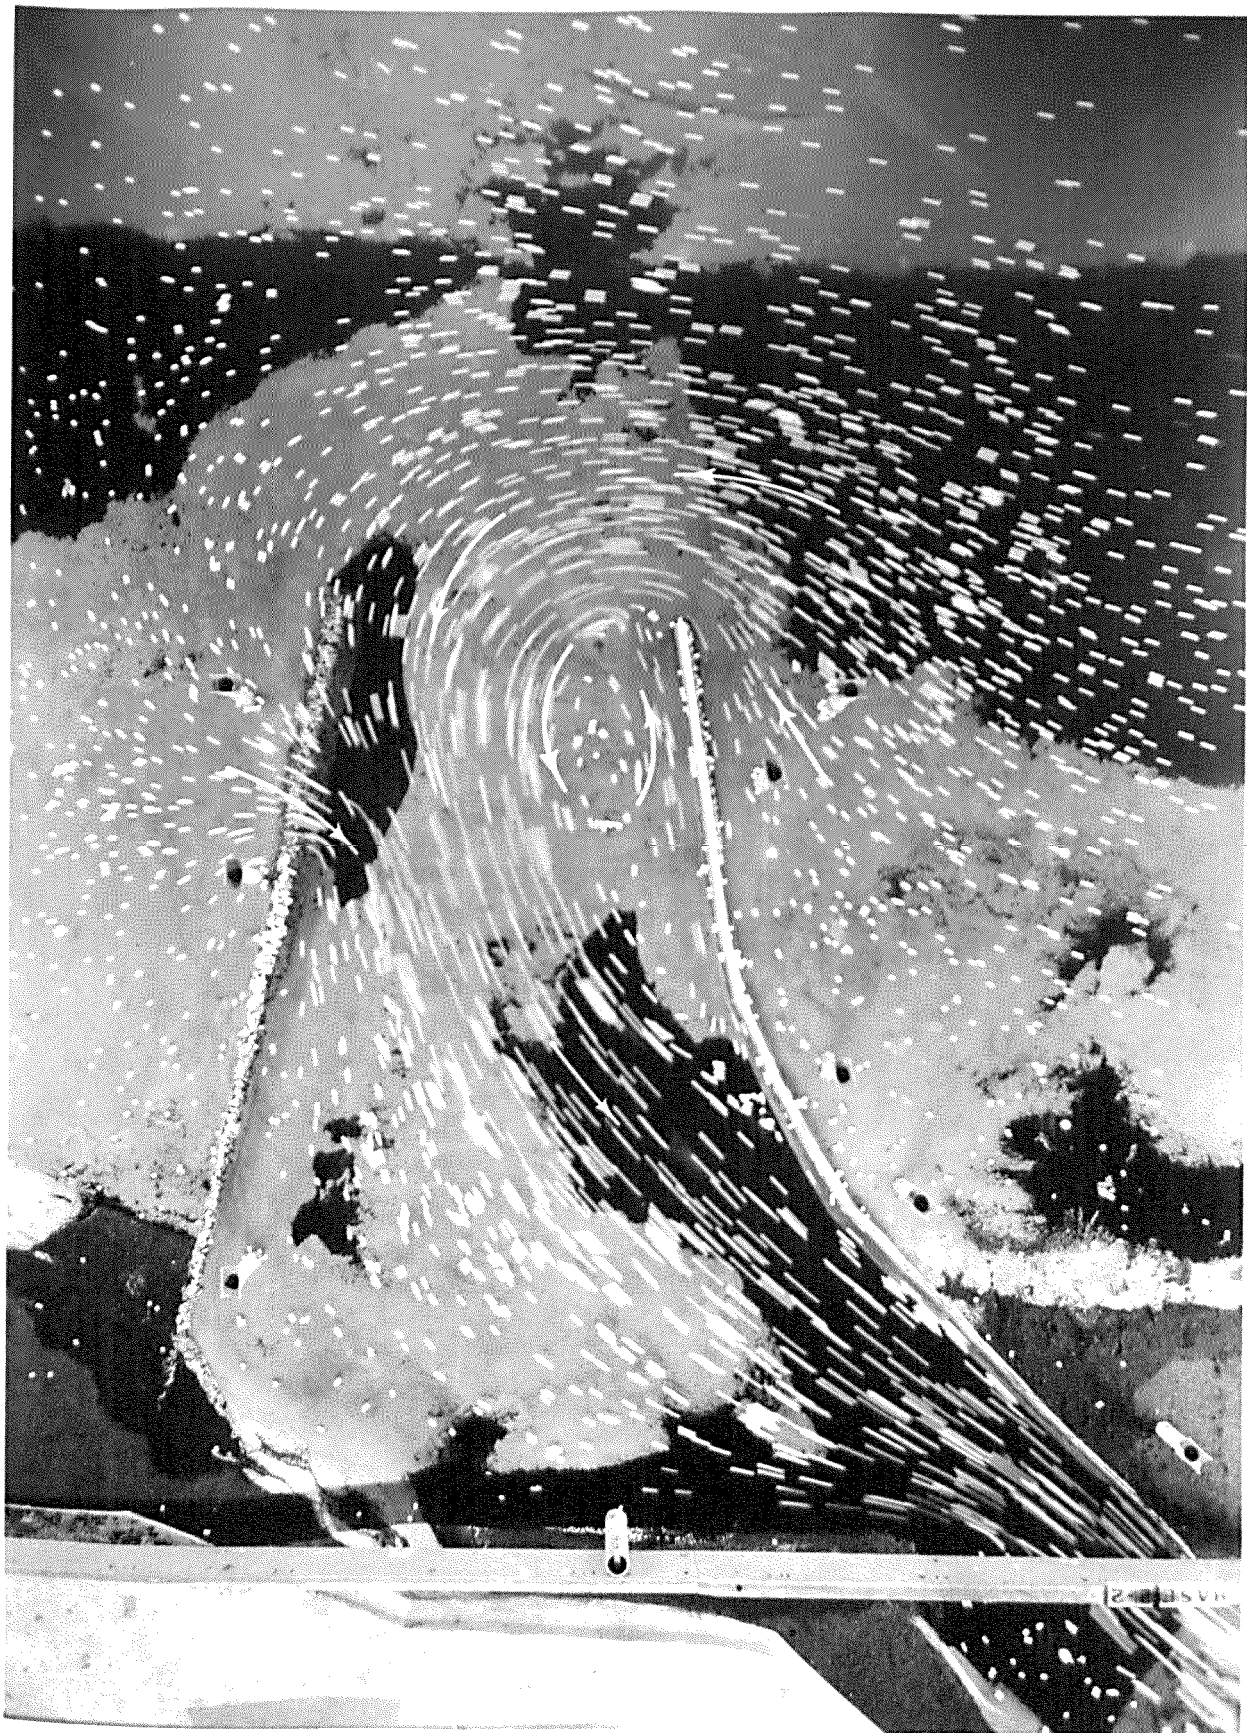
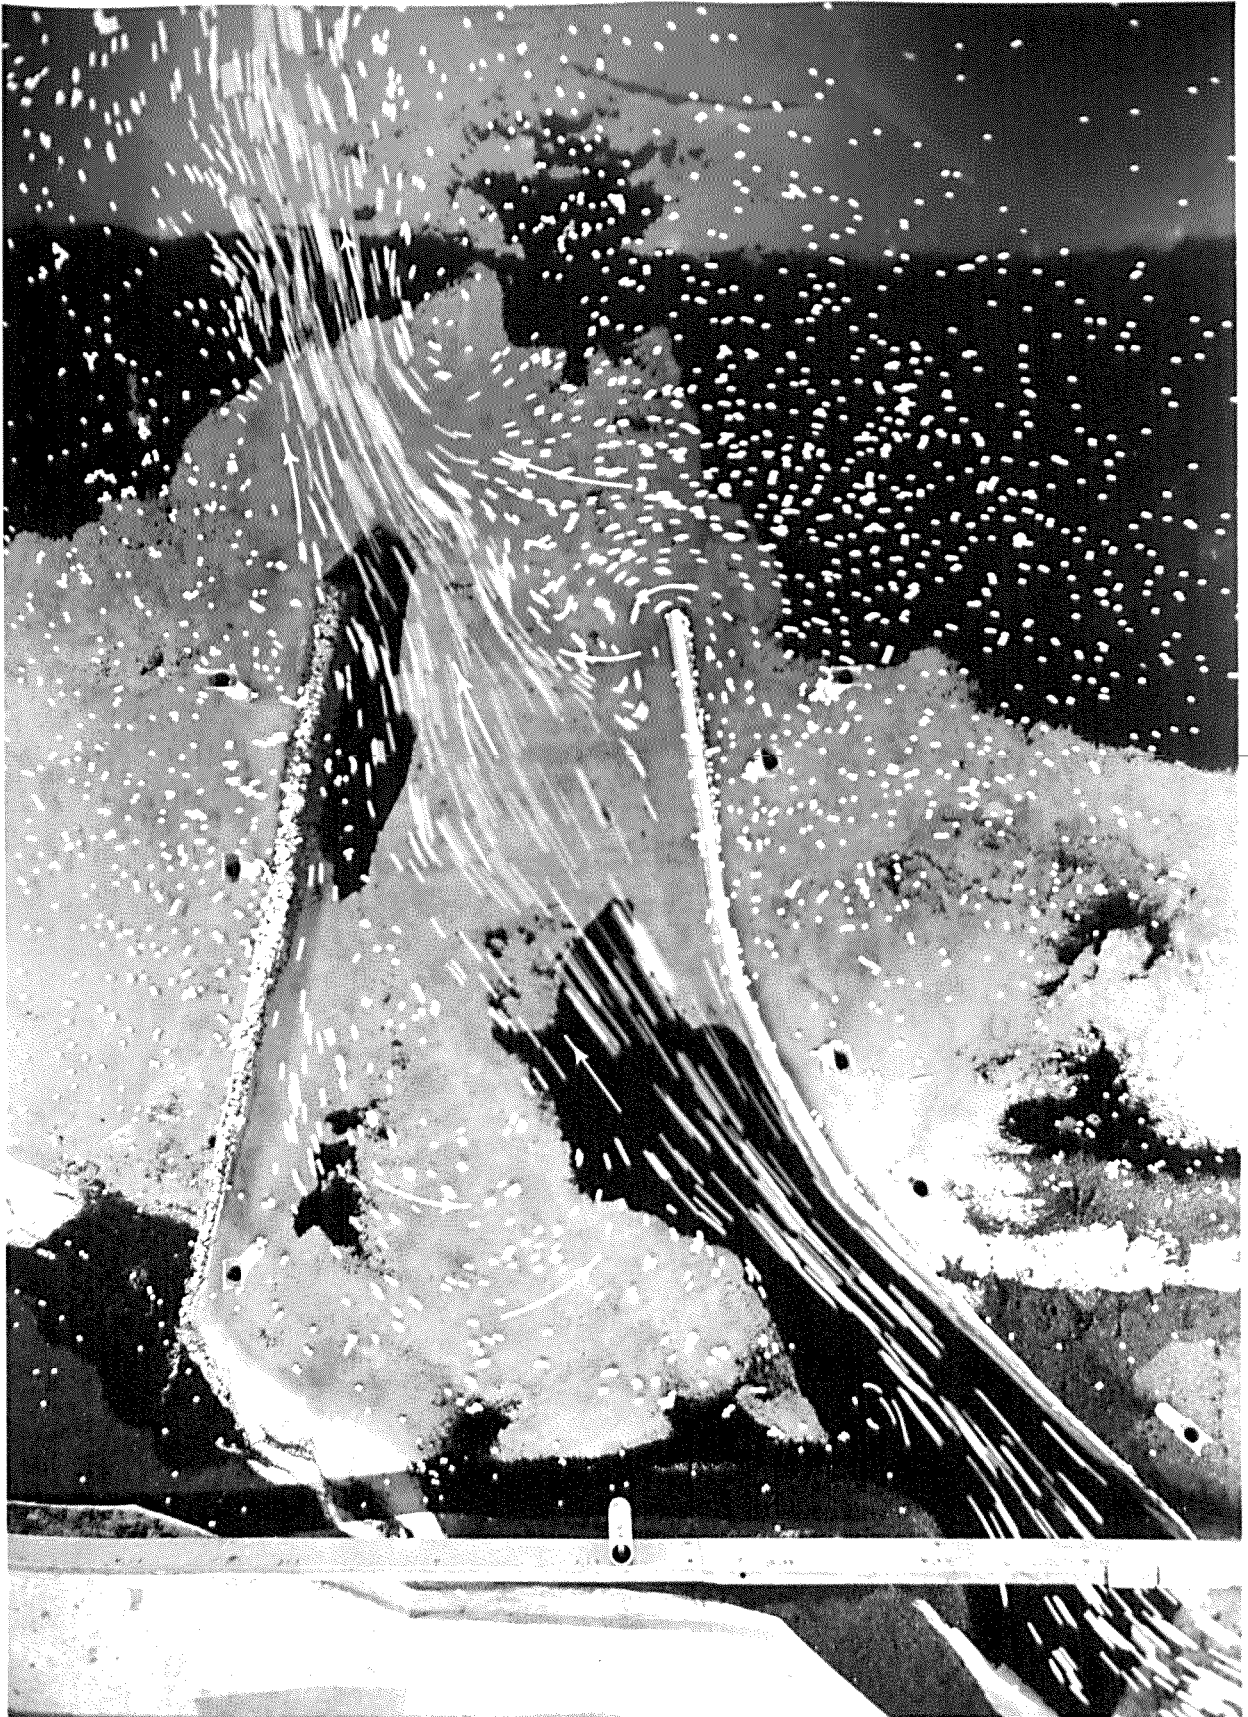
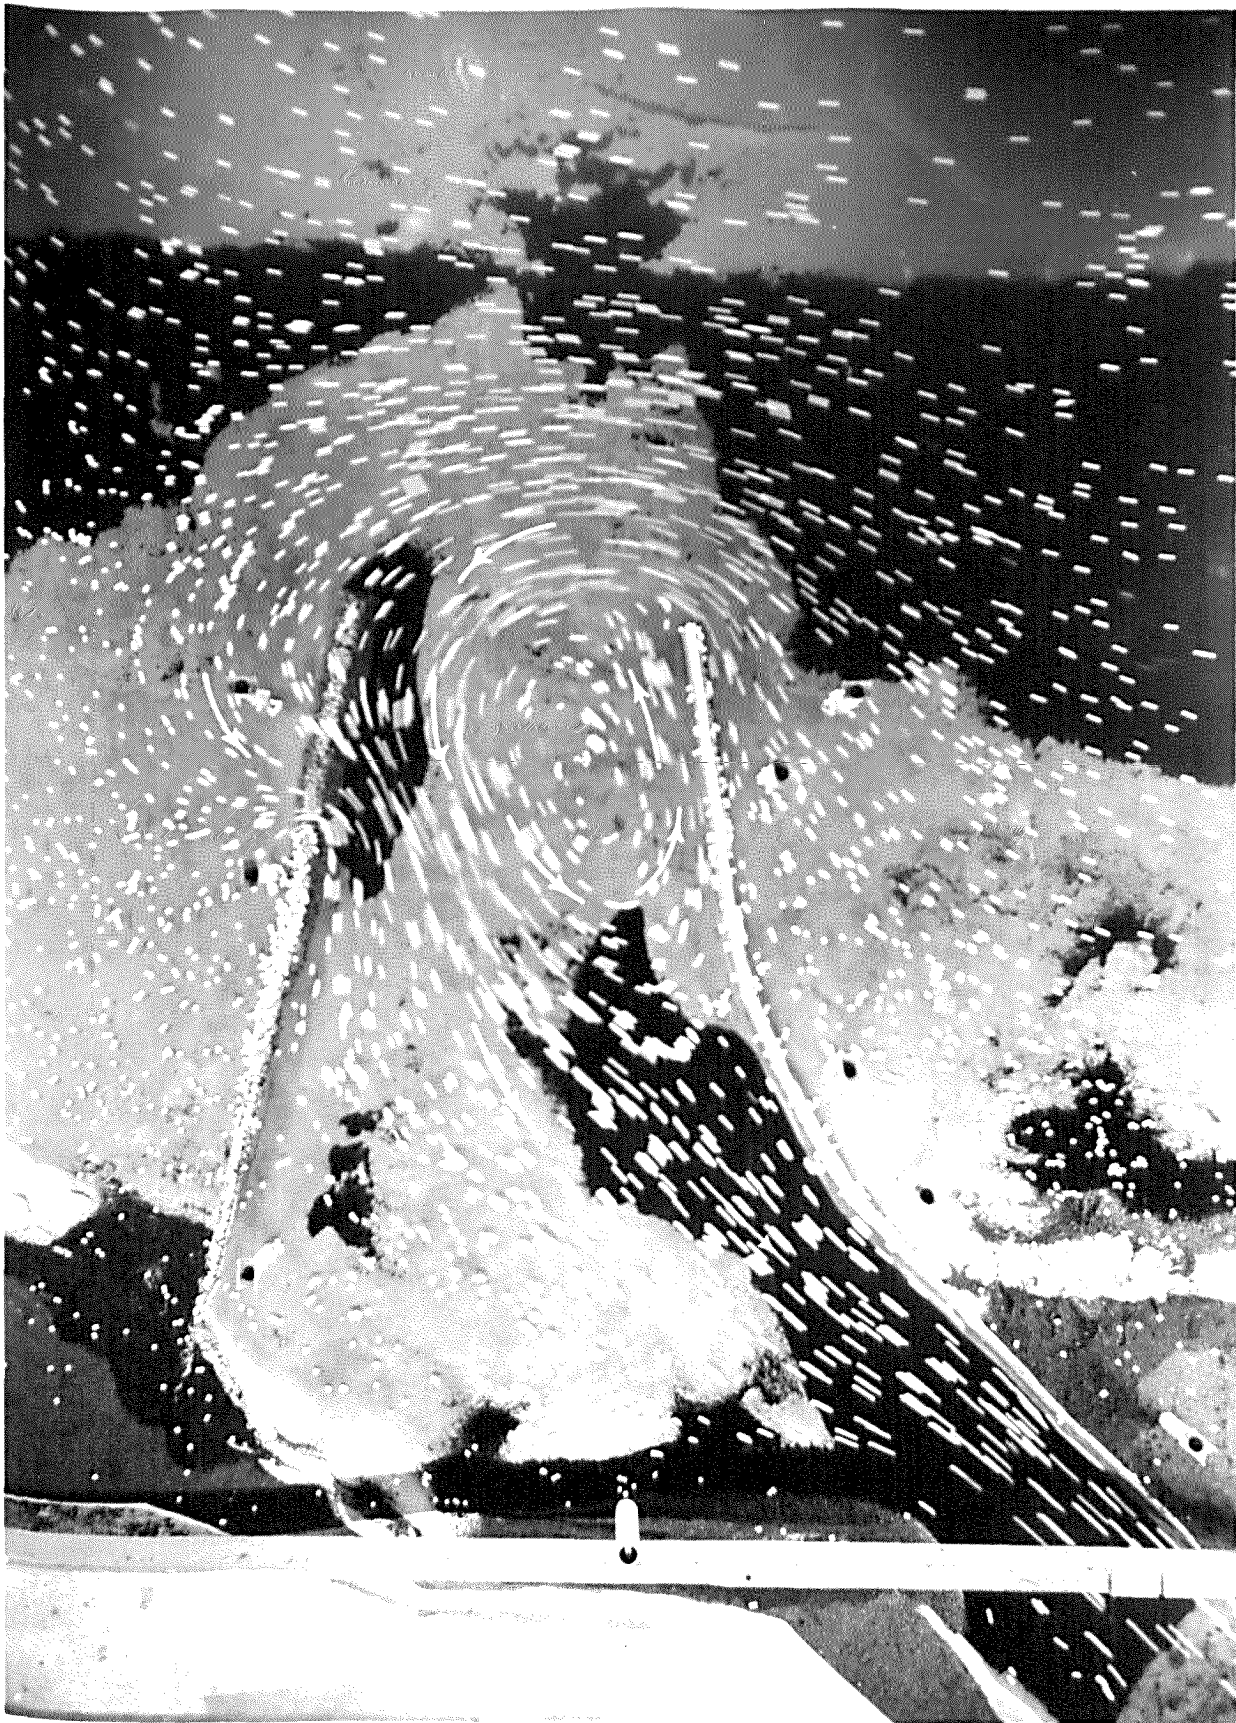
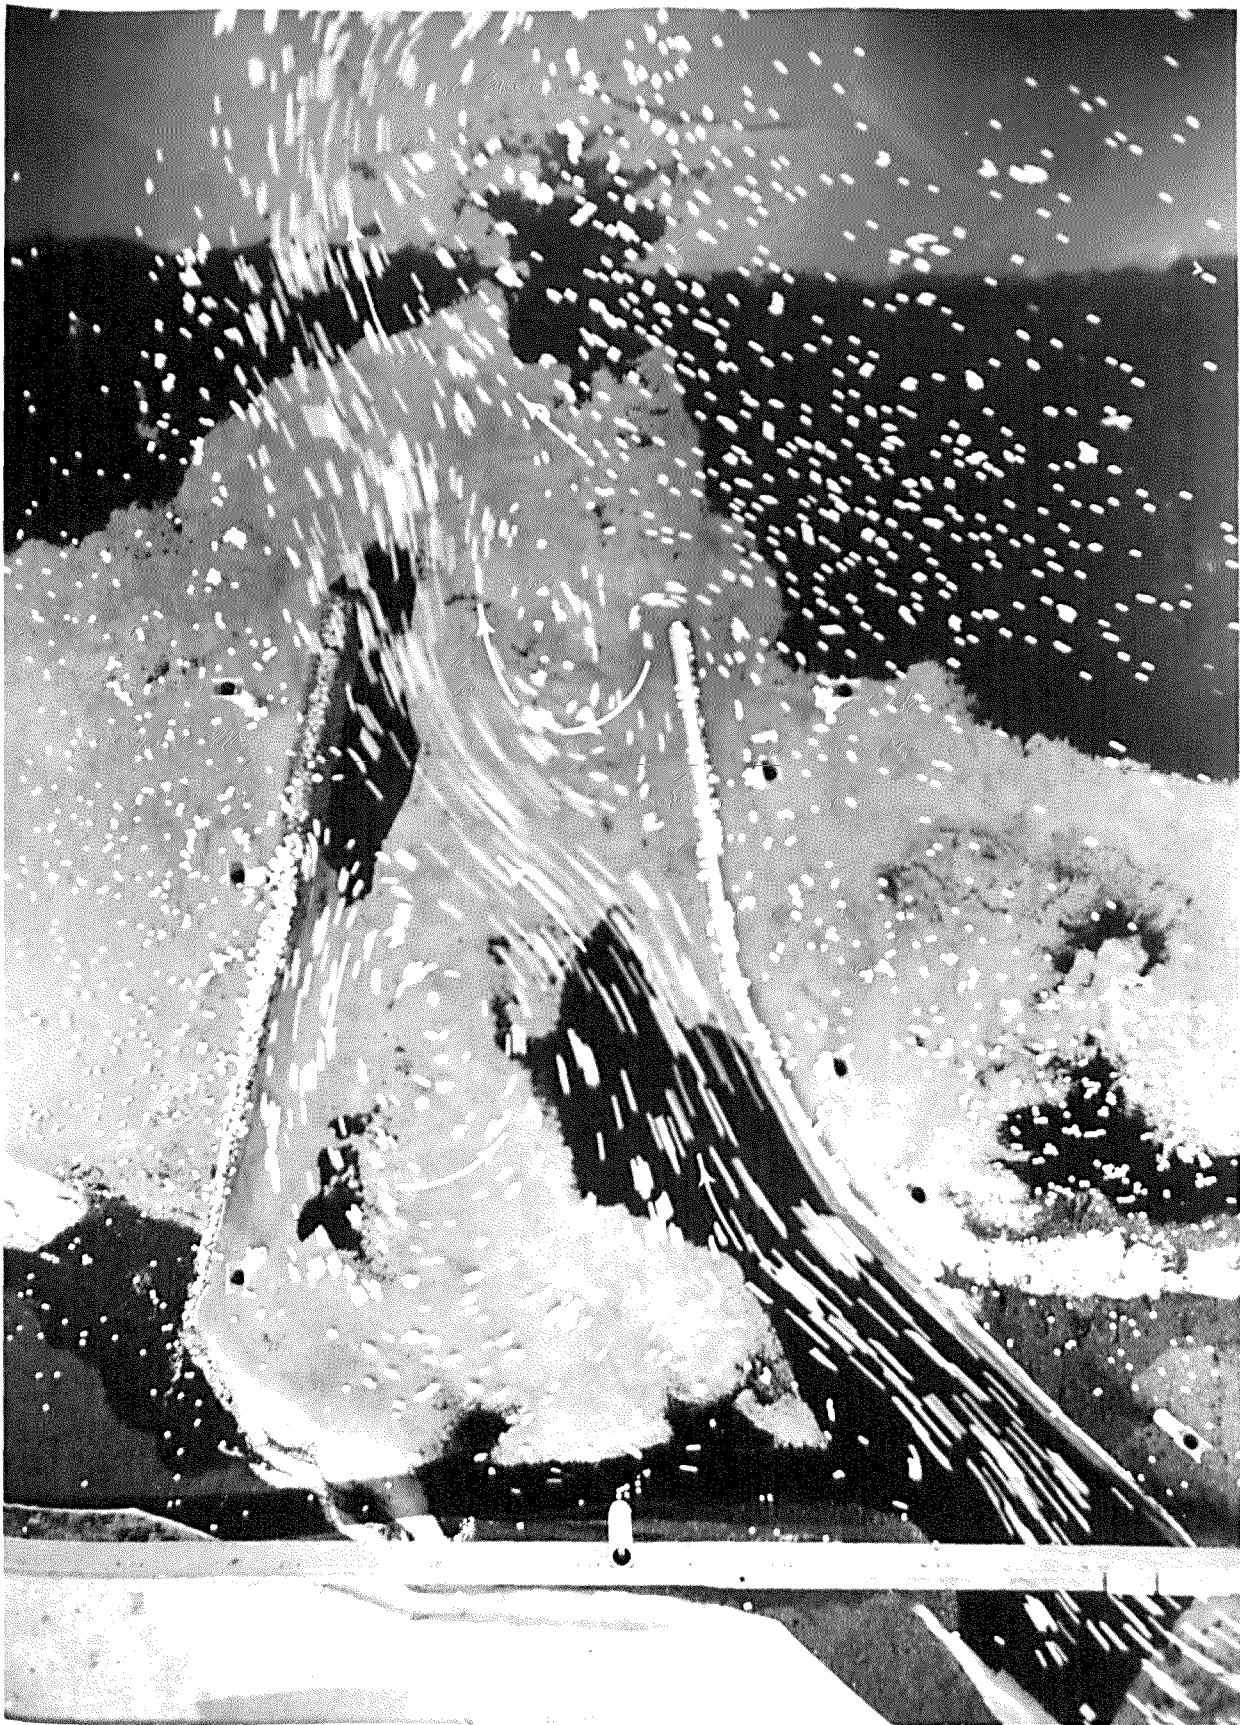
PHOTOGRAPH 6. Base Test - Current directions at strength of flood before  
HHW (hr. 10.5)

PHOTOGRAPH 7. Base Test - Current directions at strength of ebb after  
HHW (hr. 16.5)

PHOTOGRAPH 8. Base Test - Current directions at strength of flood before LHW (hr. 23.0)

PHOTOGRAPH 9. Base Test - Current directions at strength of ebb after LHW (hr. 4.0).

13. Plate 1 and photograph 1 show the scour and fill pattern obtained at the end of the bed-movement phase of the base test. The bare concrete areas on photograph 1 indicate that all of the crushed coal, which was molded to a depth of about 1.6 ft (prototype), has been swept away. The contours and shaded areas on plate 1 indicate the areas of scour and fill and, in general, the extent of fill which occurred during the test. Photographs 6 through 9 show surface current directions at strengths of flood and ebb. It will be noted on these photographs that the strongest flood and ebb currents flow alongside or over the outer end of the south jetty instead of following the alignment of the channel between the jetties. A slow-moving eddy formed in the angle between the shore and the inner end of the south jetty during ebb, while a larger eddy formed on the south side of the outer end of the north jetty during flood.

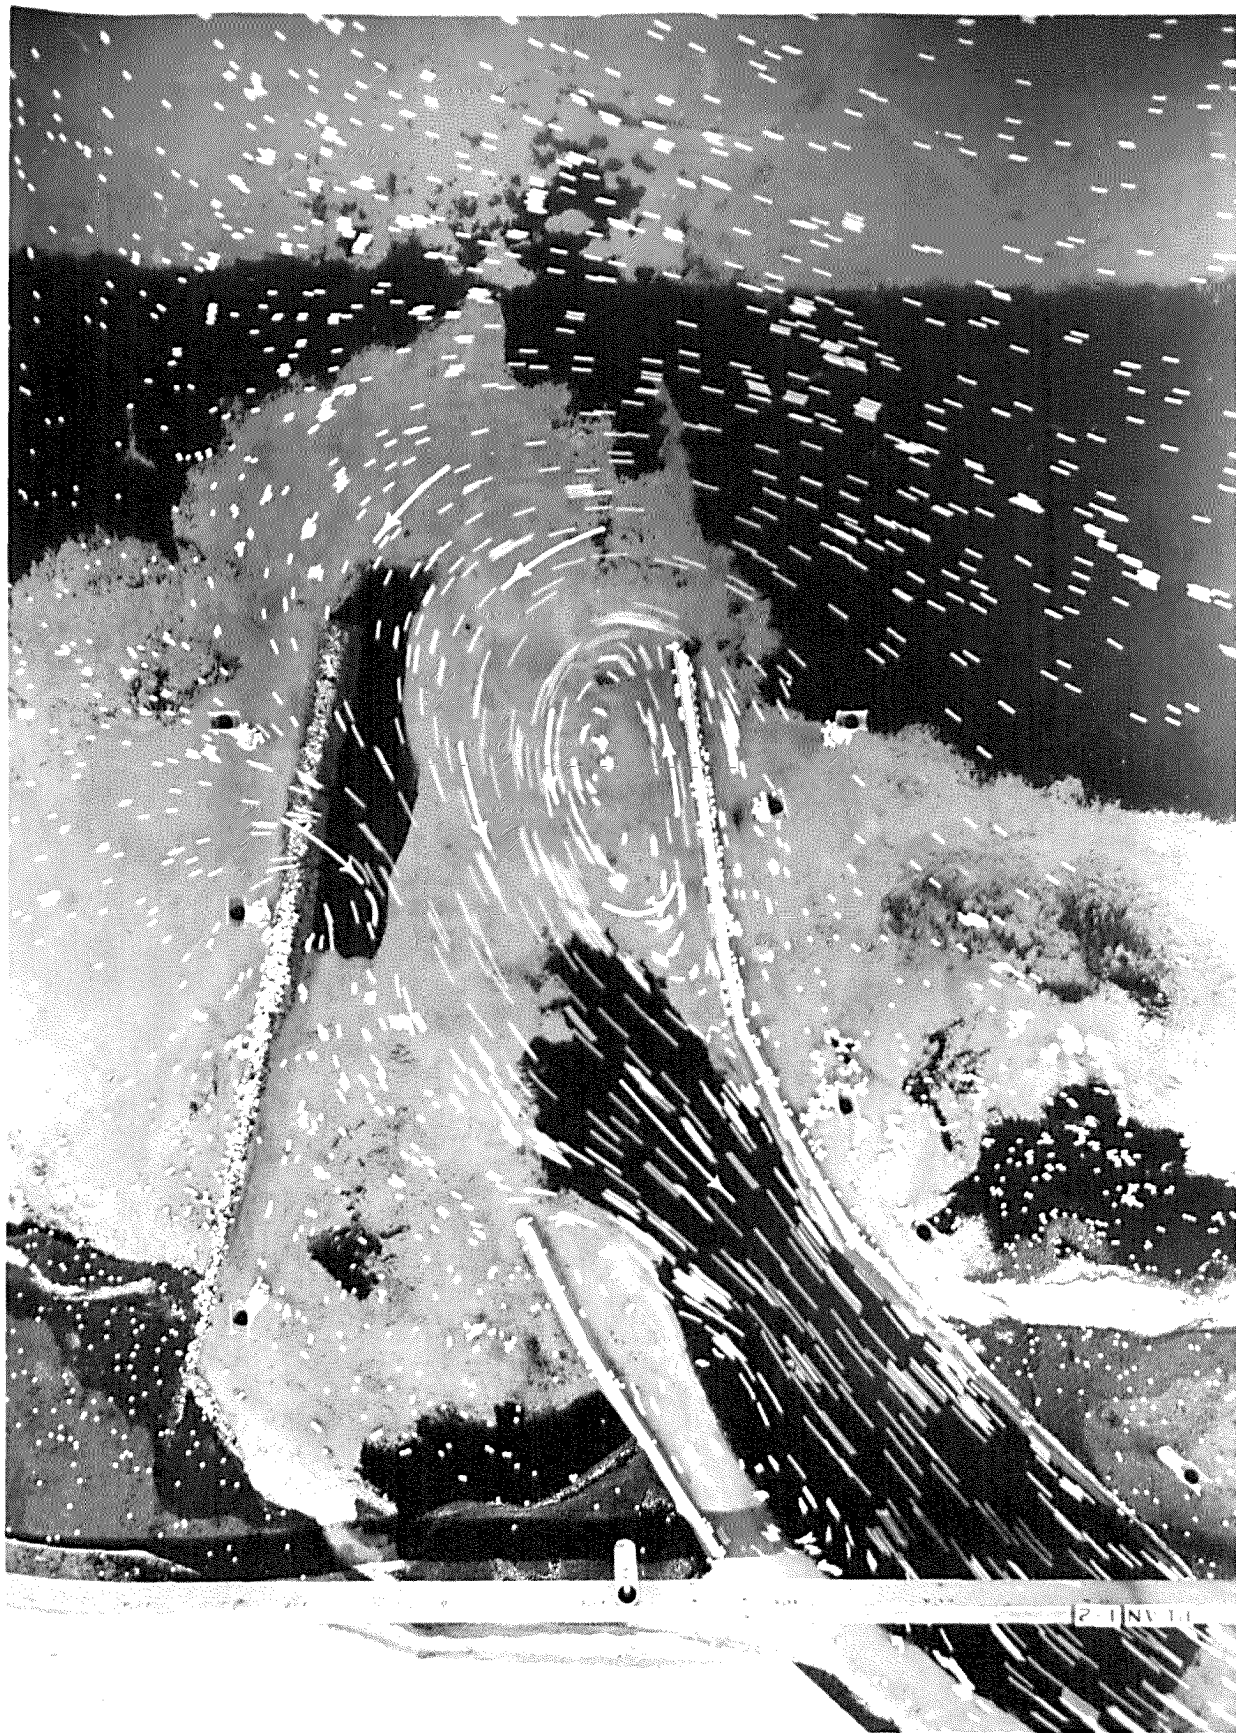
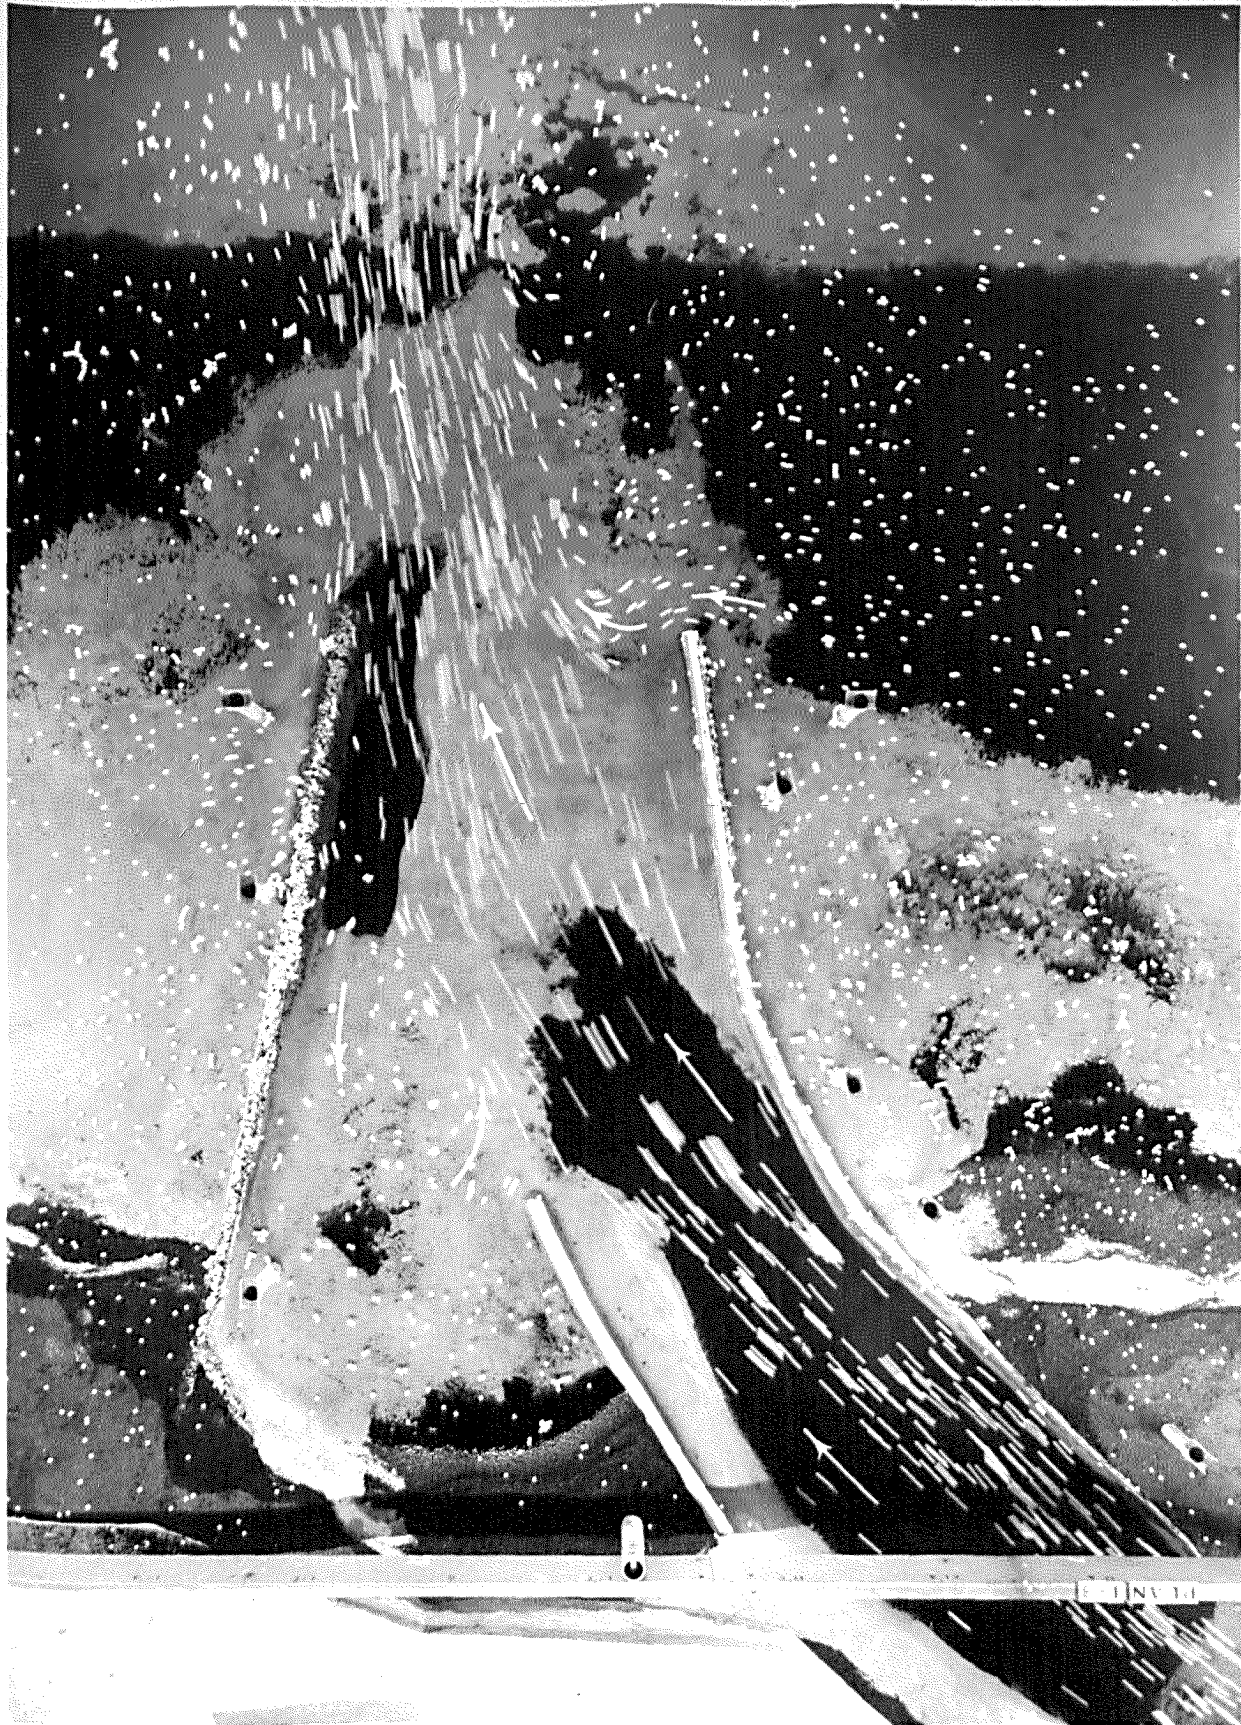
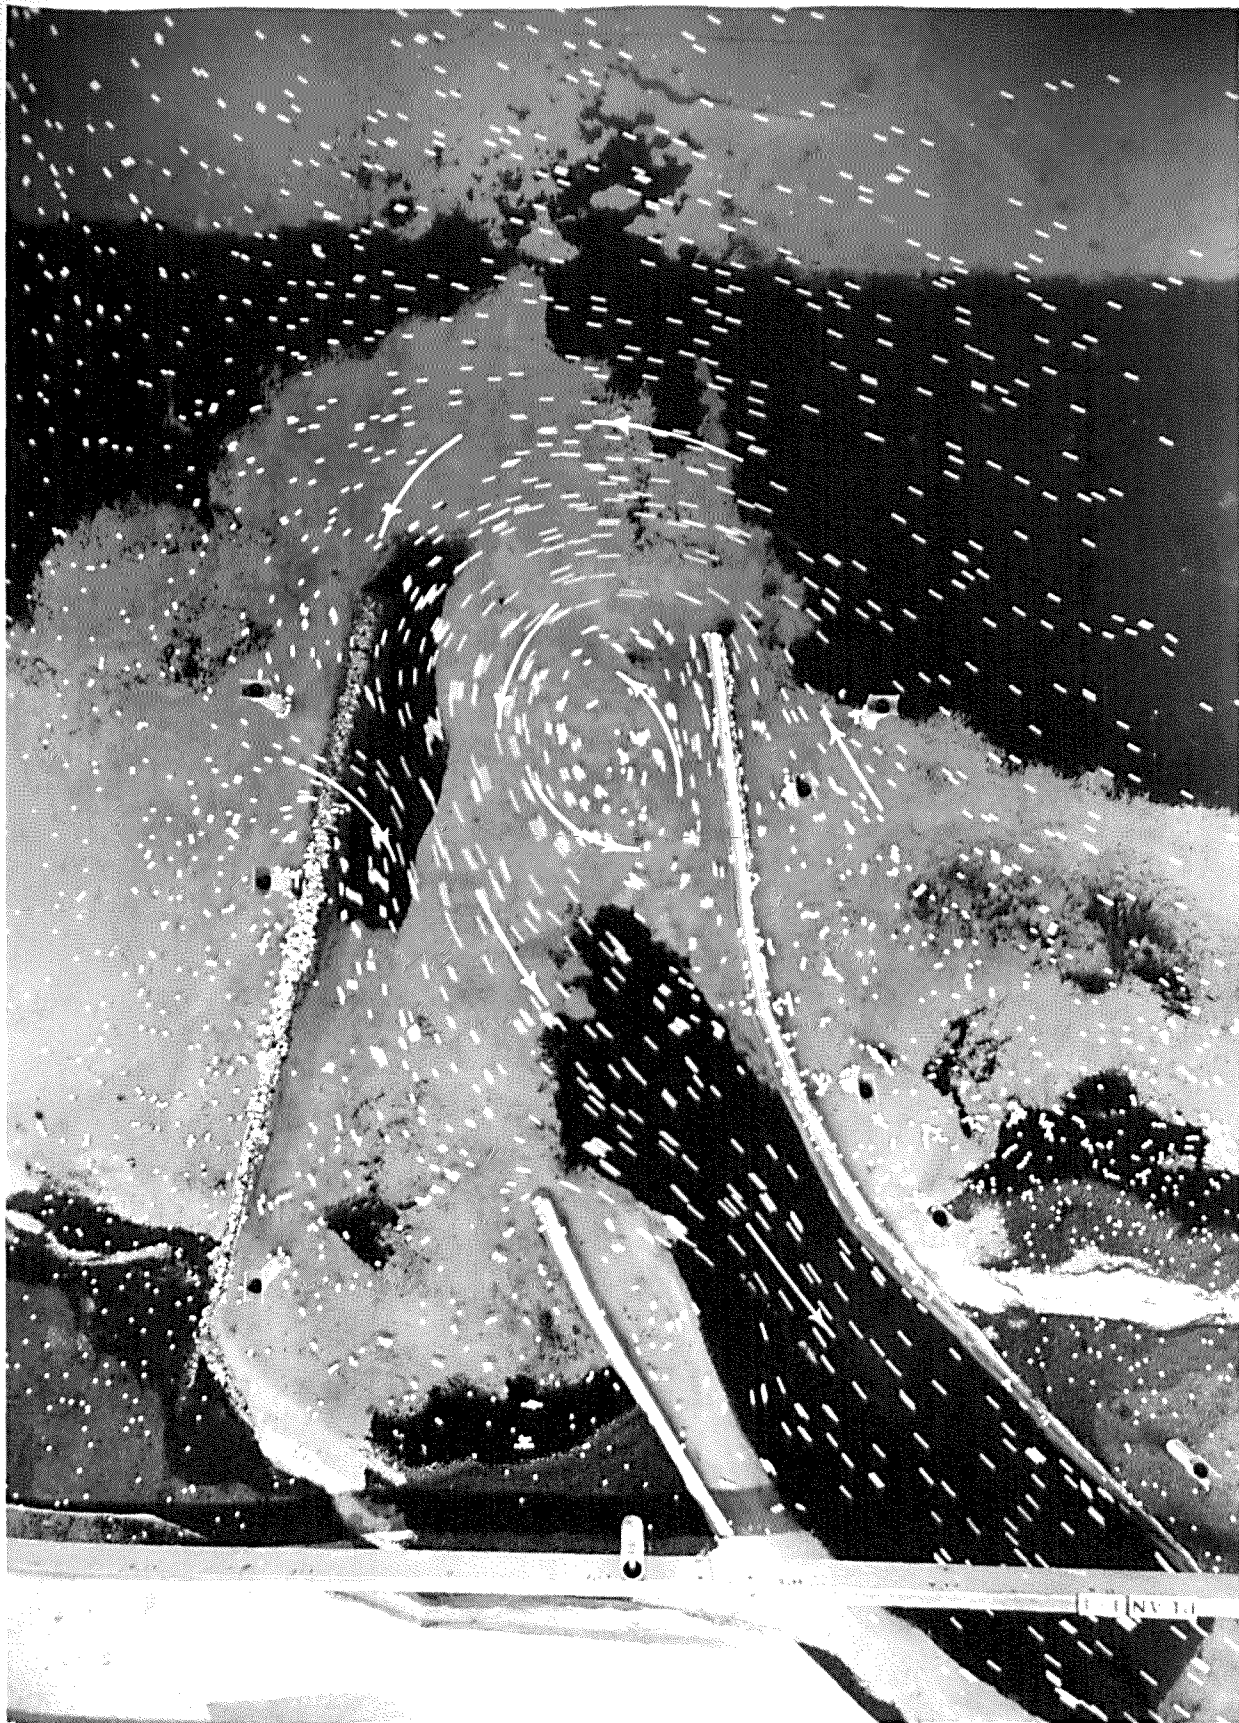
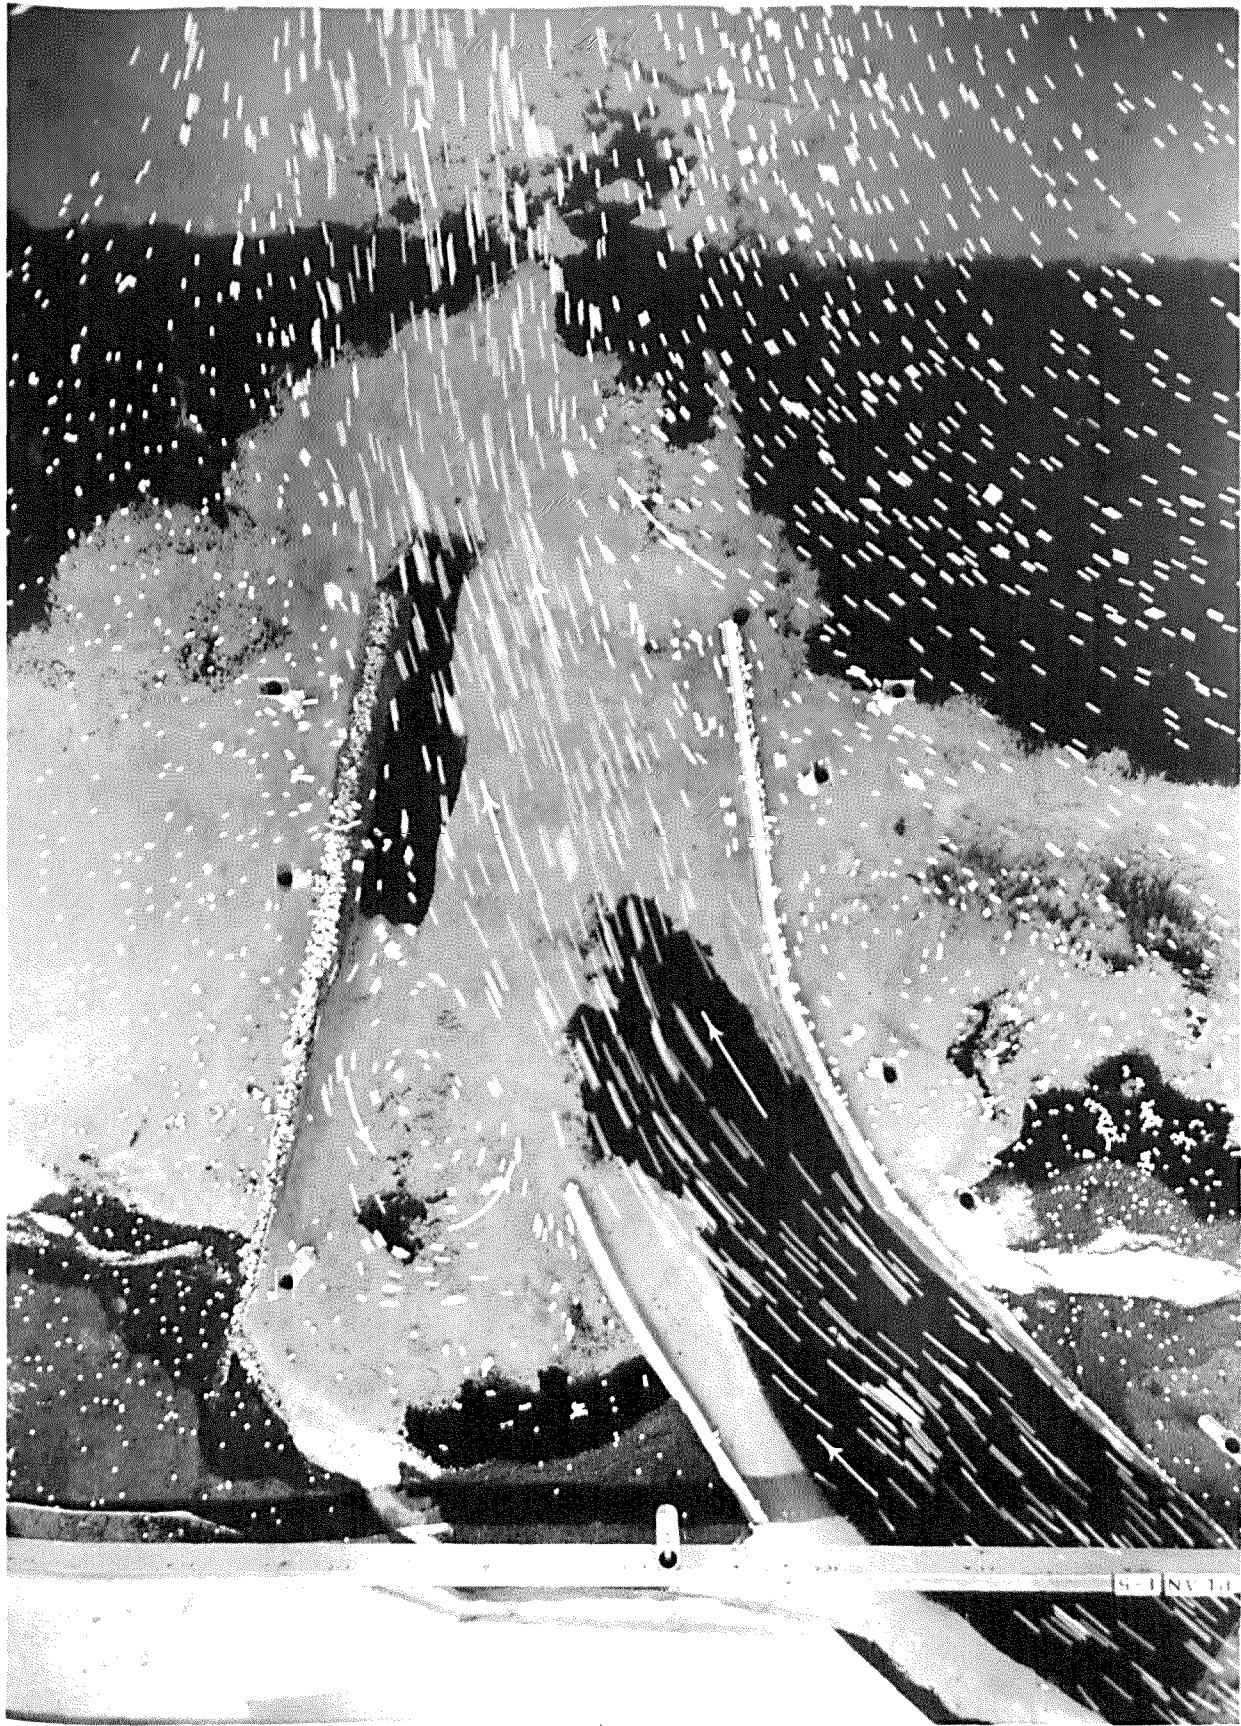
PHOTOGRAPH 10. Plan 1 - Current directions at strength of flood before HHW (hr. 10.5).

PHOTOGRAPH 11. Plan 1 - Current directions at strength of ebb after  
HHW (hr. 16.5).

PHOTOGRAPH 12. Plan 1 - Current directions at strength of flood before LHW (hr. 23.0)

PHOTOGRAPH 13. Plan 1 - Current directions at strength of ebb after  
LHW (hr. 4.0)

16. The scour and fill effected by plan 1 are shown on plate 2 and photograph 2; current directions at strengths of flood and ebb are shown on photographs 10-13; and measurements of current velocities are shown on plates 7 and 8 and in table 2. The over-all scour pattern effected by plan 1 was about the same as for the base test. A considerable volume of bed material was deposited on the south side of the plan-1 jetty, and indications were that deposition in that area would continue until the angle formed by the jetty was filled. Comparison of current direction photographs for plan 1 with those of the base test indicates that the strongest ebb currents were deflected slightly north and away from the outer end of the existing south jetty by the plan. Maximum flood currents were increased slightly and maximum ebb currents were decreased slightly from those measured during the base test; however, both
